## **National Transportation Safety Board**

**ATTACHMENT 1 to the METEOROLOGY GROUP FACTUAL REPORT  
DCA16LA214**

# UAL1945 SEA-IAH 17AUG2016

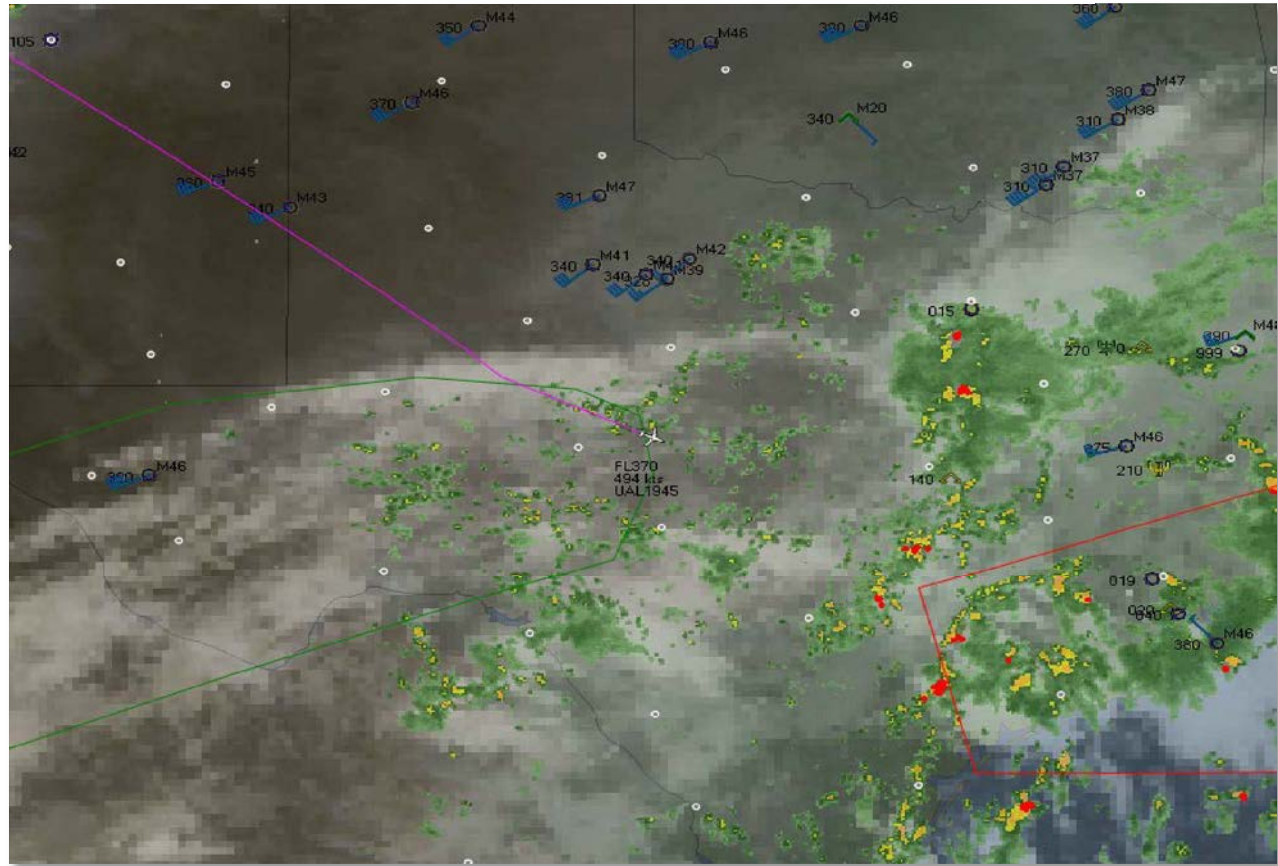
Note the position at 17z. Still near cruising altitude about 45 minutes prior to arrival. The low top shower activity would not be enough to affect UAL1945 at this altitude.

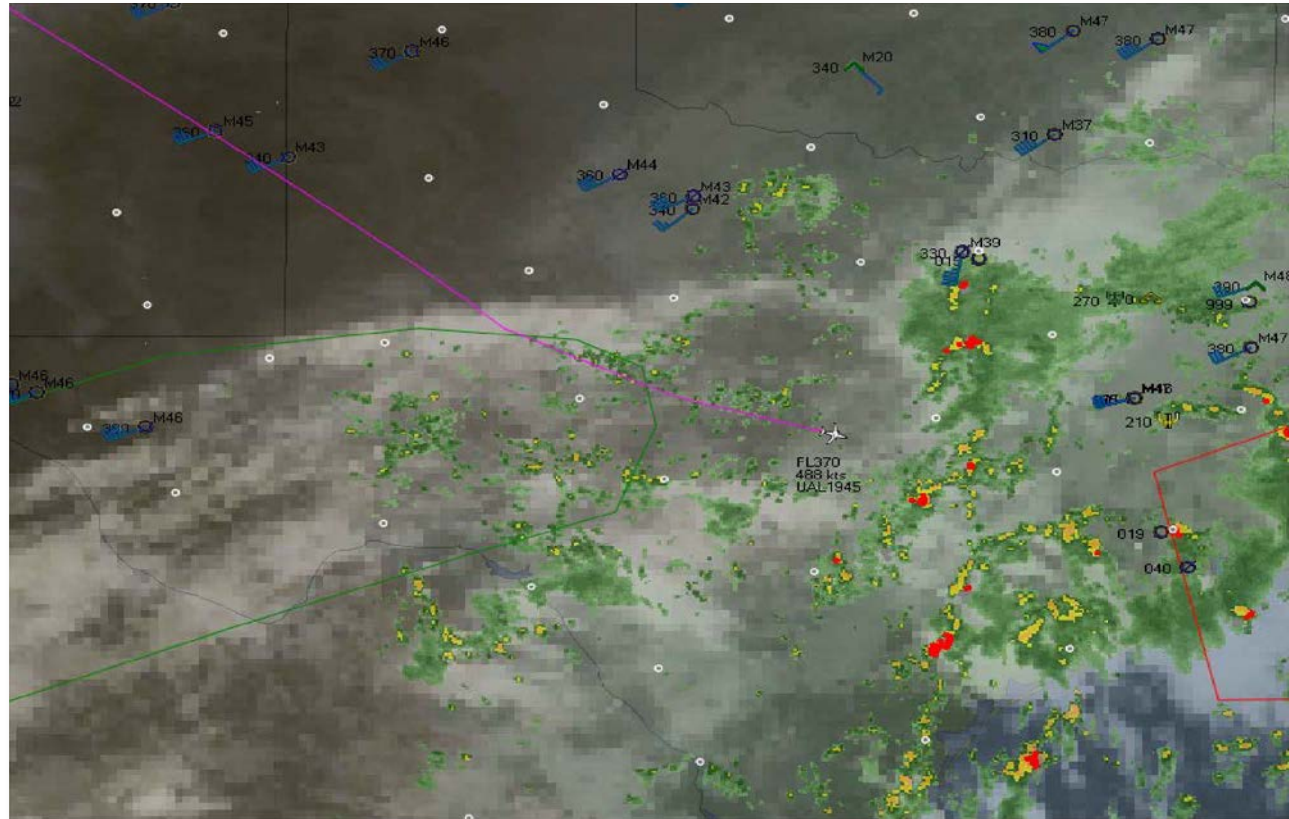
Note  
position of  
UAL1945  
at 1710z.  
Just WSW  
of KTPL.

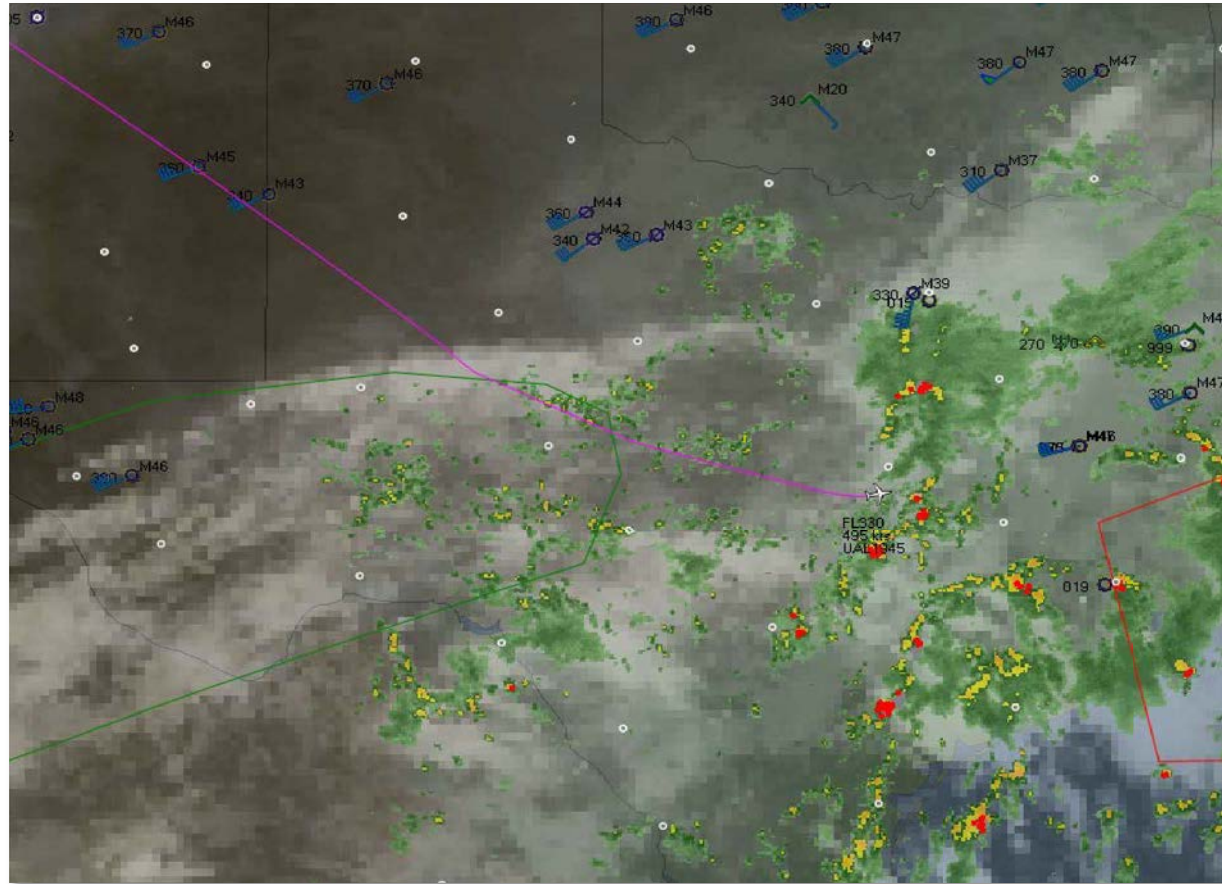
UAL 1945 at 1715z.  
Note position is now  
FL330 so it appears  
to be on descent into  
an area of scattered  
convection. There  
was a SCT-BKN FPG  
to the SE from earlier  
convection, but  
coverage does not  
meet SCT-BKN  
criteria at this time  
near UAL1945.

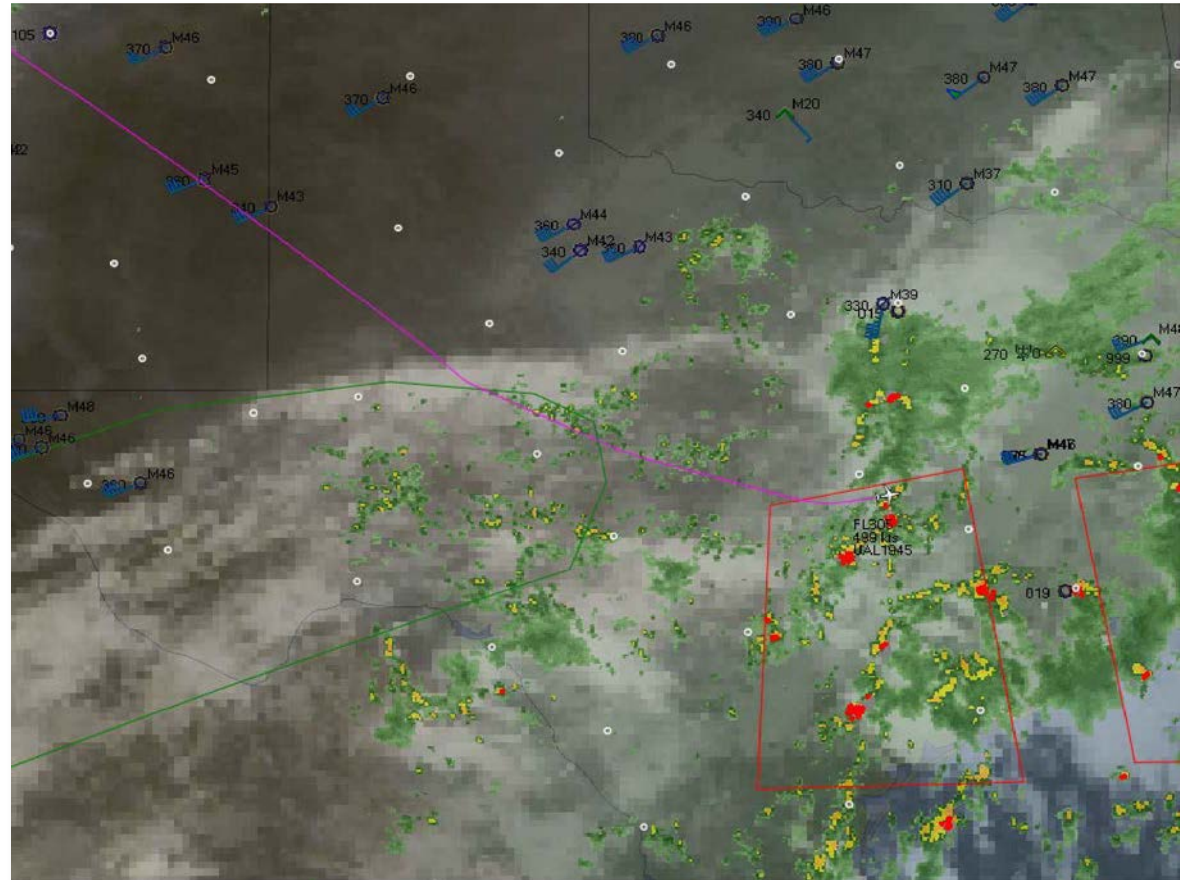
UAL1945 at 1717z.  
The aircraft is close to convection as noted by lightning. Based on the information given about being in descent, it appears that the incident may have occurred near this position. A SCT-BKN convective was drawn as convection also started to increase at this time.

- It appears the turbulence encountered by Flight 1945 on August 17th at approximately 1715z was likely related to localized convectively induced turbulence.
- Any large scale synoptic turbulence from wind shear would have occurred over western TX as noted by the stronger moisture gradient on the edge of the cirrus shield.
- PIREPS as well as AMDAR data do not show the presence of wind shear in the general area.
- The model data and AMDAR data are in good agreement which bolsters confidence that this was a localized event related to one or two convective cells near the flight path of UAL1945.

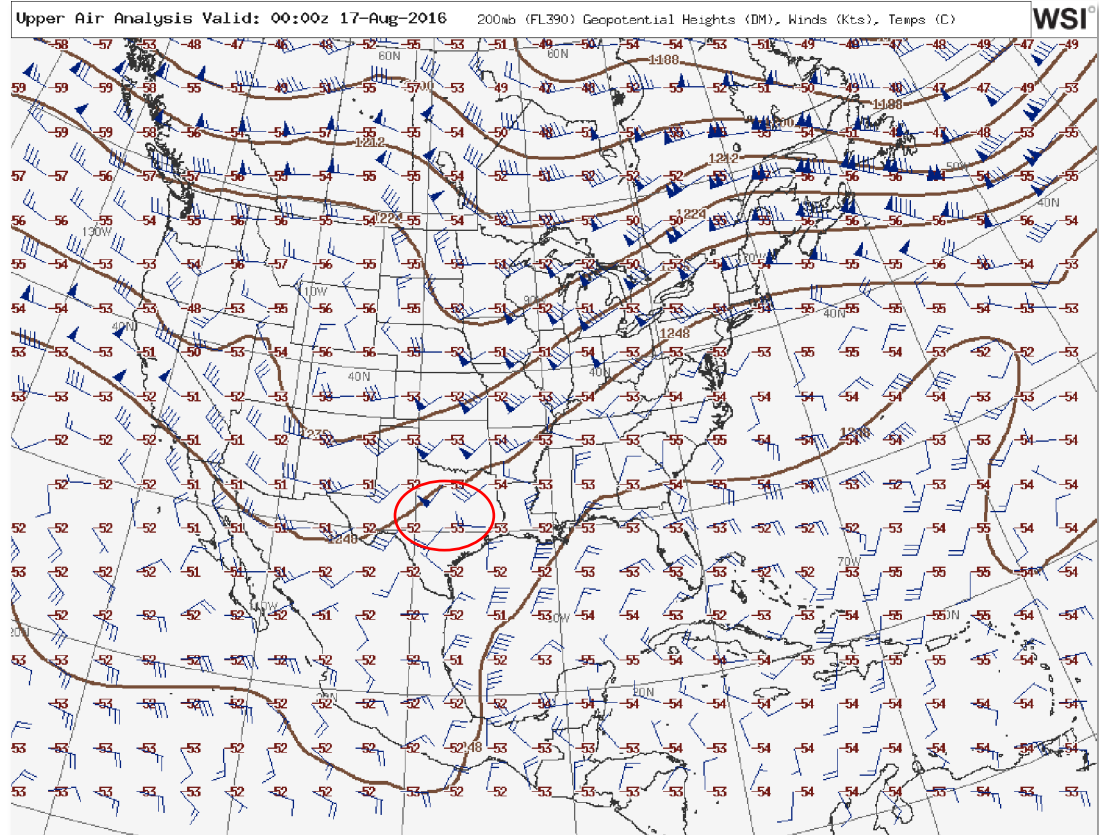
Winds near 200mb (~FL330-FL360). Note the weak winds in the general area less than 50kts at this level. The southern end of the tail of stronger winds is, however, a favorable area for upward vertical motion which would enhance convection.

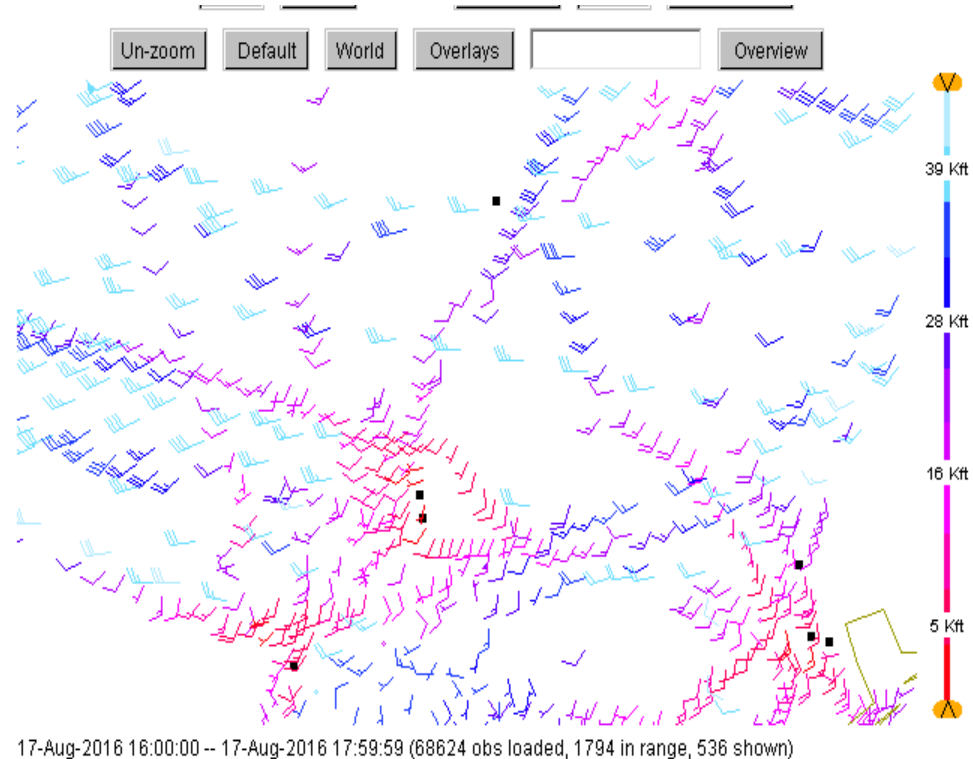
AMDAR data from  
17/16z-17/18z. IAH in the  
bottom right with  
Austin/Bergstrom noted  
by the 2 black squares.  
Note the upper level  
winds above FL300 are  
all uniform (between 35-  
45kts). It does not appear  
that any type of shear  
created the turbulence.
