# NATIONAL TRANSPORTATION SAFETY BOARD

## MATERIALS LABORATORY FACTUAL REPORT

Report No. 16-107

Place : Pascagoula, Florida  
Date : August 27, 2106  
Vehicle : Boeing 737-700  
NTSB No. : DCA16FA217  
Investigator : Pierre Scarfo, AS-40

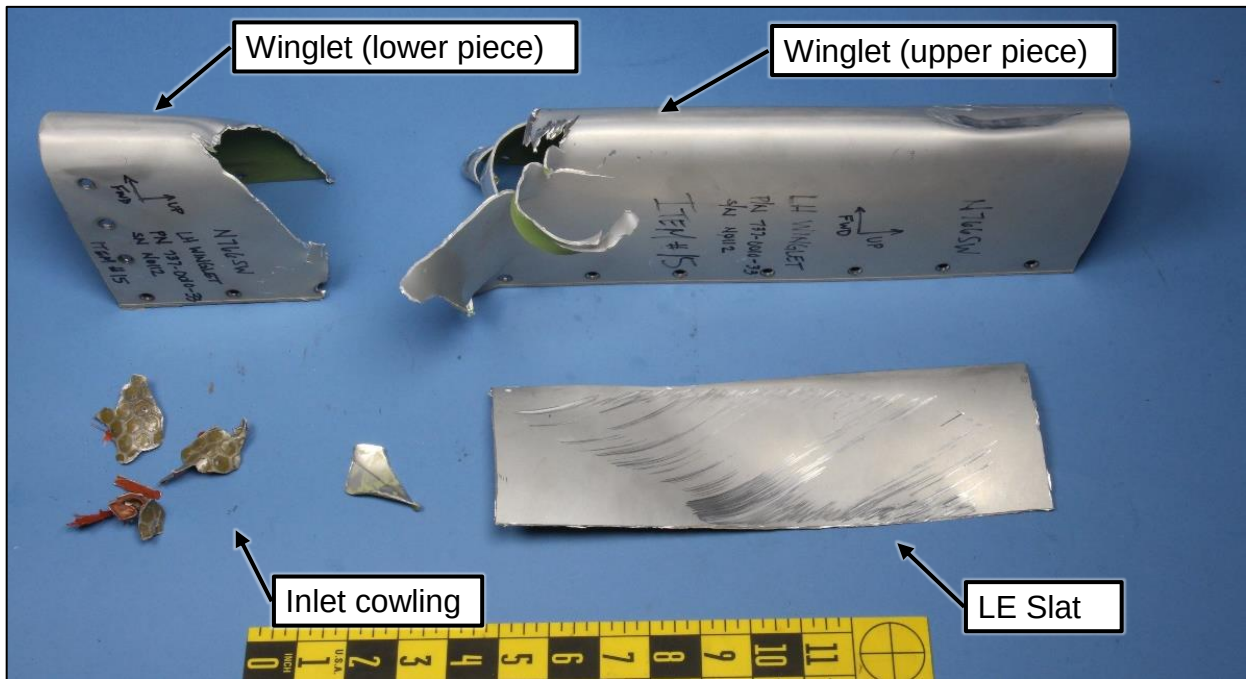
An overall view of the submitted components is shown in figure 1. The left winglet was fractured into two pieces with the upper and lower pieces indicated in figure 1. The winglet was deformed and showed sliding contact marks adjacent to the fracture and at the leading edge near the upper end of the upper piece. The number 1 leading edge slat piece had cut edges on all sides and showed sliding contact marks with associated inward deformation of the panel. The fractured and deformed inlet cowling pieces were received in bags labeled to indicate they were recovered from the winglet and from the aft drain mast.

Figure 1. Overall view of the submitted components.

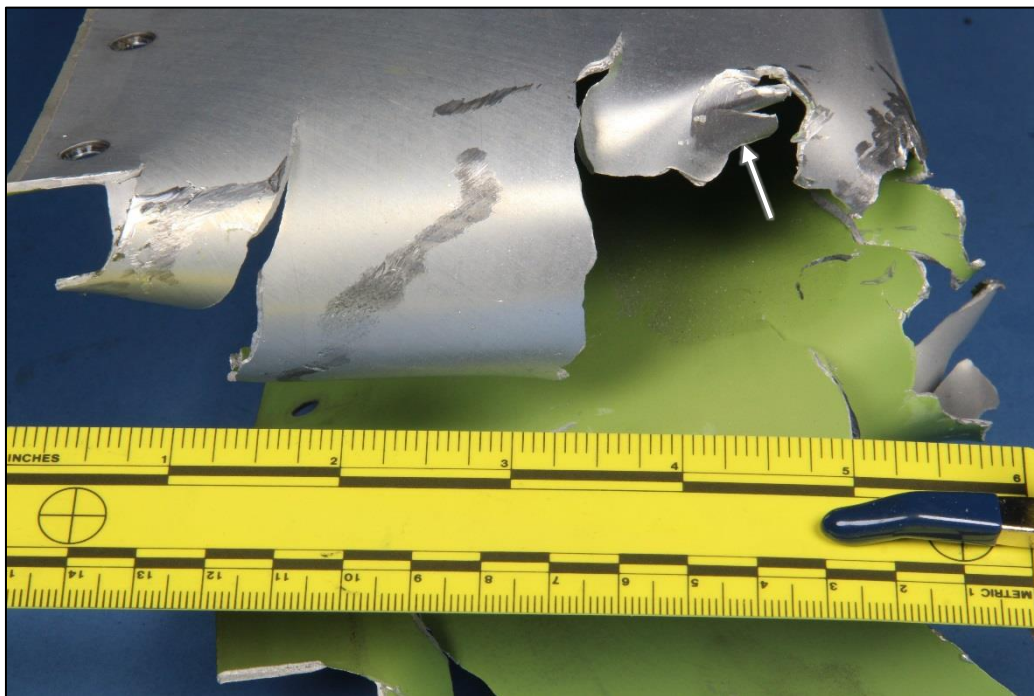
A view of the inboard side of the fractured end of the upper winglet piece is shown in figure 2. Surfaces adjacent to the fracture were generally deformed outboard and aft. Portions of the surfaces adjacent to the fracture had disturbed surface features with linear marks consistent with sliding contact with another object. An area with substantial deformation and relatively strong sliding marks was cut from the rest of the winglet piece for examination using a scanning electron microscope (SEM) and energy dispersive x-ray spectroscopy (EDS). The area of the winglet so examined is indicated with an unlabeled arrow in figure 2.

Figure 2. Fractured end of the winglet upper piece as viewed looking upward. An unlabeled arrow indicates the smeared area examined using SEM and EDS.

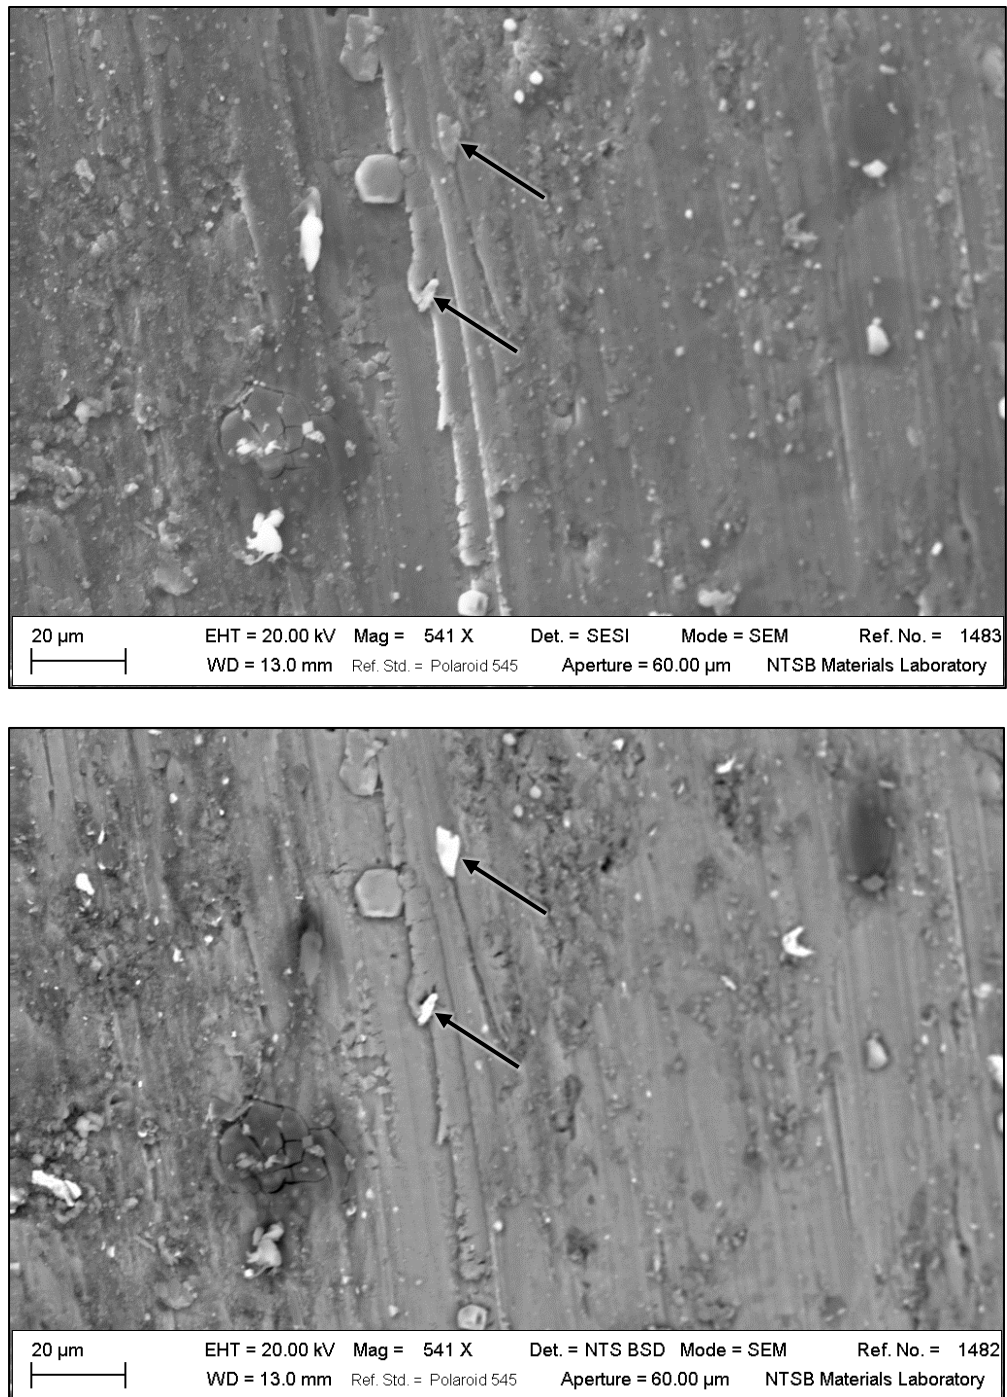
The surface of the winglet in the areas of sliding contact had a smeared appearance with linear features. A typical SEM image from the area of sliding contact is shown in the upper image in figure 3. The surface was examined in the as-received condition and was not cleaned with solvents prior to examination. Many particles were observed on the surface including particles with high peaks of sodium and chlorine.

Figure 3. SEM images of a location showing evidence of sliding contact in the area indicated in figure 2 as viewed with secondary electrons (upper image) and backscattered electrons (lower image). Unlabeled arrows indicate particles with a high of titanium in the EDS spectrum (see figure 4).

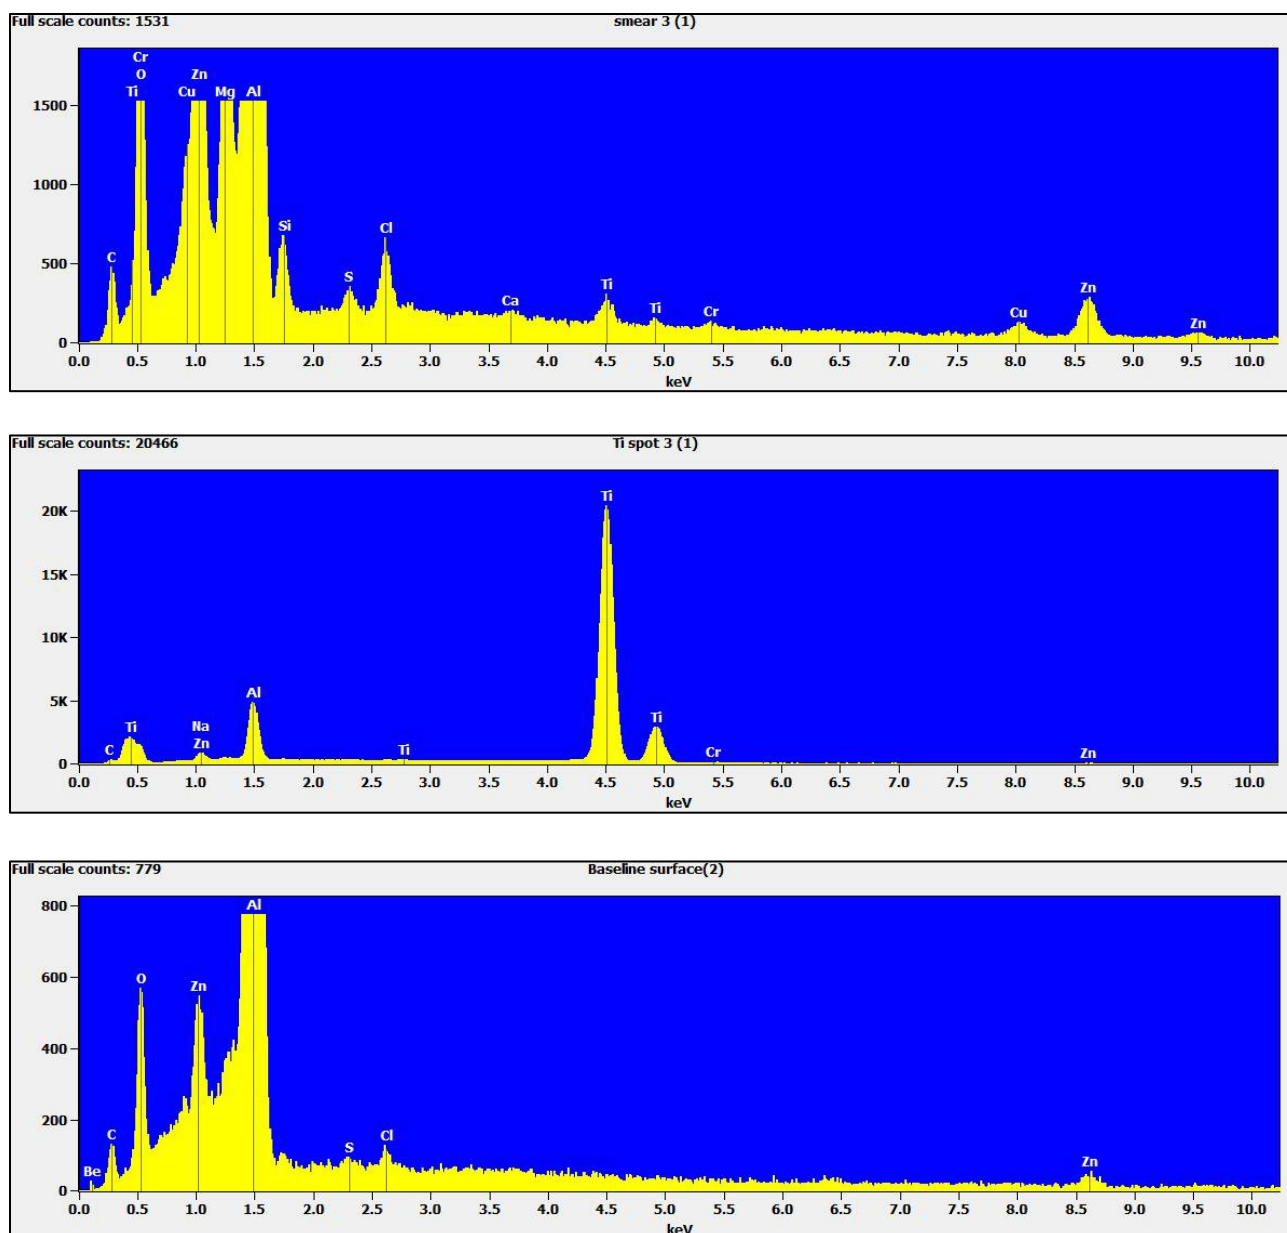
The EDS spectrum for the sliding area shown in figure 3 is presented in the upper image in figure 4. The spectrum showed peaks of aluminum, copper, magnesium, and zinc consistent with a 7000-series aluminum alloy. Additional observed peaks consisted of carbon, oxygen, silicon, sulfur, chlorine, calcium, titanium, and chromium. Several particles on the surface had a typical spectrum such as the middle image in figure 4, where a high peak of titanium was observed. Two particles with high peaks of titanium are indicated in figure 3. The particles appeared relatively bright when viewed using backscattered electrons<sup>1</sup> (see the lower image in figure 3), consistent with a relatively higher atomic weight than the surrounding material consisting of an aluminum alloy. Multiple particles such as these were observed on multiple sites examined within the region of sliding contact.

A typical EDS spectrum for areas outside of the sliding contact damage area is shown in the lower image in figure 4. The surface showed peaks of aluminum, oxygen, zinc, sulfur, chlorine, and carbon. No evidence of titanium was observed, and no particles with peaks of titanium were observed in the areas examined outside of the areas of sliding contact damage.

Figure 4. Typical EDS spectra for selected areas of the winglet. The upper image shows a spectrum associated with scanning a beam across the area of sliding contact shown in figure 3. The middle spectrum is a spectrum obtained with a spot beam centered on one of the particles indicated with unlabeled arrows in figure 3. The lower image shows a typical EDS spectrum for the surface of the winglet in areas that appeared to be free of sliding contact damage.

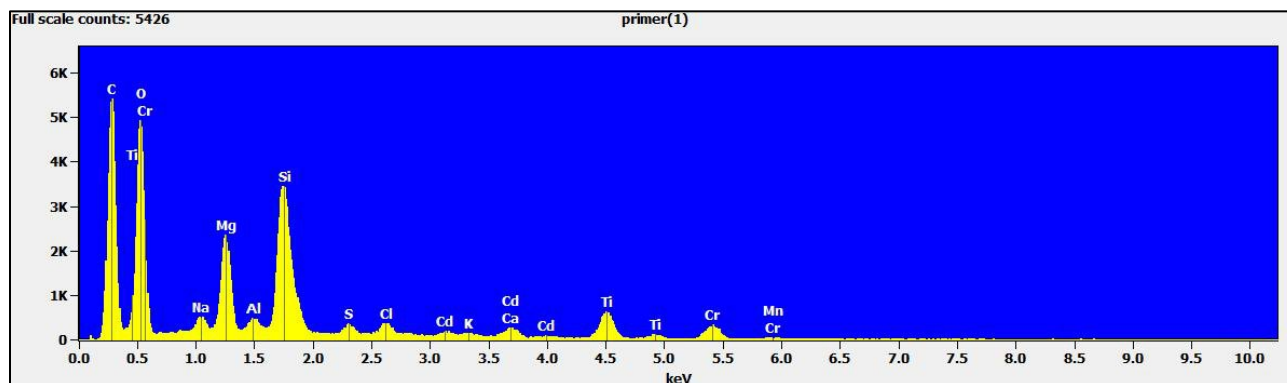
Green primer was present on the interior of the winglet, and an area of the primer was analyzed using EDS, resulting in the spectrum shown in figure 5. A titanium peak was detected associated with the primer, but higher peaks of silicon, magnesium, oxygen, and carbon were also present. No peaks of silicon, magnesium, or oxygen were detected in the typical spectrum for the particles indicated in figure 3.

Figure 5. EDS spectrum obtained scanning a beam across the green primer on a piece of the winglet.

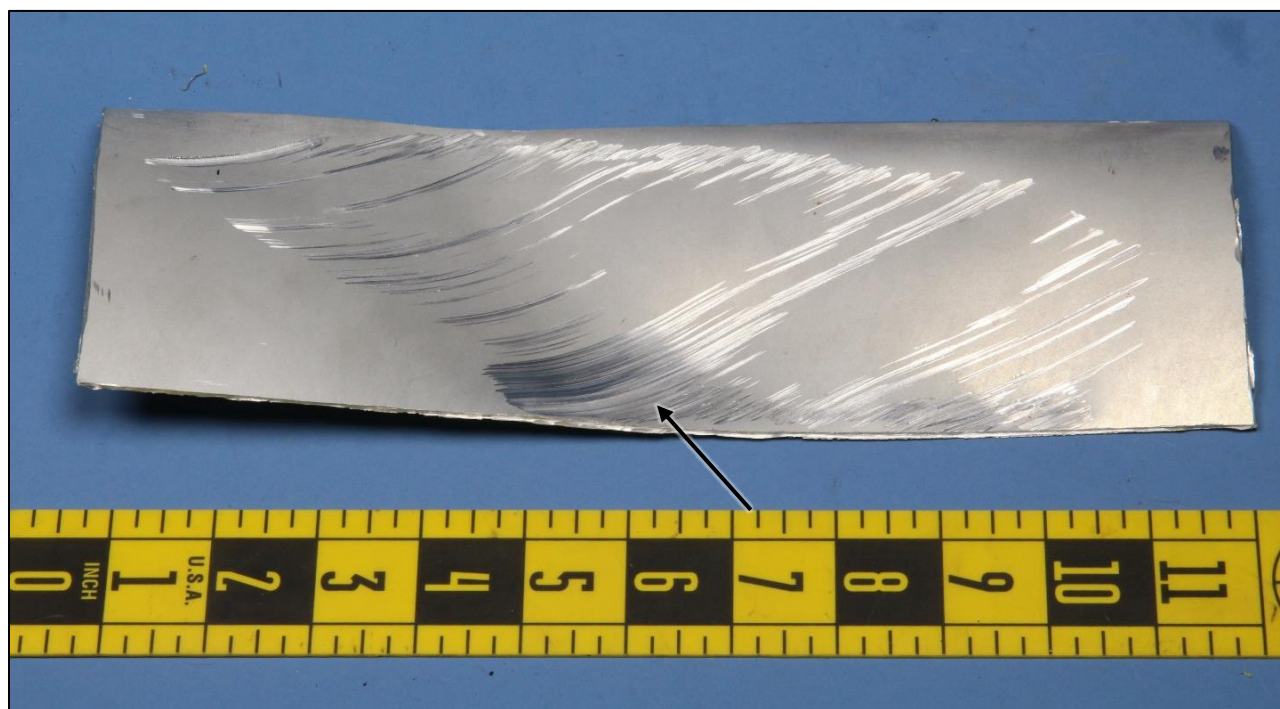
A close view of the number 1 leading edge slat piece is shown in figure 6. Sliding contact damage was observed across most of the piece, but an area near the edge of the piece at the middle of the length appeared to have some of the deepest marks (see unlabeled arrow in figure 6). The piece was cut into 3 pieces to facilitate an SEM examination of the indicated area with analysis using EDS. The pieces were blown free of loose surface debris with compressed air after cutting. No other cleaning of the surface was completed prior to examination.

Figure 6. Close view of the number 1 leading edge slat. An unlabeled arrow indicates the area examined by SEM and EDS.

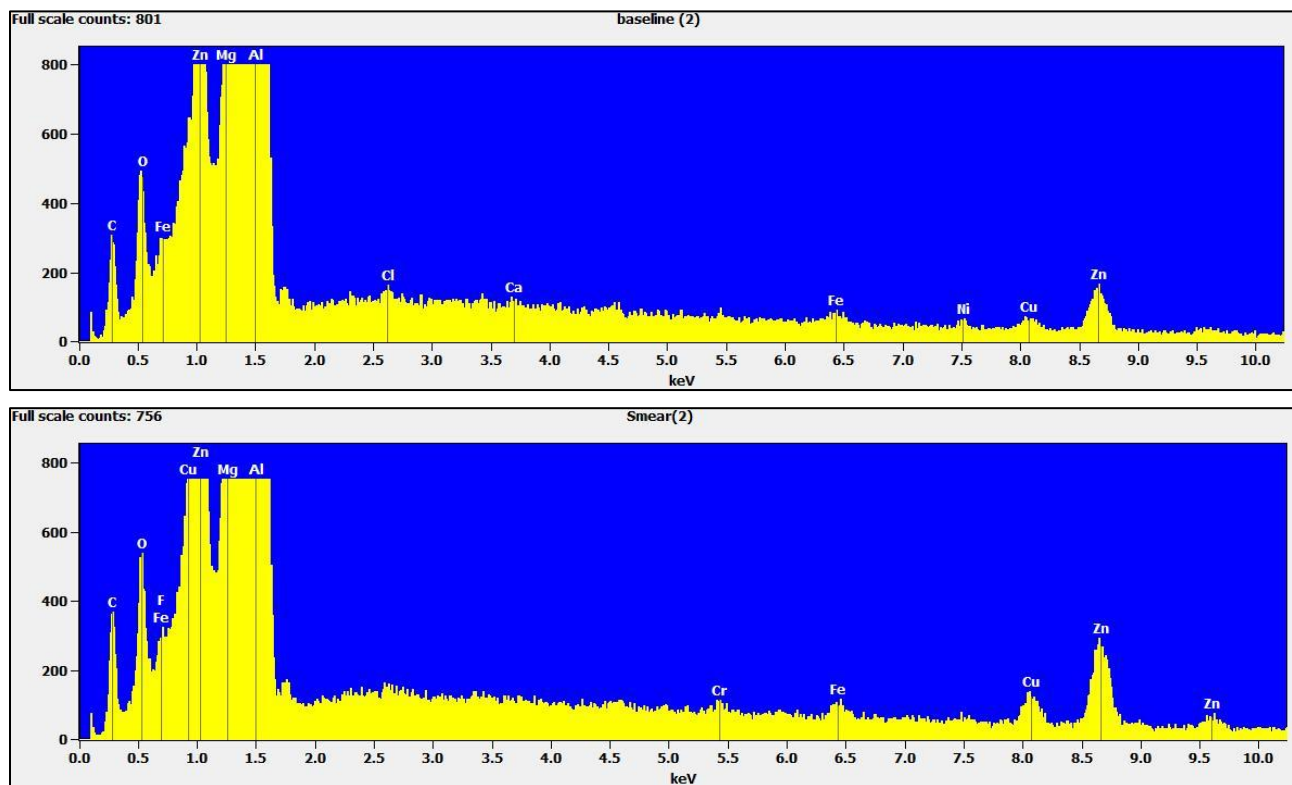
Typical spectra in areas of sliding contact damage and in areas outside of the contact damage are shown in figure 7. Both spectra showed similar spectra with elements consistent with a 7000-series aluminum alloy and smaller peaks of surface contaminants and deposits. No peak of titanium was observed in any of the areas examined on the slat piece.

Figure 7. EDS spectra for areas of the number 1 leading edge slat showing a typical spectrum from an area free of sliding contact marks (upper image) and from within an area of sliding contact marks (lower image).

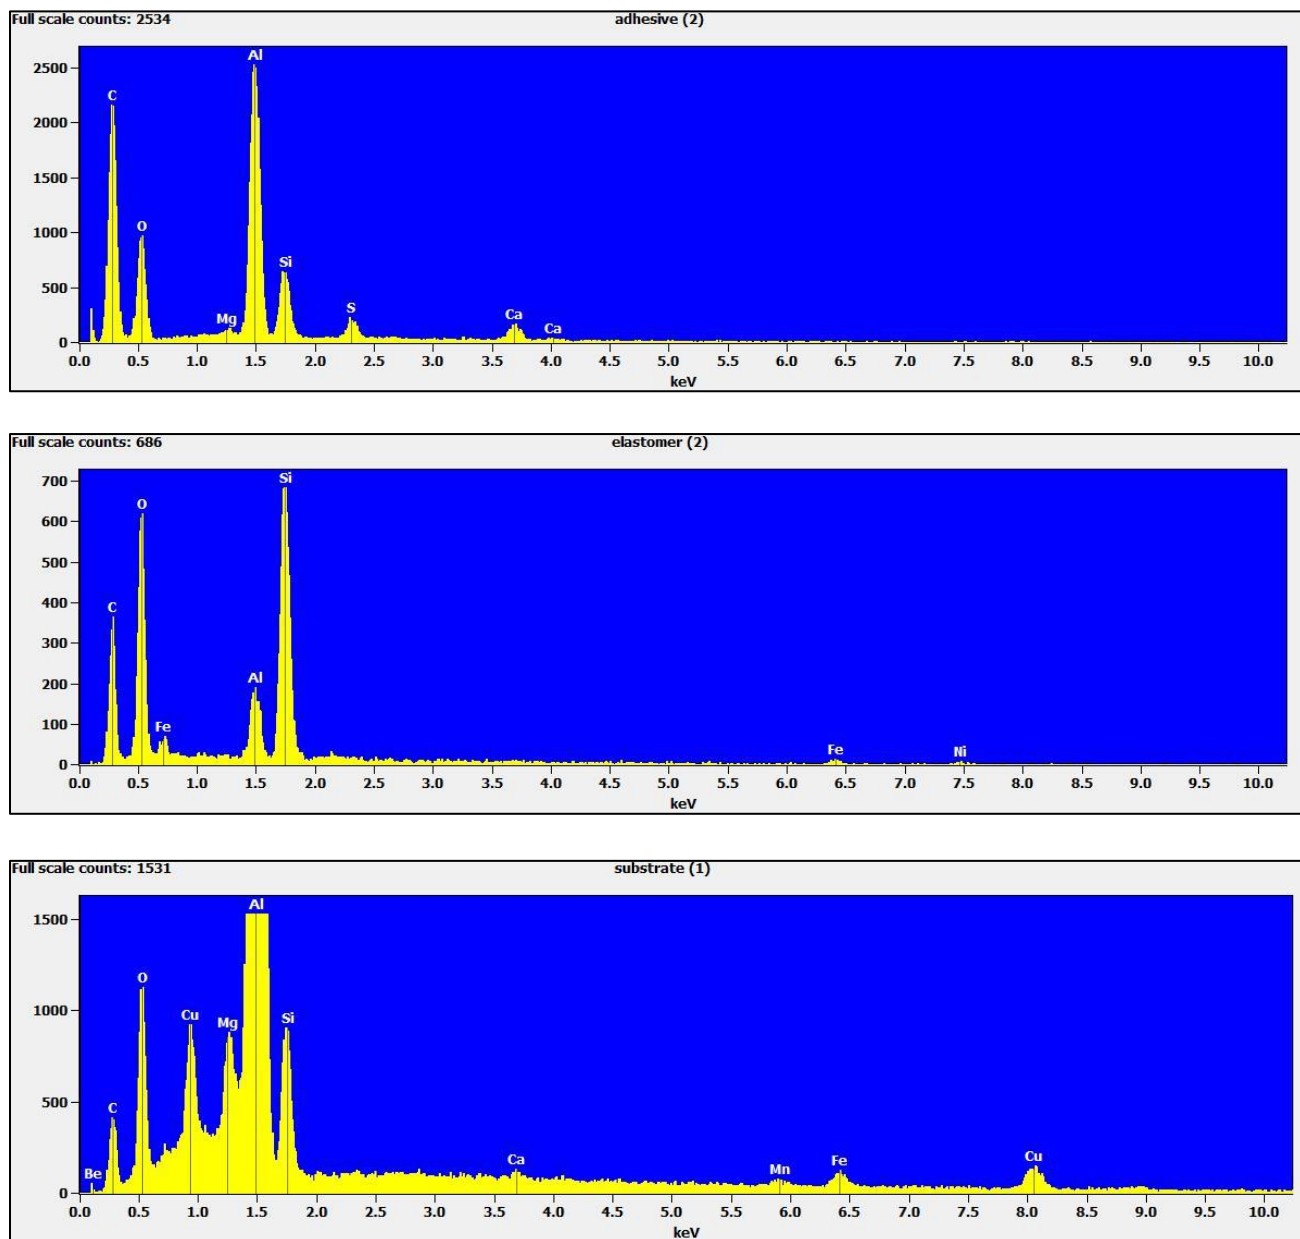
One of the inlet cowling pieces was placed in the SEM and examined using EDS in the as-received condition with no cutting or cleaning. EDS spectra for various areas of the inlet cowling piece are shown in figure 8. None of the spectra showed peaks of titanium.

Figure 8. EDS spectra from areas of an inlet cowling piece showing resin areas between honeycomb walls (upper image), red elastomer (middle image), and the metal substrate in areas where the red elastomer was pulled away from the surface (lower image).
