# NATIONAL TRANSPORTATION SAFETY BOARD

Office of Research and Engineering  
Materials Laboratory Division  
Washington, D.C. 20594

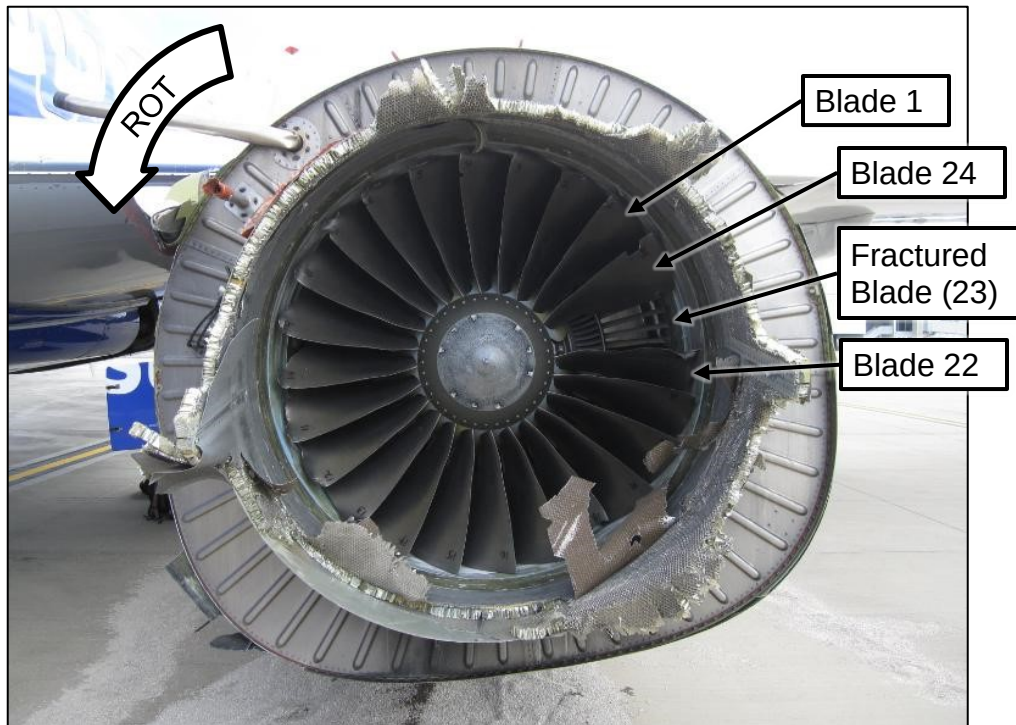
Figure 1. Overall view of the forward end of the number 1 engine after the emergency landing.

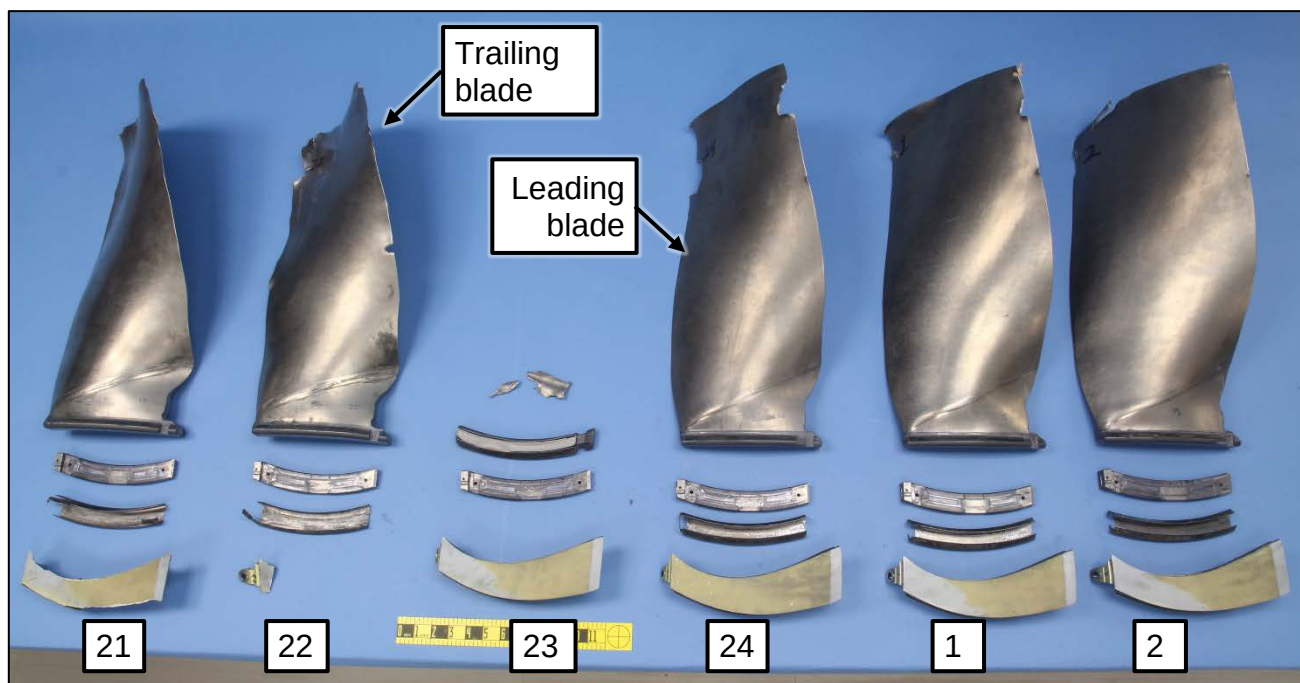
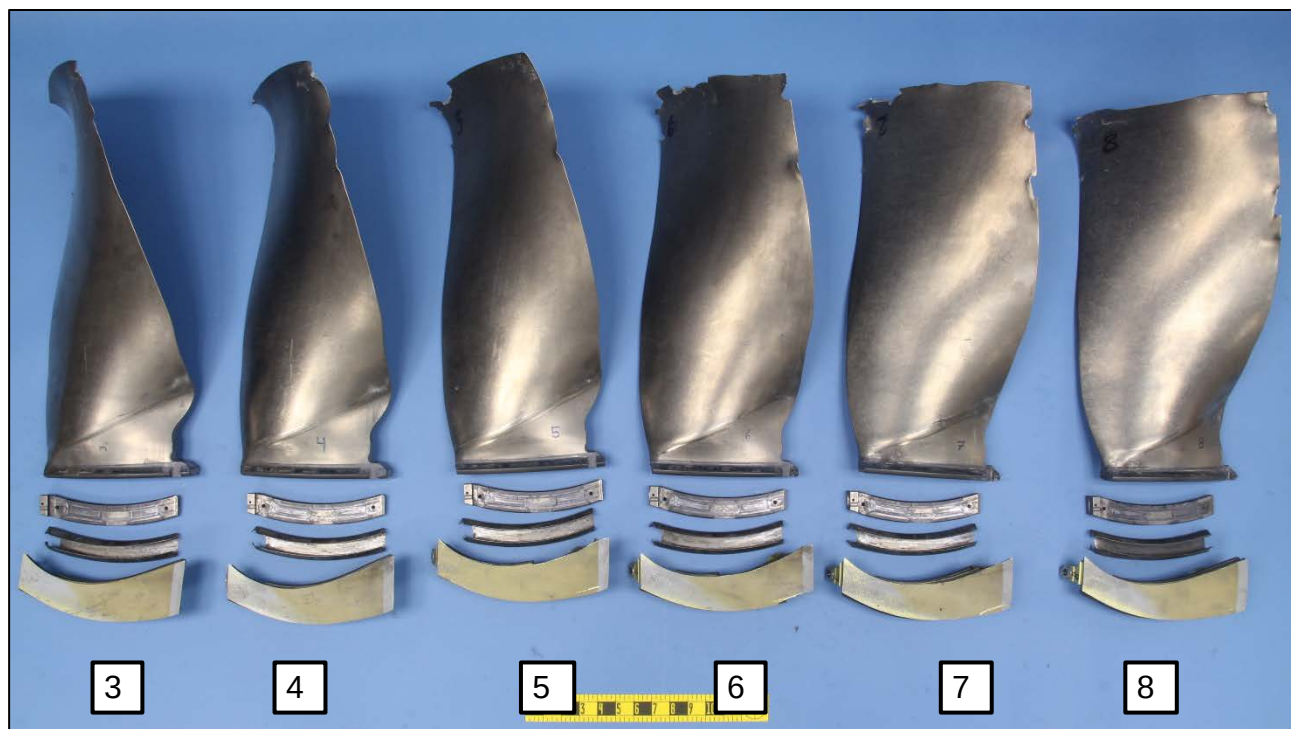
Figure 3. Overall view of submitted fan blades, fan blade spacers, fan blade shims, and fan blade platforms (shown positioned from top to bottom in each image) for blades 1 through 8 and 21 through 24. The shim for blade 23 was received on the dovetail. Blades leading and trailing the fractured blade 23 are indicated.

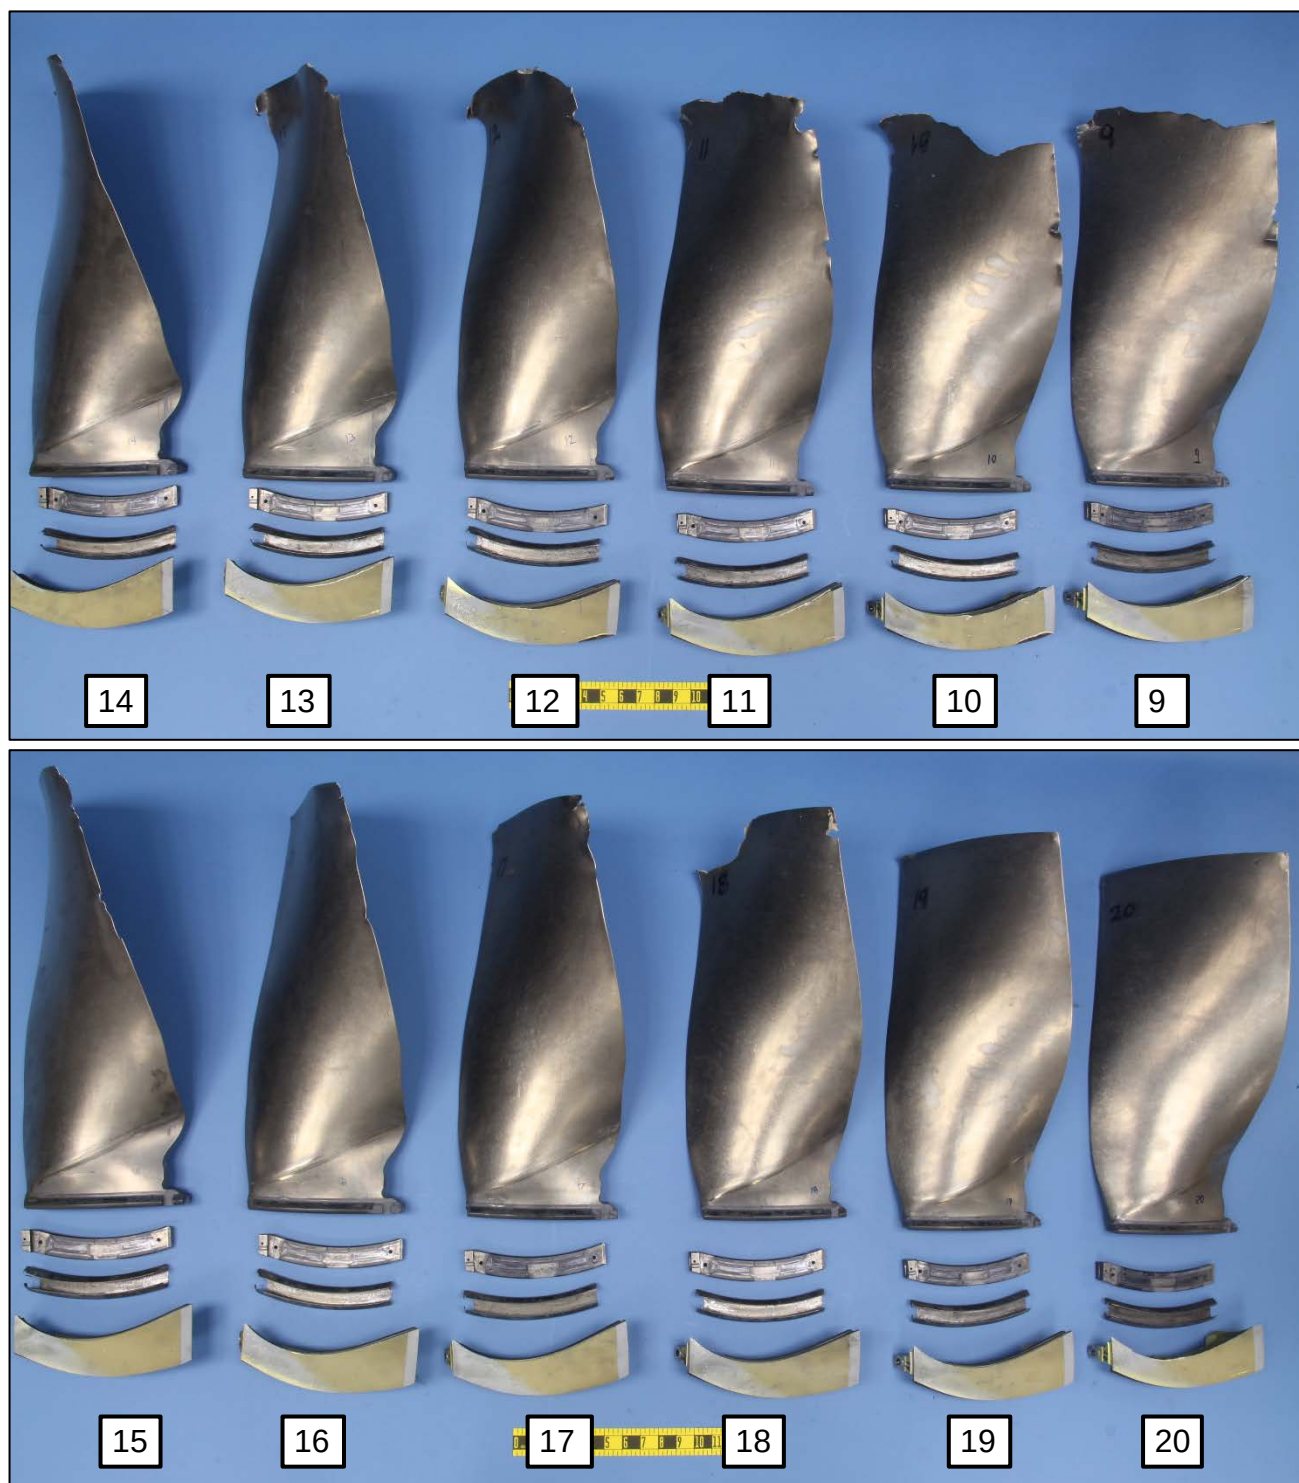
Figure 4. Overall view of submitted fan blades, fan blade spacers, fan blade shims, and fan blade platforms (shown positioned from top to bottom in each image) for blades 9 through 20.

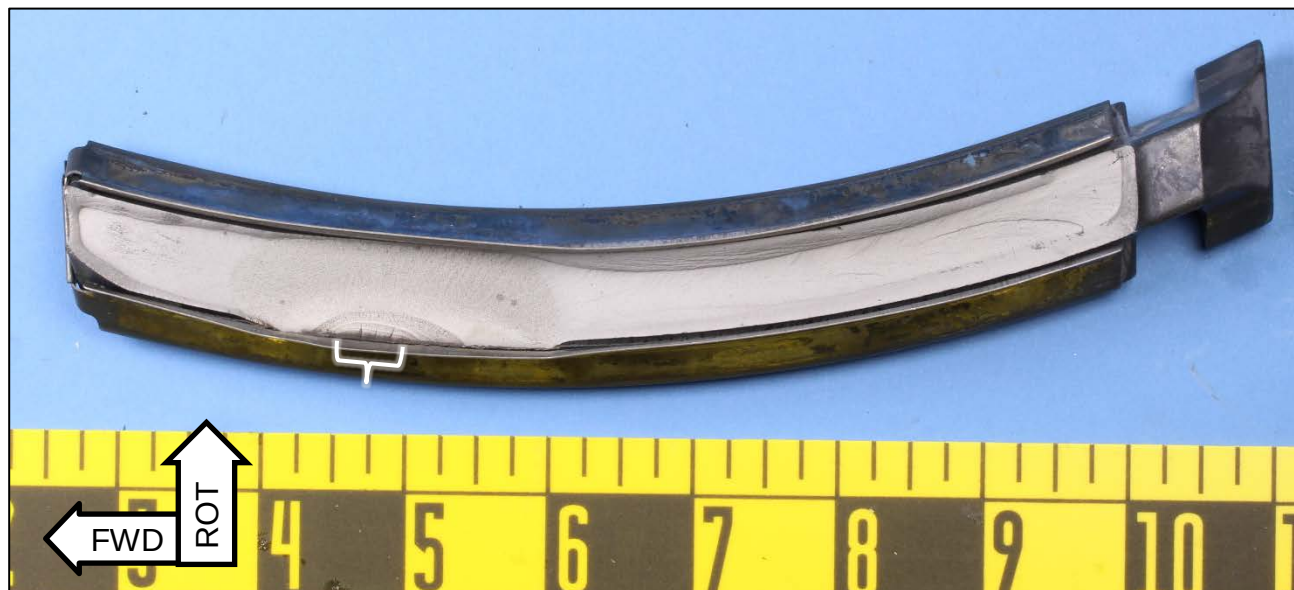
Figure 5. Overall view of the blade 23 fracture surface as received. A bracket indicates the fatigue origin area located approximately 2.1 inches aft of the forward end on the convex side of the blade.

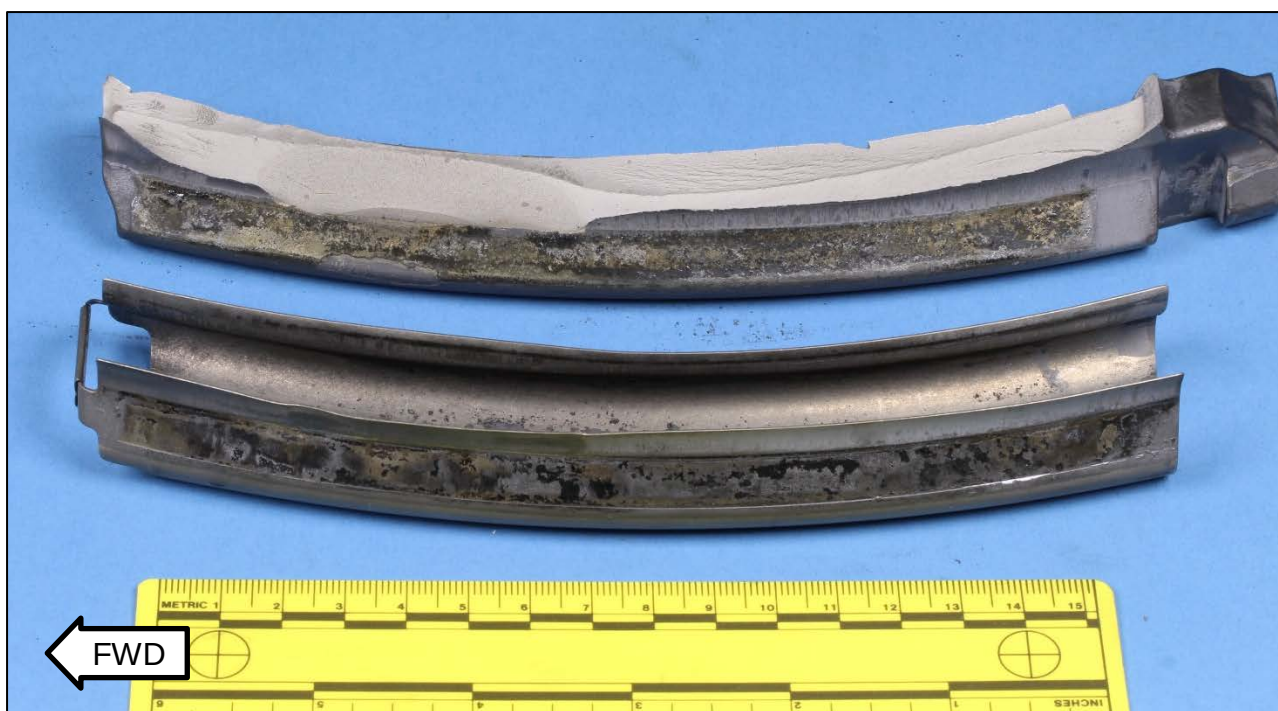
Figure 6. Overall view of the blade 23 dovetail piece and fan blade shim after the shim was disassembled from the dovetail.

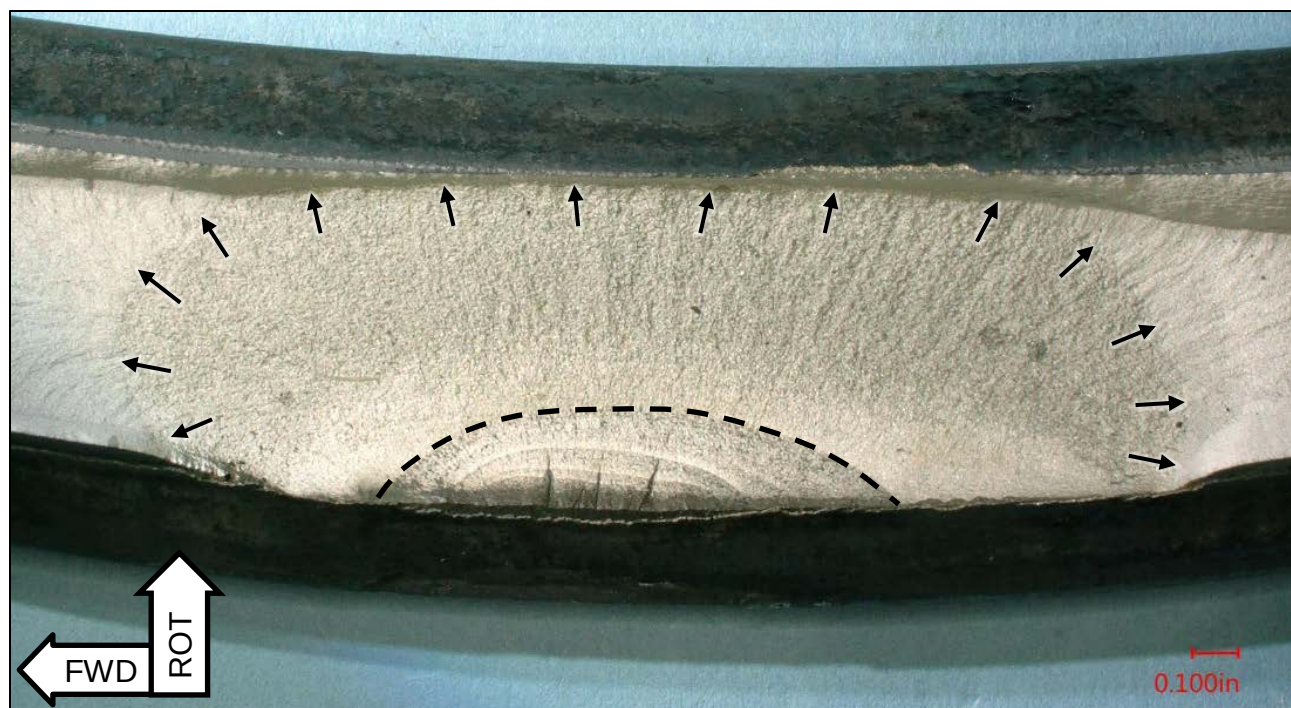
Figure 8. Close view of the fatigue region after removal of the shim. A dashed line indicates the location of the last well-defined crack arrest mark.

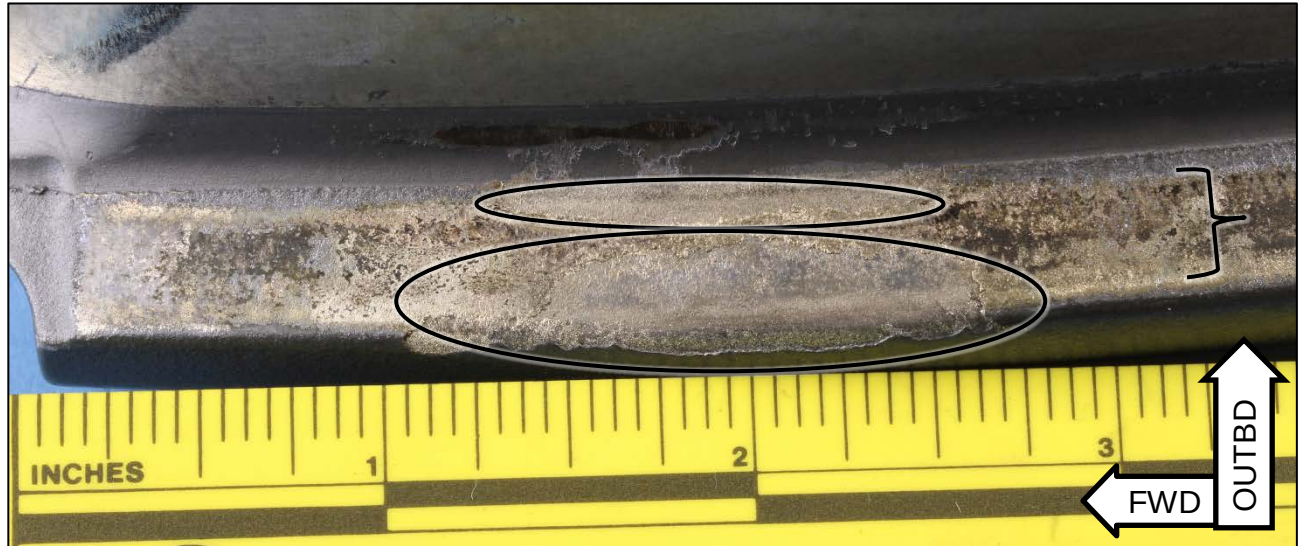
Figure 9. View of the dovetail on the convex side of blade 17 near the forward end of the blade. Circled areas were areas with missing Cu-Ni-In coating. An unlabeled bracket indicates the width of the contact face.

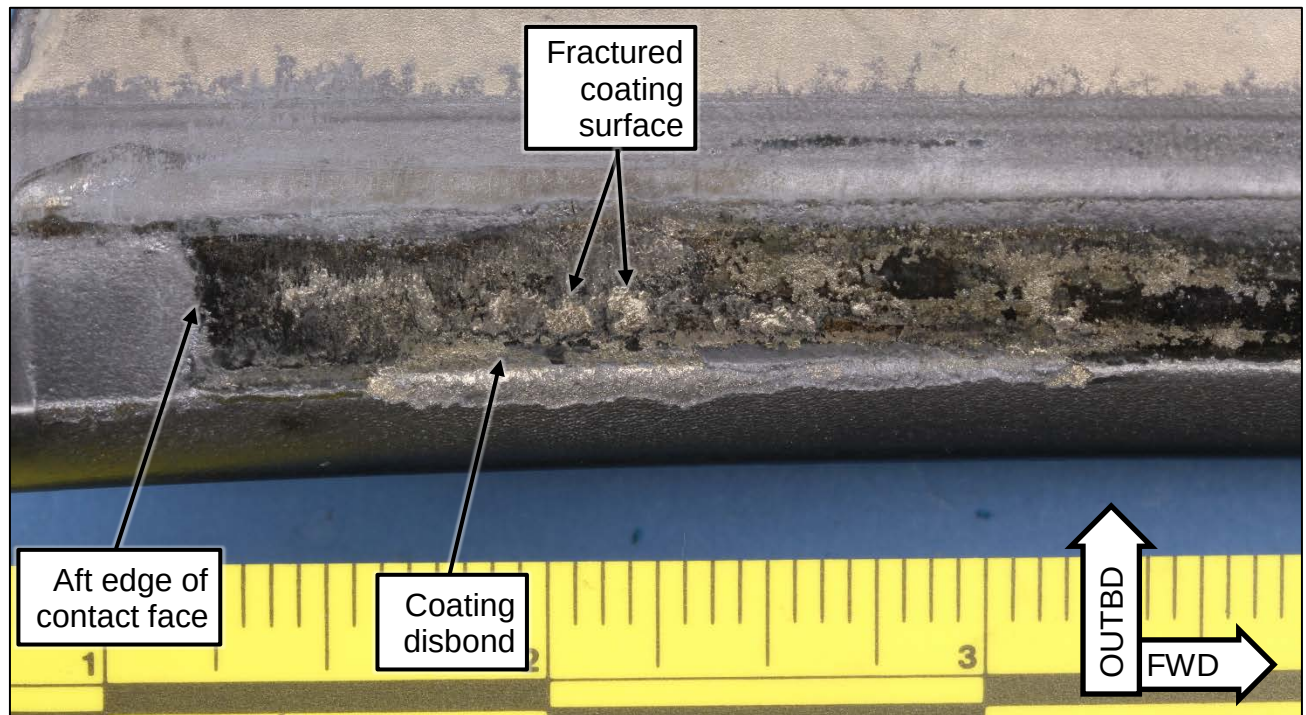
Figure 10. Close view of the Cu-Ni-In coating disbond and flaking of the adjacent lubricant layer on the concave face at the inboard edge of the contact face near the aft end of the contact face.

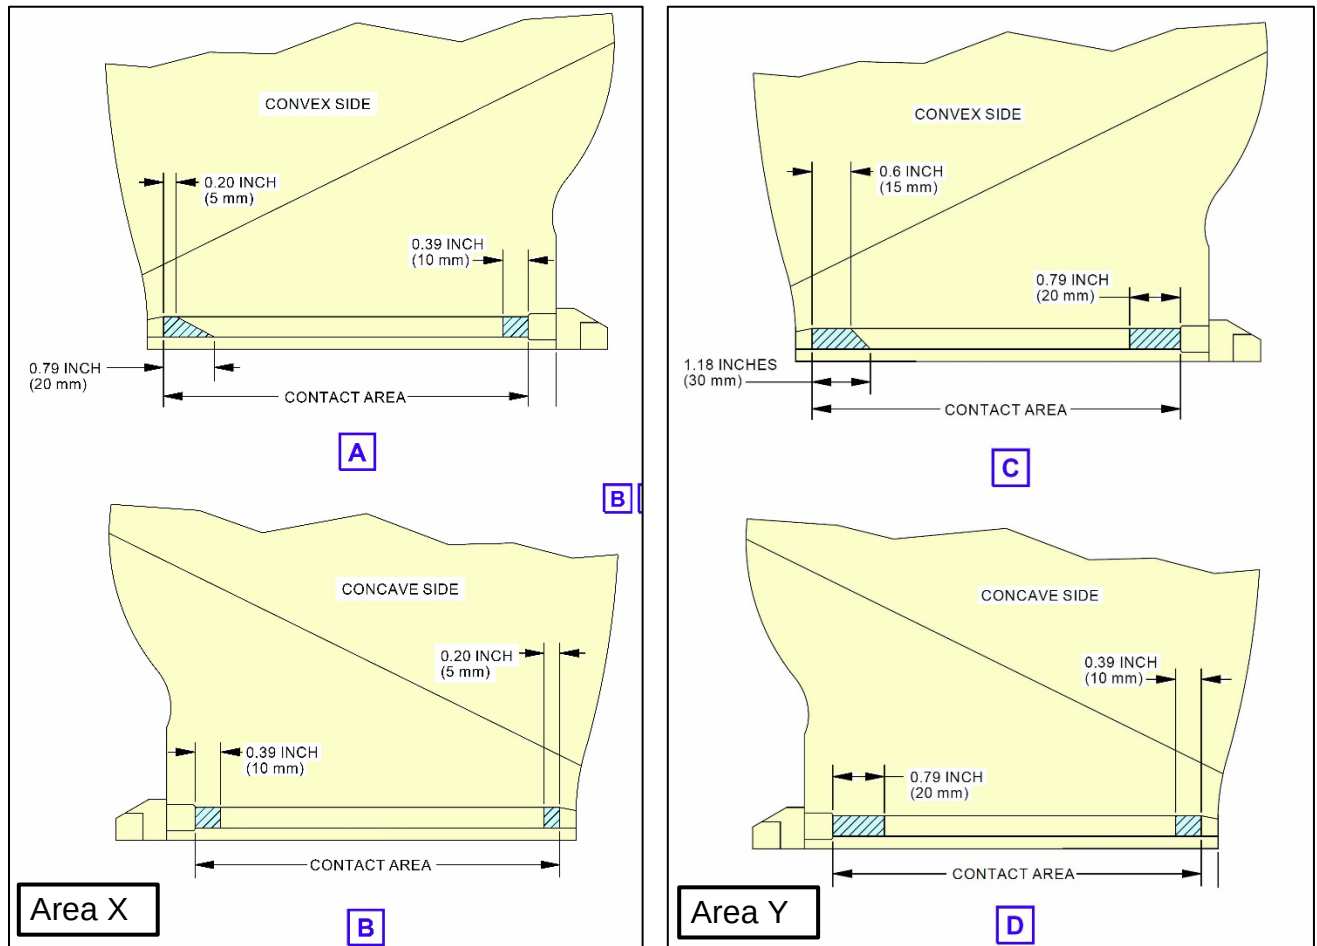
Figure 11. Drawings from the Boeing Aircraft Maintenance Manual in effect at the time of the last blade lubrication showing limits of allowable coating damage on the dovetail contact faces. Areas X and Y were defined by the green hatched areas in the drawings shown on the left and on the right, respectively.

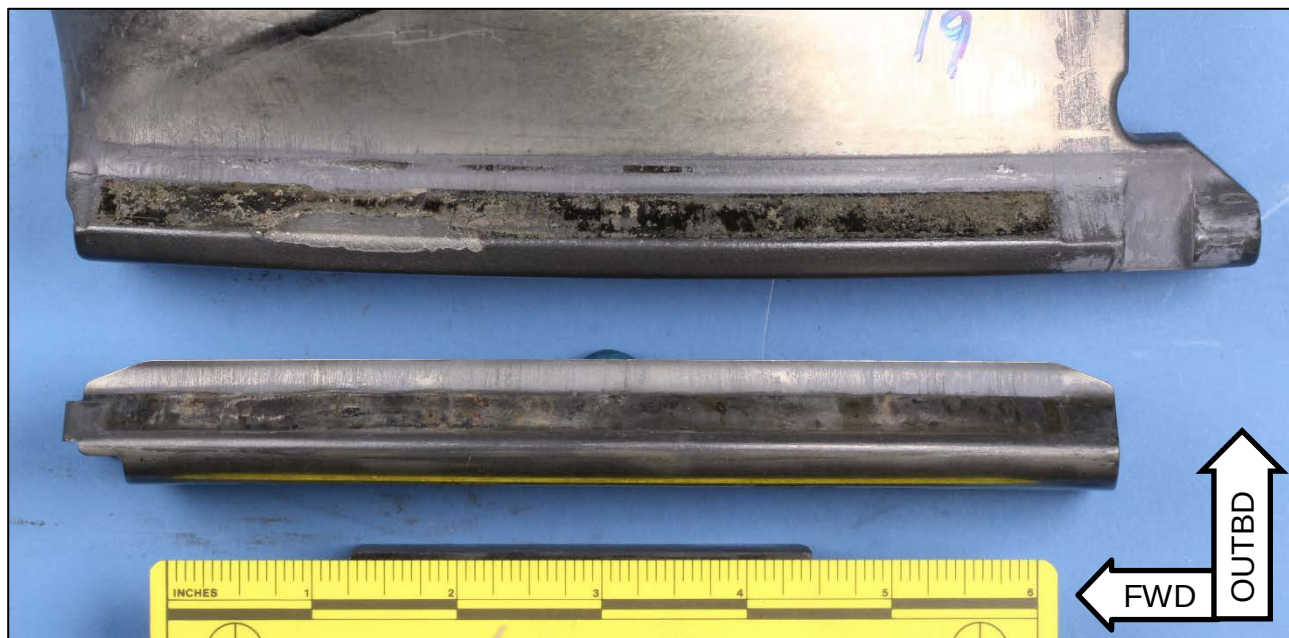
Figure 12. Blade 19 dovetail showing a visual appearance of the Cu-Ni-In coating with a mix of smoother dark gray or black areas mixed with relatively rougher light gold colored areas.

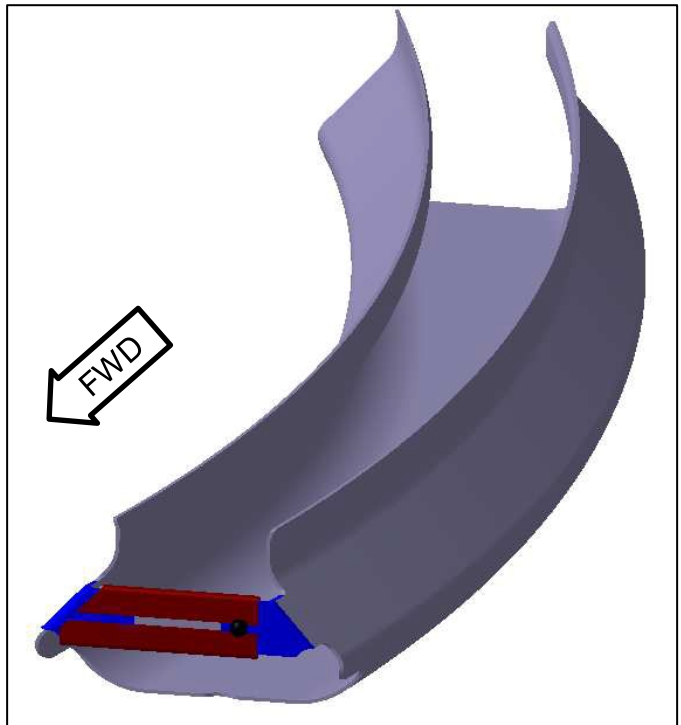
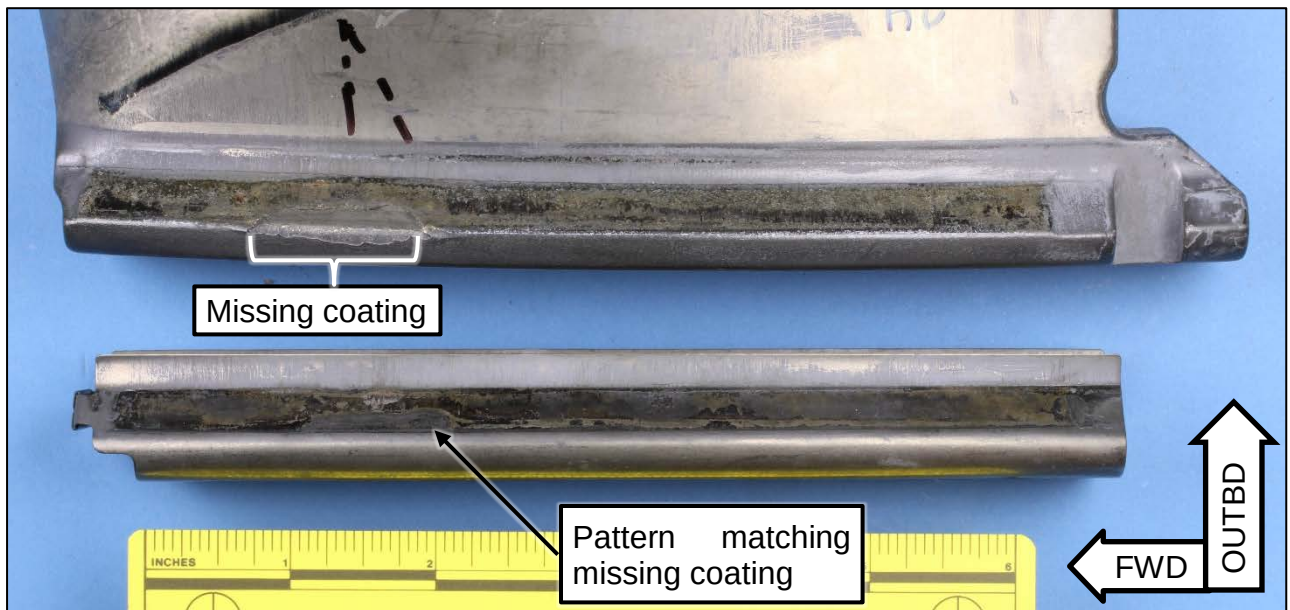
Figure 15. Blade 24 dovetail and shim. A pattern matching the area of missing Cu-Ni-In coating was visible on the shim exterior contact face.

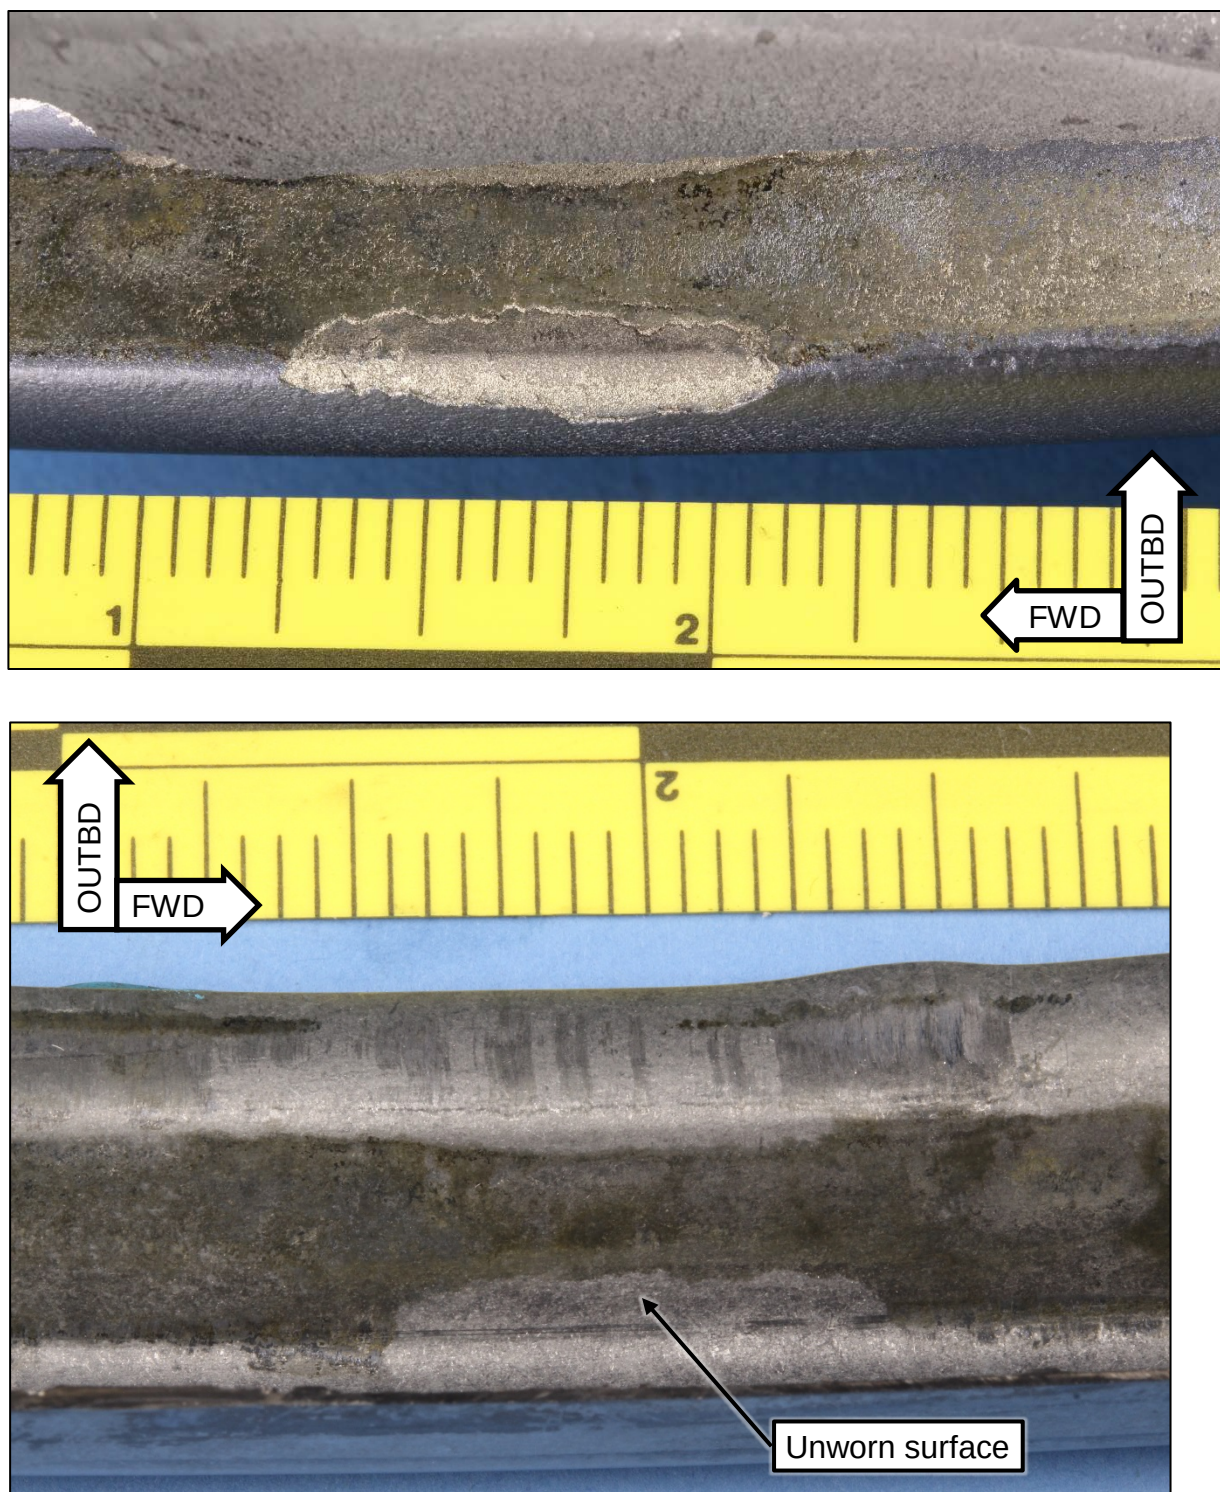
Figure 16. Views of the blade 23 dovetail at the fatigue origin area after cleaning (upper image) and the cleaned mating shim contact surface (lower image).

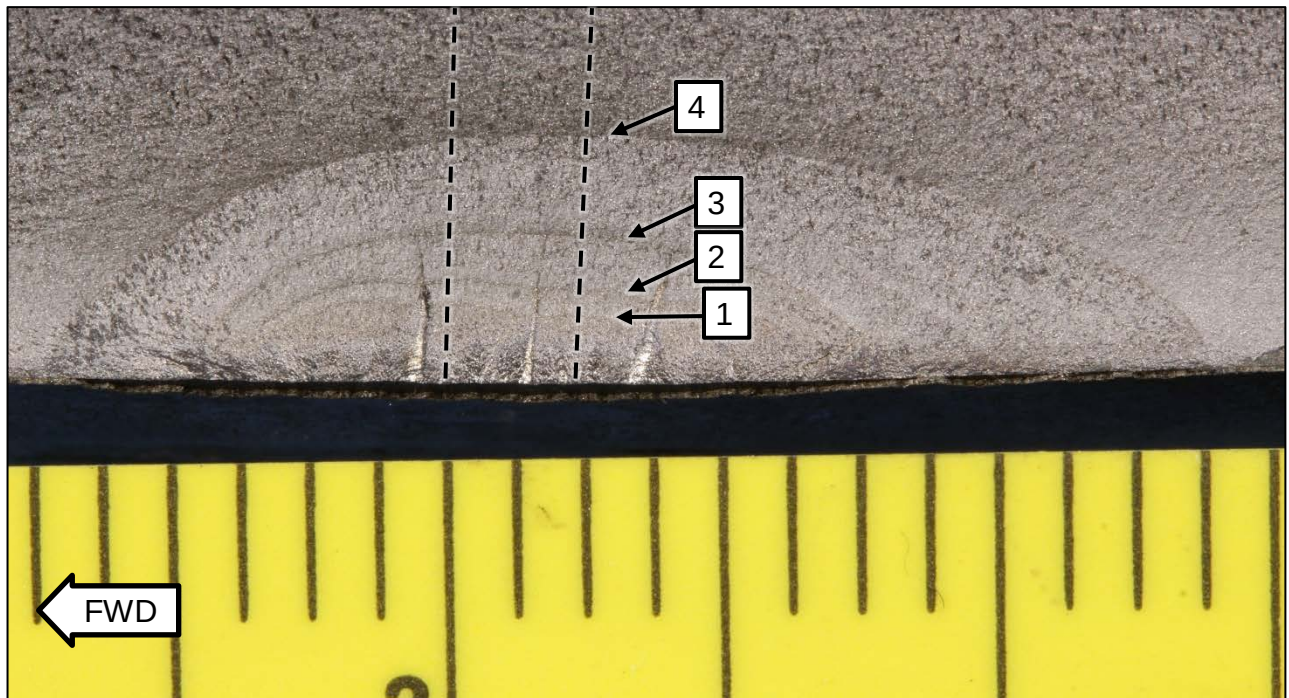
Figure 20. Close view of the cleaned origin area on blade 23. Distinct crack arrest lines are numbered, and dashed lines indicate locations where striation density was counted.

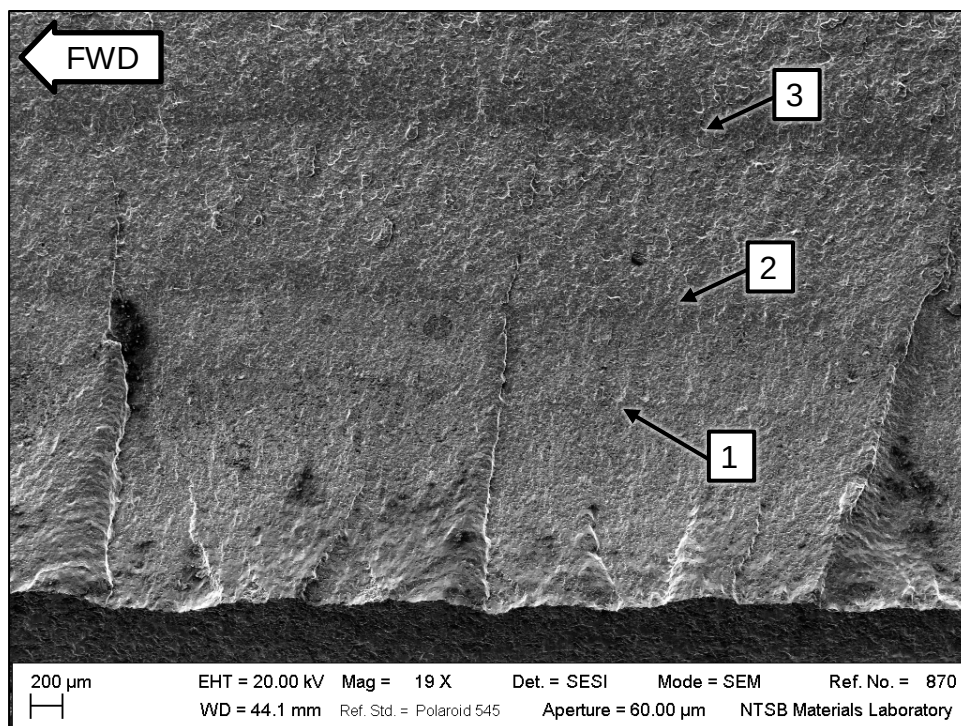
Figure 21. Overall view of the origin area after cleaning as viewed using an SEM.

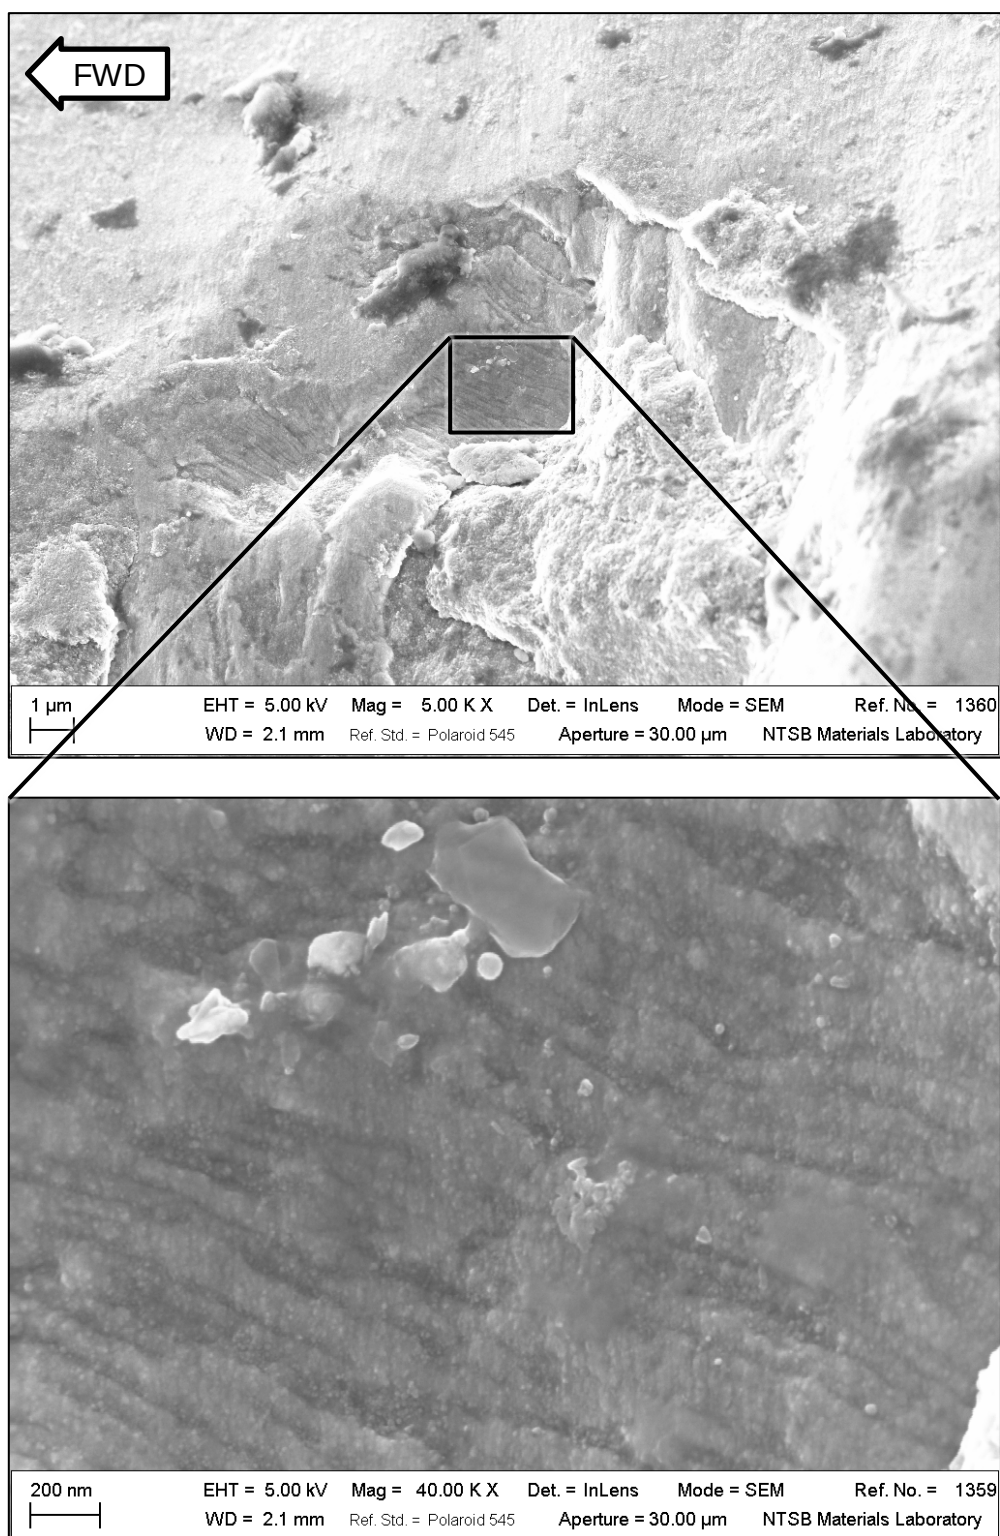
Figure 22. SEM images of the blade 23 fracture surface at 0.0082 inch from the convex surface.

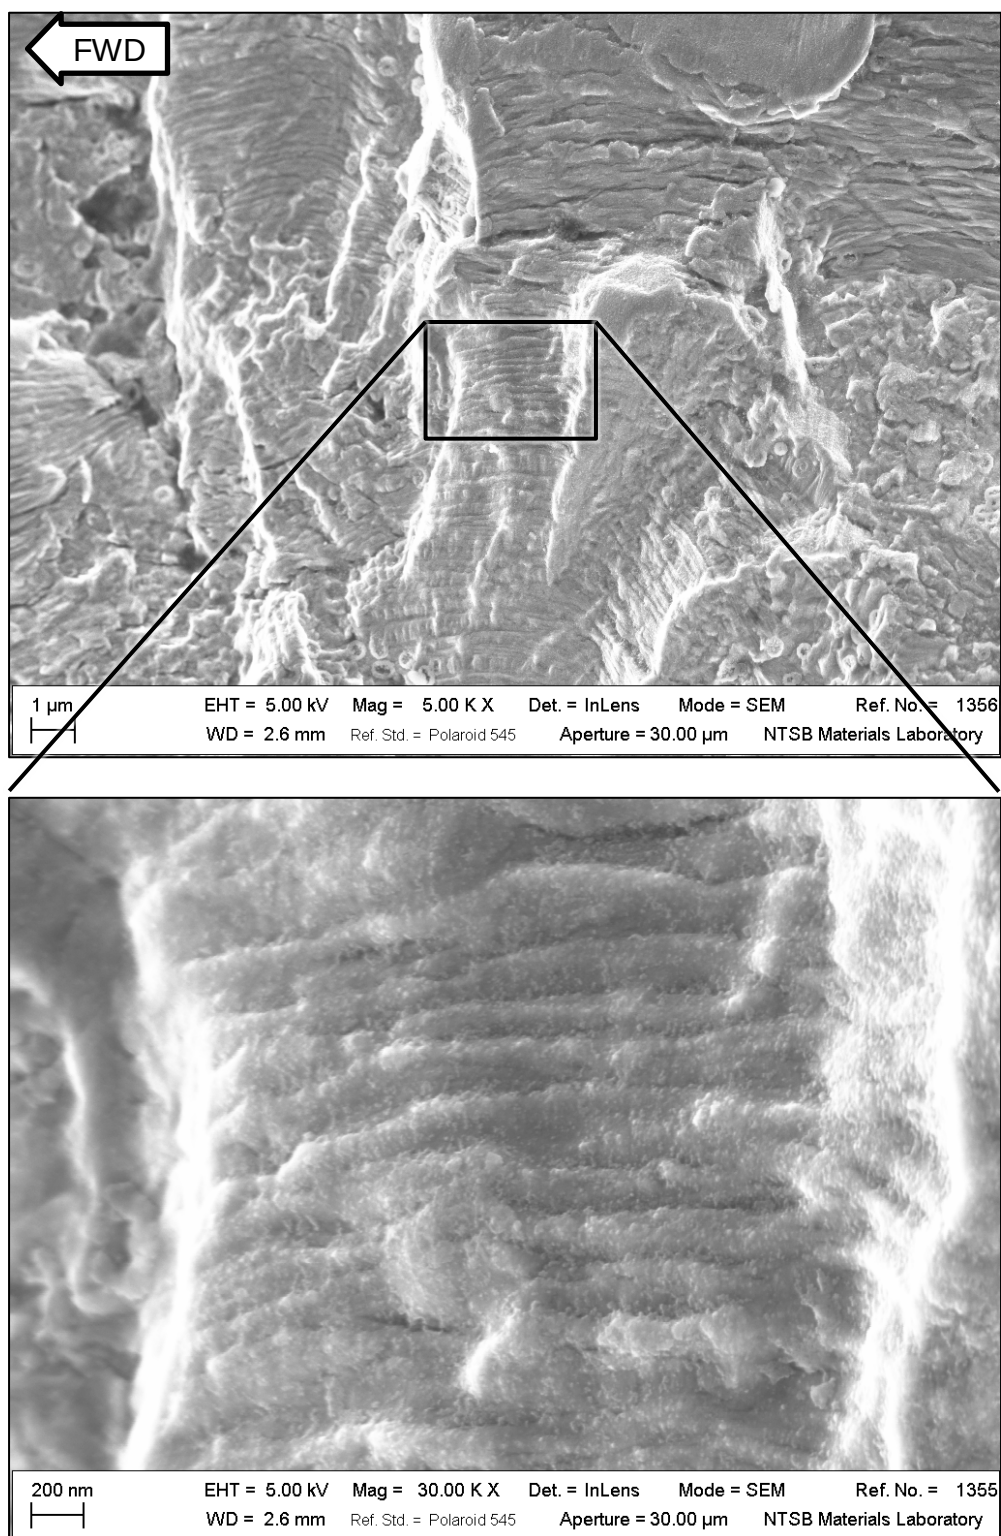
Figure 23. SEM images of the blade 23 fracture surface at 0.031 inch from the convex surface.

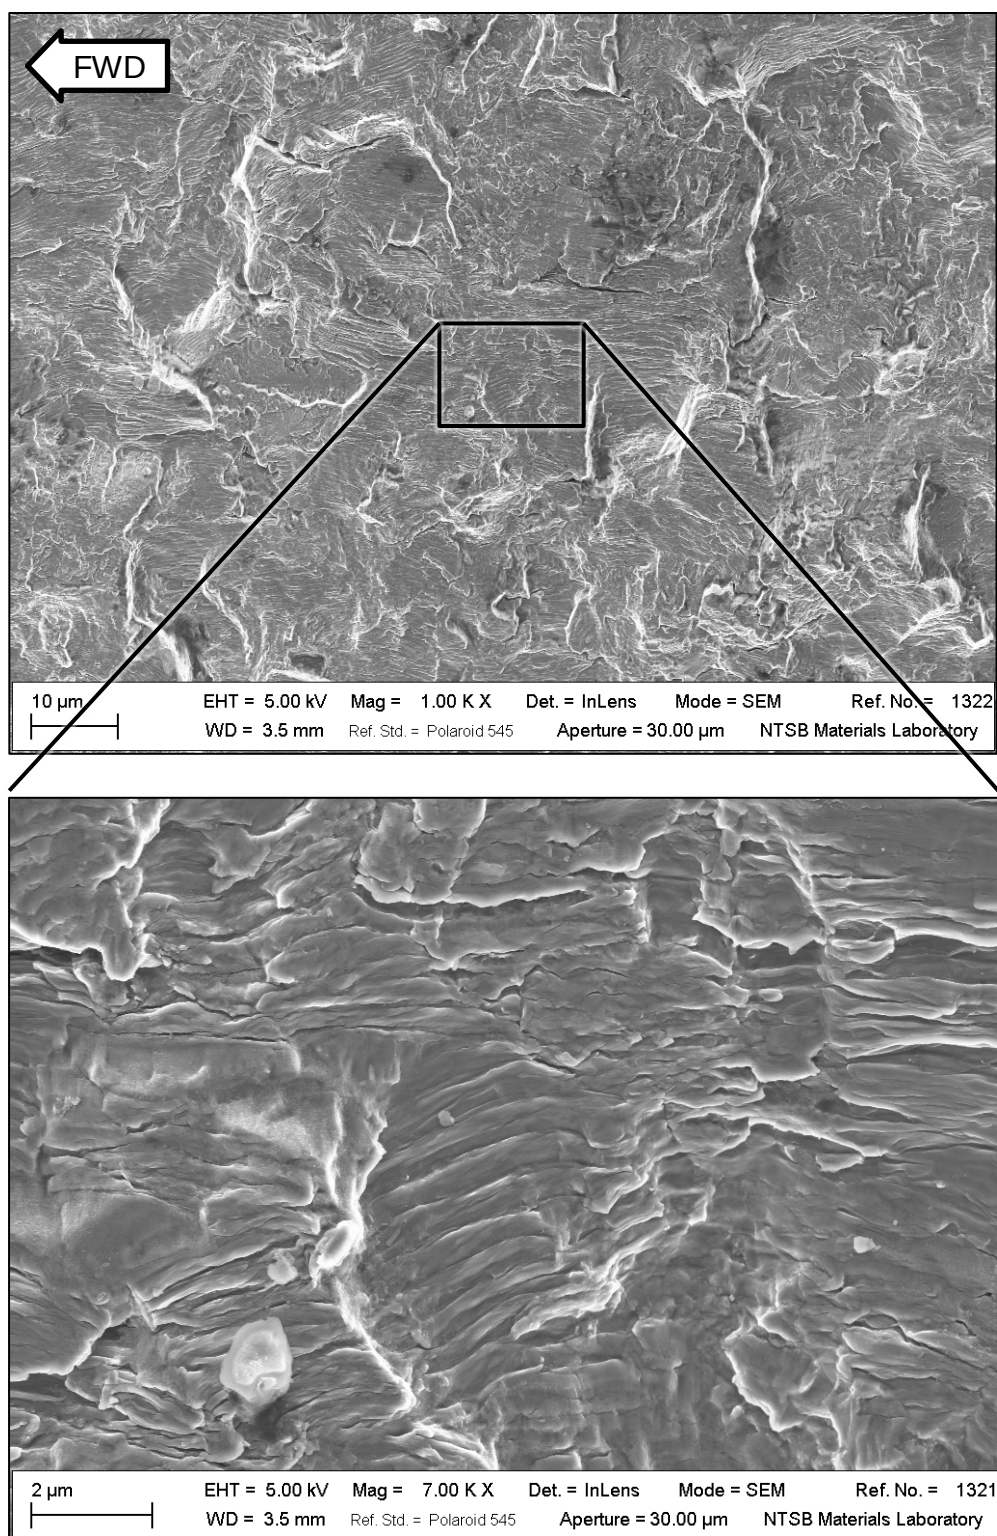
Figure 24. SEM images of the blade 23 fracture surface at 0.098 inch from the convex surface.

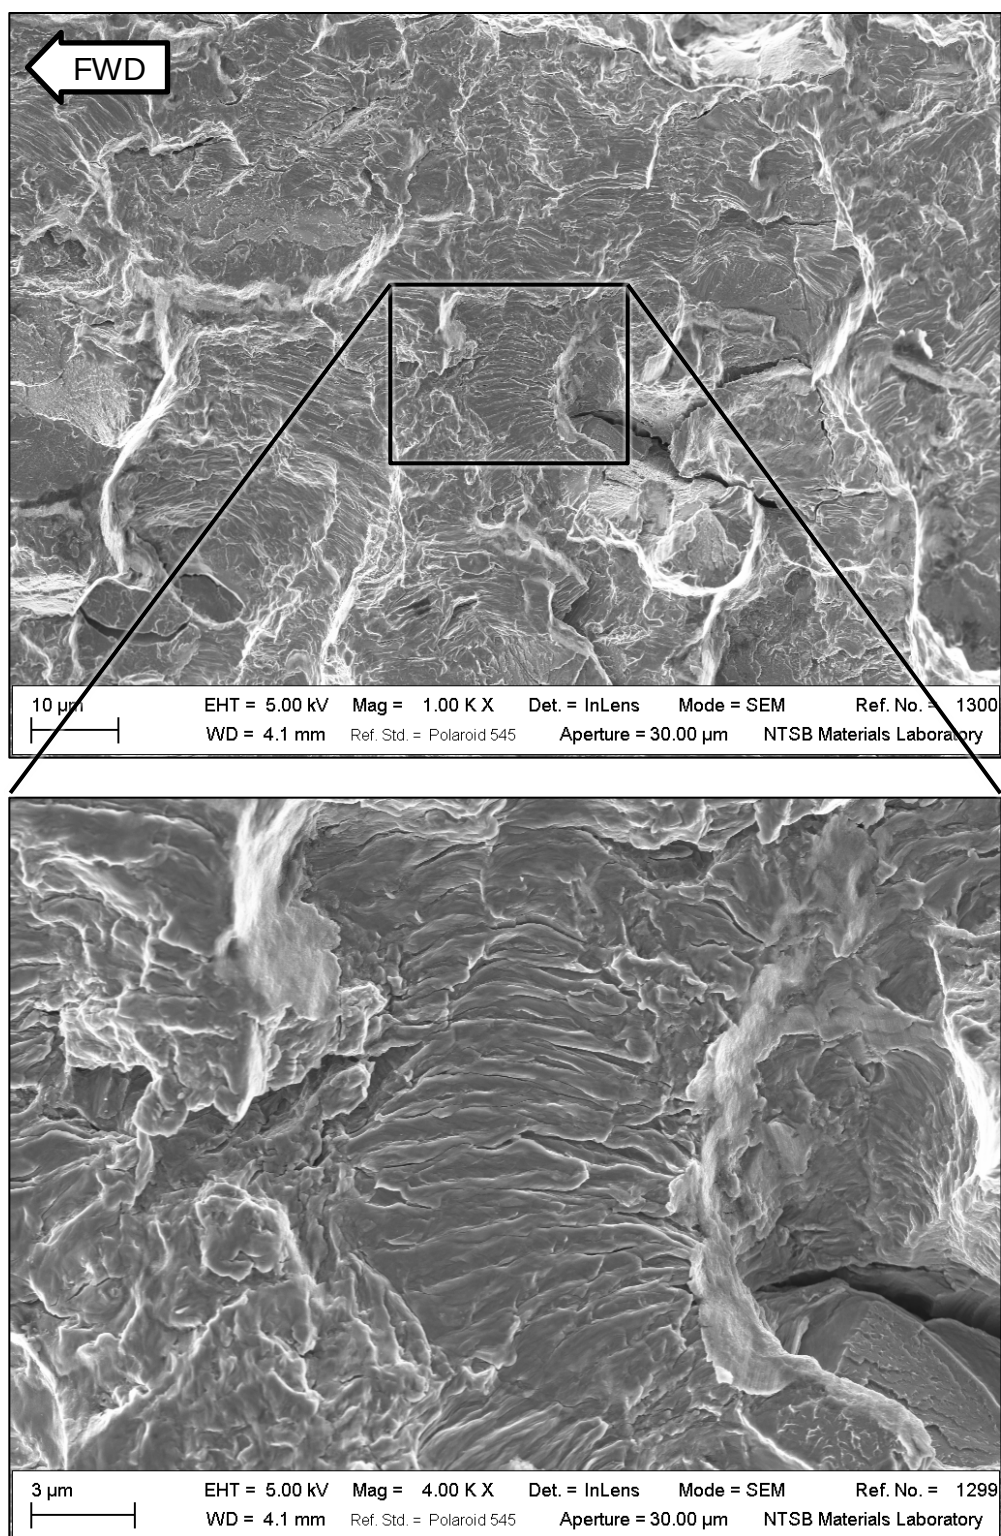
Figure 25. SEM images of the blade 23 fracture surface at 0.187 inch from the convex surface.
