# NATIONAL TRANSPORTATION SAFETY BOARD

Office of Research and Engineering  
Materials Laboratory Division  
Washington, D.C. 20594

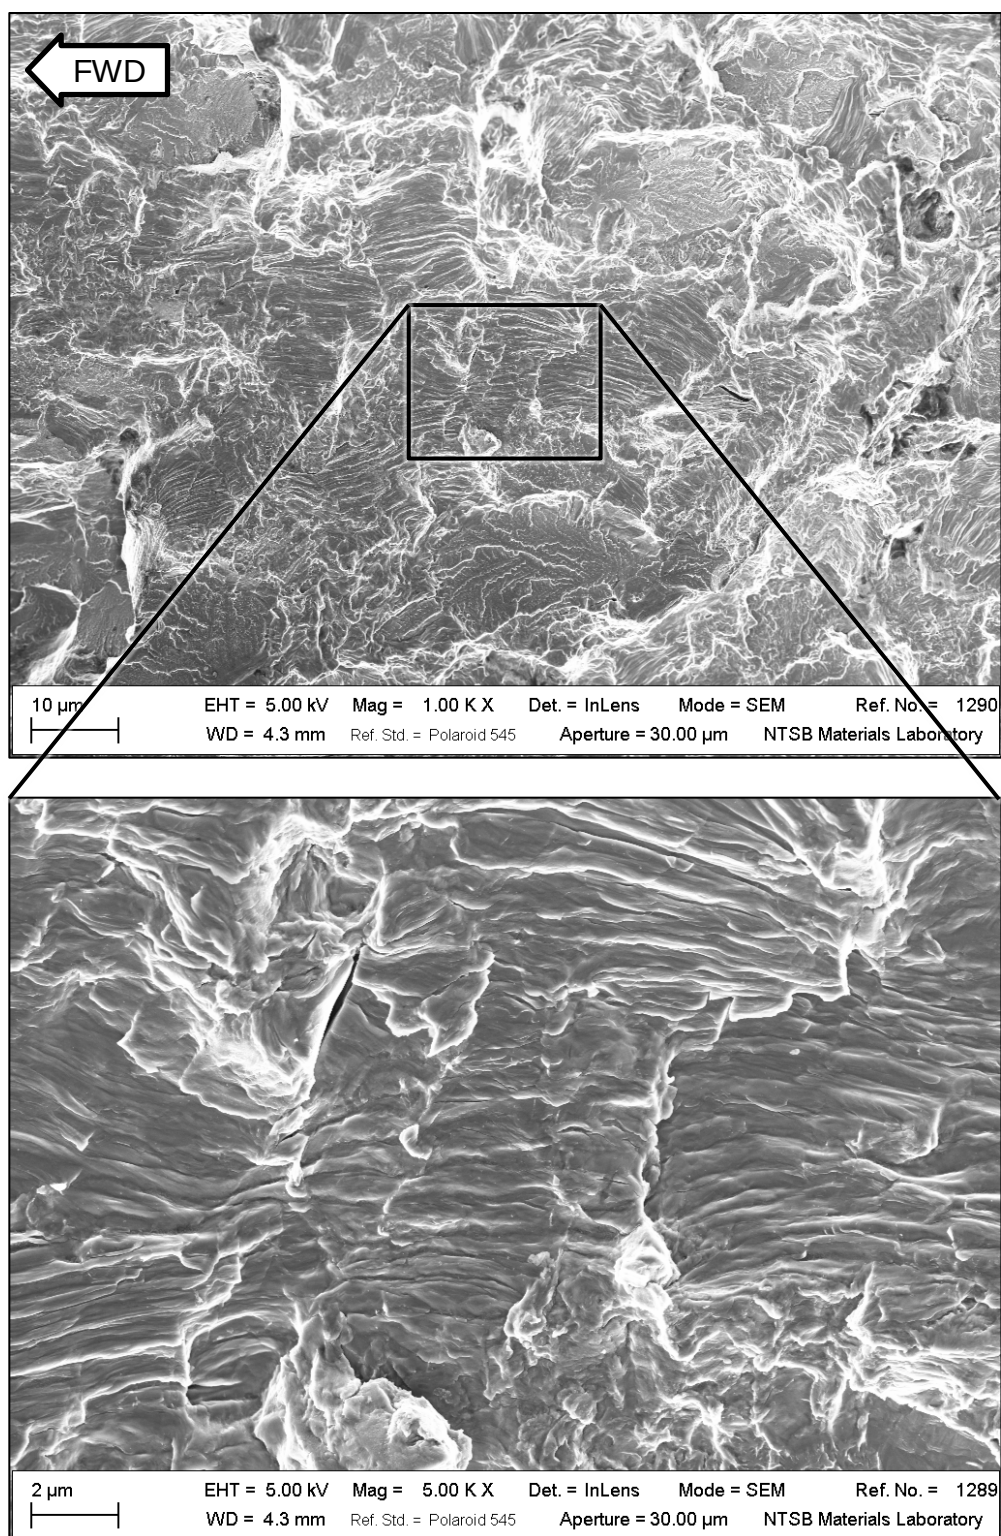
Figure 26. SEM images of the blade 23 fracture surface at 0.249 inch from the convex surface.

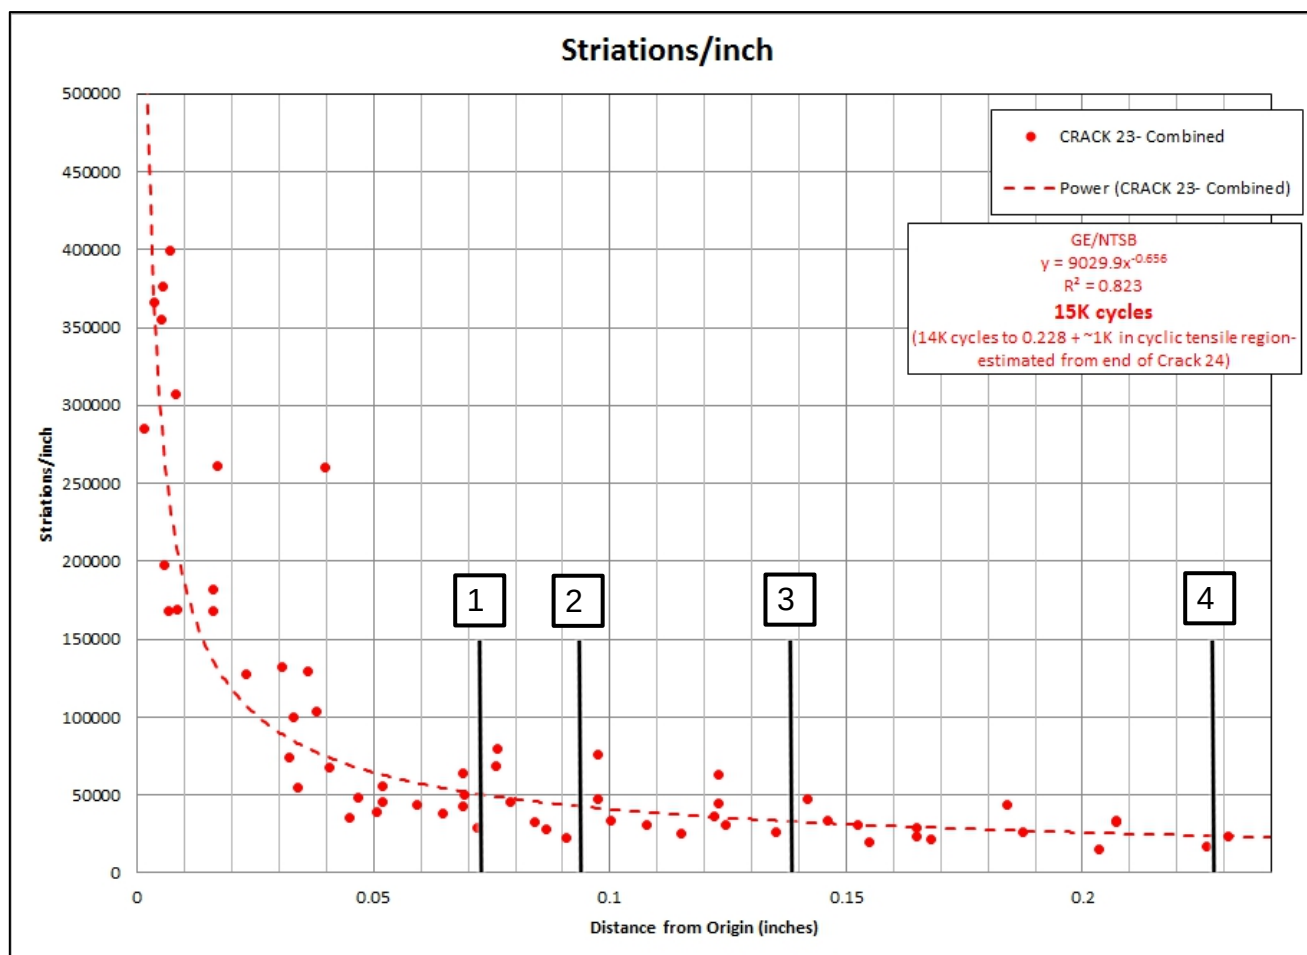
Figure 27. Striation density as a function of distance from the origin for blade 23. Locations of crack arrest lines 1 through 4 are noted on the graph.

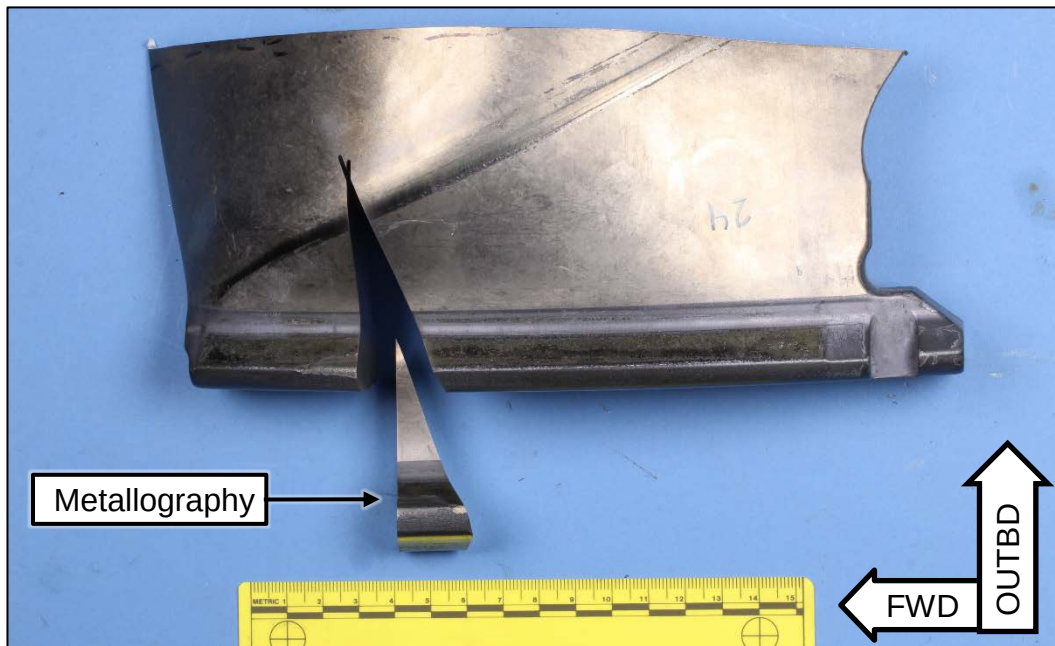
Figure 28. Overall view of the blade 24 piece sectioned for metallography on the face indicated.

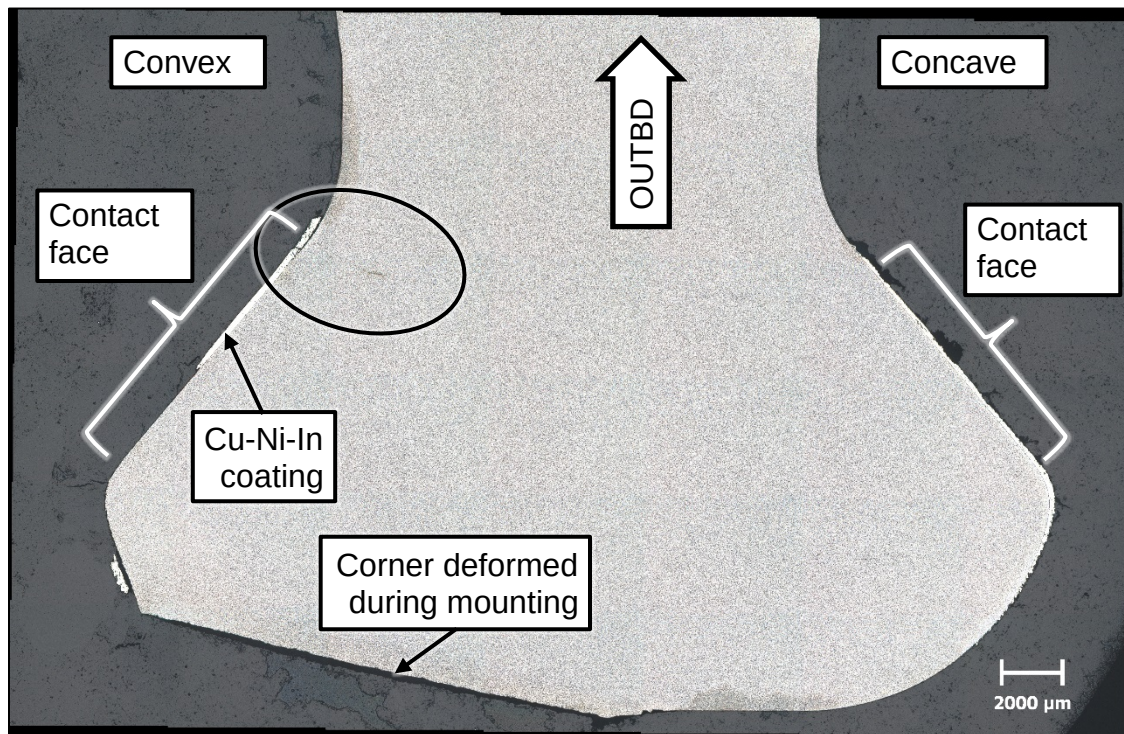
Figure 29. Macrograph showing the polished and etched transverse plane through the dovetail. Cracks were observed in the area circled on the convex side near the outboard end of the contact face. (Etchant: Kroll's reagent.)

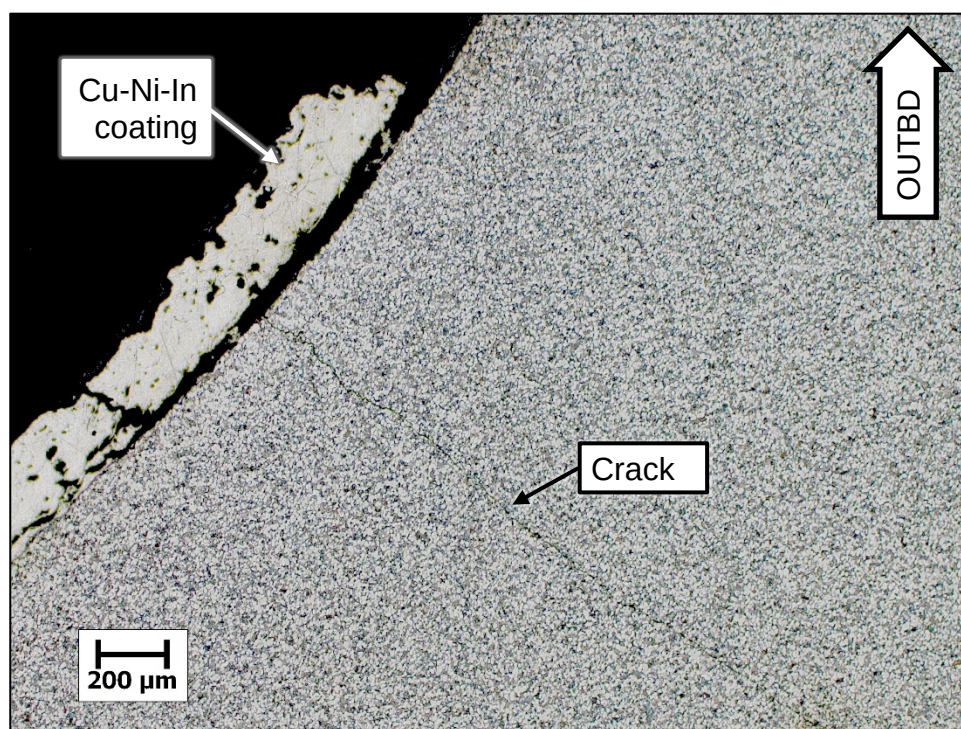
Figure 30. Micrograph of the area circled in figure 28 where the primary crack is indicated. (etchant: Kroll's reagent)

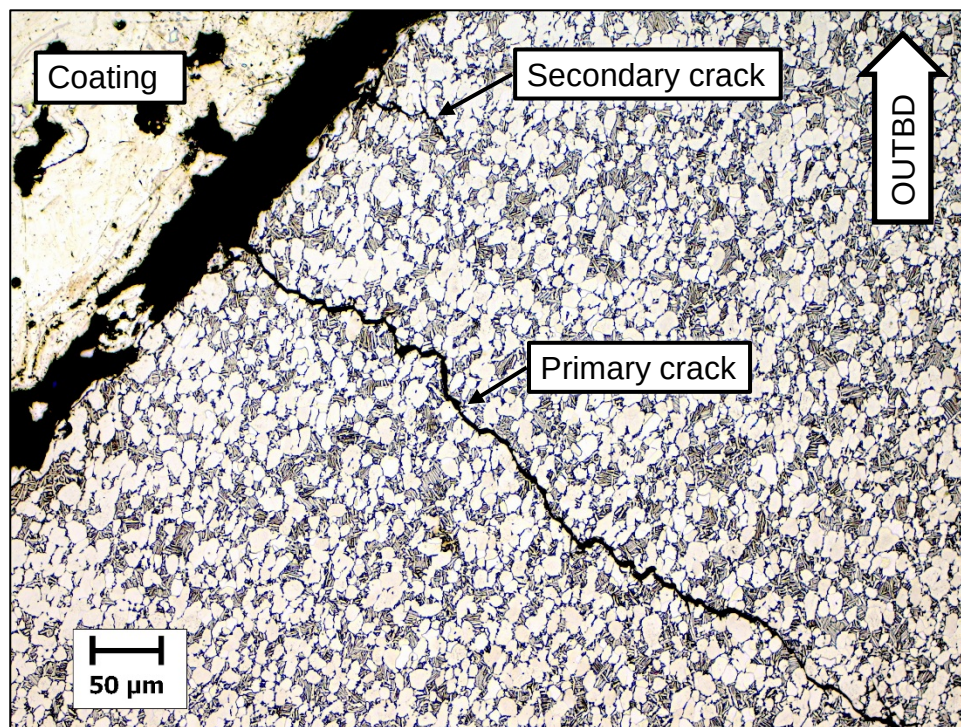
Figure 31. Micrograph of cracks emanating from under the Cu-Ni-In coating on the convex side of blade 24 showing the primary crack and a secondary crack. (Etchant: Kroll's reagent.)

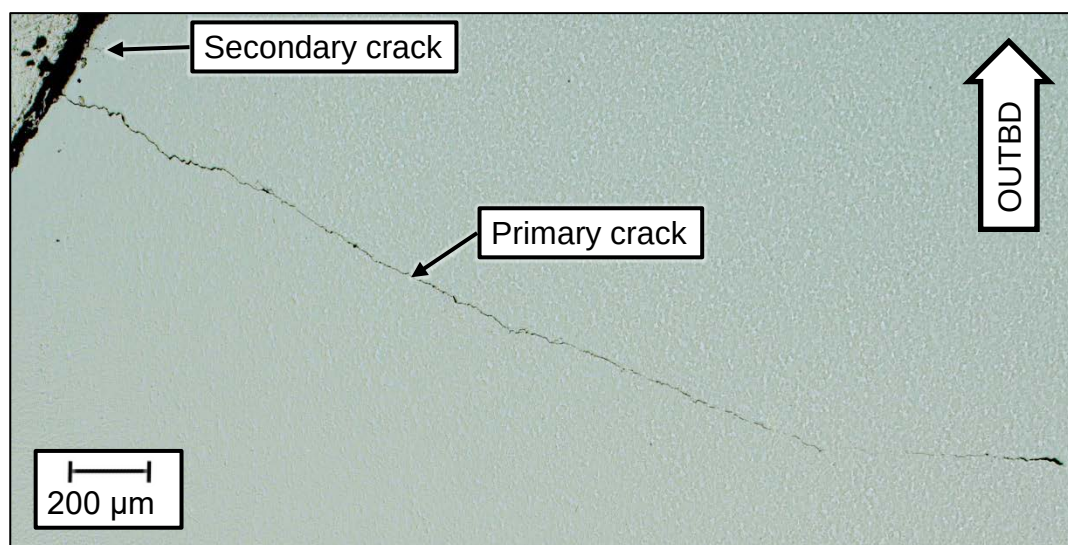
Figure 32. Overall image of the primary crack in the blade 24 cross-section after the surface had been etched with Kroll's reagent and was repolished.

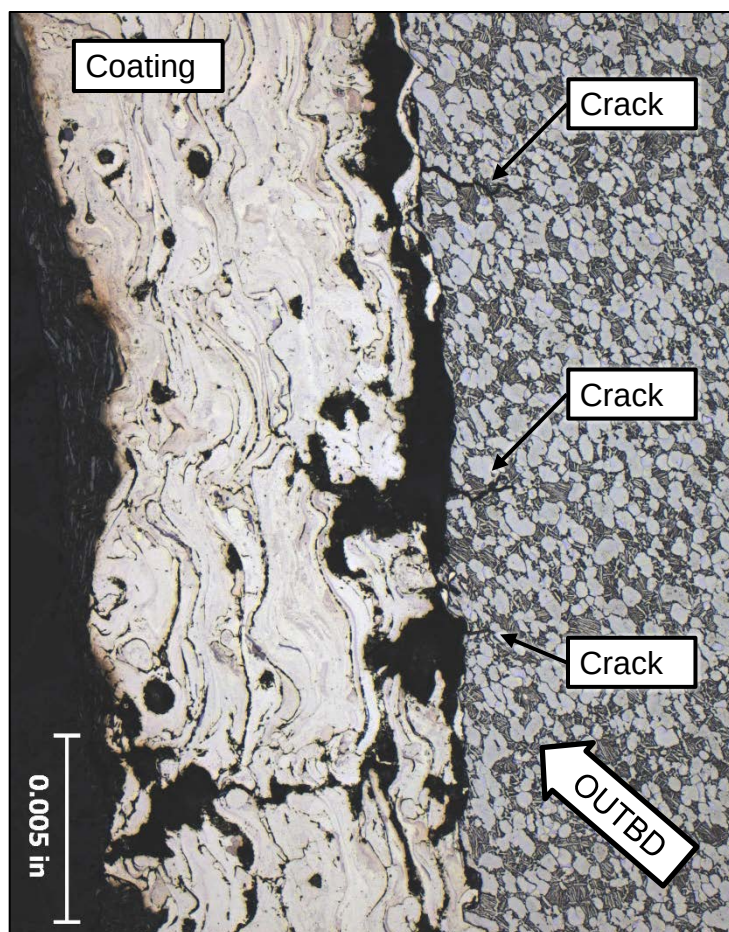
Figure 33. Secondary cracks emanating from the convex surface of blade 24 under the Cu-Ni-In coating inboard of the primary crack. (Etchant: Kroll's reagent.)

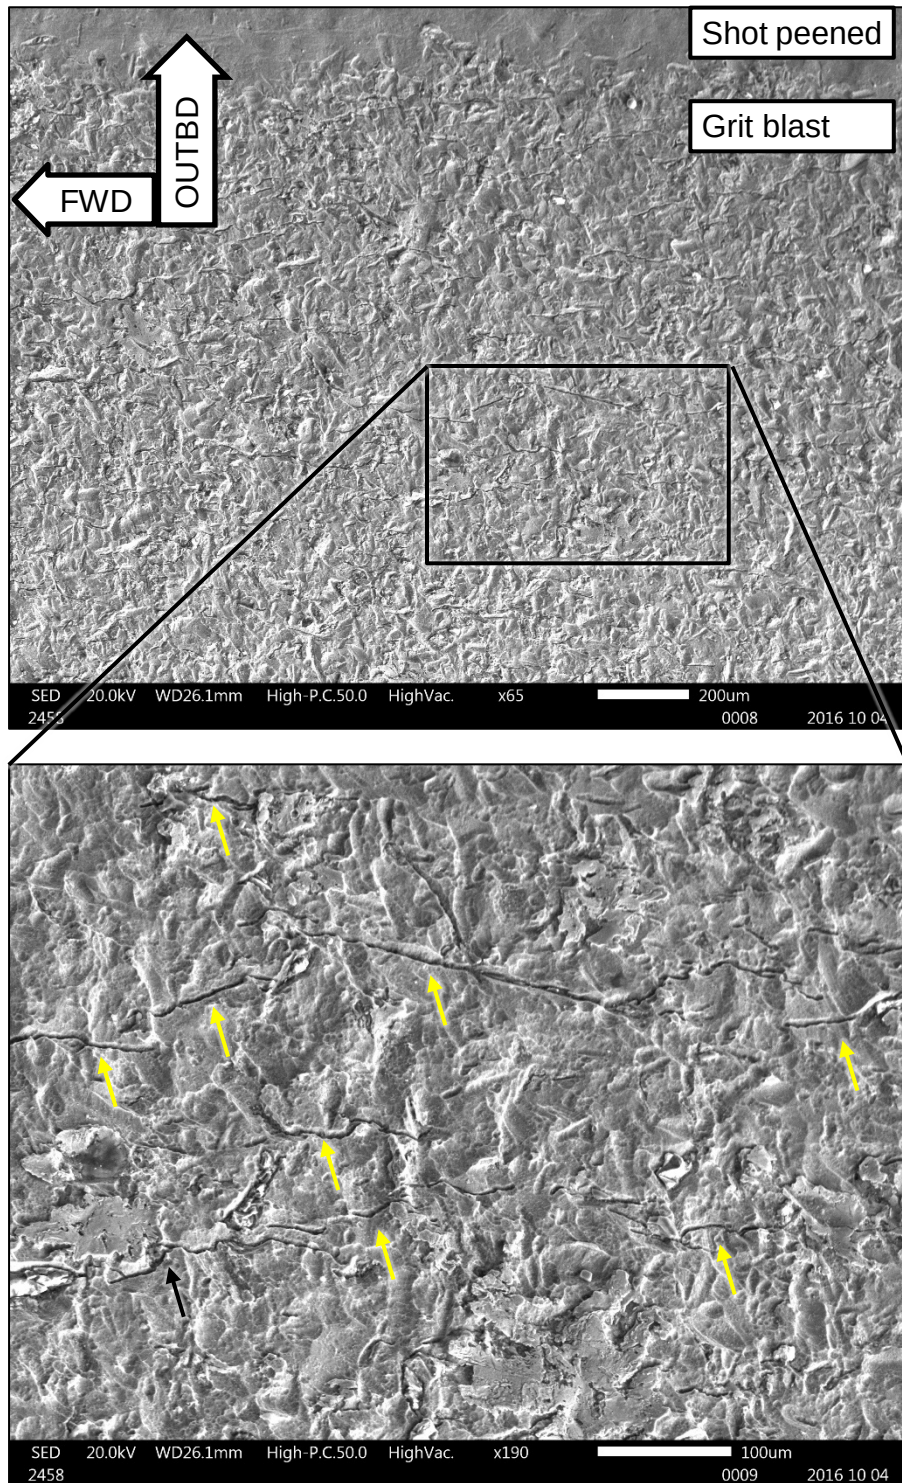
Figure 34. SEM images of a network of microcracks observed on the blade 2 surface viewed at lower magnification (upper image) and at higher magnification (lower image). Unlabeled arrows in the lower image indicate microcracks. (Images provided by GE.)

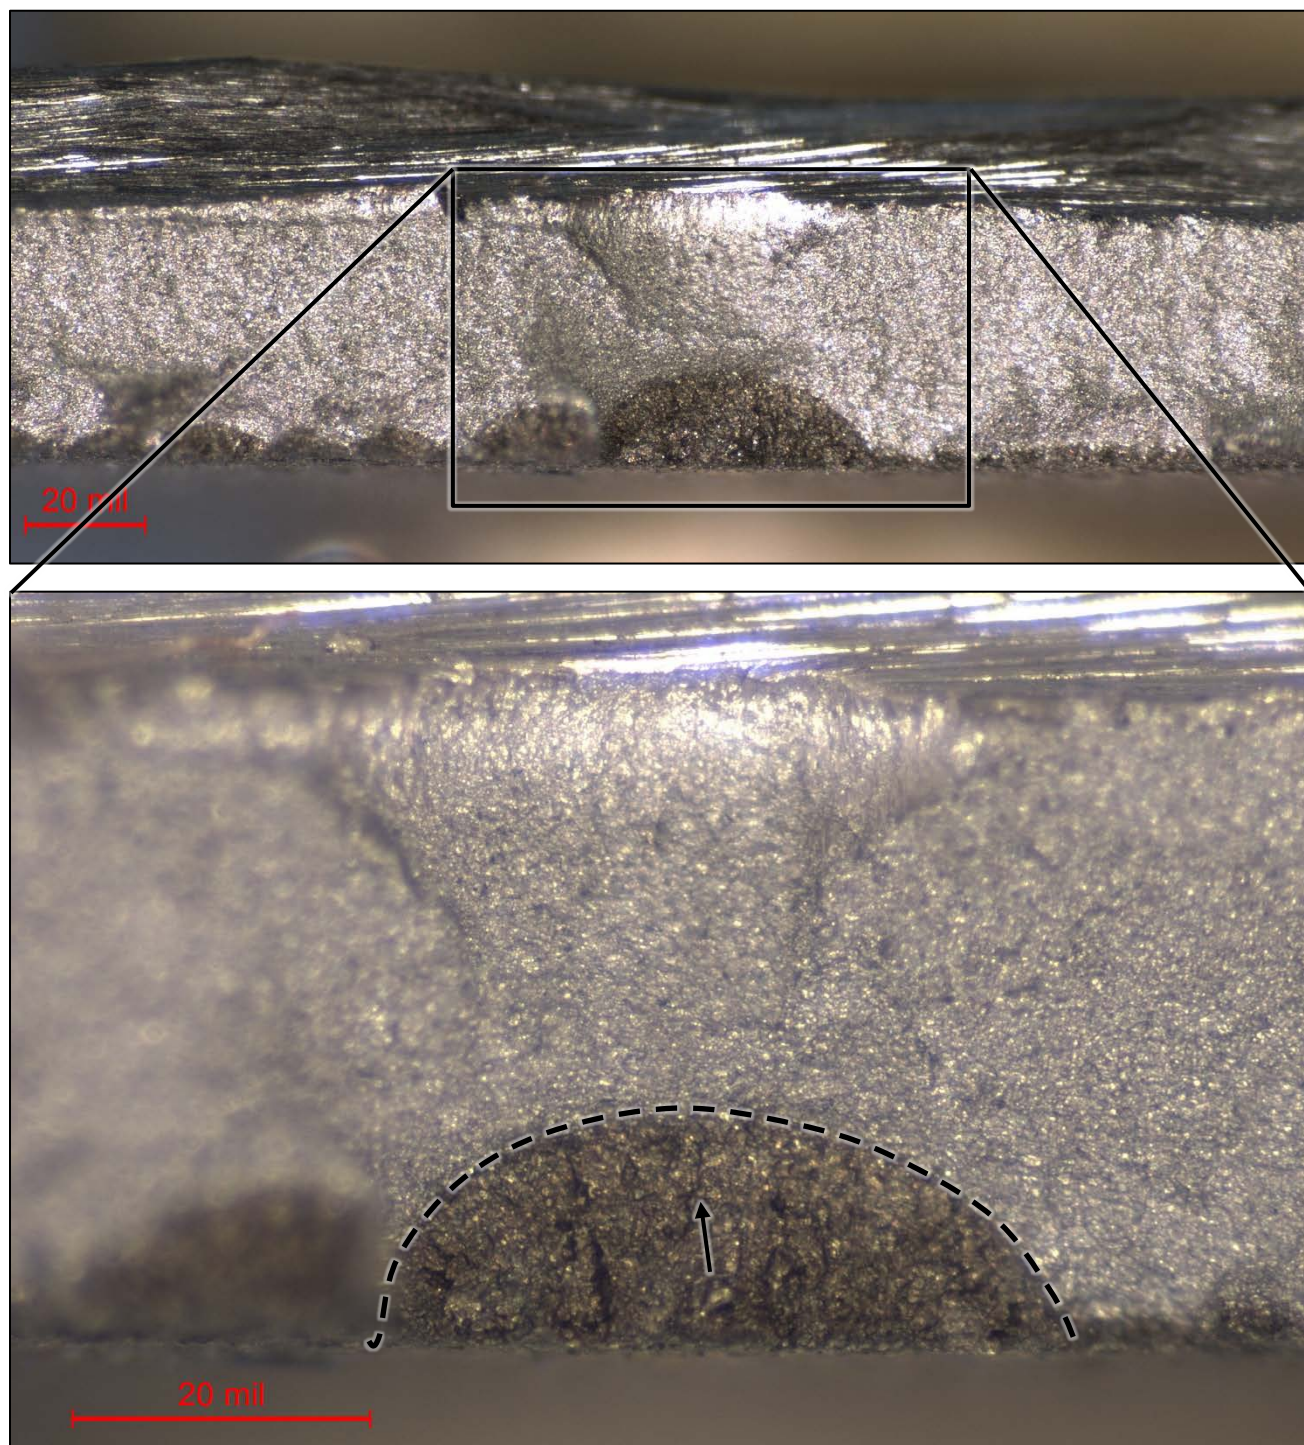
Figure 35. Optical images of the crack opened by lab fracture in blade 2. A dashed line in the lower image indicates the fatigue boundary of the primary crack feature, and an arrow indicates a crack arrest line. (Images provided by GE.)

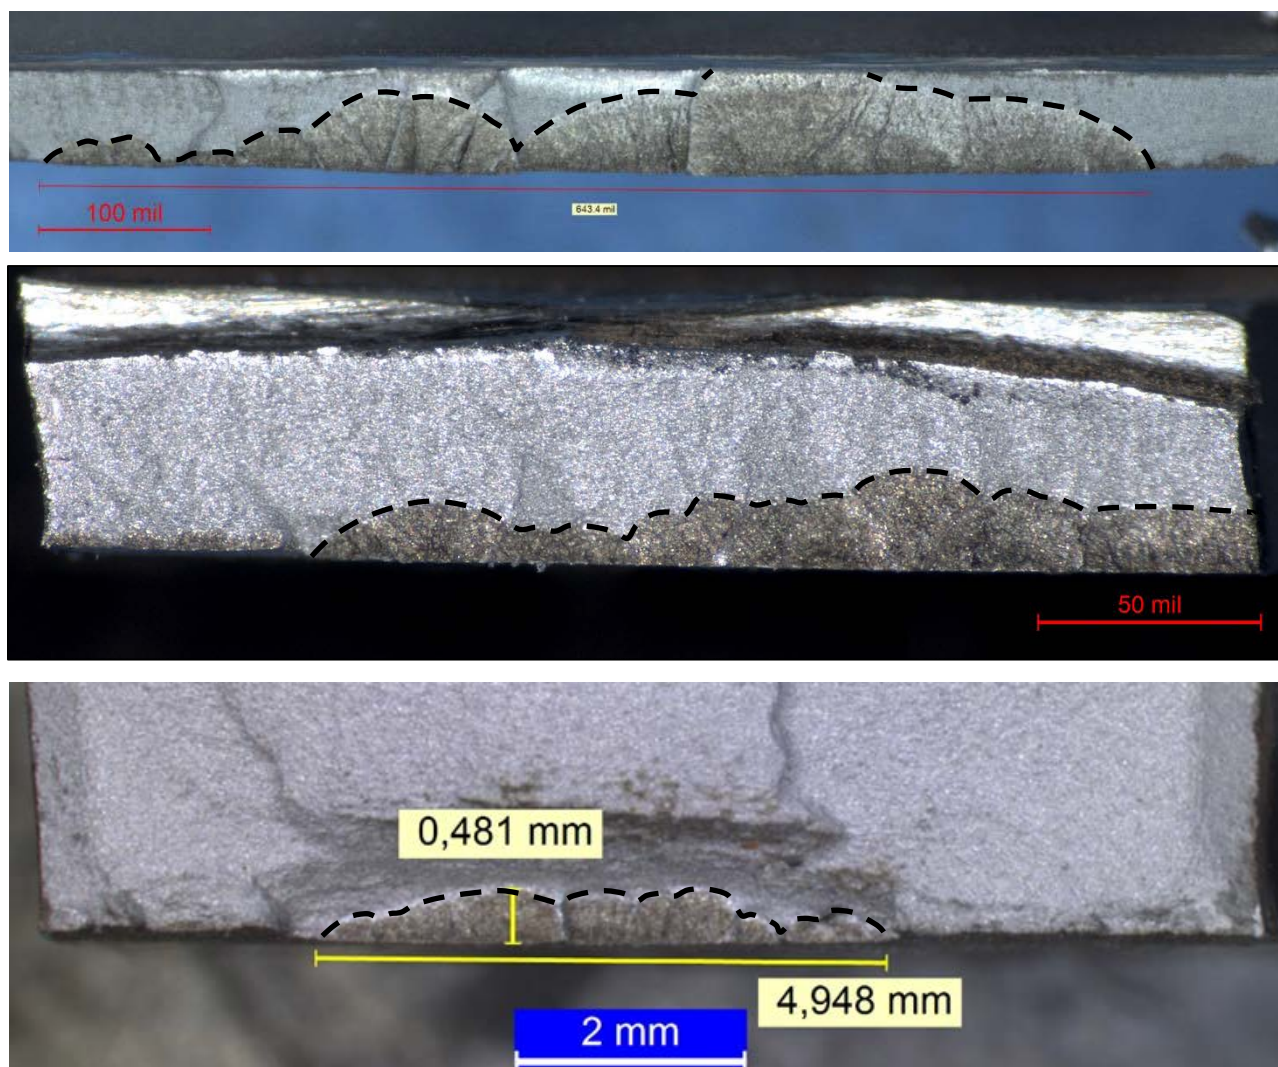
Figure 36. Optical images of cracks opened by lab fracture in blade 11 (upper image), blade 17 (middle image), and blade 19 (lower image). Dashed lines indicate the fatigue boundaries of the primary crack feature. (Upper and middle images provided by GE, and lower image provided by Safran.)

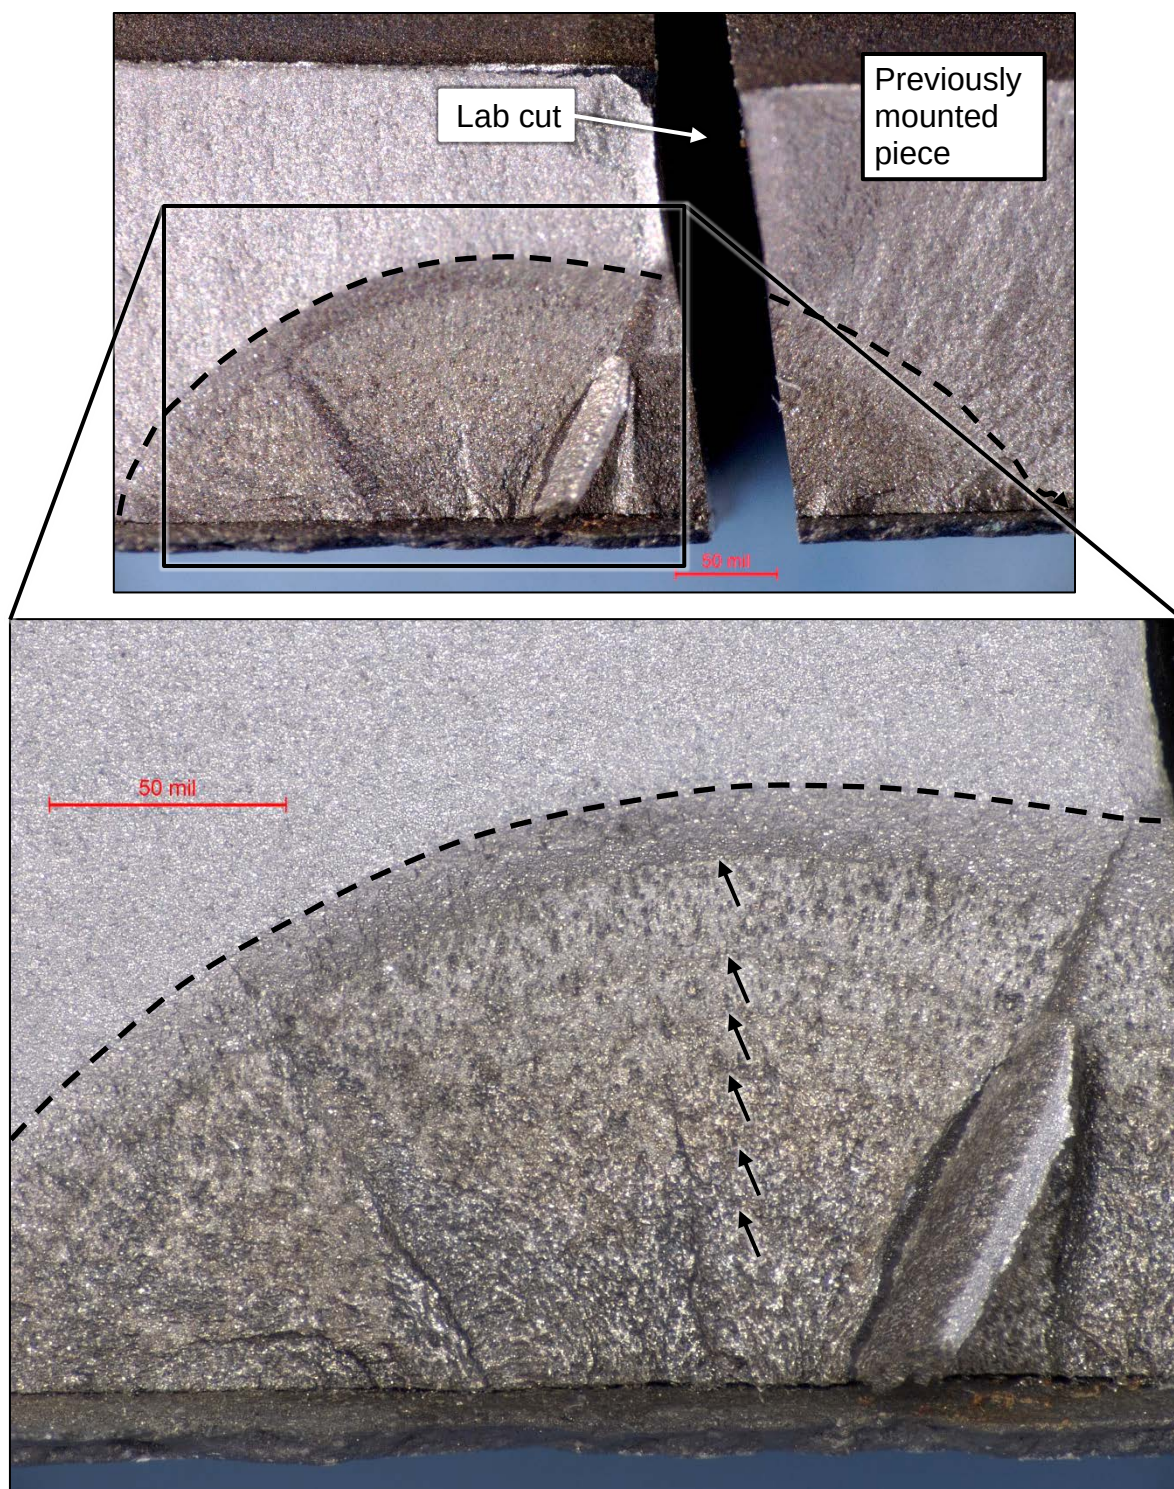
Figure 37. Optical images of the crack opened by lab fracture in blade 24. Dashed lines indicate the fatigue boundary of the primary crack feature, and arrows indicate crack arrest lines. (Images provided by GE.)

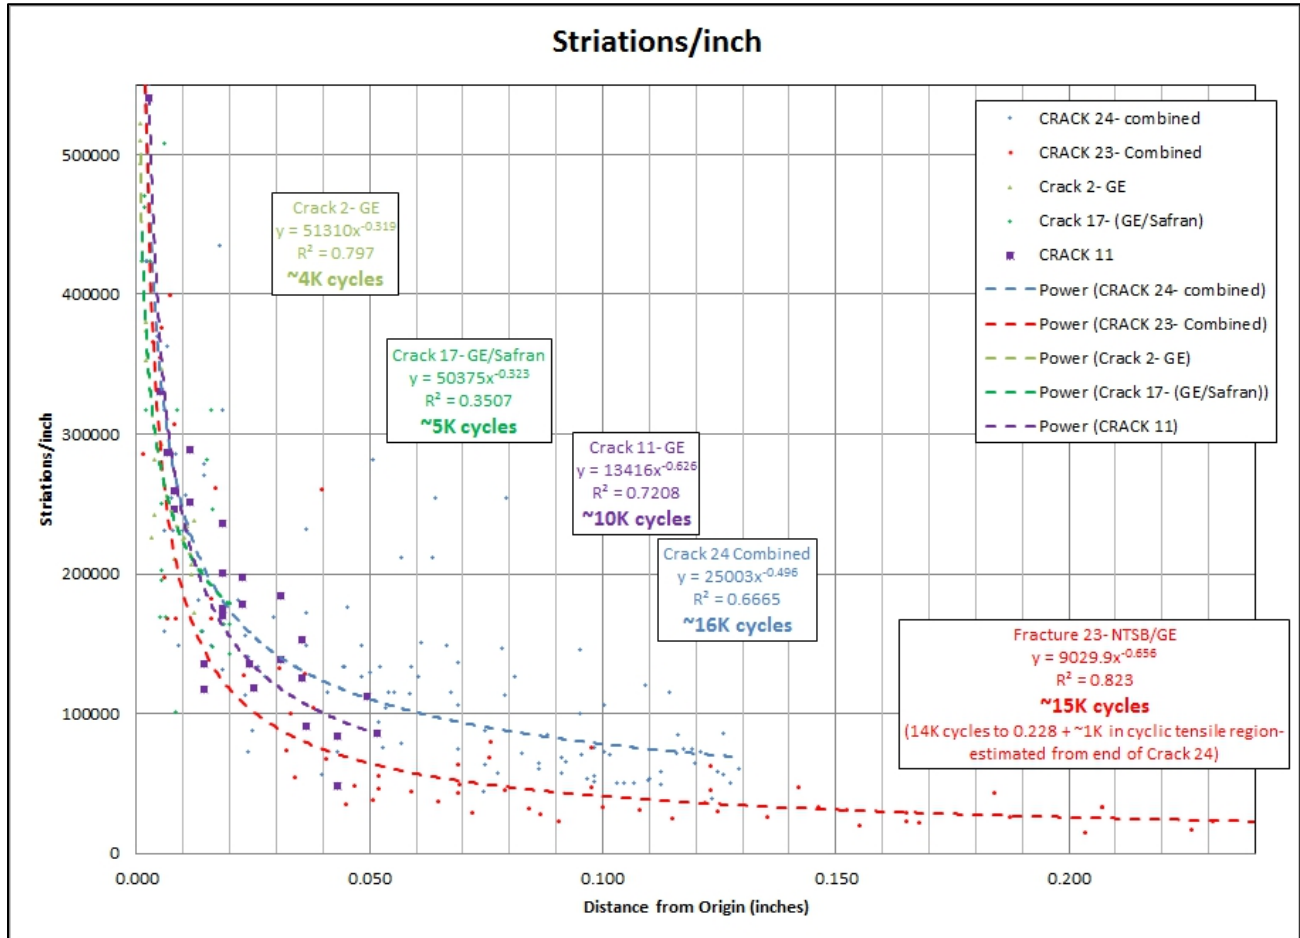
Figure 38. Striation density as a function of distance from the origin for fractured blade 23 and cracked blades 2, 11, 17, and 24. (Chart provided by GE.)

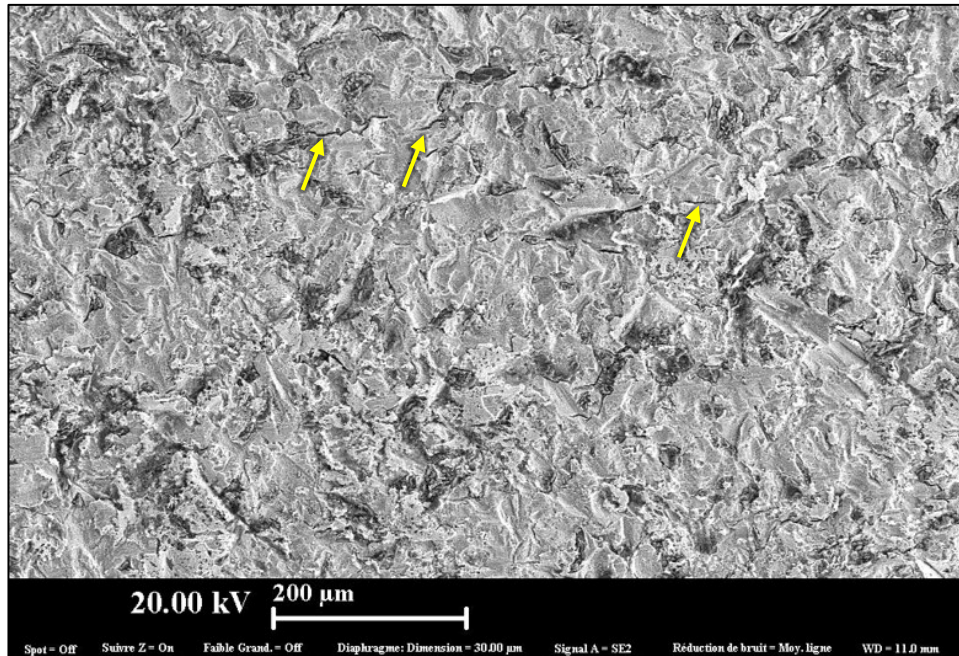
Figure 39. SEM image with unlabeled arrows indicating isolated microcracks on the surface of blade 5. (Image provided by Safran.)

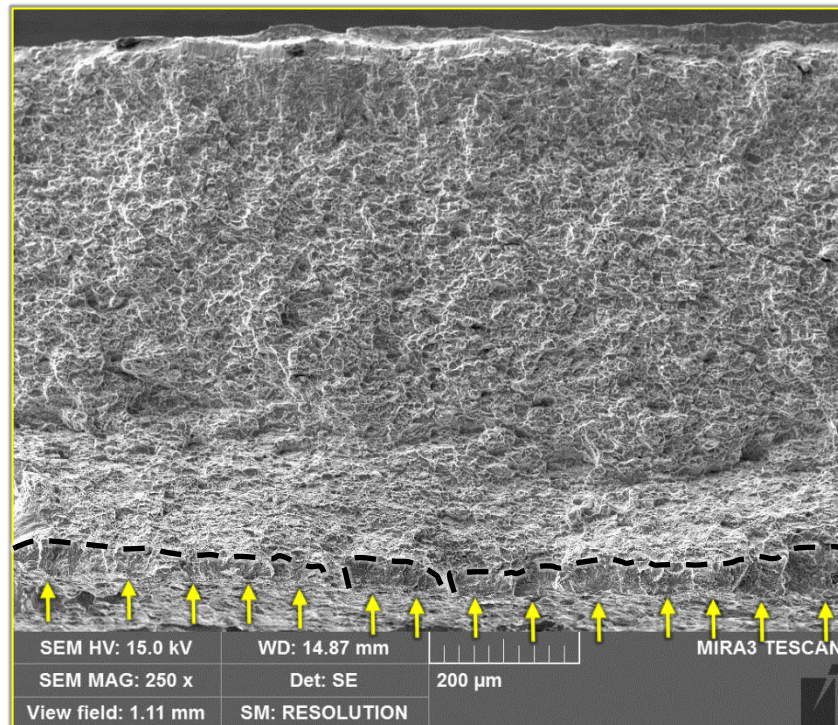
Figure 40. Network of microcracks in blade 21 opened by lab fracture. Dashed lines indicate microcrack boundaries, and arrows indicate origins at the blade surface. (SEM Image provided by GE.)

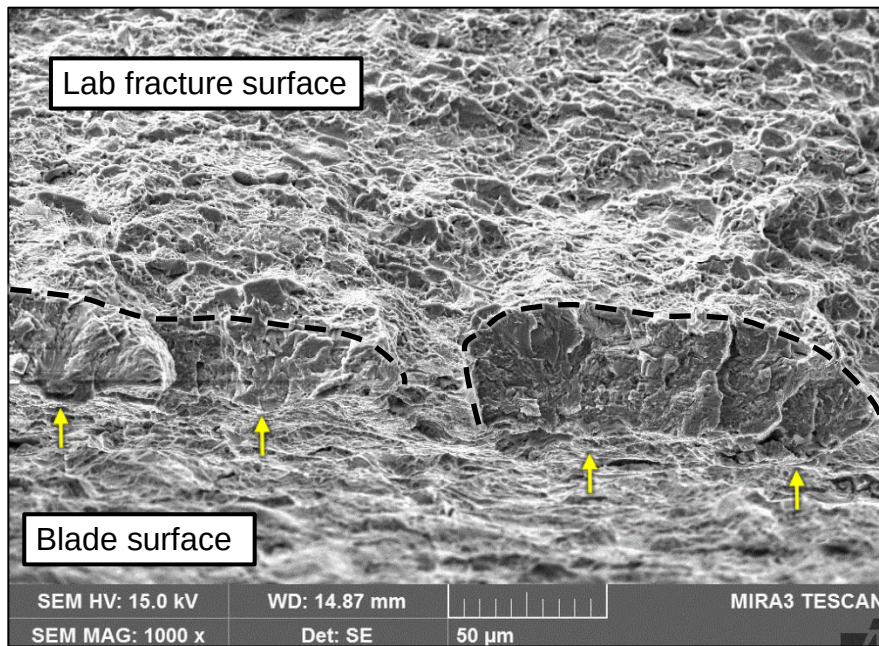
Figure 41. Closer view of microcracks in blade 21 opened by lab fracture. Dashed lines indicate microcrack boundaries, and arrows indicate origins at the blade surface. (SEM Image provided by GE.)

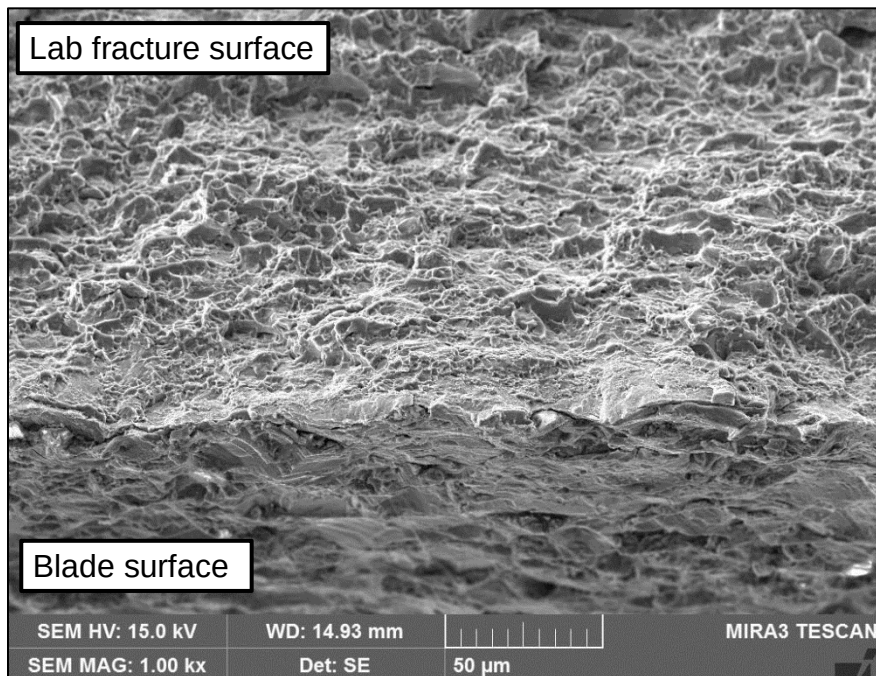
Figure 42. Lab fracture in blade 10 away from microcracks showing slant angles and dimpled fracture adjacent to the surface consistent with ductile overstress fracture. (SEM Image provided by GE.)

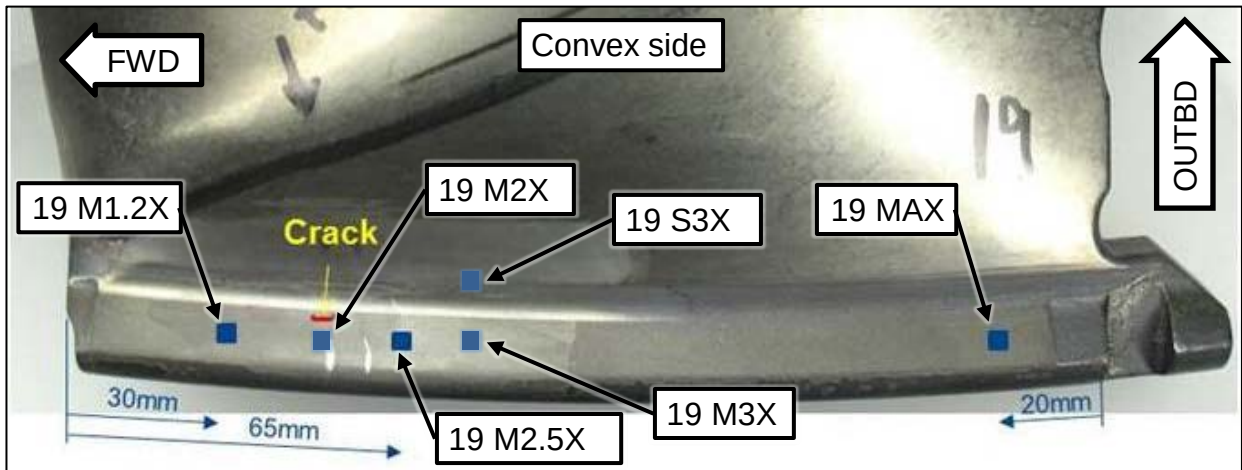
Figure 43. Approximate locations where residual stress profiles were acquired on blade 19 as indicated with blue boxes and labeled with the location reference code. (Image provided by Safran.)

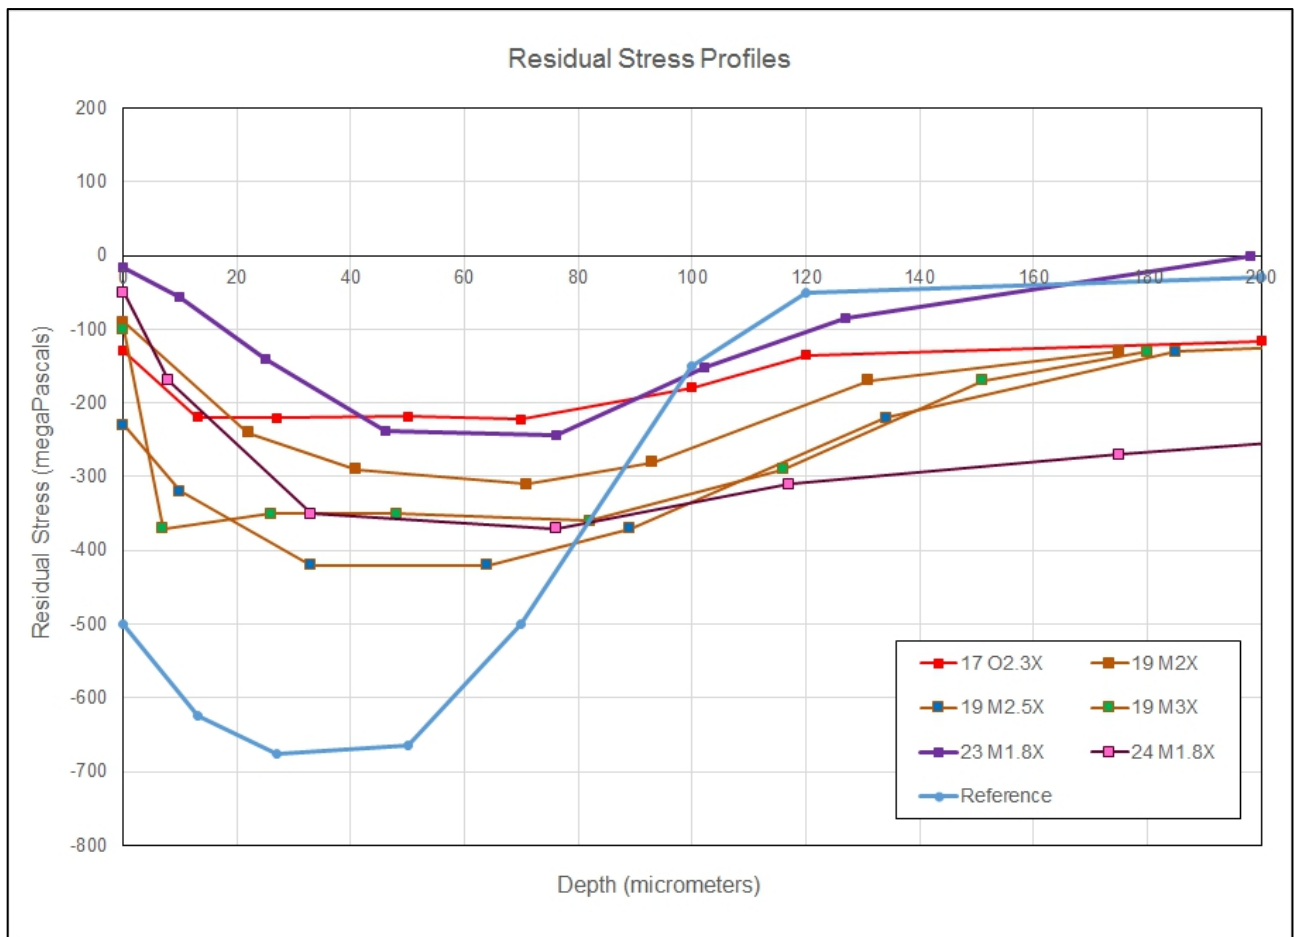
Figure 44. Residual stress profiles for cracked and fractured blades measured on the contact face near the area of cracking. The reference residual stress profile is also shown for comparison.

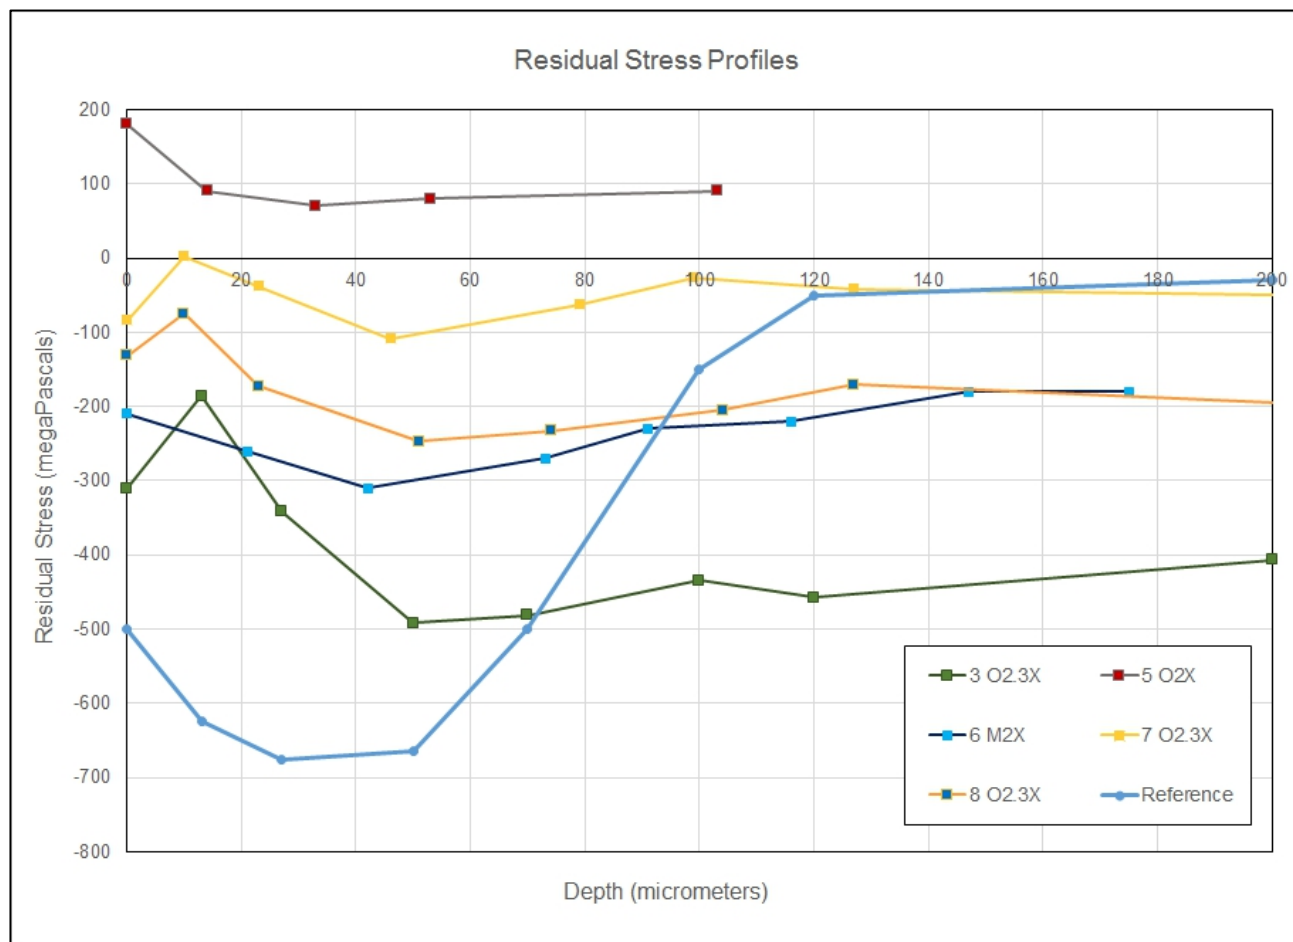
Figure 45. Residual stress profiles for blades without cracks. The profiles were acquired on the contact face in or near the area where cracks had been detected in other blades. The reference profile is also shown for comparison.

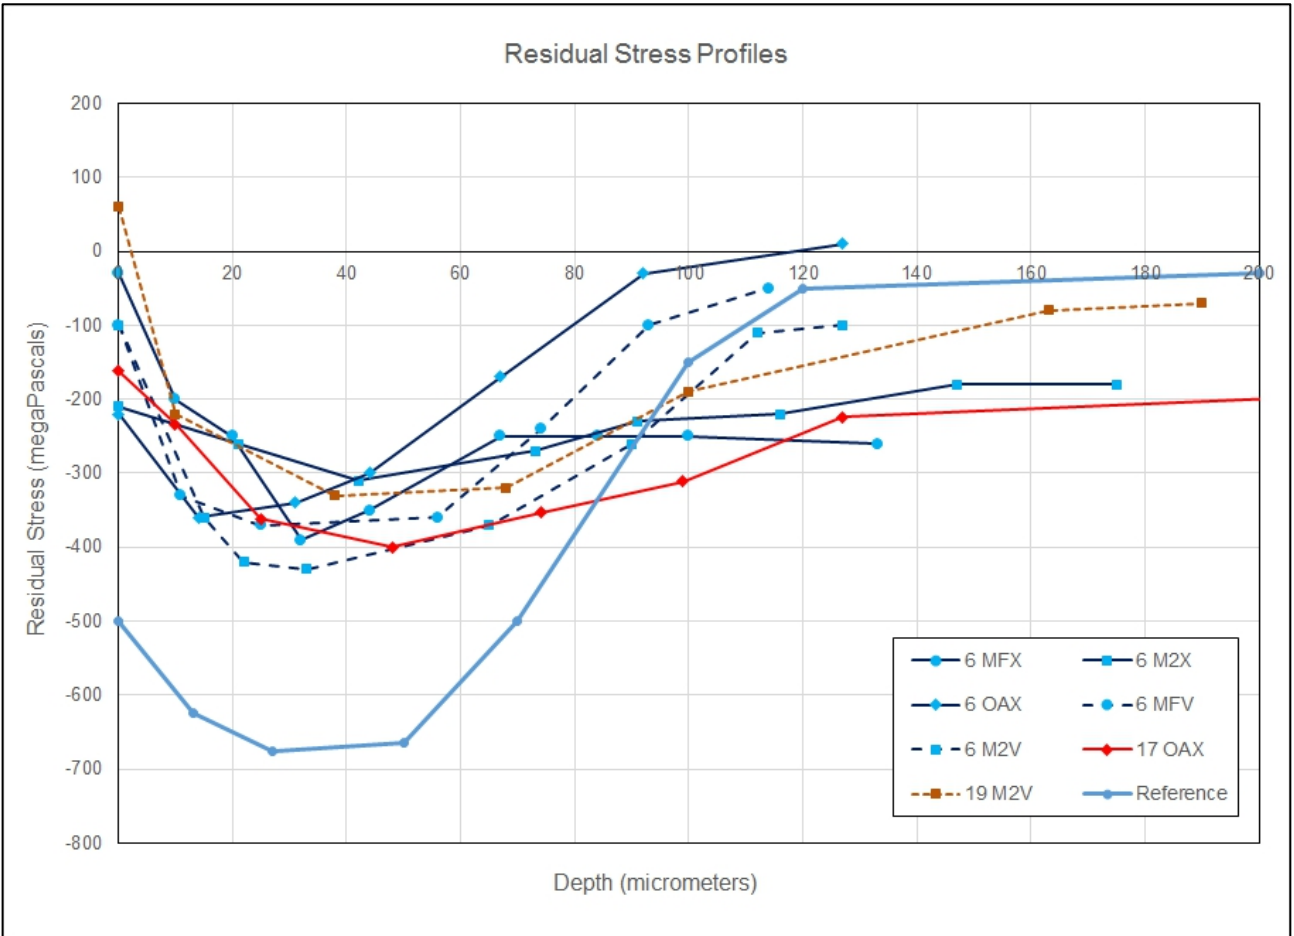
Figure 46. Abnormal residual stress profiles measured on the contact faces in areas away from cracks or microcracks. The reference profile is also shown for comparison.
