# NATIONAL TRANSPORTATION SAFETY BOARD

Office of Research and Engineering  
Materials Laboratory Division  
Washington, D.C. 20594

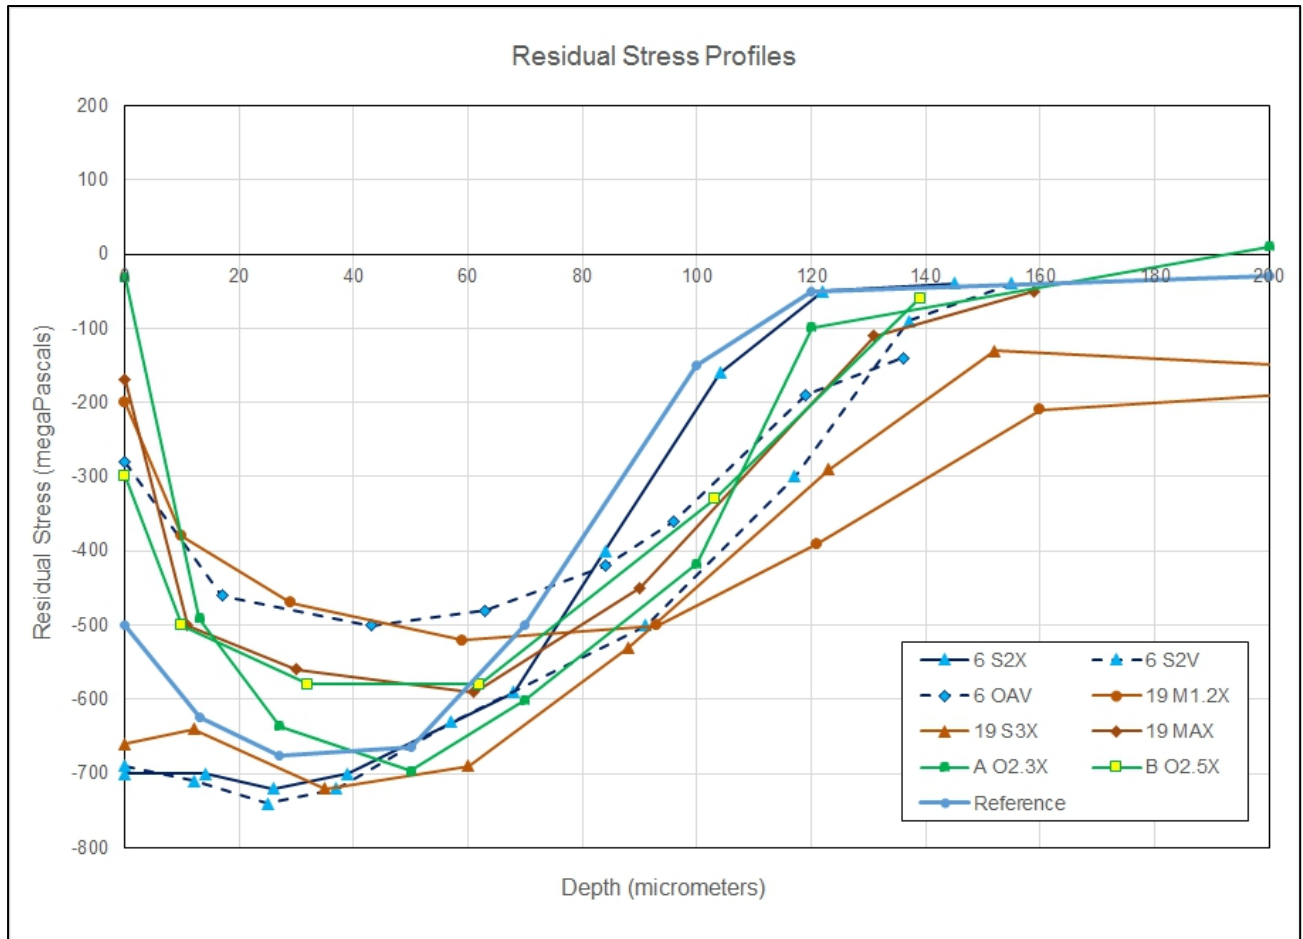
Figure 47. Residual stress profiles where the minimum residual stress value was less than or equal to -500 megapascals (rows highlighted in green in table 4).

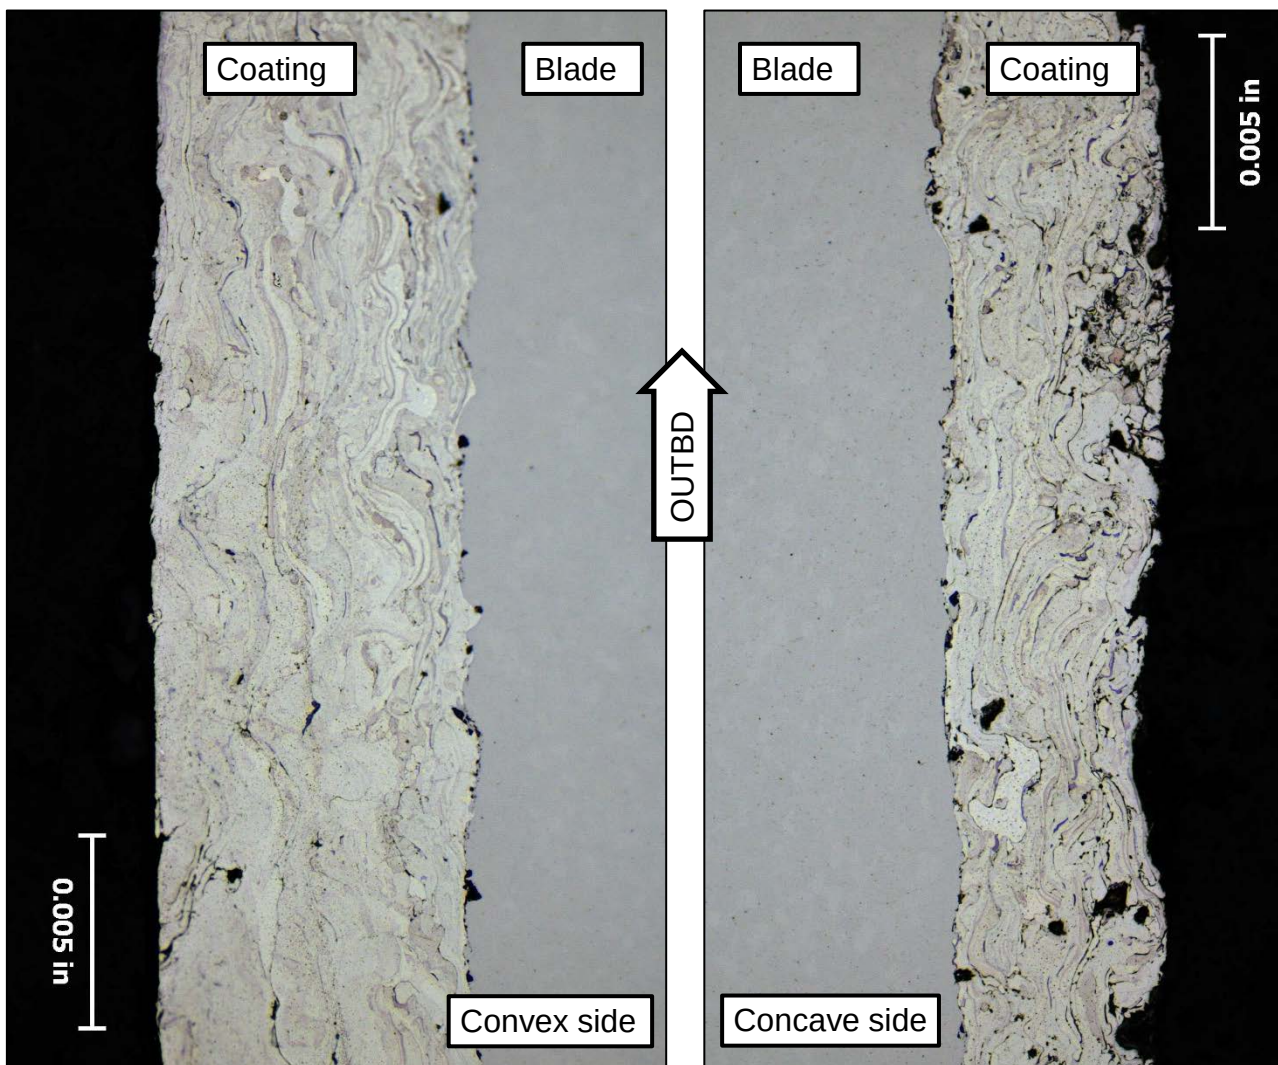
Figure 48. Views of the Cu-Ni-In coating on blade 24 as observed in the metallographic cross-section. The sample had been etched with Kroll's reagent and then repolished.

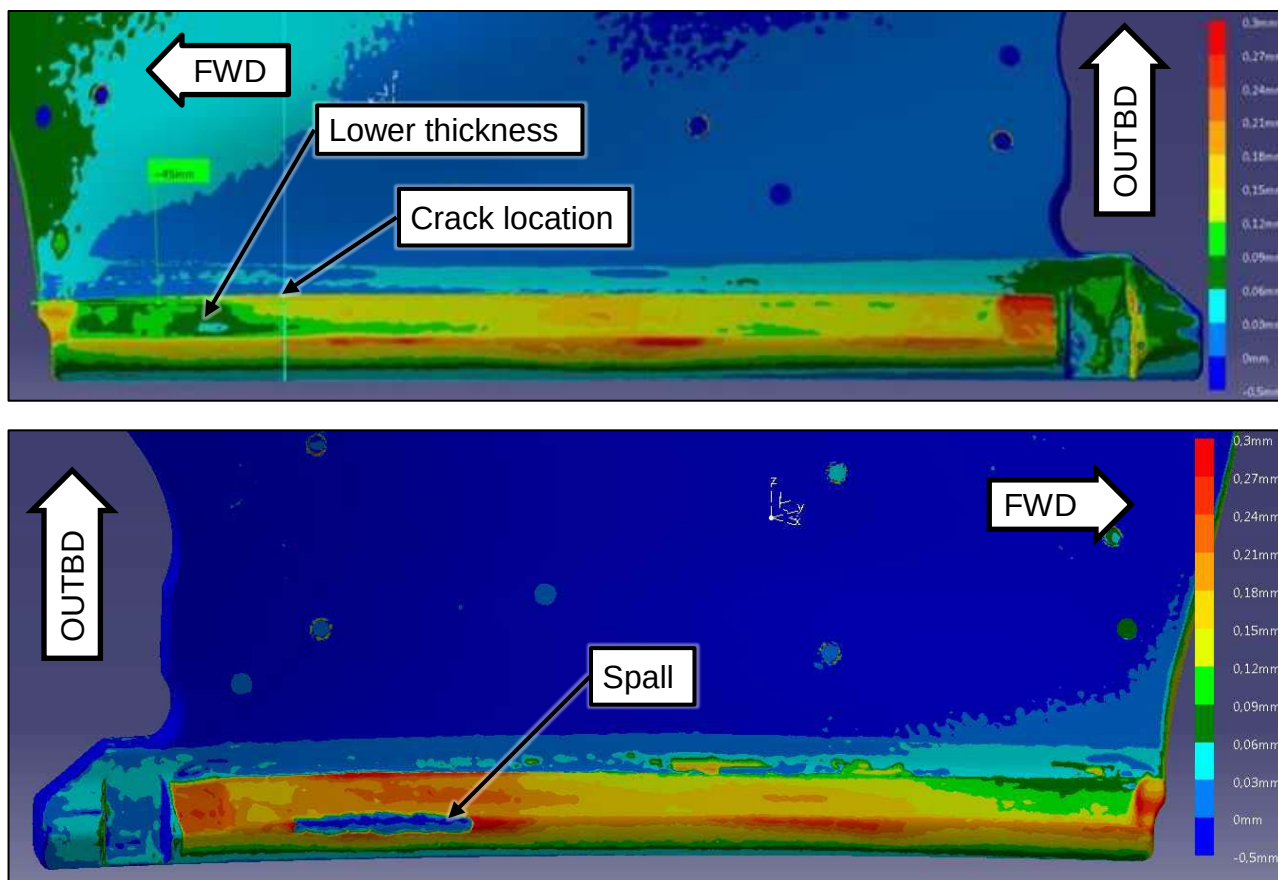
Figure 49. Coating thickness maps for the Cu-Ni-In coating on blade 1 showing the convex side (upper image) and the concave side (lower image). (Images provided by Safran.)

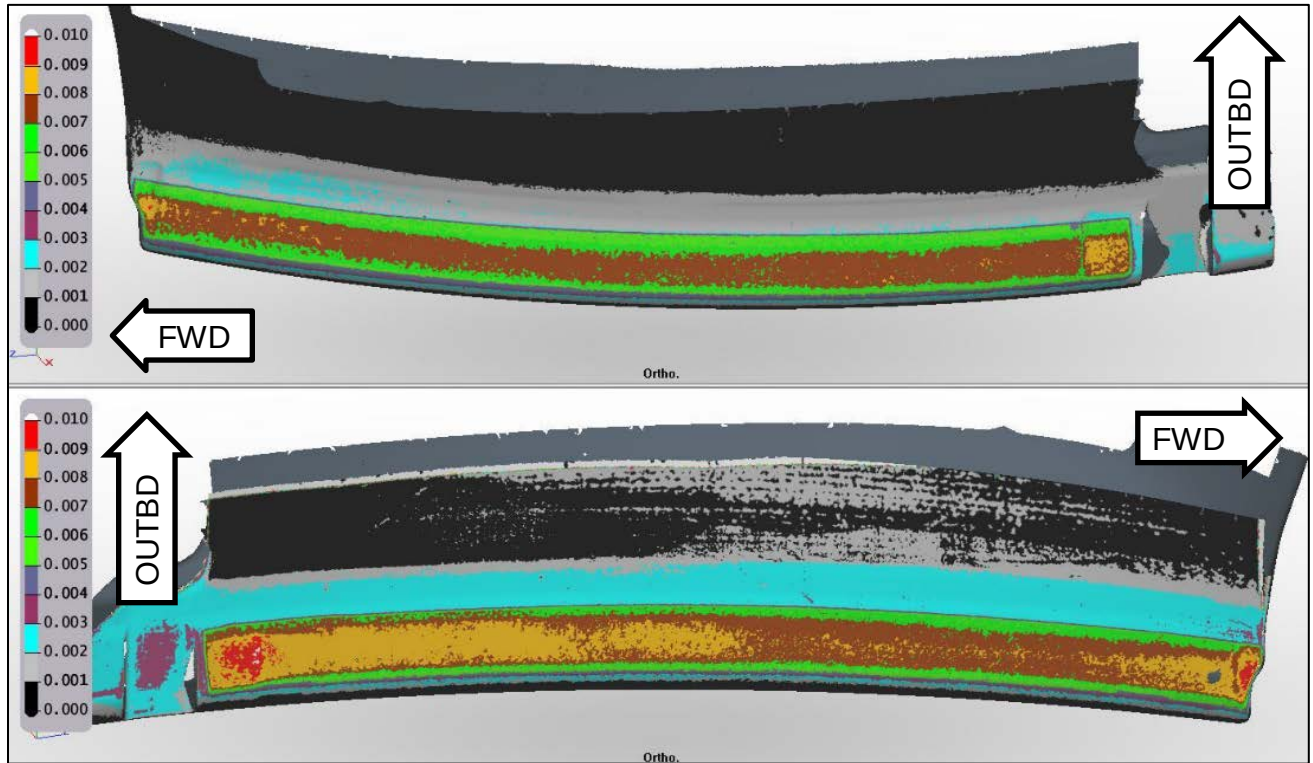
Figure 53. Thickness maps for the Cu-Ni-In coating on exemplar blade A showing the convex side (upper image) and the concave side (lower image). Coating thickness exceeding specification was observed on both sides along the length of the contact face. (Images provided by GE.)

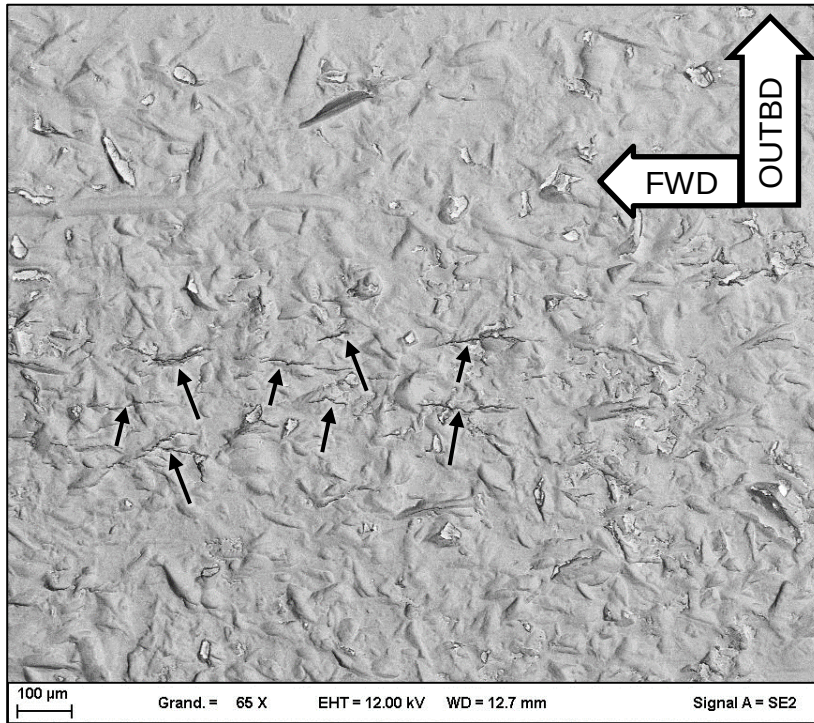
Figure 54. SEM image of the blade D surface after etching with modified Kroll's reagent where unlabeled arrows indicate microcracks. (Image provided by Safran.)

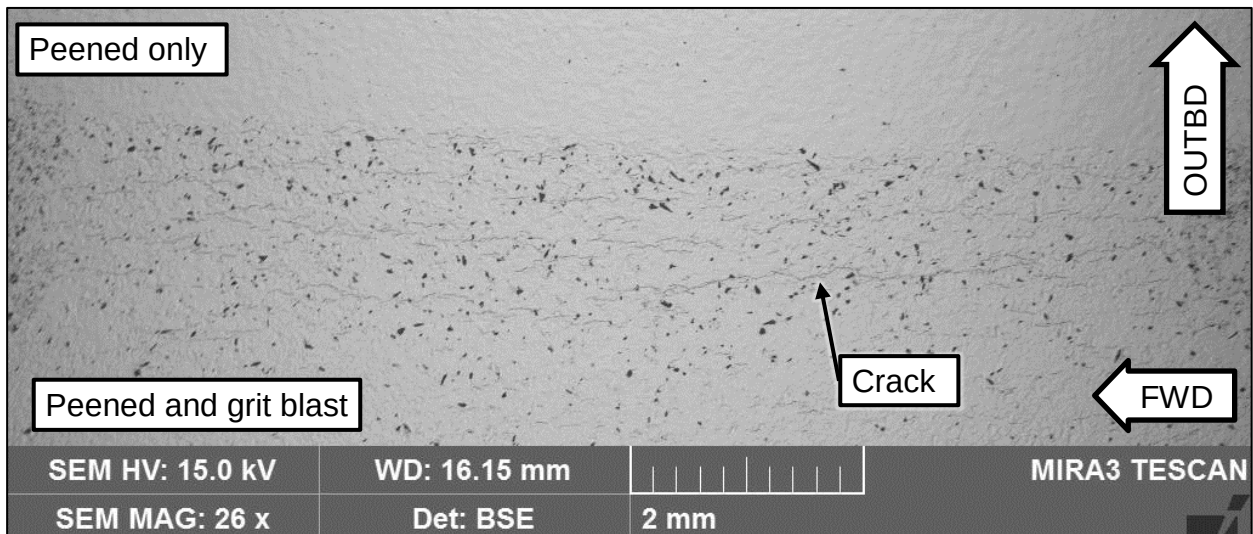
Figure 56. SEM image of the blade J surface after etching with modified Kroll's reagent showing a crack surrounded by microcracks. (Image provided by GE.)

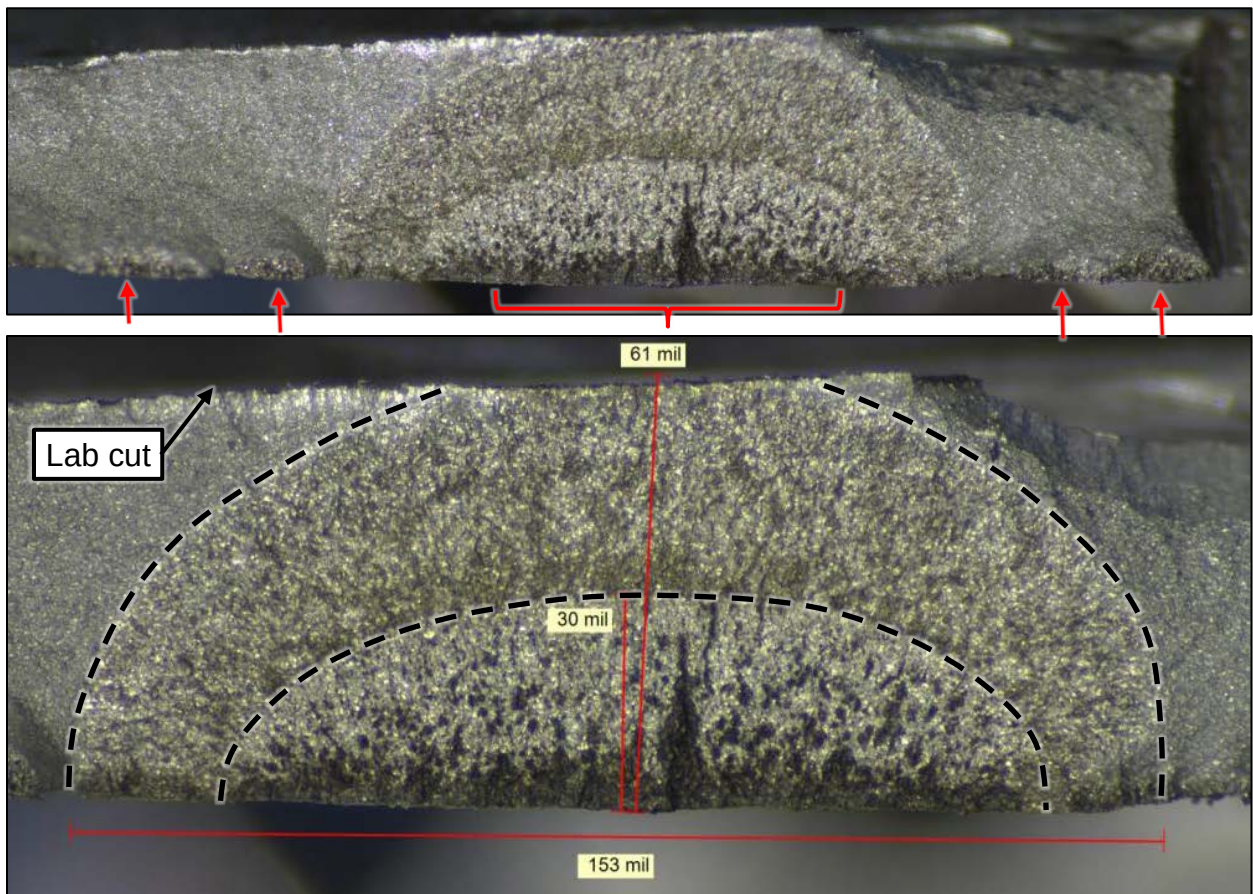
Figure 57. Optical image of the lab fracture (upper image) with a closer view of the fatigue region (lower image). Unlabeled arrows and a bracket in the upper image indicate approximate origin areas for the crack and adjacent microcracks. Dashed lines in the lower image indicate a crack arrest line and the fatigue boundary for the crack. (Images provided by GE.)

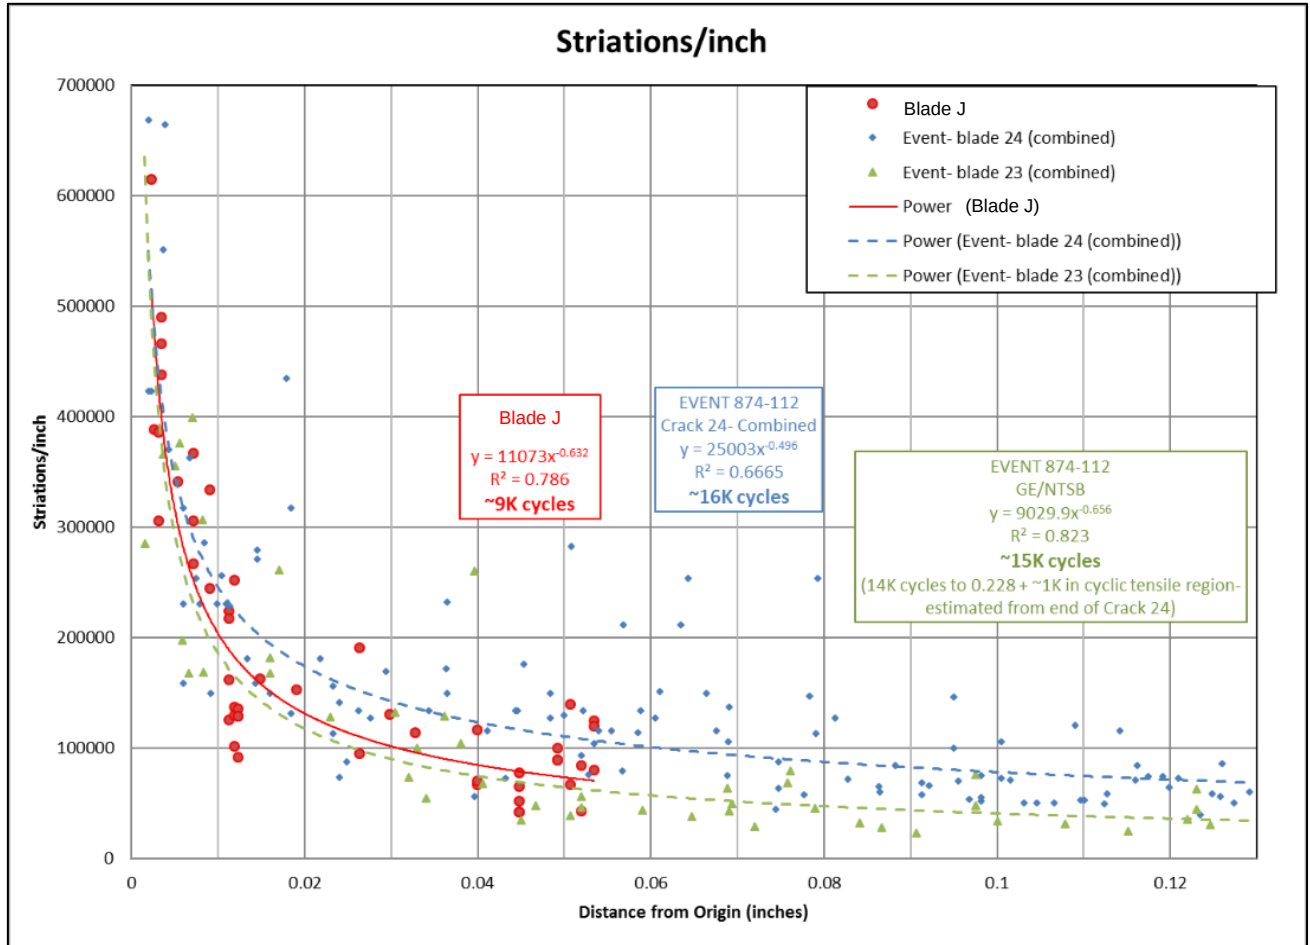
Figure 58. Striation density as a function of distance from the origin for cracked blade J. Data from accident blades 23 and 24 are also shown for reference. (Chart provided by GE.)

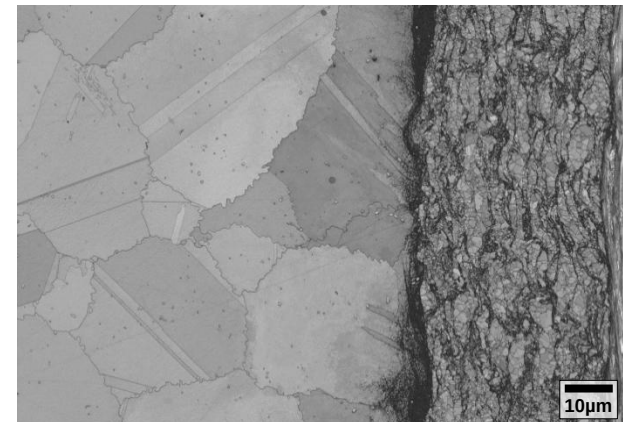
**Band Contrast** - indicates the contrast/quality of the diffraction pattern observed at every point of the map (black=worst, white=best).
