**NATIONAL TRANSPORTATION SAFETY BOARD**  
**Office of Aviation Safety**  
**Washington, D.C. 20594**

**November 12, 2018**

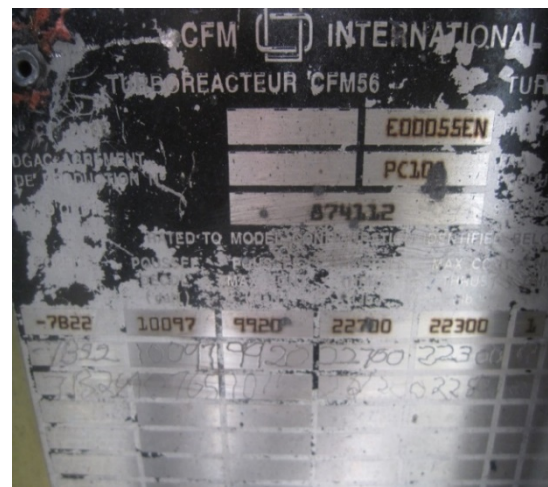
**PHOTO 1: LEFT ENGINE DATA PLATE**

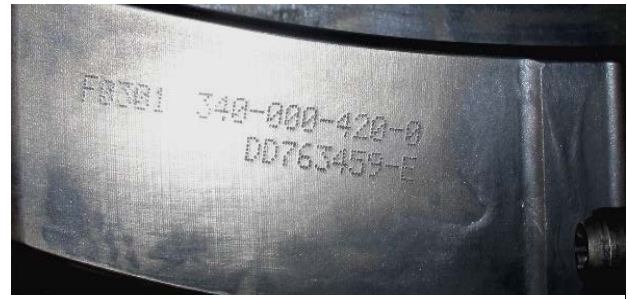
**PHOTO 2: EVENT FAN DISK PN AND SN**

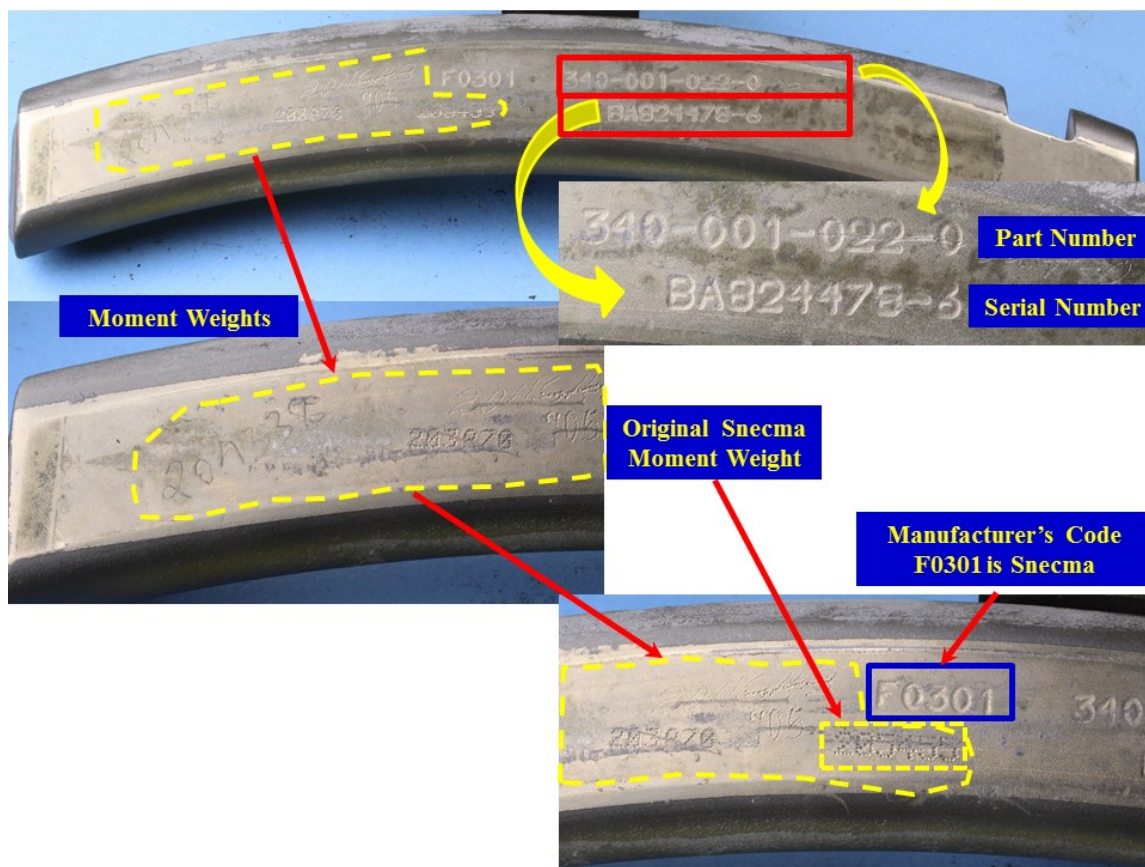
**PHOTO 3: FAN BLADE MARKING IDENTIFICATION**

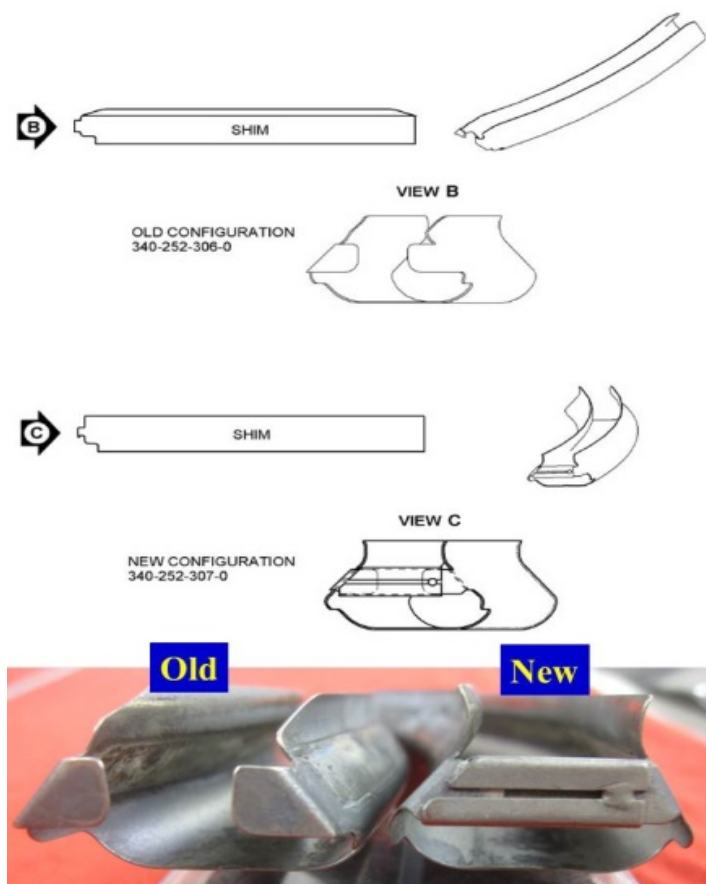
**FIGURE 4: FAN BLADE SHIM CONFIGURATION**

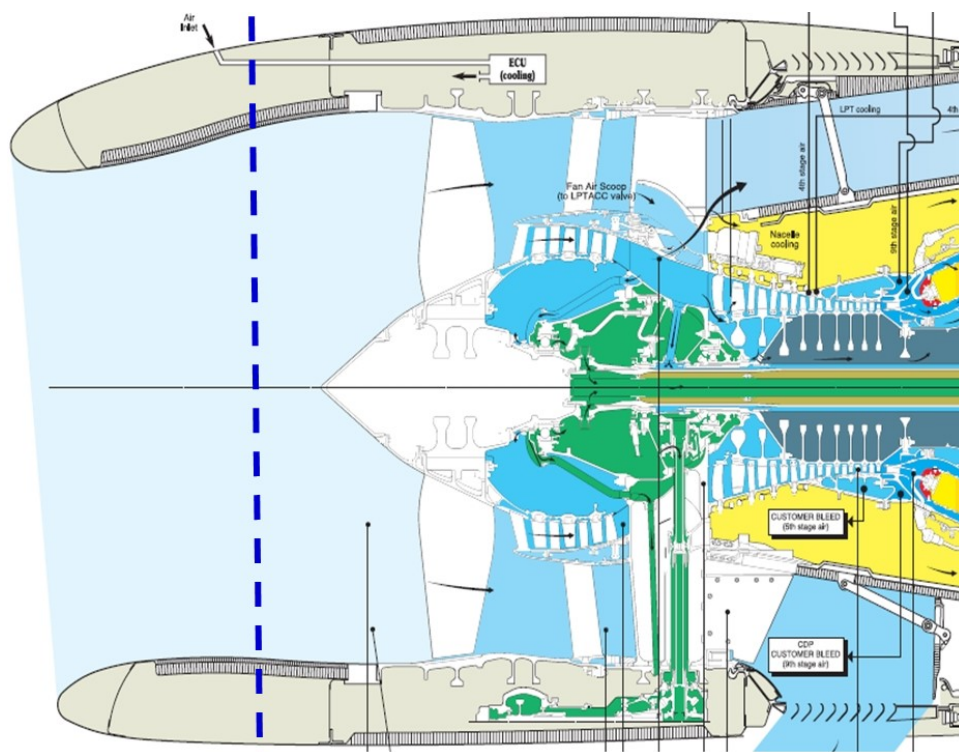
**FIGURE 11: DASHED LINE APPROXIMATE FRACTURE LOCATION**

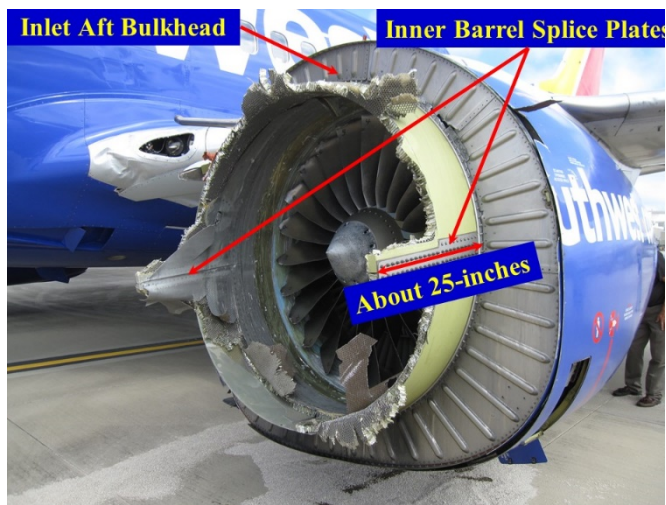
**PHOTO 8: LEFT ENGINE INLET – OUTBOARD**

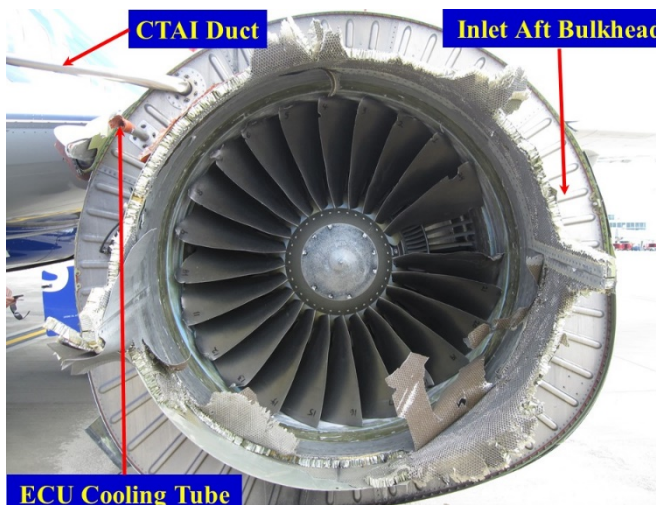
**PHOTO 9: LEFT ENGINE INLET – FRONTAL**

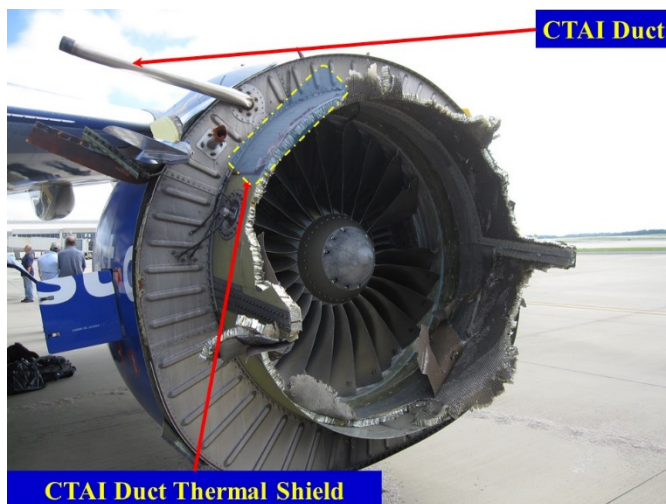
**PHOTO 10: LEFT ENGINE INLET – INBOARD**

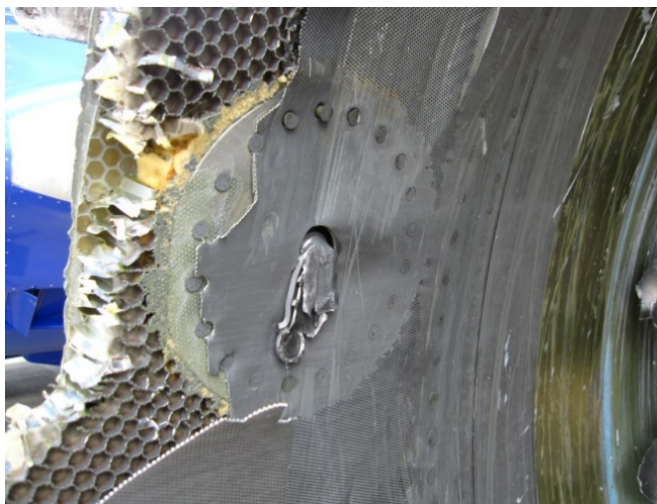
**PHOTO 11: LEFT ENGINE DAMAGED T12 PROBE**

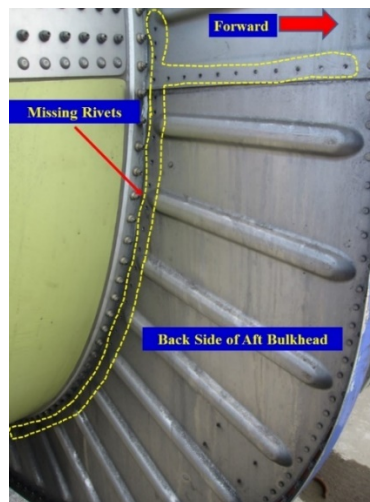
**PHOTO 12: LEFT ENGINE INLET AFT BULKHEAD MISSING RIVETS - INBOARD SIDE**

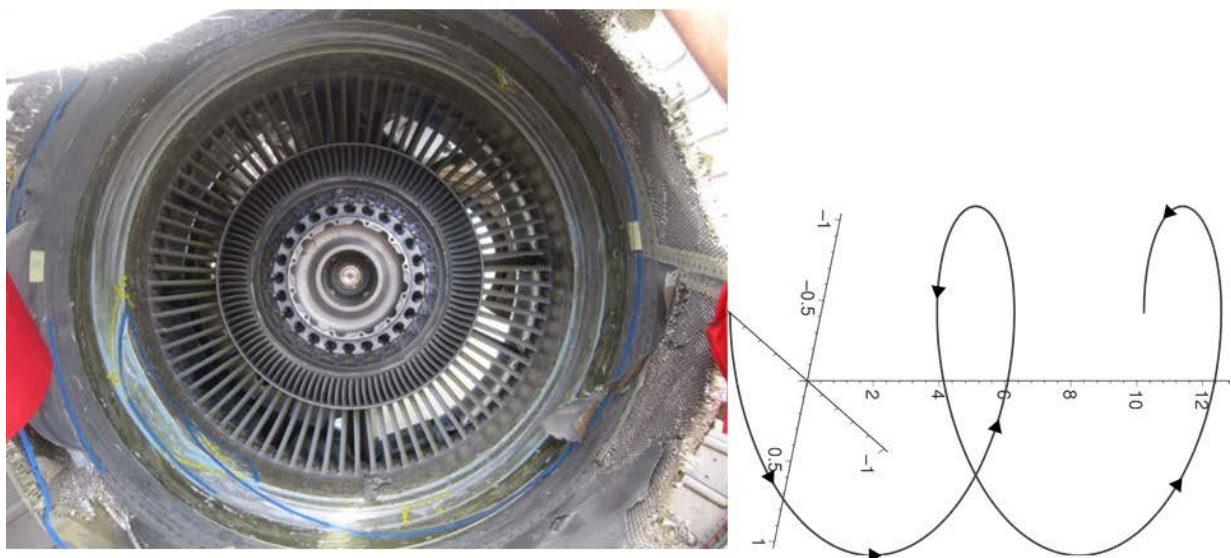
**PHOTO 13: LEFT ENGINE FAN CASE AND INLET OVERALL VIEW OF DEBRIS PATH<sup>12</sup>**

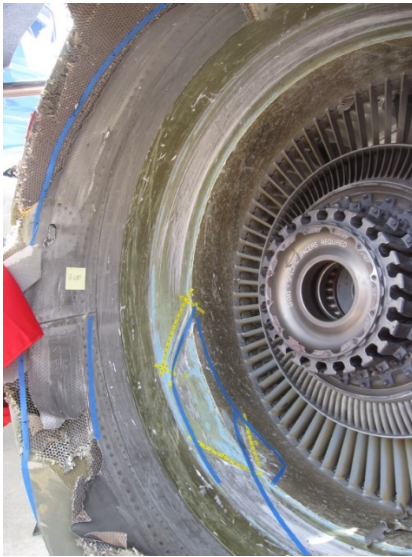
**PHOTO 14: LEFT ENGINE INLET DAMAGE AND DEBRIS PATH AT THE 3:00 O'CLOCK POSITION**

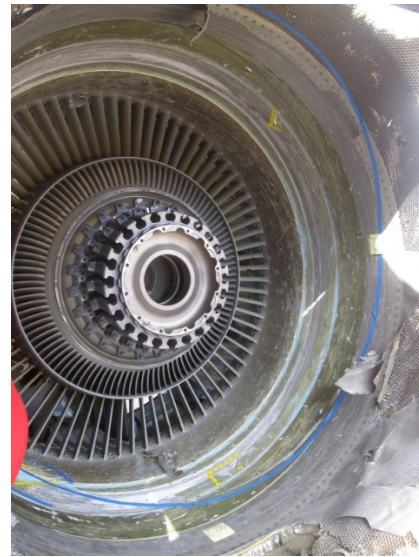
**PHOTO 15: LEFT ENGINE INLET DAMAGE AND DEBRIS PATH AT THE 9:00 O'CLOCK POSITION**

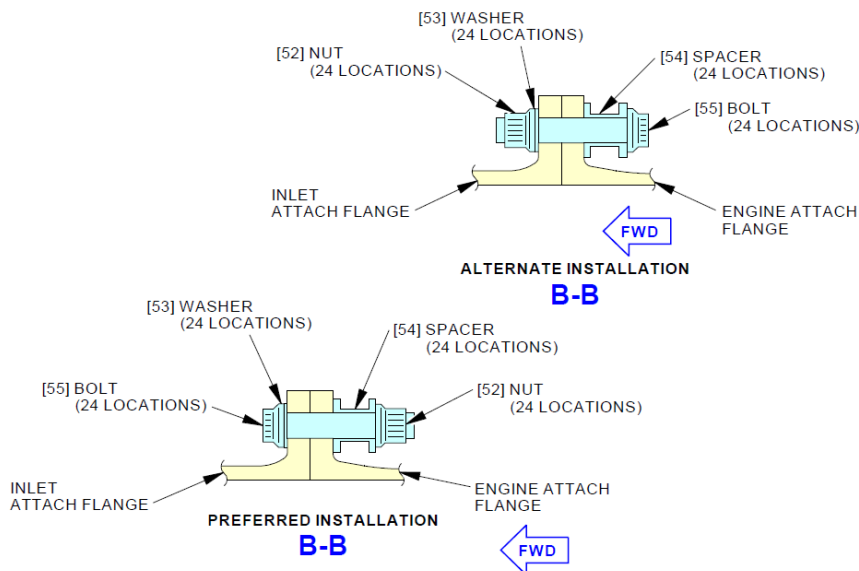
**FIGURE 12: INLET-TO-FAN CASE ATTACHMENT CONFIGURATION**

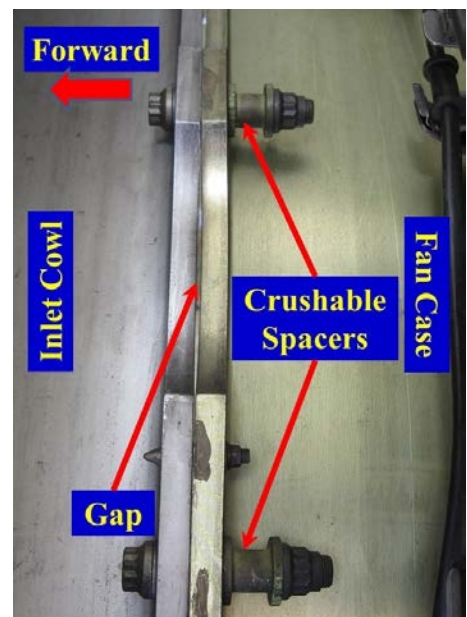
**PHOTO 16: INLET-TO-FAN CASE ATTACHMENT CONFIGURATION AND GAP BETWEEN ASSEMBLIES**

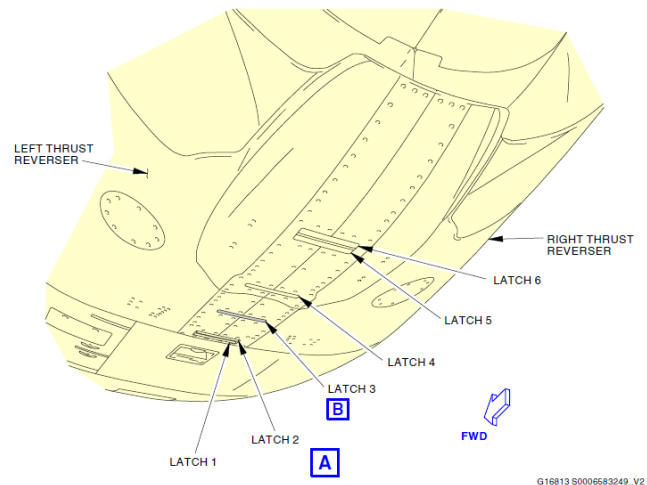
**FIGURE 13: THRUST REVERSER LATCH LOCATIONS**

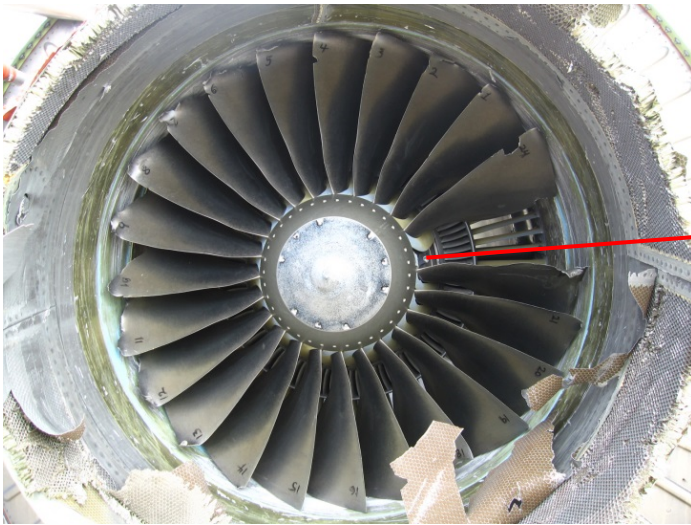
**PHOTO 17: FAN BLADE FRACTURE – NO. 23**

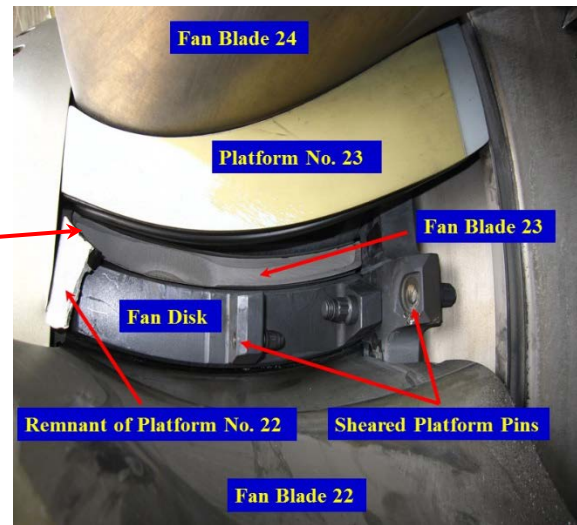
**PHOTO 18: NO. 23 ROOT STILL INSTALLED**

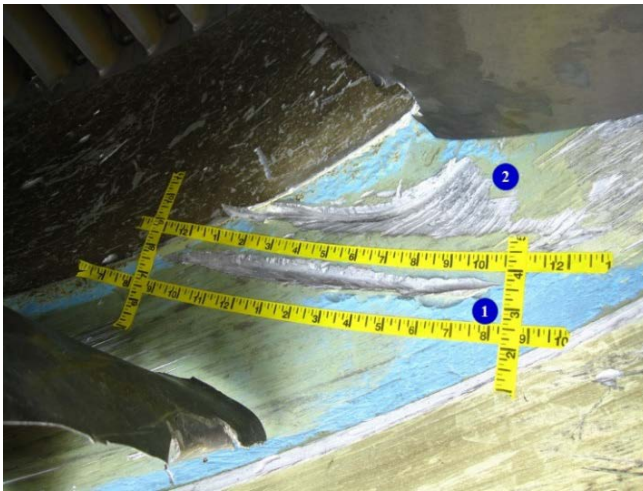
**PHOTO 19: FAN CASE IMPACTS ① AND ②**

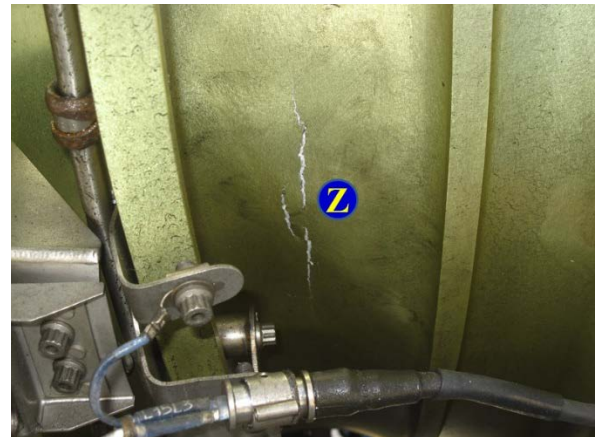
**PHOTO 24: TEAR IN THE OUTER SKIN OF THE LEFT ENGINE FAN CASE AT THE 5:00 O'CLOCK POSITION**

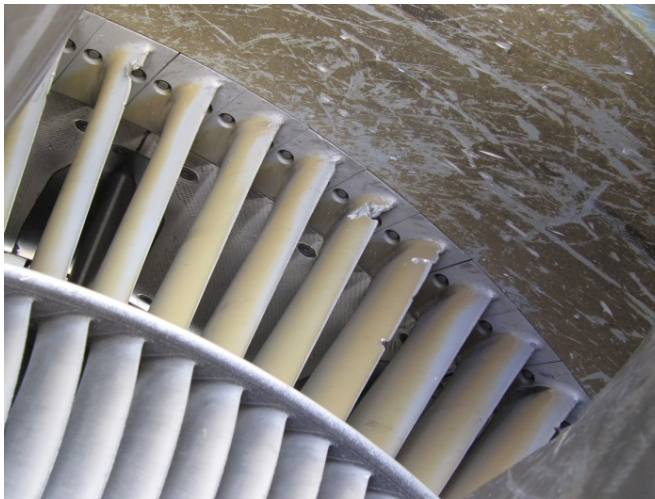
**PHOTO 25: LEFT ENGINE FAN OGV DAMAGE**

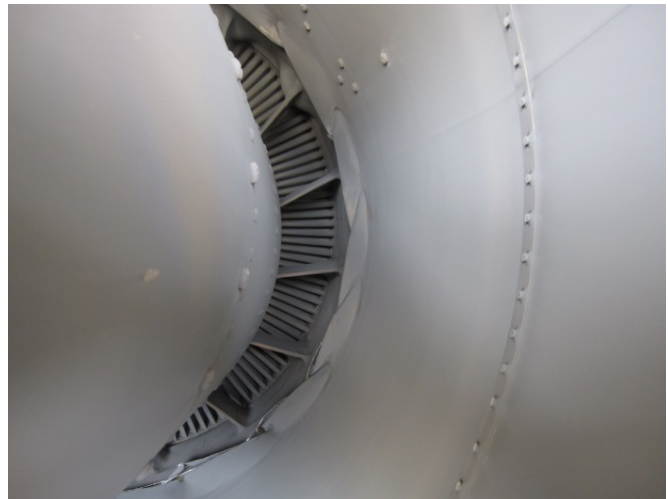
**PHOTO 26: LEFT ENGINE LPT STAGE 4 BLADES INTACT AND PRIMARY EXHAUST NOZZLE BUCKLED AND DISTORTED**

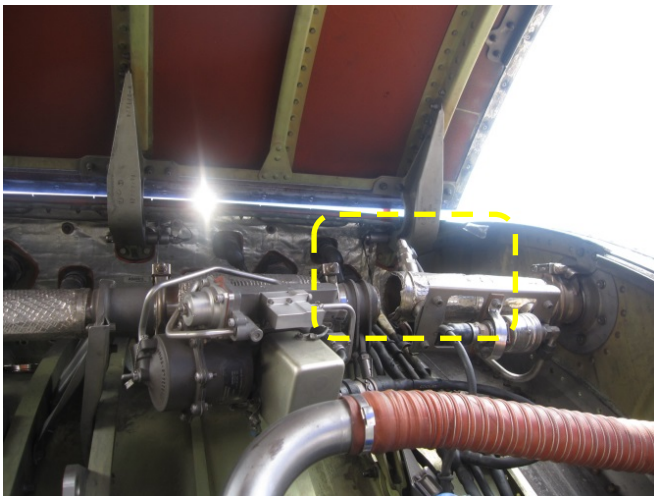
**PHOTO 27: CTAI DUCT SEPARATION**

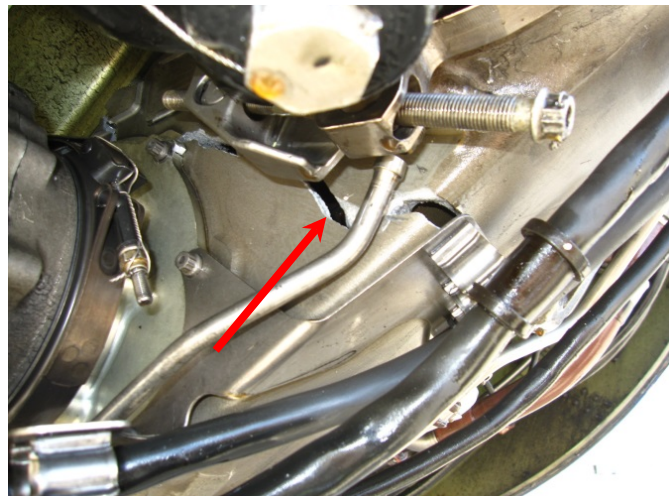
**PHOTO 28: LEFT ENGINE AGB FRACTURE**

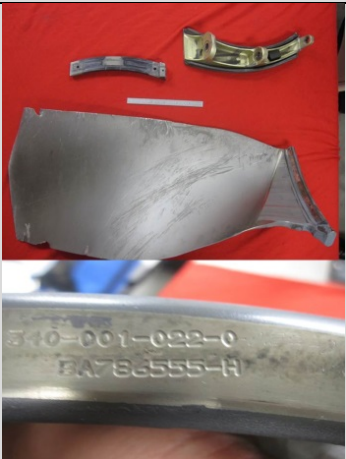
| Position | Fan Blade Part Markings | Serial Number (Photo No.1) | Condition | Picture |
|---|---|---|---|---|
| 1 | <del>PN 340-001-022-0</del><br>PN 340-001-027-0<br>F0301 - Snecma manufacturer's identification number<br>5 different MWs | BA786555-H<br>( <b>PHOTO 29</b> ) | <p><b>Airfoil:</b> LE and TE exhibited hard impact damage, tears, and missing material. LE tip curled in the direction opposite rotation. Blade tip intact; scuffing on airfoil pressure side.</p> <p><b>Blade Root:</b> Loss of coating on PS towards the TE.</p> <p><b>Shim:</b> Still installed and intact, no missing material. PN 340-252-306-0 (old configuration).</p> <p><b>Spacer:</b> No damage. PN 340-001-261-0 (F0301, F0732, and 07W25).</p> <p><b>Platform:</b> Intact, seals in good condition, was reworked <del>PN 340-001-814-0</del> PN 340-001-816-0 (F0301, FA9L6, and DL272004-5).</p> | <p><b>PHOTO 29: FAN BLADE 1</b></p> |

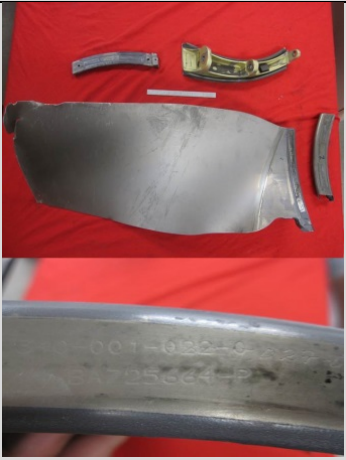
| Position | Fan Blade Part Markings | Serial Number (Photo No.1) | Condition | Picture |
|---|---|---|---|---|
| 2 | <del>PN 340-001-022-0</del><br>PN 340-001-027-0<br>F0301<br>5 different MWs | BA725664-P<br>( <b>PHOTO 30</b> ) | <p><b>Airfoil:</b> LE tip curled in direction of rotation and torn. LE hard impact damage and edge missing material. TE dented; no missing material. Scuffing on airfoil PS.</p> <p><b>Blade Root:</b> Loss of coating on PS towards the TE. Loss of coating on SS towards LE.</p> <p><b>Shim:</b> Present and intact. No missing material. PN 340-252-306-0 (old configuration).</p> <p><b>Spacer:</b> No damage. PN 340-001-261-0 (F0301, F0732, and 07W28).</p> <p><b>Platform:</b> Intact but cracked on LE, seals in good condition, was reworked <del>PN 340-001-814-0</del> PN 340-001-816-0 (F0301, FA9L6, and DL240321-8).</p> | <p><b>PHOTO 30: FAN BLADE 2</b></p> |

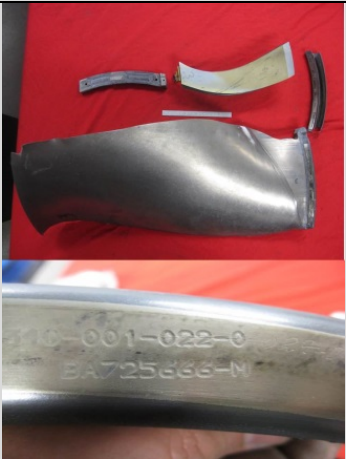
| Position | Fan Blade Part Markings | Serial Number (Photo No.1) | Condition | Picture |
|---|---|---|---|---|
| 3 | <del>PN 340-001-022-0</del><br>PN 340-001-027-0<br>F0301<br>5 different MWs | BA725666-M<br>( <b>PHOTO 31</b> ) | <p><b>Airfoil:</b> LE tip curled in direction opposite of rotation. LE and TE hard impact damage and tears. Missing material on TE tip. Scuffing on airfoil pressure side.</p> <p><b>Blade Root:</b> Loss of coating on PS towards the TE. Loss of coating on SS towards LE. More coating loss on SS than PS.</p> <p><b>Shim:</b> Present and intact. No missing material. PN 340-252-306-0 (old configuration).</p> <p><b>Spacer:</b> No damage. PN 340-001-261-0 (F0301, F0732, and 07W28).</p> <p><b>Platform:</b> Intact, LE seal missing material, no rework original PN 340-001-816-0 (F0301, FA9L6, and DL272113-K).</p> | <p><b>PHOTO 31: FAN BLADE 3</b></p> |

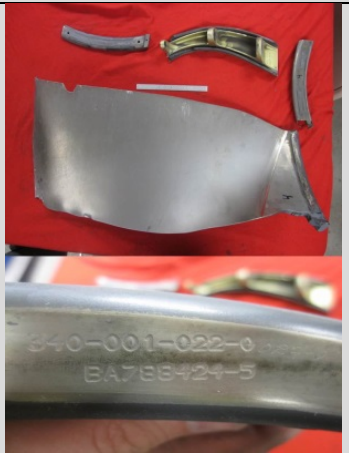
| Position | Fan Blade Part Markings | Serial Number (Photo No.1) | Condition | Picture |
|---|---|---|---|---|
| 4 | <del>PN 340-001-022-0</del><br>PN 340-001-027-0<br>F0301<br>5 different MWs | BA788424-5<br>( <b>PHOTO 32</b> ) | <p><b>Airfoil:</b> Tip curl in the direction opposite rotation; LE and TE hard body impact and missing material. TE tip missing. Minor scuffing on airfoil pressure side.</p> <p><b>Blade Root:</b> Loss of coating on SS towards LE.</p> <p><b>Shim:</b> Present and intact. No missing material. PN 340-252-306-0 (old configuration).</p> <p><b>Spacer:</b> No damage. PN 340-001-261-0 (F0301, F0732, and 07W28).</p> <p><b>Platform:</b> Intact, LE seal missing material, no rework original PN 340-001-816-0 (F0301, FA9L6, and DL272123-4).</p> | <p><b>PHOTO 32: FAN BLADE 4</b></p> |

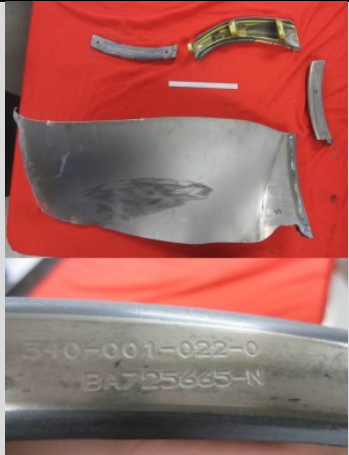
| Position | Fan Blade Part Markings | Serial Number (Photo No.1) | Condition | Picture |
|---|---|---|---|---|
| 5 | <del>PN 340-001-022-0</del><br>PN 340-001-027-0<br>F0301<br>5 different MWs | BA725665-N<br>( <b>PHOTO 33</b> ) | <p><b>Airfoil:</b> Tip curl in direction opposite rotation and missing tip material near LE. LE and TE tears. Scuffing on airfoil PS.</p> <p><b>Blade Root:</b> No visual coating loss.</p> <p><b>Shim:</b> Present and intact. No missing material. PN 340-252-306-0 (old configuration).</p> <p><b>Spacer:</b> No damage. PN 340-001-261-0 (F0301, F0732, and 07W25).</p> <p><b>Platform:</b> LE missing material. TE deformed, seal missing same area as LE missing material. Was reworked <del>PN 340-001-814-0</del> PN 340-001-816-0 (F0301, FA9L6, DL227301-N and 611307).</p> | <p><b>PHOTO 33: FAN BLADE 5</b></p> |

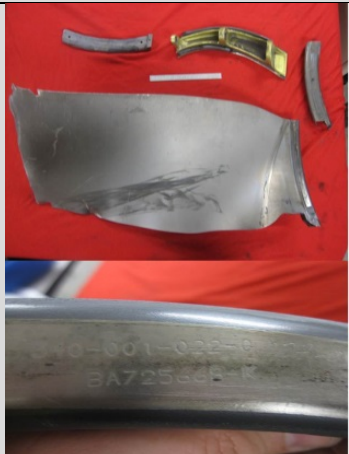
| Position | Fan Blade Part Markings | Serial Number (Photo No.1) | Condition | Picture |
|---|---|---|---|---|
| 6 | <del>PN 340-001-022-0</del><br>PN 340-001-027-0<br>F0301<br>5 different MWs | BA725668-K<br>( <b>PHOTO 34</b> ) | <p><b>Airfoil:</b> Tip curled in direction opposite of rotation. Entire tip is missing and jagged. LE and TE hard impact damage and missing material. TE dented and torn. Scuffing on airfoil PS.</p> <p><b>Blade Root:</b> No visual coating loss.</p> <p><b>Shim:</b> Present and intact. No missing material. PN 340-252-306-0 (old configuration).</p> <p><b>Spacer:</b> No damage. PN 340-001-261-0 (F0301, F0732, and 07W25).</p> <p><b>Platform:</b> LE and TE missing material. Seal missing in same areas as missing material. No rework original PN 340-001-816-0 (F0301, FA9L6, and DL272113-K).</p> | <p><b>PHOTO 34: FAN BLADE 6</b></p> |

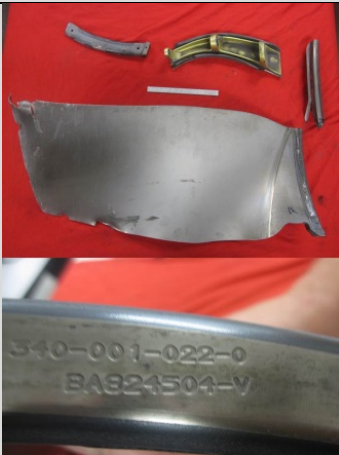
| Position | Fan Blade Part Markings | Serial Number (Photo No.1) | Condition | Picture |
|---|---|---|---|---|
| 7 | <del>PN 340-001-022-0</del><br>PN 340-001-027-0<br>F0301<br>5 different MWs | BA824504-V<br>( <b>PHOTO 35</b> ) | <p><b>Airfoil:</b> Tip curled in direction opposite of rotation. Entire tip is missing and jagged. LE and TE hard impact damage and missing material. Minor scuffing on airfoil PS.</p> <p><b>Blade Root:</b> Loss of coating on PS towards the TE.</p> <p><b>Shim:</b> Suction side LE is torn but still attached. Rest of the shim is present. No missing material. PN 340-252-306-0 (old configuration).</p> <p><b>Spacer:</b> No damage. PN 340-001-261-0 (F0301, F0732, and 07W25).</p> <p><b>Platform:</b> LE missing material. TE cracked. LE seal missing material at two spots. No rework original PN 340-001-816-0 (F0301, FA9L6, and DL272113-K).</p> | <p><b>PHOTO 35: FAN BLADE 7</b></p> |

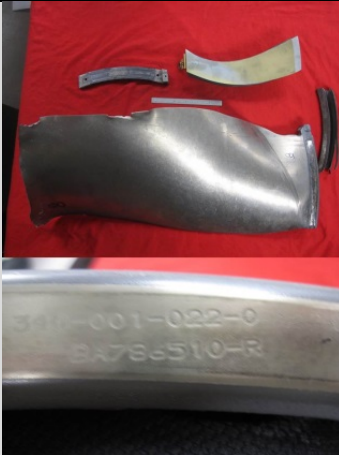
| Position | Fan Blade Part Markings | Serial Number (Photo No.1) | Condition | Picture |
|---|---|---|---|---|
| 8 | <del>PN 340-001-022-0</del><br>PN 340-001-027-0<br>F0301<br>5 different MWs | BA786510-R<br>( <b>PHOTO 36</b> ) | <p><b>Airfoil:</b> Tip curled in direction opposite of rotation. Entire tip is missing. LE and TE hard impact damage and missing material. TE edge torn.</p> <p><b>Blade Root:</b> Loss of coating on PS towards the TE.</p> <p><b>Shim:</b> SS LE is torn but still attached. Rest of the shim is present. No missing material. PN 340-252-306-0 (old configuration).</p> <p><b>Spacer:</b> No damage. PN 340-001-261-0 (F0301, F0732, and 07W25).</p> <p><b>Platform:</b> Intact but LE. Seal missing material. No rework original PN 340-001-816-0 (F0301, FA9L6, and DL272113-K).</p> | <p><b>PHOTO 36: FAN BLADE 8</b></p> |

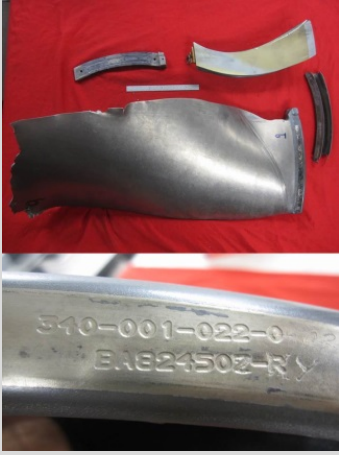
| Position | Fan Blade Part Markings | Serial Number (Photo No.1) | Condition | Picture |
|---|---|---|---|---|
| 9 | <del>PN 340-001-022-0</del><br>PN 340-001-027-0<br>F0301<br>5 different MWs | BA824502-Y<br>BA824502-R<br>(the R was X-out and replaced with the Y)<br>( <b>PHOTO 37</b> ) | <p><b>Airfoil:</b> Tip curled in the direction opposite rotation. Entire tip missing and jagged. LE near tip has what appears to be acoustic material wedged into the tear. TE hard impact damage, torn, and missing material.</p> <p><b>Blade Root:</b> Loss of coating on PS towards the TE.</p> <p><b>Shim:</b> Present and intact. No missing material. PN 340-252-306-0 (old configuration).</p> <p><b>Spacer:</b> No damage. PN 340-001-261-0 (F0301, F0732, and 07W28).</p> <p><b>Platform:</b> LE aft is cracked and LE seal is missing material. No rework original PN 340-001-816-0 (F0301, FA9L6, and DL272113-K).</p> | <p><b>PHOTO 37: FAN BLADE 9</b></p> |

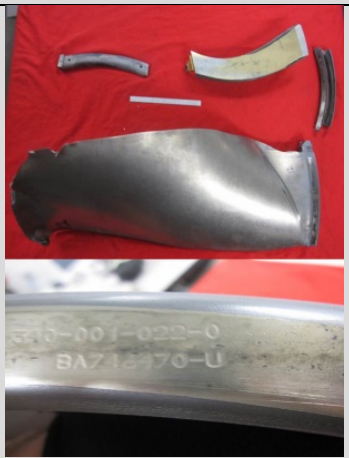
**TABLE 1: FAN BLADE HARDWARE CONDITION**

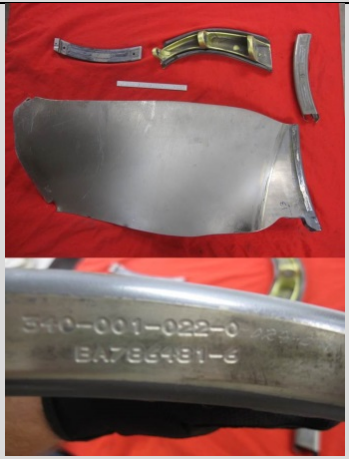
| Position | Fan Blade Part Markings | Serial Number (Photo No.1) | Condition | Picture |
|---|---|---|---|---|
| 13 | <del>PN 340-001-022-0</del><br>PN 340-001-027-0<br>F0301<br>5 different MWs | BA786481-6<br>( <b>PHOTO 41</b> ) | <p><b>Airfoil:</b> Tip curled in direction opposite rotation. TE tip missing. LE tip curled and torn. TE hard impact damage, torn and missing material. Scuffing on airfoil PS.</p> <p><b>Blade Root:</b> Loss of coating on PS towards the TE.</p> <p><b>Shim:</b> Present and intact. PN 340-252-306-0 (old configuration).</p> <p><b>Spacer:</b> No damage. PN 340-001-261-0 (F0301, F0732, and 07W25).</p> <p><b>Platform:</b> Cracked on LE and TE aft. Seal missing material LE forward. No rework original PN 340-001-816-0 (F0301, FA9L6, and DL272113-K).</p> | <p><b>PHOTO 41: FAN BLADE 13</b></p> |

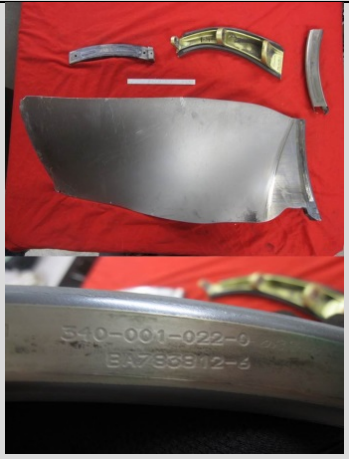
| Position | Fan Blade Part Markings | Serial Number (Photo No.1) | Condition | Picture |
|---|---|---|---|---|
| 14 | <del>PN 340-001-022-0</del><br>PN 340-001-027-0<br>F0301<br>5 different MWs | BA783812-6<br>( <b>PHOTO 42</b> ) | <p><b>Airfoil:</b> Minor tip curl in the direction opposite rotation. LE impact and missing material. TE tip torn. Minor scuffing of airfoil PS.</p> <p><b>Blade Root:</b> Loss of coating on PS towards the TE.</p> <p><b>Shim:</b> Present and intact. PN 340-252-306-0 (old configuration).</p> <p><b>Spacer:</b> No damage. PN 340-001-261-0 (F0301, F0732, and 07W28).</p> <p><b>Platform:</b> Cracked TE aft. Seals in place and good condition. Was reworked <del>PN 340-001-814-0</del> PN 340-001-816-0 (F0301, FA9L6, DL209709-11 and 5123006).</p> | <p><b>PHOTO 42: FAN BLADE 14</b></p> |

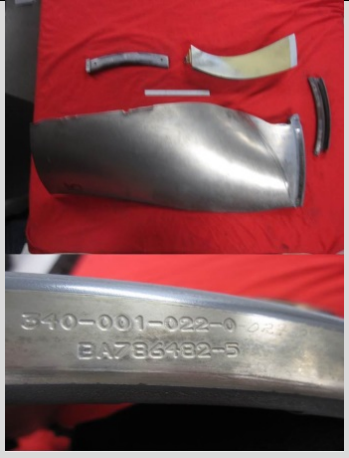
| Position | Fan Blade Part Markings | Serial Number (Photo No.1) | Condition | Picture |
|---|---|---|---|---|
| 15 | <del>PN 340-001-022-0</del><br>PN 340-001-027-0<br>F0301<br>5 different MWs | BA786482-5<br>( <b>PHOTO 43</b> ) | <p><b>Airfoil:</b> Minor LE tip bent. TE tip bent in the direction opposite rotation. TE hard impact damage, torn, and missing material.</p> <p><b>Blade Root:</b> Significant loss of coating on PS towards the TE.</p> <p><b>Shim:</b> Damage on LE PS. Cracked but in intact. PN 340-252-306-0 (old configuration).</p> <p><b>Spacer:</b> No damage. PN 340-001-261-0 (F0301, F0732, and 07W27).</p> <p><b>Platform:</b> Intact and missing seal material LE forward. No rework original PN 340-001-816-0 (F0301, FA9L6, and DL272123-4).</p> | <p><b>PHOTO 43: FAN BLADE 15</b></p> |

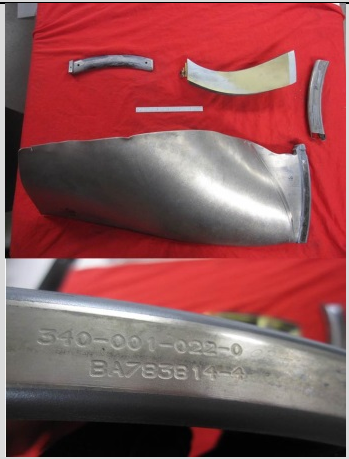
| Position | Fan Blade Part Markings | Serial Number (Photo No.1) | Condition | Picture |
|---|---|---|---|---|
| 16 | <del>PN 340-001-022-0</del><br>PN 340-001-027-0<br>F0301<br>5 different MWs | BA783814-4<br>( <b>PHOTO 44</b> ) | <p><b>Airfoil:</b> Slight bending of the LE tip in the direction opposite rotation. TE dented and torn.</p> <p><b>Blade Root:</b> No visual coating loss</p> <p><b>Shim:</b> Present and intact. PN 340-252-306-0 (old configuration)</p> <p><b>Spacer:</b> No damage. PN 340-001-261-0 (F0301, F0732, and 07W28).</p> <p><b>Platform:</b> Platform intact and undamaged. Missing seal LE edge forward. No rework original PN 340-001-816-0 (F0301, FA9L6, and DL272113-K).</p> | <p><b>PHOTO 44: FAN BLADE 16</b></p> |

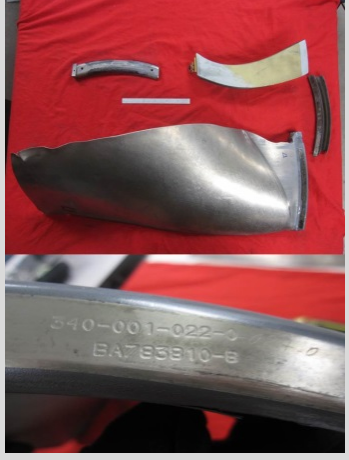
| Position | Fan Blade Part Markings | Serial Number (Photo No.1) | Condition | Picture |
|---|---|---|---|---|
| 17 | <del>PN 340-001-022-0</del><br>PN 340-001-027-0<br>F0301<br>5 different MWs | BA783810-8<br>( <b>PHOTO 45</b> ) | <p><b>Airfoil:</b> Slight tip rub and rolled material. LE tip impact damage and missing material. LE hard impact damage and missing material. TE torn near tip.</p> <p><b>Blade Root:</b> Significant loss of coating on PS towards the TE. Loss of coating on SS towards the LE.</p> <p><b>Shim:</b> Present and intact. PN 340-252-306-0 (old configuration).</p> <p><b>Spacer:</b> No damage. PN 340-001-261-0 (F0301, F0732, and 07W25).</p> <p><b>Platform:</b> Intact and no missing seal material. Was reworked <del>PN 340-001-814-0</del> PN 340-001-816-0 (F0301, FA9L6, and DL227283-H).</p> | <p><b>PHOTO 45: FAN BLADE 17</b></p> |

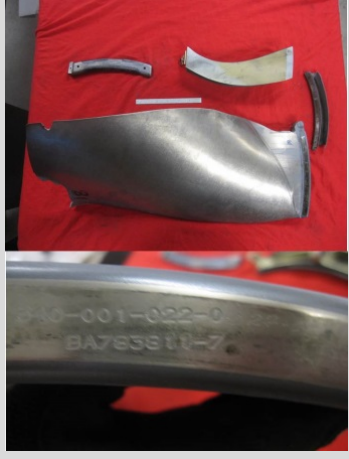
| Position | Fan Blade Part Markings | Serial Number (Photo No.1) | Condition | Picture |
|---|---|---|---|---|
| 18 | <del>PN 340-001-022-0</del><br>PN 340-001-027-0<br>F0301<br>5 different MWs | BA783811-7<br>( <b>PHOTO 46</b> ) | <p><b>Airfoil:</b> LE tip missing chunk (4 x 2-inches) and airfoil curled in direction opposite rotation. TE hard impact damage and missing material. Slight scuffing and imprint consistent with acoustic paneling geometry on airfoil PS.</p> <p><b>Blade Root:</b> Loss of coating on PS towards the TE.</p> <p><b>Shim:</b> Present and intact. PN 340-252-306-0 (old configuration).</p> <p><b>Spacer:</b> No damage. PN 340-001-261-0 (F0301, F0732, and 07W25).</p> <p><b>Platform:</b> Intact and missing seal LE forward. No rework original PN 340-001-816-0 (F0301, FA9L6, and DL272110-K).</p> | <p><b>PHOTO 46: FAN BLADE 18</b></p> |

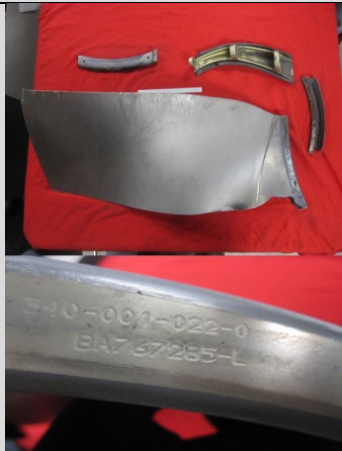
| Position | Fan Blade Part Markings | Serial Number (Photo No.1) | Condition | Picture |
|---|---|---|---|---|
| 19 | <del>PN 340-001-022-0</del><br>PN 340-001-027-0<br>F0301<br>5 different MWs | BA767285-L<br>( <b>PHOTO 47</b> ) | <p><b>Airfoil:</b> Minor tip curl LE in the direction opposite rotation. Scuffing and imprint consistent with acoustic panel geometry on airfoil PS.</p> <p><b>Blade Root:</b> Loss of coating on SS towards the LE.</p> <p><b>Shim:</b> Present and intact. PN 340-252-306-0 (old configuration).</p> <p><b>Spacer:</b> No damage. PN 340-001-261-0 (F0301, F0732, and 07W27).</p> <p><b>Platform:</b> Intact and missing seal material on LE forward. No rework original PN 340-001-816-0 (F0301, FA9L6, and DL272121-6).</p> | <p><b>PHOTO 47: FAN BLADE 19</b></p> |

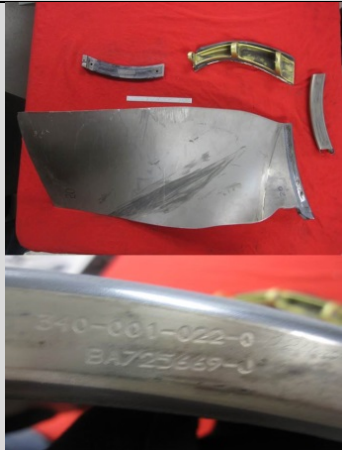
| Position | Fan Blade Part Markings | Serial Number (Photo No.1) | Condition | Picture |
|---|---|---|---|---|
| 20 | <del>PN 340-001-022-0</del><br>PN 340-001-027-0<br>F0301<br>5 different MWs | BA725669-J<br>( <b>PHOTO 48</b> ) | <p><b>Airfoil:</b> LE tear near tip. LE tip corner missing. Scuffing on airfoil PS.</p> <p><b>Blade Root:</b> Loss of coating on PS towards the TE.</p> <p><b>Shim:</b> Present and intact. PN 340-252-306-0 (old configuration).</p> <p><b>Spacer:</b> No damage. PN 340-001-261-0 (F0301, F0732, and 07W28).</p> <p><b>Platform:</b> About 80% LE missing material and entire LE seal missing. No rework original PN 340-001-816-0 (F0301, FA9L6, and DL272113-K).</p> | <p><b>PHOTO 48: FAN BLADE 20</b></p> |

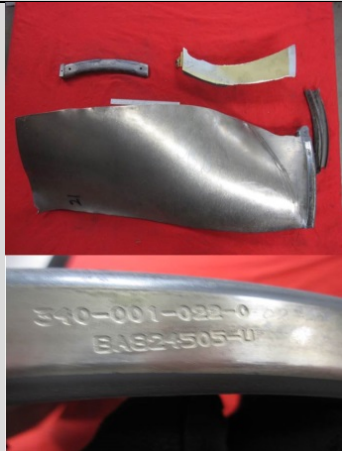
| Position | Fan Blade Part Markings | Serial Number (Photo No.1) | Condition | Picture |
|---|---|---|---|---|
| 21 | <del>PN 340-001-022-0</del><br>PN 340-001-027-0<br>F0301<br>5 different MWs | BA824505-U<br>( <b>PHOTO 49</b> ) | <p><b>Airfoil:</b> Tip curled in the direction opposite rotation. LE tip missing material. Tip rub along entire surface. TE distorted. Scuffing on airfoil PS.</p> <p><b>Blade Root:</b> No visual coating loss.</p> <p><b>Shim:</b> Heavily damaged. Small amount of material missing on PS and large portion torn. SS 80-90% is missing. PN 340-252-306-0 (old configuration).</p> <p><b>Spacer:</b> No damage. PN 340-001-261-0 (entire PN no legible but the 261 can be seen, all other marking not legible).</p> <p><b>Platform:</b> Entire LE missing material and seal. TE missing 60% material and seal. Aft pin location lug is cracked. No rework original PN 340-001-816-0 (F0301, FA9L6, and DL272113-K).</p> | <p><b>PHOTO 49: FAN BLADE 21</b></p> |

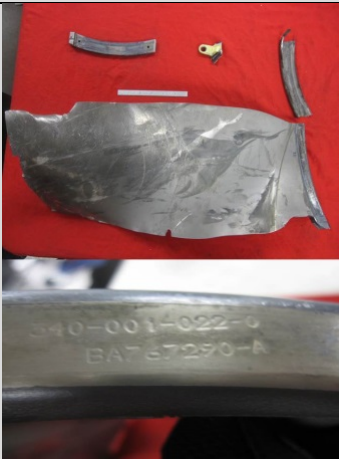
| Position | Fan Blade Part Markings | Serial Number (Photo No.1) | Condition | Picture |
|---|---|---|---|---|
| <b>22</b> | PN 340-001-022-0<br>PN 340-001-027-0<br>F0301<br>5 different MWs | BA767290-A<br>( <b>PHOTO 50</b> ) | <p><b>Airfoil:</b> Tip curled in the direction of rotation and missing material. LE curled in the direction opposite rotation. LE missing material and torn. LE, distorted. Radial imprint marks on SS of airfoil. TE impact damage, missing material and torn. Significant scuffing on airfoil pressure side.</p> <p><b>Blade Root:</b> Significant loss of coating on PS towards the TE and minor loss of coating on SS towards the TE.</p> <p><b>Shim:</b> LE and TE missing material. PN 340-252-307-0 (new configuration).</p> <p><b>Spacer:</b> No damage. PN 340-001-261-0 (F0301, F0732, and 07W25).</p> <p><b>Platform:</b> Only piece that remained was the forward most pin lug. Unable to determine PN configuration.</p> | <p><b>PHOTO 50: FAN BLADE 22</b></p> |

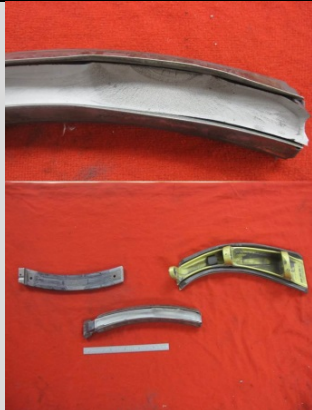
| Position | Fan Blade Part Markings | Serial Number (Photo No.1) | Condition | Picture |
|---|---|---|---|---|
| <b>23</b> | PN 340-001-022-0<br>PN 340-001-027-0<br>F0301<br>5 different MWs | BA824478-6<br>( <b>PHOTO 51</b> ) | <p><b>Airfoil:</b> Airfoil missing, all that remains is the blade root.</p> <p><b>Blade Root:</b> With shim removed at lab confirmed loss of coating on the SS towards the LE.</p> <p><b>Shim:</b> Present and intact. PN 340-252-307-0 (new configuration).</p> <p><b>Spacer:</b> No damage. PN 340-001-261-0 (F0301, F0732, and 07W27).</p> <p><b>Platform:</b> Present and in good condition. Was reworked PN 340-001-814-0 PN 340-001-816-0 (F0301, FA9L6, and DL227283-H).</p> | <p><b>PHOTO 51: FAN BLADE 23</b></p> |

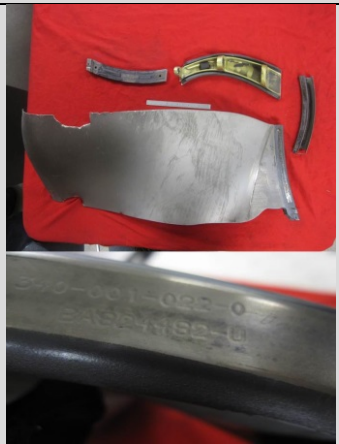
| Position | Fan Blade Part Markings | Serial Number (Photo No.1) | Condition | Picture |
|---|---|---|---|---|
| <b>24</b> | PN 340-001-022-0<br>PN 340-001-027-0<br>F0301<br>5 different MWs | BA824482-U<br>( <b>PHOTO 52</b> ) | <p><b>Airfoil:</b> Tip curled in the direction opposite rotation. LE hard impact damage and missing material (1.5- x 3-inch). TE impact damage, missing material (1- x 2-inches) and torn. Scuffing on pressure side of airfoil.</p> <p><b>Blade Root:</b> Loss of coating on PS towards the TE and loss of coating on SS towards the LE.</p> <p><b>Shim:</b> Present and intact. PN 340-252-307-0 (new configuration).</p> <p><b>Spacer:</b> No damage. PN 340-001-261-0 (F0301, F0732, and 07W27).</p> <p><b>Platform:</b> Present, undamaged and in good condition. Was reworked PN 340-001-814-0 PN 340-001-816-0 (F0301, FA9L6, and DL227254-3).</p> | <p><b>PHOTO 52: FAN BLADE 24</b></p> |

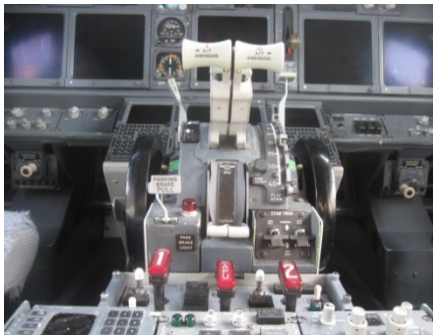
**PHOTO 53: THROTTLES,  
CUTOFF LEVERS, AND FIRE  
HANDLES**

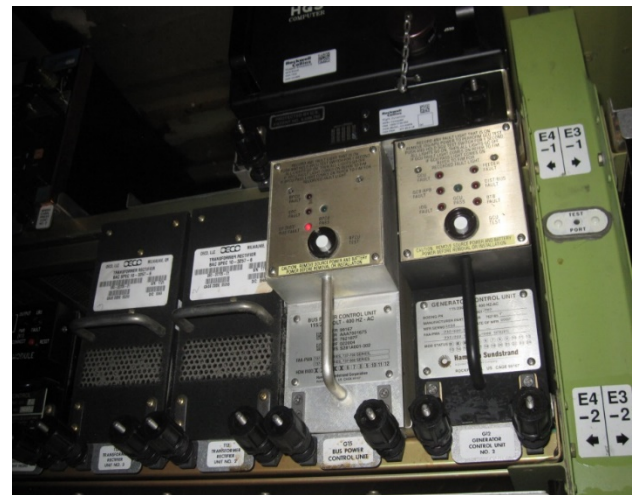
**PHOTO 56: BUS POWER CONTROL UNIT WITH FAULT LIGHT ILLUMINATED**

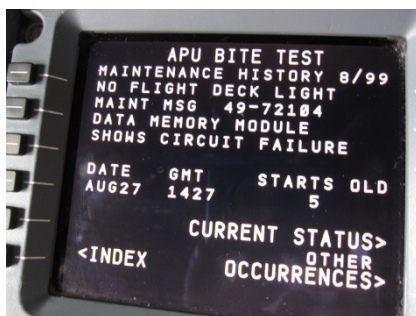
**PHOTO 57: APU FAULT –  
MEMORY MODULE CIRCUIT  
FAILURE 1427 GMT**

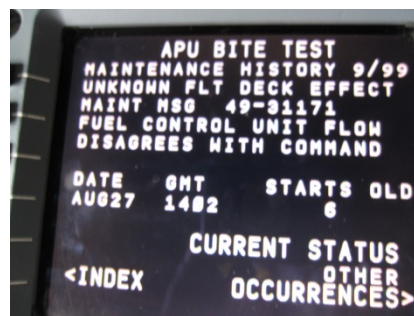
**PHOTO 58: APU FAULT – FUEL  
FLOW DISAGREE FAILURE  
1402 GMT**

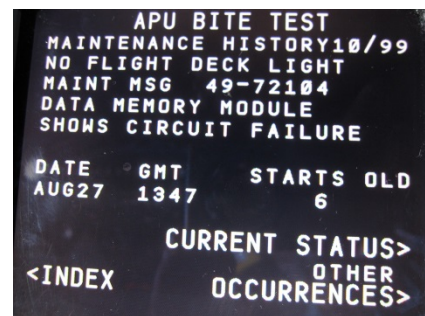
**PHOTO 59: APU FAULT –  
MEMORY MODULE CIRCUIT  
FAILURE 1347 GMT**

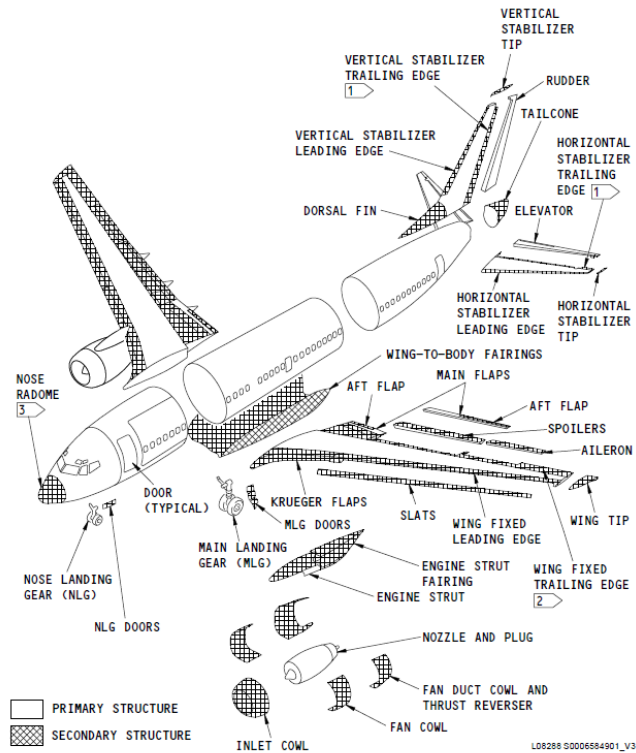
**FIGURE 15: AIRPLANE STRUCTURAL LOCATION AND NOMENCLATURE**

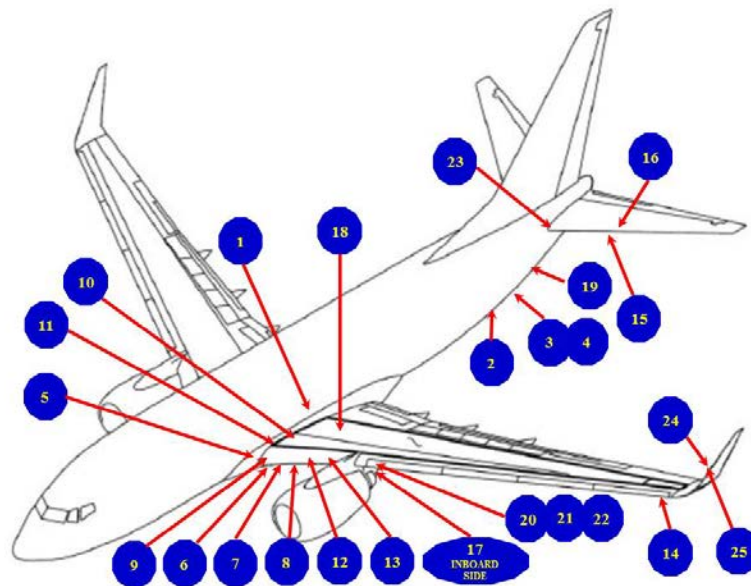
**FIGURE 16: AIRPLANE STRUCTURAL DAMAGE LOCATIONS**

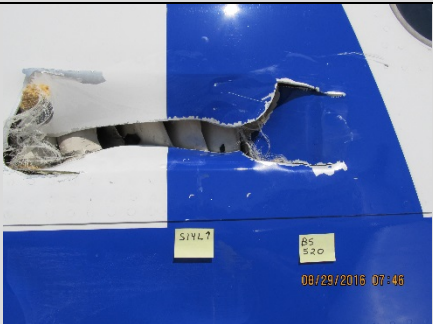
| Item Number | Location | Part Number (PHOTO NO.) | Condition | Photo |
|---|---|---|---|---|
| <b>1</b> | Section 43 between body station (BS) 500D and BS 520. Between stringers 13L and 16L. Between windows 11 and 12 at seat row 8. | 143A3150-63 (S4L-S14L), 143A3210-19 (S14L-S24L) (PHOTO 60) | Skin is dented inboard between stringers 13L and 16L. | <p><b>PHOTO 60: FUSELAGE DAMAGE</b></p> |

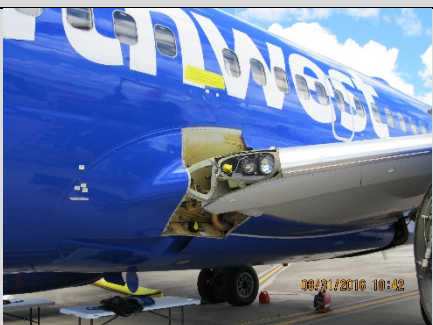
| Item Number | Location | Part Number (PHOTO NO.) | Condition | Photo |
|---|---|---|---|---|
| | | (PHOTO 61) | The yellow tape is the location of the fuselage skin puncture. | <p><b>PHOTO 61: FUSELAGE DAMAGE</b></p> |

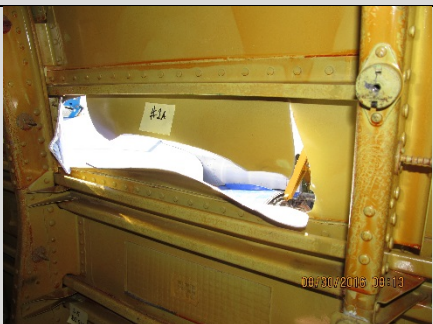
| Item Number | Location | Part Number (PHOTO NO.) | Condition | Photo |
|---|---|---|---|---|
| <b>1A</b> | Section 43 between BS 500D and BS 520. Between stringers 13L and 14L. | 143A3150-63 (PHOTO 62) | Skin puncture between stringers 13L and 14L. The puncture is about 16-inches-long x 5-inches-wide. There was damage to the air ducting behind the skin. No damage was found on the interior liner. No foreign material was found in the cabin area. Picture is without the air duct. | <p><b>PHOTO 62: FUSELAGE DAMAGE</b></p> |

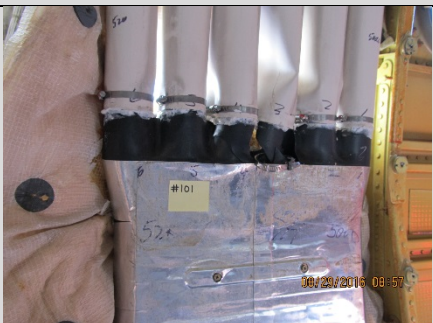
| Item Number | Location | Part Number (PHOTO NO.) | Condition | Photo |
|---|---|---|---|---|
| <b>1A</b> | Section 43 between BS 500D and BS 520. Between stringers 13L and 14L. | (PHOTO 63) | Damage to the air duct at skin puncture location from picture 62. | <p><b>PHOTO 63: FUSELAGE DAMAGE</b></p> |

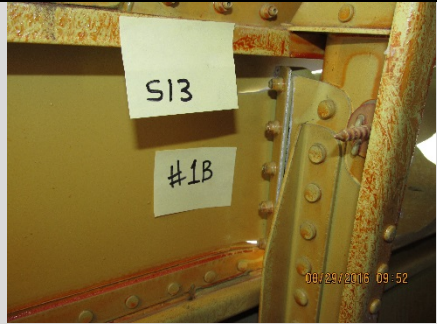
| Item Number | Location | Part Number (PHOTO NO.) | Condition | Photo |
|---|---|---|---|---|
| 1B | Section 43 BS 520 between stringers 13L and 14L. | 143A1200-145 (PHOTO 64) | The frame web connection to the shear tie is cracked the full length between stringers 13L and 14L. The shear tie is bent. There is a second crack in the frame web at the near the end of the failsafe chord. The visible portion of this crack is about 0.25-inches, but it extends an unknown length underneath the failsafe chord. | <p><b>PHOTO 64: FUSELAGE DAMAGE</b></p> |

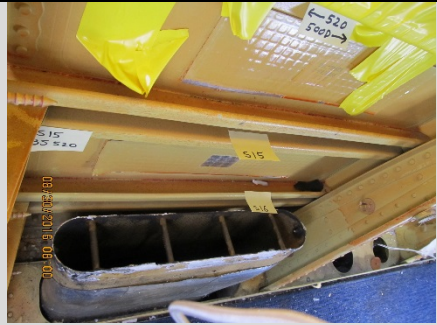
| Item Number | Location | Part Number (PHOTO NO.) | Condition | Photo |
|---|---|---|---|---|
| 1C | Section 43 BS 500D to 520. Stringers 13L to 16L. | 143A3150-63, 143A3210-19 (PHOTO 65) | Stringers 13L to 16L are bent inboard. Stringer 15L is bent more, about 0.1-inch inboard displacement. | <p><b>PHOTO 65: FUSELAGE DAMAGE</b></p> |

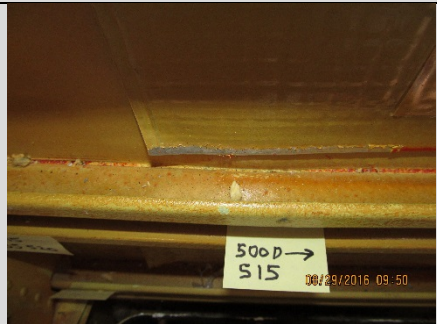
| Item Number | Location | Part Number (PHOTO NO.) | Condition | Photo |
|---|---|---|---|---|
| 1C | Section 43 BS 500D to 520. Stringer 15L. | (PHOTO 66) | See above description. | <p><b>PHOTO 66: FUSELAGE DAMAGE</b></p> |

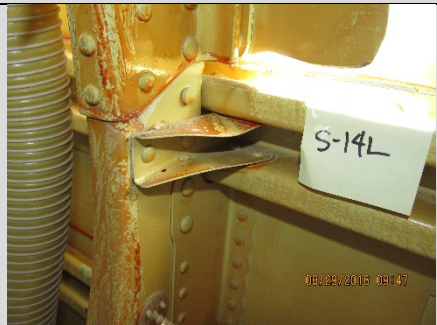
| Item Number | Location | Part Number (PHOTO NO.) | Condition | Photo |
|---|---|---|---|---|
| 1C | Section 43 BS 520. Stringer 14L. | 143A1215 (PHOTO 67) | The stringer clip is buckled. | <p><b>PHOTO 67: FUSELAGE DAMAGE</b></p> |

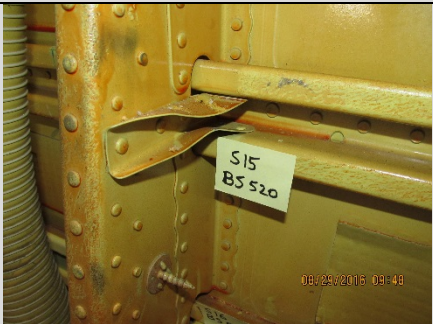
| Item Number | Location | Part Number (PHOTO No.) | Condition | Photo |
|---|---|---|---|---|
| 1C | Section 43 BS 520. Stringer 15L. | 143A1215 (PHOTO 68) | The stringer clip is buckled. | <p><b>PHOTO 68: FUSELAGE DAMAGE</b></p> |

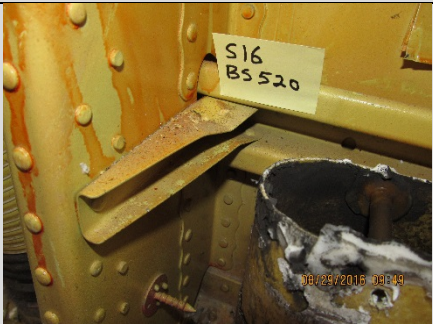
| Item Number | Location | Part Number (PHOTO No.) | Condition | Photo |
|---|---|---|---|---|
| 1C | Section 43 BS 520. Stringer 16L. | 143A1215 (PHOTO 69) | The stringer clip is buckled. | <p><b>PHOTO 69: FUSELAGE DAMAGE</b></p> |

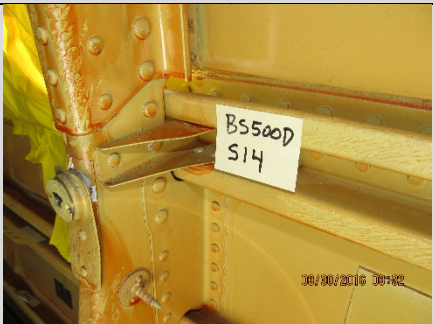
| Item Number | Location | Part Number (PHOTO No.) | Condition | Photo |
|---|---|---|---|---|
| 1C | Section 43 BS. 500D Stringer 14L | 143A1225 (PHOTO 70) | The stringer clip is buckled. | <p><b>PHOTO 70: FUSELAGE DAMAGE</b></p> |

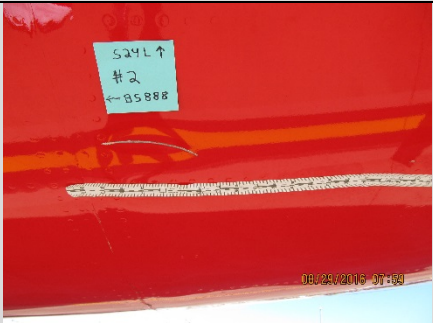
| Item Number | Location | Part Number (PHOTO No.) | Condition | Photo |
|---|---|---|---|---|
| 2 | Section 47 BS 890-895. Between Stringers 24L and 25L. | (PHOTO 71) | 5-inches-long skin gouge. Depth is about 0.020-inches at its deepest point. | <p><b>PHOTO 71: FUSELAGE DAMAGE</b></p> |
