**NATIONAL TRANSPORTATION SAFETY BOARD**  
**Office of Aviation Safety**  
**Washington, D.C. 20594**

**November 12, 2018**

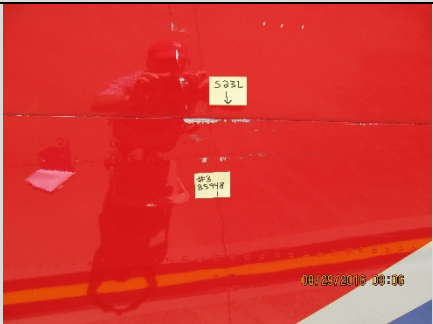
| <b>TABLE 2: AIRPLANE STRUCTURAL DAMAGE</b> | | | | |
|---|---|---|---|---|
| 3 | Section 47 BS 948, above and below Stringer 23L. | 147A3110-3 (S14L-S23L), 147A3400-4 (S23L-S23R) (PHOTO 72) | Multiple areas of minor surface gouges. | <p><b>PHOTO 72: FUSELAGE DAMAGE</b></p> |

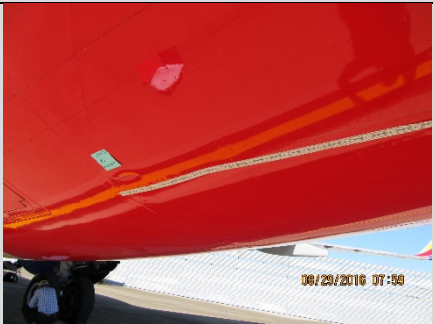
| <b>TABLE 2: AIRPLANE STRUCTURAL DAMAGE</b> | | | | |
|---|---|---|---|---|
| 4 | Section 47 Fuselage Skin, BS 906-967. Stringer 25 | 147A3400-4 (PHOTO 73) | A long narrow region of minor surface gouging was evident. | <p><b>PHOTO 73: FUSELAGE DAMAGE</b></p> |

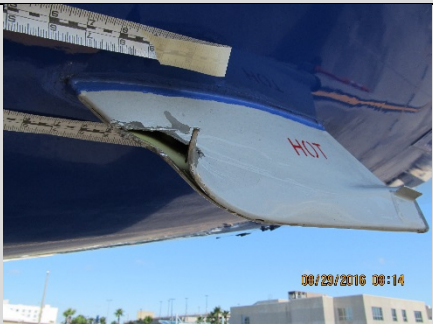
| <b>TABLE 2: AIRPLANE STRUCTURAL DAMAGE</b> | | | | |
|---|---|---|---|---|
| 19 | Section 47, BS 990. | 417T2093-10 (PHOTO 74) | Drain mast impact damage. There was a puncture about 3-inches-long x 1.5-inches-wide. A small piece of metal was found inside the drain mast. | <p><b>PHOTO 74: DRAIN MAST DAMAGE</b></p> |

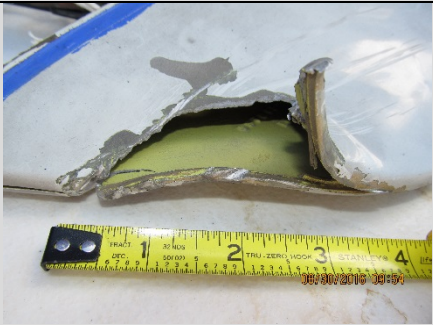
| <b>TABLE 2: AIRPLANE STRUCTURAL DAMAGE</b> | | | | |
|---|---|---|---|---|
| 19 | | (PHOTO 75) | See above description. | <p><b>PHOTO 75: DRAIN MAST DAMAGE</b></p> |

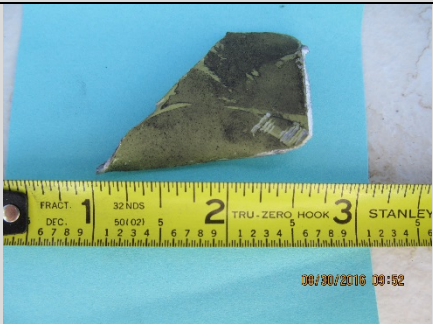
| <b>TABLE 2: AIRPLANE STRUCTURAL DAMAGE</b> | | | | |
|---|---|---|---|---|
| 19 | | Unknown (PHOTO 76) | A 1.75-inches x 1-inch piece of metal was found inside the drain mast. The thickness was about 0.049-inches. The piece was not consistent with fan blade, fan blade platform, fuselage, or drain mast material. | <p><b>PHOTO 76: DEBRIS IN DRAIN MAST</b></p> |

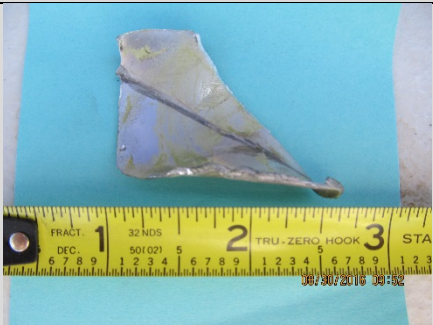
| <b>TABLE 2: AIRPLANE STRUCTURAL DAMAGE</b> | | | | |
|---|---|---|---|---|
| 19 | | (PHOTO 77) | See above description. | <p><b>PHOTO 77: DEBRIS IN DRAIN MAST</b></p> |

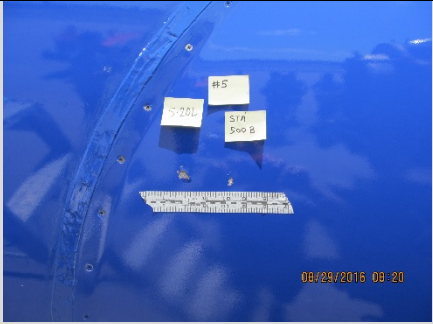
| <b>TABLE 2: AIRPLANE STRUCTURAL DAMAGE</b> | | | | |
|---|---|---|---|---|
| 5 | Wing-to-Body Fairing, BS 500B, stringer 20L. Access panel 191AL. | 149A7151-1 (PHOTO 78) | Gouges in the wing to body fairing panel. | <p><b>PHOTO 78: WING-TO-BODY FAIRING DAMAGE</b></p> |

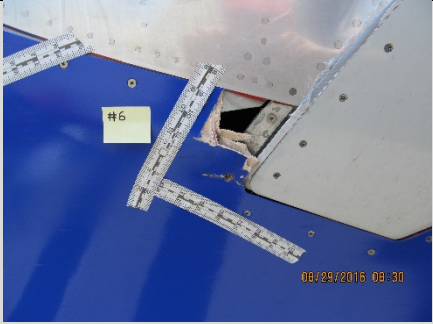
| <b>TABLE 2: AIRPLANE STRUCTURAL DAMAGE</b> | | | | |
|---|---|---|---|---|
| 6 | Wing-to-Body Fairing, BS 540. Access panel 191FL. | 149A7155-1 (PHOTO 79) | About 2-inches x 2-inches corner of the wing to body fairing was missing. | <p><b>PHOTO 79: WING-TO-BODY FAIRING DAMAGE</b></p> |

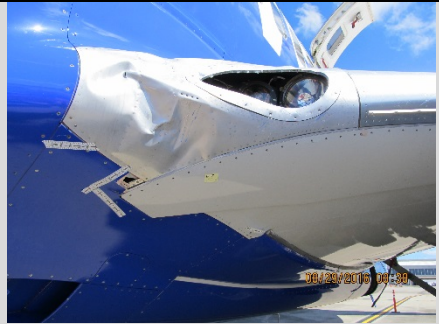
| Item Number | Location | Part Number (PHOTO NO.) | Condition | Photo |
|---|---|---|---|---|
| 9 | Side of Body to Krueger station 125.75 | (PHOTO 80) | Impact damage to the strakelet assembly. The LE skin and support ribs are dented. The light lens was shattered. | <p>PHOTO 80: STRAKELET DAMAGE</p> |

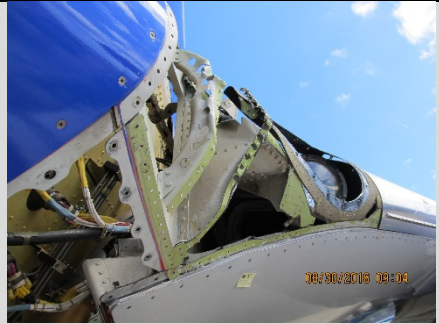
| Item Number | Location | Part Number (PHOTO NO.) | Condition | Photo |
|---|---|---|---|---|
| 9 | | (PHOTO 81)<br>(After removal for the damage skin) | The strakelet substructure was also damaged. No damage was found to wing front spar or fuselage structure behind the strakelet assembly. | <p>PHOTO 81: STRAKELET DAMAGE</p> |

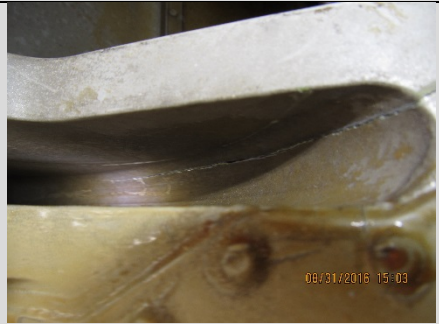
| Item Number | Location | Part Number (PHOTO NO.) | Condition | Photo |
|---|---|---|---|---|
| 9 | Krueger station 125.75 | 116A3211-5 (PHOTO 82) | A 6-inch crack was found in the outboard clevis leg of the strakelet seal rib. | <p>PHOTO 82: STRAKELET DAMAGE</p> |

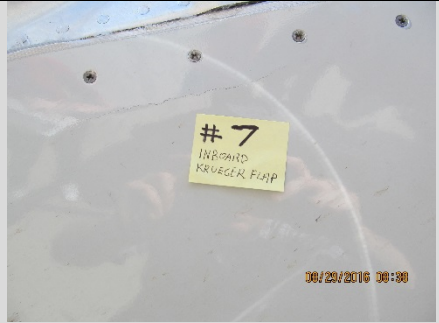
| Item Number | Location | Part Number (PHOTO NO.) | Condition | Photo |
|---|---|---|---|---|
| 7 | Inboard Krueger flap | 114A1221-3 (PHOTO 83) | Approximately 5-inches-long crack on the inboard Krueger flap. Crack is about 10-inches from the inboard edge and 1-inch aft of the forward edge. | <p>PHOTO 83: KRUEGER FLAP DAMAGE</p> |

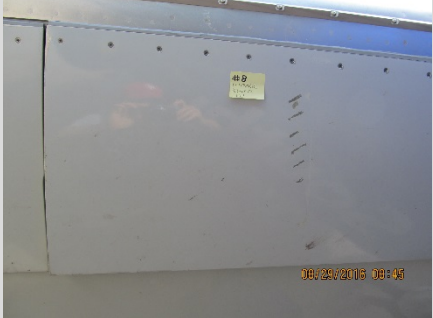
| <b>TABLE 2: AIRPLANE STRUCTURAL DAMAGE</b> | | | | |
|---|---|---|---|---|
| <b>8</b> | Outboard Krueger flap | 114A1111-3 (PHOTO 84) | Paint transfer and minor surface gouges 14-inches from the inboard edge | <p><b>PHOTO 84: WING DAMAGE</b></p> |

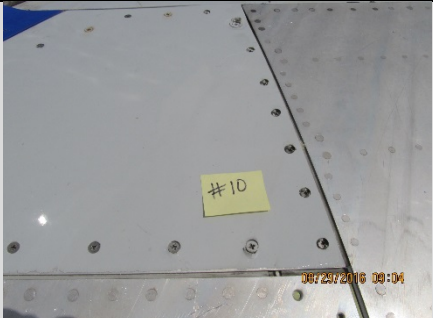
| <b>TABLE 2: AIRPLANE STRUCTURAL DAMAGE</b> | | | | |
|---|---|---|---|---|
| <b>10</b> | Krueger station 125.75. This panel is above and aft of the strakelet assembly. | 116A1210-3 (PHOTO 85) | Screws have pulled through the panel. | <p><b>PHOTO 85: WING DAMAGE</b></p> |

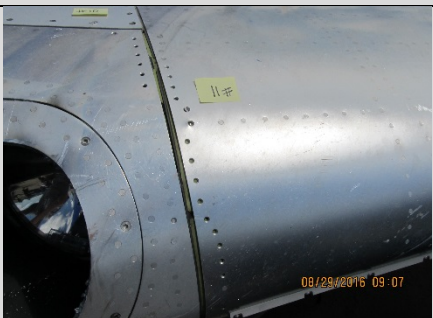
| <b>TABLE 2: AIRPLANE STRUCTURAL DAMAGE</b> | | | | |
|---|---|---|---|---|
| <b>11</b> | Krueger station 125.75 | 116A4410-7 (PHOTO 86) | The rivets attaching the LE skins were sheared. | <p><b>PHOTO 86: WING DAMAGE</b></p> |

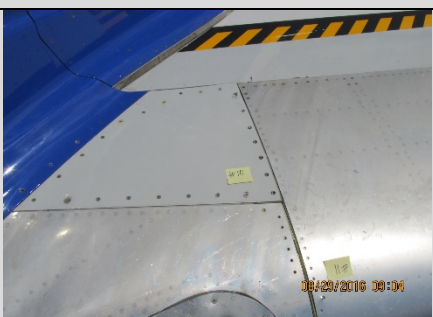
| <b>TABLE 2: AIRPLANE STRUCTURAL DAMAGE</b> | | | | |
|---|---|---|---|---|
| <b>10 and 11</b> | | (PHOTO 87) | See above items 10 and 11 descriptions. | <p><b>PHOTO 87: WING DAMAGE</b></p> |

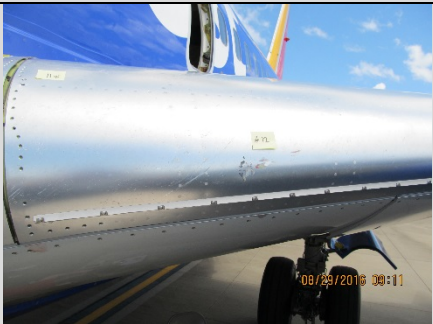
| <b>TABLE 2: AIRPLANE STRUCTURAL DAMAGE</b> | | | | |
|---|---|---|---|---|
| 12 | LE skin inboard of the engine. | 116A4410-7 (PHOTO 88) | Multiple minor surface scratches on the LE skin inboard of the engine. | <p><b>PHOTO 88: WING DAMAGE</b></p> |

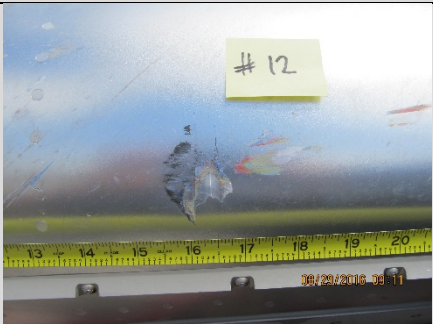
| <b>TABLE 2: AIRPLANE STRUCTURAL DAMAGE</b> | | | | |
|---|---|---|---|---|
| 12 | Krueger station 141 | 116A4410-7 (PHOTO 89) | See above description. | <p><b>PHOTO 89: WING DAMAGE</b></p> |

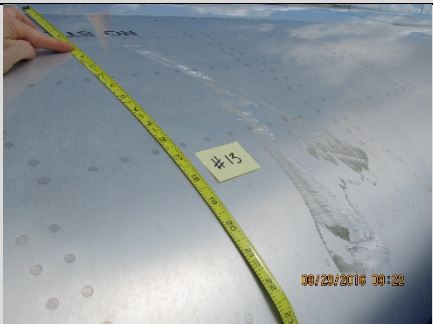
| <b>TABLE 2: AIRPLANE STRUCTURAL DAMAGE</b> | | | | |
|---|---|---|---|---|
| 13 | Krueger station 191 | 116A4410-7 (PHOTO 90) | Additional surface scratches on the LE skin inboard of the engine. Gouges are from 9-inches to 24-inches from the aft edge and located 50-inches from the inboard edge. | <p><b>PHOTO 90: WING DAMAGE</b></p> |

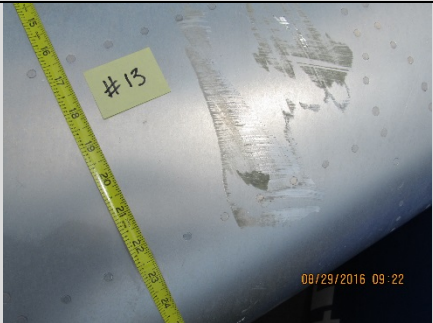
| <b>TABLE 2: AIRPLANE STRUCTURAL DAMAGE</b> | | | | |
|---|---|---|---|---|
| 13 | Krueger station 191 | 116A4410-7 (PHOTO 91) | See above description. | <p><b>PHOTO 91: WING DAMAGE</b></p> |

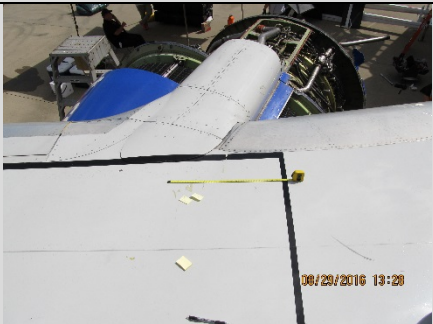
| <b>TABLE 2: AIRPLANE STRUCTURAL DAMAGE</b> | | | | |
|---|---|---|---|---|
| 18 | Wing Station (WS) 221. The forward/aft black line is WS 204 (Rib No. 5). | 112A3102 (PHOTO 92) | Gouges on the upper wing skin inboard of the engine just aft of the front spar chord. | <p><b>PHOTO 92: WING DAMAGE</b></p> |

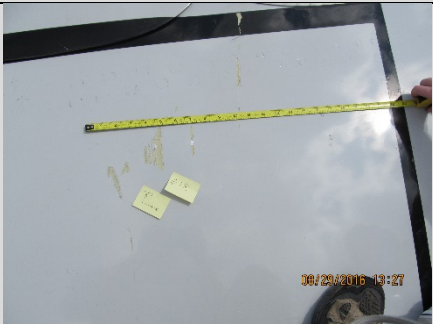
| <b>TABLE 2: AIRPLANE STRUCTURAL DAMAGE</b> | | | | |
|---|---|---|---|---|
| 18 | | (PHOTO 93) | See above description. | <p><b>PHOTO 93: WING DAMAGE</b></p> |

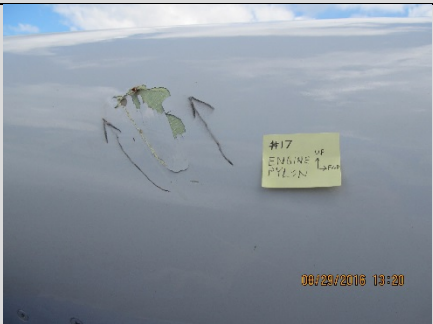
| <b>TABLE 2: AIRPLANE STRUCTURAL DAMAGE</b> | | | | |
|---|---|---|---|---|
| 17 | Engine pylon fairing on the inboard side. Engine pylon fairing panel 431BR. | 313A2121 (PHOTO 94) | Surface gouges existed on the engine pylon fairing. | <p><b>PHOTO 94: WING DAMAGE</b></p> |

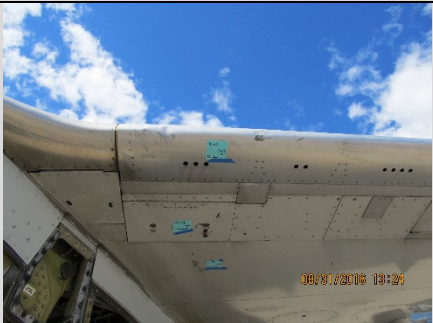
| <b>TABLE 2: AIRPLANE STRUCTURAL DAMAGE</b> | | | | |
|---|---|---|---|---|
| 20, 21, and 22 | Just outboard of the engine pylon. | (PHOTO 95) | Photo to the right shows the general location of items 20, 21, and 22. | <p><b>PHOTO 95: WING DAMAGE</b></p> |

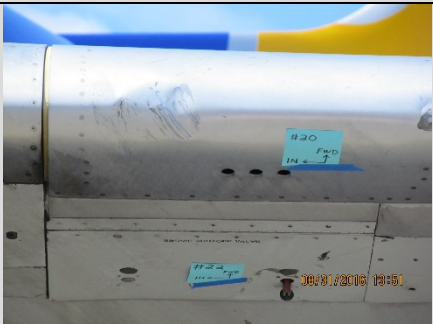
| Item Number | Location | Part Number (PHOTO NO.) | Condition | Photo |
|---|---|---|---|---|
| 20 | Slat No. 4 | 114A8041-3 (PHOTO 96) | A small dent was found near the inboard edge of slat No. 4. Additional minor scraping damage was found along its length. See photo above. | <p><b>PHOTO 96: WING DAMAGE</b></p> |

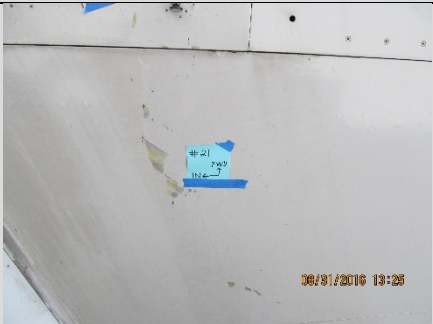
| Item Number | Location | Part Number (PHOTO NO.) | Condition | Photo |
|---|---|---|---|---|
| 21 | Lower wing skin No. 3 just outboard of the engine pylon approximately at WS 240. | 112A4103-5 (PHOTO 97) | Minor surface gouging on the lower wing skin. | <p><b>PHOTO 97: WING DAMAGE</b></p> |

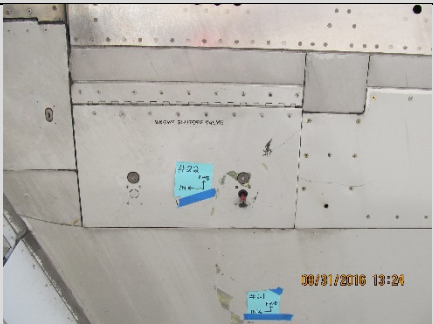
| Item Number | Location | Part Number (PHOTO NO.) | Condition | Photo |
|---|---|---|---|---|
| 22 | Engine shutoff valve access door panel 621CB. | (PHOTO 98) | Minor gouging was evident. The left latch was found in the open position. | <p><b>PHOTO 98: WING DAMAGE</b></p> |

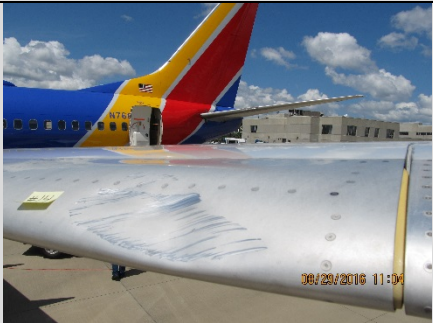
| Item Number | Location | Part Number (PHOTO NO.) | Condition | Photo |
|---|---|---|---|---|
| 14 | Slat No. 1 about 8-inches inboard from the outboard edge of the part (Slat station 511) | 114A8011-1 (PHOTO 99) | 10-inches-long x 5-inches-wide dent. The dent is approximately 0.5-inches-deep. | <p><b>PHOTO 99: WING DAMAGE</b></p> |

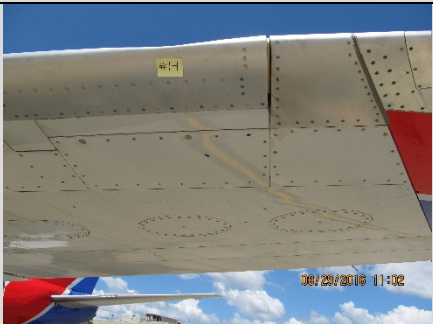
| Item Number | Location | Part Number<br>( <b>PHOTO NO.</b> ) | Condition | Photo |
|---|---|---|---|---|
| 14 | | ( <b>PHOTO 100</b> ) | See above description. | <p><b>PHOTO 100: WING DAMAGE</b></p> |

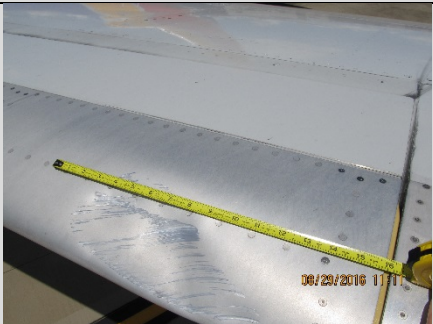
| Item Number | Location | Part Number<br>( <b>PHOTO NO.</b> ) | Condition | Photo |
|---|---|---|---|---|
| 14 | | 116A5411-1<br>( <b>PHOTO 101</b> ) | 10-inches-long x 5-inches-long dent. The dent was about 0.5-inches-deep. | <p><b>PHOTO 101: WING DAMAGE</b></p> |

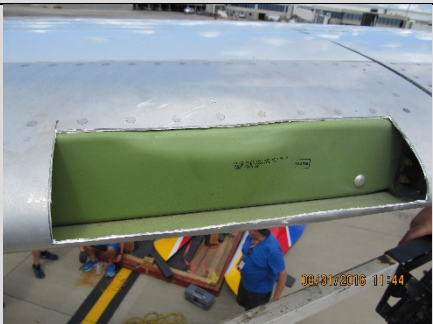
| Item Number | Location | Part Number<br>( <b>PHOTO NO.</b> ) | Condition | Photo |
|---|---|---|---|---|
| 14 | | 114A8211-1<br>( <b>PHOTO 102</b> ) | Upon removal of the LE skin, the 114A8211-1 nose beam was found dented/buckled. | <p><b>PHOTO 102: WING DAMAGE</b></p> |

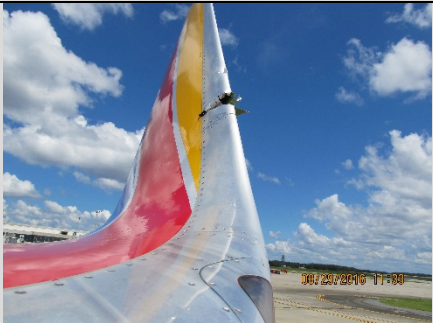
| Item Number | Location | Part Number<br>( <b>PHOTO NO.</b> ) | Condition | Photo |
|---|---|---|---|---|
| 25 | About 6-inch outboard of the inboard edge of the outboard LE skin. | 737-0350 (LE Skin),<br>737-0221 (Front Spar)<br>( <b>PHOTO 103</b> ) | The winglet LE skin was punctured, and the winglet front spar chord was partially severed. The puncture was about 5-inches-long at the LE and it about 6-inches-deep. The front spar chord was severed about 2-inches-deep at on the inboard edge and 1.5-inches on the outboard edge. The slot cut into the spar chord was about 0.375-inches-wide. | <p><b>PHOTO 103: WINGLET DAMAGE</b></p> |

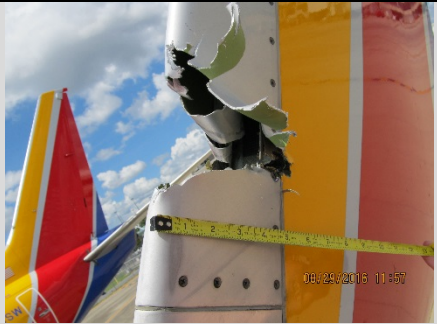
| <b>TABLE 2: AIRPLANE STRUCTURAL DAMAGE</b> | | | | |
|---|---|---|---|---|
| 25 | | ( <b>PHOTO 104</b> ) | See above description. | <p><b>PHOTO 104: WINGLET DAMAGE</b></p> |

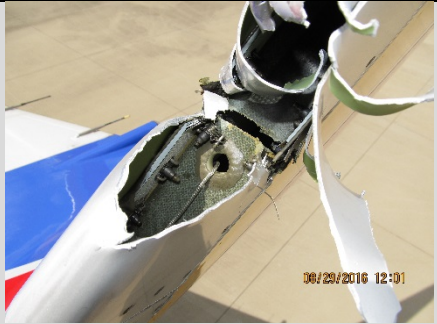
| <b>TABLE 2: AIRPLANE STRUCTURAL DAMAGE</b> | | | | |
|---|---|---|---|---|
| 25 | | ( <b>PHOTO 105</b> ) | See above description. | <p><b>PHOTO 105: WINGLET DAMAGE</b></p> |

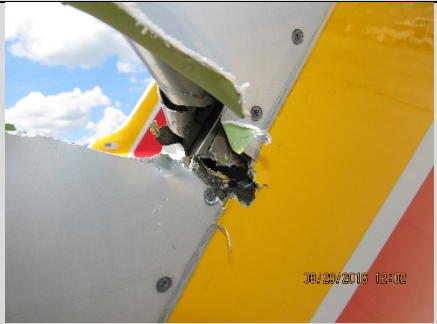
| <b>TABLE 2: AIRPLANE STRUCTURAL DAMAGE</b> | | | | |
|---|---|---|---|---|
| 25 | | ( <b>PHOTO 106</b> ) | See above description. | <p><b>PHOTO 106: WINGLET DAMAGE</b></p> |

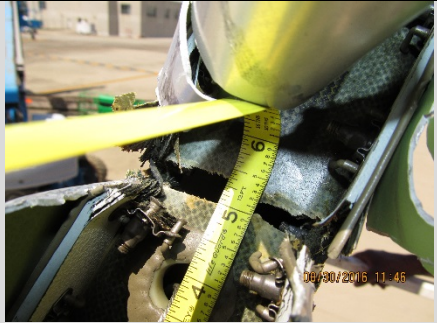
| <b>TABLE 2: AIRPLANE STRUCTURAL DAMAGE</b> | | | | |
|---|---|---|---|---|
| 25 | | ( <b>PHOTO 107</b> ) | See above description.<br>The slot cut into the spar chord was about 0.375-inches-wide. | <p><b>PHOTO 107: WINGLET DAMAGE</b></p> |

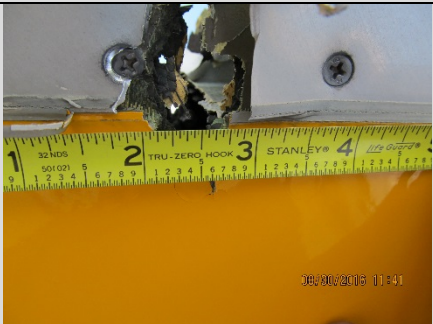
| <b>TABLE 2: AIRPLANE STRUCTURAL DAMAGE</b> | | | | |
|---|---|---|---|---|
| 25 | | ( <b>PHOTO 108</b> ) | See above description.<br>View of outboard side. | <p>08/20/2016 11:41</p> <p><b>PHOTO 108: WINGLET DAMAGE</b></p> |

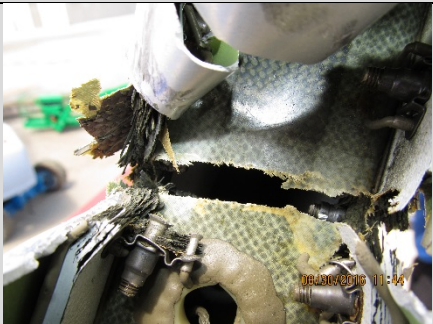
| <b>TABLE 2: AIRPLANE STRUCTURAL DAMAGE</b> | | | | |
|---|---|---|---|---|
| 25 | | ( <b>PHOTO 109</b> ) | See above description.<br>View of the winglet front spar damage. | <p>08/20/2016 11:45</p> <p><b>PHOTO 109: WINGLET DAMAGE</b></p> |

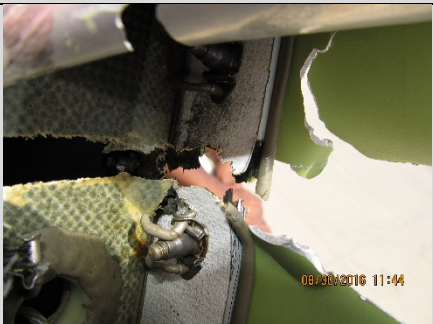
| <b>TABLE 2: AIRPLANE STRUCTURAL DAMAGE</b> | | | | |
|---|---|---|---|---|
| 25 | | ( <b>PHOTO 110</b> ) | See above description.<br>View of the outboard flange of the winglet front spar chord. | <p>08/20/2016 11:44</p> <p><b>PHOTO 110: WINGLET DAMAGE</b></p> |

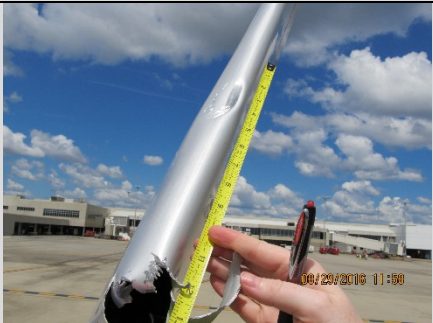
| <b>TABLE 2: AIRPLANE STRUCTURAL DAMAGE</b> | | | | |
|---|---|---|---|---|
| 24 | Winglet outboard LE skin | 737-0350<br>( <b>PHOTO 111</b> ) | There was a dent 3-inch-wide x 0.2-inches-deep located about 16.5-inches outboard from the inboard edge of the part. | <p>08/20/2016 11:50</p> <p><b>PHOTO 111: WINGLET DAMAGE</b></p> |

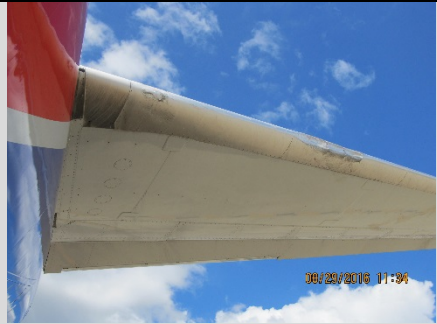
| Item Number | Location | Part Number (PHOTO NO.) | Condition | Photo |
|---|---|---|---|---|
| 15 | Horizontal stabilizer LE. LE station 133.15 to outboard tip. | 186A1210 (PHOTO 112) | Dent damage to the horizontal stabilizer from LE station (STA) 149 to 180. The LE skin torn and the LE ribs were bent. | <p>08/29/2016 11:04</p> <p><b>PHOTO 112: HORIZONTAL STABILIZER DAMAGE</b></p> |

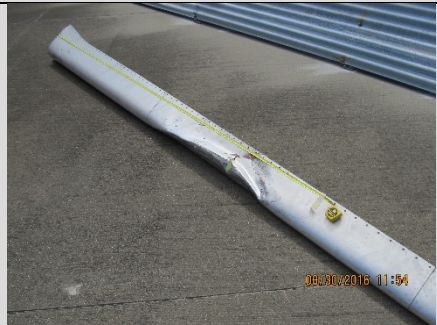
| Item Number | Location | Part Number (PHOTO NO.) | Condition | Photo |
|---|---|---|---|---|
| 15 and 23 | | (PHOTO 113) | The LE from LE STA 133.15 to tip was removed and is shown in the picture to the right. Scrapping damage was noted along much of its length. | <p>08/30/2016 11:04</p> <p><b>PHOTO 113: HORIZONTAL STABILIZER DAMAGE</b></p> |

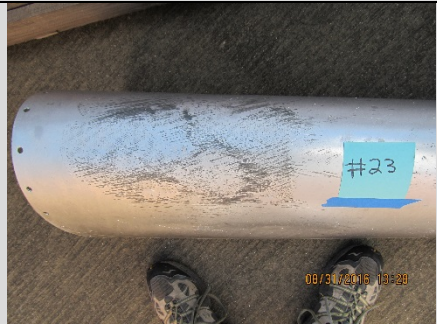
| Item Number | Location | Part Number (PHOTO NO.) | Condition | Photo |
|---|---|---|---|---|
| 23 | Horizontal stabilizer LE skin just outboard of LE STA 133.15 | (PHOTO 114) | Minor denting and surface scoring noted. The surface was imprinted with a honeycomb pattern characteristic of the engine inlet acoustic liner. | <p>08/30/2016 10:29</p> <p><b>PHOTO 114: HORIZONTAL STABILIZER DAMAGE</b></p> |

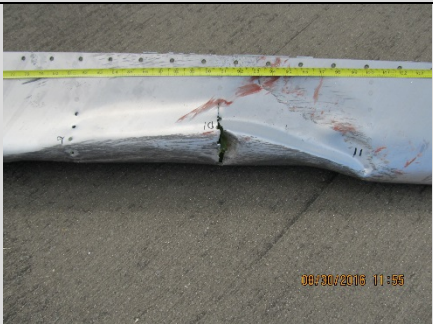
| Item Number | Location | Part Number<br>( <b>PHOTO NO.</b> ) | Condition | Photo |
|---|---|---|---|---|
| 15 | | ( <b>PHOTO 115</b> ) | The location labeled as location 10 at the deepest portion of the dent is LE STA 161.04. The dent was about 35-inches-long and 1.4-inches-deep. The LE skin had a honeycomb pattern imprinted on it and had red material transfer. Portions of the engine inlet material were found embedded in the tear of the skin. | <p><b>PHOTO 115: HORIZONTAL STABILIZER DAMAGE</b></p> |

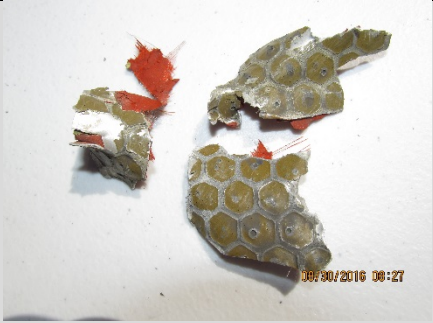
| Item Number | Location | Part Number<br>( <b>PHOTO NO.</b> ) | Condition | Photo |
|---|---|---|---|---|
| 15 | | ( <b>PHOTO 116</b> ) | Inlet material found embedded in the horizontal stabilizer LE skin tear. | <p><b>PHOTO 116: DEBRIS FOUND IN HORIZONTAL STABILIZER</b></p> |

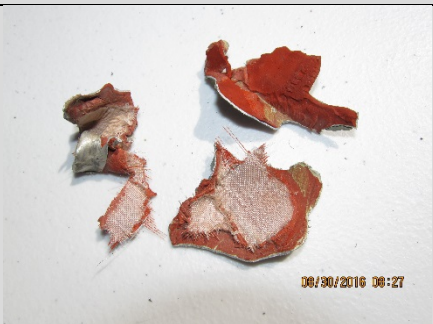
| Item Number | Location | Part Number<br>( <b>PHOTO NO.</b> ) | Condition | Photo |
|---|---|---|---|---|
| 15 | | ( <b>PHOTO 117</b> ) | Inlet material found embedded in the horizontal stabilizer LE skin tear. | <p><b>PHOTO 117: DEBRIS FOUND IN HORIZONTAL STABILIZER</b></p> |

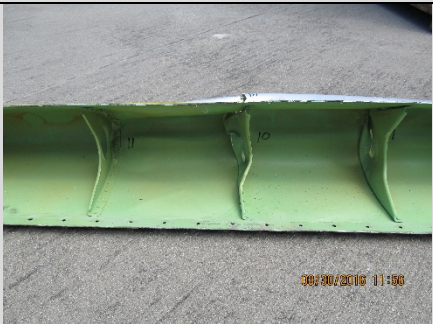
| <b>TABLE 2: AIRPLANE STRUCTURAL DAMAGE</b> | | | | |
|---|---|---|---|---|
| 15 | Horizontal Stabilizer LE STA 151.75 to 170.34 (Locations 9 to 11) | (PHOTO 118) | The horizontal stabilizer LE ribs at LE STA 151.75, 170.34, and 179.64 were buckled. | <p><b>PHOTO 118: HORIZONTAL STABILIZER DAMAGE</b></p> |

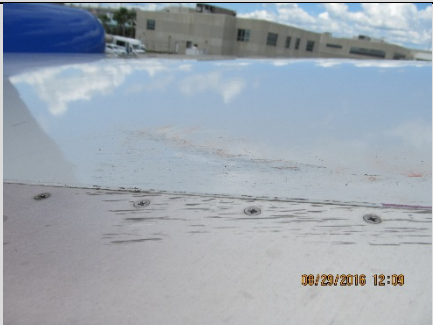
| <b>TABLE 2: AIRPLANE STRUCTURAL DAMAGE</b> | | | | |
|---|---|---|---|---|
| 16 | LE STA 155 just aft of the front spar. | 182A3002 (PHOTO 119) | 5-inches-long x 3-inches-wide x 0.095-inches-deep dent with minor gouge damage in the horizontal stabilizer upper skin. | <p><b>PHOTO 119: HORIZONTAL STABILIZER DAMAGE</b></p> |

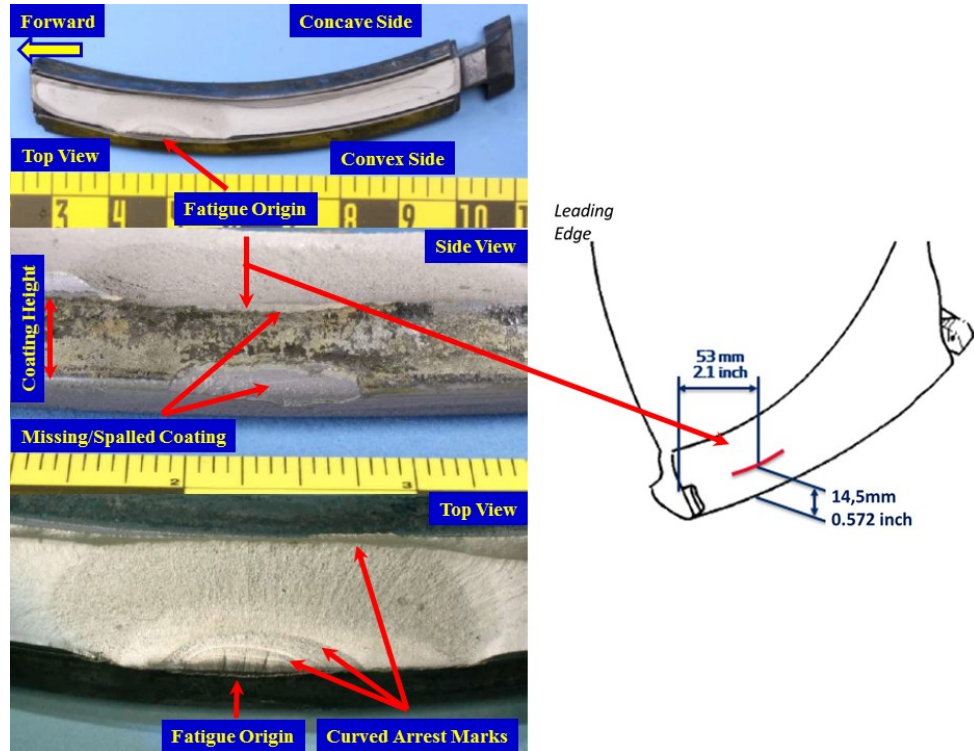
**PHOTO 120: FRACTURE SURFACE OF FAN BLADE NO. 23**

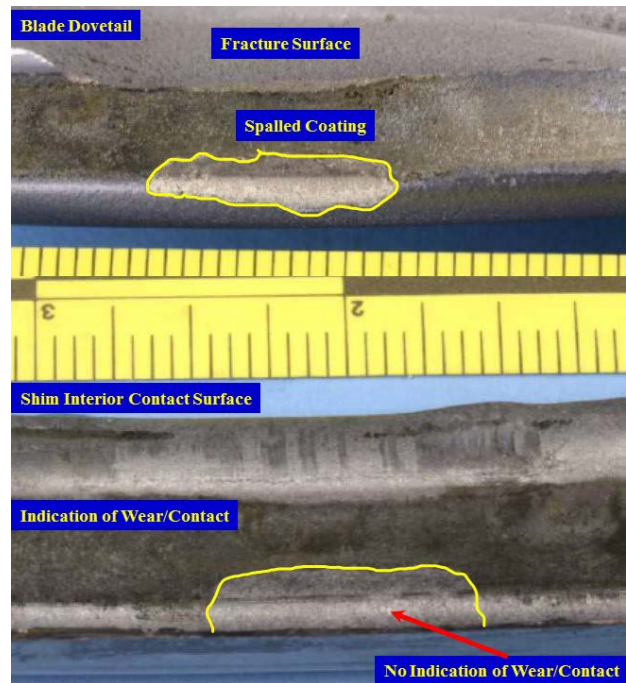
**PHOTO 121: BLADE NO. 23 DOVETAIL AND SHIM INTERIOR SURFACE COMPARISON**

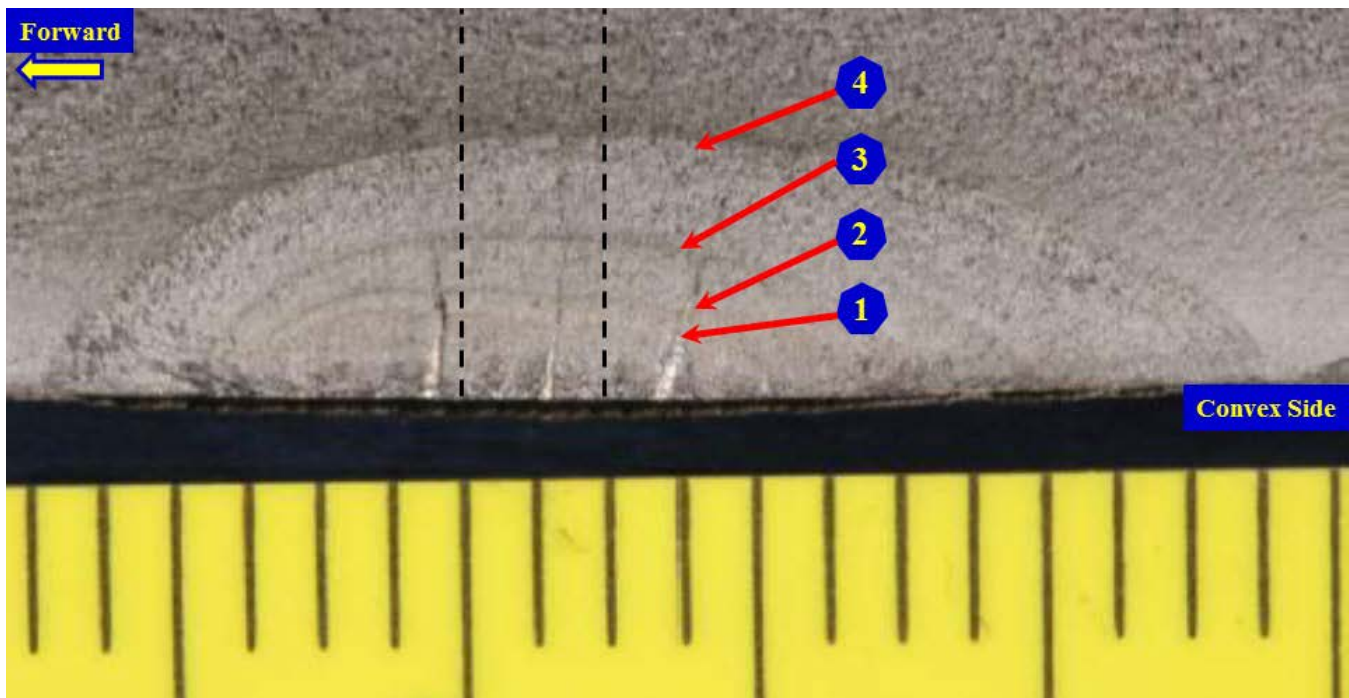
**PHOTO 122: CRACK ARREST LINES**

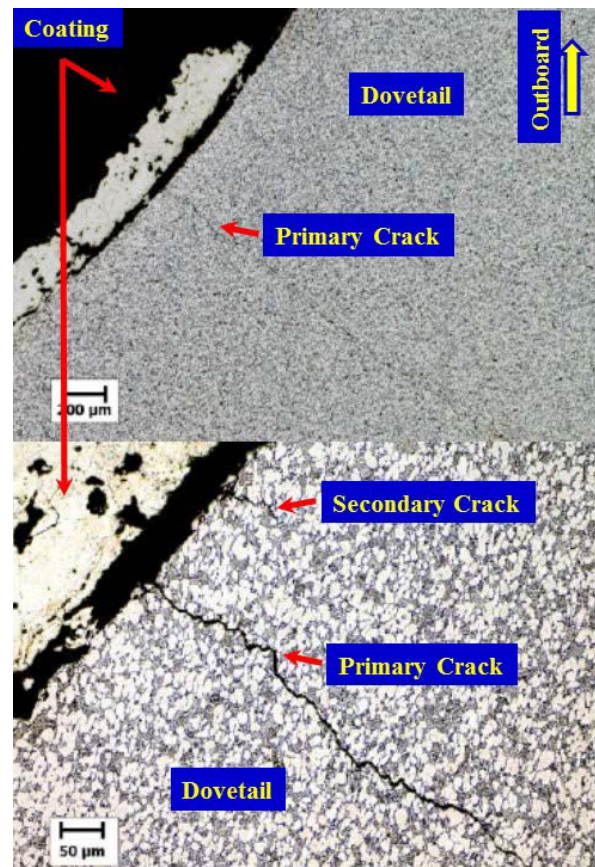
**PHOTO 123: MAGNIFIED VIEWS OF BLADE NO. 24 CRACKS AND COATING DISBONDED**

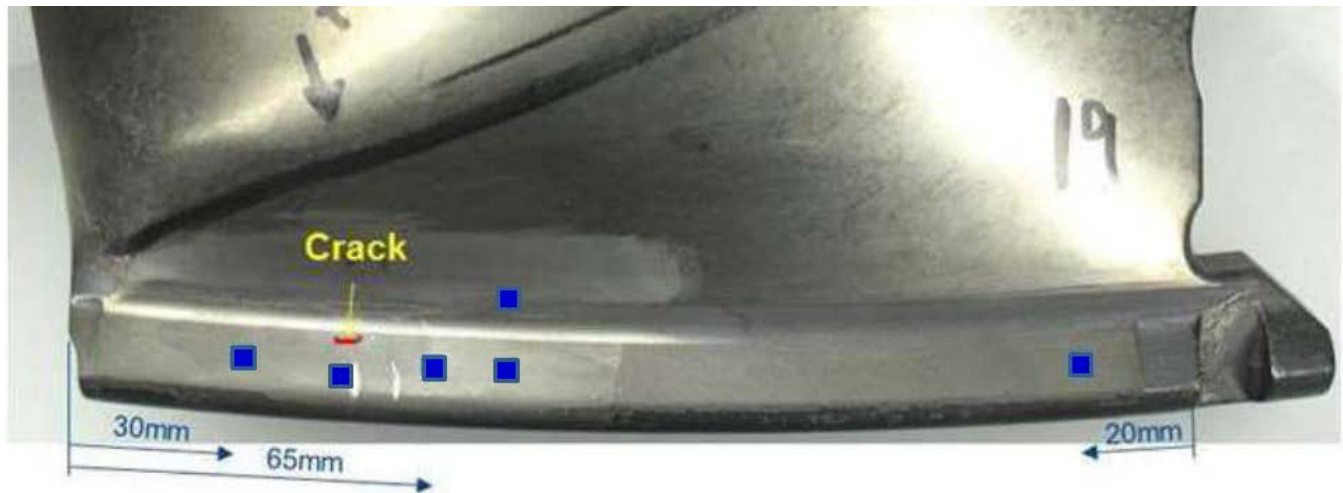
**PHOTO 124: RS MEASUREMENT LOCATIONS ON BLADE NO. 19 – TYPICAL OF OTHER BLADE LOCATIONS**

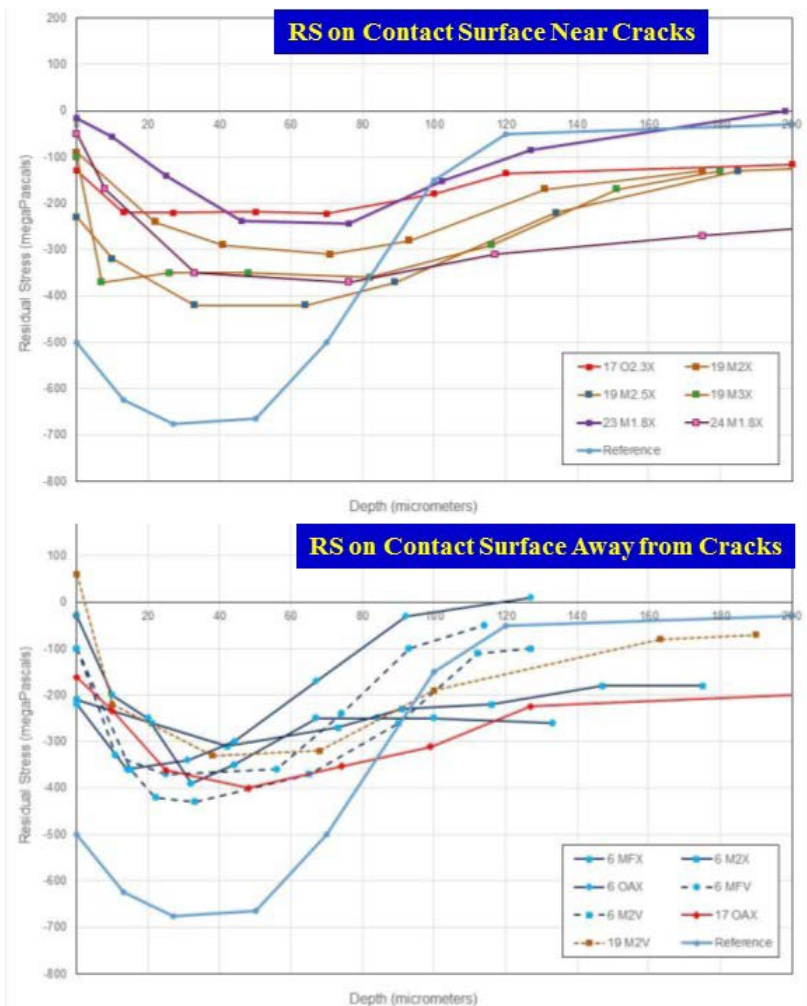
**FIGURE 17: RESIDUAL STRESS PROFILES**

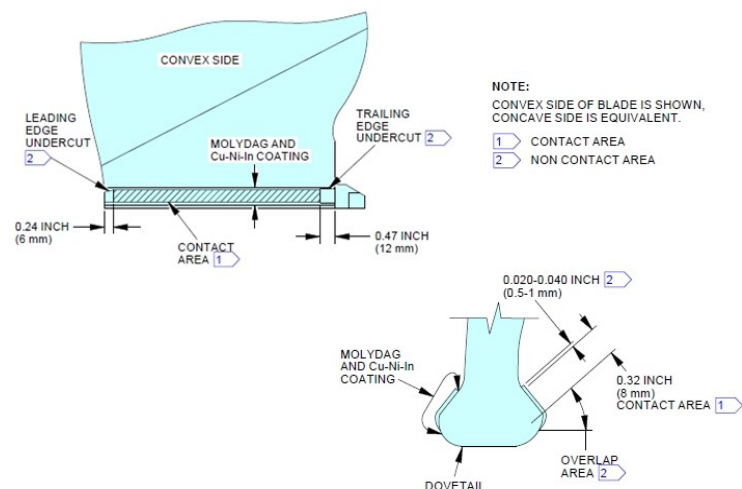
**FIGURE 18: FAN BLADE DOVETAIL CONTACT AND NON-CONTACT AREAS AND MOLYKOTE™ APPLICATION AREA**  
FIGURE COURTESY OF CFM

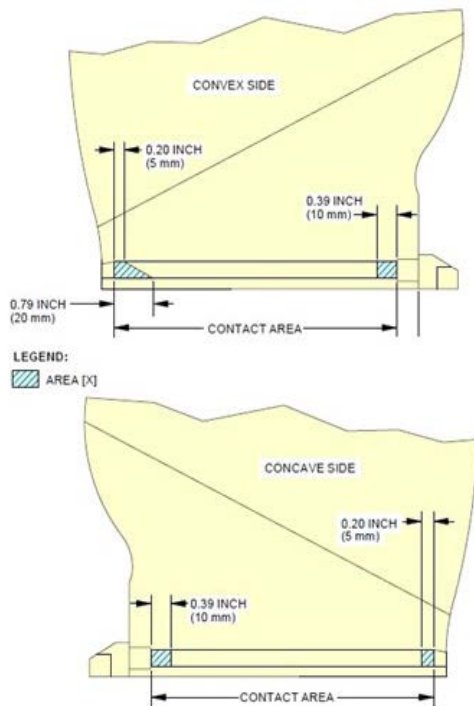
**FIGURE 19: “AREA X” LOCATIONS**

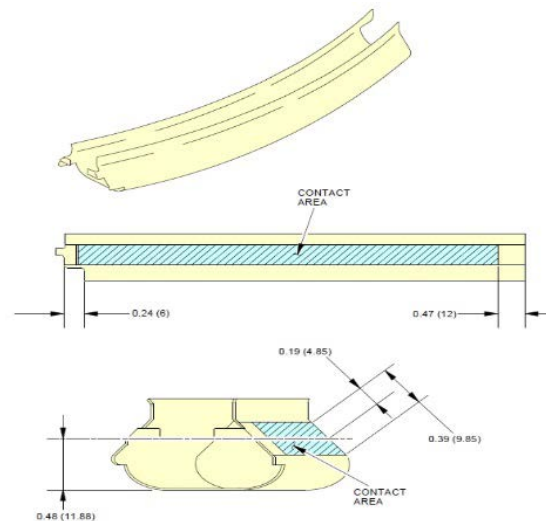
**FIGURE 21: SHIM CU-NI-IN CONTACT AREAS**  
FIGURE COURTESY OF CFM

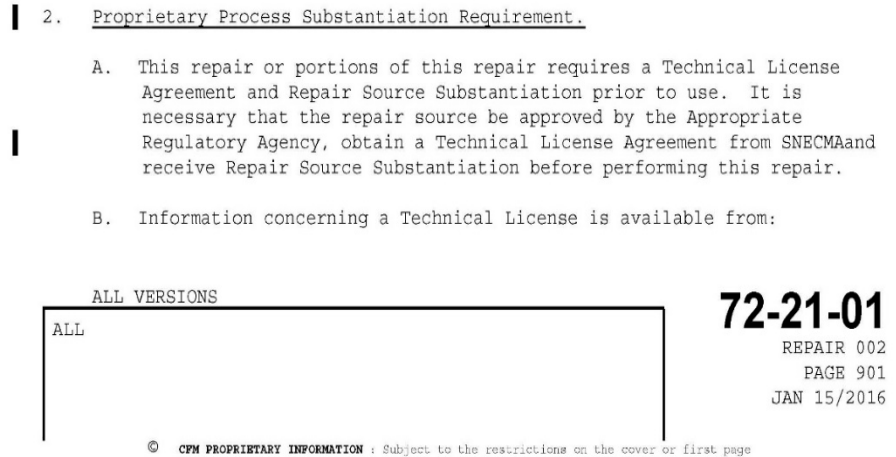
**FIGURE 22: FAN BLADE DOVETAIL CU-NI-IN COATING AND VARNISH REPAIR – 002**

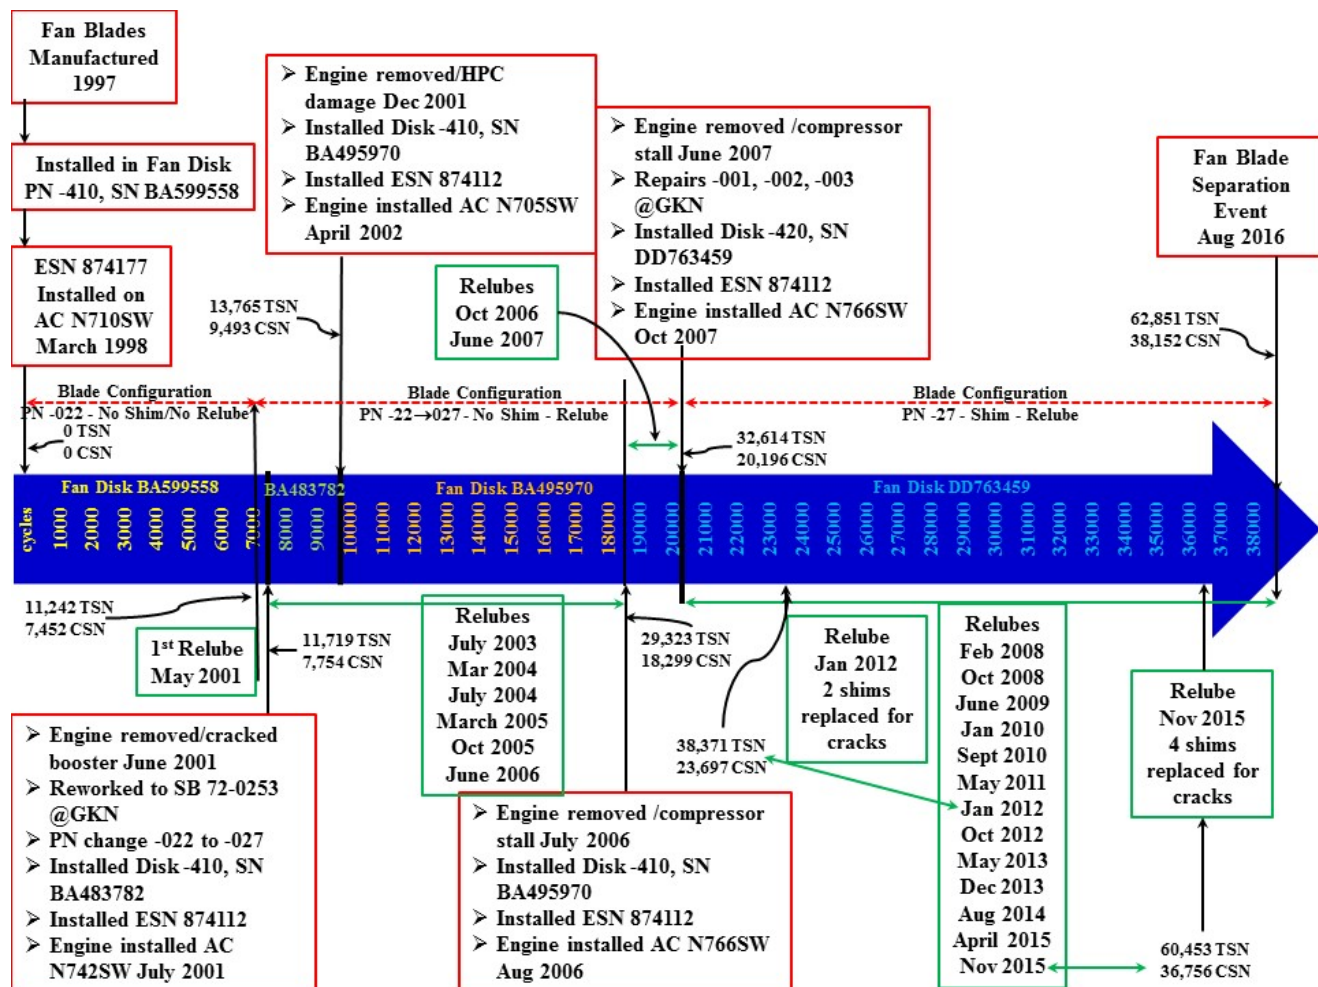
FIGURE 23: EVENT FAN BLADE SET TIMELINE

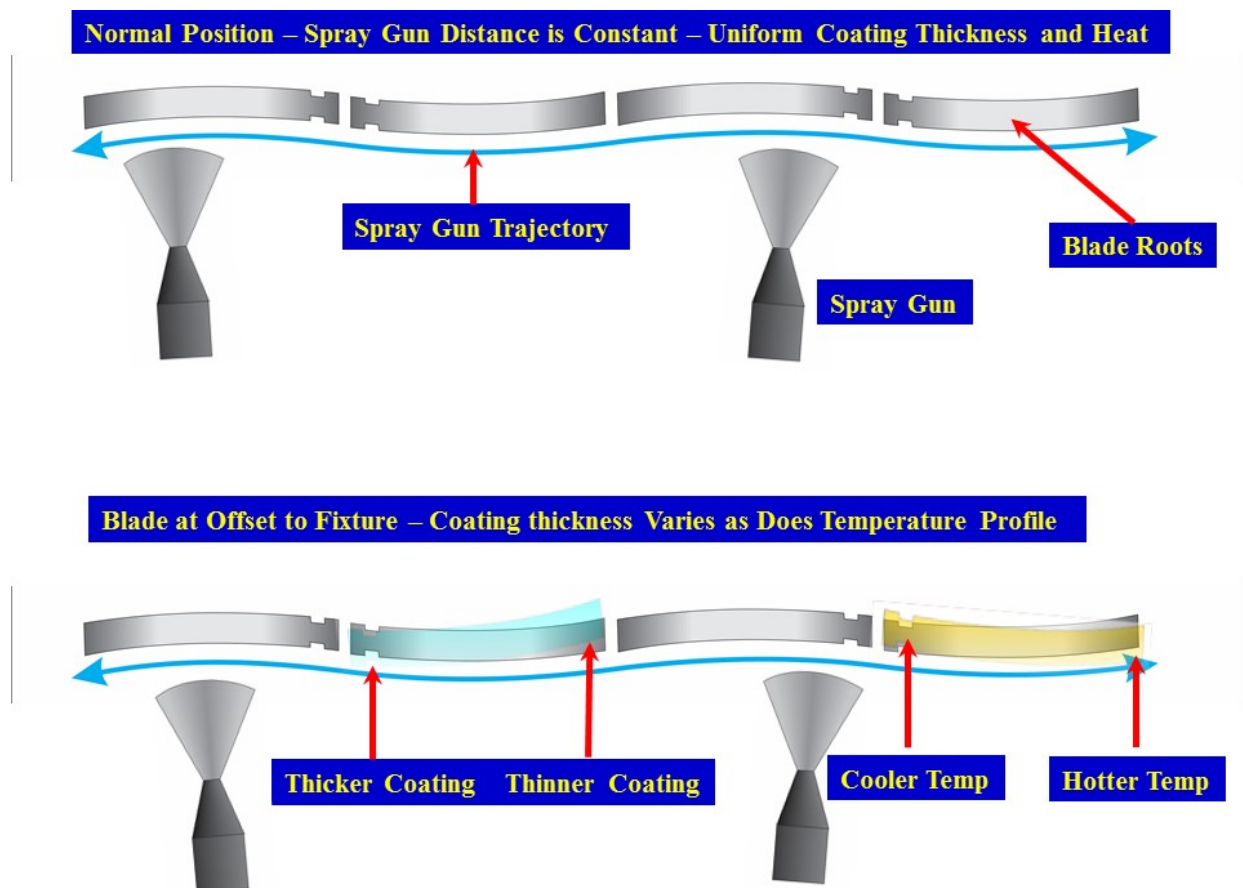
**FIGURE 24: PLASMA SPRAY COATING FIXTURE AND POSSIBLE PROJECTIONS**

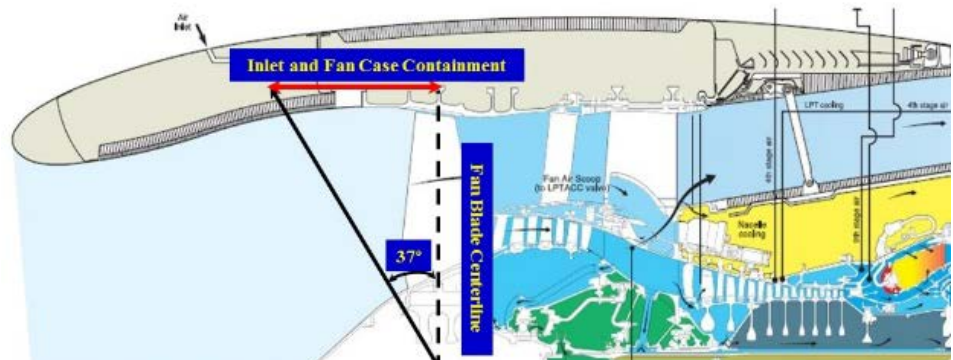
**FIGURE 26: CONTAINMENT SPREAD ANGLE CFM56-7B FBO RIG AND ENGINE FBO CONTAINMENT CERTIFICATION TEST INLET CONFIGURATION**

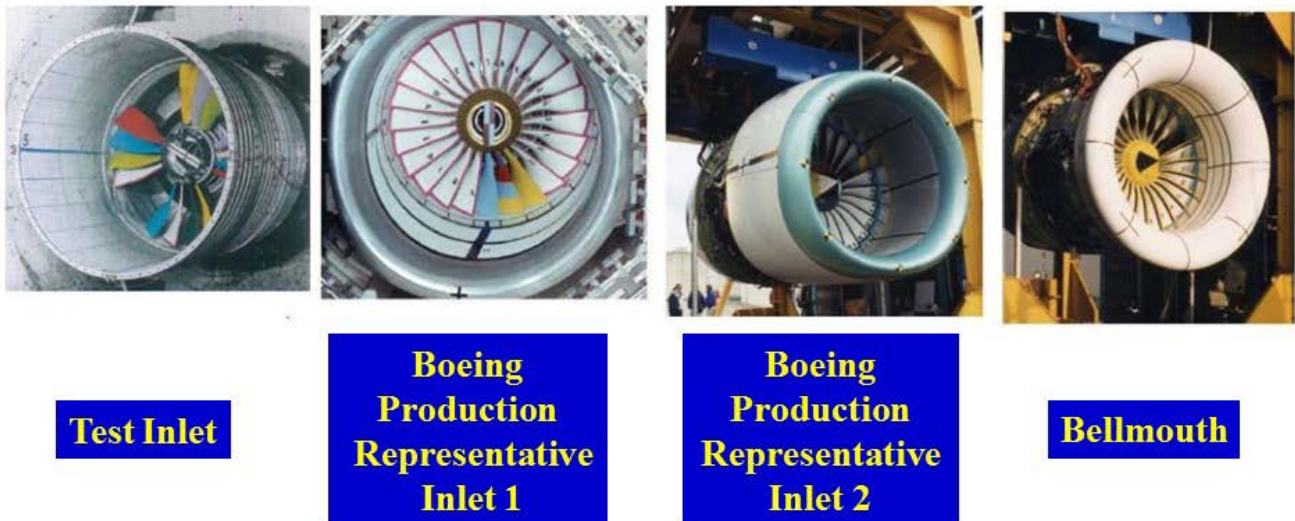
**PHOTO 125: CFM56-7B FBO RIG AND ENGINE CONTAINMENT CERTIFICATION TEST INLET CONFIGURATION**  
PHOTO COURTESY OF CFM

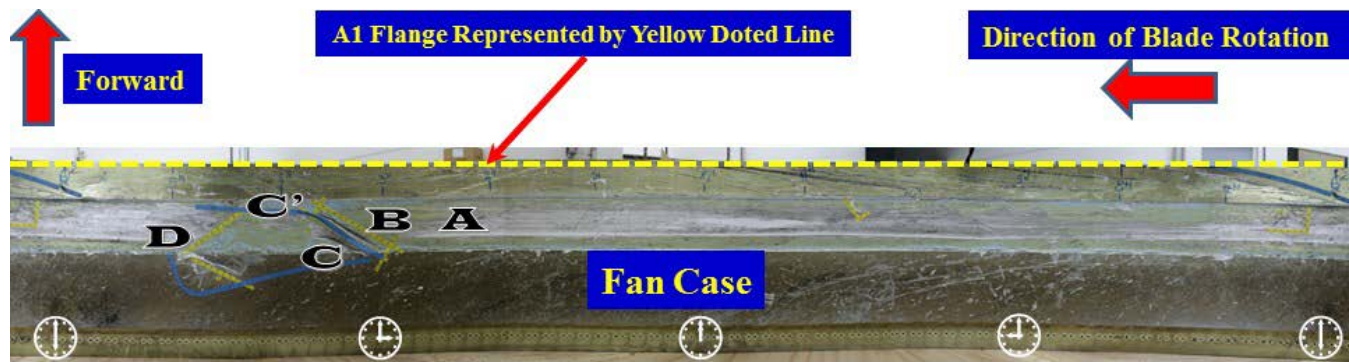
**PHOTO 126: CFM DOCUMENTATION OF FAN CASE DAMAGE**

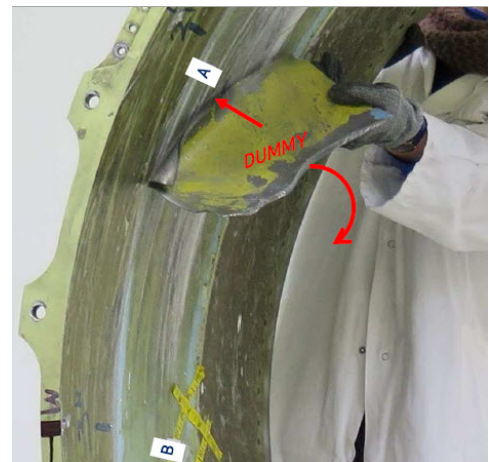
**PHOTO 127: TIP PANEL ROTATION**

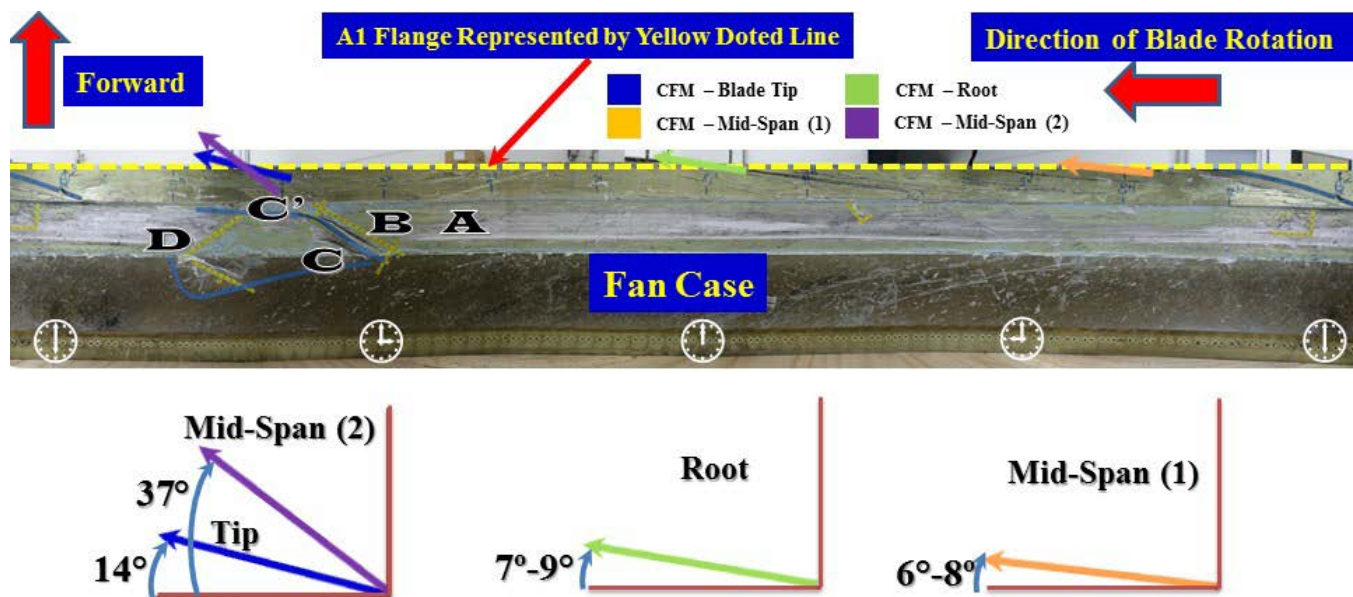
**PHOTO 128: CFM DOCUMENTATION OF FAN CASE DAMAGE & FAN BLADE FRAGMENT TRAJECTORY**  
PHOTO COURTESY OF CFM

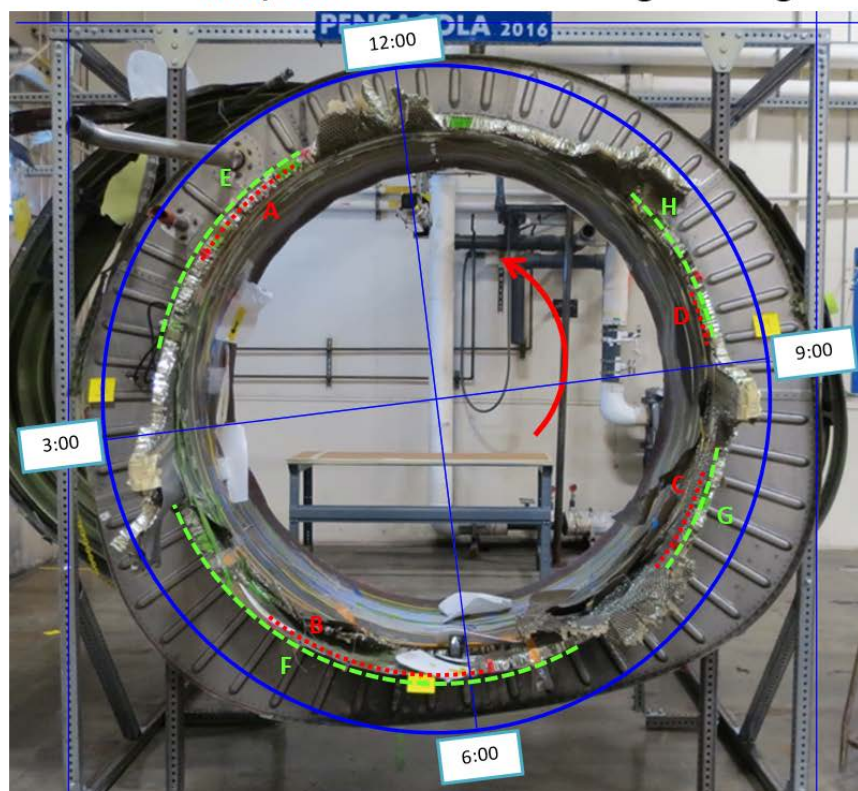
#### — — — Min Damage

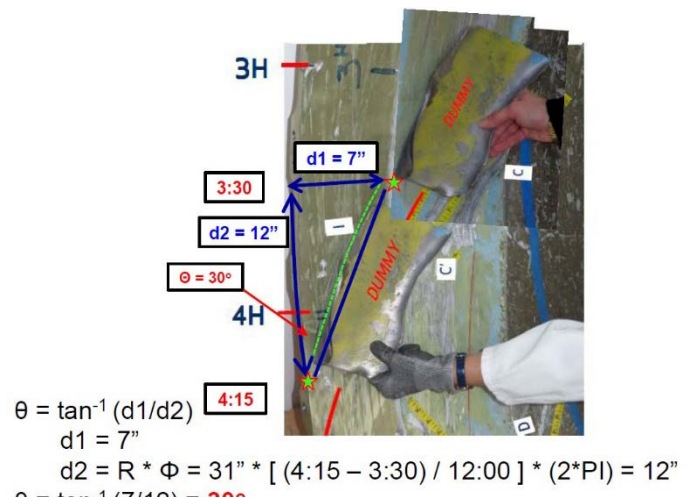
**PHOTO 130: UTAS TIP PANEL EXIT TRAJECTORY**

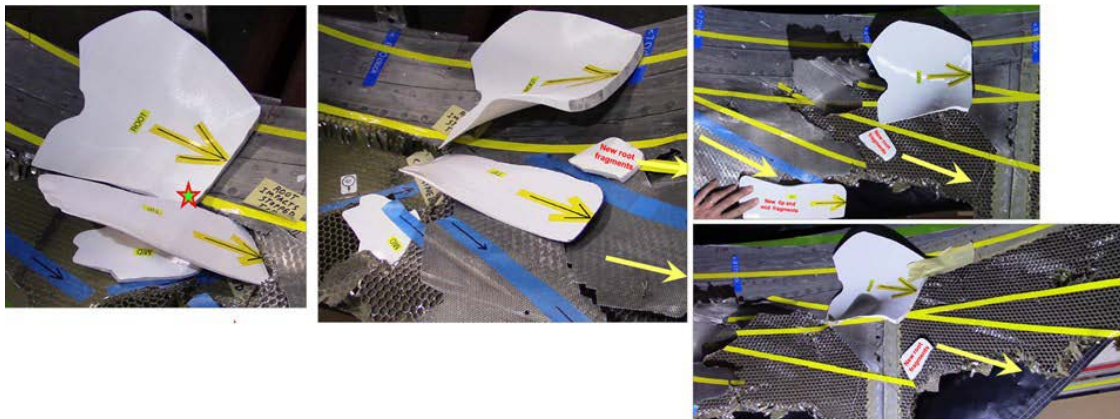
**PHOTO 132: ROOT PATH WITH INLET AND COLLISION WITH TIP PANEL**
