**NATIONAL TRANSPORTATION SAFETY BOARD**  
**Office of Aviation Safety**  
**Washington, D.C. 20594**

**November 12, 2018**

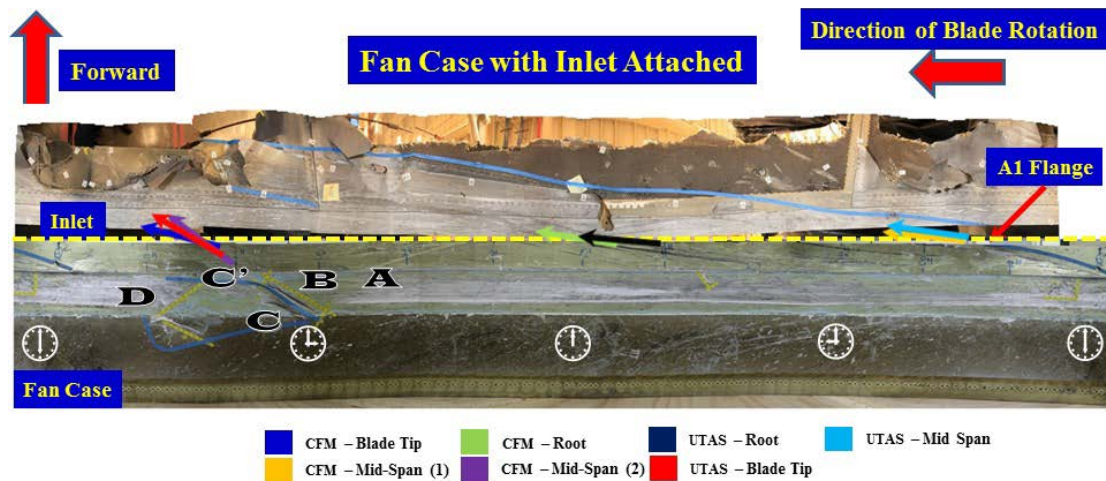
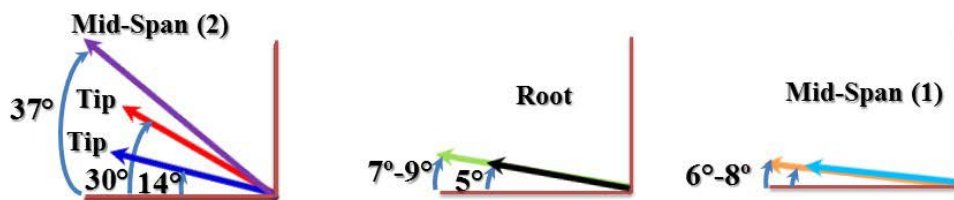
**PHOTO 133: CFM AND UTAS FAN BLADE FRAGMENT EXIT TRAJECTORY ASSESSMENT**

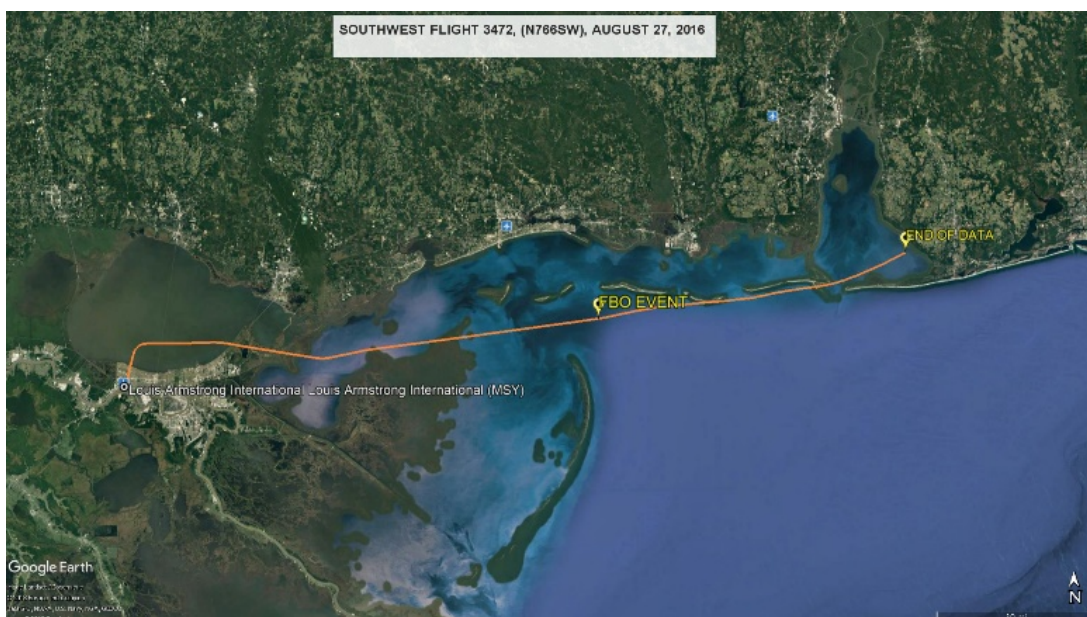
**PLOT 2: FLIGHT PATH FOR INCIDENT FLIGHT 3472**

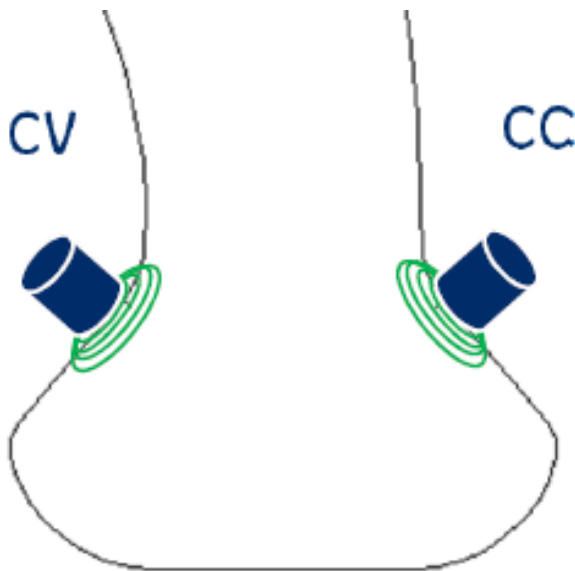
**FIGURE 27: LOCATION OF THE ECI SCAN<sup>67</sup>**

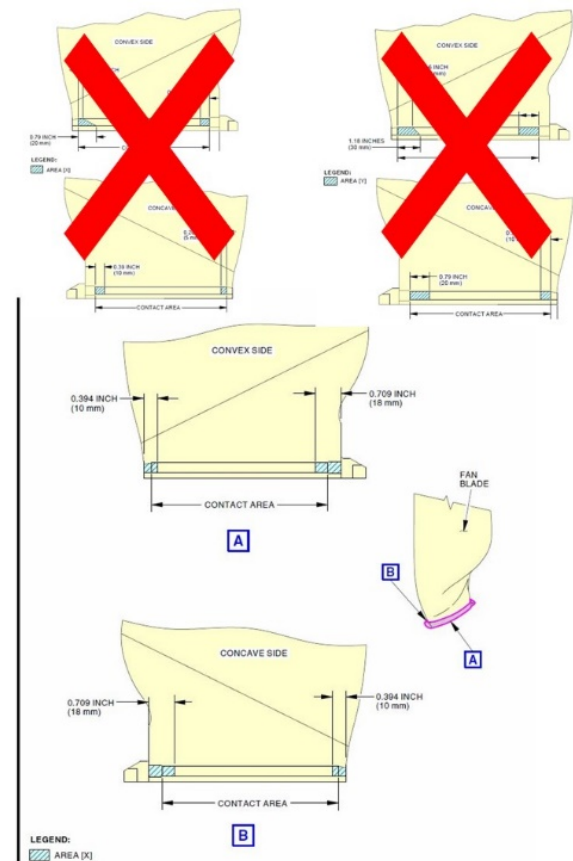
**FIGURE 28: NEW FAN BLADE DOVETAIL COATING INSPECTION**

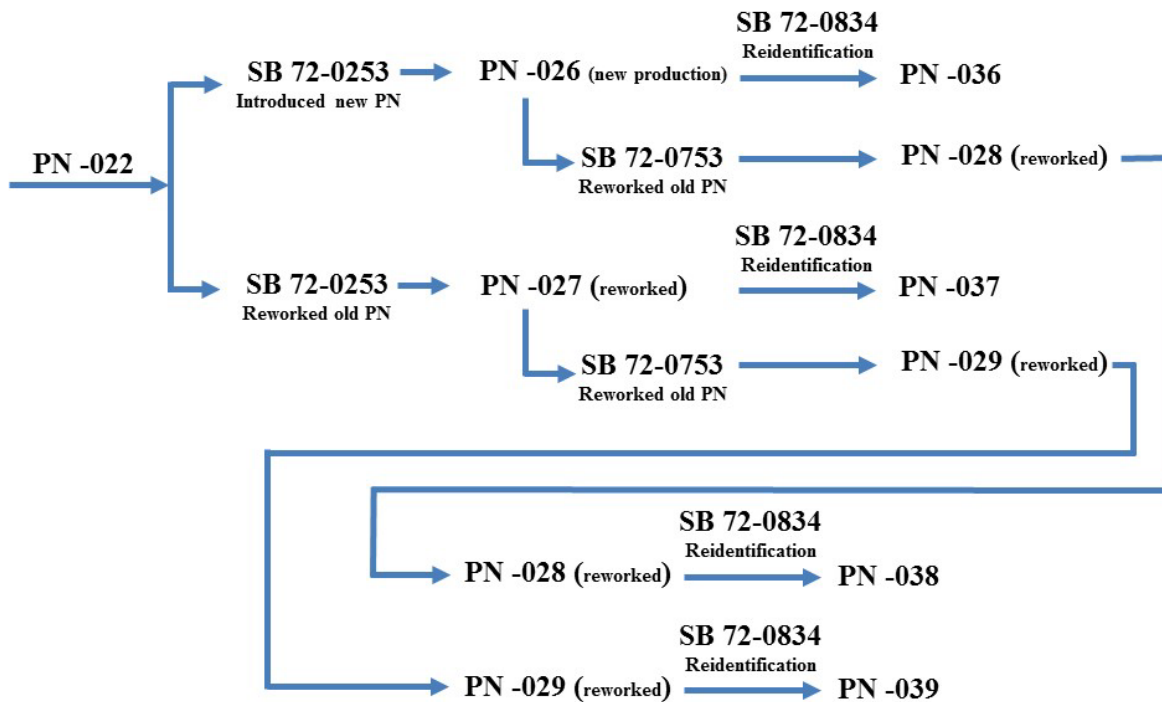
**FIGURE 30: CFM56-7B FAN BLADE CONFIGURATION CHANGES**

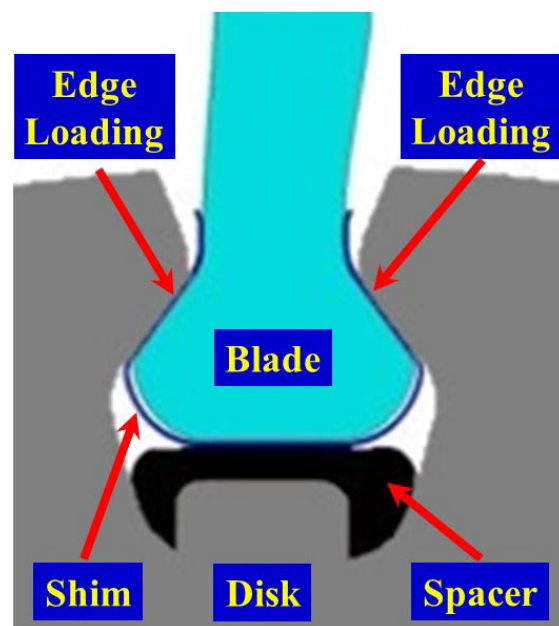
**FIGURE 31: EDGE LOAD LOCATIONS**
