## **NATIONAL TRANSPORTATION SAFETY BOARD**

### **Group Chairman's Factual Report**

#### **AIR TRAFFIC CONTROL**

**DCA16IA200**

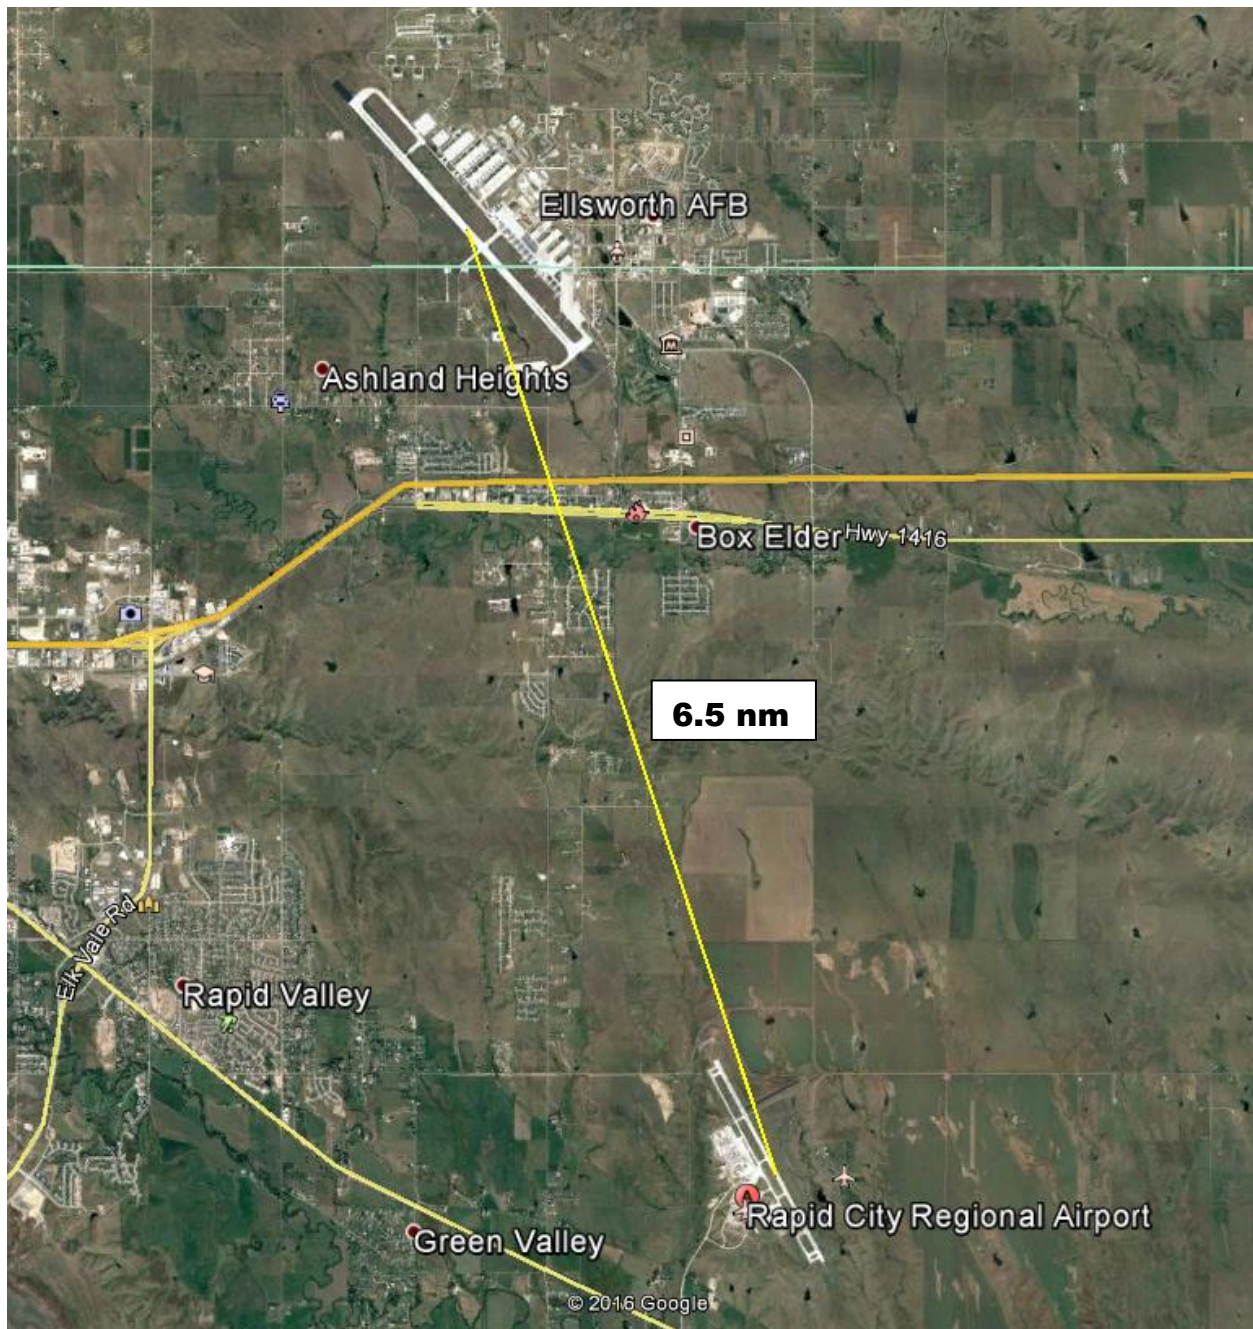
DAL2845 was an Airbus A320 operating as a scheduled Title 14 Code of Federal Regulations part 121 air carrier flight between Minneapolis and Rapid City, South Dakota (RAP). Weather conditions in the vicinity were reported as clear with 10 miles visibility. Calculated sunset at Rapid City was 2038 local time. RAP has two runways: 14/32 and 5/23. Runway 14/32 is used for air carrier operations, and is 8701 feet long by 150 feet wide. RCA has a single runway 13/31 that is 13497 feet long and 300 feet wide. The runways are located 6.5 nm apart. (Figure 1)

Figure 1 – Ellsworth AFB (RCA) and Rapid City Regional Airport (RAP), located 6.5 nautical miles apart.

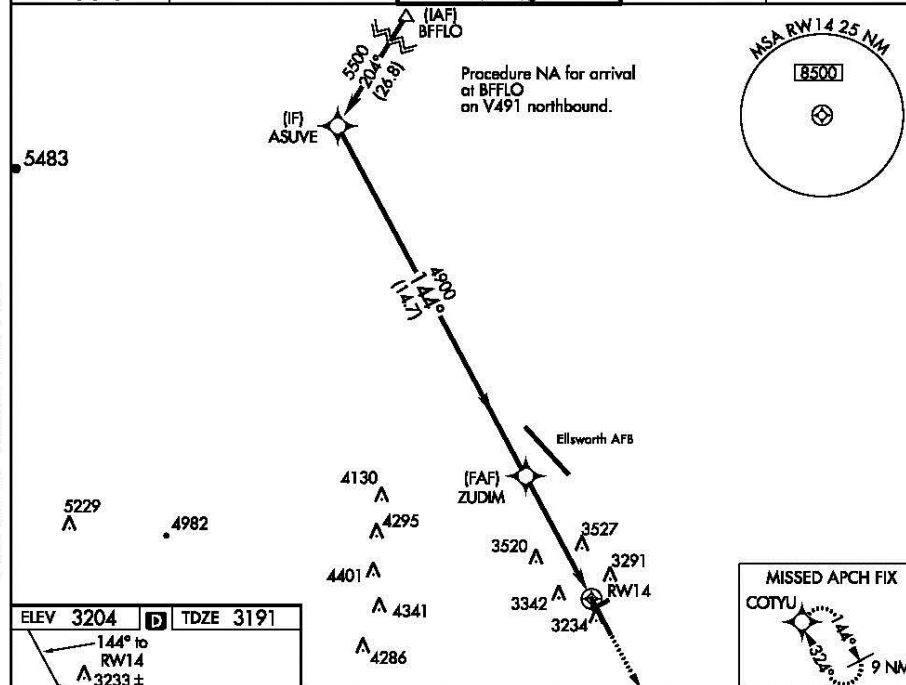
# **RNAV (GPS) RWY 14** RAPID CITY RGNL (RAP)

**⚠** Circling to Rwy 5-23 NA at night. For uncompensated Baro-VNAV systems, LNAV/VNAV NA below -14°C (7°F) or above 53°C (128°F). When local altimeter setting not received, use Ellsworth AFB altimeter setting and increase all DA 26 feet and all MDA 40 feet and increase Circling Cts C/D visibility ¼. VDP NA with Ellsworth AFB altimeter setting. Baro-VNAV NA when using Ellsworth AFB altimeter setting. Helicopter visibility reduction below 1 SM NA. DME/DME RNP-0.3 NA.

Because of the demonstrated possibility of mistaken identity, DATCF standard operating procedures in place before this incident required that pilots be advised of the proximity of RCA to RAP, as was done in this case. In addition, the location of RCA was added to Federal Aviation Administration approach charts for RAP to increase pilot awareness of the base and the possibility of confusion. Following this incident, DATCF management directed that their controllers, “...ensure that pilots arriving north of RCA on a Visual Approach to RAP report both airfields in sight, except for pilots that report that they are familiar with the local area.” In addition, RAP ATCT management directed their controllers to not issue landing clearances to aircraft inbound from the vicinity of RCA until the arriving aircraft passed the base.

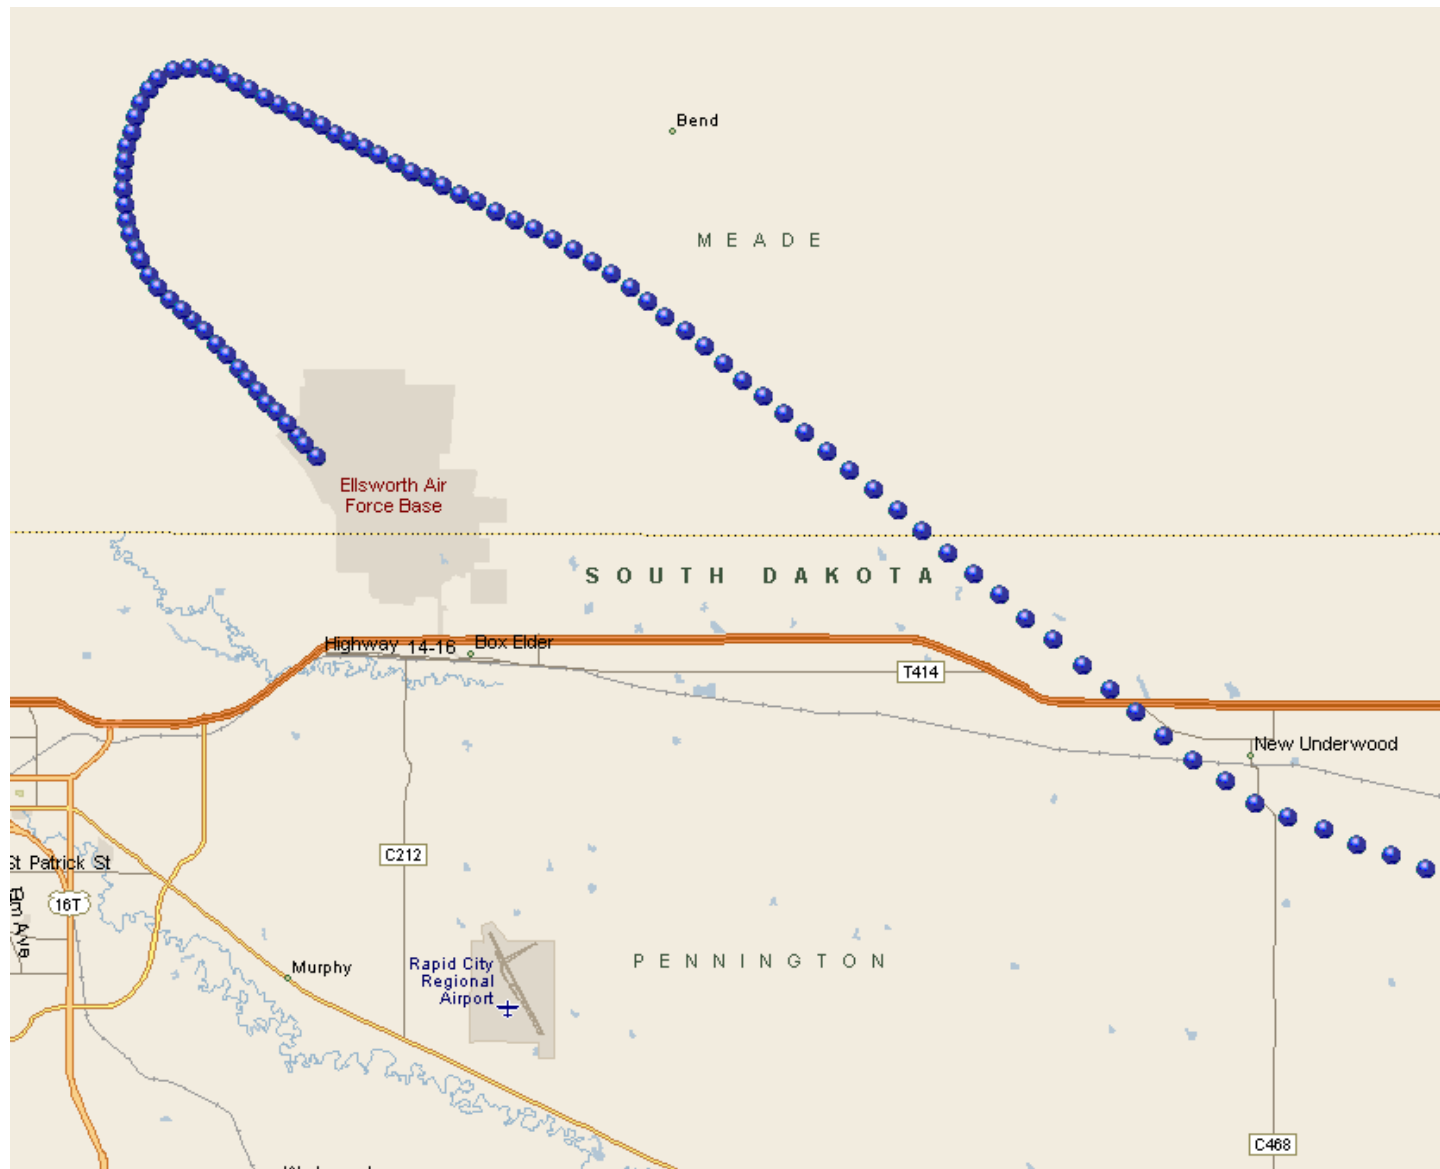
The EA controller provided radar vectors for the visual approach and advised the tower controller at RAP of the inbound flight. At 2036, the EA and RAP controllers engaged in a discussion about DAL2845 being unusually high and fast. At 2037, the EA controller tried to turn DAL2845 to heading 230, but the pilot responded, "Like to keep her a little high. You mind if we keep going out a little bit longer?" The controller instructed the pilot to continue present heading and advise when ready to proceed inbound. The extended downwind track took the aircraft northeast of RCA.

Figure 3 – DAL2845 track during vectors for the visual approach to RAP (located 6.45 nm SE of Ellsworth AFB).

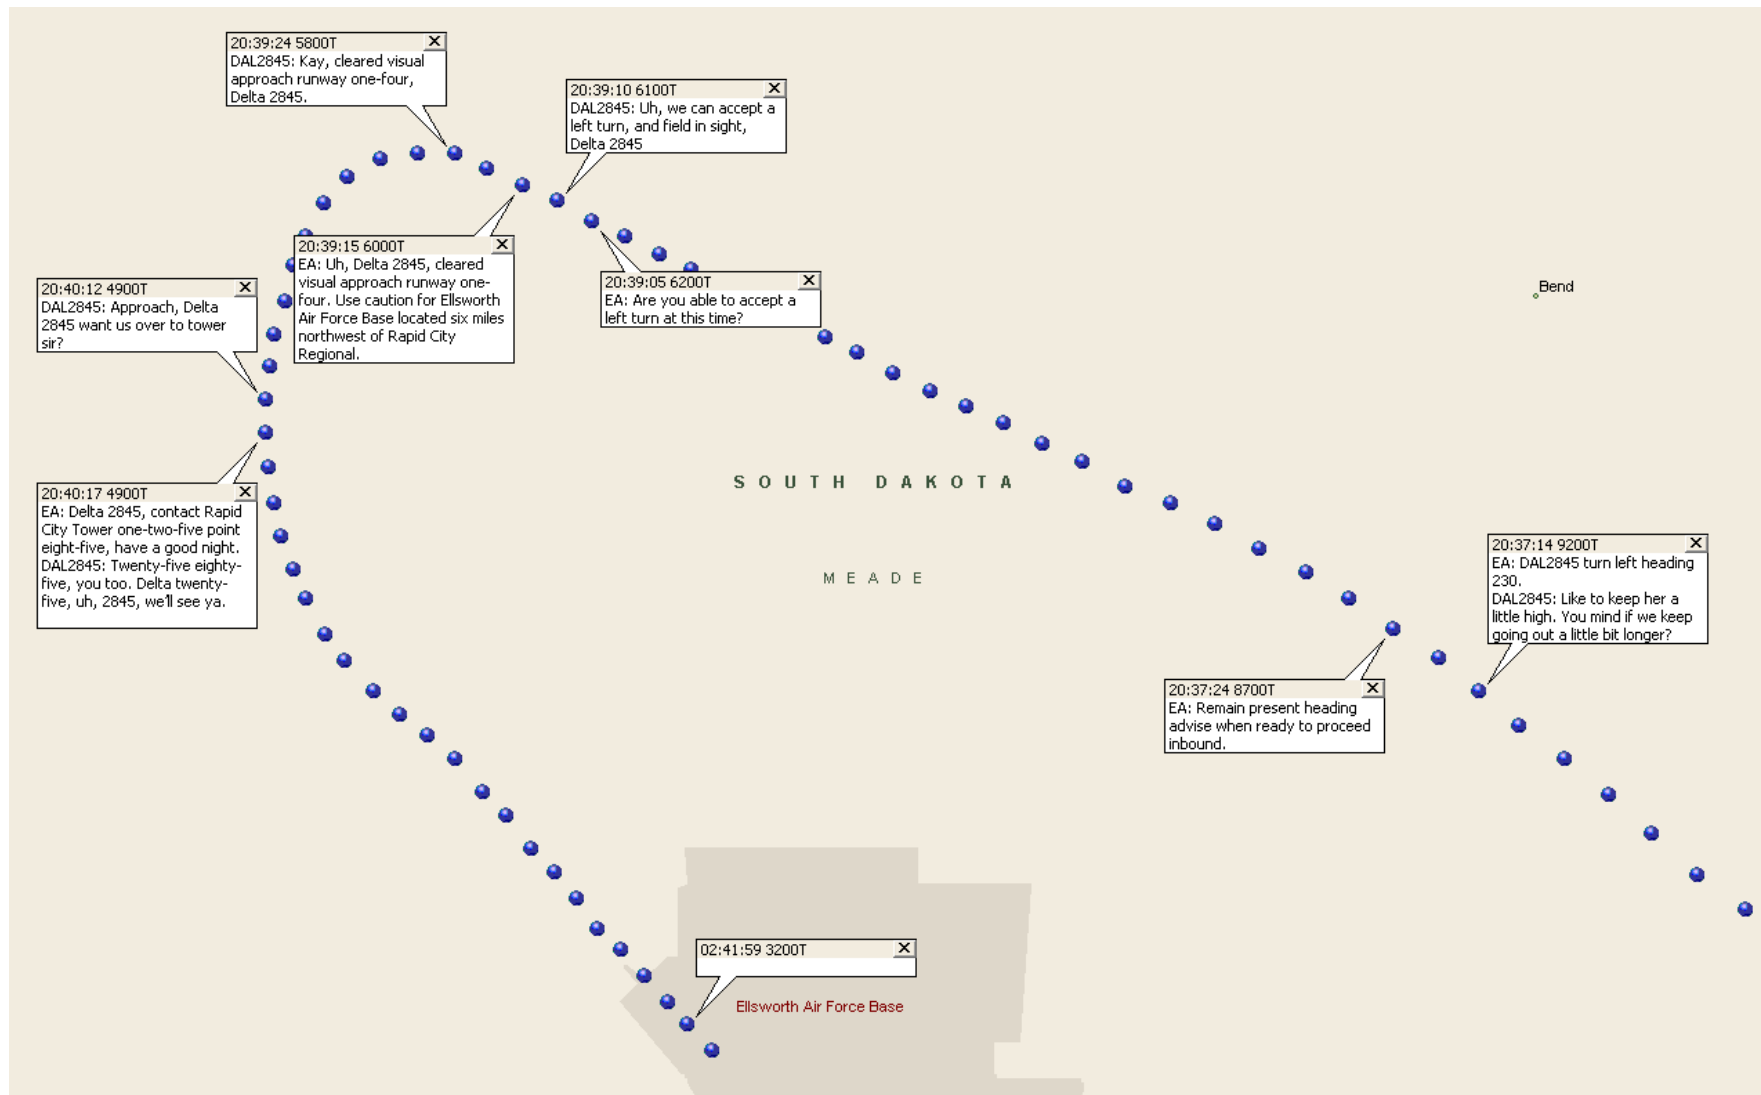
At 2039:08, the EA controller asked, "Delta 2845 are you able to accept a left turn at this time?" The pilot responded, "Uh, we can accept a left turn, and field in sight, Delta 2845." The controller replied, "Uh, Delta 2845, cleared visual approach runway one-four. Use caution for Ellsworth Air Force Base located six miles northwest of Rapid City Regional." The pilot acknowledged with, "Kay, cleared visual approach runway one-four, Delta 2845."

At 2040:10, the pilot transmitted, "Approach, Delta 2845 want us over to tower sir?" The EA controller instructed the pilot to contact RAP tower on 125.85, and the pilot acknowledged. At 2040:39, the pilot contacted RAP ATCT reporting inbound to runway 14, and the RAP controller cleared him to land on runway 14. At 2042:16, about 1 minute and 30 seconds after being cleared to land, the pilot reported that DAL2845 had landed at RCA.

Figure 4 – DAL2845 ground track with selected communications.
