## NATIONAL TRANSPORTATION SAFETY BOARD

### Group Chairman's Factual Report

## AIR TRAFFIC CONTROL

DCA16LA032

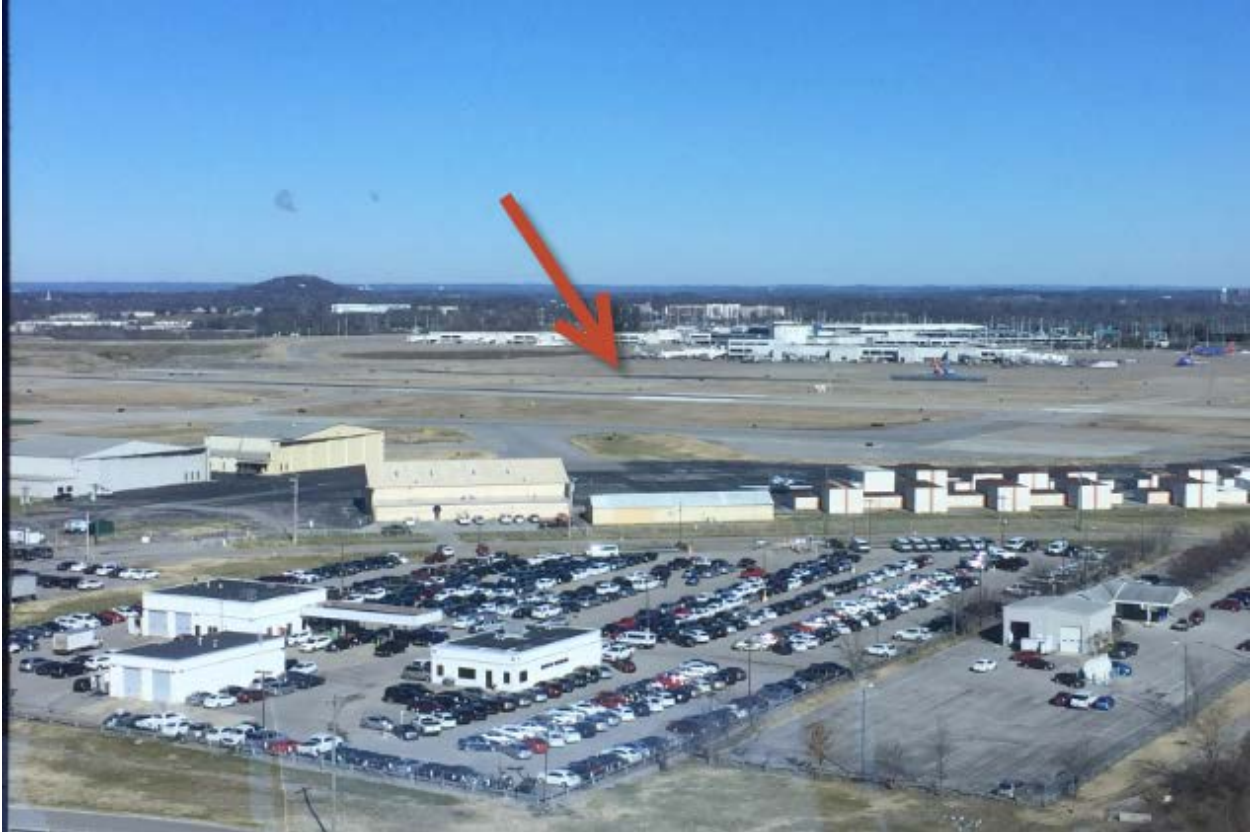
According to controller interviews, visibility of the area of SWA31 taxiway excursion was challenging because of the distance from the tower, glare from the airport terminal, and difficulty in determining the aircraft’s location so close to the ramp/apron. See figures 2, 3, and 4.

Figure 2 – Approximate location of SWA31 taxiway excursion (red arrow) as seen from the control tower during daylight hours.

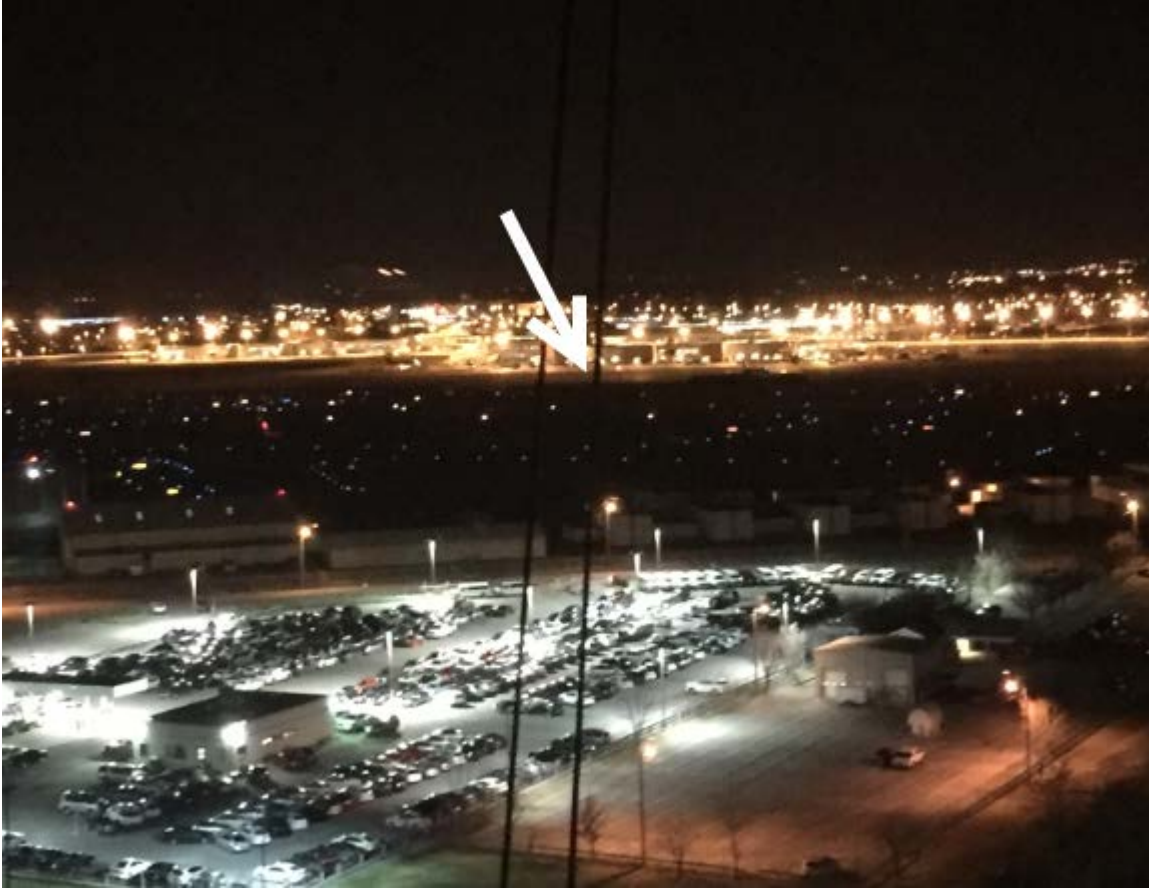
Figure 3 – Approximate location of SWA31 taxiway excursion (white arrow) as seen from the control tower at night. (SWA31 is not in this photo)

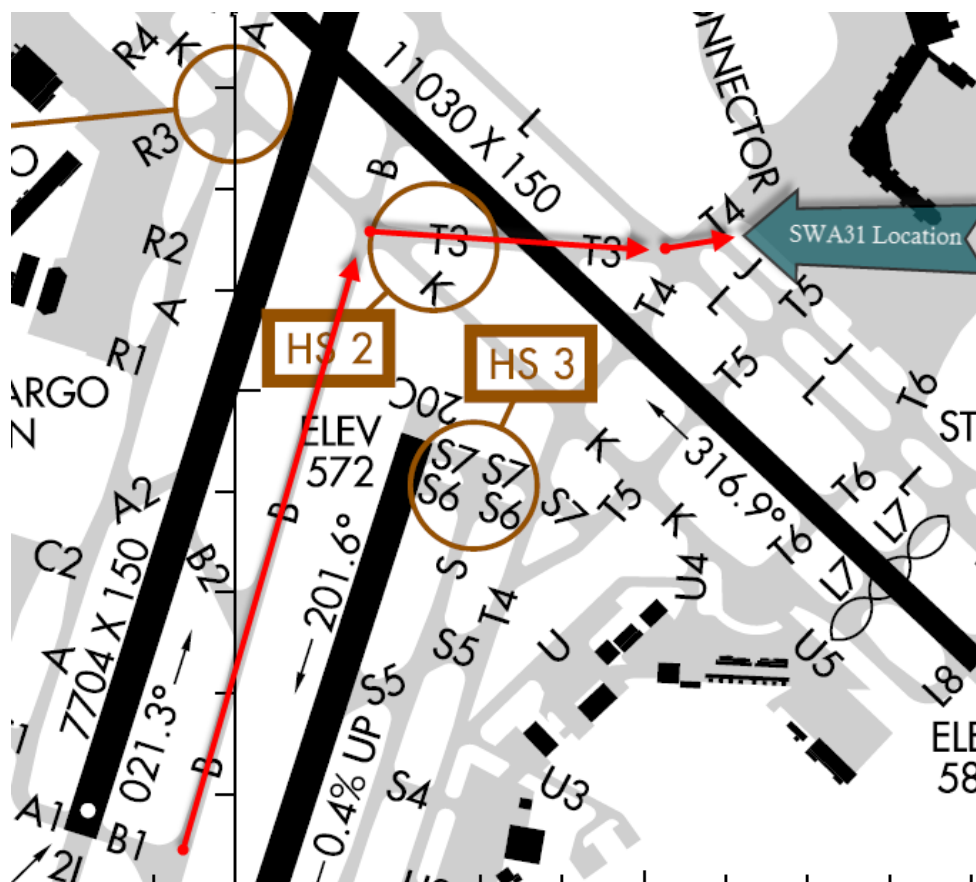
Figure 4 – SWA31 taxi route is indicated by red arrows. SWA31 location after the taxiway excursion is indicated by a green arrow.

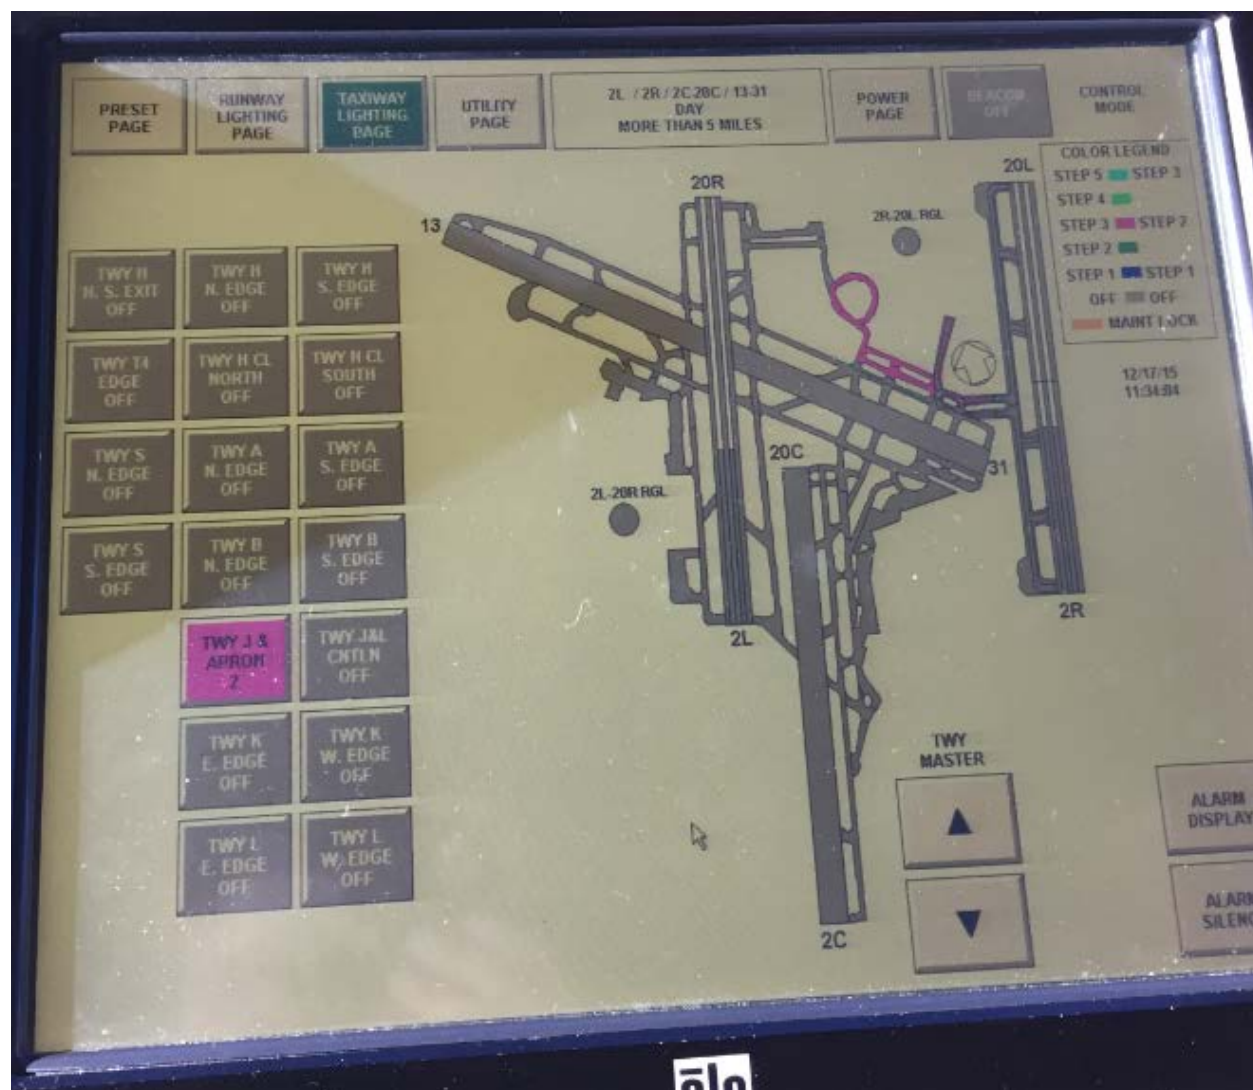
The lighting panel had preset intensity selections used according to current weather/day/night conditions and was operated by the tower controllers via a touch screen that selected lighting intensities as required by the current conditions. Specific airfield lighting configurations could be selected to operate independently of the pre-set conditions, such as turning off a specific taxiway lighting circuit. The touch screen control circuit that activated or deactivated the taxiway

centerline lights was located next to the touch screen control circuit that activated or deactivated the lighting for the ramp/apron and a portion of taxiway T4. See figure 5.

Figure 5 – The BNA ATCT airfield lighting control panel

complaints that they were too bright. It had become a common practice to turn off these centerline taxiway lights after sunset. The location of the touch screen control for these taxiways was located next to the touch screen control for taxiway J, the apron/ramp, and a portion of taxiway T4. See figure 5.
