## Damage Summary from Day 1 of N649SW in BNA

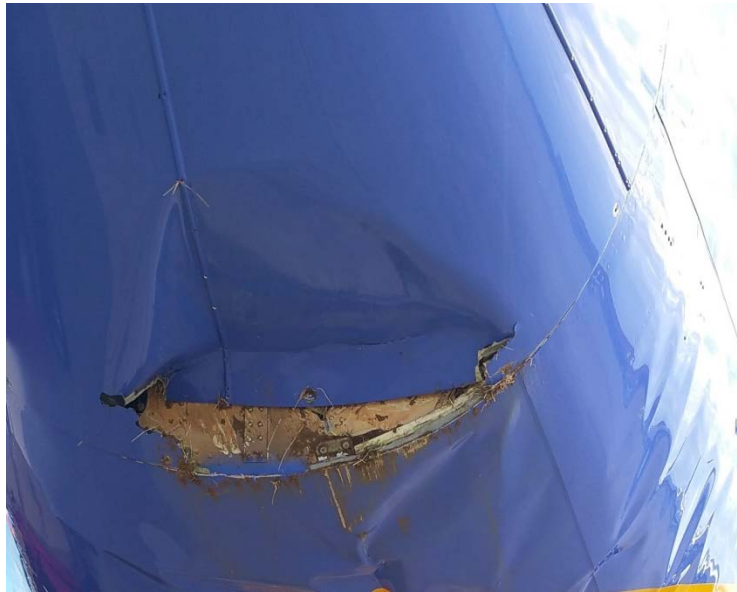
- NOSE RADOME
  - o Lower 25% extensive core, inner and outer skin plies, and edgeband damage

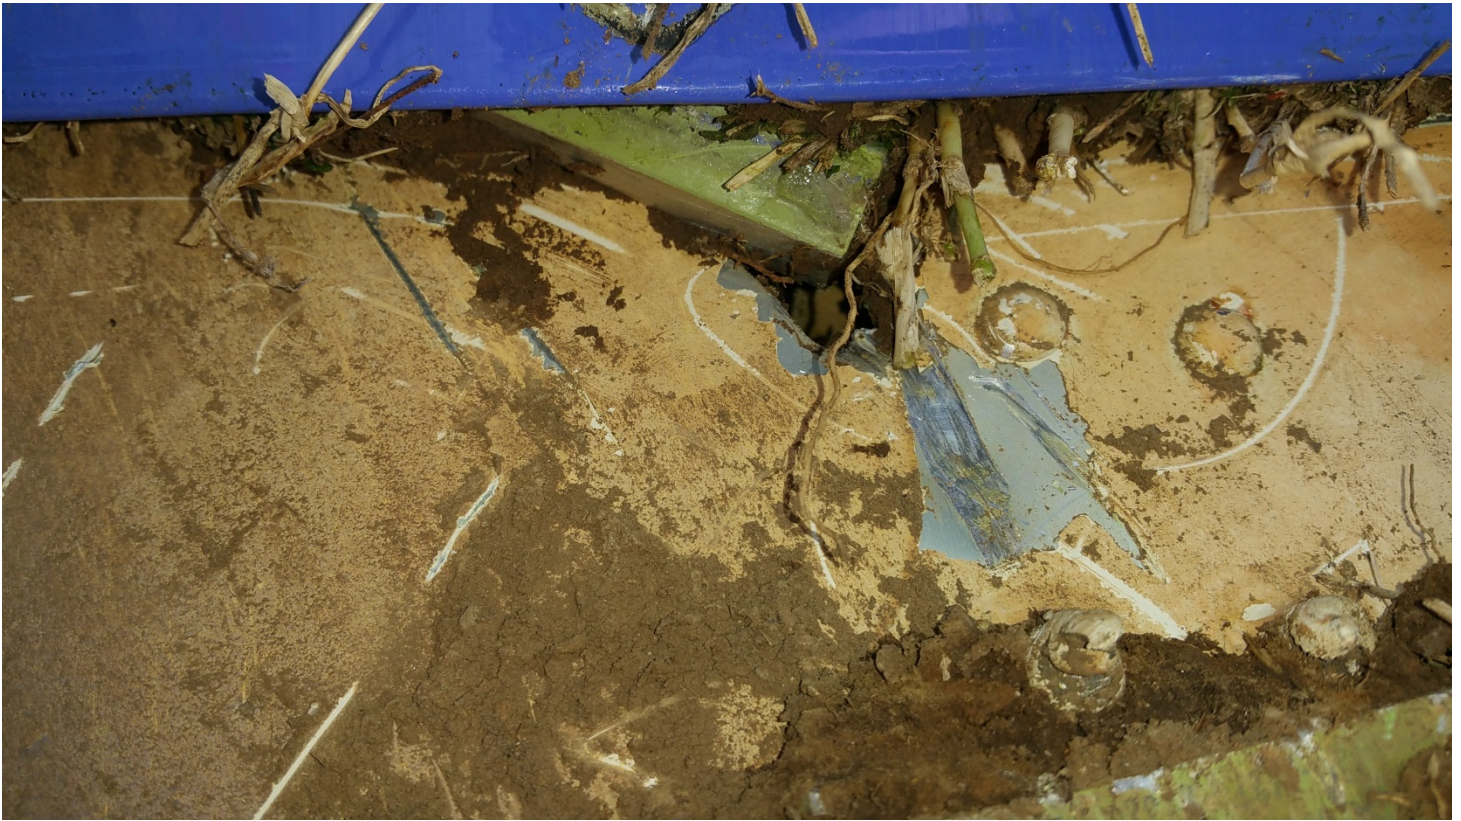
- BS178 BULKHEAD
  - Web punctured at approximately LBL 4. Requires center web replacement/repair. Damage caused by lower radome attach clip and attach fastener.

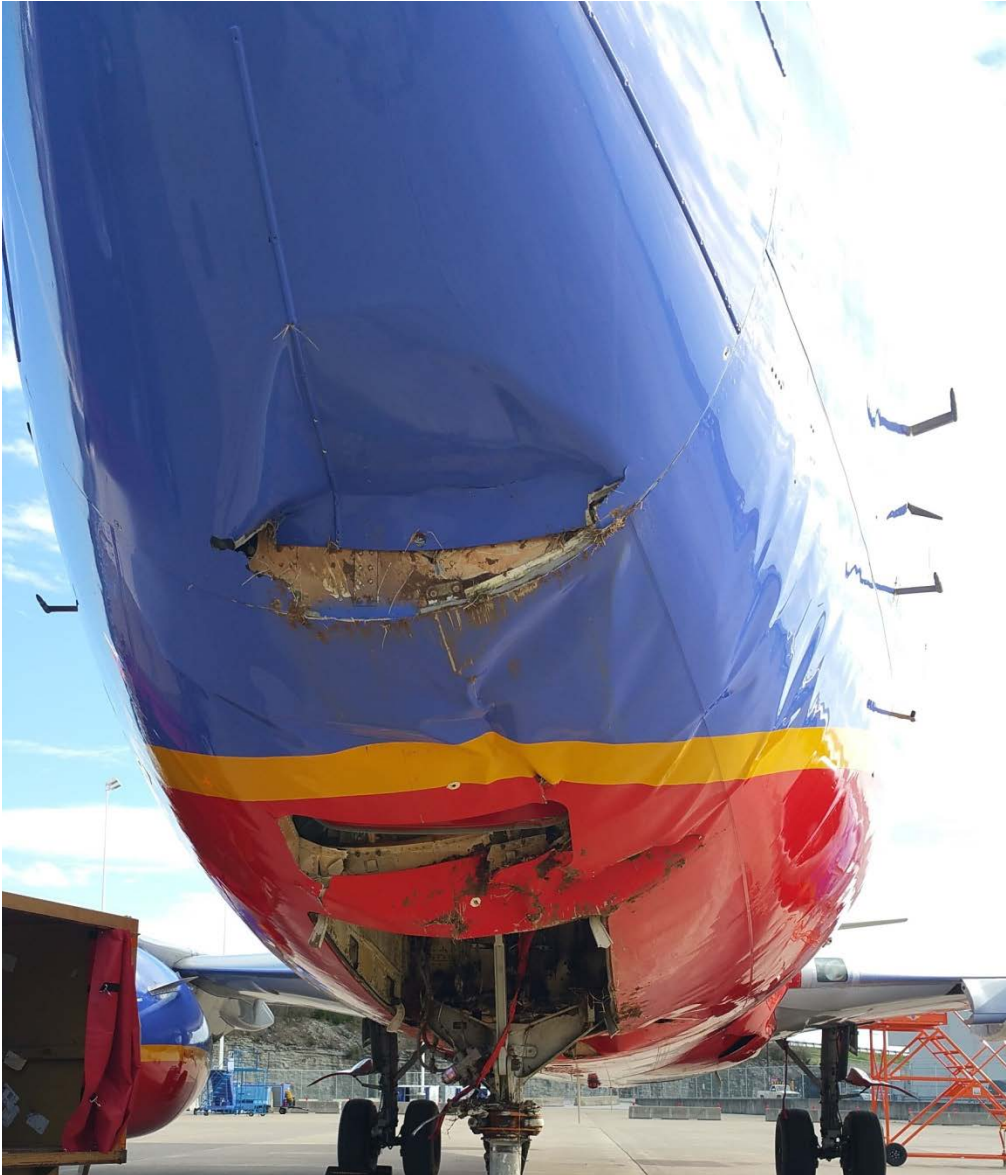
- BS 178 to BS360 STRUCTURE
  - o S-24R to S-24L BS 178-360 Skin panel replacement required. Damage excessive.
  - o S24L to S24R stringers also severely damaged. Repair probably not feasible due to short segment lengths near cutouts.
  - o All frames damaged from S19L to S24R and require lower section replacement. Repairs may be possible, but probably not economical due to ease of replacement when skins are removed.

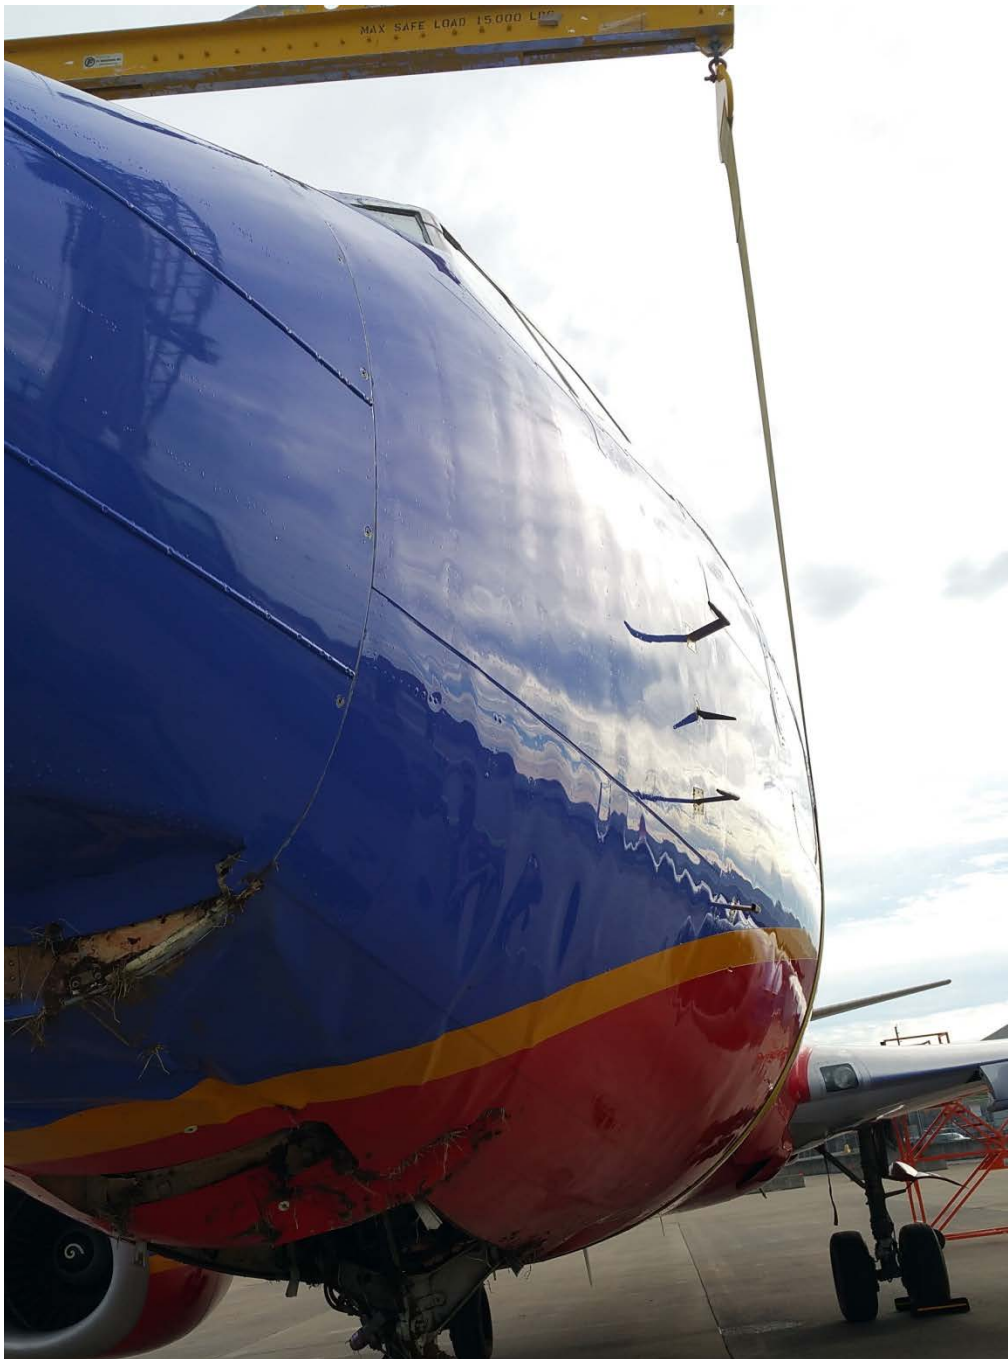
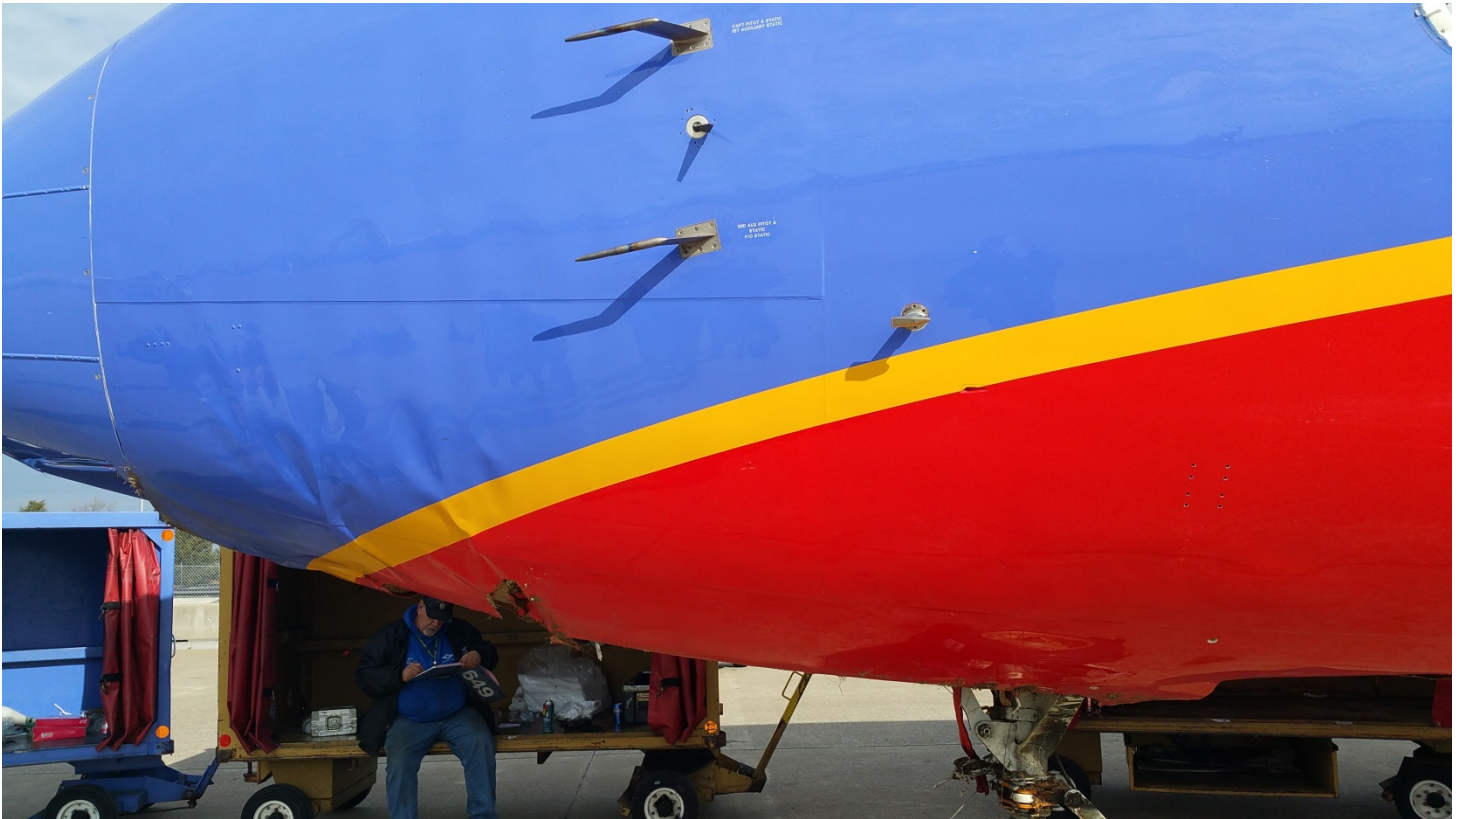
- o S-19R to S-24R Skin panel is lightly damaged and requires further assessment to determine repairs or replacement.
- o BS 178-259 S-19L to S-24L Skin panel requires replacement due to extensive buckling.

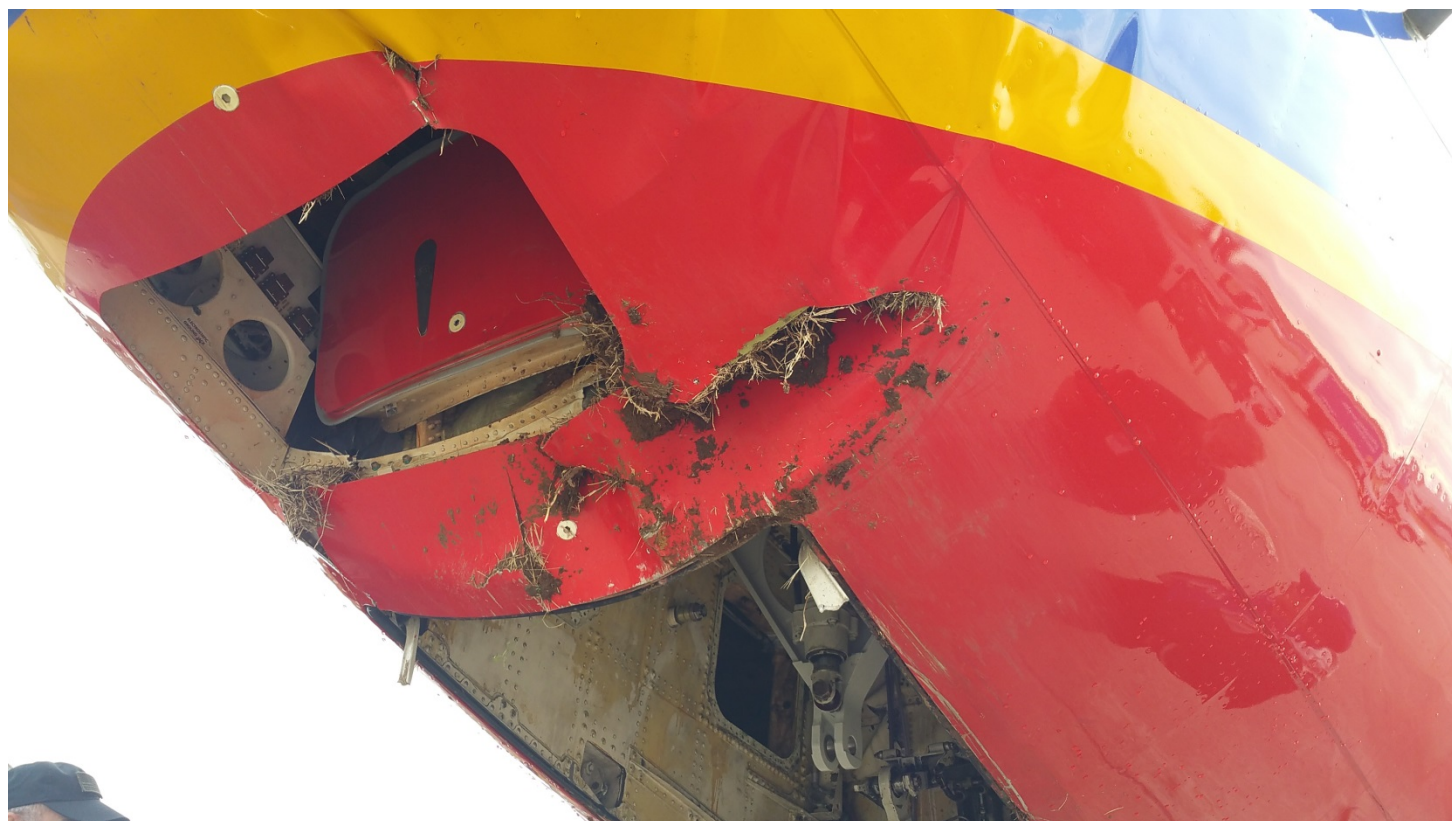
- o LH Skin panel BS 178-259 above S19L may also require replacement. There is slight skin buckling between frames. Requires further evaluation once adjacent structure is removed. May just be normal skin waviness.
- o Stringers from 19L to 24L are probably damaged and will require repairs or replacements.
- o Frame shear ties from 19L to 24L may be damaged. If so, probably not severe and can be repaired.
- o Severe damage to frames, stringers, and intercostals around the FWD E&E Bay door, NLG Wheel Well, and Main E&E Bay door.
- o Bearstraps around three door cutouts require replacement.

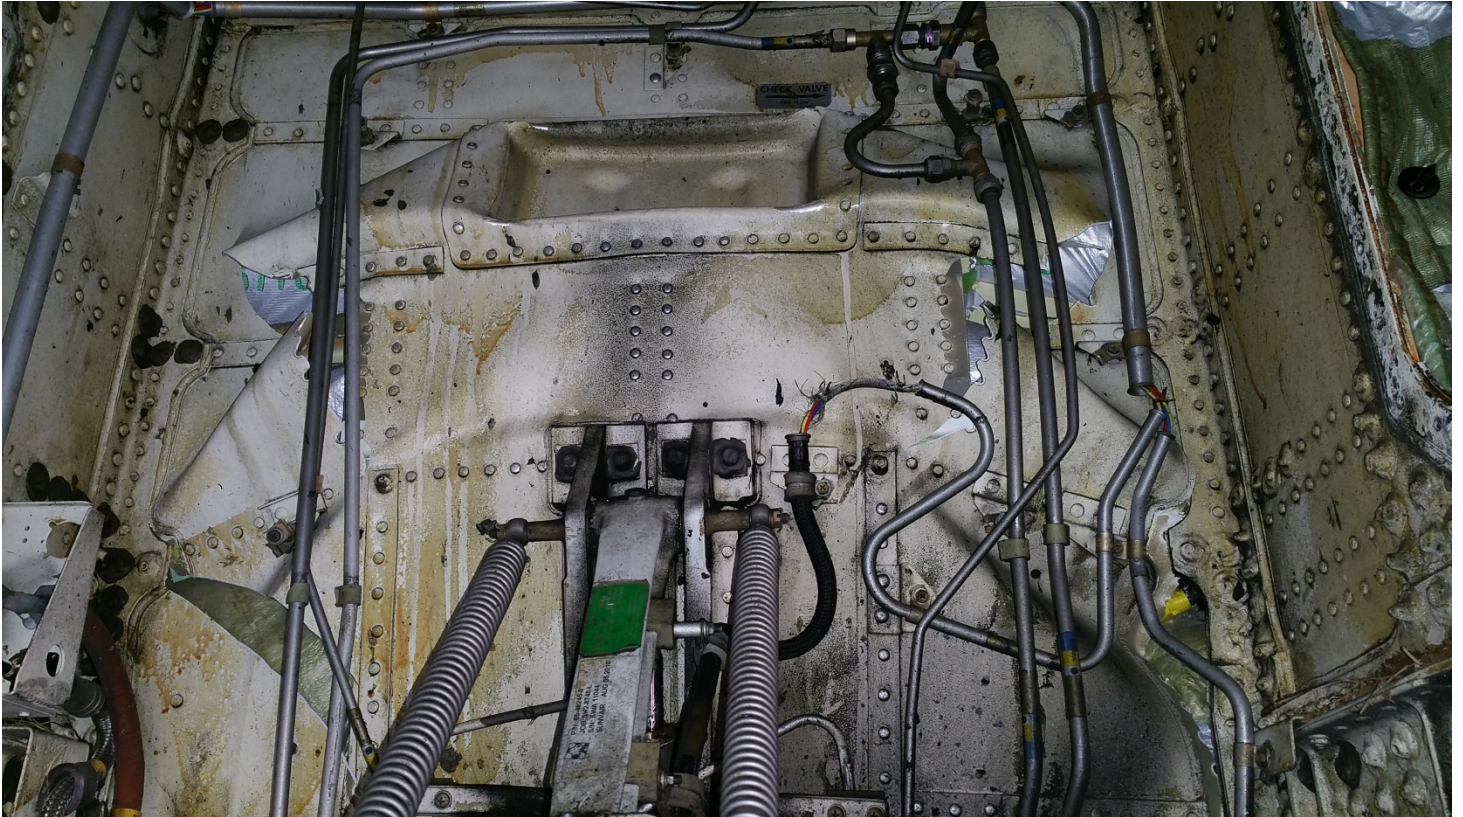
- NOSE WHEEL WELL

- o FWD Bulkhead slightly buckled. Web and some stiffeners require replacement.
- o SIDE bulkheads show no visible deformation. New NLG A-Frame and pins installed, so trunnion fitting alignment is still close to original. Side access panels removed and no backside visual damage defects noted. Further NDT inspections may detect underlying damage.
- o Ceiling deck and actuator beam show no sign of damage.
- o Aft bulkhead has extensive damage and will require extensive replacement. Frames, stiffeners, fittings, and intercostals attaching to aft bulkhead extensively damaged and require replacement.

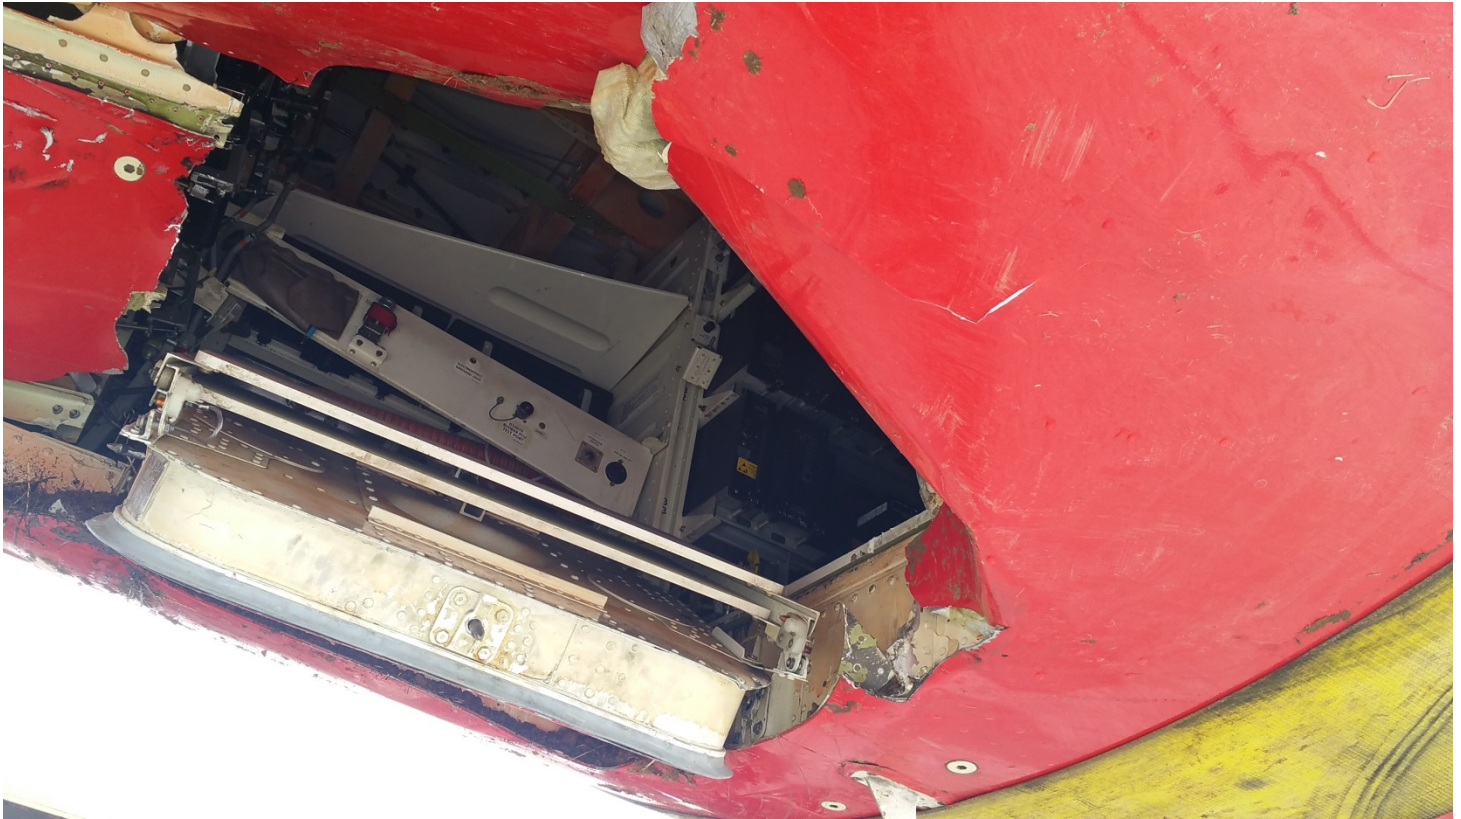
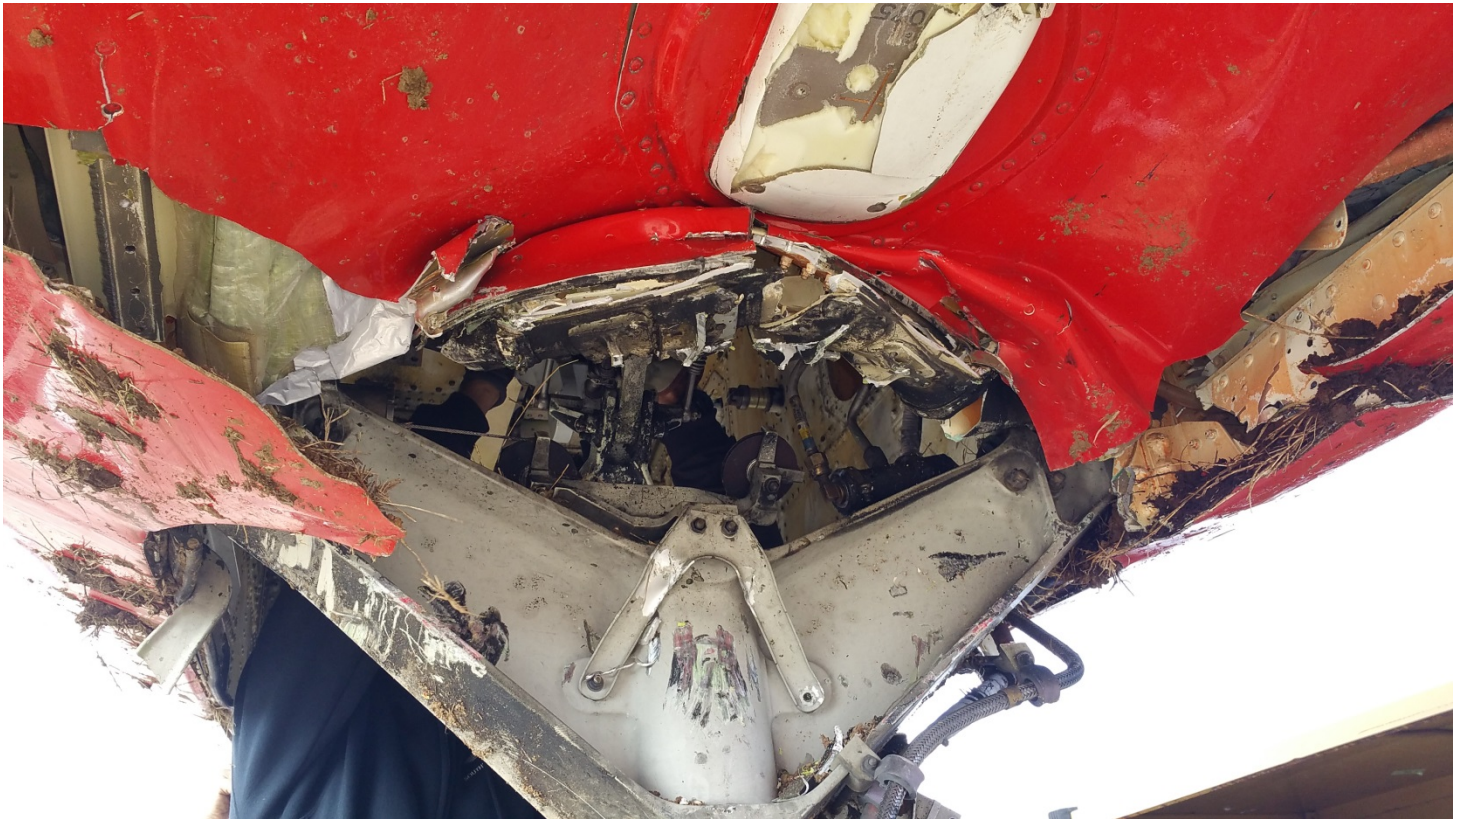
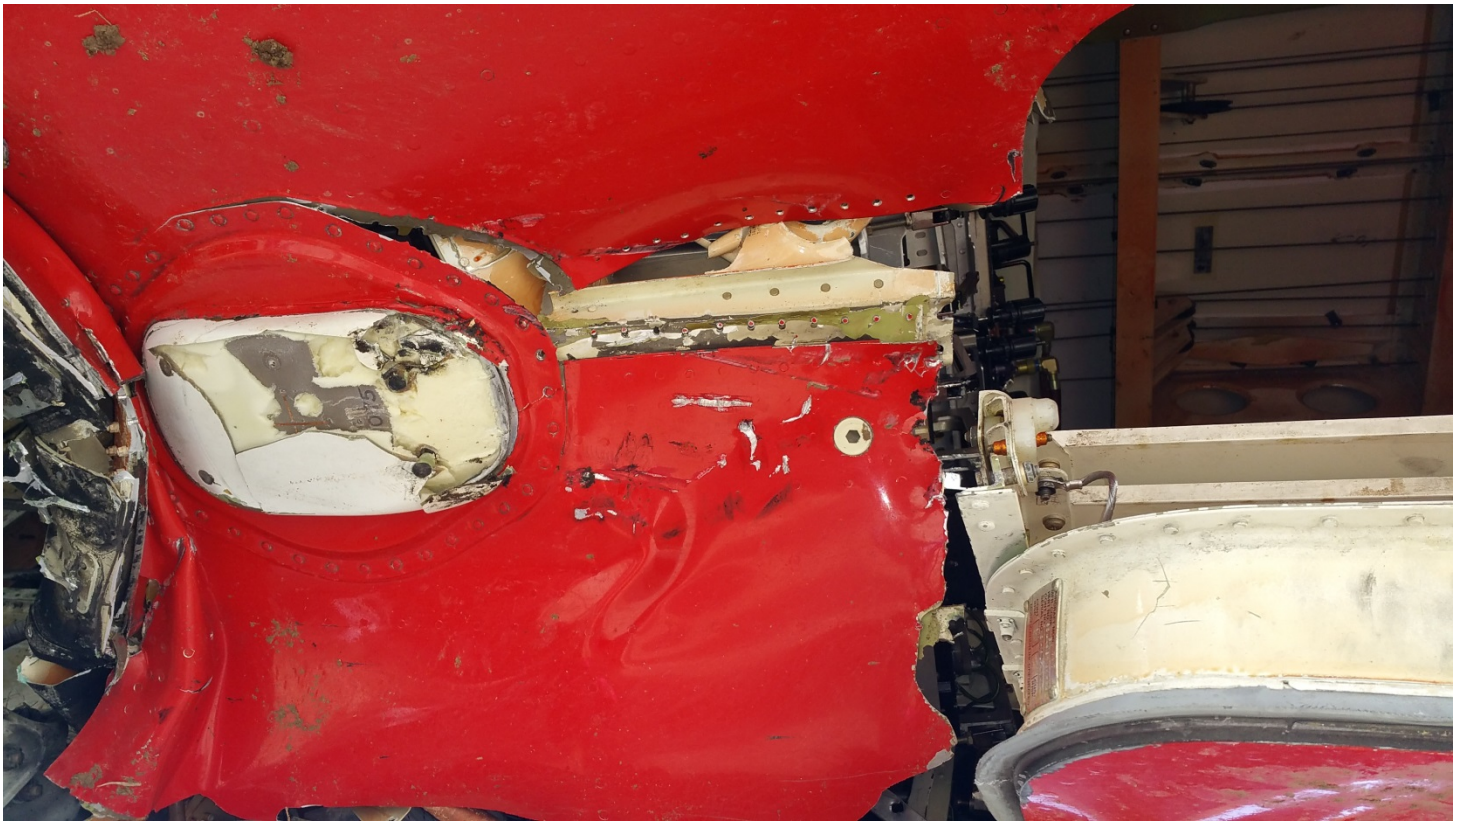
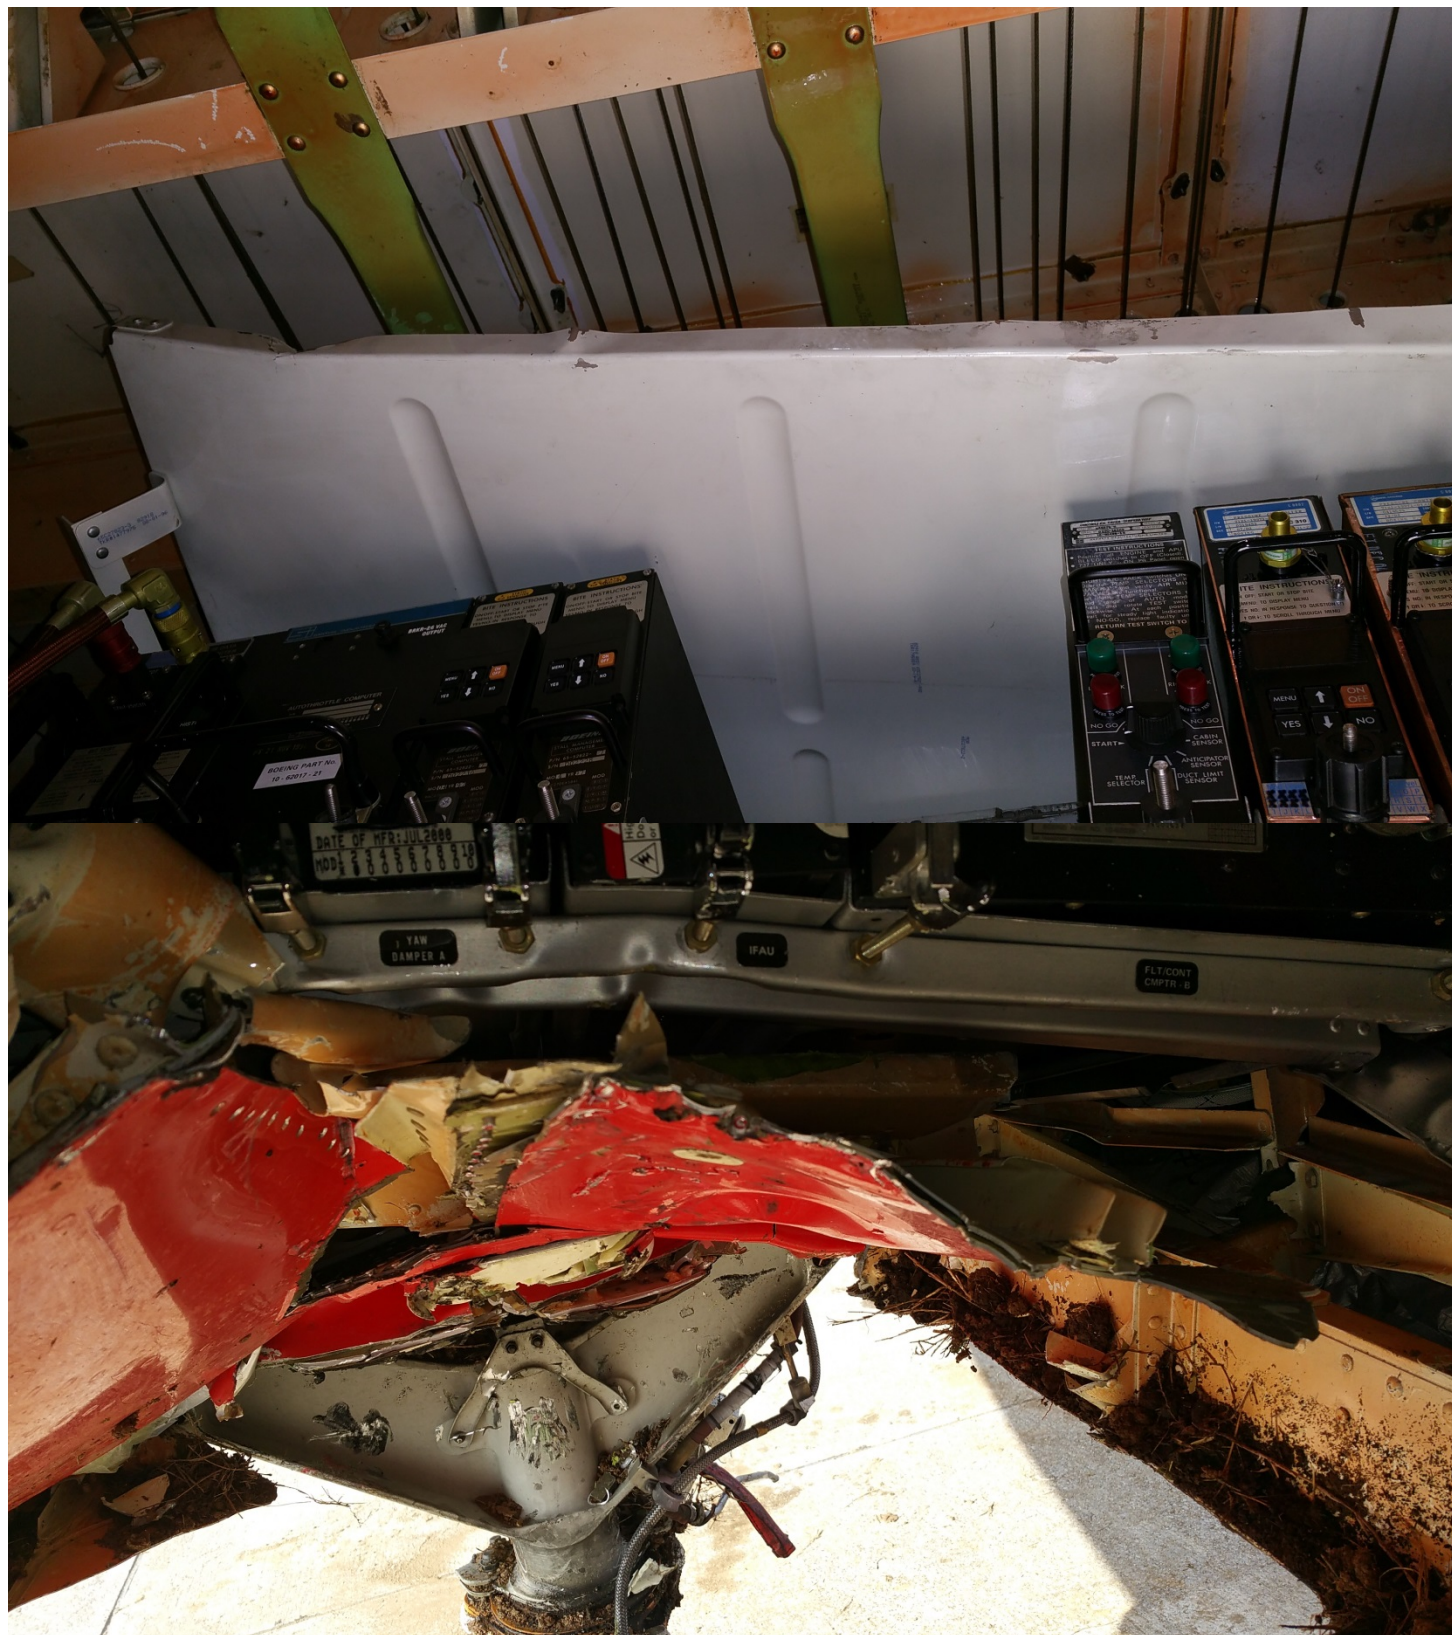
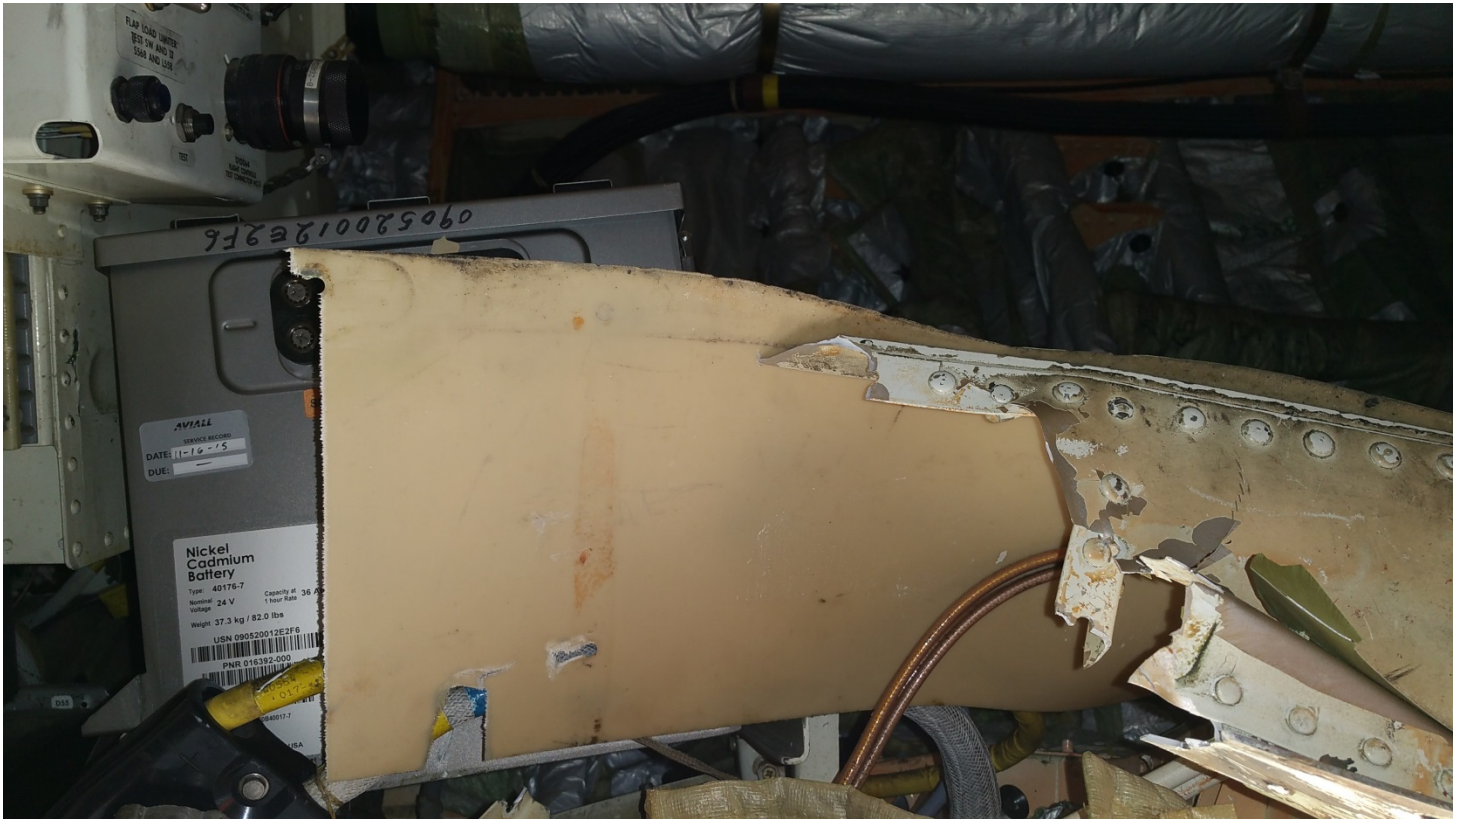
- MAIN E&E BAY

- Extensive damage to skin, bearsrtap, door and track, frames, and stringers. Multiple avionics racks damaged and displaced. Aircraft battery displaced and tray damaged. Battery was disconnected before aircraft was lifted in case of possible wiring damage/shorting. Not sure of status of avionics boxes.

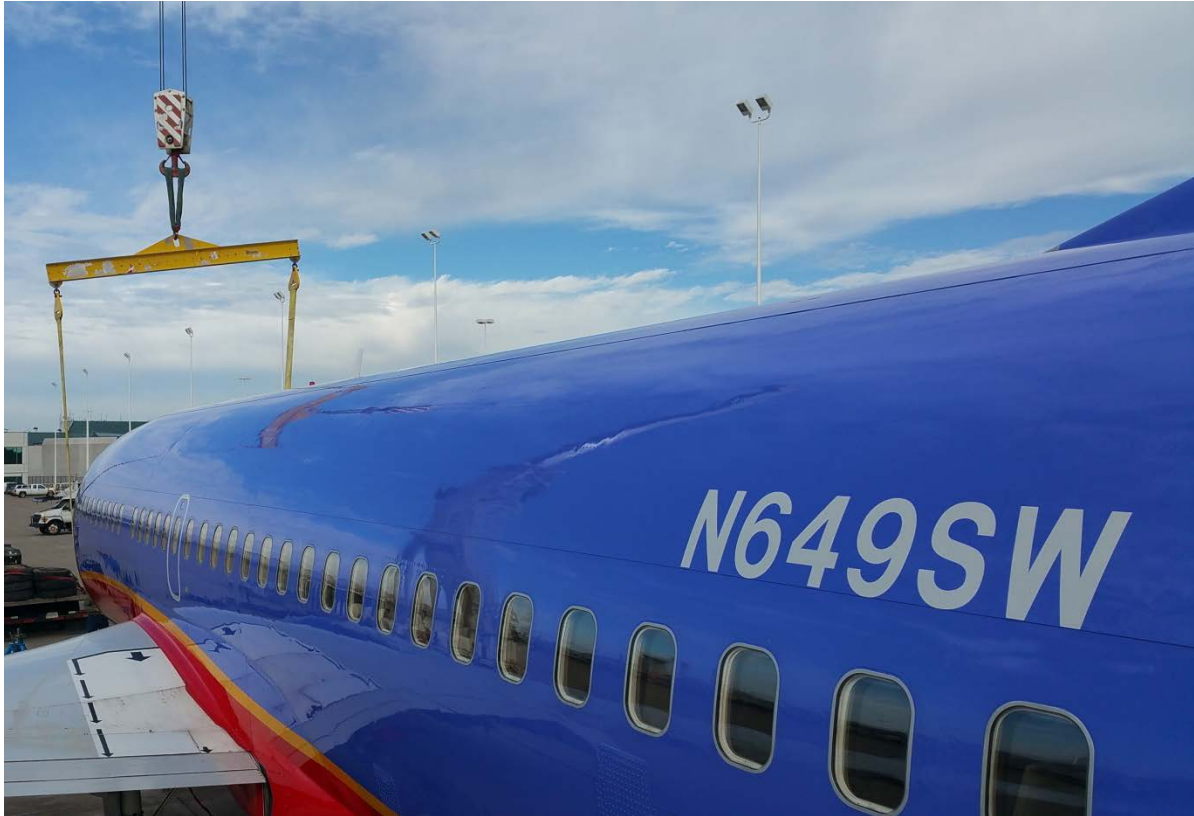
- CROWN SKINS AND BUTT JOINTS

- o No sign of any distortion of the crown skins for entire length of fuselage.

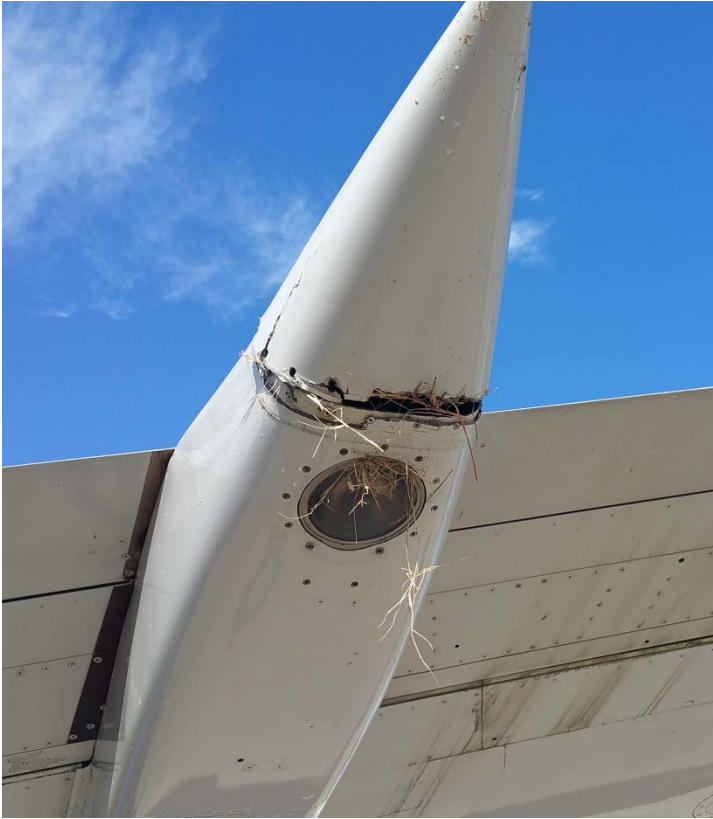
- WINGS

- o Aircraft came to rest on #2 engine and RH wing.
- o #8 Flap Track Fairing aft tailcone damaged.

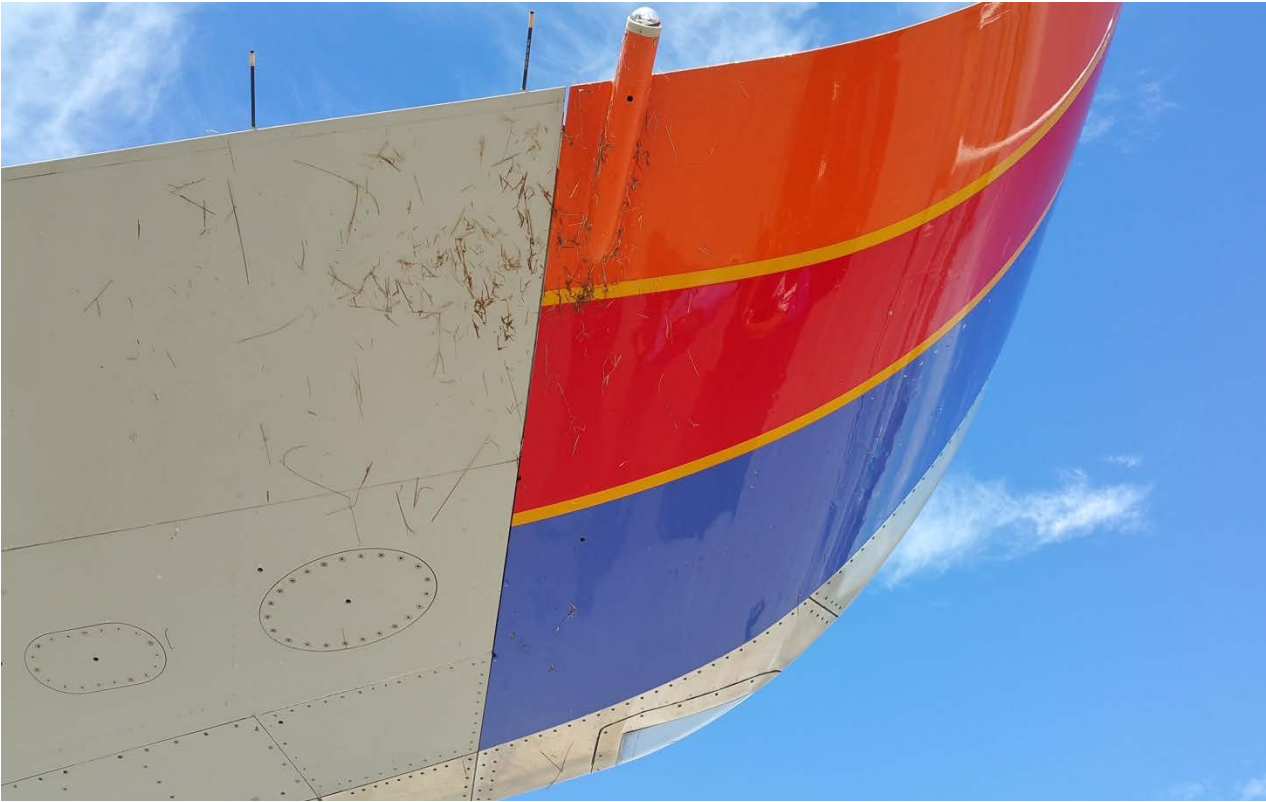
- RH Winglet touched ground, but no damage or distortion noted.

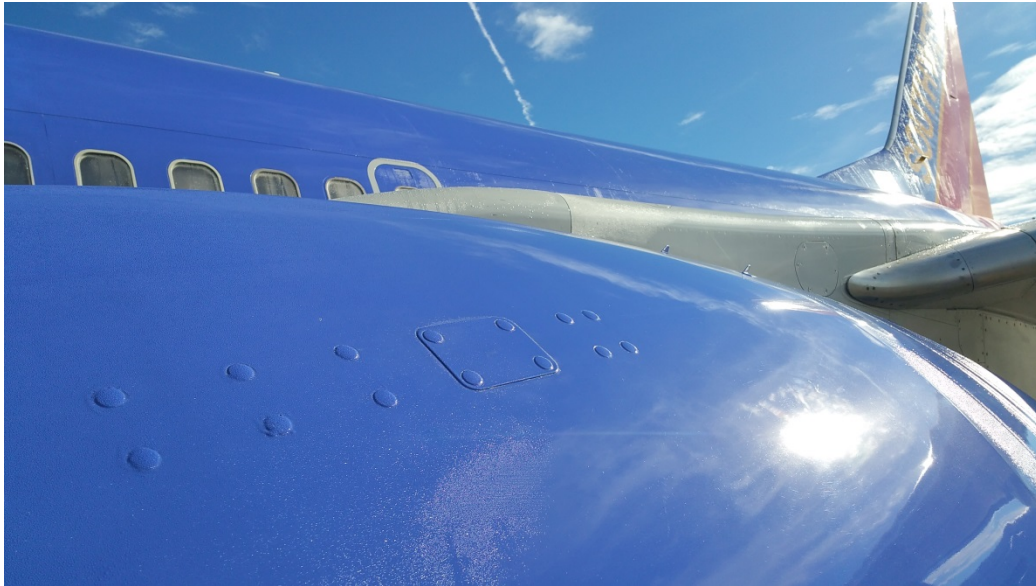
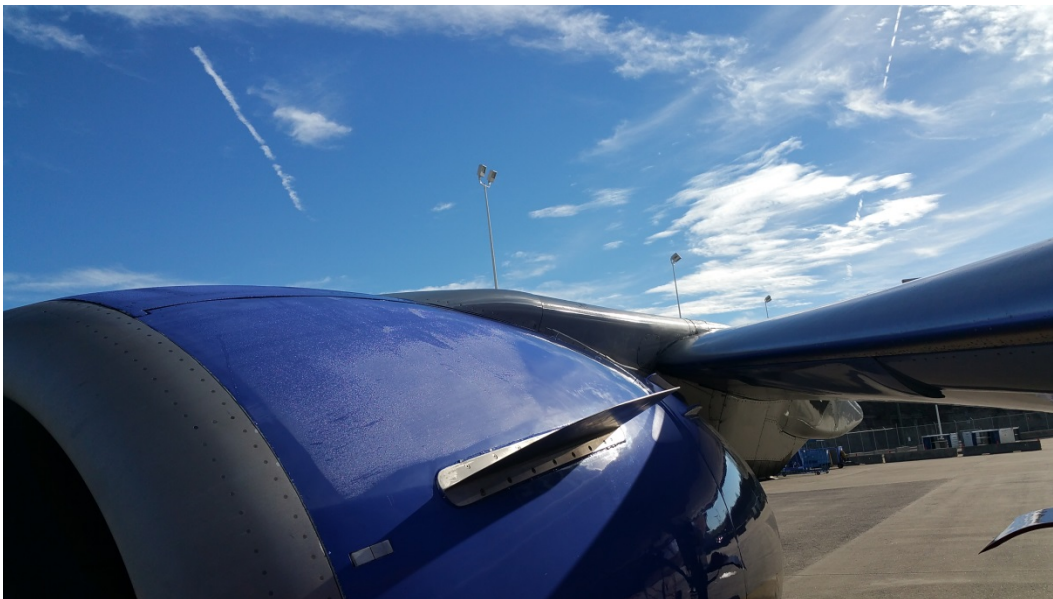
- ENGINES

- o #1 and #2 Engines both spin freely and have no visible signs of FOD ingestion.
- o Both pylons appear good. No external visual signs of excessive gaps, uneven gaps, warping or buckling, etc.

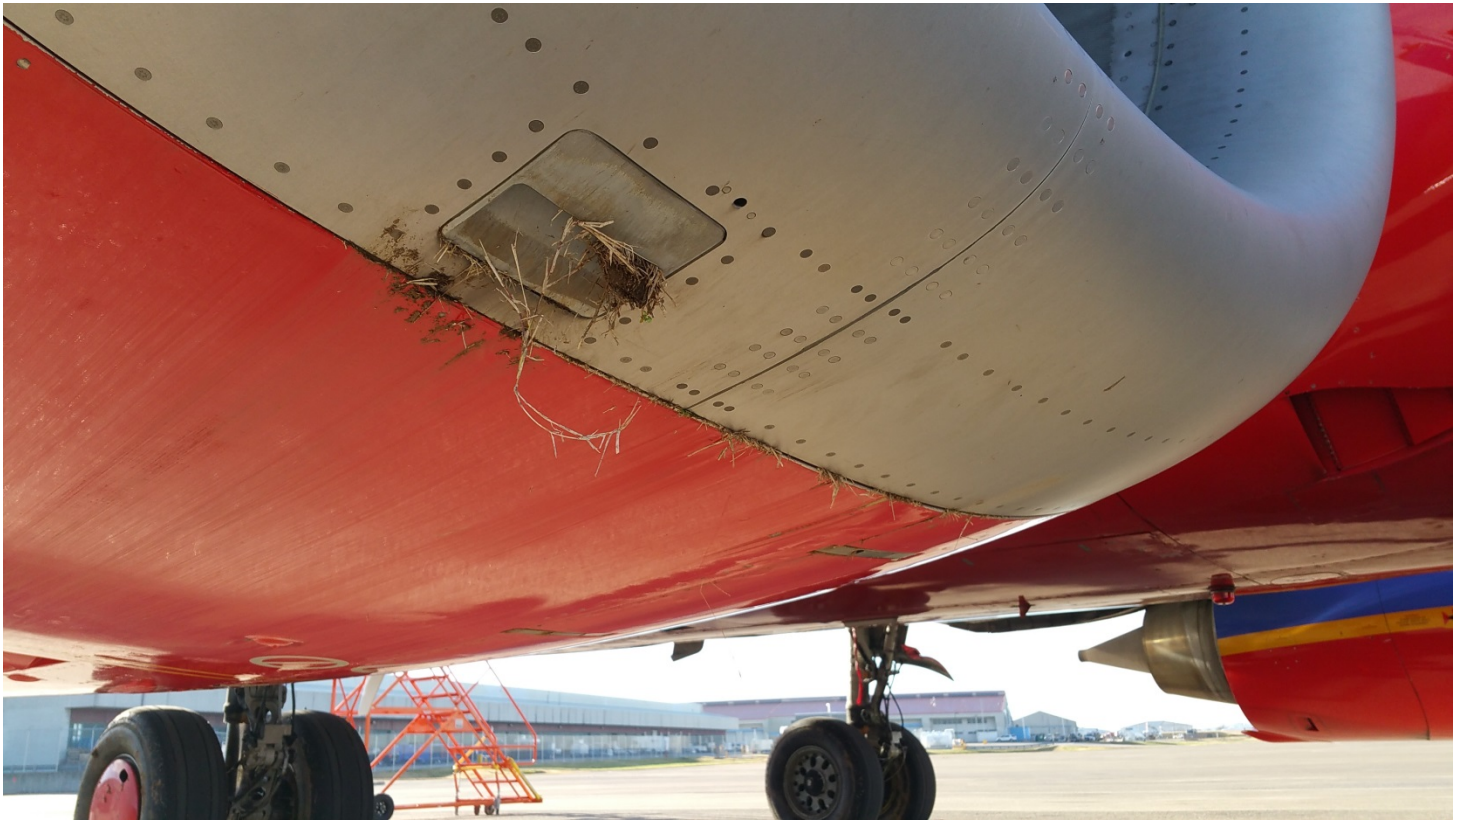
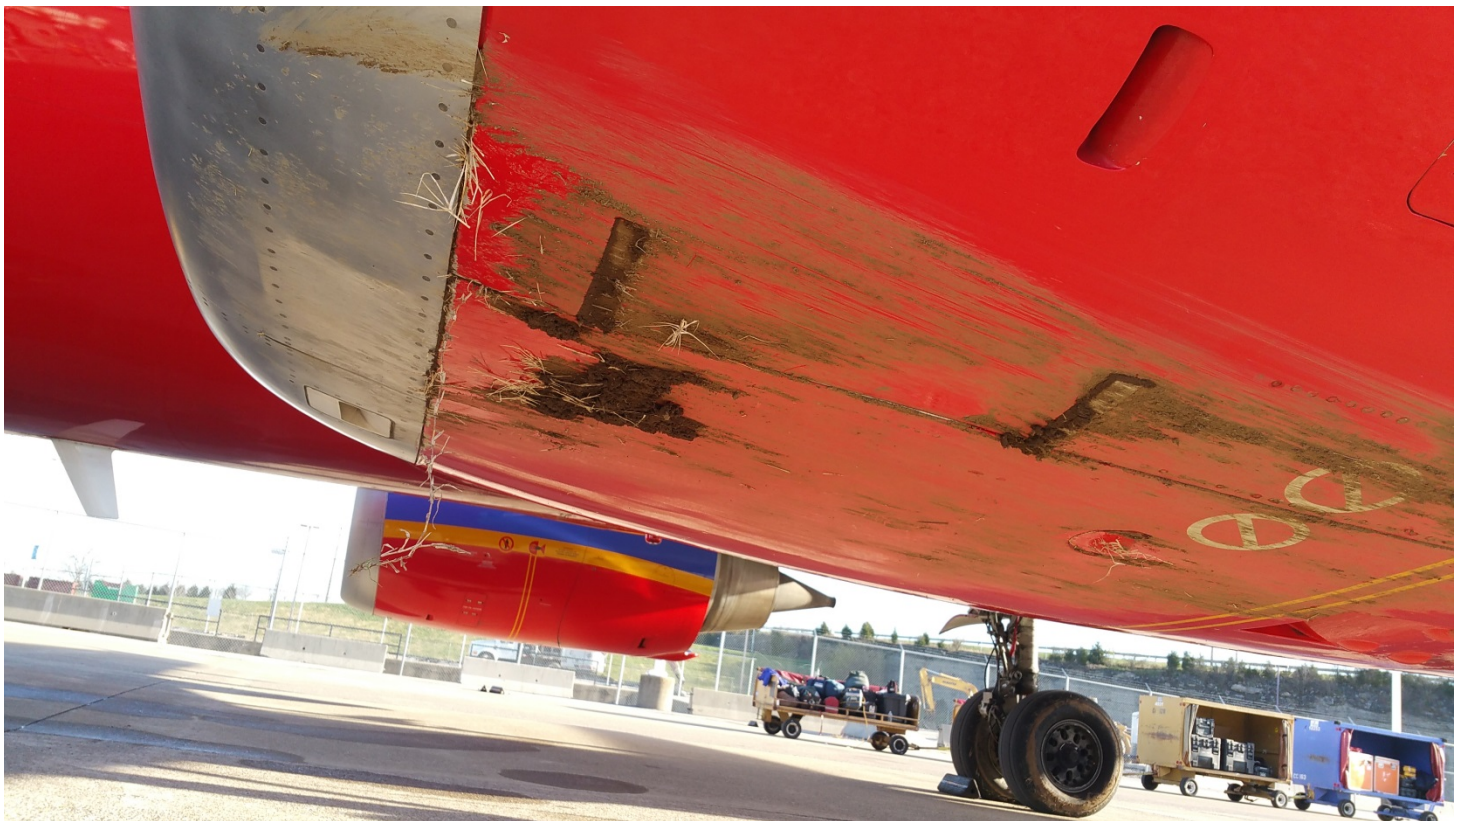
- Both engines require fan cowls and possibly inlet cowls. Damage is not severe and can probably be repaired.
