**Southwest Airlines Accident DEC15 KBNA - Weather**

**Sent:** Thursday, December 17, 2015 11:11 AM**To:** English Bill; Lawrence David; Bartlett Daniel; Frantz Marvin; Misencik Paul**Weather Conditions over Nashville, Tennessee on December 15, 2015**

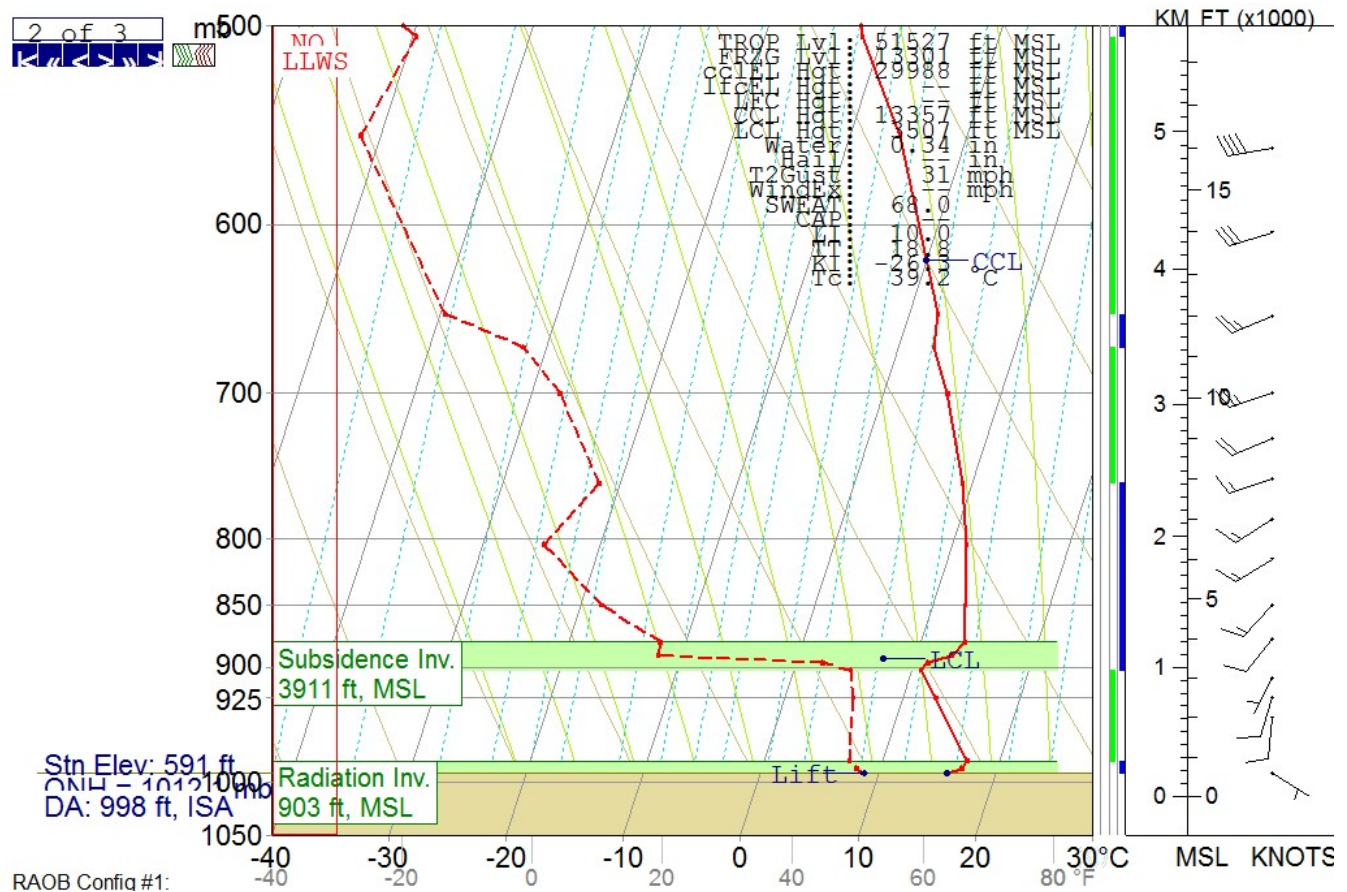
**Sounding** – The 1800 CST (0000Z on Dec. 16, 2015) KBNA sounding was examined for any potential signs of any strong low-level winds or low-level wind shear. None were identified over the area at the time. Normal nocturnal temperature inversion was developing at the surface as well as one identified aloft at 3,900 feet associated with subsidence, which resulted in winds less than 10 knots below 3,500 feet.
