## **NATIONAL TRANSPORTATION SAFETY BOARD**

### **Factual Report**

# **METEOROLOGY**

DCA17FA076

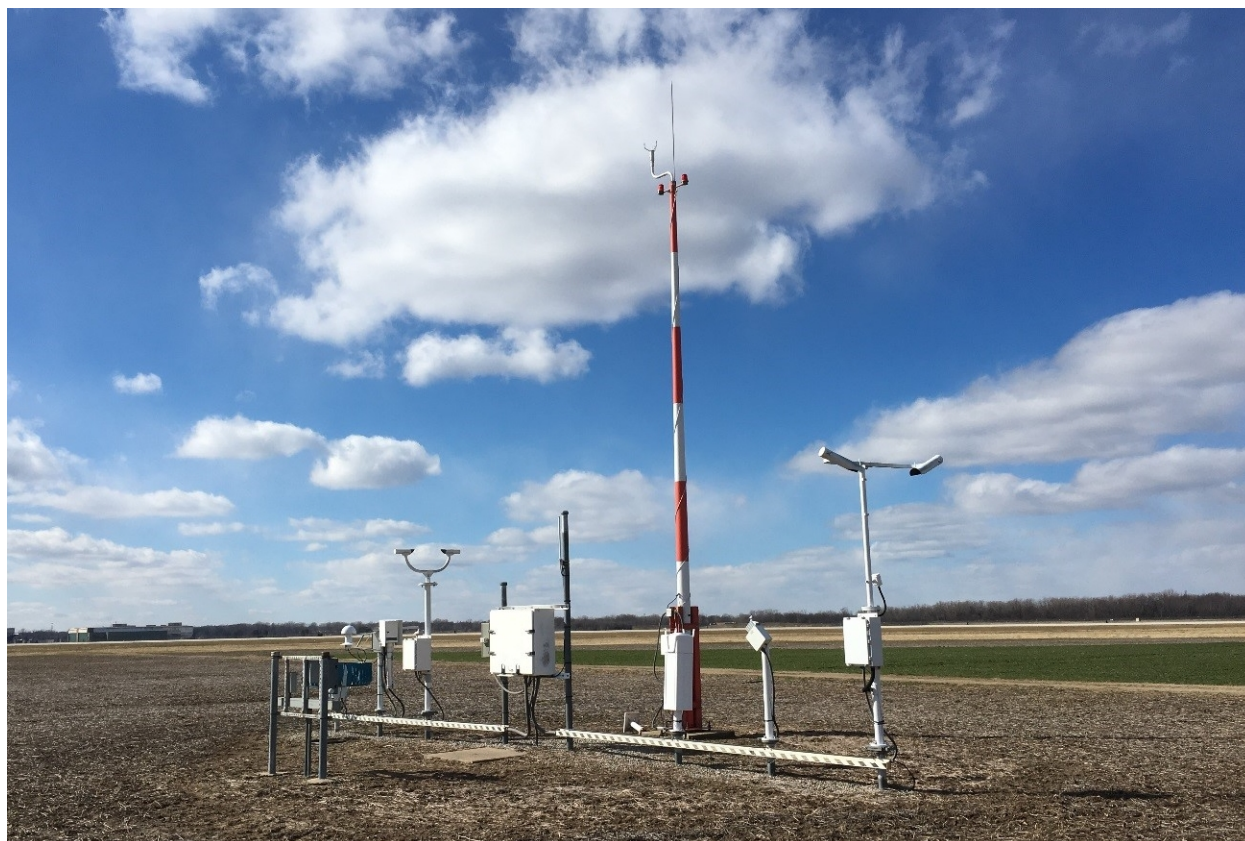
is one hour, however it is common to see the battery backup power only last 15-20 minutes. The ASOS DCP resumed normal operations at 2101 EST. There was no indication of malfunction or “misperformance” of the YIP ASOS prior to the loss of power.

Although the ASOS DCP was not providing weather observations during its power outage, METARs were being issued for YIP during this period, including the times surrounding the accident time. These observations did not contain any “live” weather information except for the altimeter setting, as well as the three-hour pressure tendency (in the “remarks” section).<sup>10</sup> According to the NWS, observations can still be publicly disseminated when the ASOS DCP is not functioning because the METARs are publicly disseminated from the ASOS’ ACU (the METARs just won’t contain any information provided directly by the DCP). According to the NWS, the ASOS’ ACU was located in the first floor equipment room of the YIP air traffic control tower (ATCT). The ASOS’ three pressure sensors were located inside the ACU cabinet, and the pressure sensors and ACU were on the same power source as the ATCT. According to YIP ATCT personnel, the YIP ATCT did not lose power during the period.

Five-minute data from the YIP ASOS for about the accident time is provided here. All expected main report body data aside from the altimeter setting is missing. See Attachment 2 for all YIP ASOS five-minute data between 1900 EST on March 5, 2017 through 1855 EST on March 8, 2017.

**Figure 4 – YIP ASOS.**

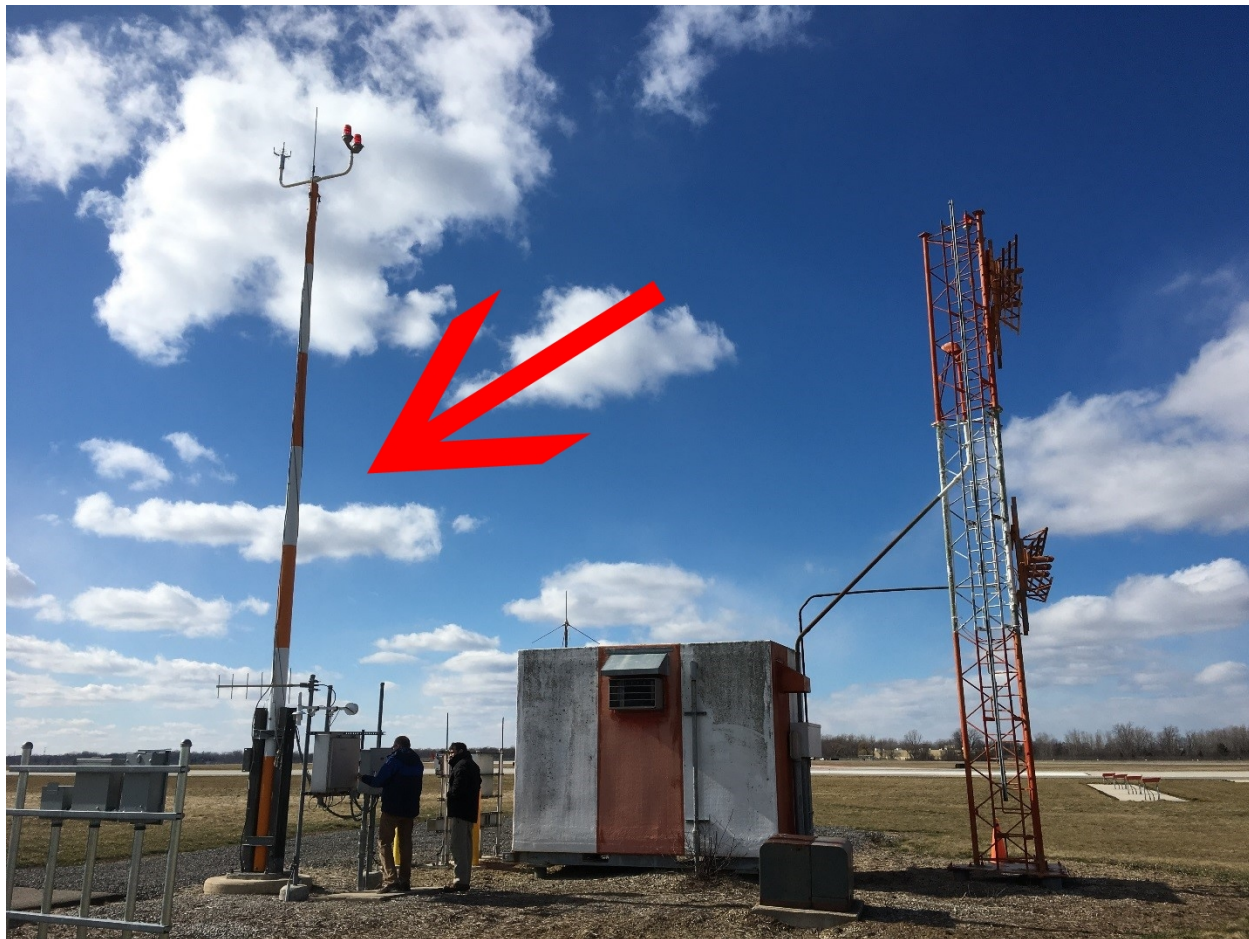
There was an FAA-owned and operated Stand Alone Weather Station (SAWS) operating at YIP on the accident day (see figures 6 and 7). The SAWS sensor suite includes an anemometer and provided “backup” weather information to the ASOS. The YIP anemometer pole height is 35 feet agl. Realtime data from the SAWS are sent to the air traffic control tower via ultra-high frequency radio link, however these data are not archived. According to the FAA, no formal archiving of SAWS data exist across the national airspace system. According to the FAA (see Attachment 6), the YIP SAWS went out of service at 1138 EST on March 8, 2017, due to a “power outage caused by high winds.” The YIP SAWS had no backup source of power.

**Figure 6 – YIP SAWS.**

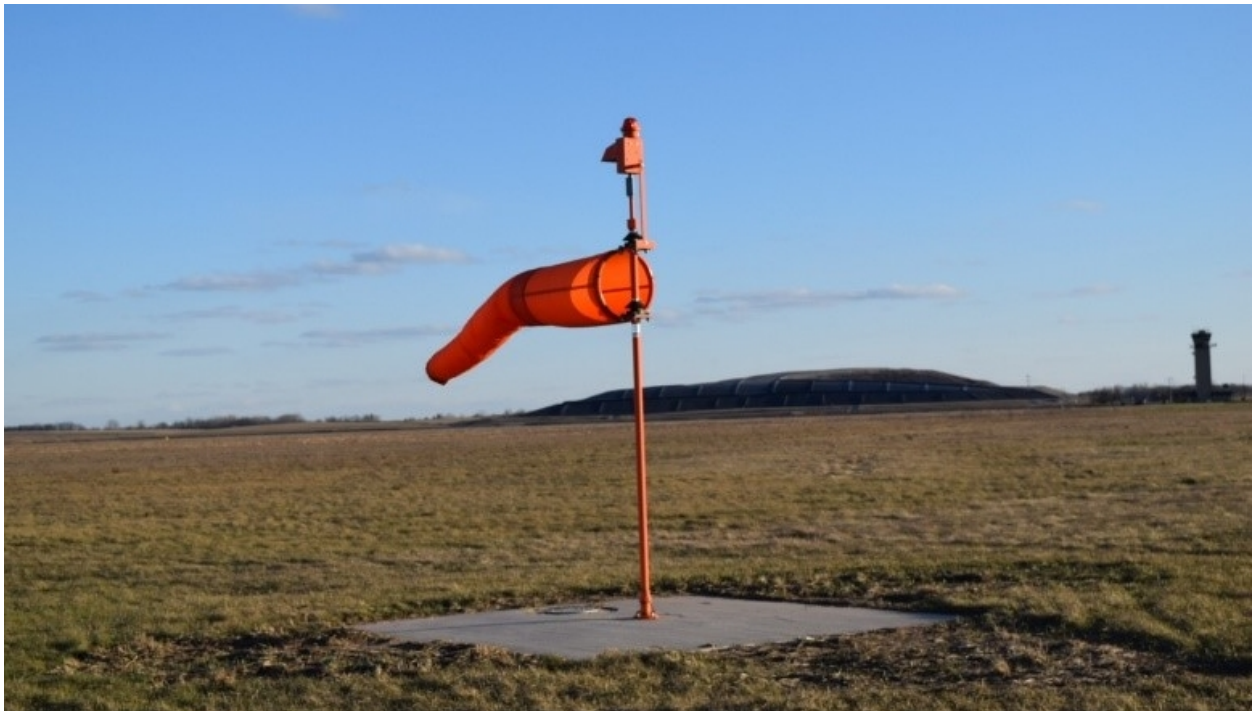
In the days following the accident, the airport authority tested the runway 27 Approach and runway 23L Approach windcones and indicated that they both rotated freely. According to the airport authority, the midfield windsock was too high to reach, but it “appeared to rotate freely during the hefty winds [on the evening the windsock was checked].”

**Figure 8** – YIP Runway 23L Approach supplemental windsock.

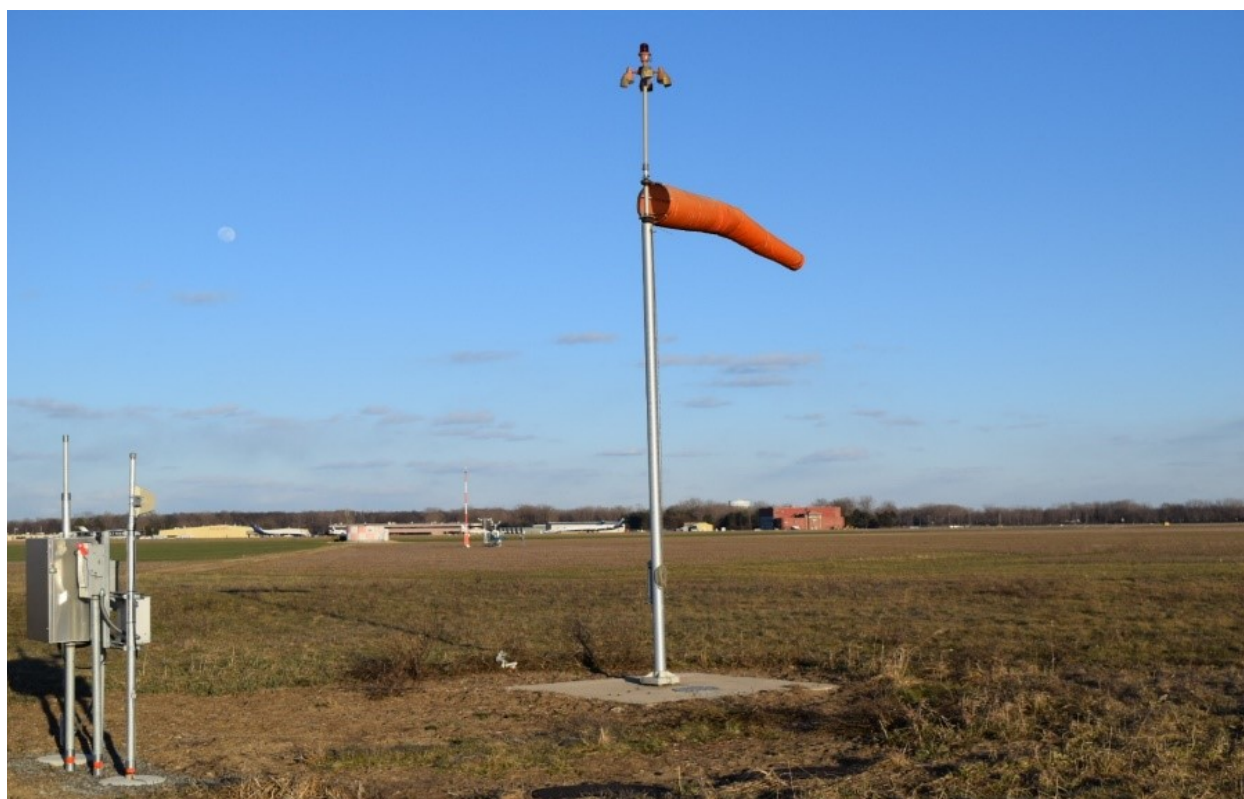
With regard to the midfield windsock (see figures 10 and 11), according to the airport authority, “...windsocks are universal and used on all of our windcones. They are FAA certified...”

**Figure 10** – YIP Runway 5R/23L Midfield primary windsock.
