----- **SYSTEMS GROUP CHAIRMAN'S FACTUAL REPORT** -----

**1 ACCIDENT:**

Location: Willow Run Airport, Ypsilanti, Michigan  
Date: March 8, 2017  
Time: about 1452 EST  
Aircraft: Boeing MD-83  
Serial Number: 53123  
Registration: N786TW

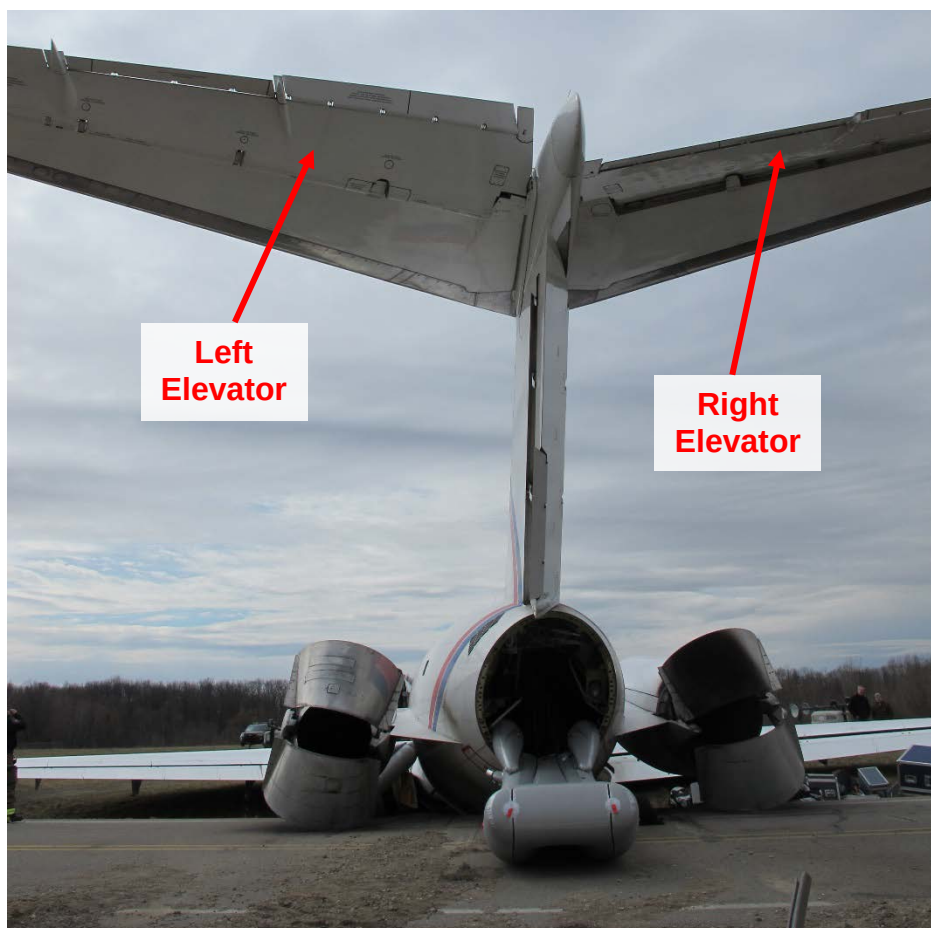
The group used a lift to inspect the elevators and attempted to move the elevators by hand. The right elevator could not be moved by hand from its trailing edge down position. The left elevator moved freely when moved by hand to the stops in the TED and TEU direction.

**Figure 14 - Elevator (and Rudder) position as viewed from behind the aircraft**

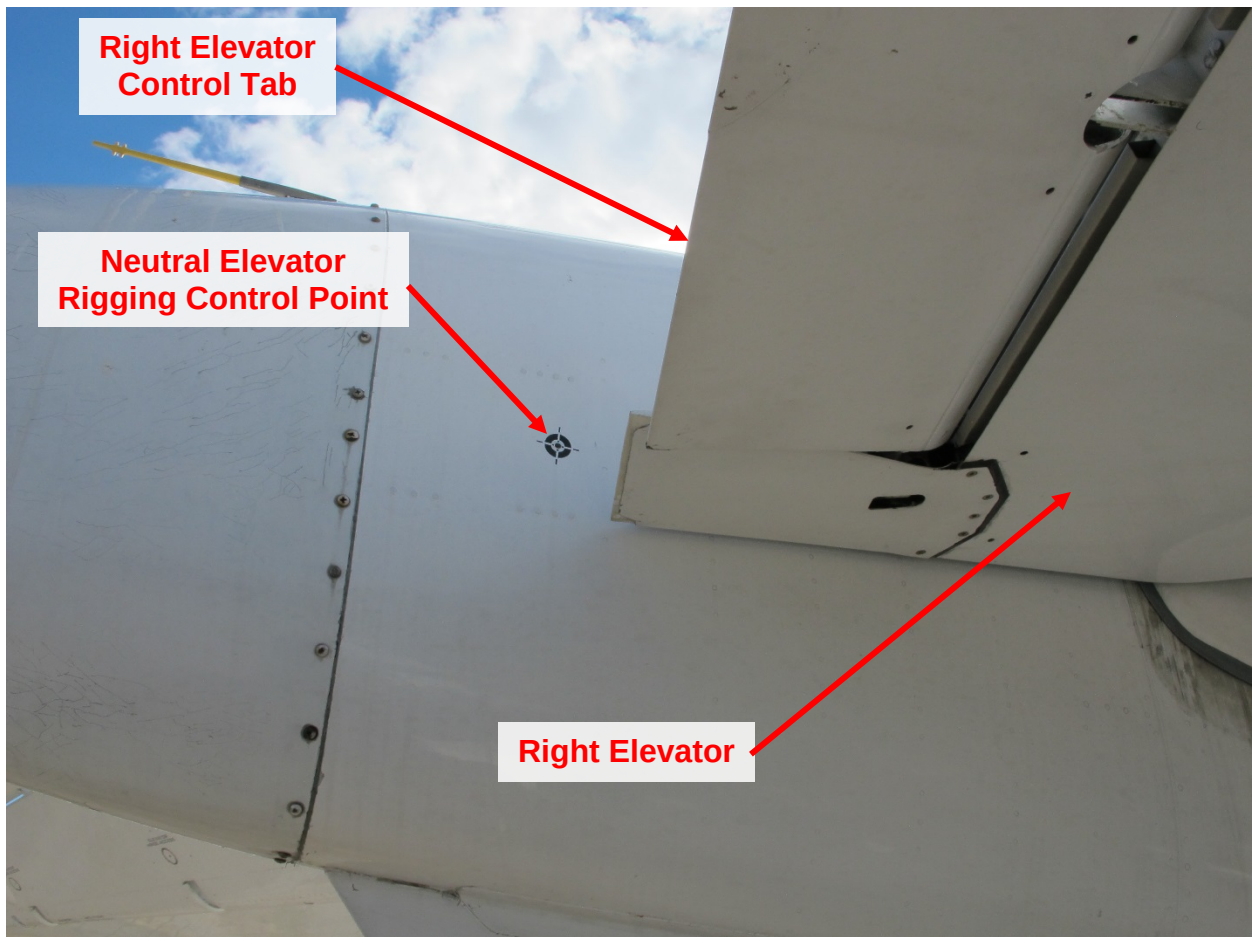
**Figure 15 - Trailing edge of the right-hand elevator (jammed position)**

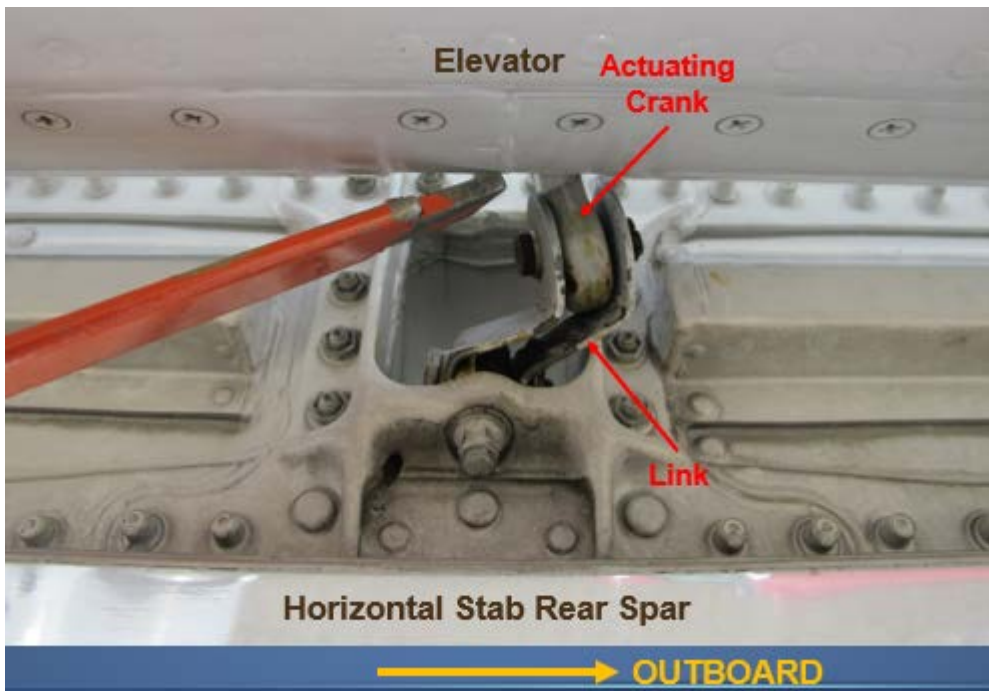
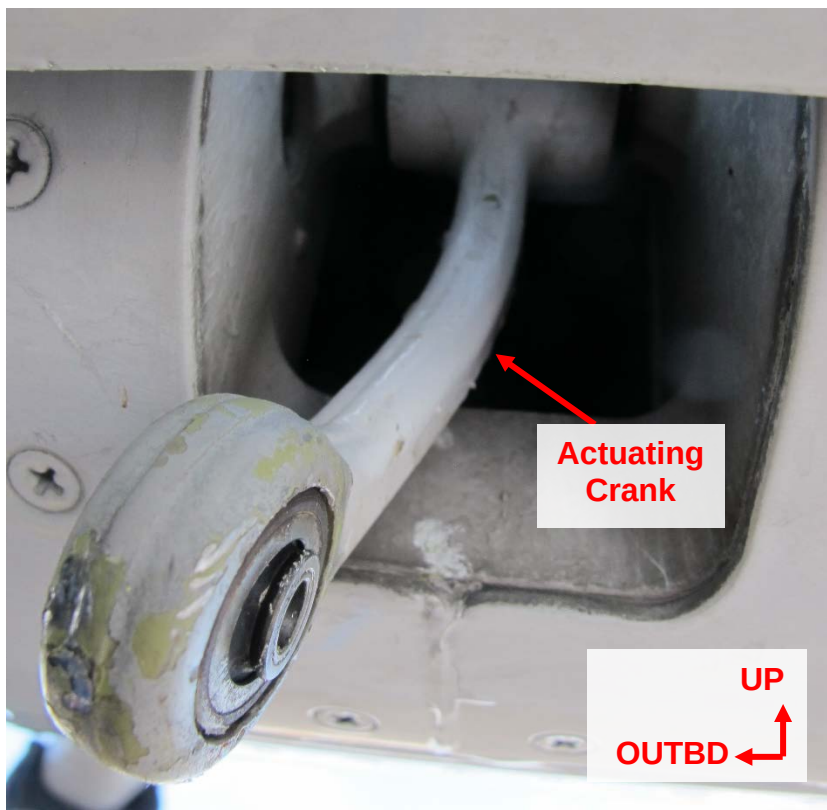
A visual examination of the tab hinges and control linkages found that the inboard right geared tab links and actuating crank were damaged and in an over-centered position. The two links and the actuating crank arm were bent in an outboard direction, Figure 16 and Figure 17.

Figure 16 - Inboard right hand geared tab attachment at horizontal stab rear spar as found (orange bar used by group to point to damaged links)

Figure 17 - Damaged Actuating Crank Arm after links removed

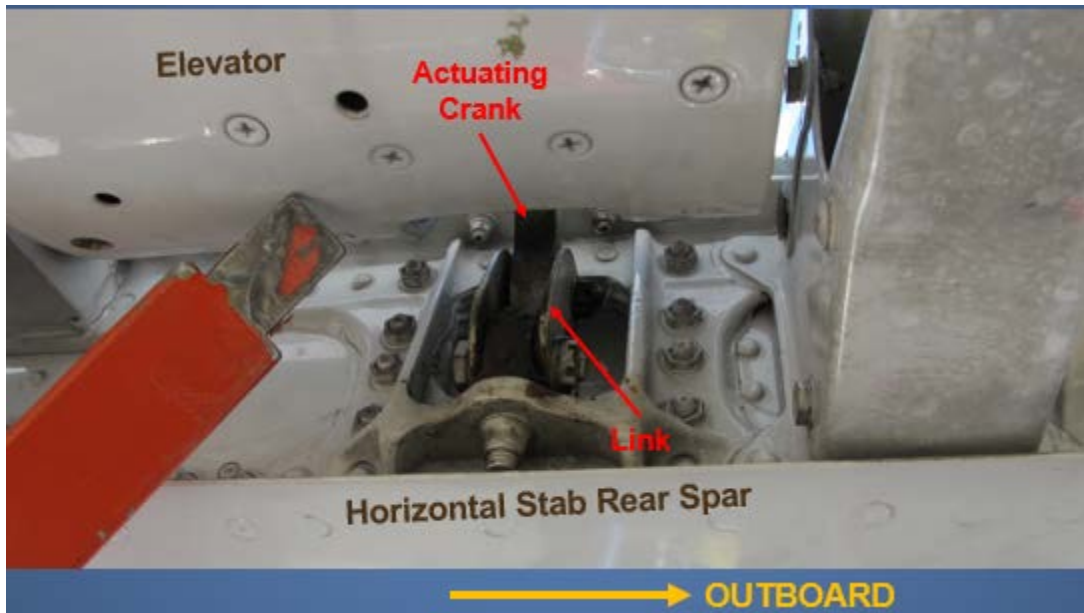
A visual examination of the remaining drive linkages for the outboard end of the right geared tab (ref. Figure 18) and both ends of the left geared tab found no defects or obstructions. All appropriate attachment hardware was present for all hinge fittings and control linkage connections on the control, geared and anti-float tabs.

**Figure 18 - Outboard right hand geared tab attachment at horizontal stab rear spar (orange bar used by group to point to links)**

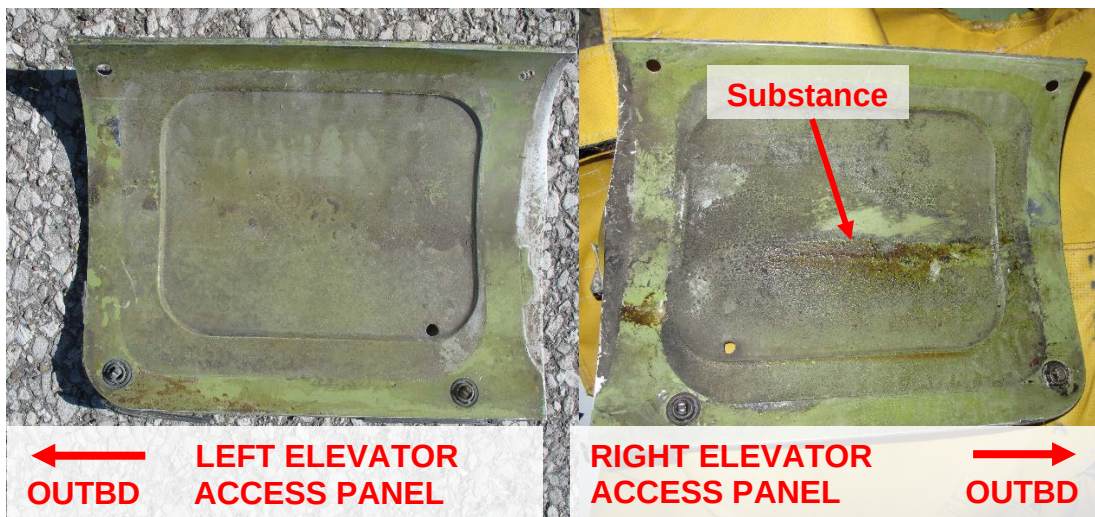
Access panels for the elevator dampers were removed to allow inspection of both dampers. The left damper and area around the installation was clean. The right damper outer surface and the inside of the access panel had a brown, tacky substance, Figure 20. All attachment hardware was present and accounted for both dampers.

**Figure 20 - Left and right elevator damper access panels (interior side shown)**

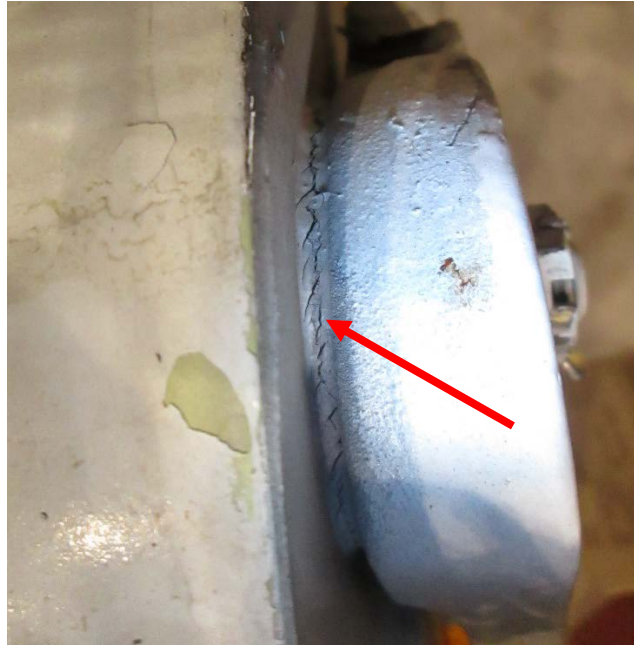
A visual inspection conducted of the stop arm noted that the sealant that is located between the stop arm and the closeout rib showed cracking along the circumference of the torsion bar, Figure 22.

**Figure 22 - Sealant (cracking noted by arrow) between the LH elevator stop arm and closeout rib.**

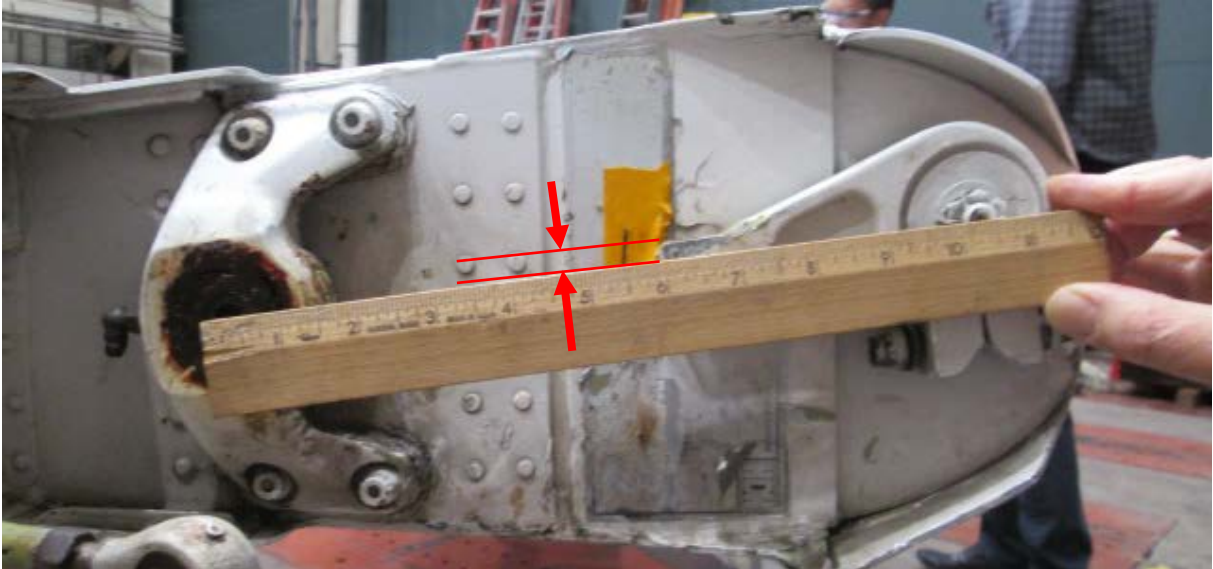
A straight edge was placed on the center of the torsion bar and aligned with the center of the elevator hinge bearing. A measurement was taken from the straight edge to the upper surface of the stop arm, Figure 23. For the left elevator the measurement was approximately 0.22 inches. The measurement was slightly outside of the manufacturer's drawing tolerance but within the range of adjustment for the elevator stops.

**Figure 23 - Alignment check of the LH stop arm with respect to the elevator hinge point**

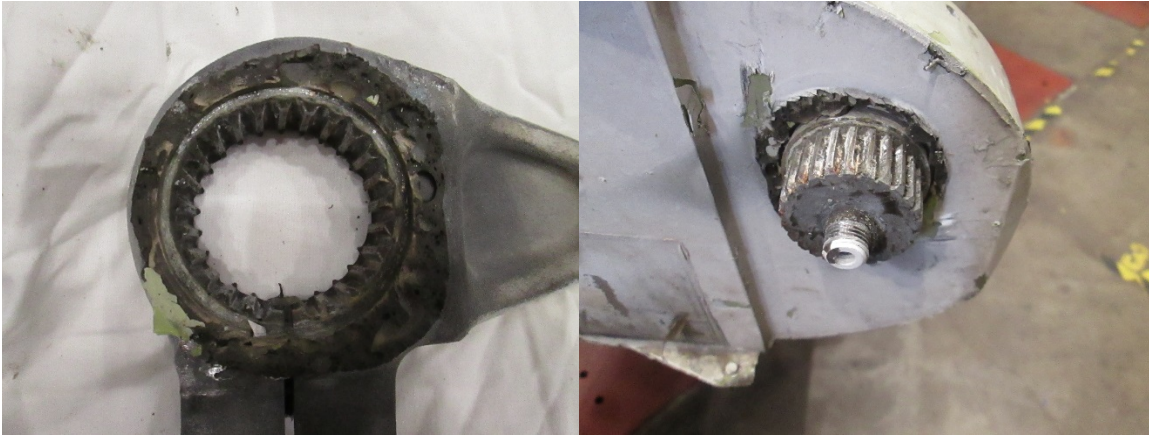
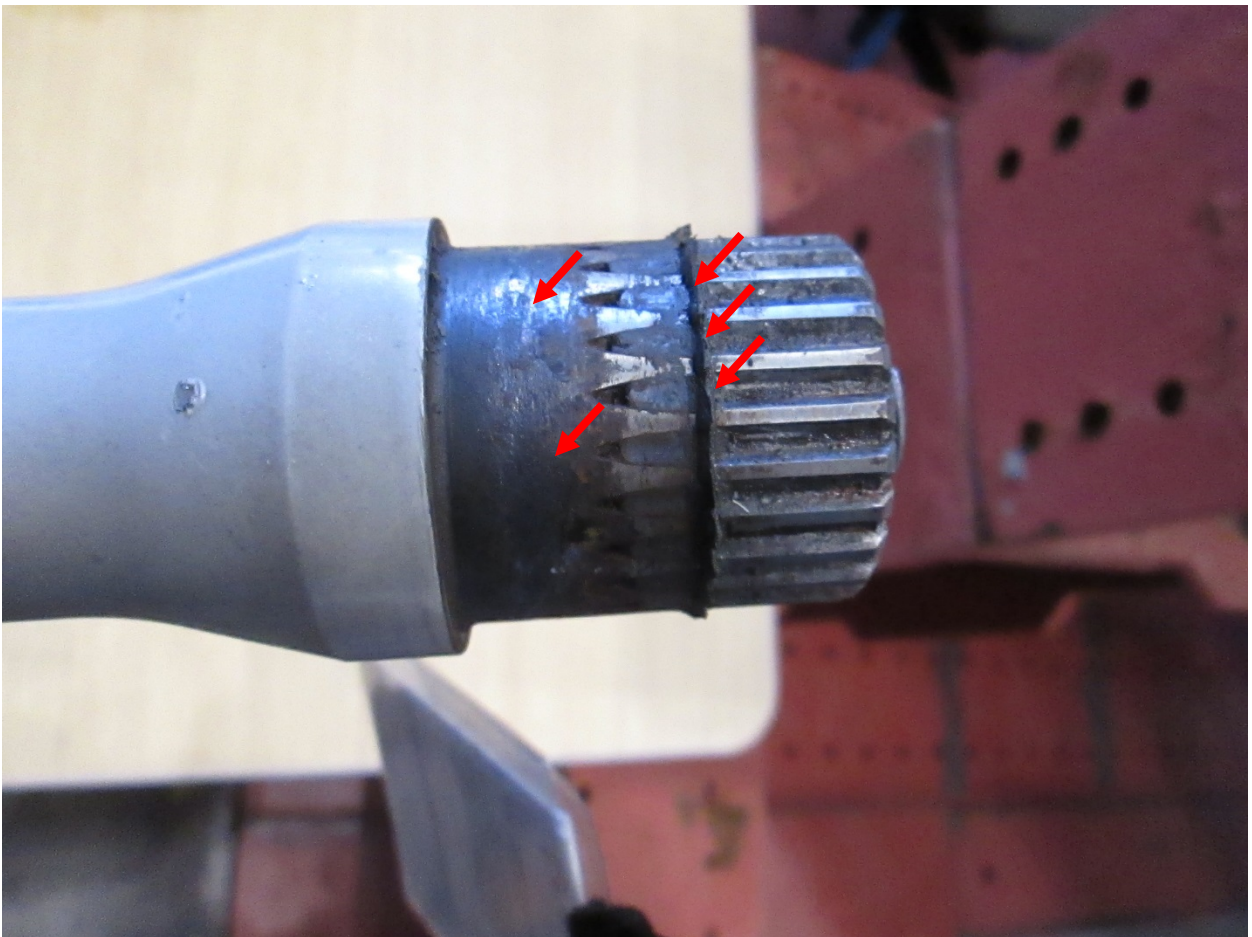
The torsion bar removal could not be accomplished by the overhaul manual procedure. Additional force was required to remove the torsion bar. During the removal process, the threaded end which is used to secure the stop arm was damaged. The splines on the

torsion bar and stop arm did not show signs of damage, Figure 25. Sealant filled portions of the spline in the vicinity of the wing rib bearing. A visual inspection of the inner surfaces of the bearing and the mating surface of the torsion bar revealed small areas of sealant adhered to both surfaces, Figure 26.

**Figure 25 - Mating spline surfaces of the left elevator stop arm and torsion bar**

**Figure 26 - Torsion bar spline and bearing surface with sealant after removal from elevator (arrows highlight sealant areas, not all areas highlighted)**

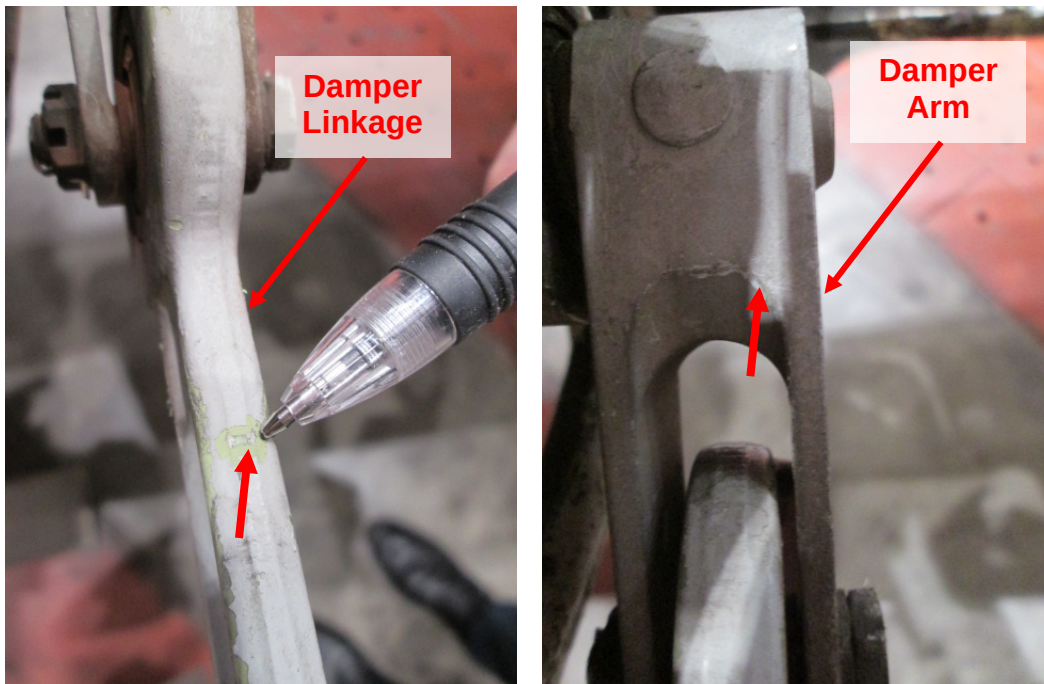
The RH elevator damper linkage was inspected and a witness mark on the linkage was noted approximately 1.9 inches from the attachment bolt. A corresponding mark was noted on the elevator damper arm, Figure 29.

**Figure 29 - Witness marks on RH elevator damper (arrow highlights witness mark)**

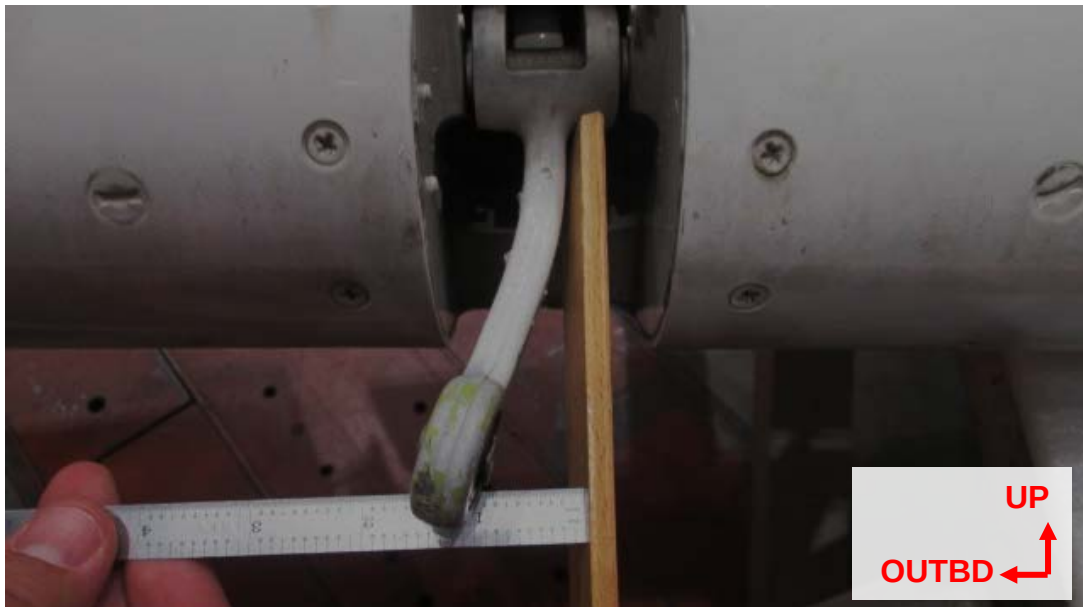
As noted on scene the crank assembly for the inboard geared tab pushrod was found damaged. The crank arm was displaced in an outboard direction, approximately 0.95 inches from its normal position, Figure 30.

**Figure 30 - RH Elevator actuating crank arm displacement**

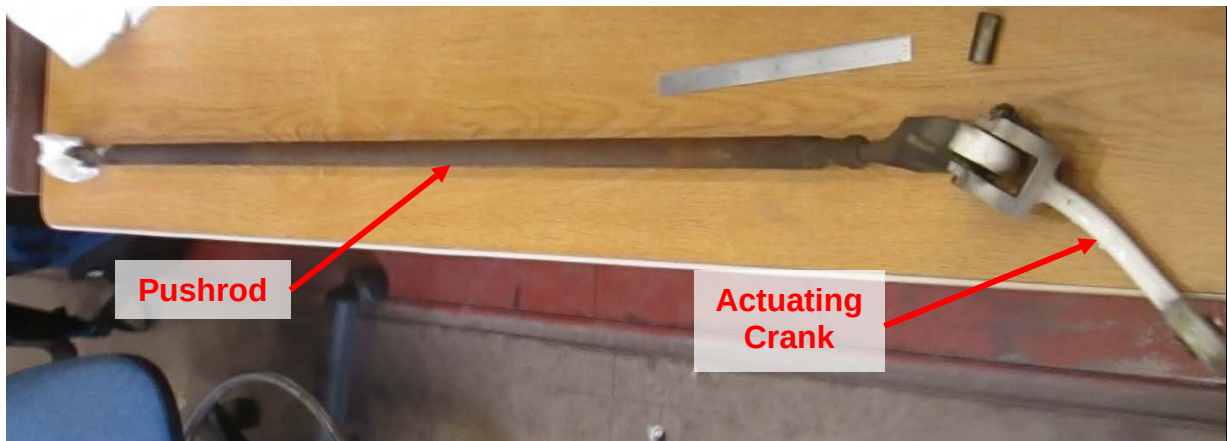
The inboard geared tab pushrod and actuating crank were removed, Figure 32. The inboard geared tab pushrod did not exhibit any signs of bending. The adjustable rod end, which connects with the geared tab control horn, jam nut, stop washer and safety wire were present and secure. The pushrod (not including the rod ends) was measured to be 26 15/16 inches. The measurement from the angled rod end to the fixed rivet was 3 inches. Both measurements were consistent with manufacturer drawings.

**Figure 32 - RH Inboard geared tab pushrod and actuating crank**

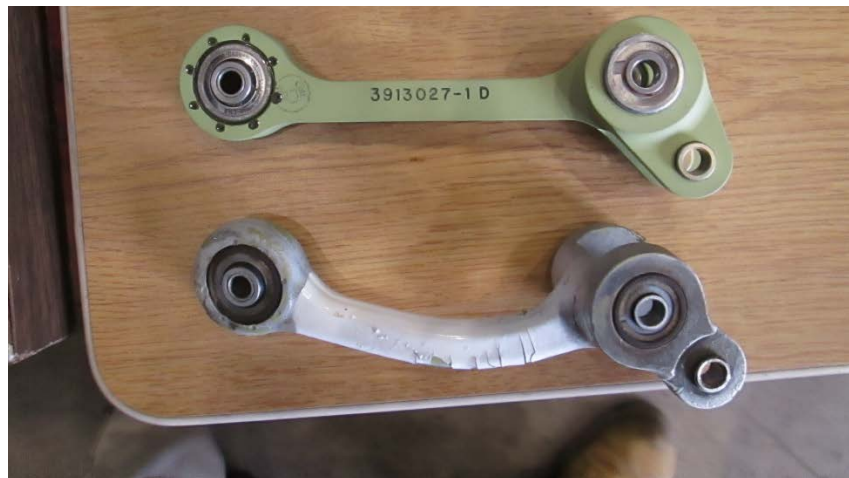
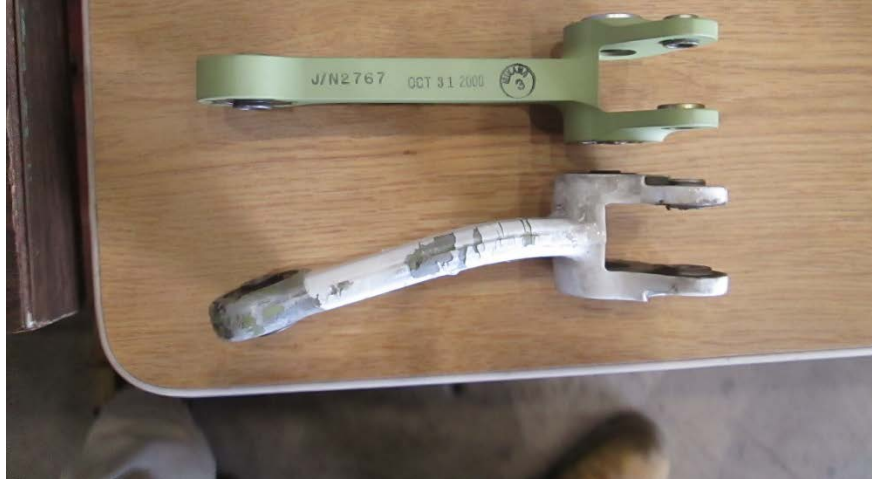
As previously noted, the actuating crank was bent in an outboard direction. The bearings were free to rotate with no noticeable signs of binding. Figure 33 and Figure 34 show the actuating crank with an exemplar unit. The exemplar unit was obtained from Boeing spares and is an acceptable substitute part for field replacement. The original and accident parts were made from a forging and the current manufactured substitute part is a machined unit.

**Figure 33 - Side view comparison of accident and exemplar RH actuating crank**

**Figure 34 - View looking down at accident and exemplar RH elevator actuating crank**

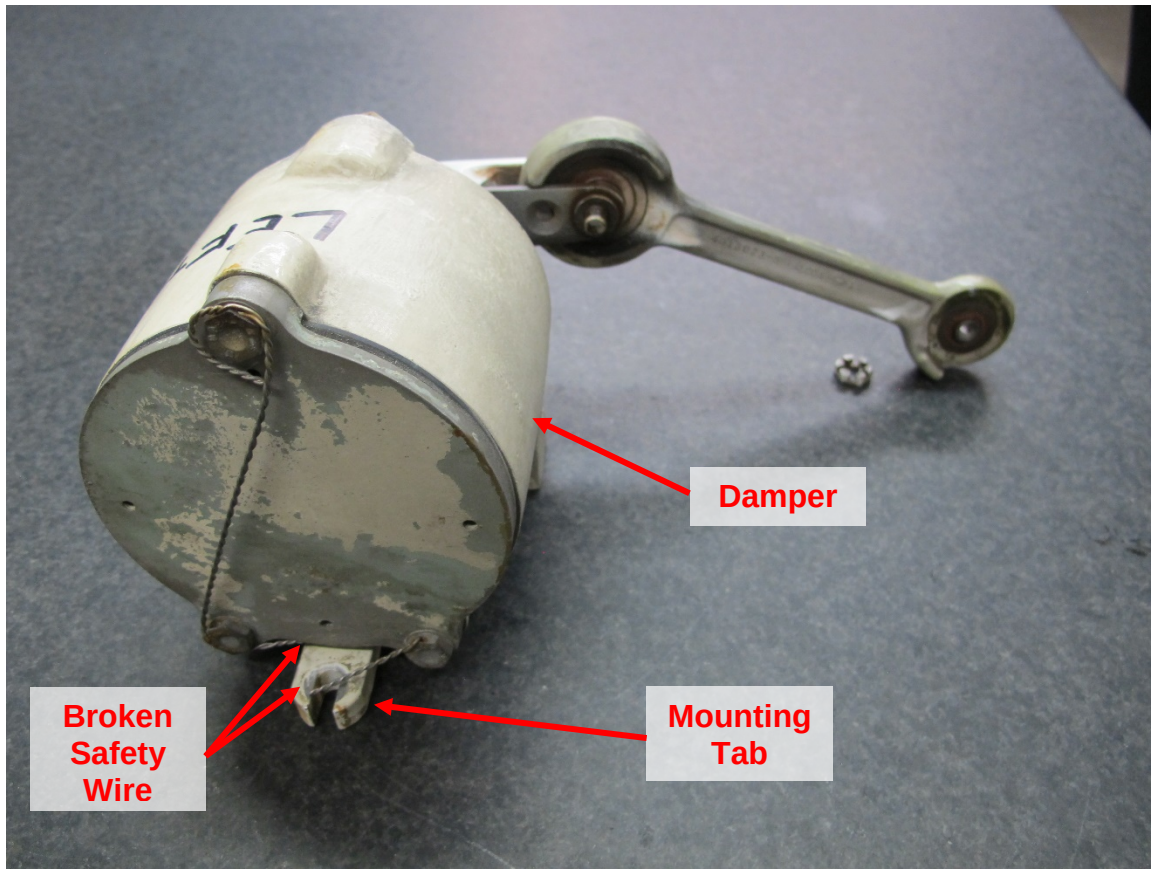
The accident aircraft dampers were visually inspected. The LH damper had a broken safety wire in the vicinity of one of the aircraft mounting tabs, Figure 35. None of the bolts secured by the safety wire appeared to be displaced.

**Figure 35 - LH Elevator Damper with broken safety wire noted**

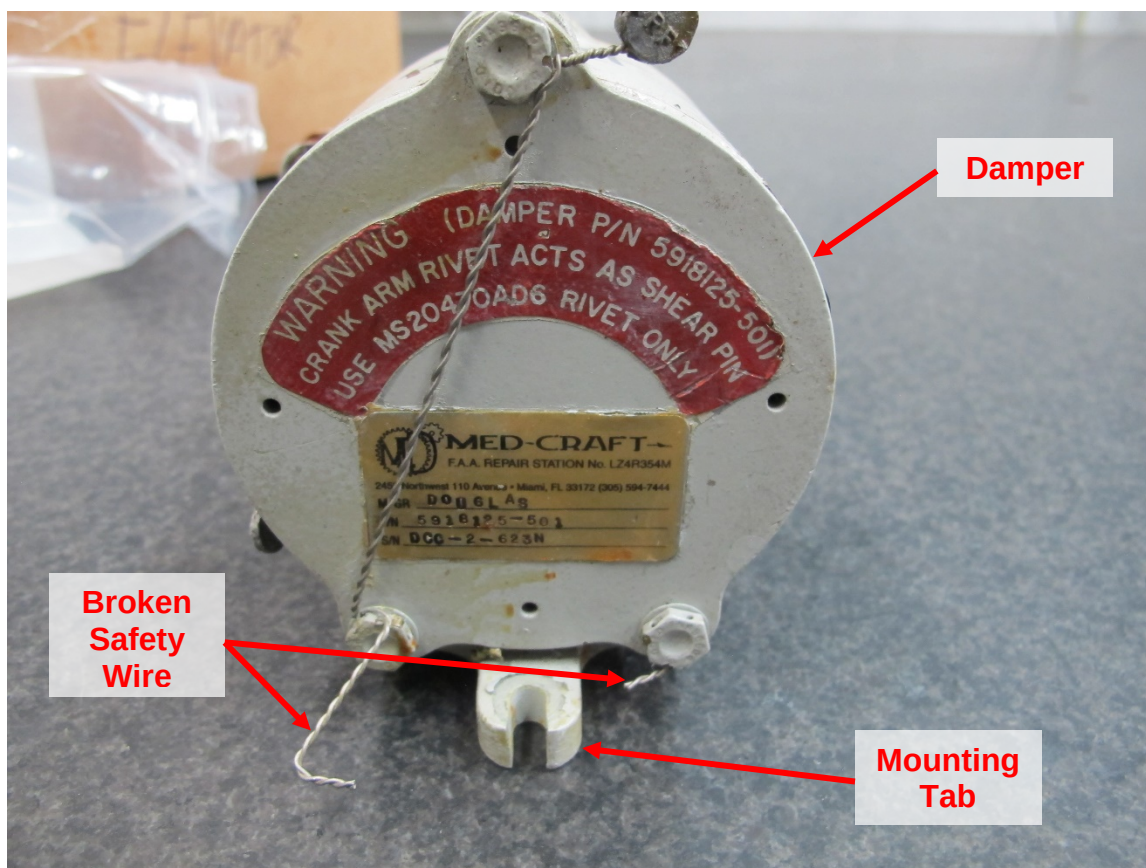
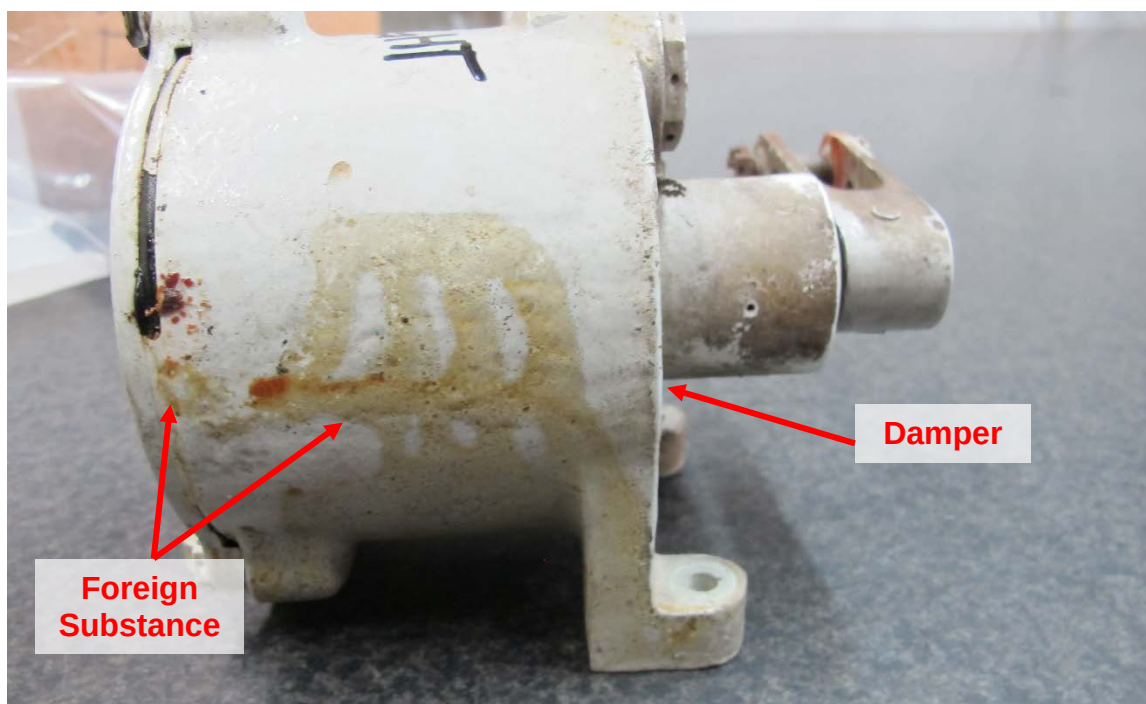
The RH damper had a broken safety wire in the vicinity of one of the aircraft mounting tabs, Figure 36. None of the bolts secured by the safety wire appeared to be displaced. The unit case had an area covered in a brownish, tacky, substance, Figure 37. Careful examination of the rear cap diaphragm, pins, plug and shaft did not reveal a source of a possible leak from the damper assembly. Overhaul facility personnel stated that the color of the substance was inconsistent with the manufacturer's specified silicone oil used in the damper assembly, which is typically clear and colorless.

Figure 36 - RH Elevator damper with broken safety wire noted

Figure 37 - RH Elevator damper case showing areas of foreign substance

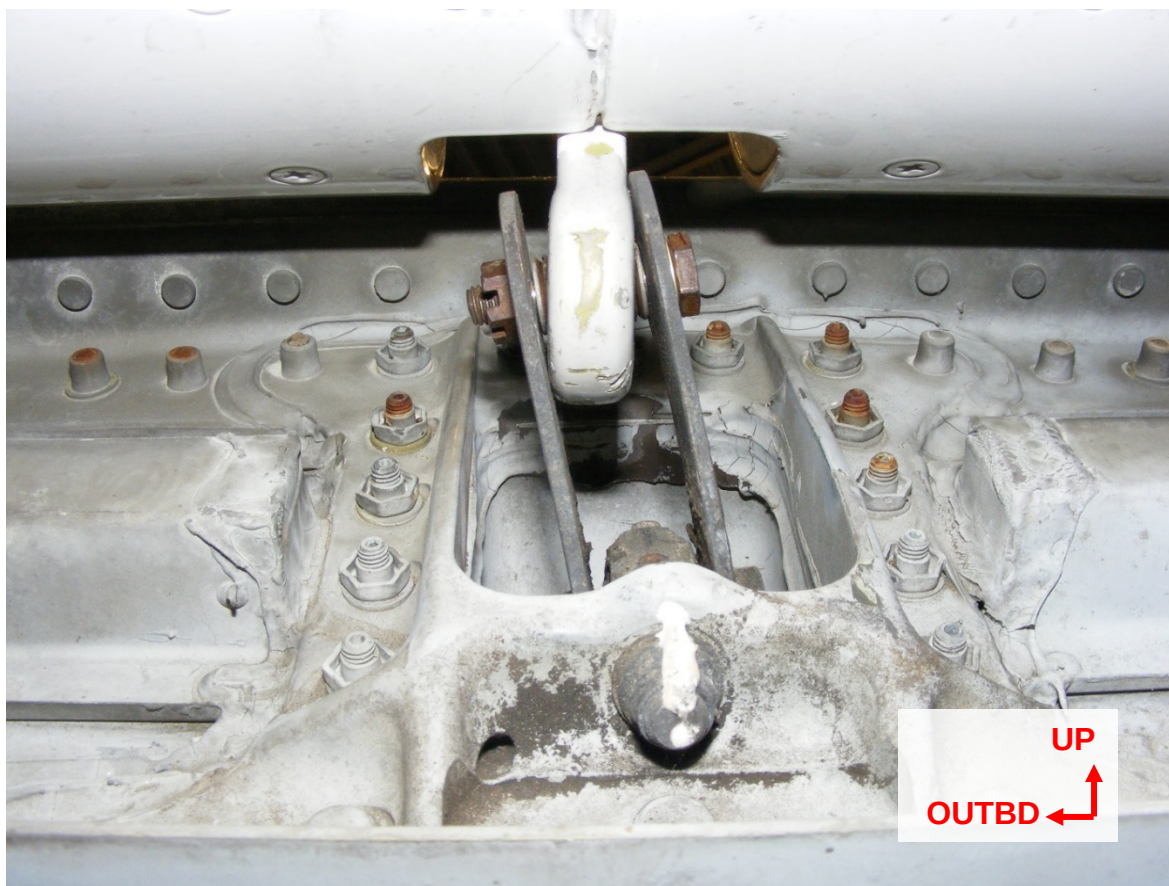
**Figure 53 - Gear Tab Inboard Linkage in over-centered condition**

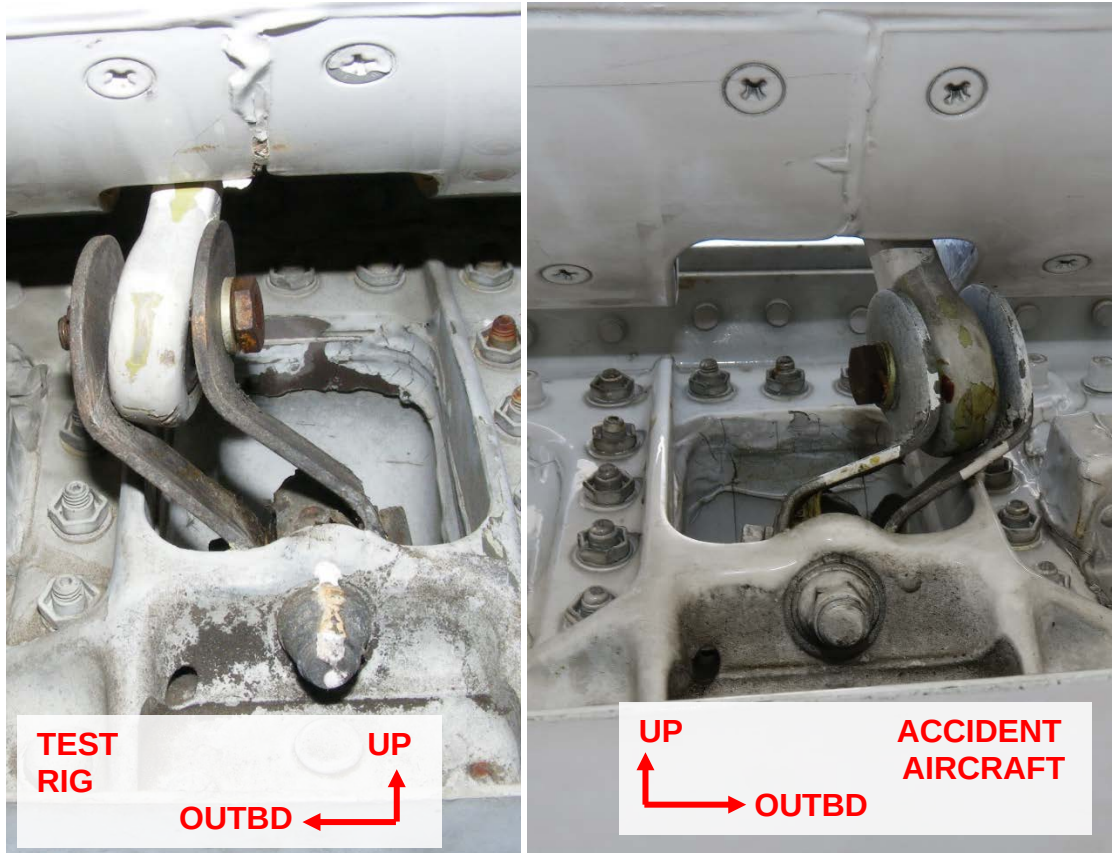
Figure 54 – Side by Side comparison of final test rig results with accident aircraft damage after lifting load application
