NATIONAL TRANSPORTATION SAFETY BOARD

**Group Chairman's Factual Report**

**STRUCTURES**

**DCA17FA076**

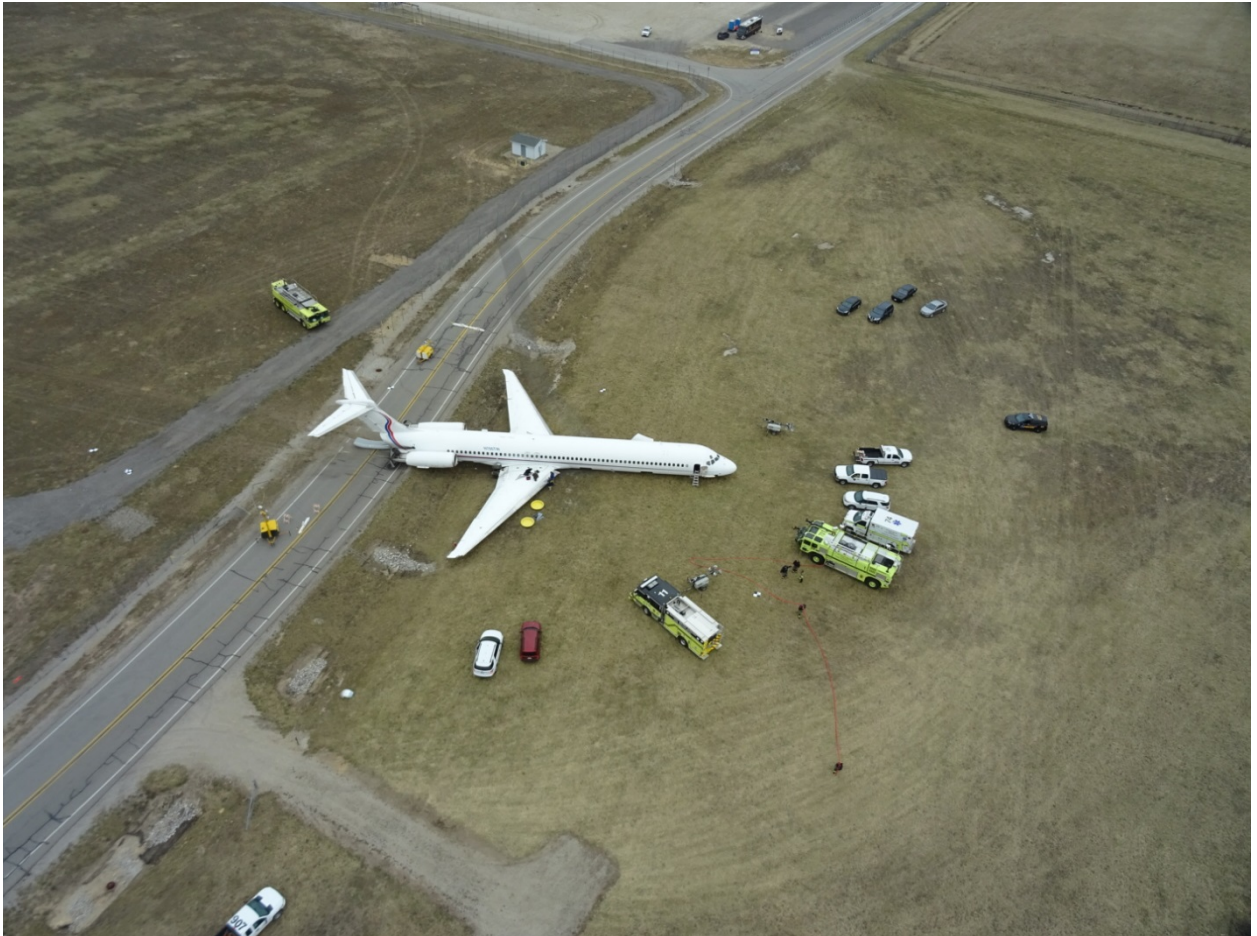
Figure 1 – Overhead view of airplane

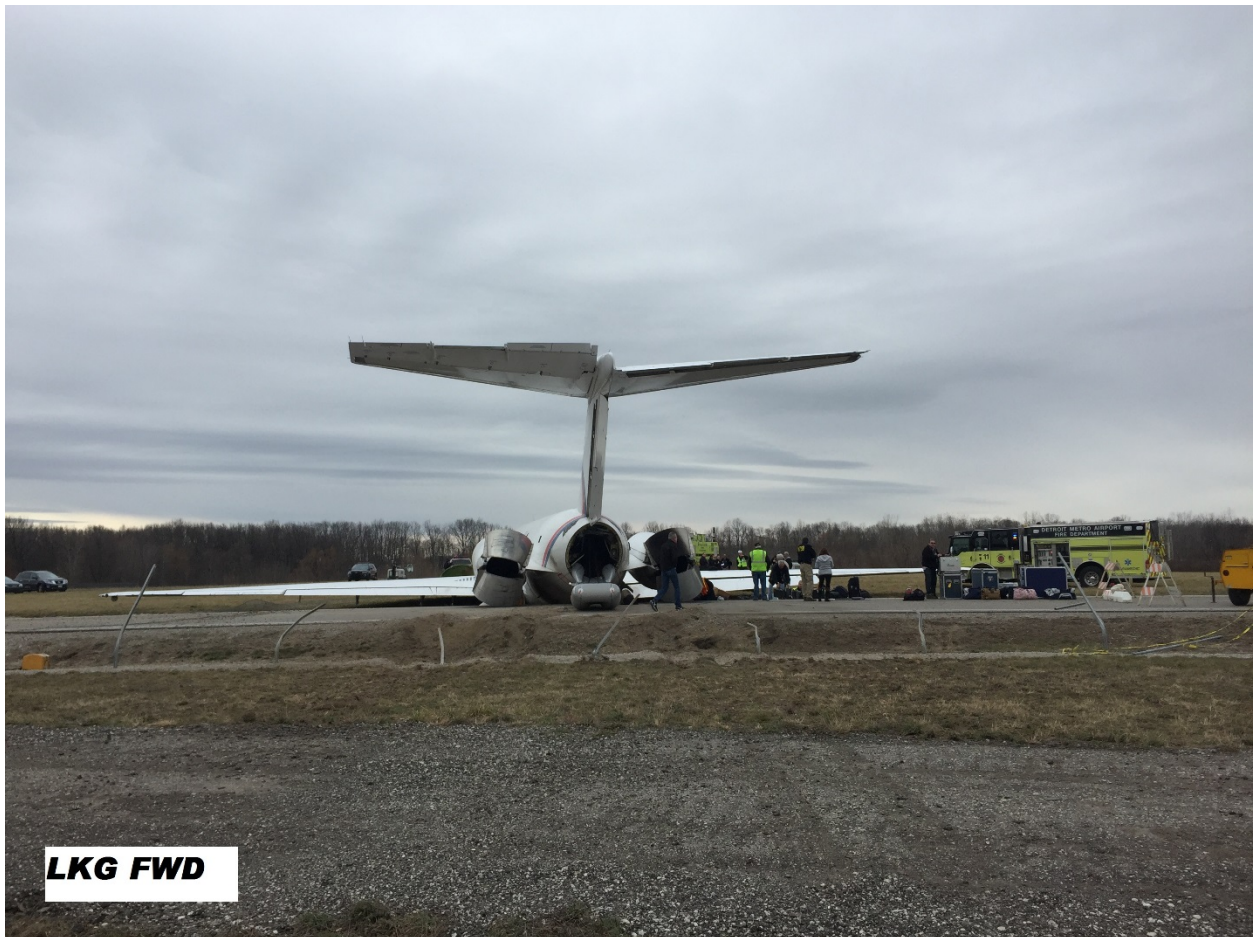
Figure 2 - View of impact area and perimeter fence

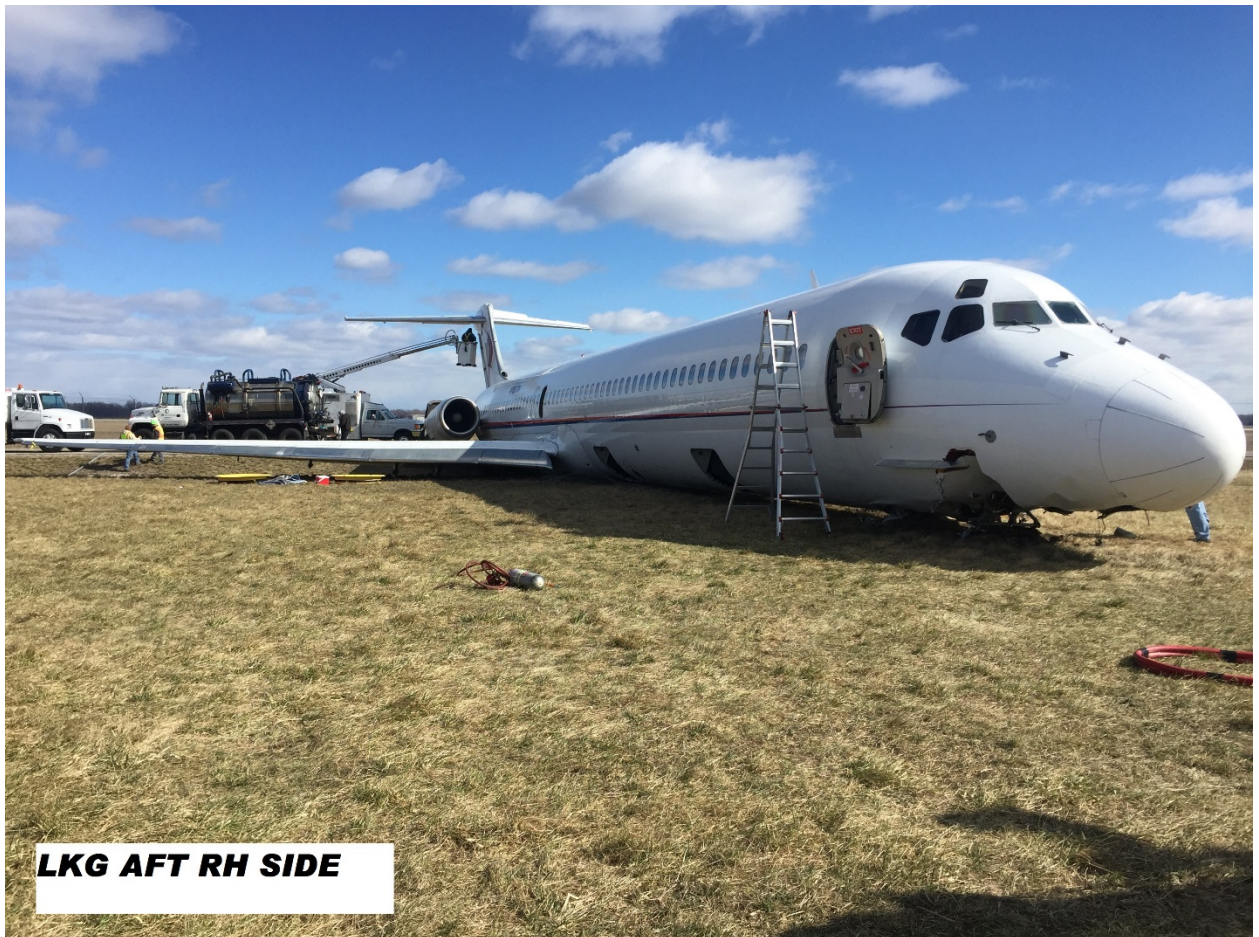
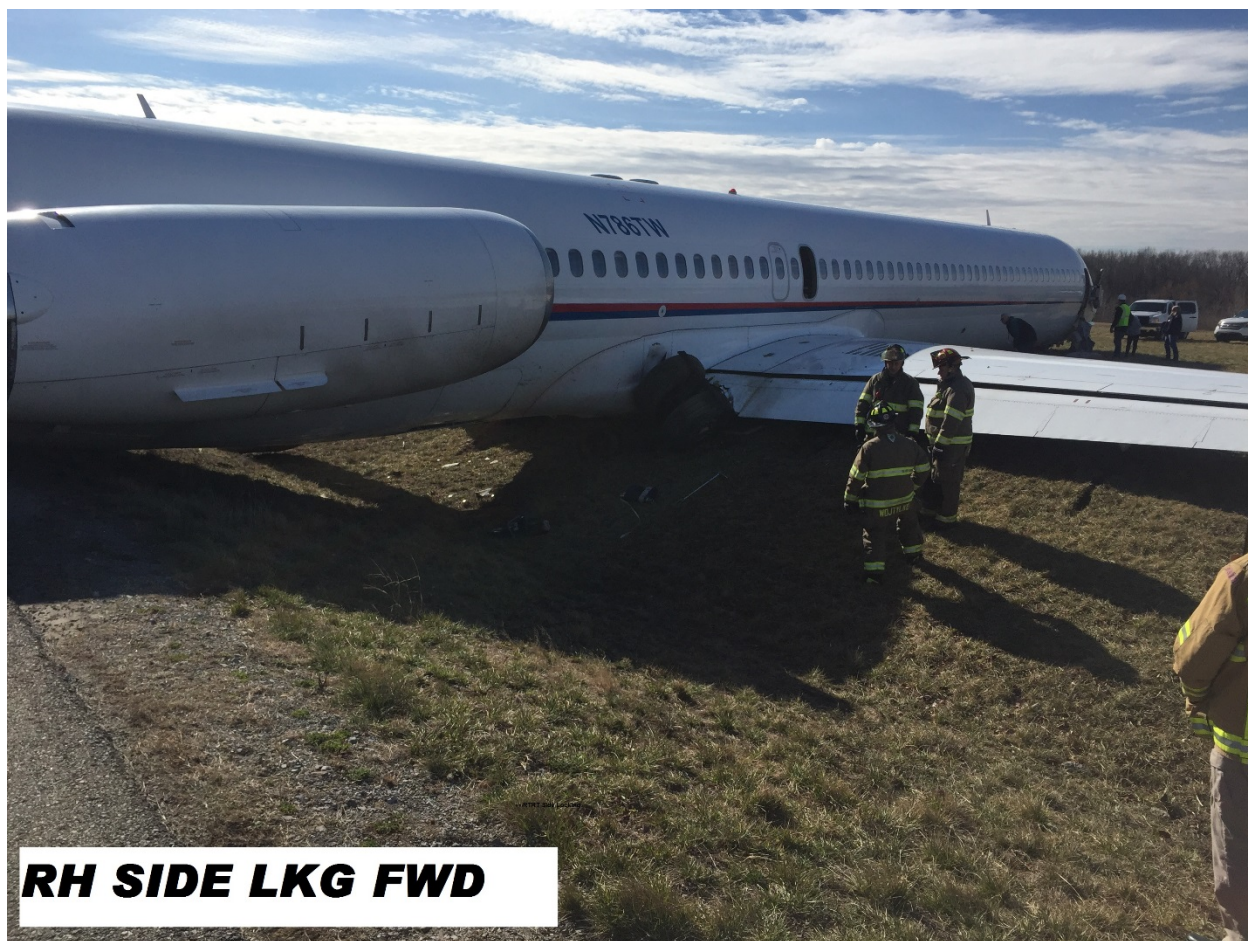
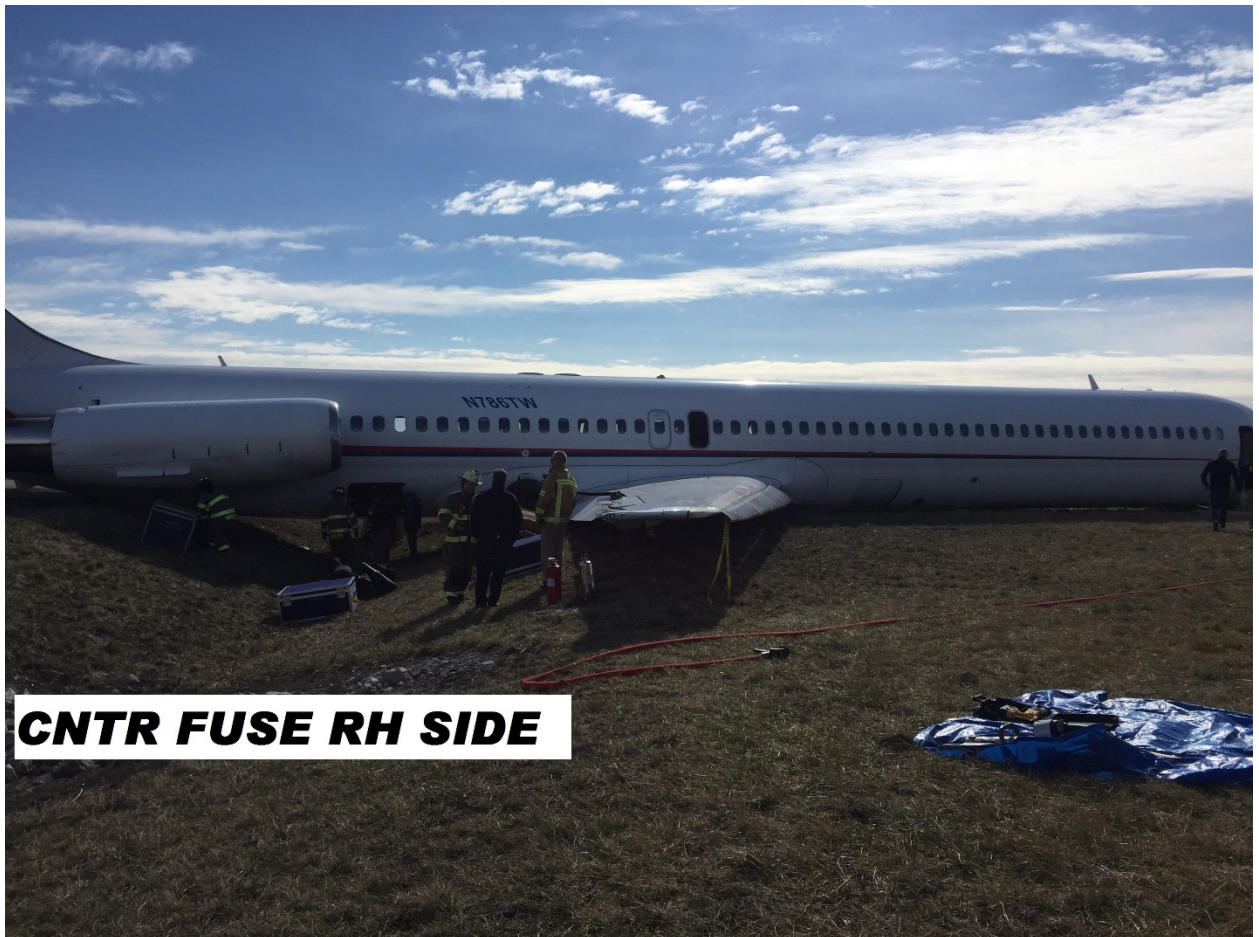
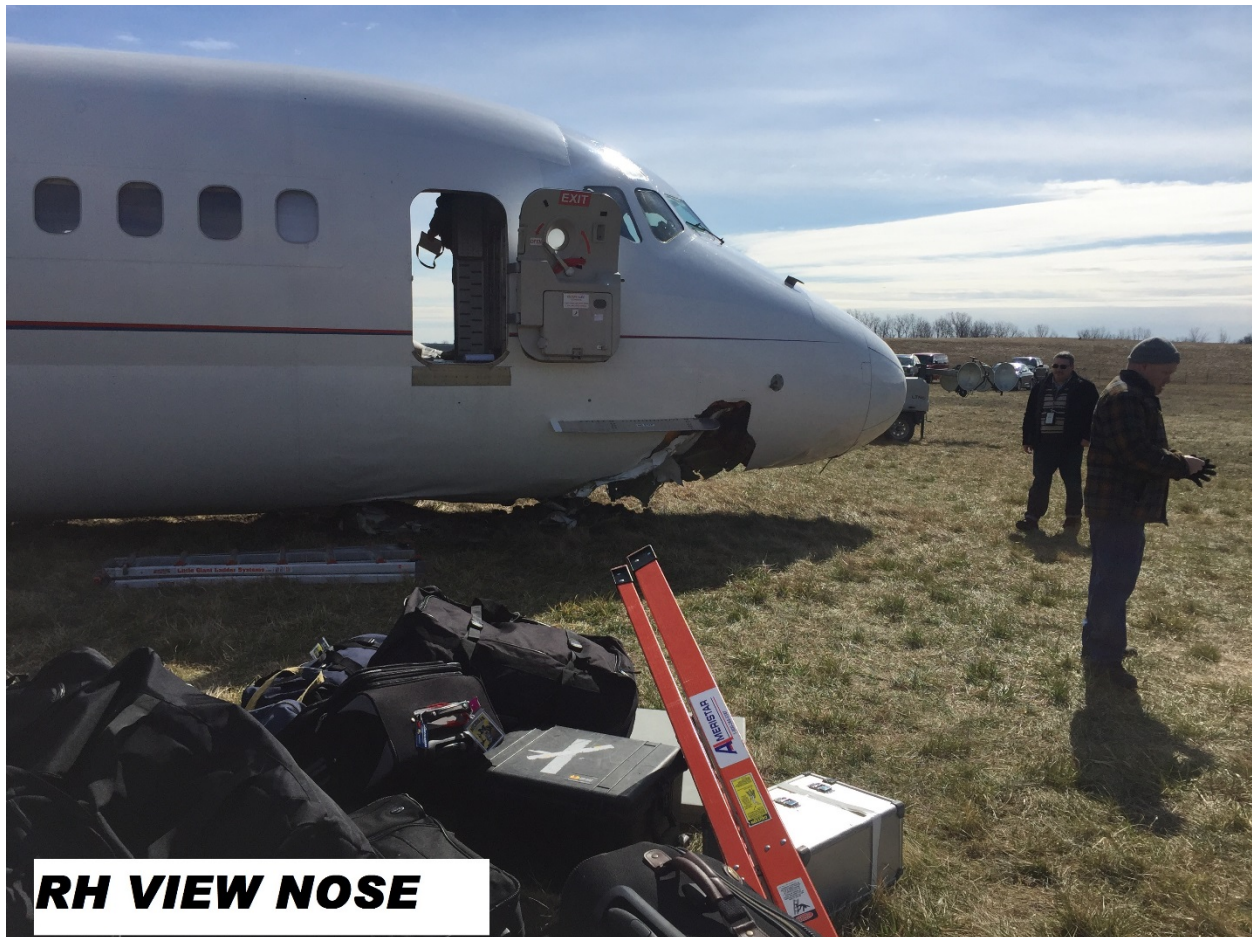
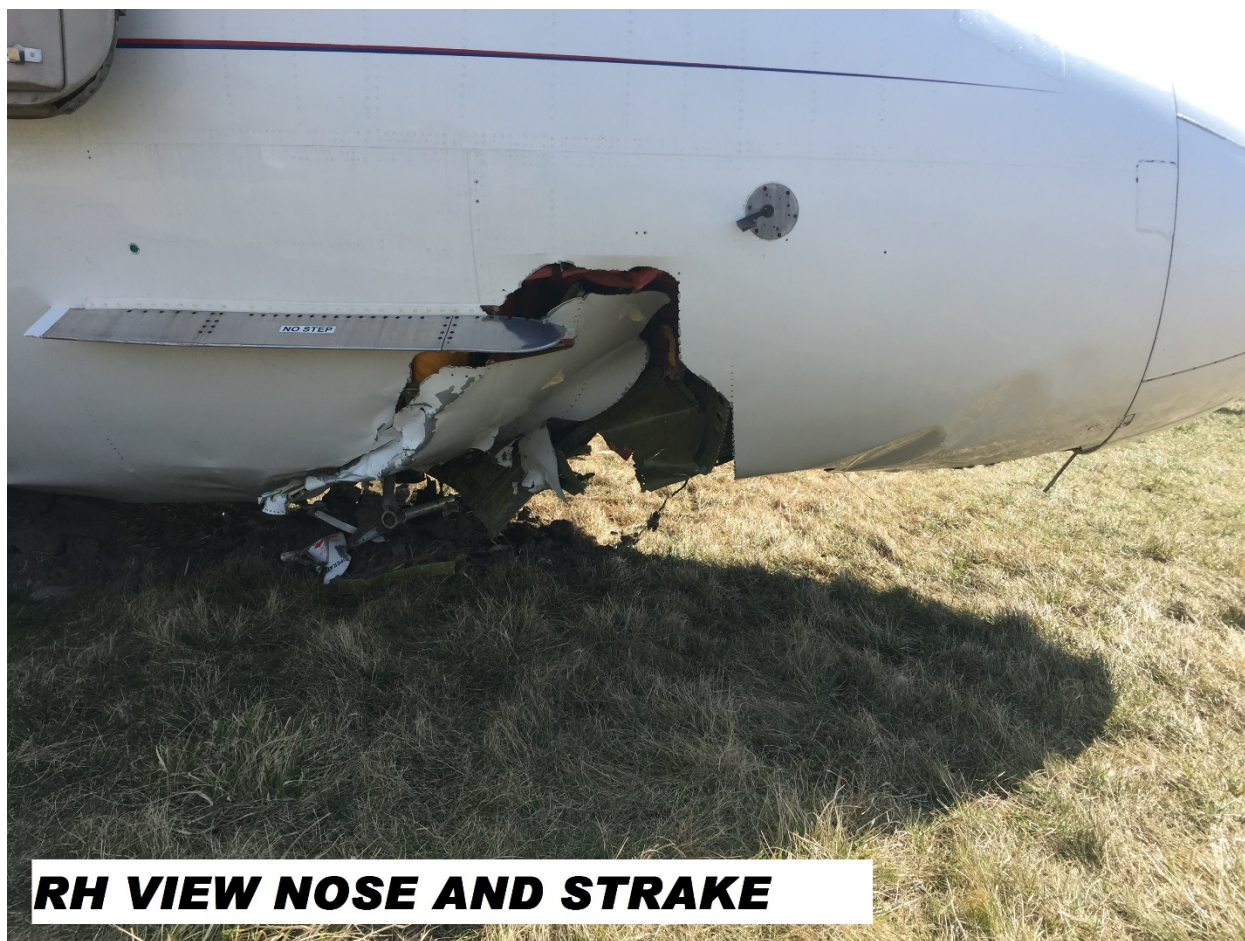
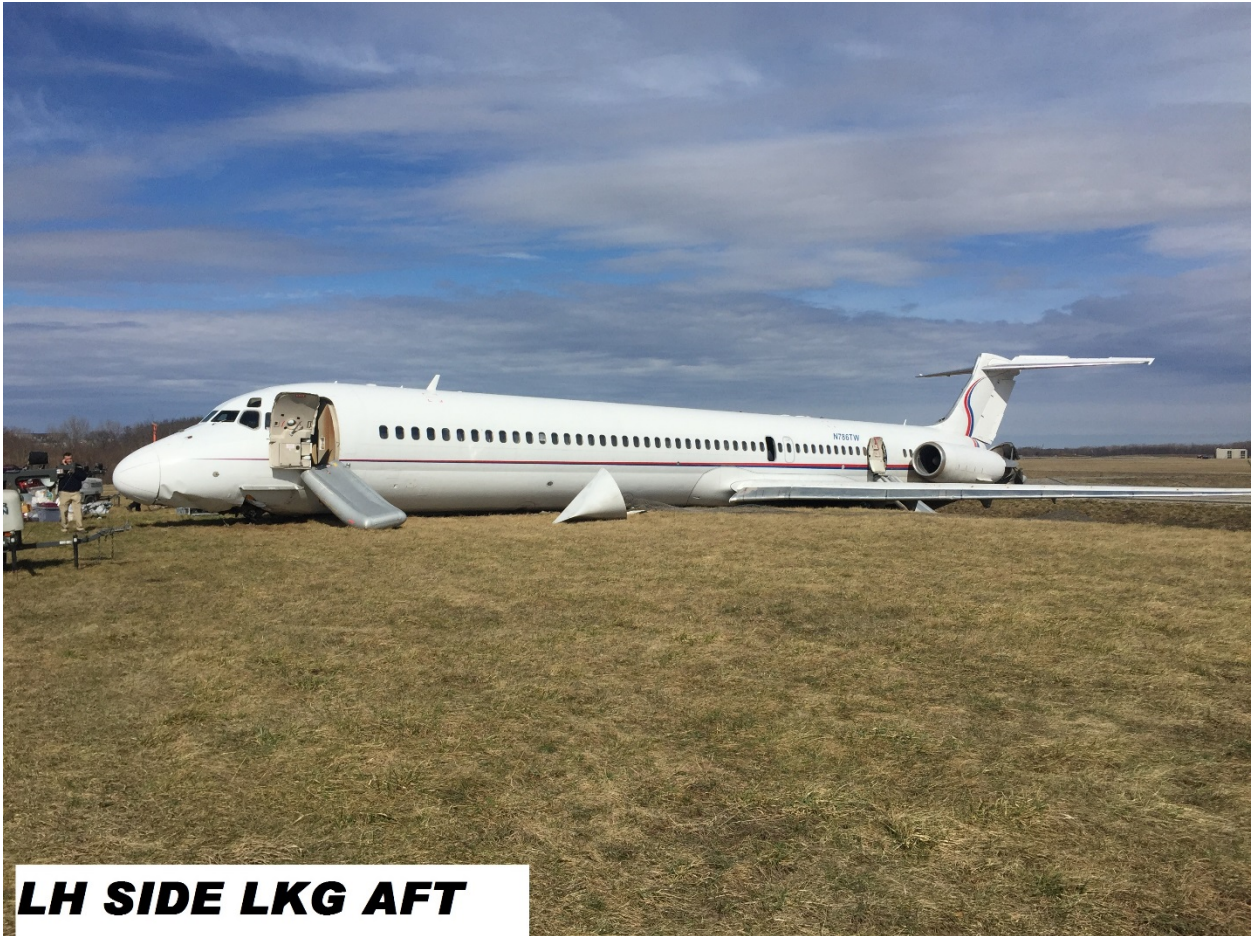
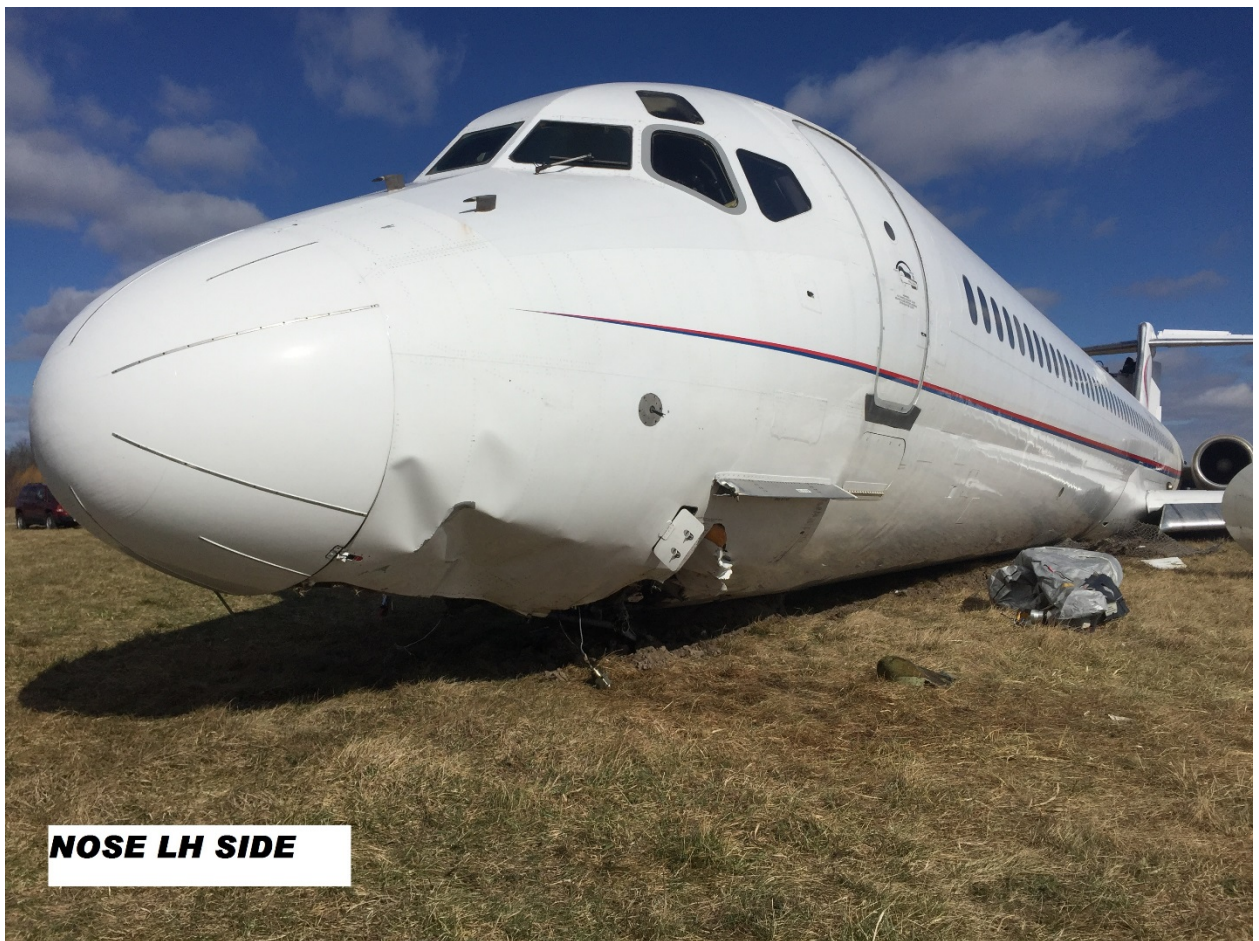
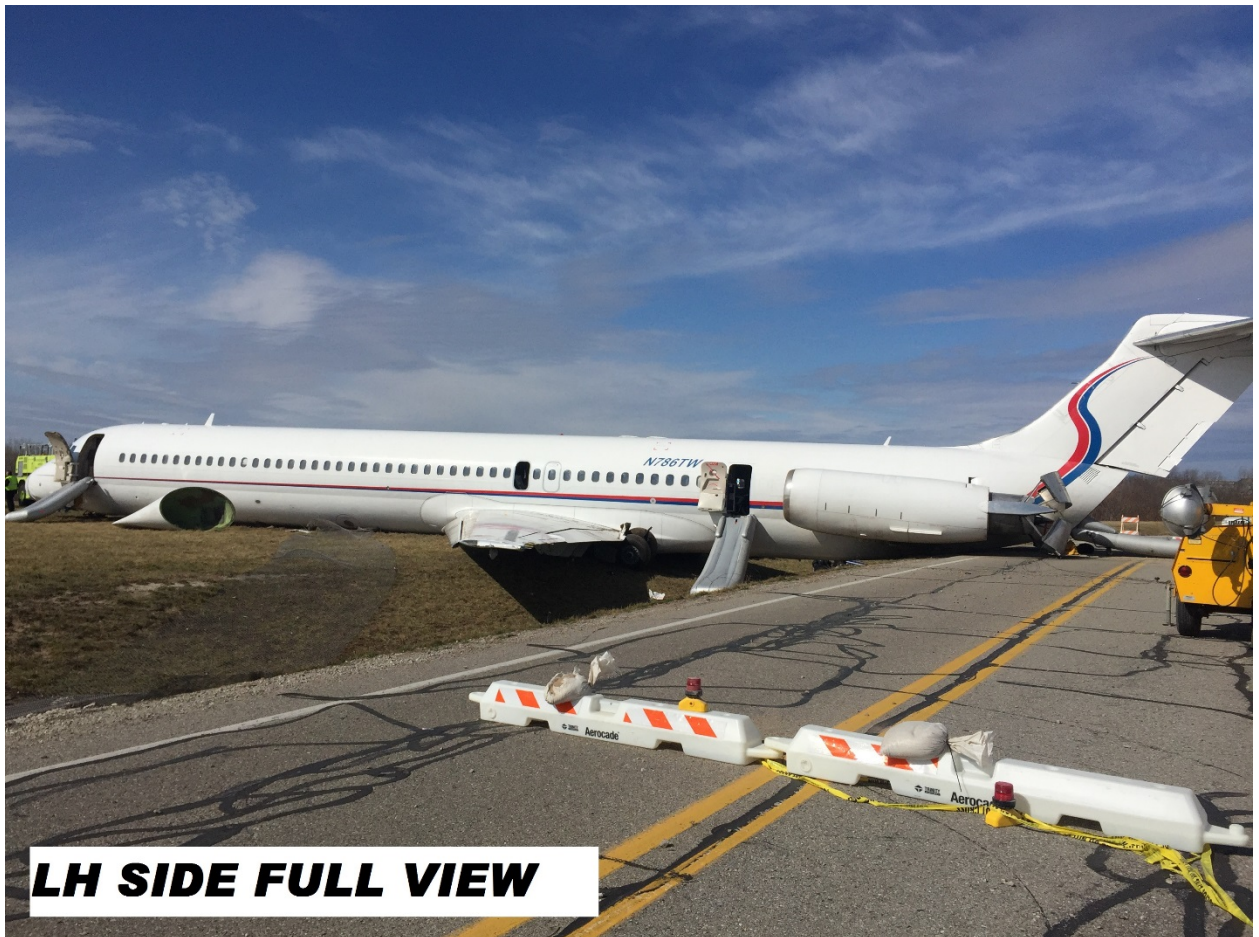
The fuselage exterior lower skin panel assemblies including longeron and frames exhibited severe buckling, deformations, missing sections, and severed internal structure at numerous locations from fuselage station (STA) 37 to fuselage STA 229, from longeron 18 left hand (LH) to longeron 18 right hand (RH) to just below the RH side cusp. The damage was consistent with the nose gear collapsing aft and the fuselage impact with the ground. The LH and RH nose skin strakes were damaged and or severed at their leading edges. The LH angle of attack (AOA) vane also separated from the airplane. The RH AOA vane was intact.

Figure 3 – Right side viewed looking aft

Figure 4 – Right hand side viewed looking forward

Figure 5 – Right hand side center fuselage

Figure 6 – Right hand side nose

Figure 7 – Right nose damage close up

Figure 8 – Left hand side viewed looking aft

Figure 9 – Left side view of the nose

Figure 10 – Left side view

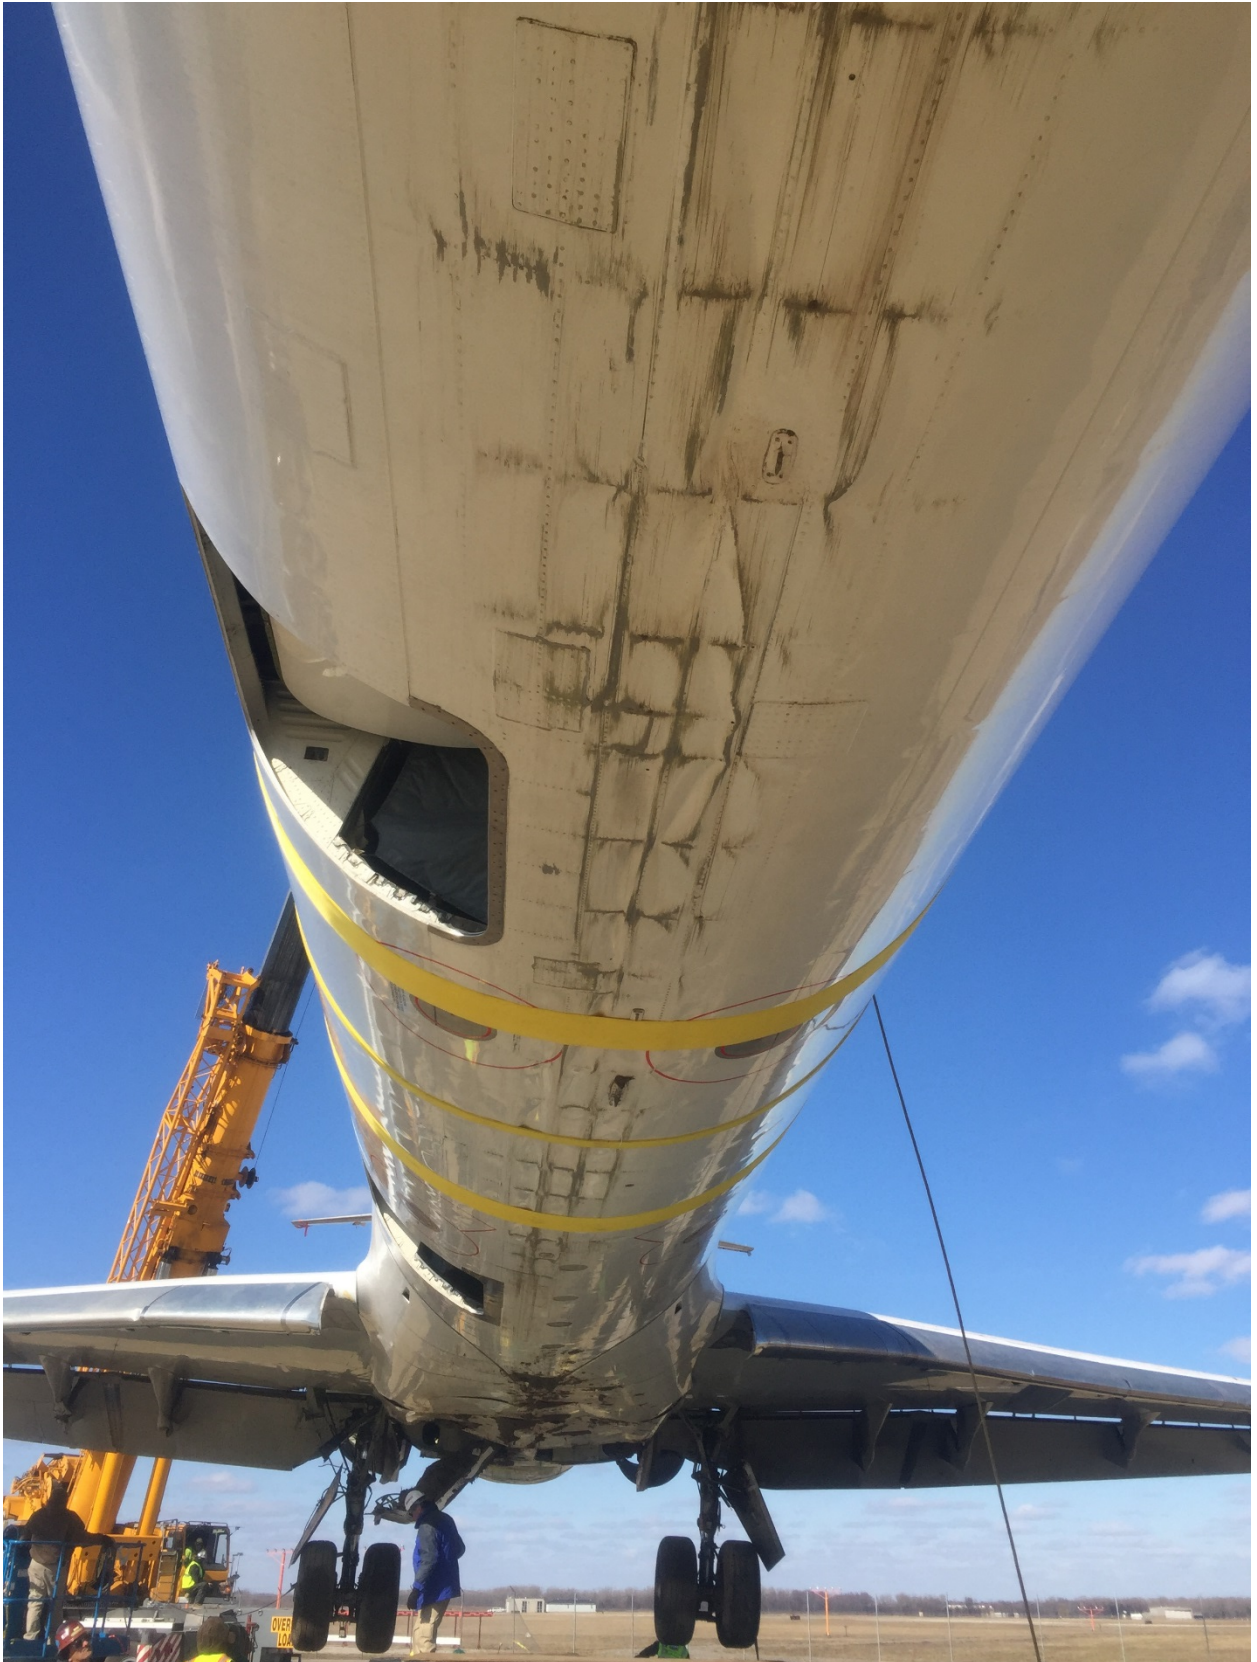
The fuselage lower skin panel assemblies from longeron 26 LH to longeron 26 RH, extending from STA 229 to approximately STA 1429 were abraded and the deformation was consistent with impact damage. Numerous sections of the skin lower lobe skin panels were worn through exposing the longerons and substructure.

A large skin puncture and upward deformation due to impact with ground severed the longerons at STA 229 extending from longeron 26 LH to longeron 26 RH.

Figure 11 – Lower fuselage damage

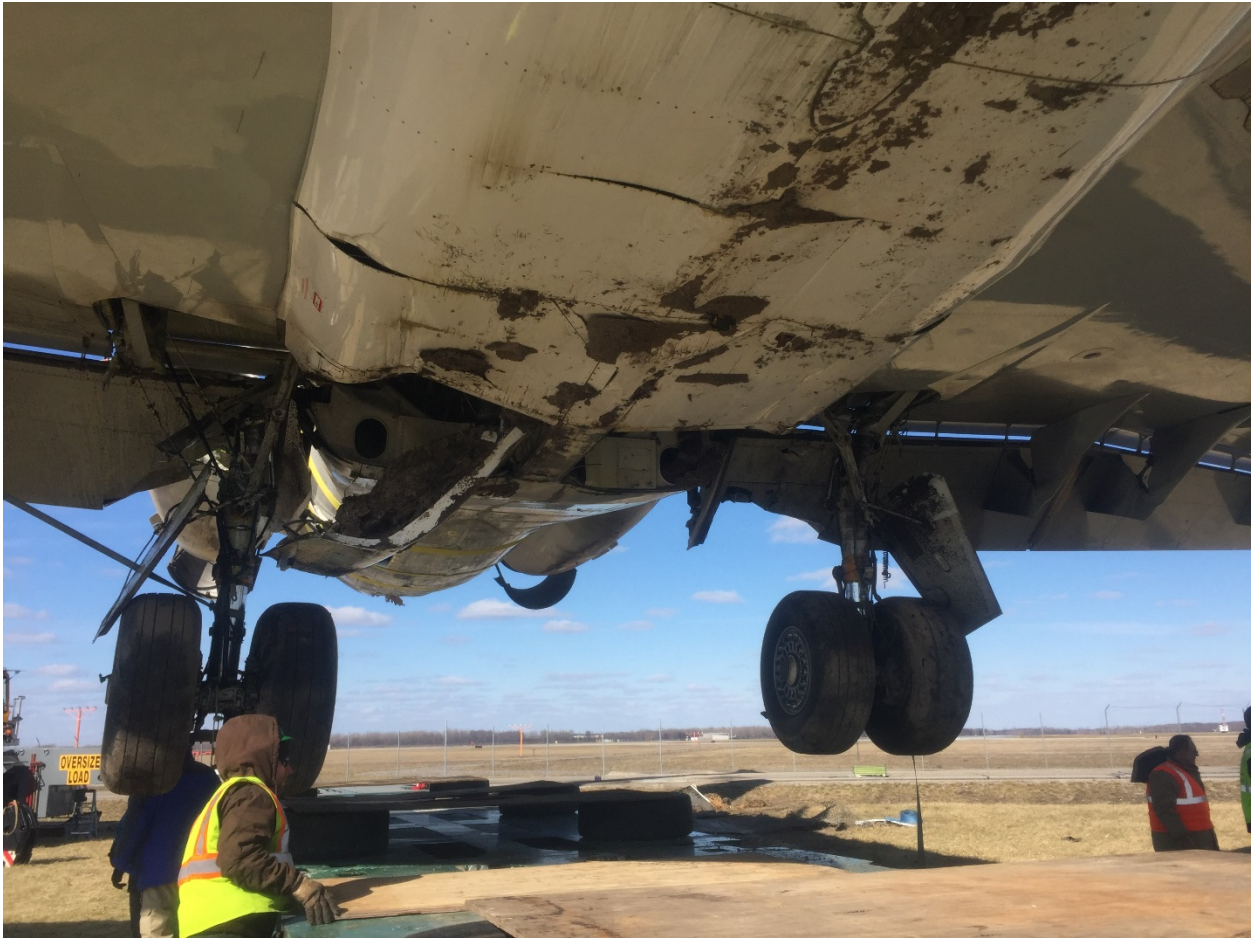
Figure 12 – Lower fuselage damage

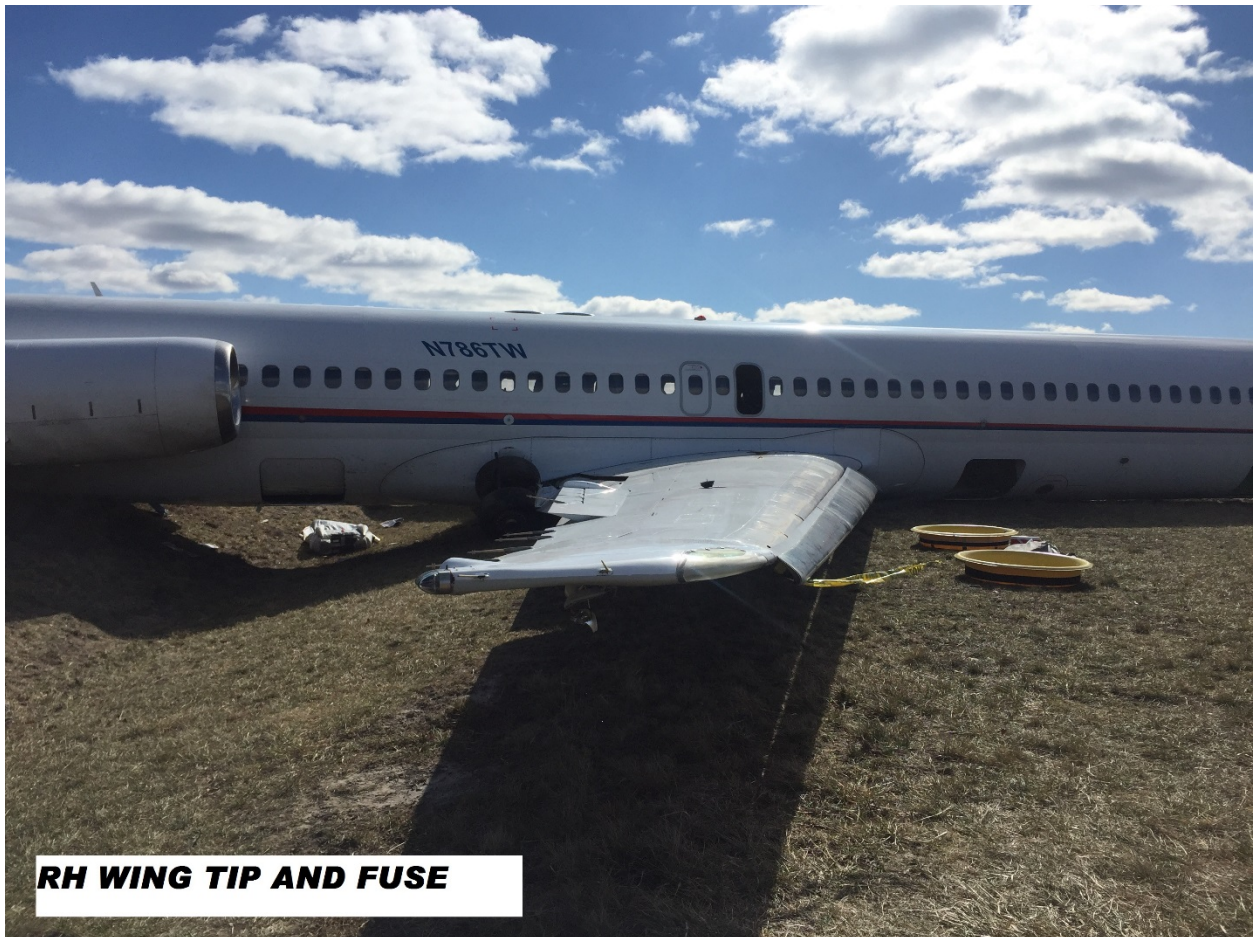
The leading edge (LE) apex of the slats exhibited impact damage along the span of the wing, the impact (dented) areas run along the entire length of the wing slat apex approximately ten (10) feet apart matching the spacing of the fence posts.

Figure 13 – Right wing leading edge

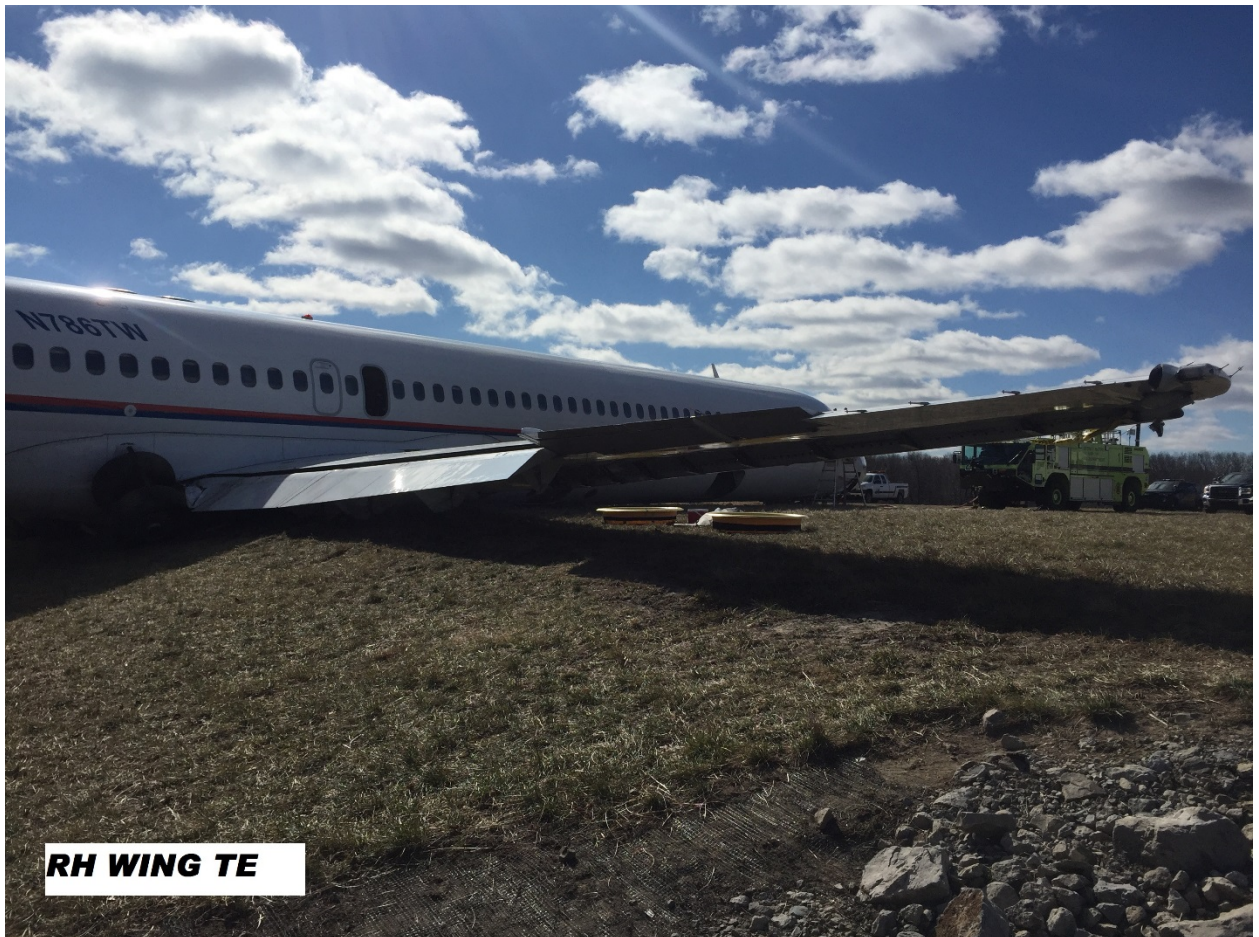
All of the aerodynamic control and high lift surfaces were remained attached to the wing. The inboard section of the flap was damaged by impact with the MLG wheel and tire assembly after it rotated aft during the accident sequence. The MLG separated at the strut, and rotated aft due to contact with either dirt berms located forward and aft of the access road during the rejected take-off (RTO). The aft rotation of the MLG penetrated both the inboard section of the flap surface and the aft wing-to-fuselage fillet fairing.

Figure 14 – Right wing trailing edge

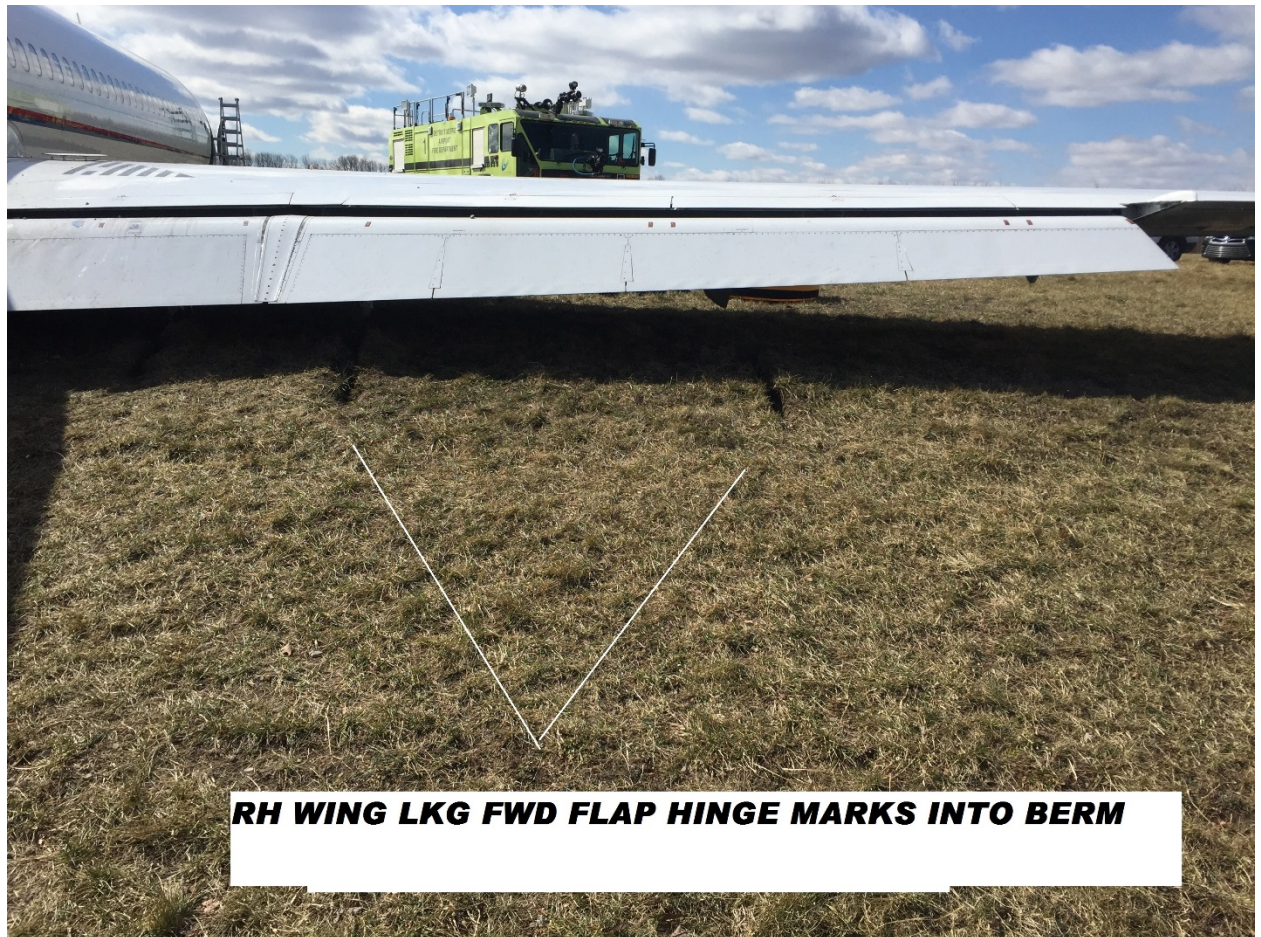
The two inboard wing flap lower hinge-fitting pivot points contacted the dirt berm as evidenced from the ground witness marks along the berm just aft of the hinge lines. The flap hinge lower fairings were damaged and crushed from impact with the ground.

**RH WING LKG FWD FLAP HINGE MARKS INTO BERM**

Figure 15 - Right wing flap track ground scars

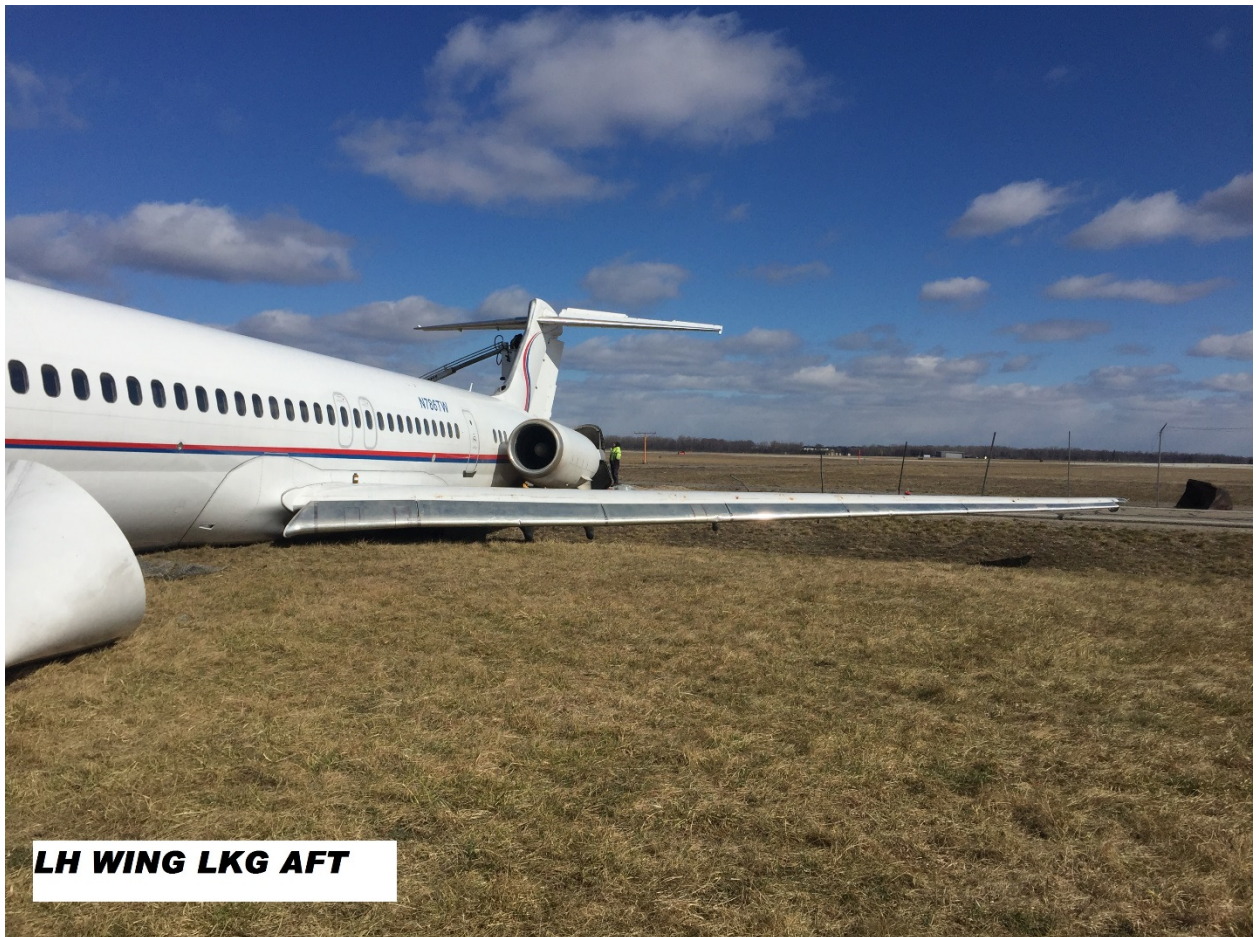
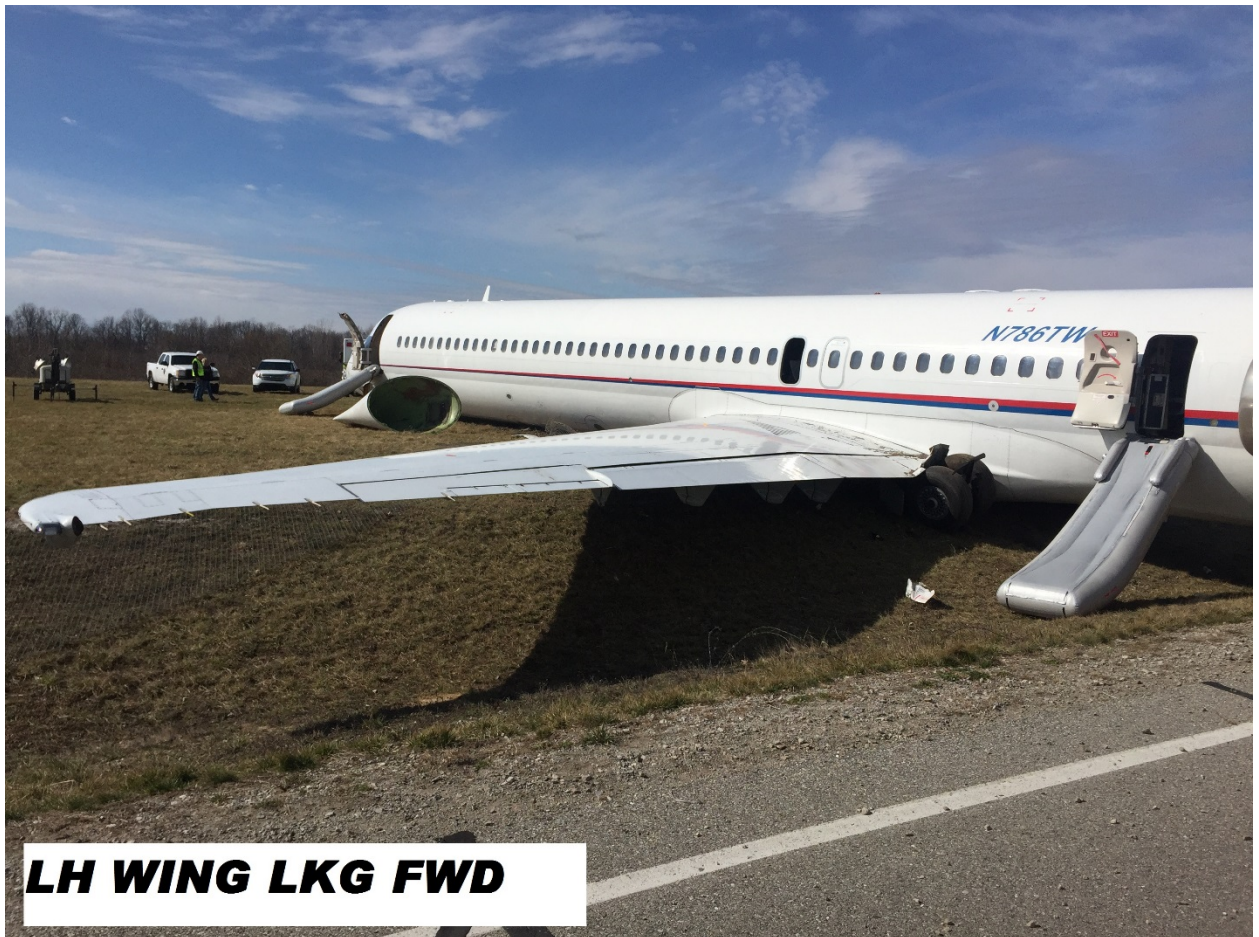
The lower wing surface and wing-to-body fairings were distorted, substantially damaged, and separated from the fuselage due to ground impact. Several areas along the wing-to-body lower fairings had damage to the internal substructure.

All of the aerodynamic control and high lift surfaces remained attached to the wing. The inboard section of the flap was damaged by impact with the MLG wheel and tire assembly after it rotated aft during the accident sequence. The MLG separated at the strut, and rotated aft due to contact with either dirt berms located forward and aft of the access road during the rejected take-off (RTO). The aft rotation of the MLG penetrated both the inboard section of the flap surface and the aft wing-to-fuselage fillet fairing. The aft rotation of the MLG does not appear to have affected the wing-to-fuselage fillet fairing, as was the case on the RH side.

The leading edge (LE) apex of the slats exhibited impact damage along the span of the wing, the impact (dented) areas run along the entire length of the wing slat apex approximately ten (10) feet apart matching the spacing of the fence posts.

Figure 16 - Left wing viewed looking aft

Figure 17 - Left wing viewed looking forward
