NATIONAL TRANSPORTATION SAFETY BOARD

**Group Chairman's Factual Report**

**STRUCTURES**

**DCA17FA076**

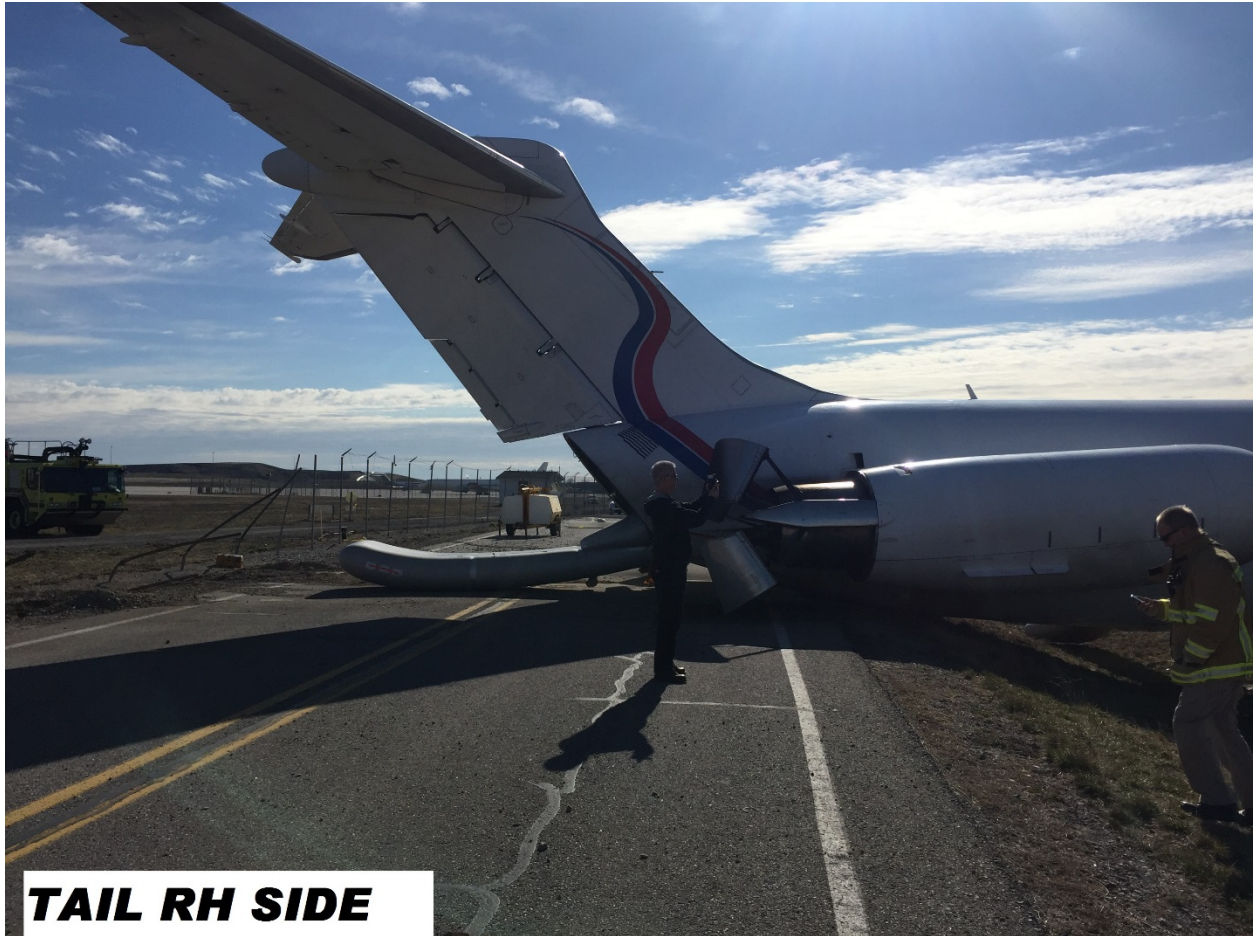
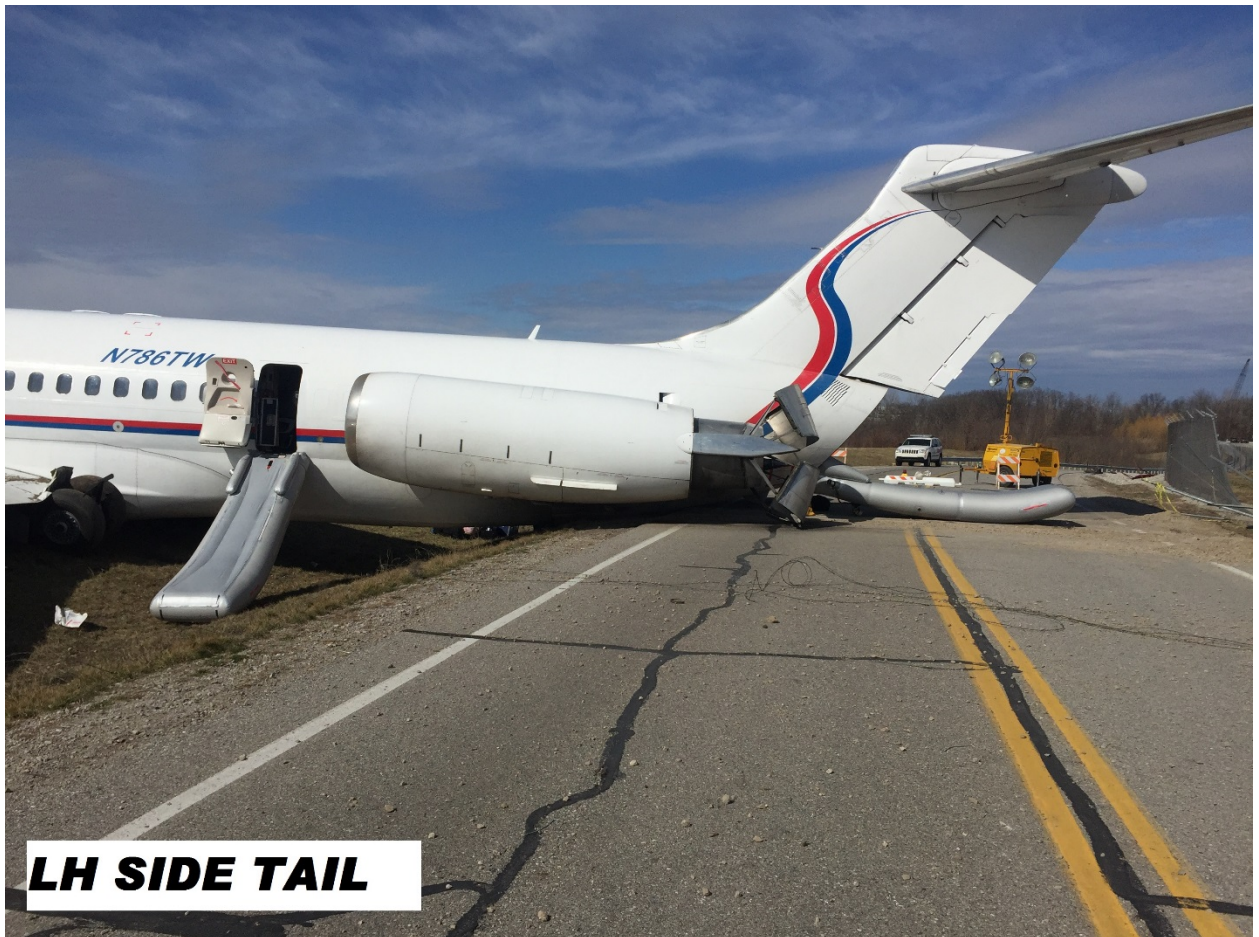
Both the vertical stabilizer and rudder exhibited no evidence of structural damage when viewed from the ground.

Both the right and left hand stabilizers and elevators exhibited no signs of structural damage when viewed from the ground.

Figure 18 - Right side view of the tail

Figure 19 - Left side view of the tail

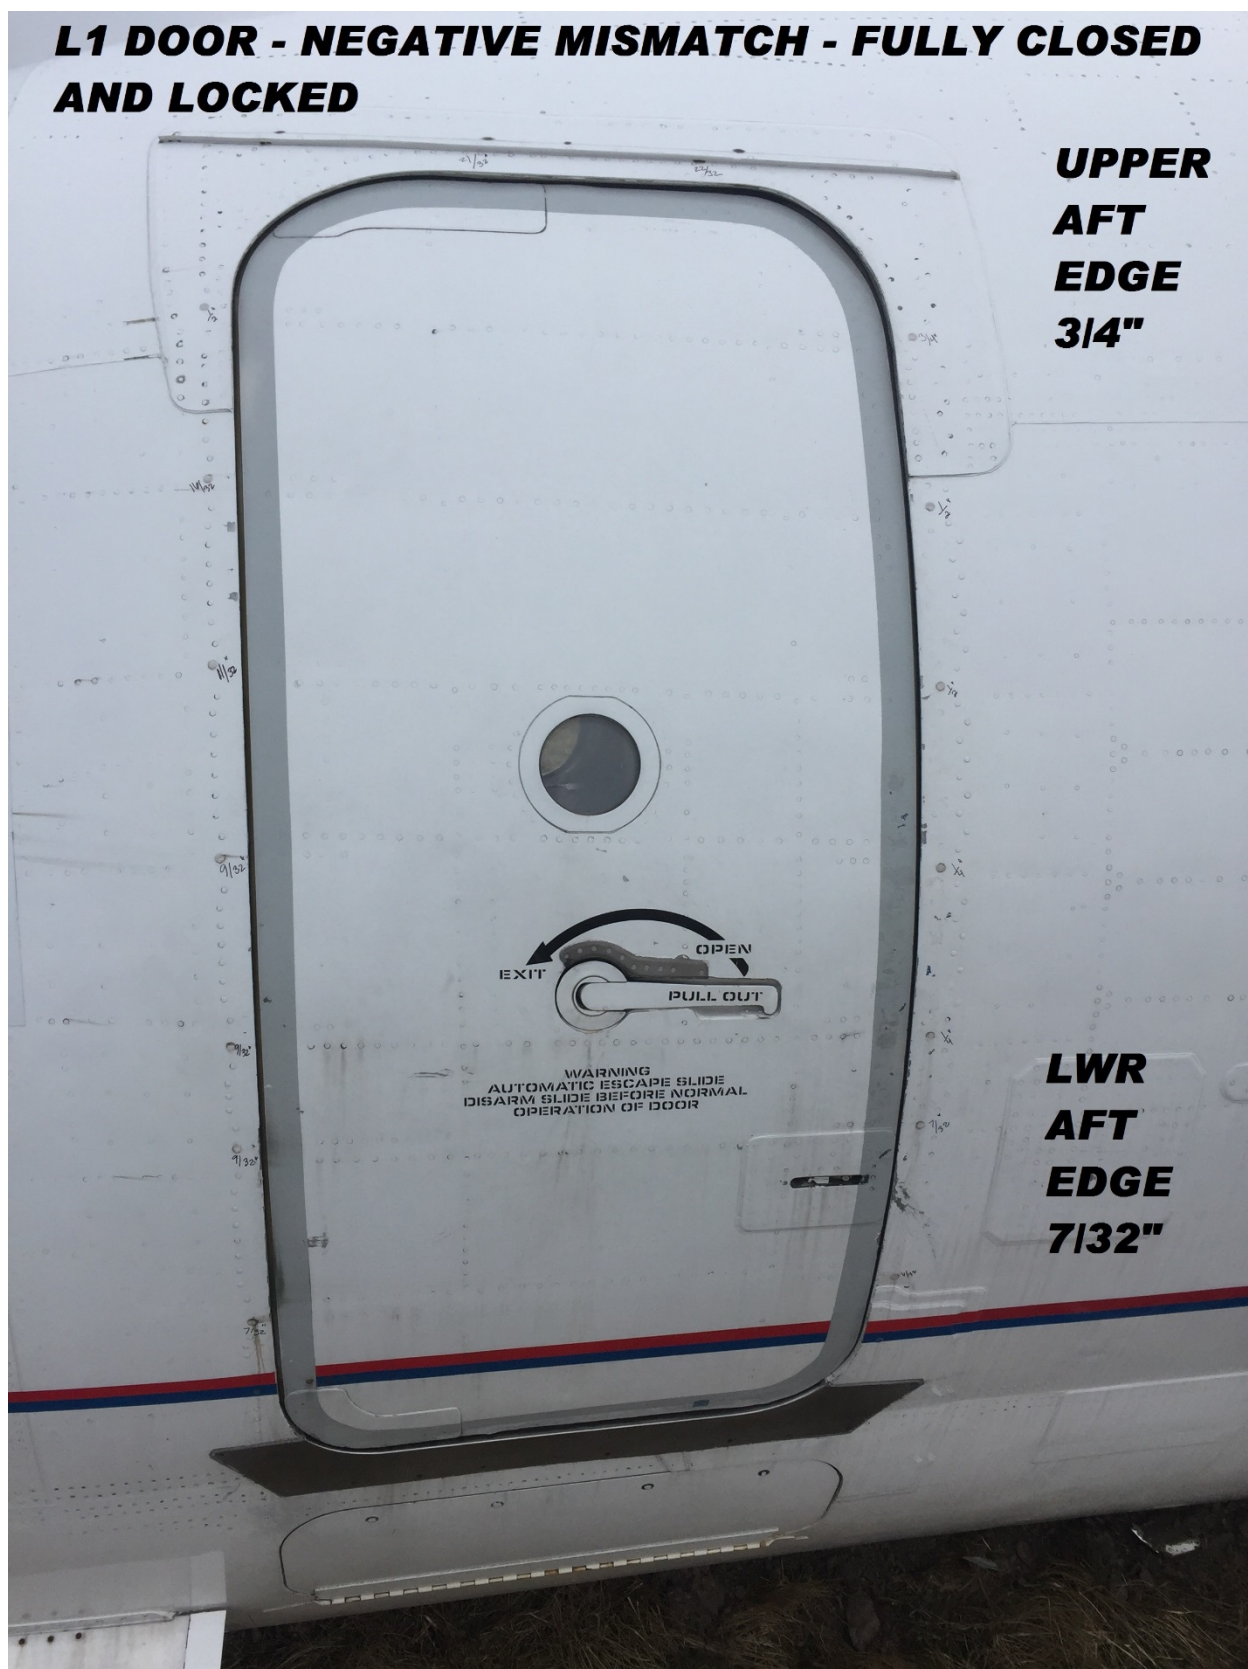
The PED 1L remained attached to the airplane. The door when returned to the closed and locked position exhibited evidence of excessive fuselage distortion between door skin and fuselage skin. Measurements at the doorstop locations along the forward and aft edges of the doorjamb verified the fuselage distortion. The largest inward door mismatch between the door and fuselage measured  $\frac{3}{4}$  of an inch at the upper aft stop location, and  $\frac{1}{2}$  of an inch at the upper forward stop location.

Figure 20 – Main entry door (L1)

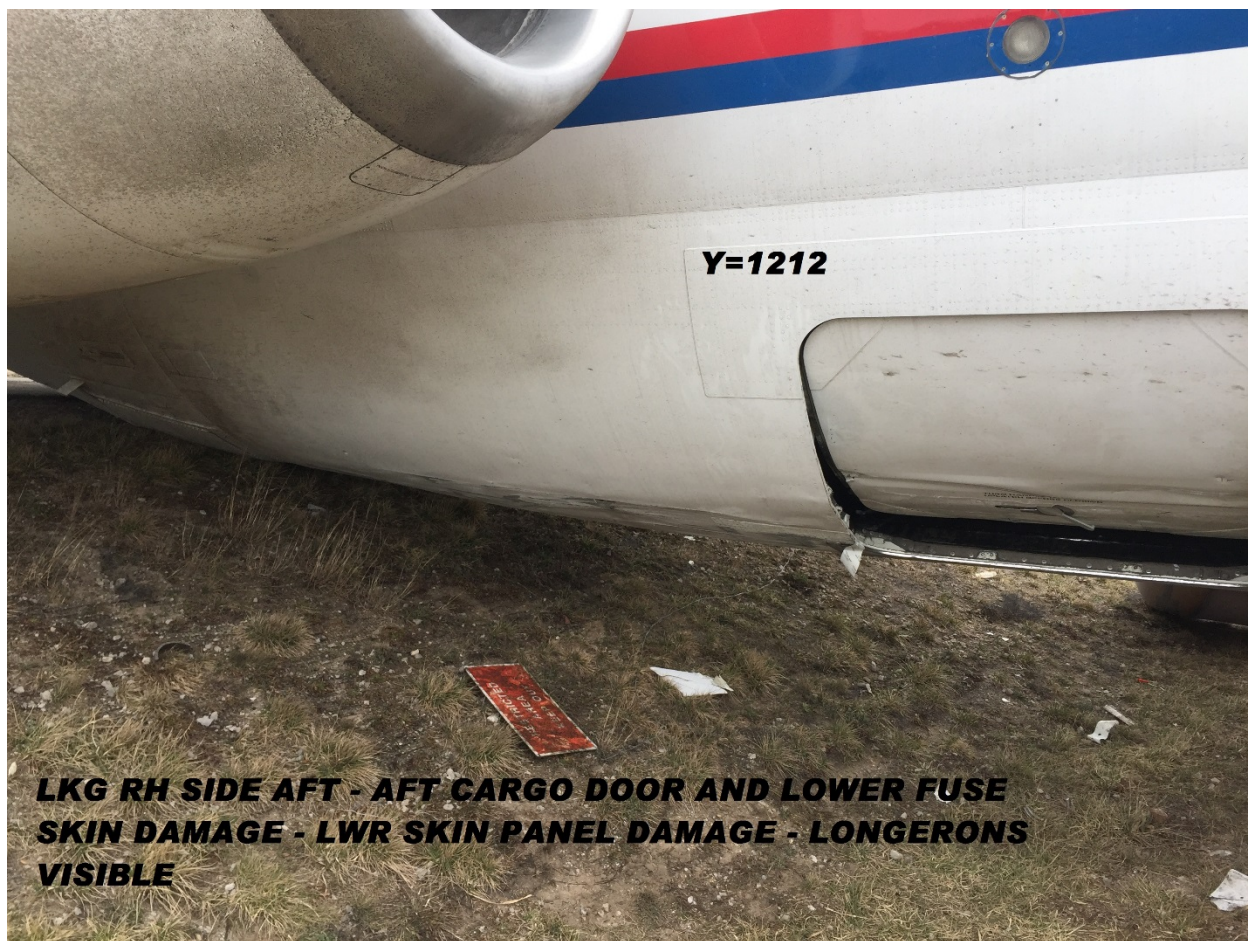
The LACD remained attached to the fuselage at the upper hinge and exhibited substantial damage along the doorjamb forward and aft edges consistent with ground impact. The door was jammed in an ajar position. Access to the cargo compartment required the use of hydraulic scissor jaws to pry open the cargo door.

Figure 21 – Aft cargo door

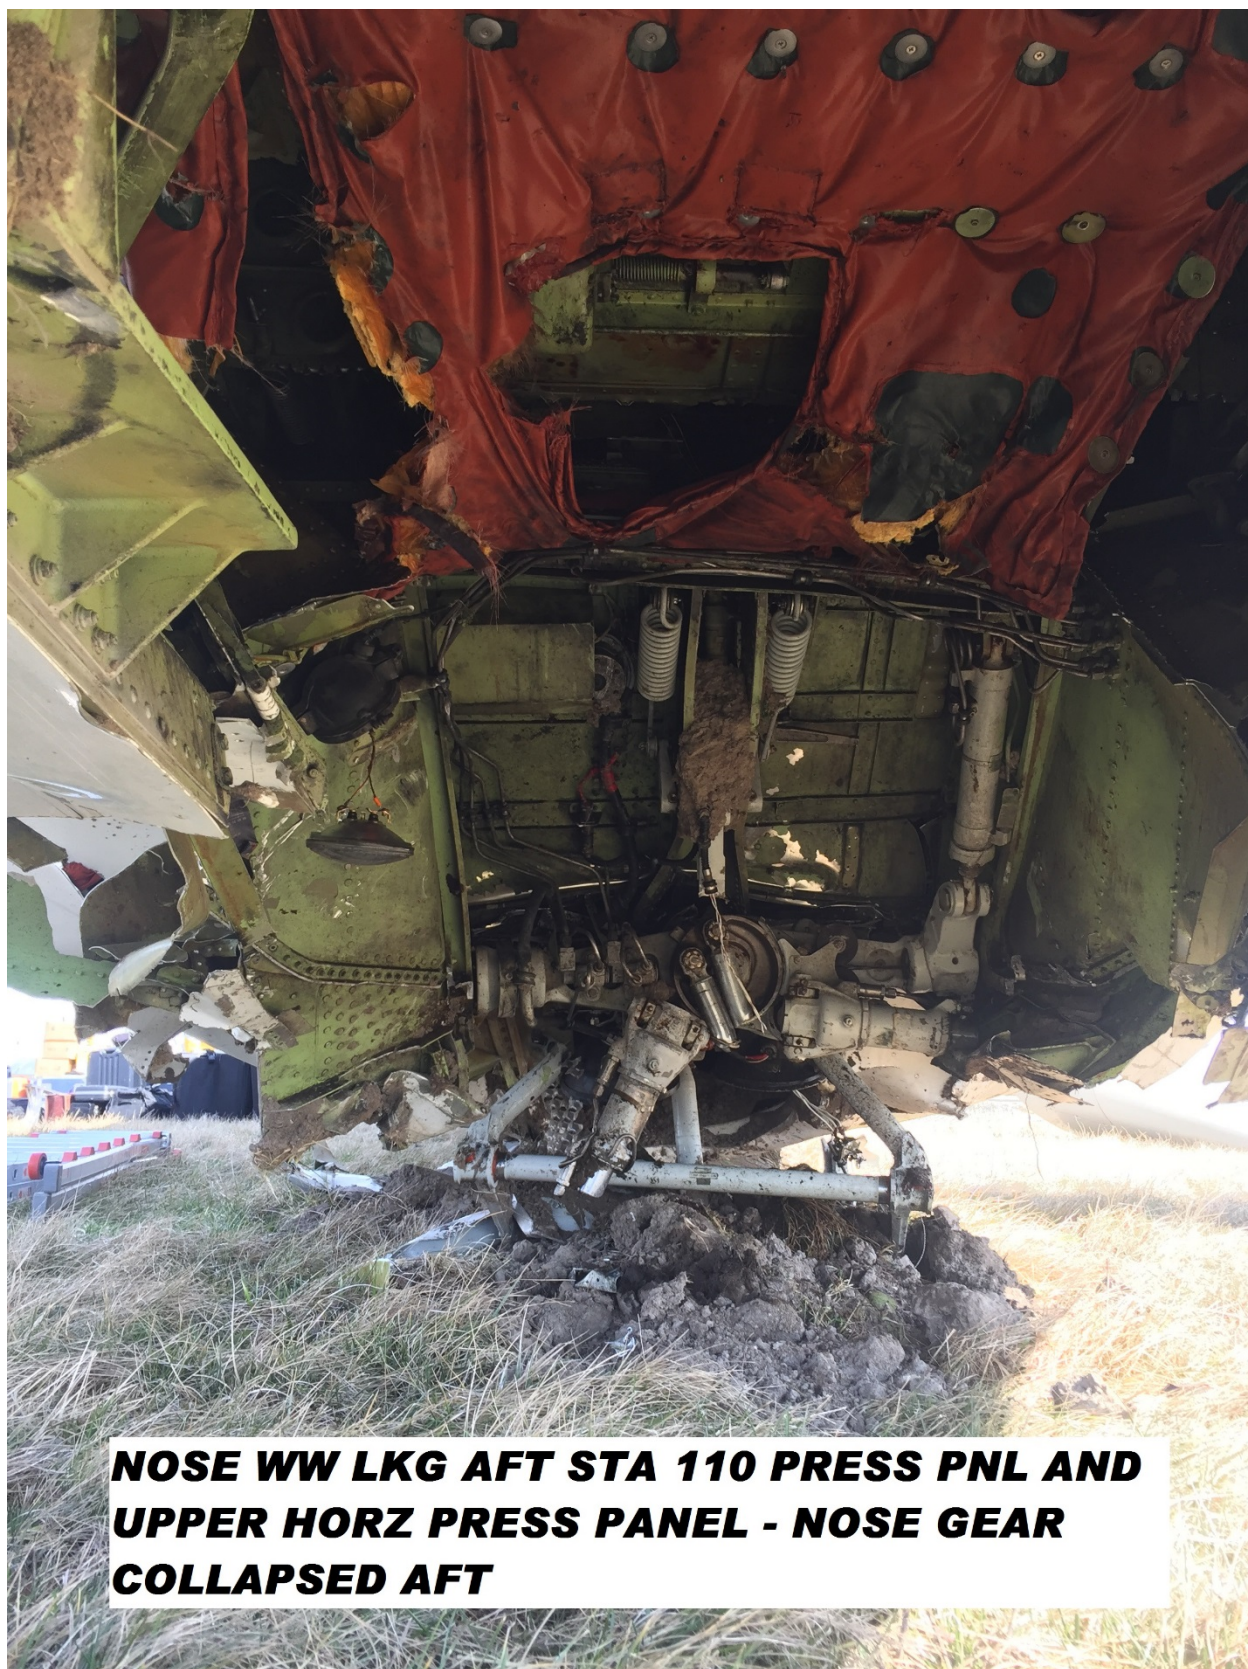
The nose landing gear (NLG) fractured during the impact sequence and rotated aft into the STA 110 bulkhead (BHD) and the forward electrical and equipment (E&E) compartment. The nose wheel well (NWW) LH and RH NLG trunnion support fittings and tunnel areas were fractured and bent during the impact sequence. The NLG WW upper pressure panel was creased and buckled due to impact forces. Components of the NLG, including the nose steering actuators and retract actuator trunnion attach fittings were severed and sheared due to impact forces.

The STA 110 BHD was deflected aft into the forward avionics bay from contact with the NLG. The upper horizontal pressure panel in the nose landing gear wheel well area sustained structural damage from the impact forces.

All of the examined fracture surfaces exhibited features consistent with overstress with no evidence of fatigue.

Figure 22 – Nose wheel well damage

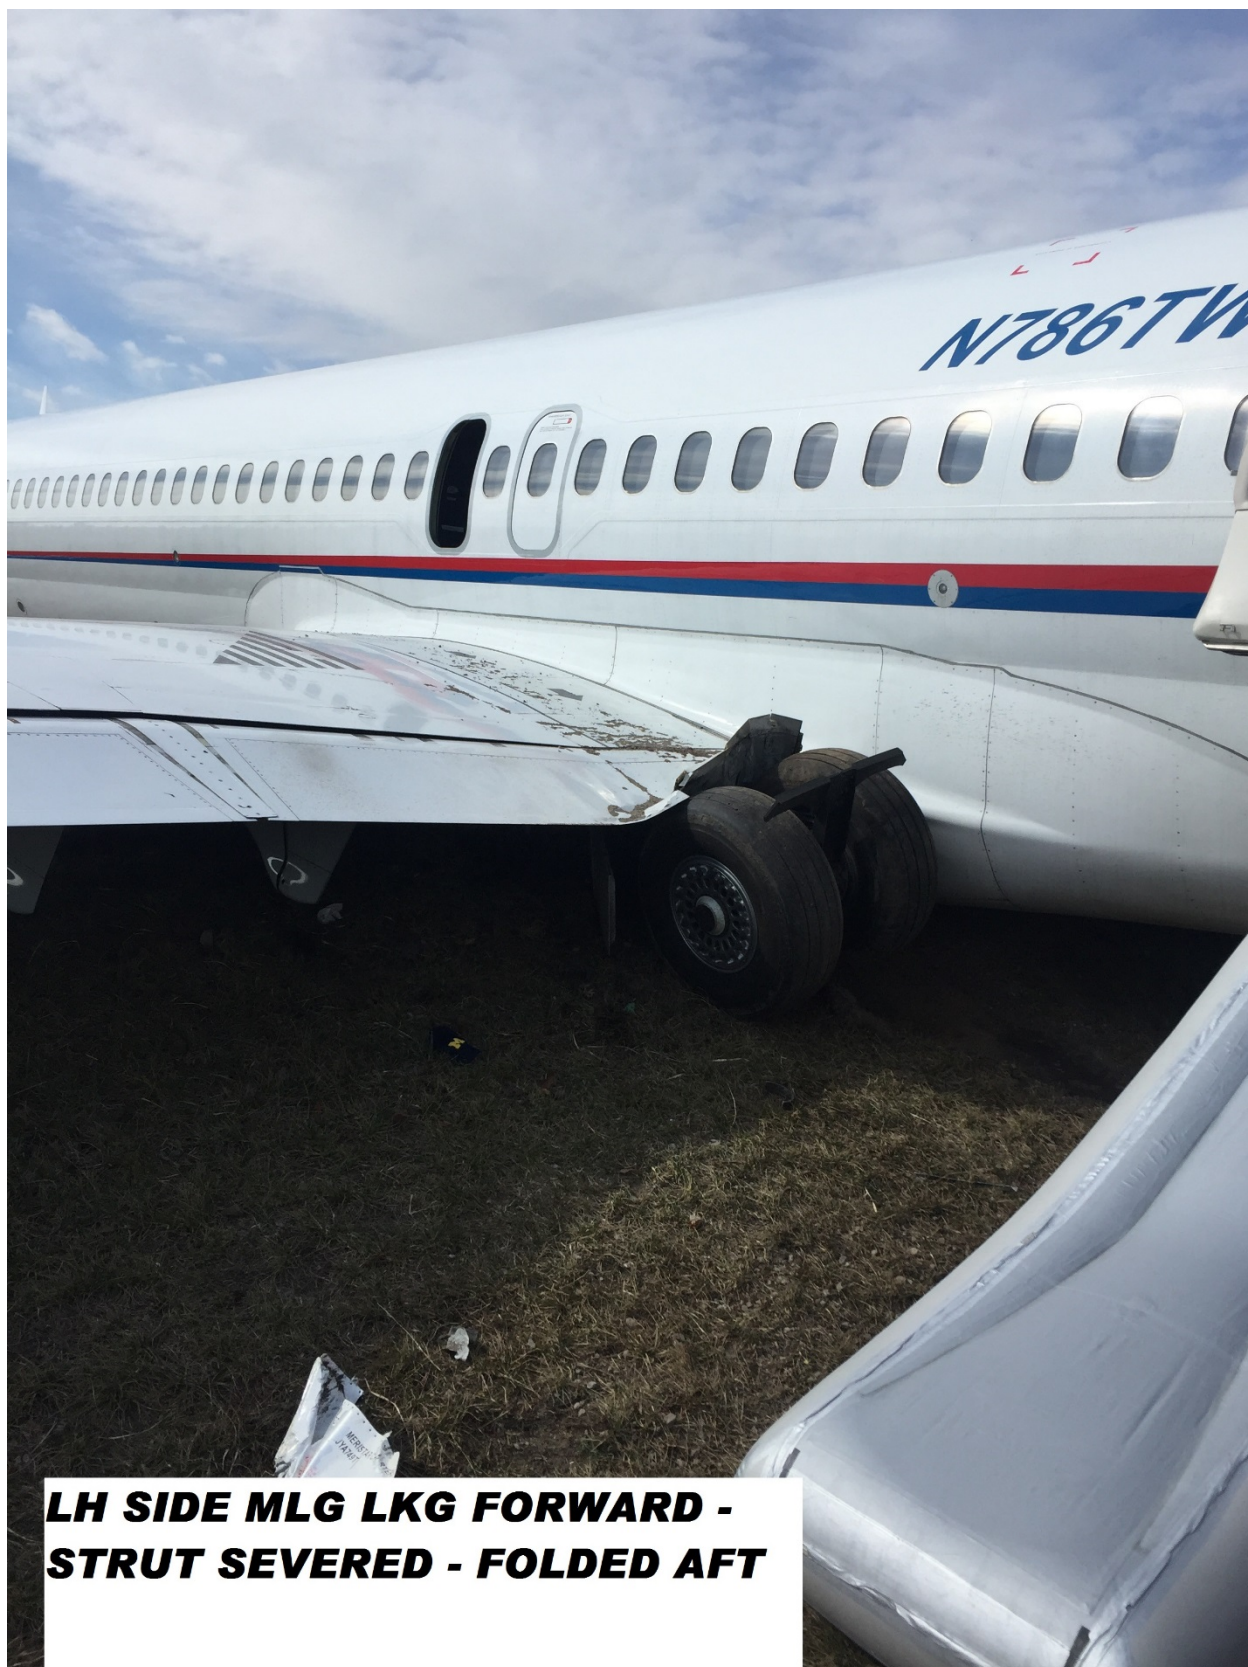
Both of the main landing gear (MLG) rotated aft during the impact sequence contacting and penetrating the inboard flap surface. The lower wing area below, adjacent, and surrounding the MLG exhibited evidence of fluid splash from the gear strut breakage. The MLG strut sheared at the outer strut cylinder and separated in two pieces.

All of the examined fracture surfaces exhibited features consistent with overstress with no evidence of fatigue.

Figure 23 – Left hand main gear damage

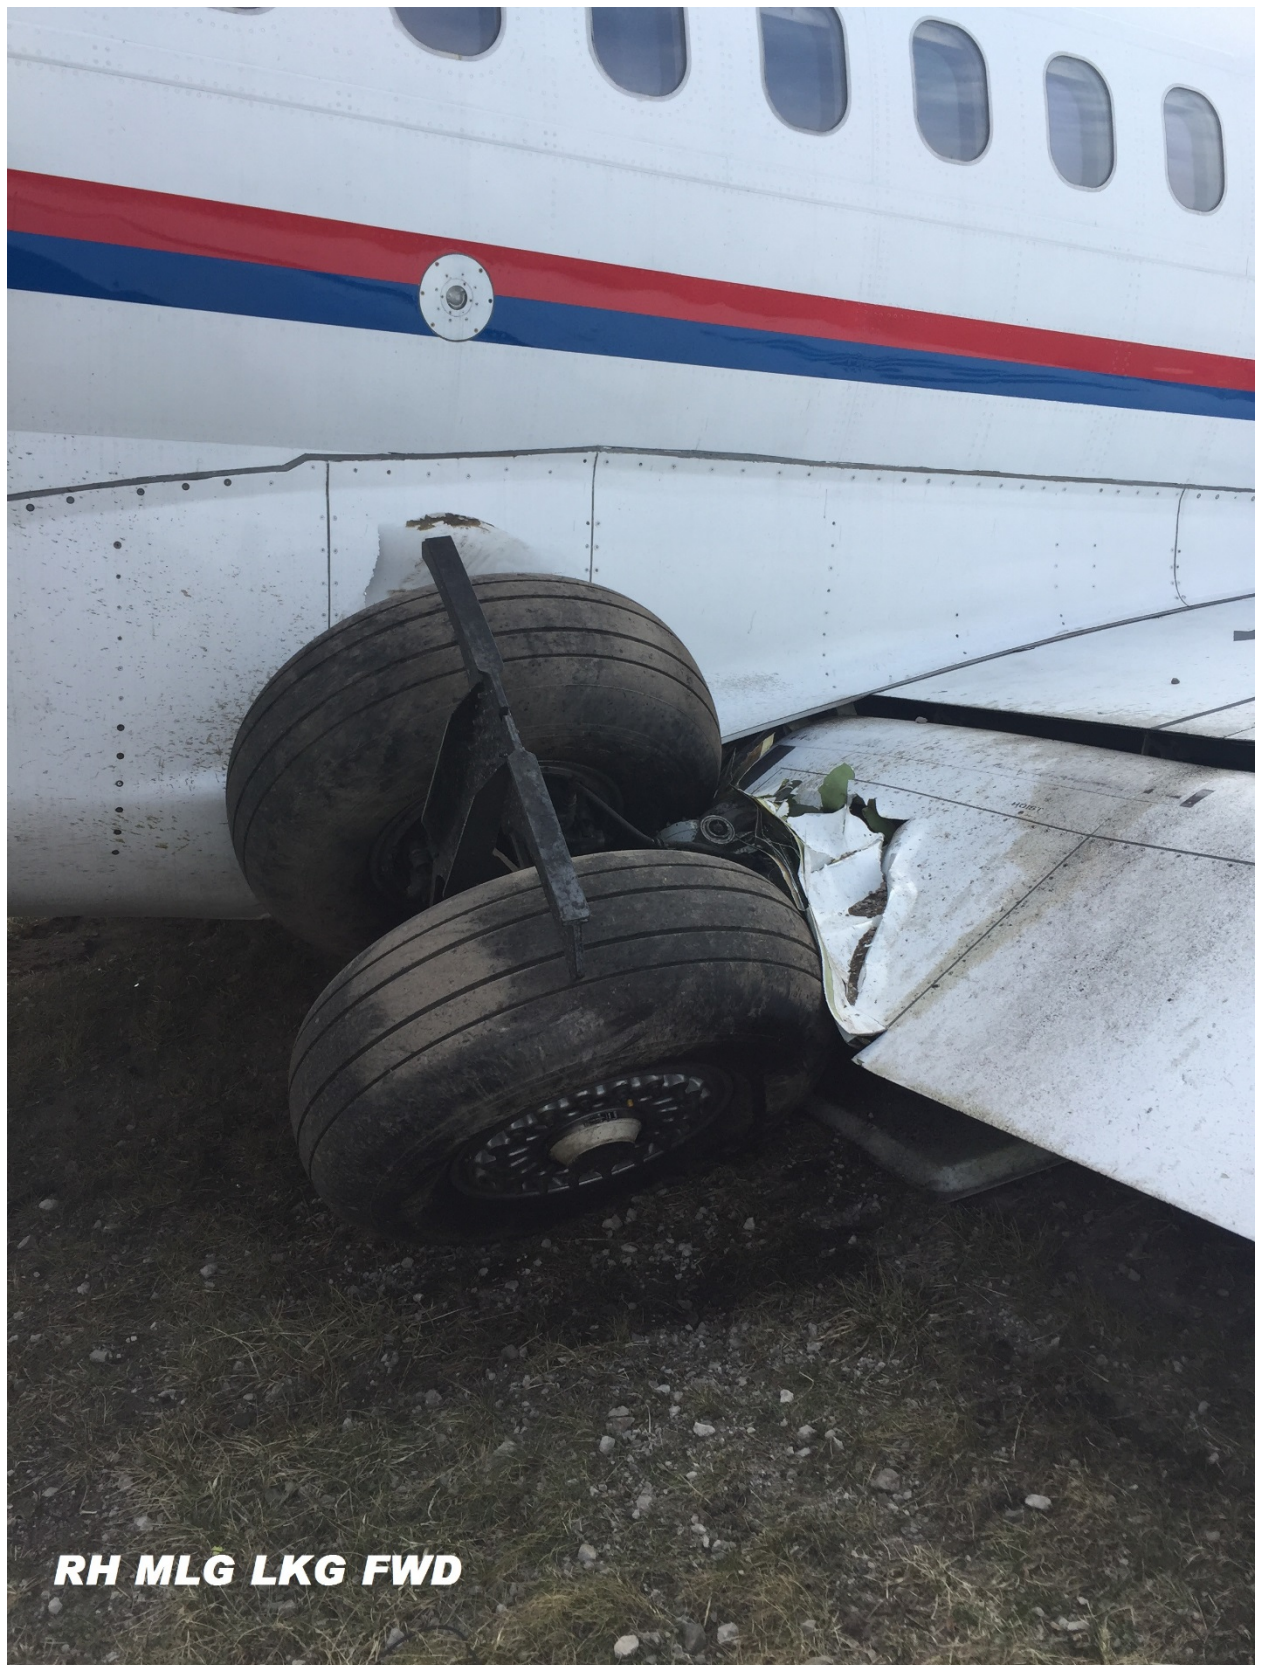
Figure 24 – Right hand main gear damage

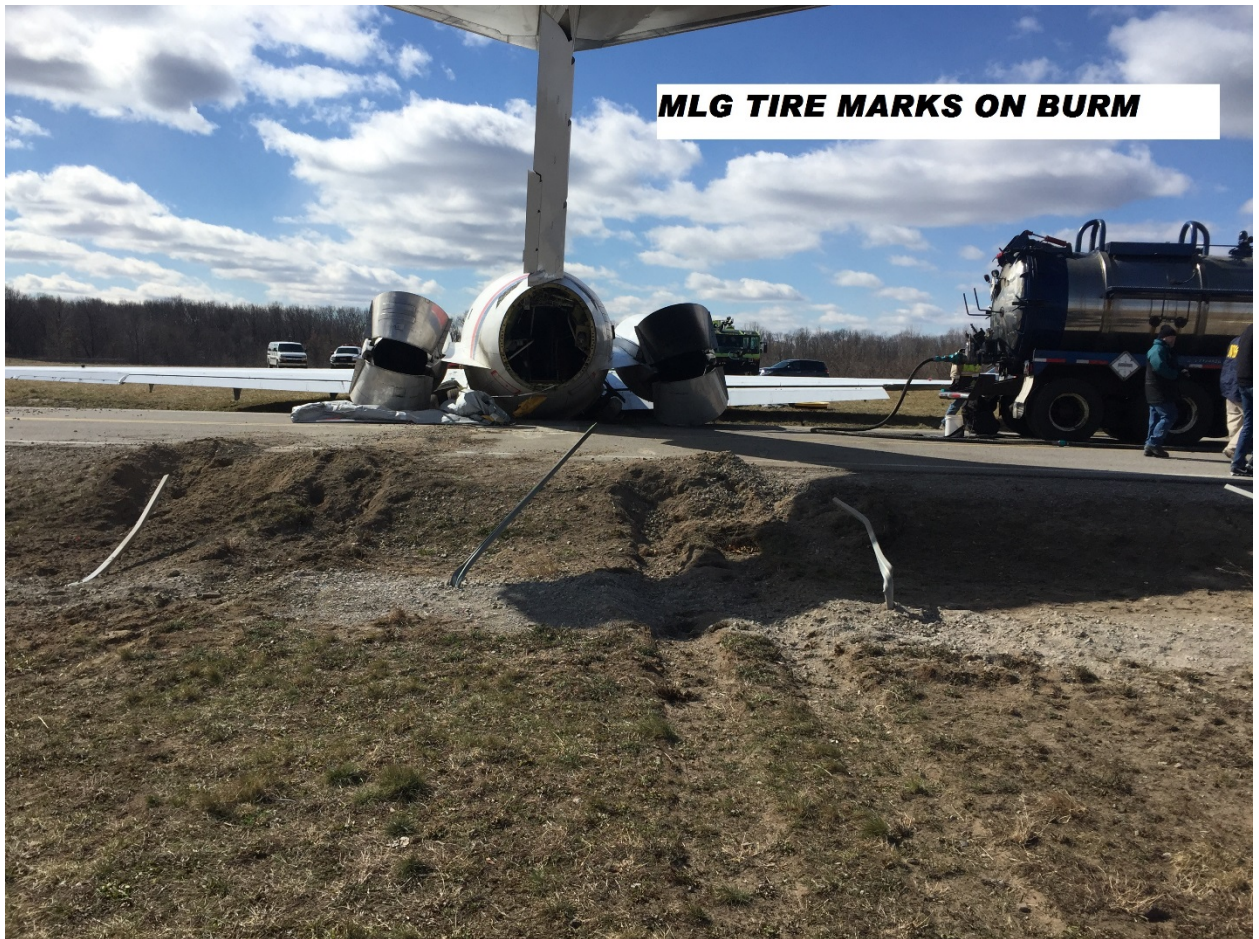
Figure 25 – Main gear marks at impact area
