Subject: Boeing Submission for Ameristar MD-83 N786TW Runway Overrun  
Following a Rejected Takeoff at Ypsilanti, Michigan – 8 March 2017

**Ameristar Air Cargo MD-83 N786TW  
Runway Overrun Following A  
Rejected Takeoff at  
Ypsilanti, MI  
8 March 2017**

**The Boeing Company  
1 May 2018**

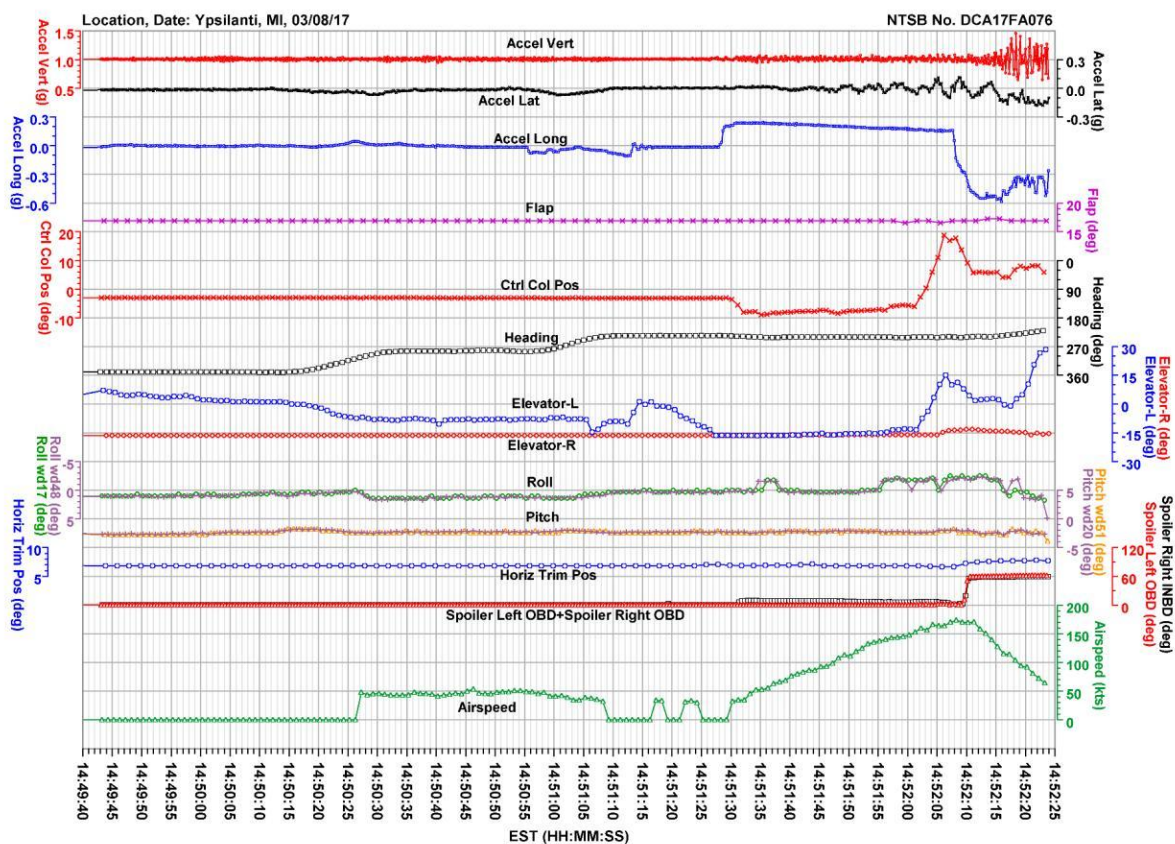
The following plot of some FDR parameters shows the left elevator was moving as the airplane was taxiing and during the takeoff roll. Additionally, the left elevator appears to have responded normally to the control column input that was initiated during the takeoff roll at approximately 14:52:01 EST. The right elevator did not appear to move from the elevator's trailing edge down limit of approximately 16.5 degrees, as the airplane was taxiing and during the initial takeoff roll. At approximately 14:52:01 EST, the right elevator only moved approximately 3 degrees trailing edge up, in response to the control column input.

The flight data recorder captured several prior flights and activities between flights. For the prior flight, both elevators were moving as expected.<sup>7</sup>

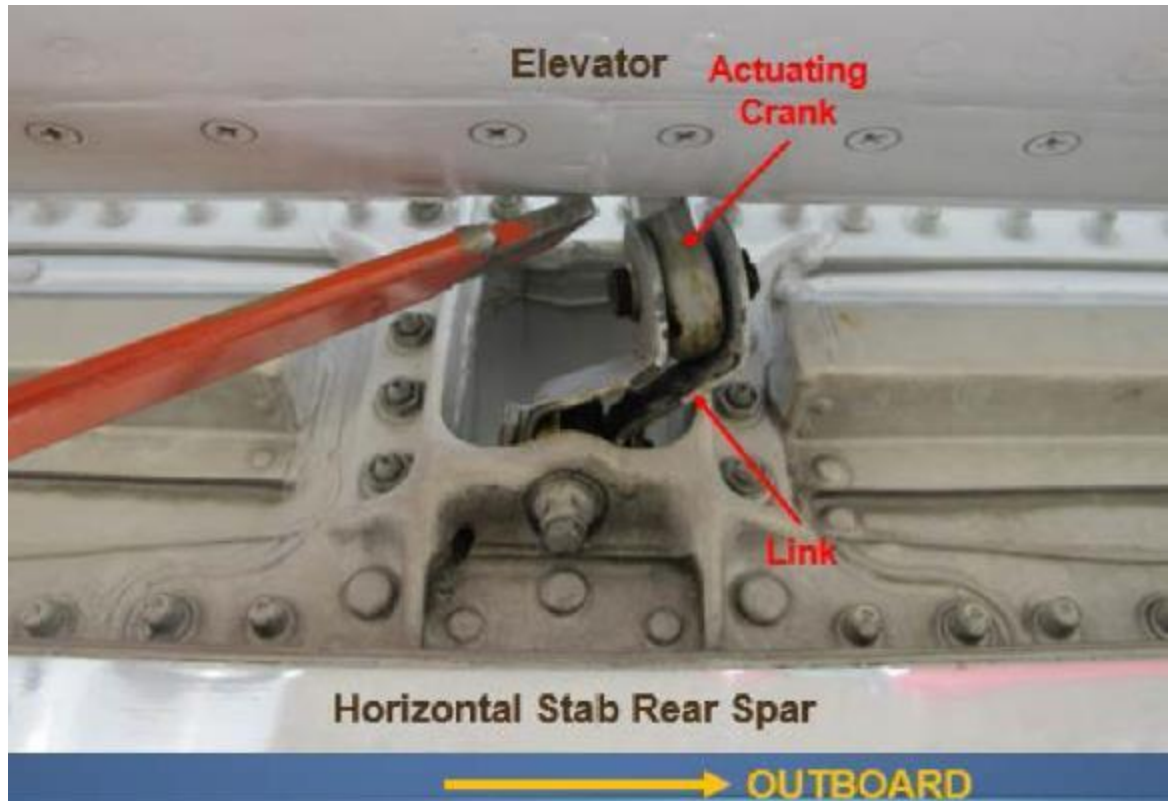
A visual examination of the tab hinges and control linkages found that the inboard right geared tab links and actuating crank were damaged and in an over-centered position. The two links and the actuating crank arm were bent in an outboard direction.<sup>17</sup>

The damaged links and associated attachment hardware were removed. After the links were removed, the right elevator was free to move, by hand, within the confines of the elevator stops.<sup>18</sup>

**Inboard right hand geared tab attachment at horizontal stab rear spar as found (orange bar used by group to point to damaged links)**

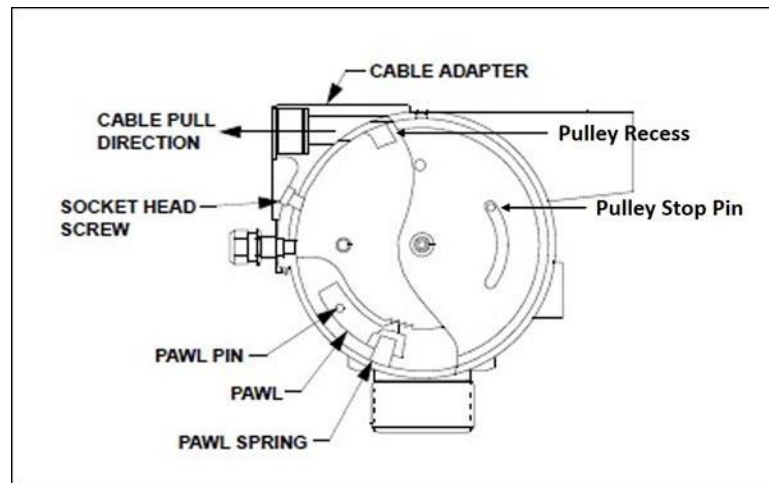
**Inflation valve**

The evacuation slide was evaluated at the manufacturer's facility and it was noted the slide had partially deployed during the evacuation with no evidence of gas flow from the RVA into the slide. The RVA was inspected and found with a fully charged reservoir with the valve pulley in the closed position. The manual inflation release cable (pulled by the flight attendant during the evacuation) was located inside the shipping box. The cover plate on the valve's internal mechanism was removed to reveal the pulley, pulley recess, lock pin and pawl.<sup>20</sup> The valve was re-assembled, and the valve release cable was installed by rotating the pulley to the 'valve open' position, inserting the cable ball end of the cable into the pulley recess, and then rotating the pulley back to the 'valve closed' position.<sup>21</sup> A 'floor run' inflation of the slide assembly was performed by withdrawing the valve release cable from the RVA. The slide successfully inflated.<sup>22</sup>

The RVA was removed from the slide. The inflation valve was disassembled to simulate the potential for incorrectly installing the valve release cable assembly. The investigation revealed that the cable ball could be retained inside the housing without actually engaging the pulley recess.<sup>23</sup> If the cable ball is not engaged in the pulley recess, it is possible the valve will not open to inflate the evacuation slide when the manual release cable is pulled. The evacuation slide manufacture has made modifications to the Component Maintenance Manual valve testing procedures to ensure the cable ball is retained in the pulley recess in revision #29, dated July 14, 2017.<sup>24</sup>

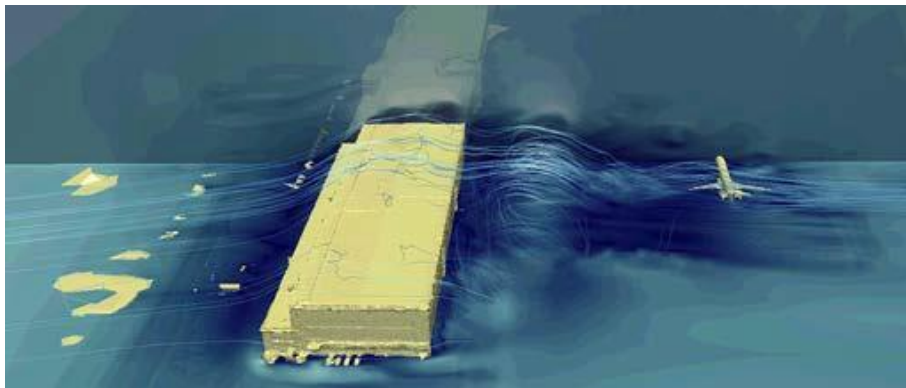
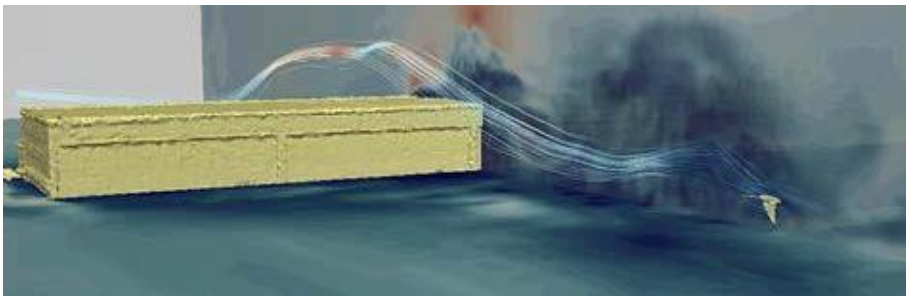
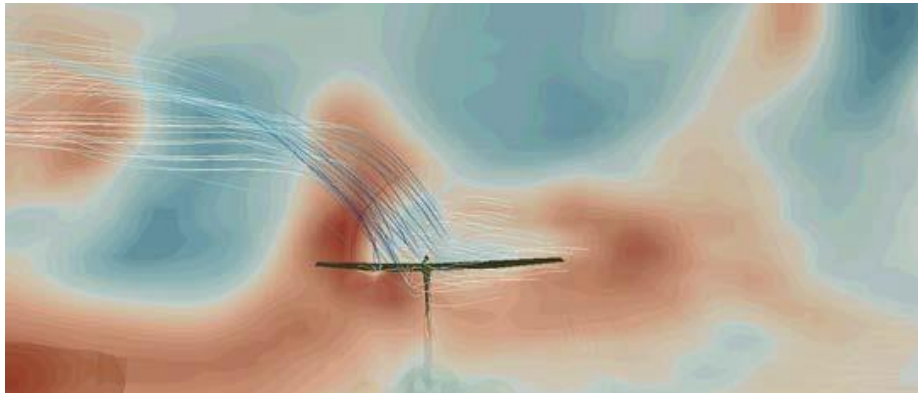
The following figures from the simulation show that over time, the structure affected the predominantly horizontal wind flow and caused varying magnitudes of turbulence with dynamic vertical (both up and down) wind components to impact the airplane's tail.

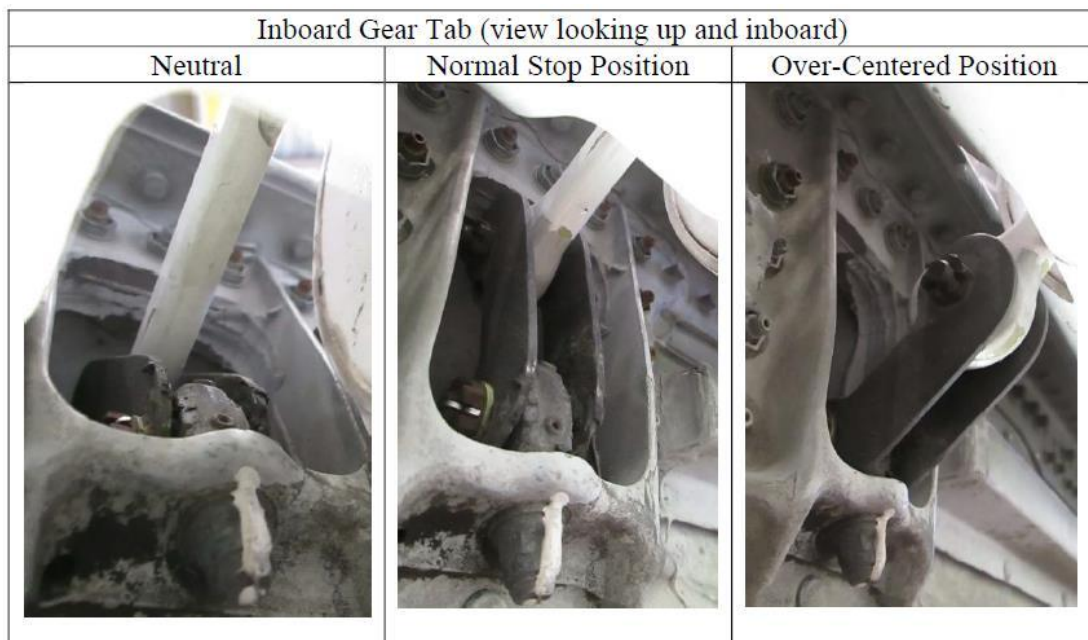
It was noted during testing that when weights representing gusts of 60 knots and greater were dynamically applied to the elevator, the torsion bar would continue to rotate after the elevator stop arm contacted the elevator stop, and the geared tab's inboard links and actuating crank would travel to an over-center condition. To simulate the dynamic wind conditions, the elevator was positioned full trailing edge up before a simulated downward wind load was applied.

**Inboard geared tab link and actuating crank position compared to elevator position**

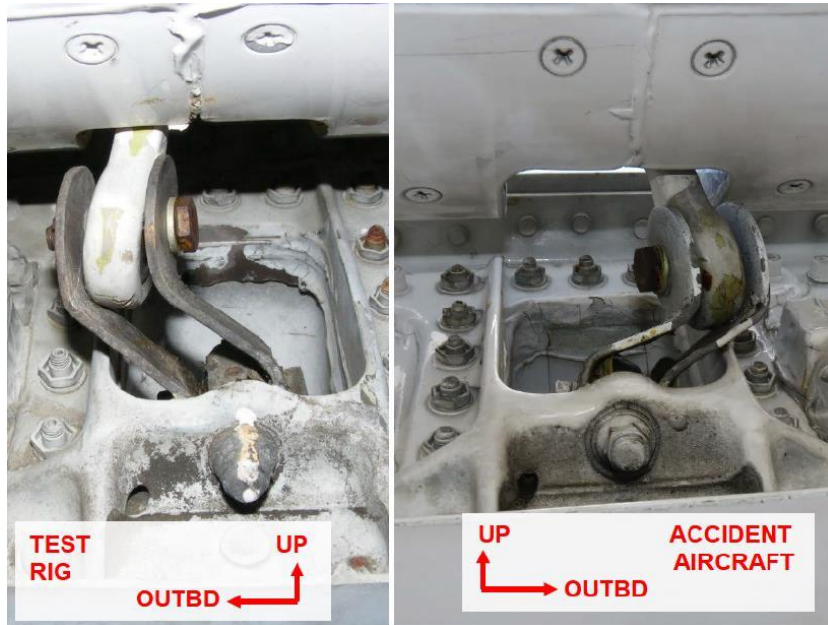
It was also found that if the links and actuating crank were in an over-center condition and an upward force was applied to the elevator, such as that caused by the force of the control tab on the elevator when the column is pulled for takeoff rotation, the links and crank would bend in a similar fashion to the links and crank found during the post-accident inspection of the accident airplane.

**Side by Side comparison of test results with accident aircraft damage after upward force application**
