**NATIONAL TRANSPORTATION SAFETY BOARD  
OFFICE OF AVIATION SAFETY  
WASHINGTON, D.C. 20594**

**POWERPLANT GROUP CHAIRMAN'S FACTUAL REPORT  
NTSB ID: DCA17LA182**

Location: Denver, Colorado  
Date: July 2, 2017  
Time: 1319 local  
Aircraft: CL-0600-2C10 (Regional Jet Series 701), N796SK, S/N 10300

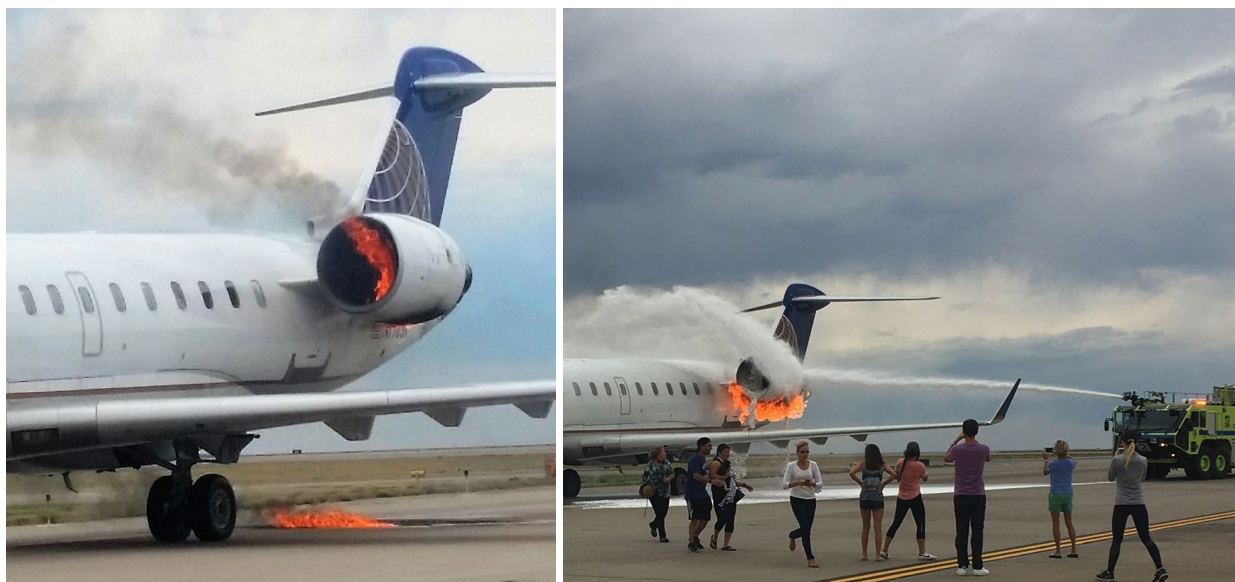
On July 2, 2017 at 1319 (local) SkyWest Airlines CL-0600-2C10 (Canadair Regional Jet (CRJ) 700), N79SK, powered by two GE CF34-8C5B1 (8C) turbofan engines, experienced a left engine undercowl fire following landing at Denver International Airport, Denver, Colorado (DEN). The airplane was operating as a Title 14 Code of Federal Regulations Part 121 scheduled flight from Aspen/Pitkin County Airport (ASE) to DEN. The flight had landed and the thrust reversers were stowing as the airplane exited Runway 34R when the flight crew observed a L ENG SRG OPEN Caution. The crew reduced engine power to idle and continued to taxi. A L ENG FIRE warning appeared 75 seconds later. Discharge of both left nacelle fire extinguishing bottles did not extinguish the fire. The odor but not the presence of smoke in the cabin was reported. The flight crew stopped the aircraft and shut down the engine. Fire was observed inside the left inlet cowl, at the left pylon, and at a pool of fuel on the ground beneath the airplane. The passengers were evacuated to the taxiway through the main cabin door. There were no injuries. See Figure 1.

Figure 1. Left engine undercowl fire during passenger egress, two views

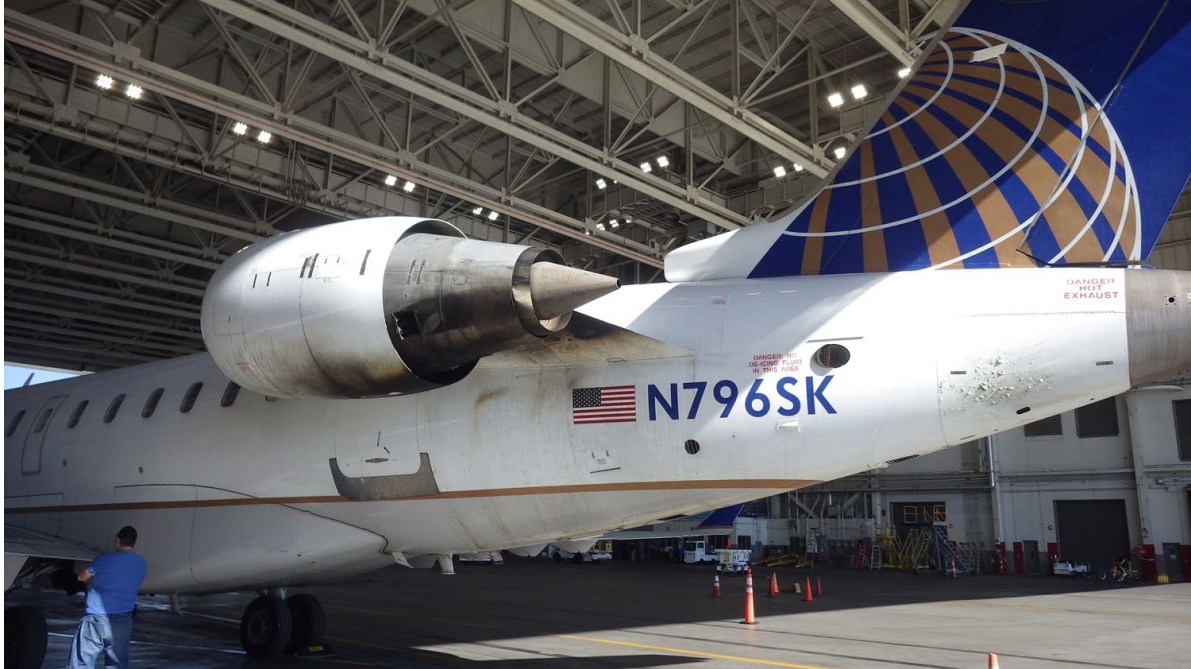
The left engine nacelle, left engine pylon, local areas of the fuselage and the APU access door were fire damaged. The underside of the left pylon was heat discolored and the paint was blistered and peeling. The pylon surface was severely damaged along the trailing edge and at the outboard edge near the fan discharge. See Figures 8 and 12.

Later maintenance inspection of the pylon determined that the fire caused structural damage to the pylon, requiring major repair or replacement (substantial damage). This resulted in the event being re-classified as an accident.

Figure 8. Thermal damage to left side of the airplane

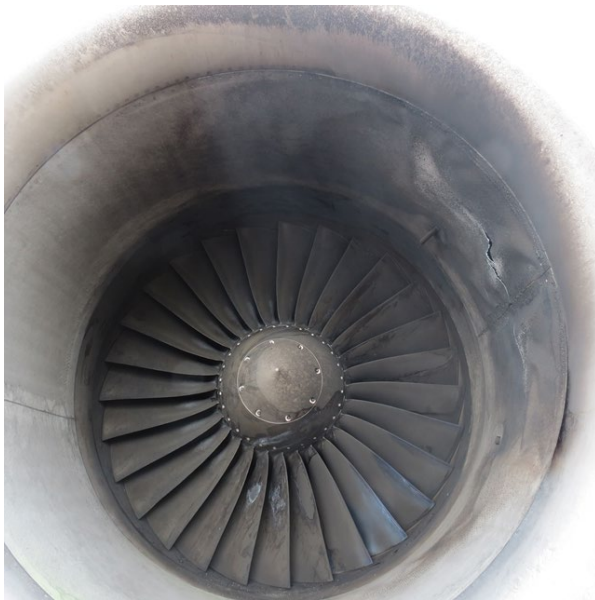
The inlet cowl outer barrel leading edge was heat distressed. The inner barrel surface was heat-deformed between 6 and 1 o'clock. The acoustic liners in this area were buckled between 7 and 11 o'clock and there was a 7-inch crack at 9 o'clock. See Figure 9. The back of the FADEC compartment, which is axially in line with the inner barrel fire damage, was discolored and buckled. See Figure 10.

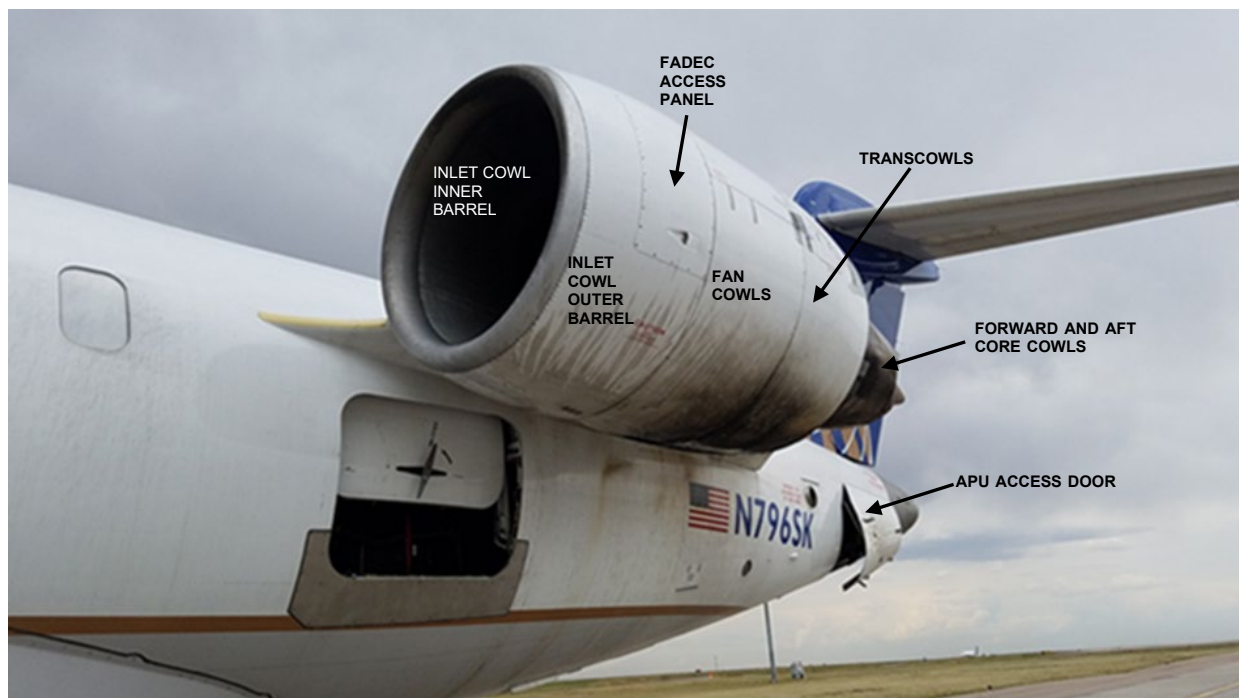
No damage was noted to the upper fan cowl and the upper translating cowl doors (transcowls). The lower fan cowl outer surface was streaked with fire extinguishing residue and soot. See Figure 11.

Figure 11. Left nacelle showing thermal damage

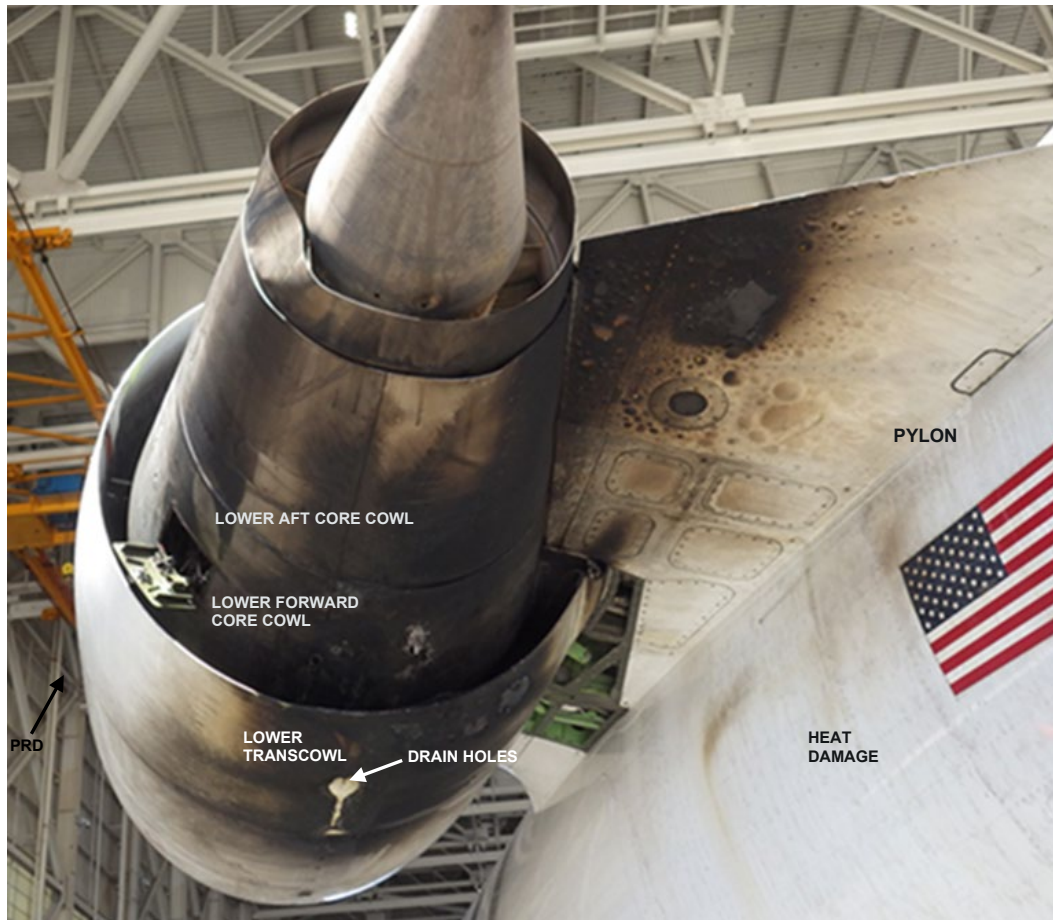
The lower transcowl surface was coated with soot between 3 and 9 o'clock except for a small area at 6 o'clock near cowl drain holes. See Figure 12. The reverser was manually deployed with the cowl open to expose the thrust reverser components for inspection. No cascade or translating cowl thermal damage was found.

The upper forward core cowl was undamaged. The lower forward core cowl outer surface was blackened with soot. The PRD was open.<sup>7</sup> The PRD was covered with soot and a soot trail extended aft. No damage was noted to the engine externals visible through the PRD opening. The aft core cowl was heavily sooted between 3 and 9 o'clock and deformed at 5 o'clock. The primary exhaust (conic) nozzle was inwardly deformed between 7 and 8 o'clock.<sup>8</sup> See Figure 12.

<sup>8</sup> It was determined that the aft core cowl and primary exhaust conic nozzle was deformed during the fire mitigation when high pressure spray struck the hot components.

Figure 12. Left nacelle and pylon damage

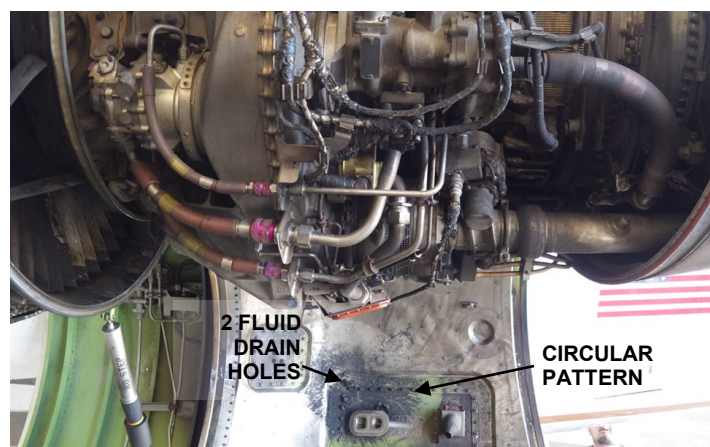
The core cowl inside surfaces were locally sooted. The lower forward core cowl inside surface exhibited carbon residue near the nacelle drain at 6 o'clock. There was a circular discoloration pattern in this area that encompassed portions of the nacelle drain and gang drain mast, and axial deformation along the 5 o'clock plane. See Figure 13.

Figure 13. Lower forward core cowl inside surface

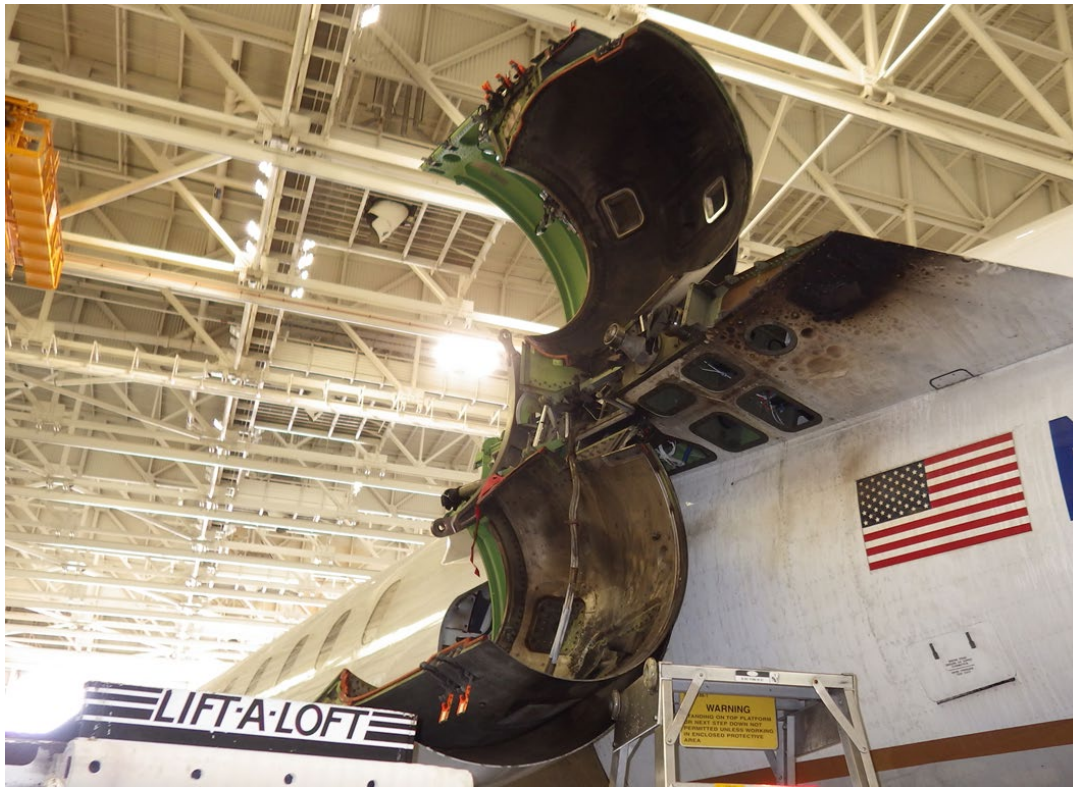
Inspection of the forward and aft engine fire zone seals found them in good condition with no evidence of functional failure. See Figure 14.

Figure 14. Open cowling doors and view of pylon damage

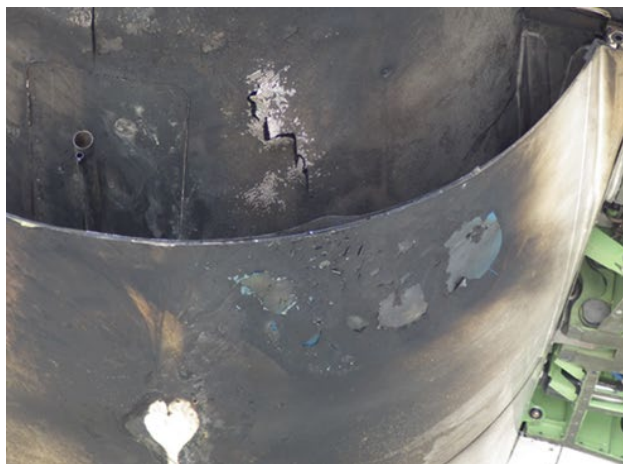
An area of intense thermal damage was observed on the lower forward core cowl and lower transcowl between 5 and 6 o'clock, with exposed honeycomb structure at 6 o'clock. The cowling was not penetrated beneath this damage. See Figures 15 and 16.

Fig 15. Lower transcowl and core cowl thermal distress

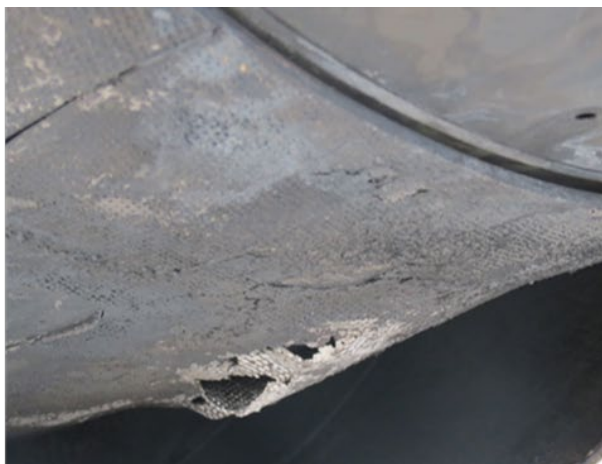
Fig 16. Exposed honeycomb structure in the lower forward core cowl

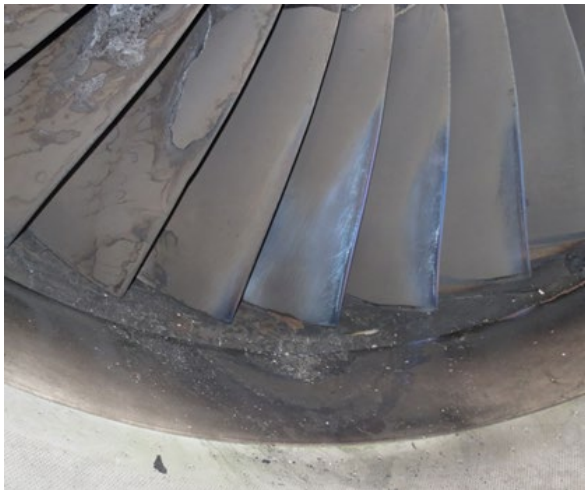
The fan blades were locally discolored. The fan blade rub strip was thermally damaged between 4 and 8 o'clock. See Figure 17. The fan frame struts, and the fan outlet guide vane (OGV) surfaces were coated with soot and discolored. The OGVs between 4 and 6 o'clock were fire-damaged (oxidized). See Figure 18.

Figure 17. Fan blade and blade path thermal damage

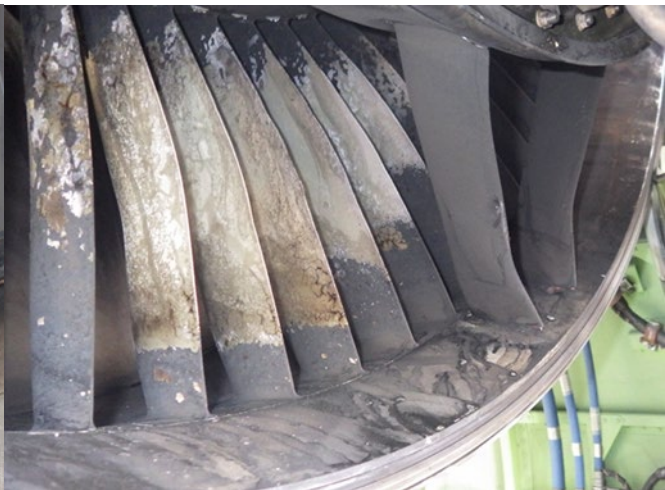
Figure 18. Fan OGV thermal damage

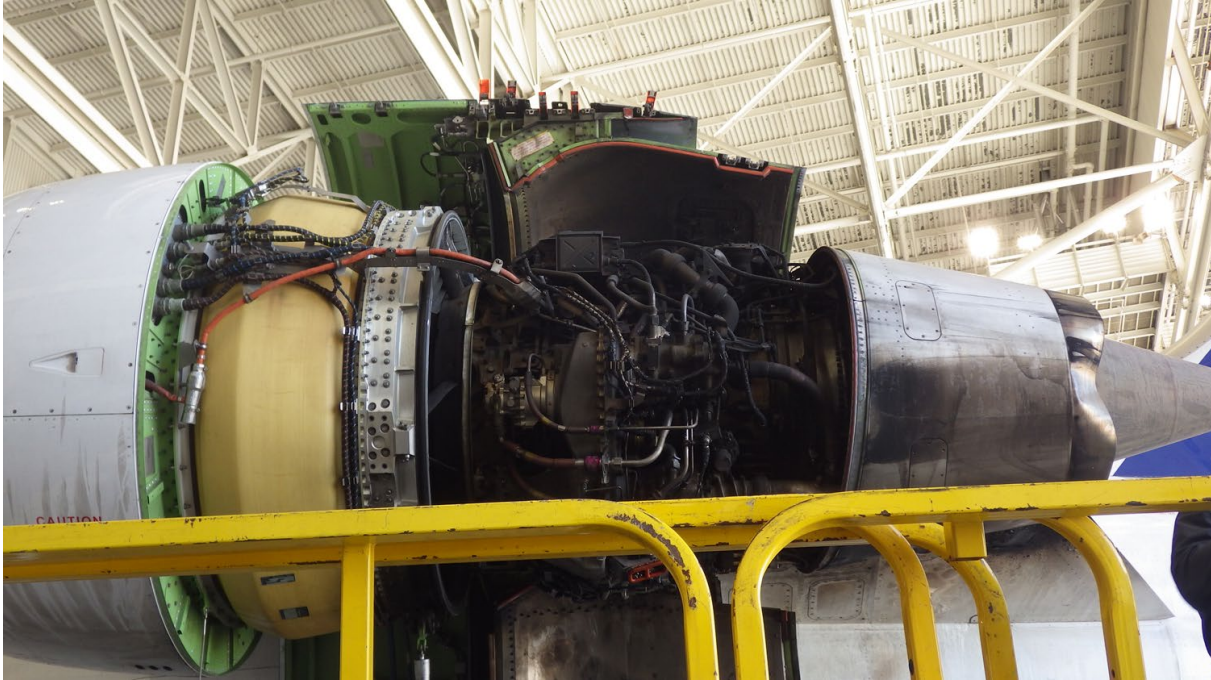
The external engine components between 7 and 5 o'clock were coated with soot. See Figure 19.

Figure 19. Engine core externals

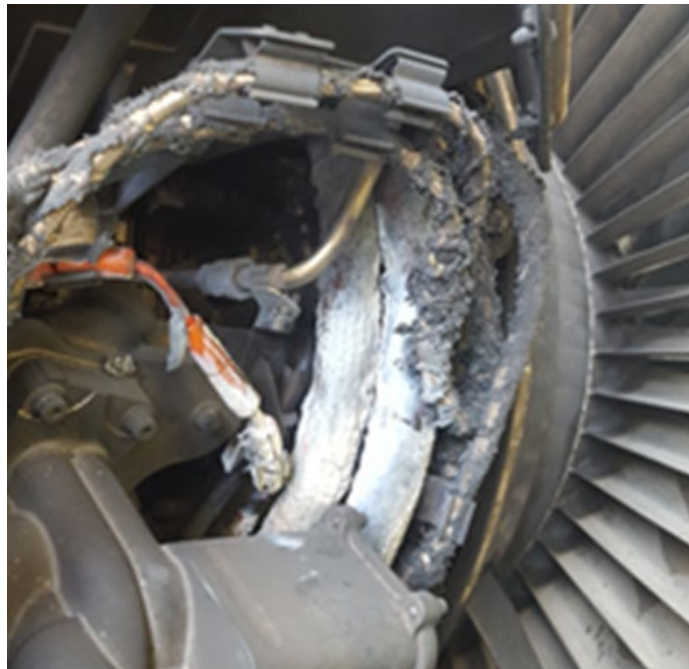
Some of the wiring harness overbraid was consumed and fluid tube fire sleeves displayed areas of white discoloration consistent with exposure to excessive temperature. See Figure 20.

Figure 20. Exemplar engine externals fire damage

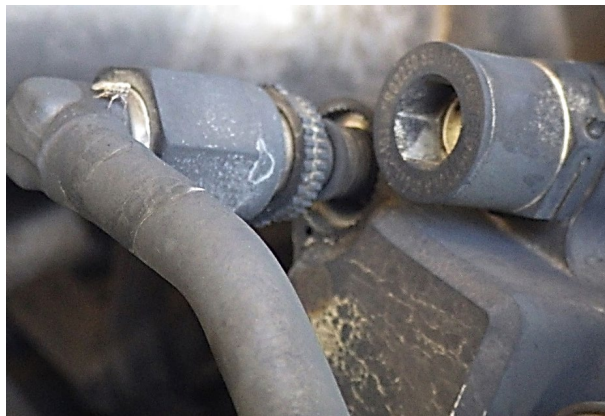
The OBV supply port fitting was found pulled out of the housing. See Figures 21 and 22. Worn threads were observed in the housing supply port bore. The fitting O-ring was blackened and appeared intact. The fuel supply tube was securely attached to the fitting.

Figure 21. Fitting pullout

A new P/N 4123T71P05 (P05) OBV design with the rosan -05 to -06 expander supply and return fittings replaced with larger rosan -06 to -06 standard fittings was proposed. More data were required to understand fitting pullout root cause.

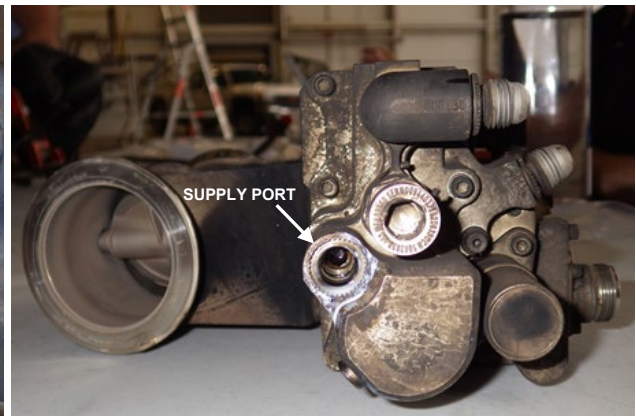
Fig 22. Failure OBV following removal from airplane

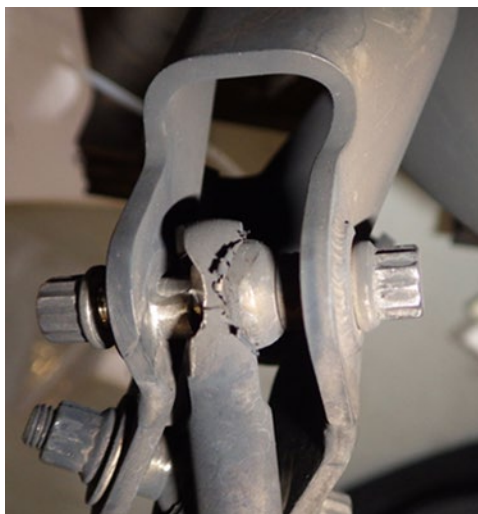
The left and right forward ECS links were found loose and heavily worn at their manifold attachment rod ends. See Figures 23 and 24.

Figure 23. Forward left link. The backed-off nut was not as found

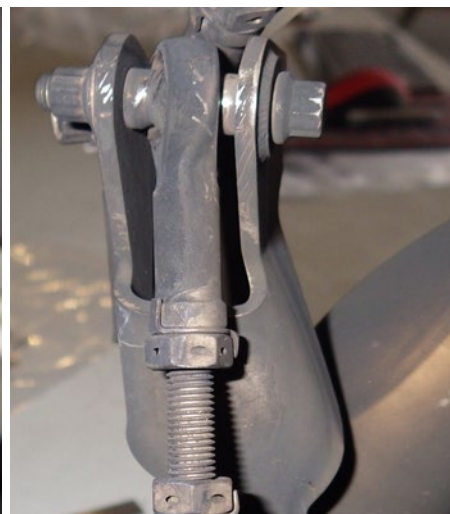
Figure 24. Right forward link

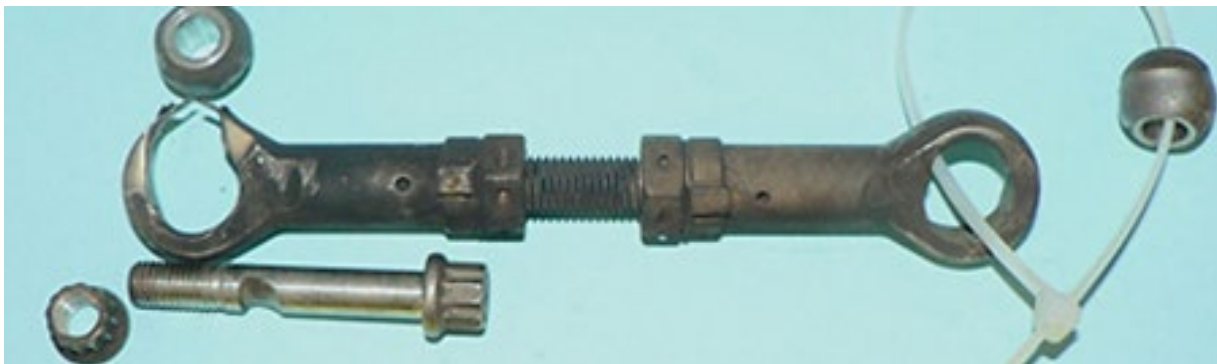
Figure 25. Left forward ECS link

The left forward link length was 4.044 inches.<sup>10</sup> The anti-rotation tabs showed some outer surface damage but no evidence of re-bending (re-use). Both rod ends were severely worn. Hammer force and a drift were required to remove the manifold attachment hardware. See Figure 25. The forward bushing was missing material in line with the severe ECS link wear. The aft (welded) bushing was intact. See Figure 26 (a). The rod end housing was worn completely through on one side. An approximate 0.07-inch deep by 0.25-inch long divot of shank material was missing from the (0.25-inch shank diameter) bolt. See Figure 26 (b). The surface texture in the damaged areas of the rod end, bearing, and bolt shank was smooth, consistent with fretting (small displacement amplitude, lower stress) wear. See Figure 26 (c).

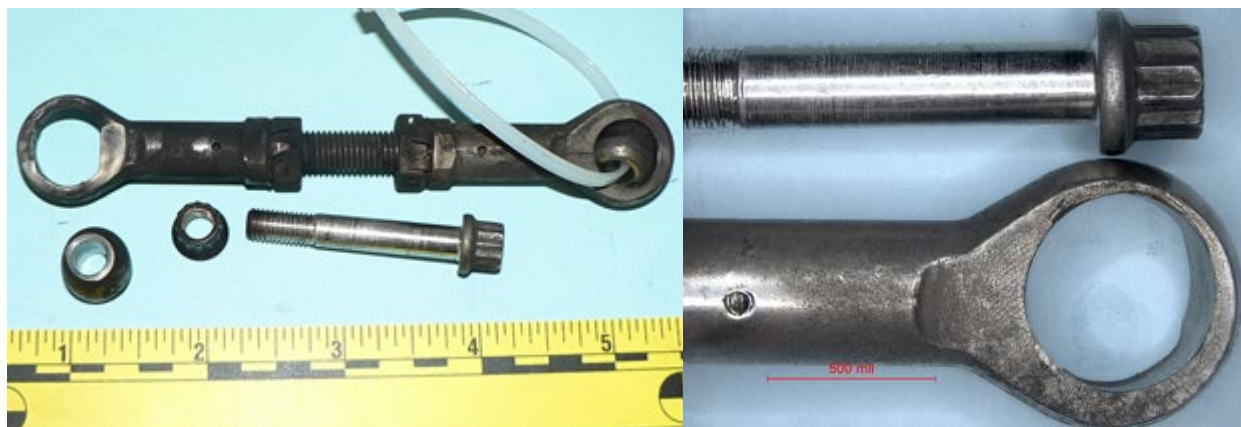
The forward ECS link length was 4.121 inches. The anti-rotation tabs showed no evidence of re-bending. The nut on the bolt attaching the right forward ECS link at the manifold fork was seized and was freed using lubricant. The forward bushing could be rotated forward and aft. The (welded) aft bushing showed no appreciable wear. General visual inspection of the bolt and nut loading surfaces found no significant wear. The external diameter of the manifold attachment rod end was 0.809 inch, conforming with the engineering drawing. The entire rod end ball ID surface was worn. The entire uniball bearing surface was worn. The ball diameter, 0.562 inch, conformed with the engineering drawing.

The external diameter of the engine-attached rod end was 0.809 inch, conforming with the engineering drawing. The entire rod end ID surface was worn and the two flat surface features were worn away. A region of 'tiger stripes' was noted. The entire surface of the uniball bearing was worn and showed an area of tiger striping consistent with the marks found on the rod end ID. The ball diameter, 0.562 inch, conformed with the engineering drawing. See Figure 28.

Figure 28. Right forward ECS link

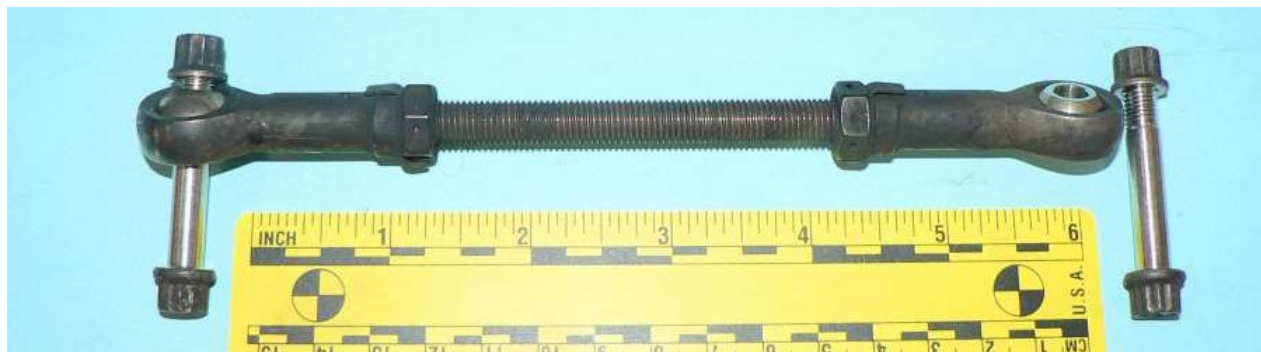
The aft ECS link length was 7.047 inches. The anti-rotation tabs showed no re-bending marks. The rod ends were nominally on the same plane as regards twist. The attachment bolt and nut loading surfaces showed no appreciable wear. The external diameter of the rod end attached at the manifold was 0.807 inch, conforming with the engineering drawing. The entire rod end ball ID surface was worn. The uniball bearing exhibited opposing circular wear marks; this wear was superficial except for a step change noted at the base of one of the circular marks. The bearing diameter was 0.562 inch (0.5615 in the worn area), conforming with the engineering drawing. The external diameter of the engine-attached rod end was 0.806 inch, conforming with the engineering drawing. The bearing ID showed superficial wear and fresh circumferential scoring marks. The bearing diameter was 0.562 inch, conforming with the engineering drawing. See Figure 29.

Figure 29. Aft ECS link

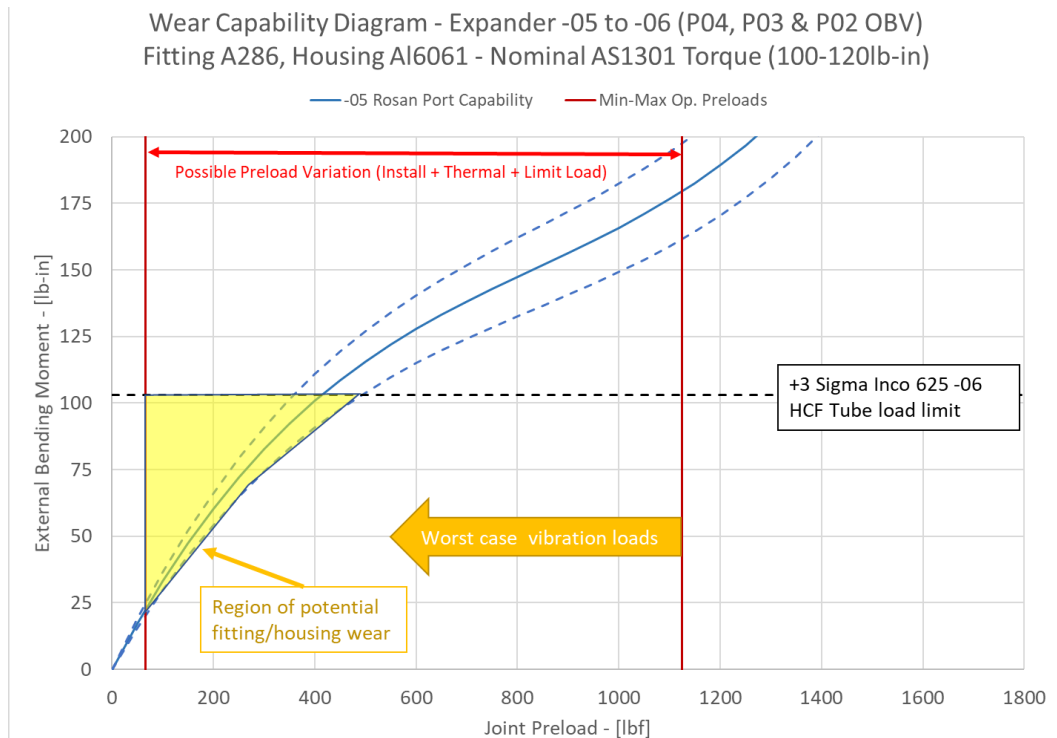
Rotary flex tests of the -05 to -06 expander fitting joint using preload data and the  $\geq 103$  lb-in bending moment upper load limit found a large region of potential port wear, confirming that the P04 OBV -05 to -06 expander fitting joint was susceptible to port wear due to low preload within worst case engine vibration loads. See Figure 31.

Figure 31. Legacy OBV -05 to -06 expander fitting joint wear capability showing inadequate design margin to withstand system loads

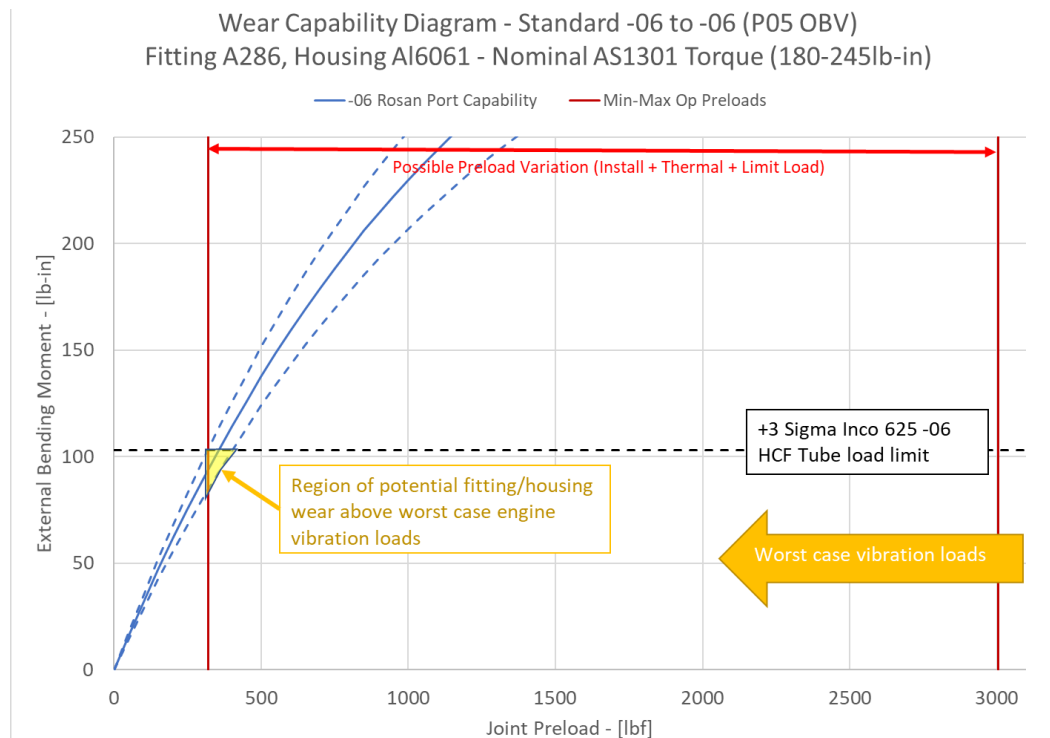
Similar rotary flex tests of the -06 to -06 standard fitting joint verified the P05 OBV as capable of withstanding system loads up to the Inconel 625 HCF capability. The tests revealed a small region of possible port wear should loads exceed the Inconel 625 -06 HCF material capability threshold. See Figure 32.

Figure 32. P05 wear capability verified to the Inconel 625 HCF tube load limit. A small region of potential port wear was observed just above worst-case engine vibration loads
