# NATIONAL TRANSPORTATION SAFETY BOARD

## MATERIALS LABORATORY ADDENDUM REPORT

Report No. 17-018B

Place : Ft. Lauderdale, Florida  
Date : October 28, 2016  
Vehicle : FedEx MD-10-10F, N370FE  
NTSB No. : DCA17MA022  
Investigator : Daniel Bower, AS-10

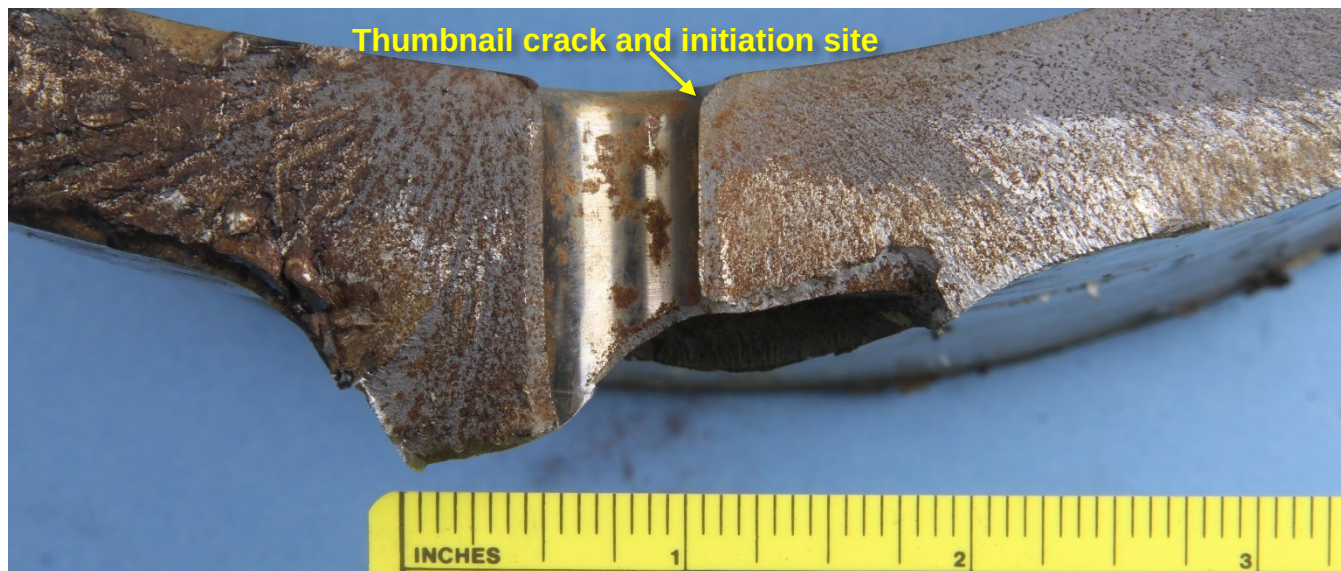
This NTSB Materials Laboratory Addendum Report details the fatigue analysis performed on the thumbnail crack at the radius transition of the Schrader valve bore and inner diameter of a main landing gear (MLG) cylinder (see Figure 1). The thumbnail crack, originating at a corrosion pit at this radius transition, exhibited alternating bands of fatigue and overstress, as well as a band of intergranular fracture. The extent of these fatigue features extended to a minimum of approximately 0.110 inches along the inner diameter of the cylinder and a maximum of approximately 0.192 inches (4.871 mm) along the air valve bore.

Figure 1 – The landing gear fracture about the bore, after sectioning from the landing gear.

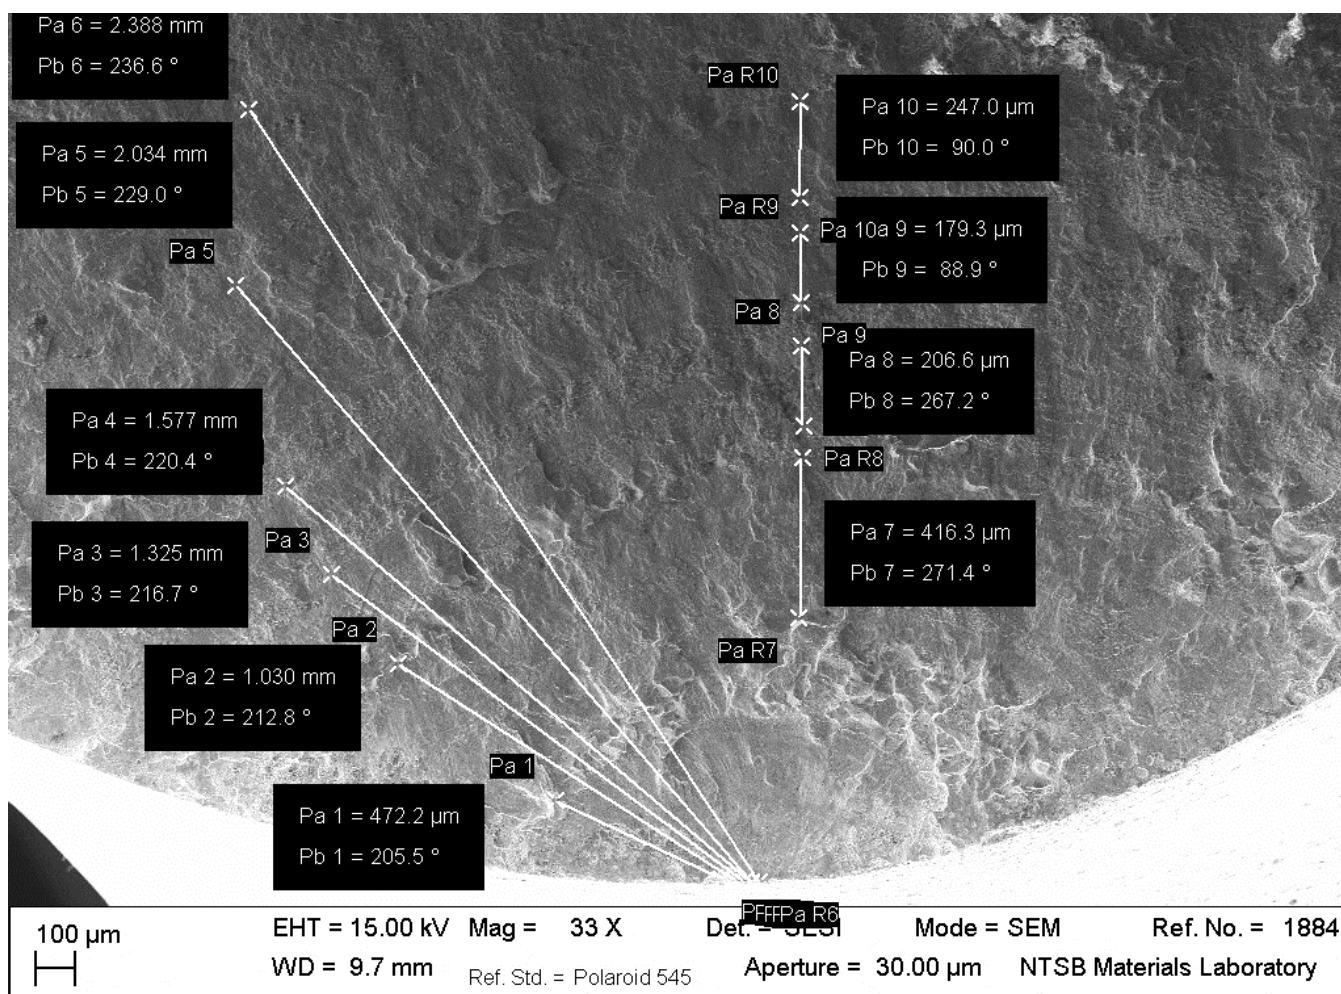
As stated previously, there was a band of intergranular fracture surrounding the first half-millimeter of fatigue and three overstress bands alternating with fatigue, before a final mixed fatigue and overstress band (illustrated in Figure 2 with measurements from the initiation site). A closer view of these bands, along with their measured depths, are illustrated in Figure 3 through Figure 6.

Figure 2 – Secondary electron (SE) micrograph showing the distances from the initiation site to the different failure mode bands (left side), and the depths of the secondary fatigue bands (right).

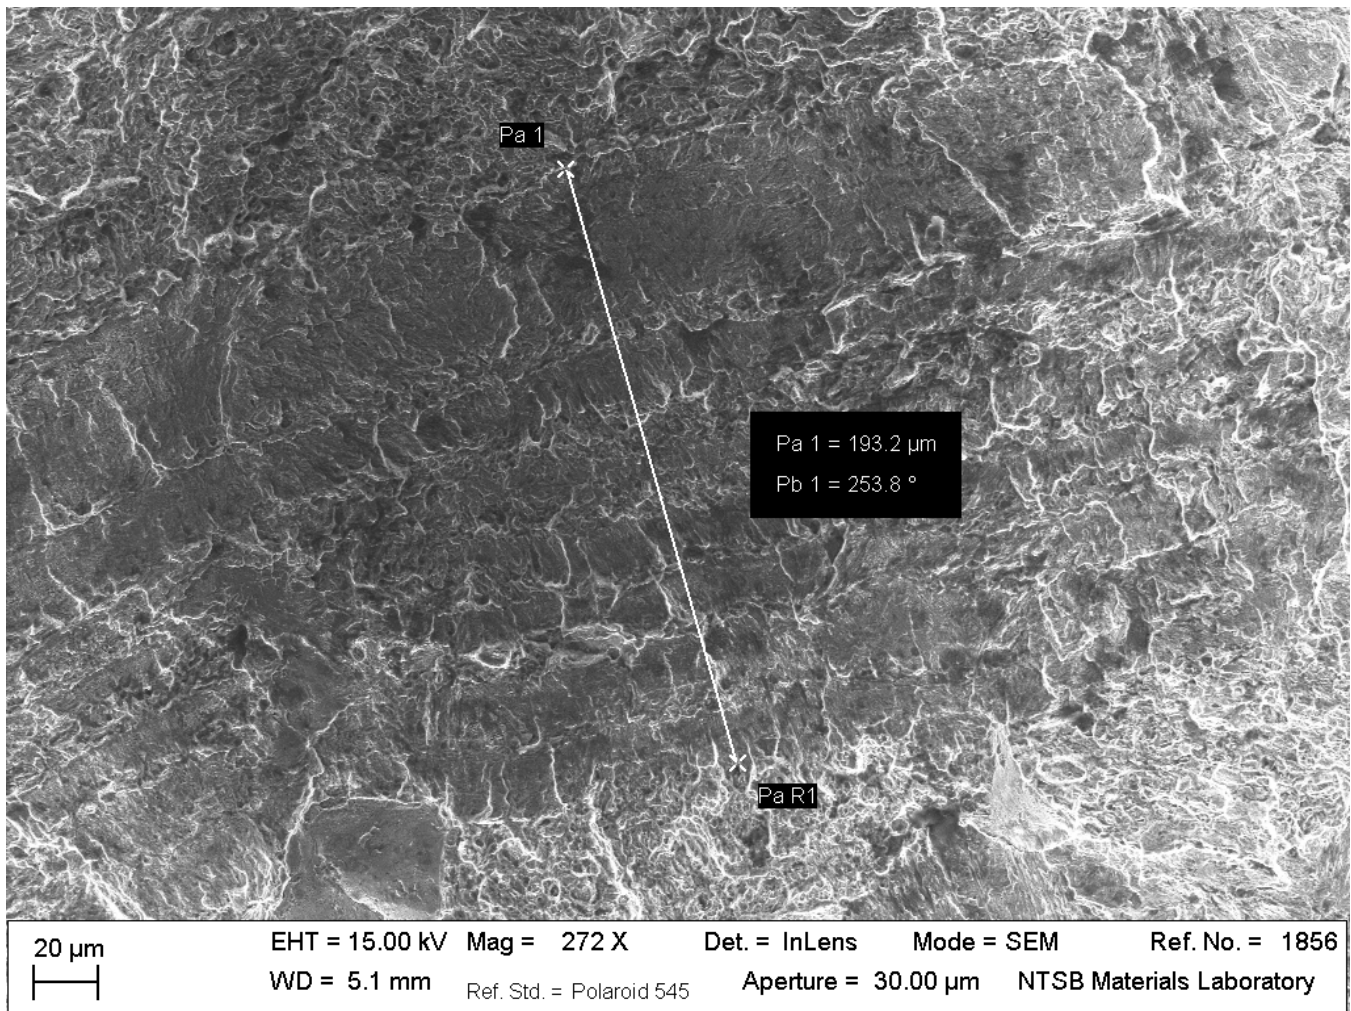
Figure 3 – SE micrograph of the 2<sup>nd</sup> fatigue band (after overstress).

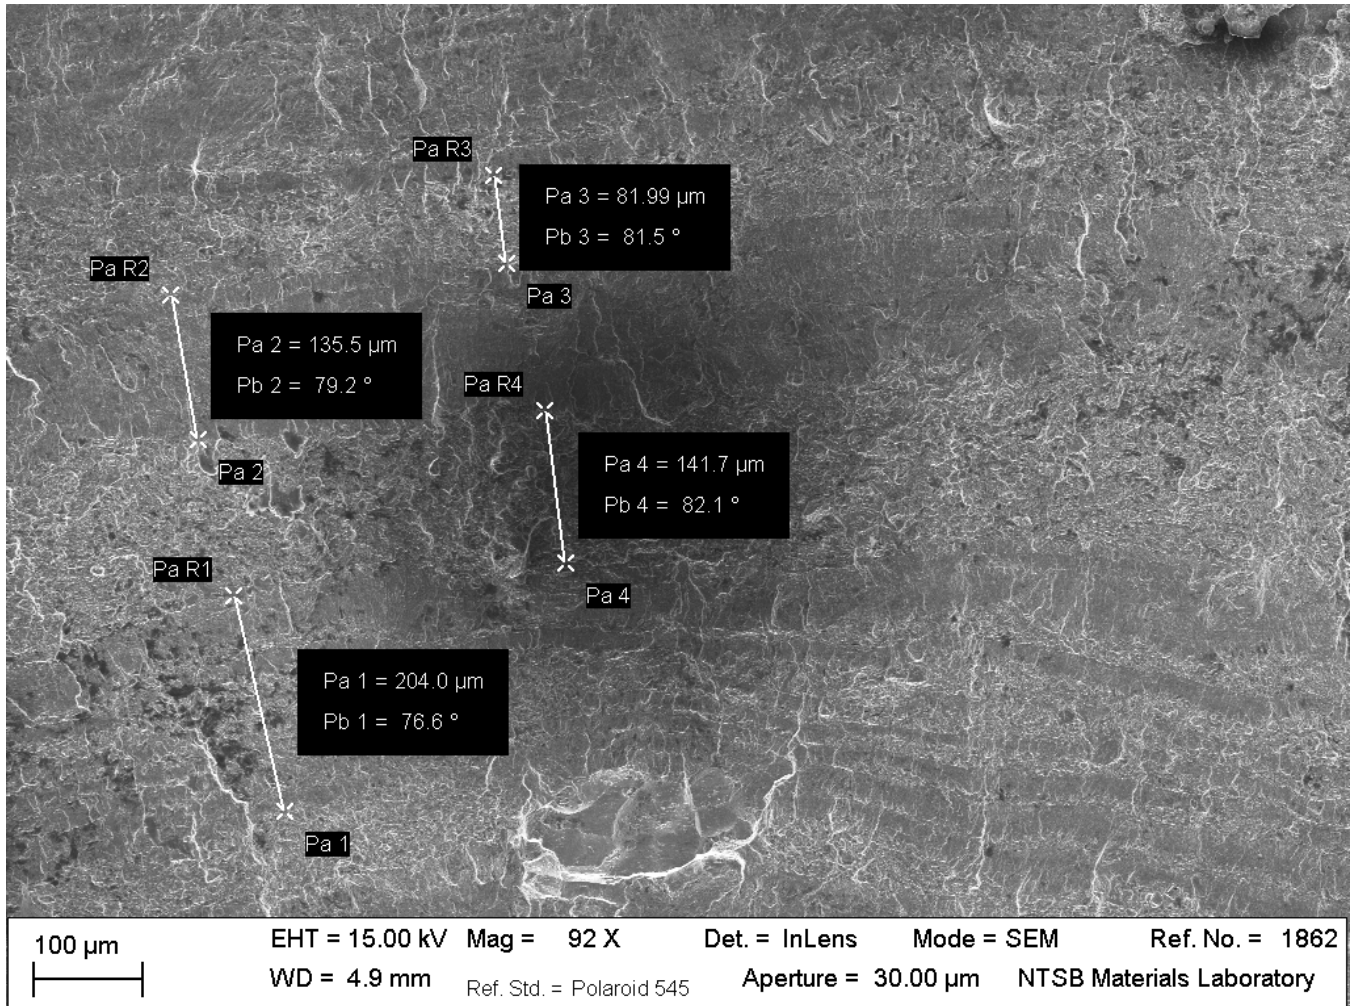
Figure 4 – SE micrograph showing fatigue bands 2 and 3 (left measurements) and overstress bands 2 and 3 (right measurements).

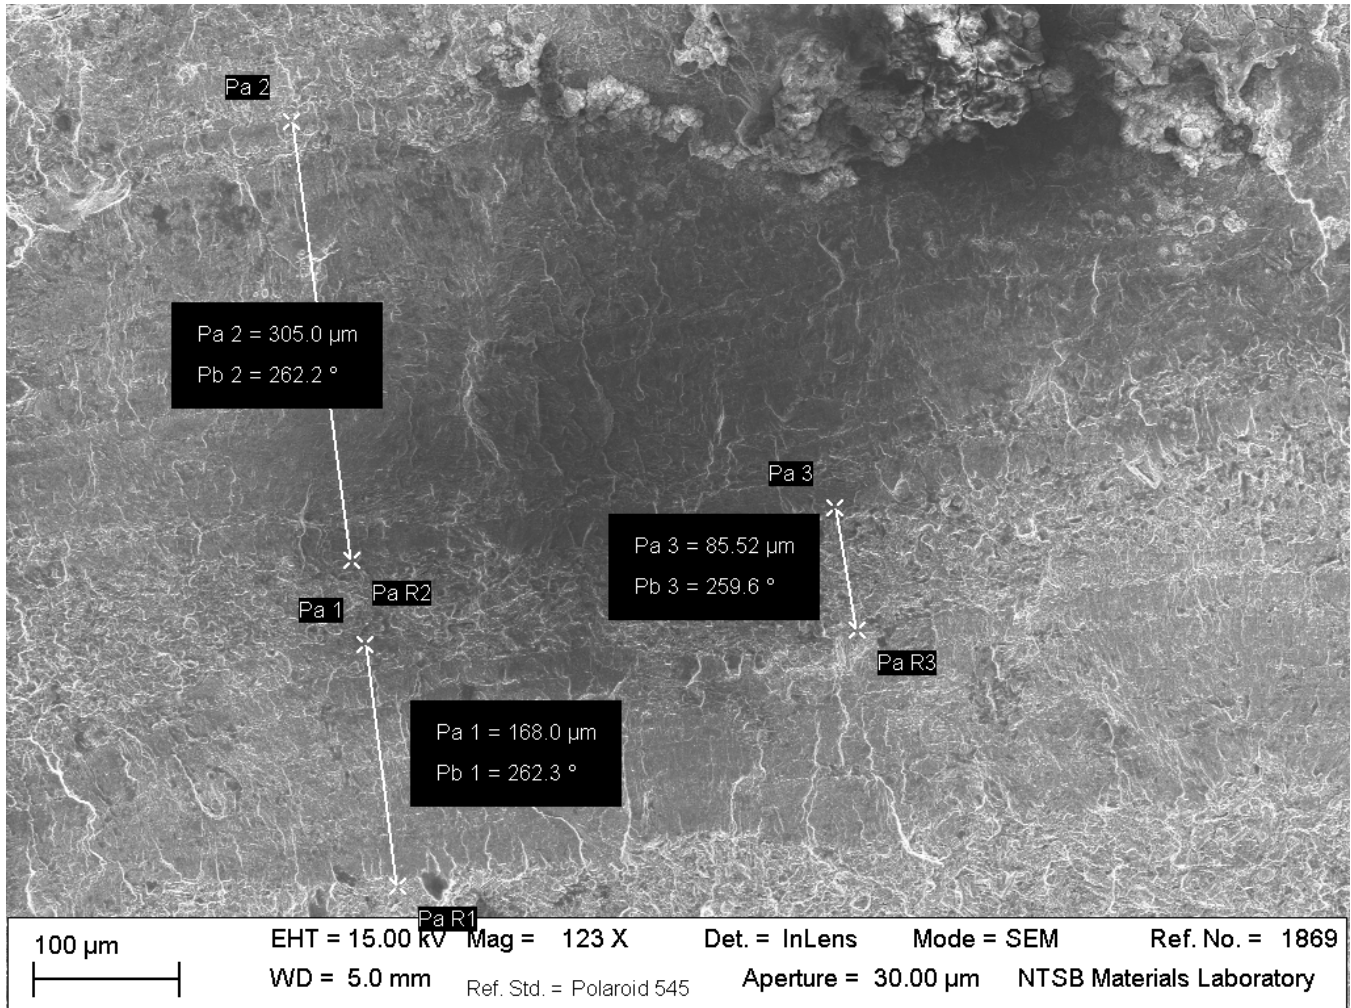
Figure 5 – SE micrograph showing fatigue bands 4 and 5 (left measurements) and overstress bands 4 (right measurement).

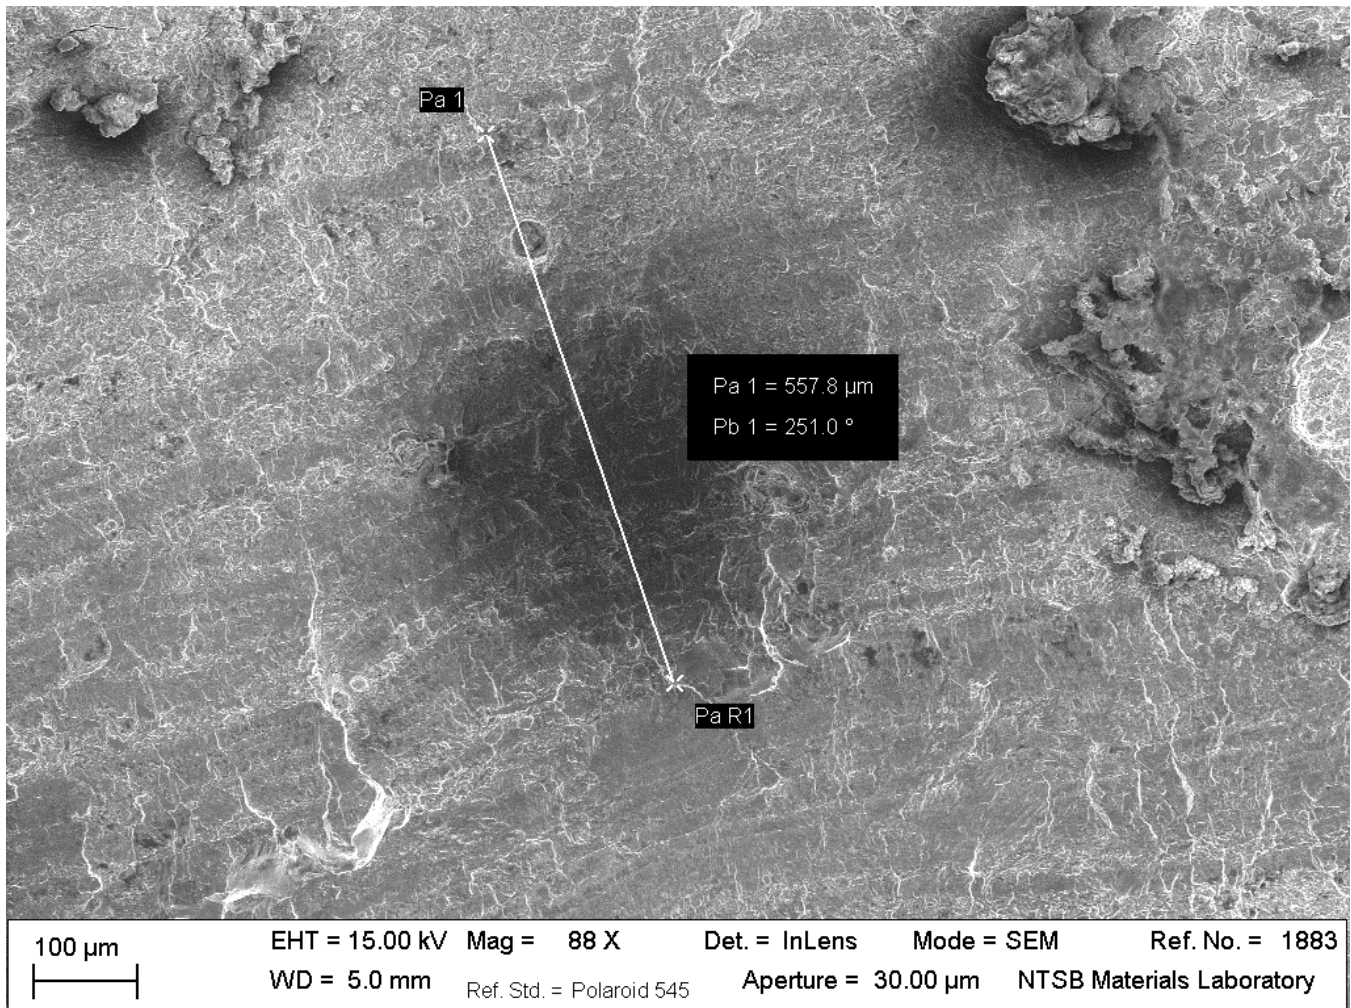
Figure 6 – SE micrograph showing the mixed mode band after fatigue band 4 in Figure 5.

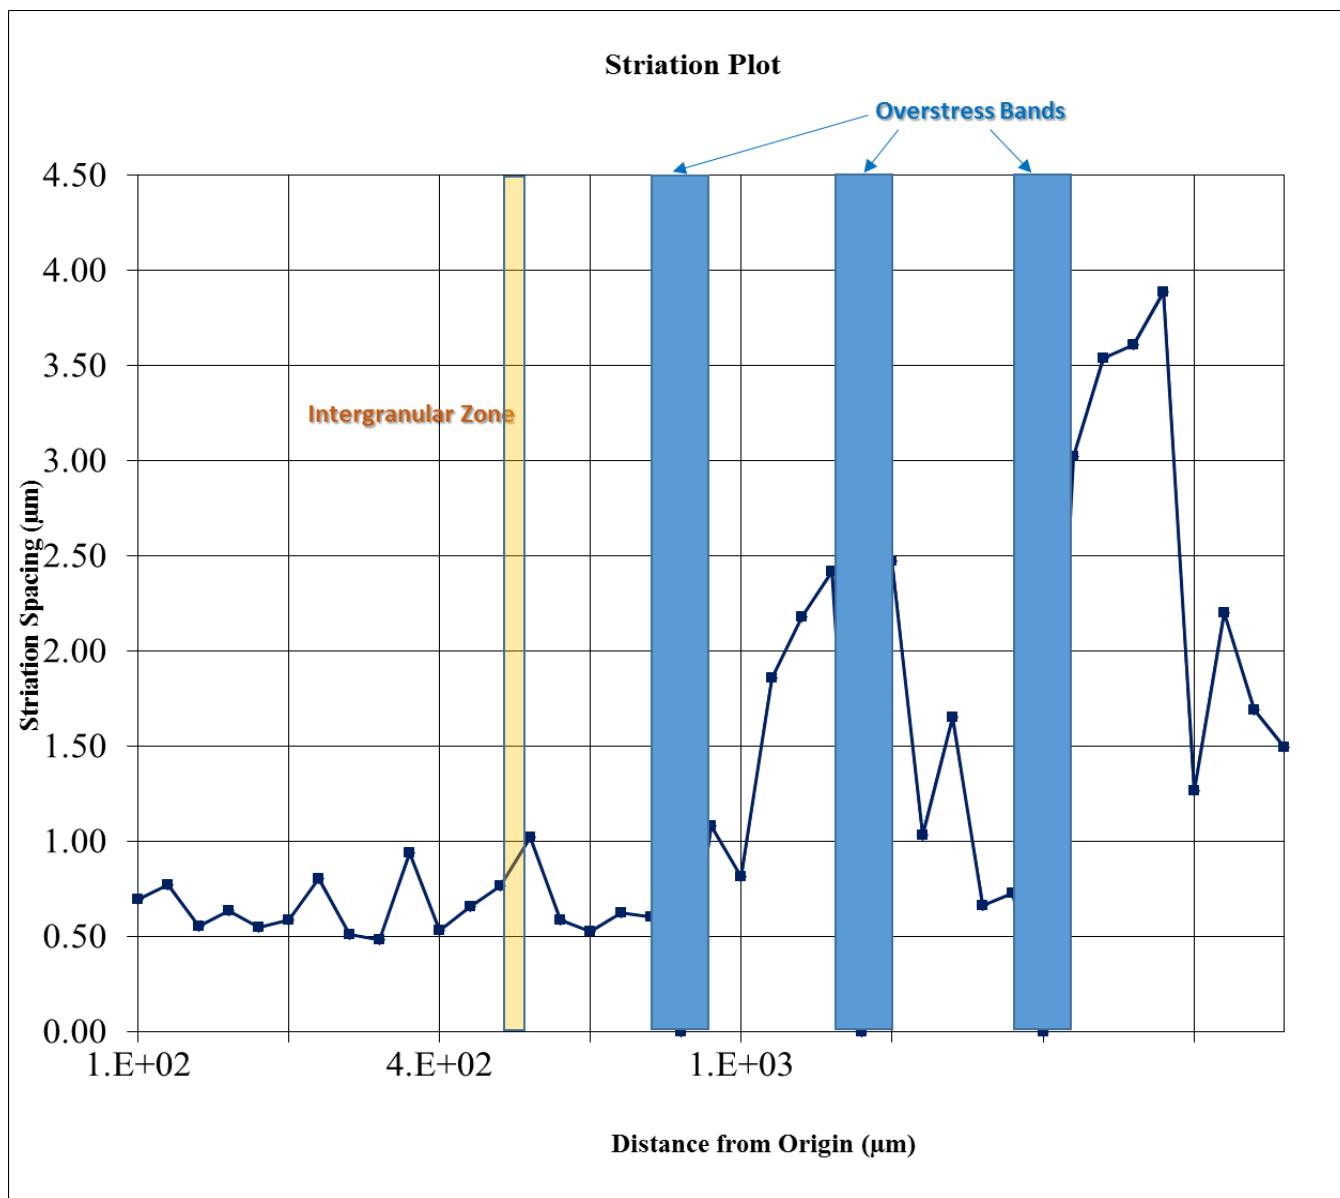
- Striation count in 1<sup>st</sup> fatigue thumbnail (origin to intergranular): 526
- Striation count in 1<sup>st</sup> fatigue thumbnail (intergranular to overstress band 1): 165 (691 total to this point)
- Striation count before overstress band 1: 691
- Striation count in 2<sup>nd</sup> band: 253 (944)
- Striation count in 3<sup>rd</sup> band: 242 (1186)
- Striation count in 4<sup>th</sup> band: 218 (1404)

Figure 46 shows a chart plotting the data of Table I, which illustrated the calculated striation spacing at each distance from the fatigue crack initiation site. The relative locations of the intergranular zone and overstress bands are overlaid on the figure.

Figure 46 – Chart summarizing the fatigue analysis results from Table I, plotting the striation spacing, in  $\mu\text{m}$ , versus the distance from the fatigue crack origin, also in  $\mu\text{m}$ . The intergranular zone is represented in light orange, and three of the overstress bands are represented in blue.
