# NATIONAL TRANSPORTATION SAFETY BOARD

Office of Research and Engineering  
Materials Laboratory Division  
Washington, D.C. 20594

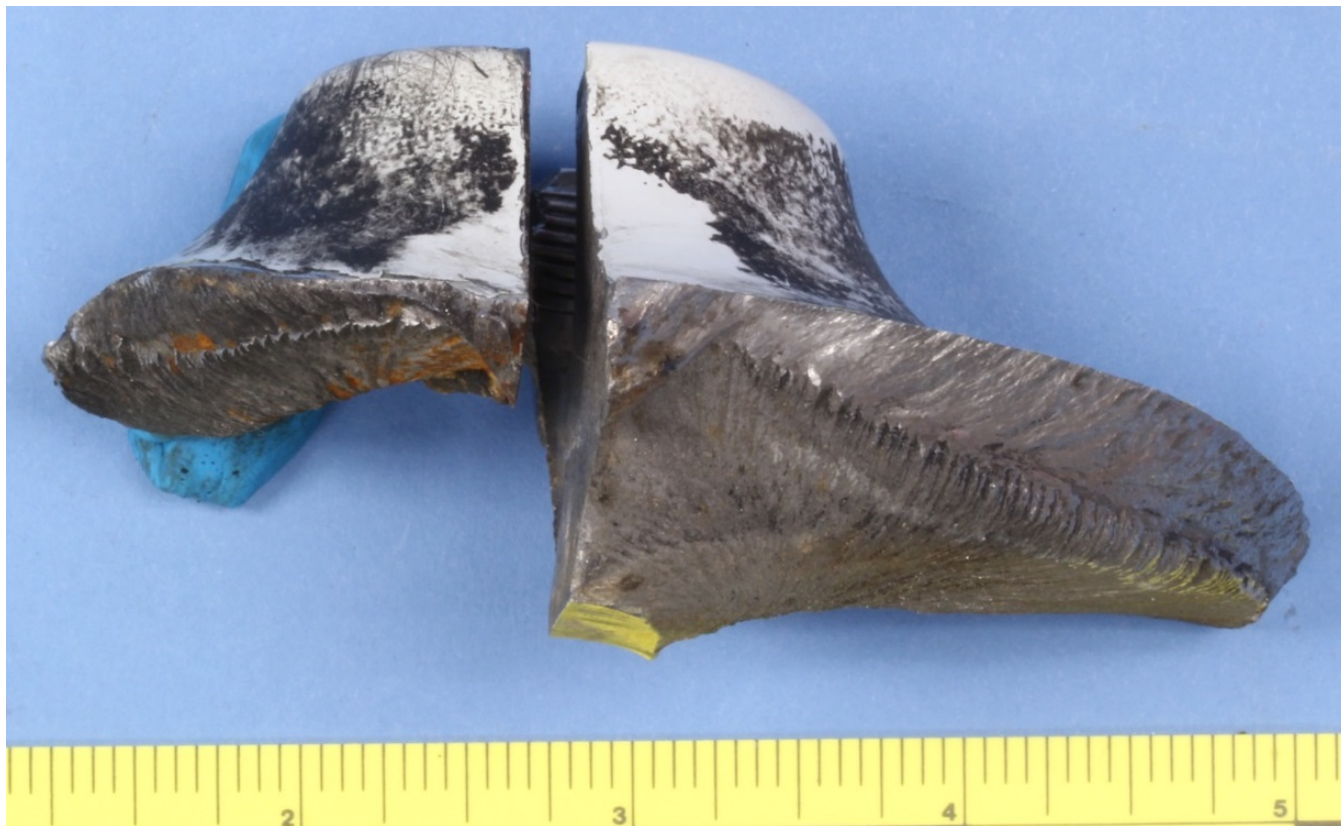
Figure 1 – The landing gear cylinder fragments, as received. The arrow denotes the location of the flat fracture surface.

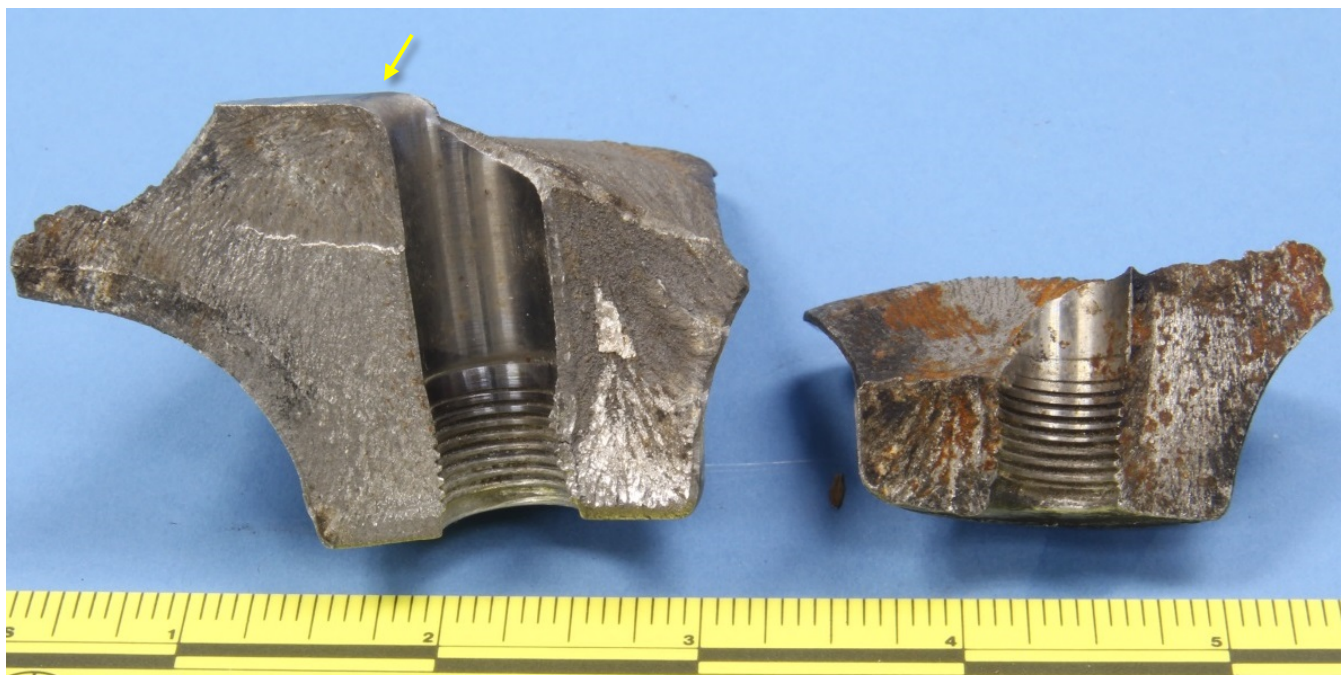
Figure 2 – The fracture surface along the Schrader valve bore of the cylinder fragment. The progressive fracture is located on the fragment on the left, denoted by the arrow.

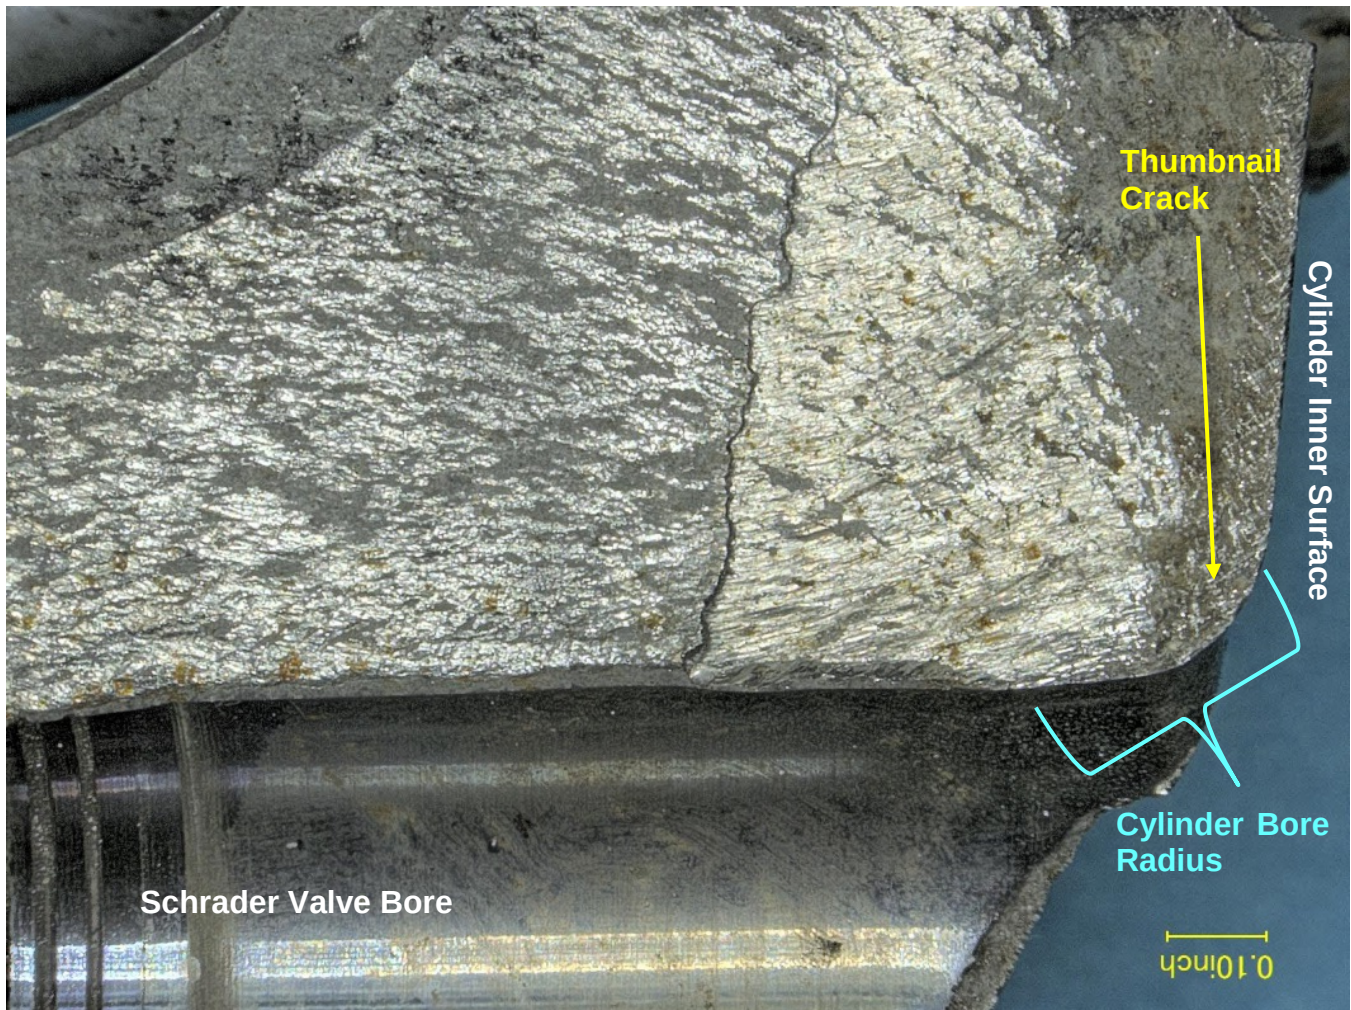
Figure 3 – A closer view of the progressive fracture on the cylinder fragments, showing the crack emanating from the radius inside of the valve bore.

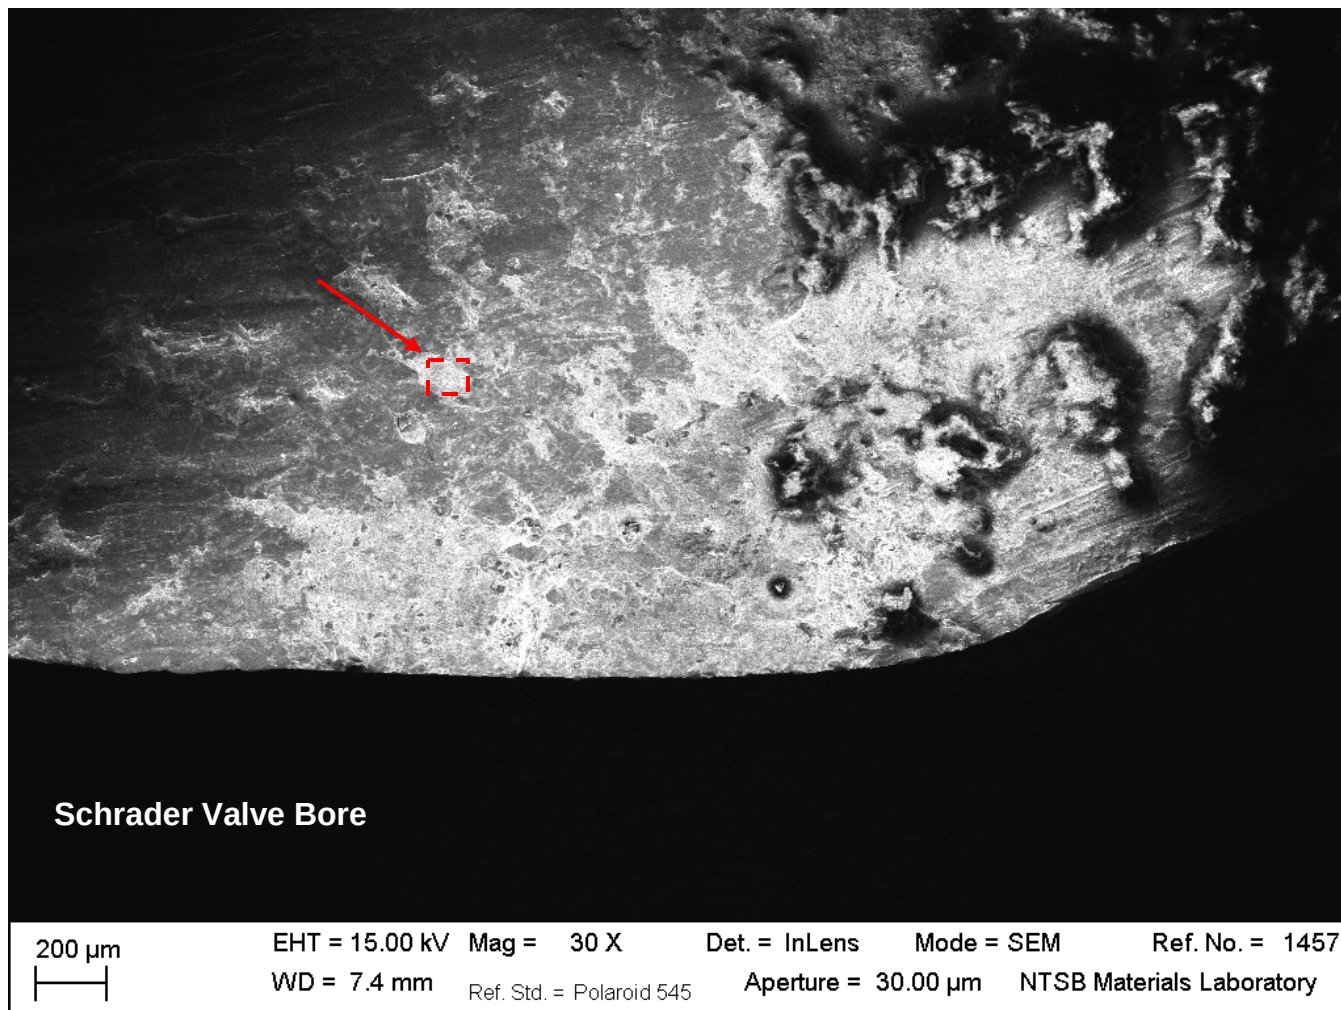
Figure 4 – Secondary electron (SE) micrograph showing a closer view of the fatigue crack in Figure 3. The boxed area (arrow) is shown in Figure 5.

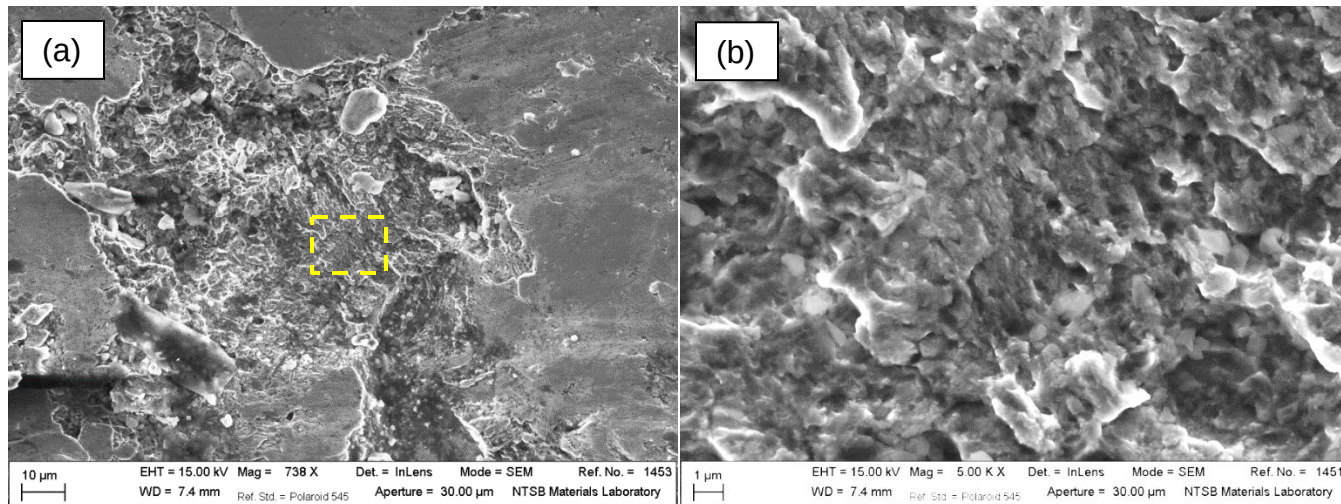
Figure 5 – SE micrographs showing a closer view of (a) the boxed area in Figure 4, showing fatigue striations highlighted in the boxed area, magnified in (b).

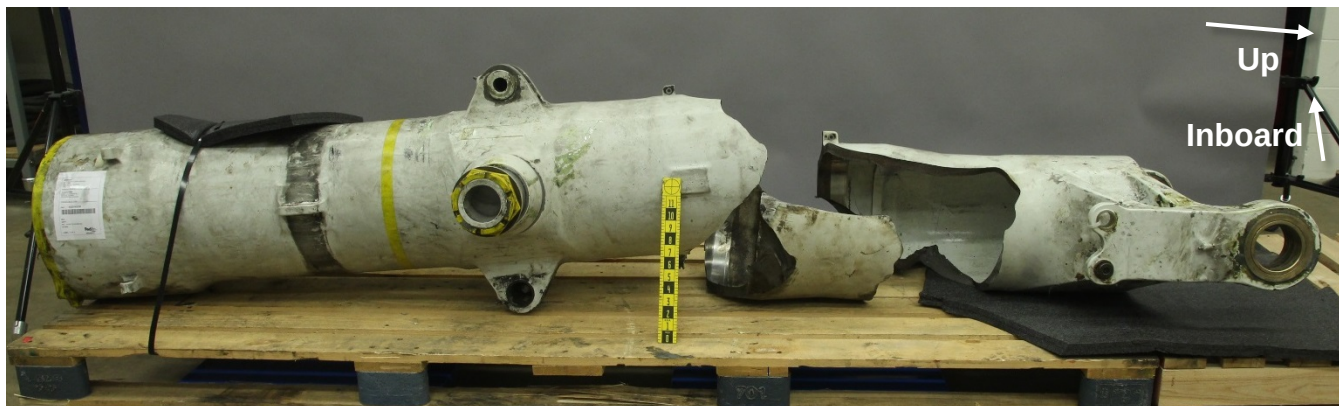
Figure 7 – The large landing gear pieces, after rearranging to show their positions at fracture, viewed forward looking aft. The fill valve bore is located on the aft side of the cylinder (not pictured).

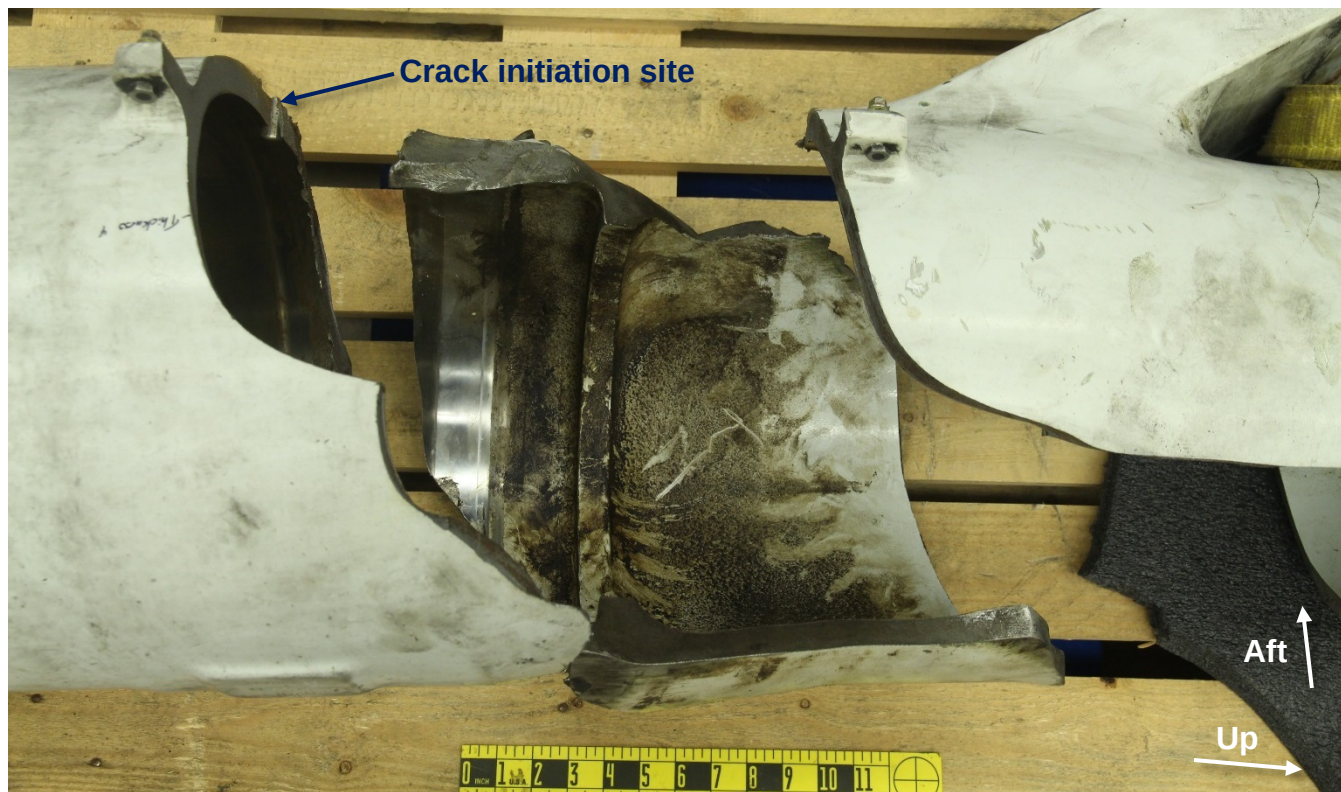
Figure 8 – The main fracture region of the landing gear, with the initial fracture region shown.

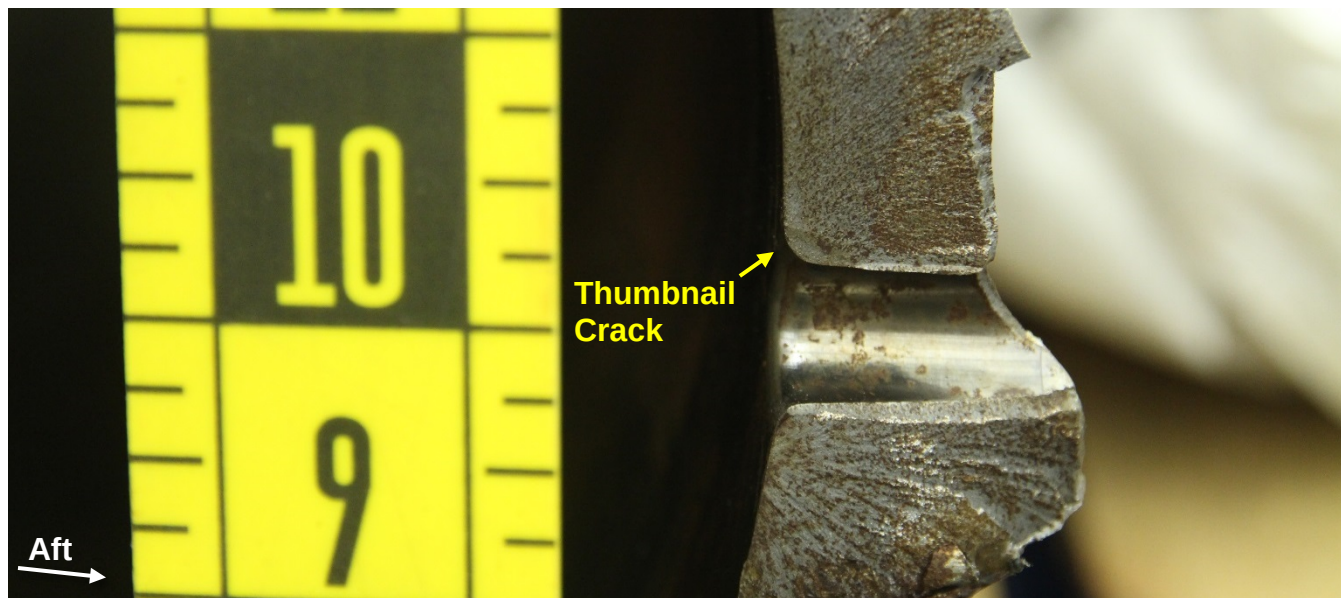
Figure 9 – The thumbnail crack at the bore.

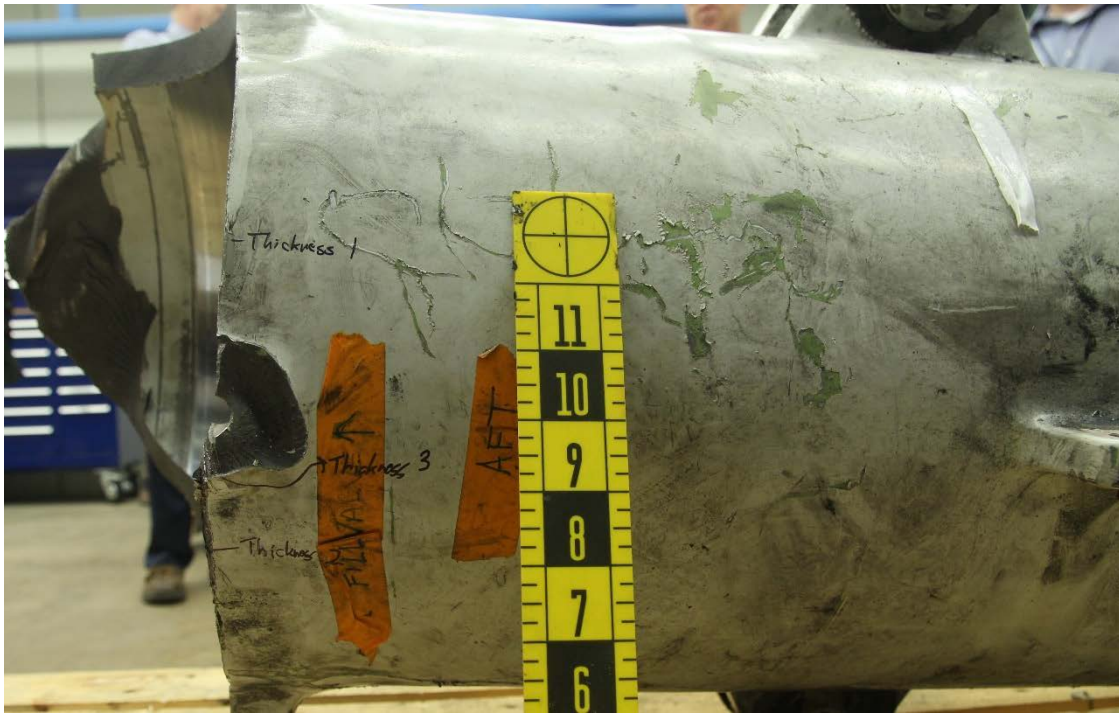
Figure 10 – The side of the largest landing gear fragment, showing thickness measurement locations 1 through 3.

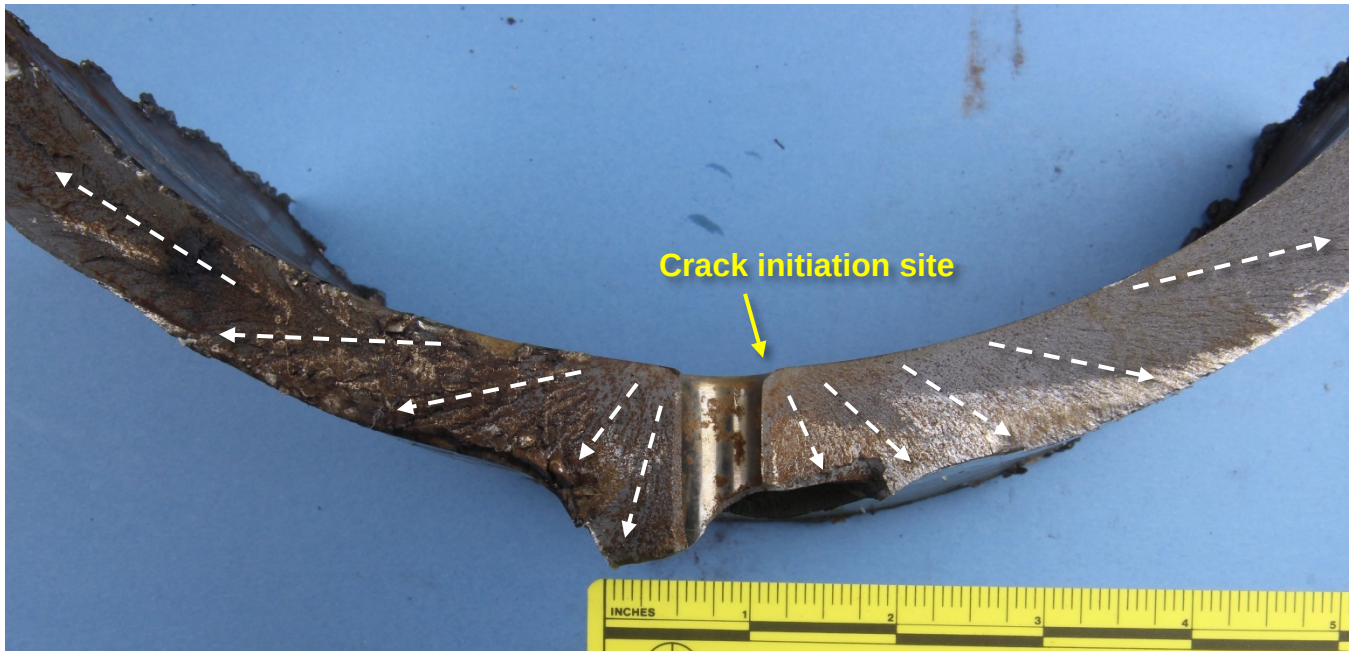
Figure 12 – The landing gear fracture about the bore, after sectioning from the landing gear.

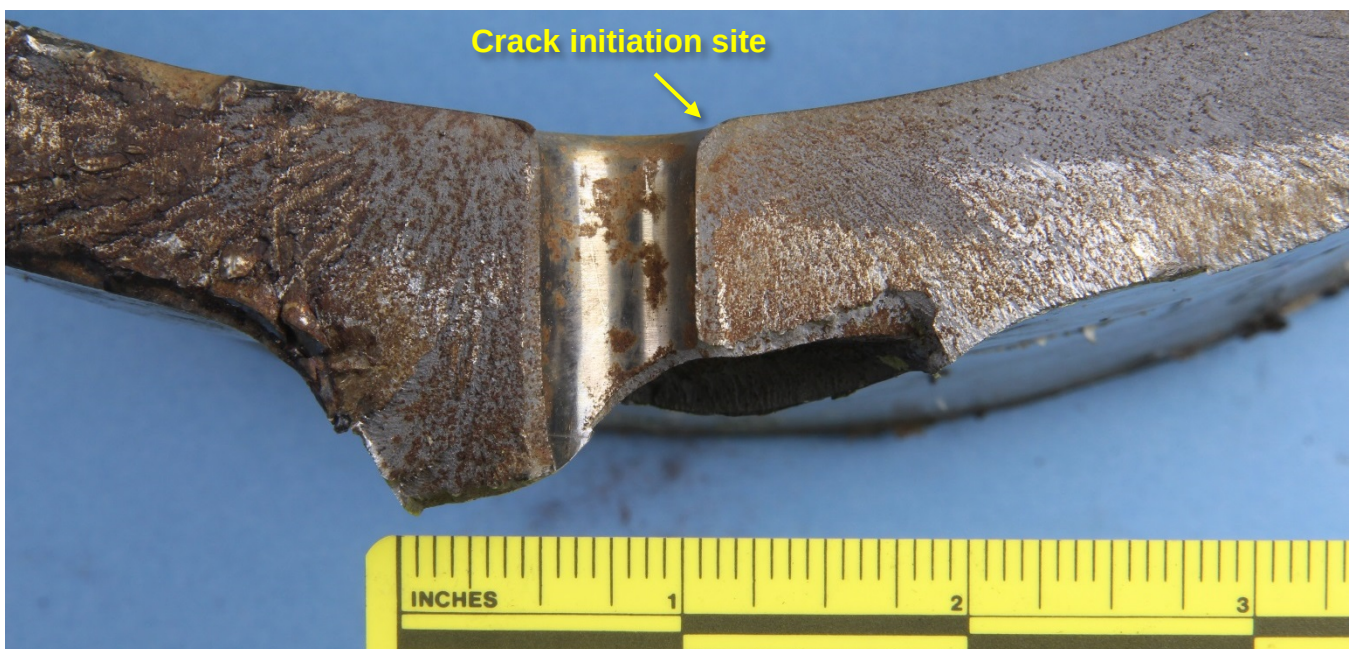
Figure 13 – Closer view of the thumbnail crack in Figure 12.

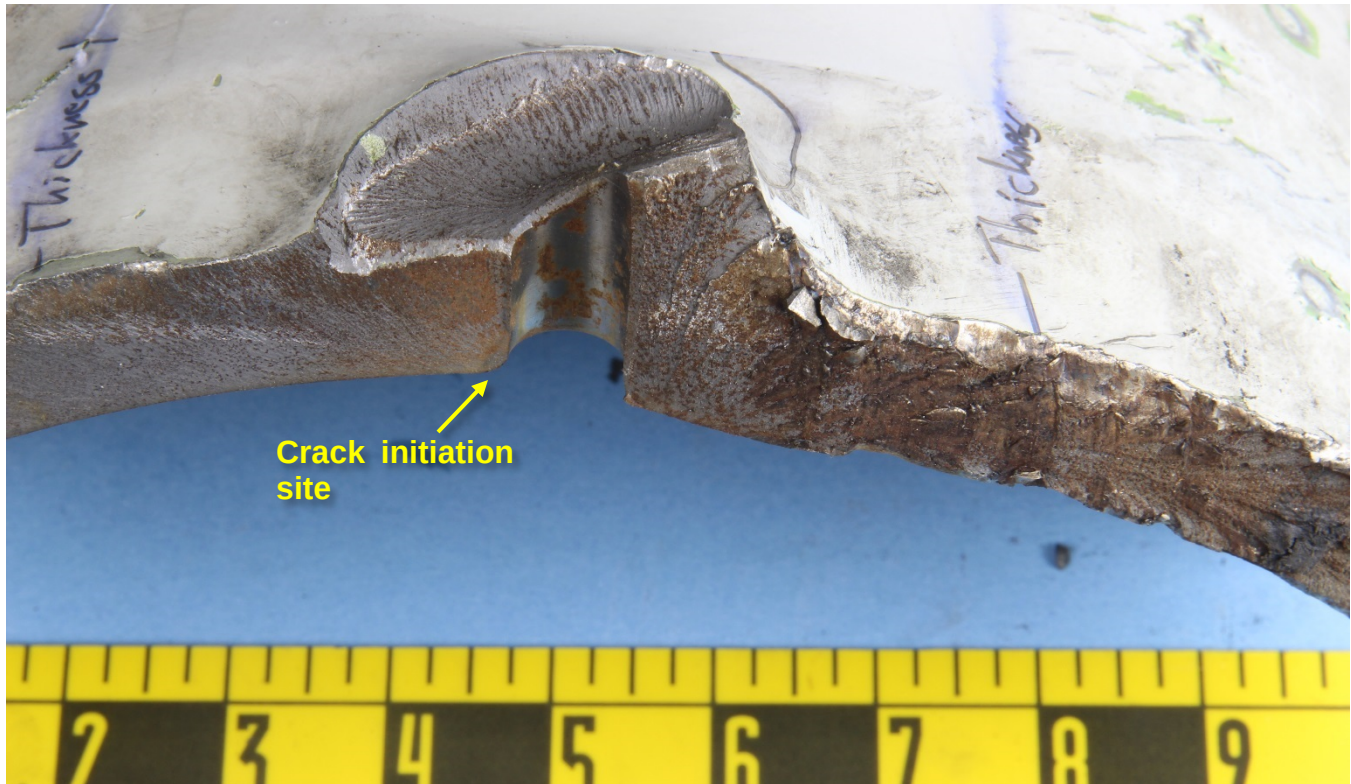
Figure 14 – The initial point of the fracture at the bore, viewed from the outside surface.

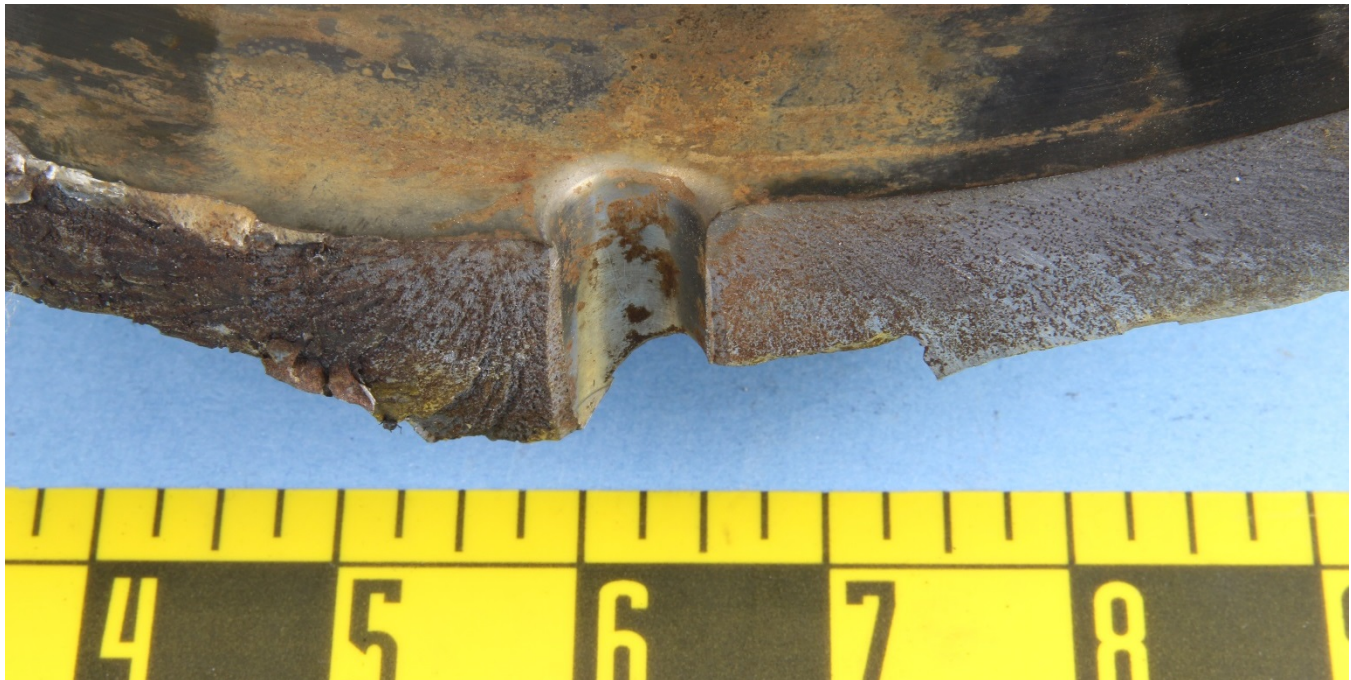
Figure 15 – A view of the thumbnail crack, angled from the inside surface.

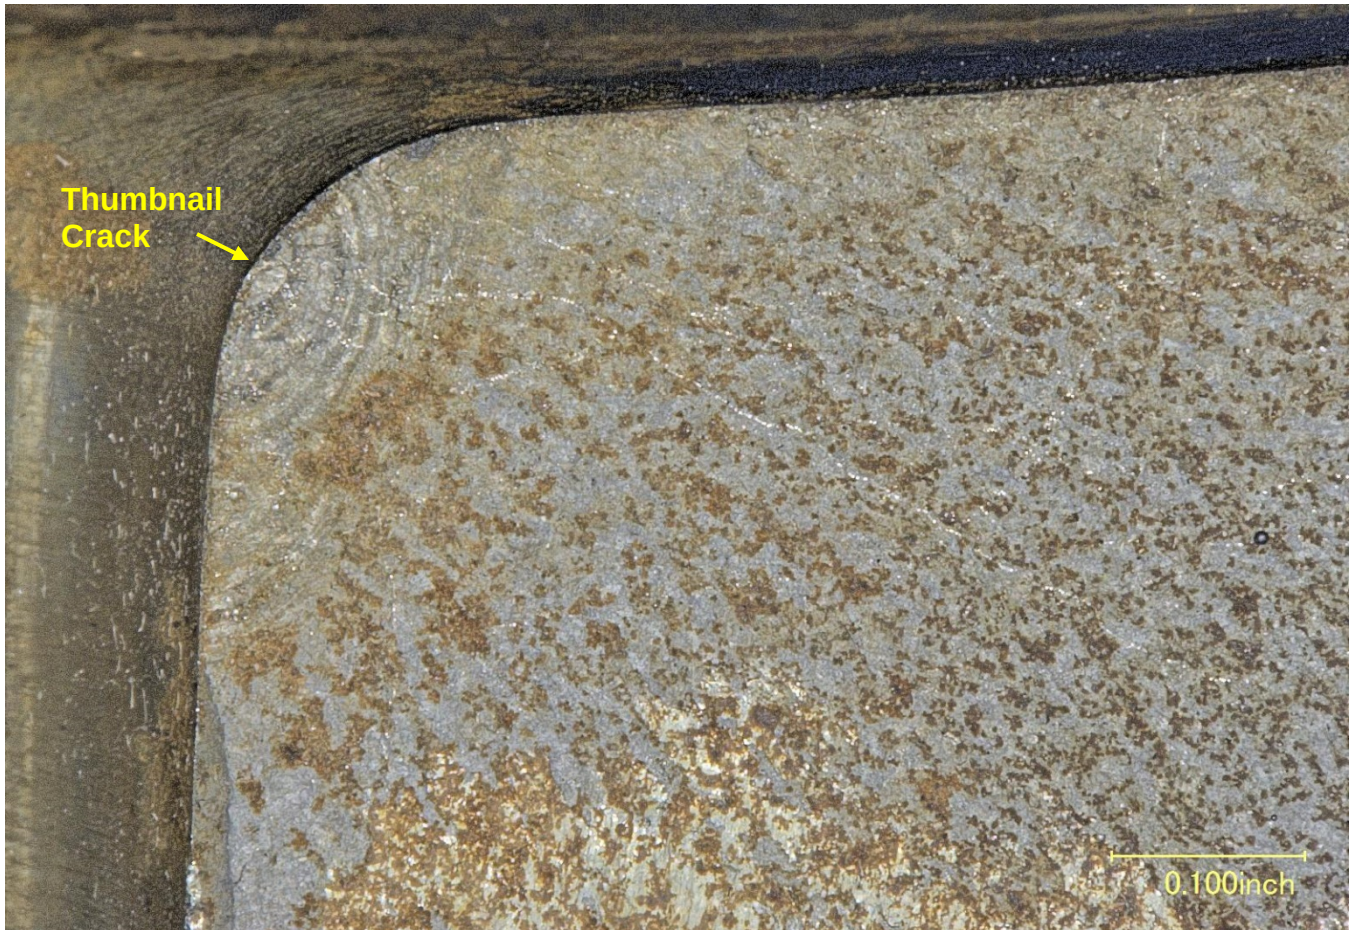
Figure 16 – The thumbnail crack at the initial point of fracture, showing crack arrest marks.

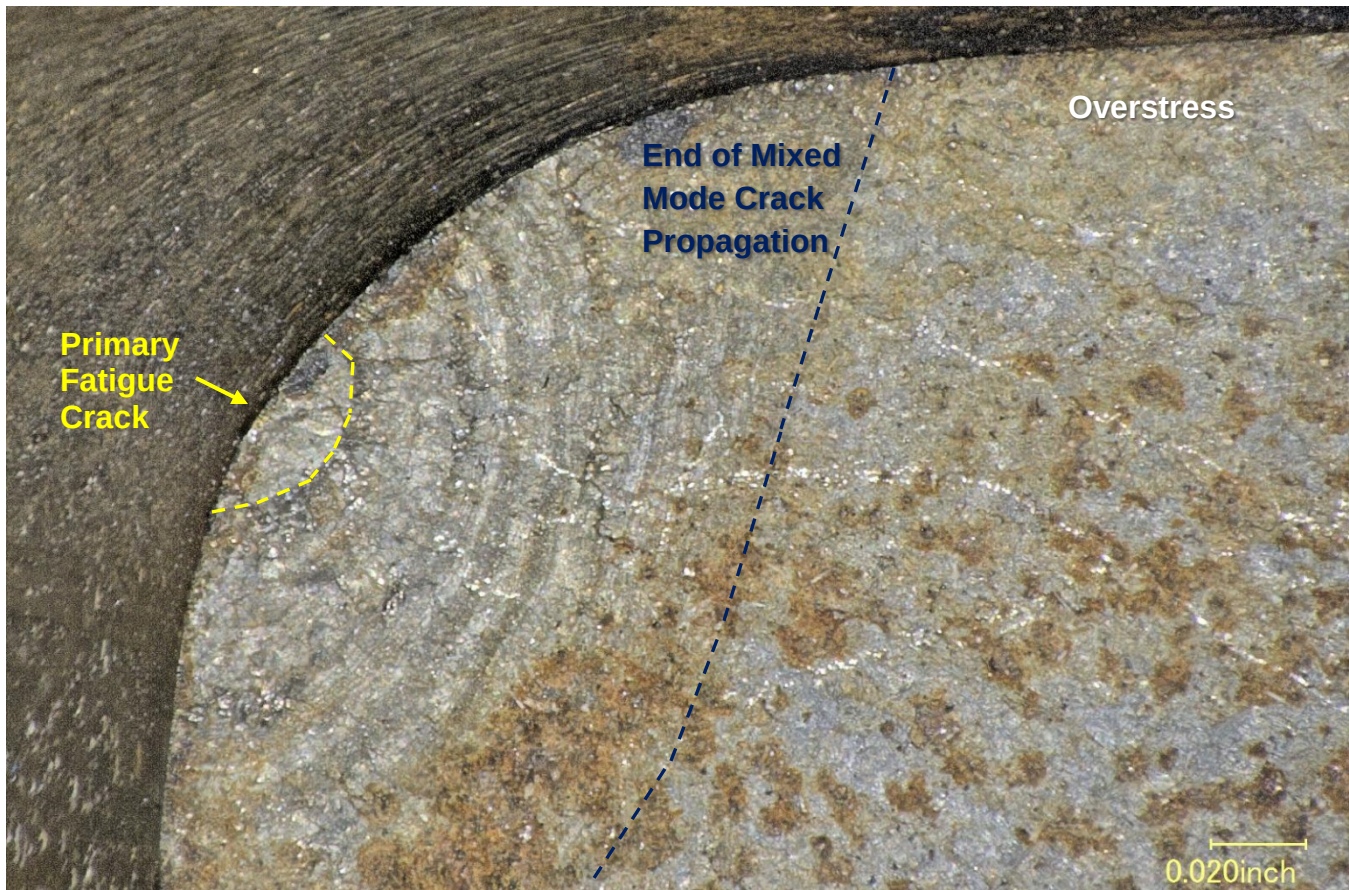
Figure 17 – Closer view of the thumbnail crack from Figure 16. The primary fatigue crack region (before the intergranular region) is highlighted by dashed yellow lines. The end of the all fatigue and mixed mode cracking is highlighted by the dashed green lines.

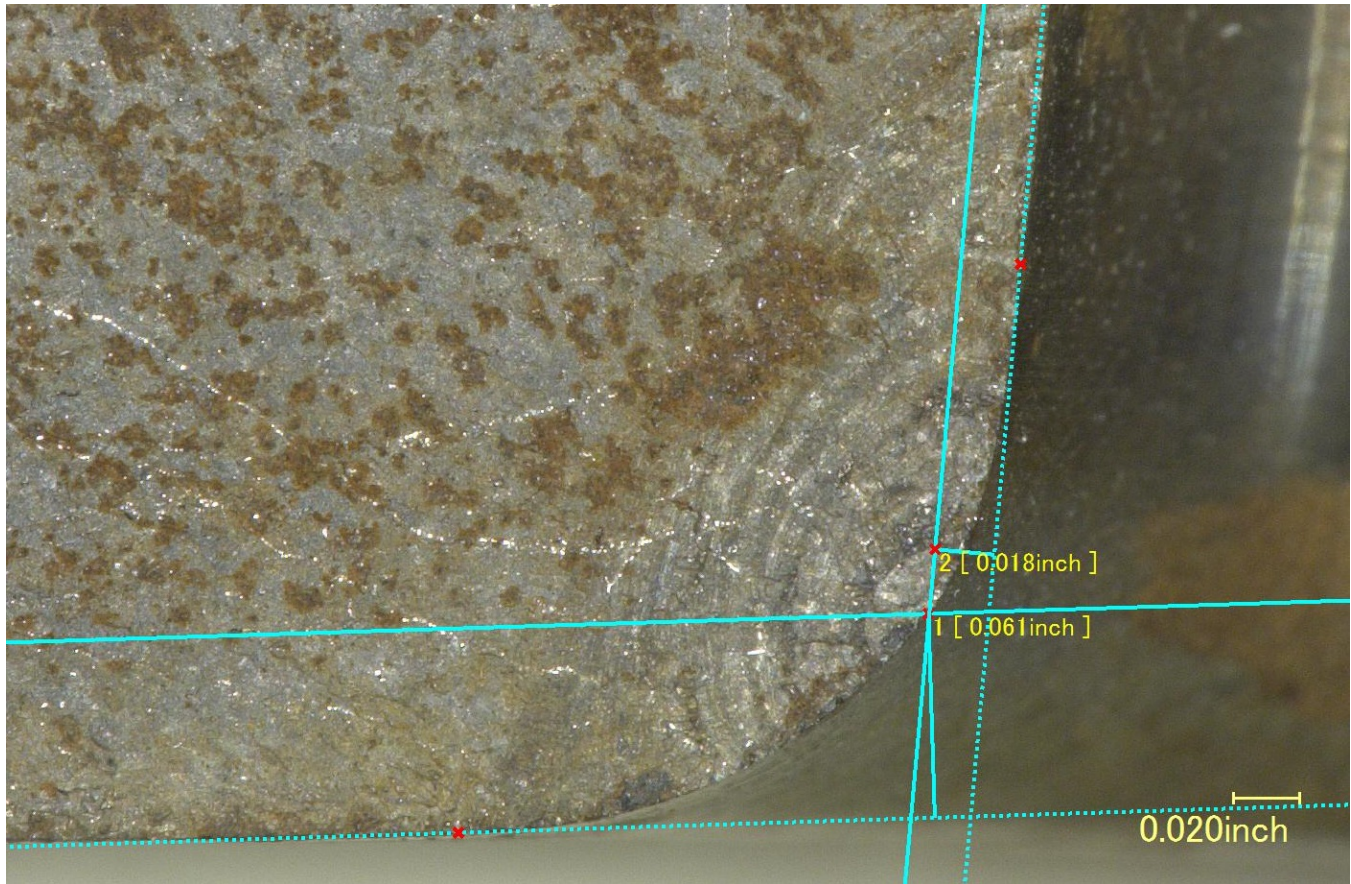
Figure 18 – Key measurements of the thumbnail crack relative to other surfaces. The radial depth of the crack initiation site to the valve bore was 0.018 inches, and the distance of the initiation site to the cylinder diameter was 0.061 inches.

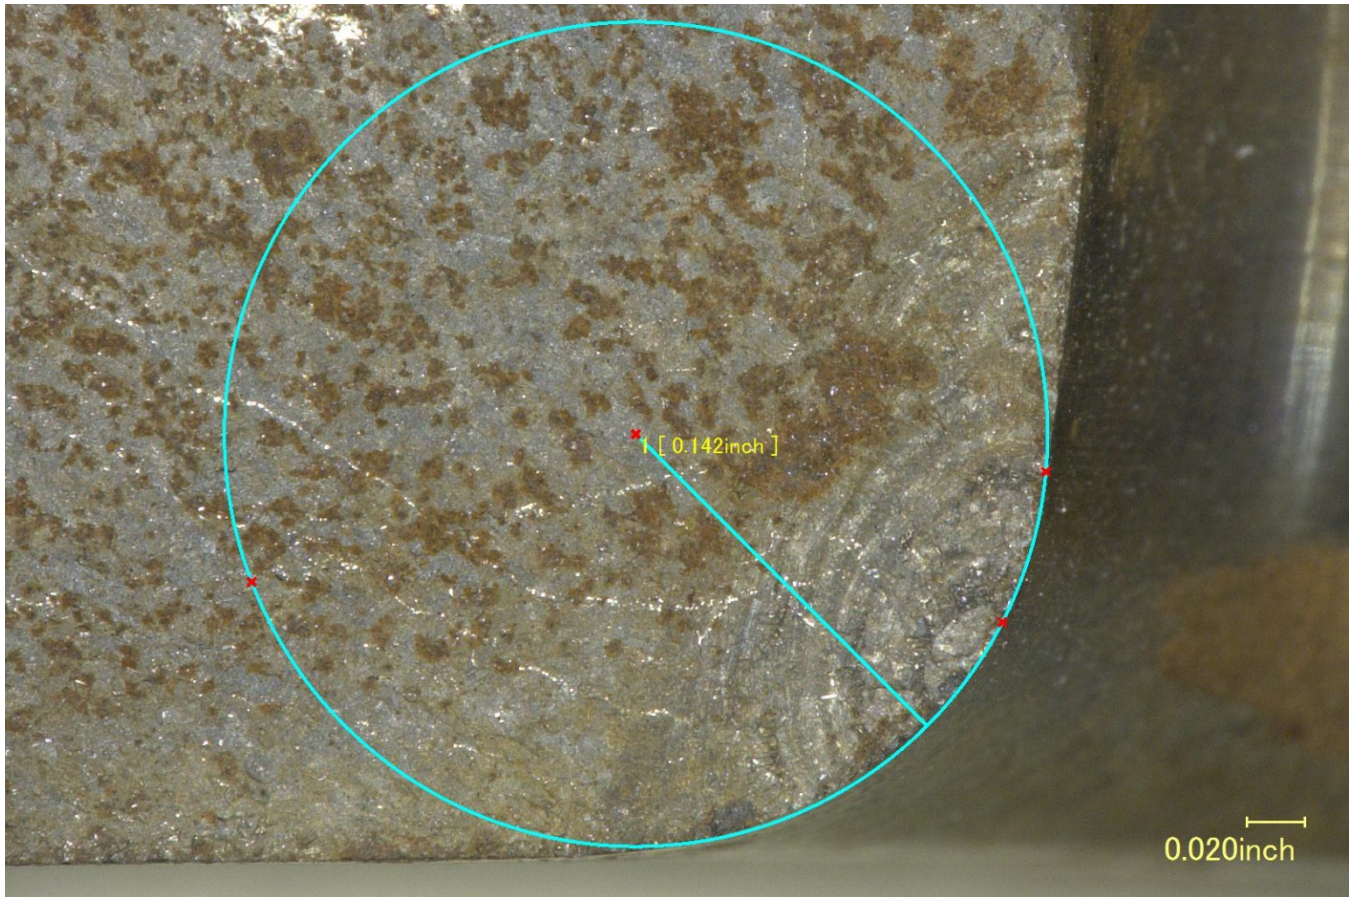
Figure 19 – Radius of curvature measurement at the thumbnail crack location.

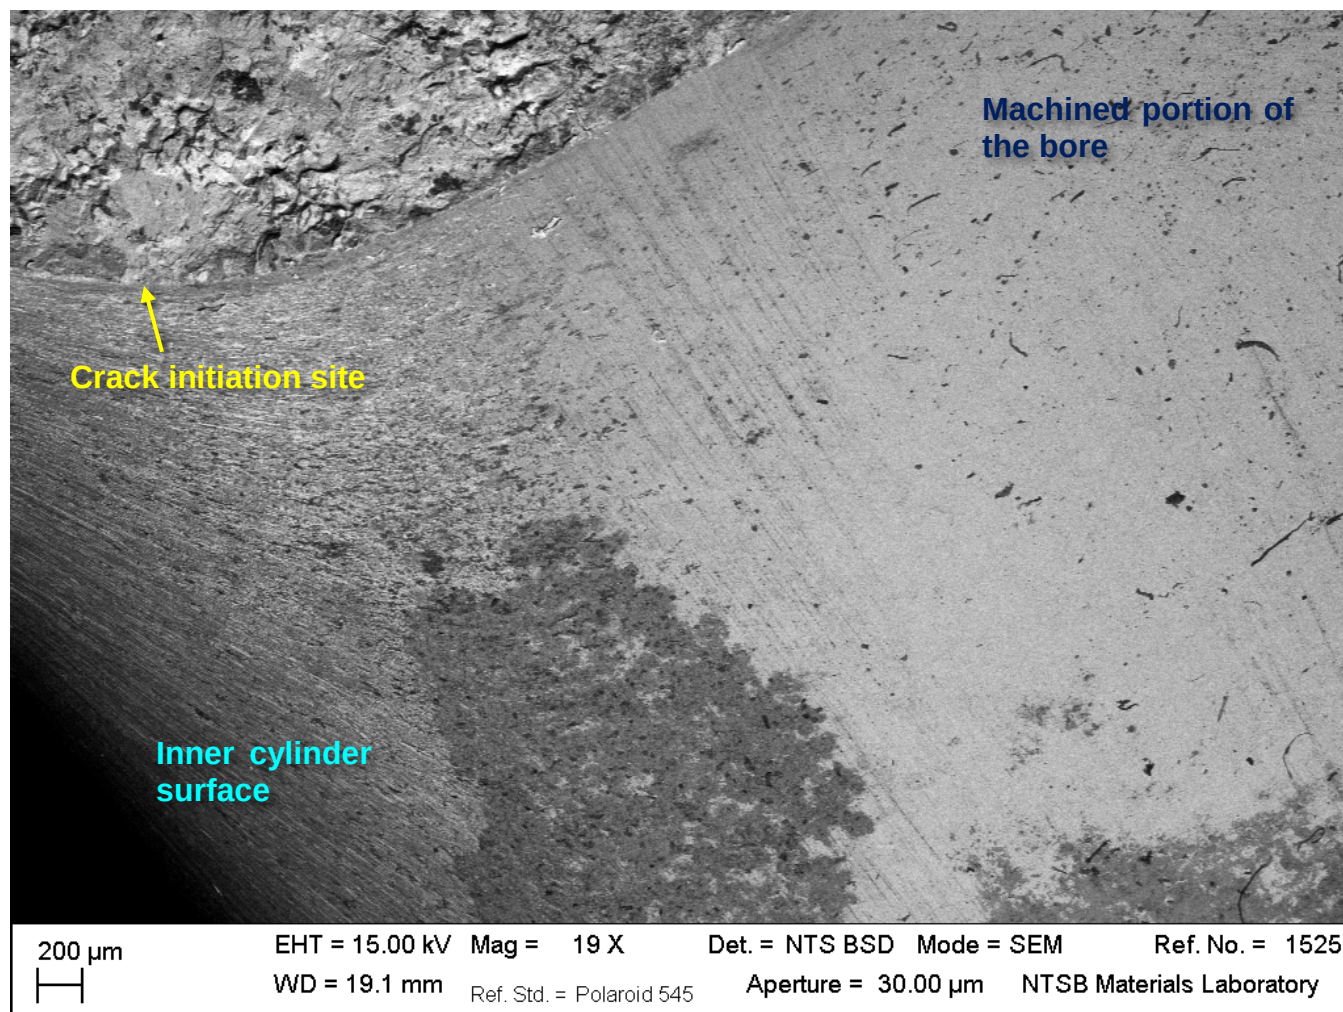
Figure 20 – Backscattered electron (BE) micrograph of the fracture surface initiation area, viewed tilted with the inner bore and inner surface shown.

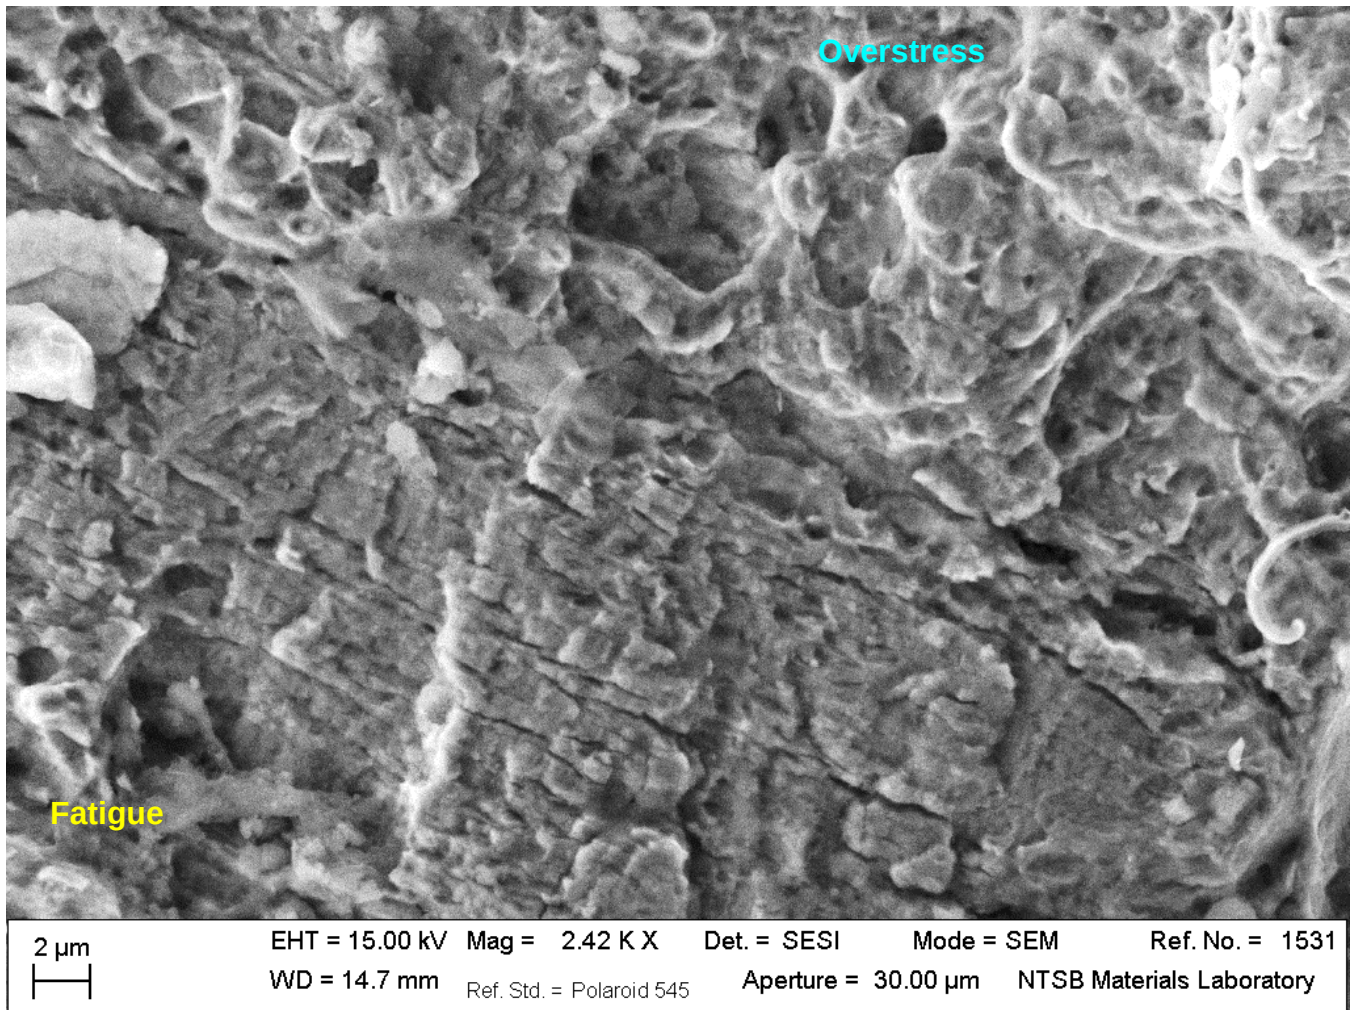
Figure 21 – SE micrograph of the end of the fatigue crack, showing striations.

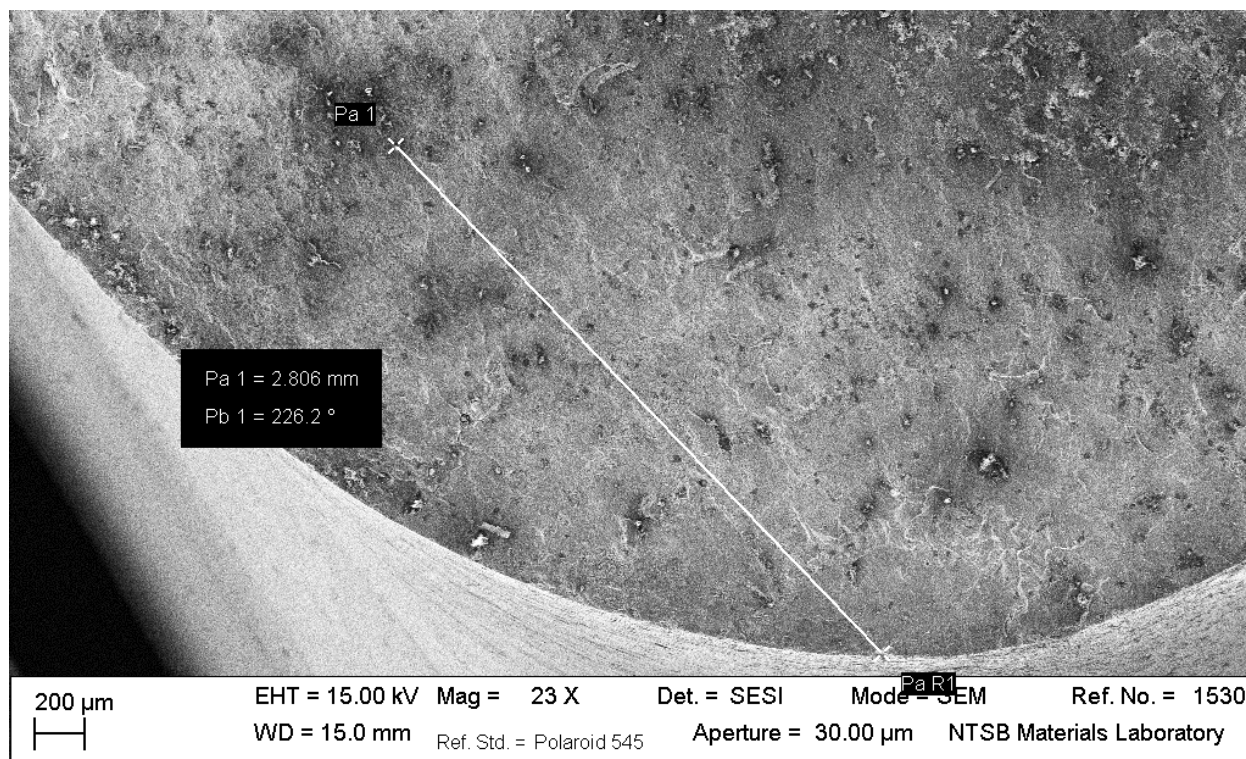
Figure 22 – SE micrograph showing the measured distance of the shorter side of the fatigue thumbnail crack.

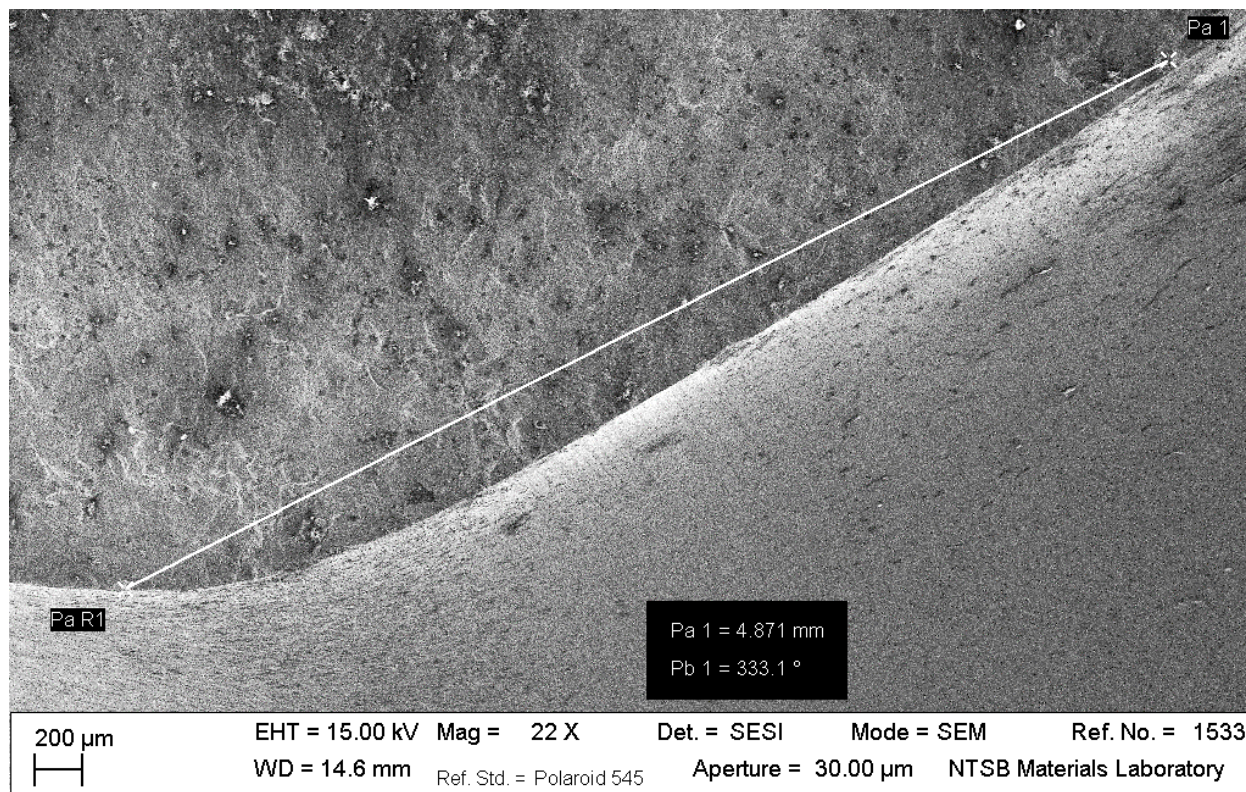
Figure 23 – SE micrograph of the thumbnail showing the extent of the fatigue cracking.
