# NATIONAL TRANSPORTATION SAFETY BOARD

Office of Research and Engineering  
Materials Laboratory Division  
Washington, D.C. 20594

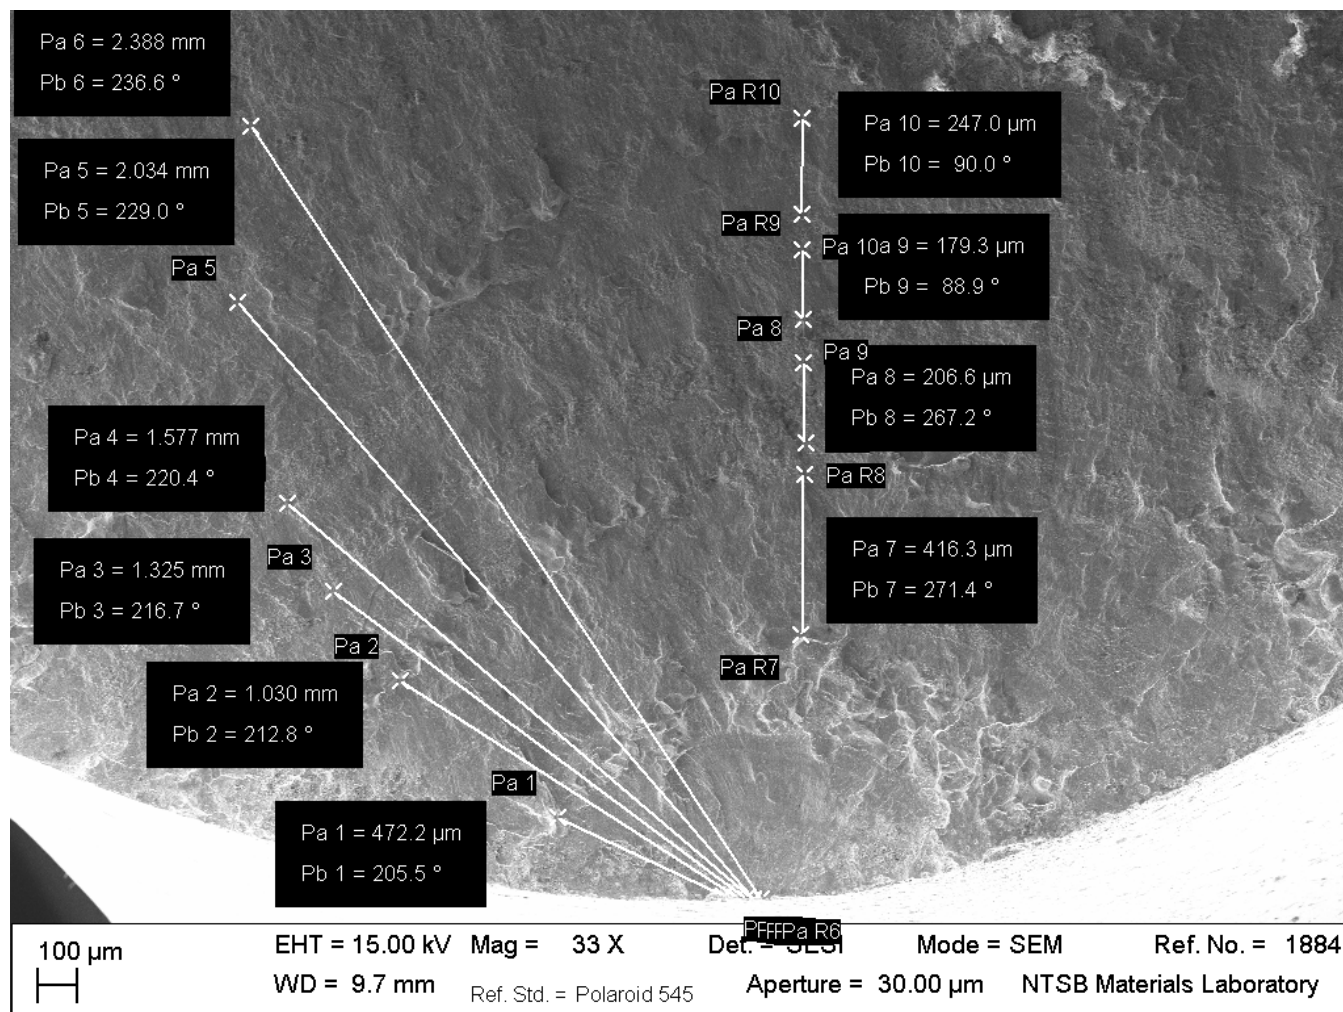
Figure 24 – SE micrograph showing the distances from the fatigue crack initiation site to the different failure mode bands (left side), and the depths of the secondary fatigue bands (right).

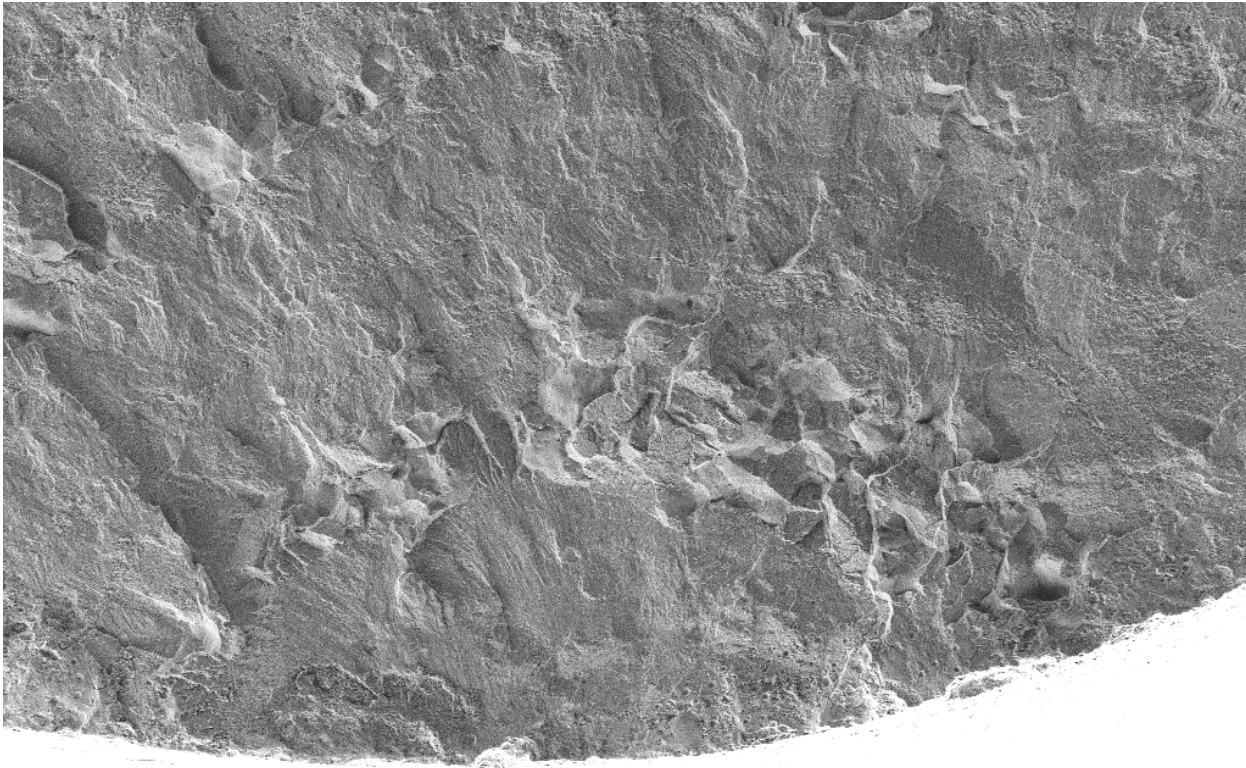
| 100 $\mu$ m | EHT = 15.00 kV | Mag = 59 X | Det. = SEI | Mode = SEM | Ref. No. = 1841 |

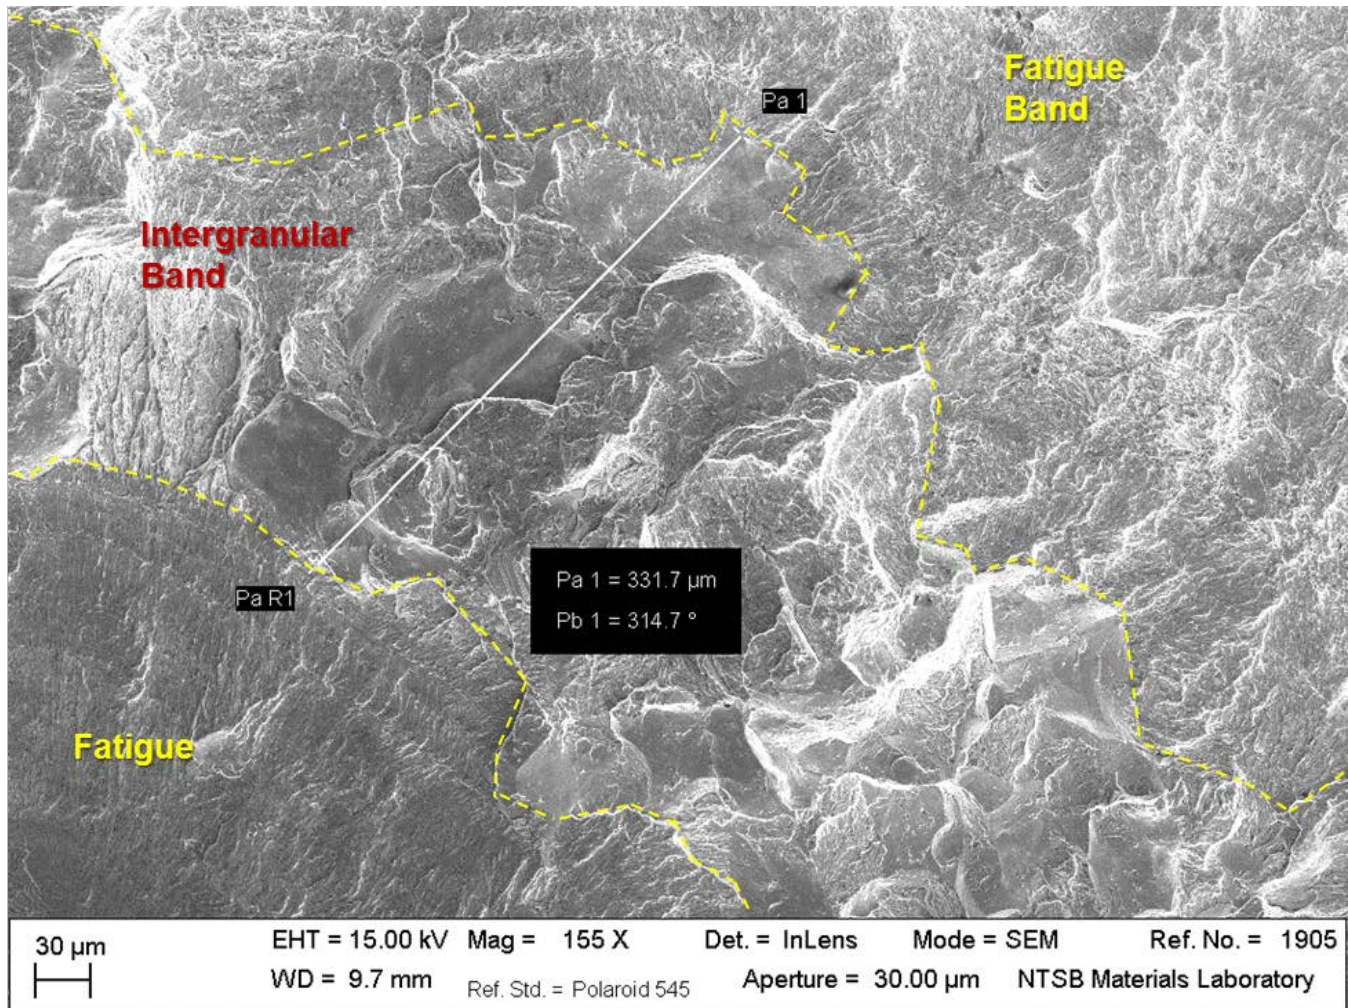
Figure 26 – SE micrograph showing the intergranular band on the landing gear fracture surface.

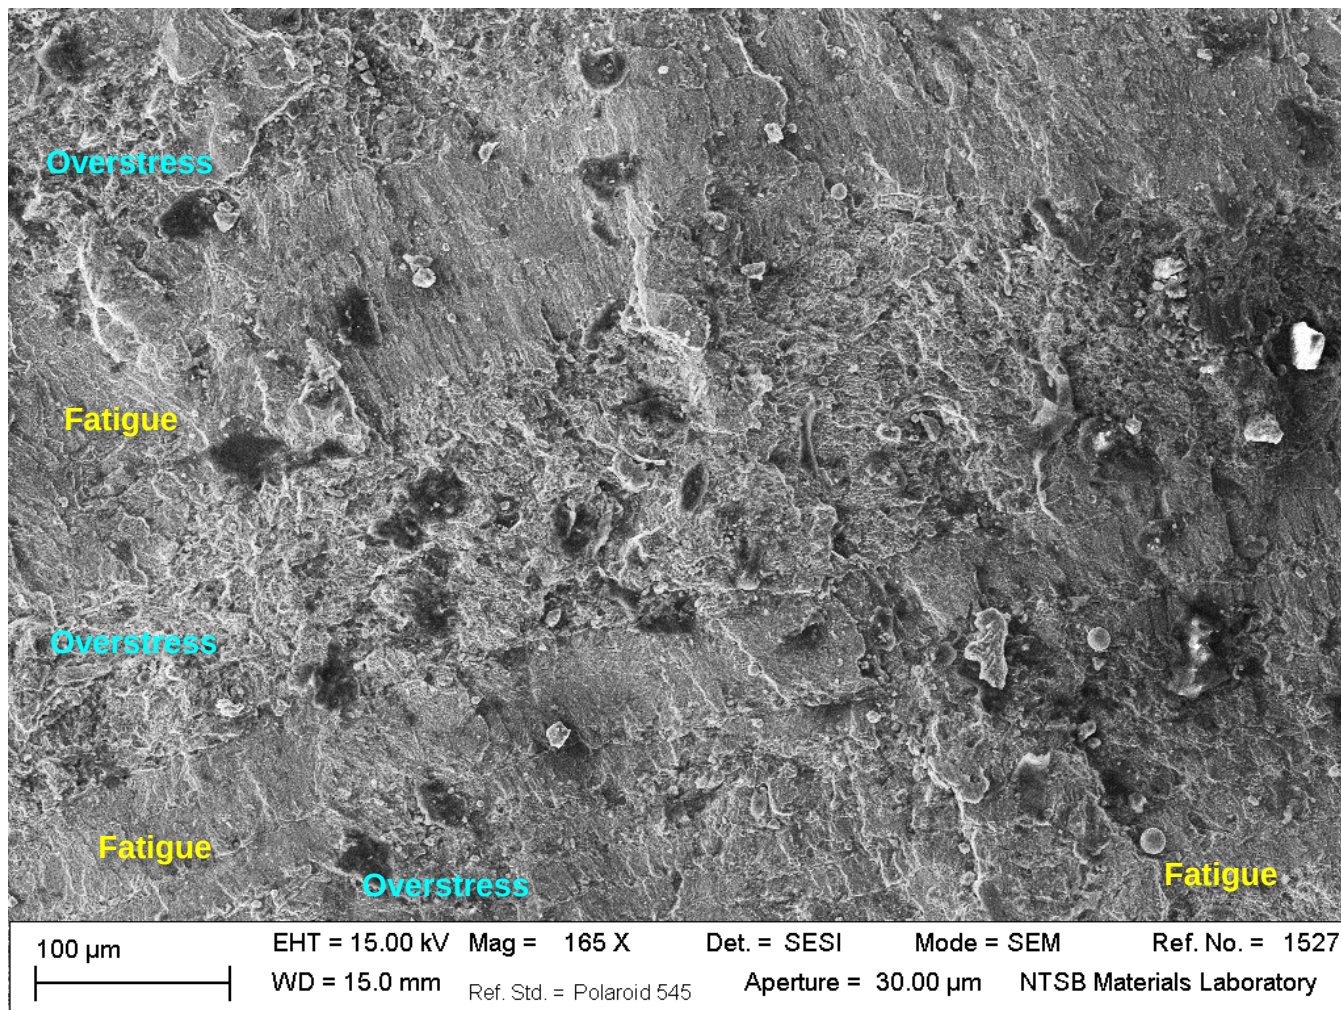
Figure 27 – SE micrograph showing intermittent overstress (dimple rupture) regions among fatigue crack growth.

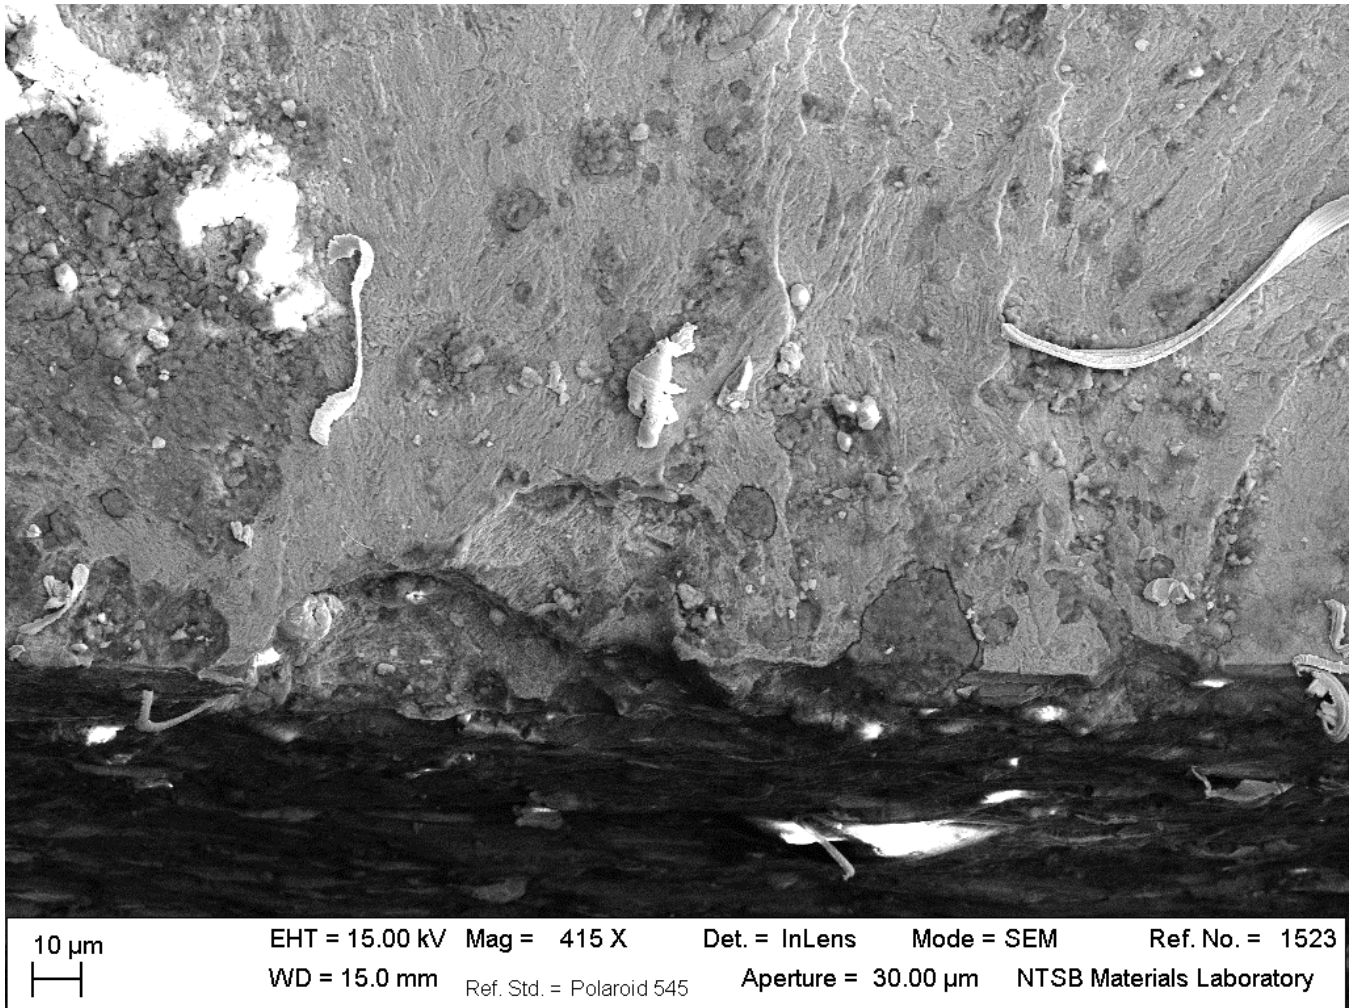
Figure 28 – Backscattered electron (BE) micrograph of the fatigue crack initiation site, showing a corrosion pit.

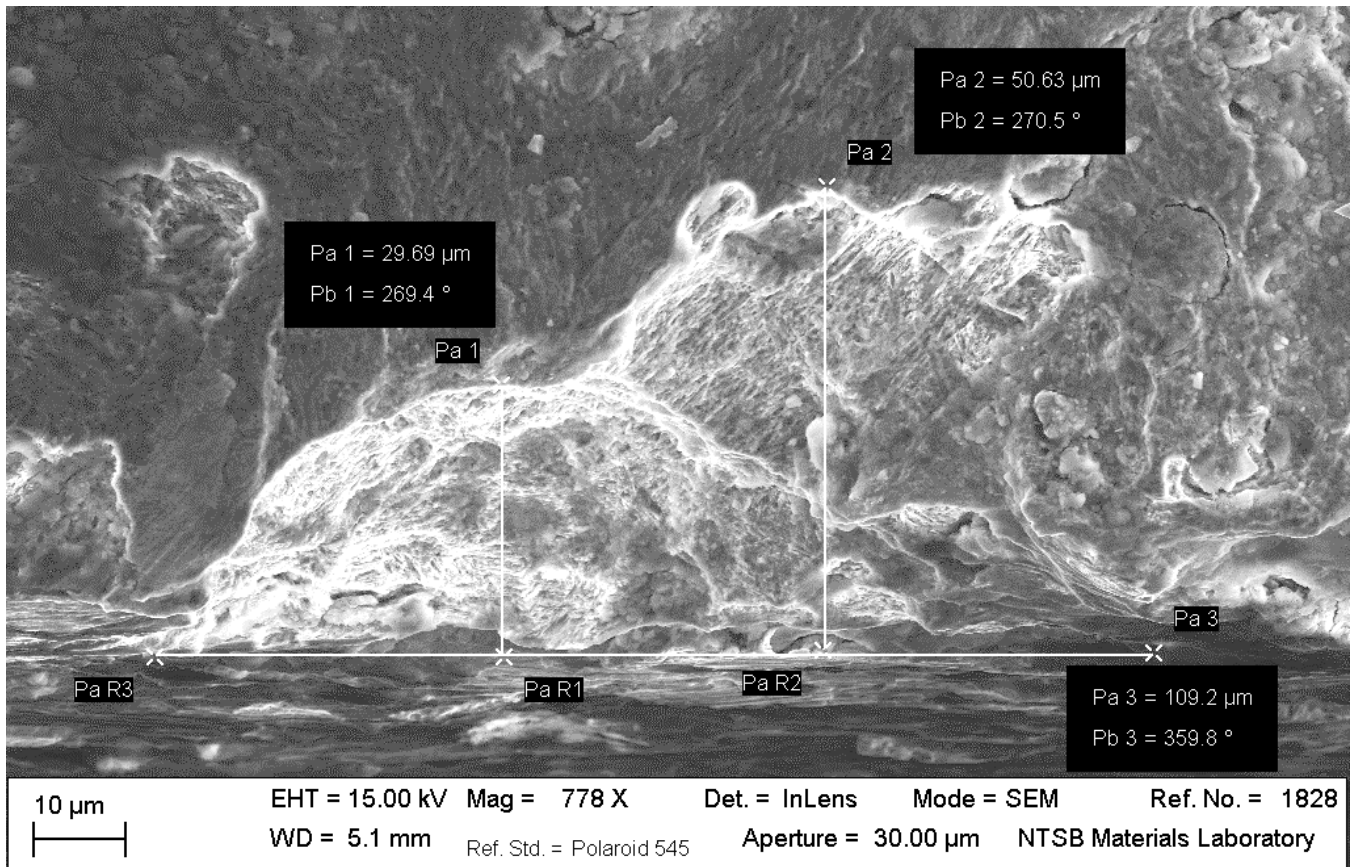
Figure 29 – SE micrograph of showing measurements of the corrosion pit in Figure 28.

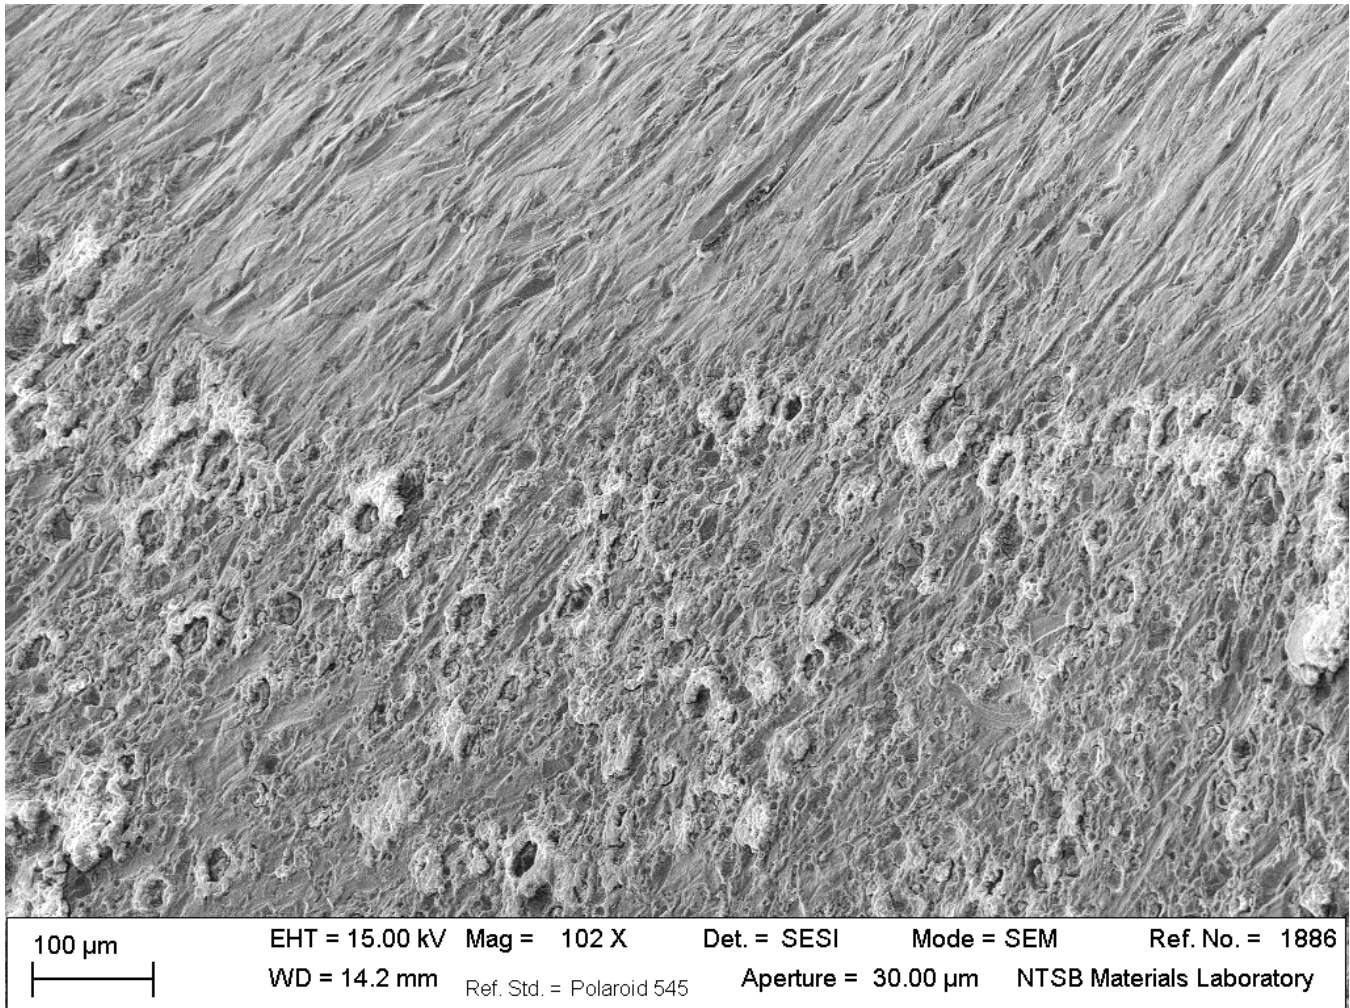
Figure 30 – SE micrographs showing colonies of corrosion pits at the radius of the bore.

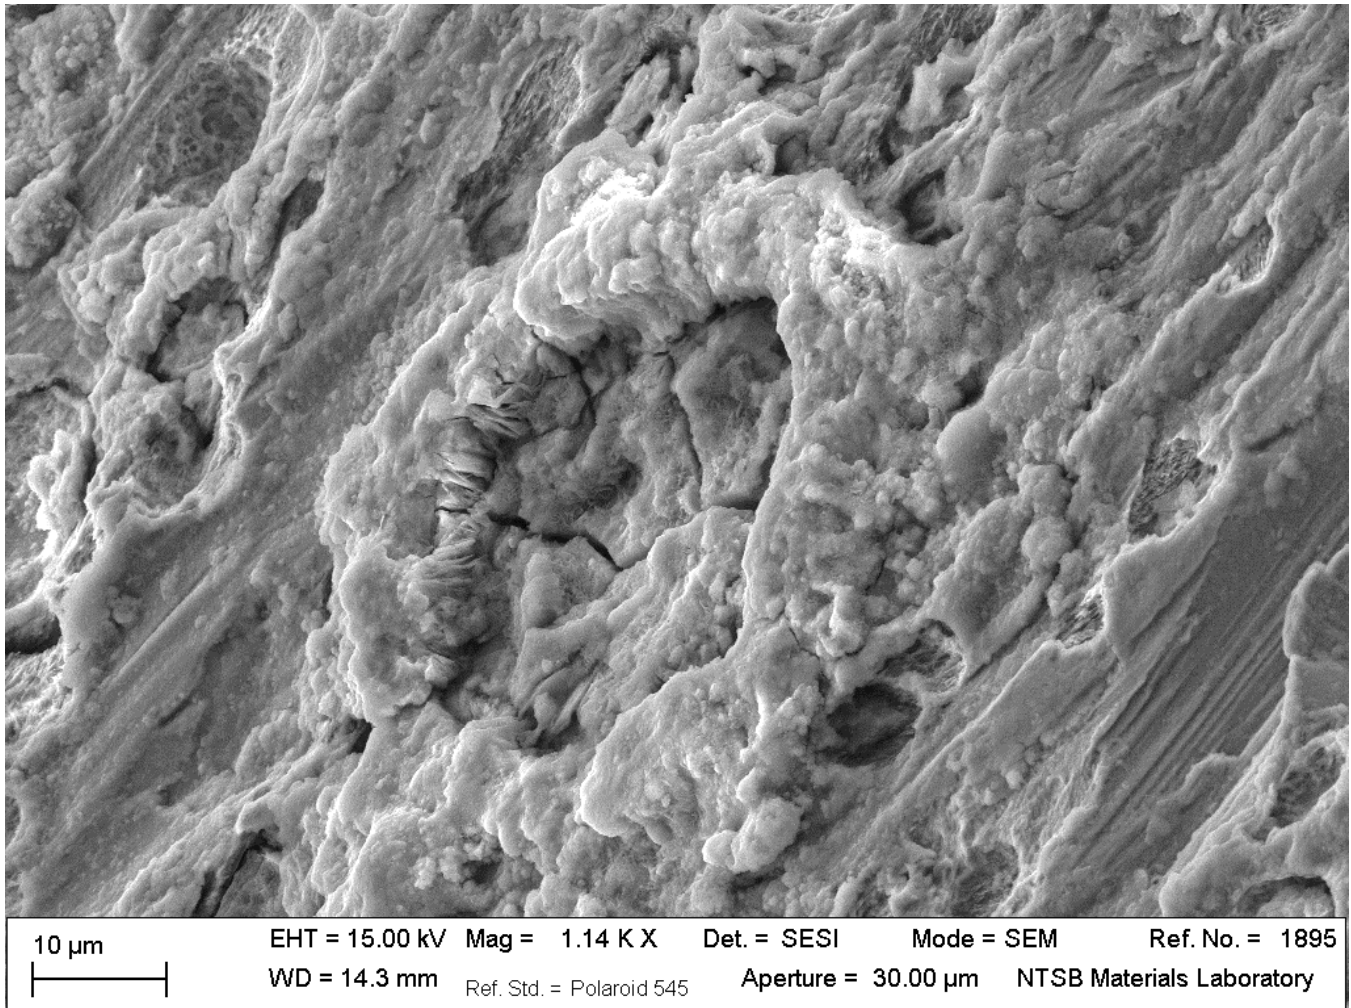
Figure 31 – SE micrograph showing a closer view of a corrosion pit on the valve bore.

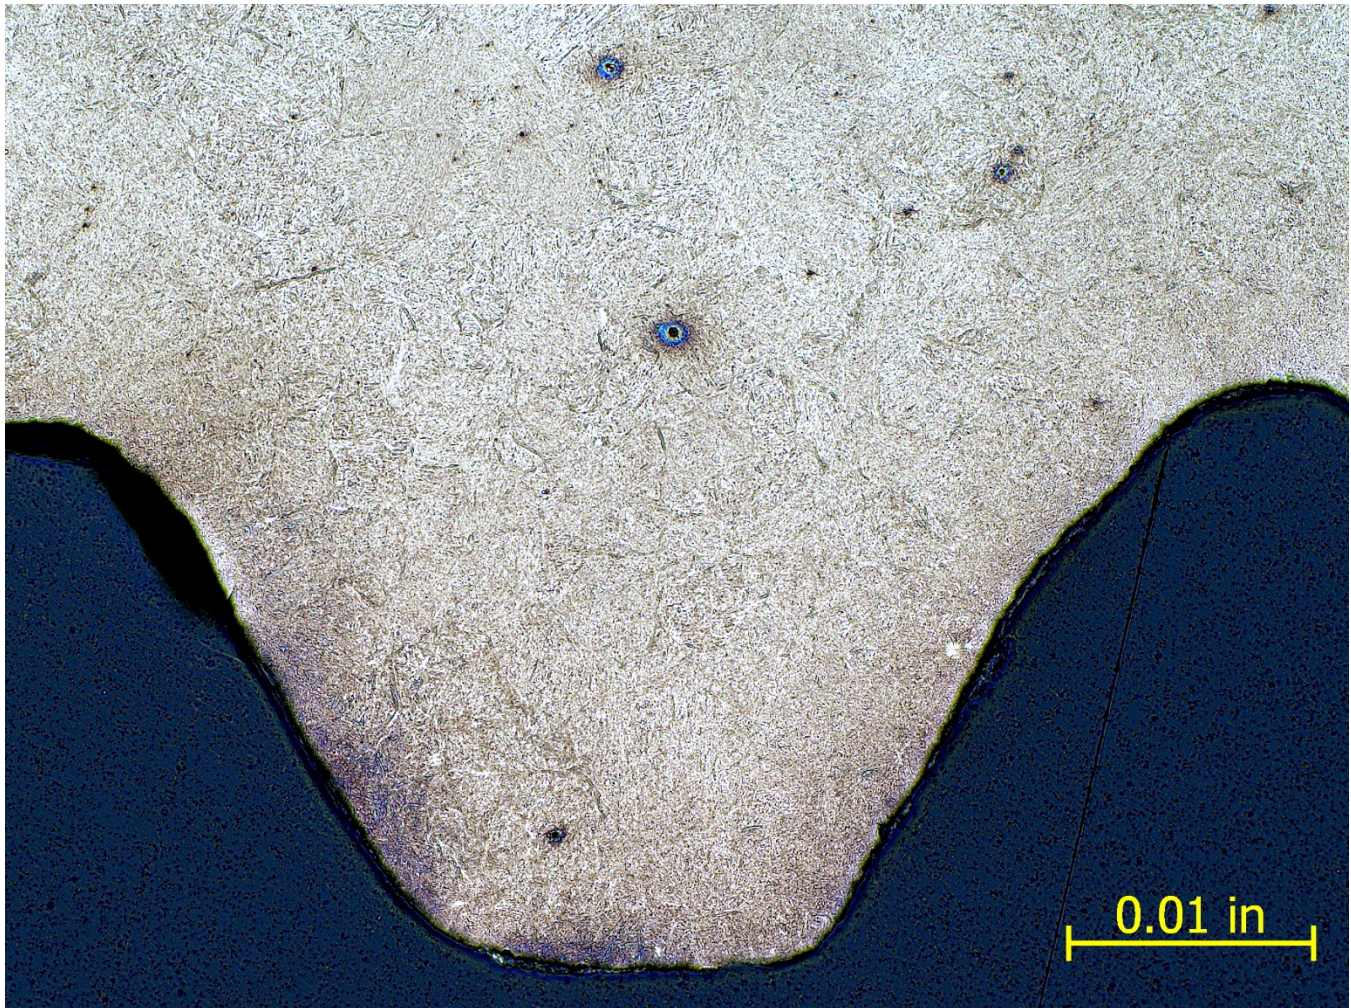
Figure 32 – Bright field micrograph of a cross-section of a thread root in the bore (~100X, etched 2% Nital).

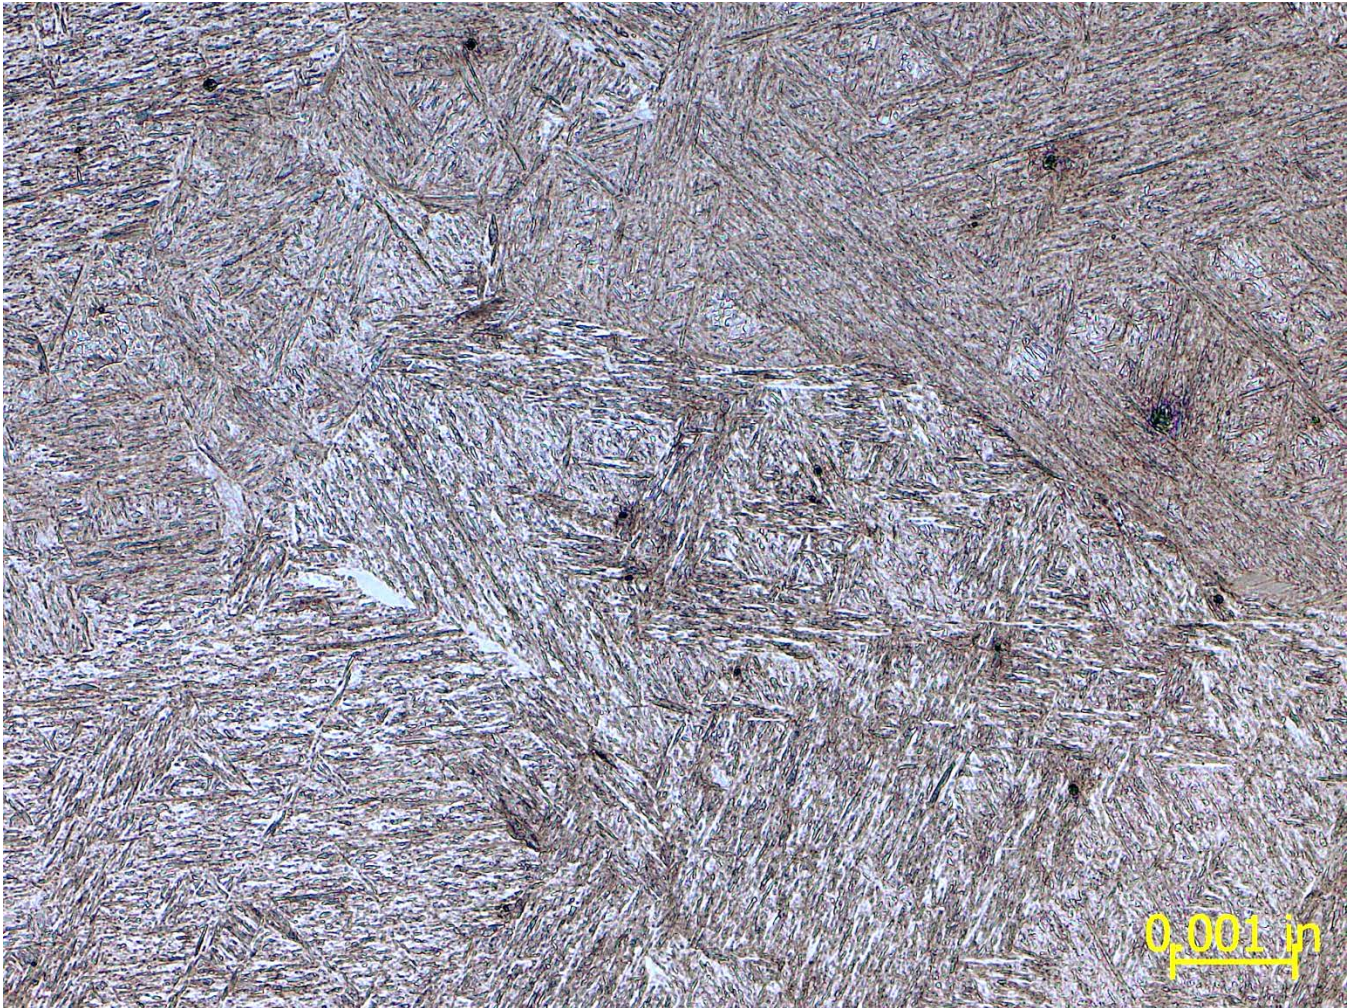
Figure 33 – Bright field micrograph showing the etched microstructure of the landing gear cross section, consistent with tempered martensite features (~500X, etched 2% Nital).

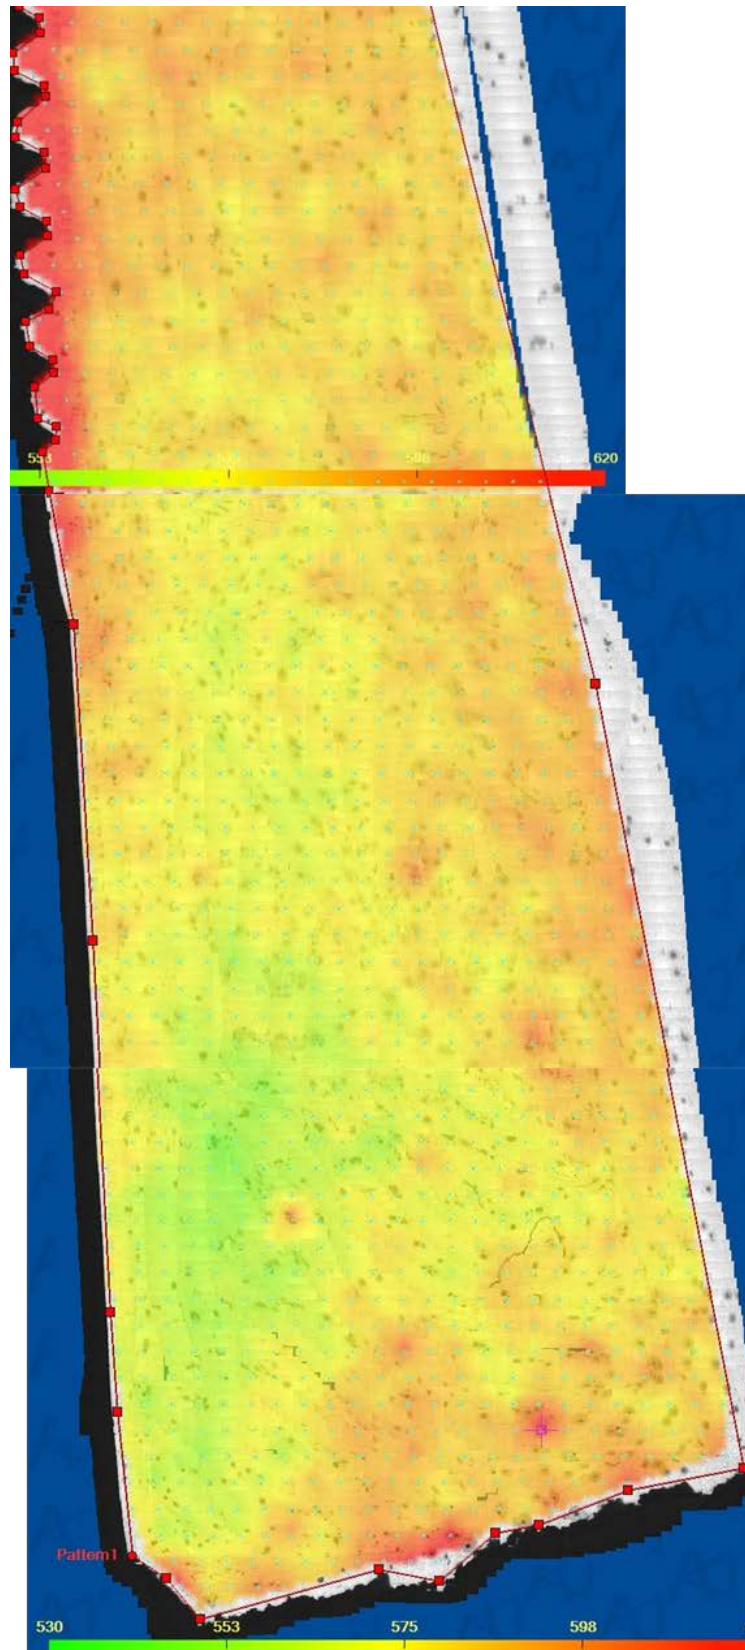
Figure 34 – False color microindentation hardness map of a cross-section of the material near the bore fracture surface. The hardness ranges from green, representing 52 HRC (530 HV<sub>500</sub>), to red, 56 HRC (620 HV<sub>500</sub>).
