**Internal Memorandum**

**Subject:** II17-206 FLT SAFETY/NTSB – PUSHBACK DAMAGE: DAL2421 12-DEC-17 DTW-DTW MD-88-88  
N924DL (924) CAP: AKIYAMA, J.S.; FO: LYNCH, S.F.

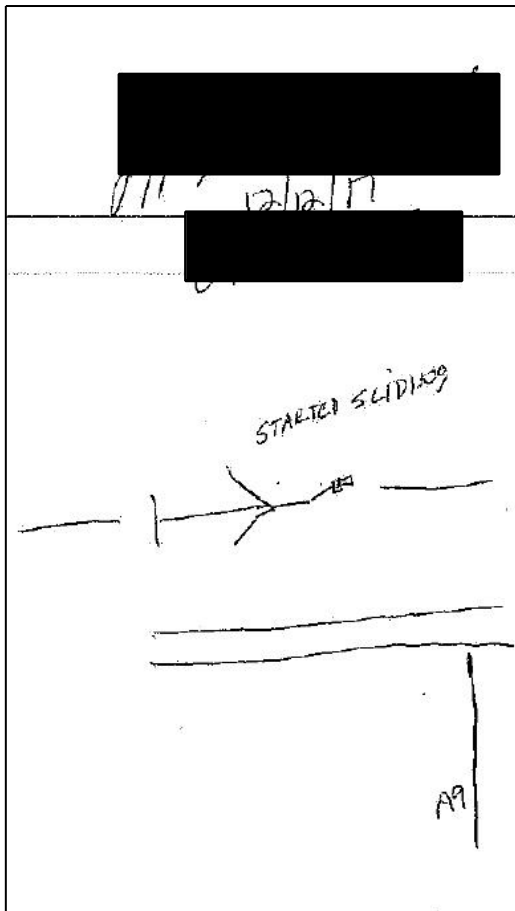
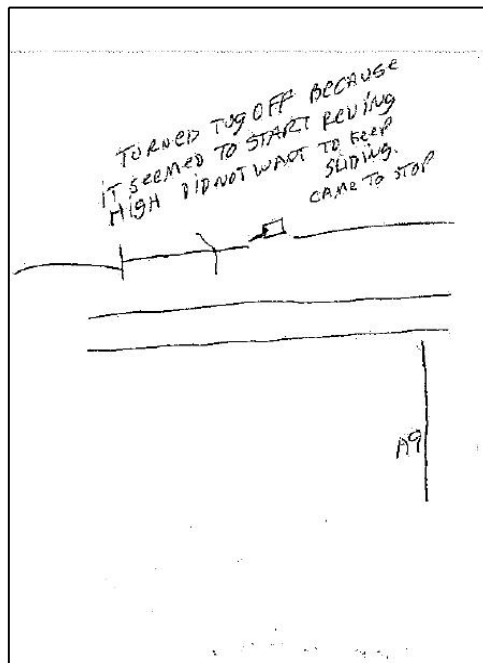
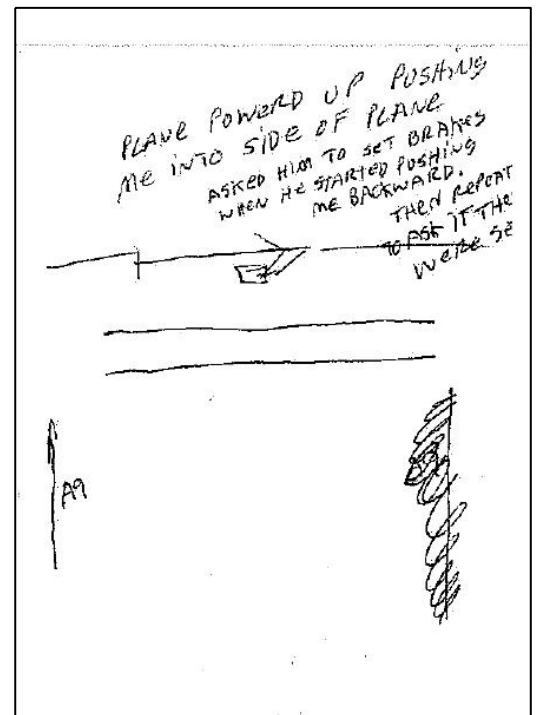
-Damage to Aircraft/Equipment/Facility/Other -What type of GSE was involved? -Who was involved?  
 -Where were you? -What were you doing? -What did you see? -When did you see it?  
 - Was the ALA/AIC present at the time of the incident? PUSHING AIRCRAFT TAIL NORTH  
 OUT OF A9 AS I WAS COMPLETING TURN TUG STARTED SLIDING A BIT  
 THEN PUSHBACK WHILE FOOT ON BRAKE STARTED REVING HIGH. I THEN  
 SHUT PUSHBACK OFF BUT AIRCRAFT SEEMED TO POWER UP PUSHING  
 THE PUSHBACK BACKWARD AT LEAST A COUPLE HUNDRED FEET. PUSHBACK  
 ENDED SLAMING INTO SIDE OF AIRCRAFT. I ASKED PILOT SEVERAL  
 TIMES IF BRAKES WERE SET BECAUSE HE WAS PUSHING ME  
 BACKWARDS. I ASKED PILOT TO SET BRAKES BUT AFTER HE WAS  
 PUSHING ME BACKWARDS.

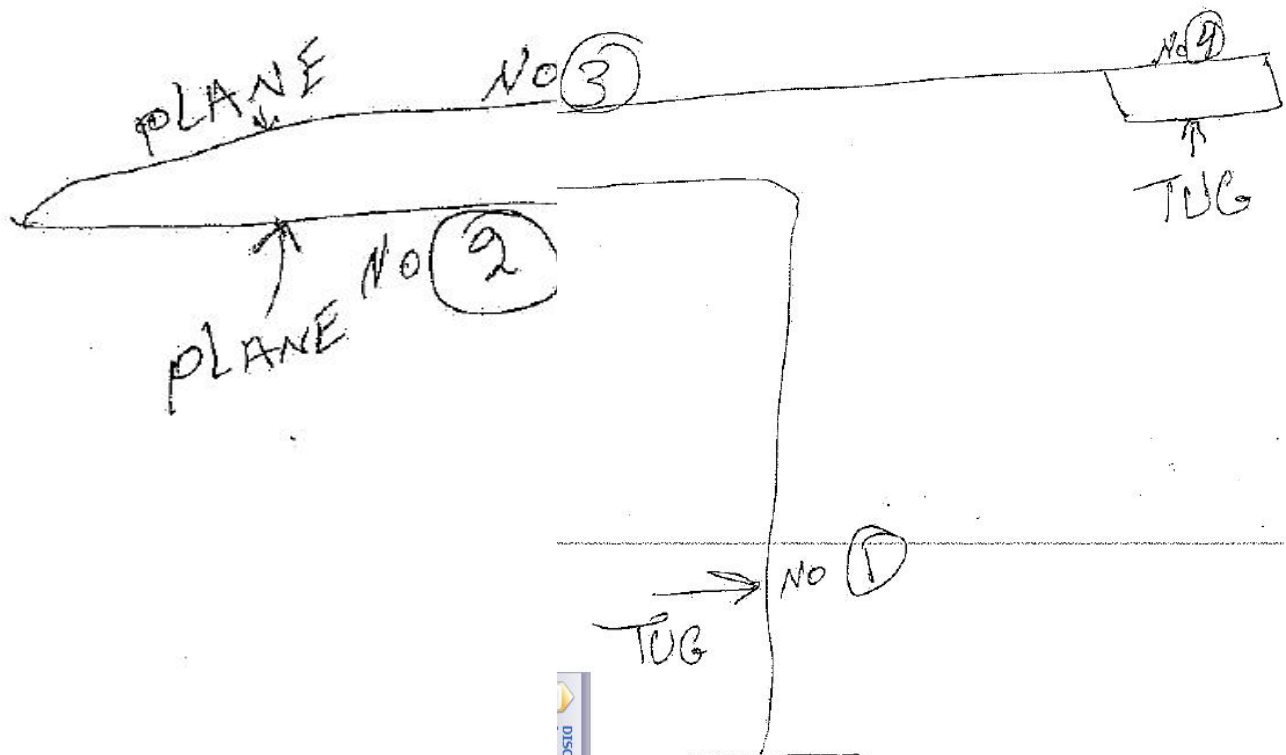
JEFF PUCK PLANE HE MAKE  
LEFT TURN IN HE STOP  
THEN PLANE PUCK THE TUG  
FORT TEN THE TUG TURN  
IN IIT THE PLANE  
IN STAY MOVEN  
[REDACTED] 12-12-17
