## National Transportation Safety Board

RE: NTSB Investigation DCA18FA144 World Atlantic Landing Gear Failure

The investigation into the Caribbean Sun (dba World Atlantic) Boeing MD-83 (N807WA) accident that occurred in Alexandria, LA on April 20, 2018, has been completed and parts or hardware that were retained to support the investigation are due to be returned.

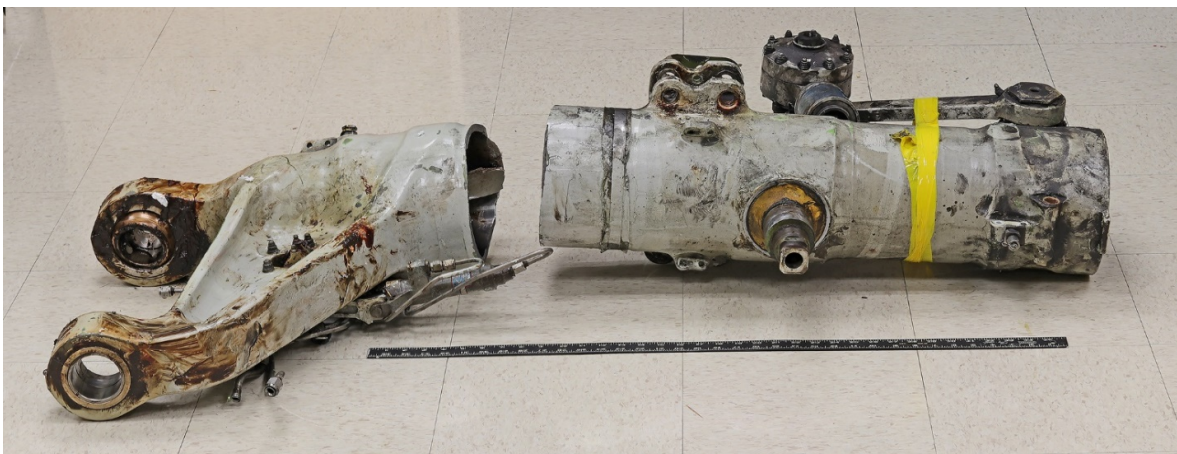
On-scene, the right main landing gear's outer cylinder was found fractured roughly in half. Both halves were shipped to Boeing's Huntington Beach facility in Huntington Beach, California, for further examination. The upper half of the outer cylinder measured about 20.4 inches and the lower half of the outer cylinder measured about 29.9 inches. A fatigue fracture was identified along the break in the outer cylinder, and two sections, about 3.5-inch by 2-inch each, were cut from each half of the outer cylinder. The NTSB retained one of the removed sections of the fatigue fracture for further analysis and Boeing retained the other removed section for analysis. Boeing also retained the remainder of the two halves of the outer cylinder at their Huntington Beach facility.

Landing gear outer cylinder as received at Boeing's Huntington Beach facility

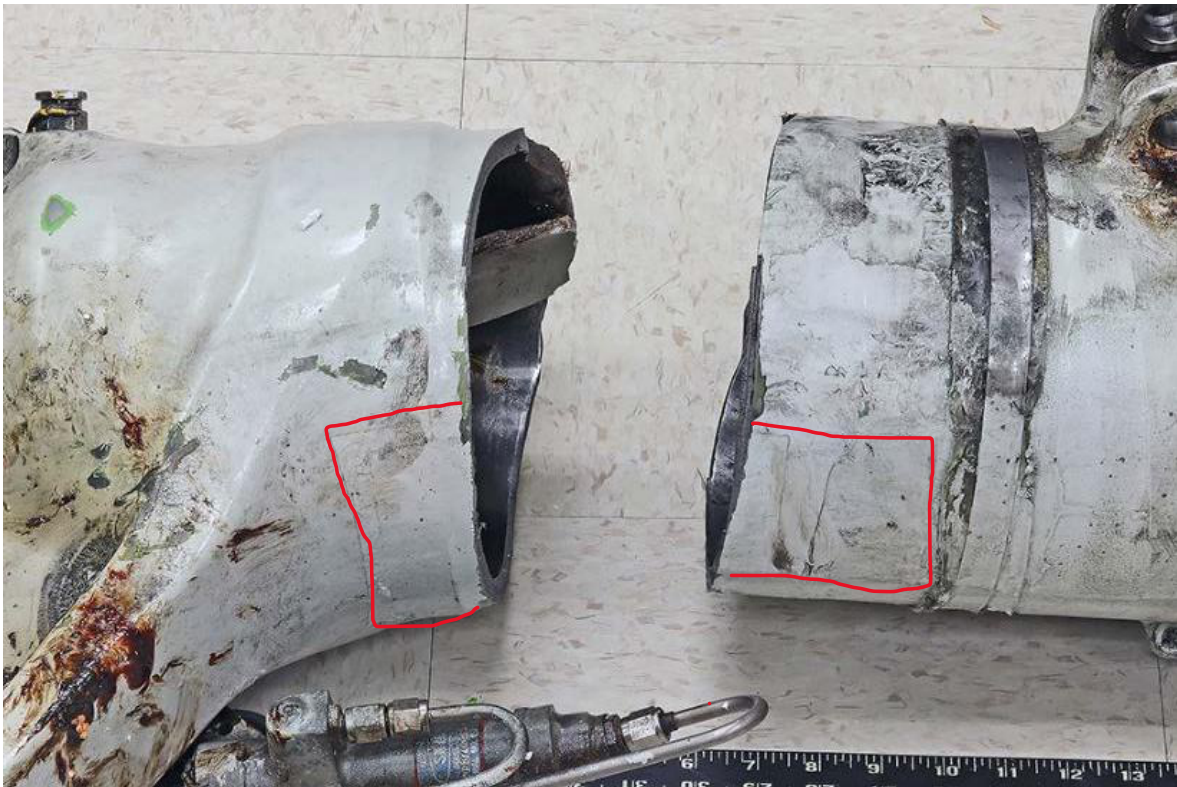
Outer cylinder with red markings indicating cutting area

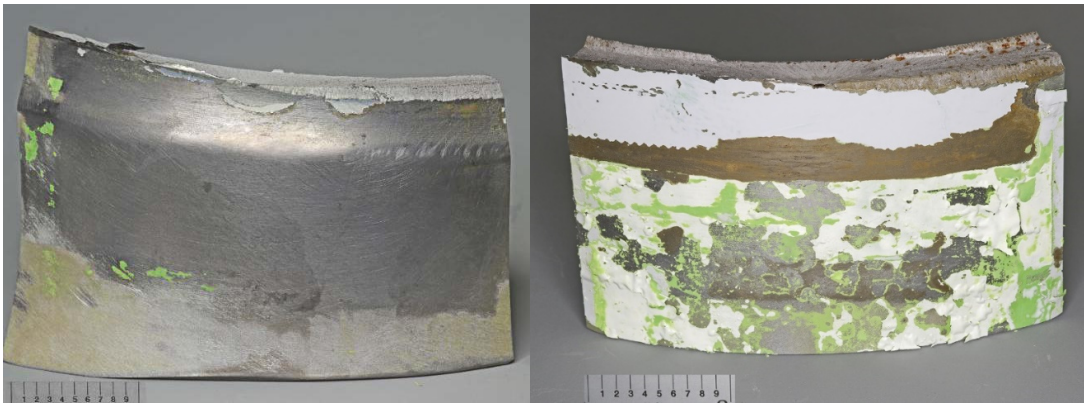
Upper Section removed (retained by NTSB) Lower section removed (retained by Boeing)

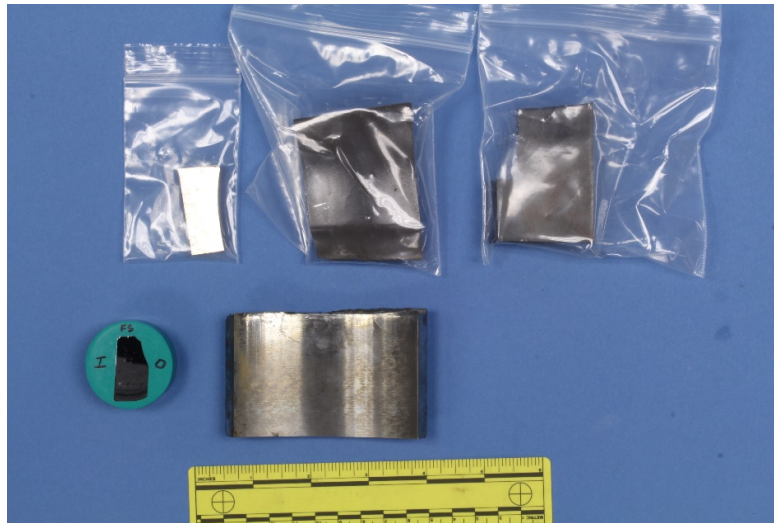
Parts as returned from NTSB Materials Lab
