# NATIONAL TRANSPORTATION SAFETY BOARD

## MATERIALS LABORATORY FACTUAL REPORT

Report No. 18-057

Place : Alexandria, Louisiana  
Date : April 20, 2018  
Vehicle : Boeing MD-83, N807WA  
NTSB No. : DCA18FA144  
Investigator : Lorenda Ward, AS-10

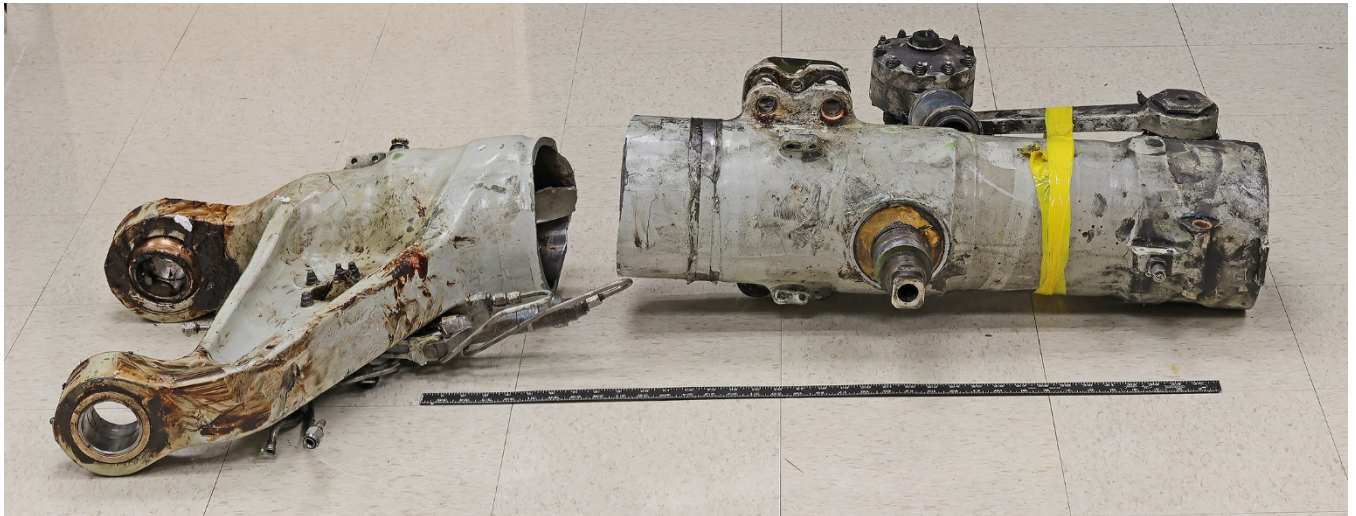
The fractured landing gear was removed, crated, and sent to Boeing's facility in Huntington Beach, CA for group examination from May 1 to May 5, 2018. The parts are shown as received in Figure 1 and Figure 2. The right main landing gear outer cylinder had fractured circumferentially with one pair of mating fracture surfaces. The fracture was oriented perpendicular to the gear's longitudinal direction and had progressed around the

Figure 1 – The fractured right main landing gear, as received.

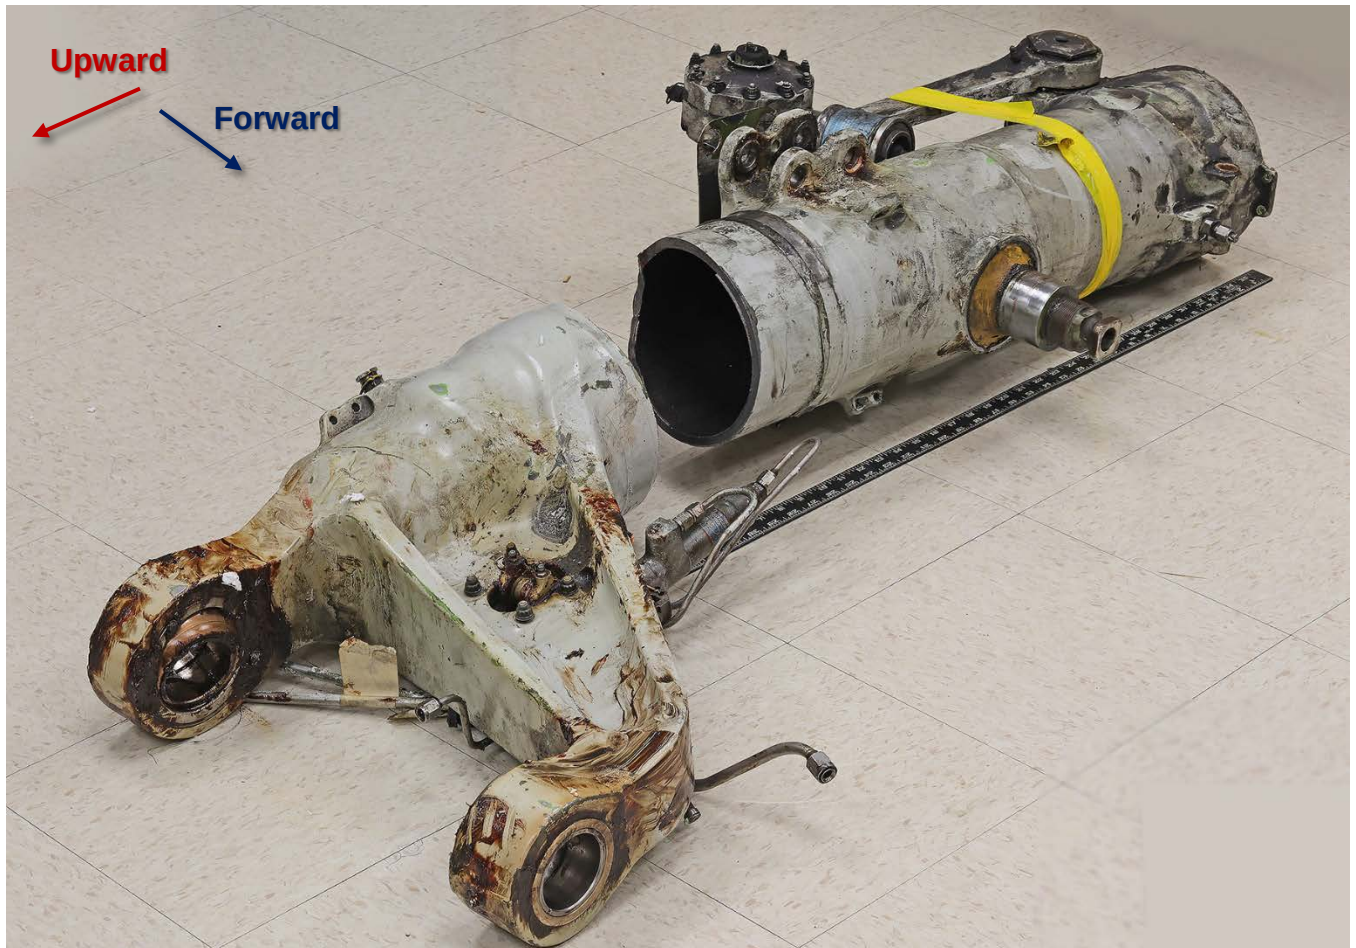
Figure 2 – An angled view of the landing gear cylinder, as received.

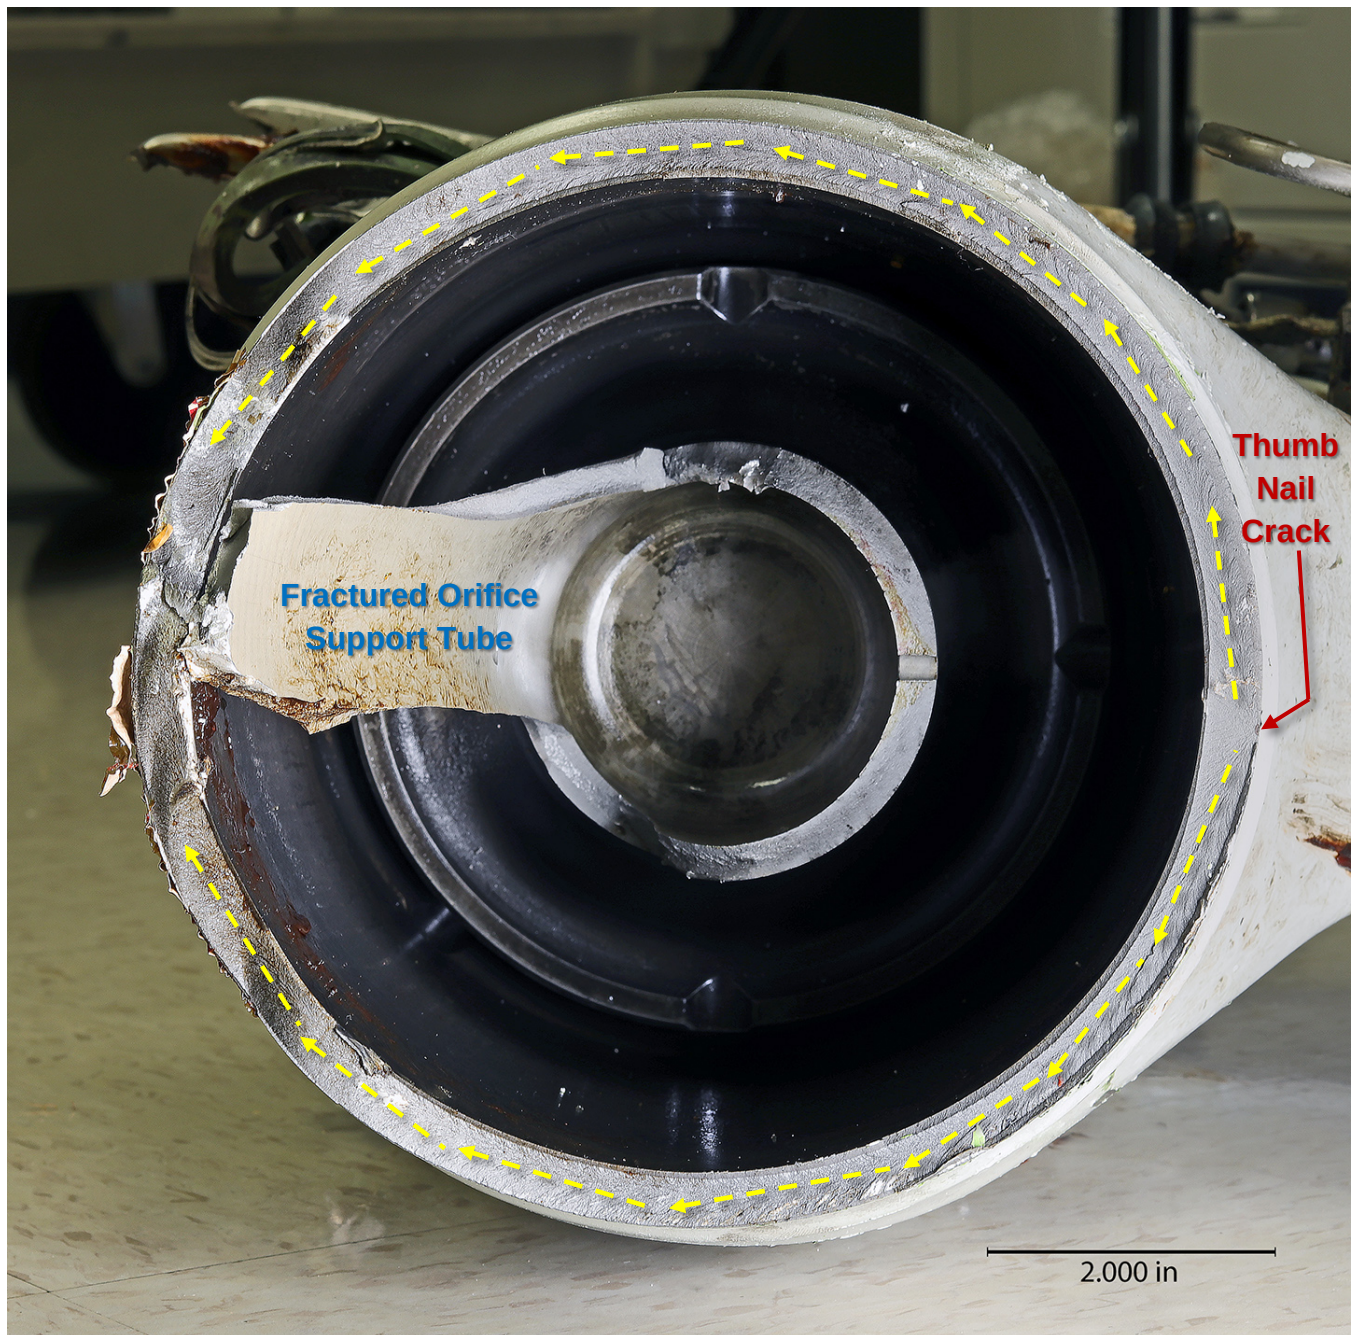
The macroscopic features were mirrored on each mating face of the fracture surface. Most of the fracture surface exhibited a dull, gray luster, with a rough surface texture (see Figure 3). Shear lips were present on the edges of the fracture surface on the outward and inward surfaces. The primary fracture feature on both fracture surfaces were chevron marks and river patterns, consistent with having emanated from the forward face of the cylinder, advancing circumferentially through the cylinder cross-section around to the aft.

Figure 3 – View of the upper fracture surface of the cylinder. The dashed arrows show the general fracture direction, from the thumbnail crack on the forward side to the aft side.

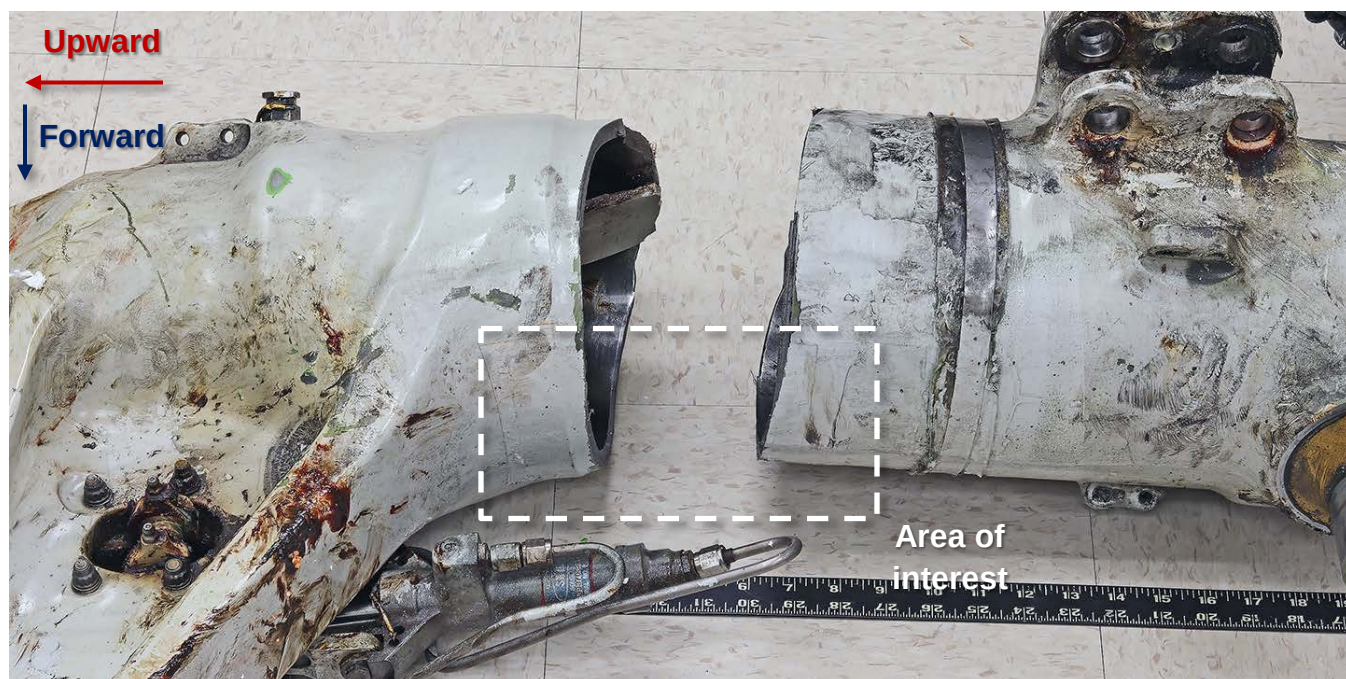
The forward face of the exterior of the fractured landing gear is shown in Figure 4. This area exhibited a rectangular-shaped area that measured 4 inches longitudinally and 5 inches circumferentially. The outlines of this area are highlighted in Figure 5 and Figure 6, which show the forward sides of the upper and lower cylinder fracture surface, respectively. After partial chemical stripping of the paint and primer from this area, the material was tested using Fourier Transform Infrared (FTIR) spectroscopy to determine if it was consistent with a protective tape or with paint.<sup>3</sup> The material examined was found to be consistent with paint, and no indications of material consistent with a prescribed (but optional) tape were found.

Figure 4 – Closer view of the forward side of the fractured landing gear, showing the area of fracture initiation on the forward side (white boxed area).

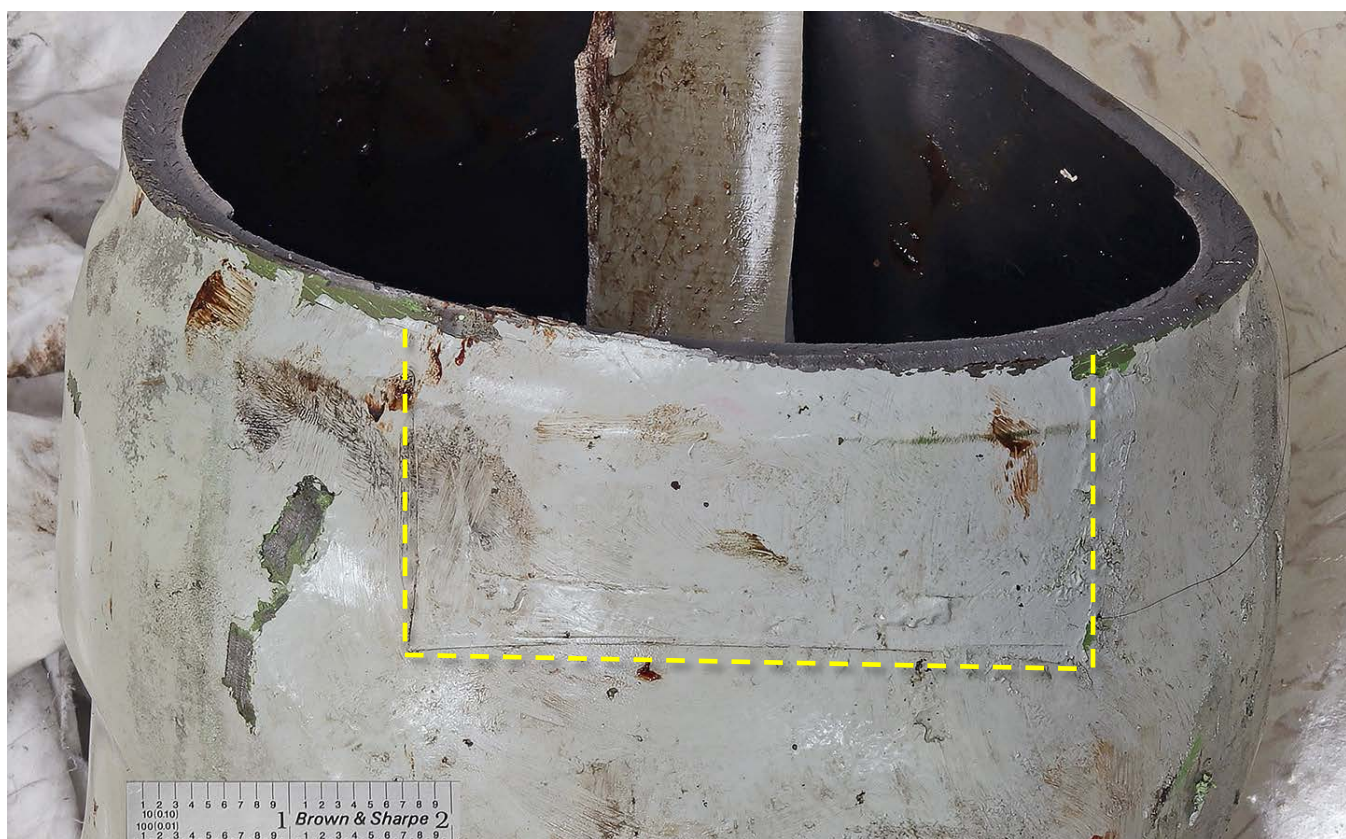
Figure 5 – View of the upper fracture surface, viewed from the forward side. The boxed area highlights the masked and repainted area.

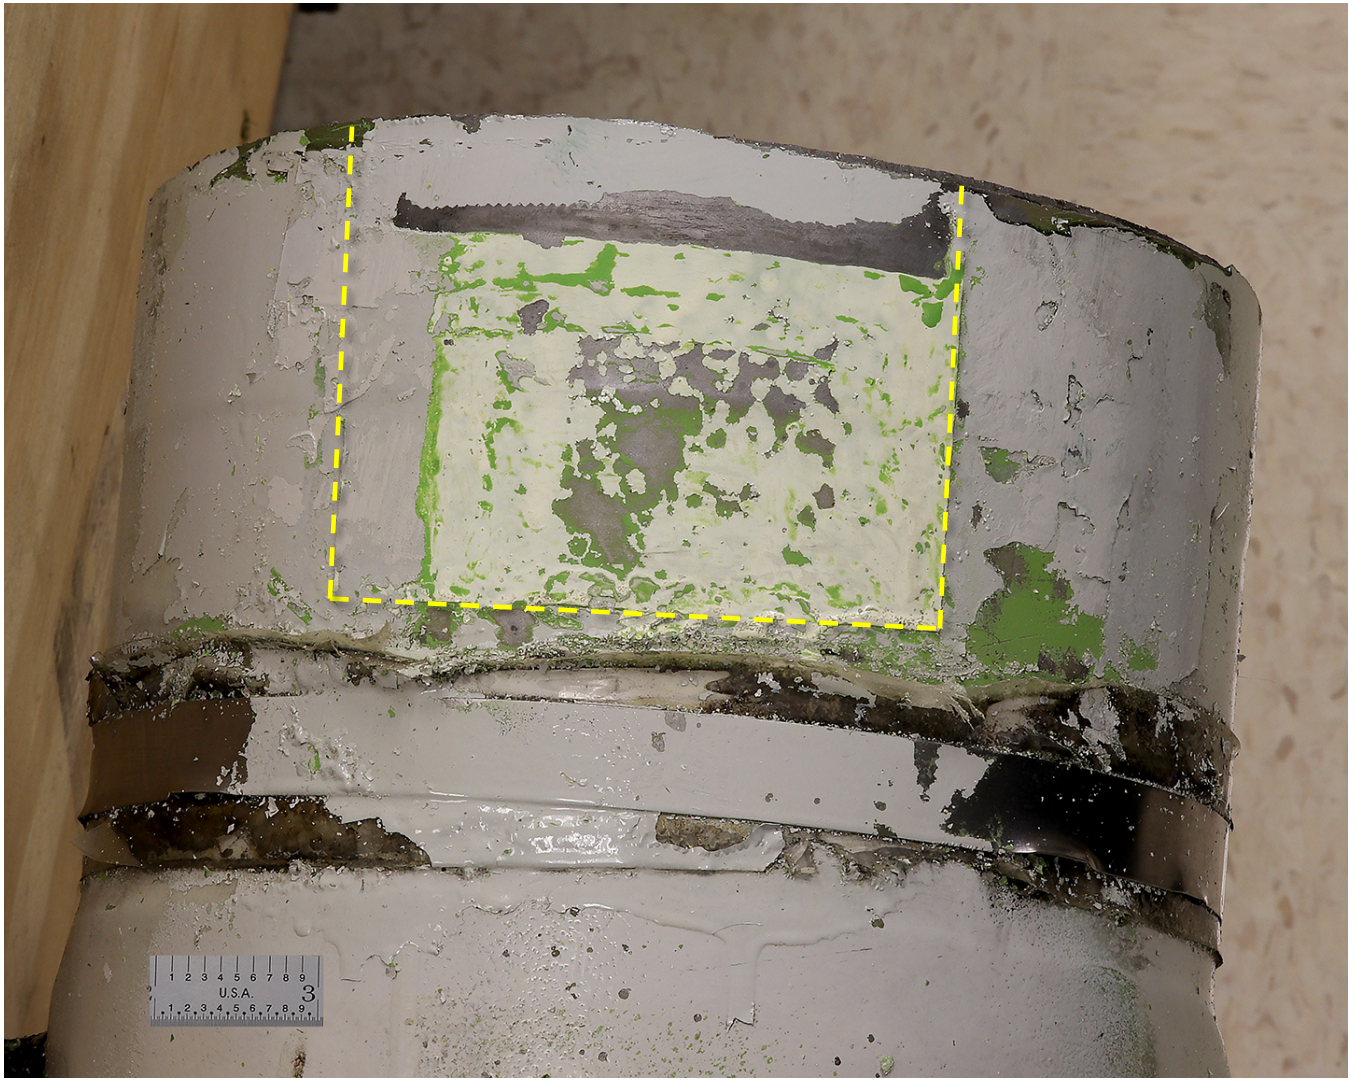
Figure 6 – View of the lower fracture surface, after some paint stripping. The boxed area highlights the masked and repainted area.

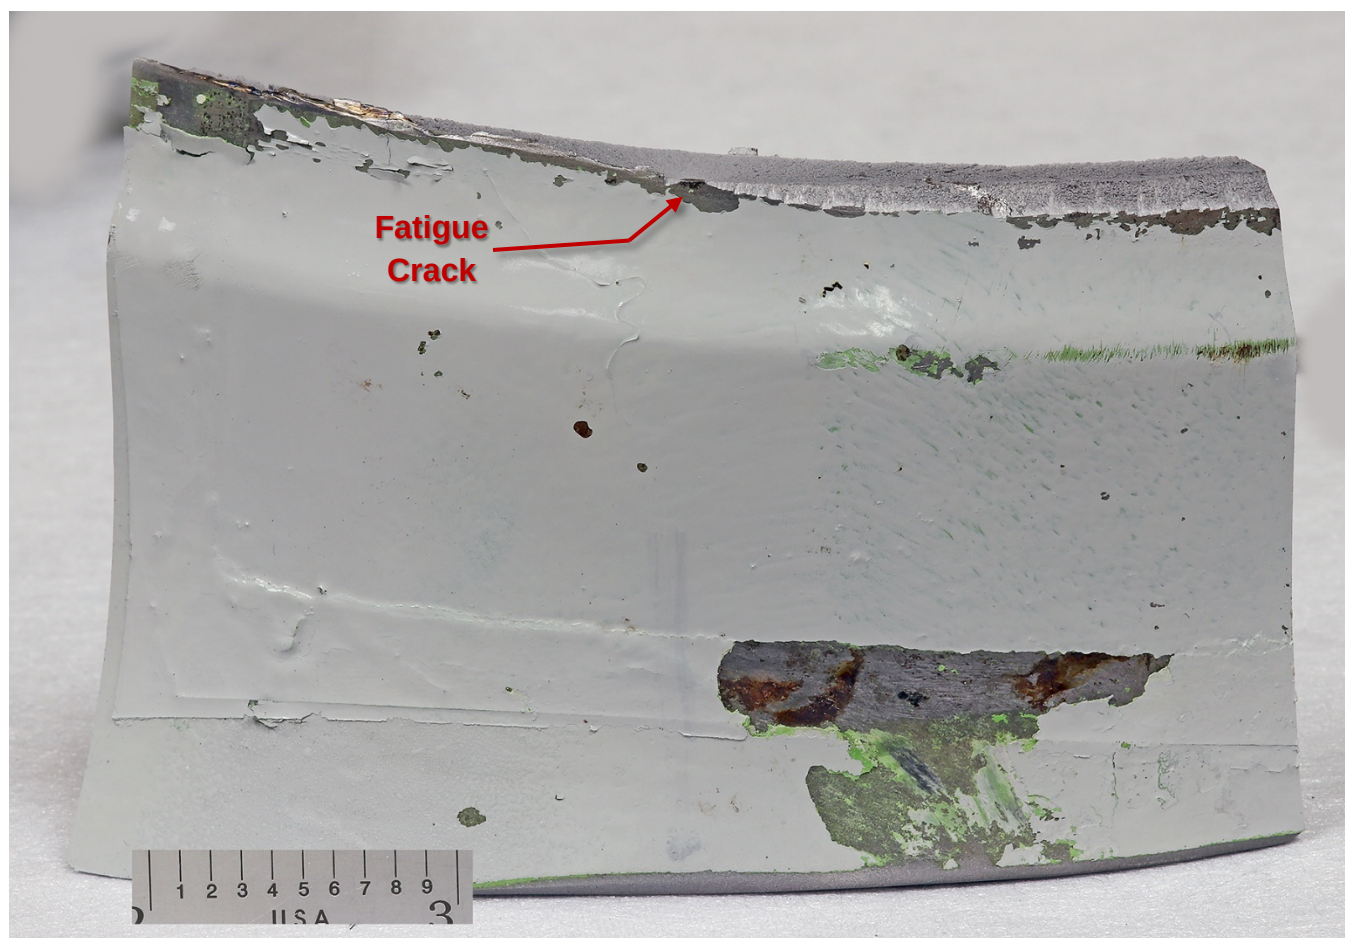
The mating sides of the fracture surface were sectioned from the larger cylinder assembly, and then again sectioned about the initiation site to facilitate microscopic examination. Figure 7 shows the portion of the upper fracture surface, after sectioning and before removal of paint and primer.

Figure 7 – Section of the upper fracture surface, after sectioning.

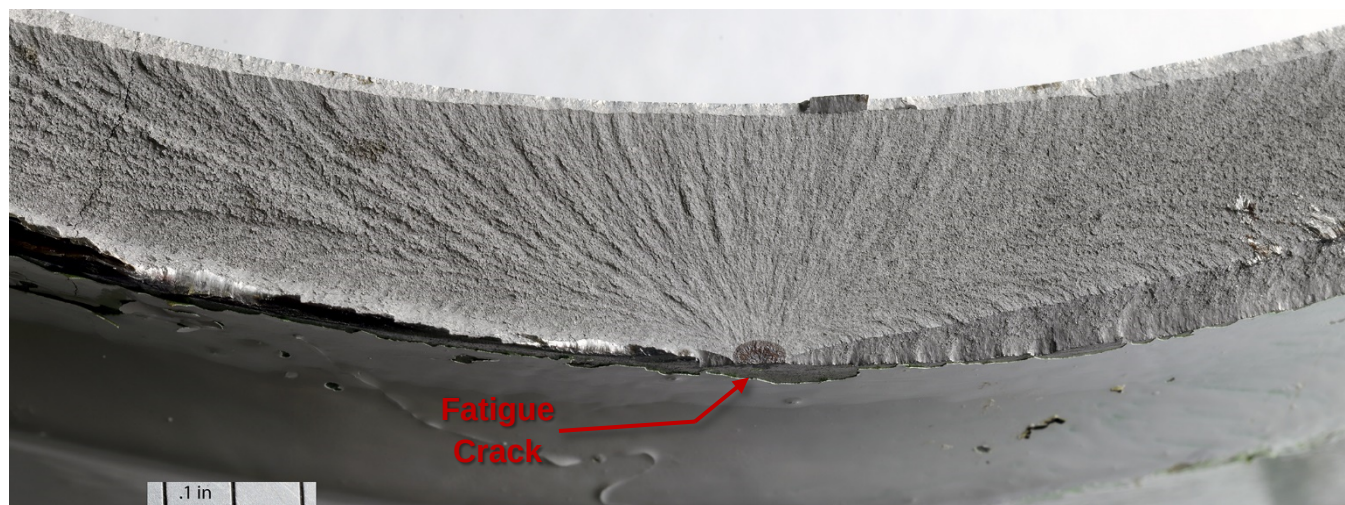
Figure 8 shows the fracture surface, which exhibited chevron marks emanating from a small thumbnail crack on the forward side of the cylinder exterior (bottom of Figure 8). The thumbnail crack is highlighted from a planar view in Figure 9 and Figure 10, and at an oblique angle in Figure 11. The thumbnail crack exhibited crack arrest, or beach, marks, consistent with progressive fracture, later determined to be fatigue. The thumbnail crack measured 0.035 inches (0.89 mm) in depth, and 0.072 inches in length (1.84 mm). No

Figure 8 – Closer view of the crack initiation site on the upper fracture surface.

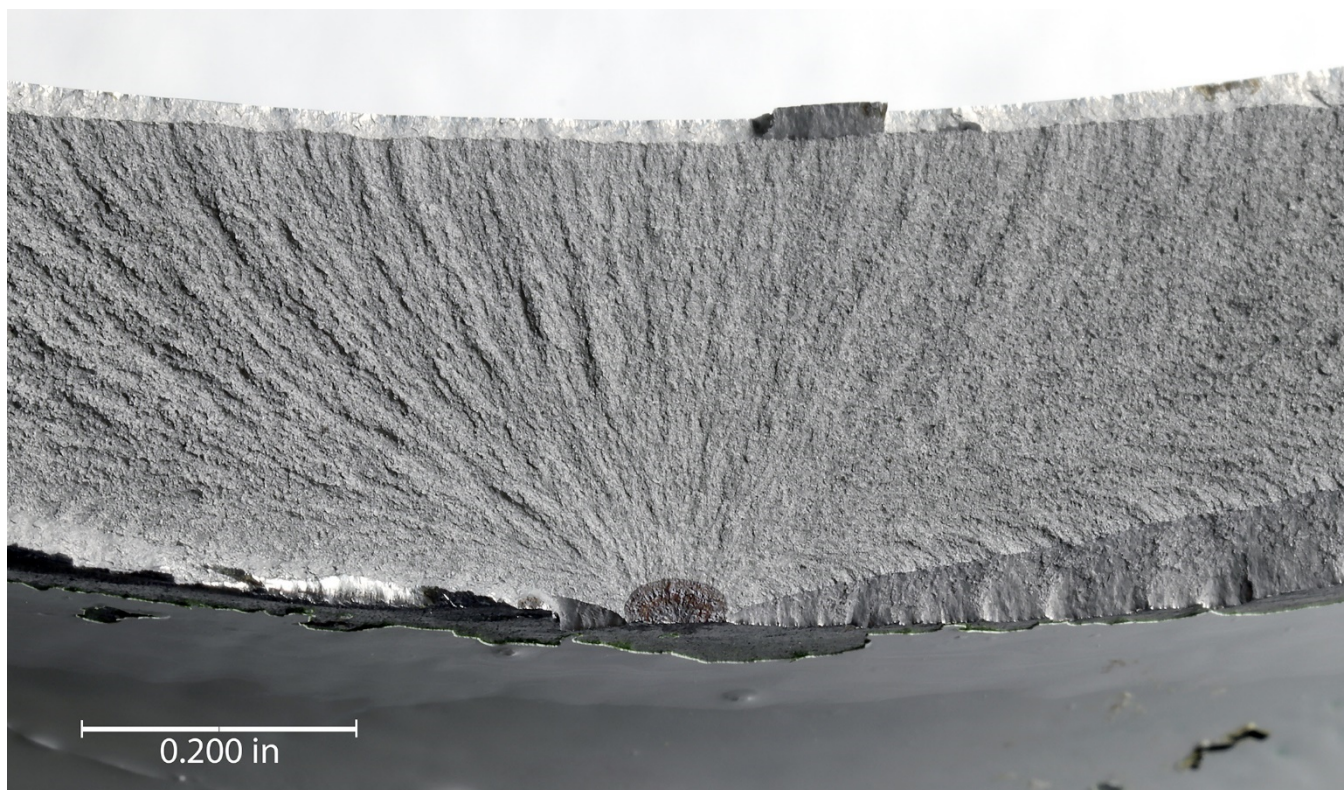
Figure 9 – Closer view of the crack initiation site, showing the thumbnail crack.

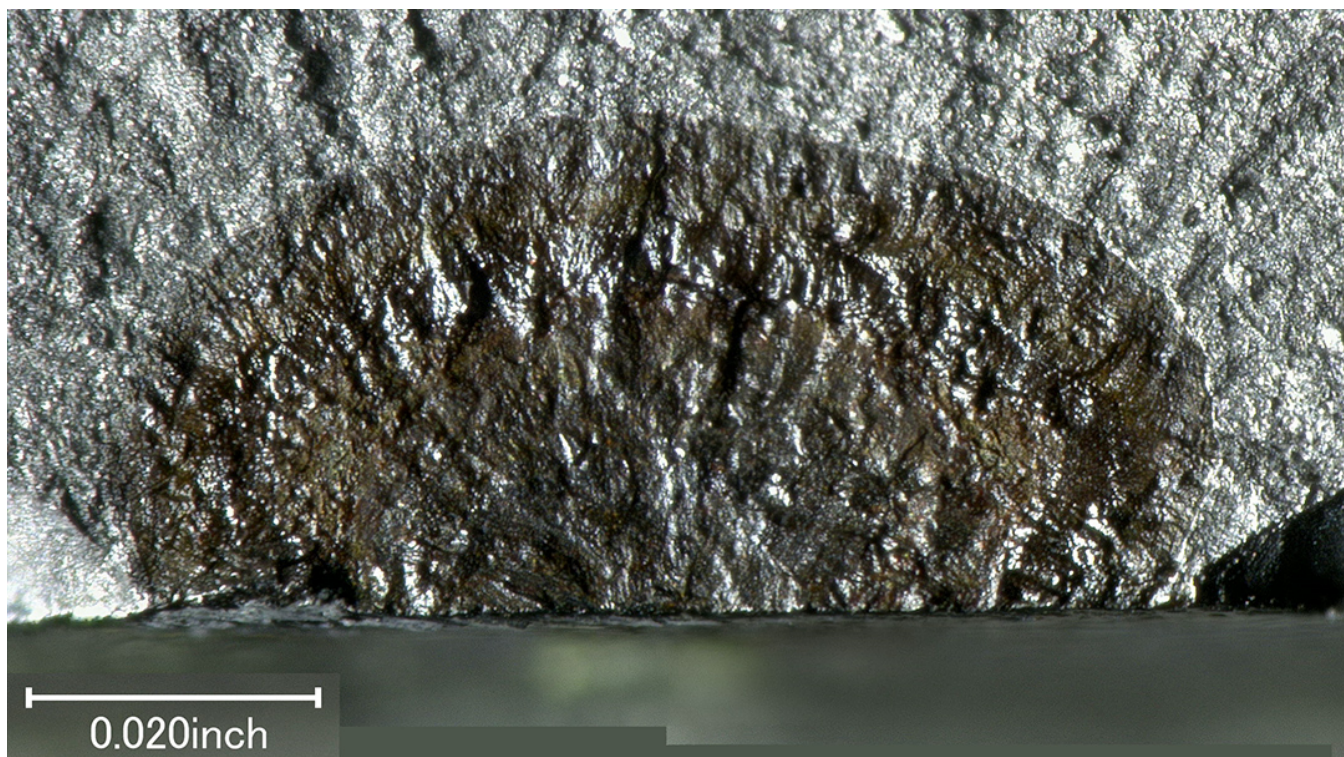
Figure 10 – The thumbnail crack on the upper fracture surface, as received.

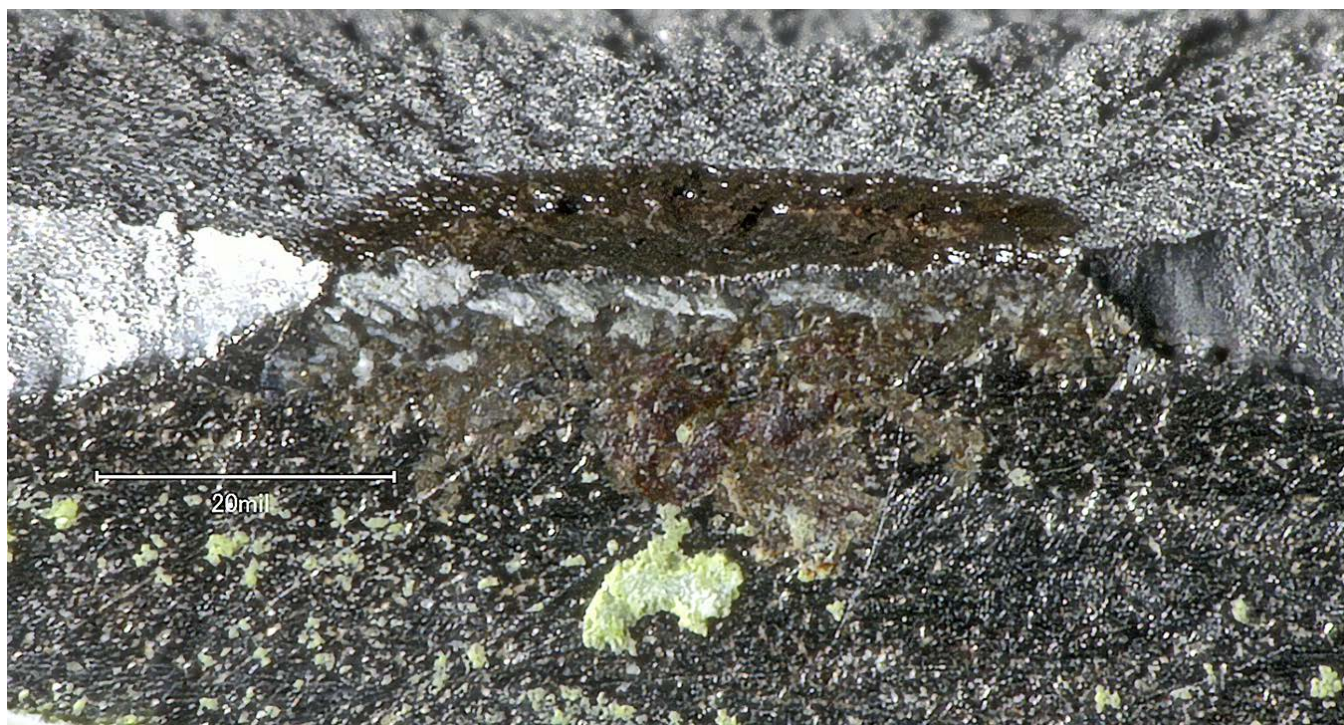
shear lips or chevron marks were located at this thumbnail crack. The area on the cylinder exterior exhibited features consistent with smearing.

Figure 11 – The thumbnail crack in Figure 10, shown at an angle to show the exterior of the cylinder.

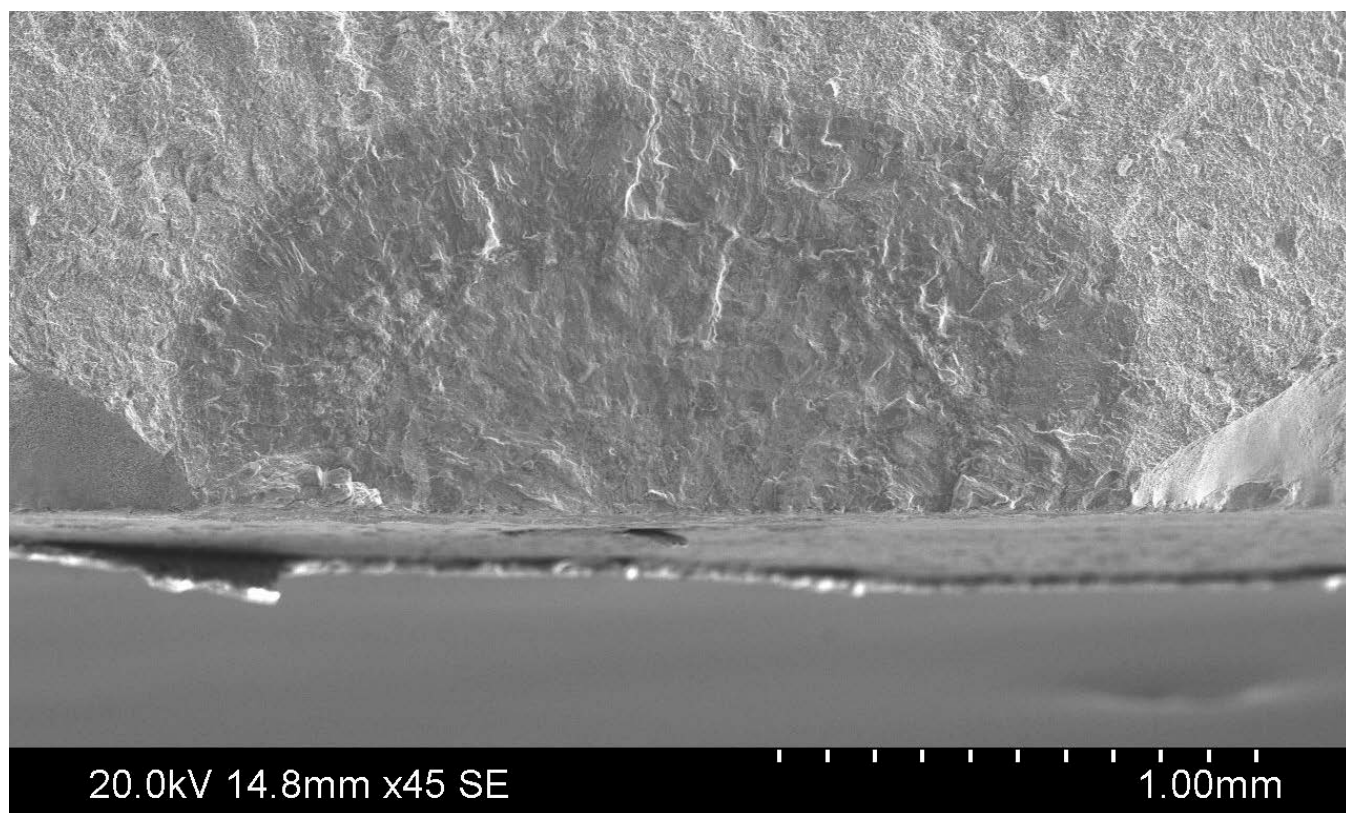
Figure 12 shows the thumbnail crack on the upper fracture surface. Consistent with what was observed in Figure 11, the crack initiation site had been damaged by smearing (see Figure 13 and Figure 14). As shown in Figure 13b, much of the fracture surface exhibited dark pock-marked features, consistent with oxide on a metal surface.<sup>5</sup> This fracture surface oxidation was consistent with oxidation that occurs on an exposed metal surface after crack initiation and/or fracture.

Figure 12 – Secondary electron (SE) micrograph of the fatigue crack on the upper fracture.

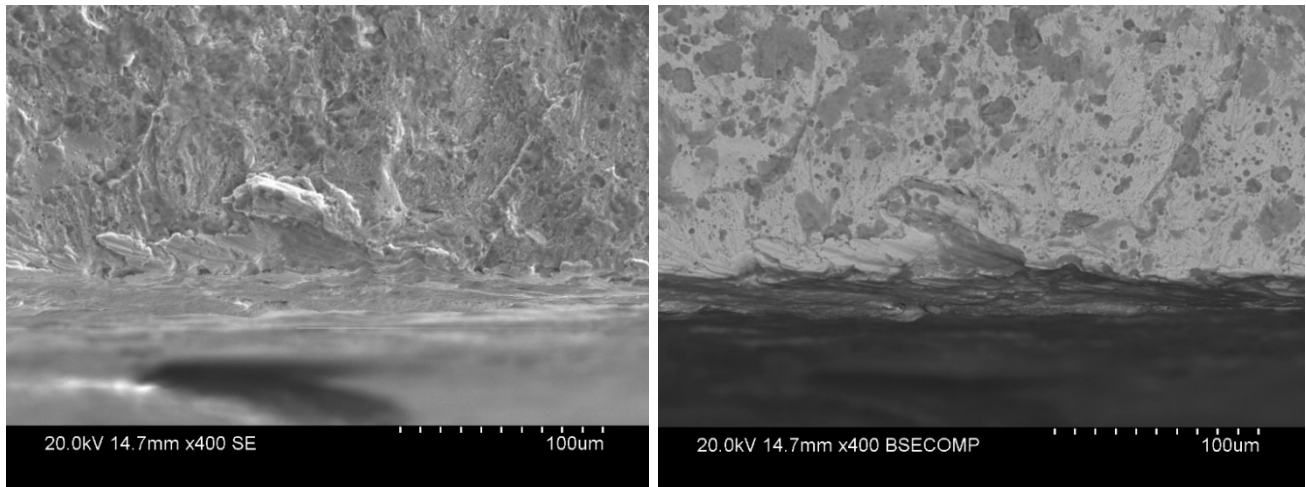
Figure 13 – The fatigue crack initiation site of the upper fracture, which had been damaged by post-fracture smearing view with (a) secondary electrons and (b) backscattered electron (BE).

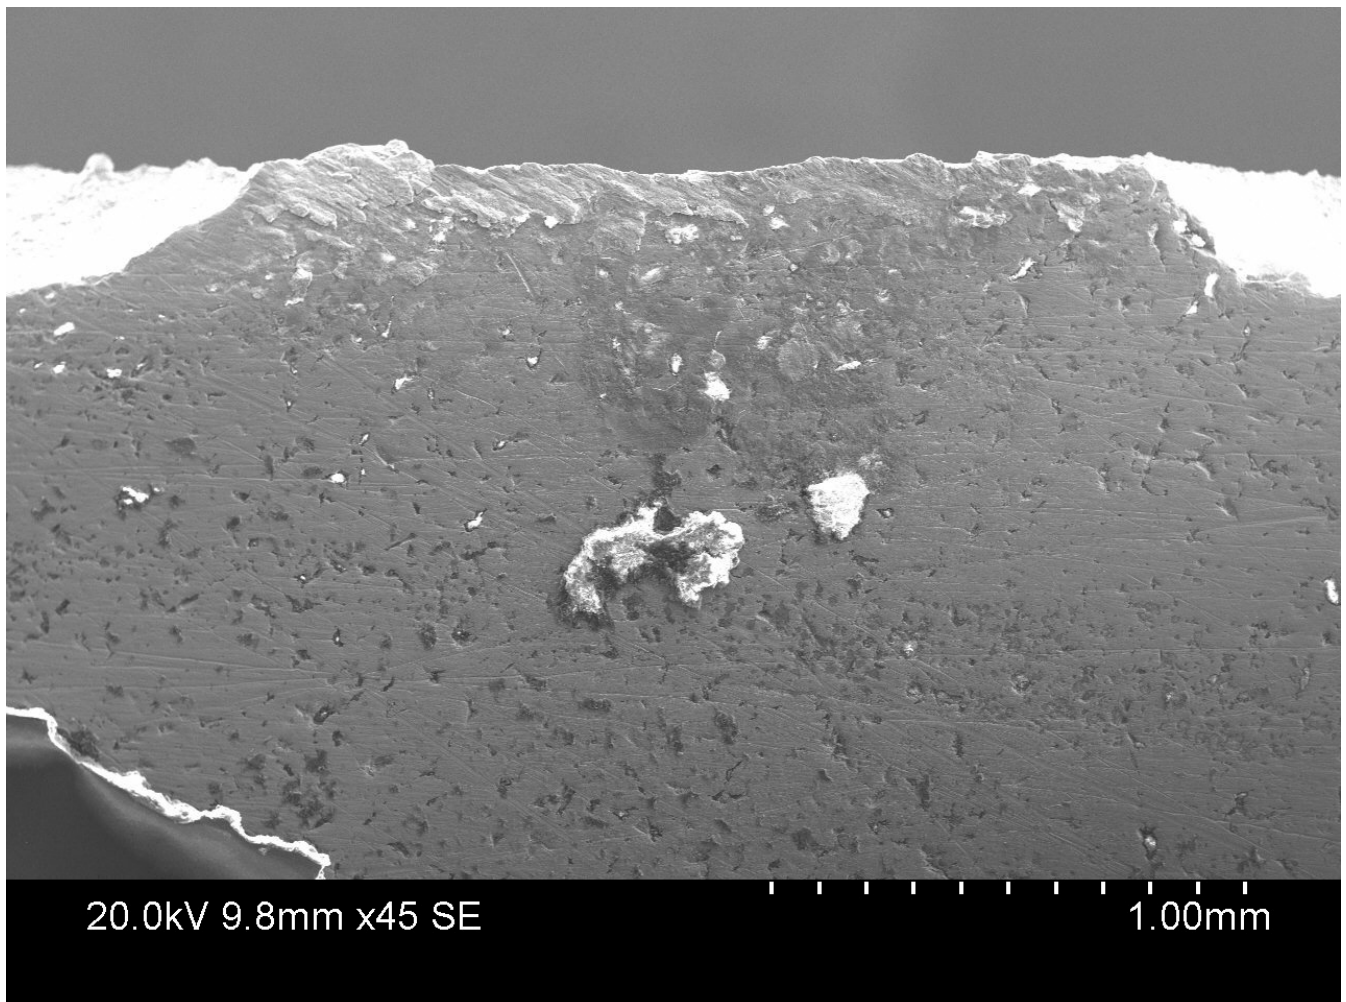
Figure 14 – SE micrograph of the cylinder exterior at the fatigue crack initiation site, showing smearing.

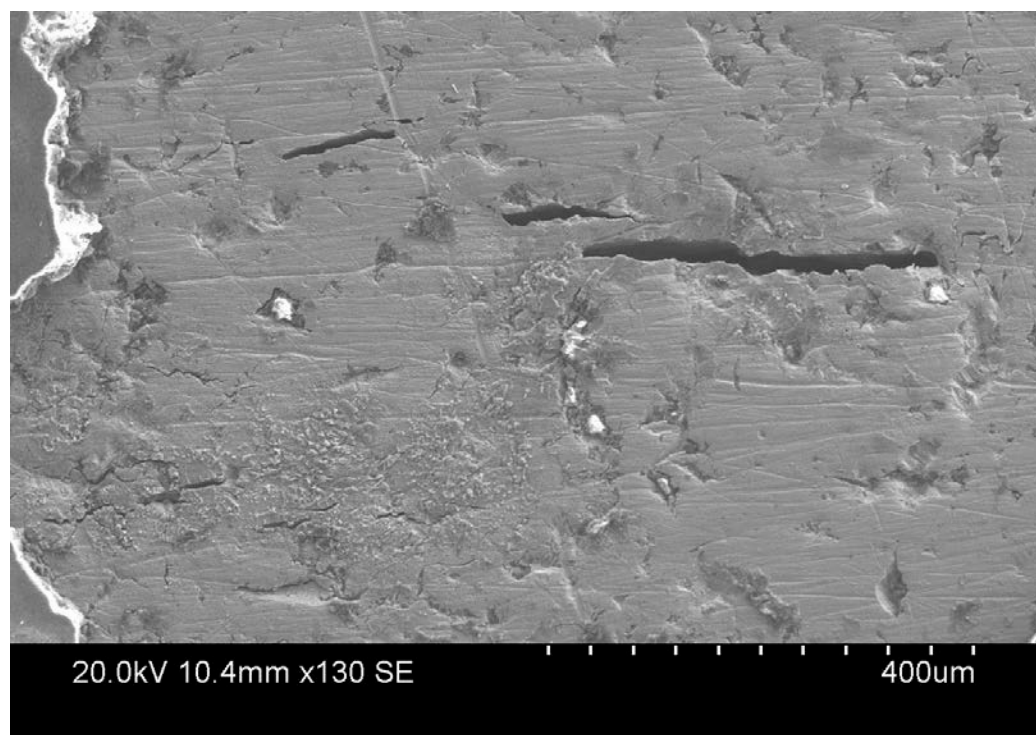
The exterior of the cylinder near the fracture surface also exhibited secondary cracks, oriented parallel to the fracture surface fatigue crack. A typical example is shown in Figure 15. The largest of these cracks near the upper fracture surface was 0.013 inches (0.33 mm) in length.

Figure 15 – SE micrograph of secondary cracks near the upper fracture surface.

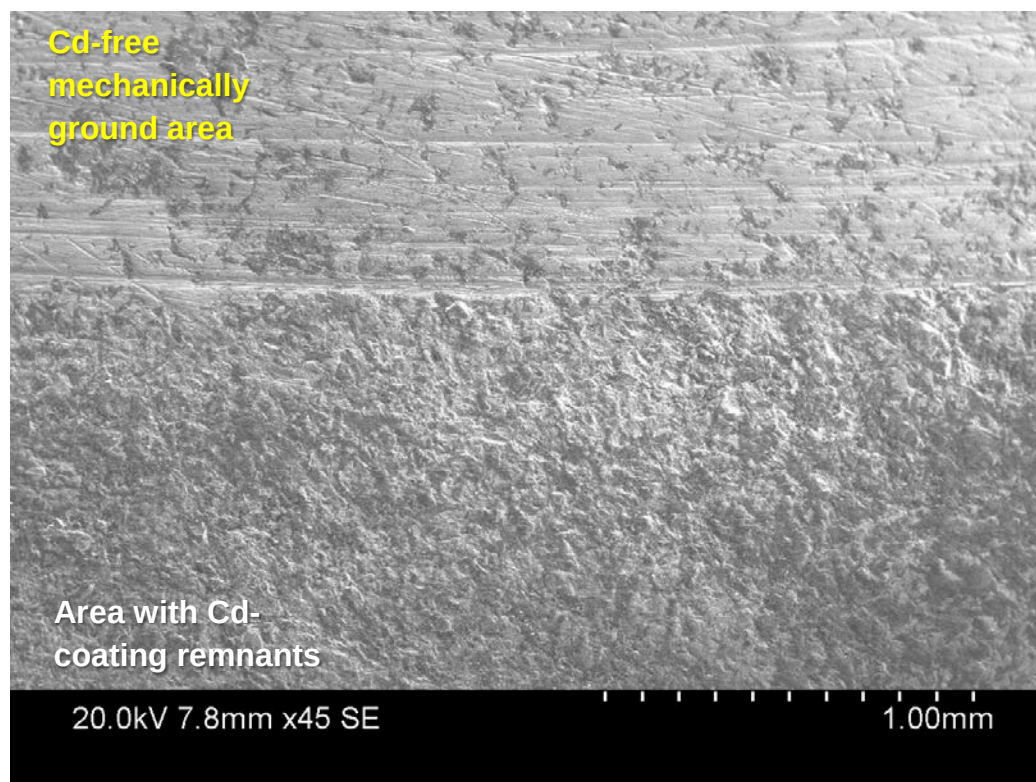
As described earlier, the elevated area on the forward side of the cylinder around the fracture surface was found by chemical analysis to be consistent only with the paint and primer, not with a protective tape. After chemical stripping of paint and primer in the area, no other coating or material was found on the cylinder surface. The region surrounding the fracture surface was absent of any indication of a cadmium (Cd) layer. The surface texture exhibited scratch marks consistent with mechanical grinding. Outside of this region, evidence of a Cd electroplated coating was present (see Figure 16).

Later inspection of both these areas by EDS found no Cd electroplating near or around the fracture surface, but Cd was present outside this area. Therefore, the area around the fracture surface was consistent with having been masked, stripped of paint and primer, removing the Cd electroplating by mechanical means, and then re-primed and painted.

Figure 16 – SE micrograph of the cylinder exterior near the upper fracture surface, showing the region with and without Cd coating.

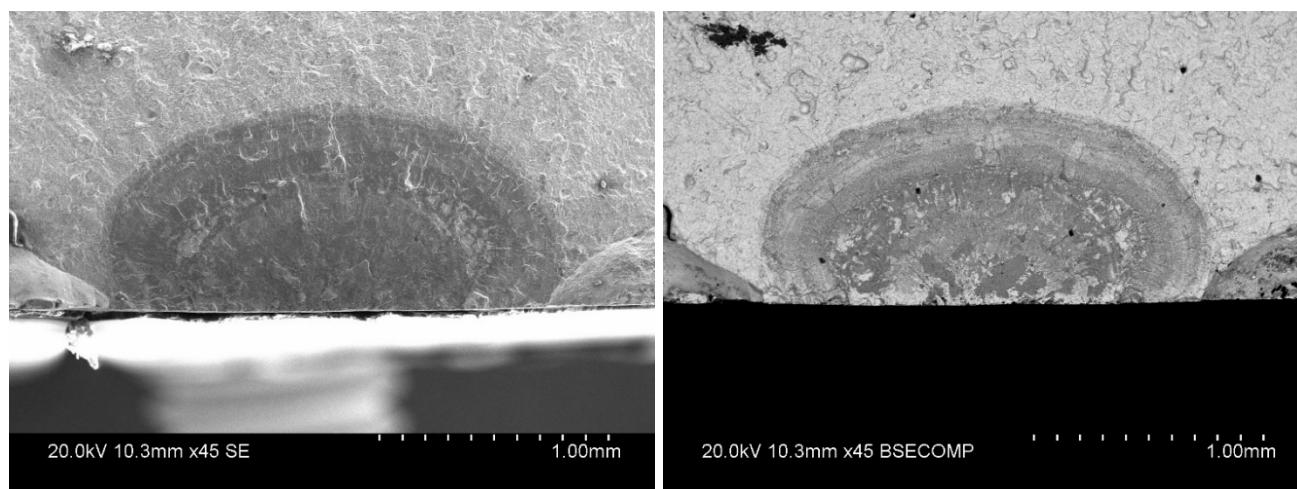
The lower fracture surface was inspected using a SEM. The thumbnail crack on this mating side exhibited less oxidation and contamination than the upper fracture and is shown in Figure 17. The end of the thumbnail crack is shown Figure 18. Closer examination of the thumbnail crack revealed fatigue striations, consistent with fatigue crack propagation (Figure 19).

Figure 17 – The fatigue thumbnail crack on the lower fracture surface, viewed in (a) SE and (b) BE modes.

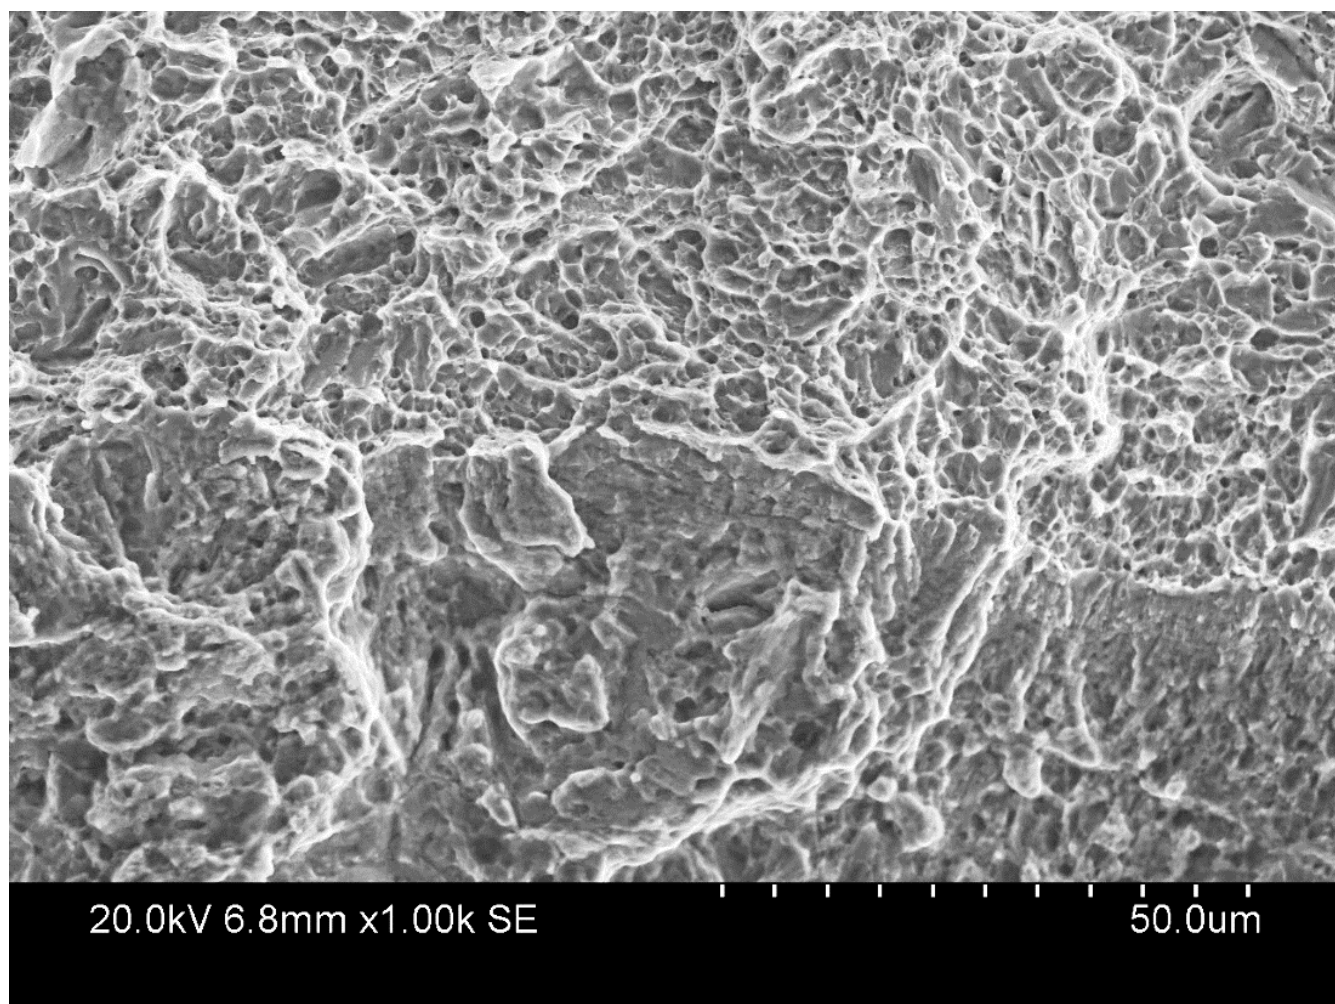
Figure 18 – SE micrograph of the end of the fatigue crack on the lower fracture.

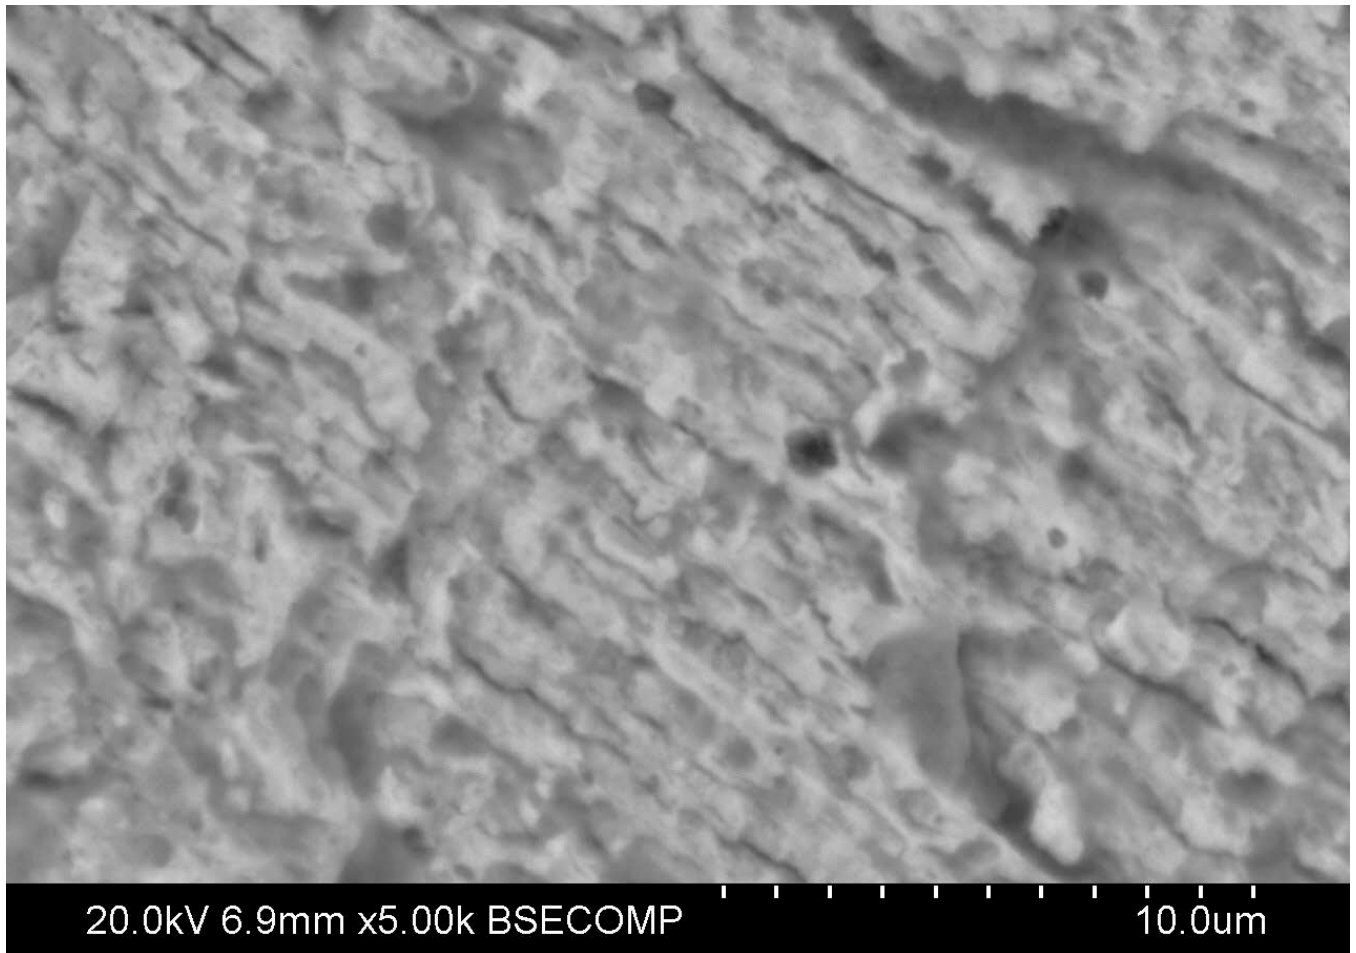
Outside the crack, dimple rupture was found—this was consistent with subsequent overstress fracture of the gear cylinder on the landing at the time of the accident. Later examination of the lower fracture thumbnail crack revealed three overstress bands or “jumps.” These were 0.022 inch (0.56 mm), 0.030 inch (0.76 mm), and 0.033 inch (0.83 mm) from the origin of the crack (the total crack depth was 0.035 inch [0.89 mm]).

Figure 19 – BE micrograph of fatigue striations on the lower fracture thumbnail crack.
