# NATIONAL TRANSPORTATION SAFETY BOARD

## MATERIALS LABORATORY FACTUAL REPORT

Report No. 18-057

Place : Alexandria, Louisiana  
Date : April 20, 2018  
Vehicle : Boeing MD-83, N807WA  
NTSB No. : DCA18FA144  
Investigator : Lorenda Ward, AS-10

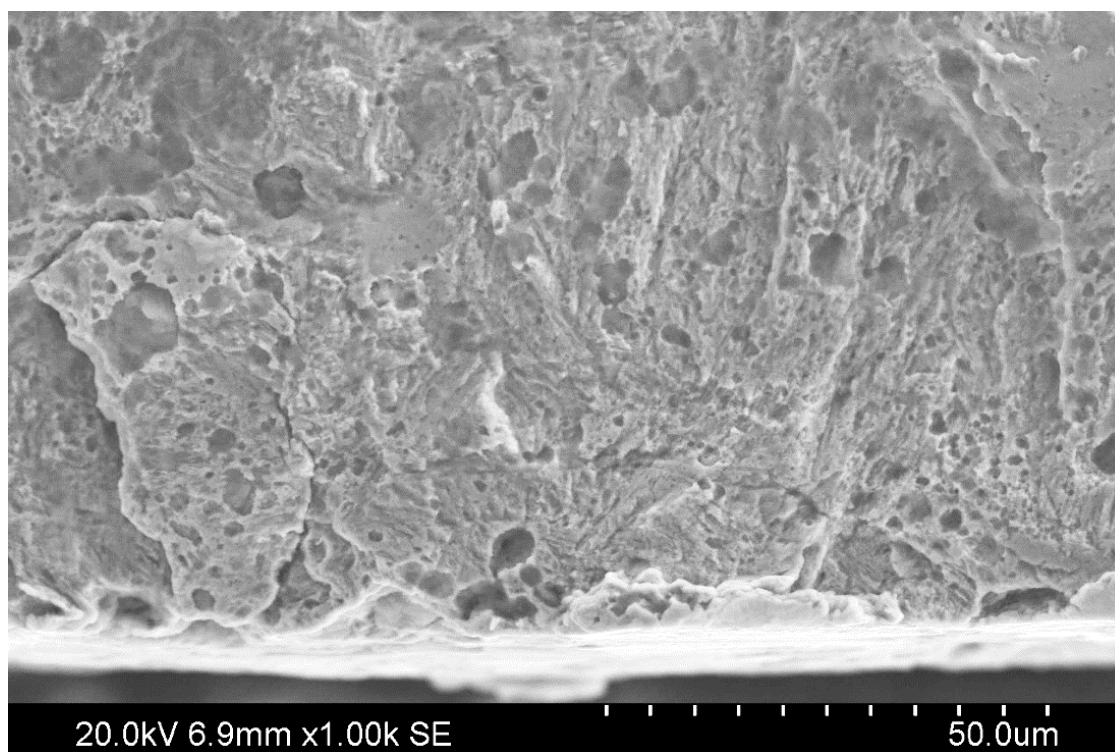
Unlike the upper fracture surface, the fatigue crack initiation site was relatively undamaged on the lower fracture (see Figure 20 and Figure 21). There were corrosion pits adjacent to the fatigue crack initiation site as deep as 6  $\mu\text{m}$  ( $2.36 \times 10^{-4}$  inch), but there were none located at the initiation site.

Figure 20 – SE micrograph of the fatigue crack initiation site on the lower fracture surface.

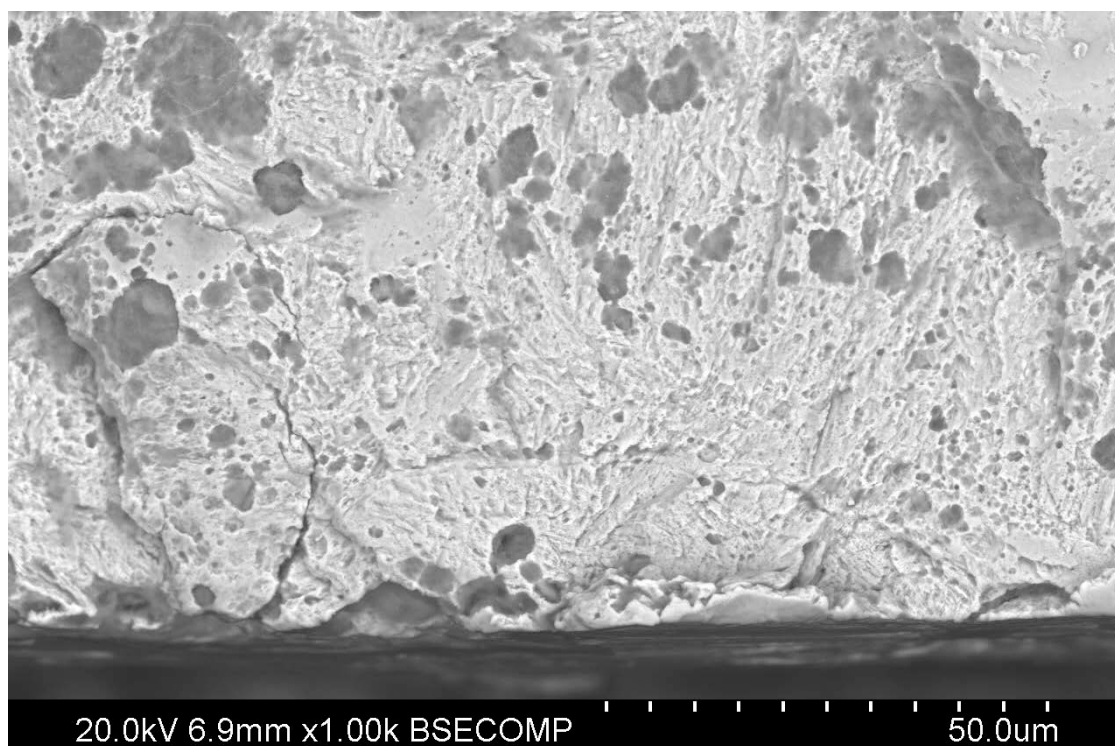
Figure 21 – BE micrograph of the fatigue crack initiation site on the lower fracture surface.

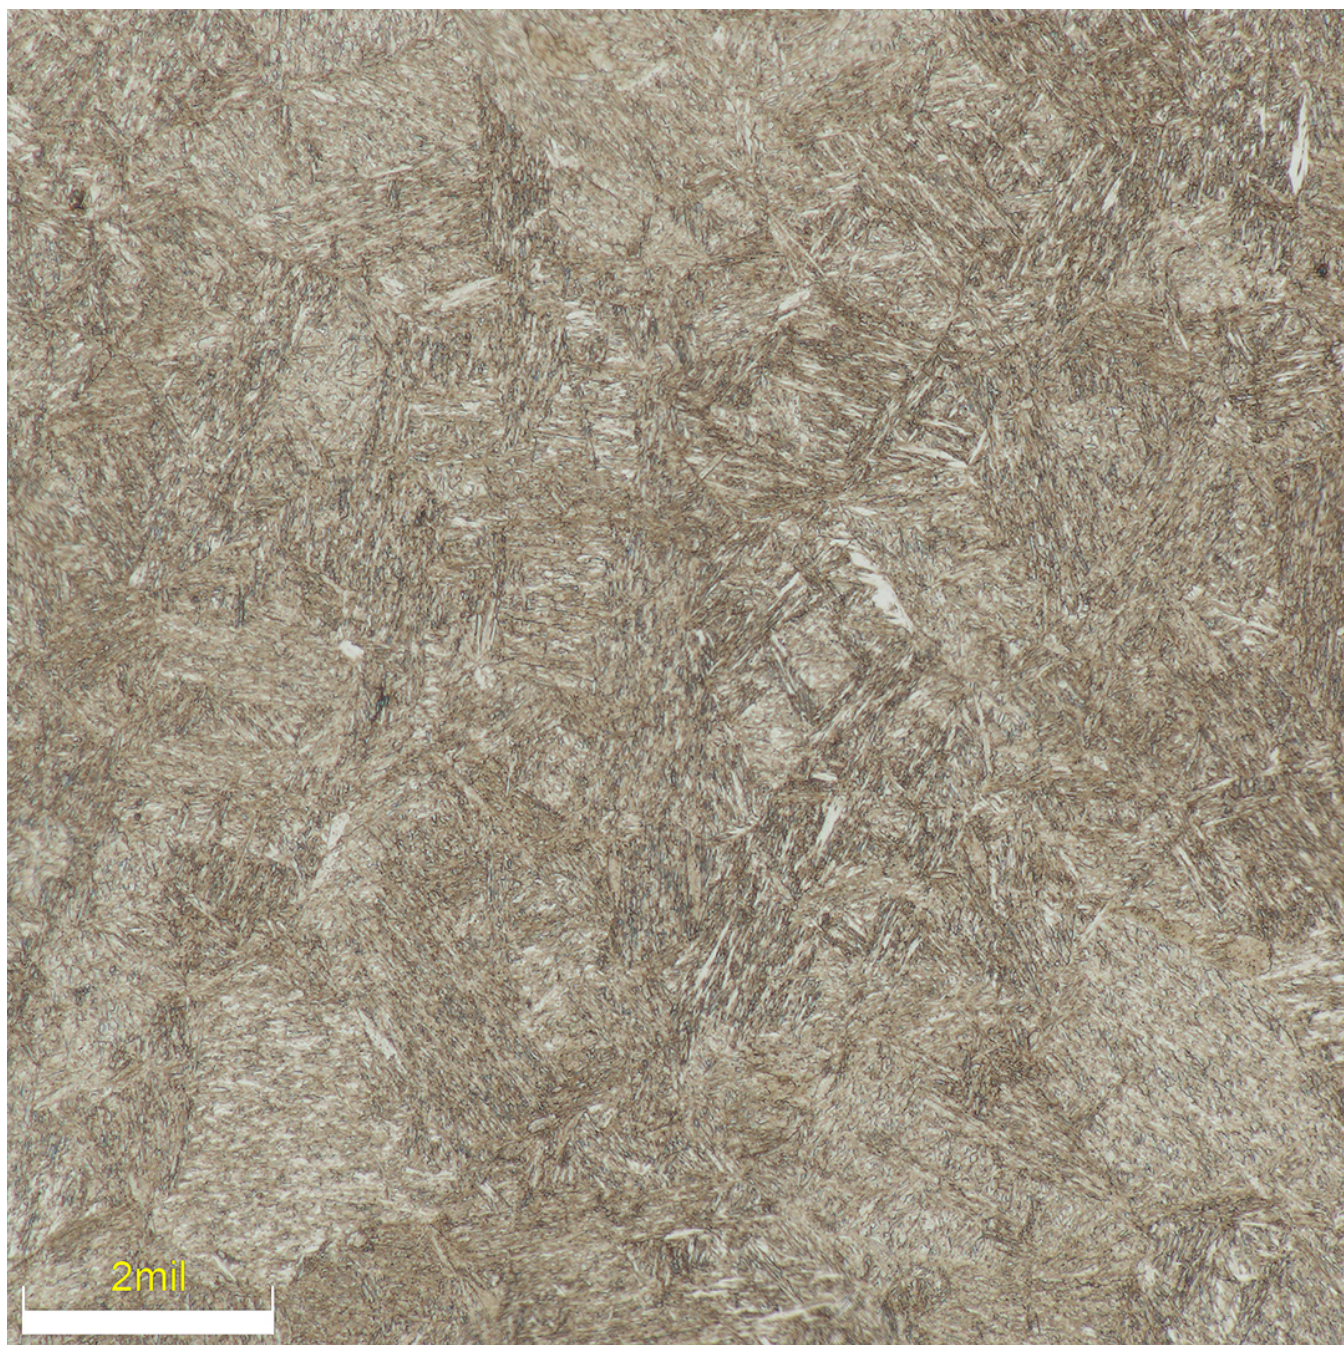
A portion of the upper fracture surface section was mounted, polished, and etched. Figure 22 reveals a typical area of the microstructure of the cylinder. The microstructure was consistent with tempered martensite with equiaxed prior-austenite grain boundaries, typical for this alloy and hardness.

Figure 22 – Bright field (BF) optical micrograph, showing a typical area of the cylinder microstructure, showing tempered martensite (~500X, etched 2% Nital).

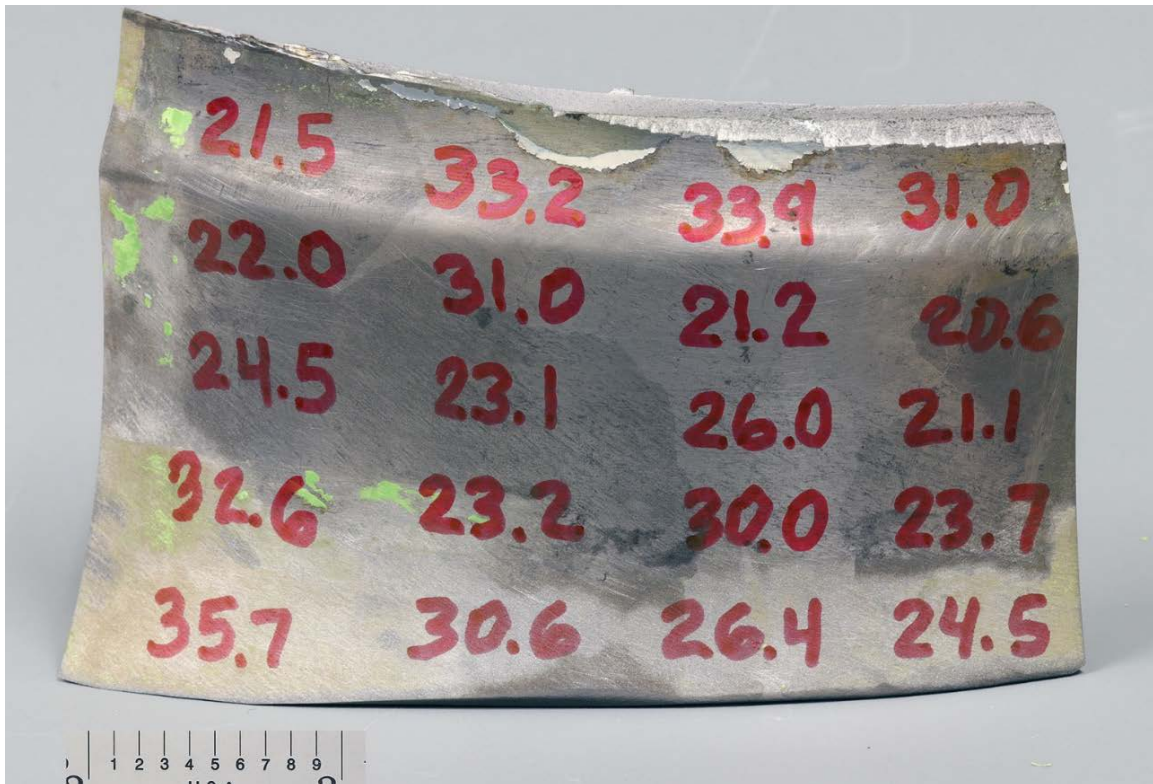
The interior surface of the cylinder exhibited chatter marks consistent with grinding operations. The external surface was Barkhausen magnetic noise tested to examine for excessive mechanical damage.<sup>9</sup> No indications of magnetization change severe enough to indicate grinding damage to the cylinder were found (readings were written directly on segment shown in Figure 23). The exterior cylinder surface of the upper fracture surface was etched using a Nital solution.<sup>10</sup> No indications of color change, consistent with the

Figure 23 – The Barkhausen magnetic noise results, written on the section containing the upper fracture (values represent magnetoelastic parameter change with increasing magnetization).

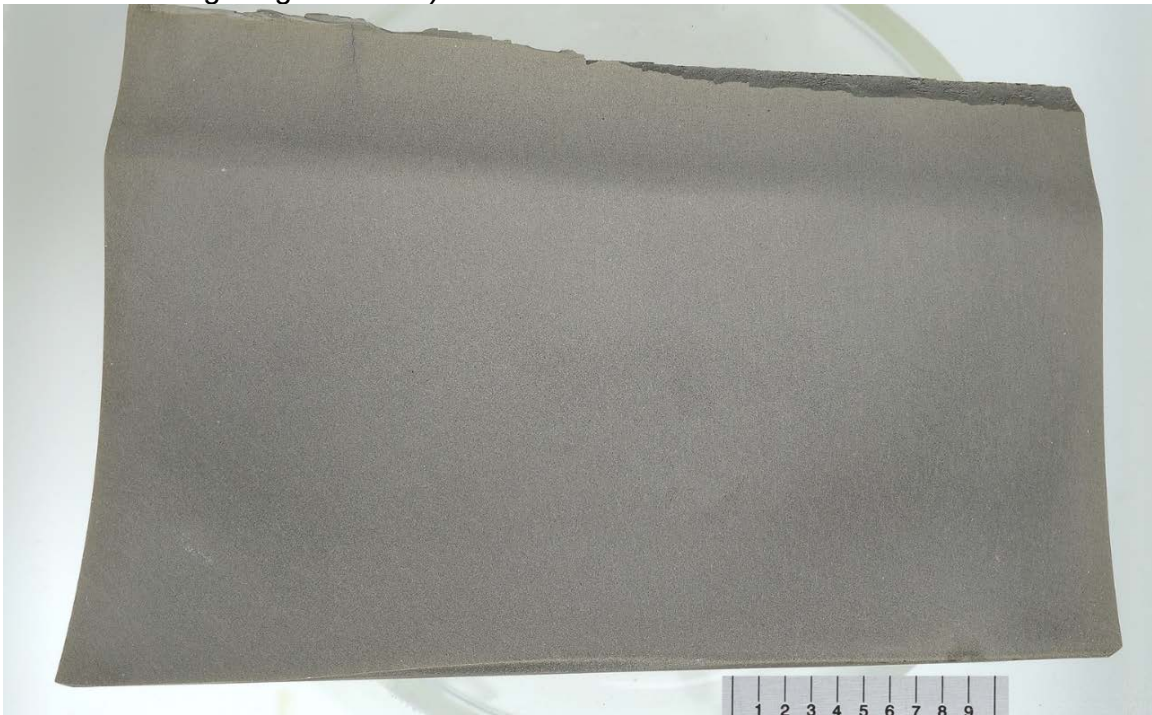
effects excessive grinding or mechanical abuse, were observed visually from the etching examination (see Figure 24).

Figure 24 – The section of the upper fracture surface exterior, after Nital etching the surface. There were no areas consistent with excessive darkened or lightened surface color.

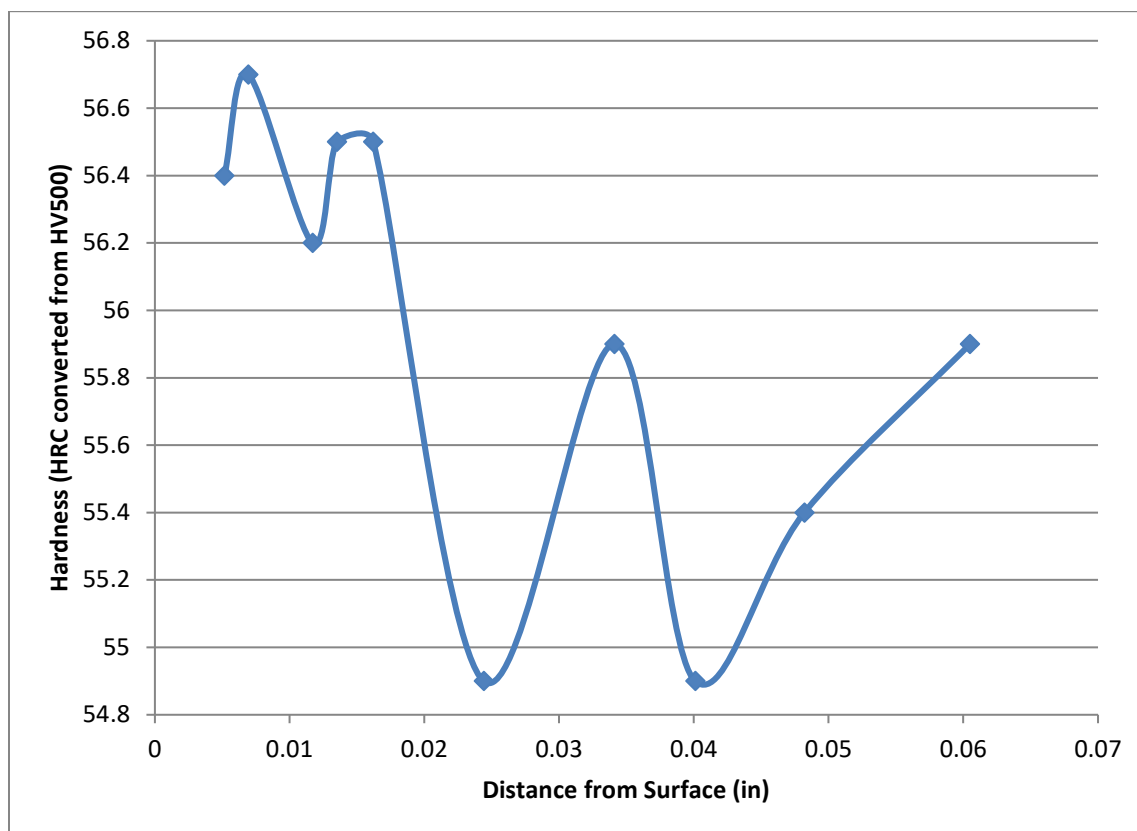
An area near the fracture surface was inspected using microindentation hardness tests to determine if there was an appreciable change in local hardness between the cylinder surface and cylinder interior. A section of the cylinder was mounted and polished, and the microindentation hardness was tested per ASTM E384.<sup>11</sup> The values were converted per ASTM E140.<sup>12</sup> As demonstrated in Figure 25, the hardness of the surface of the material was consistent with that obtained further inward. The highest hardness value measured was 57 HRC (627 HV<sub>500</sub>) 0.007 inch from the surface, and the lowest values of 55 HRC (594 HV<sub>500</sub>) were obtained 0.024 inch and 0.040 inch from the surface. These data were not consistent with a layer of decarburization or areas of excessive hardness on the surface.

Figure 25 – Chart of hardness results from the exterior surface of the cylinder near the fracture surface, in HRC (converted from HV<sub>500</sub> per ASTM E140).
