# NATIONAL TRANSPORTATION SAFETY BOARD

## MATERIALS LABORATORY ADDENDUM REPORT

Report No. 18-057B

Place : Alexandria, Louisiana  
Date : April 20, 2018  
Vehicle : Boeing MD-83, N807WA  
NTSB No. : DCA18FA144  
Investigator : Lorenda Ward, AS-10

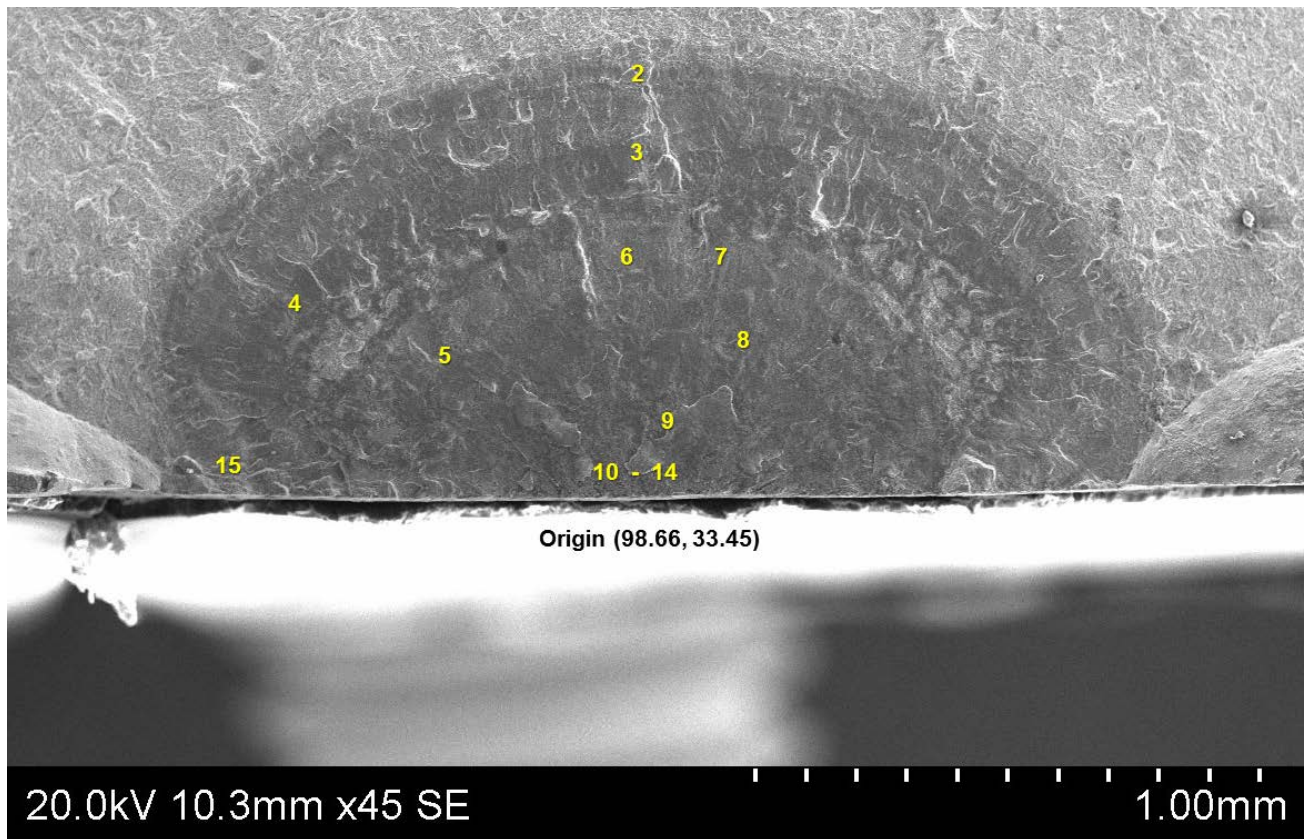
This NTSB Materials Laboratory Addendum Report details the fatigue analysis performed on the thumbnail crack on the upper fracture surface of the landing gear cylinder (see Figure 1). Using a scanning electron microscope (SEM) the thumbnail crack was measured as being 0.035 inches (0.89 mm) in depth and 0.072 inches (1.84 mm) in length.

Figure 1 – Secondary electron (SE) micrograph of the thumbnail-shaped fatigue crack on the lower fracture surface, with relative locations of the 15 micrographs in Figure 3 through Figure 16 labeled.

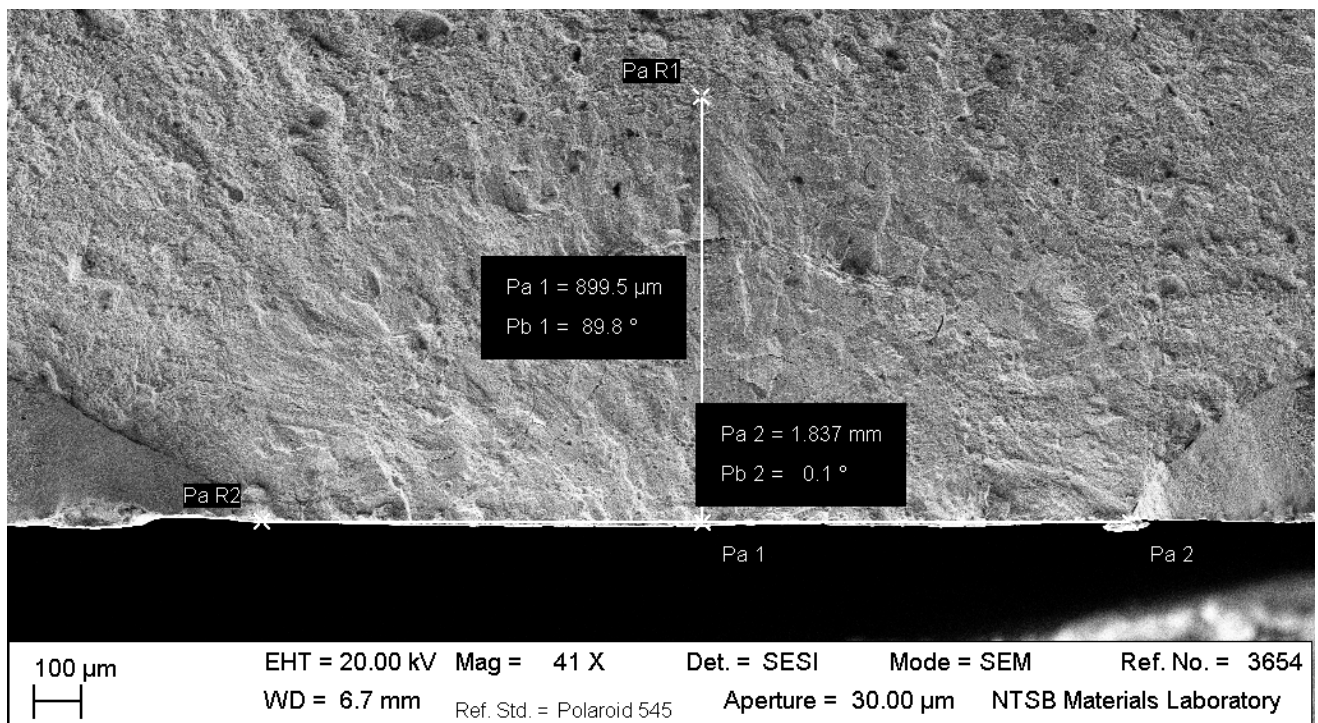
Figure 2 – SE micrograph showing the measured depth and length of the thumbnail crack.

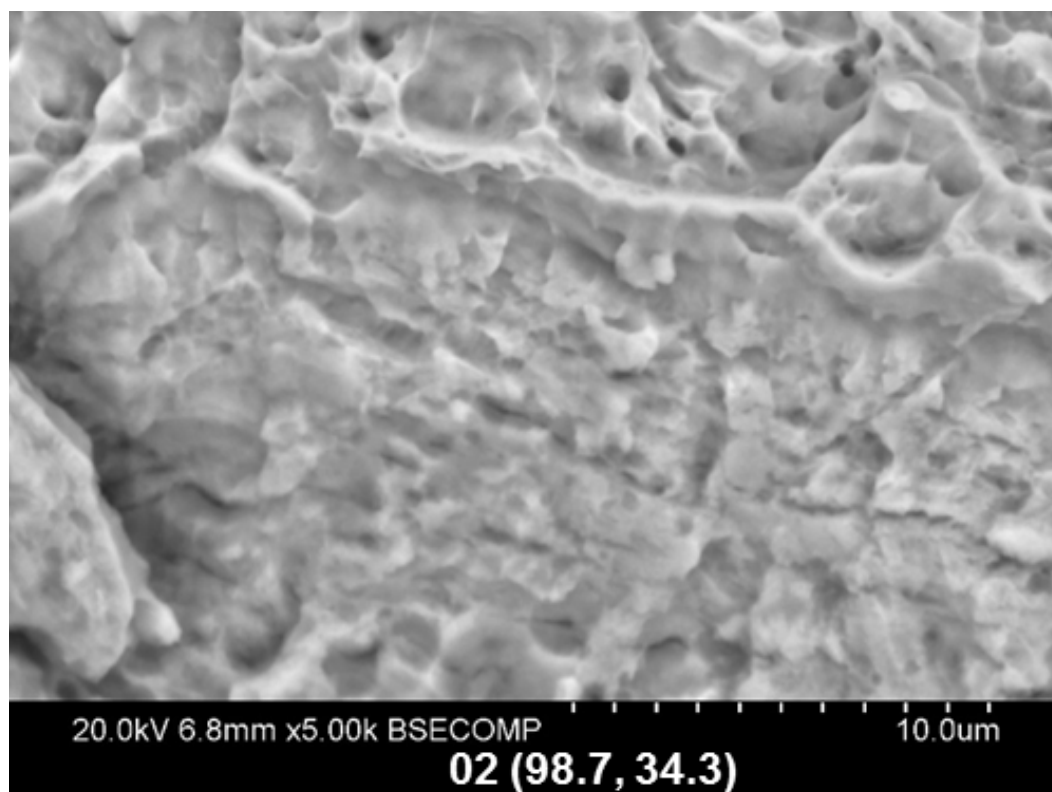
Figure 3 – SE micrograph with striation measurements at site 2 on the fracture surface.

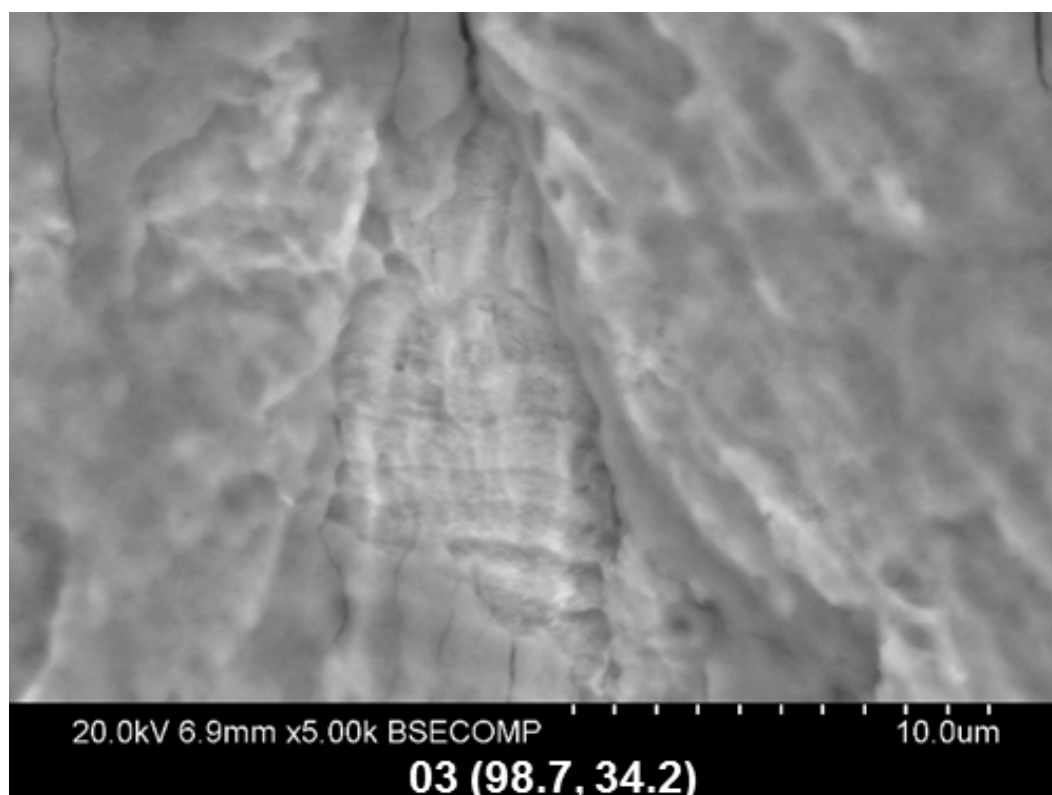
Figure 4 – SE micrograph with striation measurements at site 3 on the fracture surface.

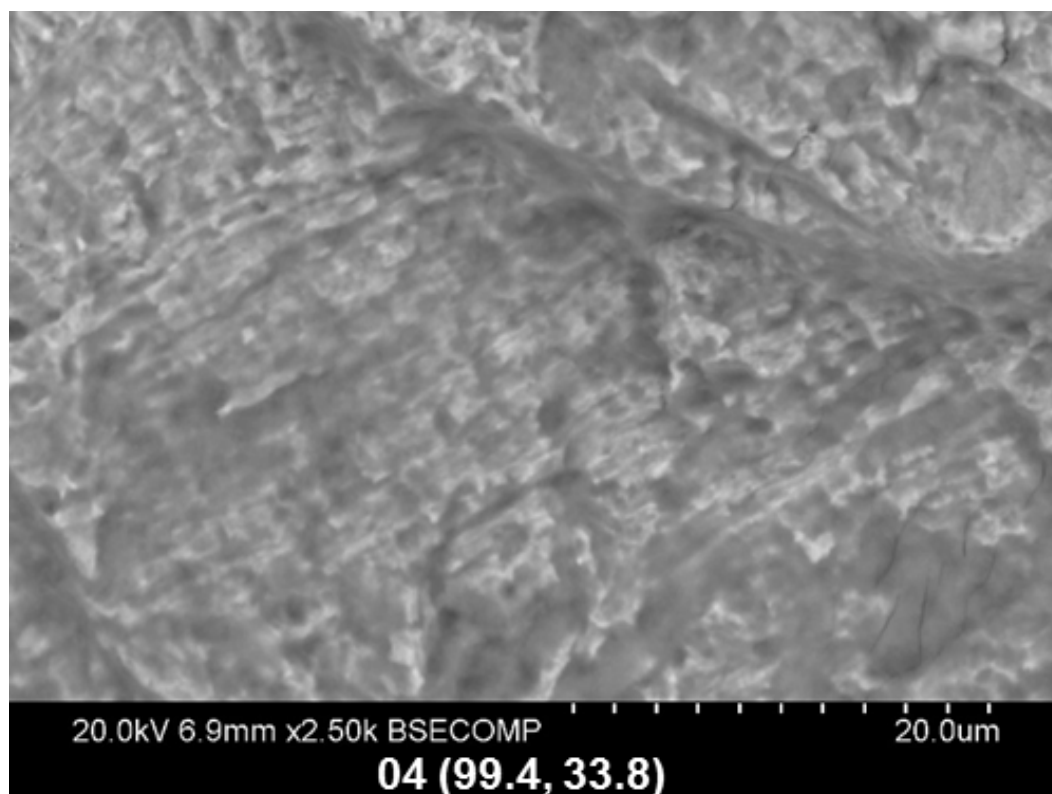
Figure 5 – SE micrograph with striation measurements at site 4 on the fracture surface.

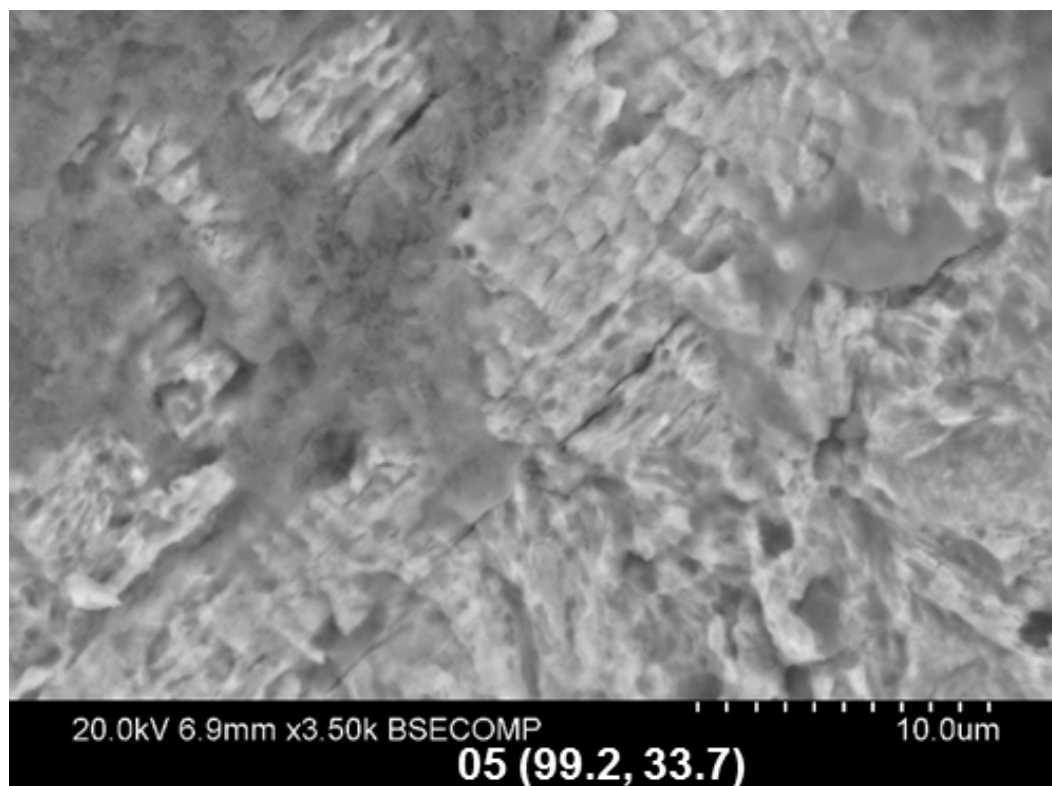
Figure 6 – SE micrograph with striation measurements at site 5 on the fracture surface.

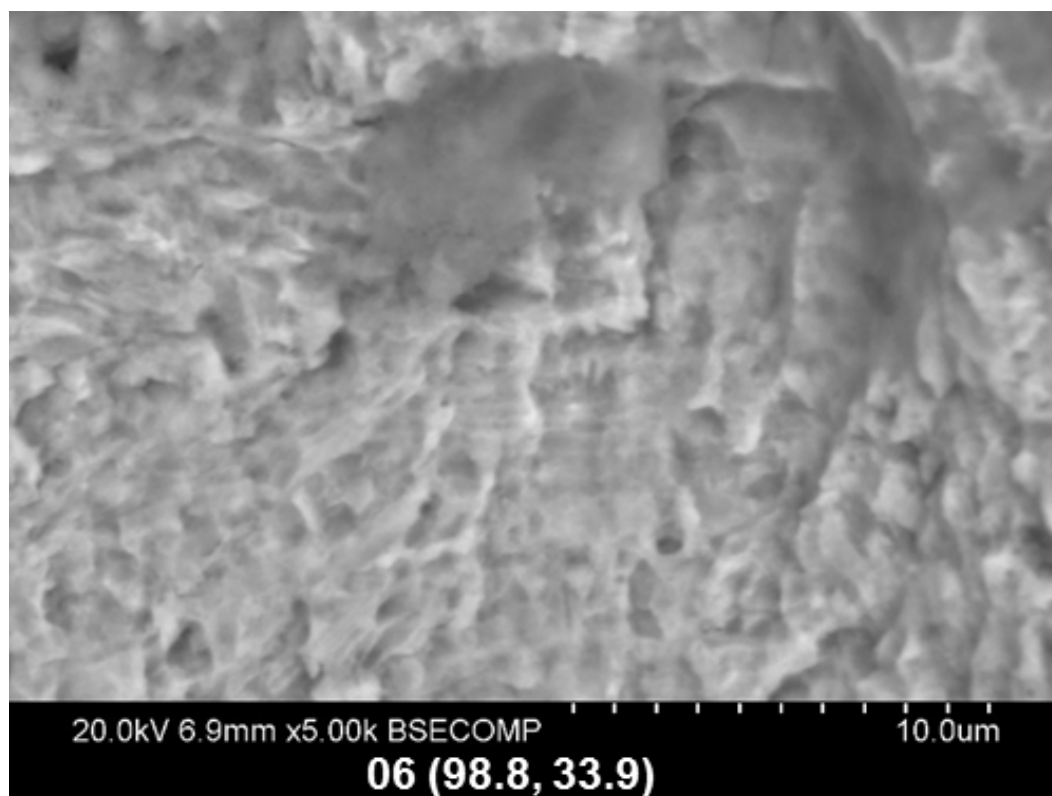
Figure 7 – SE micrograph with striation measurements at site 6 on the fracture surface.

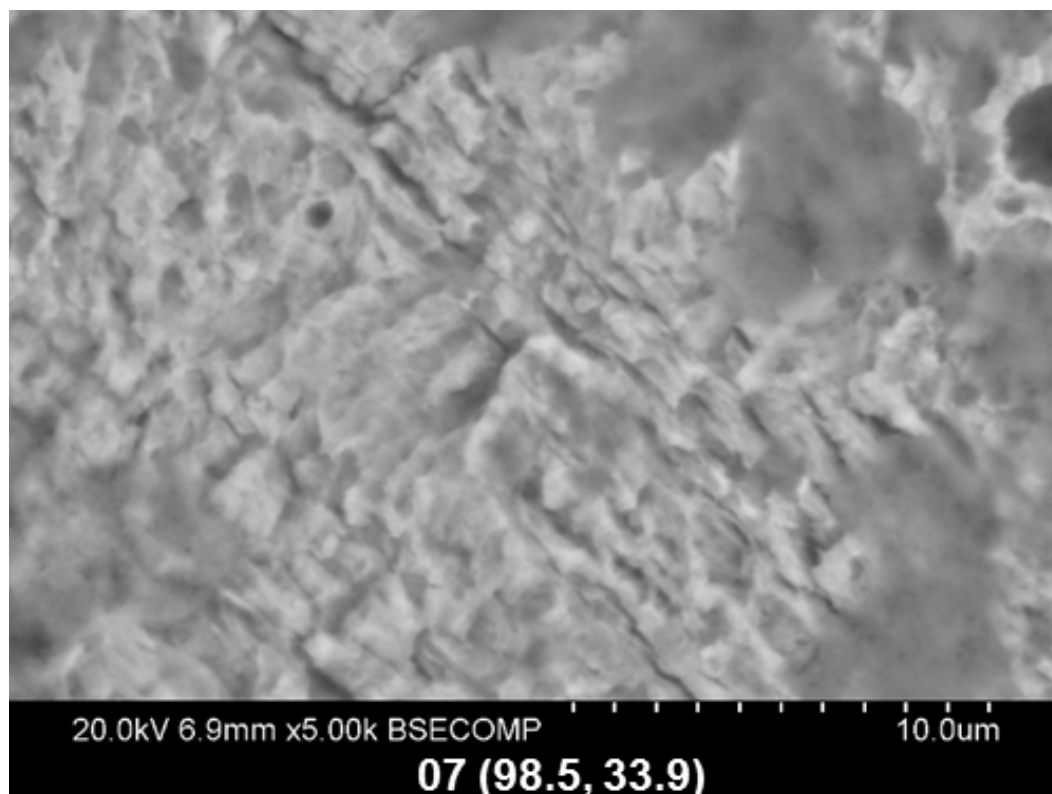
Figure 8 – SE micrograph with striation measurements at site 7 on the fracture surface.

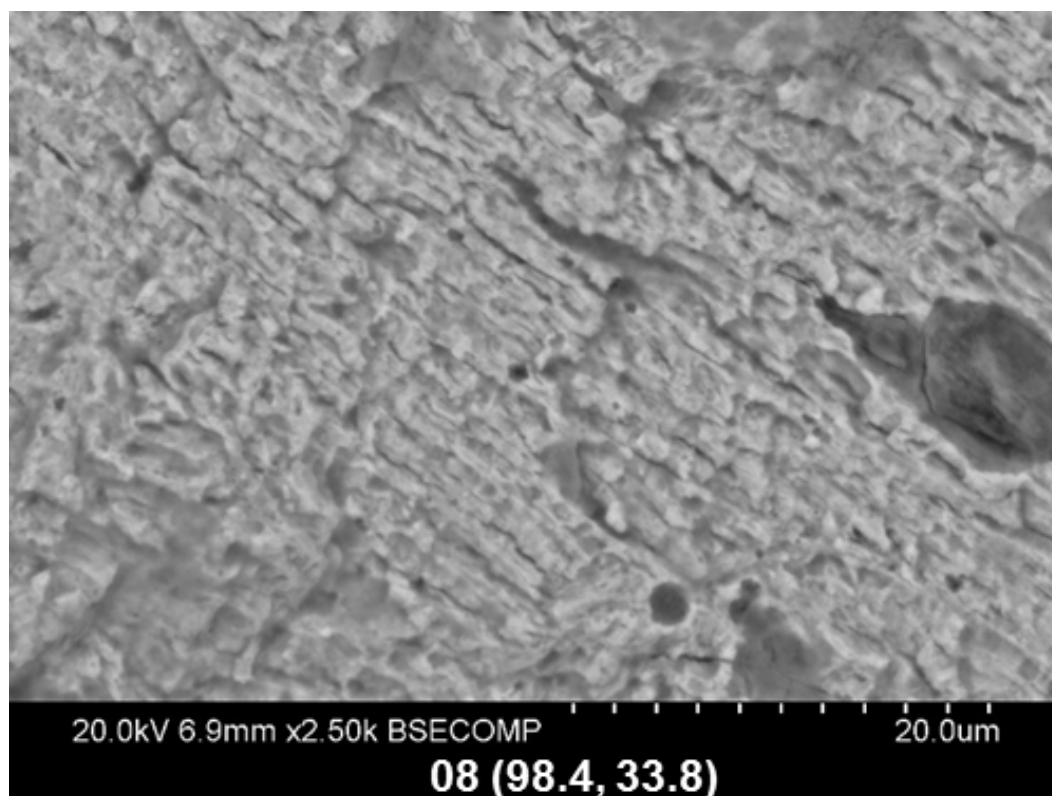
Figure 9 – SE micrograph with striation measurements at site 8 on the fracture surface.

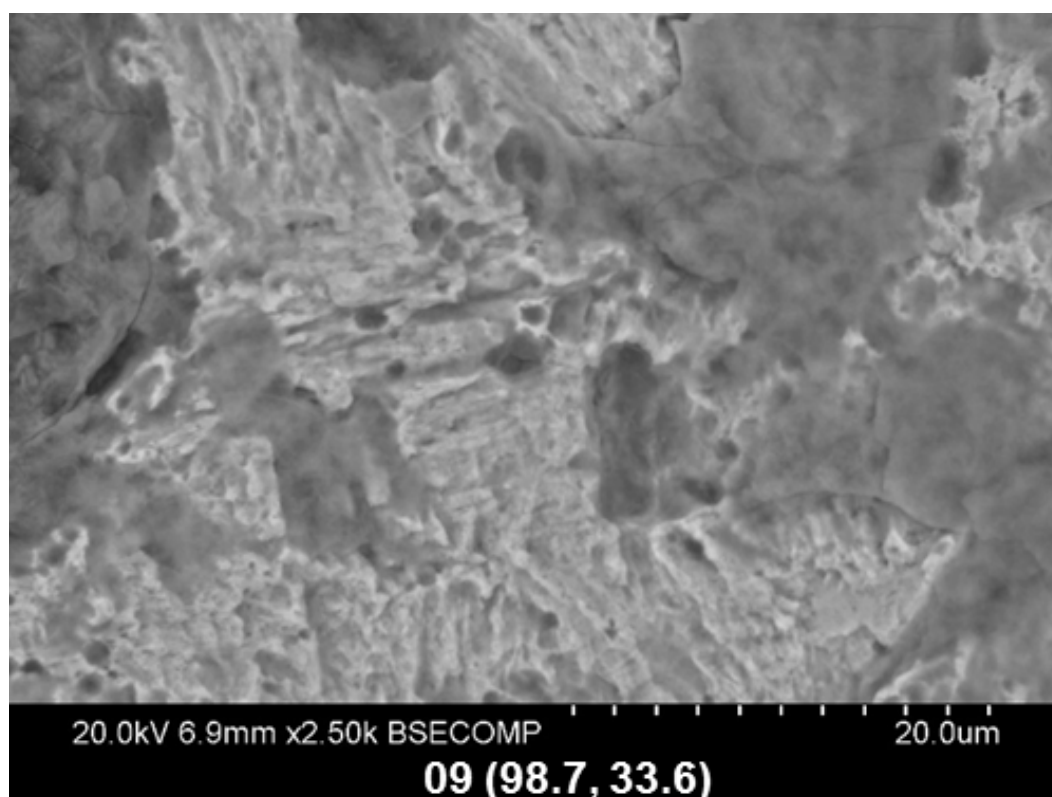
Figure 10 – SE micrograph with striation measurements at site 9 on the fracture surface.

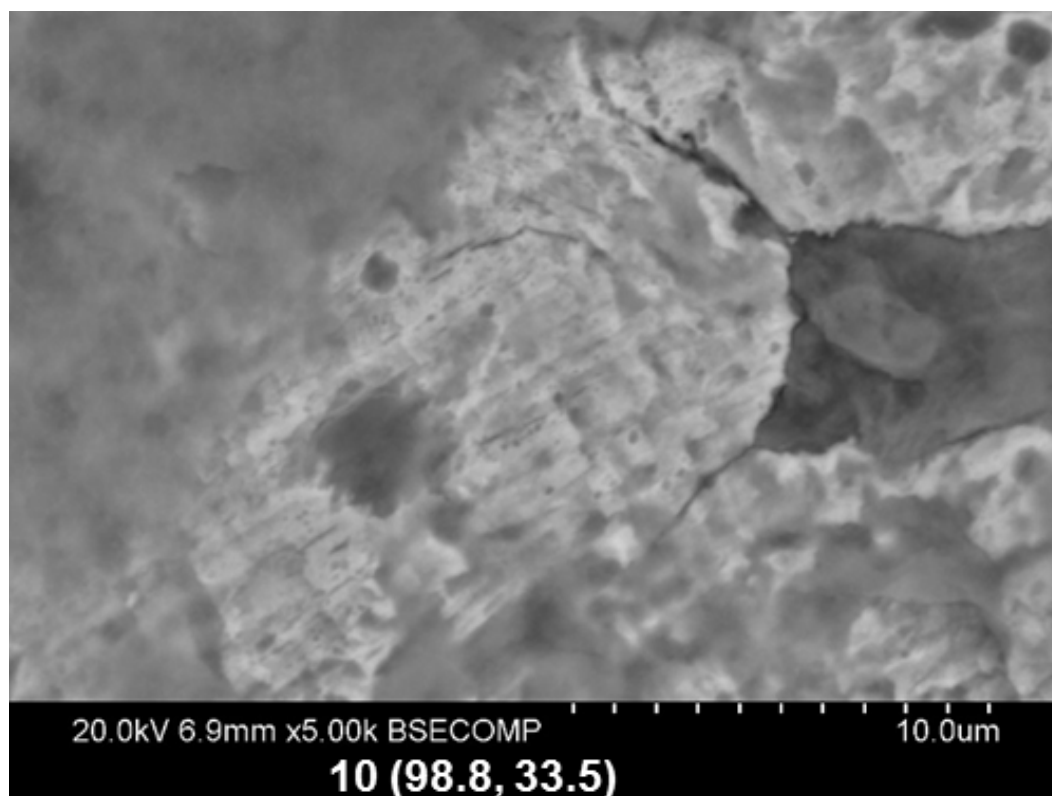
Figure 11 – SE micrograph with striation measurements at site 10 on the fracture surface.

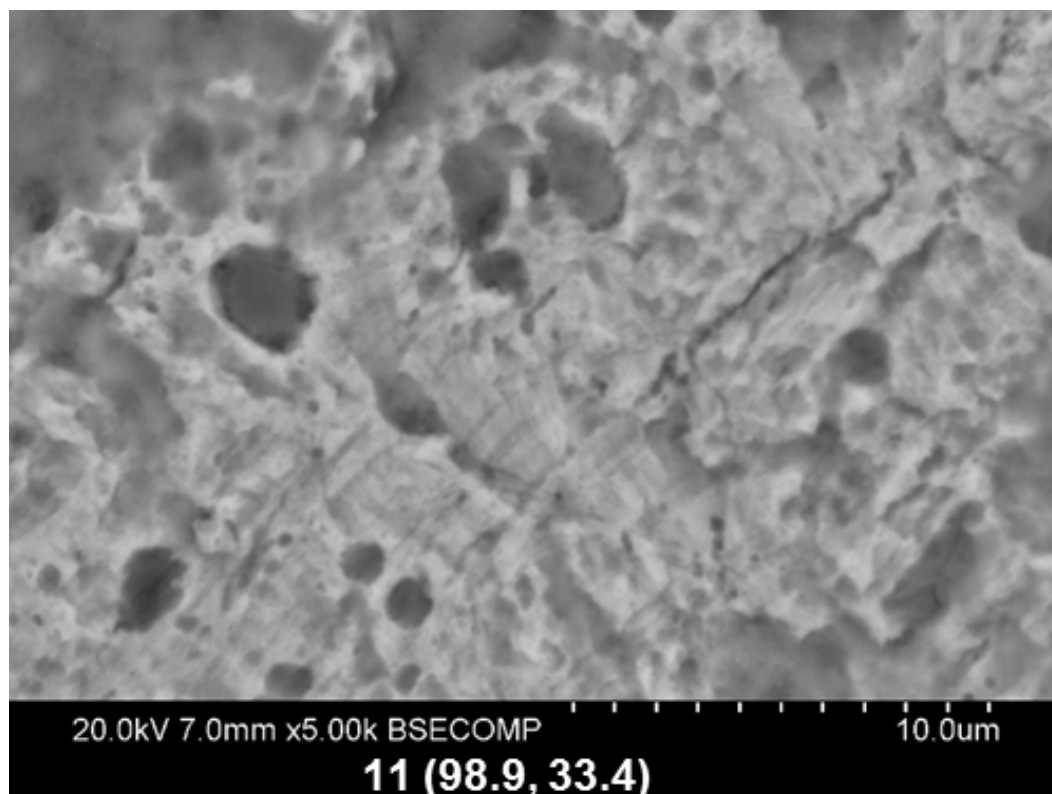
Figure 12 – SE micrograph with striation measurements at site 11 on the fracture surface.

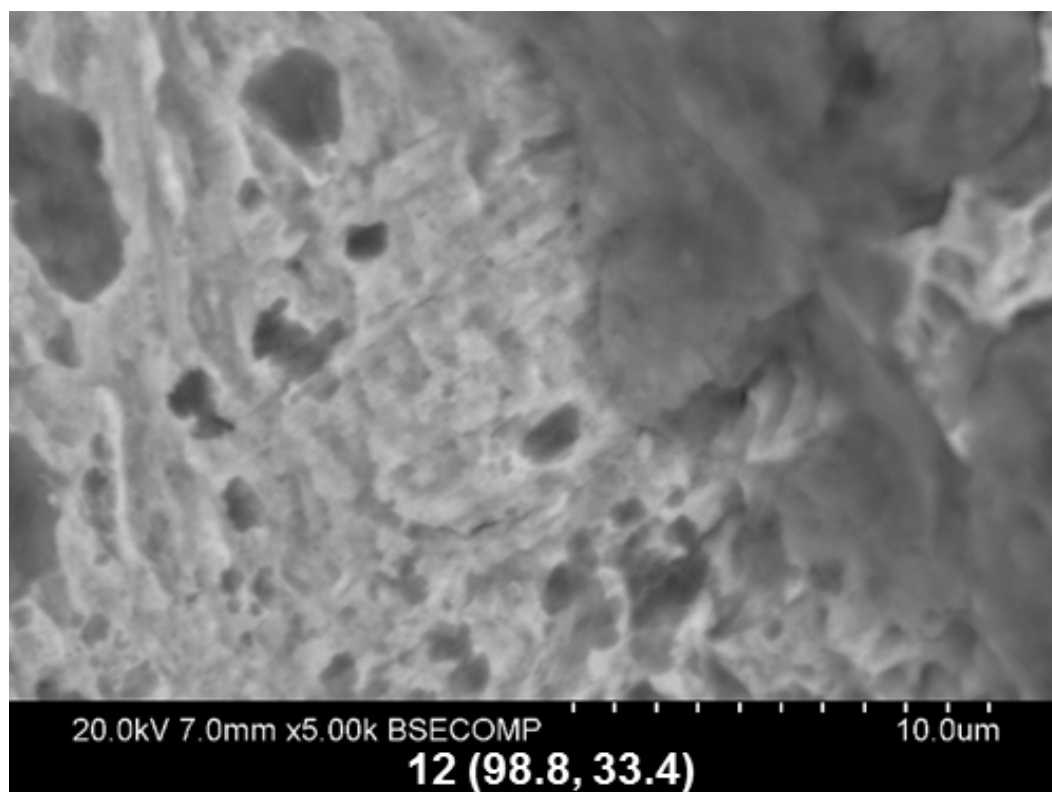
Figure 13 – SE micrograph with striation measurements at site 12 on the fracture surface.

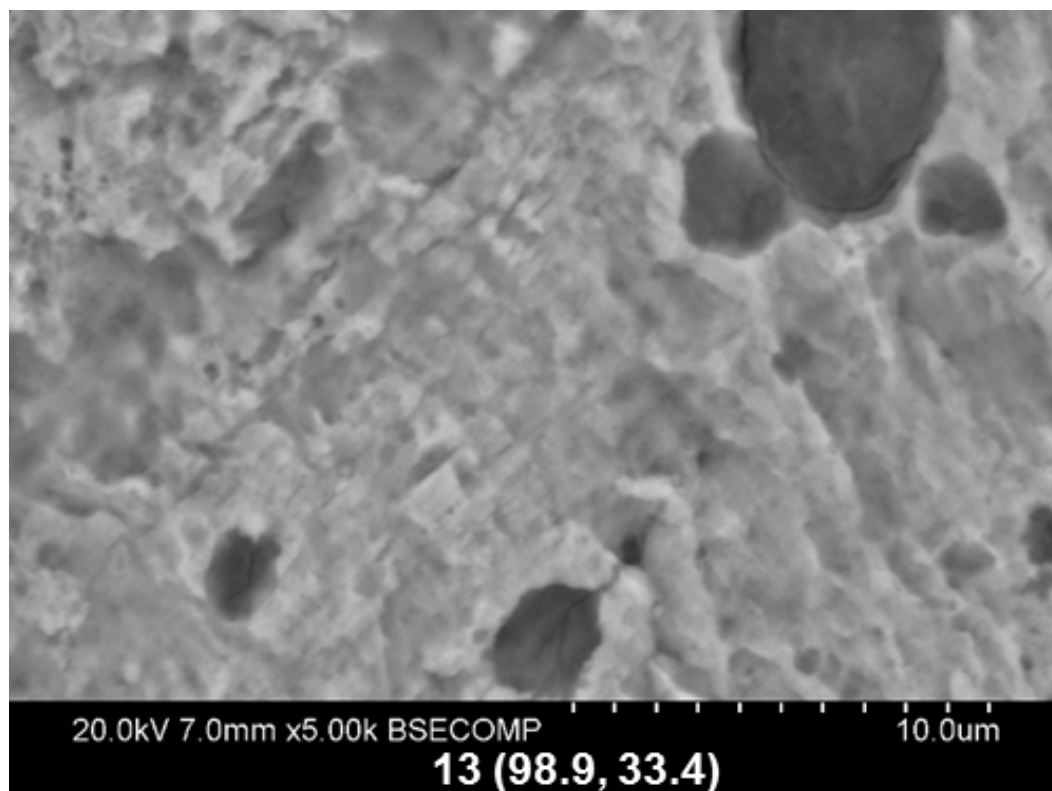
Figure 14 – SE micrograph with striation measurements at site 13 on the fracture surface.

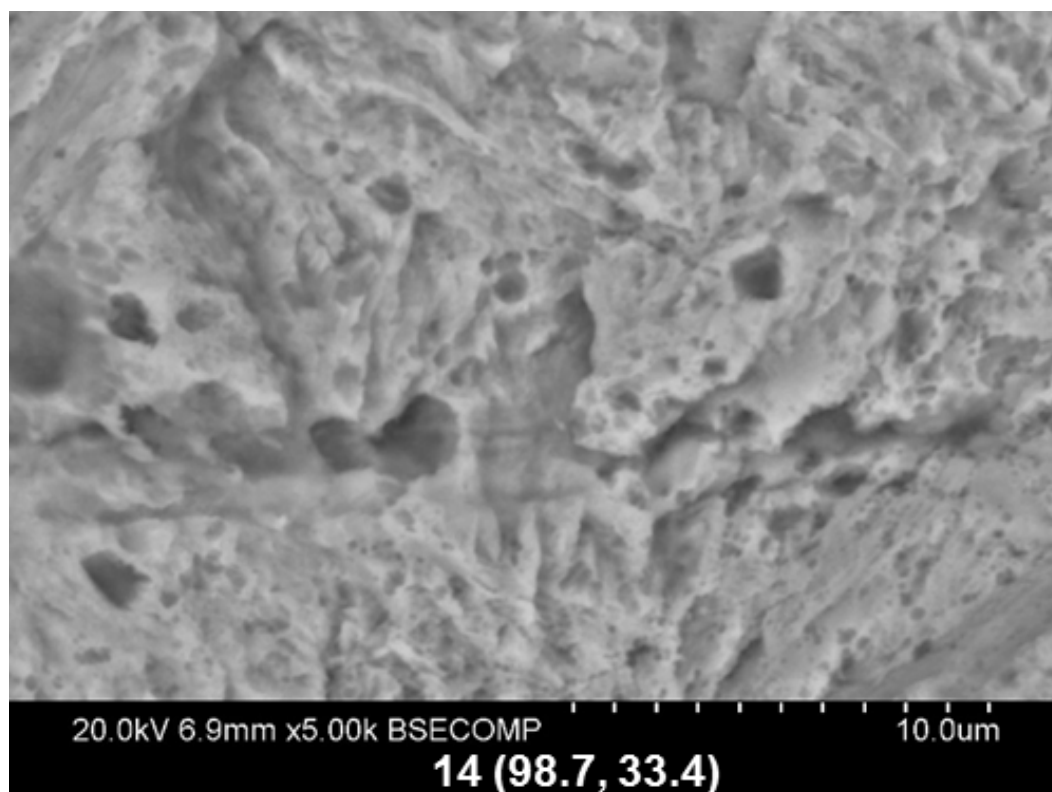
Figure 15 – SE micrograph with striation measurements at site 14 on the fracture surface.

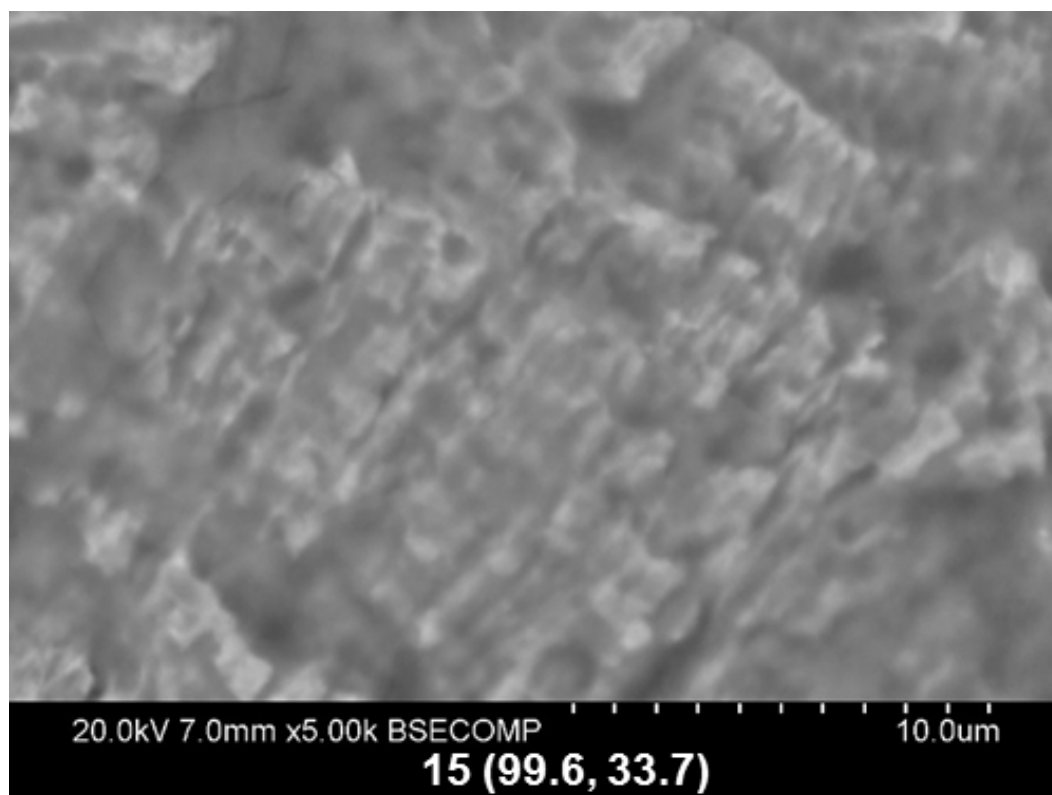
Figure 16 – SE micrograph with striation measurements at site 15 on the fracture surface.

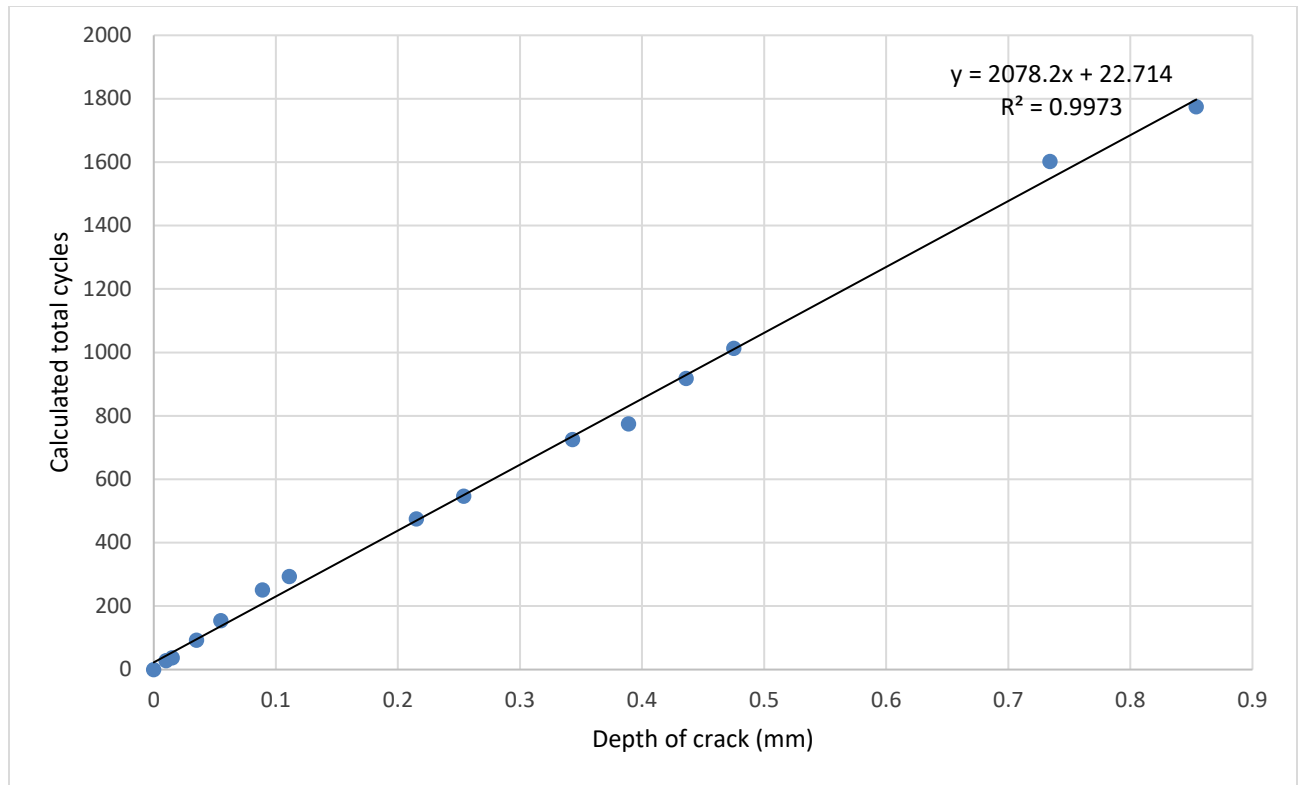
Of interest to the study was the estimated crack length at the time of the last inspection. The number of cumulative cycles versus crack depth was plotted in Figure 17. A linear regression of the data was performed, with the data in over 99% agreement. Using the regression formula, the crack depth at 218 cycles prior to the end of the crack (1556 cycles) was 0.029 inches (0.738 mm). The estimated crack length at this time would have been 0.059 inches (1.507 mm).

Figure 17 – Plot of the cumulative calculated number of cycles (based on striation count) per depth counted. The data was fitted to a linear regression, with the formula and  $R^2$  information on the chart.
