NATIONAL TRANSPORTATION SAFETY BOARD  
Office of Aviation Safety  
Washington, DC 20594

**SURVIVAL FACTORS GROUP SLIDE TEARDOWN REPORT**

| Aircraft | : | MD-83 [N807WA] |
| NTSB # | : | DCA18FA144 |

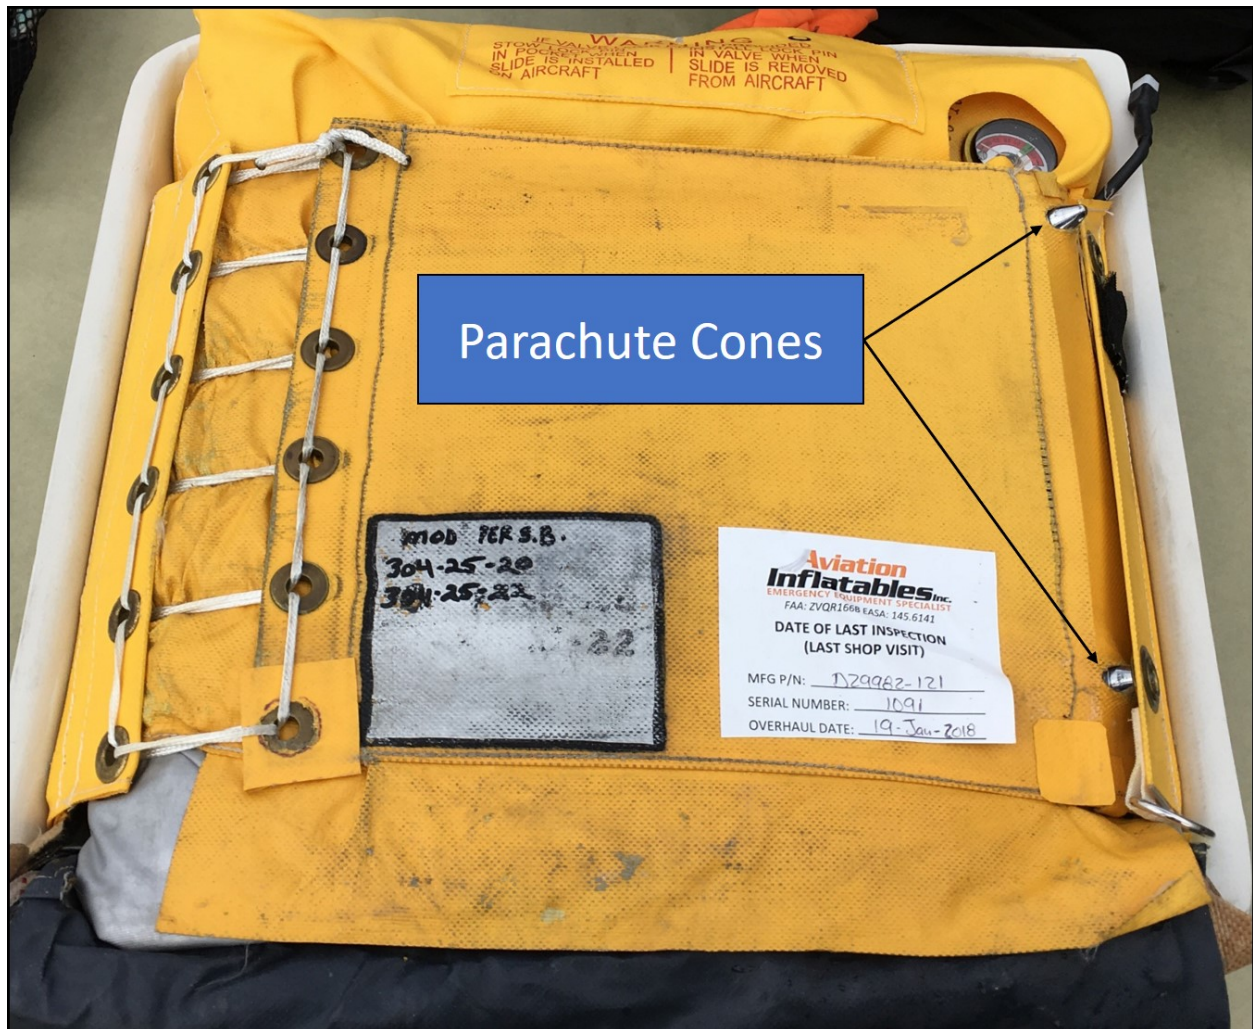
The slide was still in its packed condition with no evidence of gas flow (un-inflated) from the RVA (photograph 1). The inflation cable was found loose in the shipping box. It was in good condition and identified as part number 62957-103 consistent with the the CMM. The parachute cones on the lacing cover were found disengaged (the parachute pins had been withdrawn and the grommets from the associated lacing cover flap had released as expected after manual deployment). The slide was still folded tightly within the packboard. The lacing cover was in good

**Photograph 1 – Packed slide as received.**

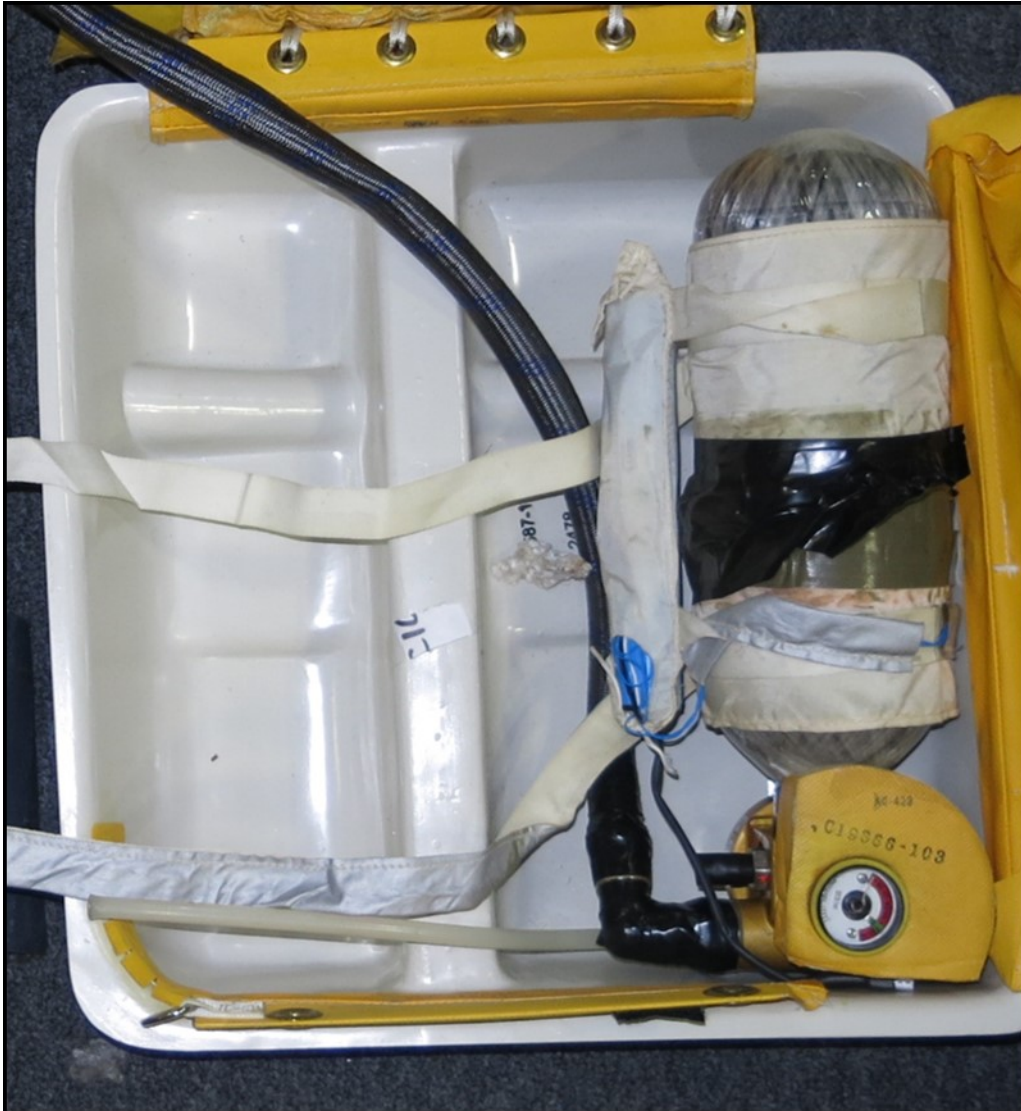
The RVA was removed from the packboard and disconnected from the inflation hose (photograph 2). No obvious defects or damage were noted on the inflation valve or the reservoir. The part number on the inflation hose C17734-105 was consistent with the CMM. The hose was identified as having been hydrotested in January 2018 and appeared to be in good condition. The RVA was confirmed to be fully discharged.

**Photograph 2 – Reservoir and valve assembly (RVA) in packboard.**

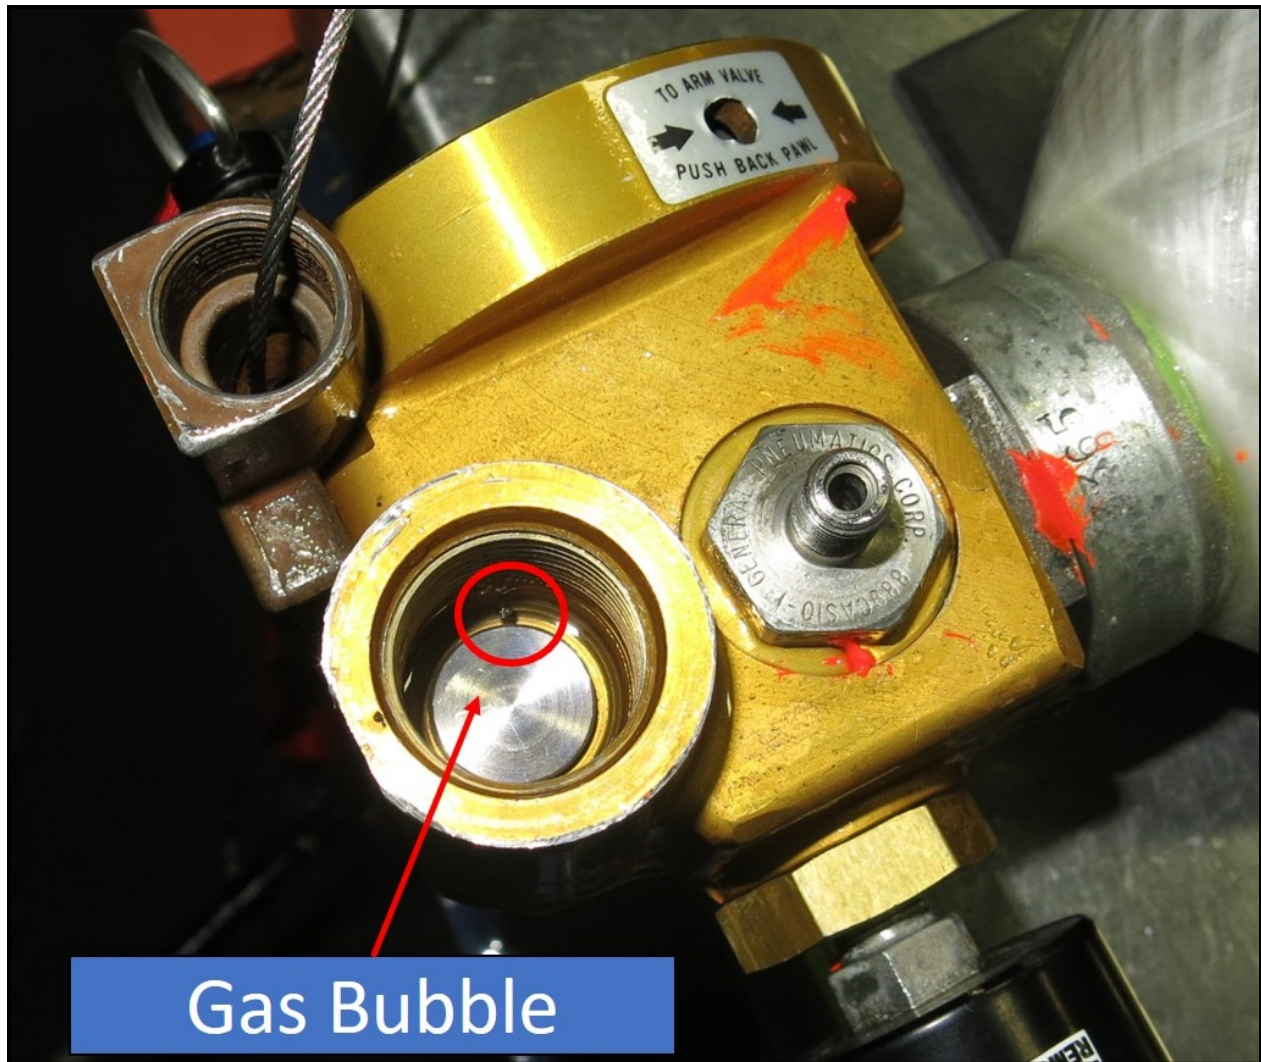
Using a special fitting in the discharge port of the inflation valve, the RVA was charged to approximately 200 psig. All threaded connections between the components of the RVA were inspected using leak detection fluid and no leakage was observed. The inflation valve was rotated to the closed position with the inflation cable installed. The RVA was then charged to CMM specifications using carbon dioxide and nitrogen. Leak detection fluid on the outlet port of the inflation valve identified a small leak next to the regulator piston (photograph 3).

**Photograph 3 – Leak observed in valve outlet port.**

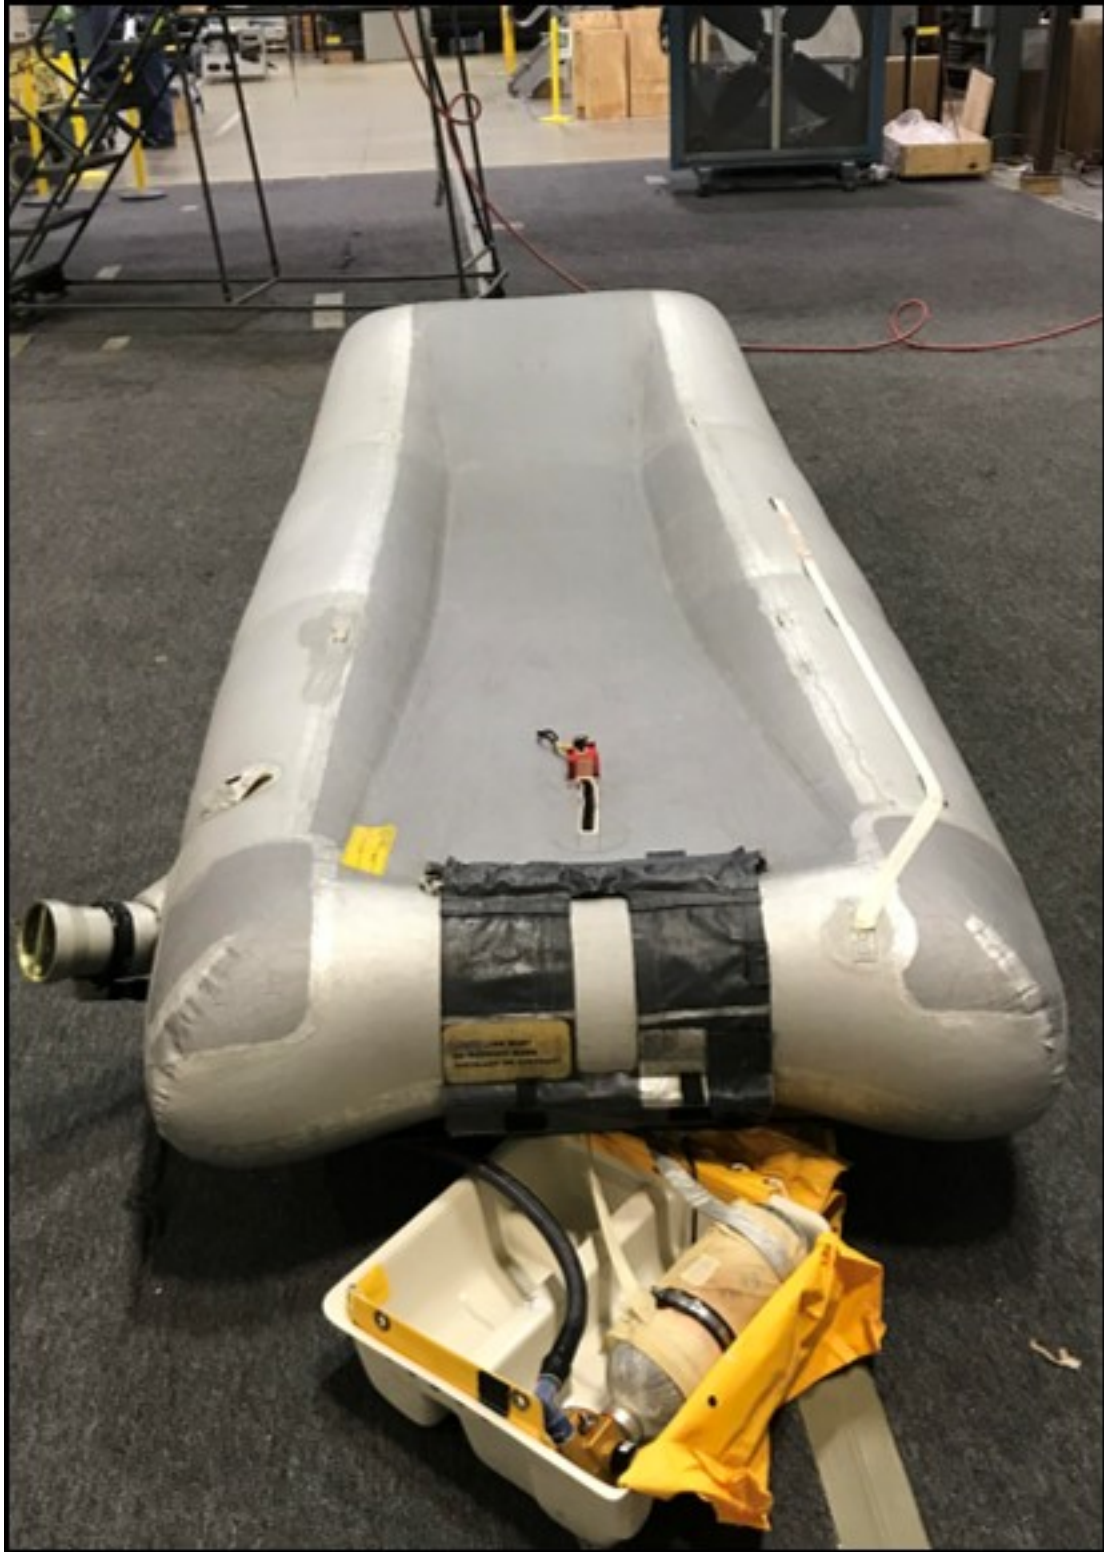
The charged RVA was then installed into the packboard and the inflation hose connected to the inflation valve. The slide was unfolded to conduct a floor run inflation test. The pull force to initiate inflation was within CMM specification at 11.5 lbs. The slide inflated with no issues noted (photograph 4).

**Photograph 4 – Successful floor run slide inflation.**

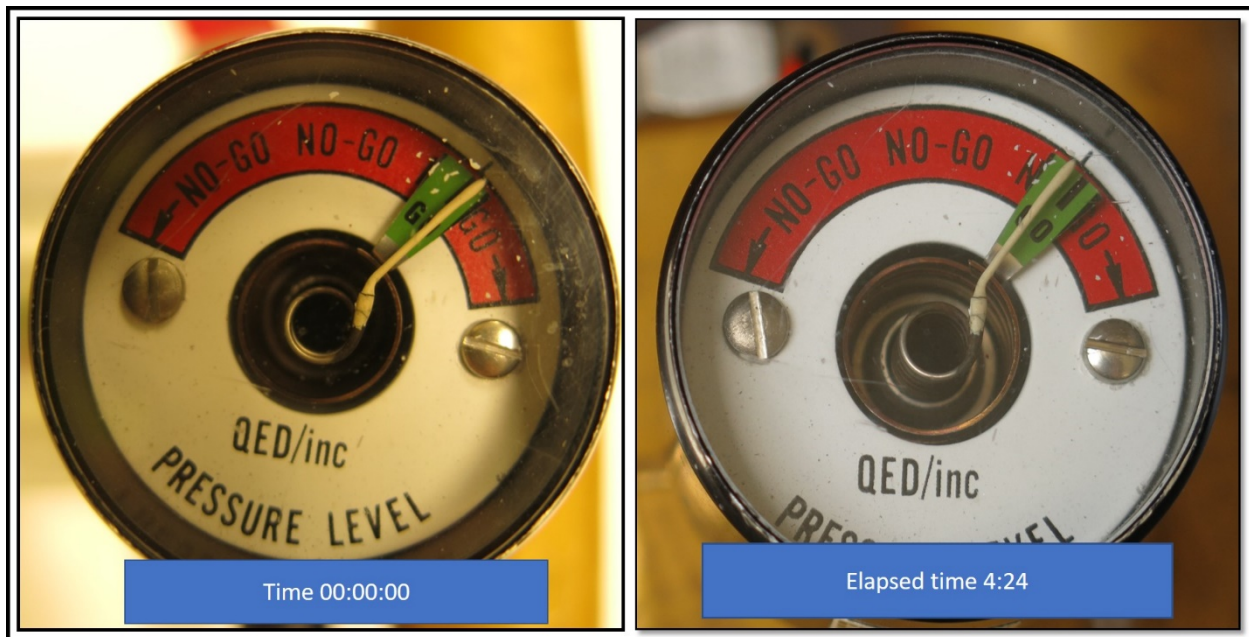
The inflation valve was removed from the reservoir and installed on a pressure chuck p/n 65712-5 for testing purposes. The valve was pressurized to a point within the green “GO” band as indicated on the pressure gauge shown (left-hand side of photograph 5). When observed about 4 hours and 24 minutes later the gauge showed evidence of a pressure loss (right-hand side of photograph 5). The needle position was observed below the green band about 12-18 hours after the test.

**Photograph 5 – Pressure gauge needle position before and after test.**
