ENGINEERING DOCUMENT NUMBER 4865

INVESTIGATION REPORT

World Atlantic Airlines MD80 Forward Slide Deployment Failure  
Public Docket

Slide Evacuation System D29982-121  
Serial number 1091

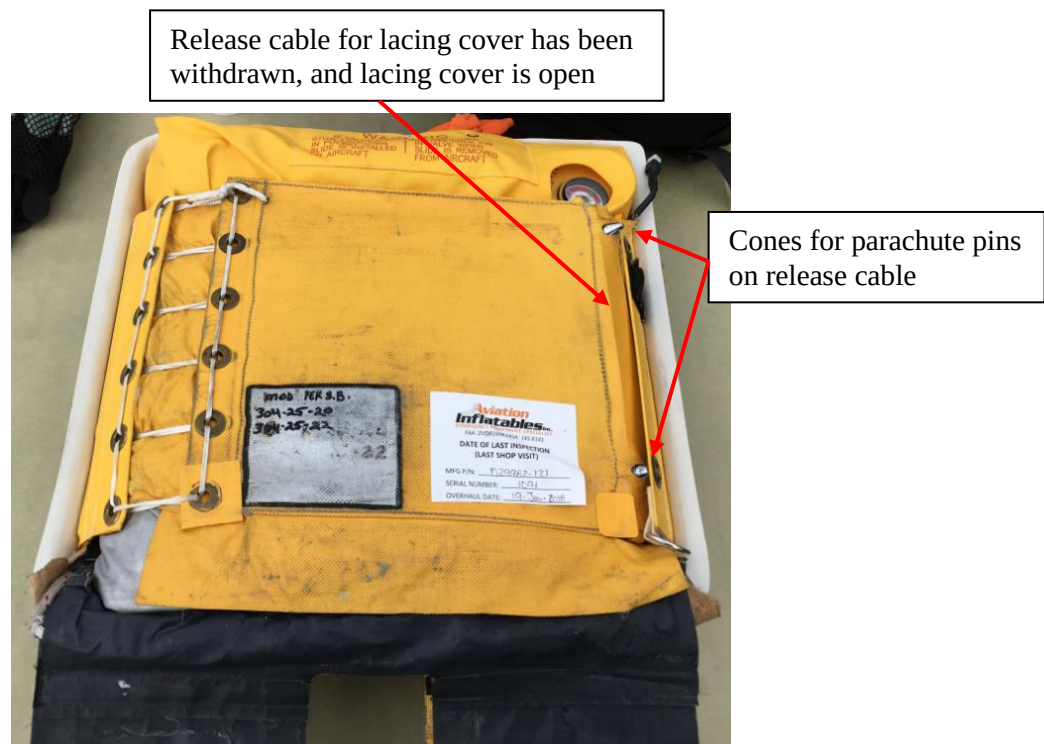
After the event, the National Transportation Safety Board (NTSB) provided a photo of the forward door slide that failed to inflate, shown in Figure 1 below.

This photo shows that the release cable for the lacing cover had been pulled away. The release cable for the lacing cover has two parachute pins that are inserted through metal cones on the lacing cover to secure the lacing cover together. These parachute pins had been withdrawn from these cones, so the lacing cover was open to release the slide for inflation. However, the slide did not inflate as expected, and the slide remained within the confines of the lacing cover.

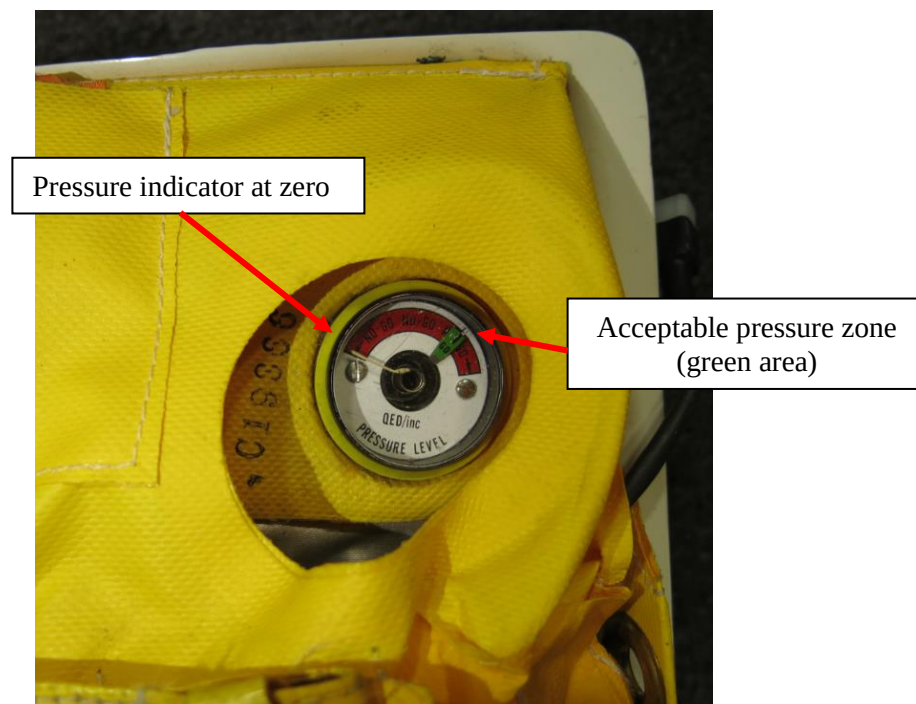
Figure 2  
Zero Gas Pressure

The NTSB provided a photo of the pressure gage on the reservoir and valve assembly after the event, which is shown in Figure 2. The gage indicated that the inflation gas reservoir was empty.

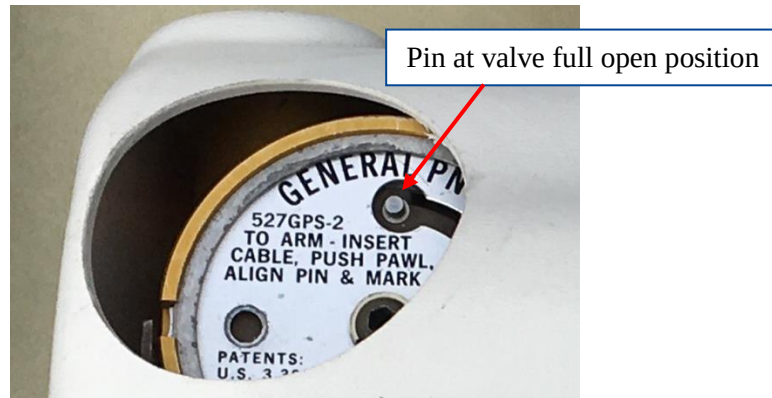
Figure 3  
Indicator Pin Showing Inflation Valve is Full Open

The NTSB also provided a photo of the indicator pin on the inflation valve assembly, which is visible on the rear of the packboard. This pin, shown in Figure 3, is in the

position that indicates that the valve is in the fully open position. This is the expected position following a slide deployment, after the inflation valve has been opened to release the inflation gas in the reservoir.

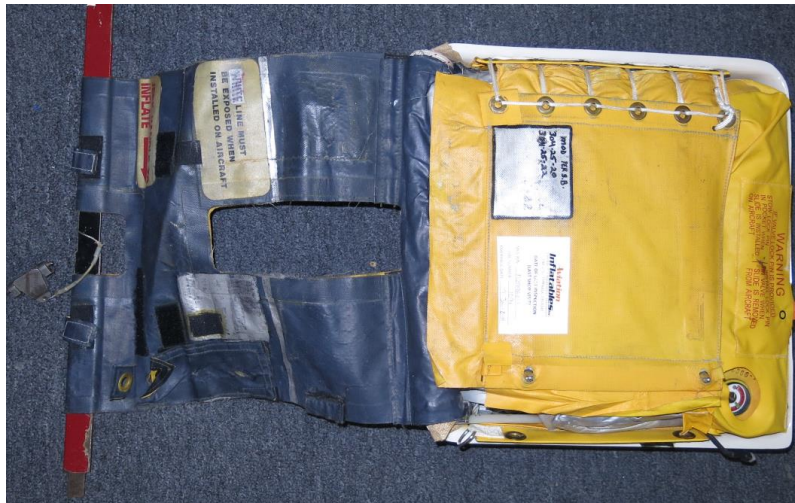
Figure 4  
Slide System Prior to Inspection

The slide system, shown in Figure 4, was in the same condition as shown in the photo provided by the NTSB after the event (reference Figure 1). The release cable for the lacing cover had been pulled free of the slide system, which released the parachute pins that secure the lacing cover in place over the packed slide assembly. The parachute cones on the lacing cover had disengaged from the grommets on the adjacent lacing cover flap, and the lacing cover was free to open. The lacing cover was in good condition with no findings.

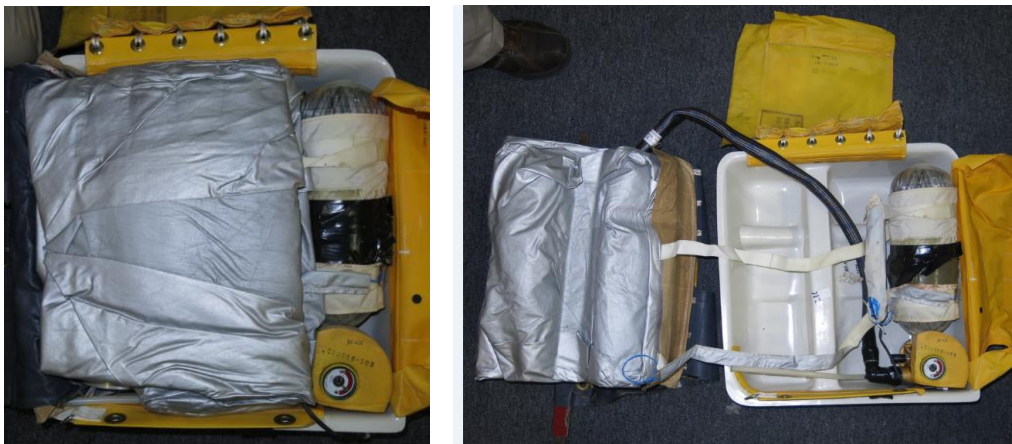
Figure 5  
Slide Still in Packed Condition

The slide was in its folded and packed condition within the packboard tray as shown in Figure 5. There was no evidence of inflation of the folded slide assembly.

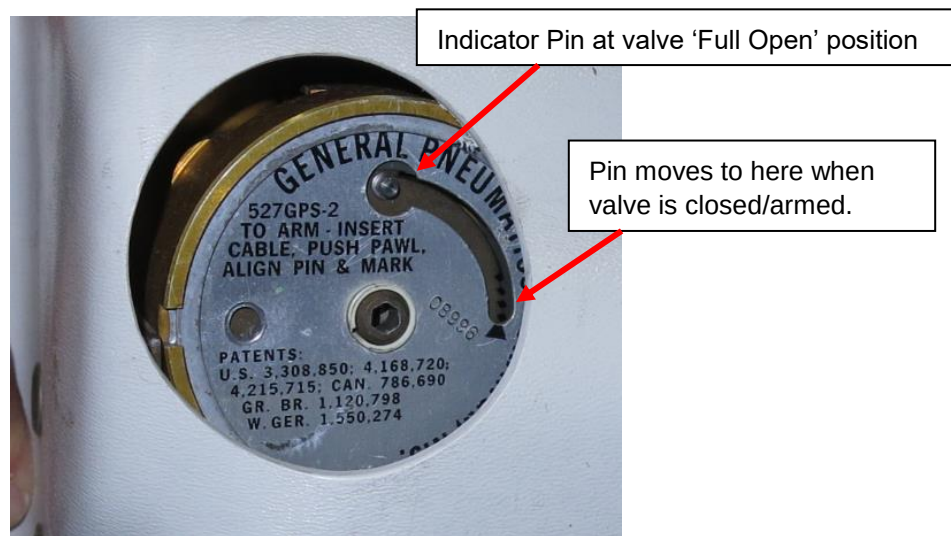
Figure 6  
Valve Position Indicator Pin

The pressure gage on the Reservoir and Valve Assembly (RVA) indicated that the reservoir had zero pressure. The filler valve on the inflation valve was opened, and there was no release of gas, which confirmed that the gas reservoir was empty. The indicator pin on the inflation valve was confirmed to be in the 'valve open' position, as shown in Figure 6.

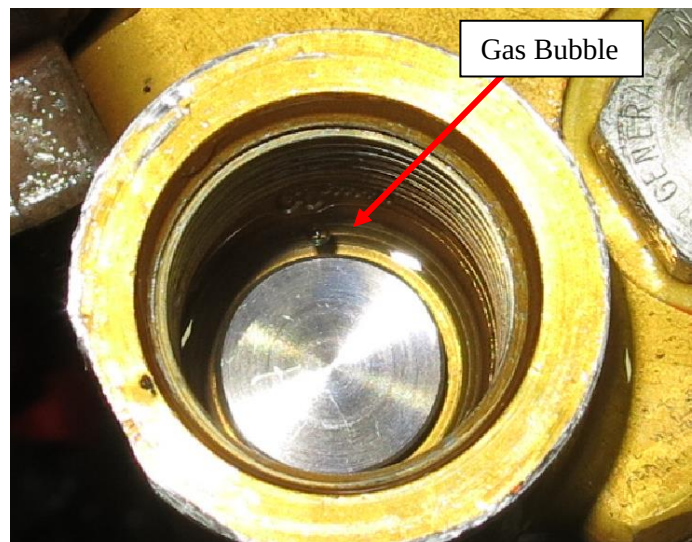
Figure 7  
Leak at Inflation Valve Outlet Port

The inflation valve was closed and armed with the inflation cable. The RVA was then charged with carbon dioxide and nitrogen gases per CMM requirements. Using a small pool of leak detection fluid, a small leak was detected in the outlet port of the inflation valve as shown in Figure 7.

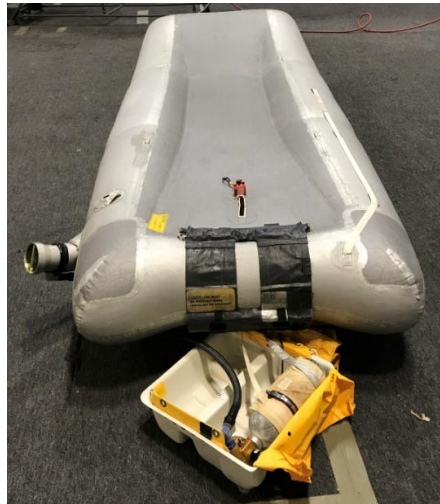
Figure 8  
Successful Floor Run

The charged RVA was then installed on the packboard, and the inflation hose was connected to the inflation valve. The slide was unfolded and a floor run inflation test was performed. The slide inflated successfully as shown in Figure 8, with no issues

noted. The pull force to initiate inflation was measured to be 11.5 lbs., which is within the CMM specification of 15 lbs. max.

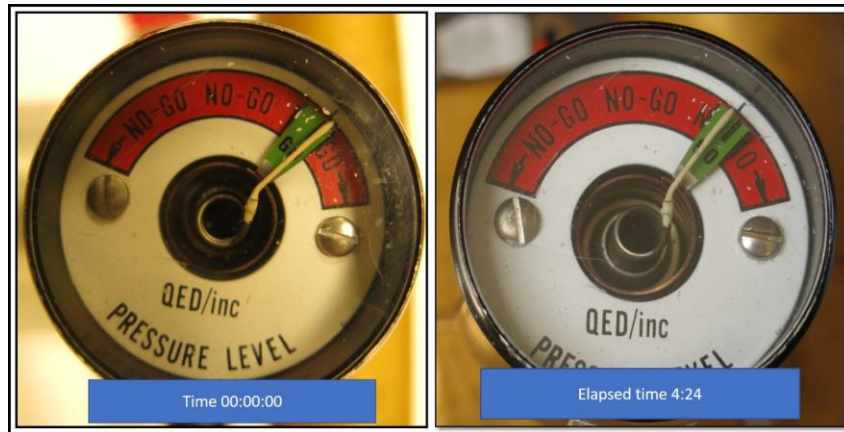
Figure 9  
Pressure Loss after 4 hours 24 minutes

Following the floor run, the inflation valve was removed from the reservoir and installed on a Pressure Chuck for testing purposes. The valve was then pressurized to a point within the green “GO” Band on the pressure gage and a photograph was taken of the gage indicator position. This photo is shown on the left hand side of Figure 9. After 4 hours 24 minutes, the pressure gage showed visible evidence of a pressure loss as shown by the photo on the right hand side of Figure 9.

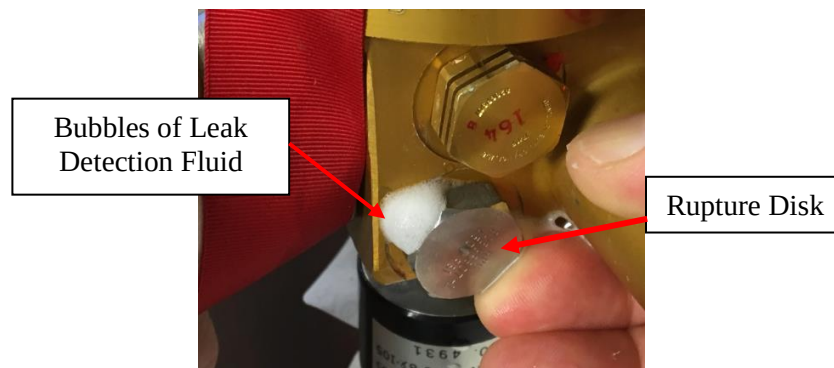
Figure 11  
Rupture Disk Outlet Leaking

The leak through the Rupture Disk Assembly was verified by sealing one of the outlet vents with a finger and then filling the other outlet vent with leak detection fluid. The bubbles of leak detection fluid from the outlet vent confirmed that the leak through the Rupture Disk was still active, as shown in Figure 11.

The likely root cause is that the gas reservoir was empty when the incident occurred, which is supported by the leak found through the Rupture Disk Assembly.

The inflation valve was found with a slow leak that would have bled off all of the inflation gas in the Reservoir and Valve Assembly over a period of several months. Regular monitoring of the pressure gage on this evacuation slide system should have detected that the gas pressure had decreased to an unacceptable level prior to the incident.

All Air Cruiser Component Maintenance Manuals (CMMs) for evacuation slide systems recommend periodic in-service inspections at intervals to be determined by the operator. During these inspections, the pressure gages are to be checked for acceptable pressure to ensure that the gas reservoir in these systems is sufficient for emergency use.

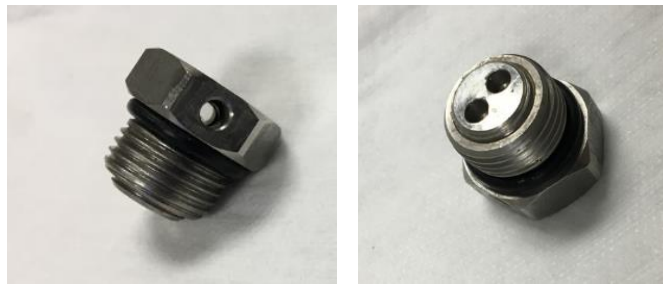
Figure 12  
Rupture Disk Assembly

After discharging the inflation gases in the reservoir, the Rupture Disk Assembly was removed from the inflation valve body. The Rupture Disk Assembly had no obvious signs of damage or corrosion on the exterior surfaces as shown in Figure 12. The Rupture Disk Assembly was identified as “GPC 826GPS07-1 4500 psi”, which is the correct part number and limiting pressure value.

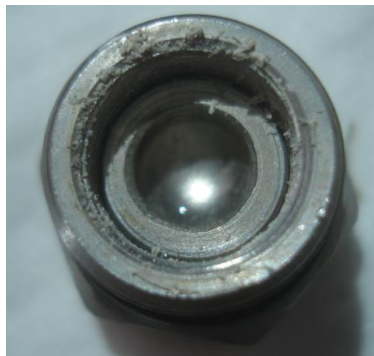
Figure 14  
Internal Rupture Disk Intact

Once the threaded plug was removed, the rupture disk was visible and intact as shown in Figure 14. There was no evidence of cracks or other defects. The debris shown in the photo is consistent with previously applied thread sealant.

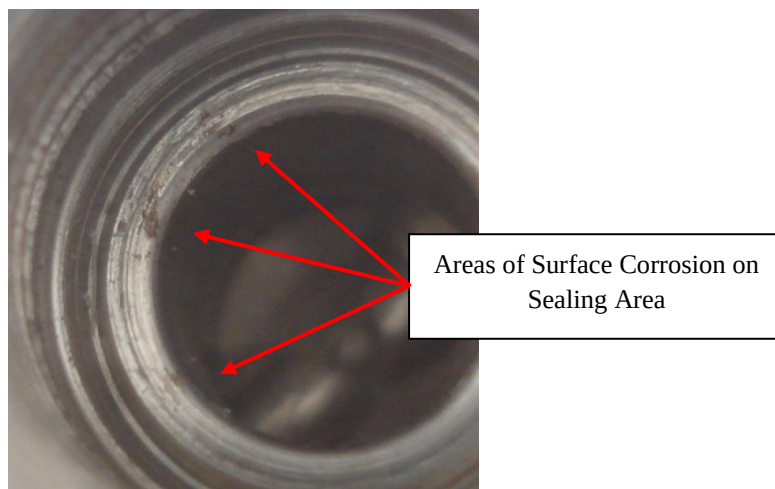
Figure 15  
Minor Surface Corrosion

Inspection of the interior rim inside the body of the rupture disk assembly found three small areas of surface corrosion, shown in Figure 15. These areas are located on the sealing surface where the rupture disk makes contact with the assembly body.
