NATIONAL TRANSPORTATION SAFETY BOARD  
Office of Aviation Safety  
Washington, DC 20594

**SURVIVAL FACTORS GROUP INFLATION VALVE TEARDOWN REPORT**

| Aircraft | : | MD-83 [N807WA] |
| NTSB # | : | DCA18FA144 |

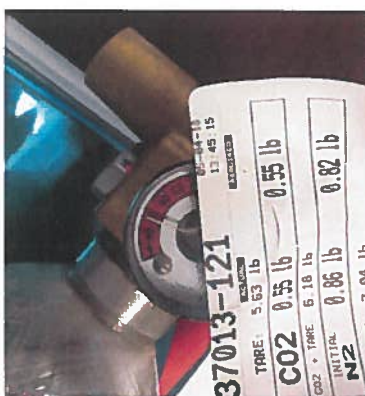
1. The reservoir and inflation valve assembly was removed from quarantine for inspection. The valve part number was confirmed to be D18294-107 with serial number B490-6100.
2. The pressure gage reading is shown in Photograph 1.

**Photograph 1 – Current Gage Indication.**

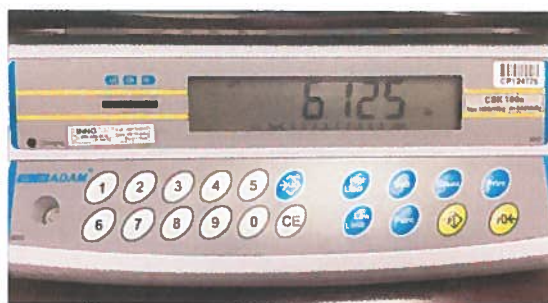
3. The reservoir and valve assembly was then weighed, with a total weight reading of 6.125 lbs. as shown in Photograph 2. The weight lost to date via leakage was 0.875 lbs. (The reservoir and valve assembly weighed 7.0 lbs. total on 4 May 2018).

**Photograph 2 – Reservoir and Valve Assembly Weight.**

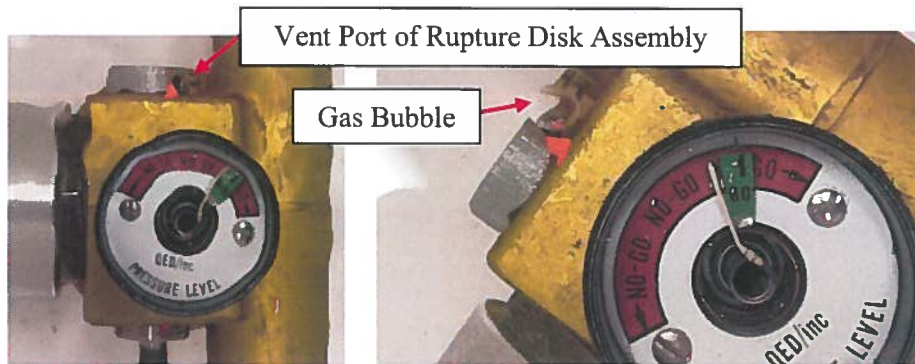
4. Subsequent to the investigation performed on 3 May 2018, the reservoir and valve assembly was submerged in an alcohol bath to confirm the origin of the gas leakage. This test revealed a periodic release of a gas bubble emanating from the Rupture Disk Assembly,

as shown in Photograph 3. No other locations of gas leakage were noted during this dunk test, including the valve outlet as previously identified during the May teardown. Consequently, this follow up investigation concentrated on the Rupture Disk Assembly.

**Photograph 3 – Gas Leakage From Rupture Disk Assembly.**

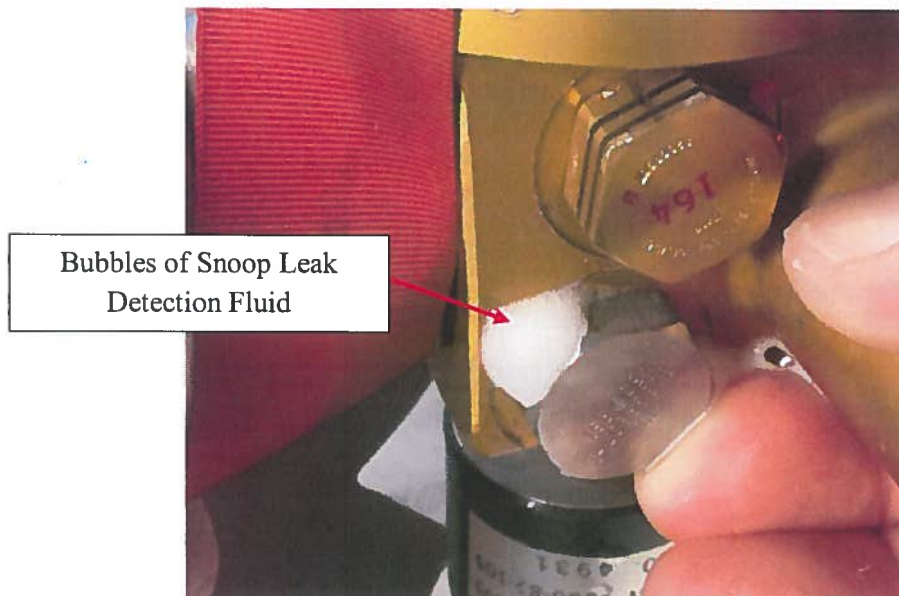
5. This investigation began by filling the outlet ports of the Rupture Disk Assembly with Snoop leak detection fluid. Evidence of continued leakage thru these ports was immediately apparent as shown in Photograph 4.

**Photograph 4 – Snoop on Rupture Disk Discharge Port.**

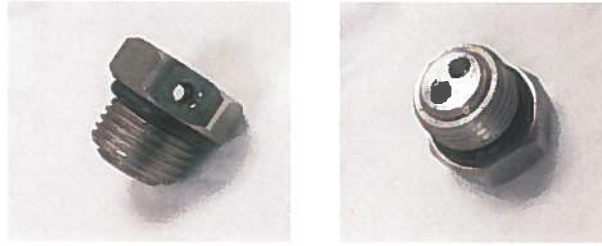
6. The reservoir was discharged thru the filler valve port. The Rupture Disk Assembly was then removed from the inflation valve body. The Rupture Disk Assembly had no obvious signs of damage or corrosion as shown in Photograph 5. The Rupture Disk Assembly was identified as “GPC 826GPS07-1 4500 psi”.

**Photograph 5 – Rupture Disk Assembly.**

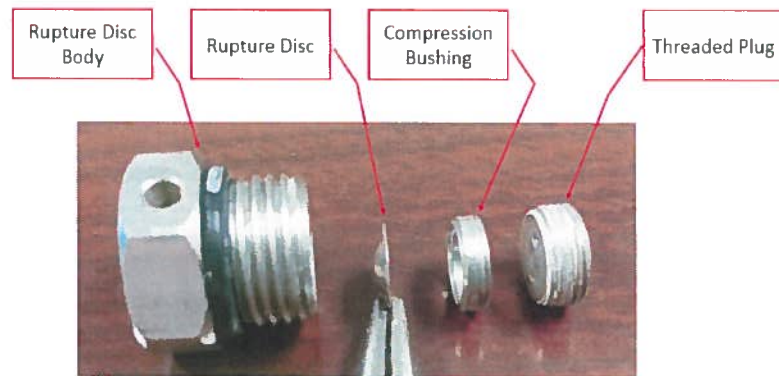
7. An exploded view of the Rupture Disk Assembly is shown in Photograph 6. The interior rupture disk seats against the body of the Assembly by a compression bushing, which is secured using a threaded plug. The rupture disk is securely held against the compression bushing by a matching V-shaped edge around both components. This V-shaped edge maintains the pressure seal and limits movement of the rupture disk within the Assembly. The key sealing surfaces are shown in Photograph 7.

**Photograph 6 – Rupture Disk Assembly Exploded View.**

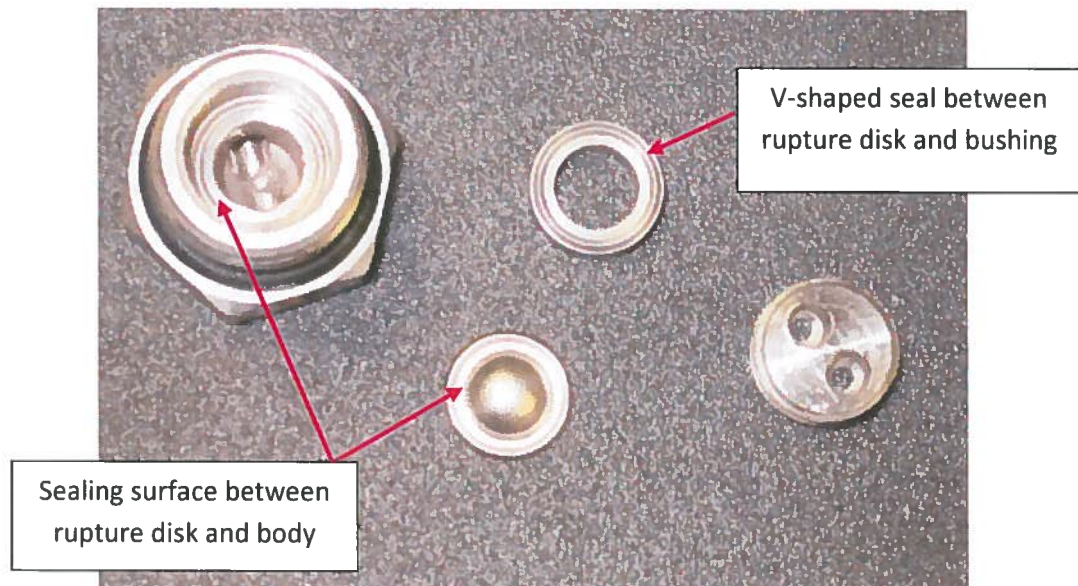
**Photograph 7 – Rupture Disk Assembly Components.**

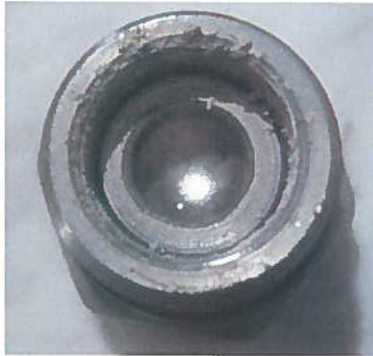
8. The threaded plug was carefully loosened and removed to gain access to the interior of the Assembly. The plug was adequately secured in place and appeared to be undamaged upon removal. The removal torque could not be measured due to a requirement for special tooling.
9. Once the threaded plug was removed, the rupture disk was visible and intact as shown in Photograph 8. There was no evidence of cracks or other defects. The debris shown in the Photograph is consistent with previously applied thread sealant.

**Photograph 8 – Rupture Disk Assembly.**

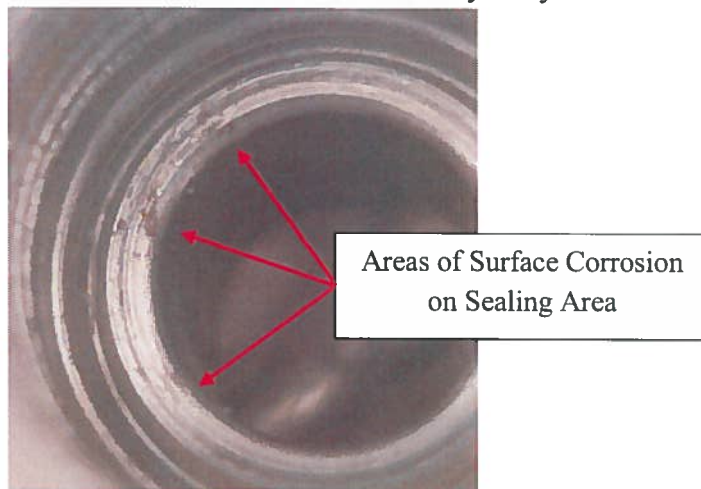
10. The compression bushing and the rupture disk were carefully removed for further inspection. No evidence of damage or corrosion was found around the edges of the rupture disk or on the compression bushing.
11. Inspection of the interior rim inside the body of the rupture disk assembly found three small areas of surface corrosion, shown in Photograph 9. These areas are located on the sealing surface where the rupture disk makes contact with the assembly body.

**Photograph 9– Minor Surface Corrosion.**
