# Metallurgical Investigation Final Report

**Subject:** Metallurgical Investigation of Fan Blades No. 11 and No. 10 from PW4077 Engine 777049

**Date:** October 9, 2018

# PW4077 P777049 Fan Blade Fracture Investigation

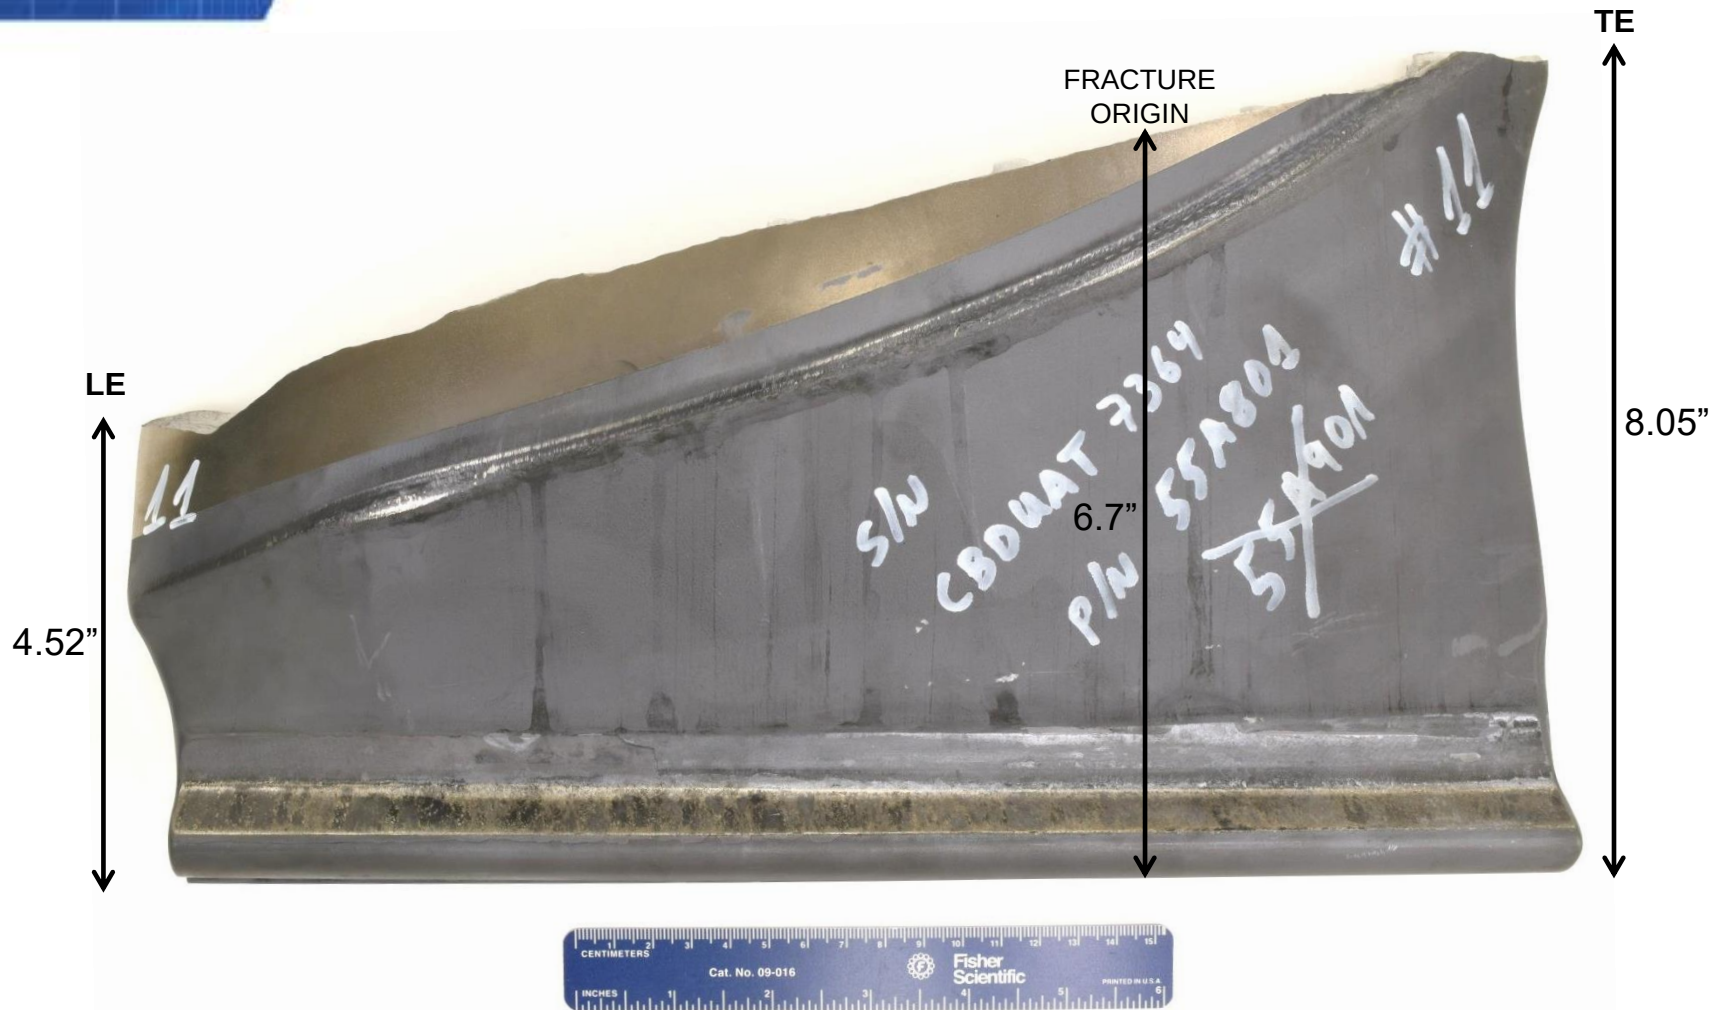
Figure 2 - Overall view of Blade #11, root portion, convex side.  
Attachment 1

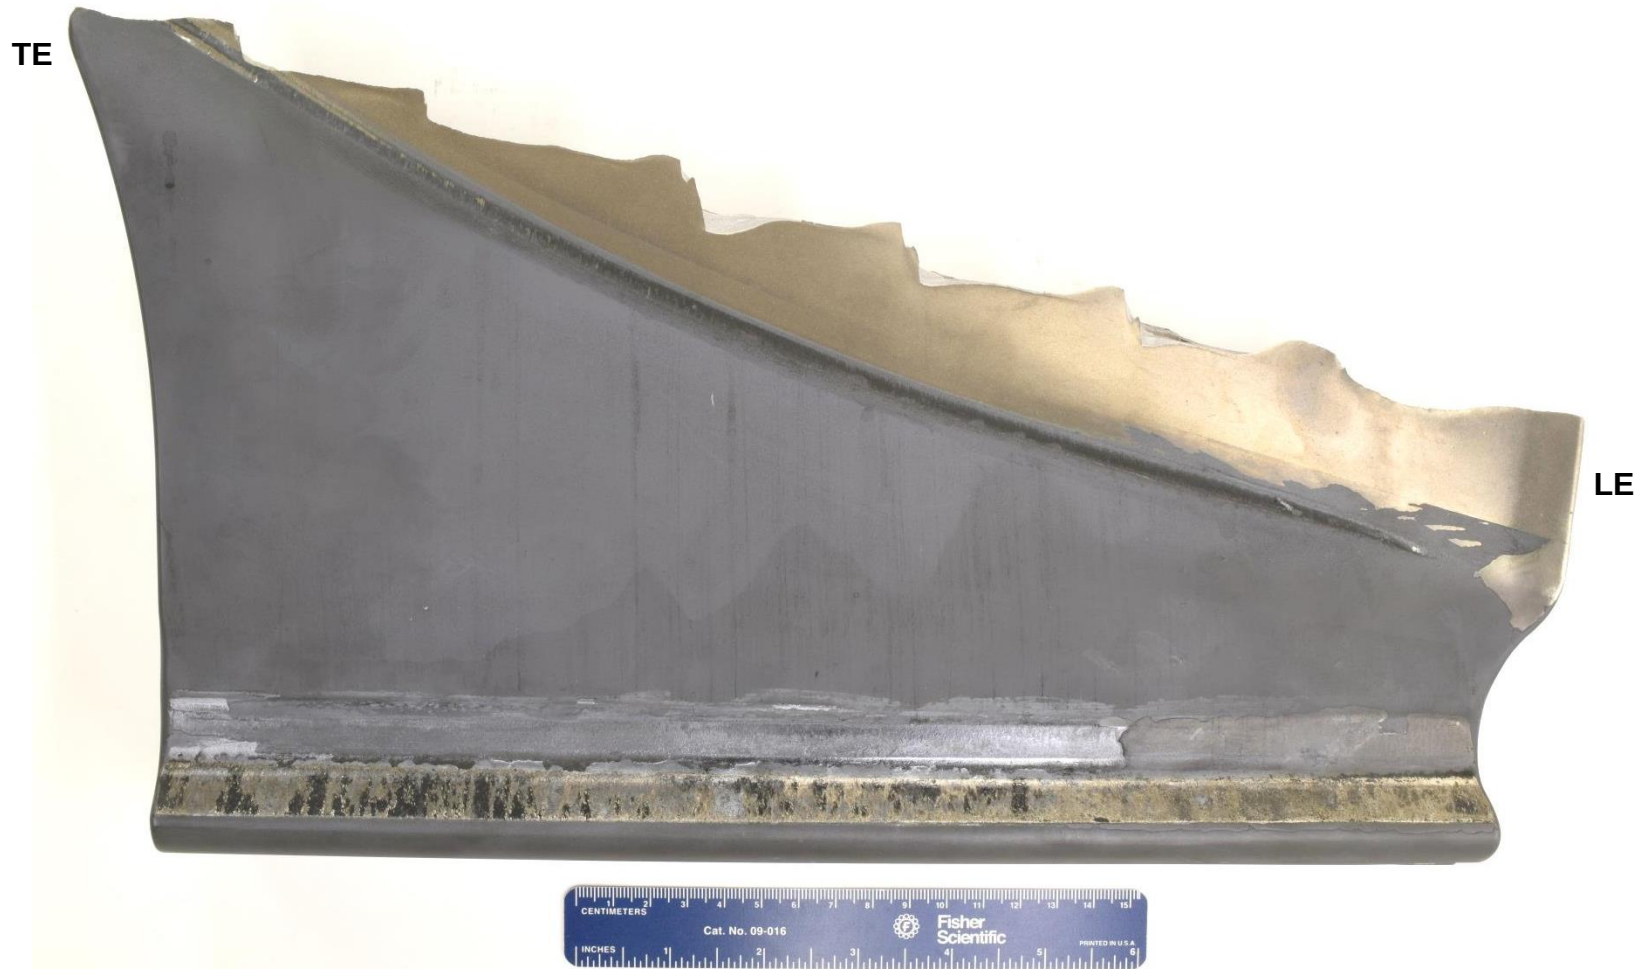
Figure 3 - Overall view of Blade #11, root portion, concave side.  
Attachment 1

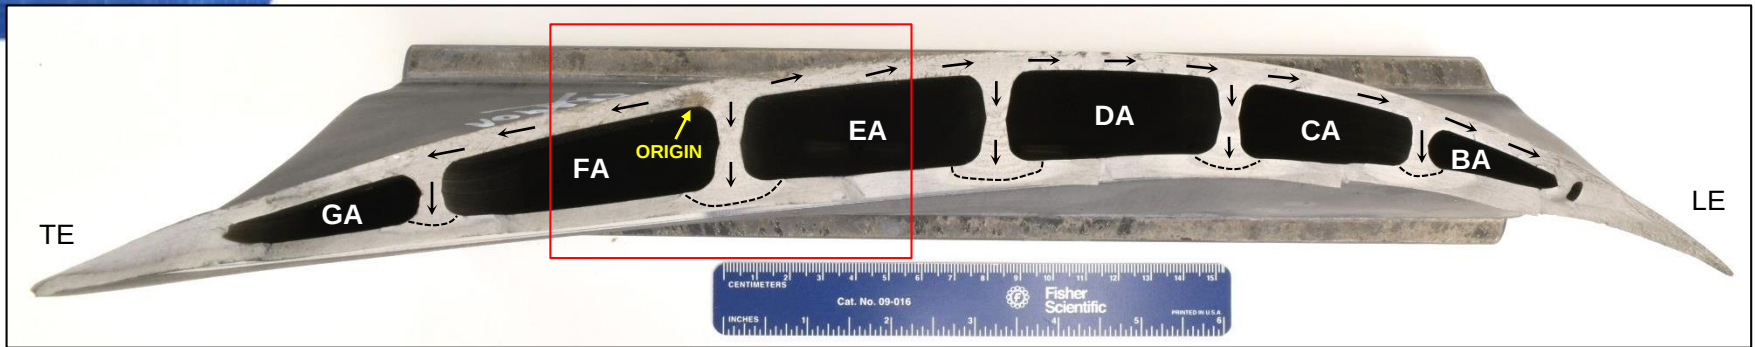
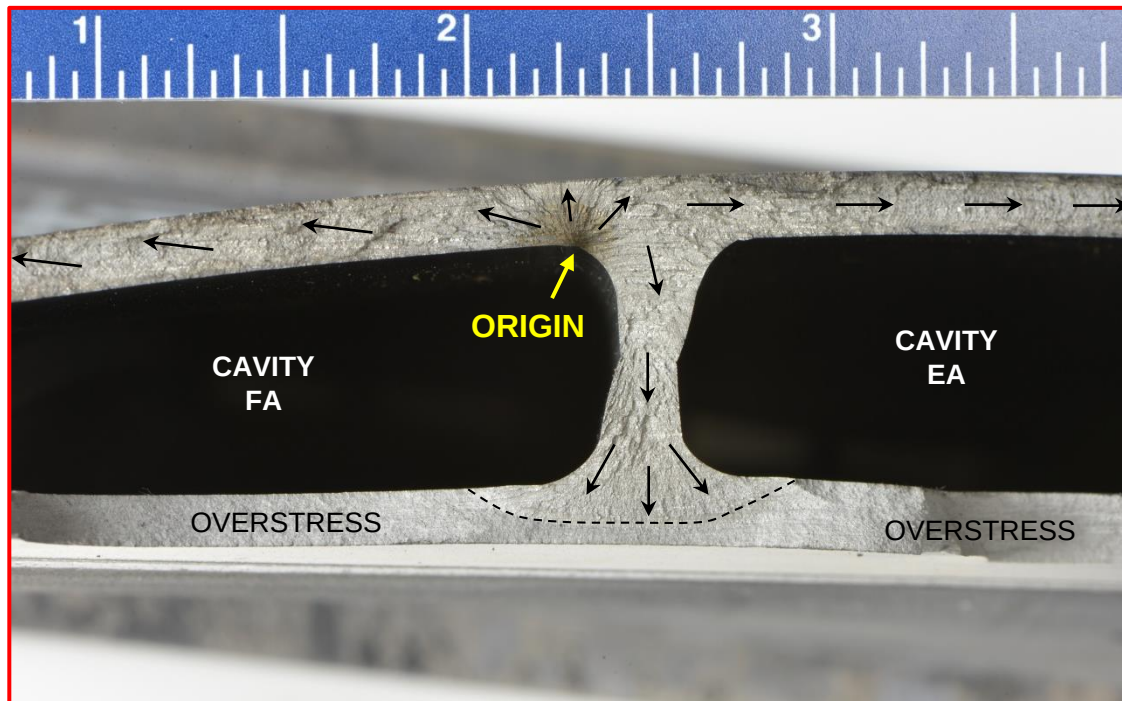
Visual examination of the fracture surface (inboard half of fracture) revealed evidence of fatigue progression from the transition between the internal surface of the convex side wall and the internal rib separating cavities FA and EA, ~6.7” outboard of the root bottom (**Figure 4**). A raised band of coarse machining marks (e.g. a machining mismatch) was observed on the internal cavity surface at the fatigue origin. Initial replication of this feature revealed it measured ~0.050” wide and had a step height of ~0.004” (**Figures 5 – 7**). The surface roughness of the mismatch was an Ra of 67 µin, as measured via stylus profilometer, compared to the limit of 63 µin max.

Figure 4 - Overall and close-up views of Blade #11 (root portion) fracture surface showing propagation from fatigue origin on the internal side of the convex wall at forward end of cavity FA.

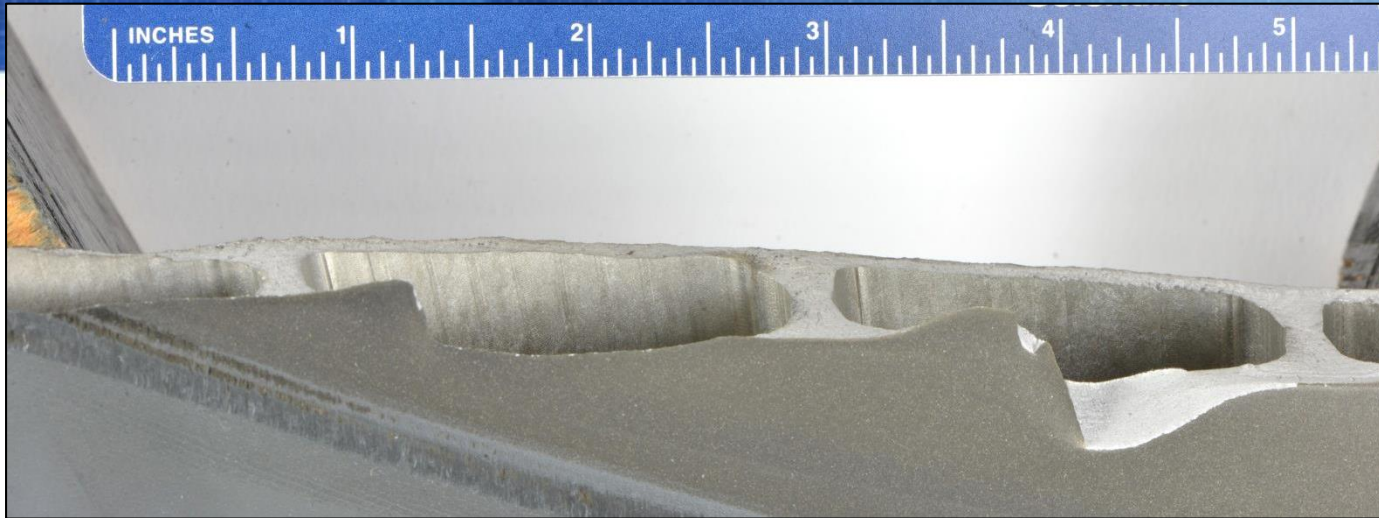
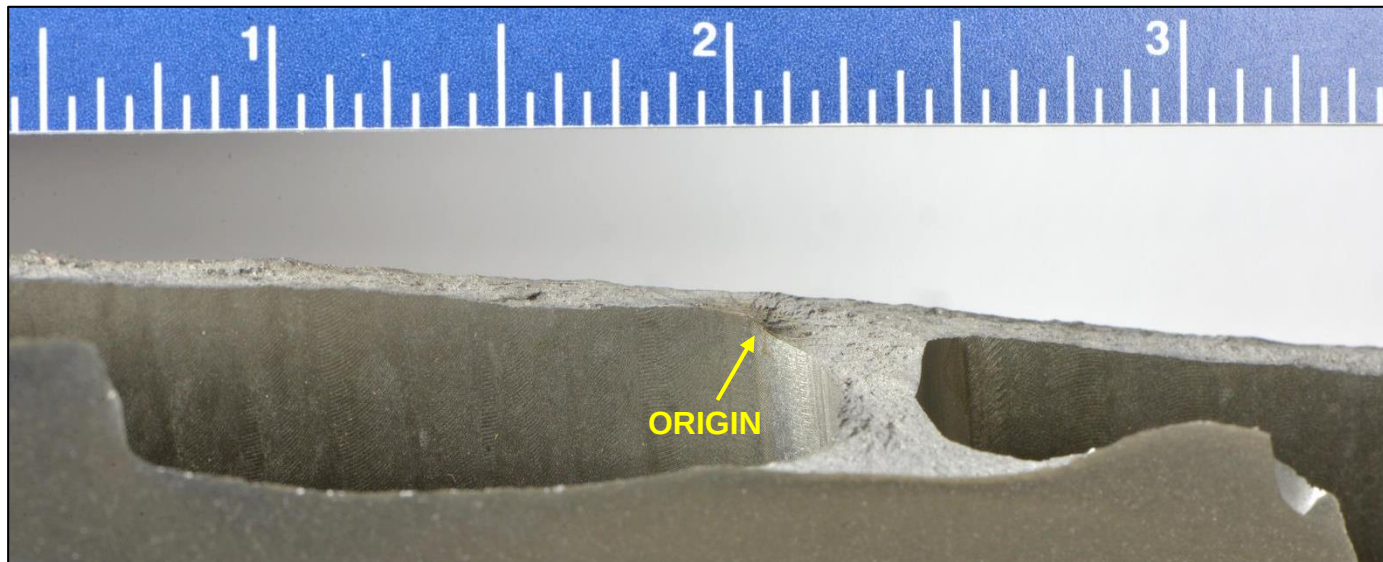
Figure 5 - Angled views of internal cavity side of convex wall at cavities FA and EA.

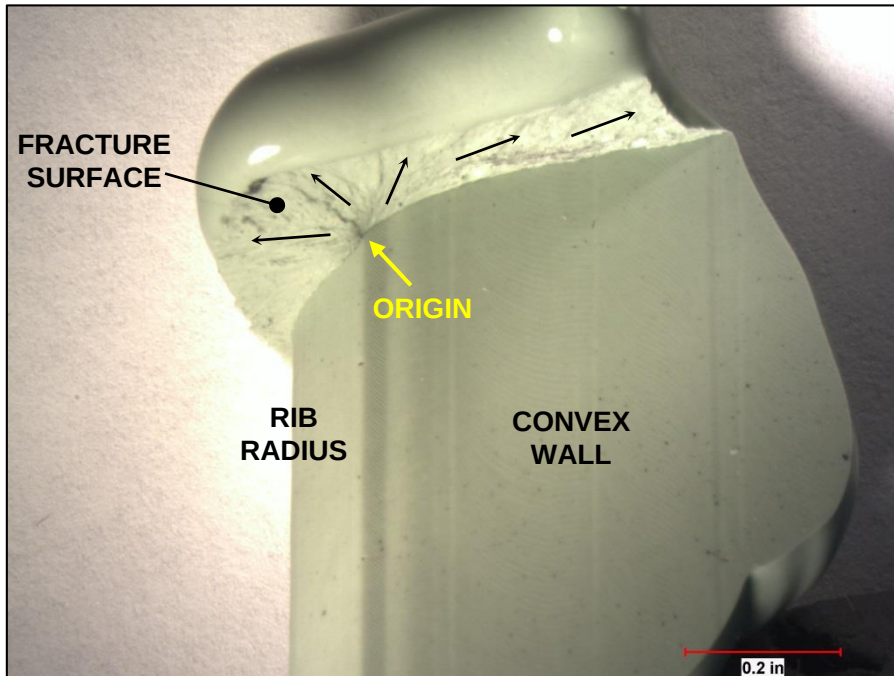
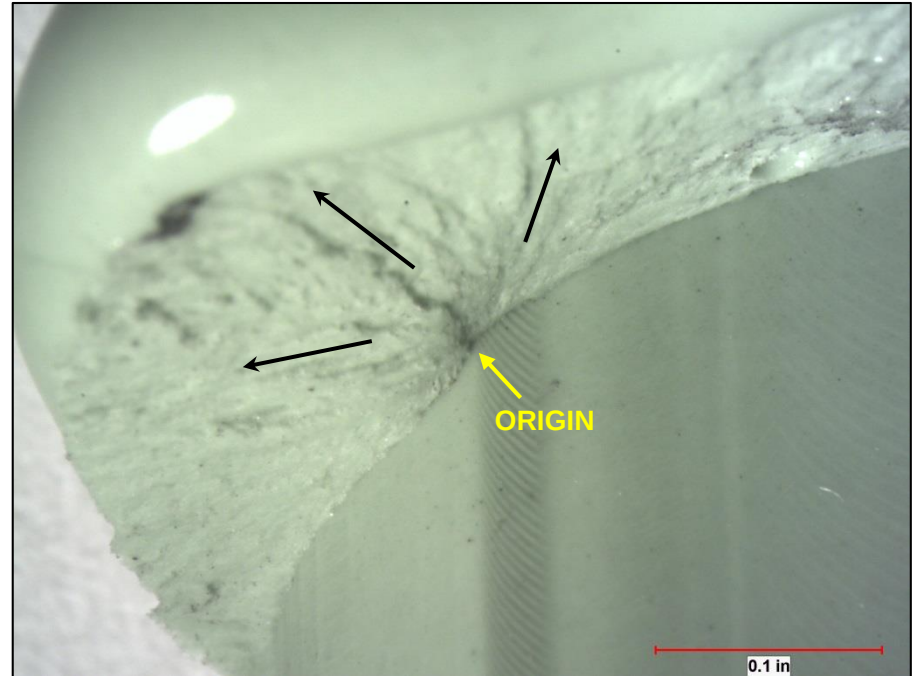
Figure 6 - Close-up views of polyvinylsiloxane rubber replica taken of internal cavity radius geometry at fatigue origin location.

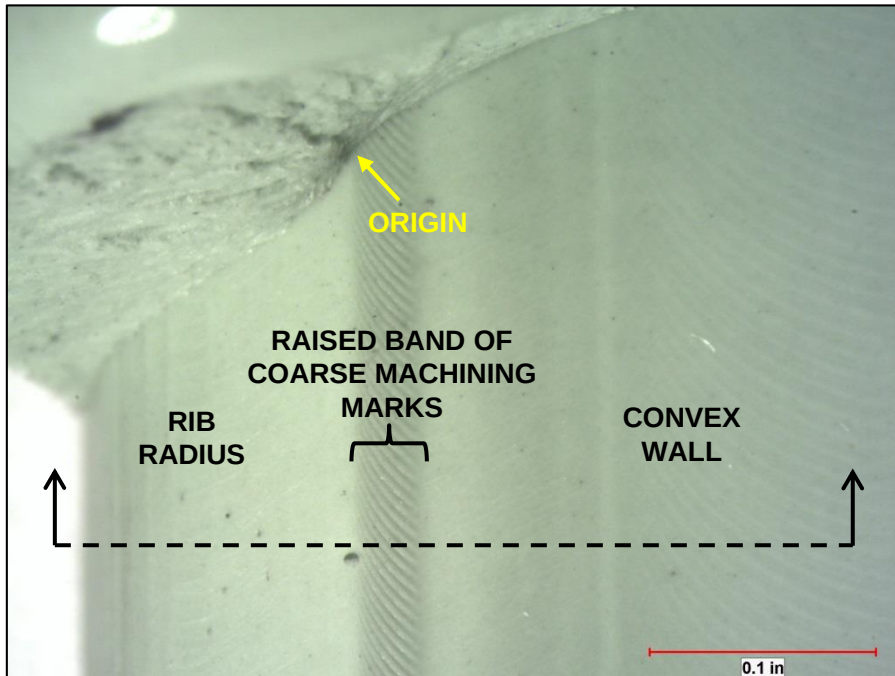
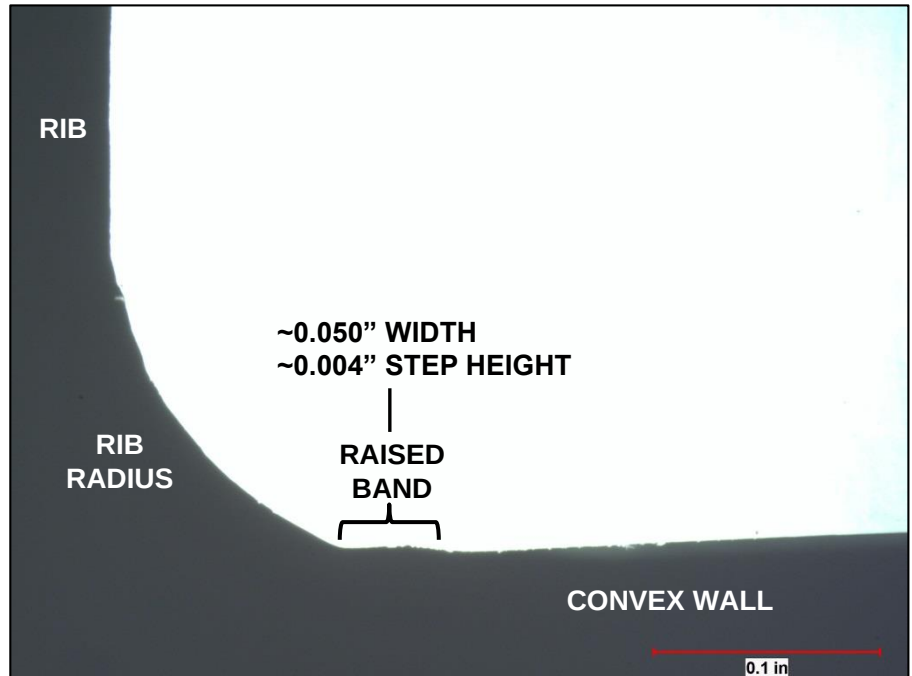
Figure 7 - Higher magnification views of polyvinylsiloxane rubber replica of internal cavity radius geometry at fatigue origin location.

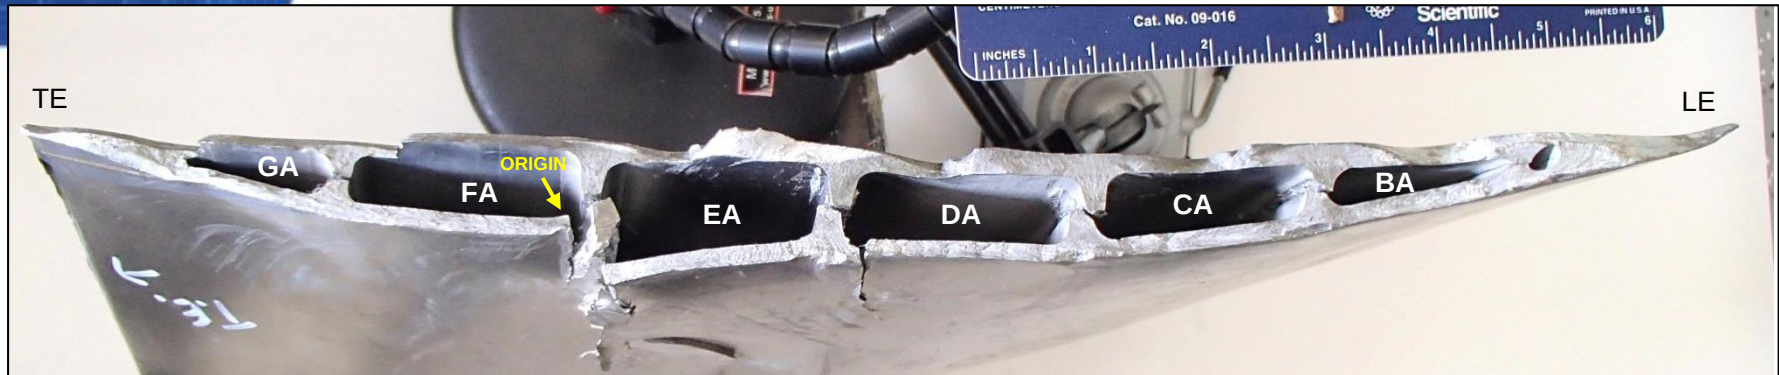
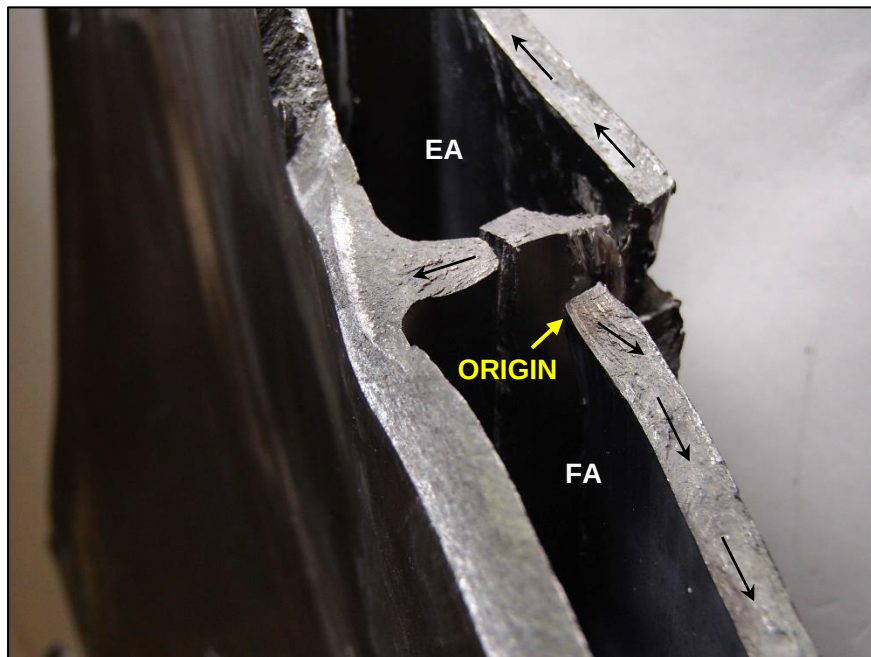
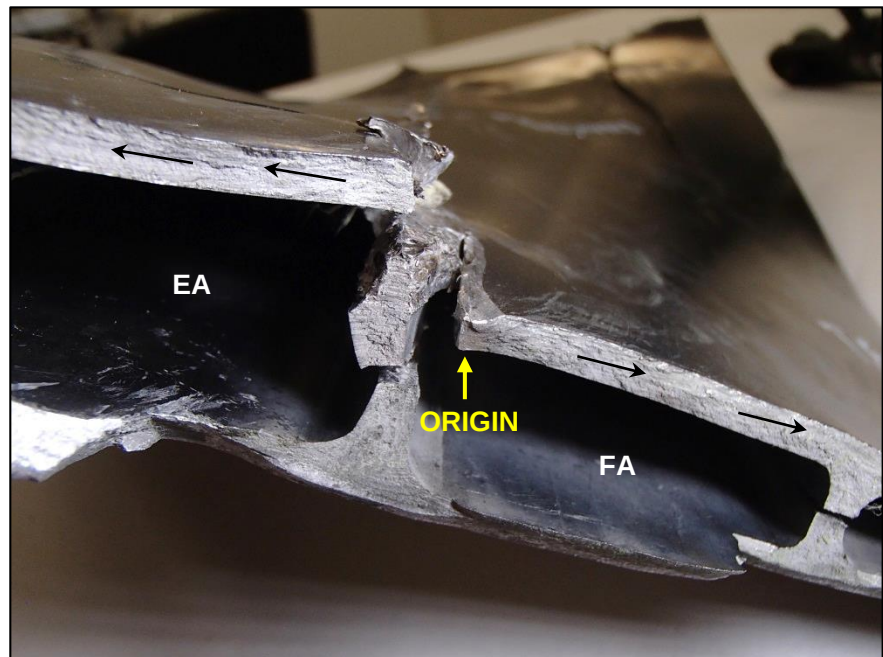
The outboard half of the fracture on the recovered airfoil portion was also visually reviewed and found to exhibit extensive secondary damage to the origin area including spanwise tearing between the convex wall and rib and along the adjacent diffusion bond line of the rib (**Figure 8**). Due to the extensive damage, no further analysis of this portion of the blade was completed.

Figure 8 - Overall and close-up views of Blade #11 (airfoil portion) fracture surface and fatigue origin.

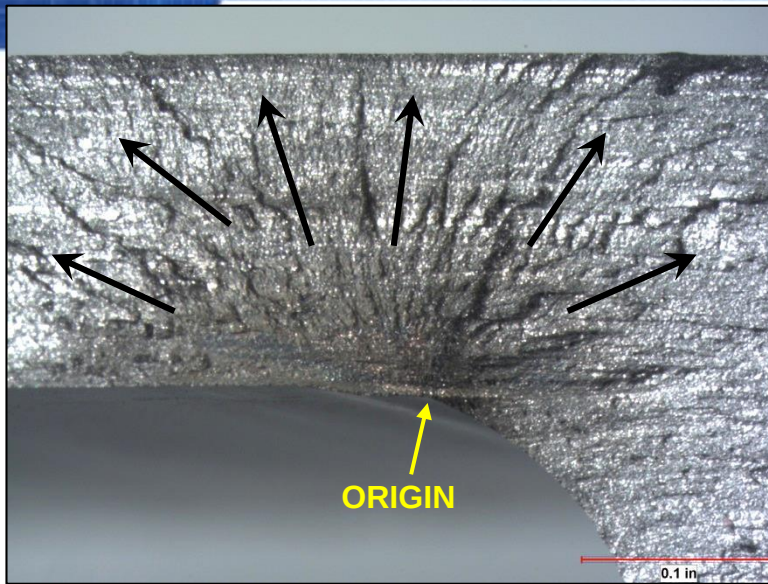
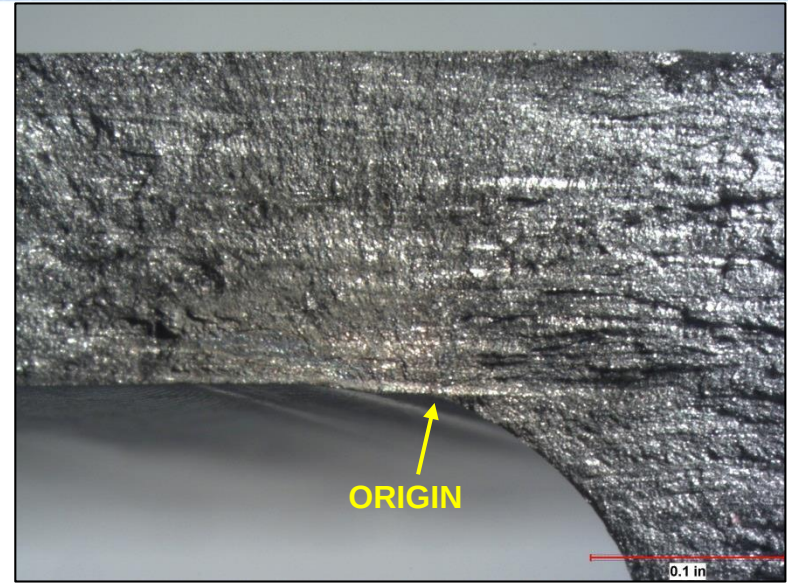
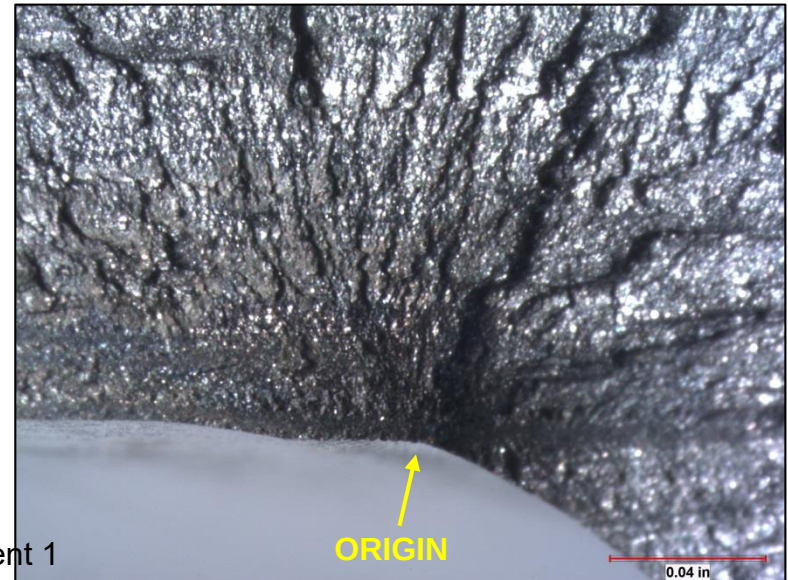
Figure 10 - Higher magnification views of fatigue origin area.

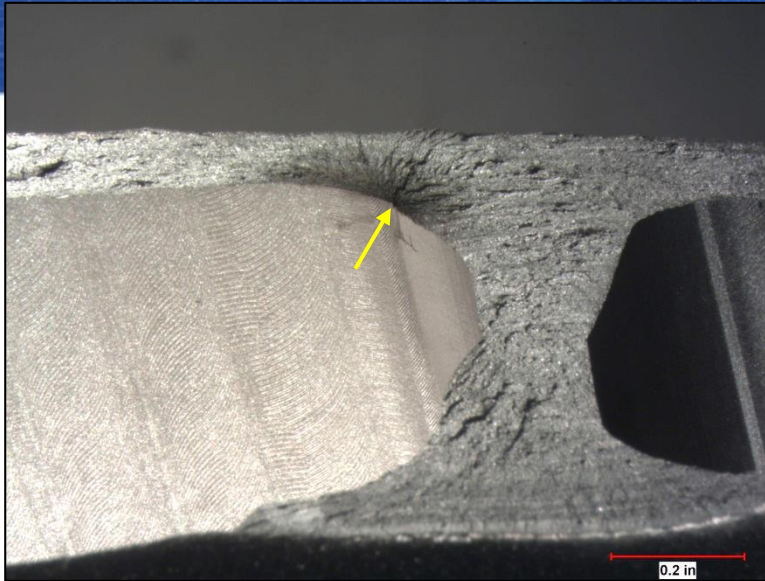
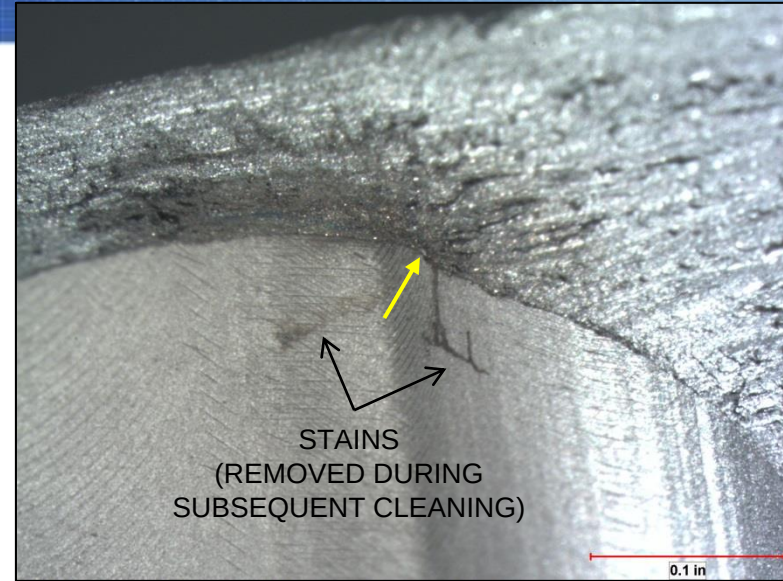
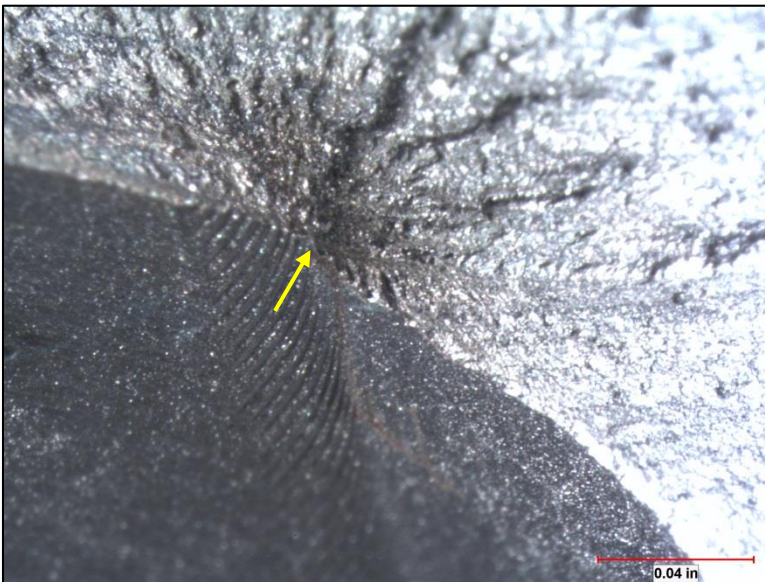
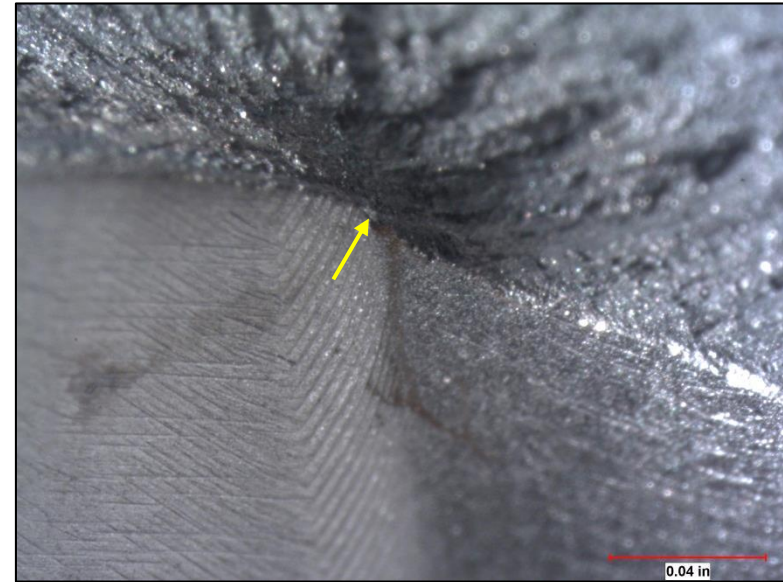
Figure 11 - Higher magnification views of fatigue origin area, tilted to show internal cavity FA surface machining features.

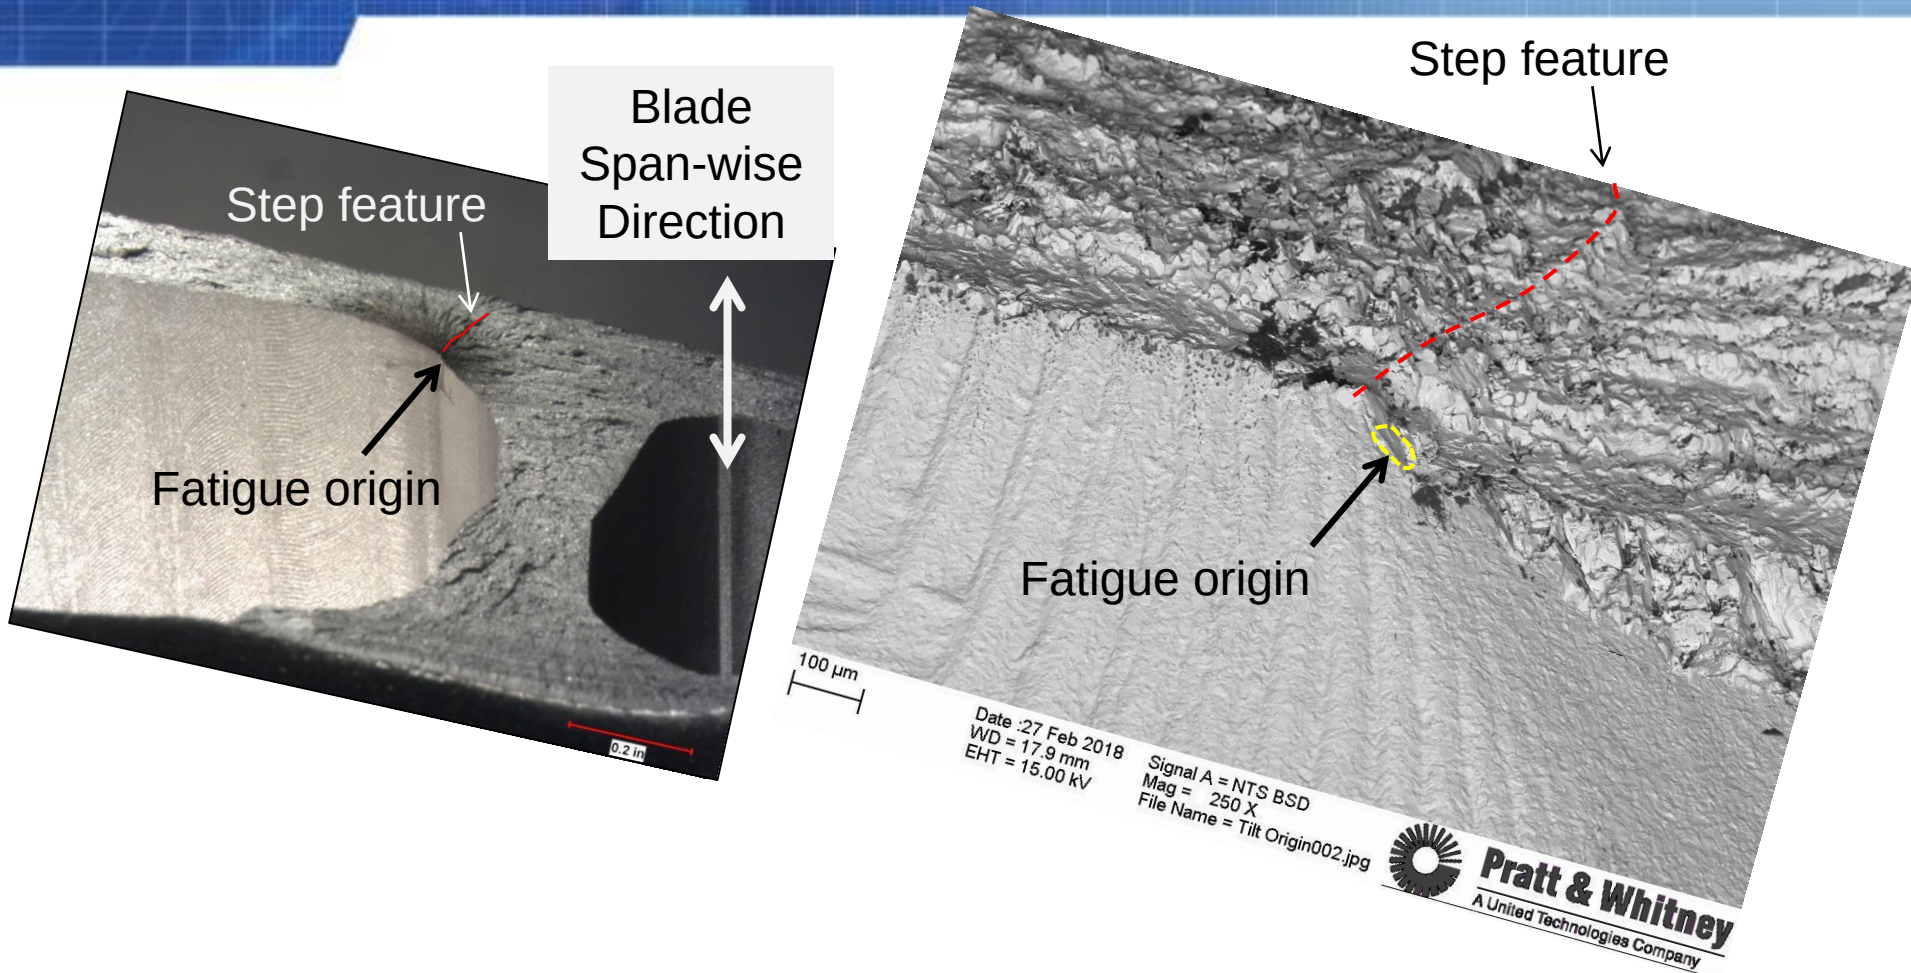
Figure 12 - The fracture progressed at an angle from perpendicular to the blade spanwise direction. The fatigue origin area was more steeply angled, resulting in a step which divided the fatigue progression into two halves. A high magnification examination of the cavity surface adjacent to the fatigue origin did not find evidence of damage due to “sparks” or “chips”. Attachment 1

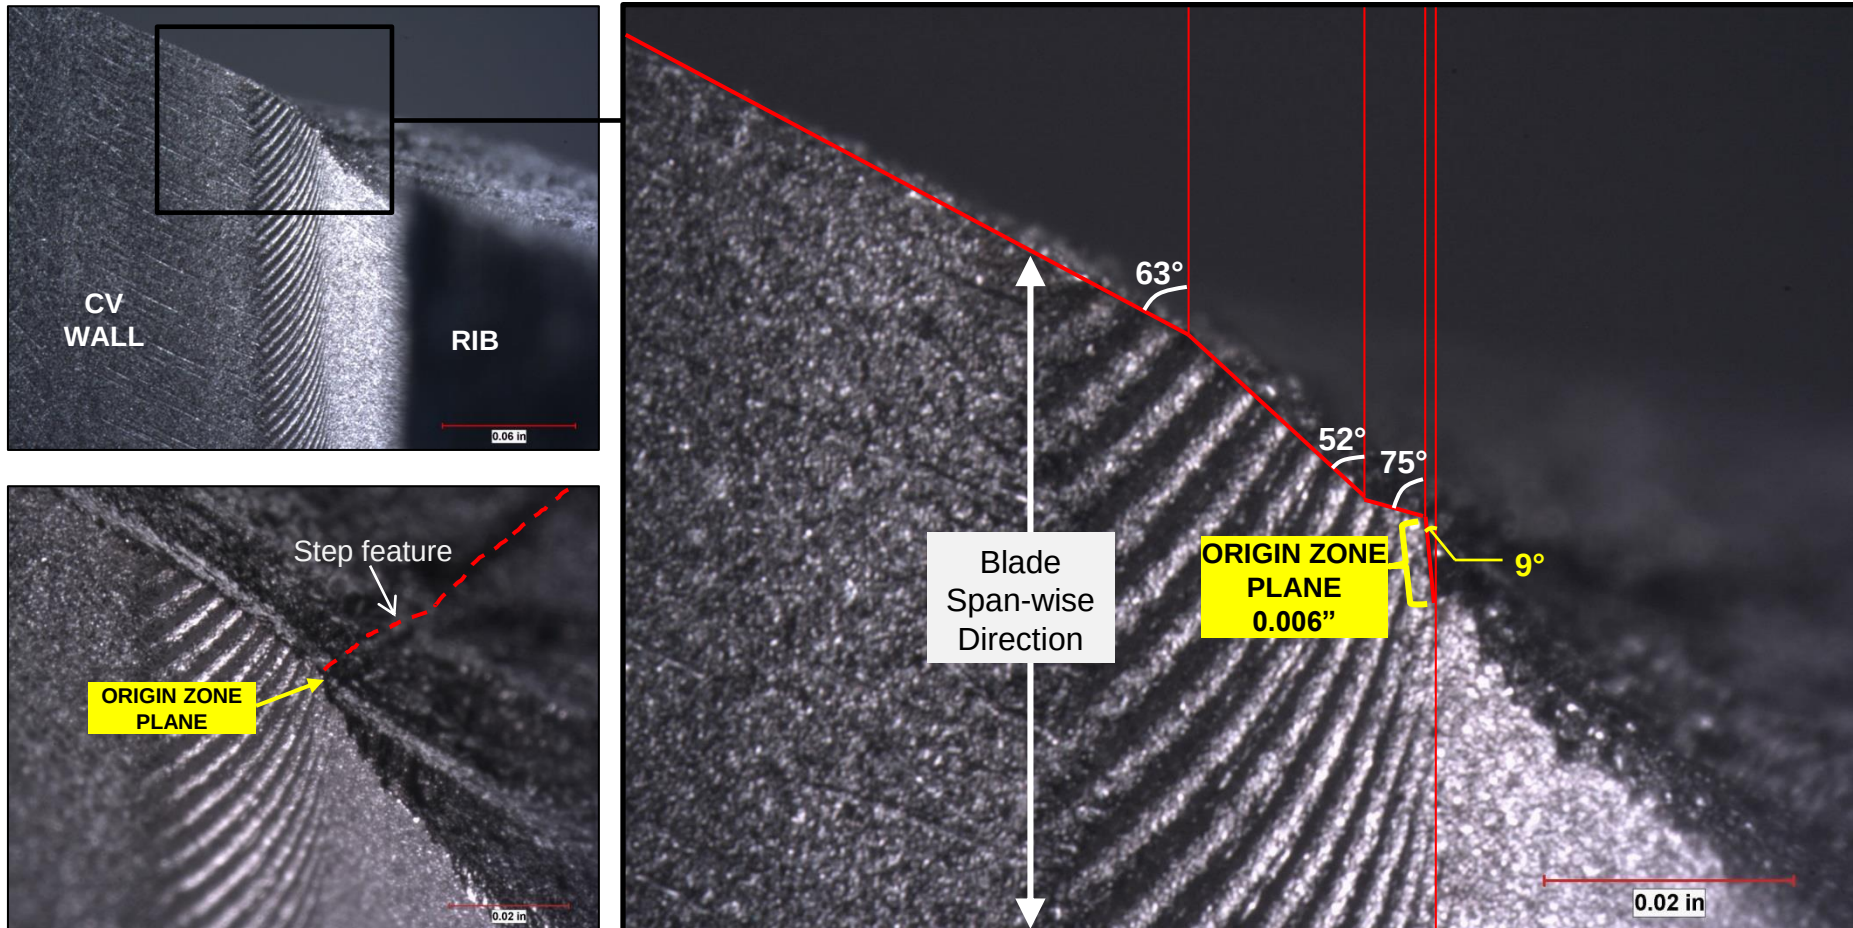
Figure 13 – The plane of the fatigue origin zone measured  $\sim 9^\circ$  off the span-wise axis of the blade when using the machining pass as a guide.

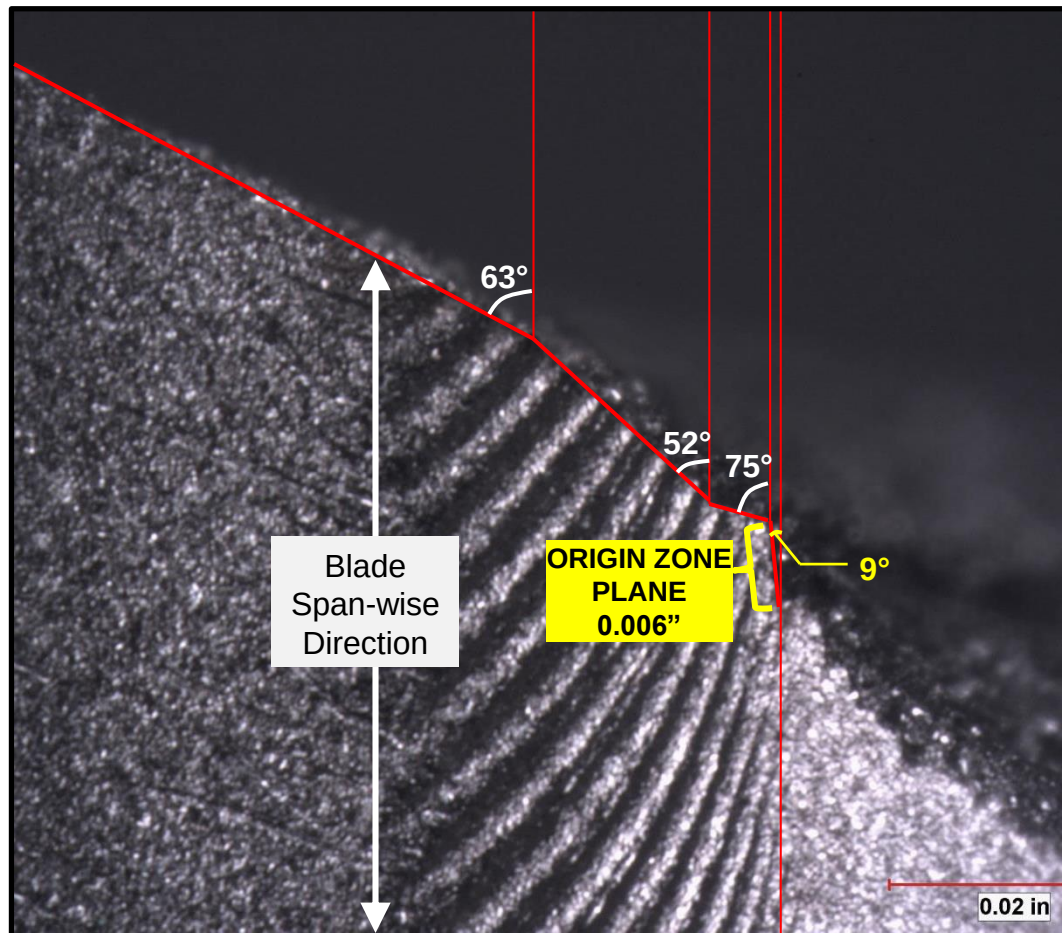
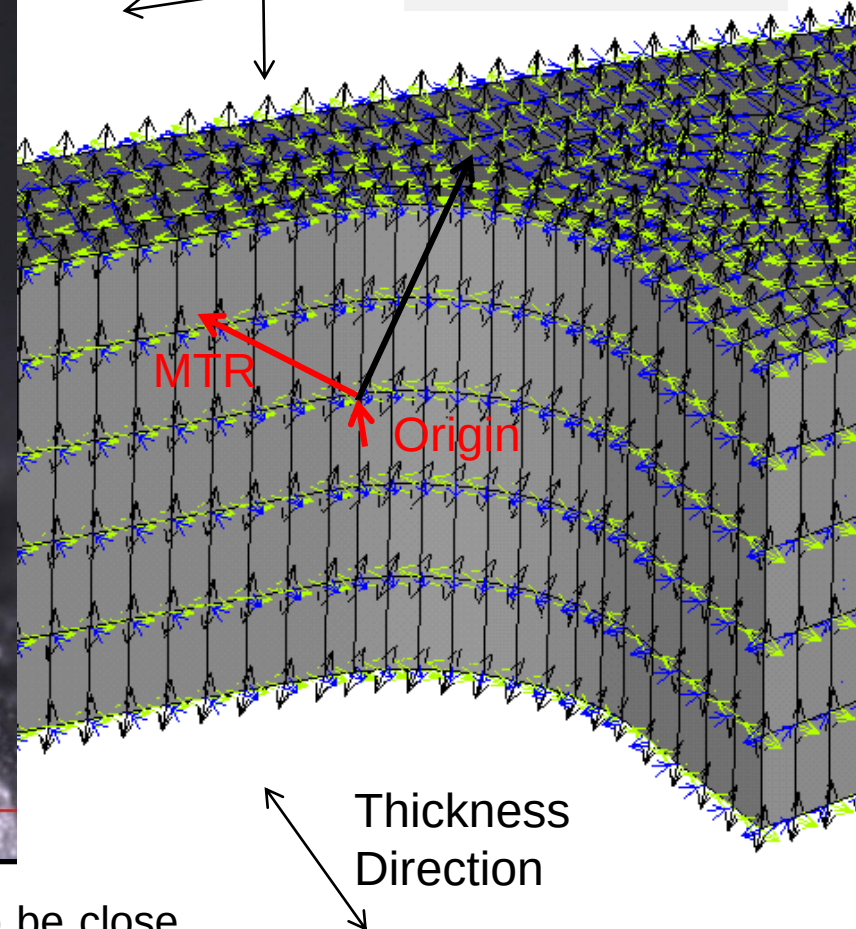
Figure 14 - Fracture surface 63° tilt area appeared to be close to perpendicular to the primary stress direction.

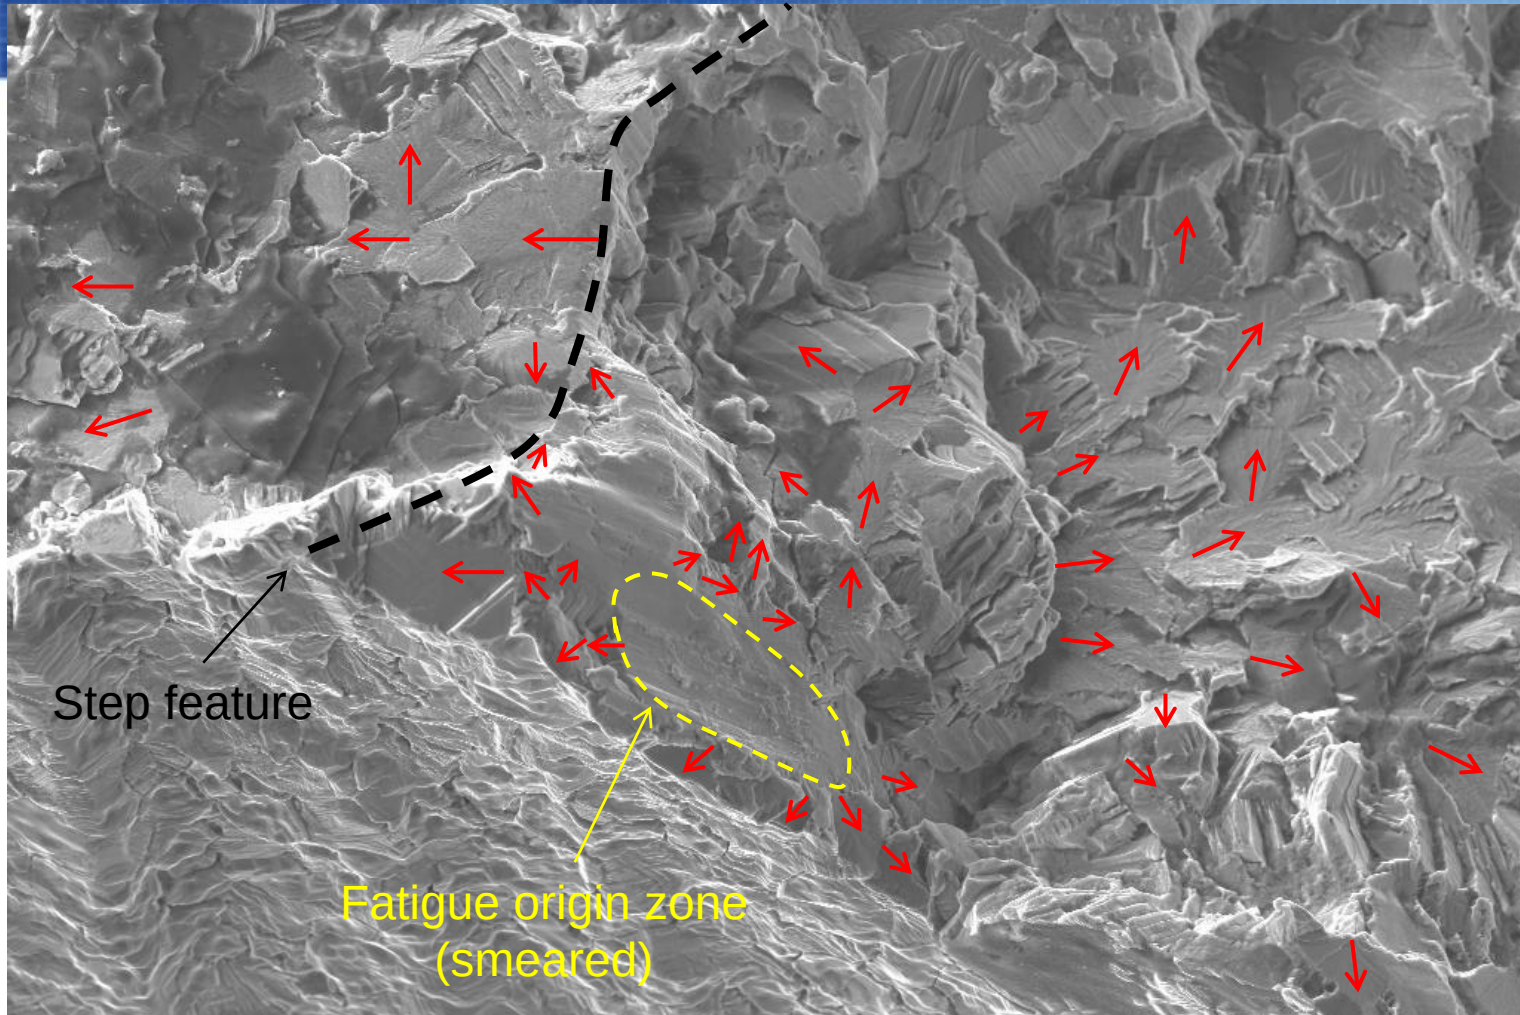
Figure 15 - Showing crack initiation details. The fatigue origin zone could be traced to an area slightly sub-surface, ~1-2 grains deep. The origin zone itself had been smeared due to secondary damage, removing fracture features, so an individual grain origin could not be identified.

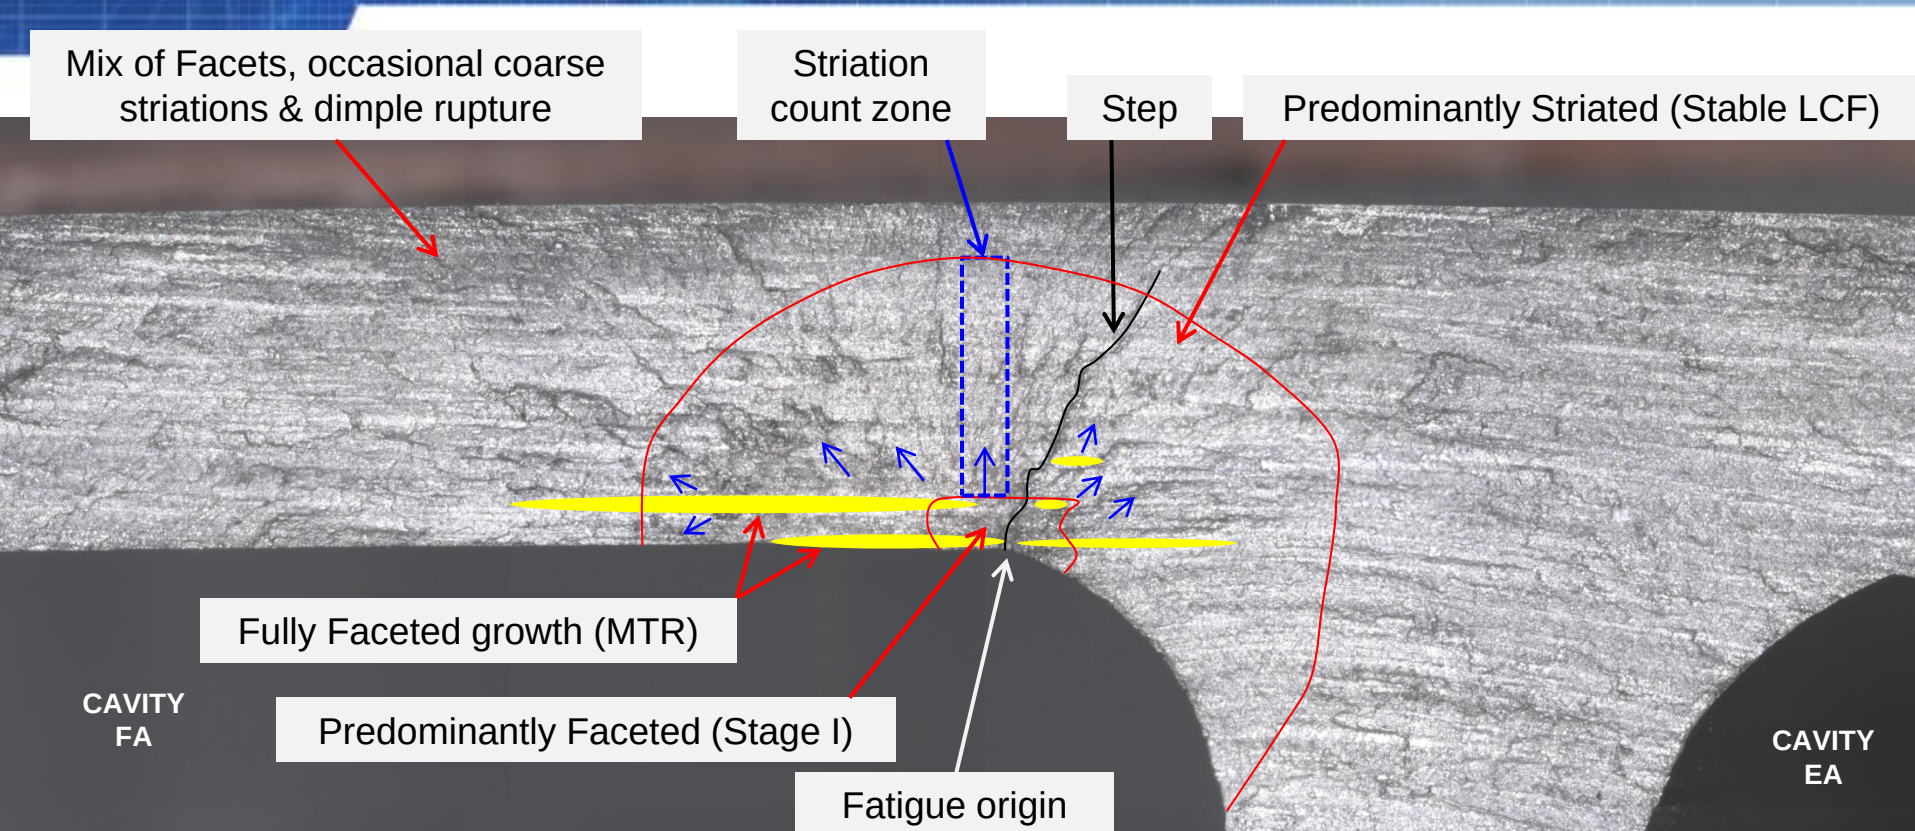
Figure 17 - Showing regions of fatigue crack propagation beyond the origin zone.

- Predominantly faceted growth mixed with striations was found within 0.032" of origin.
- Several areas of fully faceted growth were detected (yellow zones) suggestive of micro-texture regions (MTR's). Note these were associated with early fatigue progression and not fatigue initiation.
- Beyond 0.032" from the origin was a region of predominantly fatigue striations, suggesting stable LCF. The striation count was performed in this region within the blue box.
