# Metallurgical Investigation Final Report

**Subject:** Metallurgical Investigation of Fan Blades No. 11 and No. 10 from PW4077 Engine 777049

**Date:** October 9, 2018

# PW4077 P777049 Fan Blade Fracture Investigation

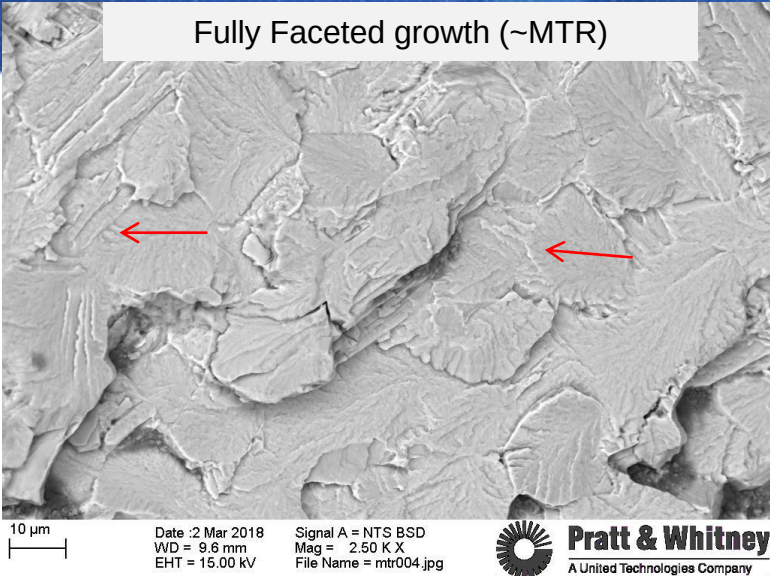
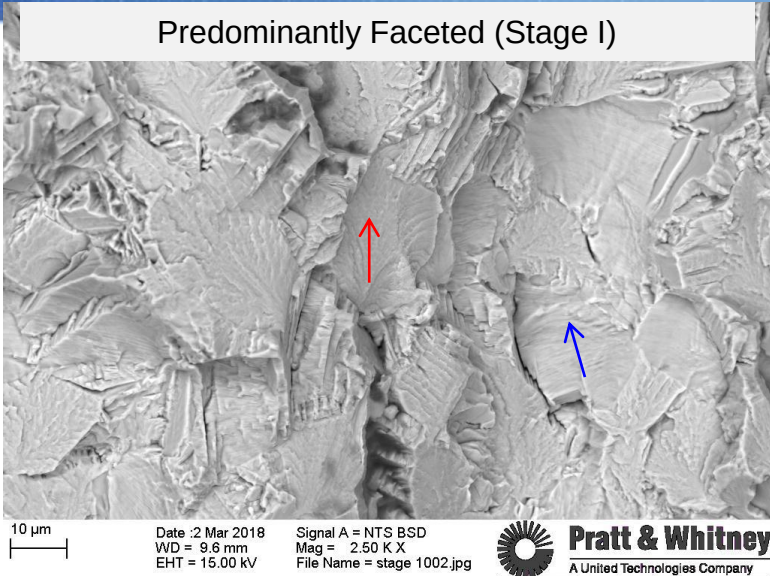
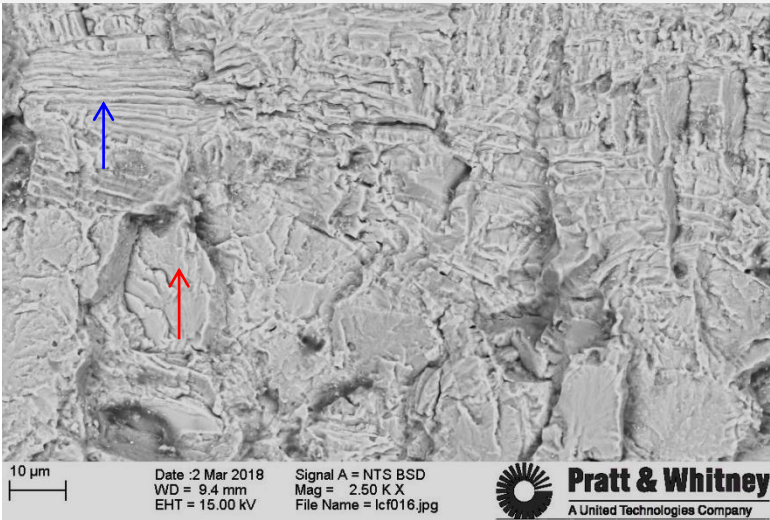
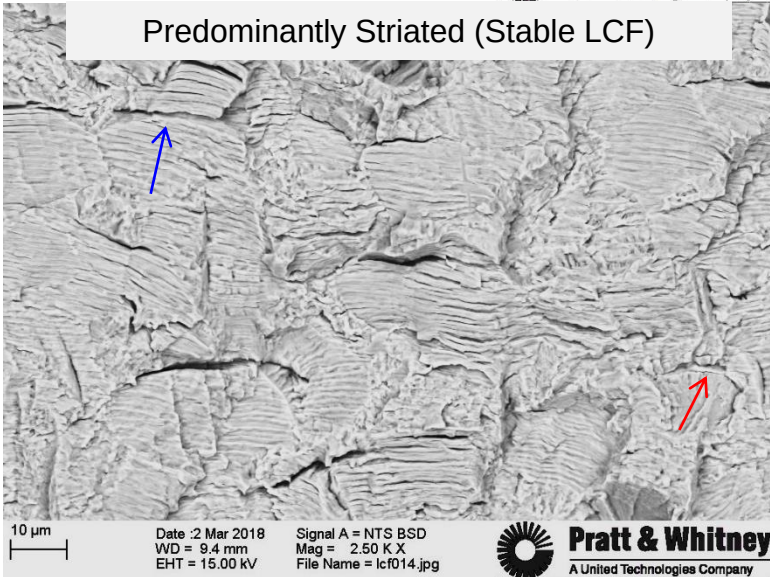
Mixed Facets & coarse striations (beyond stable LCF)

Figure 18 - Showing typical fatigue modes. Arrows denote direction of fatigue progression.

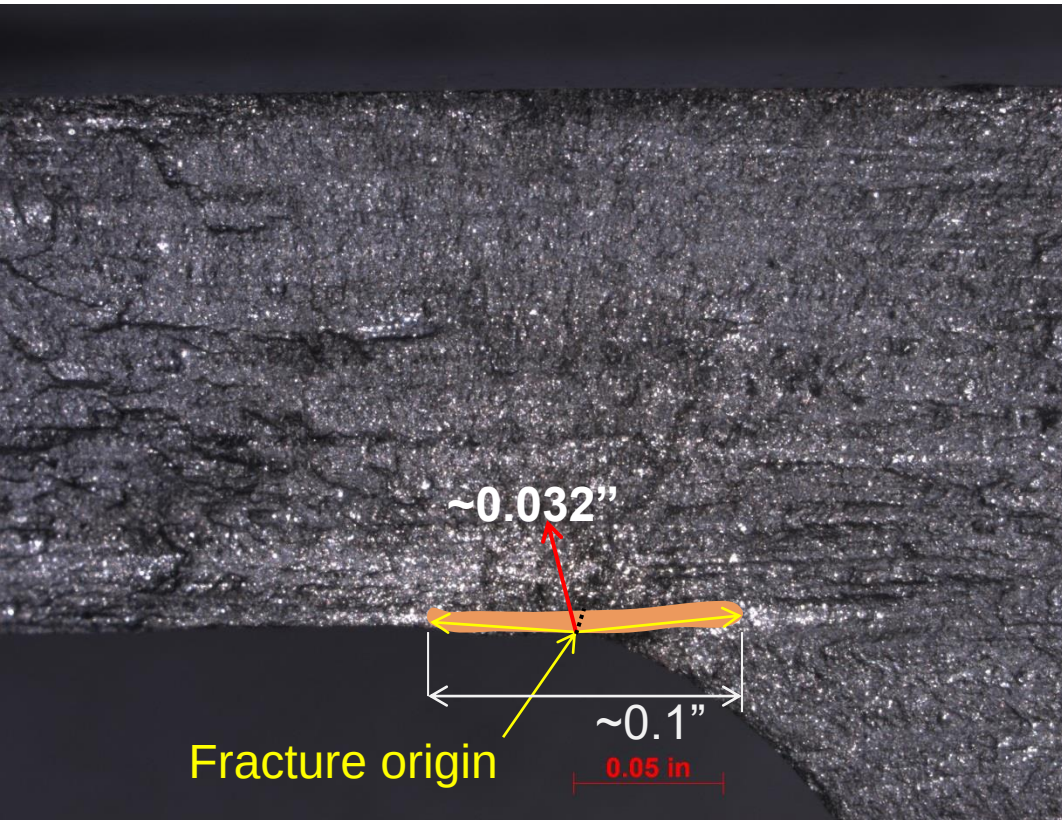
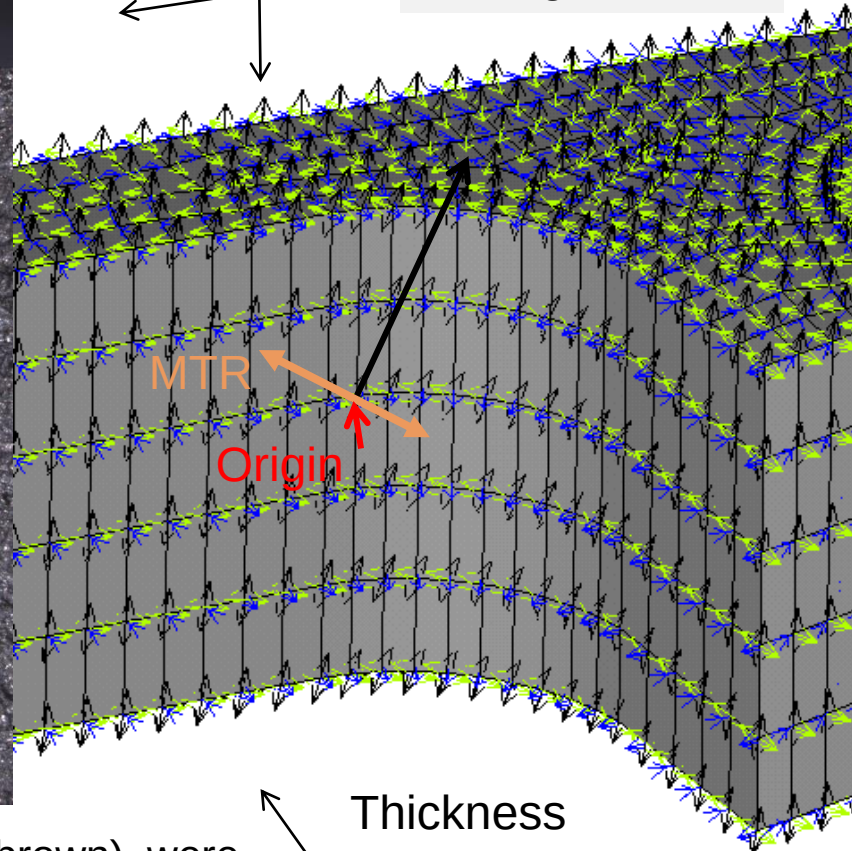
Figure 19 – The FESEM exam suggested MTR's (brown) were present near the fracture origin. The estimated size of the crack initiation zone including the MTR's was  $\sim 0.032 \times 0.100$ ".

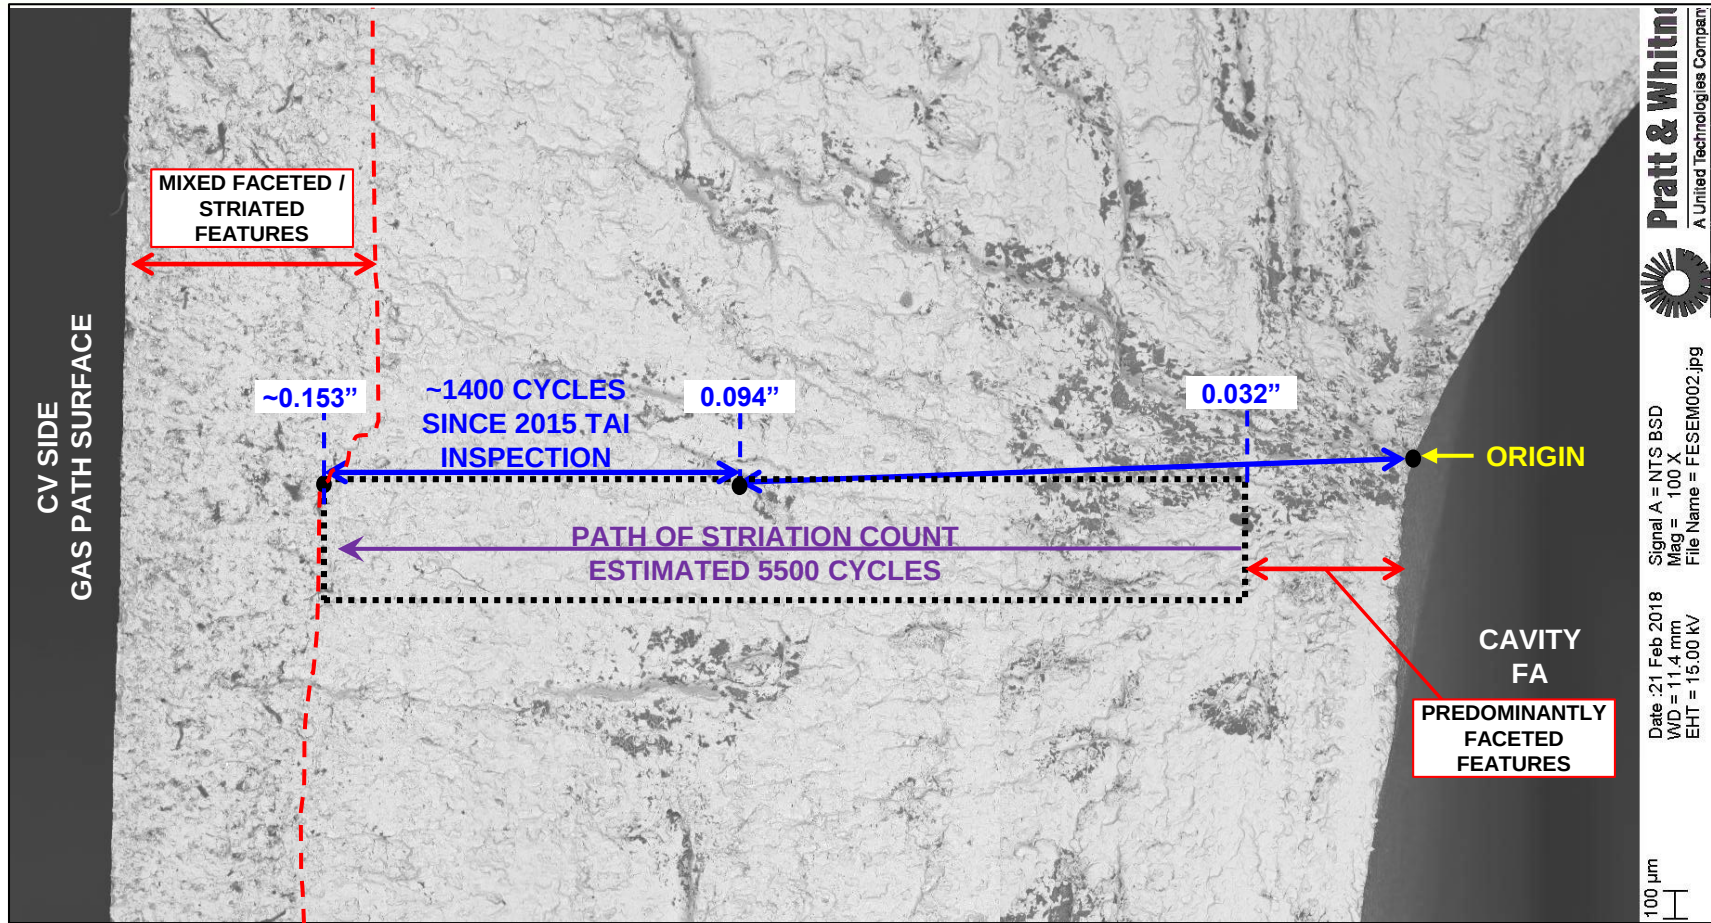
Beyond 0.032" deep from the origin was a region of predominantly fatigue striations, suggesting stable low cycle fatigue (LCF) propagation (**Figures 17 – 19**). A striation count performed within a rectangular zone through this stable LCF region  $\sim 0.032$ " – 0.153" from the origin estimated 5500 cycles of LCF crack propagation (**Figure 20**). The blade was last inspected via thermal acoustic imaging (TAI)  $\sim 1400$  cycles ago in 2015. Based on the striation count data, the crack would have been  $\sim 0.094$ " deep at that time. The extent of the stable LCF propagation zone measured approximately 0.153" - 0.189" from the origin. Beyond the stable LCF zone, the fracture mode exhibited a mix of faceted growth with occasional areas of coarse striations as well as a gradual transition to dimple rupture with increasing distance from the origin. The mixed-in dimple rupture features suggested a transition to unstable cracking. The faceted growth in this area was consistent with crack extremity areas of hollow fan blade fatigue specimen that were tested under dwell LCF conditions. It was considered possible that a high cycle fatigue (HCF) driver may also have been contributing to crack growth beyond the stable LCF zone, although HCF progression would have been expected to form bands of faceted growth, which were not observed. The onset of bulk dimple rupture (e.g. unstable tearing) ranged between 0.336" (in rib) and 0.851" (in convex side wall) from the origin (**Figure 21**).

Figure 20 - Predominantly striated fatigue crack growth (LCF) was observed ~0.032" - 0.153" from origin. Striation count within rectangular zone through this region estimated 5500 cycles of LCF crack propagation. Attachment 1

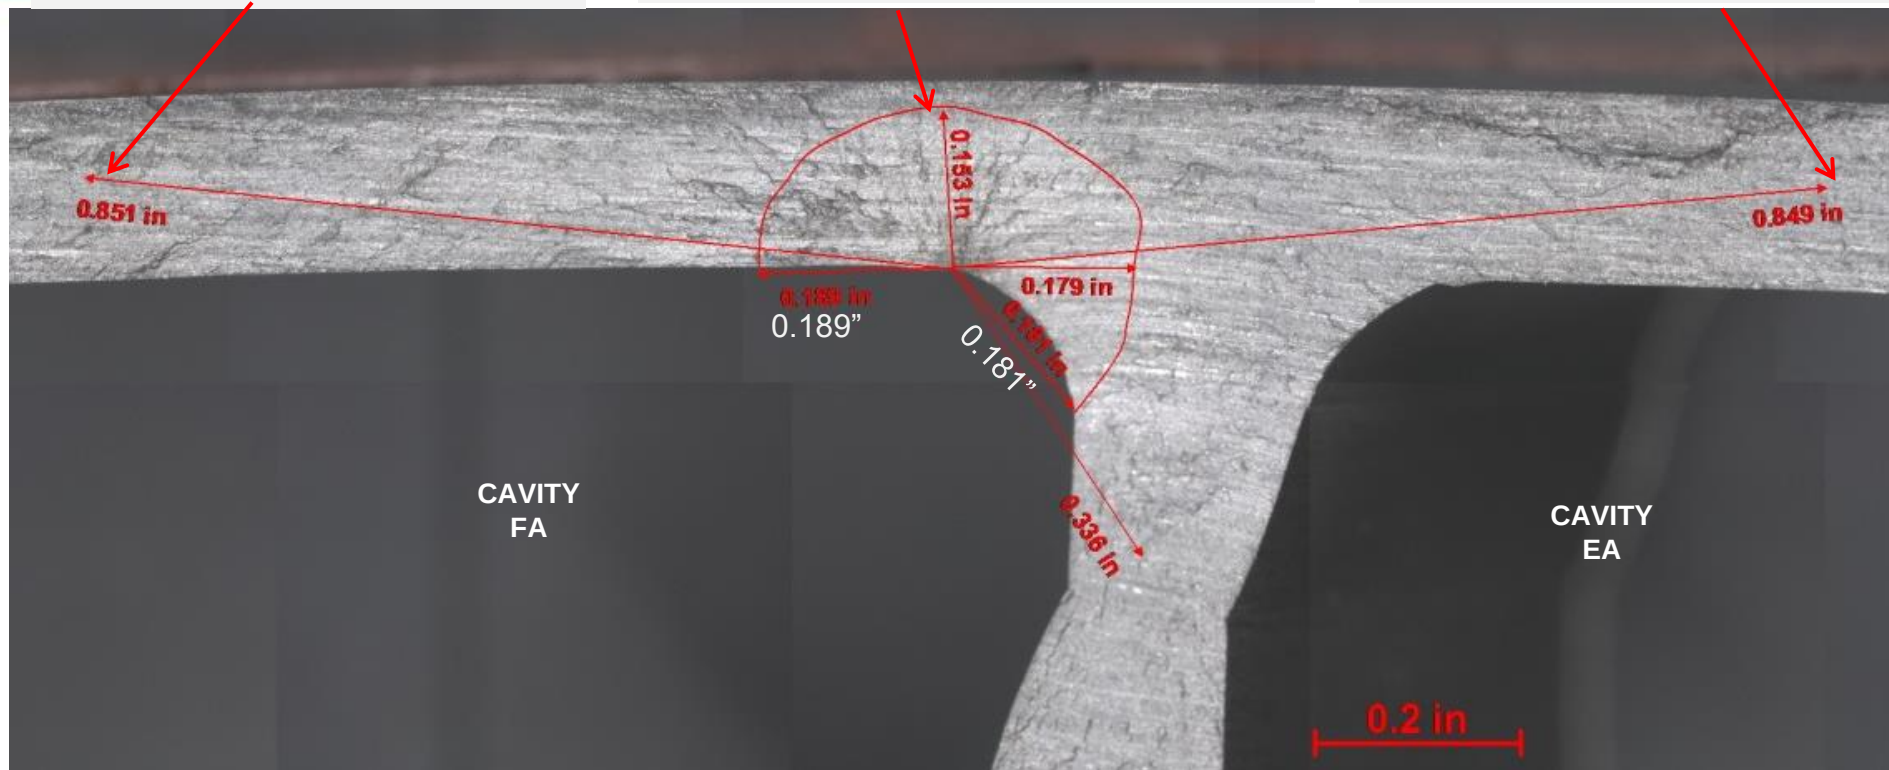
Figure 21 –

- Showing extent of stable LCF zone, which measured up to 0.153 - 0.189" from the origin.
- Beyond the stable LCF zone, the fracture mode exhibited a mix of faceted growth with occasional areas of coarse striations as well as a gradual transition to dimple rupture with increasing distance from the origin.
- The onset of bulk dimple rupture (e.g. un-stable tearing) ranged between 0.336" (in rib) and 0.851" (in convex side wall), from the origin.

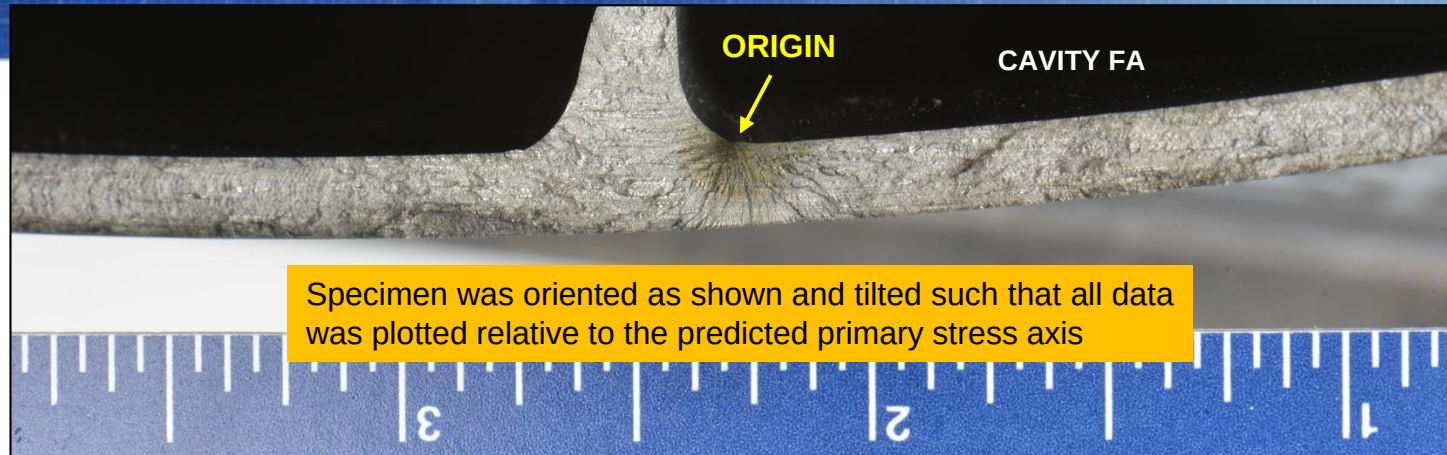
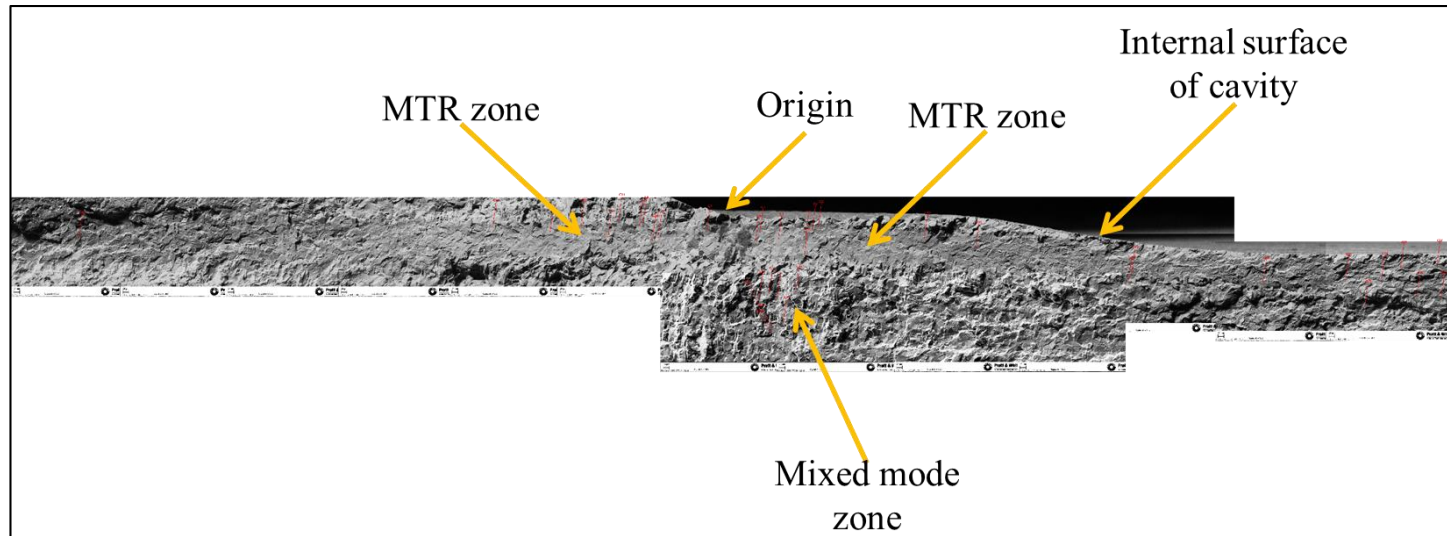
Figure 22 – Macro image of fracture surface (top) showing orientation used during EBSD scanning and secondary electron SEM image of fracture surface (bottom) showing origin and associated micro-texture region (MTR).

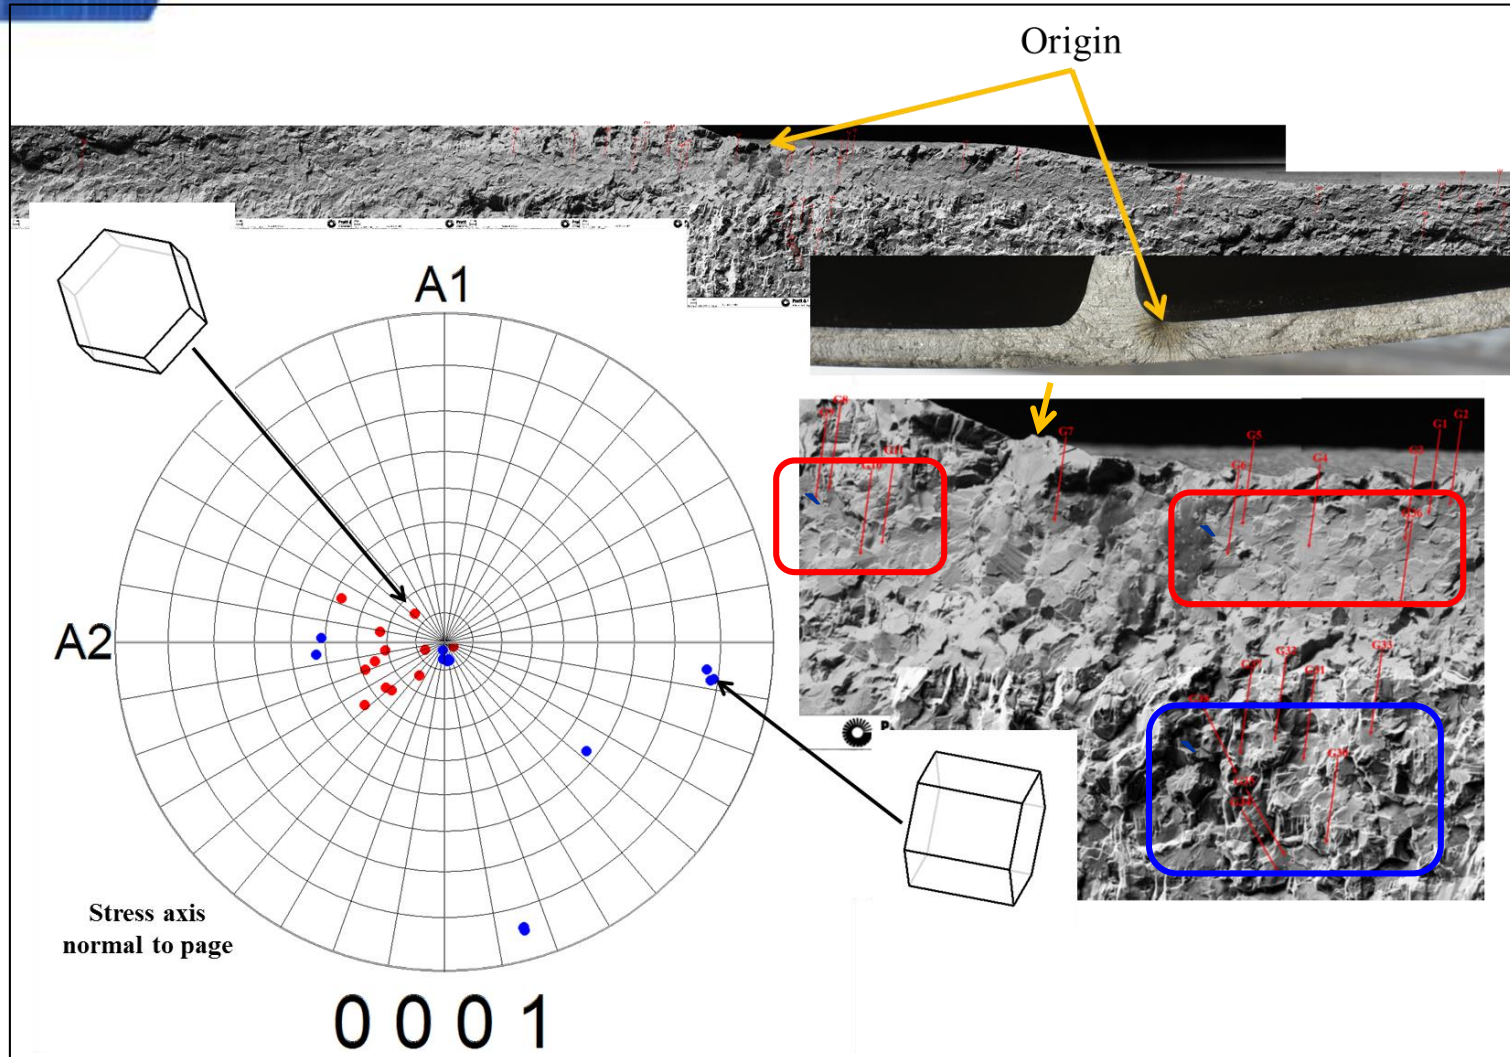
Figure 23 – Basal plane orientations in the MTR passing through the origin (red) and mixed mode region (blue).

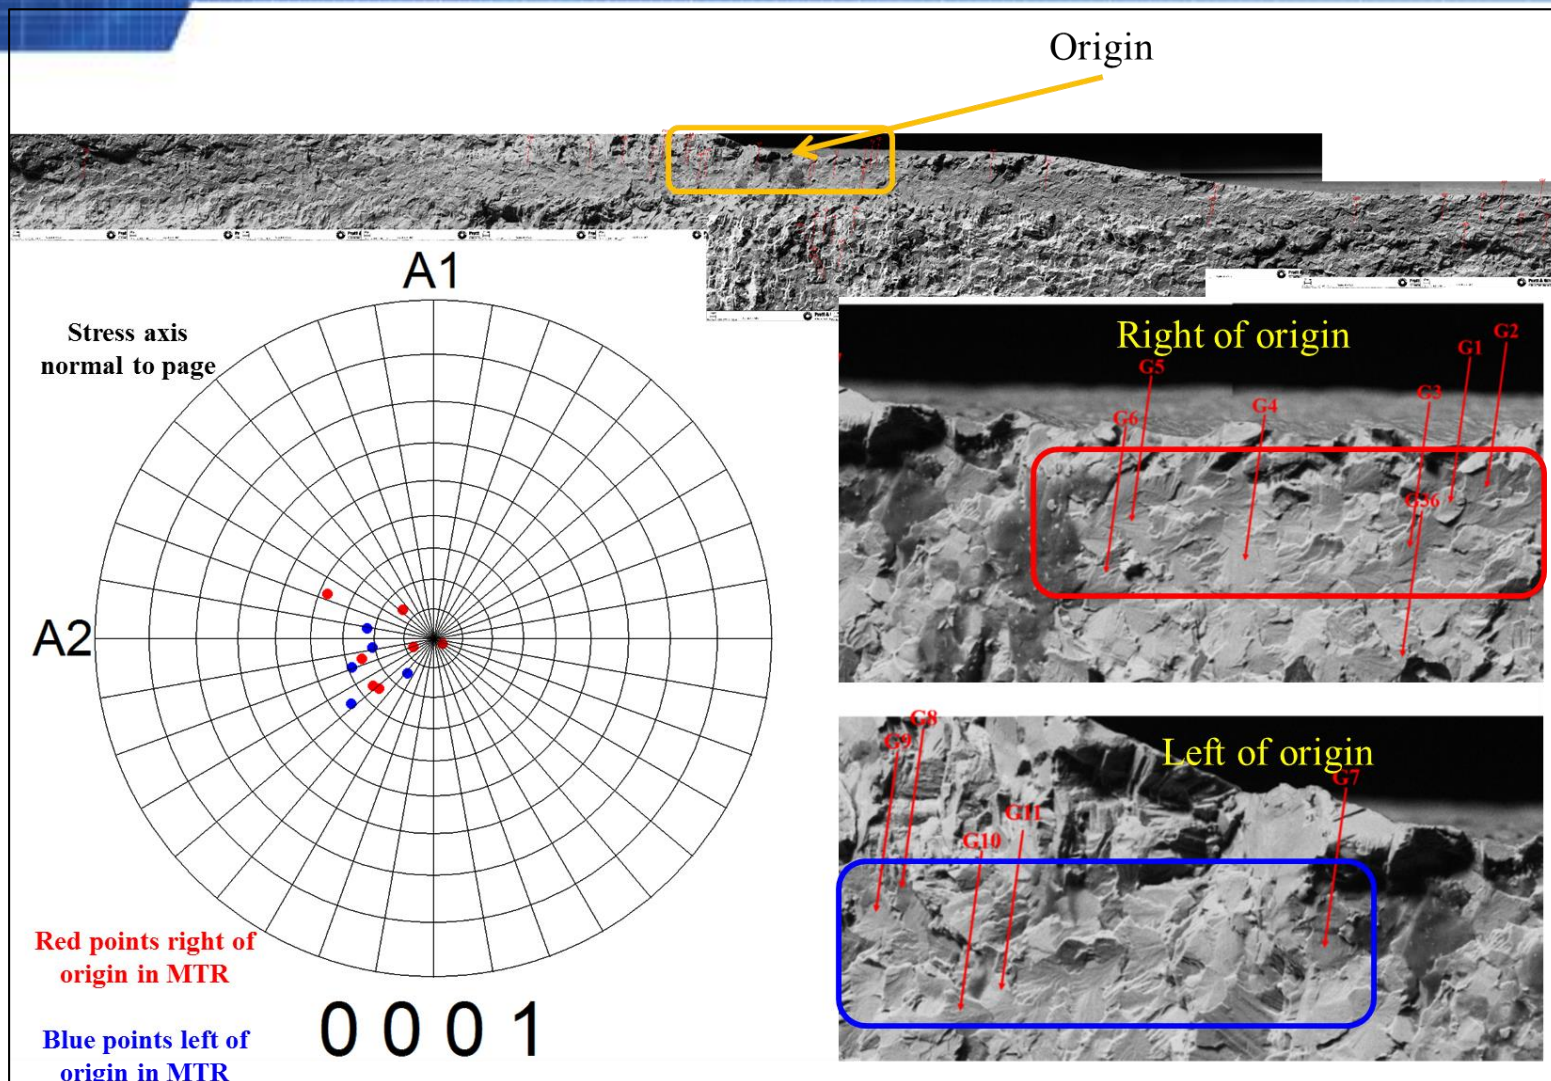
Figure 24 – Comingling of grain orientations in the MTR either side of the origin indicate that a single contiguous MTR is possible.

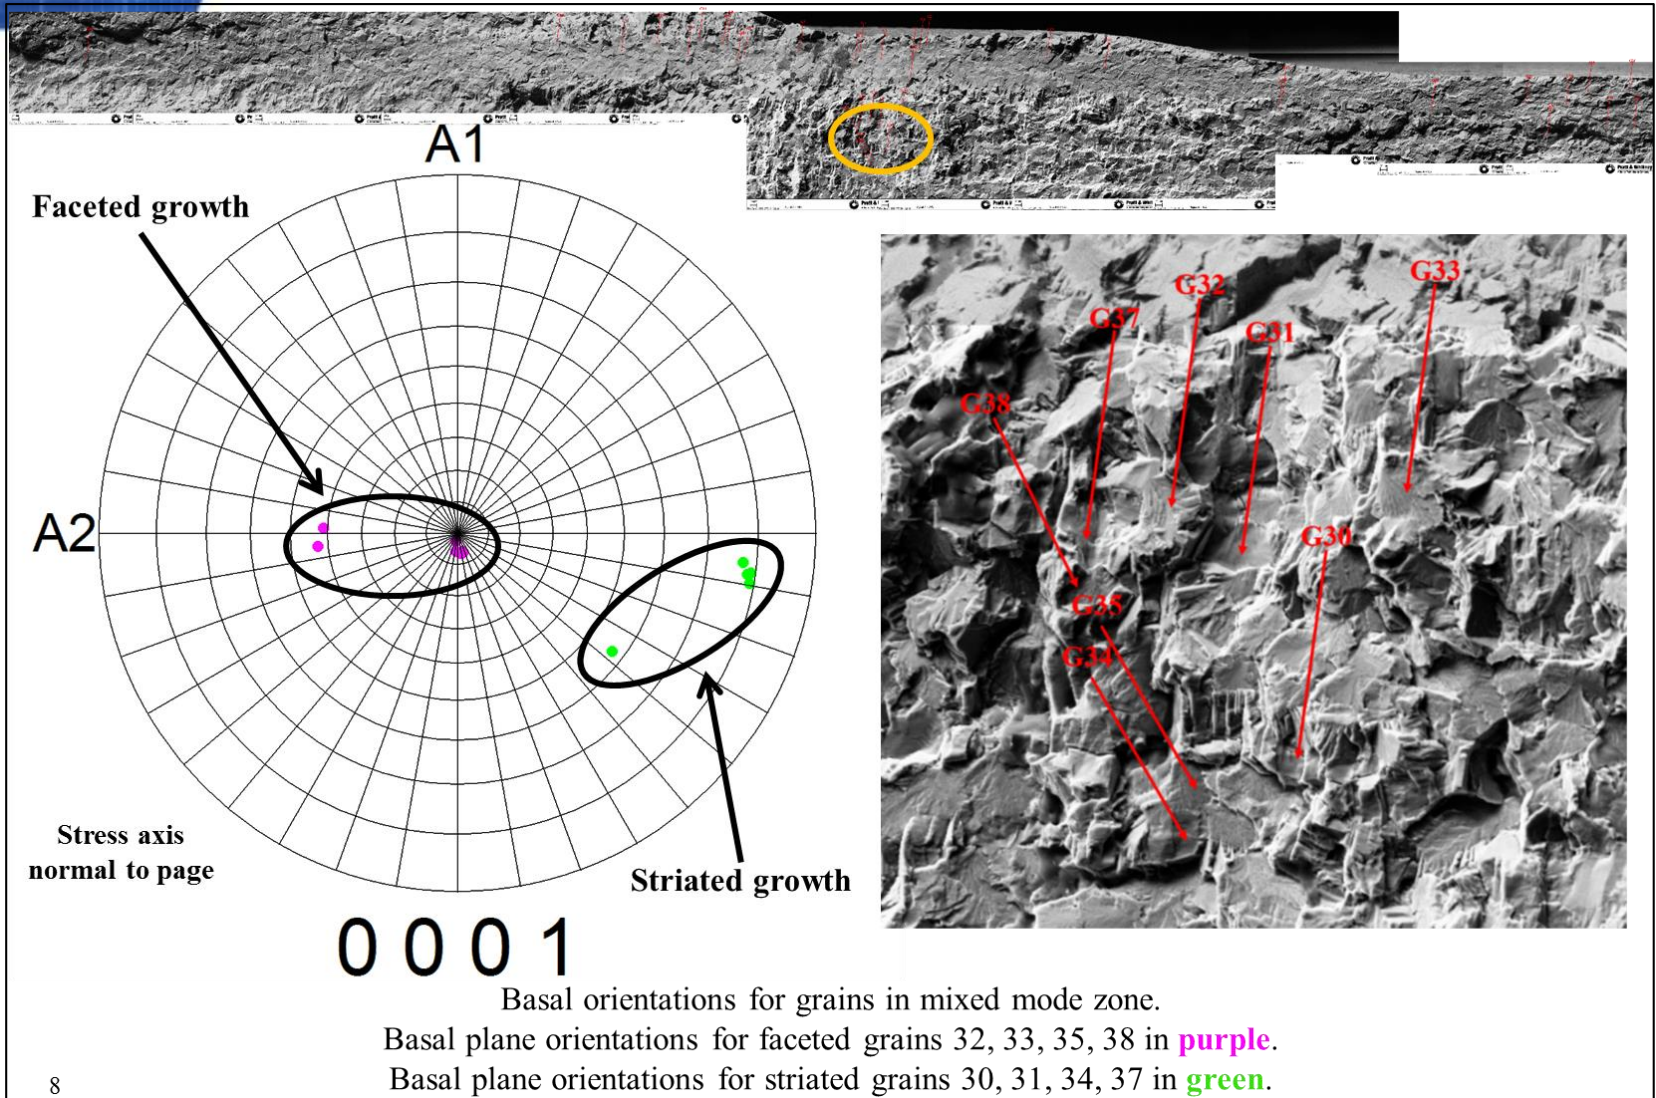
basal orientations tilted  $>50^\circ$  from the stress axis (**Figure 25**). Orientations were determined in two cases where a transition in crack growth mode from faceted to striated was observed in directly adjacent grains within the mixed mode region. In both cases, the faceted grains had basal plane orientations close to perpendicular to the stress axis, while the directly adjacent striated grains had basal plane orientations  $>75^\circ$  from the stress axis (**Figures 26 – 27**).

Figure 25 – Basal plane orientations for grains in mixed mode zone.

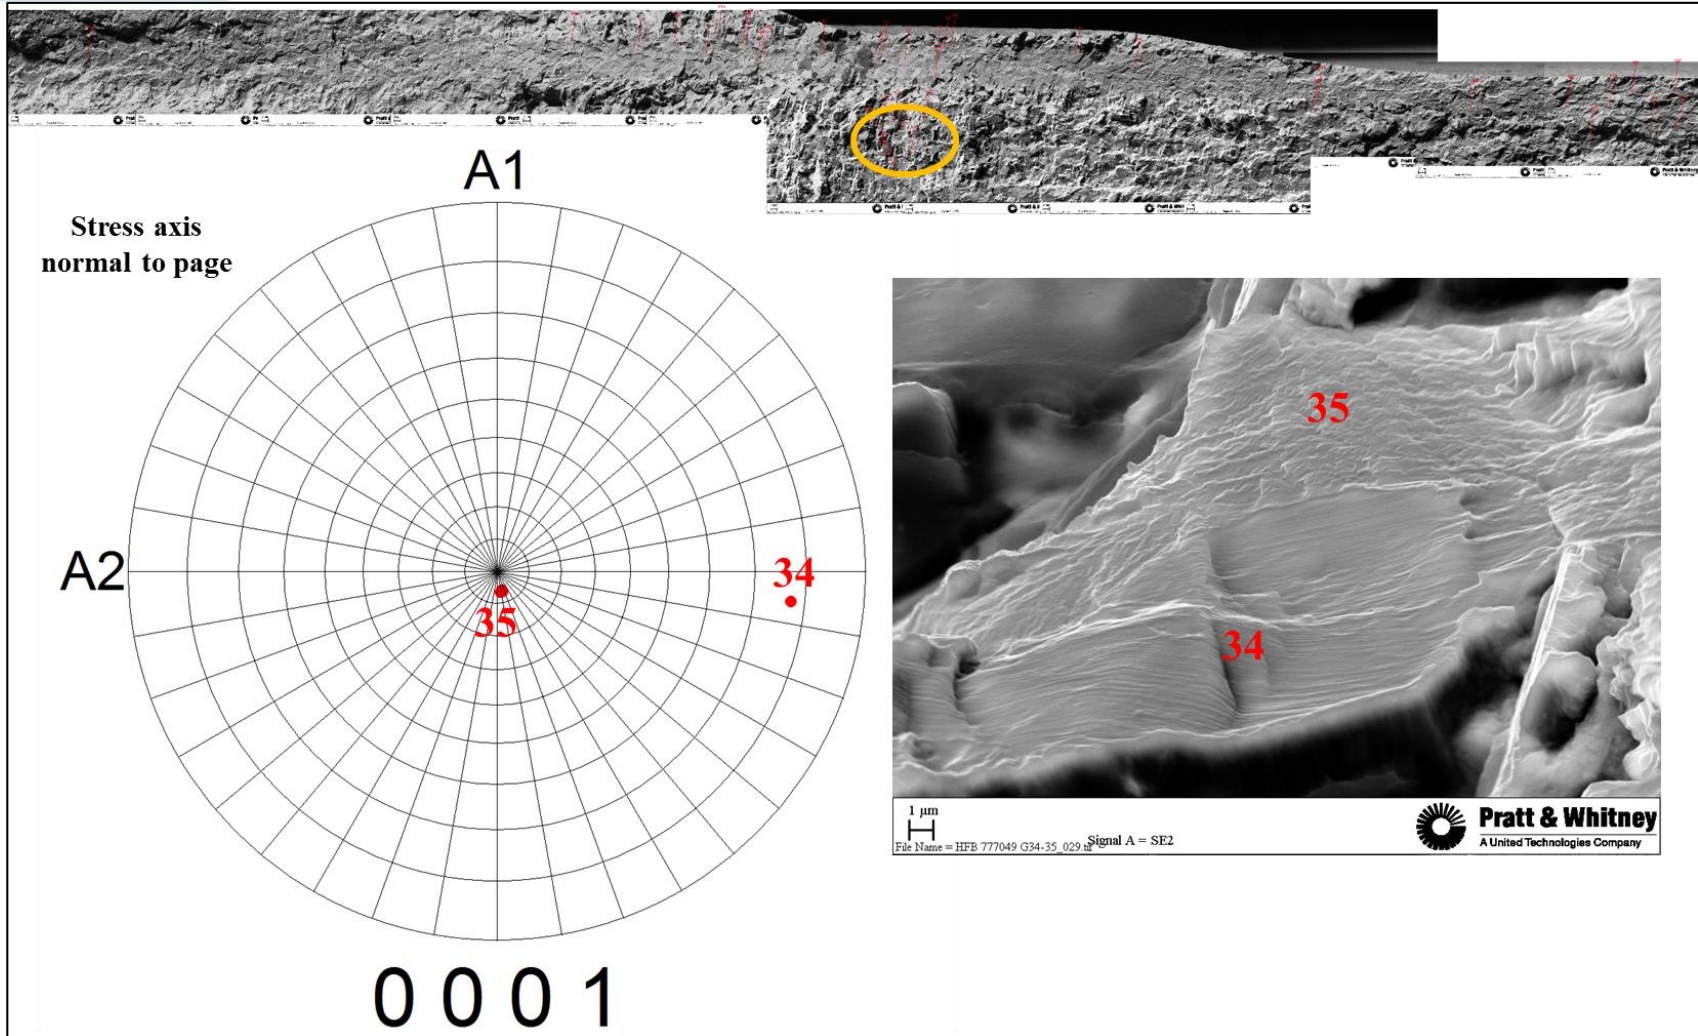
Figure 26 – Basal plane orientations associated with striated growth (34) and faceted growth (35).

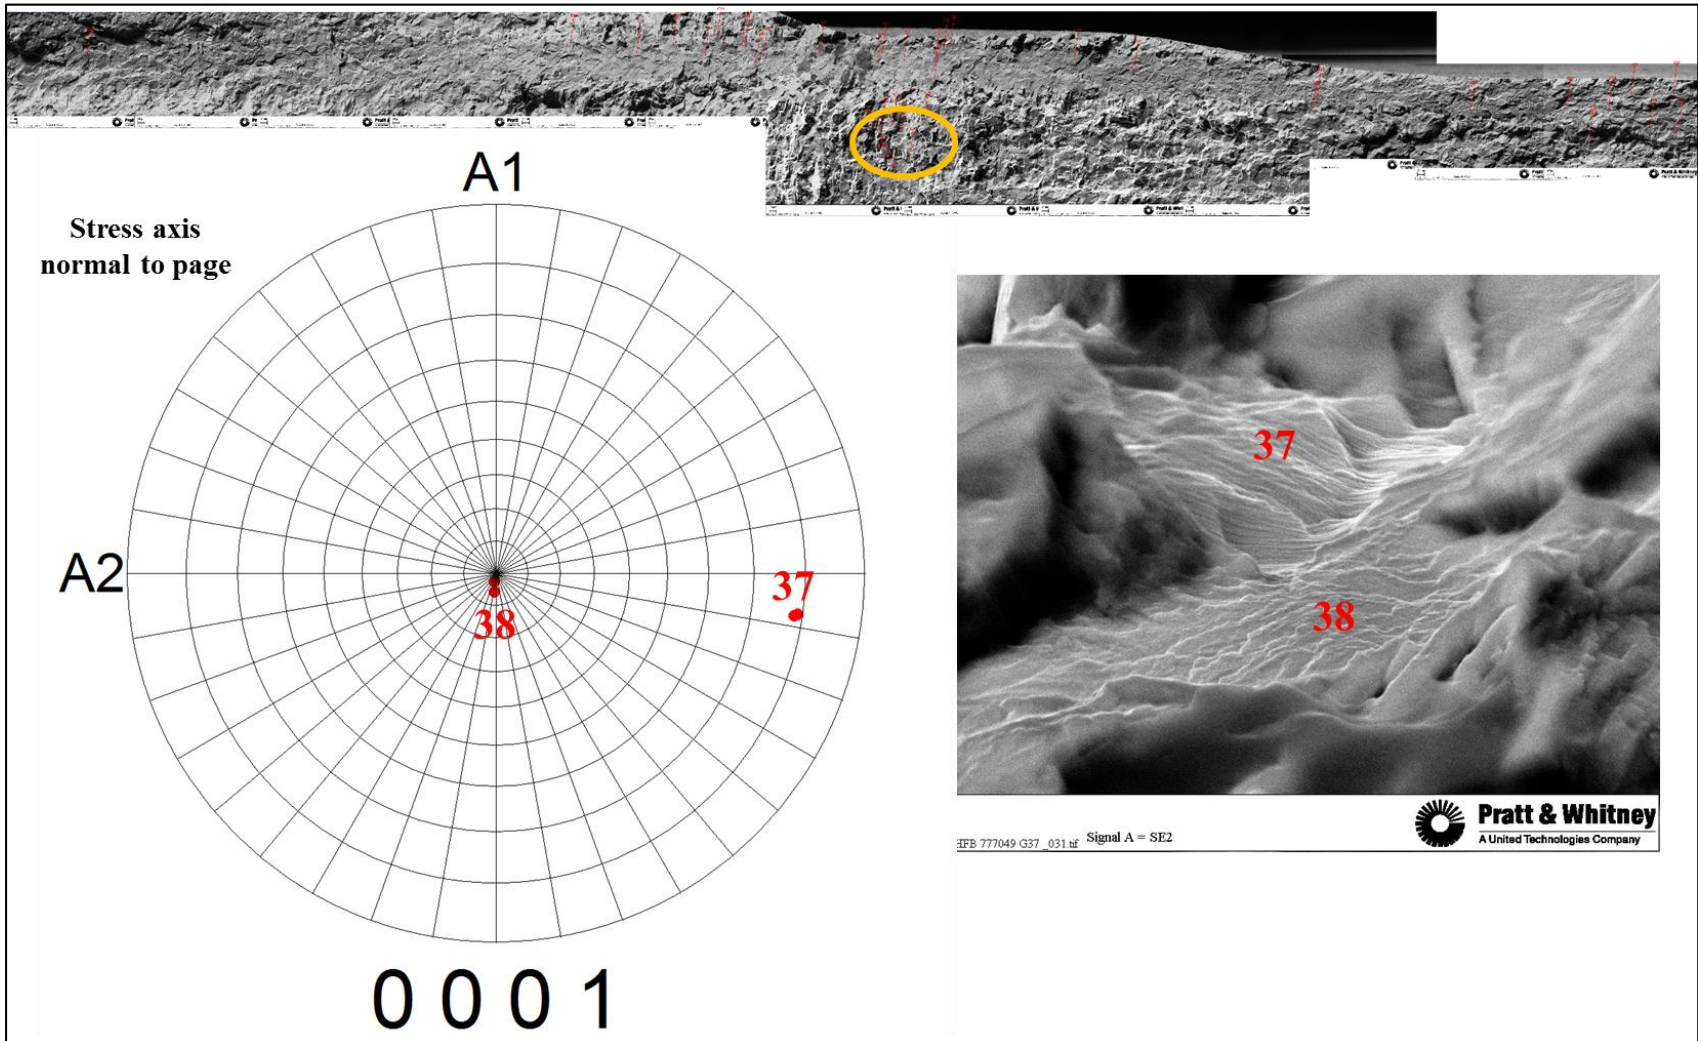
Figure 27 – Basal plane orientations associated with striated growth (37) and faceted growth (38).

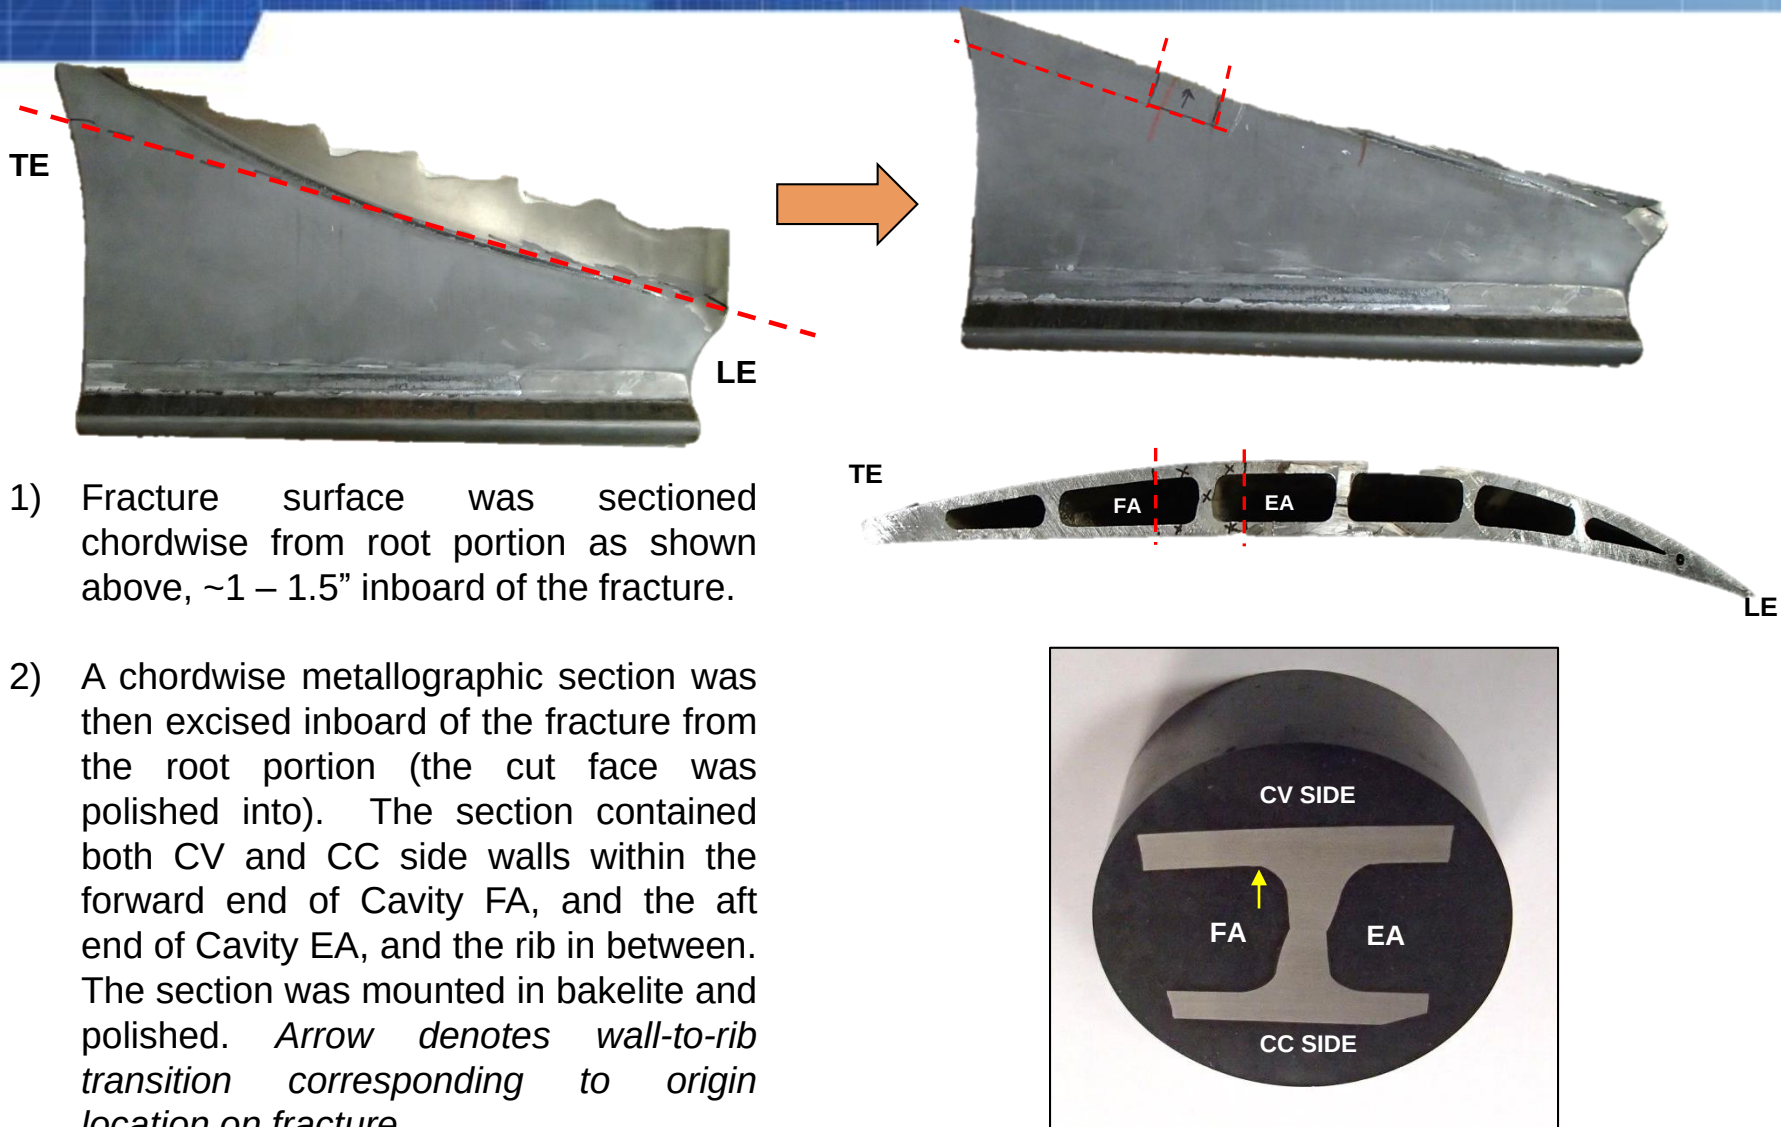
Attachment 1  
Figure 28

In tandem with the FESEM evaluations of the fracture surface, a metallographic section was prepared  $\sim 1 - 1.5''$  inboard of the fracture plane for evaluation of the internal cavity surface, wall-to-rib transition geometry corresponding to the fatigue origin area, and bulk microstructure. The section was oriented chordwise (but at the same angle as the fracture plane) and contained both convex and concave side walls within the forward end of cavity FA, and the aft end of cavity EA, and the adjoining spanwise rib (**Figure 28**). Step height of the machining mismatch in the section measured  $0.004'' - 0.005''$ , which met the requirement. Machining mark height and spacing within the mismatch measured up to  $\sim 0.0005''$  and  $0.005''$ , respectively. The size of the transition radii on either side of the mismatch were also approximated via best-fit circles and appeared to meet the requirements (**Figure 29**). A similar transition geometry with a machining mismatch was also observed within the transition radius on the opposite side of the rib, at the aft end of cavity EA (**Figure 30**). Examination of the section after etching to reveal microstructure showed no microstructural deformation along the as-machined internal cavity surfaces, including at the mismatch associated with the origin area (**Figure 31**). No alpha case was observed along the internal cavity surfaces (**Figure 32**). Bulk microstructure in the section was acceptable to the material specification requirements (**Figure 33**).

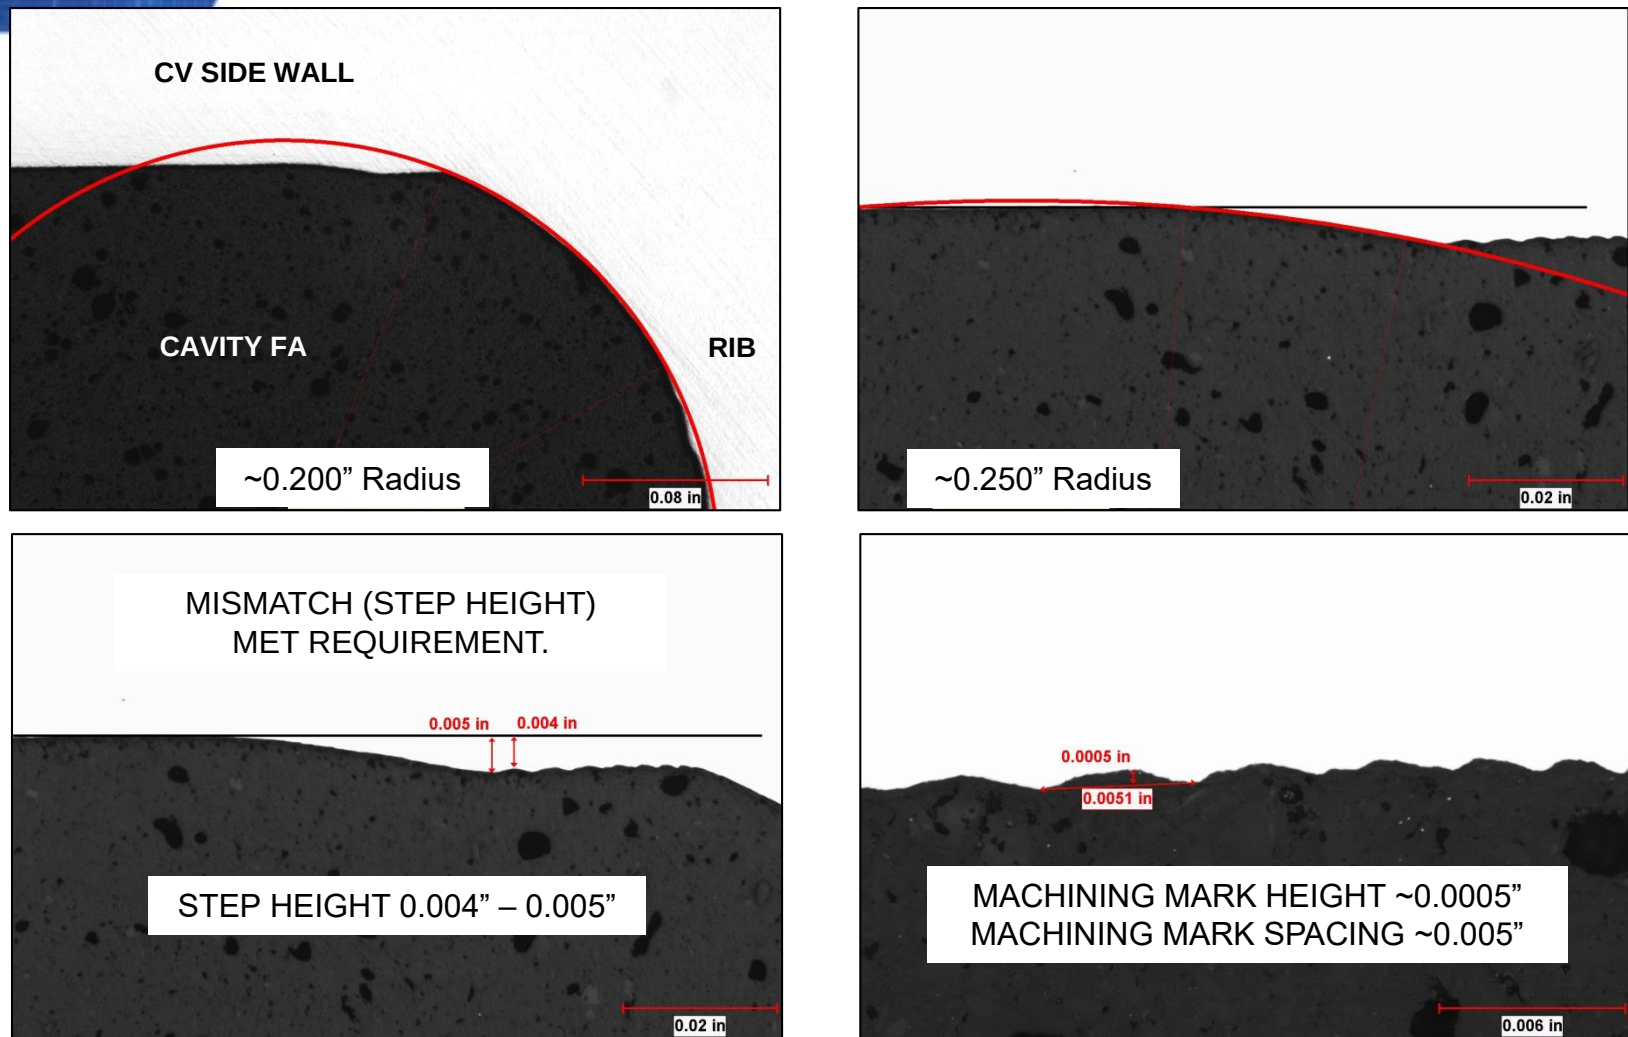
Figure 29 - Photomicrographs of section in un-etched condition with wall-to-rib transition geometry measurements.

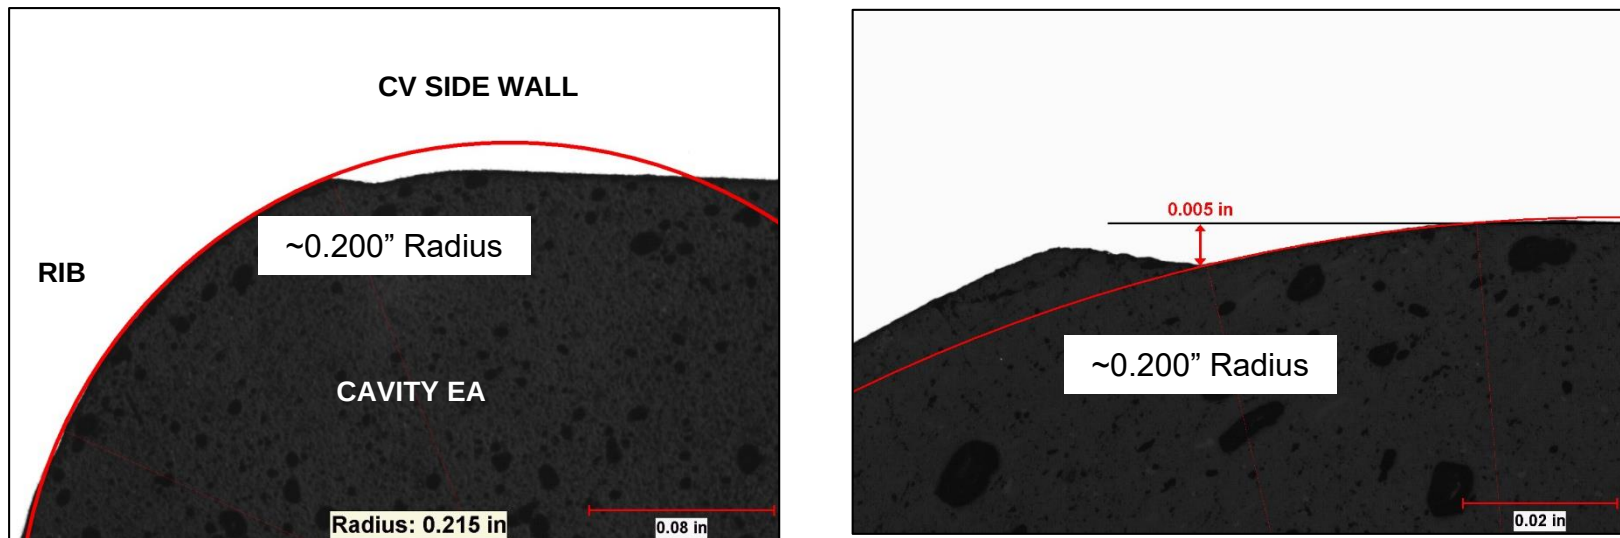
Figure 30 - Photomicrographs of section in un-etched condition with wall-to-rib transition geometry measurements.
