# Metallurgical Investigation Final Report

**Subject:** Metallurgical Investigation of Fan Blades No. 11 and No. 10 from PW4077 Engine 777049

**Date:** October 9, 2018

# PW4077 P777049 Fan Blade Fracture Investigation

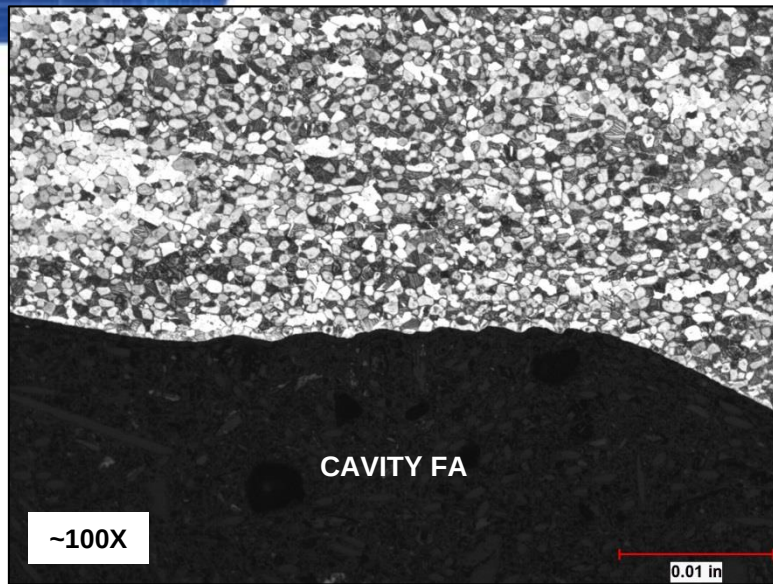
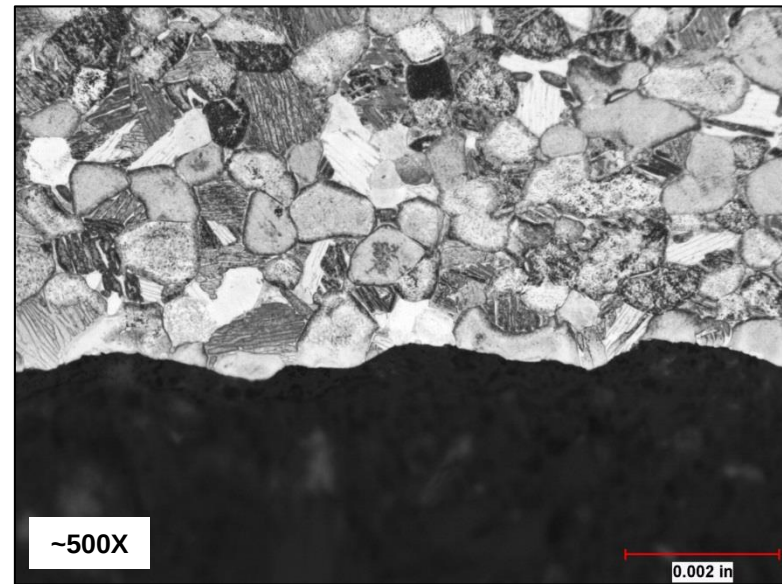
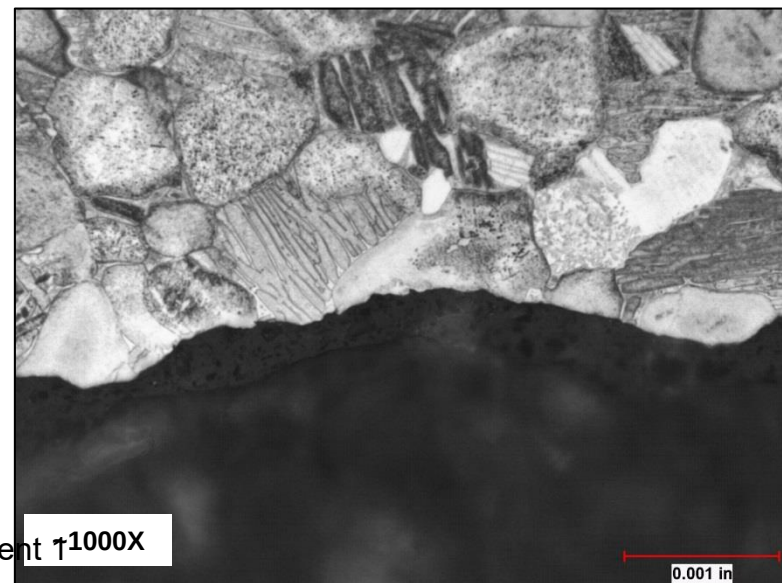
Figure 32 - Examination revealed no alpha case along the internal cavity surface.

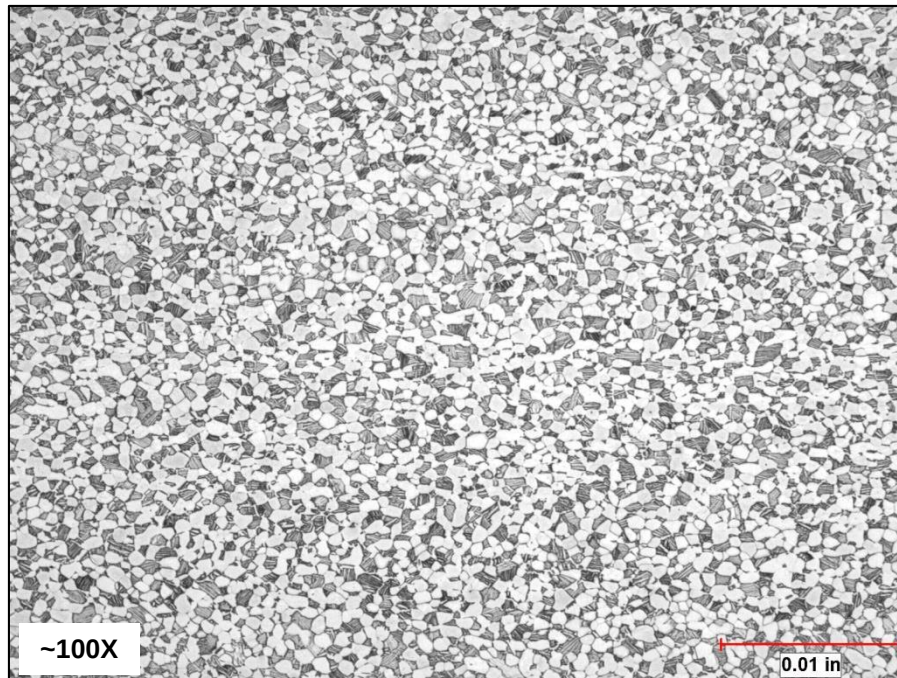
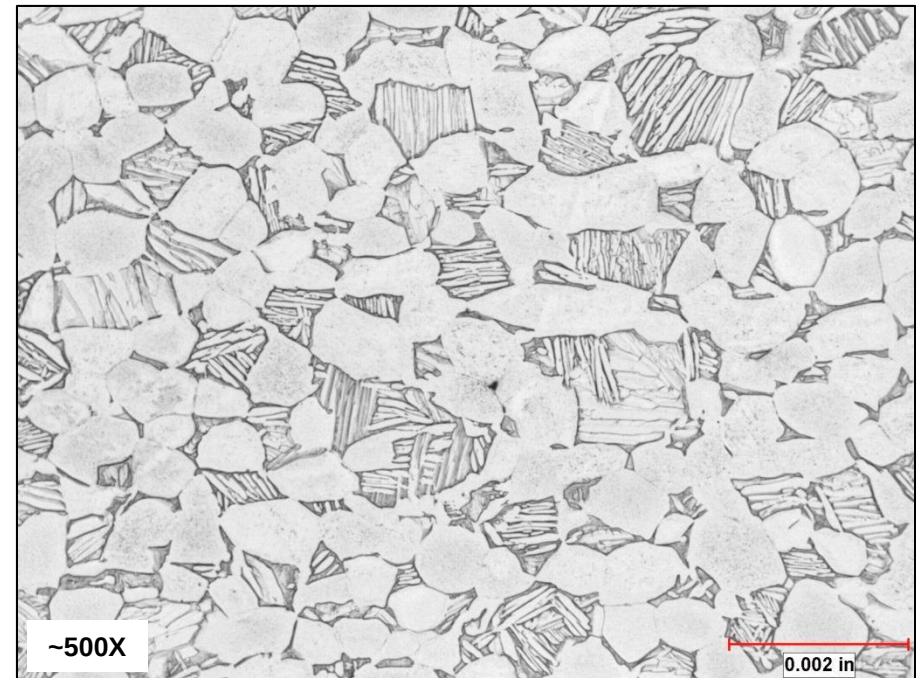
Figure 33 - Bulk microstructure was acceptable to specification requirements.

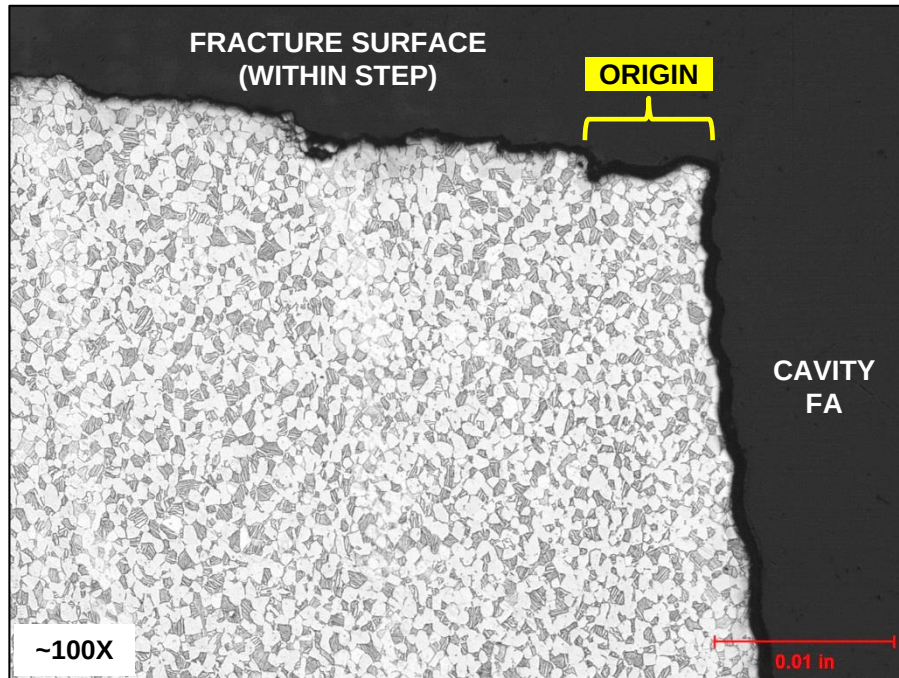
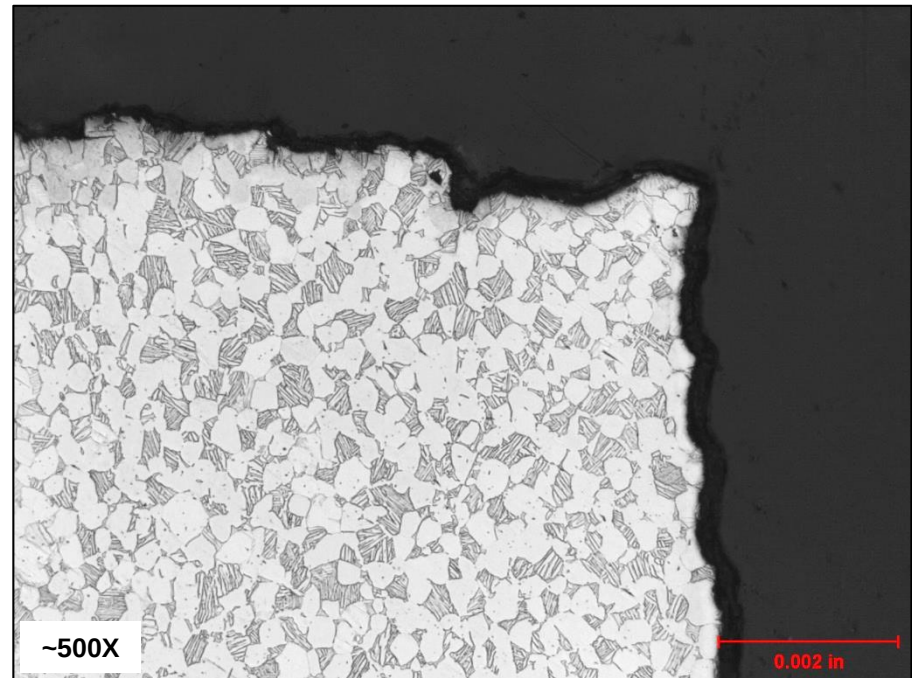
Prior to destructive evaluation of the fracture origin area, acetate tape replications were collected to preserve the fracture surface. One fracture surface replica was sent to United Airlines per their request. A second was retained by P&W MPE. Once it was deemed that all non-destructive examination of the fracture surface had been exhausted, a metallographic section was prepared into the fatigue origin area (**Figures 34 – 36**). The section was ground and polished until the plane intersected the origin as perpendicular as possible to the airfoil spanwise direction (a near-chordwise plane). Examination of the section after etching to reveal microstructure confirmed no evidence of microstructural damage from “sparks” or “chips” or deformation from abusive machining along the internal cavity surface, and no microstructural anomalies at the origin (**Figure 37**).

Figure 37 - Photomicrographs of metallographic section prepared through origin showing no microstructural anomalies.

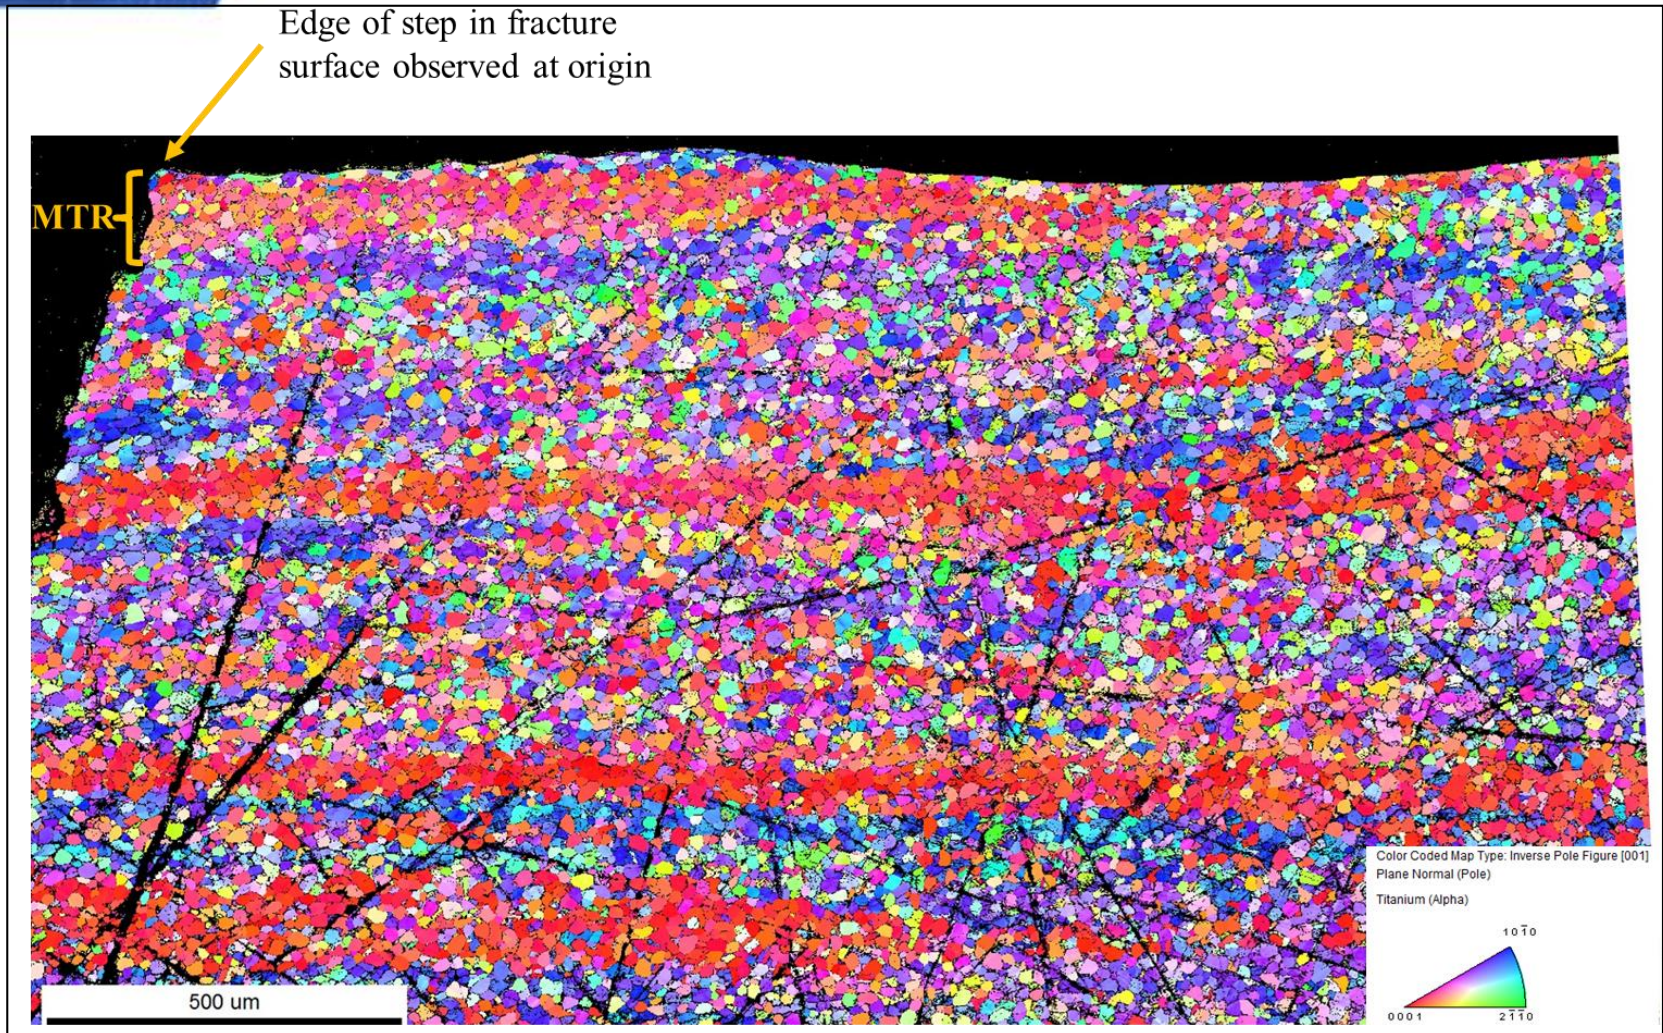
An orientation image mapping (OIM) evaluation of the fatigue origin section completed via EBSD/FESEM confirmed that an MTR band containing grains with similar basal plane orientations intersected the fracture origin area (**Figure 38**). Additional MTR bands were identified in nearby areas. Two of the MTR bands could be correlated with areas identified as MTR's during the fracture surface examination (**Figure 39**). A photomicrograph montage of the section taken at the same magnification and orientation as the OIM image (after etching the section to reveal microstructure) is shown in **Figure 40** for comparison. This microstructure was acceptable to the material specification requirements.

Figure 38 – EBSD scan of micro polished into origin. Microtexture band is evident at origin, confirming fracture surface observations. The black lines represent sample preparation artifacts.

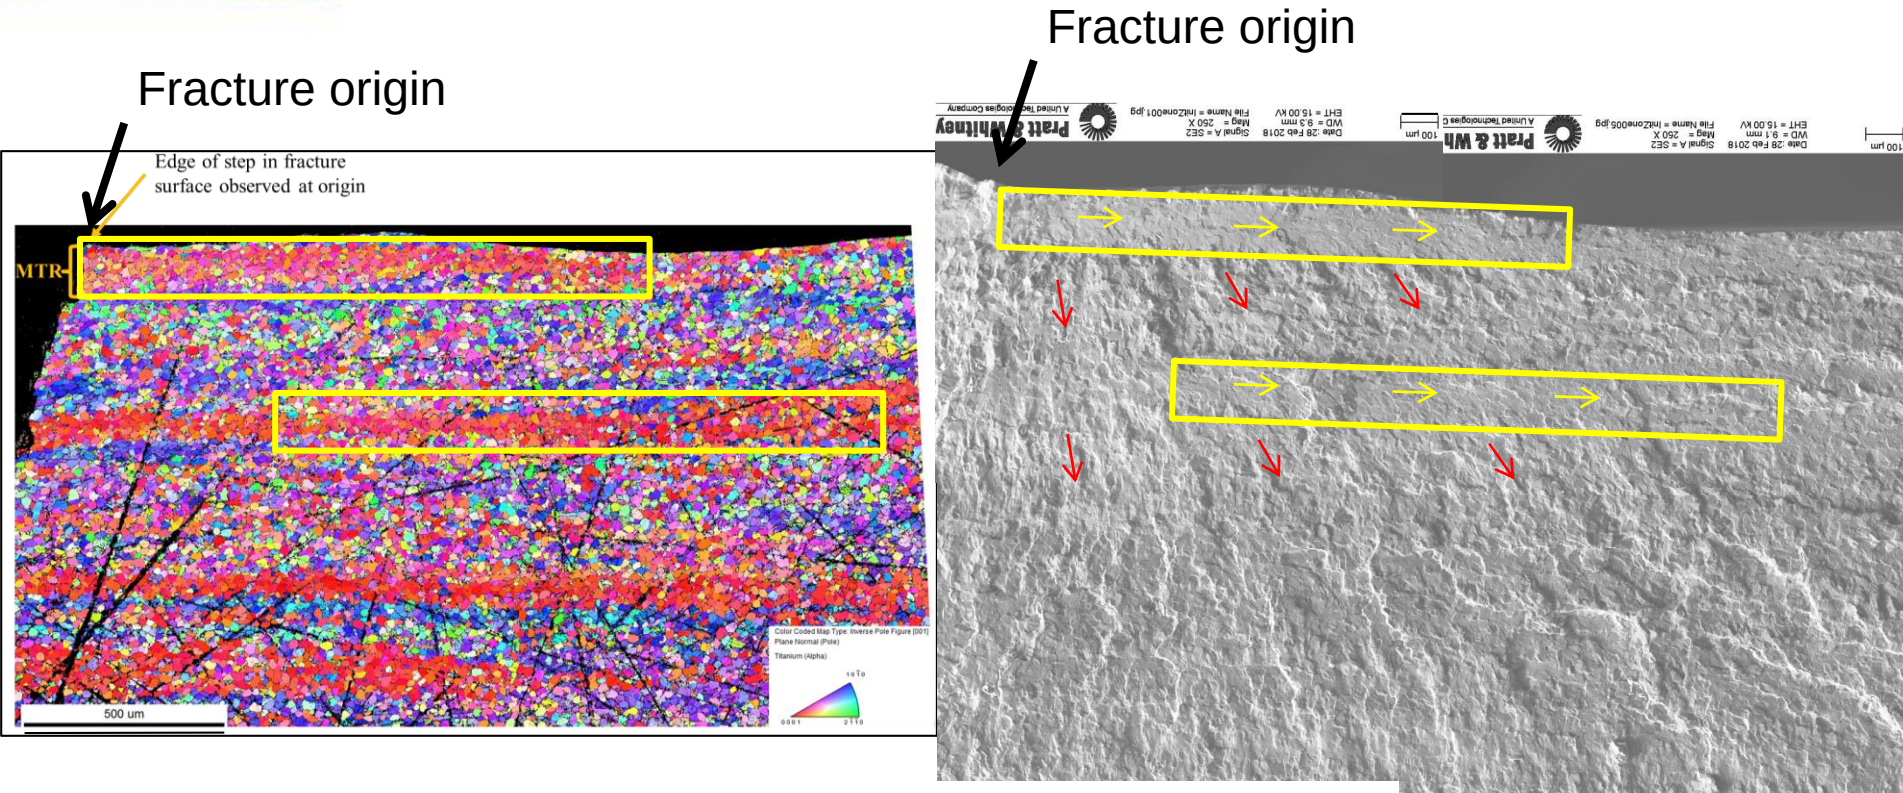
Figure 39 – EBSD scan of micro polished into origin (left) and (right) prior fracture surface appearance for same area at similar magnification. The yellow boxes show micro-texture bands with similar near basal grain orientations coincided with areas of fully faceted growth progressing chord-wise or along the MTR (yellow arrows). Typical fatigue progression directions are also shown (red arrows).

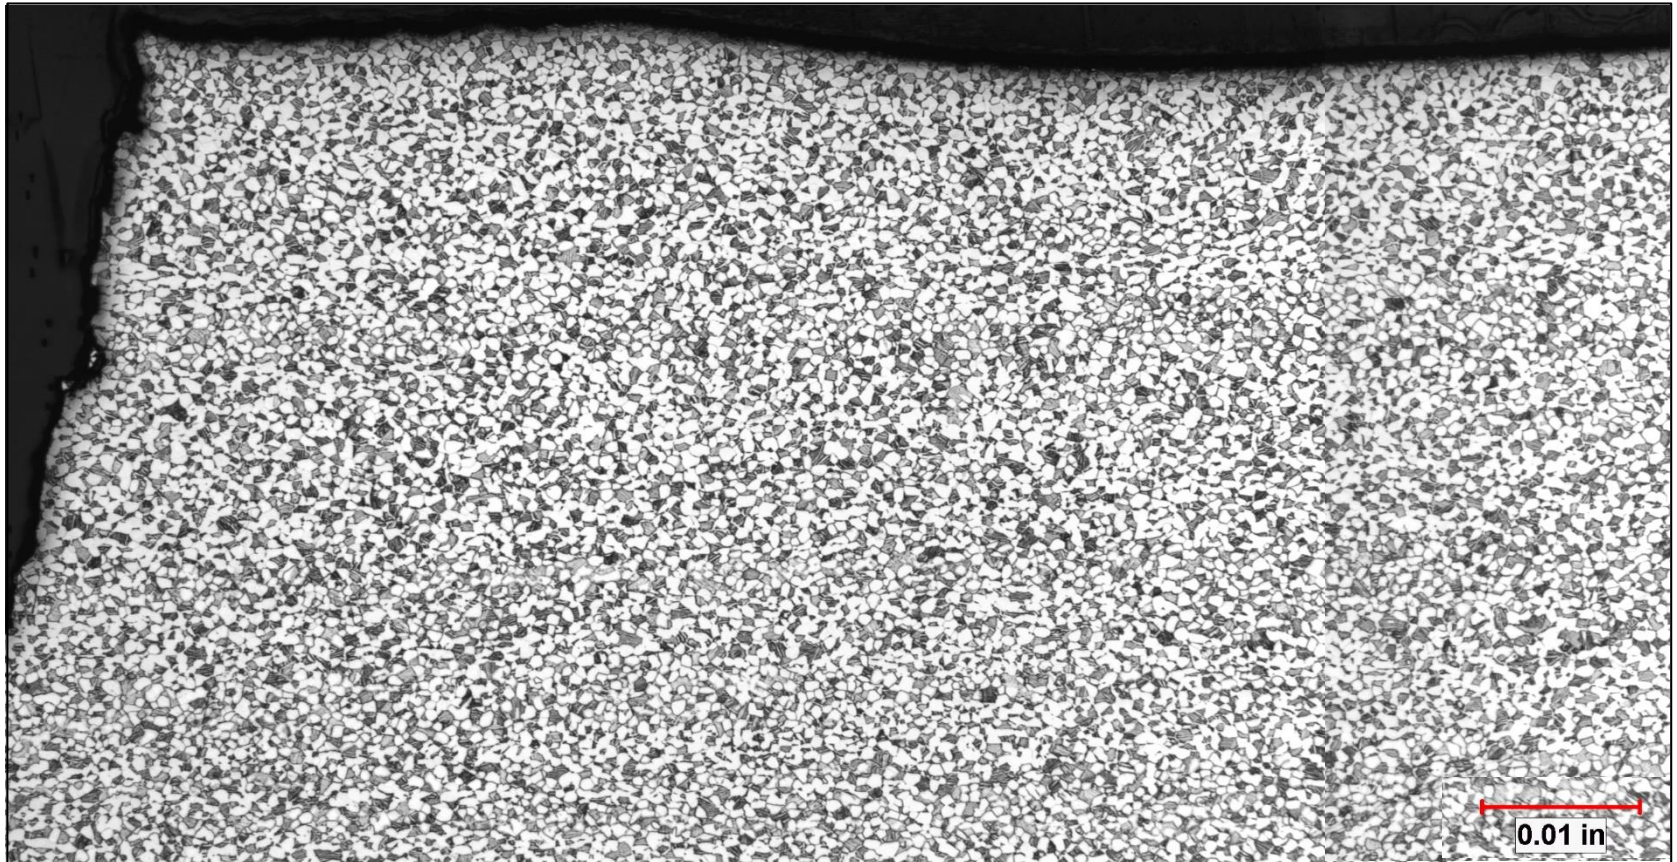
Figure 40 - Photomicrograph montage of origin area after etching metallographic section, taken at similar magnification and orientation as EBSD scan from Figure 39. The microstructure in this area was consistent with properly processed Ti-6Al-4V fan blade material.

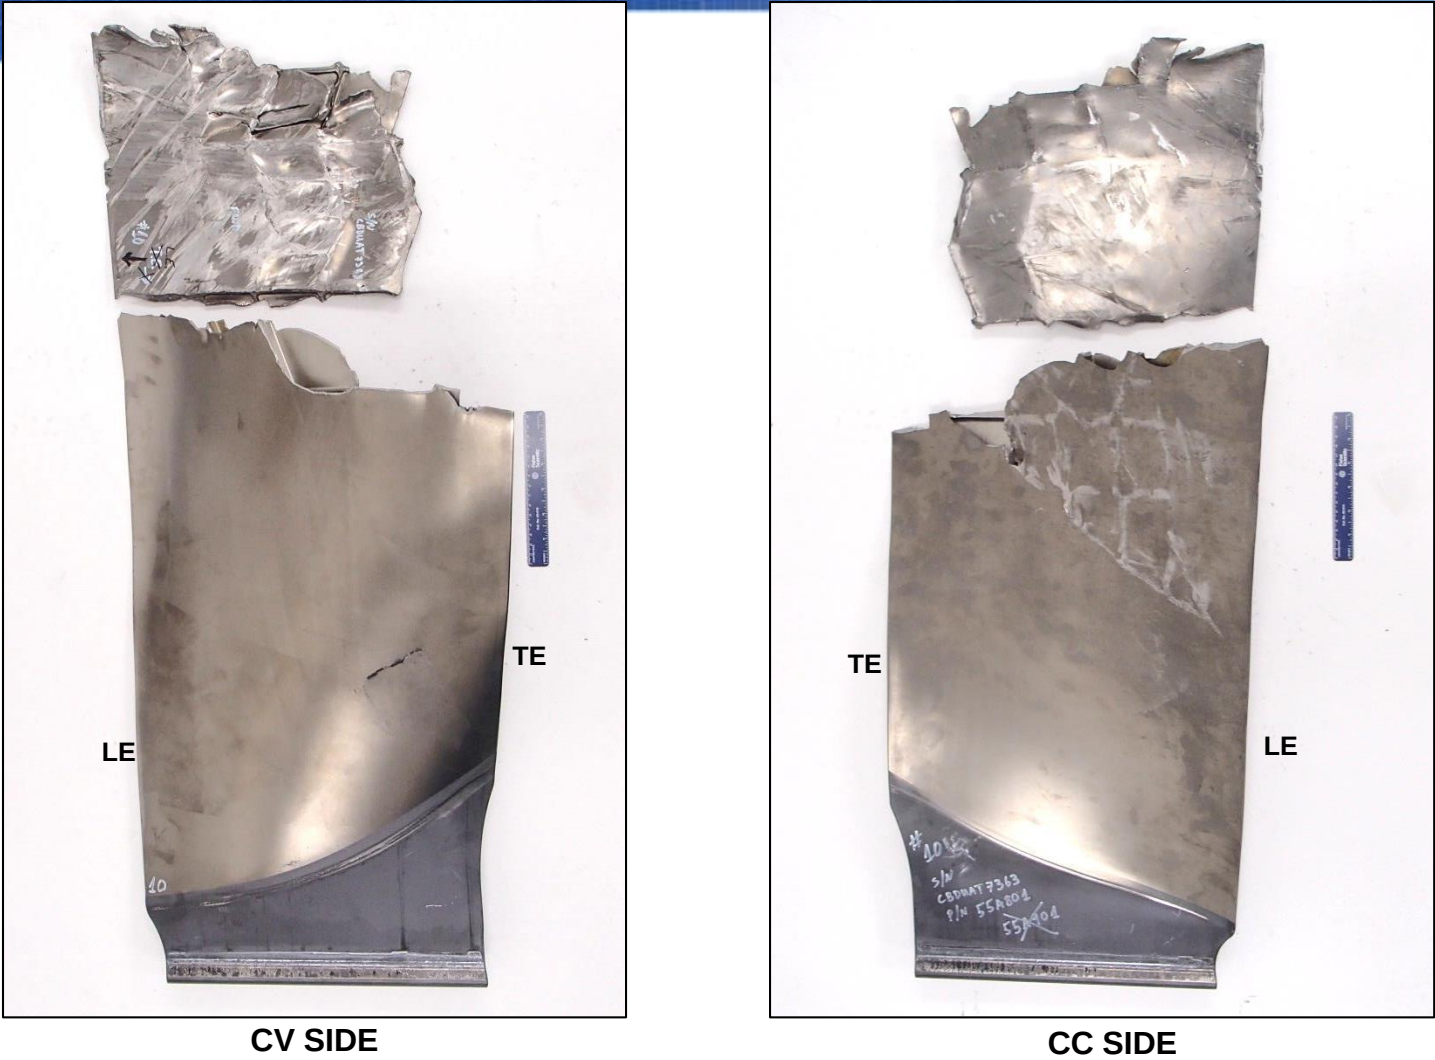
Figure 41 - Overall views of fractured following Blade #10.

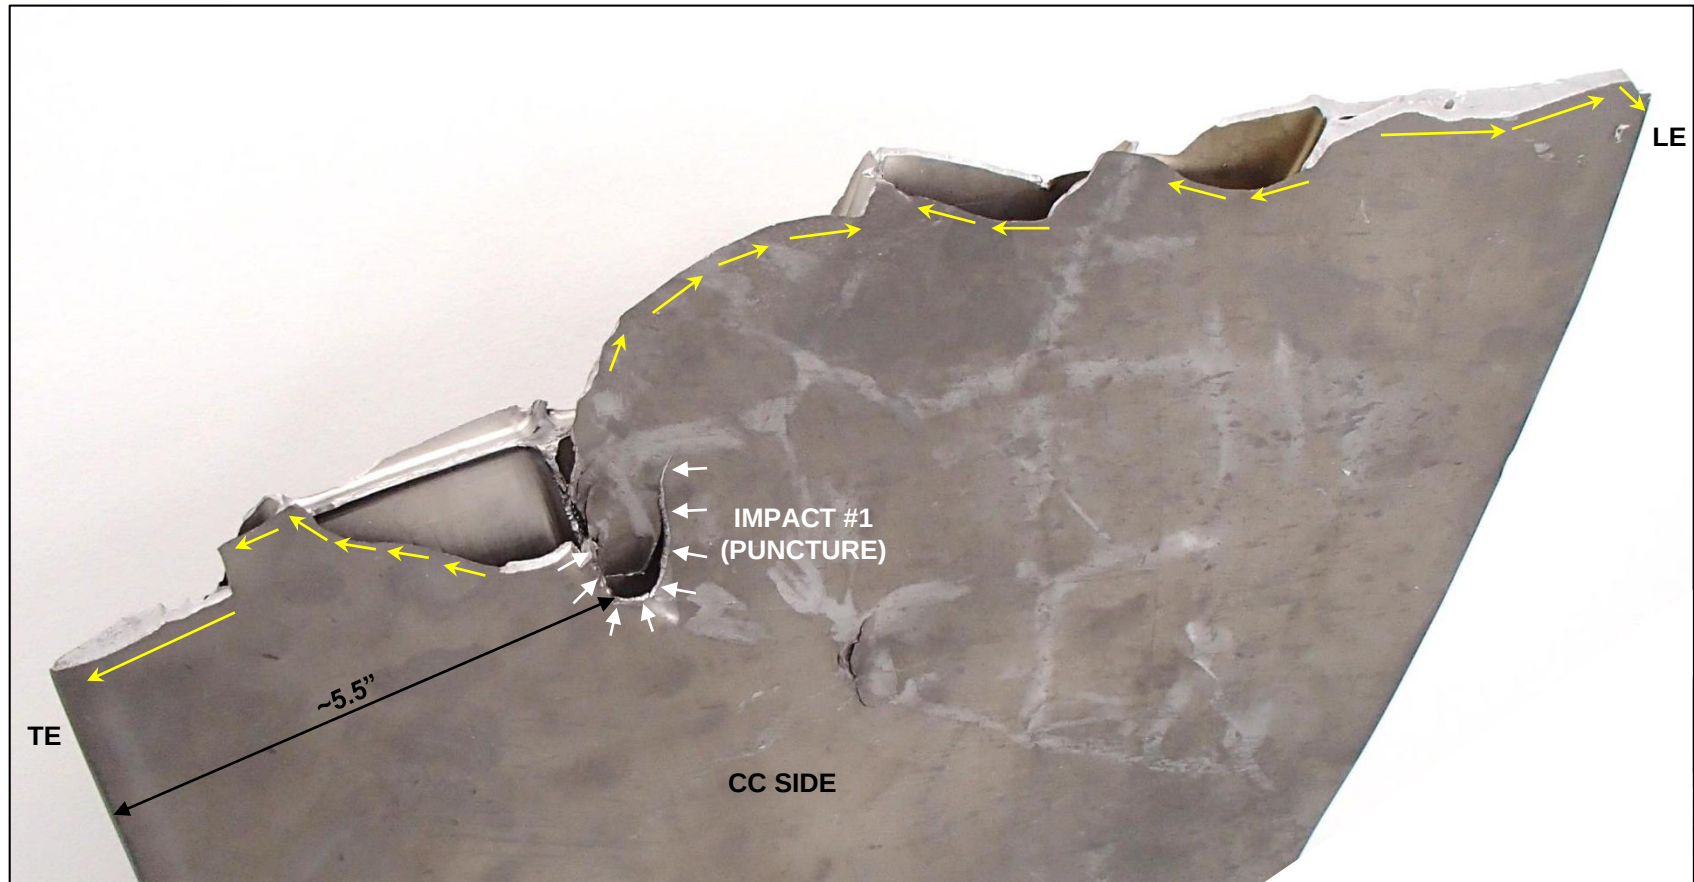
Figure 43 - Close-up view of Blade #10 fracture, inboard portion, from concave side. Directionality of overstress features (arrows) indicated fracture emanated primarily from puncture in concave wall ~21.5" above root bottom and ~5.5" forward of the trailing edge.

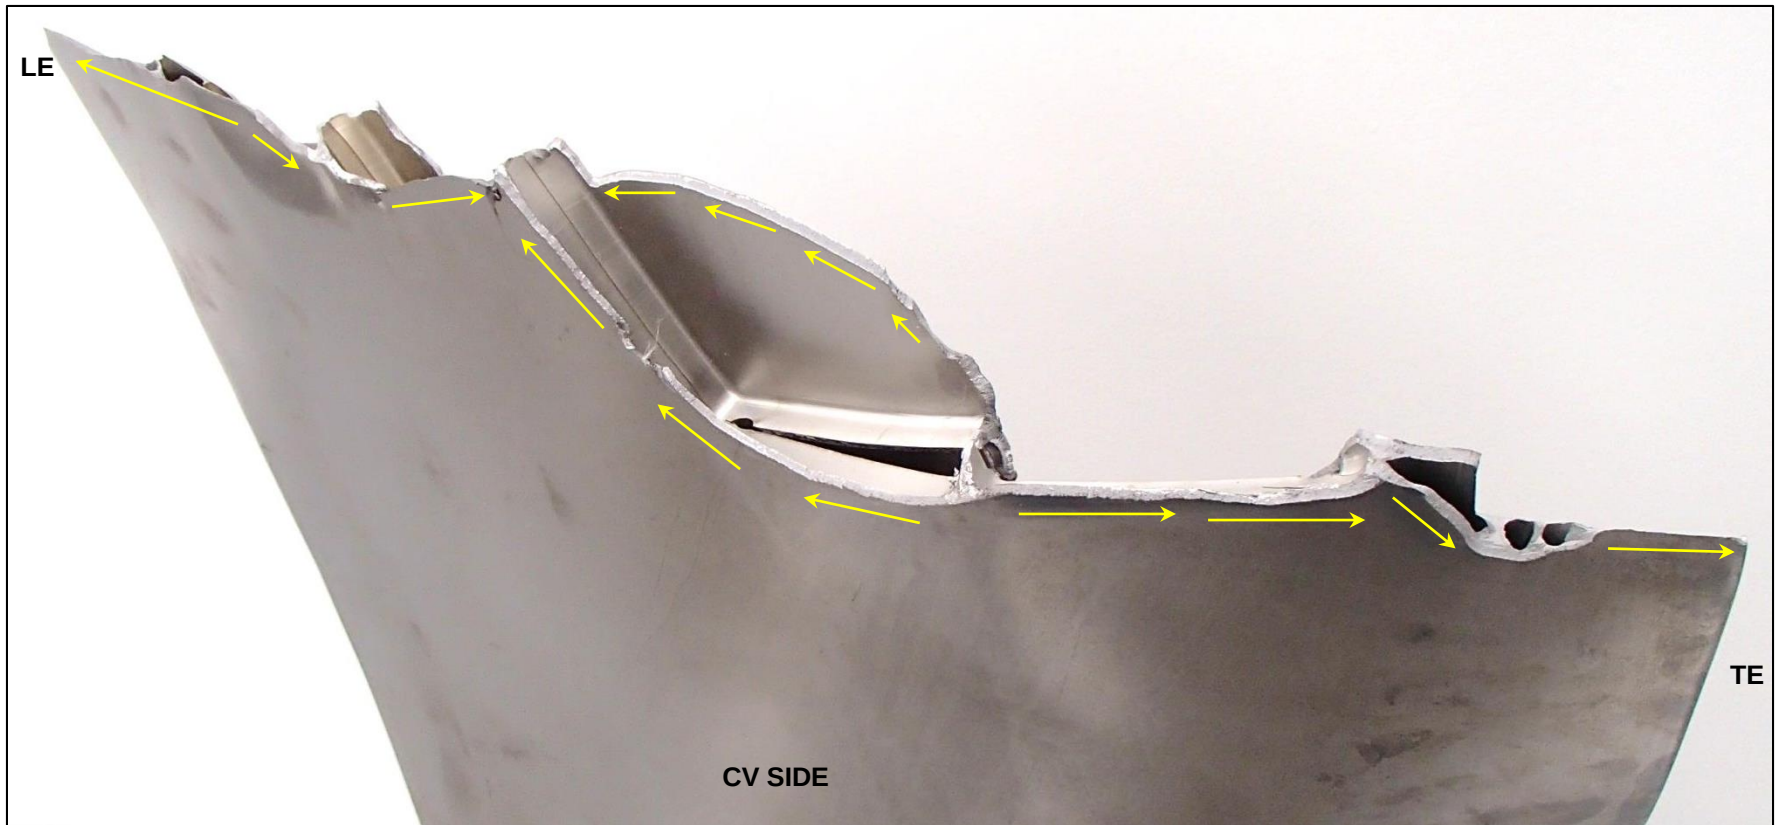
Figure 44 - Close-up view of Blade #10 fracture, inboard portion, from convex side. Directionality of overstress features (arrows) indicated fracture emanated primarily from puncture in concave wall ~21.5" above root bottom.

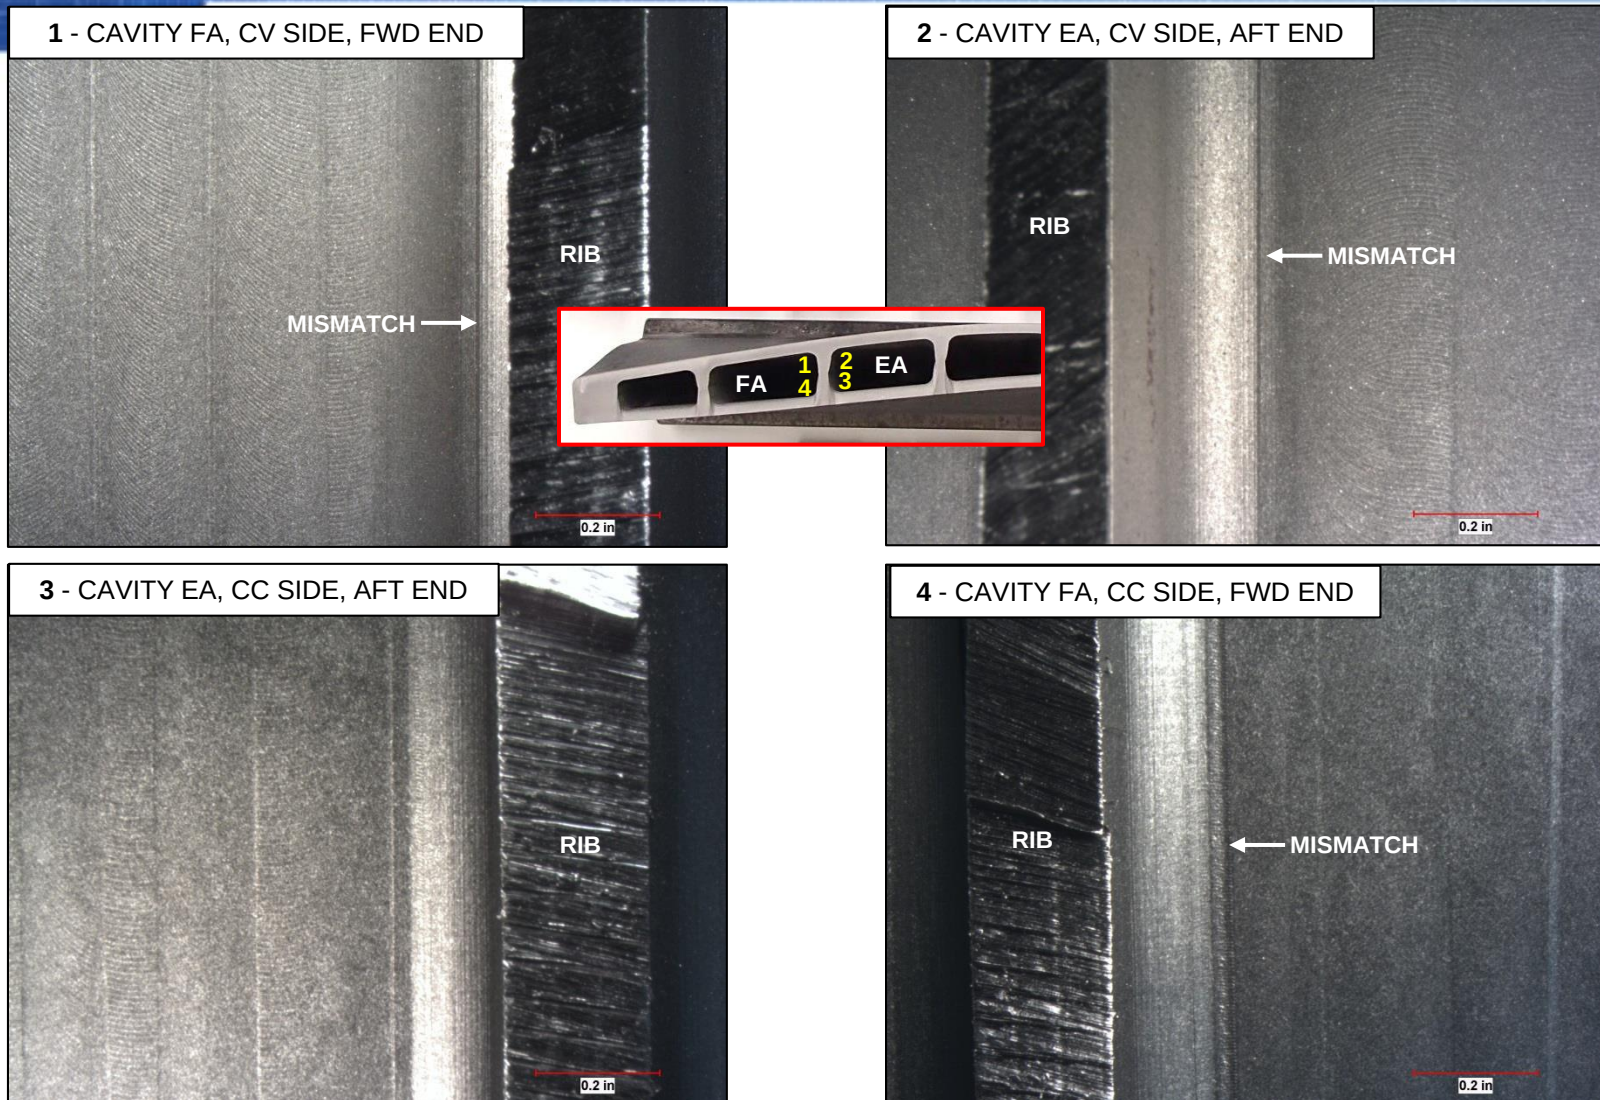
The blade was sectioned chordwise where shown in **Figure 46** (bounding the area corresponding to the fracture origin location on Blade #11) and each internal cavity was filleted open to examine the as-machined features in comparison to Blade #11. Examination typically revealed machining mismatches/cusps at the wall-to-rib transitions that were less prominent than what was observed on Blade #11 (**Figure 47**).

Figure 47 - Examination of the internal cavities typically revealed machining mismatches at the wall-to-rib transitions that were less prominent than what was observed on Blade #11.

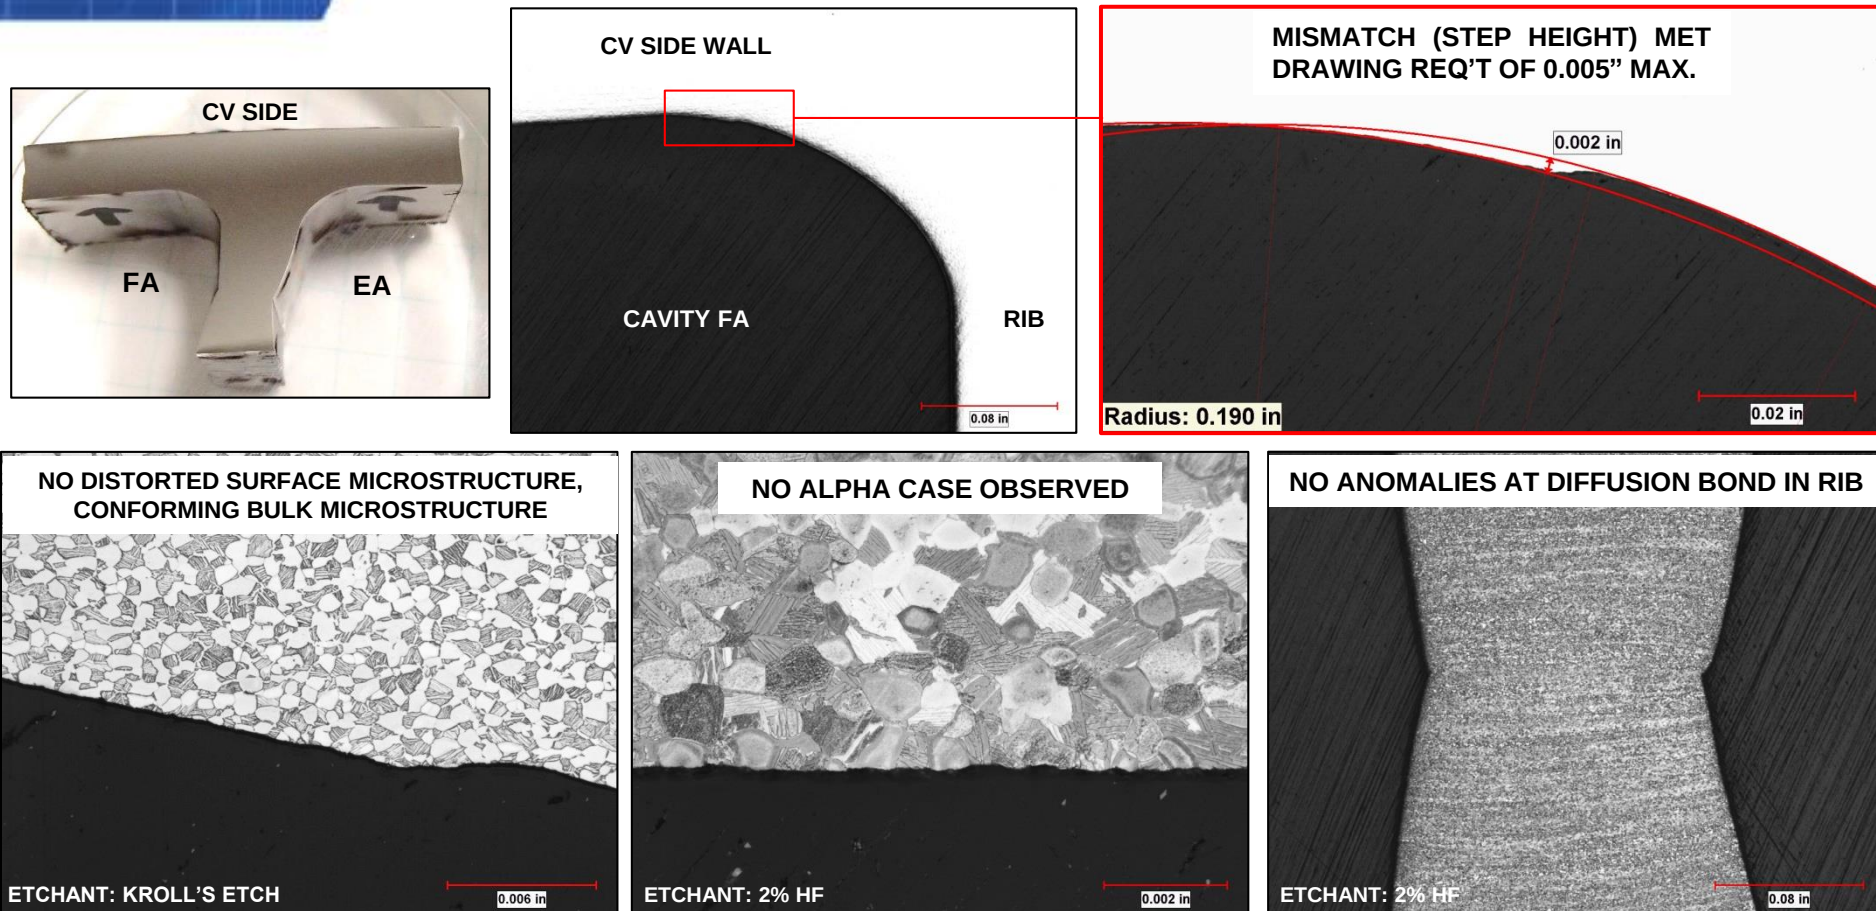
A chordwise metallographic section was prepared through Blade #10 at a location similar to the section prepared through Blade #11 shown in Figure 28. Review of the section revealed a slight machining mismatch (~0.002” step height) in the transition between the convex side wall and rib, no evidence of microstructural deformation or alpha case along the internal surfaces, no anomalies associated with the diffusion bond in the rib, and a bulk microstructure that appeared acceptable to the specification requirements (**Figure 48**).

Figure 48 - A chordwise metallographic section was prepared through Blade #10 at a location similar to the section prepared through Blade #11 shown in Figure 28. Review of the section revealed a slight machining mismatch (~0.002" step height) in the transition between the convex side wall and rib, no evidence of microstructural deformation or alpha case along the internal surfaces, no anomalies associated with the diffusion bond in the rib, and a bulk microstructure that appeared acceptable to the specification requirements.
