# **National Transportation Safety Board**

## **Performance Study**

### **Specialist Report**

| NTSB Number: | DCA18IA265 |

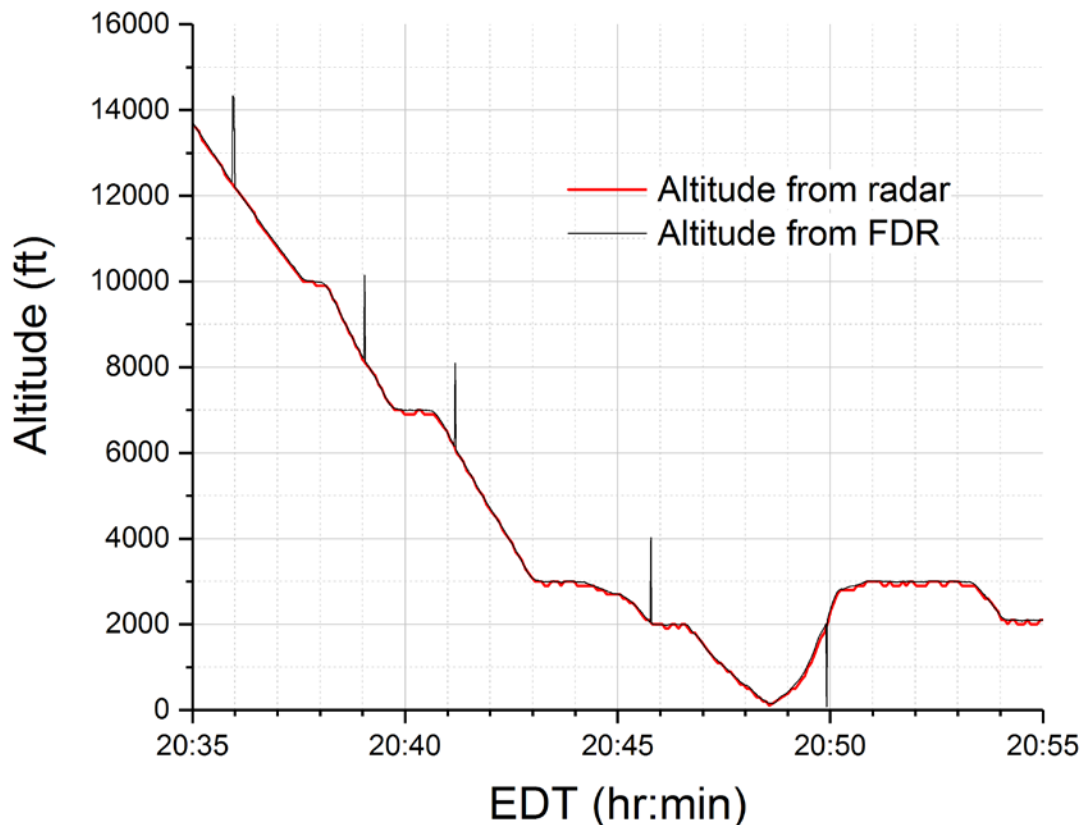
The FDR did not record universal time, so FDR data was synchronized using the altitude recorded by the PHL radar. Figure 1 shows altitude from PHL radar and the time-adjusted FDR recorded altitude versus local time in Philadelphia (EDT).

**Figure 1.** Altitudes from radar and incident airplane FDR.

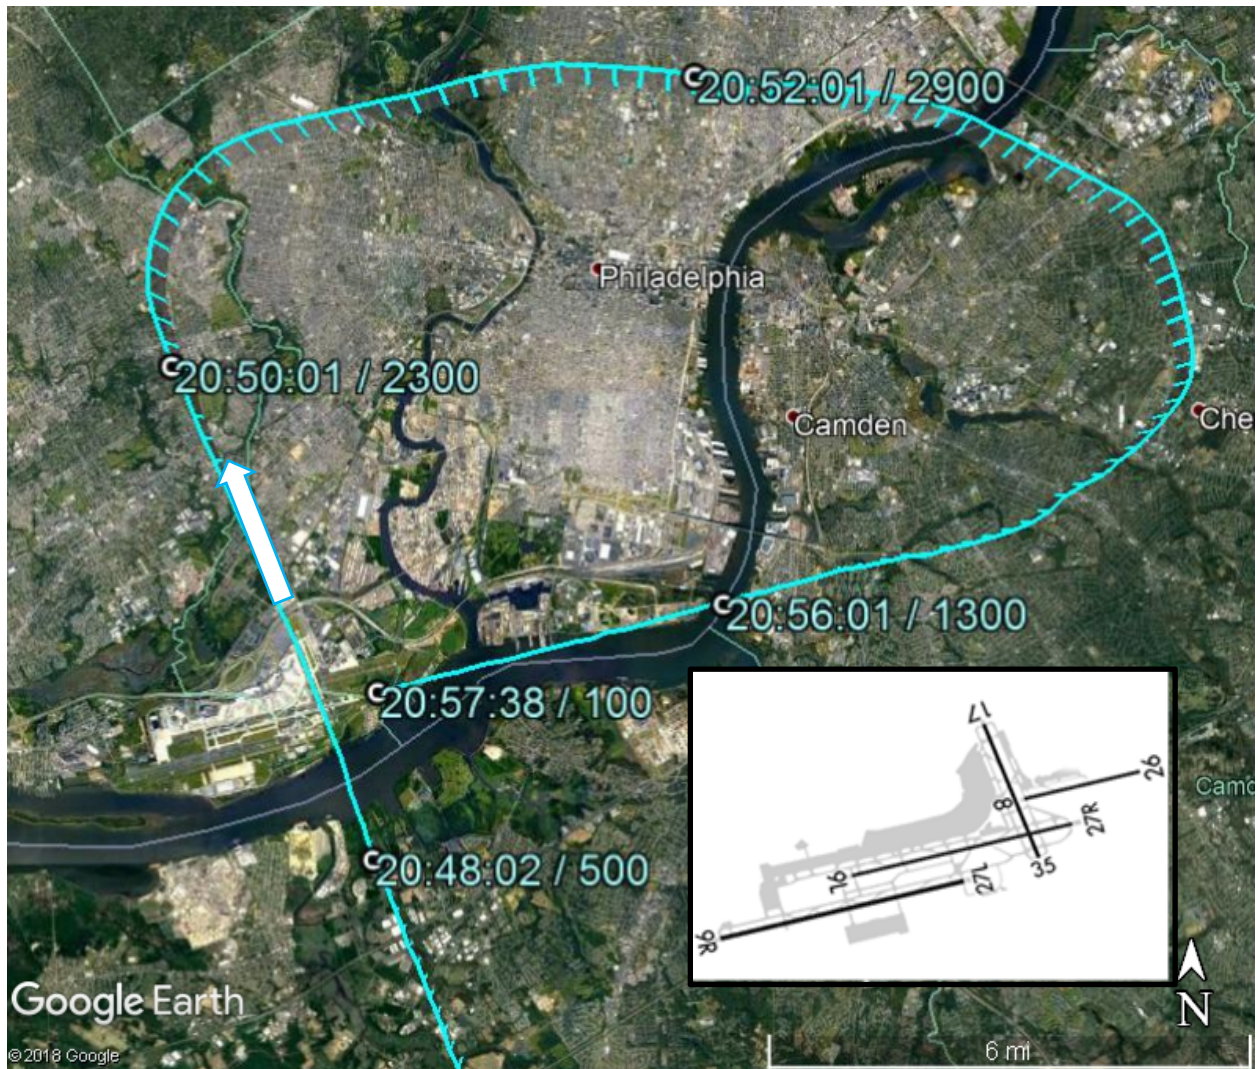
The airplane was to land on Runway 35 at PHL. Figure 2 shows the approach to Runway 35, the go-around, and the landing on Runway 27R. Figure 3 shows the airplane lined up with Taxiway E, to the left of Runway 35, rather than the intended runway surface. The centerlines of Runway 35 and Taxiway E are 400 ft apart. The runway is 150 ft wide, while the taxiway is 100 ft wide.

**Figure 2.** Airplane path to runway 35, go around, and landing on 27R. The inset is a diagram of the PHL airport.

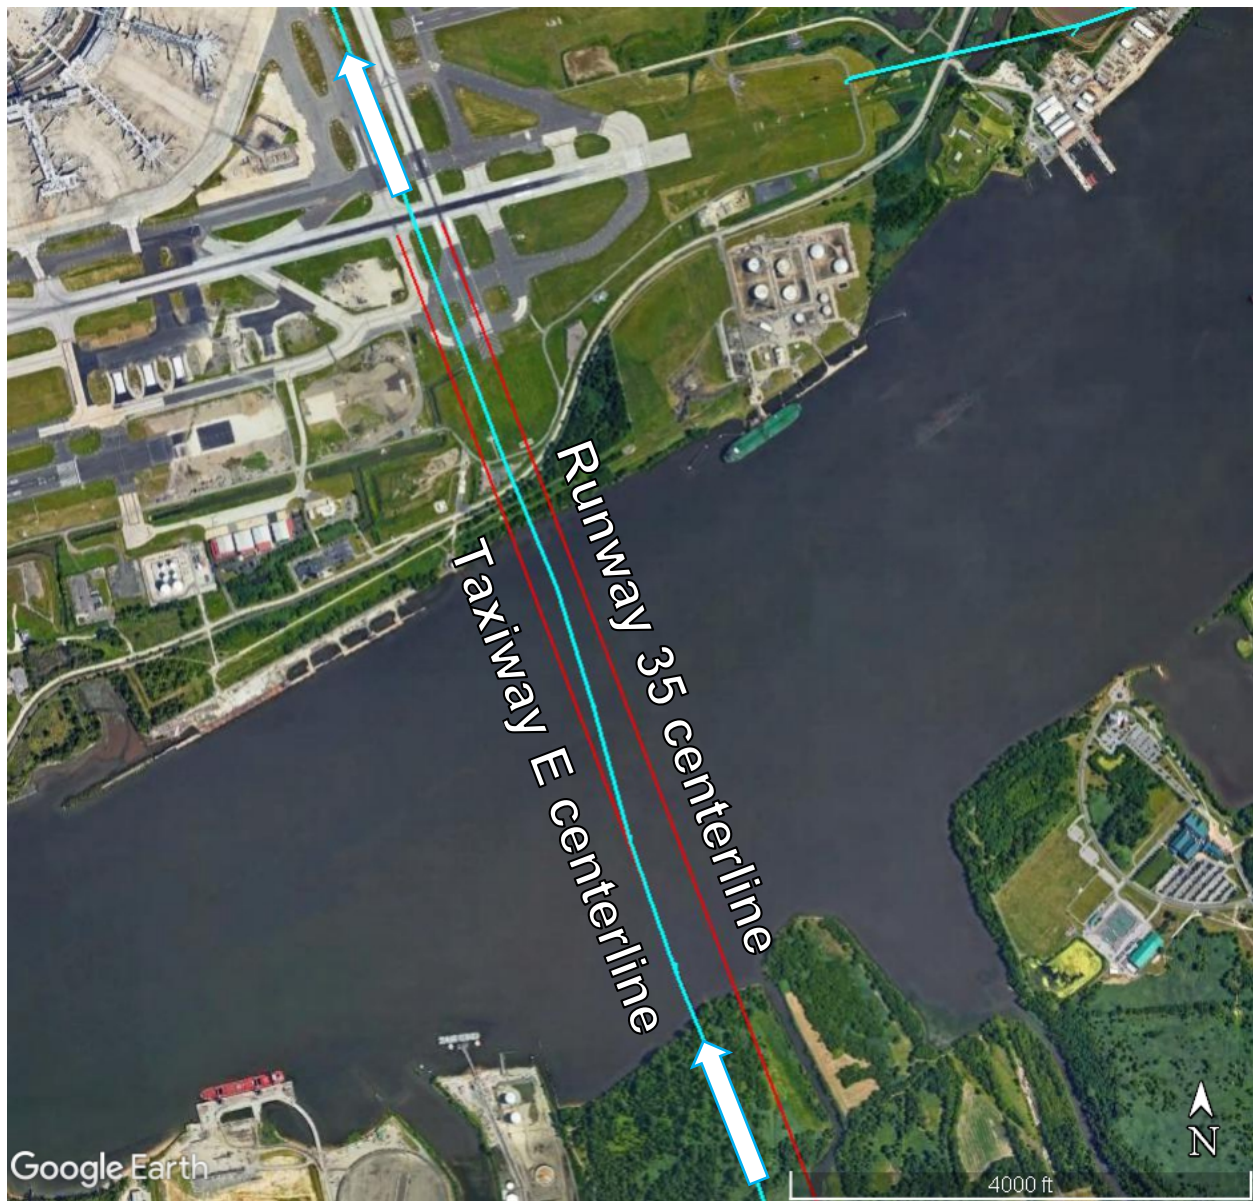
**Figure 3.** Airplane path in blue, the direction is indicated by white arrows. The airplane was lined up with Taxiway E, rather than Runway 35.

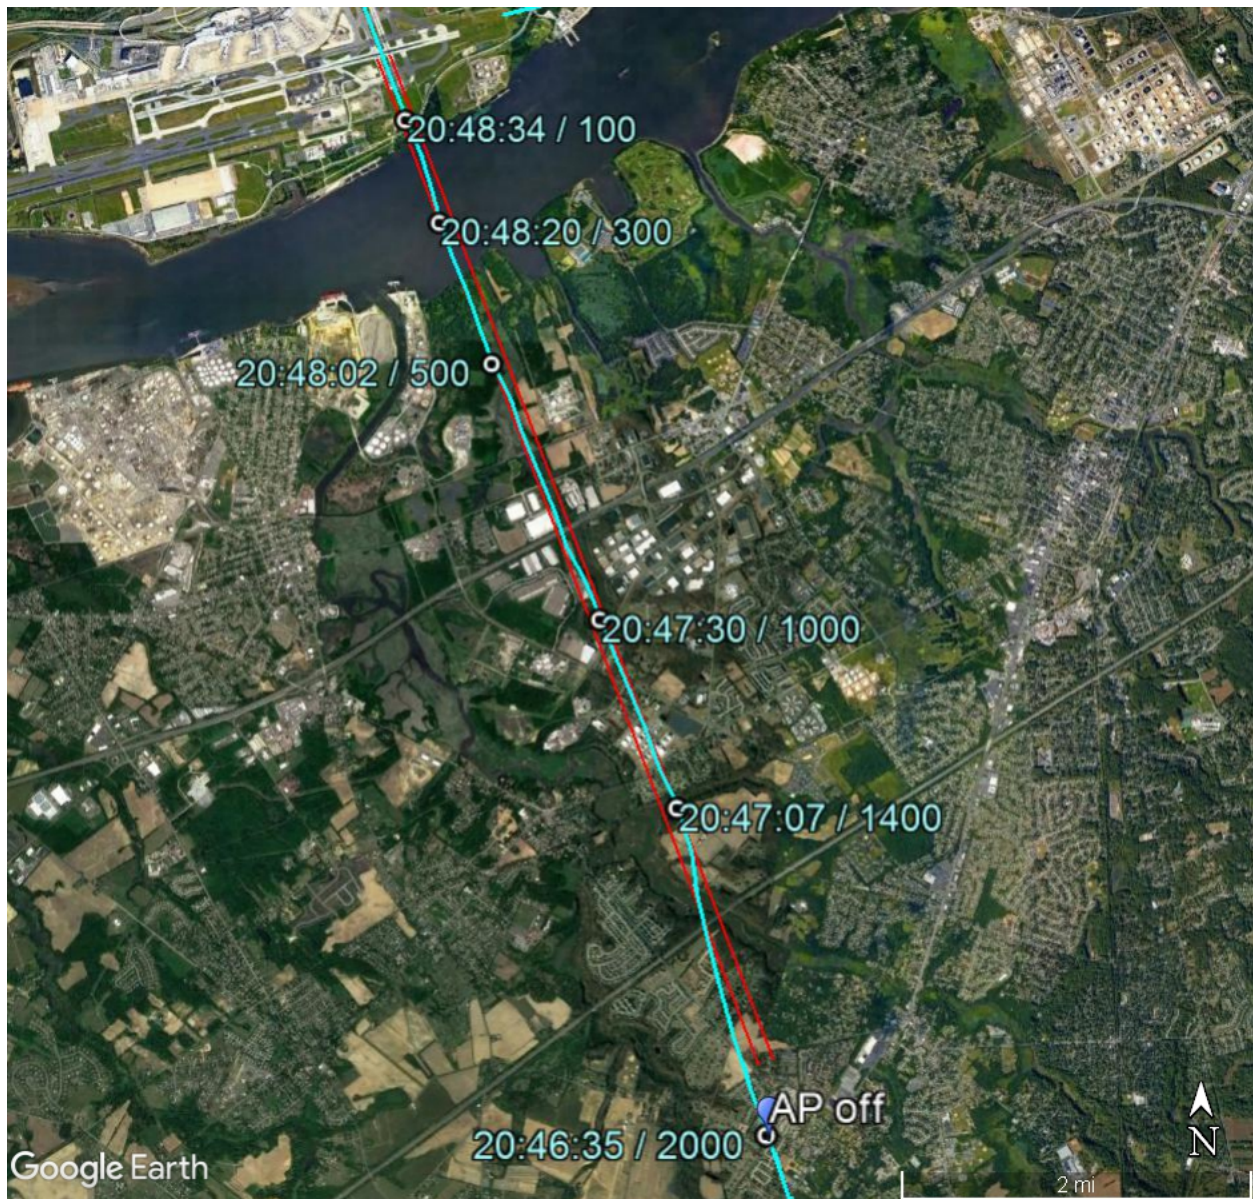
The autopilot was disengaged at 20:46:35, when the airplane was about 5.5 NM from the runway threshold (Figure 4). The airplane aligned with the centerline of runway 35 at 20:47:07. At 20:47:30, the airplane moved to the left and by 20:48:02 it was lined up with Taxiway E. At 20:48:20, the airplane began to move right again and initiated a go-around while between the extended centerlines of the taxiway and the runway.

**Figure 4.** Airplane approach to Runway 35 with autopilot disengagement noted.

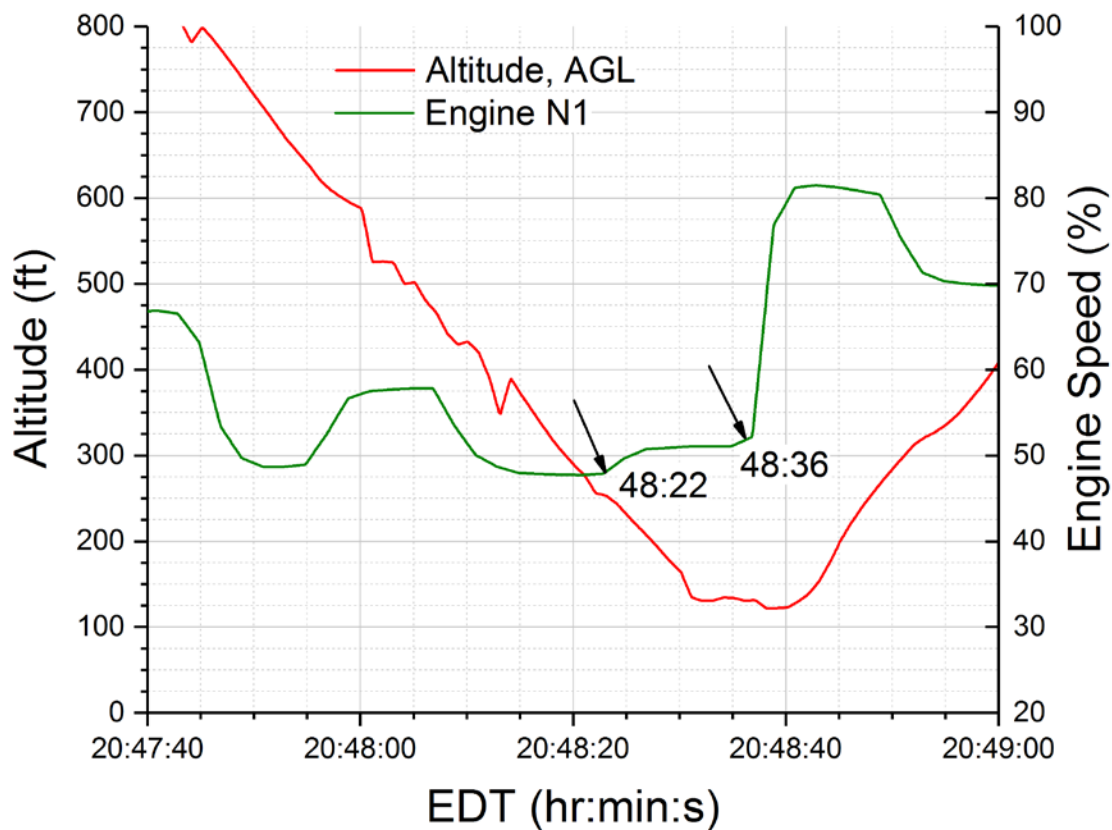
The FDR did not record a go-around parameter. The engines were advanced slightly from 47% to 51% at 20:48:22 (Figure 5), which corresponds to the time when the airplane left the alignment with the taxiway and began moving right towards the runway alignment (Figure 4). Then, at 20:48:36, the engines were advanced to above 80% and the airplane began to climb. This occurred when the airplane was about 125 ft above the ground and about 500 ft from the paved surfaces of the airport.

**Figure 5.** Altitude above ground level and engine speed versus time. Two increases in N1 and their times are noted with arrows.
