**NATIONAL TRANSPORTATION SAFETY BOARD**

**Attachment 4 –Eaton Hydraulic Engine Driven Pumps Investigation Report**

**DCA18LA163**

# LEVEL 1 INVESTIGATION REPORT

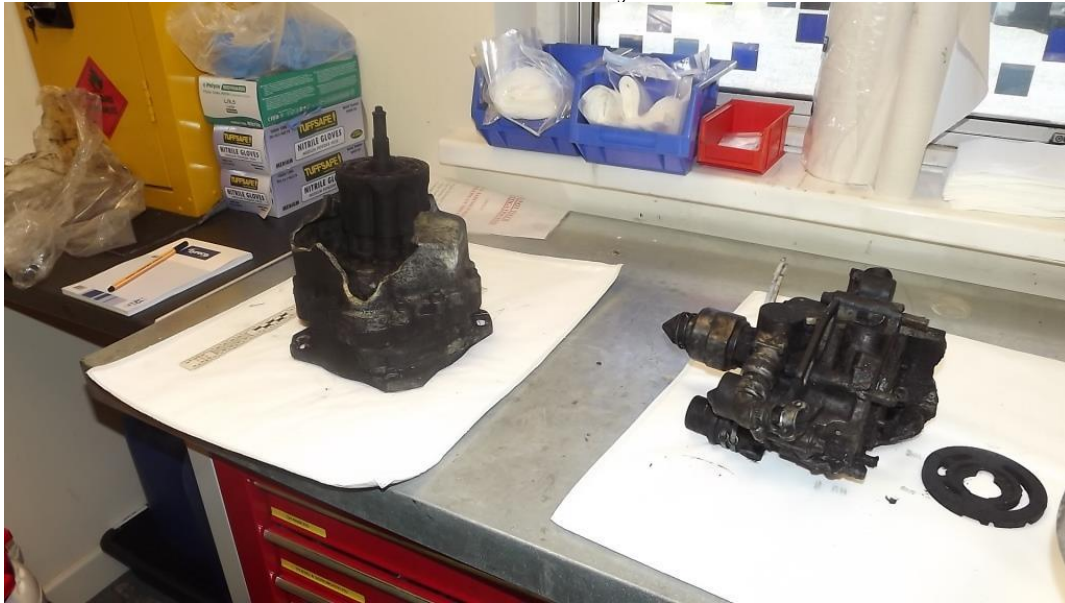
**Photo No 4 EDP Sections as Received**

Both sections were unpacked and placed on a workbench for a visual inspection. The EDP Serial No G0710126 was confirmed by Delta Airlines.

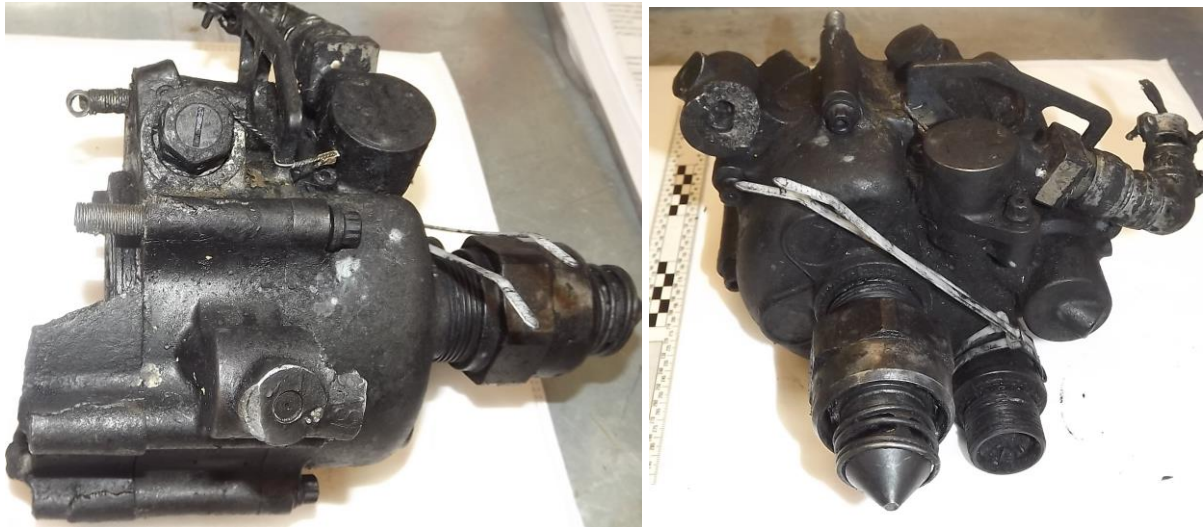
**Photo No 5A and 5B: Valve Block External Surfaces**

- All surfaces were blackened and covered with soot.
- A section of material from the case drain port was missing.
- The remains of a hose end connection (non EDP part) was attached to the hydraulic suction port.
- The wafer plate fell off its locating pins during normal handling of the material.
- External fasteners and steel inserts were exposed where surrounding aluminum material from the adaptor block had melted, some of the screws were bent.
- The Electrical Depressurising Valve (EDV) aircraft electrical connector was still fitted, only partial remains of the electrical lead was left.
- The compensator wire locking was still attached.
- A section of the fractured aluminum housing was attached to the adaptor block.
- A section of aluminum adaptor block material appeared to have melted and folded over.

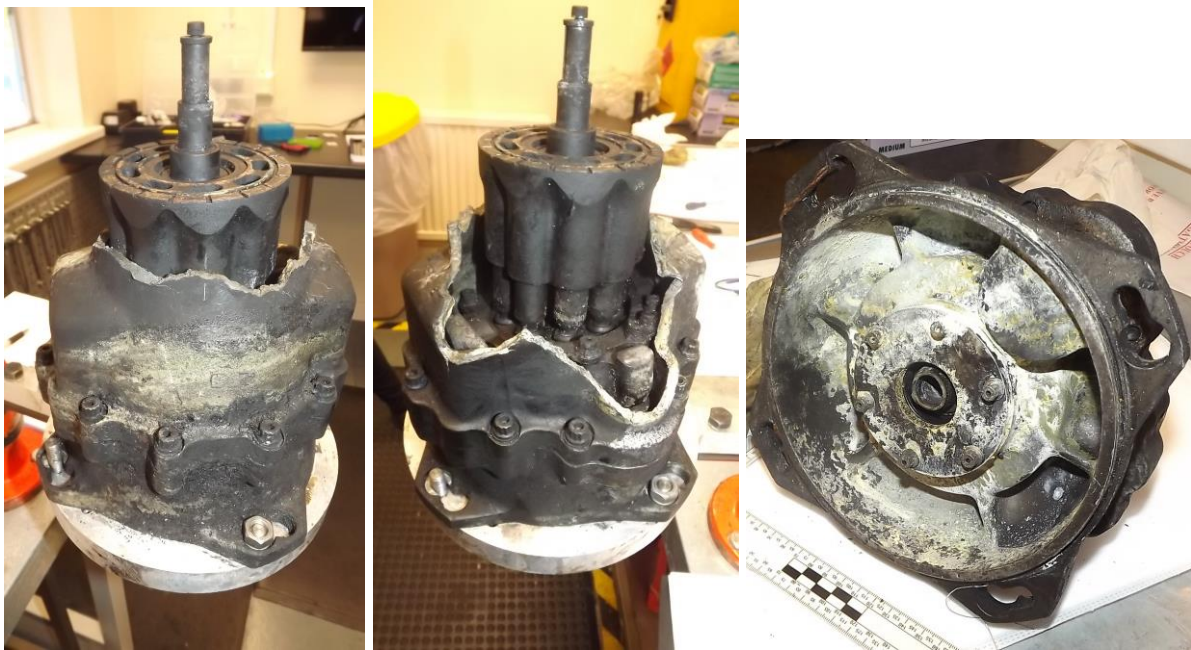
**Photo No 6A, 6B and 6C: External Surfaces Housing and Mounting Flange Cavity**

- External surfaces were burnt, blackened and covered with soot/thermally stressed hydraulic fluid.
- The mounting flange cavity and one side of the housing was stained with a yellow tinge, possibly due to burning or fire extinguishant residue.

- The internal components were in a similar condition, unidentified sand coloured grains were adhered to the internal components.
- It was noted that a large section of the aluminum housing was missing, the actuator piston and identity plate was also missing.

- The coupling shaft had sheared, the EDP spline end was retained in the driveshaft.
- The cylinder block was sitting abnormally high on the driveshaft.

- The impeller washer and screw were still retained and screwed onto the driveshaft. This was considered unusual as the impeller is screwed onto the shaft and retained by the washer but remained in the valve block section.

- The rotating group appeared to be intact with no visual evidence of mechanical failure.
- There was no visual evidence of metallic contamination within the EDP indicative of running surface degradation.

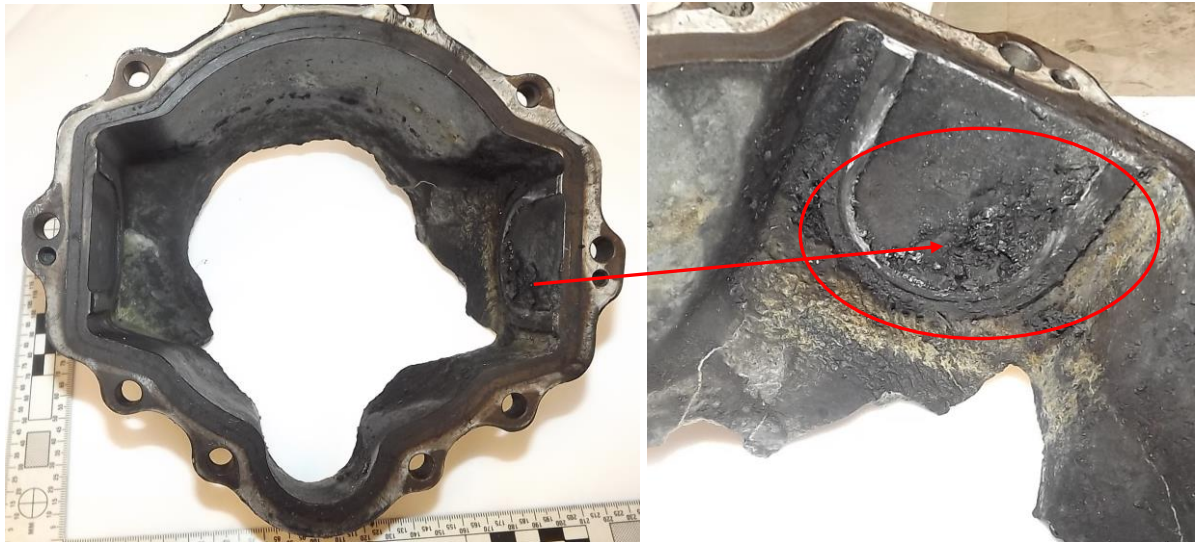
**Photo No 10A and 10B : Housing**

The housing screw torque values were evaluated, correct assembly torque limits are 290 to 300 lbf.in. The evaluation confirmed a reduction in torque where movement was detected with a calibrated torque wrench set at 100 lbf.in.

Upon removal inspection found the entire internal surface area was blackened, a build up of sludge (possibly thermally stressed fluid) had collected on one side adjacent to the pintle bearing.

There was no evidence of internal mechanical damage.

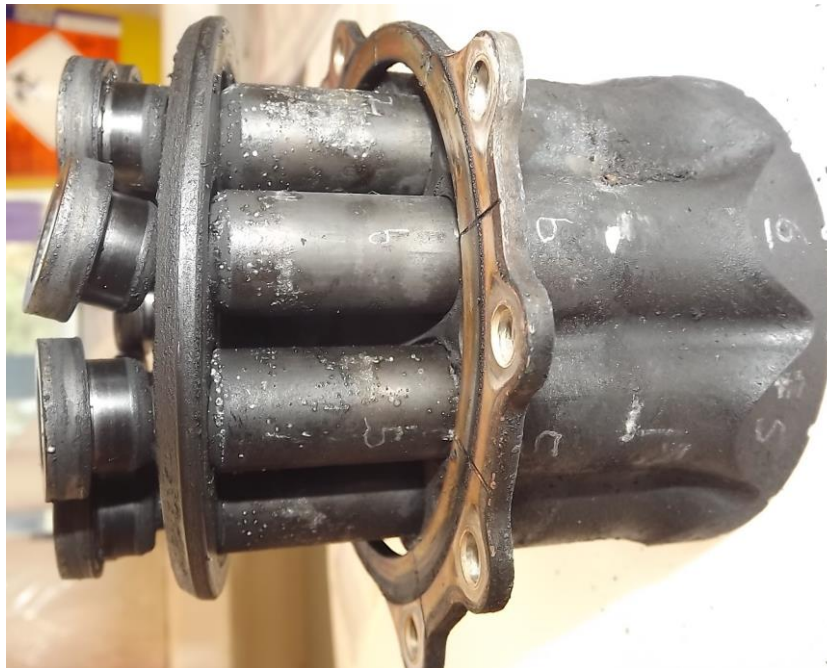
**Photo No 11 : Cylinder Block, Pistons, Piston Shoe Retainer Plate and Dial Plate**

- All components were coated with thermally stressed fluid.
- All nine pistons were seized in their respective cylinder block bores, no attempt was made to remove any piston and shoe subassembly.
- The piston shoes were scuffed and scratched but maintained a healthy layer of bronze with no evidence of abnormal / excessive wear.
- There was no visual evidence of piston shoe retainer plate mechanical deformation. The bronze bearing surface on the plate was intact and appeared to be in a good condition with no evidence of abnormal loading or excessive wear.

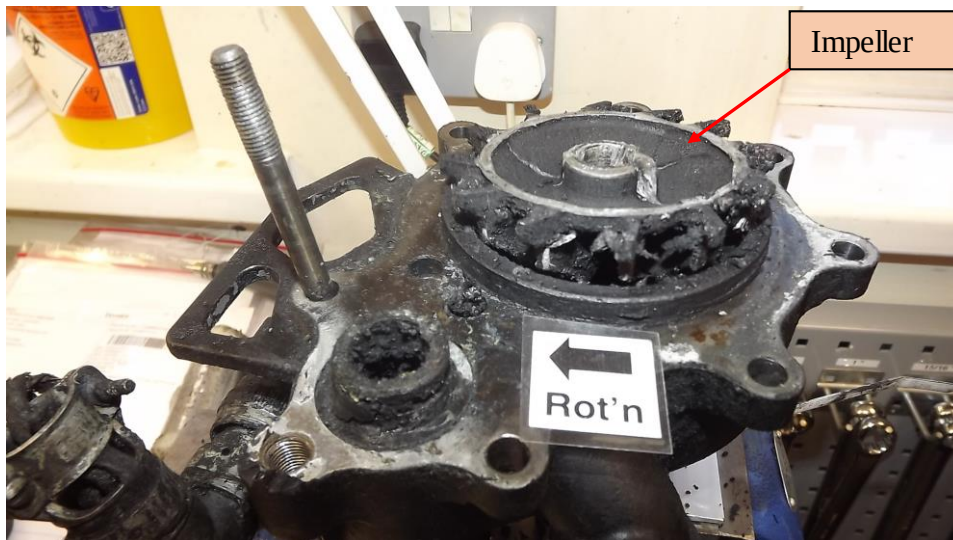
**Photo No 13A : Impeller Retained in Adaptor Block**

The impeller was retained in the valve block and had fragmented into three major pieces. The fracture surfaces were fibrous in appearance. All surfaces were covered in a thick coating of thermally stressed fluid. Multiple impeller blades were bent and surface scoring was evident where running contact was made with the adaptor block.

*Evidence suggests that following failure of the pump housing, shear loading of the bolt and washer pulling through the impeller caused the failure of the impeller and also fractured the tips off the vanes. During this failure the torque on the coupling shaft would have increased.*

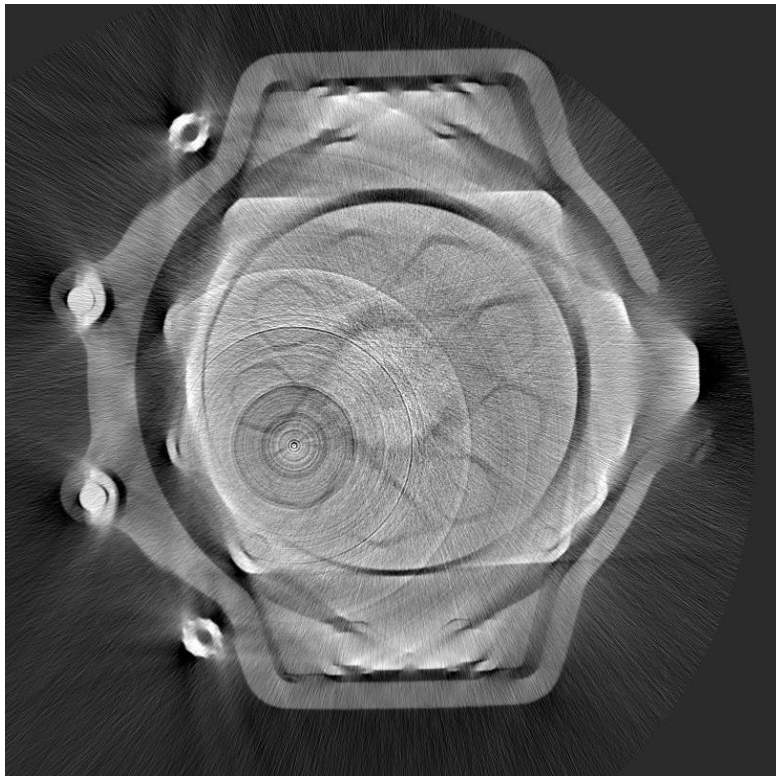
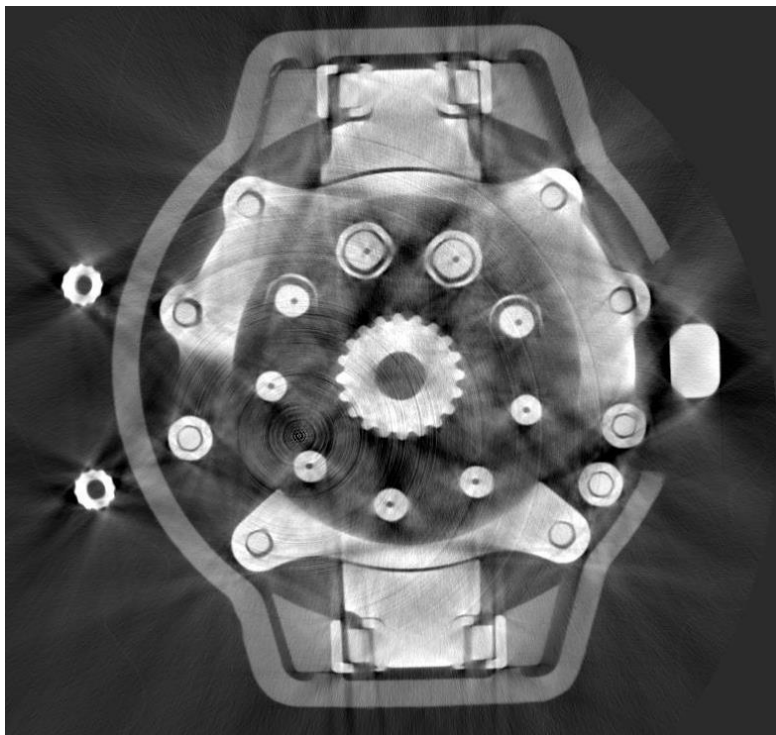
## APPENDIX A: IMAGES FROM CT SCAN

- The quality and resolution of the live images observed was considered sufficient to examine the rotating group section.
- The images confirmed the rotating group assembly was intact with no component damage or visible abnormalities evident.
