**NATIONAL TRANSPORTATION SAFETY BOARD**

**Attachment 10 –Pratt & Whitney PW4168A-1D LPT Case Materials Analysis  
Report**

**DCA18LA163**

# PW4168 ESN 733603 UNDERCOWL FIRE LPT CASE EXAMINATION

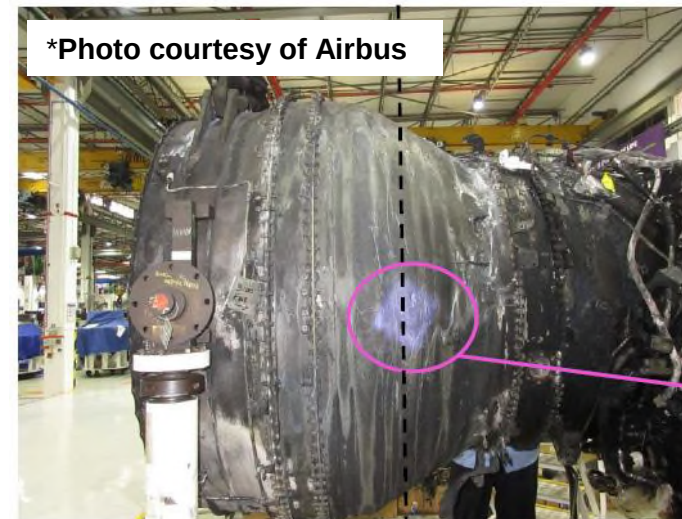
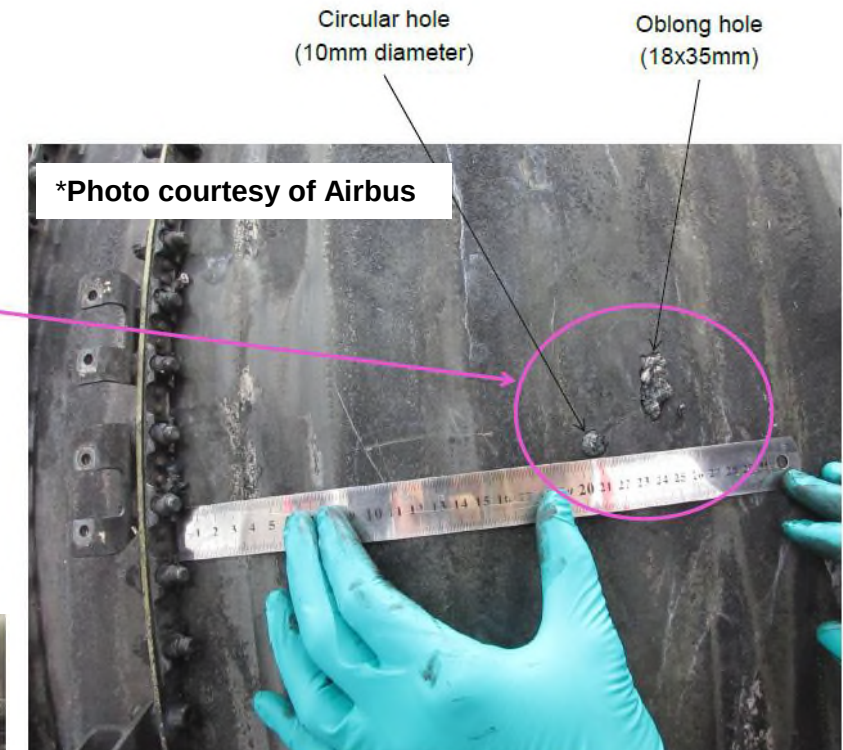
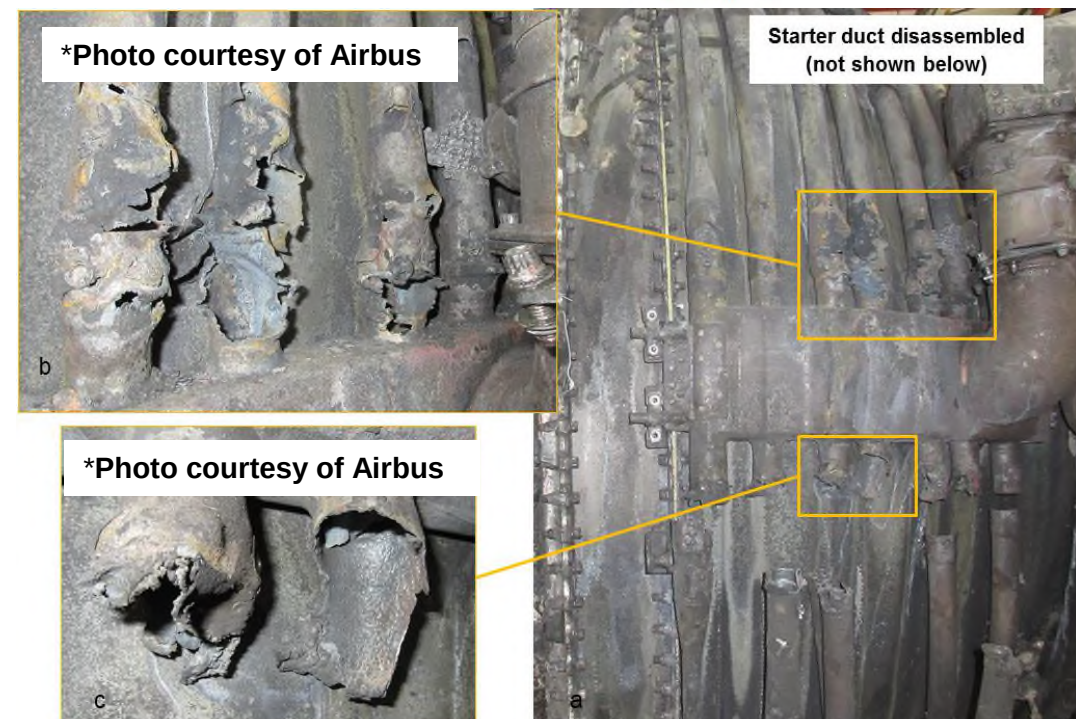
- During teardown, two holes in the LPT case located in line with the TCC duct were noted
- The TCC manifolds and external surface of the case in the area of the holes exhibited significant thermal damage
- The holes were filled with molten material

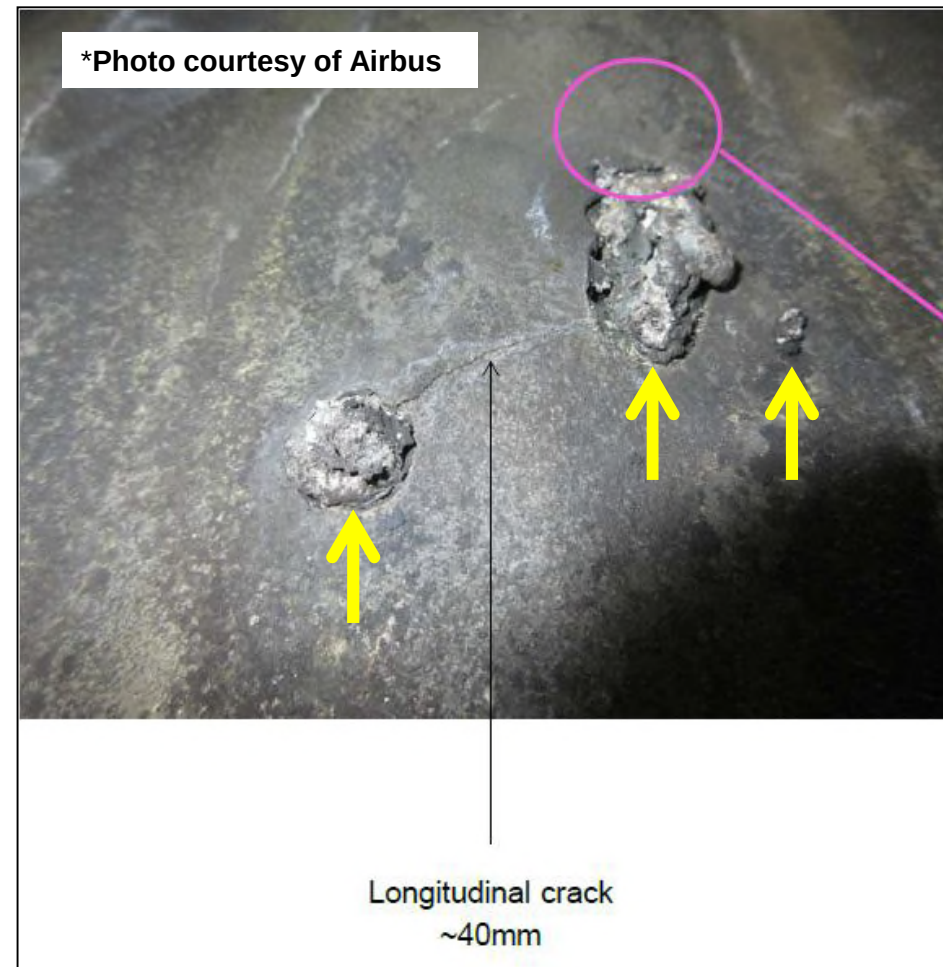
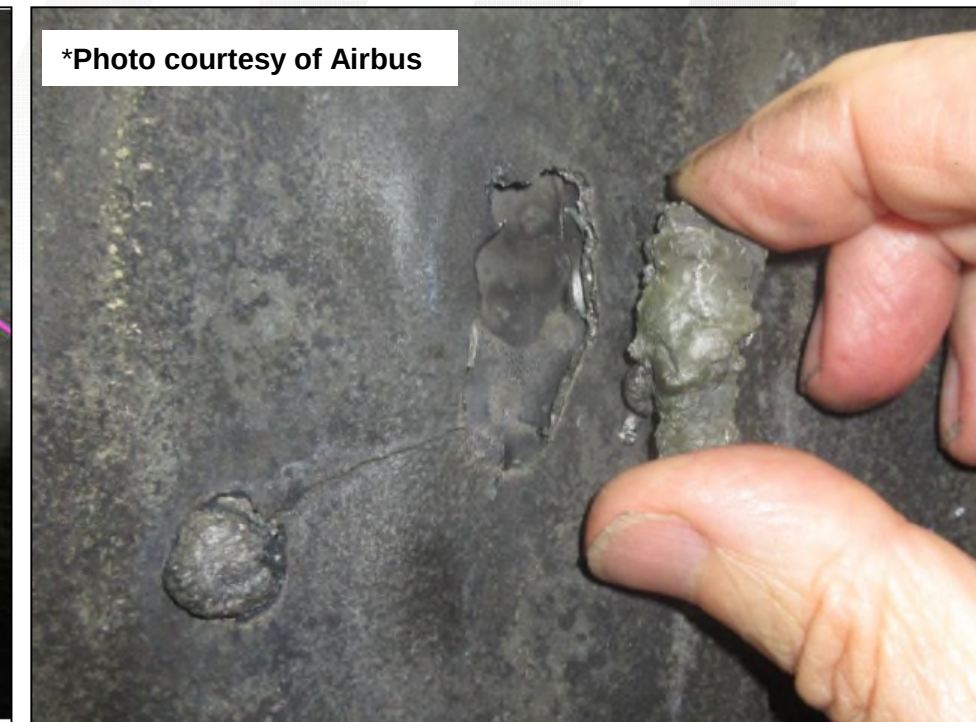
- Airbus teardown report identified two large regions of molten material filling the holes in the thermally damaged area
- These two large regions of molten material were removed during the Airbus visit and were not returned to Pratt & Whitney East Hartford for examination
- Review of the photos contained in the report found that the two large regions were similar in appearance to a third, much smaller surface deposit (yellow arrows, right)
- Continued teardown found that the 4<sup>th</sup> stage rotor and BOAS appeared intact with no significant damage noted

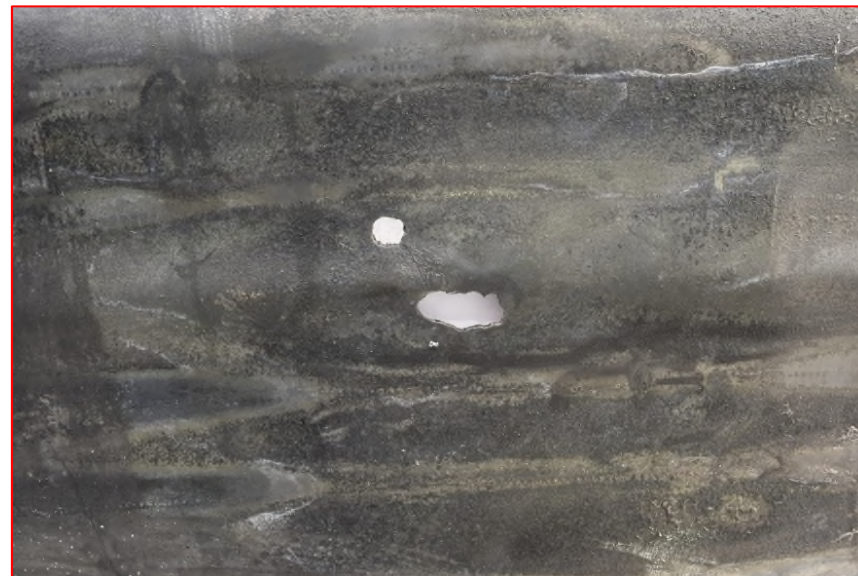
- Visual review of the outer surface of the case as-received found that the area surrounding the 3 o'clock position (ALF) was dark and discolored
  - The surface in this area exhibited a dark, mottled appearance and texture from sooting and metal splatter
- Away from this area, the surface appeared smooth and lighter in color
- Deformation of the outer surface of the case was observed, particularly in the plane of the 4<sup>th</sup> stage rotor

Dark, mottled surface with sooting and metal splatter

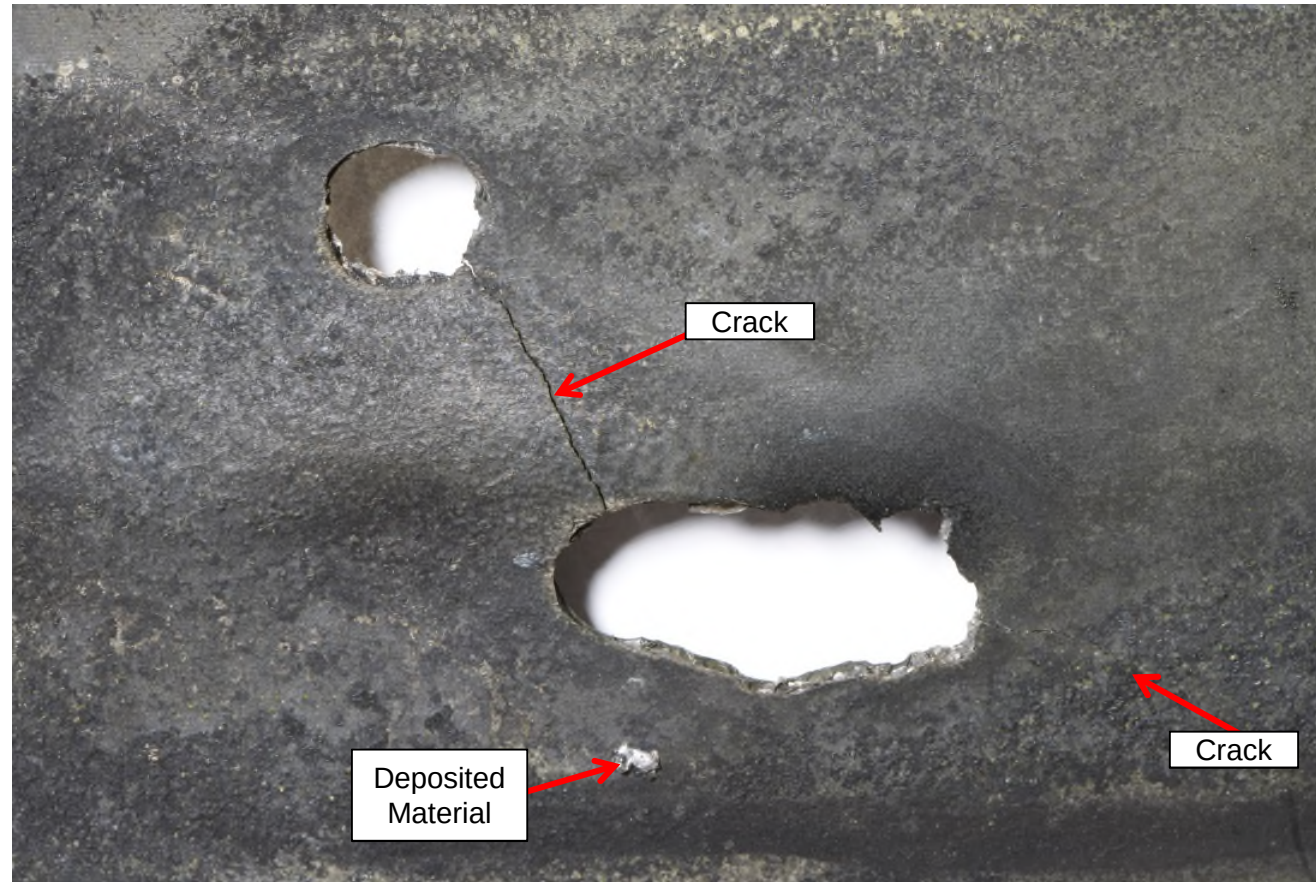
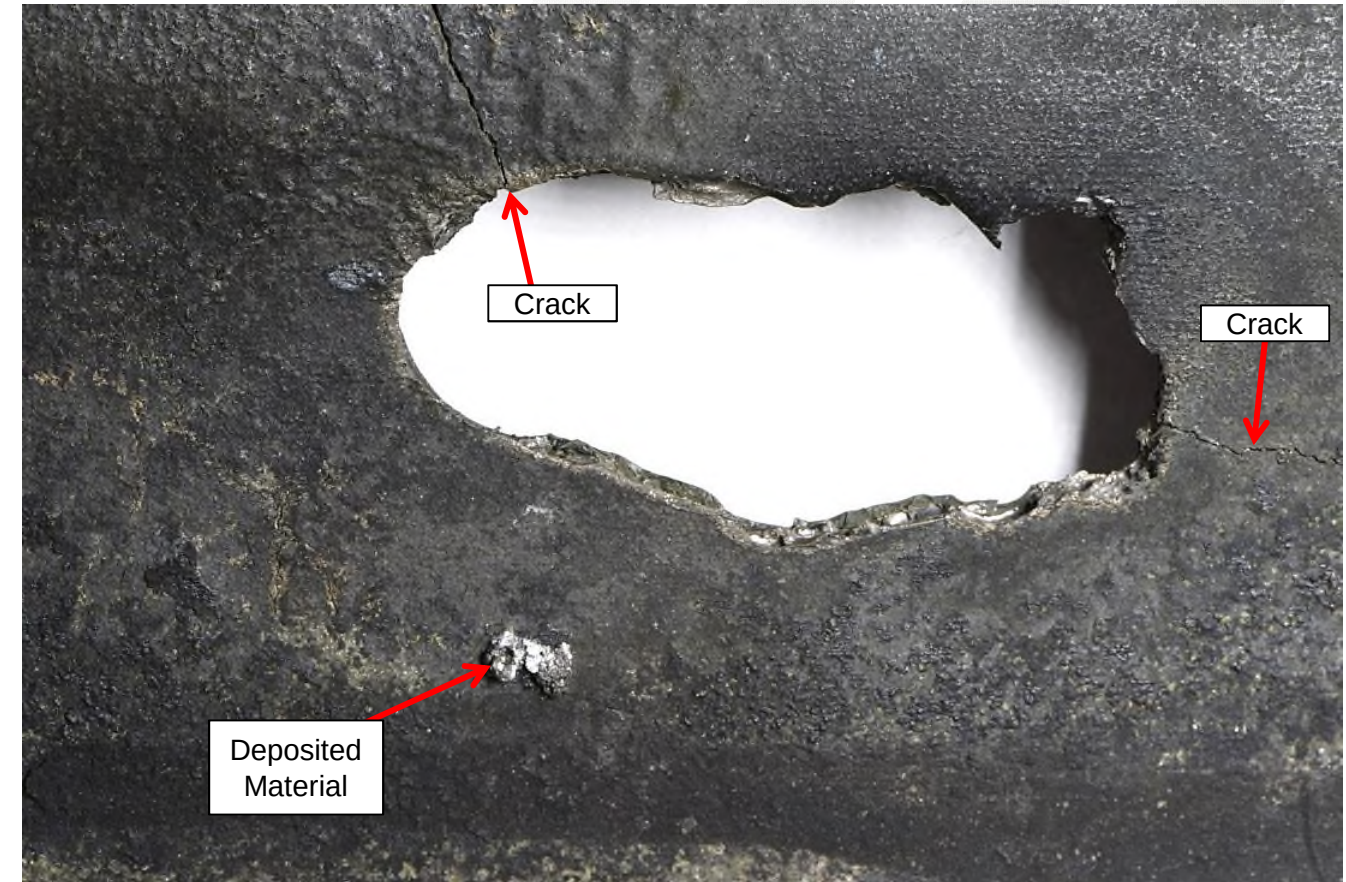
- The OD surface of the case surrounding the holes exhibited a dark, mottled appearance consistent with exposure to a significant thermal event.
- Cracks were observed between the two holes and extending from the larger hole.
- Deposited material noted during the teardown was still in place adjacent to the larger hole.
- No other deposits of significant height were observed on the external surface of the case.

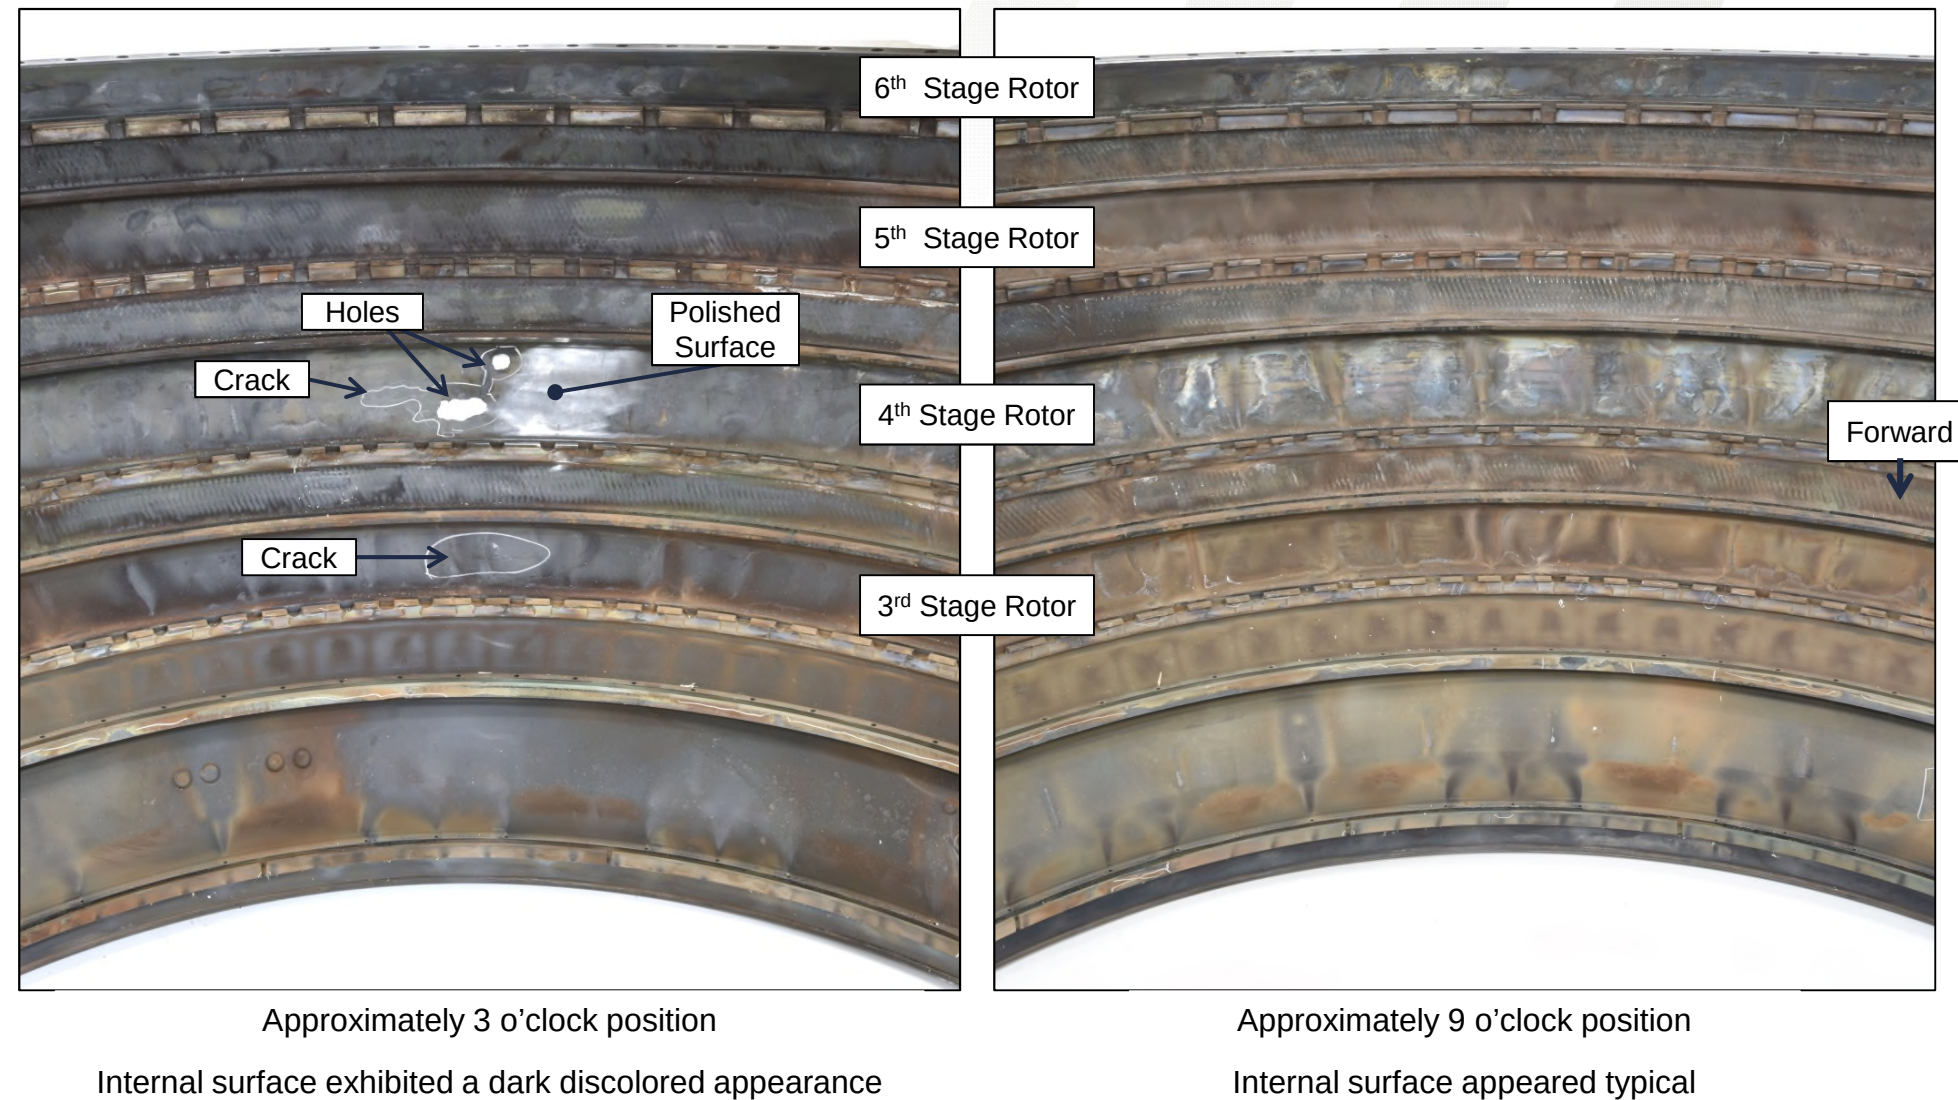
- Review of the internal surface of the case found that the region surrounding the holes (3 o'clock position, ALF) exhibited a dark, discolored appearance
- Two holes were observed in the plane of the 4<sup>th</sup> stage rotor. Cracking was observed in the planes of both the 3<sup>rd</sup> and the 4<sup>th</sup> stage rotors
- The internal surface adjacent to the holes appeared to have been lightly cleaned/polished

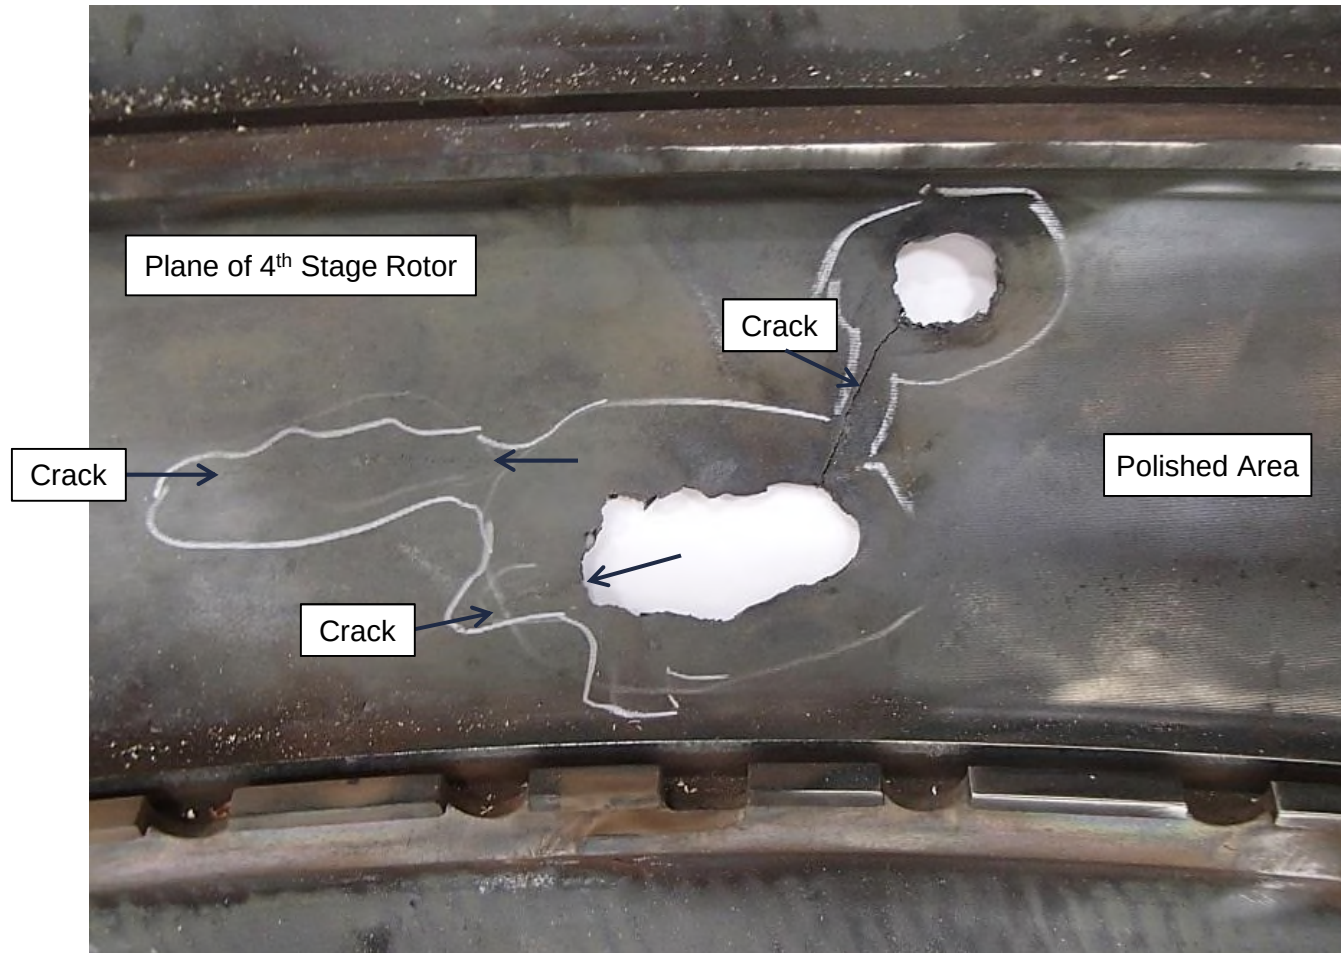
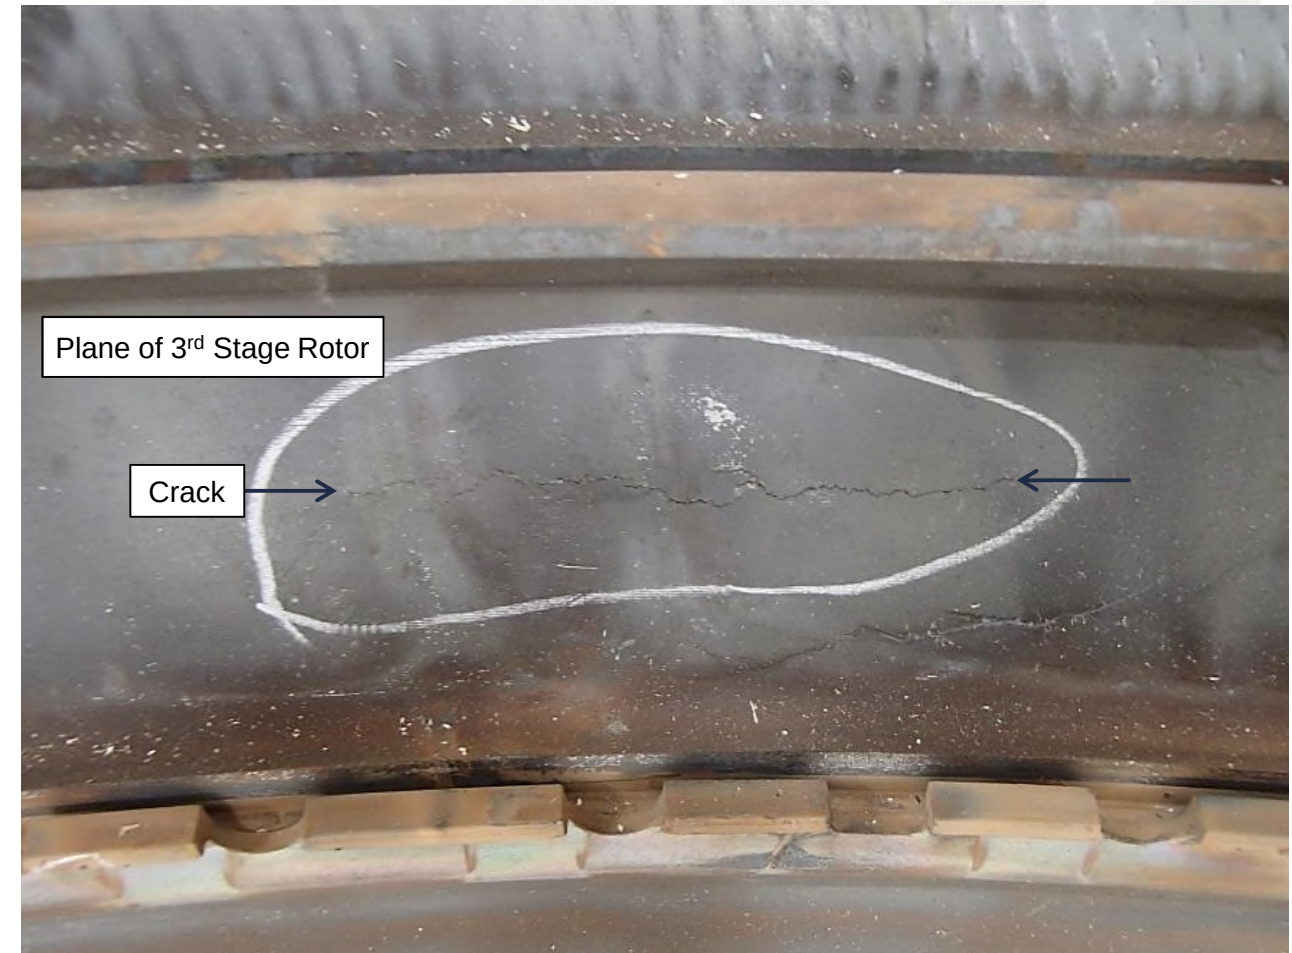
- Cracking in the plane of the 3<sup>rd</sup> stage rotor and a portion of the cracks in the plane of the 4<sup>th</sup> stage rotor did not appear to have extended through wall
- The internal surface adjacent to the holes in the plane of the 4<sup>th</sup> stage rotor appeared to have been lightly cleaned/polished

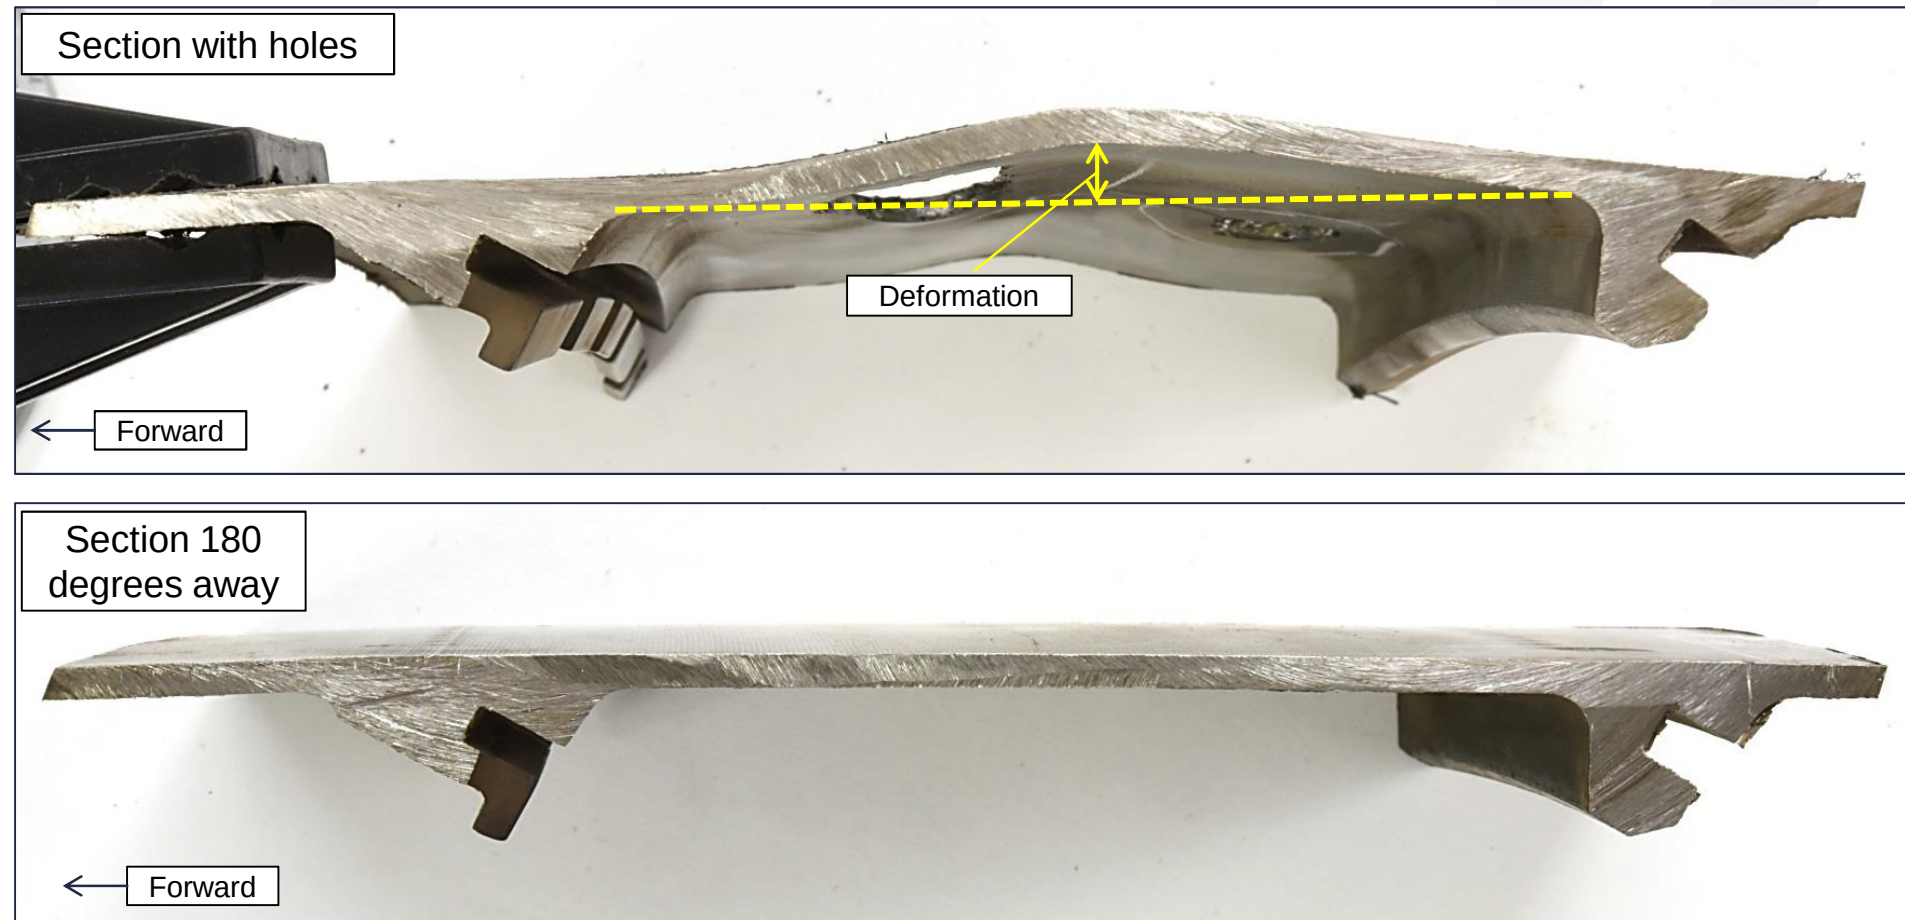
- Two sections were removed from the case
  - One section included both the holes and deposited material in the plane of the 4<sup>th</sup> stage rotor
  - The second section was from the plane of the 4<sup>th</sup> stage rotor, approximately 180 degrees away from the holes
- The section with the holes appeared deformed/buckled when compared to the section 180 degrees away

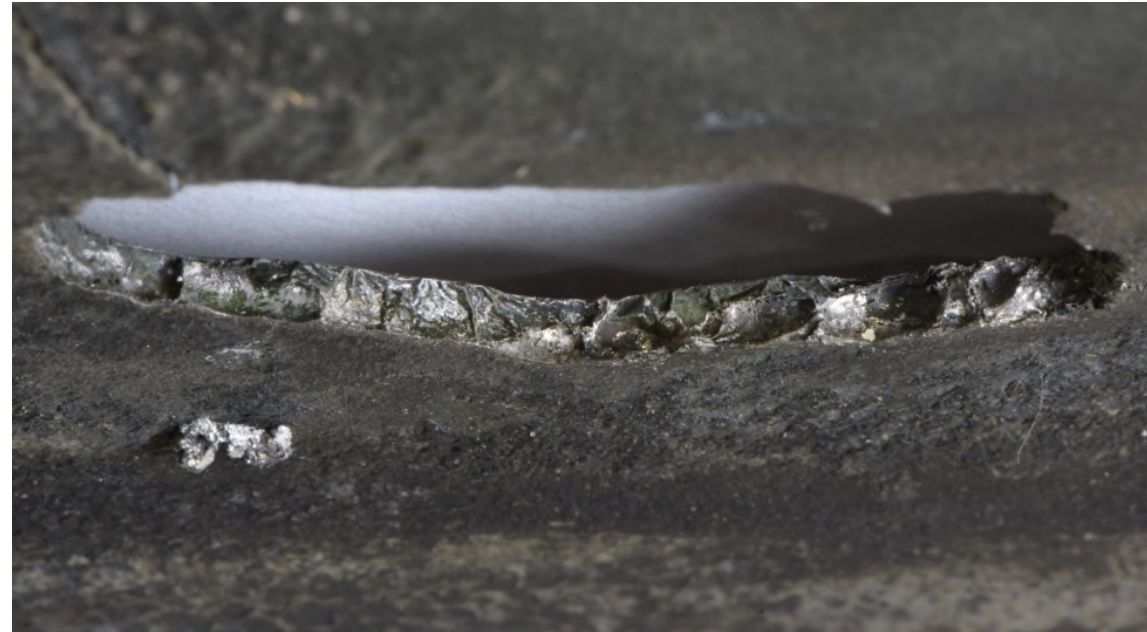
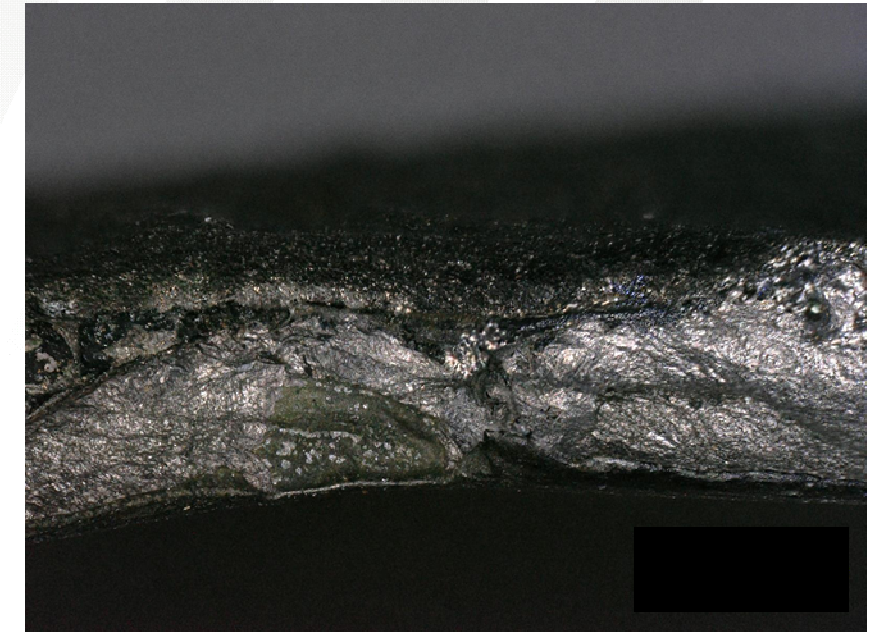
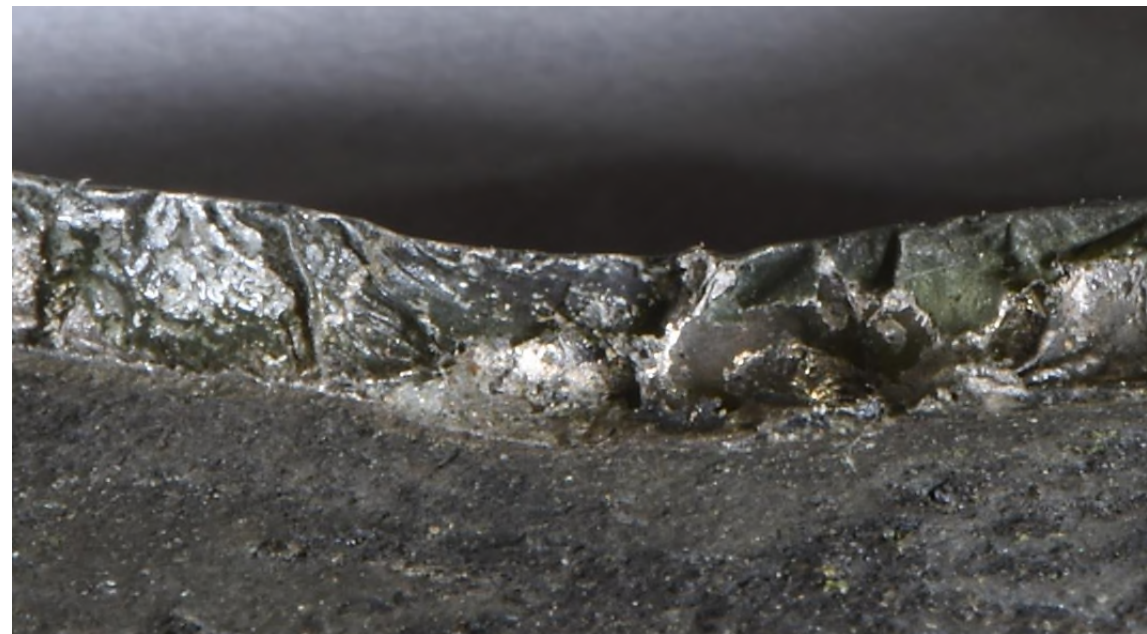
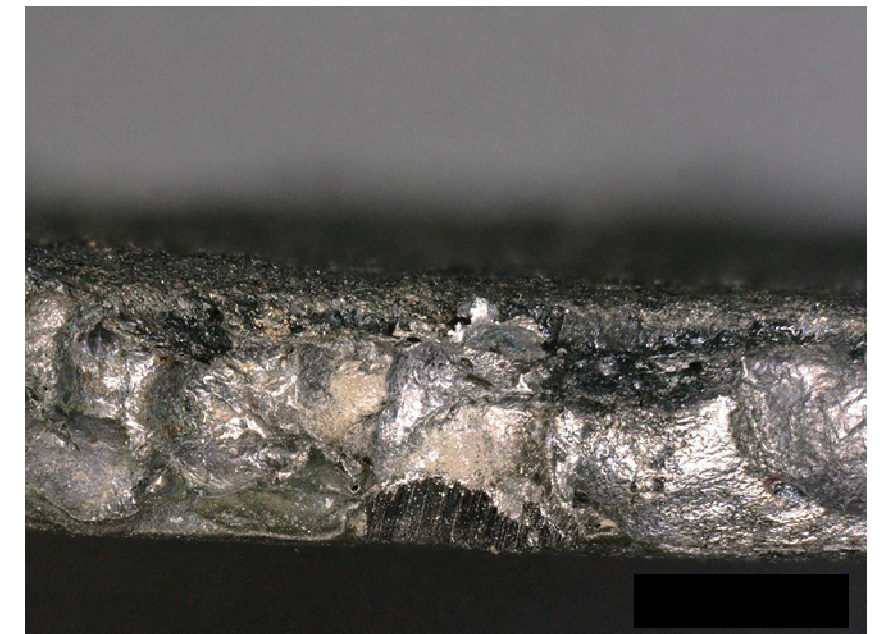
- Visual and binocular review of the hole surfaces was completed
- The surfaces exhibited an intergranular appearance with evidence of melting (grain boundary decohesion and/or liquation)
- The surface appearance was suggestive of significant grain growth
- No evidence of fatigue was observed

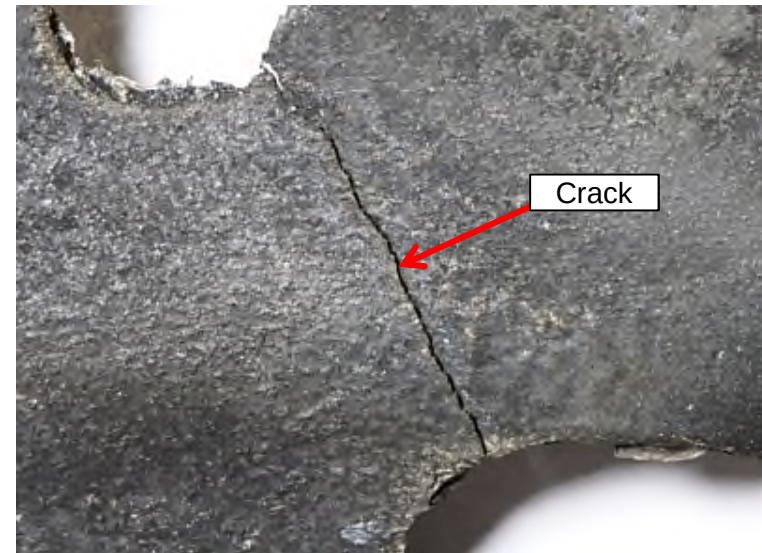
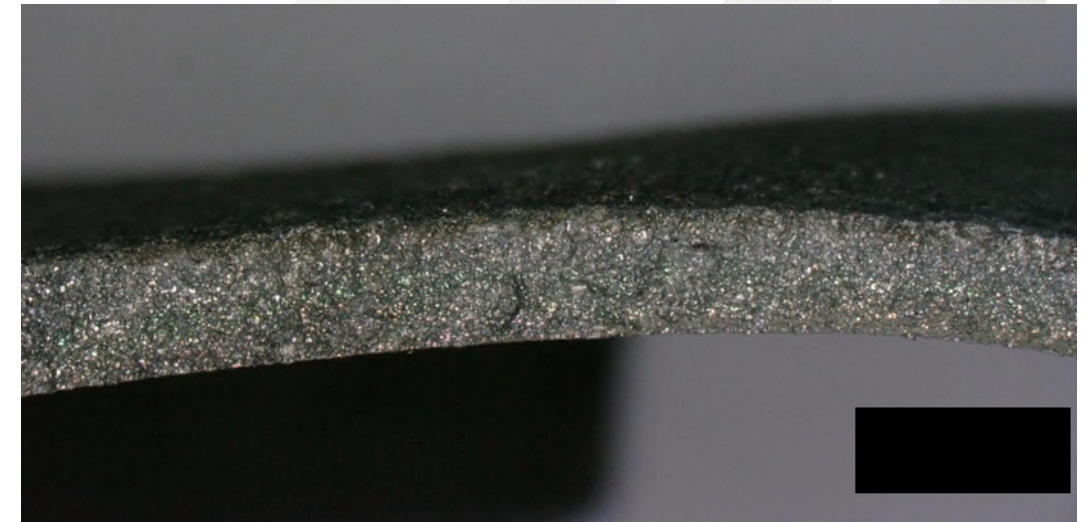
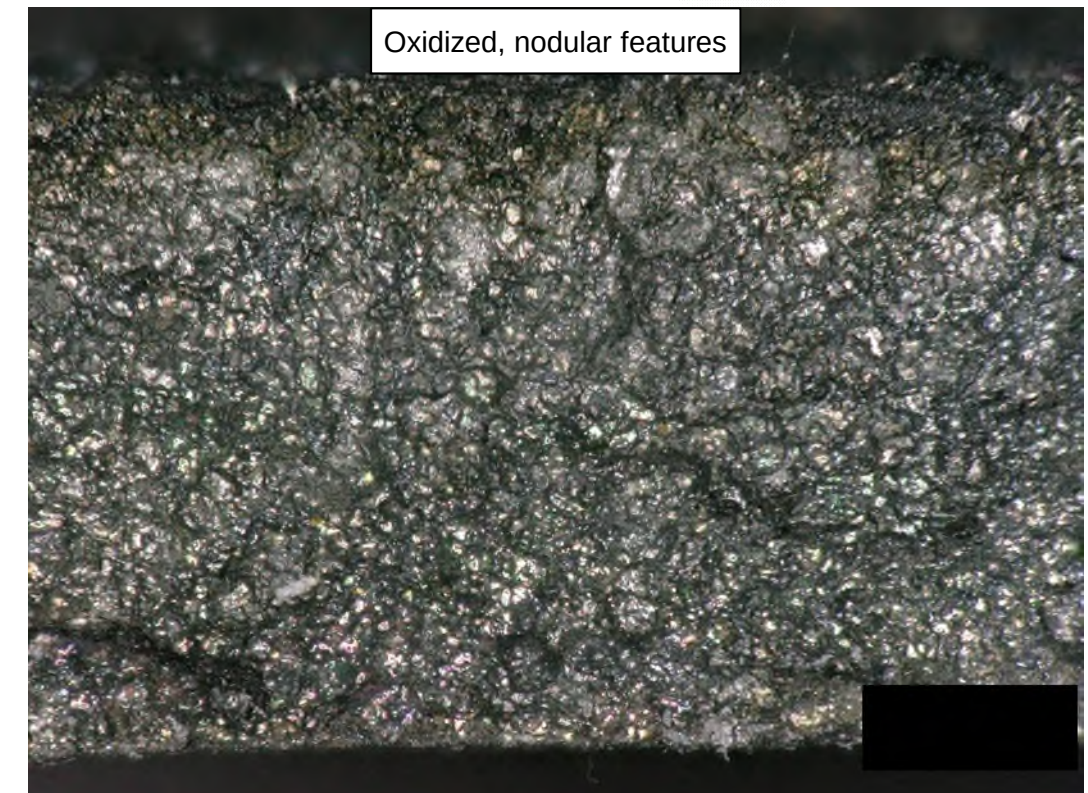
- The crack between the two holes was fractured open for review
- The crack surface exhibited an oxidized, nodular appearance consistent with intergranular cracking
- Crack features suggested a smaller grain size than that observed at the hole

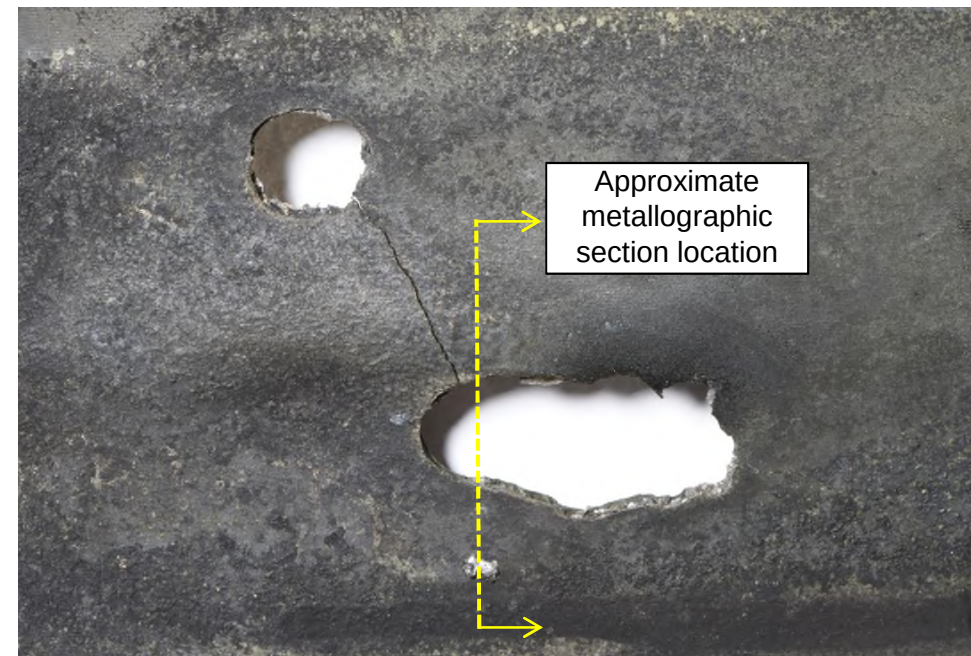
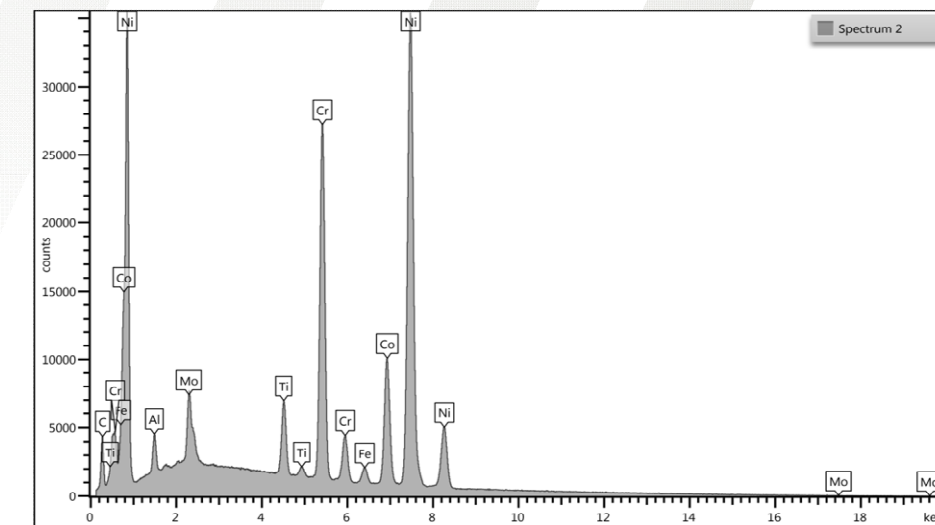
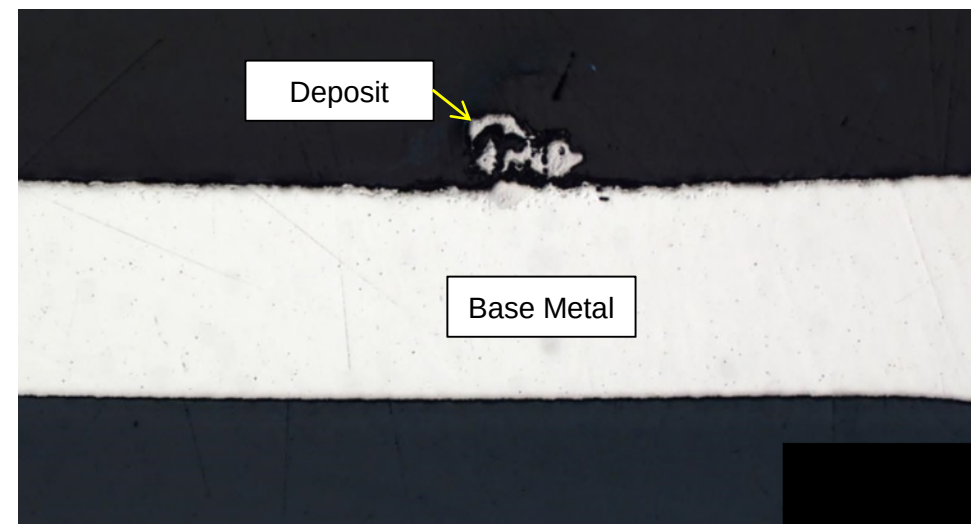
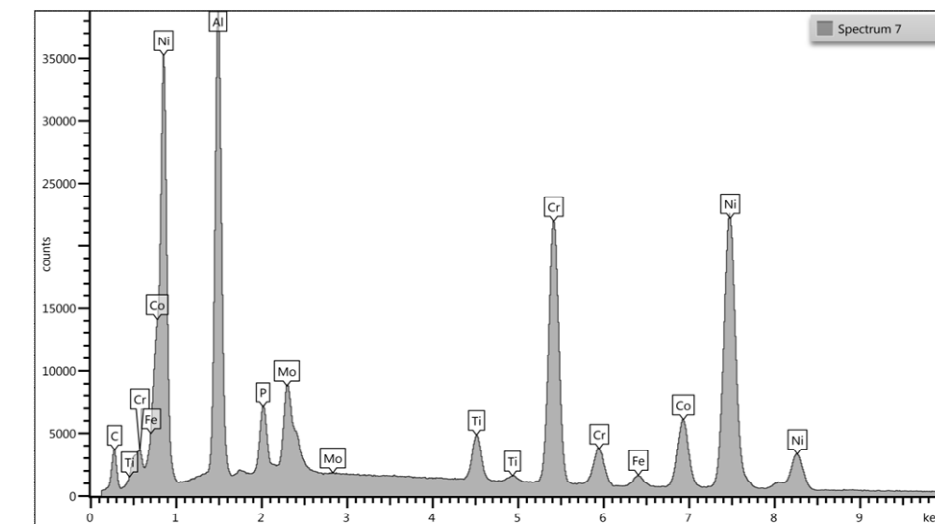
- A metallographic section was prepared through the deposit on the OD of the case
  - An oxide layer was observed on the case OD surface and the deposit surface
  - Some mixing/diffusion was observed into the base metal
- SEM/EDS analysis confirmed the base metal composition to be consistent with Waspaloy
- SEM/EDS analysis of the deposit typically found a composition with high amounts of aluminum, nickel, and chromium
  - The relative percentages of the elements varied depending on the location
  - This composition did not match any known materials

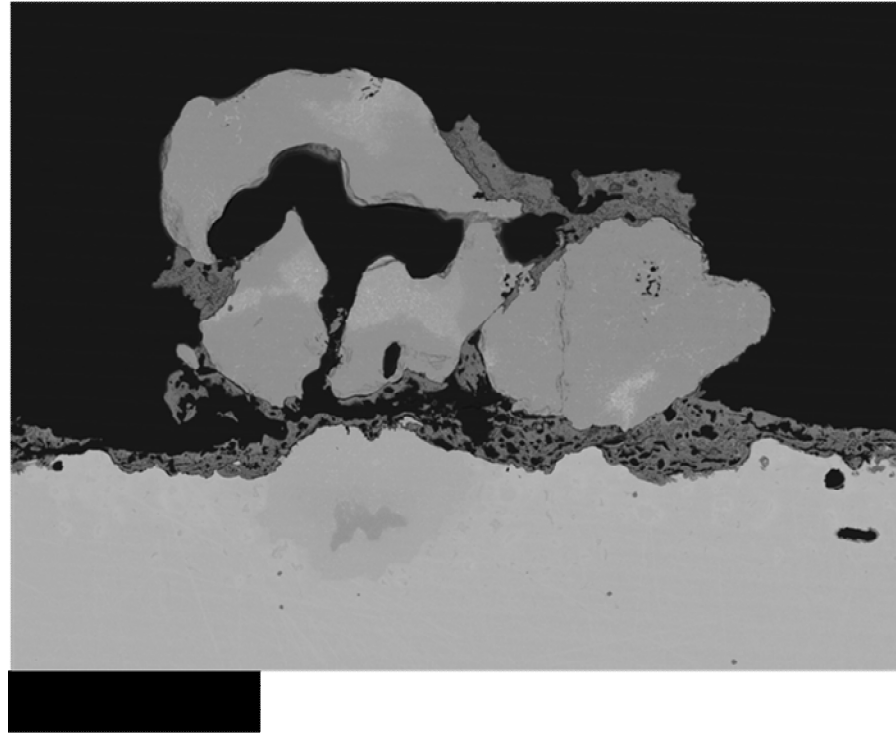
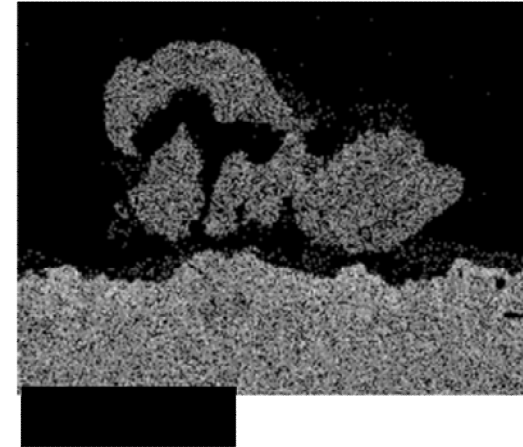
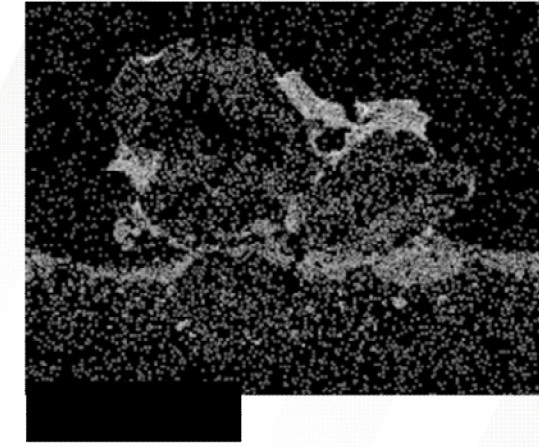
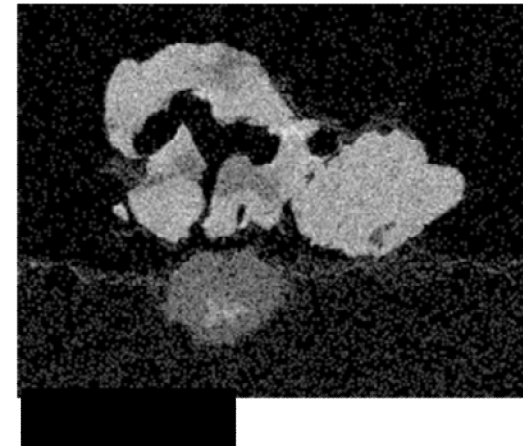
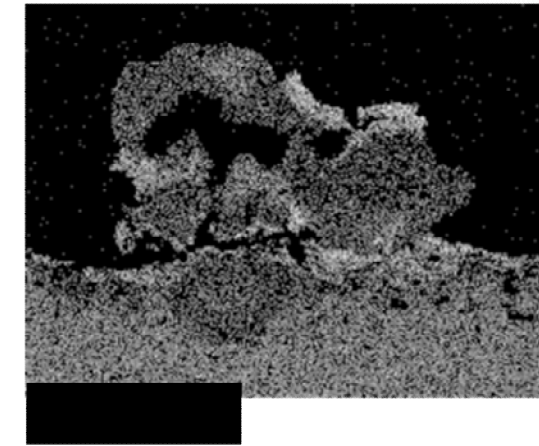
- SEM energy dispersive spectroscopy (EDS) and maps showed that the deposit included a high concentration of aluminum
- The composition of the deposit was not uniform; this indicated a mixture of different materials
- A layer of phosphorous was observed on the deposit and along the surface of the case; phosphorous is commonly found in hydraulic fluid and oil
