**NATIONAL TRANSPORTATION SAFETY BOARD**

**Attachment 10 –Pratt & Whitney PW4168A-1D LPT Case Materials Analysis  
Report**

**DCA18LA163**

# PW4168 ESN 733603 UNDERCOWL FIRE LPT CASE EXAMINATION

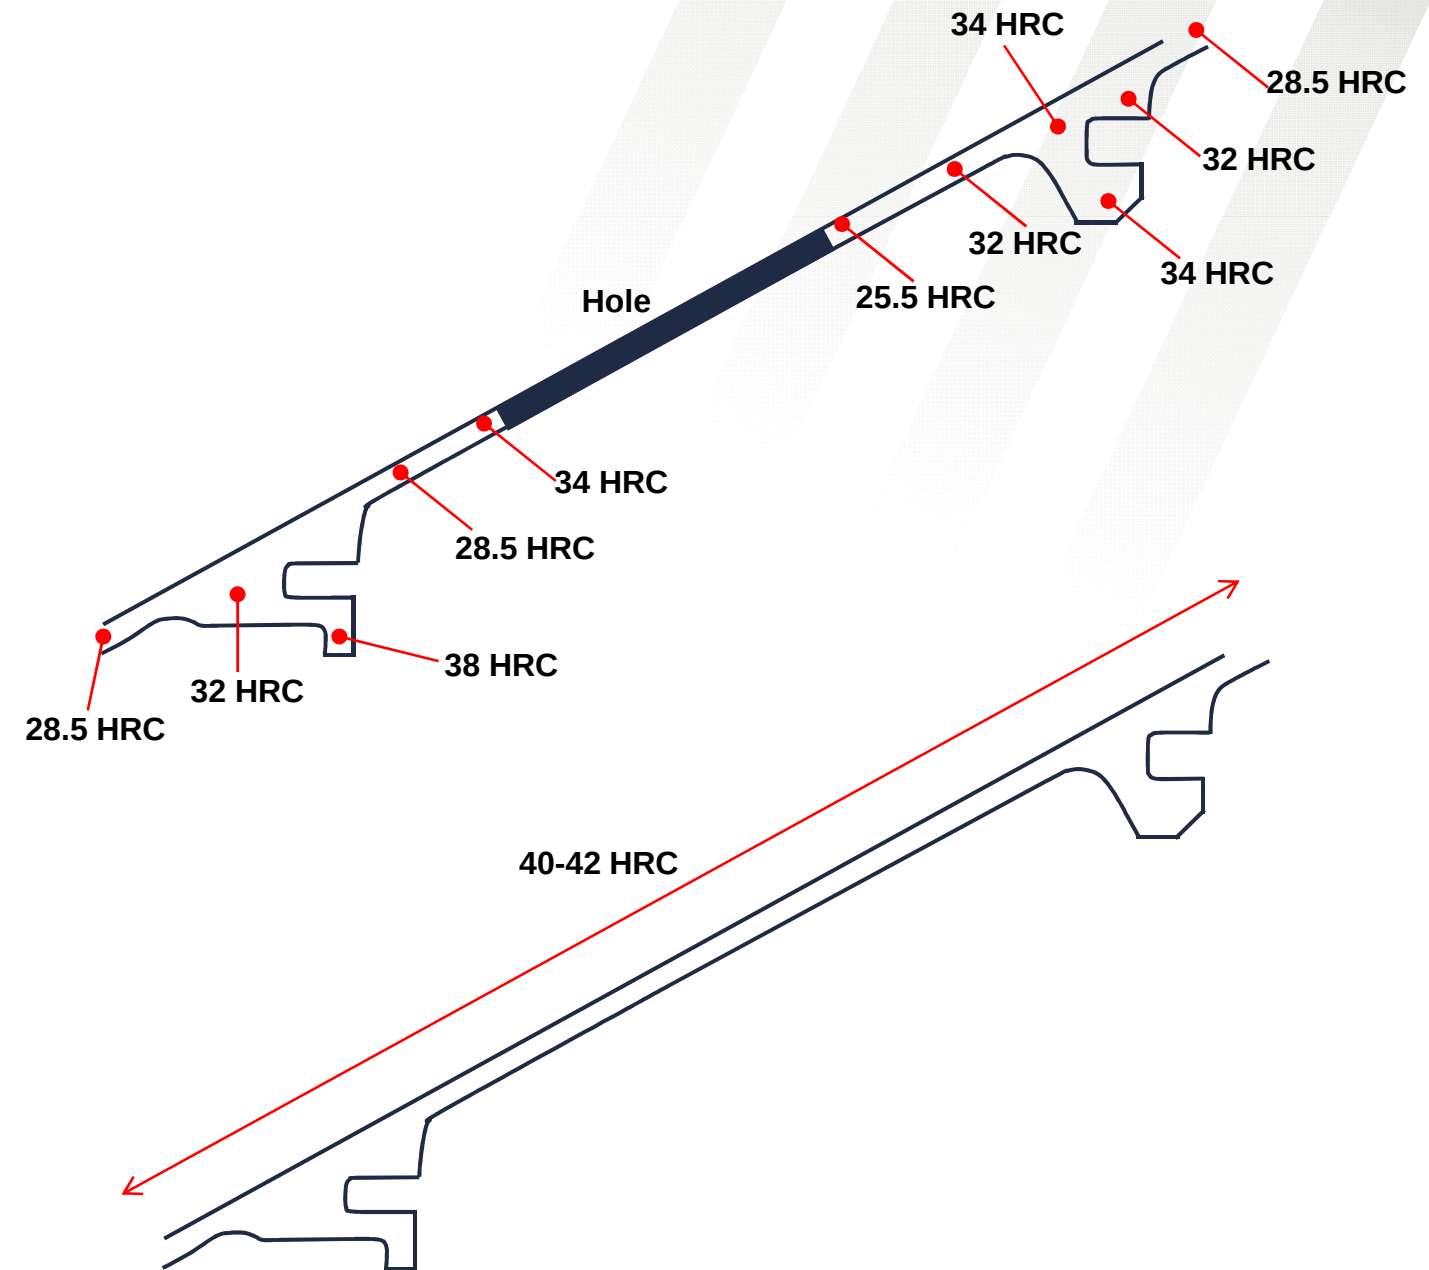
- Hardness measurements were taken across the section prepared through the deposit and hole
- Measurements ranged from a minimum of 25.5 HRC to a maximum hardness of 38 HRC
- Locally higher values near the hole may have been a result of rehardening of the material
- These hardness measurements indicate exposure to elevated temperatures of at least 1700F, based on a study of 10 hour exposures
- Hardness measurements on the section 180 degrees away ranged 40-42 HRC with no significant variation observed; these values conformed to the hardness requirement for the material

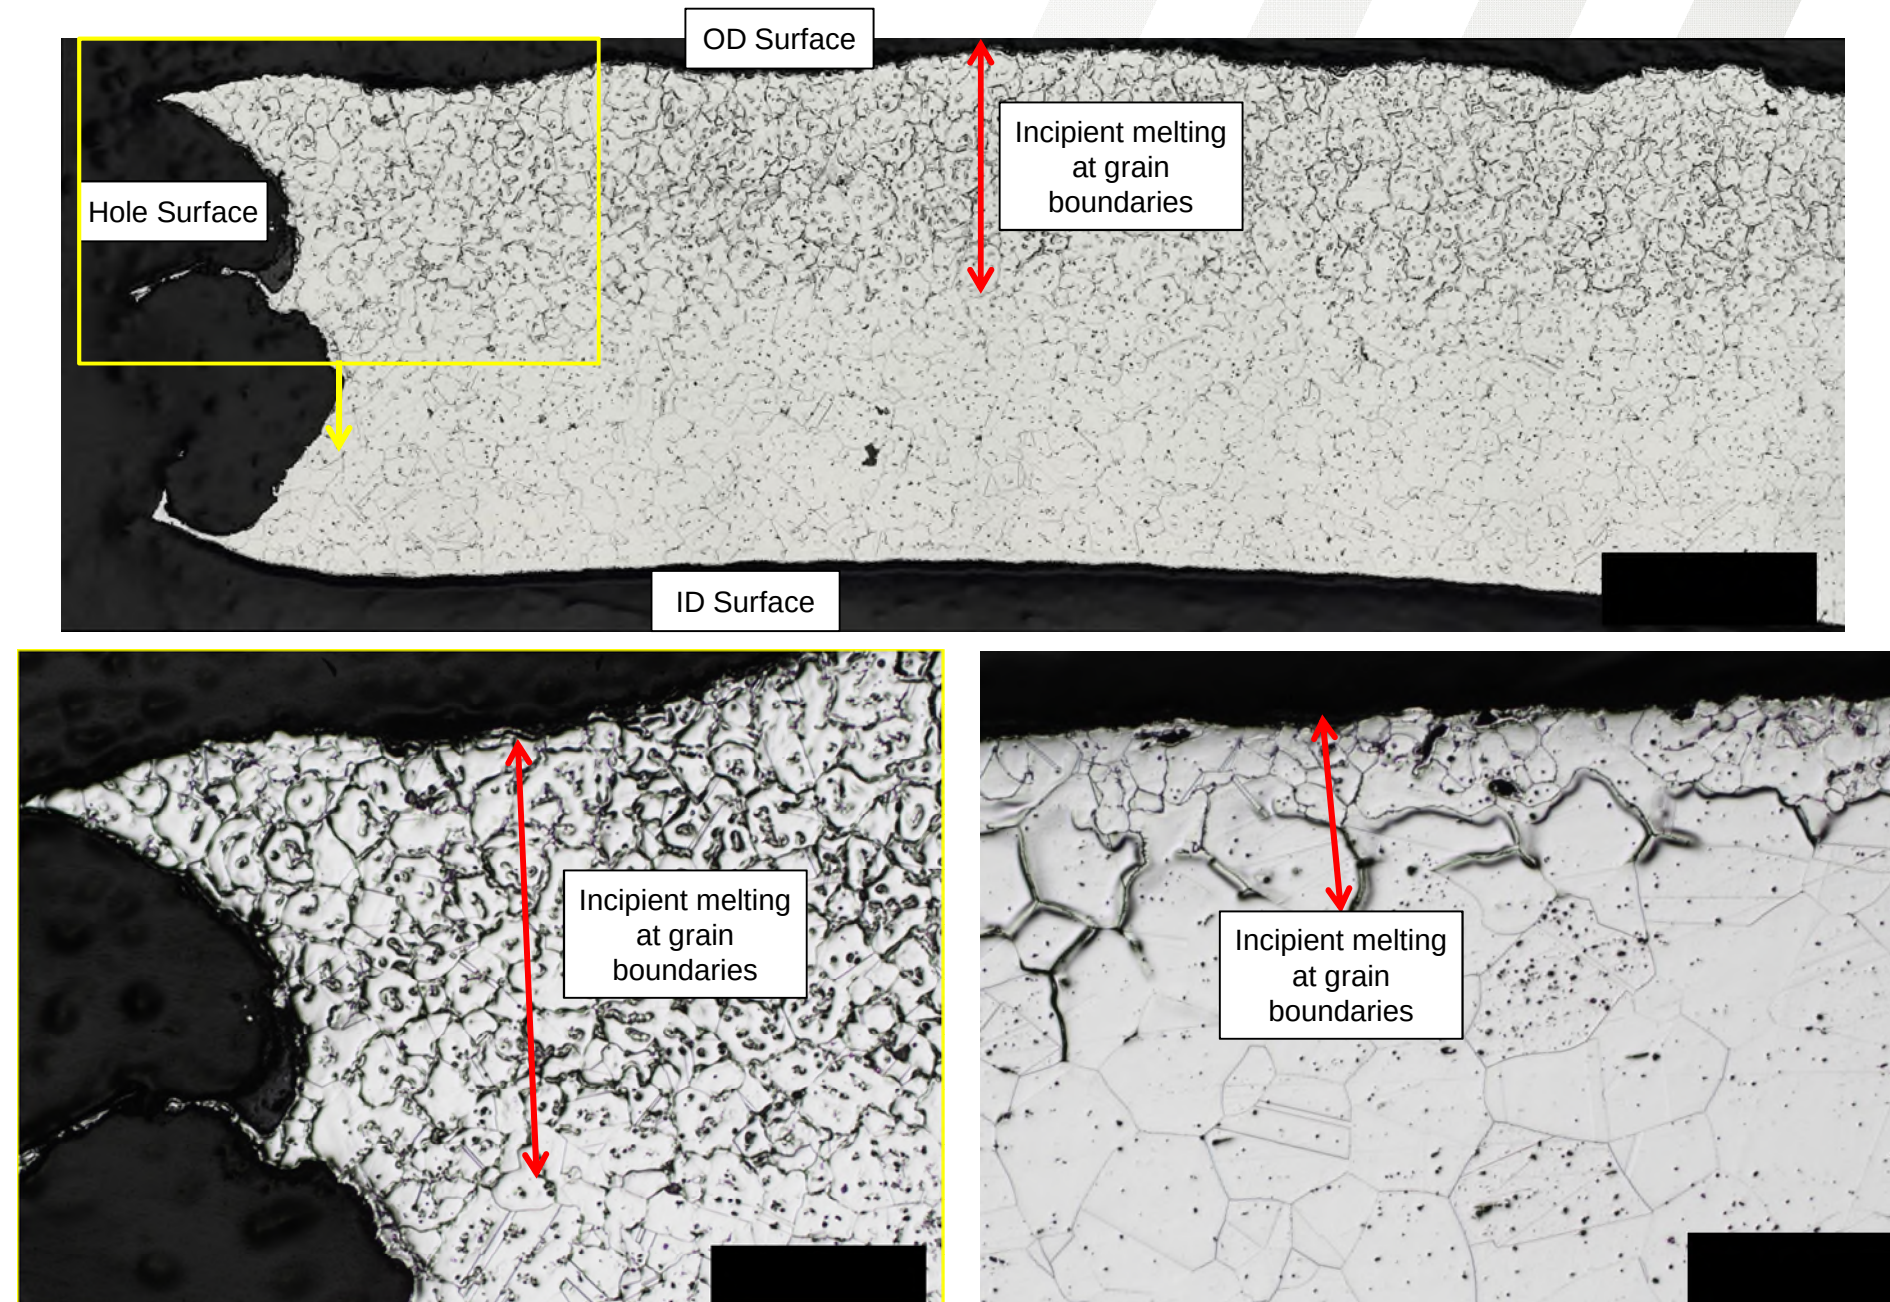
- Metallographic examination of the section prepared through the hole and deposit found evidence of significant thermal exposure
- Evidence of incipient melting at the grain boundaries was observed at the OD surface near the hole and extending up to halfway through the wall thickness
- Incipient melting in this material occurs at temperatures greater than 2400F

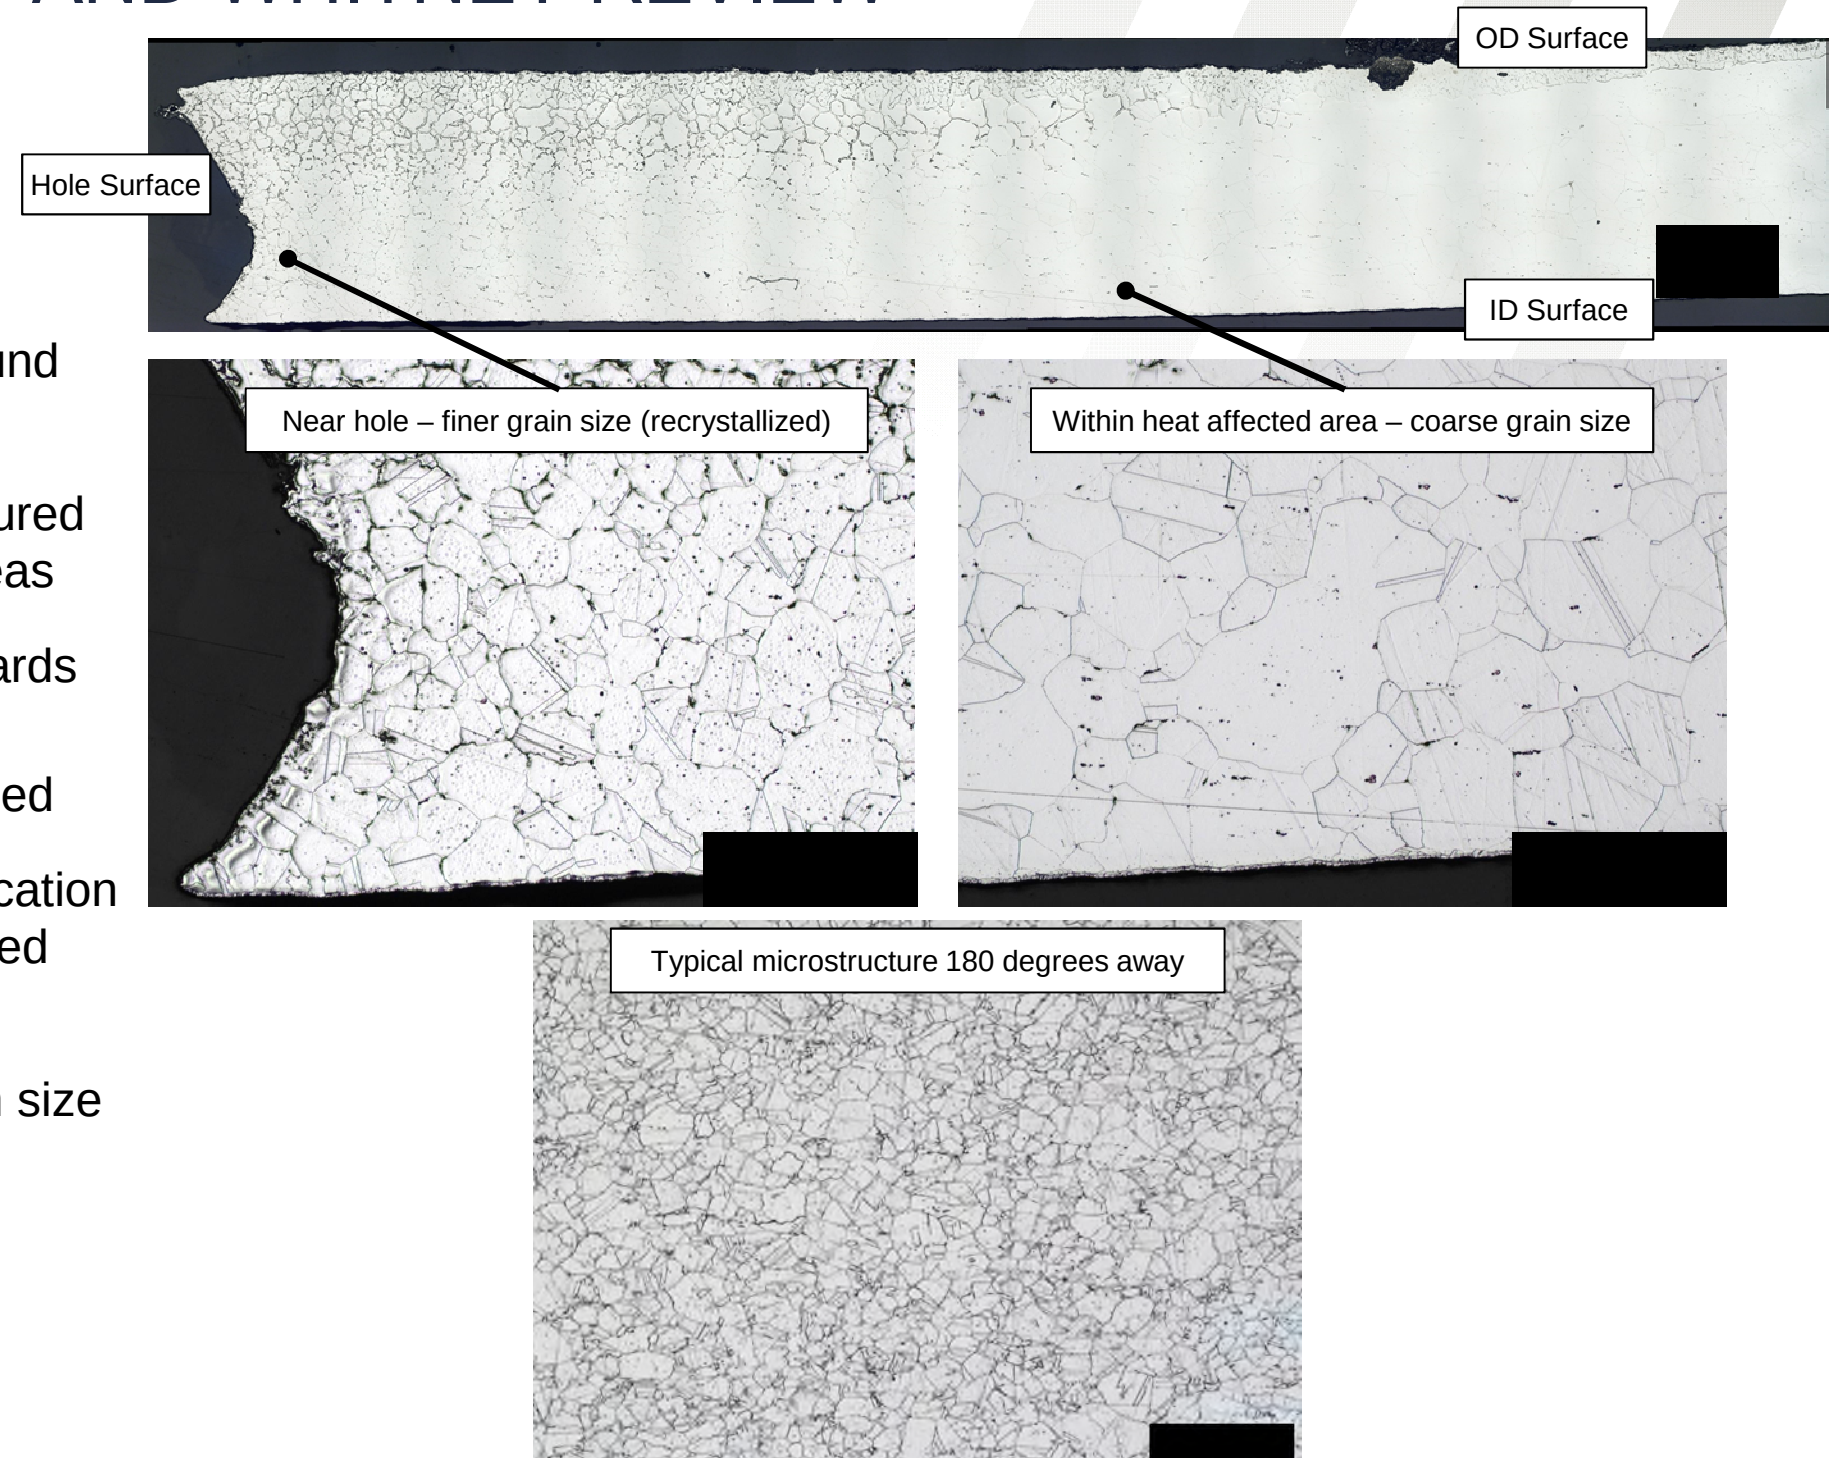
- Metallographic examination of the section prepared through the hole and deposit found evidence of significant thermal exposure
- Grain size in the heat affected area measured approximately ASTM 0 in the coarsest areas
- Immediately adjacent to the hole and towards the OD surface, grain size appeared finer – Grains in this area had likely recrystallized
- Grain size through the section from the location 180 degrees away from the holes measured ASTM 5 typical
- The material specification requires a grain size of ASTM 3 or finer
