**NATIONAL TRANSPORTATION SAFETY BOARD**

**Attachment 8 –Airbus No. 2 Engine/Pylon Fuel Connection Materials**

**DCA18LA163**

## A330 MSN 578 DAL fire event- RH Engine/Pylon Fuel Connection

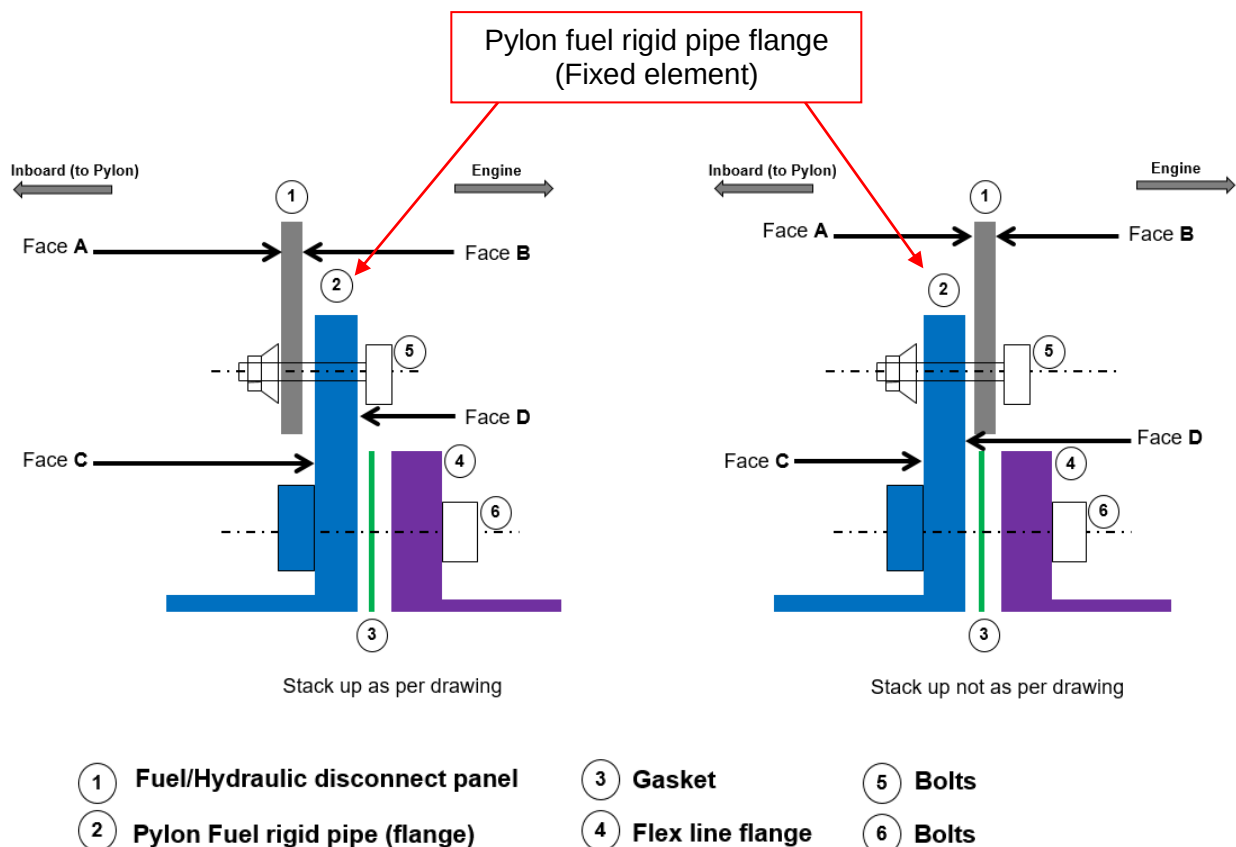
**Figure 4: Installation of pylon fuel rigid pipe flange as per drawing and incorrect**

The onsite inspection revealed that the installation of the flex line to the pylon fuel rigid pipe was performed correctly. However the pylon fuel rigid pipe flange was not connected as per drawing to the Fuel/Hydraulic disconnect panel (Figure 5). During this initial inspection there was no clear indication that the flange has been assembled on the correct location at one point in time. The as per drawing vs not as per drawing installation of the pylon fuel rigid pipe flange can be seen in Figure 4 to Figure 6.

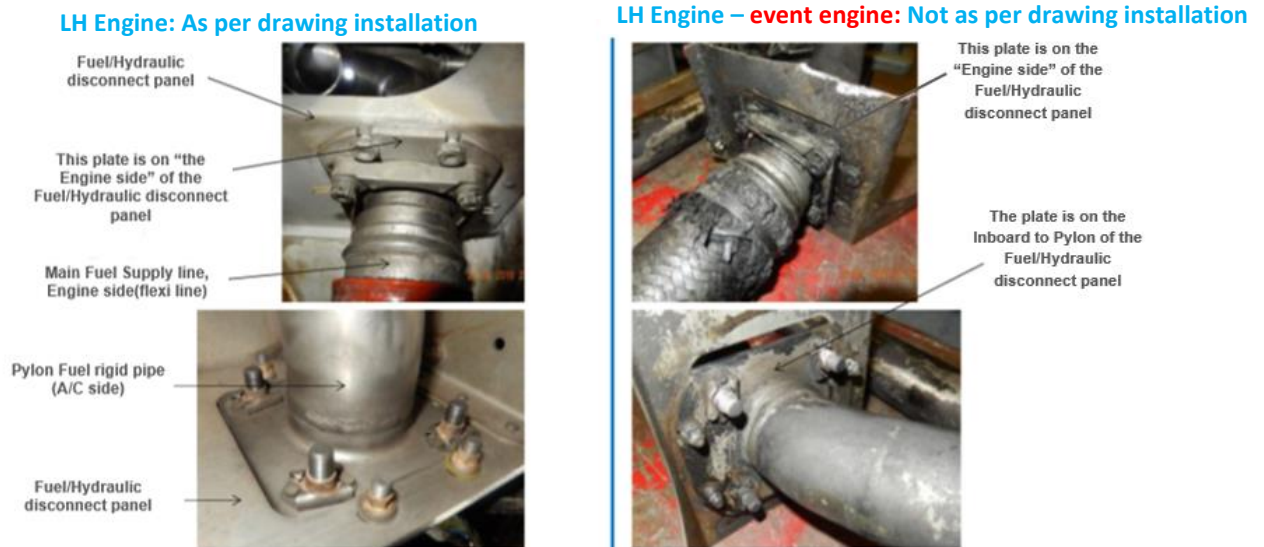
**Figure 5: As per drawing vs not as per drawing installation of the Pylon fuel rigid pipe flange on event engine**

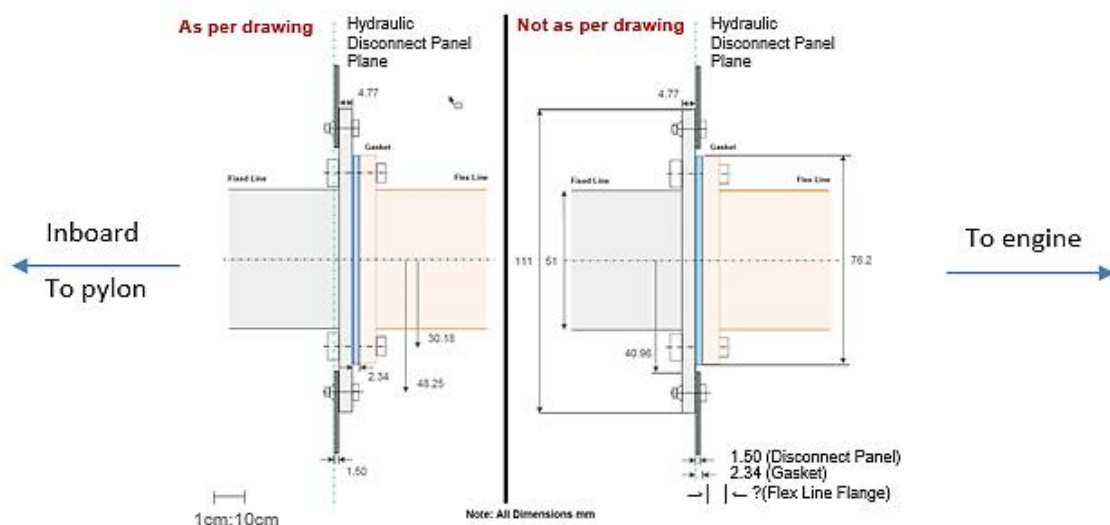
According to the installation stack-up the installation not as per drawing of the pylon fuel rigid pipe flange caused an offset. The flex line connection plane has been moved inboard by 4.77 mm representing the pylon fuel rigid pipe flange thickness plus 1.50 mm representing the fuel/hydraulic disconnect panel thickness which results in a total offset of 6.27 mm (Figure 6).

**Figure 6: Design of the junction of pylon fuel pipe and flexible fuel line as per design and the observed not as per drawing assembly**

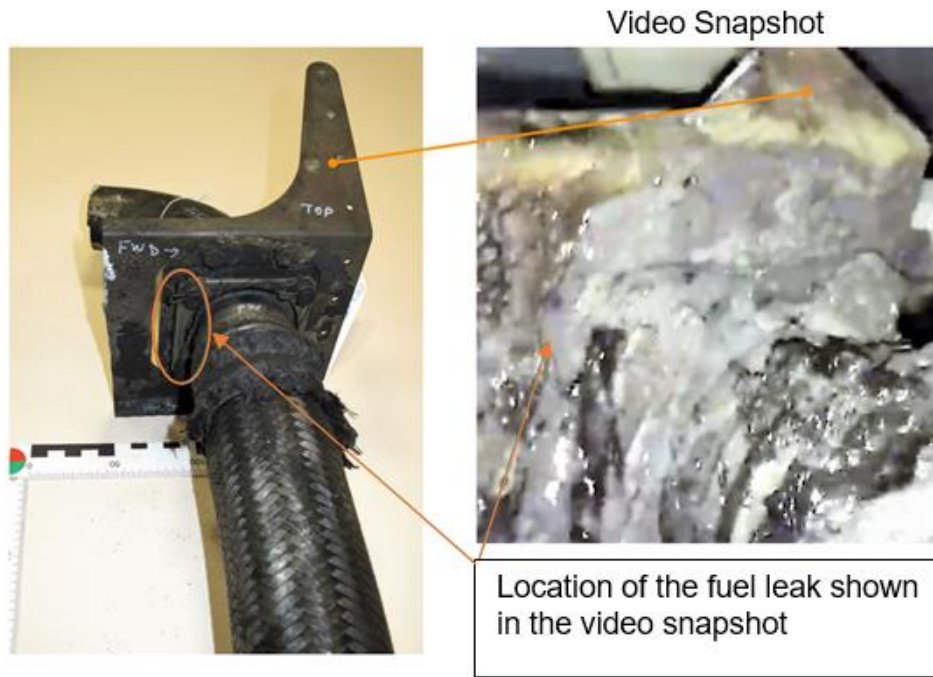
The on-site inspection shortly after the event showed that fuel sprays out of the flexible line as well fuel escapes at the flange-gasket connection. Figure 7 shows a snapshot taken from the on-site video documentation and the related location on the connection of the cut-out taken after the onsite inspection.

**Figure 7: Location of fuel leakage at the flex line and the gasket location**

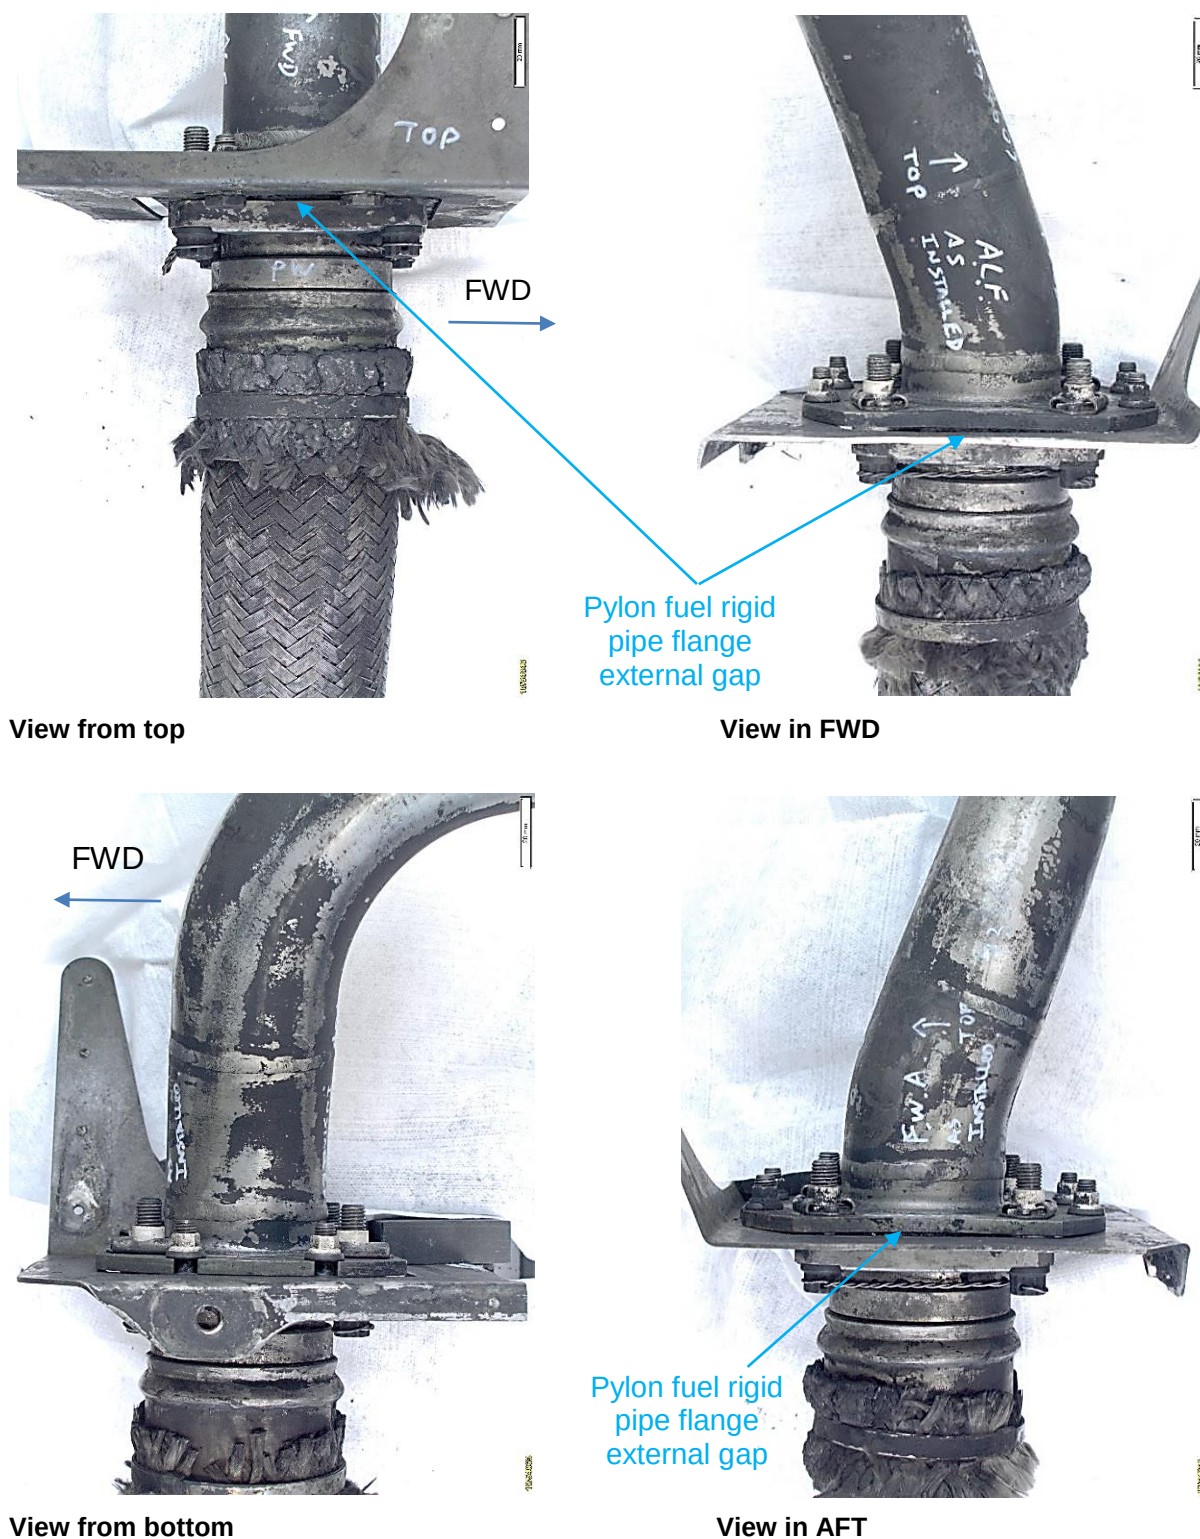
Figure 10: Engine / pylon fuel connection each view is rotated by 90°;  
Observation: Pylon fuel rigid pipe flange connection is gapping externally

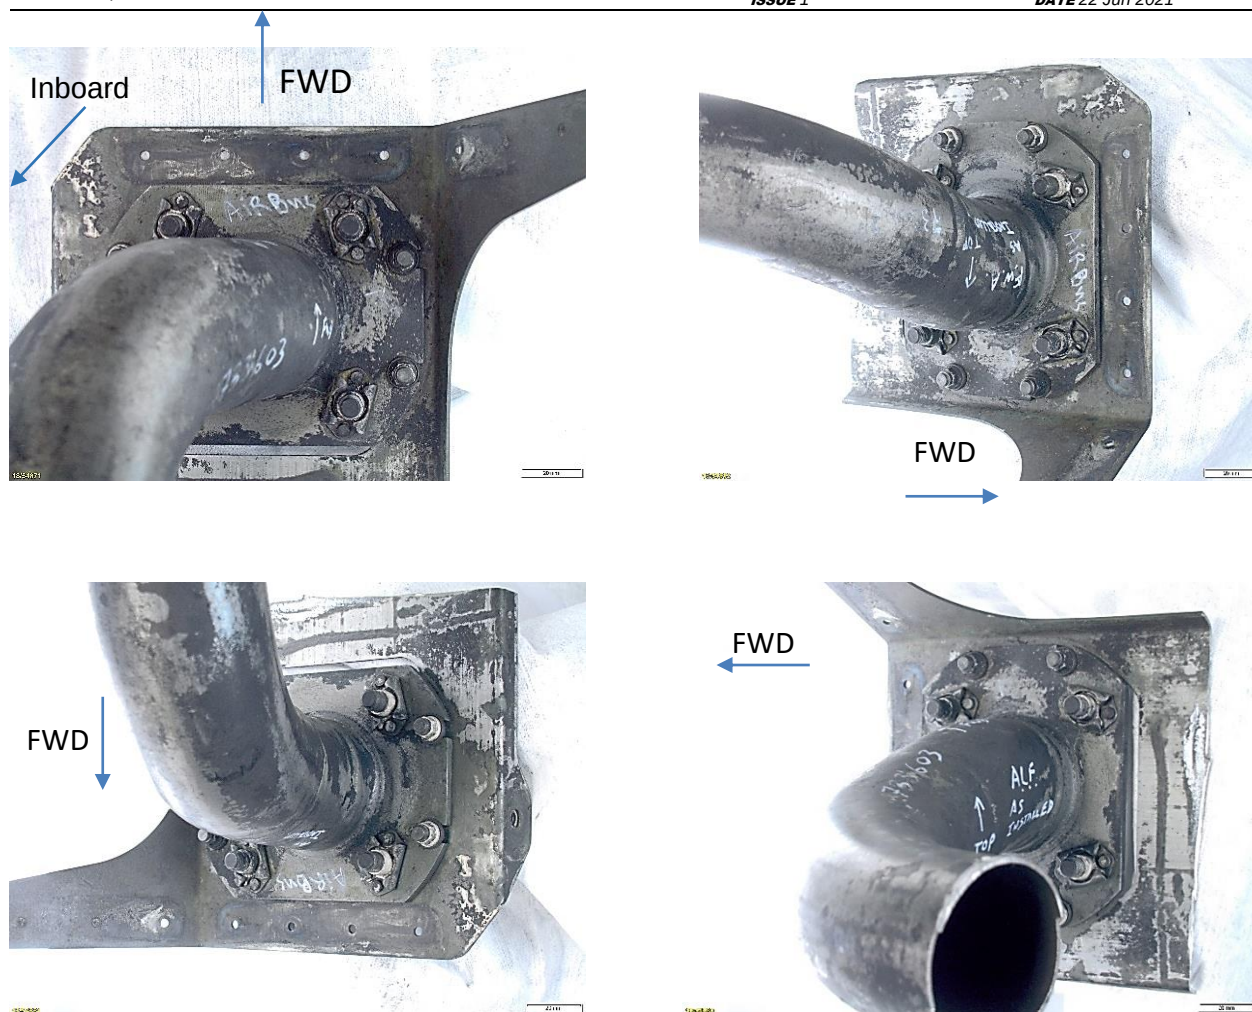
- The pylon fuel rigid pipe flange is assembled at the inboard side of the fuel/hydraulic disconnect panel (Figure 10 and Figure 11) which is not in accordance with the drawing.
- Clearance was found between the flex line sleeve and the fuel/hydraulic disconnect panel cut-out (see Figure 12 and Figure 13 and 3D measurement (chapter 4.2)) which is in accordance with the drawing.
- All bolts and the lock-wires are in the correct place (Figure 13).
- By a qualitative visual flatness check it can be seen that the flex line sleeve and the pylon fuel rigid pipe flange present a slight non-flatness of the outer surface (Figure 14).
- The flex line showed after disassembly from the sleeve, melted material residue close to the flex line cut location (Figure 15).

**Figure 11: Engine / pylon fuel connection views of the pylon fuel rigid pipe flange from In-side**

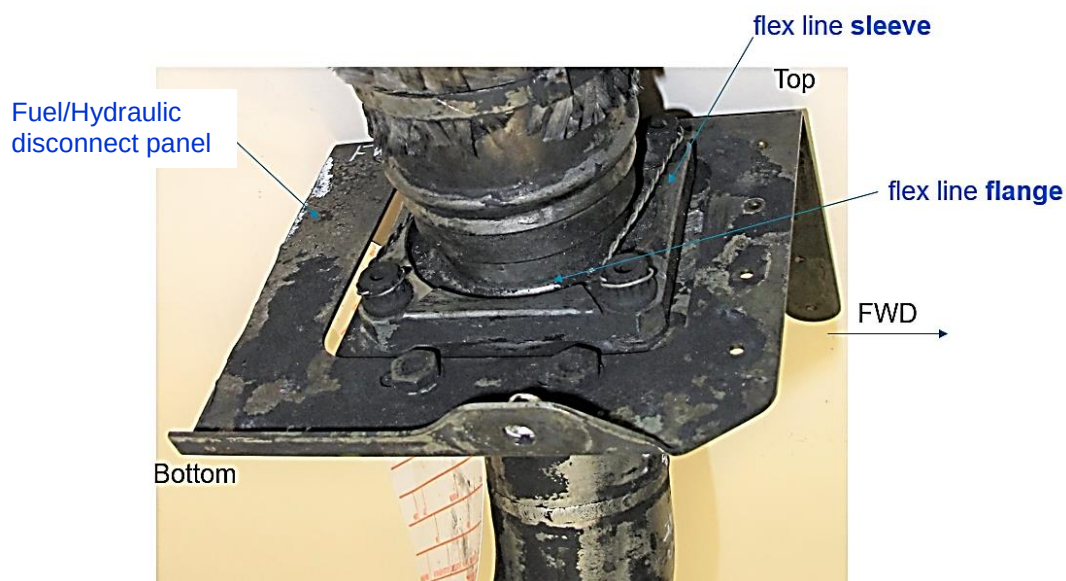
Figure 12: View from OTB (outboard) side - flex line sleeve and flange position to the fuel/hydraulic disconnect panel – no contact between sleeve and fuel/hydraulic disconnect panel

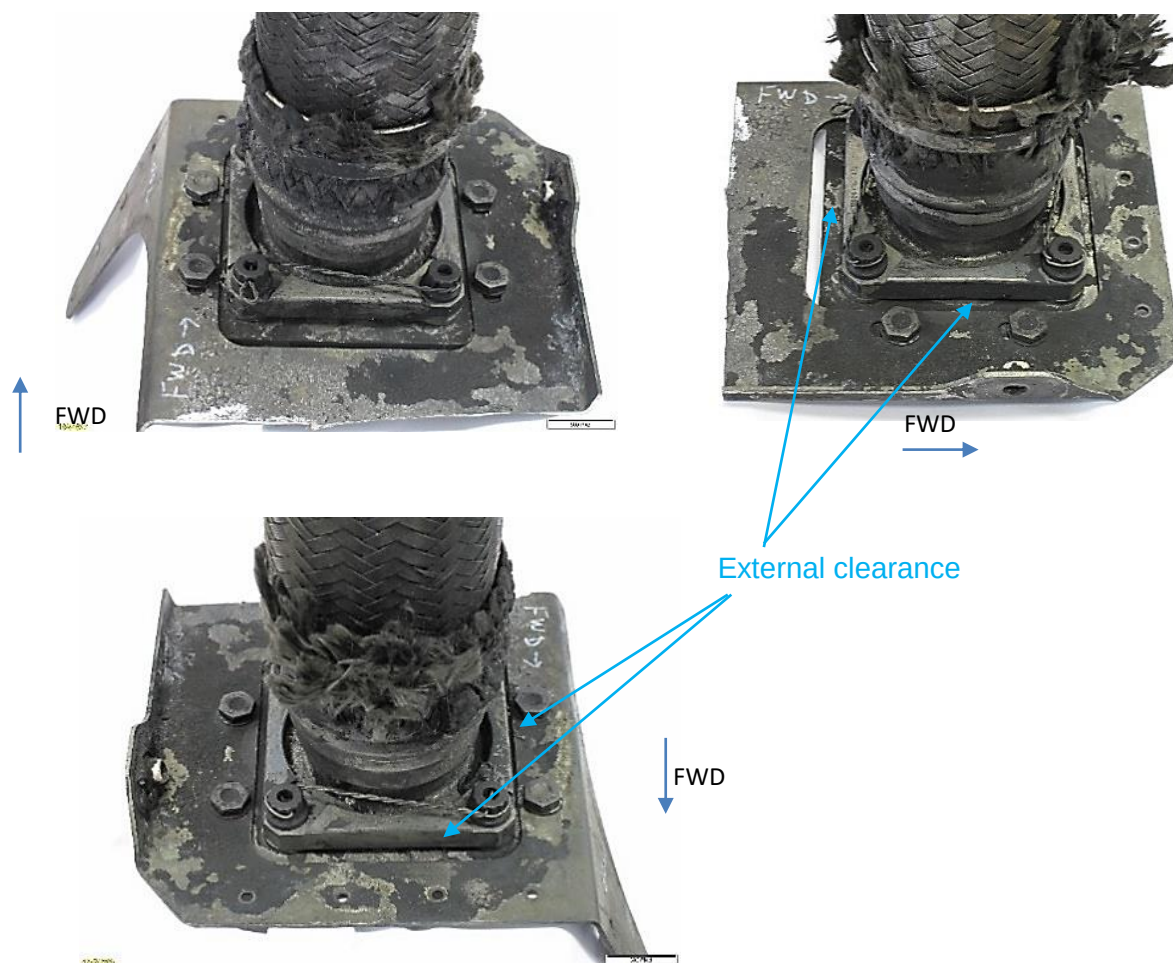
Figure 13: View from OTB - no contact of flex line sleeve to the fuel/hydraulic disconnect panel, cf. also 3D scan

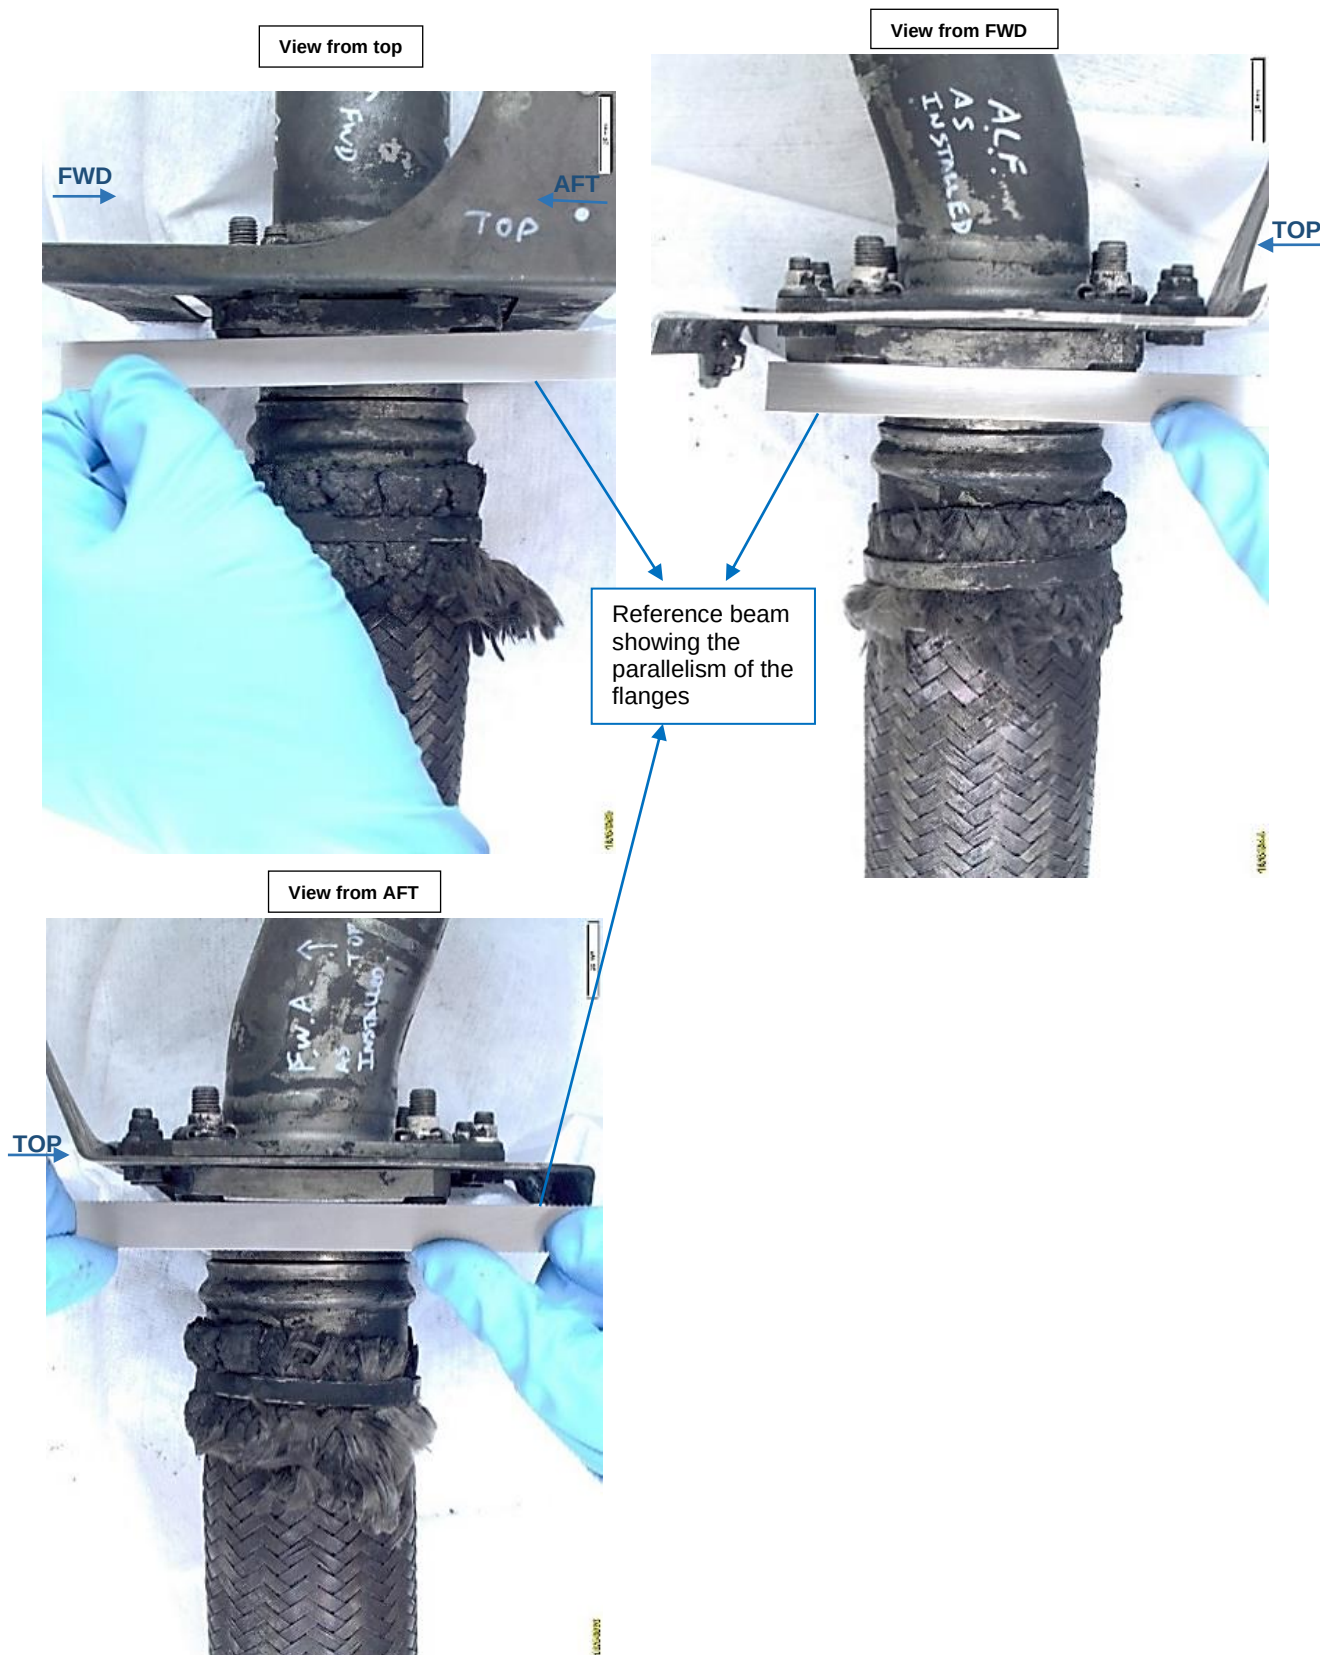
**Figure 14: Flex line sleeve - qualitative sleeve flatness check on the outer surfaces**

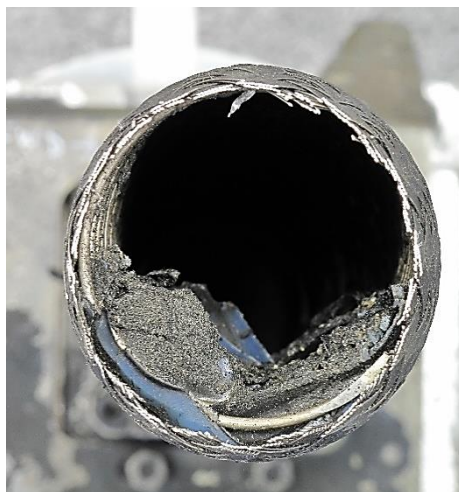
Figure 15: Flex line view in inboard direction presenting melted material on bottom side, at cut location

Due to the event the PTFE tube has no longer its original structure and melted material was found on the bottom side of the flex line at the cut location.

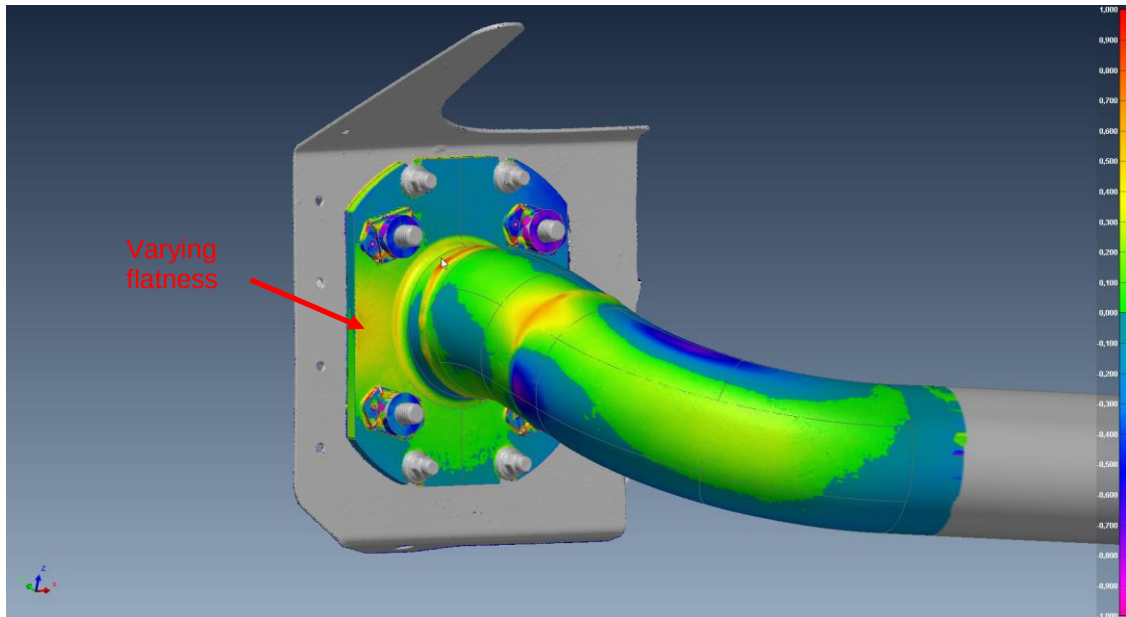
The inboard side of the pylon fuel rigid pipe flange is not flat, mainly on the “long sides” of the flange. The maximum deviation can be observed at FWD side (Figure 18).

**Figure 18: Varying flatness of pylon fuel rigid pipe flange at FWD side**

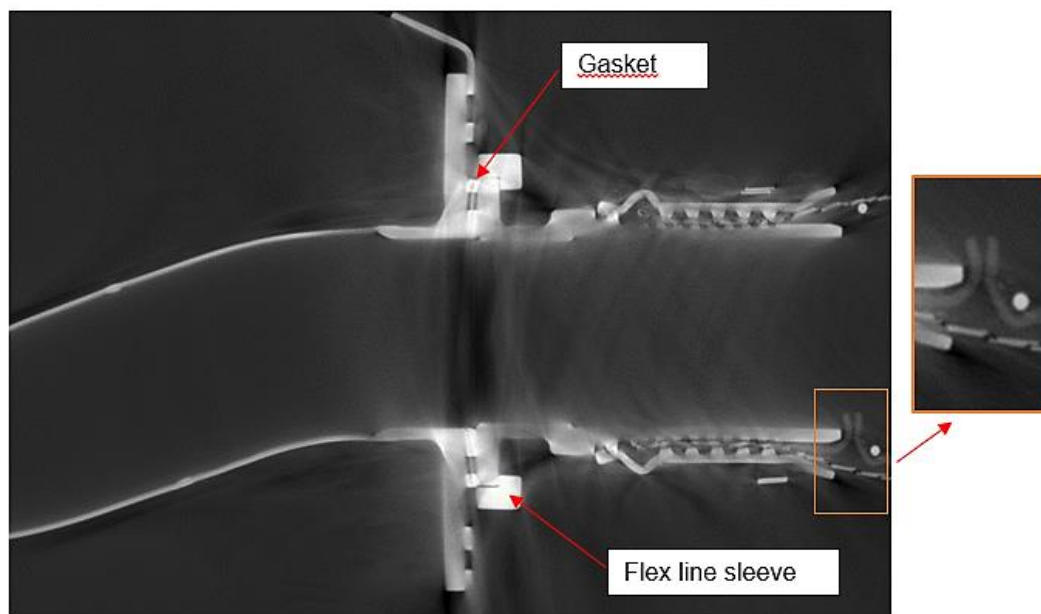
The available X-ray data were analyzed during the investigation team meeting in Bremen. Due to X-ray artefacts the data were preliminary assessed to be detailed enough in the area of concern to support the examination further. However the X-ray data could proof that the gasket was installed (see Figure 23).

Figure 23: X-ray CT snapshot of the volume data, gasket installed between the flanges

**Conclusion:** Area highlighted with orange border in Figure 23 to be further investigated for checking if the PTFE shows signs of cracking.

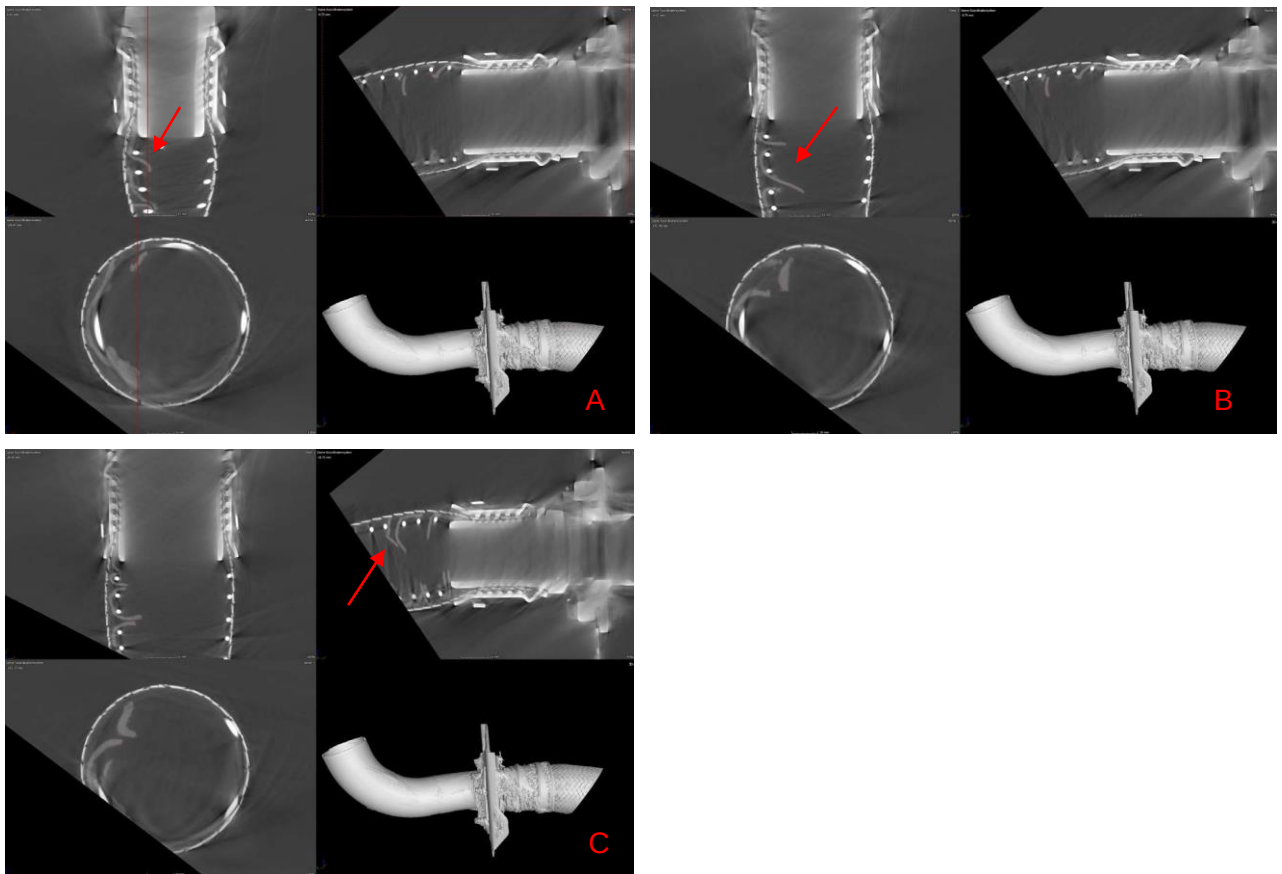
**Figure 25: X-Ray CT scan showed single openings (indicated with arrows) of the PTFE tube - view A, B and C**

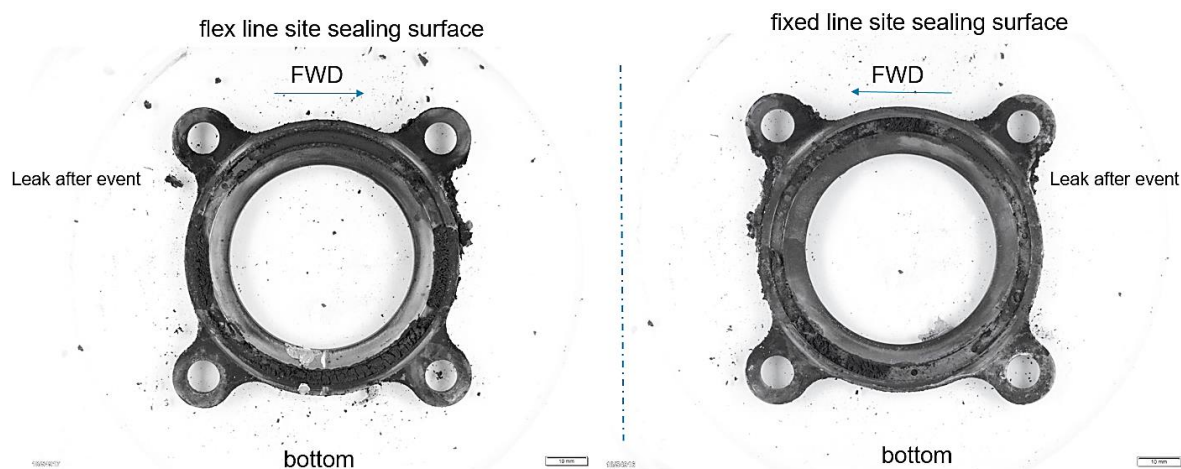
- Related to the cut-out of the fuel/hydraulic disconnect panel, the installation of the pylon fuel rigid pipe flange were orientated more in FWD direction.
- Residues in the rubber seal groove of the gasket has been found. It is supposed they are remains of the installed rubber seal. Thus, the rubber seal was no longer acting as seal after the fire event, explaining the leak reported in Chapter 3 (Figure 7).

**Figure 28: Gasket with residue in the rubber seal groove before cleaning**

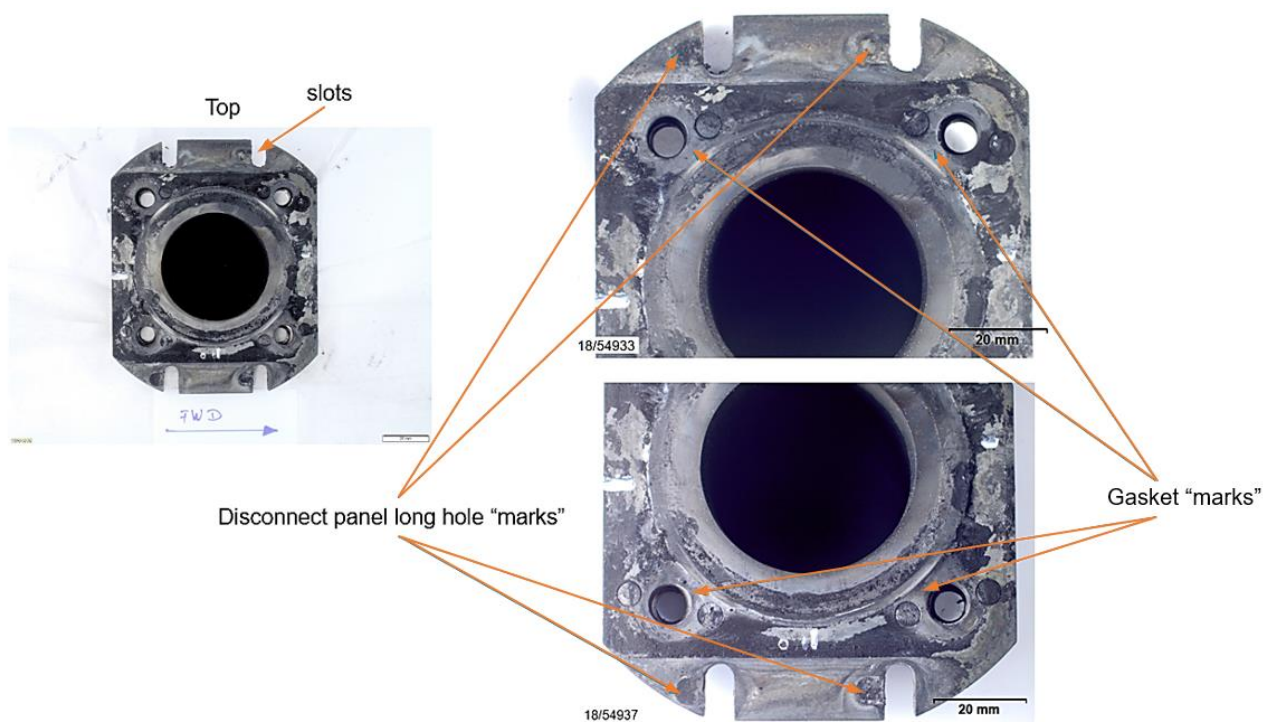
- Contact marks of the long holes of the fuel/hydraulic disconnect panel and contact marks of the gaskets holes can be observed on the pylon fuel rigid pipe flange.

**Figure 29: Pylon fuel rigid pipe flange with various contact marks, before cleaning**

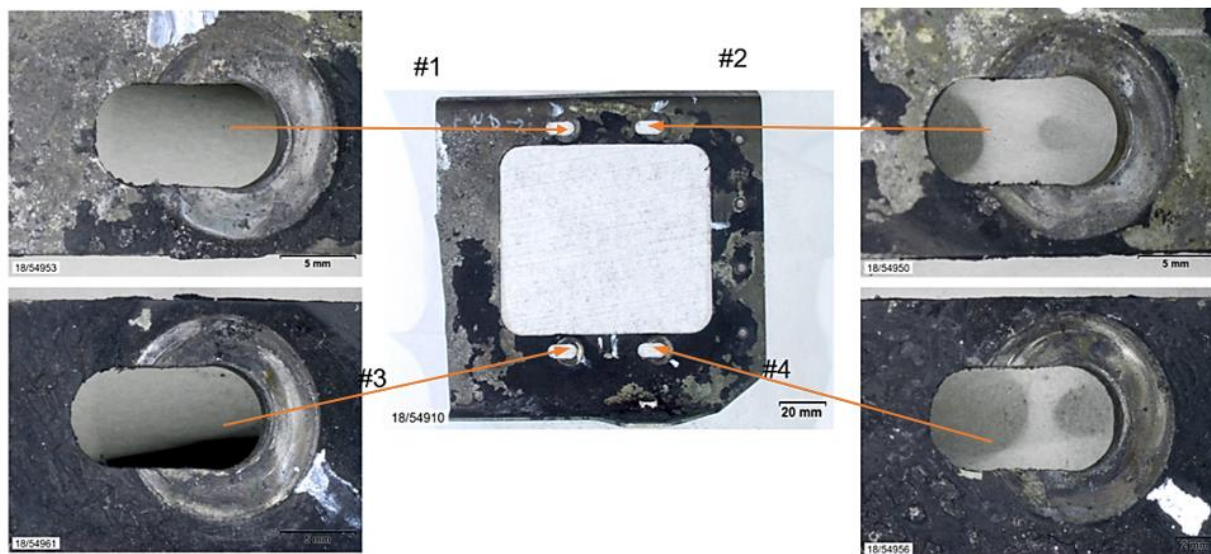
**Figure 30: Fuel/hydraulic disconnect panel outboard side (before cleaning) - presenting abrasion from bolt head, partly discoloration and deformation of long holes**

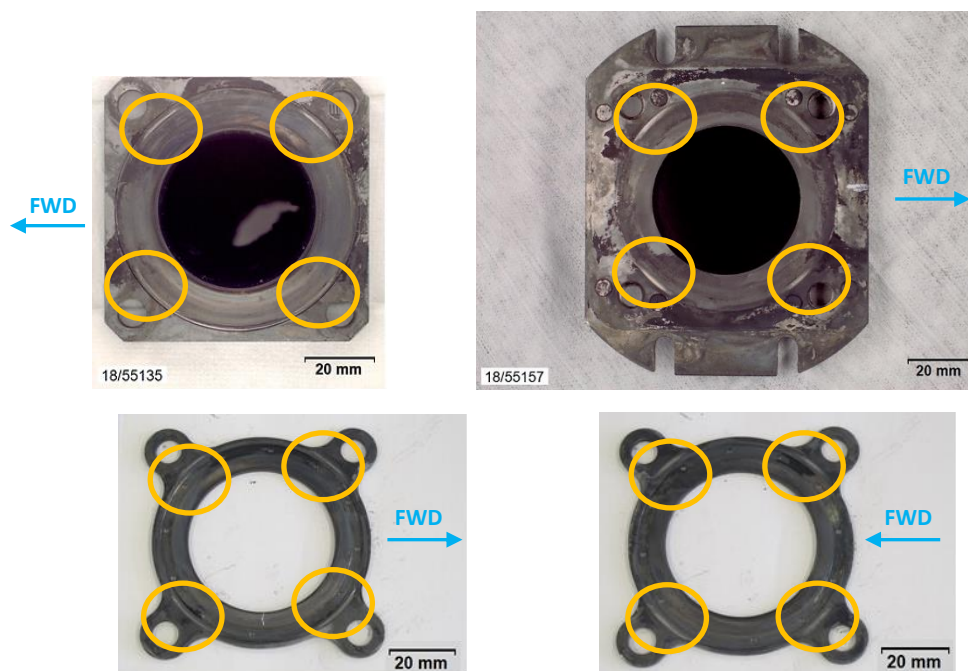
It can be observed that the pylon fuel rigid pipe flange, the flex line flange and both sides of the gasket present marks caused by contact during assembly at the same position. This indicates contact and/or possible relative (micro) movement of these parts in assembled conditions (Figure 33).

**Figure 33: Pylon fuel rigid pipe flange, flex line flange and gasket with assembly marks at the same positions**

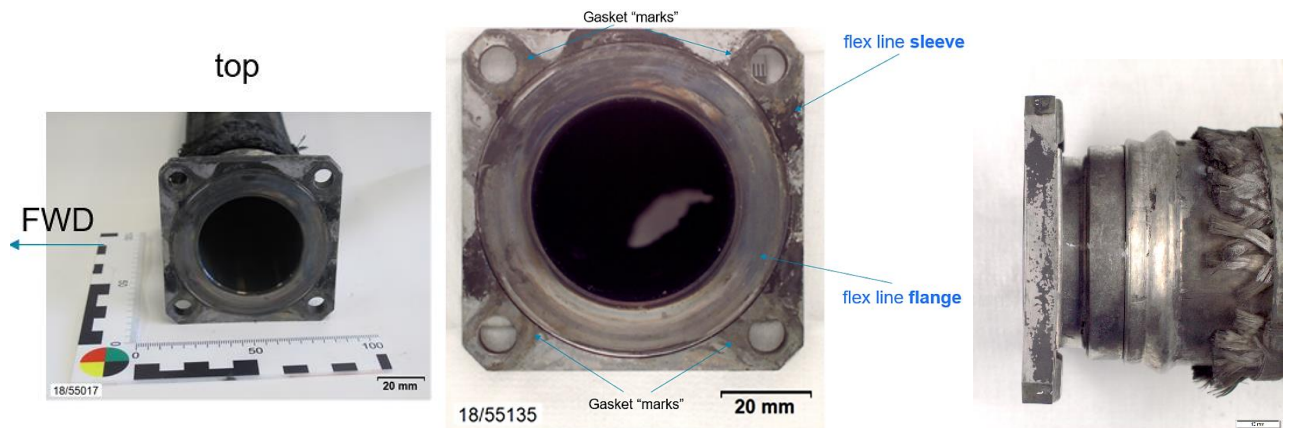
The 3D scan shows the flex line sleeve in view parallel to the pylon fuel rigid pipe flange and the fuel/hydraulic disconnect panel. This means the flex line sleeve is assembled in plane condition (Figure 19 and Figure 20). This observation was confirmed after disassembling (Figure 35).

**Figure 35: Flex line flange and sleeve with “marks” – after cleaning, flange and sleeve installed in the same plane (no tilt of sleeve)**

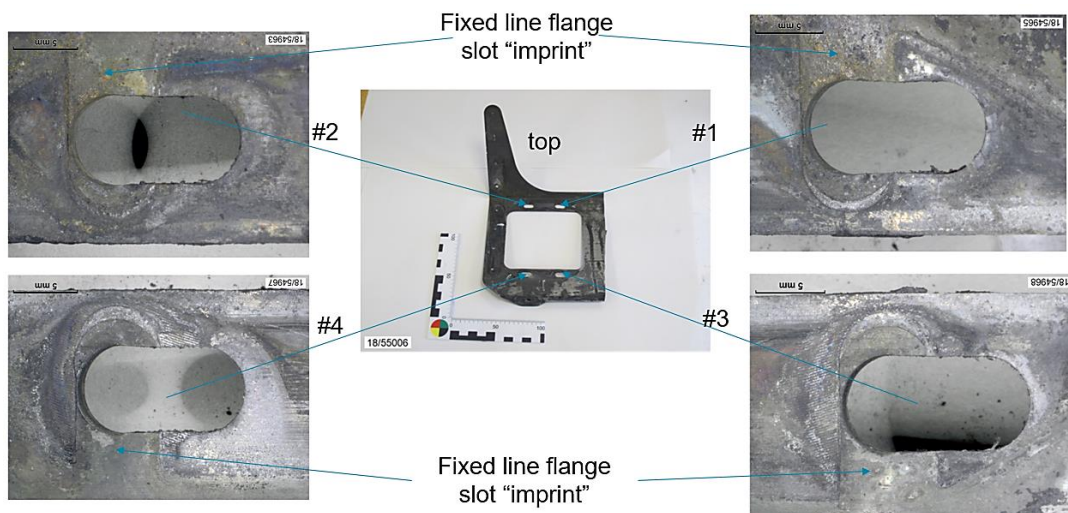
**Figure 36: Fuel/hydraulic disconnect panel inboard side presenting Pylon fuel rigid pipe flange “imprints” – after cleaning**

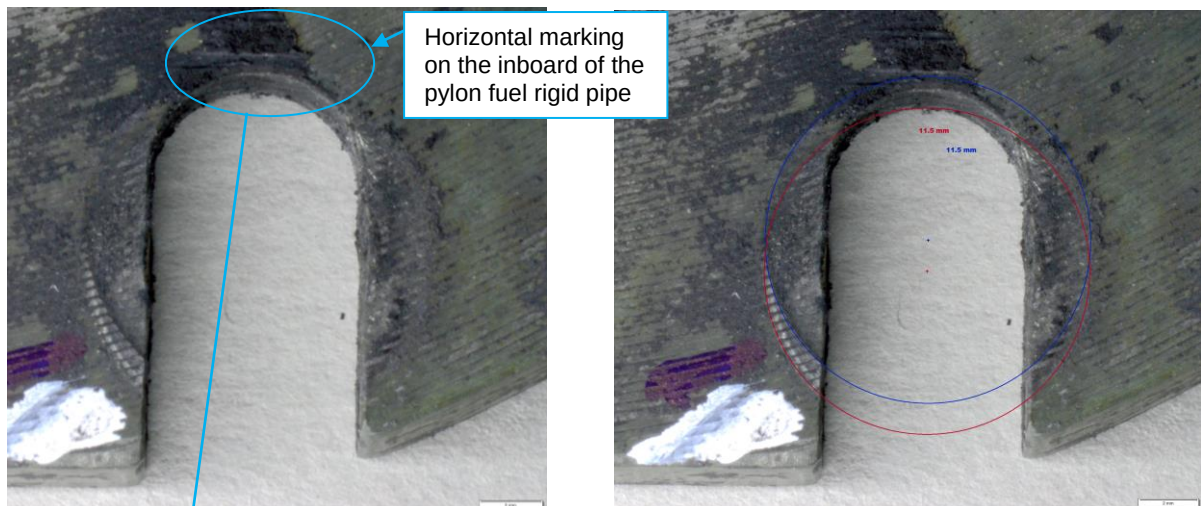
*Outcome:* The measurements have shown that the opening of (Face A) the fuel/hydraulic disconnect panel clearance (Figure 44) does not match with the distance between the imprints found on the pylon fuel rigid pipe flange (Face C) (Figure 43).

**Conclusion:** Thus the outcome there is no evidence for installation as per drawing and also is confirmed the 2 instalations not as per drawing.

Figure 43: Face C - Imprint on the pylon fuel rigid pipe

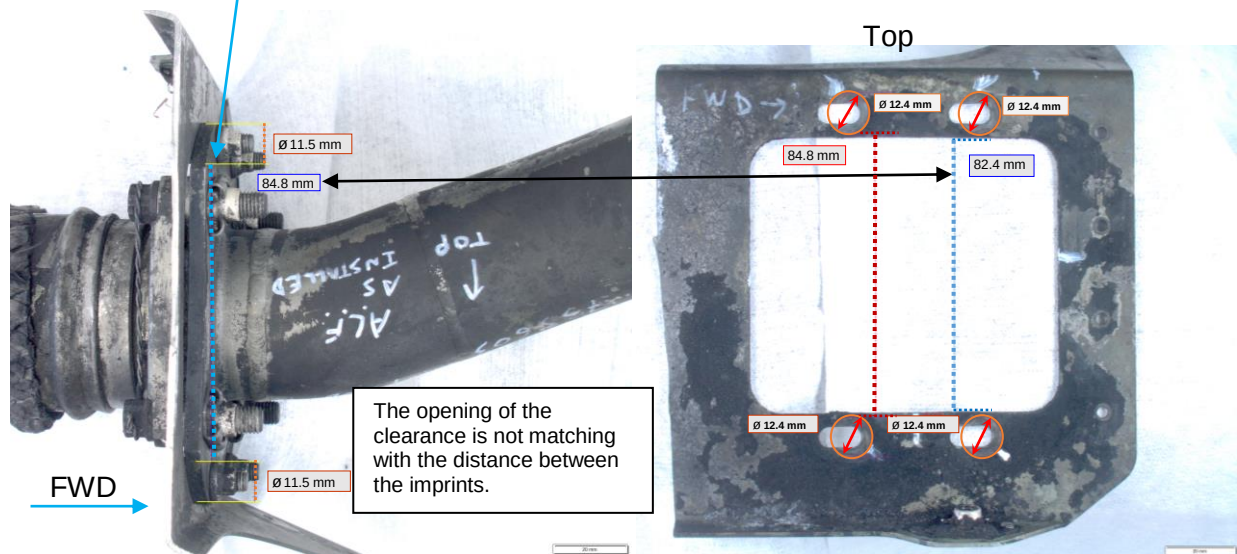
Figure 44: Face A- Distance measurement between the opening of the fuel/hydraulic disconnect panel clearance and distance on the rigid flange between the nuts.

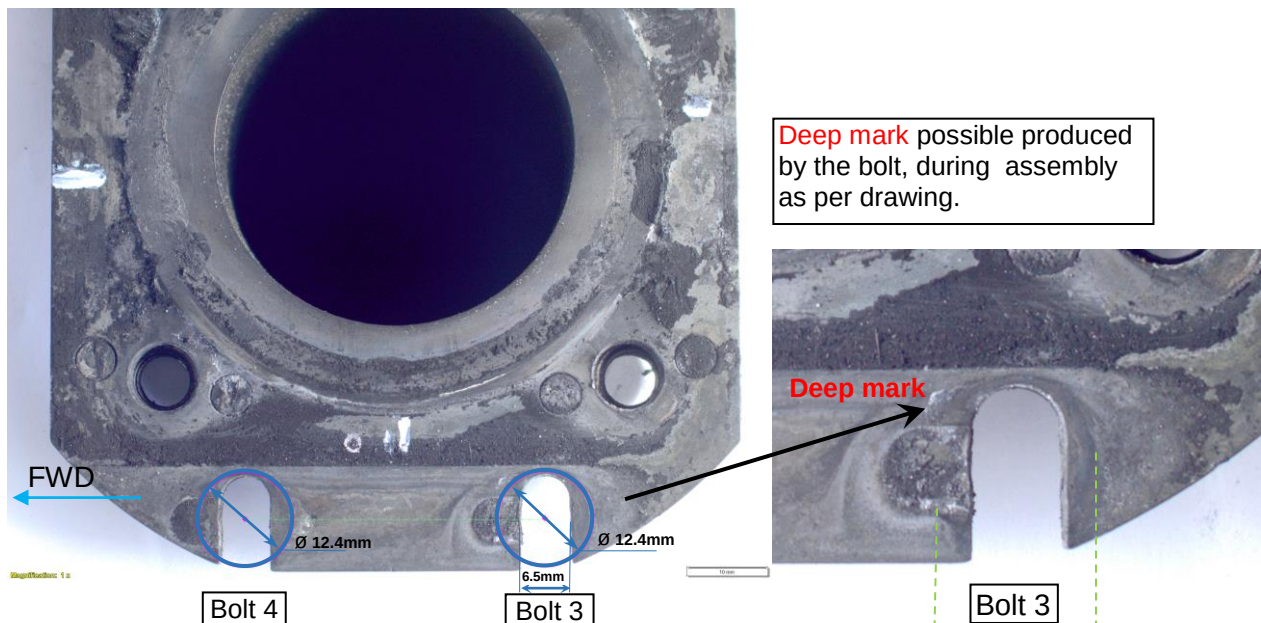
**Outcome:** The pylon fuel rigid pipe flange (Face D) shows imprints with the same size ( $\varnothing 12.4\text{mm}$ ) as the bolt head and matching with the imprints on the fuel/hydraulic disconnect panel (Face B). It can also be observed that the imprint from the pylon fuel rigid pipe flange shows a deep mark highlighting the round pattern of the bolt head.

**Conclusion:** Hence the outcome, evidence of as per drawing installation has been identified.

Figure 45: Face D-Fuel rigid pipe flange imprint measurements

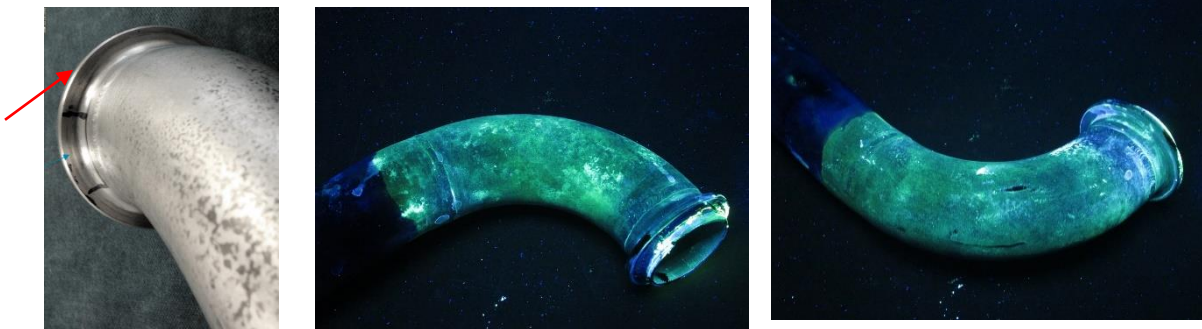
It was reported that during a first inspection after the event a crack indication was identified at the pylon fuel rigid pipe pylon site end.

Therefore a penetrant inspection in the area was performed. The penetrant inspection revealed no crack.

Additionally an HFEC inspection was done without crack indication.

**Figure 48: Penetrant inspection of pylon fuel rigid pipe pylon end without finding**  
**Conclusion:** Following the NDT inspection no findings have been recorded.

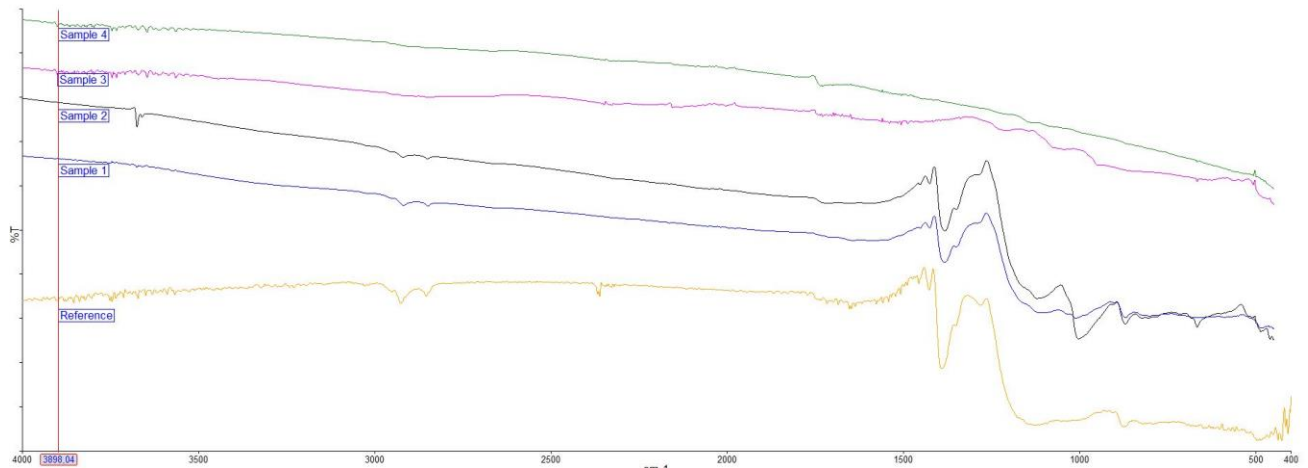
thermal decomposition. Nevertheless, a match with fluorinated rubber was found as material which is a typical rubber seal material.

**Figure 53: The results identifies the residue found in the gasket groove, as rubber seal (fluorinated rubber)**

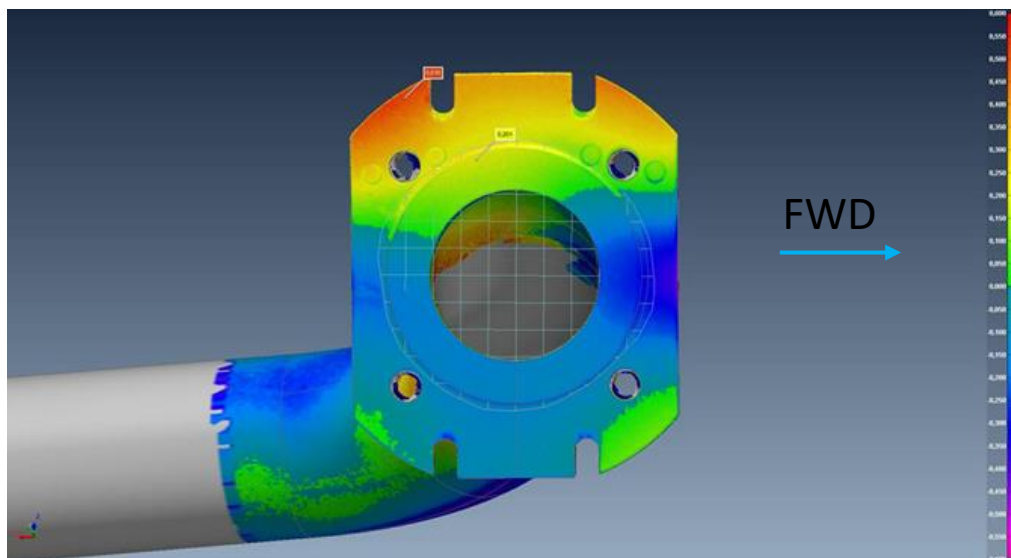
Taking the boundary conditions mentioned above into account the flatness of the circular mating surface of the pylon fuel rigid pipe flange is identified as being out of plane by 0.201 mm. The outer deformation is identified via 3D scan as 0.501 mm (Figure 55).

**Figure 55: Pylon fuel rigid pipe flange deviation from CAD model represented by 3D scan, outboard side**
