**NATIONAL TRANSPORTATION SAFETY BOARD**

**Attachment 9 –Hydraulic Check Valve and Hydraulic Case Drain Filter  
Materials Analysis Report**

**DCA18LA163**

## A330 MSN 578 DAL fire event - hydraulic check valve Technical Report

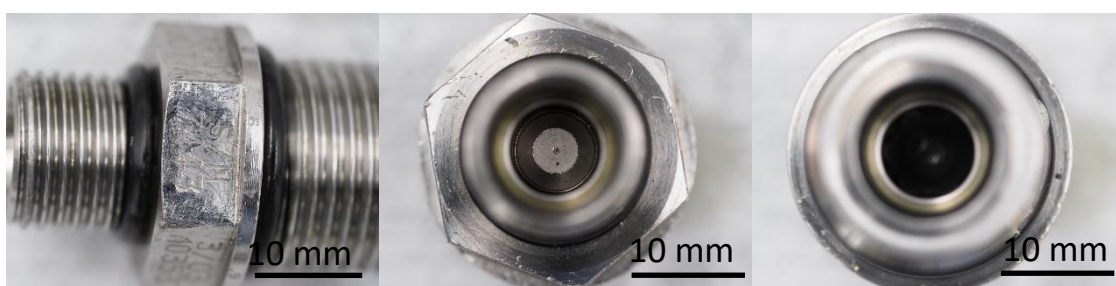
*Figure 1 shows the hydraulic check valve (S/N: 7443) at incoming visual inspection*

At incoming visual inspection the check valve shows scratches and mechanical wear on the outside surface as seen in Figure 1.

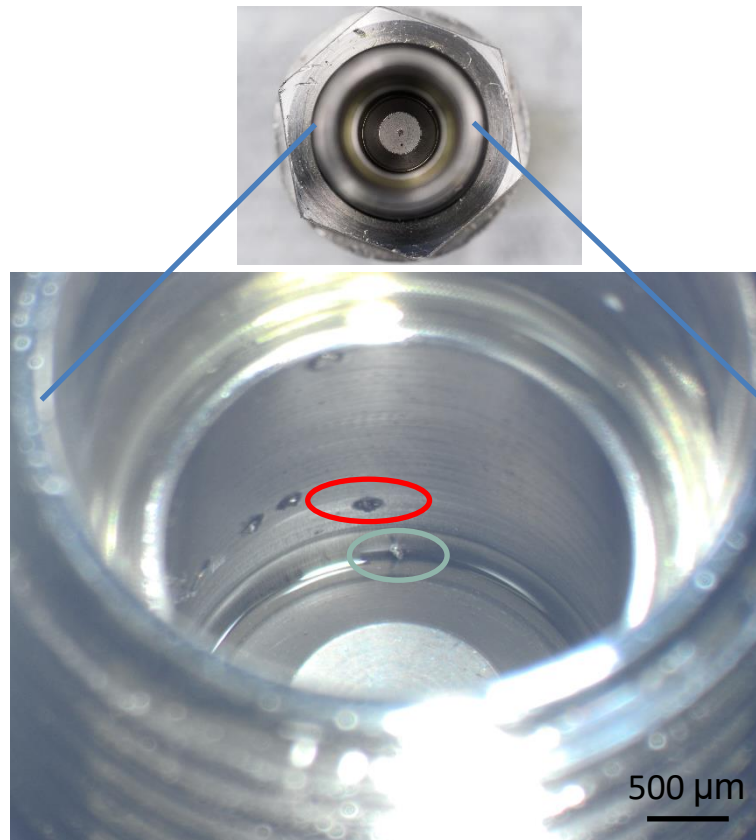
*Figure 2 shows the inside walls of the hydraulic check valve (S/N: 7443) in the vicinity of the closing head*

Figure 2 reveals the presence of particles attached to the inside walls of the check valve. On the image several of such particles are identified. Two of them are highlighted with green and red circles.

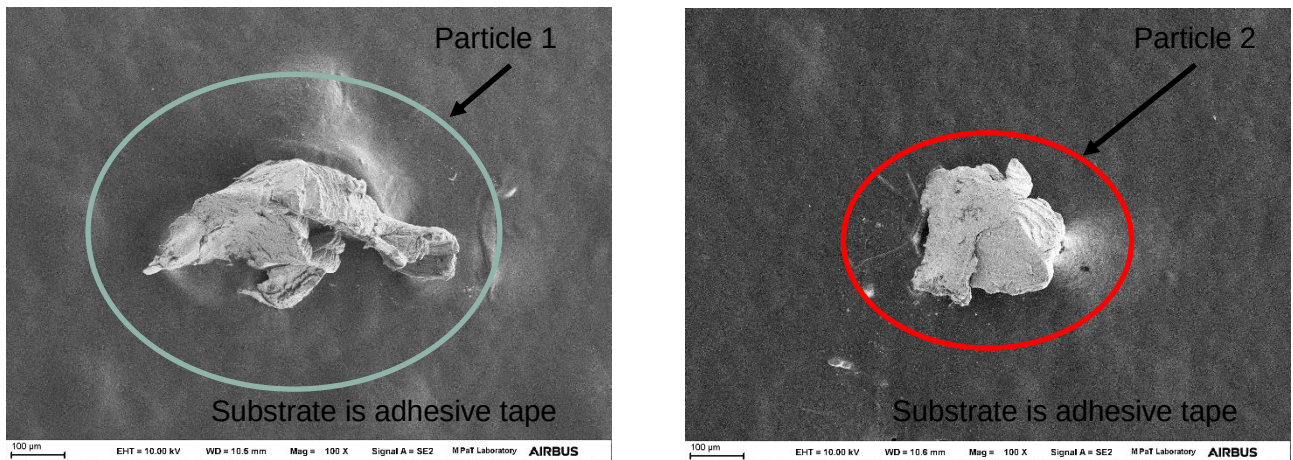
Figure 3 shows electron microscopy images of the particles transferred from the inside surface of the hydraulic check valve (S/N: 7443)

Figure 3 shows the particles transferred from the inside surface of the check valve. The substrate is adhesive tape. The maximum extension of the particles are about 480 and 200 µm, respectively.

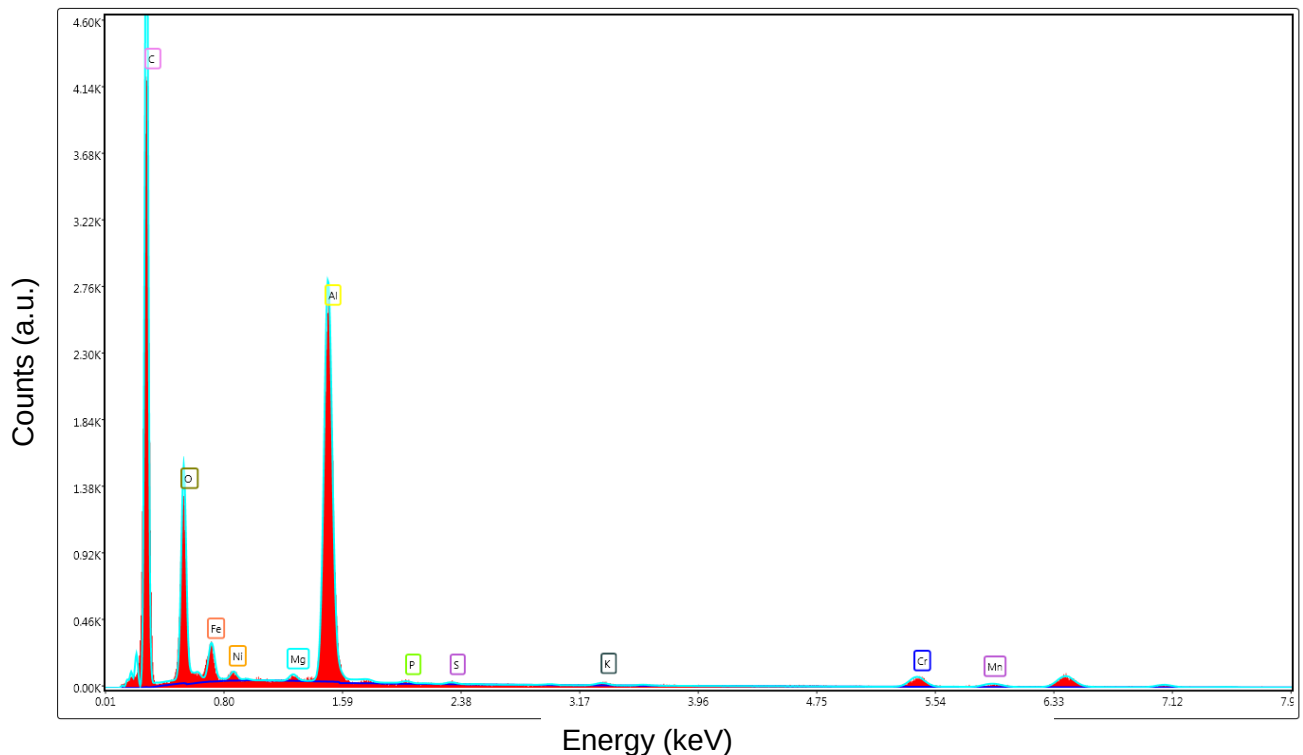
Figure 4 shows the energy dispersive x-ray spectroscopy analysis of particle 1

Figure 4 shows the energy dispersive x-ray spectroscopy analysis of particle 1 shown in Figure 3. The spectrum reveals the presence of mainly Al, C and O. Based on the analysis of the spectrum it is inferred that the presence of C and O is mainly due to residues on the surface of the particle and the particle is mainly constituted by Al.

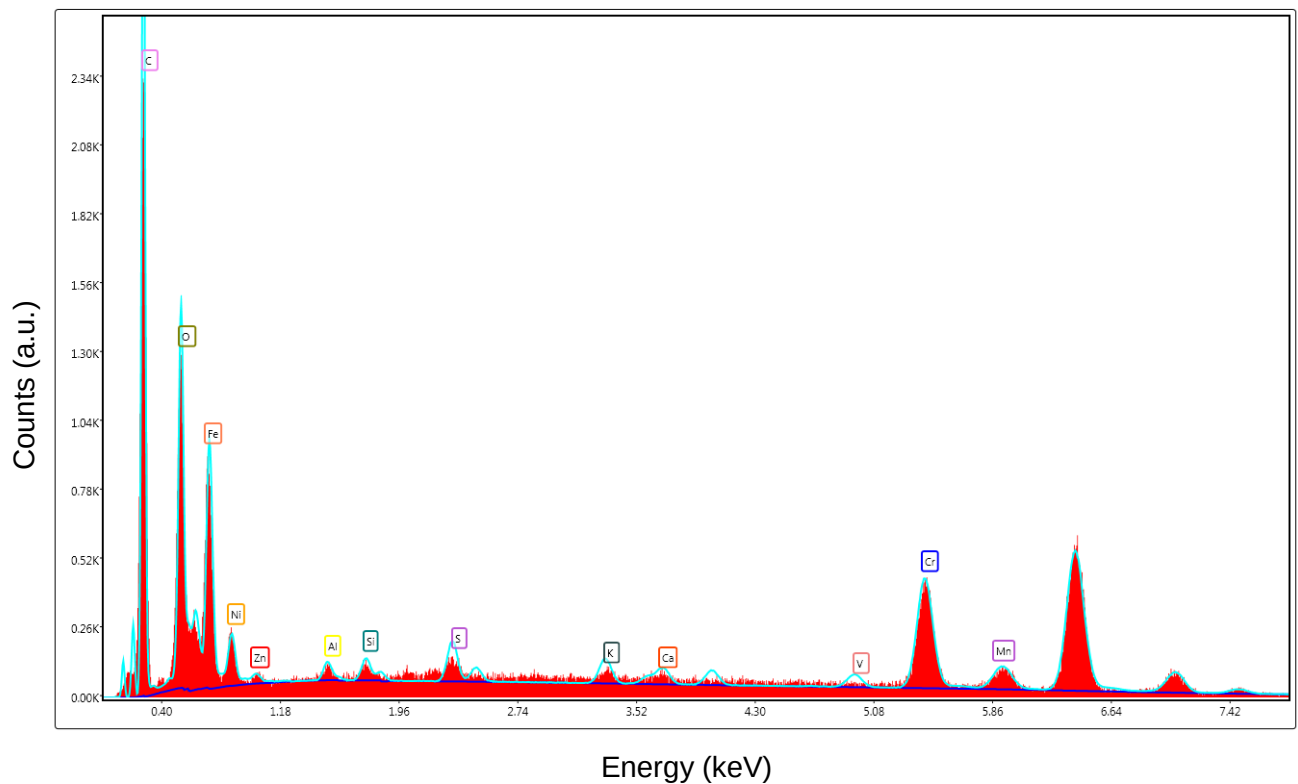
*Figure 5 shows the energy dispersive x-ray spectroscopy analysis of particle 2*

Figure 5 shows the energy dispersive x-ray spectroscopy analysis of particle 2 shown in Figure 3. The spectrum reveals the presence of mainly C, O and Fe. Furthermore, Cr and Ni are detected. Based on the analysis of the spectrum it is inferred that the presence of C and O is mainly due to residues on the surface of the particle and that the particle is mainly constituted by corrosion resistant steel.

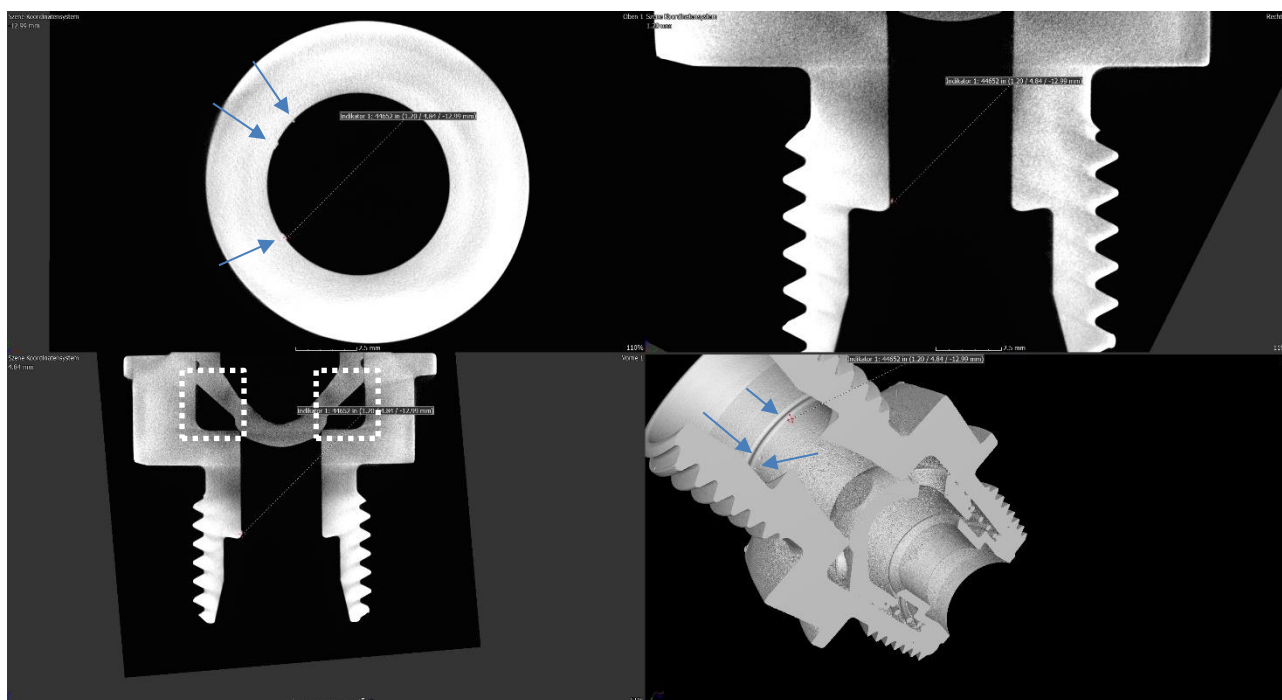
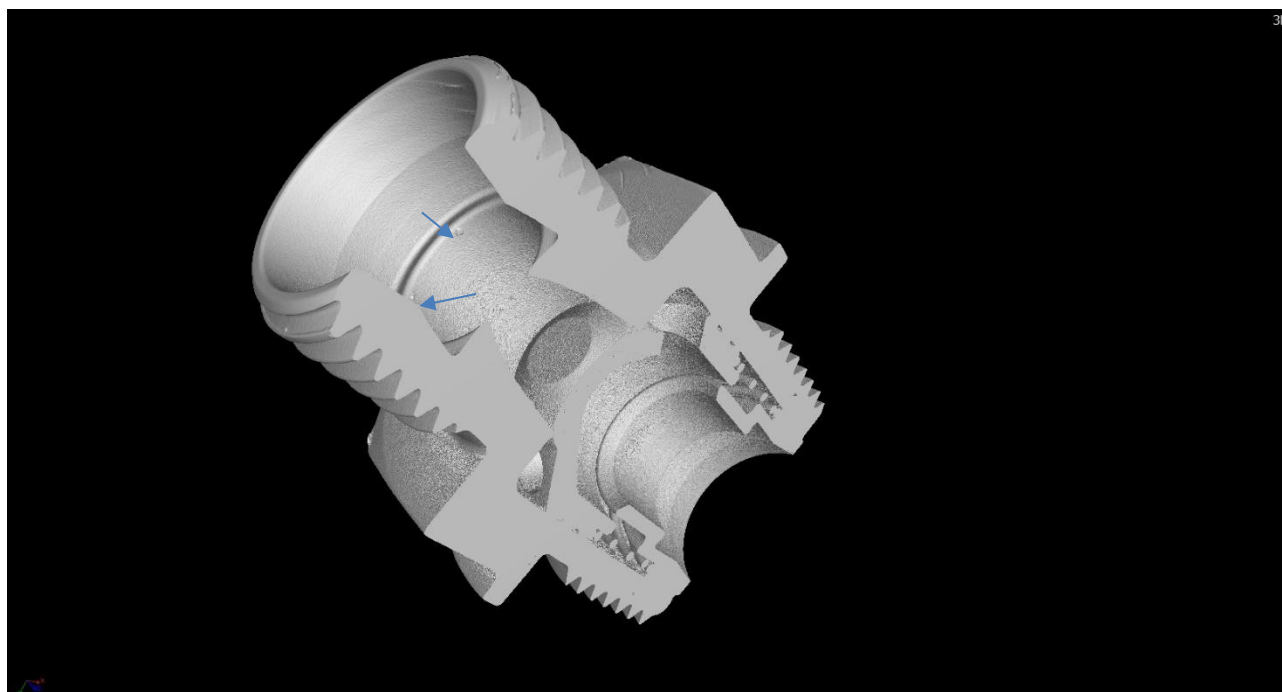
Figure 6 shows computer tomography images of the hydraulic check valve

Figure 7 shows a computer tomography image of the hydraulic check valve

The computer tomography images of Figure 6 and Figure 7 show cut planes of the check valve. The computer tomography analysis reveals the presence of particles attached to the inside wall of the

hydraulic check valve. The depicted cut planes are chosen to display the particles identified. In Figure 6 and Figure 7 the identified particles are highlighted with blue arrows. Hence, the computer tomography analysis is in line with the microscopy analysis presented in section 3.2. No particles could be identified in the area behind the sealing edge of the pop-in, highlighted by dashed boxes in Figure 6. Hence, the computer tomography analysis reveals the presence of particles on the inner walls of the check valve upstream of the pop-in sealing edge. However, no particles are identified behind the sealing edge.

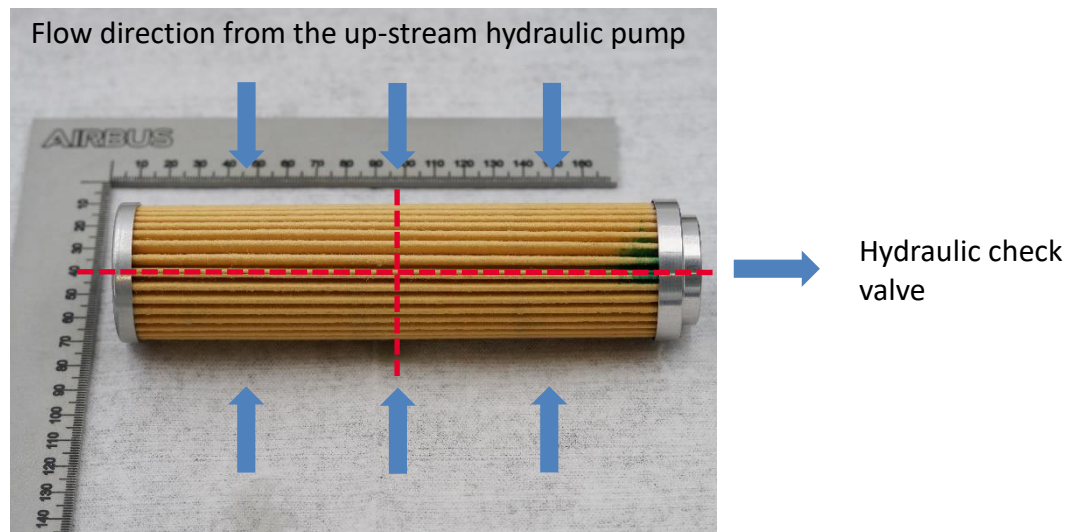
A new hydraulic filter was examined. The filter is of the same type, which was installed upstream to the hydraulic check valve at the time of incident. The hydraulic filter was investigated to better understand the constitution of the filter and to be able to evaluate the filter as a potential source of contaminants itself. The filter was cut into 4 pieces as indicated by the red lines in Figure 8 for further analysis. The blue arrows indicate the flow direction of the hydraulic fluid in operation. The hydraulic fluid flows from the hydraulic pump through the outside surface of the filter and exits the filter towards the check valve to the right. Further analysis can be seen in Figure 9.

Figure 8 shows the hydraulic filter with the part number 7554849

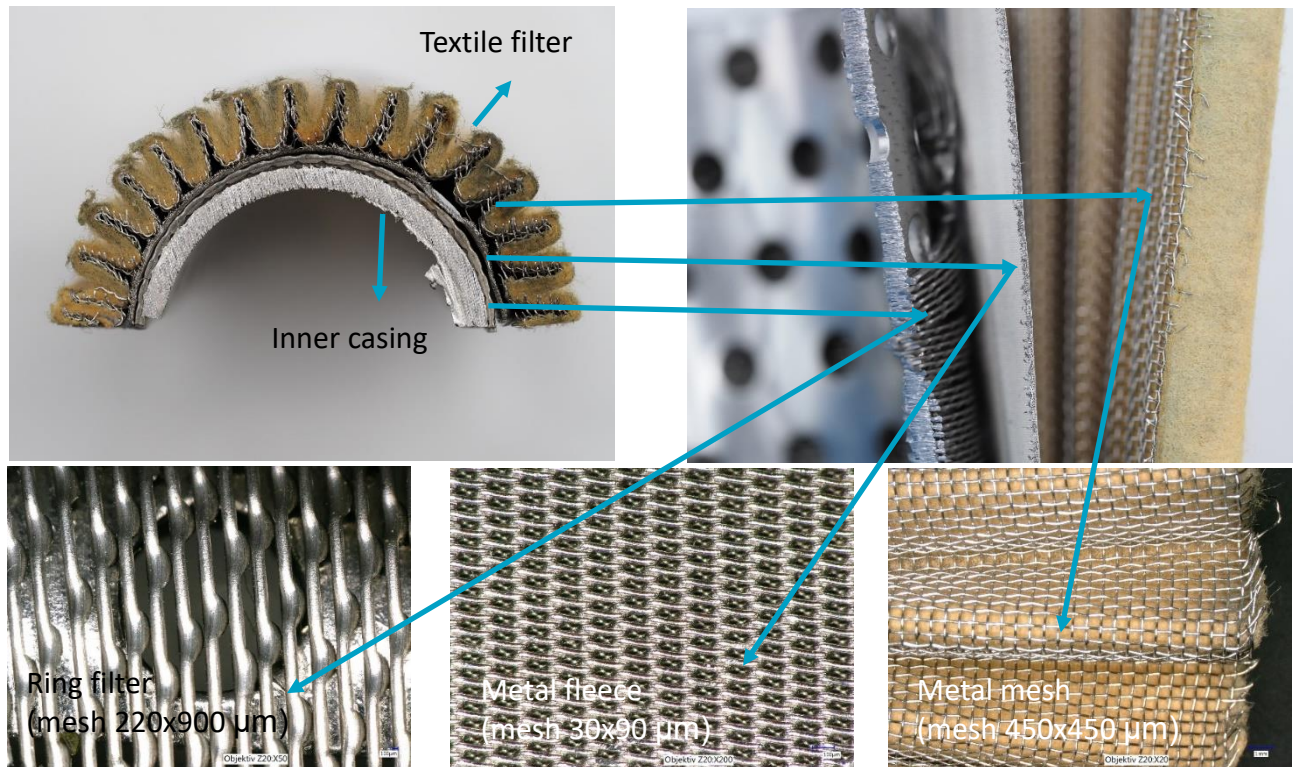
Figure 9 shows a cross-section of the hydraulic filter and microscopic images of the individual layers

In the top left image in Figure 9 the cross section of the hydraulic filter is shown. Five layers are identified in the macroscopic cross-section, which are from the inside towards the outside an inner casing, a ring filter, a metal fleece, a metal mesh and a textile filter. The image on the top right shows a side view into the opened layer structure. Microscopic images of the ring filter, metal fleece and metal mesh are shown below. The individual mesh sizes are 220x900 µm, 30x90 µm and 450x450 µm for the ring filter, metal fleece and metal mesh, respectively. Comparing the mesh size of the metal fleece with the size of the particles found inside the check valve it can be concluded that these type of metallic particles cannot have passed through an intact and operational filter of this type.

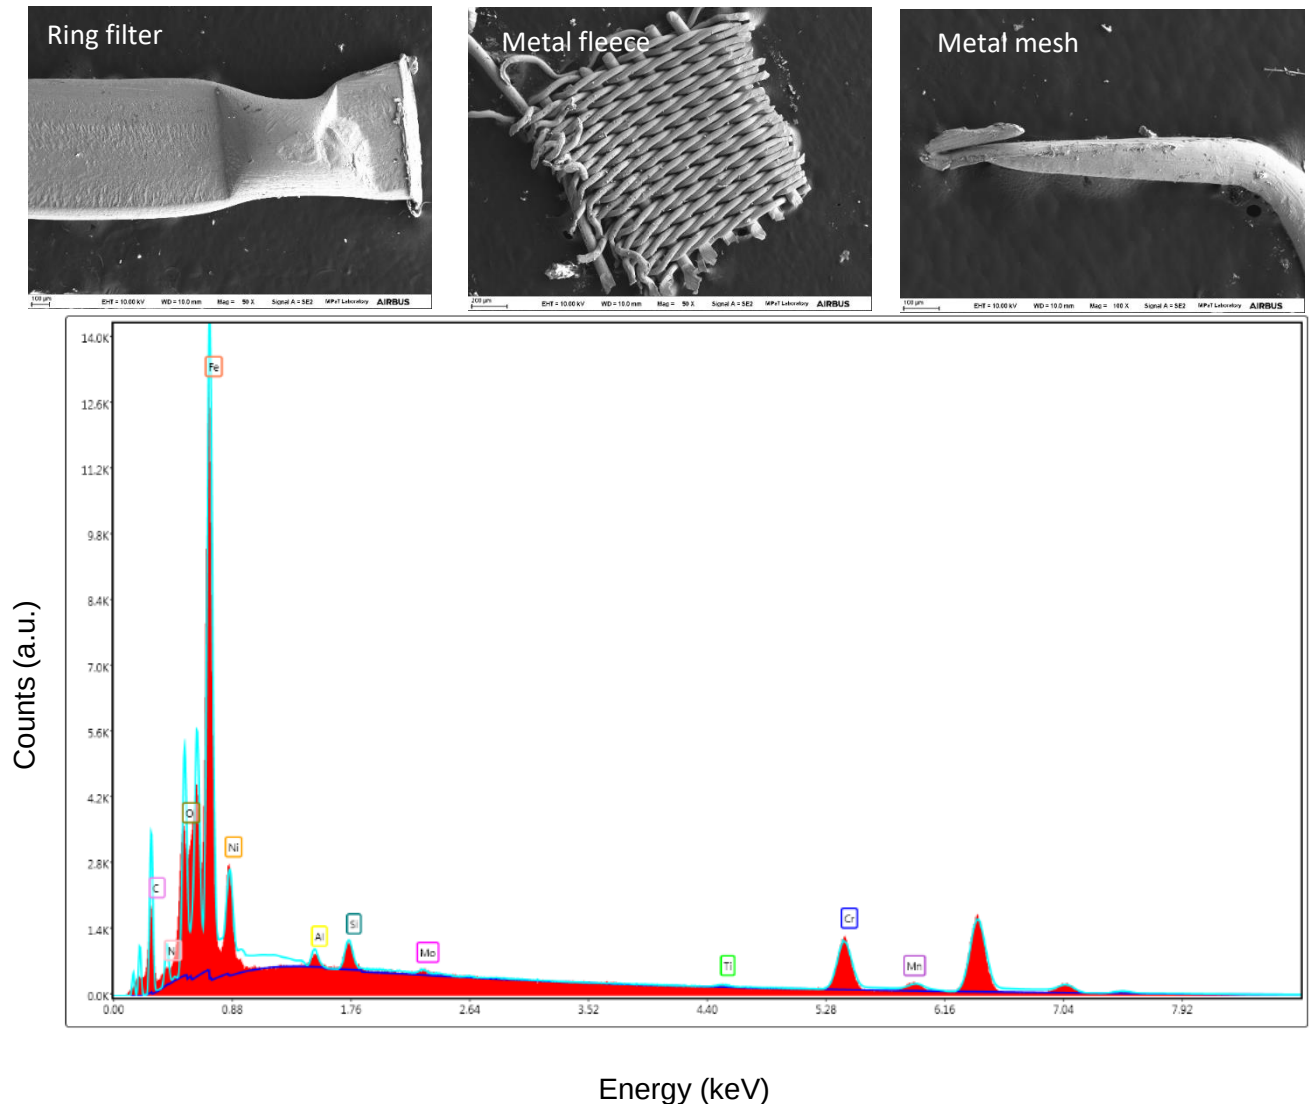
Figure 10 shows electron microscopy images of cut outs of the ring filter, metal fleece and metal mesh. Furthermore, the energy dispersive x-ray spectroscopy analysis of the different filter layers is shown.

The top three images of Figure 10 show electron microscopy images of the ring filter, metal fleece and metal mesh. For the ring filter and metal mesh individual wires were cut out for this analysis. The lower graph shows the energy dispersive x-ray spectroscopy analysis of these three filter layers. The presence of Fe-Cr-Ni infers that all three filter layers are made of corrosion resistant steels. Hence, from the energy dispersive x-ray analysis, it can be inferred that one of the particles found inside the hydraulic check valve (S/N: 7443) and the filter layers are comprised of corrosion resistant steel. Hence, the metallic filter layers could be a source for the Fe-Cr-Ni containing particles found inside the yellow case drain valve.

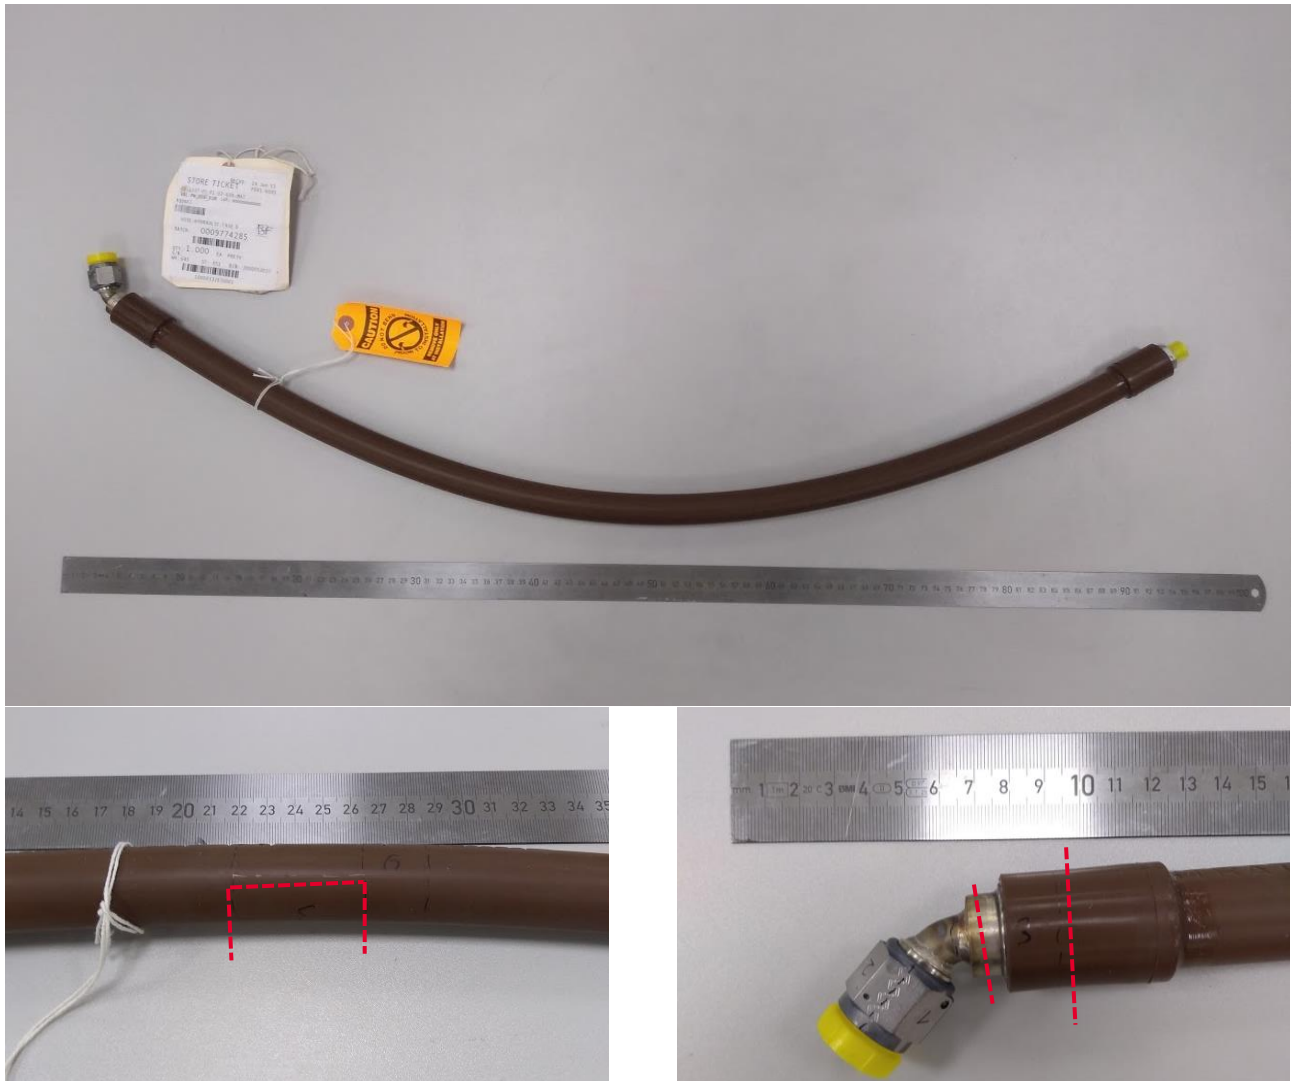
A new hydraulic flexible hose was examined. The hose is of the same type, which was installed upstream to the hydraulic check valve at the time of incident. The hose was investigated to better understand its constitution and to be able to evaluate it as a potential source of contaminants itself. Figure 11 shows the new flexible hose as received. The flexible hose is about 1 m long and comprised of metallic connectors on either-side and an outer sleeve. The two cut-outs indicated in

*Figure 11 – visual inspection of a new hydraulic flexible hose.*

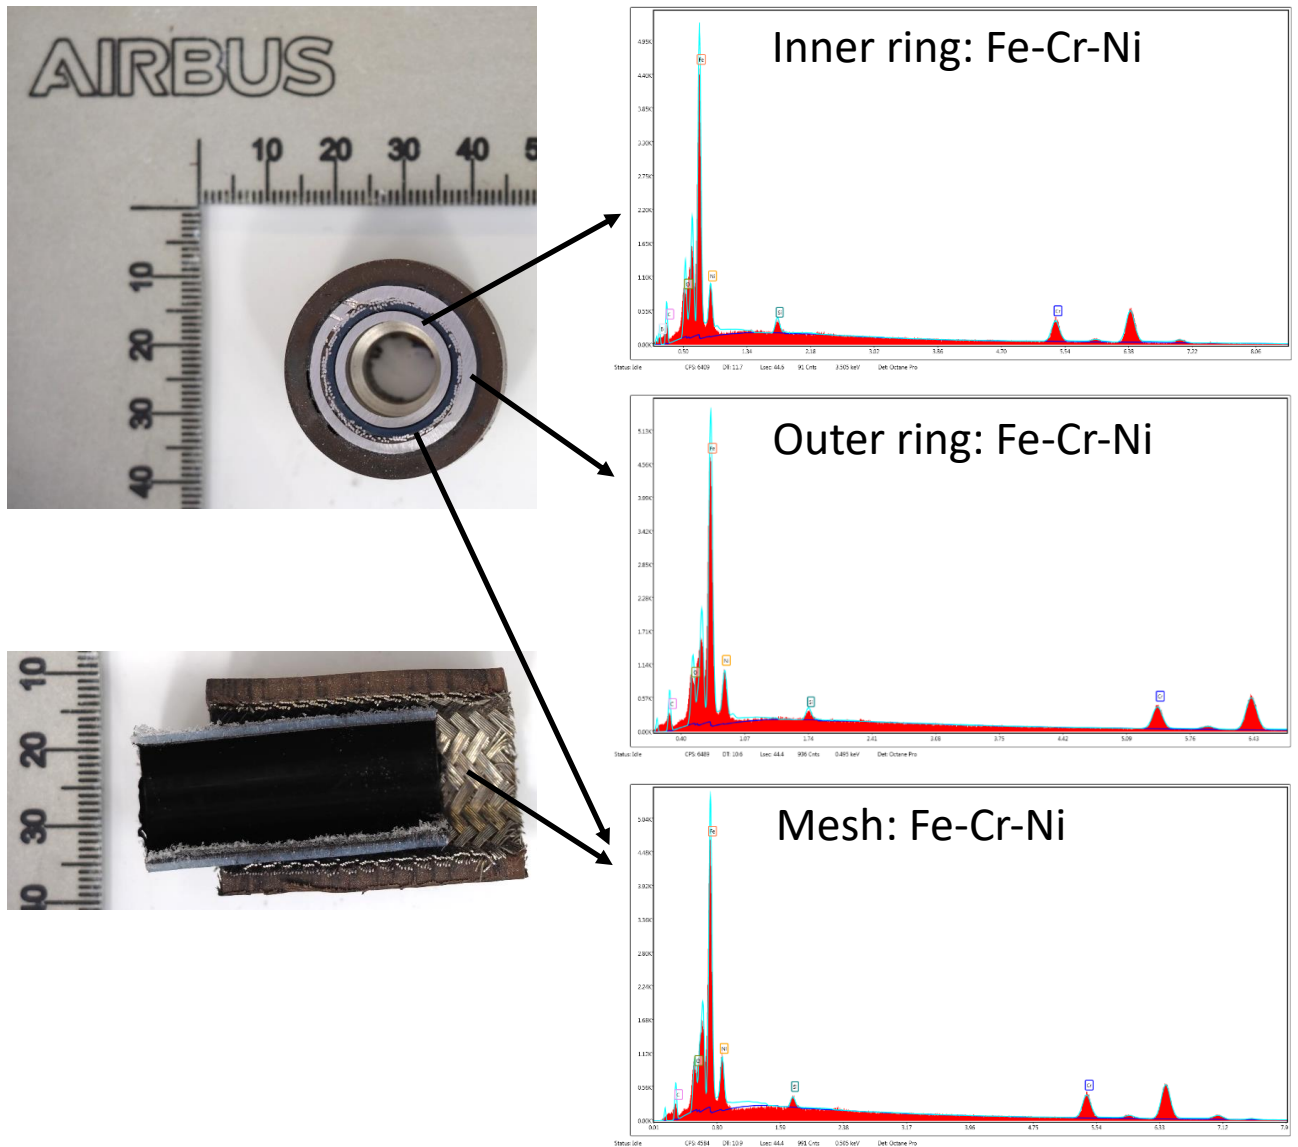
Figure 12 shows cross-sections of the flexible hose cut-outs. Furthermore, the energy dispersive x-ray spectroscopy analysis of the different metallic layers are shown.

From the cross-sectional analysis shown in Figure 12 it is learned that the flexible hose is comprised of an inner liner, a metal mesh and an outer sleeve. In addition, the connector is comprised of two metallic rings. Chemical analysis shows that the inner ring, the outer ring and the mesh of the flexible hose contain Fe-Cr-Ni. Hence, these layers are made out of corrosion resistant steel. The sealing within the flexible hose is enabled through the inner non-metallic liner. Hence, even though the flexible hose contains materials, which are chemically similar to the Fe-Cr-Ni particles identified in the yellow case drain valve, in case of thermal degradation most probably the sealing function fails before metallic parts are released from the hose.
