**NATIONAL TRANSPORTATION SAFETY BOARD**  
**Office of Aviation Safety**  
**Washington, D.C. 20594**

**Powerplants Group Chairman's Factual Report**  
**NTSB No: DCA18LA163**

Location: Hartsfield-Jackson Atlanta International Airport (ATL) – Atlanta, Georgia

Aircraft: Airbus A330-323, N806NW, Delta Air Lines Flight 30

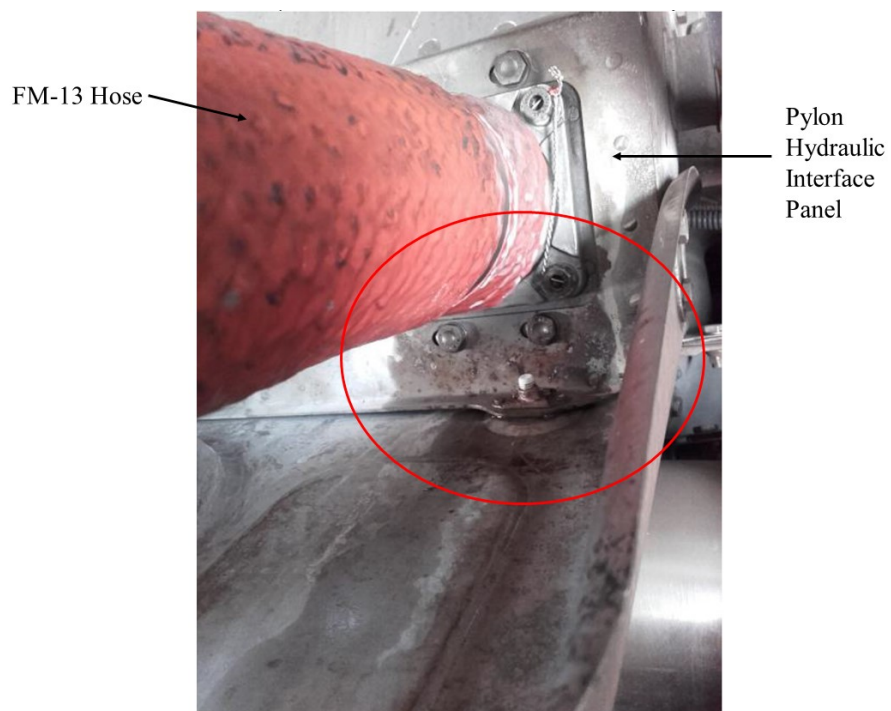
**Photo 1- Fuel Leak Finding at AMS, April 15, 2018 (Photo Courtesy of DAL AMS Maintenance)**

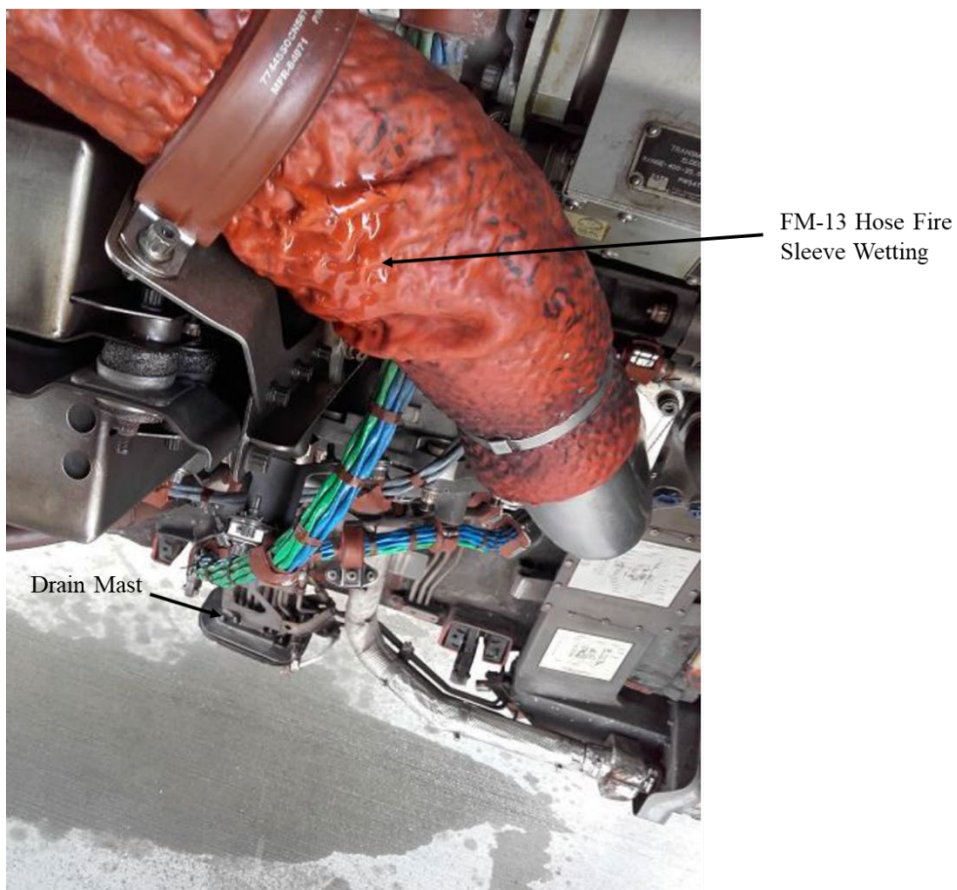
**Photo 2- FM-13 Hose Wetted and Puddling Under Engine Drain Mast at AMS, April 17, 2018 (Photo Courtesy of DAL AMS Maintenance)**

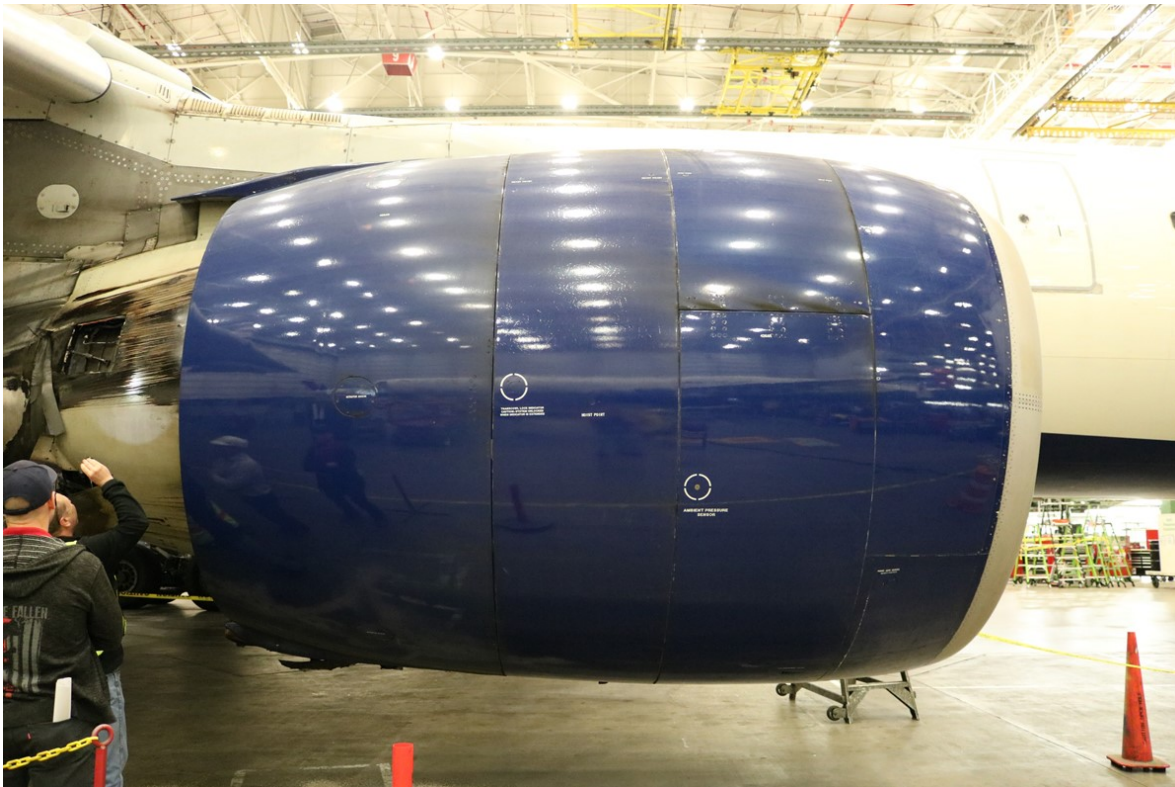
The airplane was moved to the DAL TechOps maintenance hangar after the accident flight. The inlet, aft, and forward fan cowls were intact, but had discoloration along the cowl door interface seams (**Photo 4**). The thrust reverser cowls had sooting and discoloration on the exterior surfaces. Both PRDs and both service access panels on the inboard thrust reverser door were found open. The outboard (right) reverser door upper PRD was separated and missing, the bottom PRD was open, and the service access panel was separated and found resting loose in the cowl. The outboard thrust reverser door PRD was later recovered near Lawrenceville, Georgia and returned to DAL.

**Photo 4- No. 2 Engine, Outboard Side**

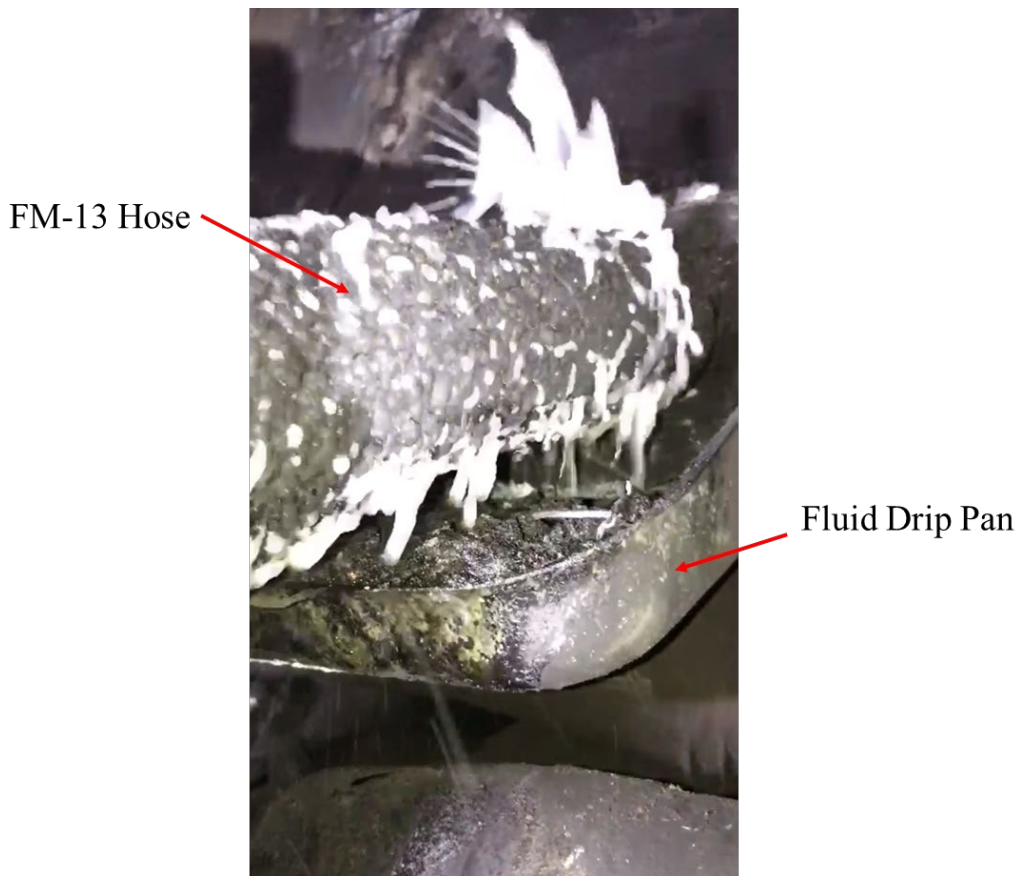
Before the investigation team arrived in ATL, the NTSB gave DAL permission to perform a FM-13 hose fuel pressurization check. The No. 2 engine fire handle was reset in the cockpit to open the LPSOV and gravity feed fuel into the FM-13 hose. Minor fuel wetting was observed along the length of the FM-13 hose after the LPSOV was opened, but no clear leak origin was visible. The fuel boost pump was cycled on, and a large quantity of fuel sprayed through the FM-13 hose outer wall (**Photo 5**). Fuel was also observed dripping at the main fuel supply line to pylon hydraulic interface panel connection. Charred debris was collected in the pylon hydraulic interface panel drip tray prior to the pressurization check. The No. 2 engine was removed and transferred to the DAL TechOps engine test cell shop for examination. The FM-13 hose lower flange was separated from the engine fuel pump as part of the engine removal process. The FM-13 hose lower flange to engine fuel pump attaching bolt run-on torque values were measured by setting a torque wrench to 180 inch-pounds (in.-lbs.), the minimum bolt torque called out in the Aircraft Maintenance Manual (AMM) and recording the number of turns in the clockwise

**Photo 5- Upper Section of FM-13 Hose Immediately After the Boost Pump was Turned On**

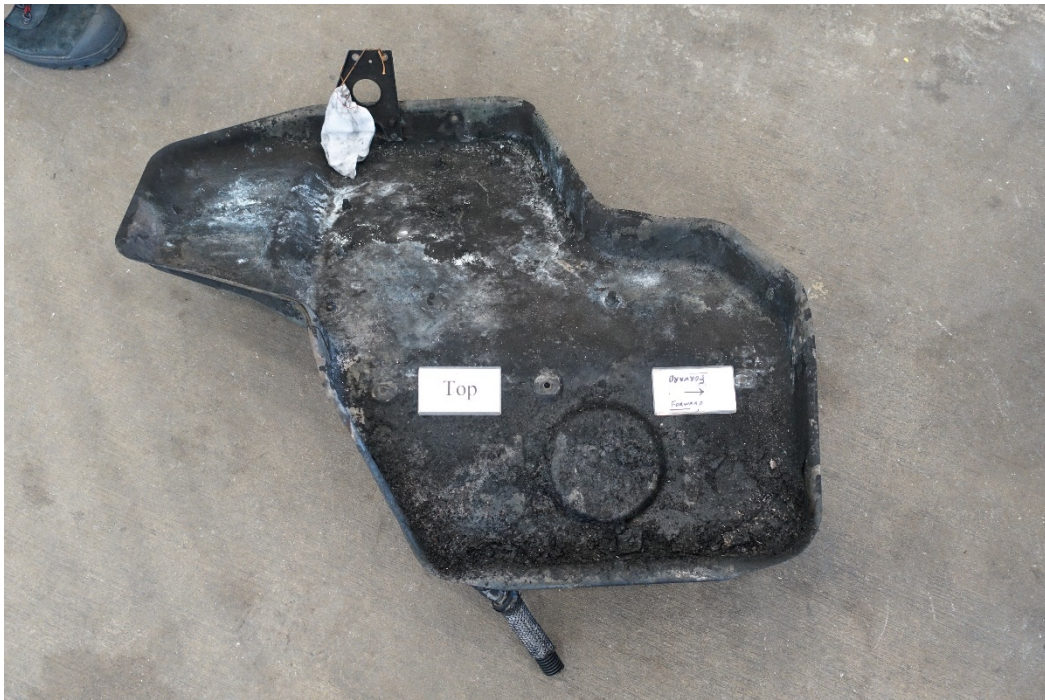
under the pylon hydraulic interface panel was thermally damaged on all surfaces and had charred debris and residue accumulation in the pan catch surface (**Photo 9**).

**Photo 9- Fluid Drip Pan Located Under Pylon Hydraulic Interface Panel**

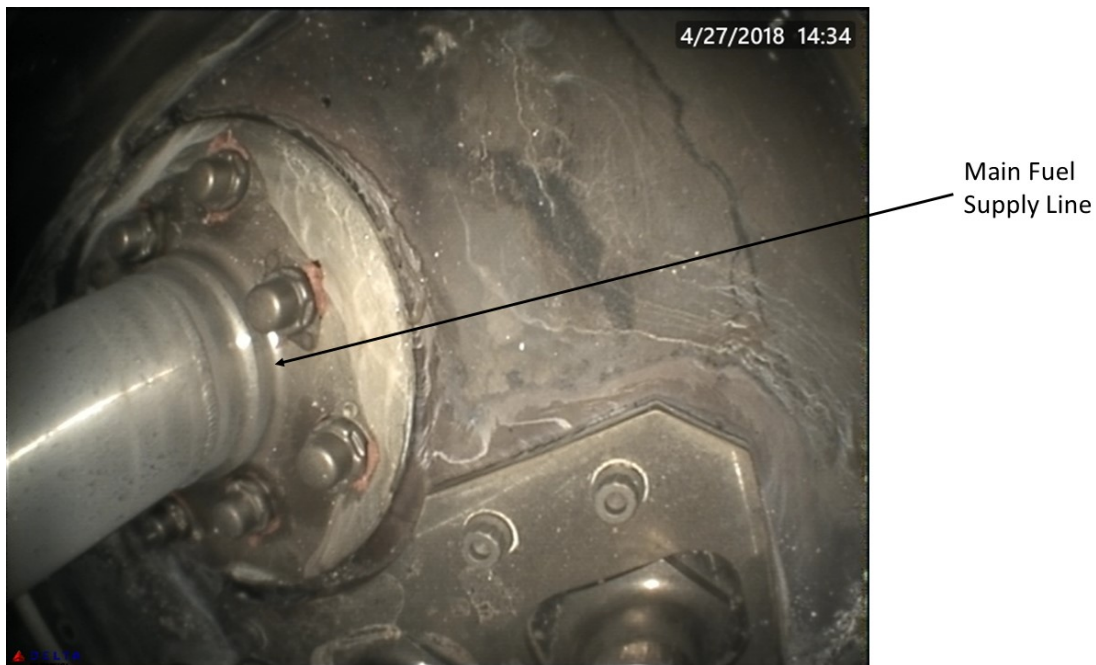
A borescope inspection of the inside of the pylon box was performed to check for indications of thermal damage or fluid accumulation. There were no anomalies noted other than what appeared to be a light residue on the pylon box adjacent to the main fuel supply line (Photo 10).

**Photo 10- Borescope Photo of Rigid Main Fuel Supply Pipe Flange Inside Pylon**

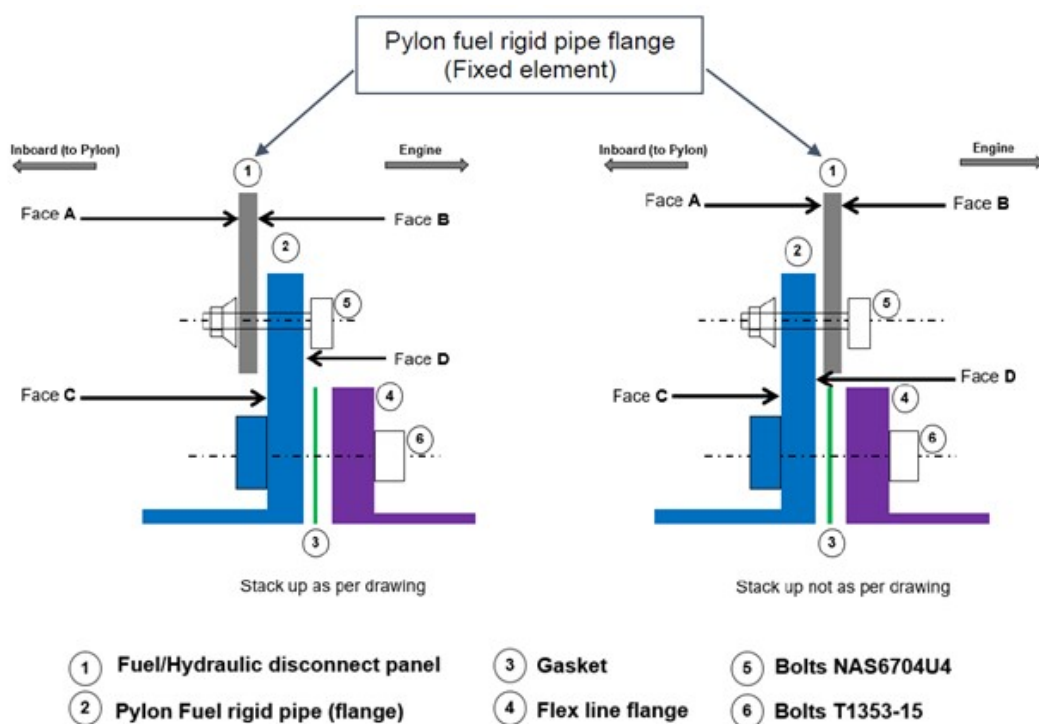
**Figure 11- FM-13 Hose to Rigid Fuel Pipe Stack-Up, (L) Per Drawing, (R) Accident No. 2 Engine (Figure Courtesy of Airbus)**

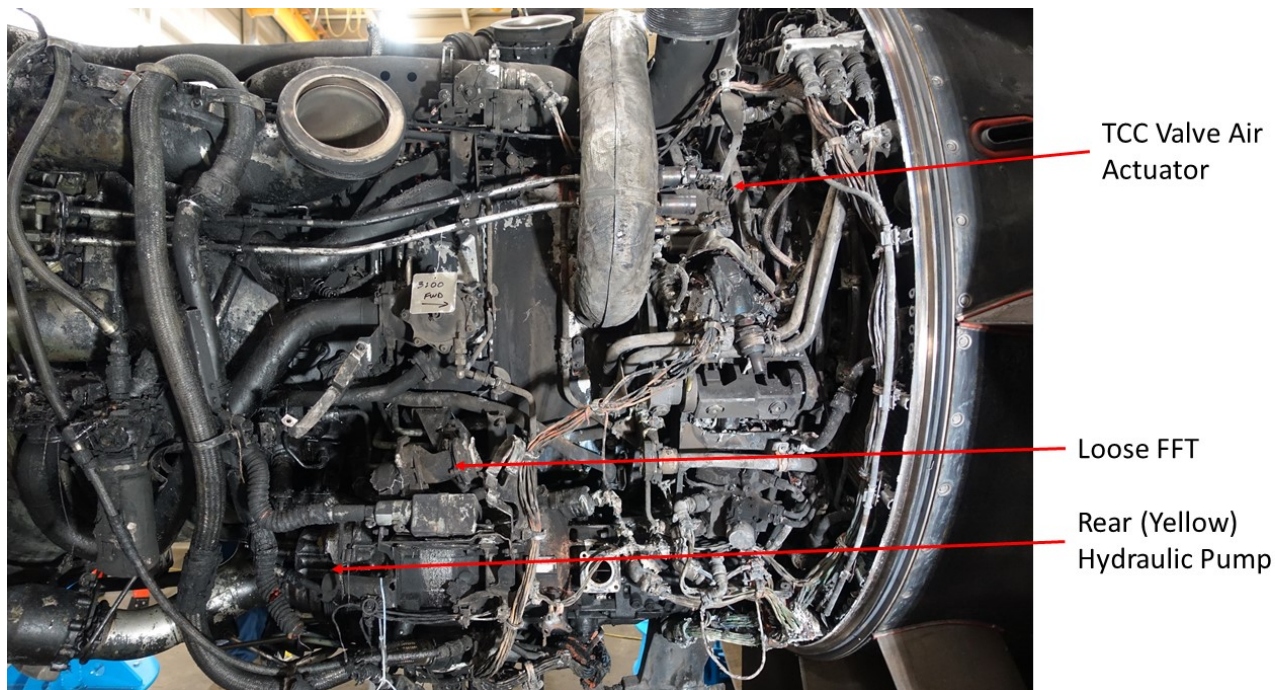
The exterior engine surfaces aft of the D1 flange exhibited thermal damage, discoloration, and heavy sooting. The thermal damage and discoloration were most concentrated circumferentially from the 12 to 6 o'clock positions, axially between the D1 flange and the P flange (LPT to turbine exhaust case). All wire sheathing and clamps in the area were discolored and brittle. The turbine case cooling (TCC) valve air actuator located at the 2 o'clock position, about six inches aft of the D1 flange, was thermally consumed. The stator vane actuator (SVA) was heavily sooted and had melted metal slag on the top of the actuator housing. The fuel flow transmitter (FFT) was separated at the inlet and outlet ports and was resting loose on an air duct<sup>15</sup>. About half of the loose FFT housing was fractured. The forward section of the fuel flow divider valve (FDV) was separated up to the support bracket between the fuel manifold supply lines and the divider valve. The eight fuel manifold supply lines were intact. Both igniter leads were separated from the igniters and the bottom ignition exciter box was loosely hanging from the engine but had been secured to an engine bracket with a zip tie during engine removal. Both igniters and the igniter leads were discolored and thermally damaged. The yellow (forward) hydraulic EDP housing was partially fragmented, and as previously noted, the aft section of the housing was separated and remained attached to the yellow hydraulic pressure line on the pylon interface panel (**Photo 16**). The yellow EDP shaft was sheared. The yellow hydraulic filter housing was separated and missing. The starter was intact but heavily sooted and the starter air valve duct was separated and missing from the 1 to 3 o'clock positions. The TCC lines were thermally damaged and separated between the 2 and 3 o'clock positions on

the LPT case. The exhaust gas temperature (EGT) thermocouple harness on the TEC was damaged from the 3 to 4 o'clock positions.

**Photo 16- Damaged Components on the Right Side of the Engine**

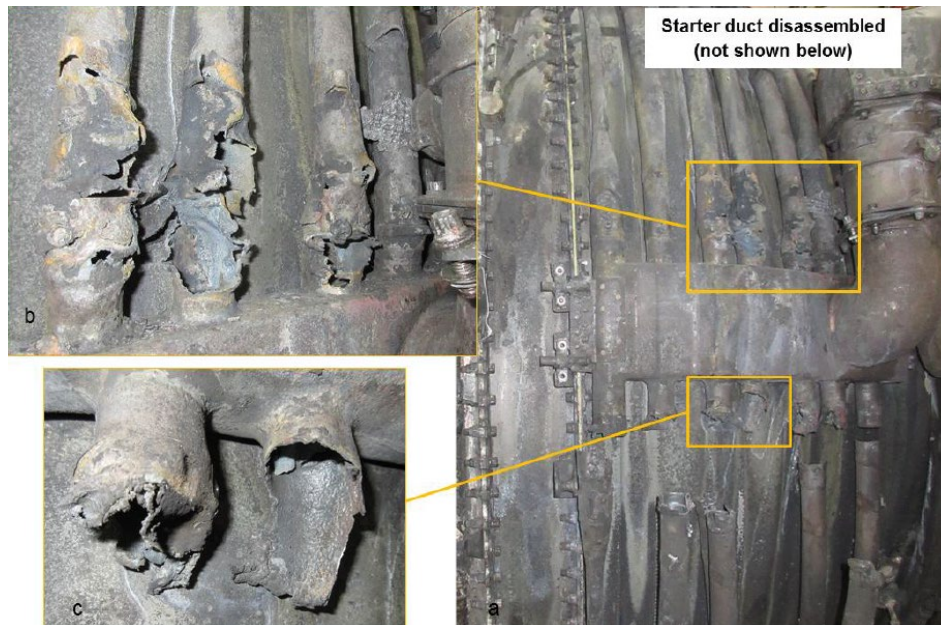
**Photo 17- No. 2 Engine Turbine Case Cooling Manifold, Right Side of Engine, ~3 o'clock Position (Photos Courtesy of Airbus)**

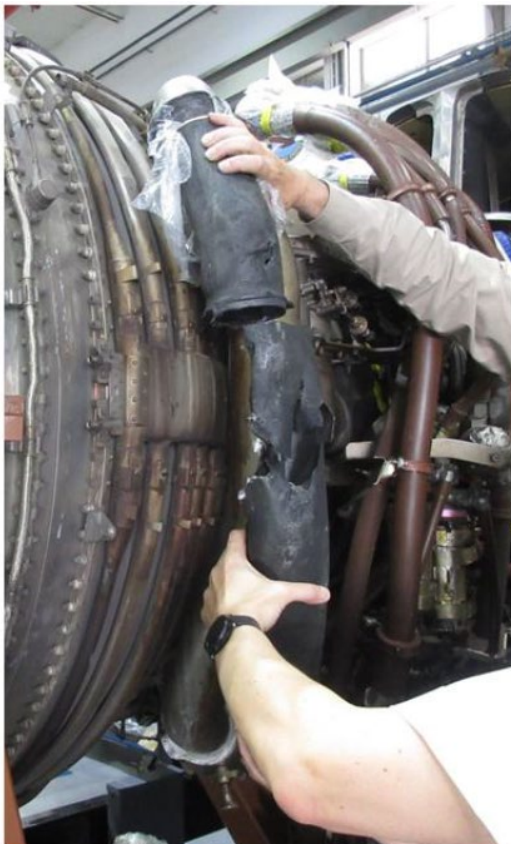
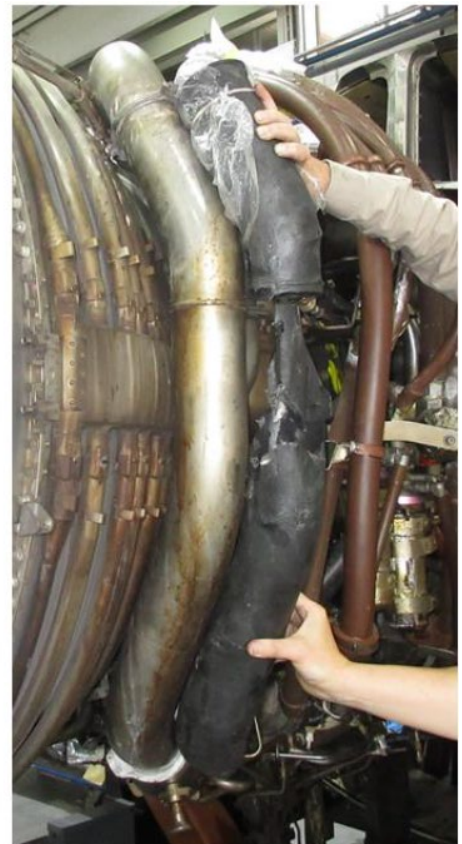
**Photo 18- No. 2 Engine Starter Duct Damage, (L) Accident Engine, (R) Exemplar Engine (Photos Courtesy of Airbus)**

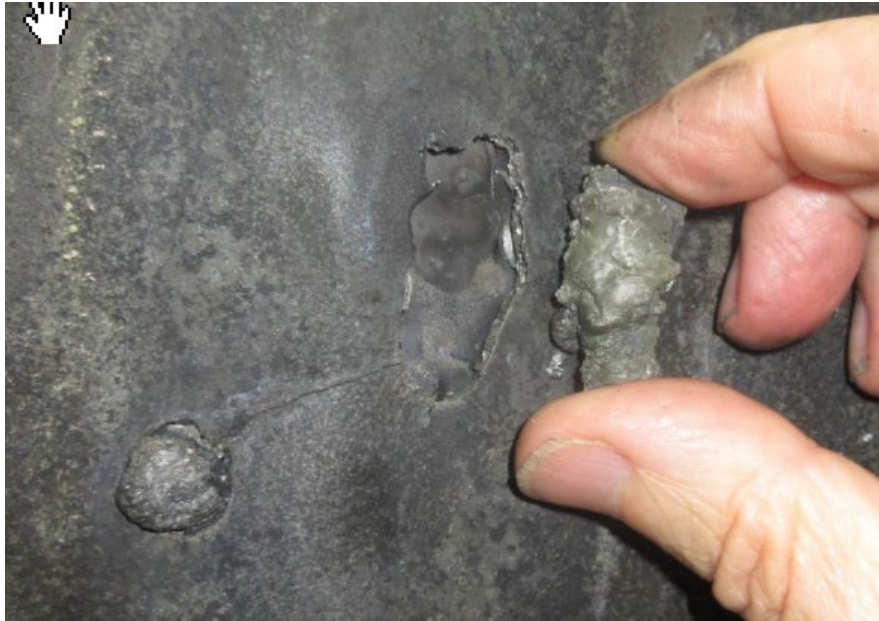
**Photo 20- Photograph of Resolidified Metal Adhered to LPT Case (Photo Courtesy of Airbus)**

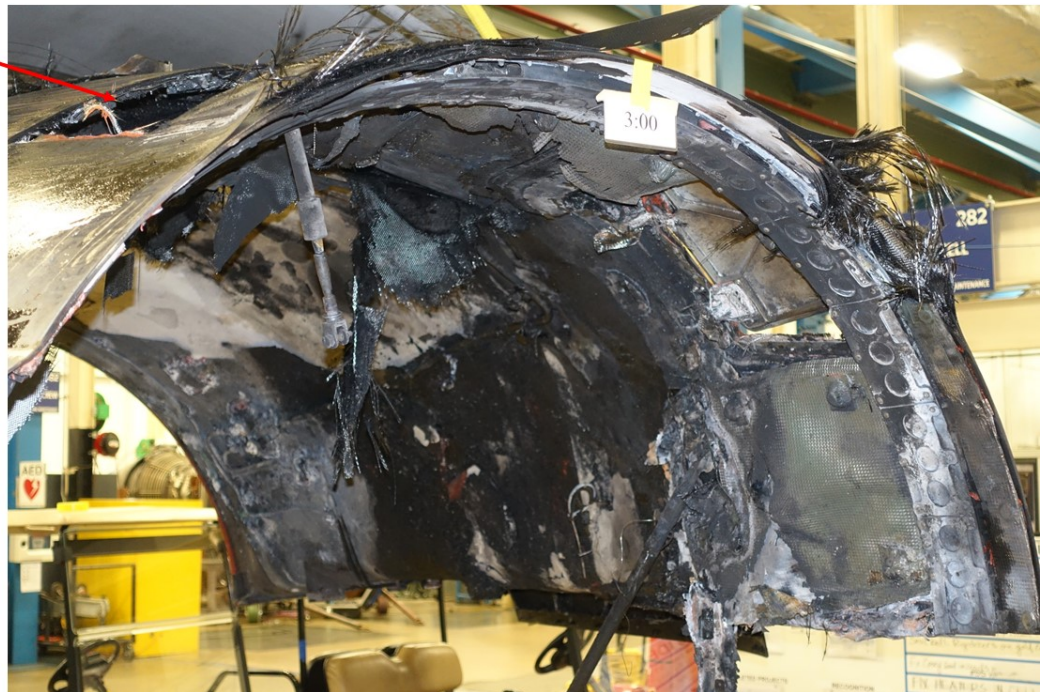
Upper PRD  
Separated

**Photo 22- No. 2 Engine Right (Outboard) Thrust Reverser Door, Upper PRD Separated**

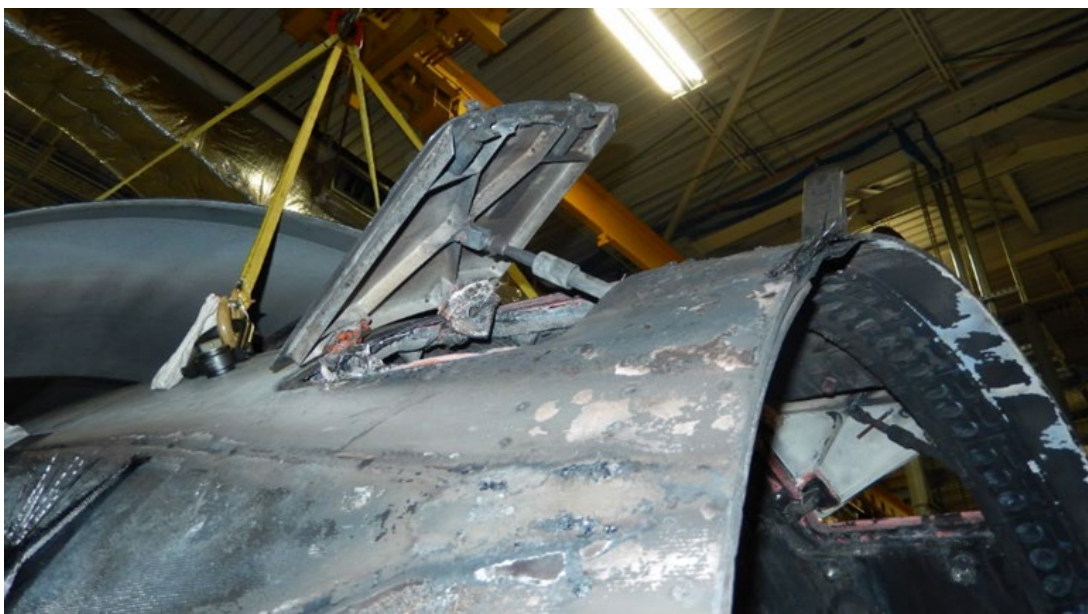
The left thrust reverser door torque box was in good condition. The translating sleeves were intact but thermal damage was observed at the 6 o'clock position. The IFS outer skin was sooted, discolored, and blistered (**Photo 24**). The inner surface fire blanket of the IFS exhibited discoloration, sooting, and thermal damage on all surfaces (**Photo 25**). The fire blanket was partially detached from the IFS structure between the 6 and 8 o'clock positions. The upper and lower PRDs and both the IDG and oil tank access door were in the fully open position. The PRD and access door hinges were discolored and sooted but did not appear deformed. The fire detection loop was complete and secure, but all wire sheathing exhibited thermal damage and most of the isolator grommets were thermally consumed. The IFS outer skin had traces of soot and discoloration aft of the PRD and access door openings, consistent with fire/smoke and hot gases exiting the PRDs during flight.

**Photo 24- No. 2 Engine Left Thrust Reverser Door, Upper and Lower PRDs Open**

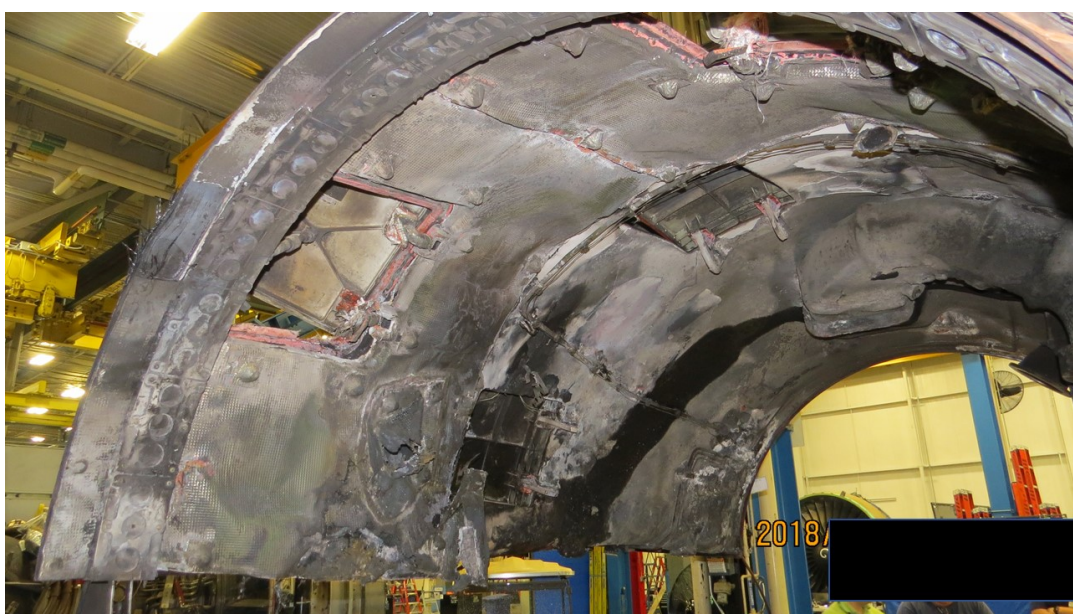
**Photo 25- No. 2 Engine Left (Inboard) Thrust Reverser Door IFS Fire Blanket**

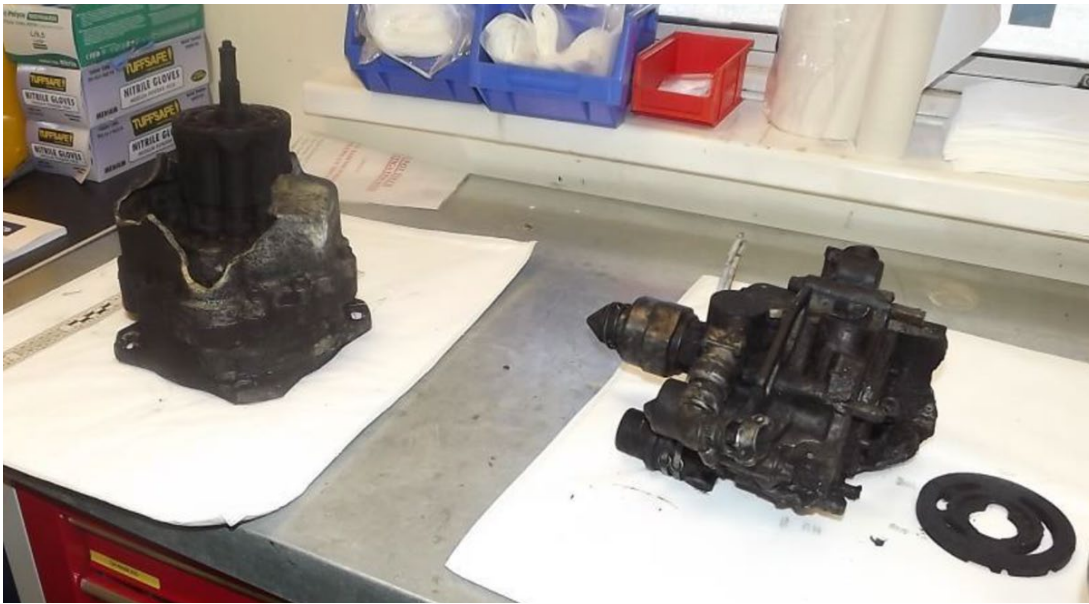
As noted in the engine examination section, the yellow engine driven hydraulic pump was found separated into two pieces. Both pieces were shipped to Airbus-Bremen and then onto the OEM, Eaton Aerospace Systems in Bedhampton, Hampshire, United Kingdom (**Photo 30**). A group exam was completed with party members from the United Kingdom Air Accident Investigation Brach (AAIB), the BEA, Airbus, DAL, and Eaton from April 10-11, 2019.

**Photo 30- Yellow Hydraulic Engine Driven Pump, as Received at Eaton (Photo Courtesy of Eaton)**

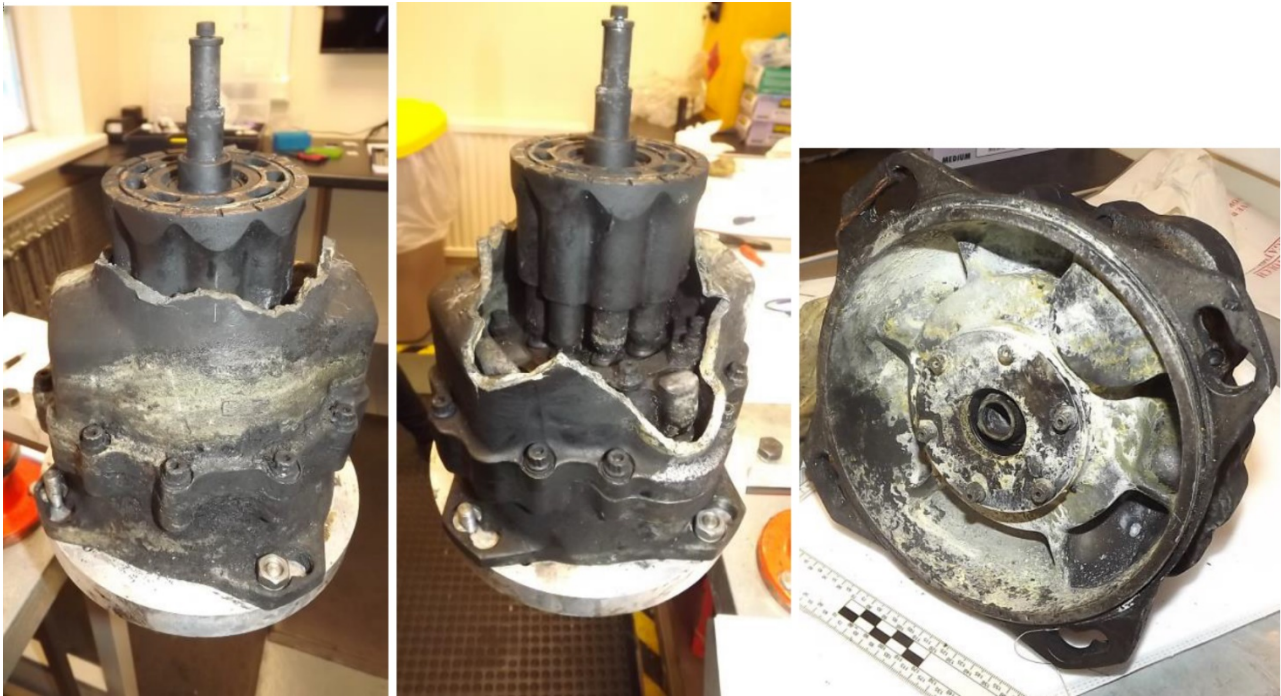
The bottom EDP piece contained the rotating group, and the top piece contained the valve block, compensator, adaptor block, and wafer plate (**Photo 31**). An inspection of the dynamic surfaces did not reveal any evidence of excessive or accelerated wear or mechanical failure. The aluminum impeller was thermally damaged and fractured into three pieces (**Photo 32**). There was no evidence of EDP malfunction prior to the engine fire event.

**Photo 31- Yellow Hydraulic Engine Driven Pump, Bottom Section (Photos Courtesy of Eaton)**

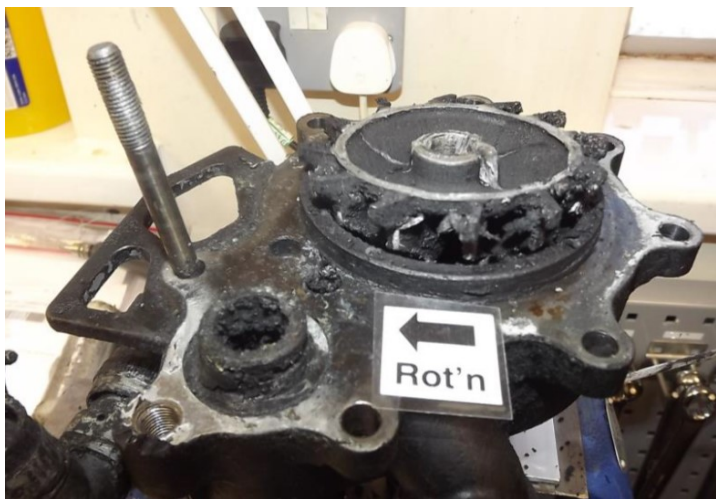
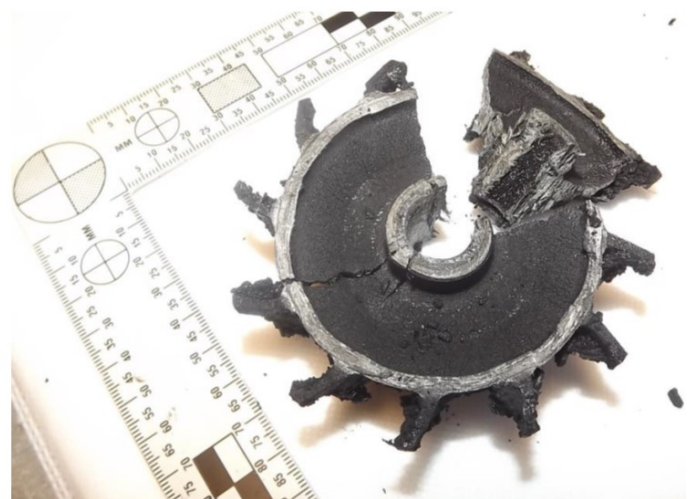
**Photo 32- Yellow Hydraulic Engine Driven Pump Impeller (Photos Courtesy of Eaton)**

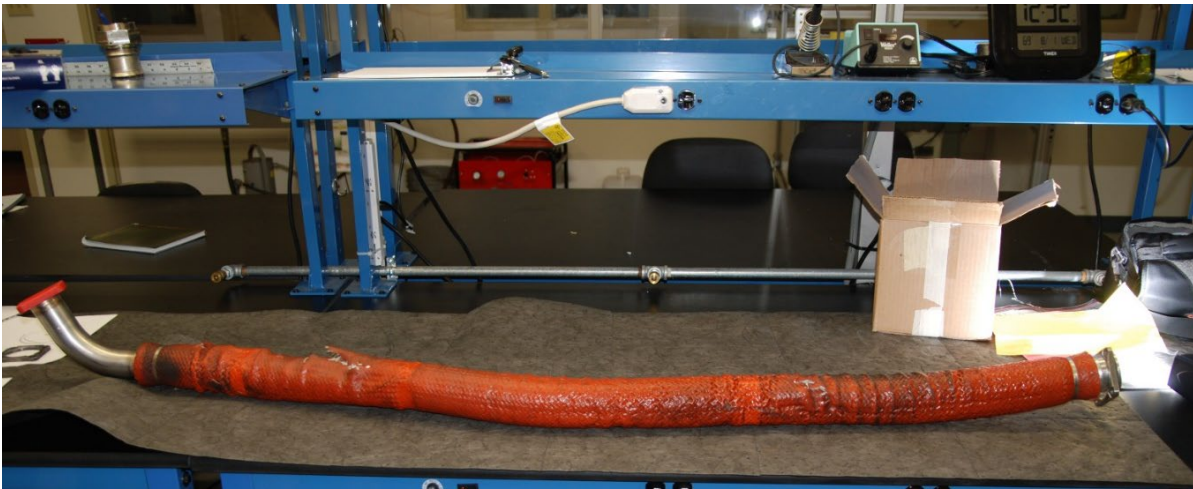
The AMS FM-13 hose fire sleeve had multiple tears and exhibited degradation of the silicone layer (**Photo 34**). The hose was installed in the Parker Stratoflex pressure test bench with production tooling (**Photo 35**). The test bench used water as the pressure fluid. The hose was leak tested at the pressures and time durations shown below in **Table 4**. No leaks were observed.

**Photo 34- AMS FM-13 Hose, As Received**

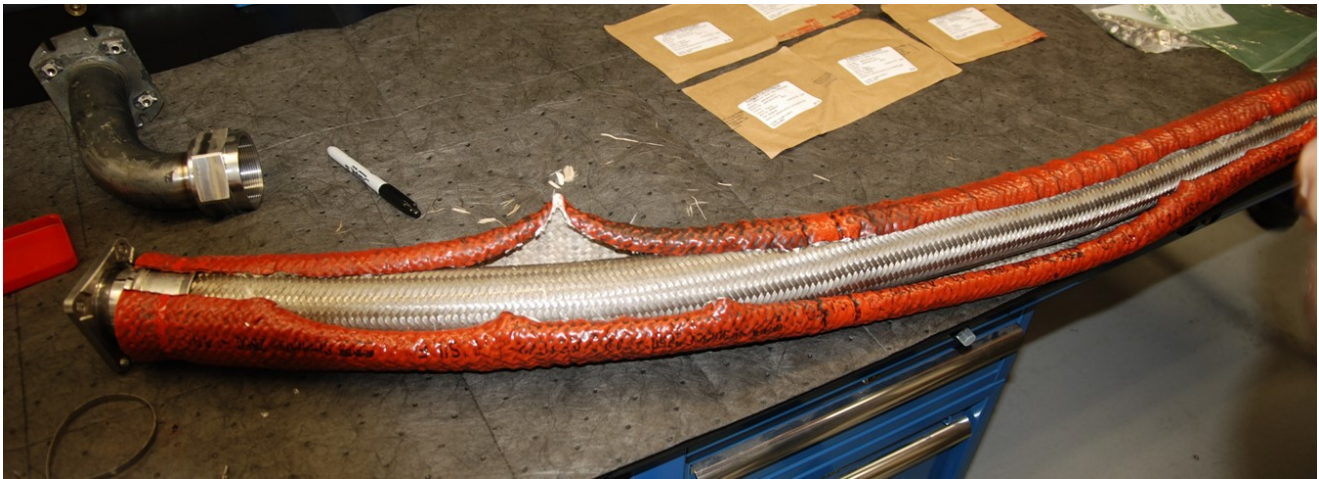
The AMS FM-13 hose fire sleeve was cut lengthwise and removed after testing to examine the metallic braid. The metallic braid was intact and in good condition with no visible nicks or deformation (**Photo 36**).

**Photo 36- AMS FM-13 Hose Fire Sleeve Removal**

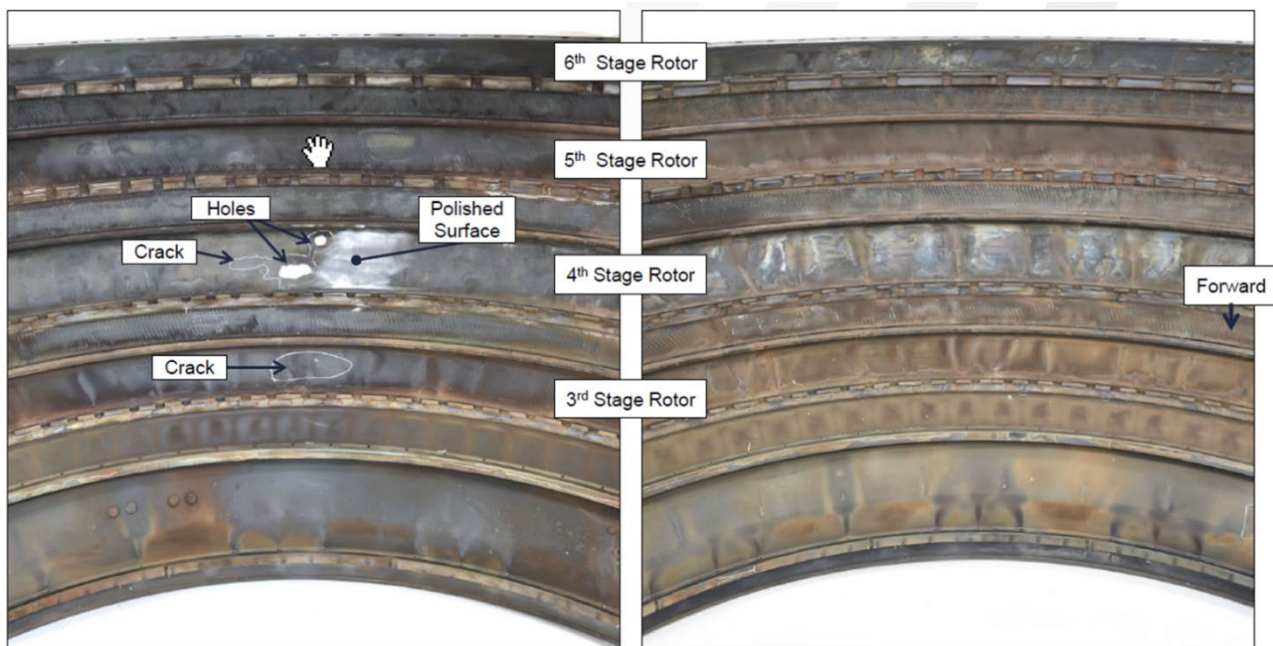
Approximately 3 o'clock position  
Internal surface exhibited a dark discolored appearance
