## NATIONAL TRANSPORTATION SAFETY BOARD

### Maintenance Records – Factual

NTSB No: DCA18MA142

Operator: Southwest Airlines  
Location: Philadelphia, Pennsylvania  
Date: April 17, 2018  
Time: 11:03 Eastern Daylight Time<sup>1</sup>  
Airplane: Boeing 737-7H4, Registration Number: N772SW, Serial No: 27880

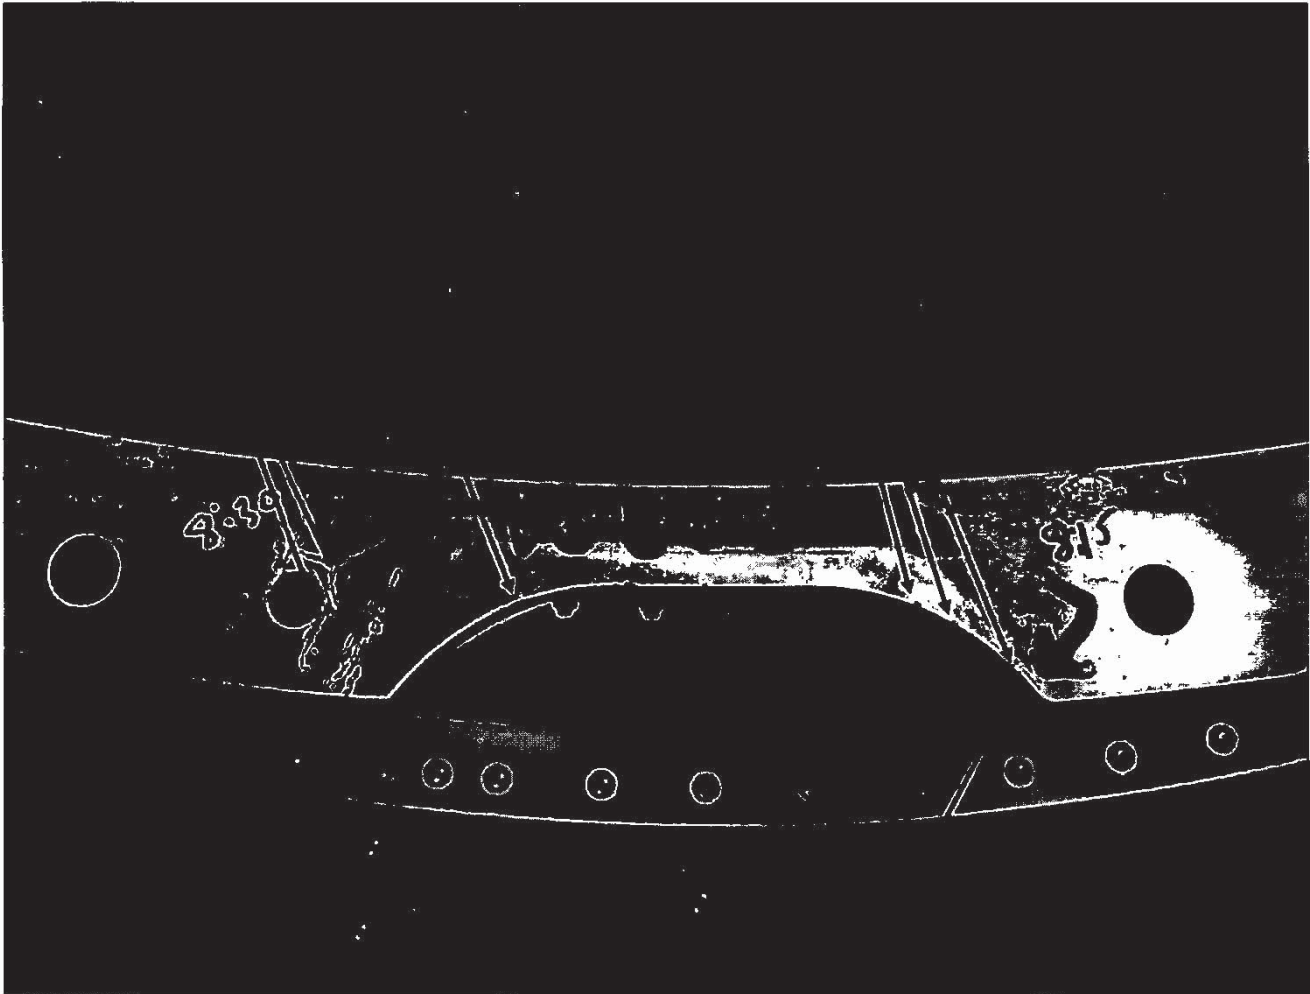
| Discrepancy: Attach Ring has several nicks along attach Lug from 8:00 to 8:30 positions | Corrective Action: Repaired per EA-1-771-1098 |

**Nicks and Scratches shown at 8:15/8:30 O'clock Positions**

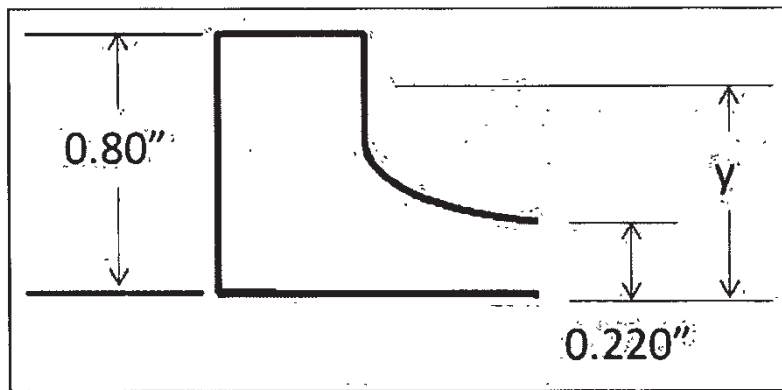
**Figure 1 – 1 (Sheet 3 of 6)**

**Section Cut across the Flange Blended Out**

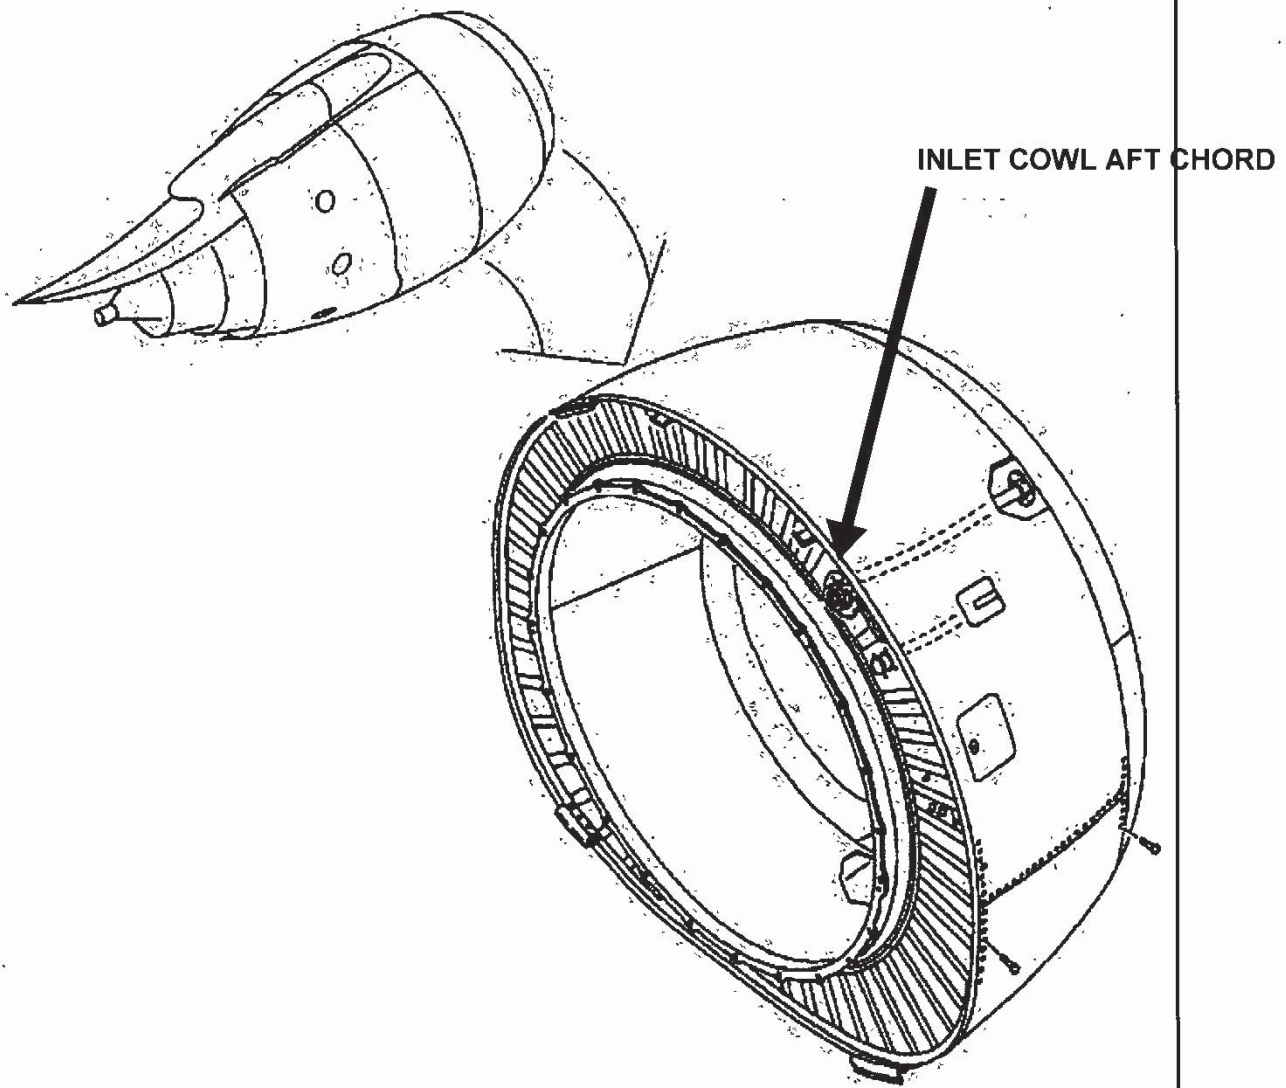
FIGURE 1 - INLET COWL AFT CHORD

| Discrepancy: UPPER Chord<br>is worn. | Corrective Action: Installed upper Chord<br>JAW CMM 71-11-22 & SKM<br>51-40-02 |

| Discrepancy: Lower Chord<br>is worn | Corrective Action: removed and<br>Replaced lower Chord<br>JAW CMM 71-11-22 |
