DOCKET NO. SA-542

# NATIONAL TRANSPORTATION SAFETY BOARD

NTSB ID No. DCA18MA142

## TIMELINE STUDY

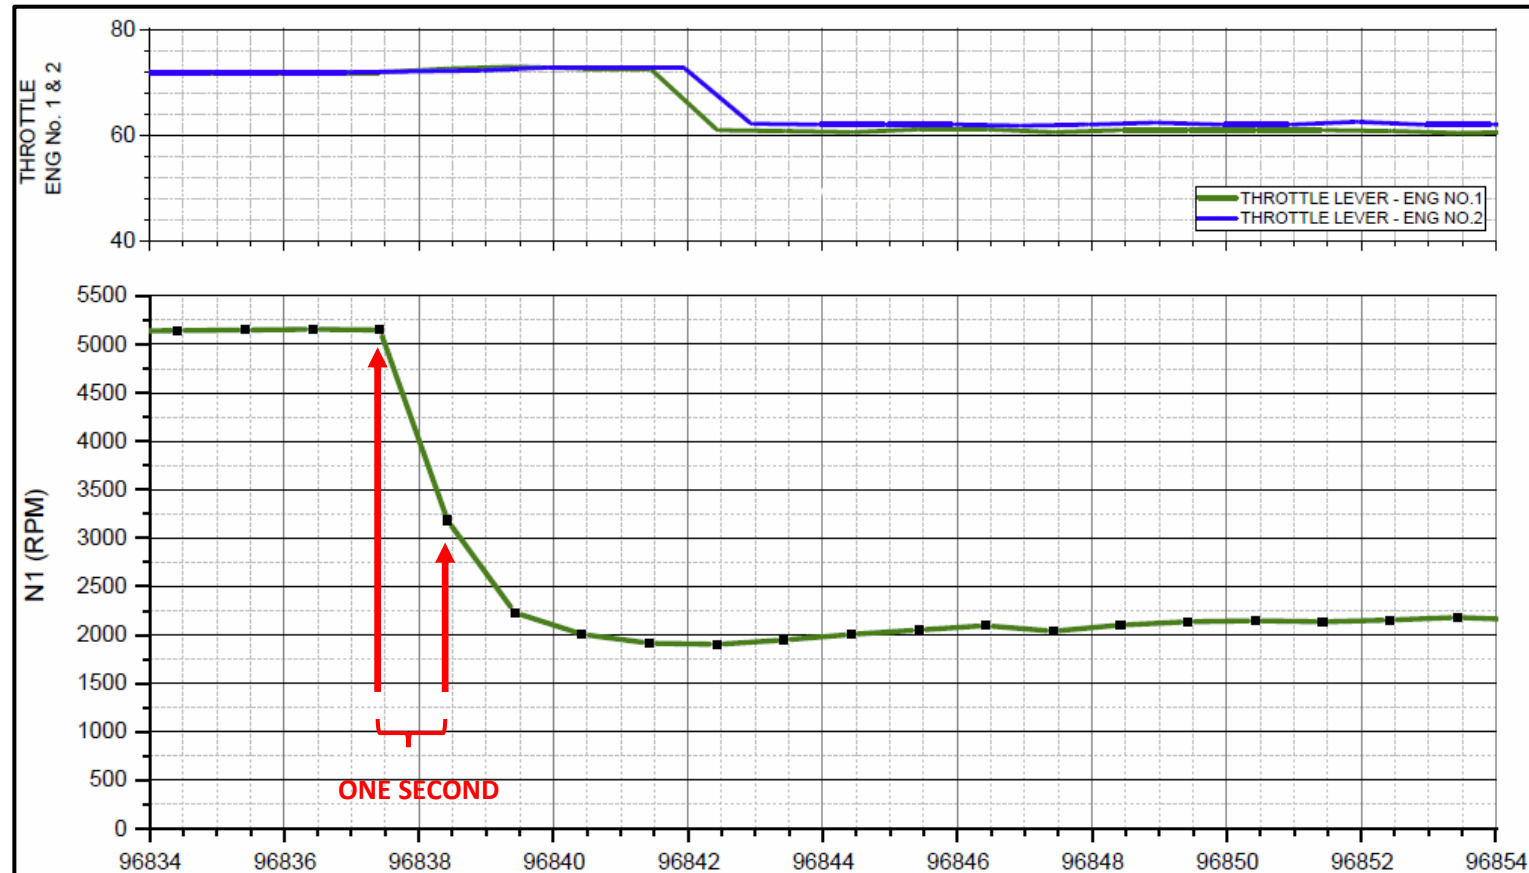
FIGURE 1 - Data showing the reduction of N1 after the FBO event

The engine fan speed (N1) and the position of the throttles before and after the fan-blade-out event were determined by reviewing flight data recorder (FDR) data (Figure 1). The data revealed that the left engine's fan speed was 5,149 rpm just prior to the event and then rapidly decreased between times 96837.42 and 96838.42.

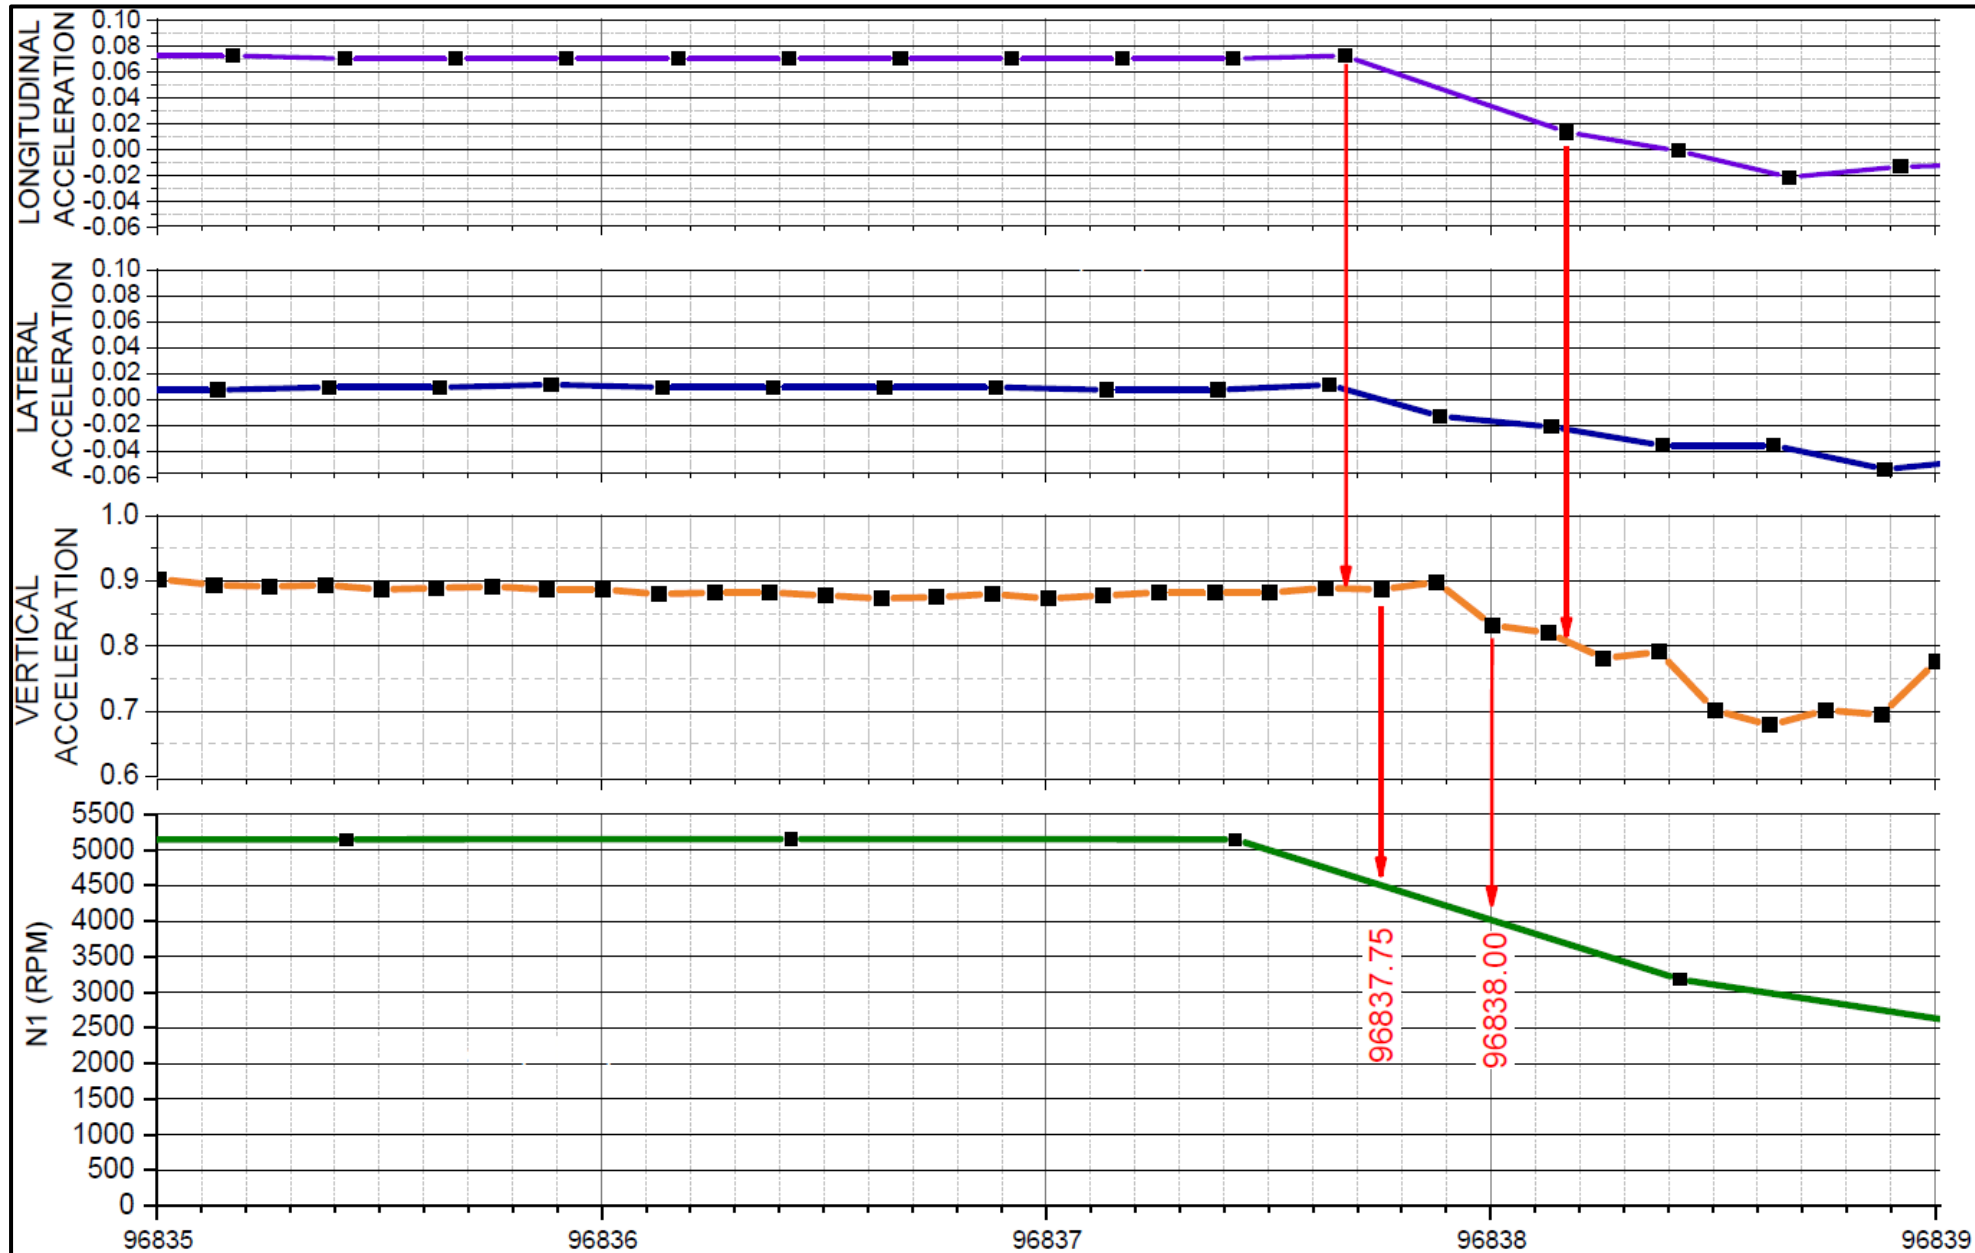
FIGURE 2 - FDR Data showing acceleration data and left engine speed (N1)

**FBO**  
**TIMING ANALYSIS:**  
Based on the acceleration data, the FBO likely occurred between SRN 96837.75 & 96838.00

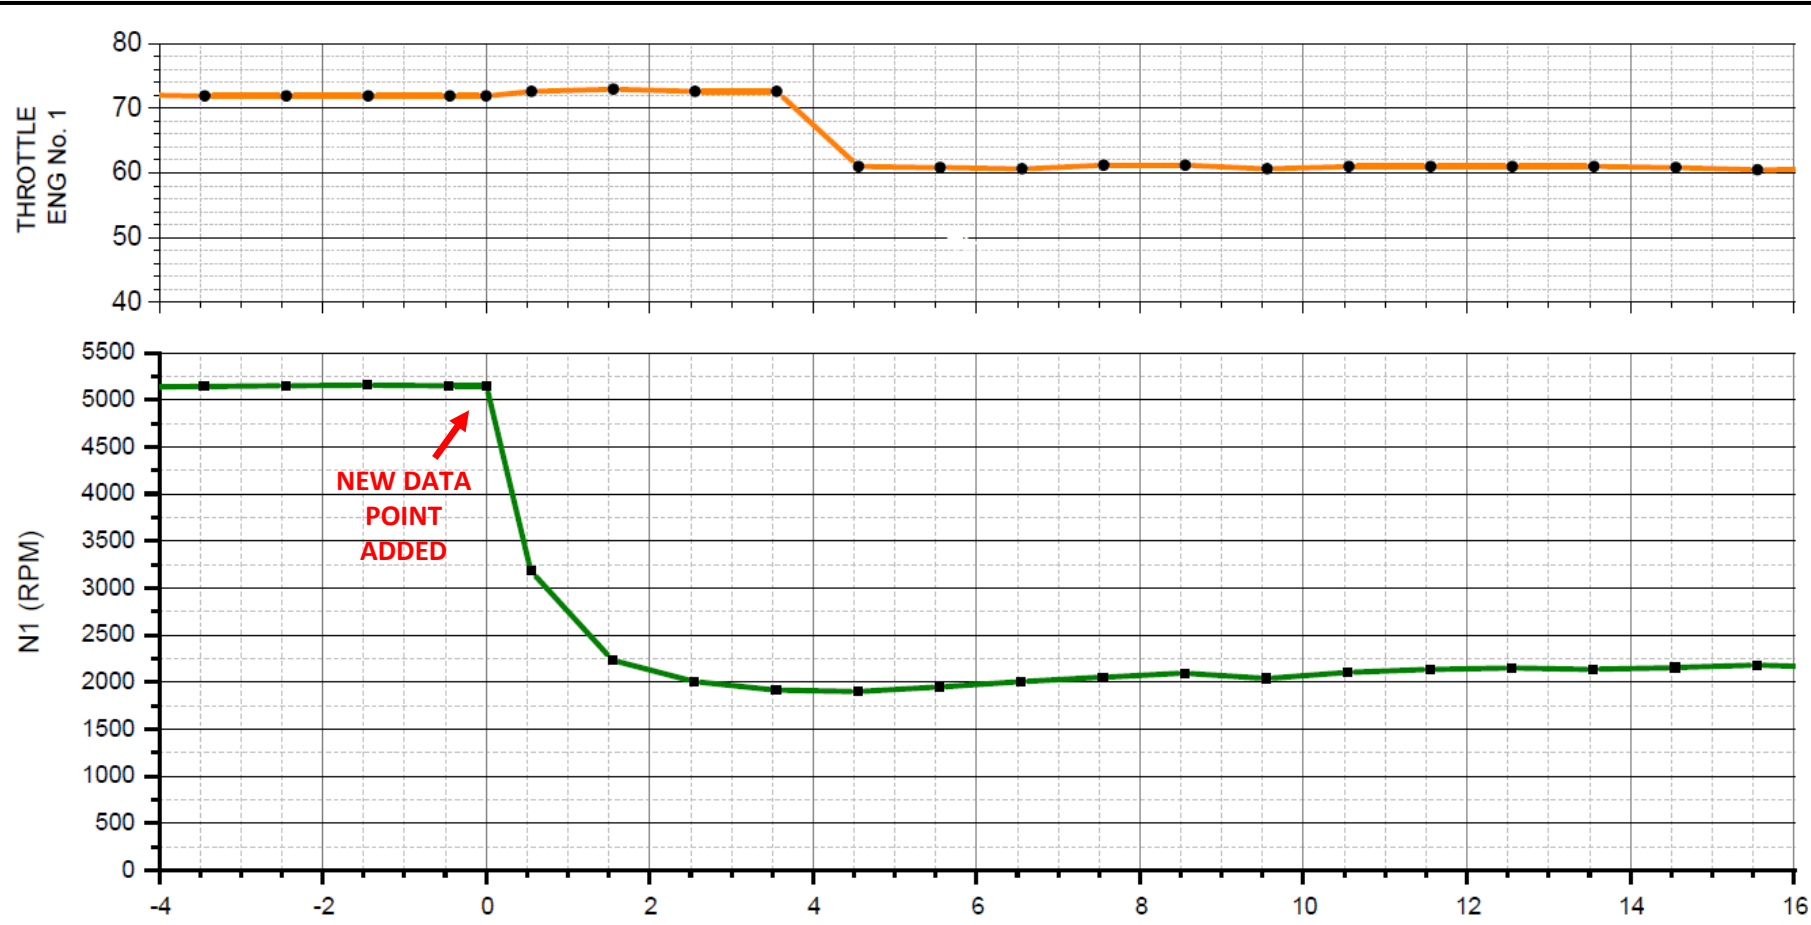
FIGURE 3 - FDR Data showing left throttle position (%) and left engine speed (N1)

1. Based on the position changes of the acceleration data, the FBO likely occurred sometime within the range of SRN 96837.75 & 96838.00 (see previous slide).
2. For further SOE analysis, it will be assumed that the FBO occurred at the midpoint between the time range (96837.88). And as such, this point will become the new time = 0 point.
3. A data point was inserted into the engine fan speed (N1) plot (Figure 3) to represent the calculated time of the FBO

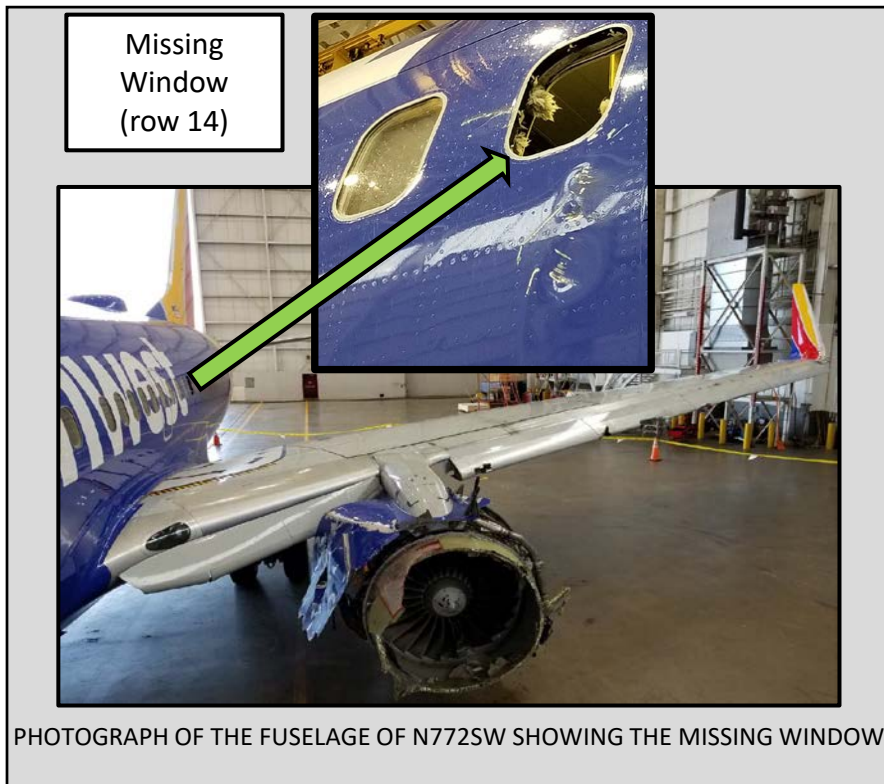
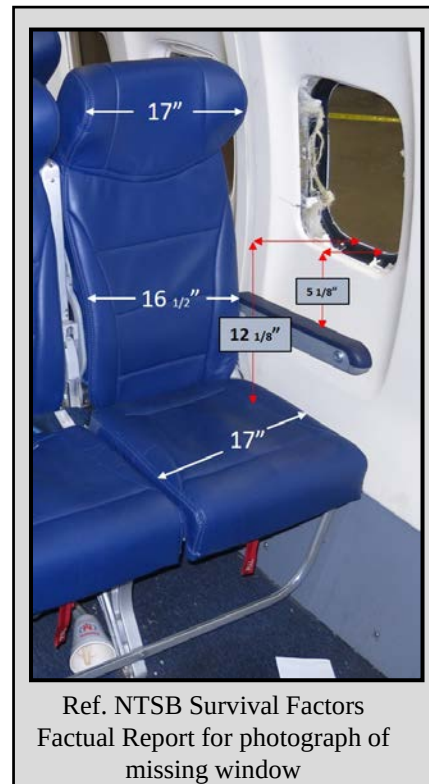
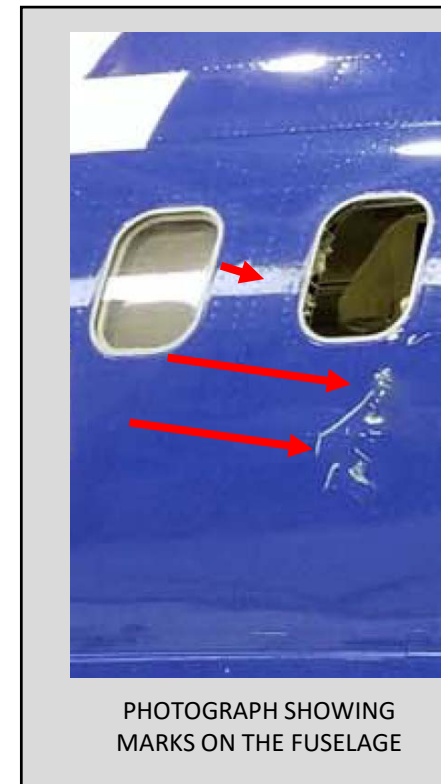
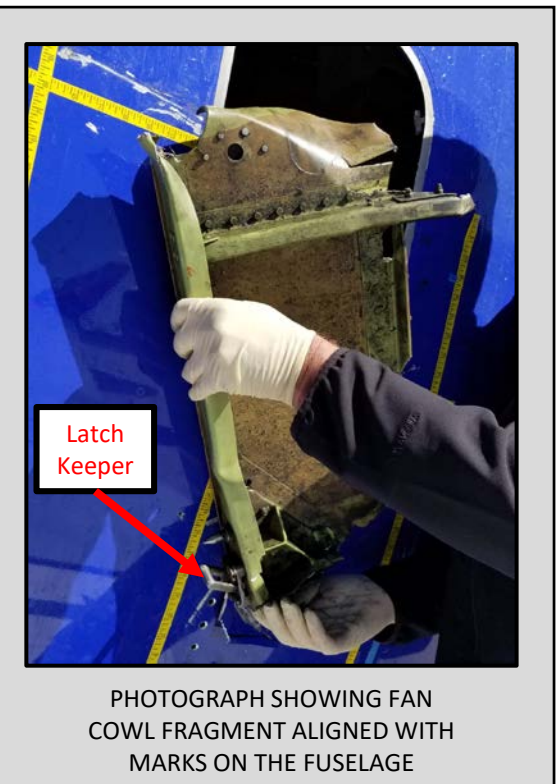
Examination of the fuselage (exterior and interior) revealed that the window at row 14 was not present. Neither the window assembly or any remnants of the assembly were found. Examination of the area near the window revealed impact marks on the exterior of the fuselage forward and below the window. The characteristics of some of the marks on the fuselage were consistent with the characteristics of a fragment of the inboard fan cowl.

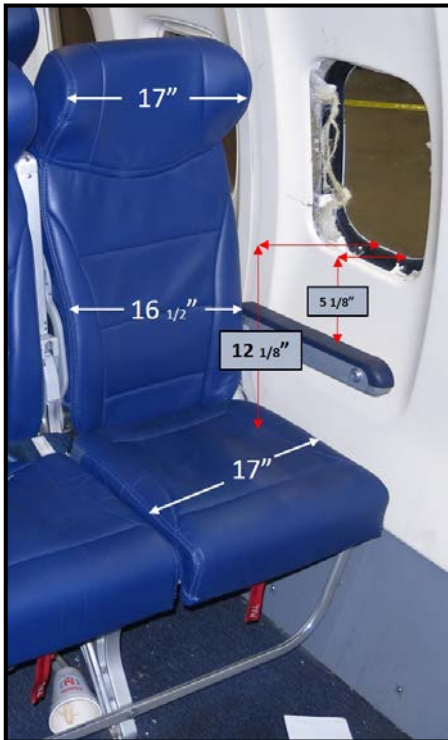
Ref. NTSB Survival Factors Factual Report for photograph of missing window

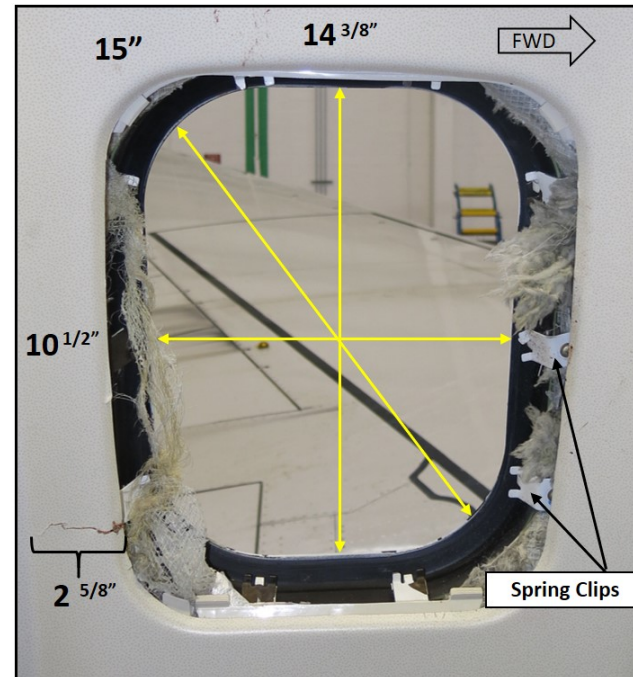
Ref. NTSB Survival Factors Factual Report. The window has an approximate area of  $167.6 \text{ in}^2$

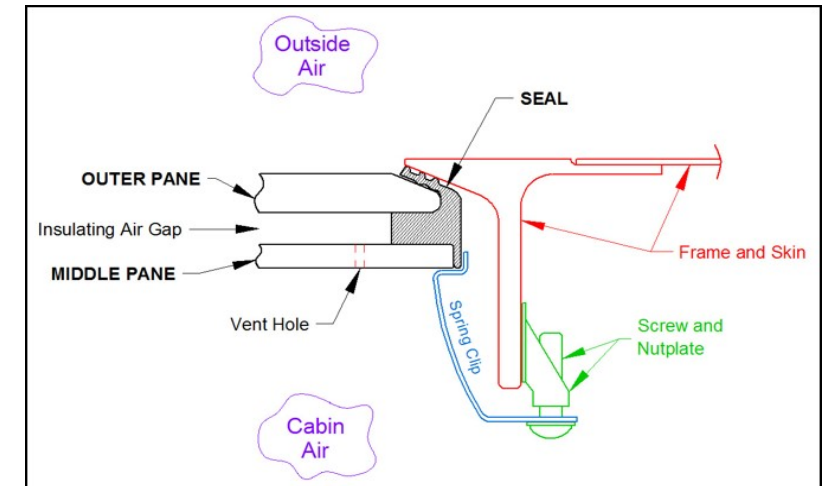
Ref. NTSB Survival Factors Factual Report. The aircraft window is installed with a rubber seal and 10 spring clips

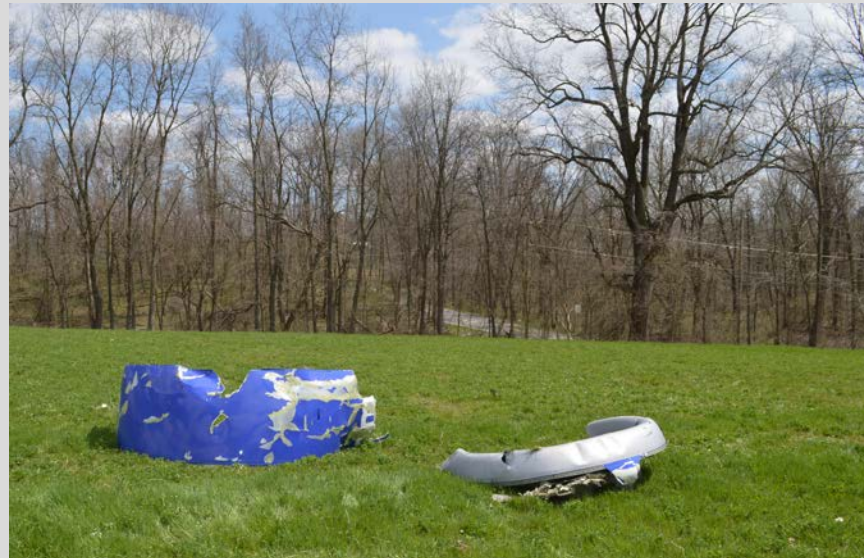
PHOTOGRAPH OF THE LOWER LIPSKIN  
AND OUTER BARREL IN A DITCH

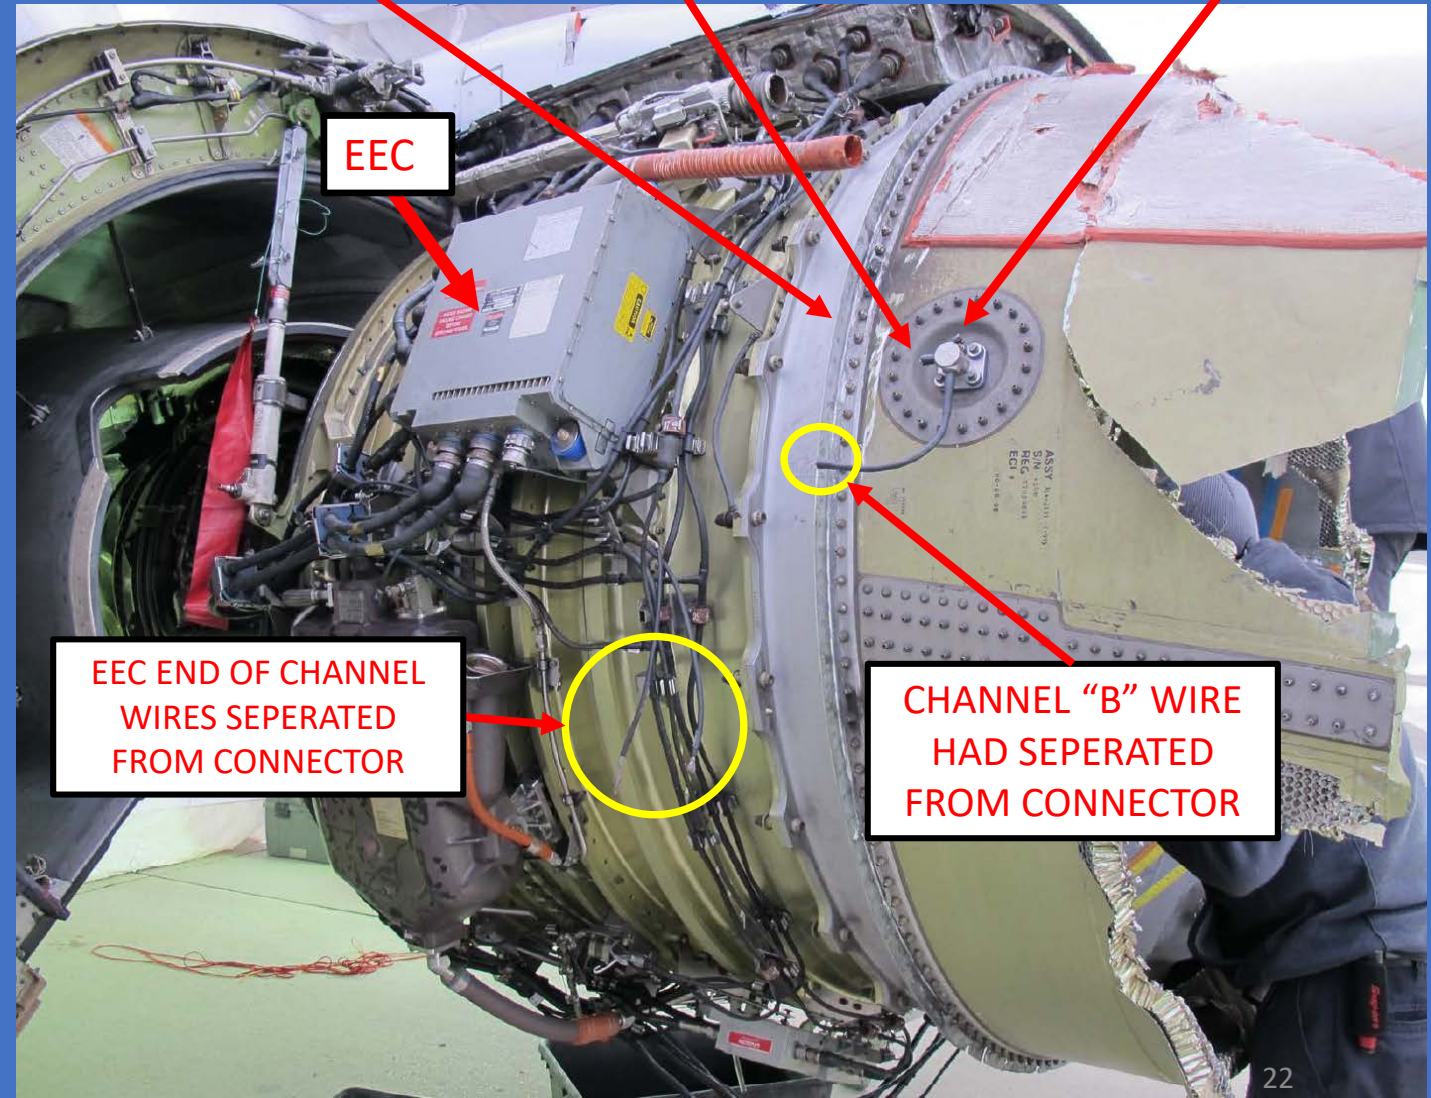
- EEC was intact and attached to engine
- T12 Sensor was intact and in-place
- SENSOR wiring was damaged
- Aft bulkhead was not present

AFT BULKHEAD  
NOT PRESENT 360°

CHANNEL "A" WIRE  
FRACTURED AT SENSOR

GROUND WIRE  
FRACTURED AT SENSOR

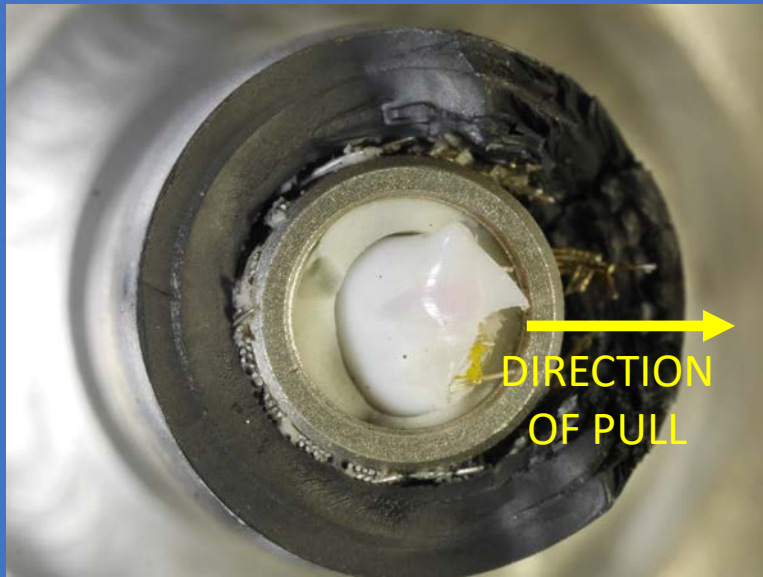
- T12 Probe was in good condition
- All examined wire fractures are consistent with tension overload
- Observed 'pull' direction for 'A' channel wire was consistent with a 'downward' (airplane sense) direction.

CHANNEL "A" FRACTURED AT PROBE

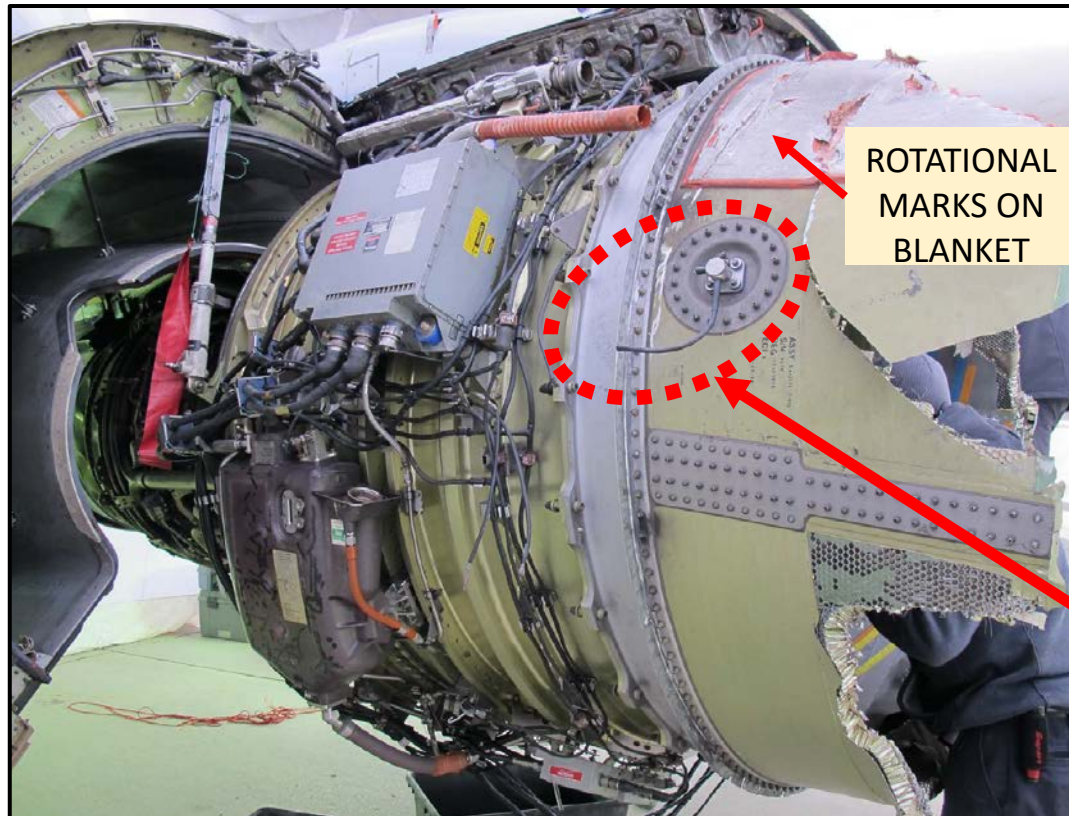
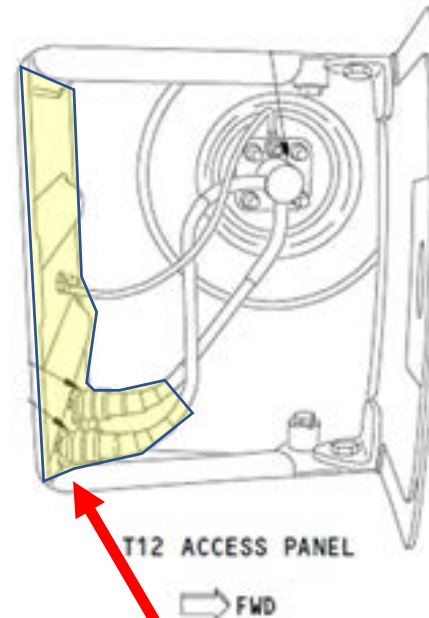
- EXACT TIMING FOR WHEN THE INLET (OR PORTIONS OF THE INLET) DEPARTED THE ENGINE IS NOT KNOWN AT THIS TIME.
- THE T12 SENSOR WIRING WAS LIKELY DAMAGED WHEN THE AFT BULKHEAD (SECTION WHERE WIRES WERE ATTACHED) MOVED SUFFICIENTLY.
- THE T12 CHANNEL "A" SENSOR WIRING WAS SEVERED BETWEEN 6.2 AND 7.15 SECONDS AFTER THE FBO

PORTION OF AFT BULKHEAD NOT FOUND

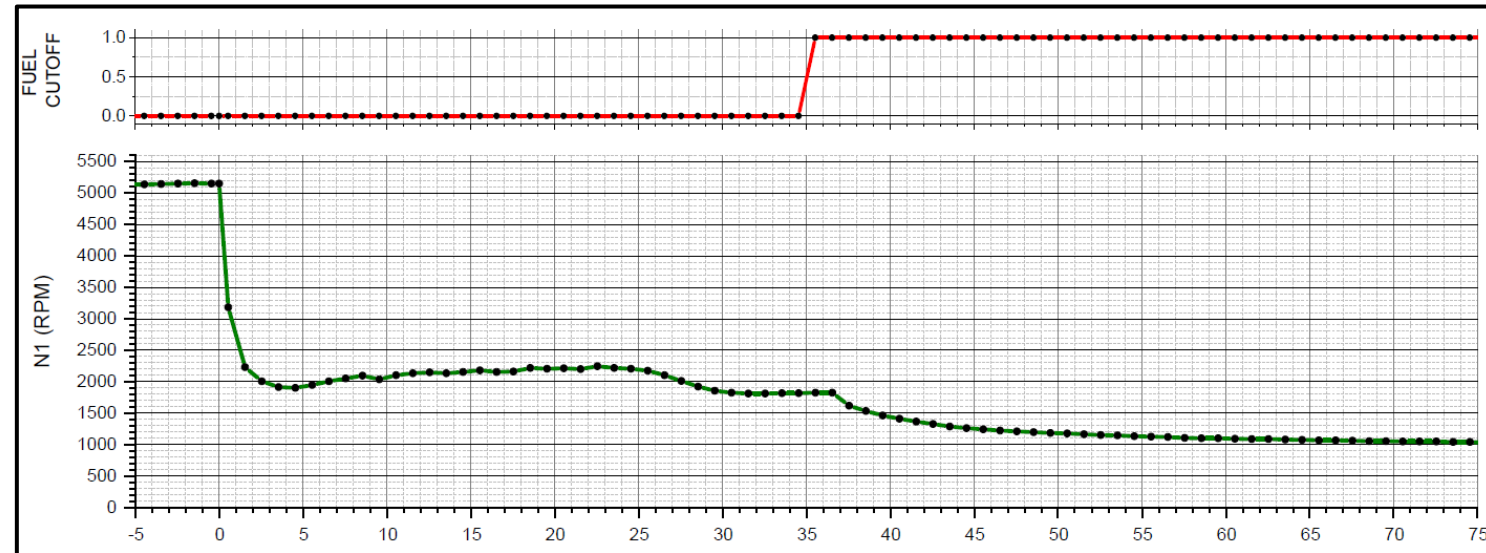
FIGURE 1 – N772SW Fuel Cutoff to Left Engine

The timing for when the fuel was cutoff to the left engine was determined by reviewing flight data recorder (FDR) data. The data revealed that the Eng1 Cutoff discrete (left engine fuel cutoff) transitioned from 0 (run) to 1 (Cutoff) between times 96872.41 and 96873.41. Aligning the timing of the fuel was cutoff discrete with the calculated timing of the FBO indicates that the fuel to the left engine was cutoff between 34.41 and 35.41 seconds after the FBO
