**NATIONAL TRANSPORTATION SAFETY BOARD**

**STRUCTURES GROUP CHAIRMAN'S FACTUAL REPORT**

**NTSB No.: DCA18MA142**

NATIONAL TRANSPORTATION SAFETY BOARD  
Office of Aviation Safety  
Washington, D.C. 20594  
November 7, 2018

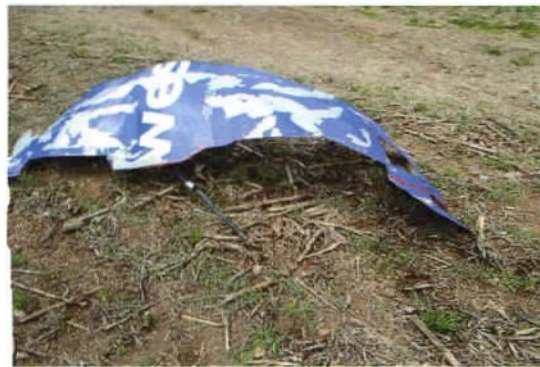
Figure 8 – Outer Barrel, Part 1 Site 1(P1S1)

Part 1 Site 1 (P1S1) was found in place and recovered by two Pennsylvania Game Commission employees. The part was placed in storage and the location had been marked. The piece was reported as being found with the painted side facing upwards, and the control arm submerged into the ground approximately four inches. It was located at 40.4192790, 76.0904399. See Figure 8.

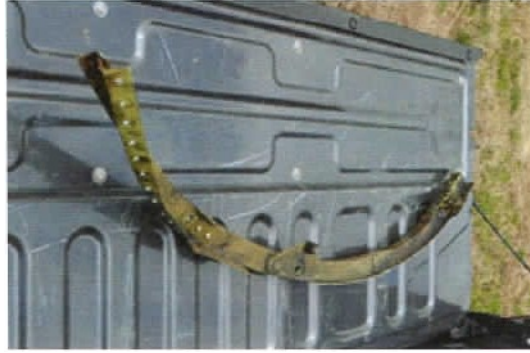
Figure 9 – Fan Cowl Frame, Part 3 Site 1 (P3S1)

Part 3 Site 1 (P3S1) was recovered in the tree line which separates the 9th and 16th fairways of the Heidelberg Country Club, 1 Club House Drive, Bernville, PA. The part was located at 40.42605833, 76.12555556. See Figure 9.

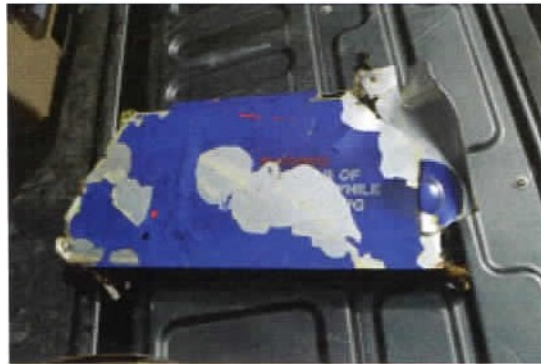
Figure 10 – Section of the Inboard Fan Cowl, Part 4 Site 1 (P4S1)

Part 4 Site 1 (P4S1) was recovered on the woman's tee of the 17th hole of the Heidelberg Country Club, 1 Club House Drive, Bernville, PA. The part was located at 40.42888889, 76.12833333. See Figure 10.

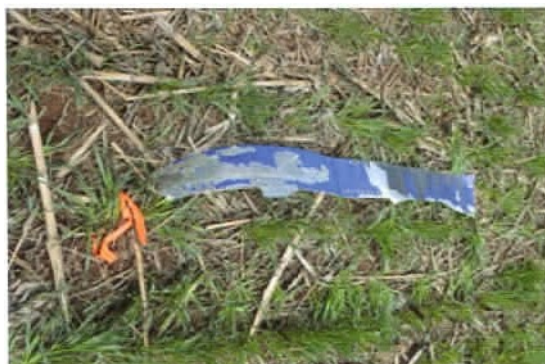
Figure 11 - Fan Cowl, Part 5 Site 1 (P5S1)

Part 5 Site 1 (P5S1) was recovered in place and located at 40.4197168, 76.0924710. See Figure 11.

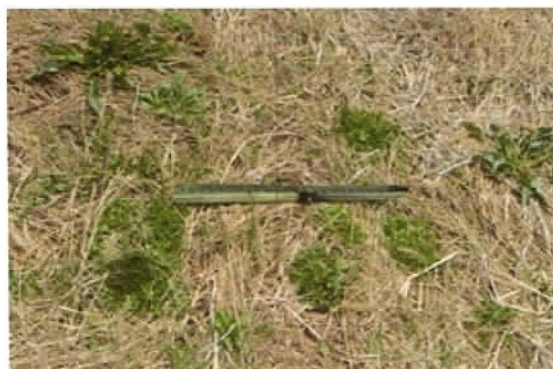
Figure 12 – Fan Cowl, Part 6 Site 1 (P6S1)

Part 6 Site 1 (P6S1) was recovered in place and located at 40.4192145, 76.0906424. See Figure 12.

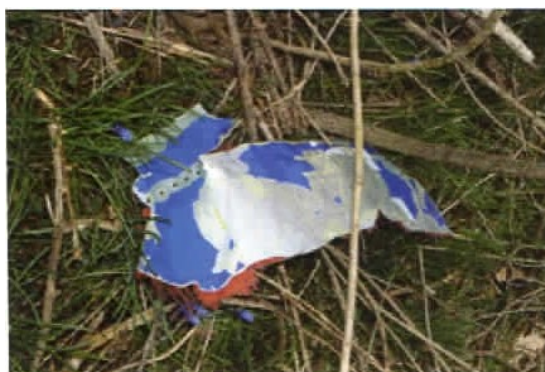
Figure 13 – Fan Cowl, Part 7 Site 1 (P7S1)

Part 7 Site 1 (P7S1) was recovered in a wooded area in place and located at 40.4197224, 76.00876859. See Figure 13.

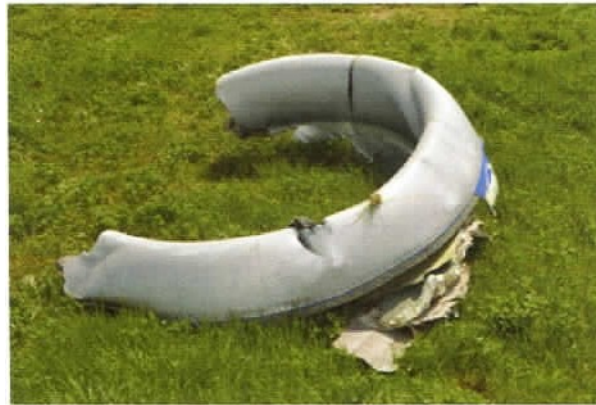
Figure 14 - Upper D-Duct, Part 1 Site 2 (P1S2)

Part 1 Site 2 (P1S2) was recovered in place and located at 40.421134, 76.1597123. See Figure 14.

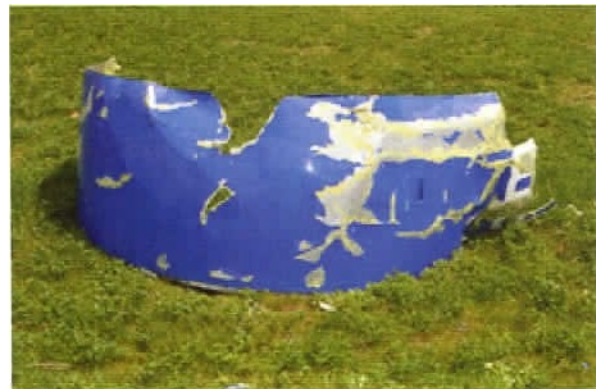
Figure 15 – Upper Outer Barrel, Part 2 Site 2 (P2S2)

Part 2 Site 2 (P2S2) was recovered in place and located at 40.421134, 76.1597123. See Figure 15.

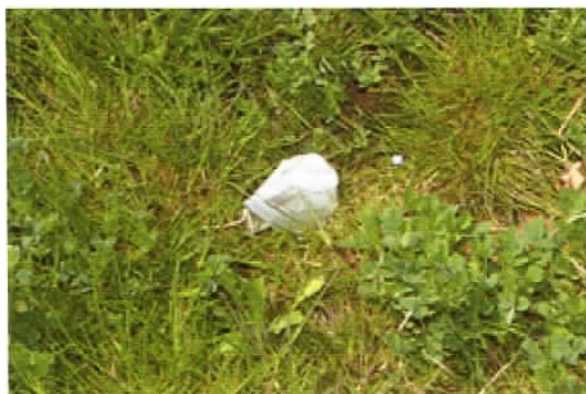
Figure 16 – Metallic and honeycomb part, Part 3 Site 2 (P3S2)

Part 3 Site 2 (P3S2) was recovered in place and located at 40.421134, 76.1597123. See Figure 16.

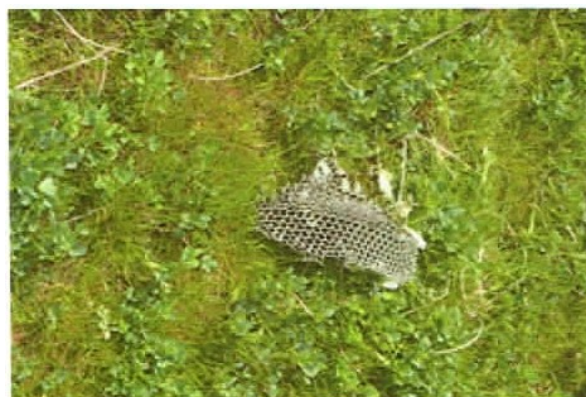
Figure 17 – Metallic honeycomb, Part 4 Site 2 (P4S2)

Part 4 Site 2 was recovered in place and located at 40.421134, 76.1597123. See Figure 17.

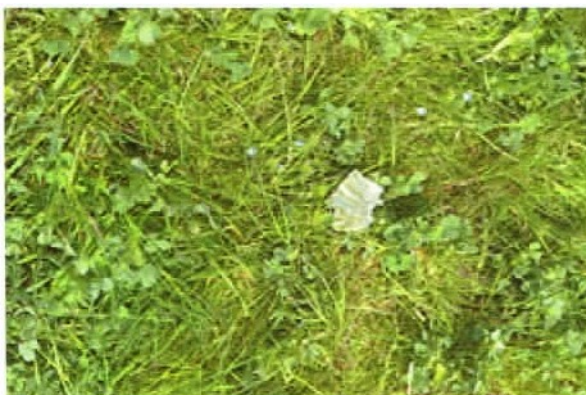
Figure 18 – Honeycomb, Part 5 Site 2(P5S2)

Part 5 Site 2 (P5S2) was recovered in place and located at 40.421134, 76.1597123. See Figure 18.

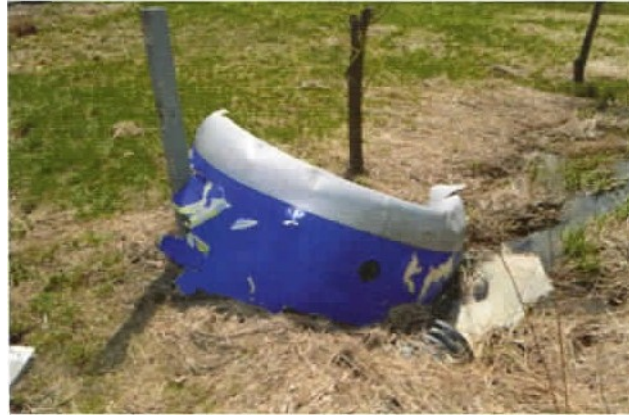
Figure 19 – Lower D-Duct and Outer Barrel, Part 1 Site 3 (P1S3)

Part 1 Site 3 (P1S3) was recovered in place and located at 40.424090, 76.1657070. A local resident notified authorities of the location of the part. See Figure 19.

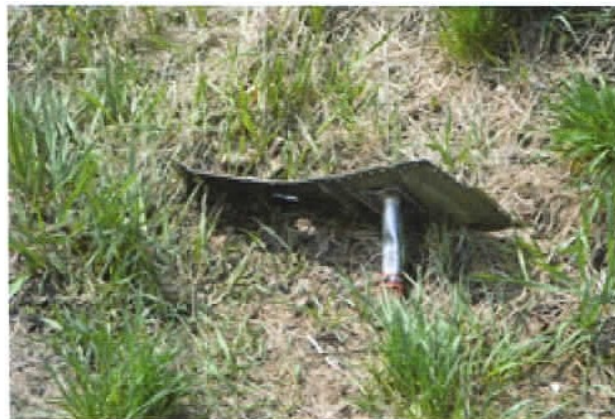
Figure 20 – Aft Bulkhead Section, Part 1 Site 4 (P1S4)

Part 1 Site 4 (P1S4) was recovered in place and located at 40.39528, 76.1341108. The property owner notified the authorities of the location of the part. See Figure 20.

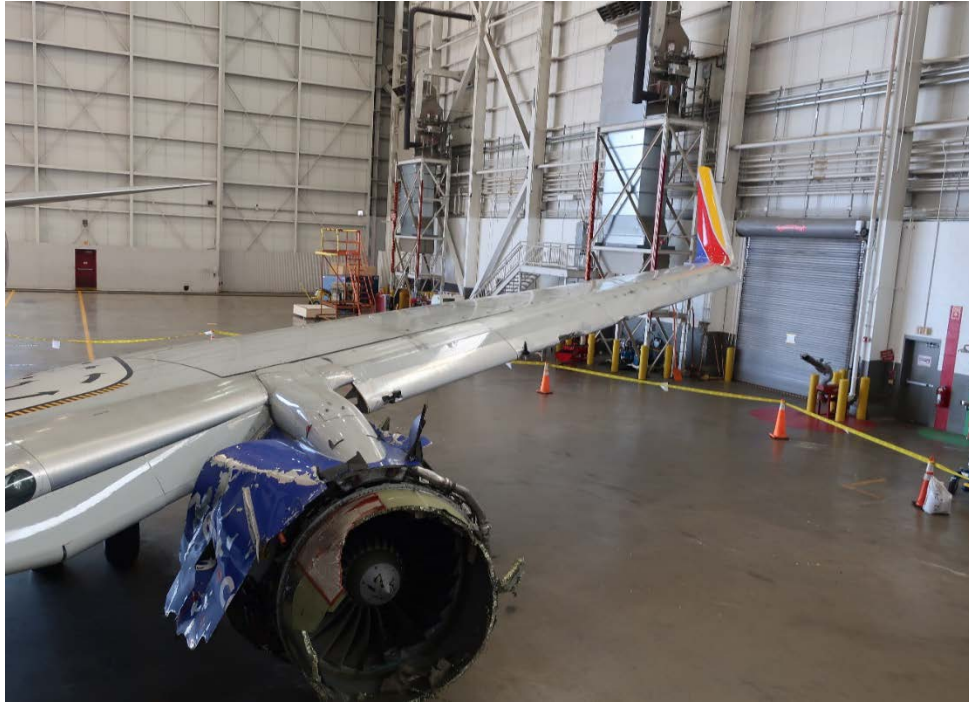
The airplanes left hand side fuselage, wing leading edges, wing upper and lower surfaces and the horizontal stabilizer exhibited evidence of impact damage along with blue and red paint transfers. The impact damage consisted of surface scratching, skin gouging and skin penetrations.

Figure 21 – Overview of wing and inlet damage

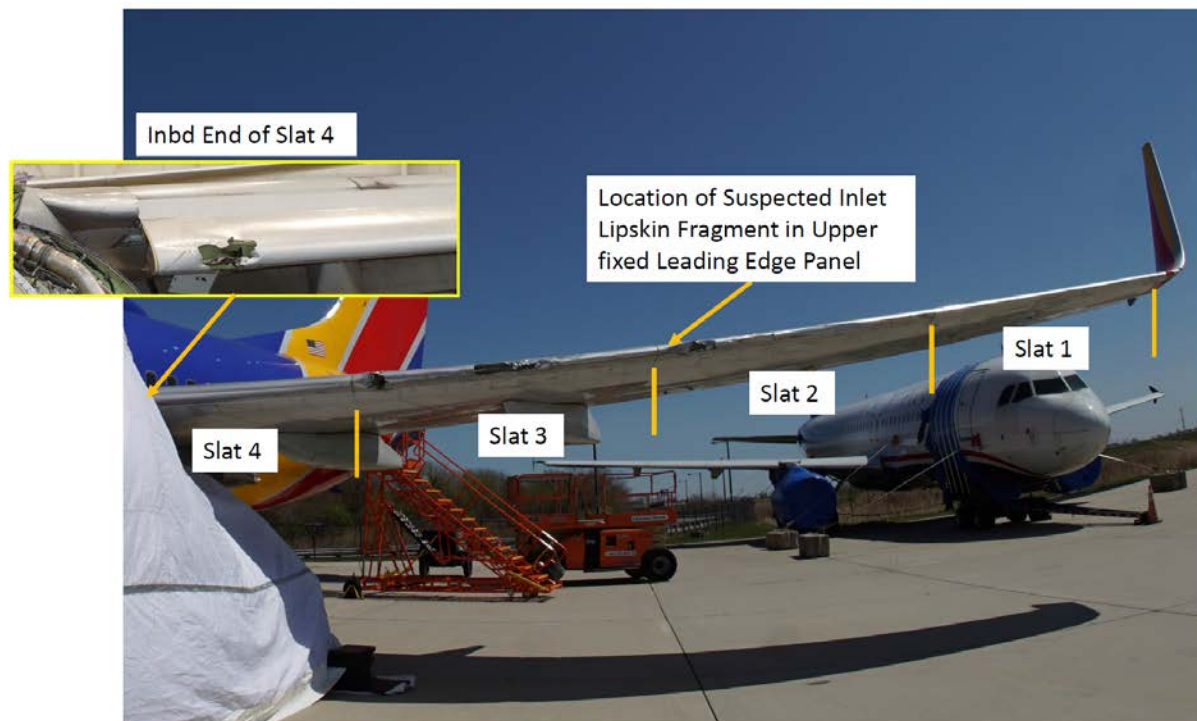
Figure 22 - Wing leading edge damage

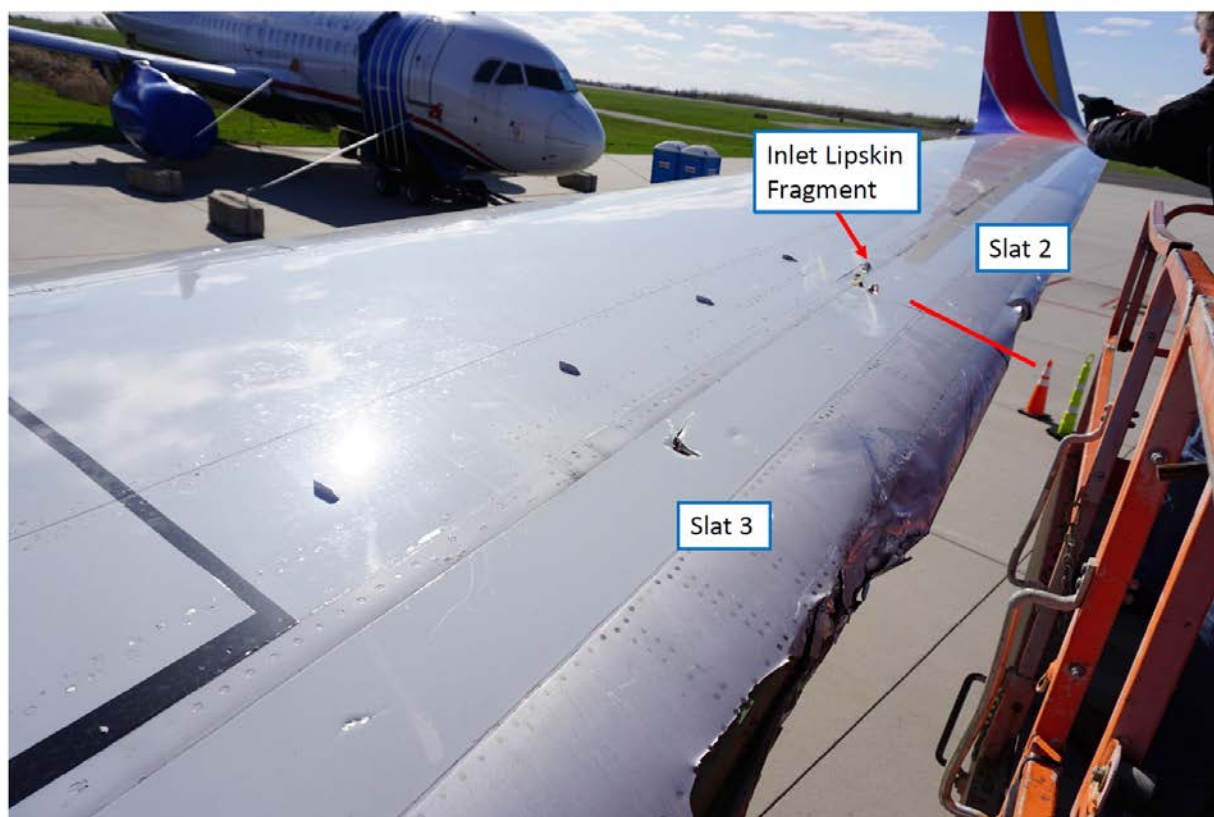
Figure 23 - Outboard wing upper surface damage

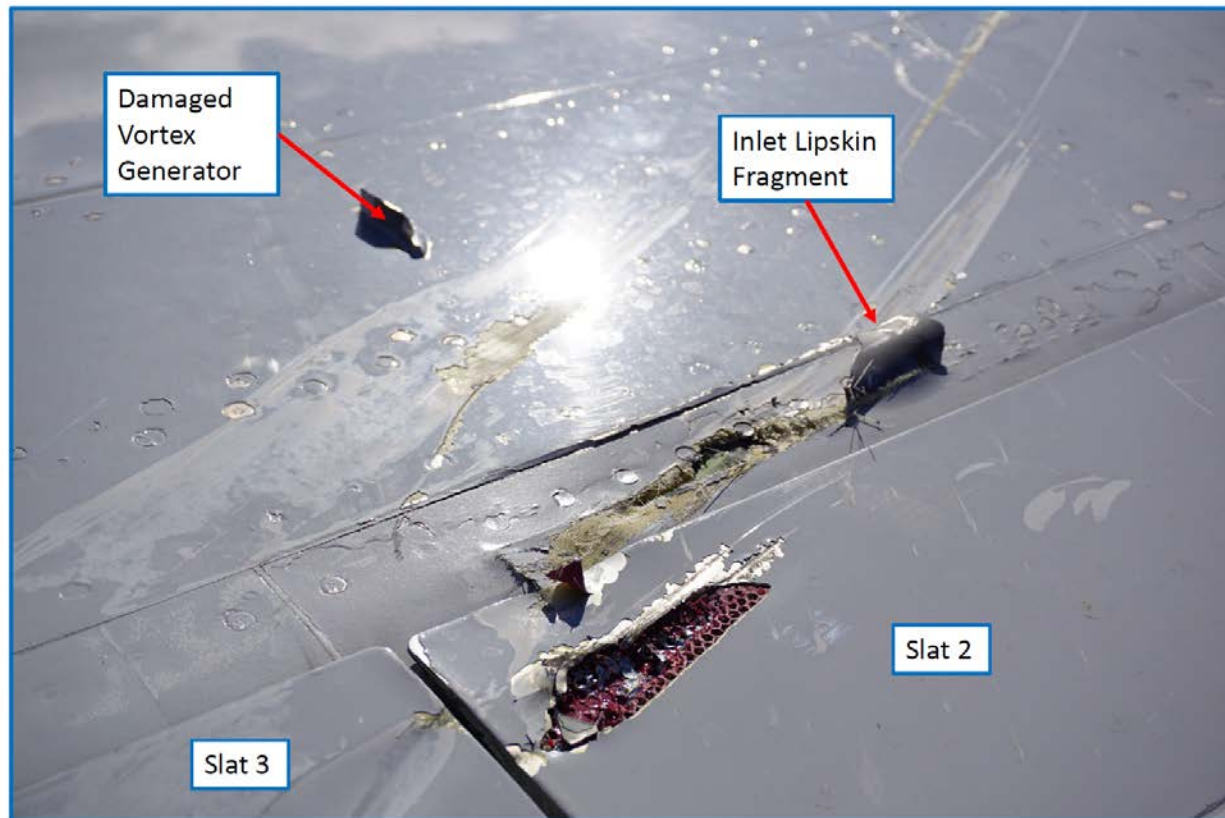
Figure 24 – Inlet fragment detail

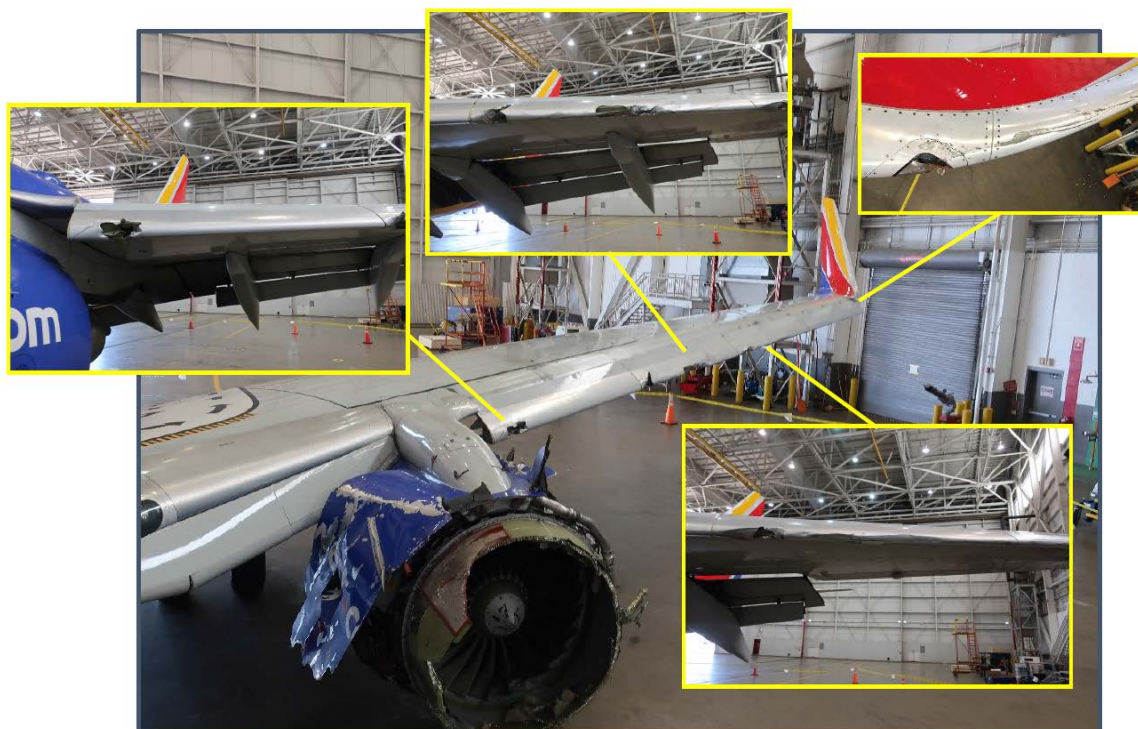
Figure 25 – Wing leading edge damage

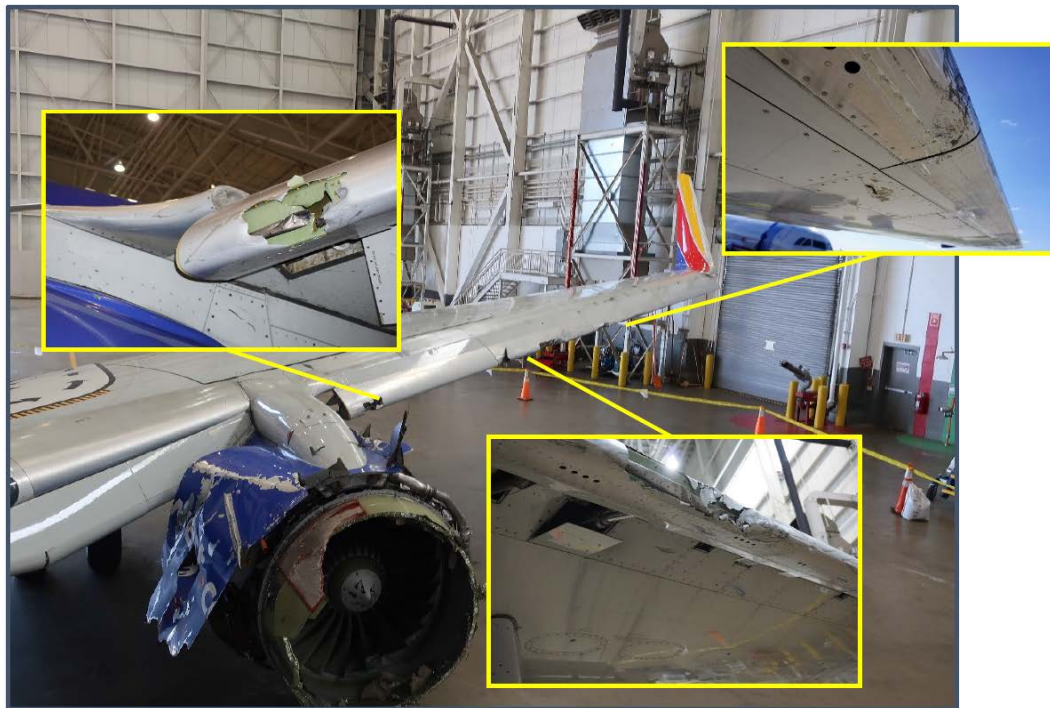
Figure 26 – Wing leading edge damage

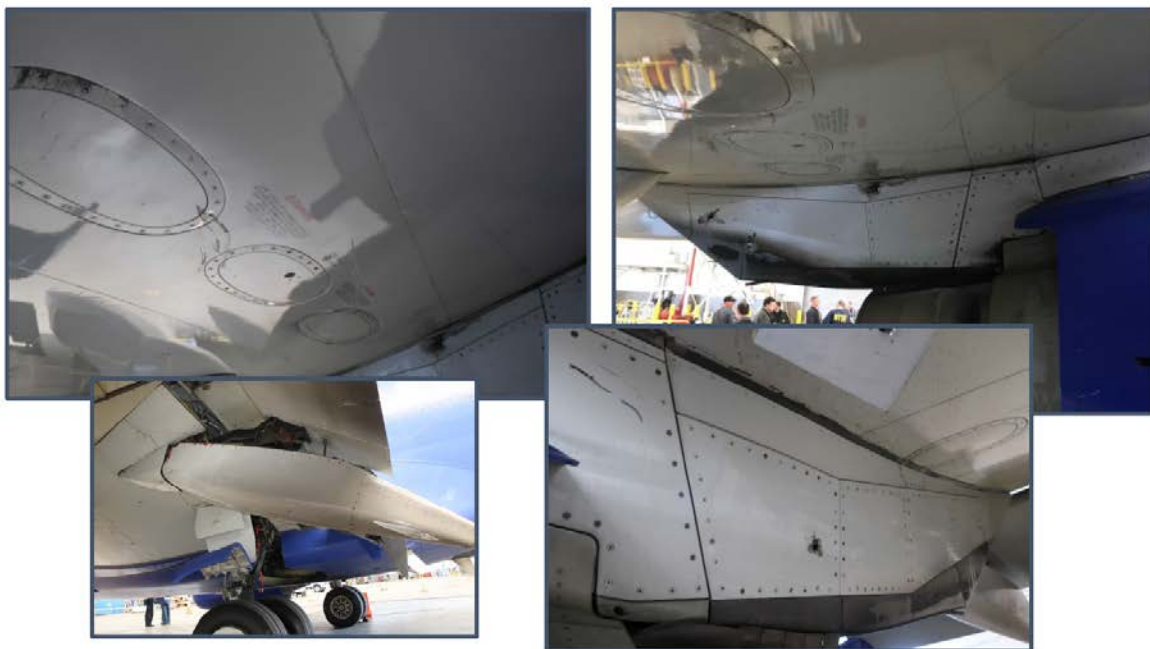
Figure 27 – Wing lower surface damage

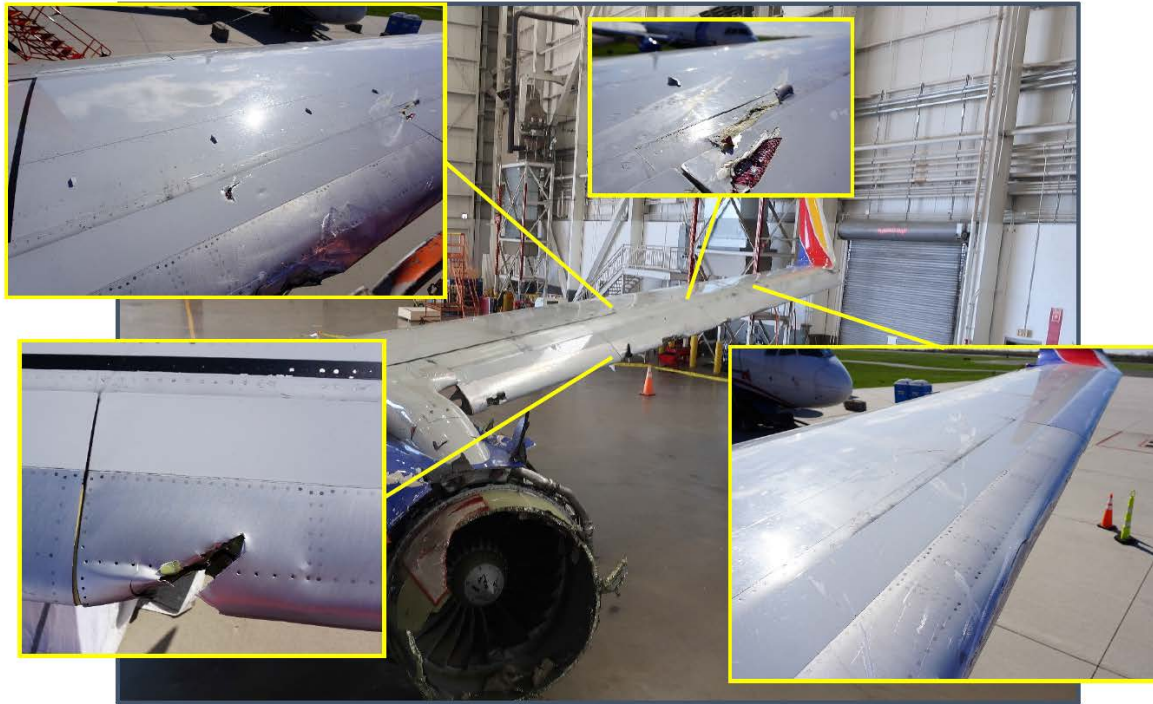
Figure 28 - Wing upper surface damage

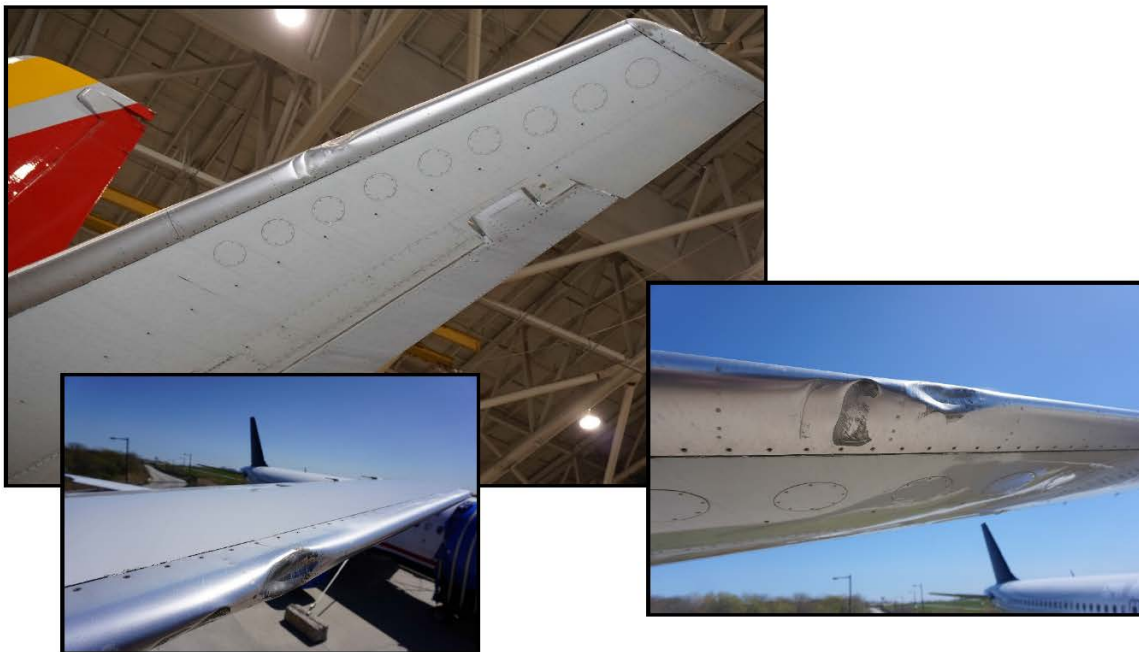
Figure 29 – Horizontal stabilizer damage

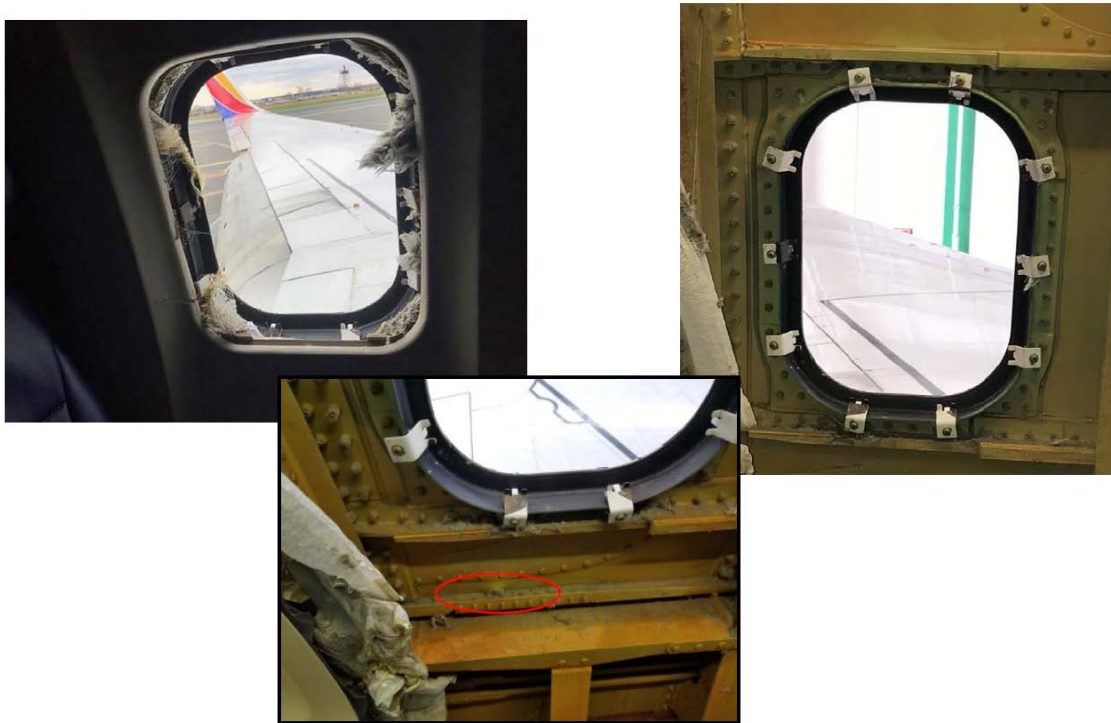
None of the window inner and outer panes or the seal were recovered from inside the airplane or during the ground recovery of airplane debris. The cowling structure that impacted the fuselage caused a small puncture to the fuselage skin just below the incident passenger window.

Figure 32 – Interior fuselage impact damage<sup>1</sup>

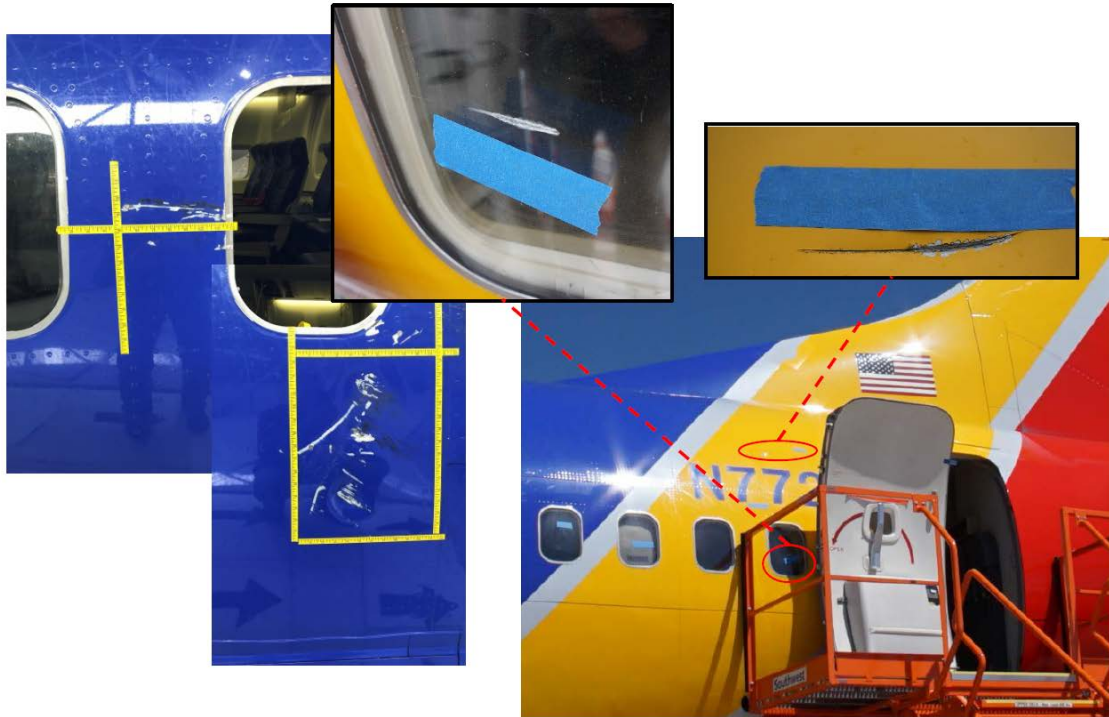
Figure 33 - Exterior fuselage impact damage

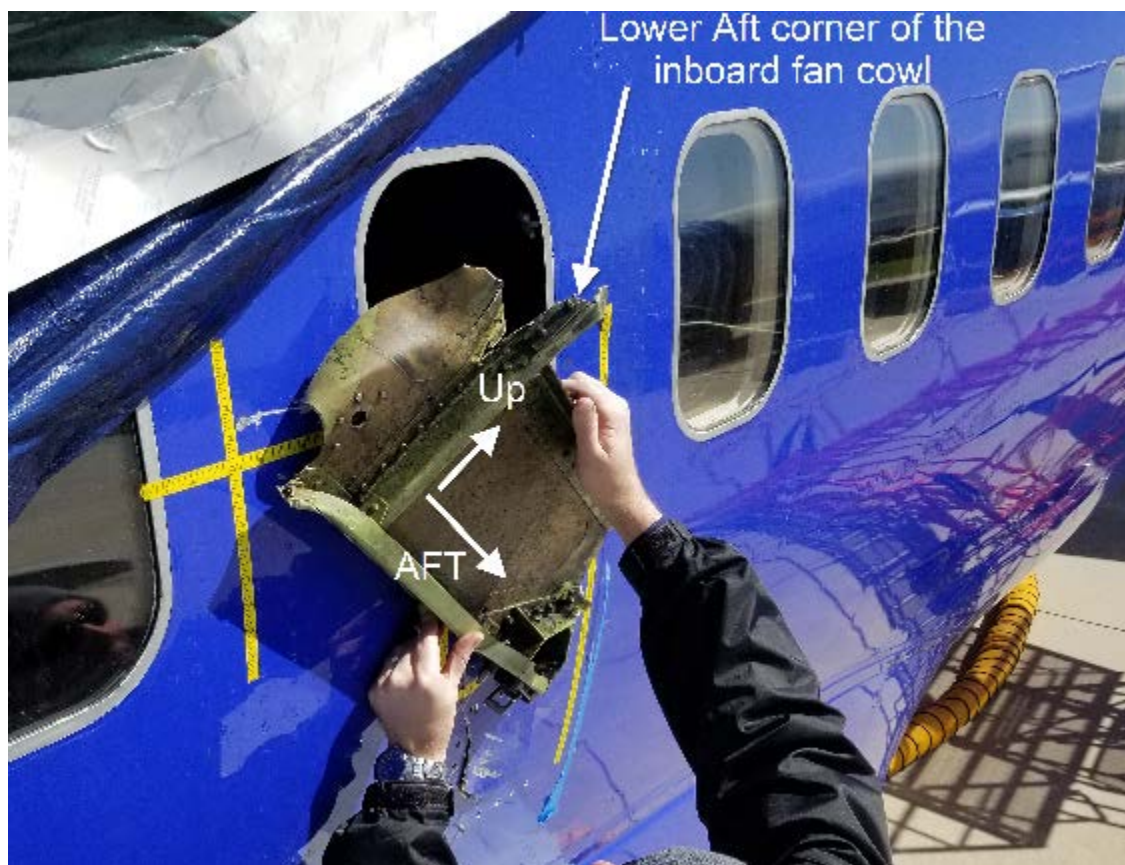
The lower aft corner of a portion of the inboard fan cowl that departed the airplane was compared to the fuselage damage between fuselage stations 700 to 727, and stringers 12 left to 15 left. The lower aft most corner of the inboard fan cowl exhibited evidence of impact damage. The fuselage skin below the window just above stringer 14 left also exhibited evidence of impact damage. There were additional witness marks in the fuselage skin just forward of the window at about stringer 12 left.

Figure 34 – Fan cowl to fuselage witness mark comparison

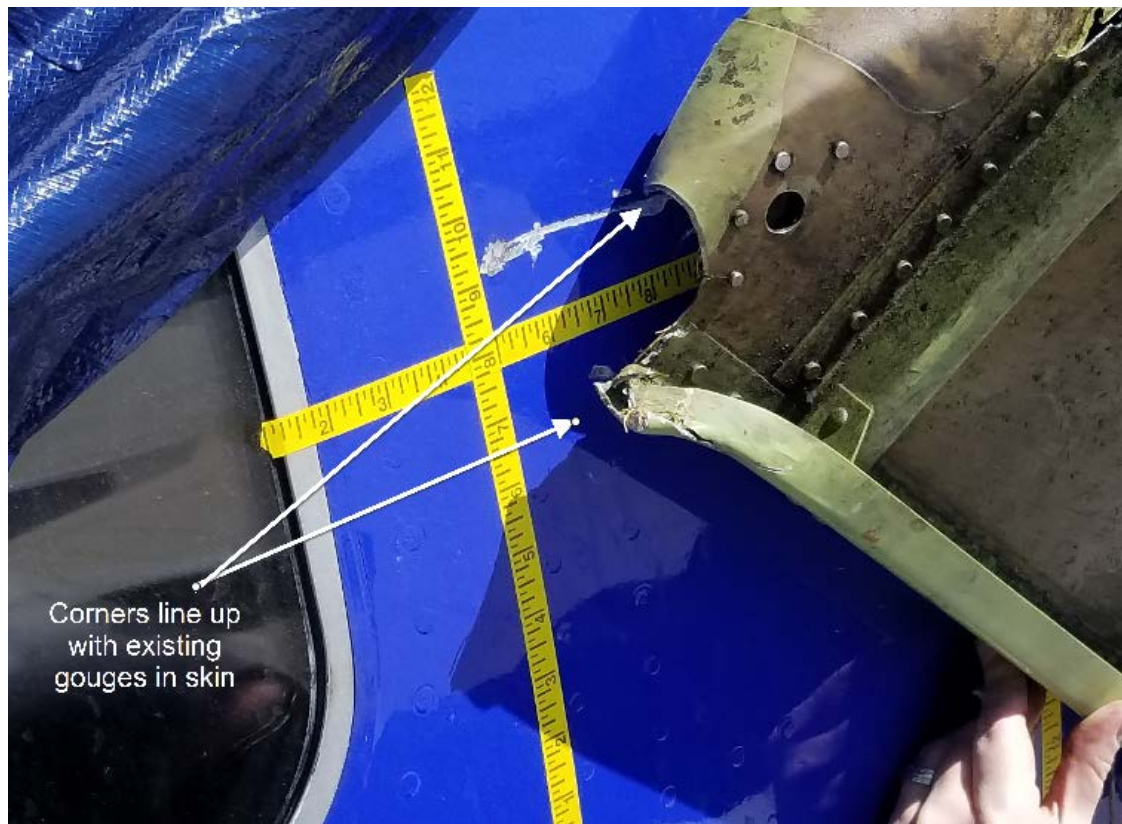
Figure 35 – Detailed witness mark comparison

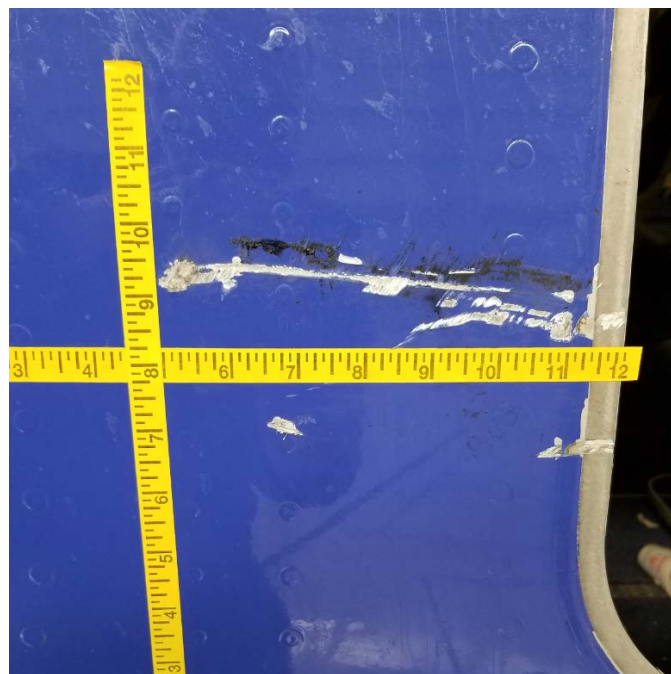
Figure 36 – Fuselage skin damage at stringer 12L

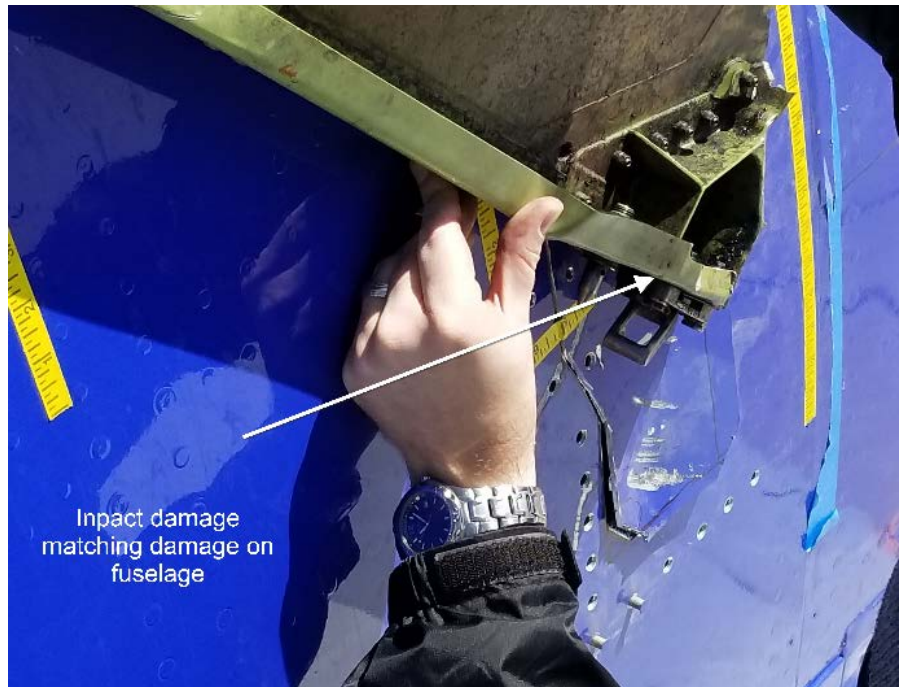
Figure 37 - Lower corner fuselage to fan cowl section witness mark comparison

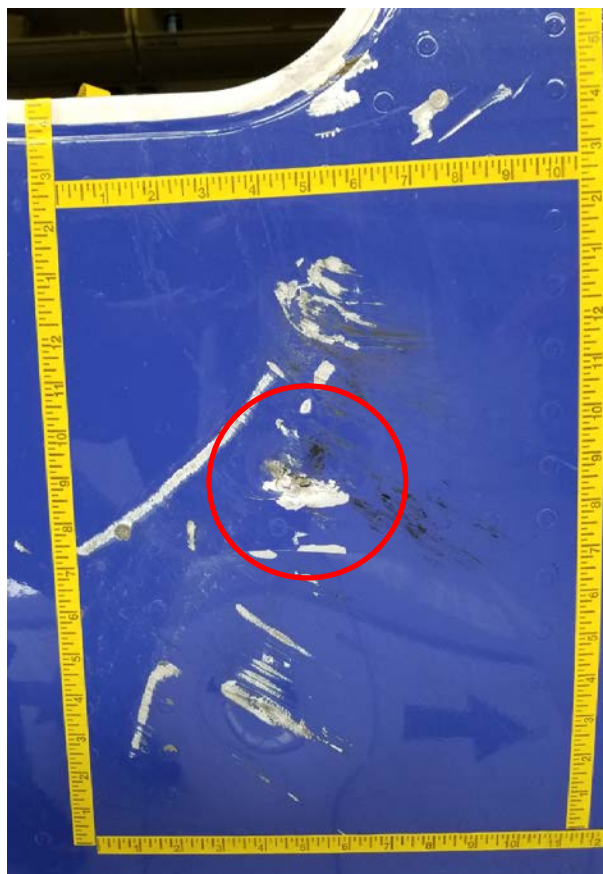
Figure 38 – Lower passenger window impact damage detail

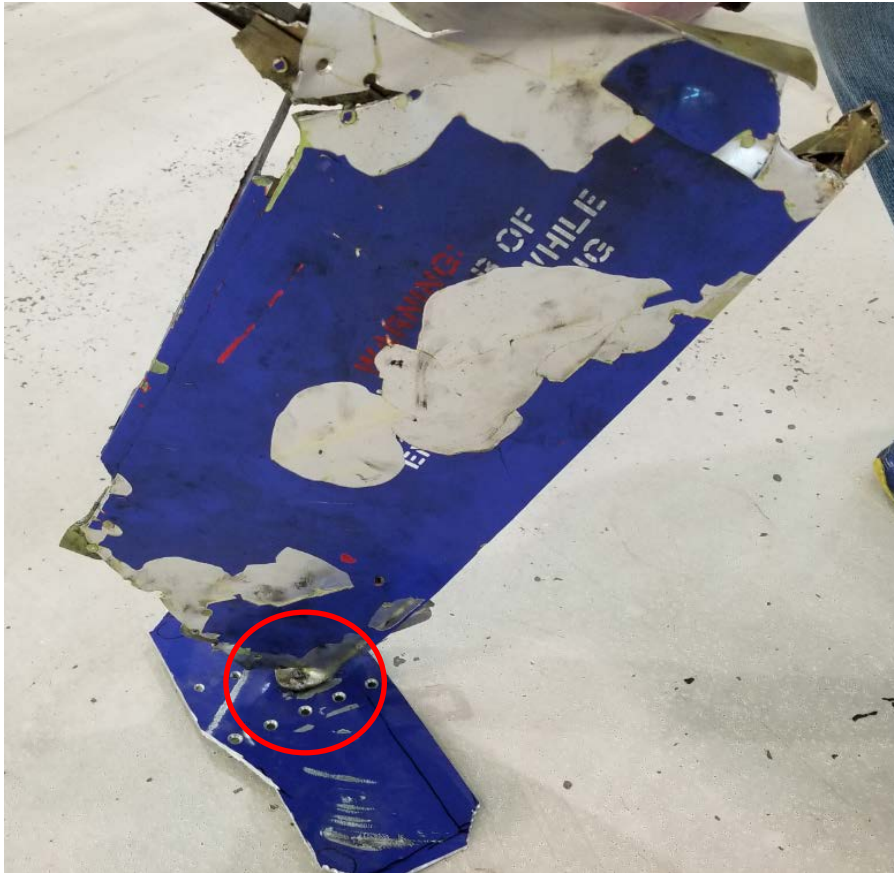
Figure 39 – Figure 38 impact damage to fan cowl section comparison

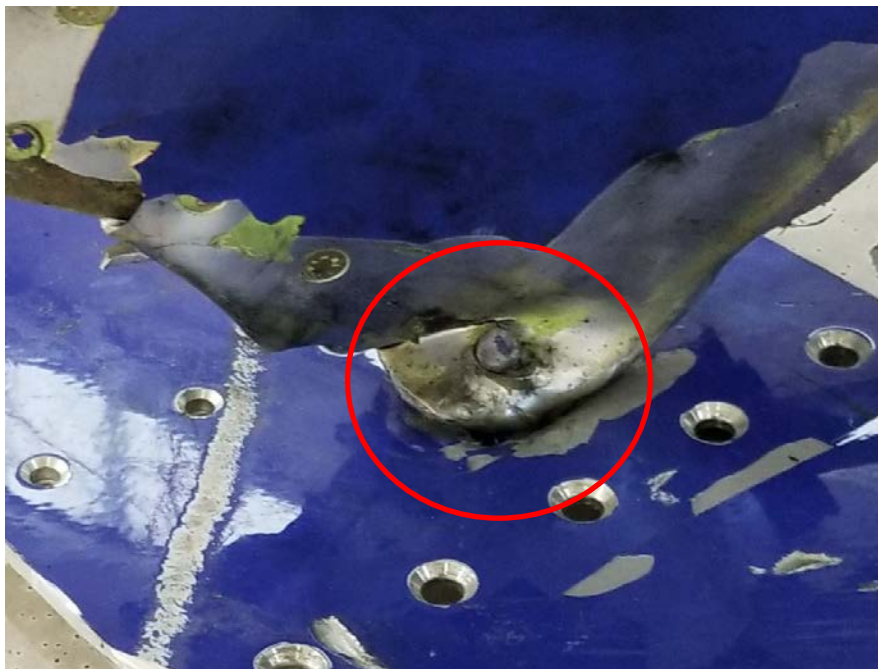
Figure 40 – Figure 39 detail view

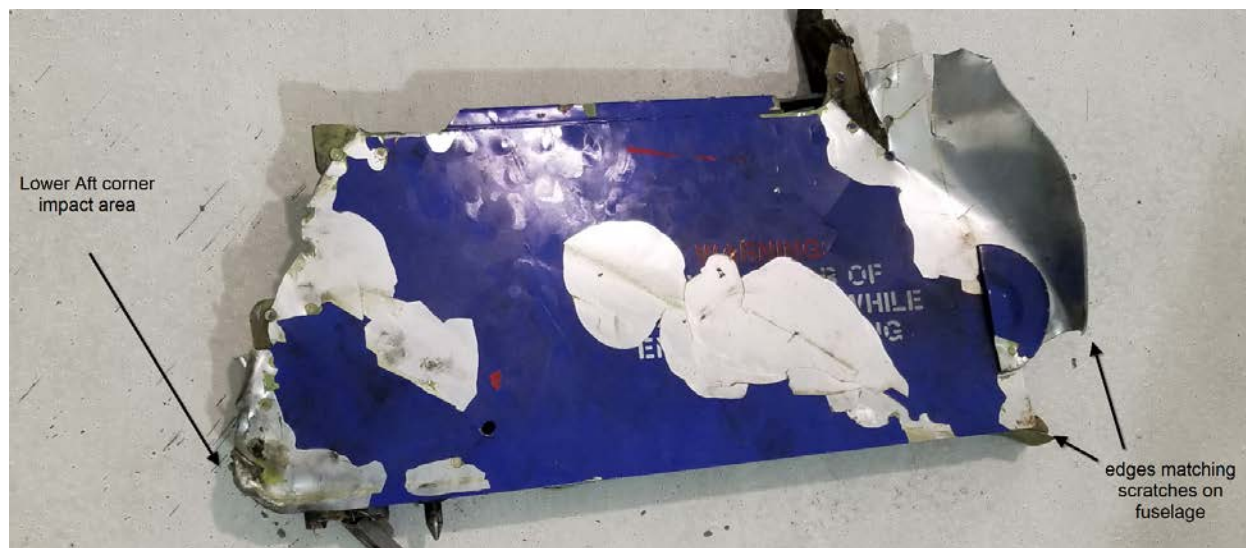
Figure 41 – Separated fan cowl structure
