# BACKGROUND

On April 17th, 2018 SWA 1380 experienced a fan blade out (FBO) event at FL 320. The FBO event resulted in portions of the inlet and fan cowl departing the aircraft, specifically the inlet d-duct, inlet outer barrel, forward sections of the inlet inner barrel and large sections of the fan cowl. In support of the NTSB, Collins Aerospace (Collins) documented the condition of the inlet and fan cowl components that remained on the aircraft as well as the recovered hardware that departed the A/C. The recovered hardware and the remaining portions of the inlet and fan cowl were removed from the aircraft and were shipped to the Collins facility in Chula Vista, California.

# Fan Blade Fragment Trajectories and Inlet Damage

# COLLINS INLET FAN FRAGMENT DAMAGE ASSESSMENT

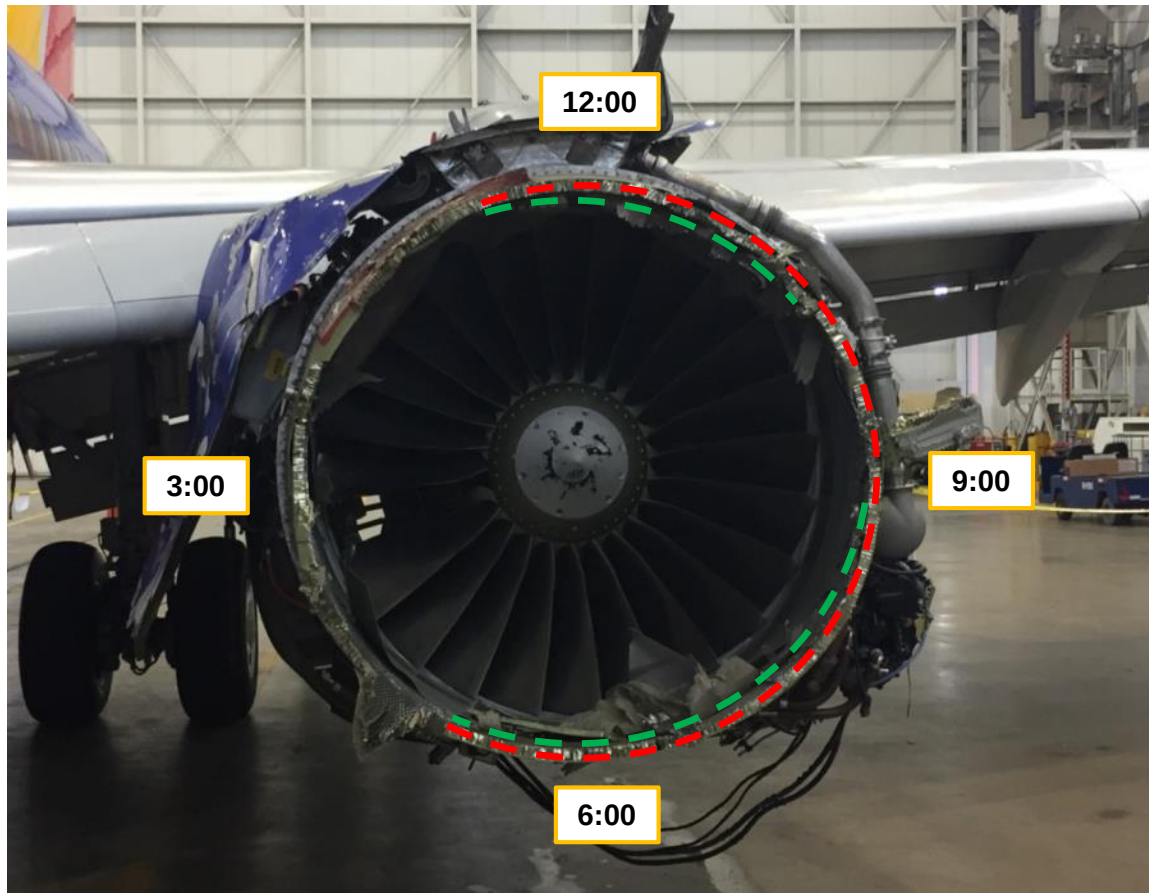
**240°** Perforate skin damage

**180°** Back skin shear damage  
(75° + 105°)

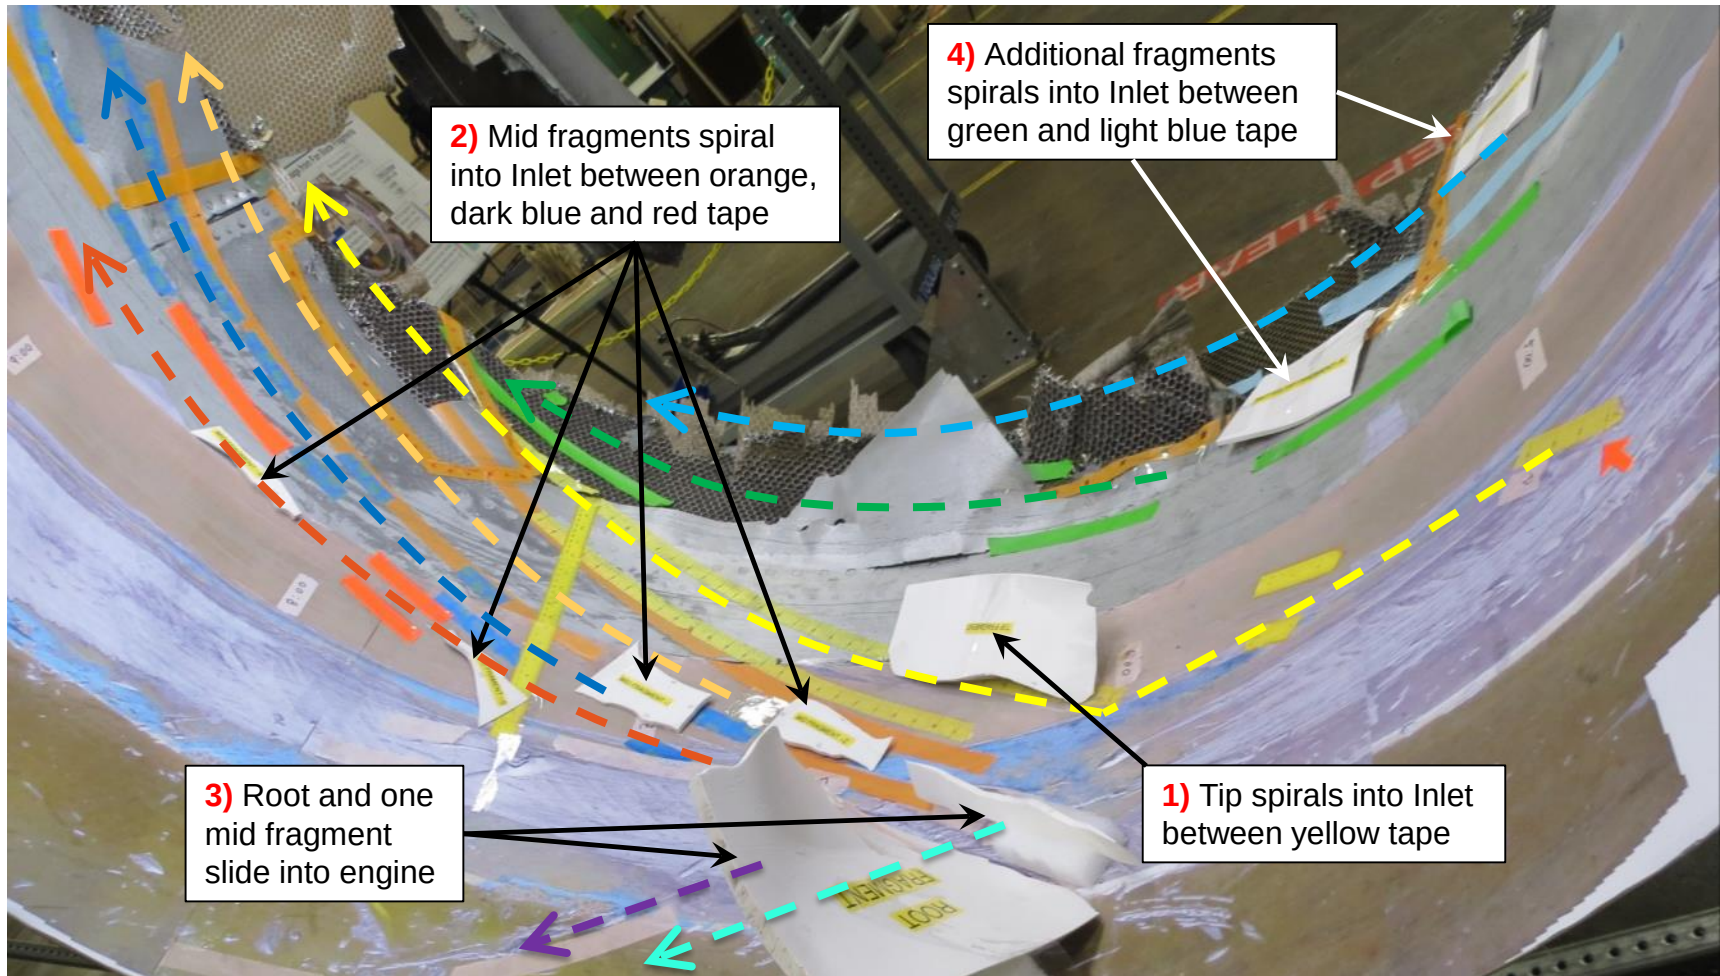
View Looking Forward

## FAN CASE AND INLET DAMAGE DEFINES TRAJECTORIES

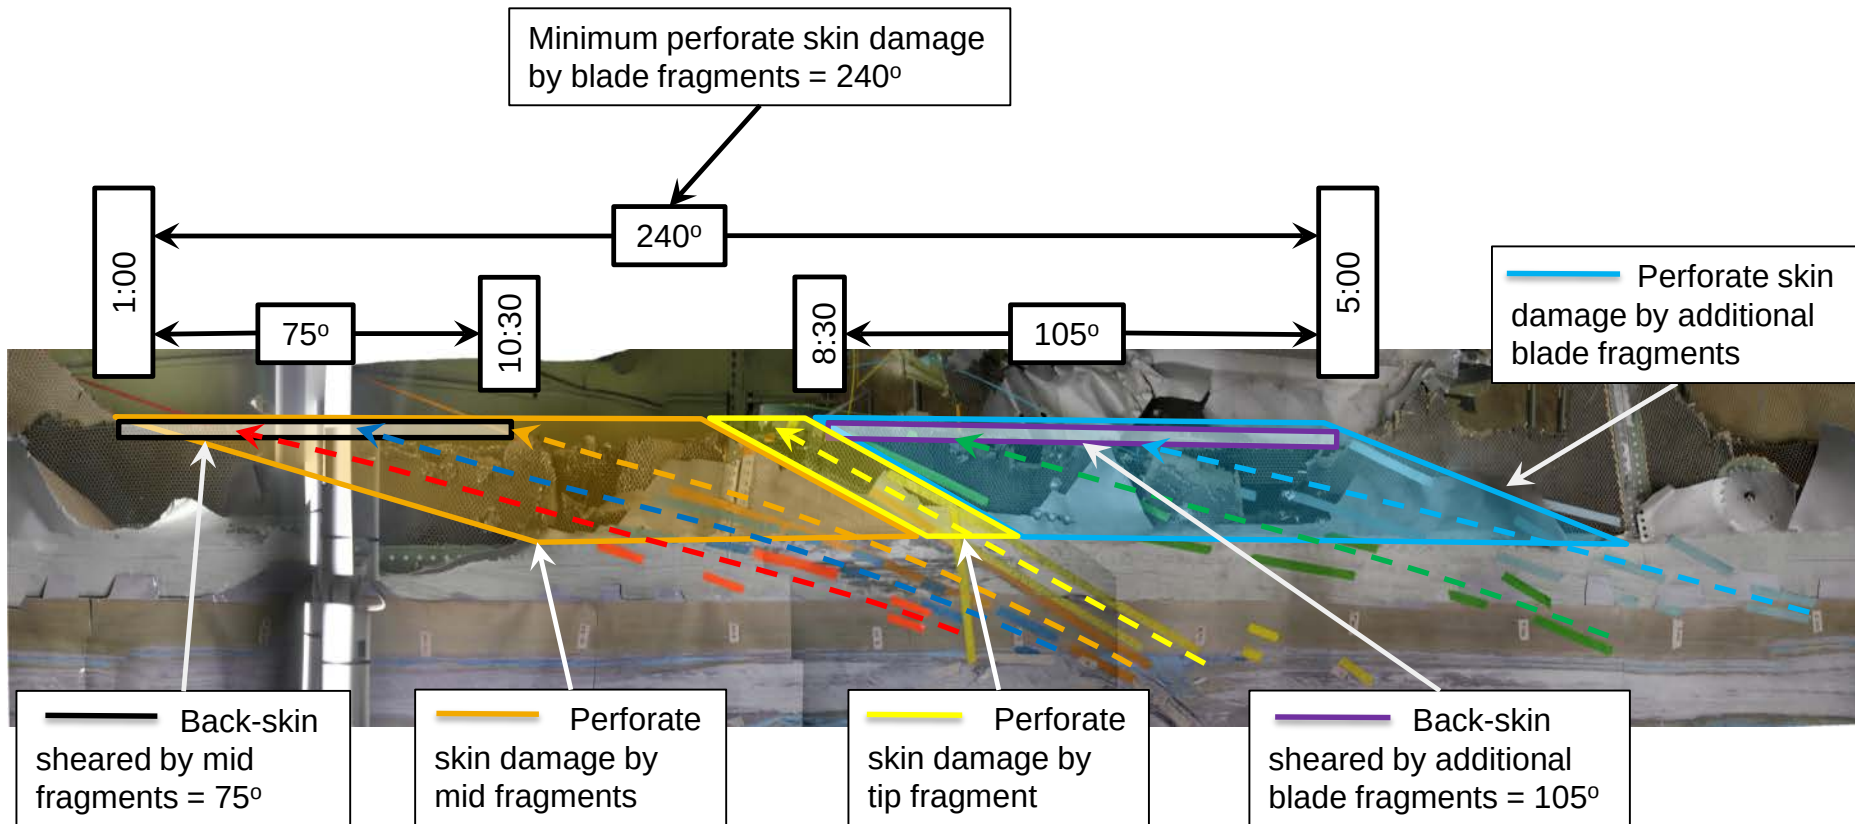
## PERFORATE SKIN AND BACK SKIN DAMAGED BY FAN BLADE FRAGMENTS

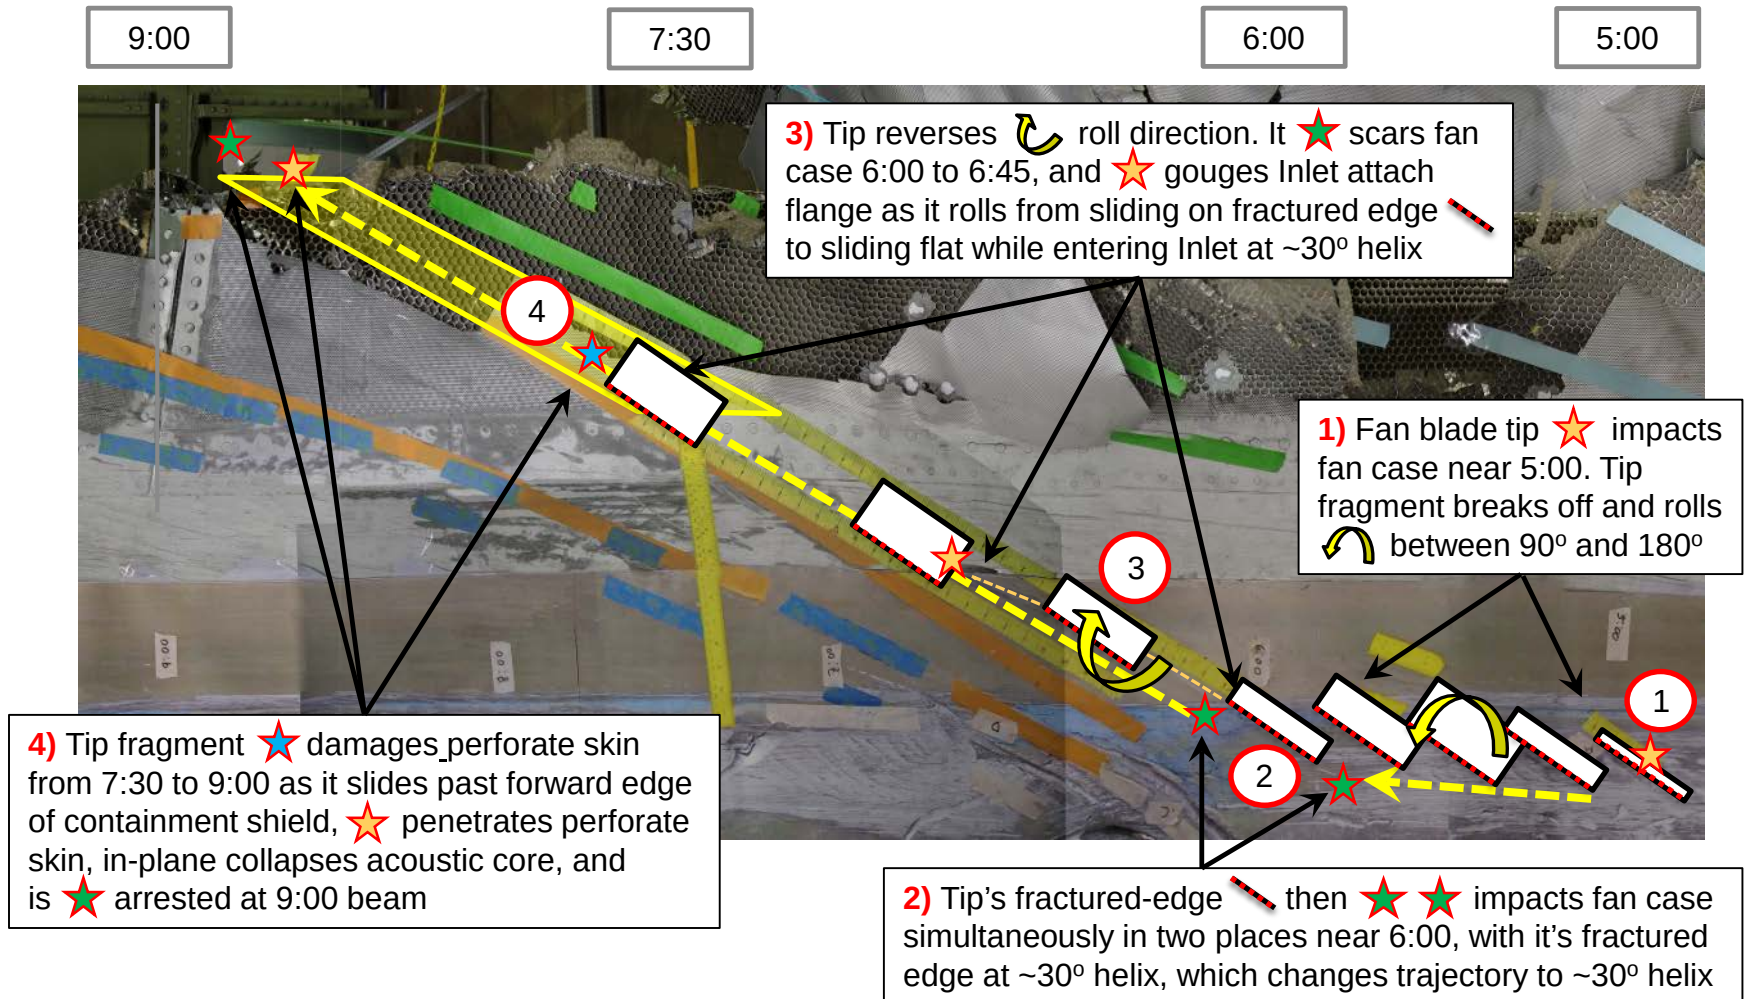
TIP FRAGMENT DAMAGES ATTACH RING, PERFORATE SKIN, AND IMPACTS 9:00 BEAM

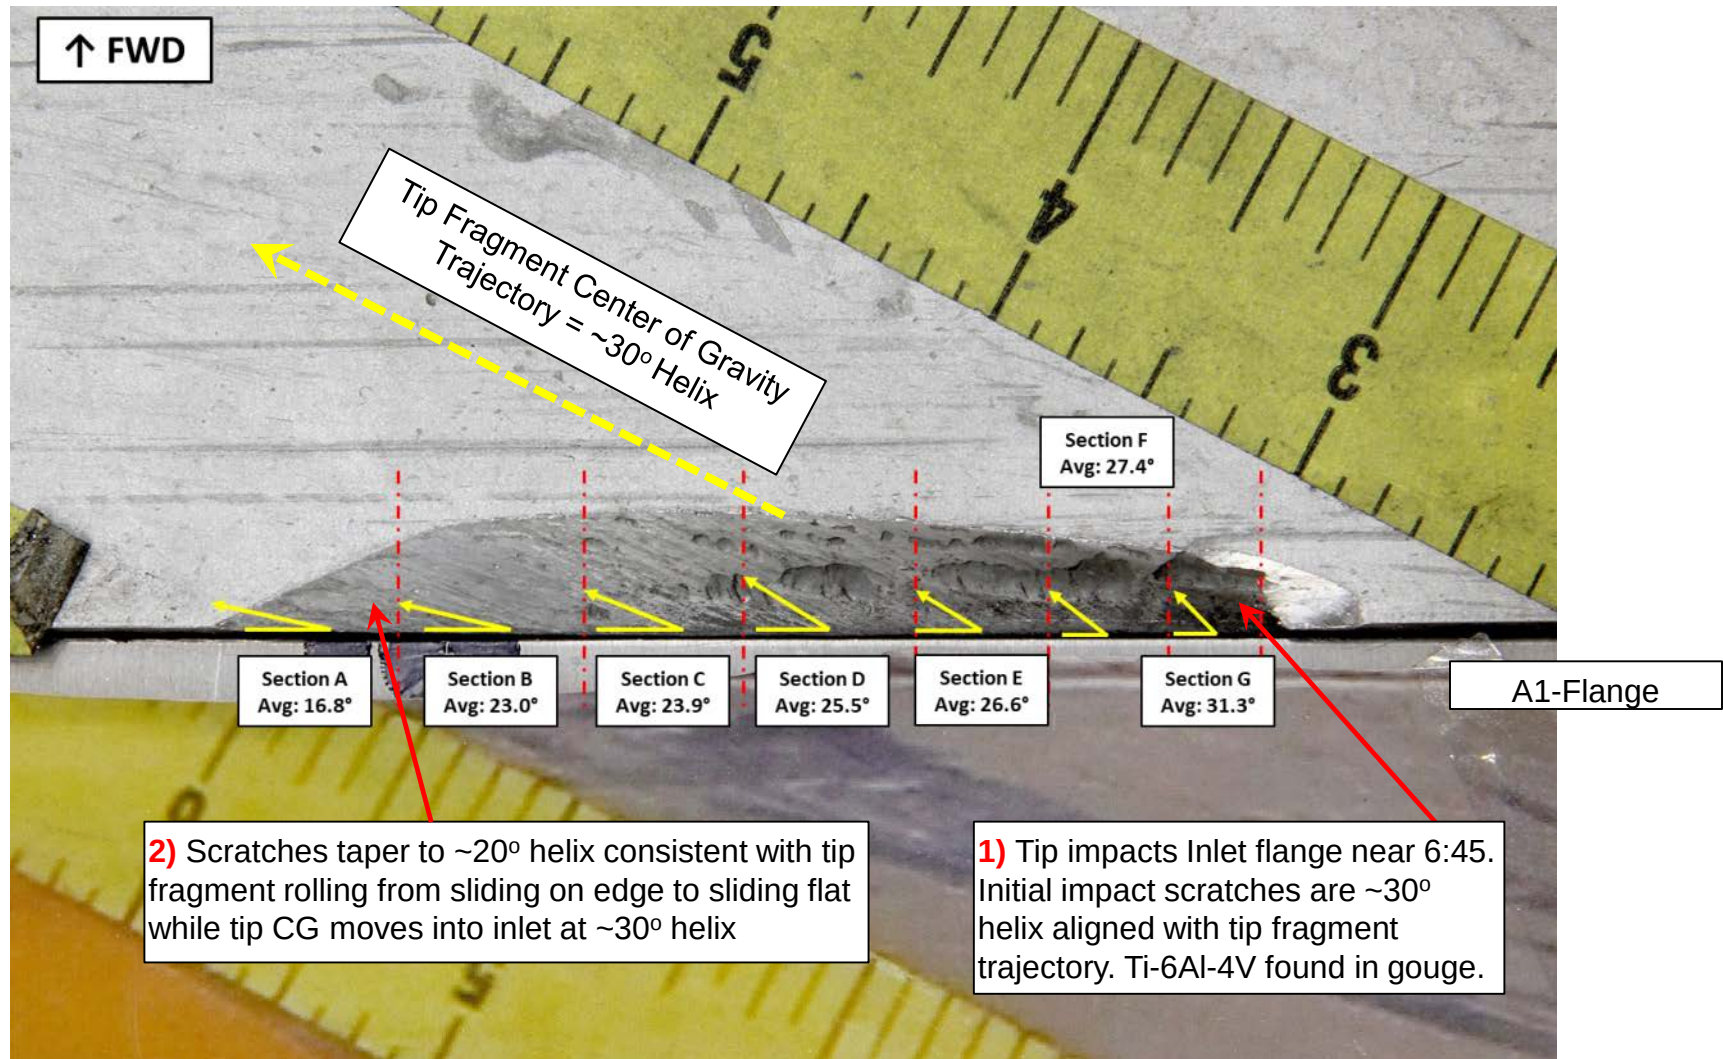
TIP FRAGMENT CAUSED  $\sim 20^\circ$  TO  $\sim 30^\circ$  SCRATCHES IN GOUGE

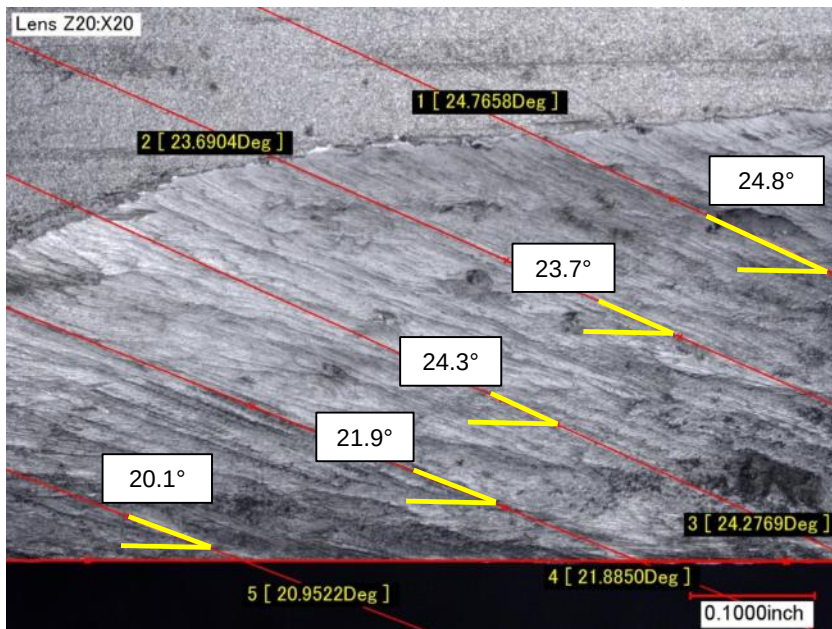
TIP FRAGMENT CAUSED  $\sim 20^{\circ}$  TO  $\sim 30^{\circ}$  SCRATCHES IN GOUGE

Section B (Avg:  $23.0^{\circ}$ )

Section G (Avg:  $31.3^{\circ}$ )

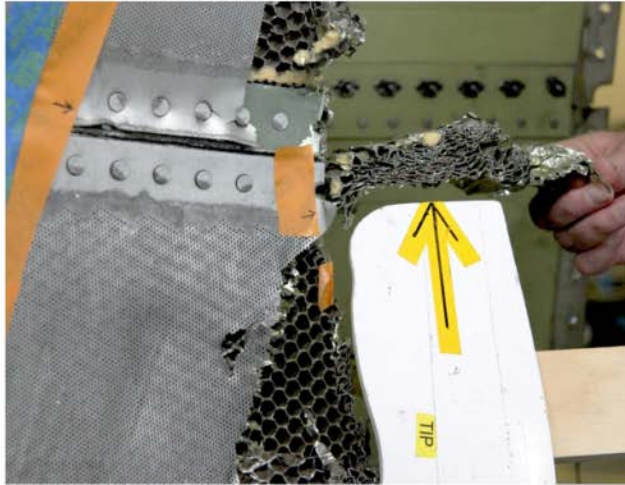
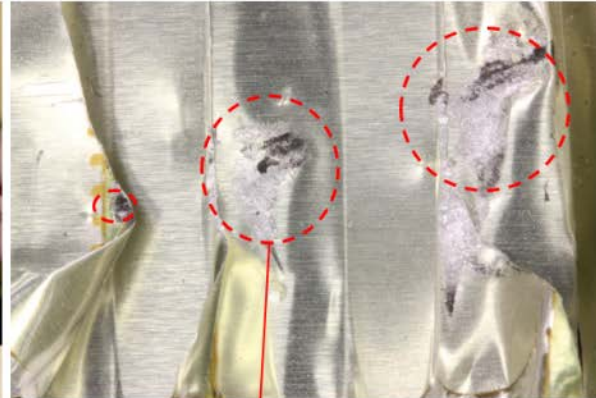
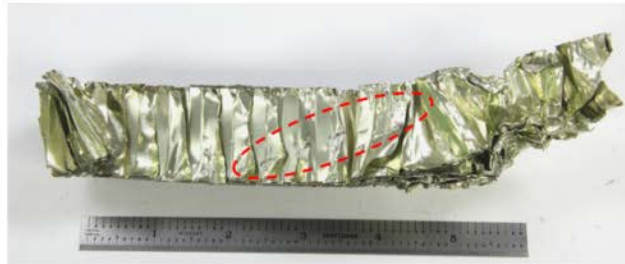
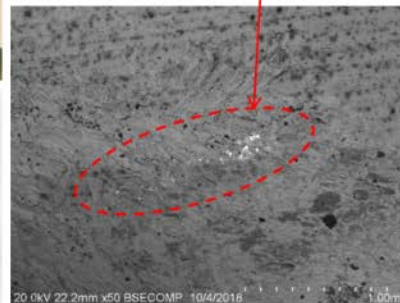
- 9:00 Core Crease – Ti-6Al-4V Particles

- Titanium Alloy particles found impacted and imbedded in the Core sheet metal

Titanium Alloy  
Particles Impacted  
and Imbedded

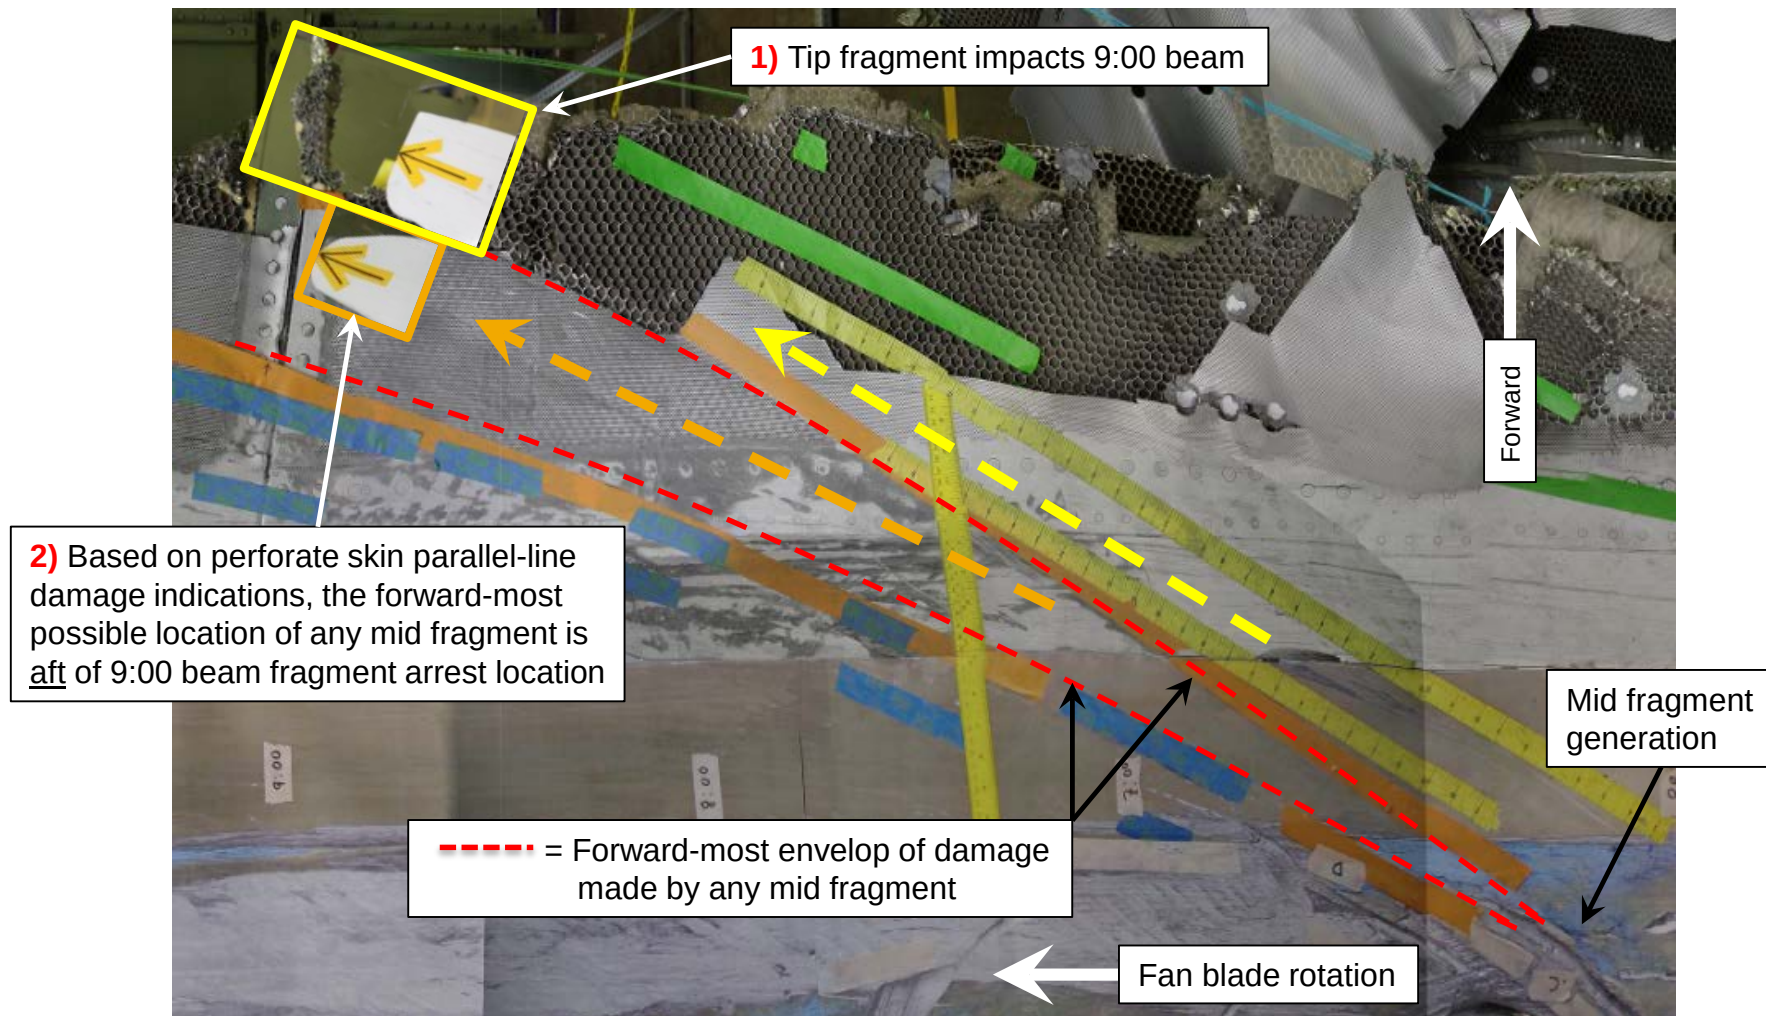
MID FRAGMENT WAS NOT ARRESTED AT 9:00 BEAM

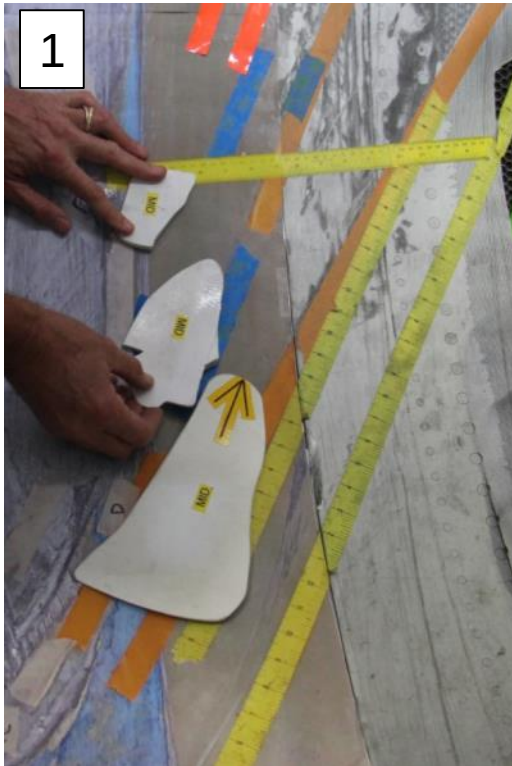
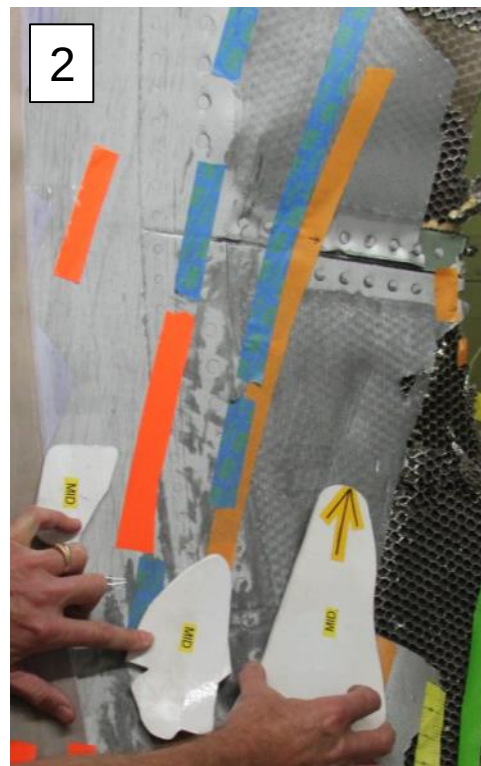
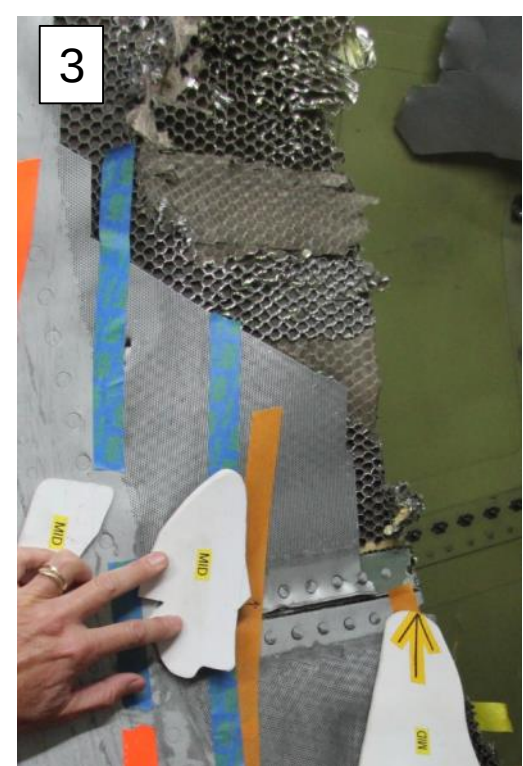
1), 2), 3) Mid fragments spiral into Inlet at  $20^{\circ}$  -  $30^{\circ}$  helix trajectory damaging perforate skin from 7:30 to 1:00

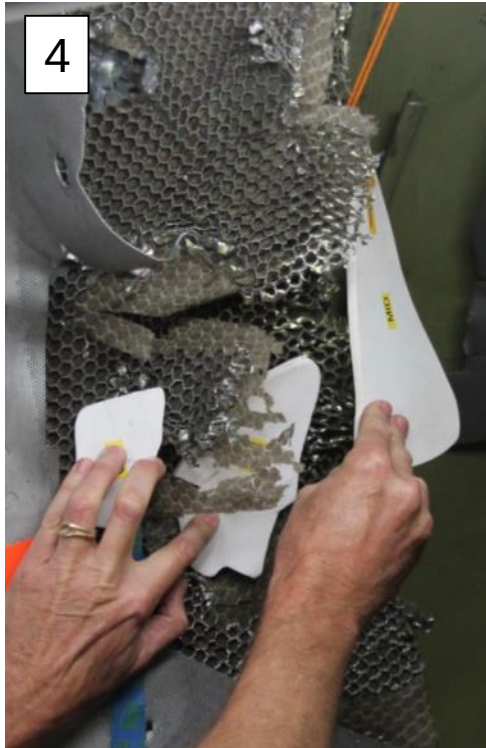
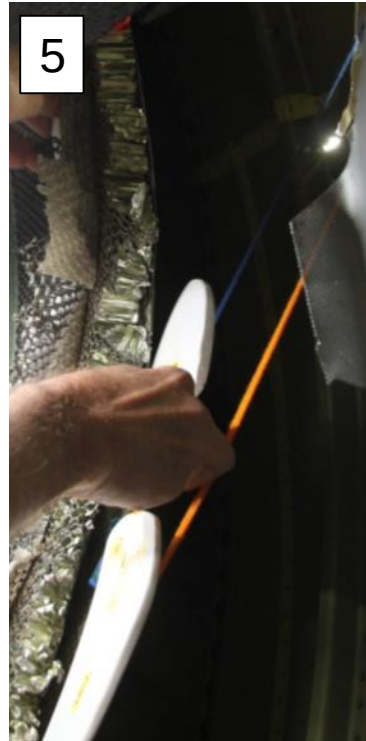
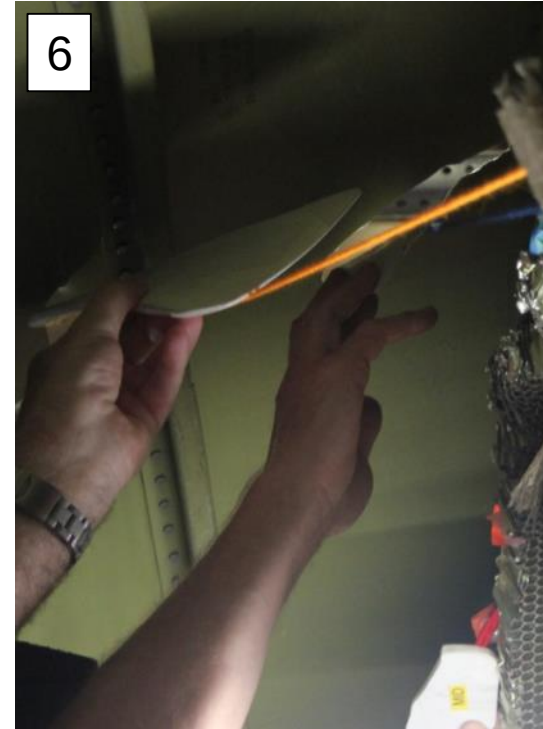
- 4) Penetrate perforate skin and shear back-skin just forward of containment shield from 10:30 to 1:00. Ti-6Al-4V was found in acoustic core, back-skin and containment shield between 11:00 and 12:00
- 5) Traverse from inner barrel to outer barrel
- 6) Penetrate outer barrel in two locations near 12:00

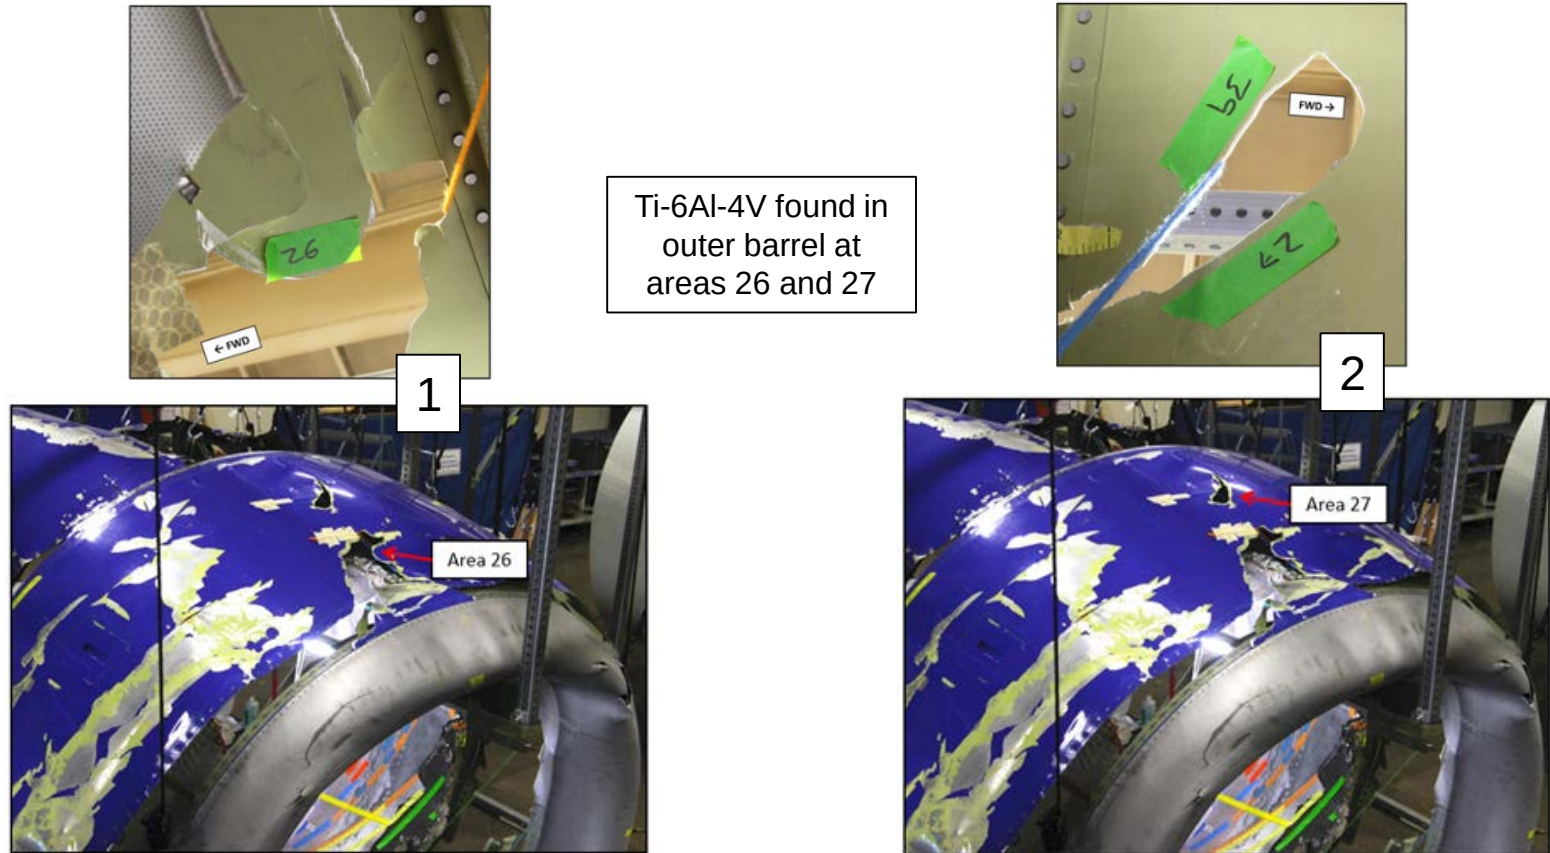
- 1) First mid fragment penetrates outer barrel near 12:00 (Area 26: forward of first mid fragment penetration)
- 2) Second mid fragment penetrates outer barrel near 12:00 (Area 27: just forward of containment shield)

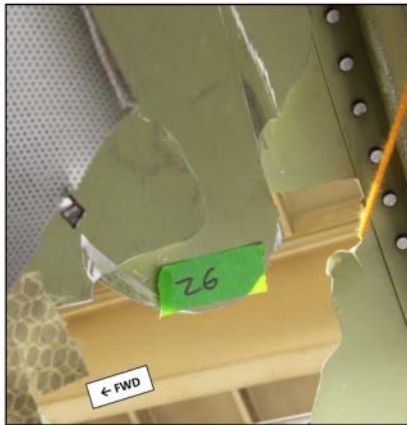
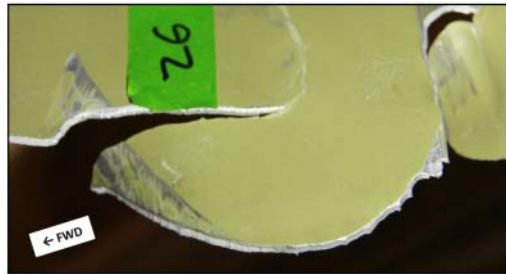
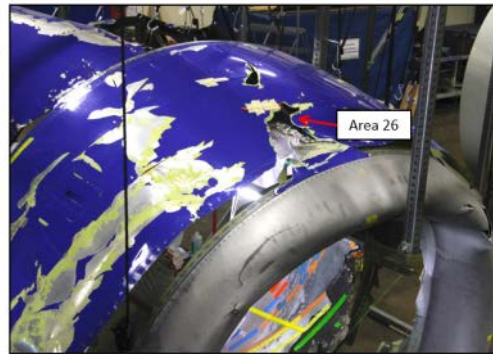
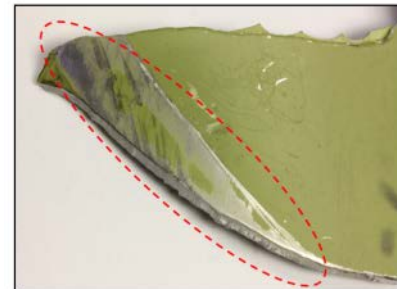
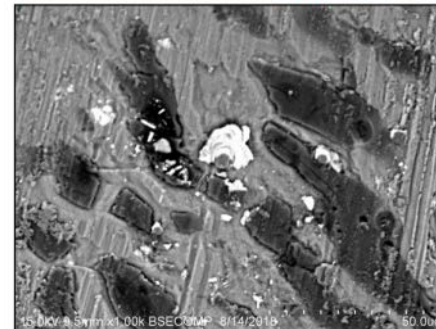
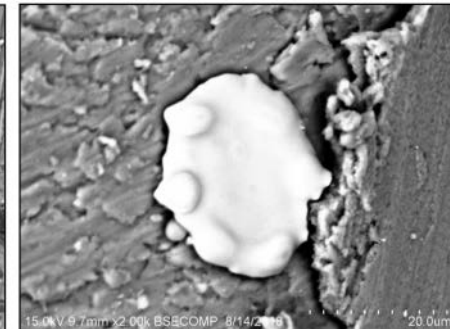
- Outer Barrel Damage – 12:00 – Ti-6Al-4V Particles

Titanium Alloy  
Particles Impacted  
and Imbedded

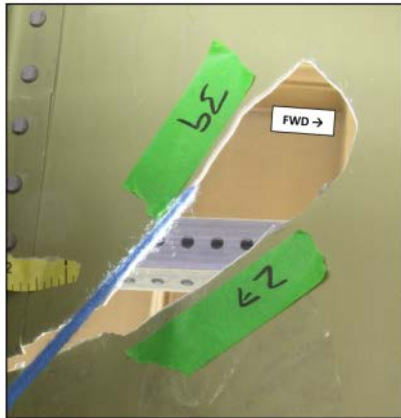
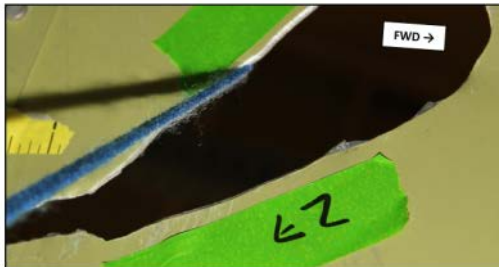
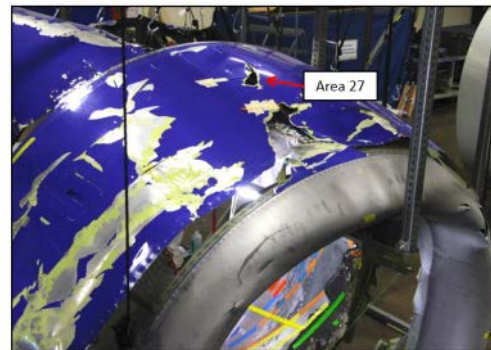
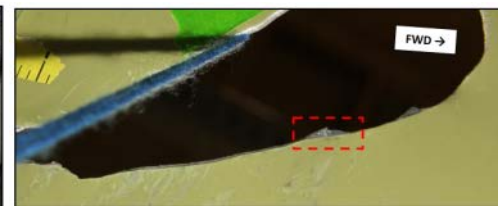
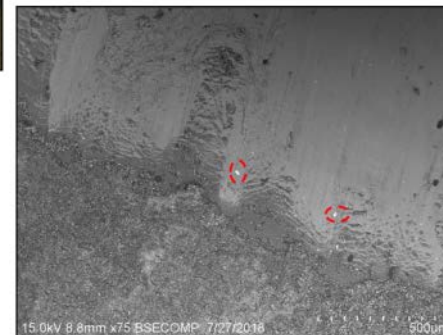
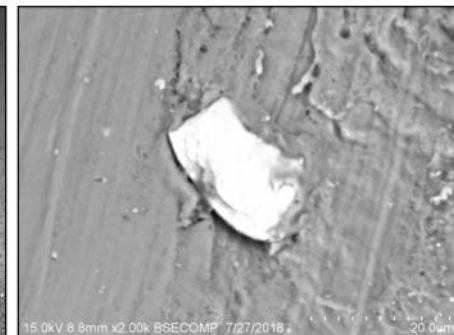
- Outer Barrel Damage – 12:00 – Ti-6Al-4V Particles

Titanium Alloy  
Particles Impacted  
and Imbedded

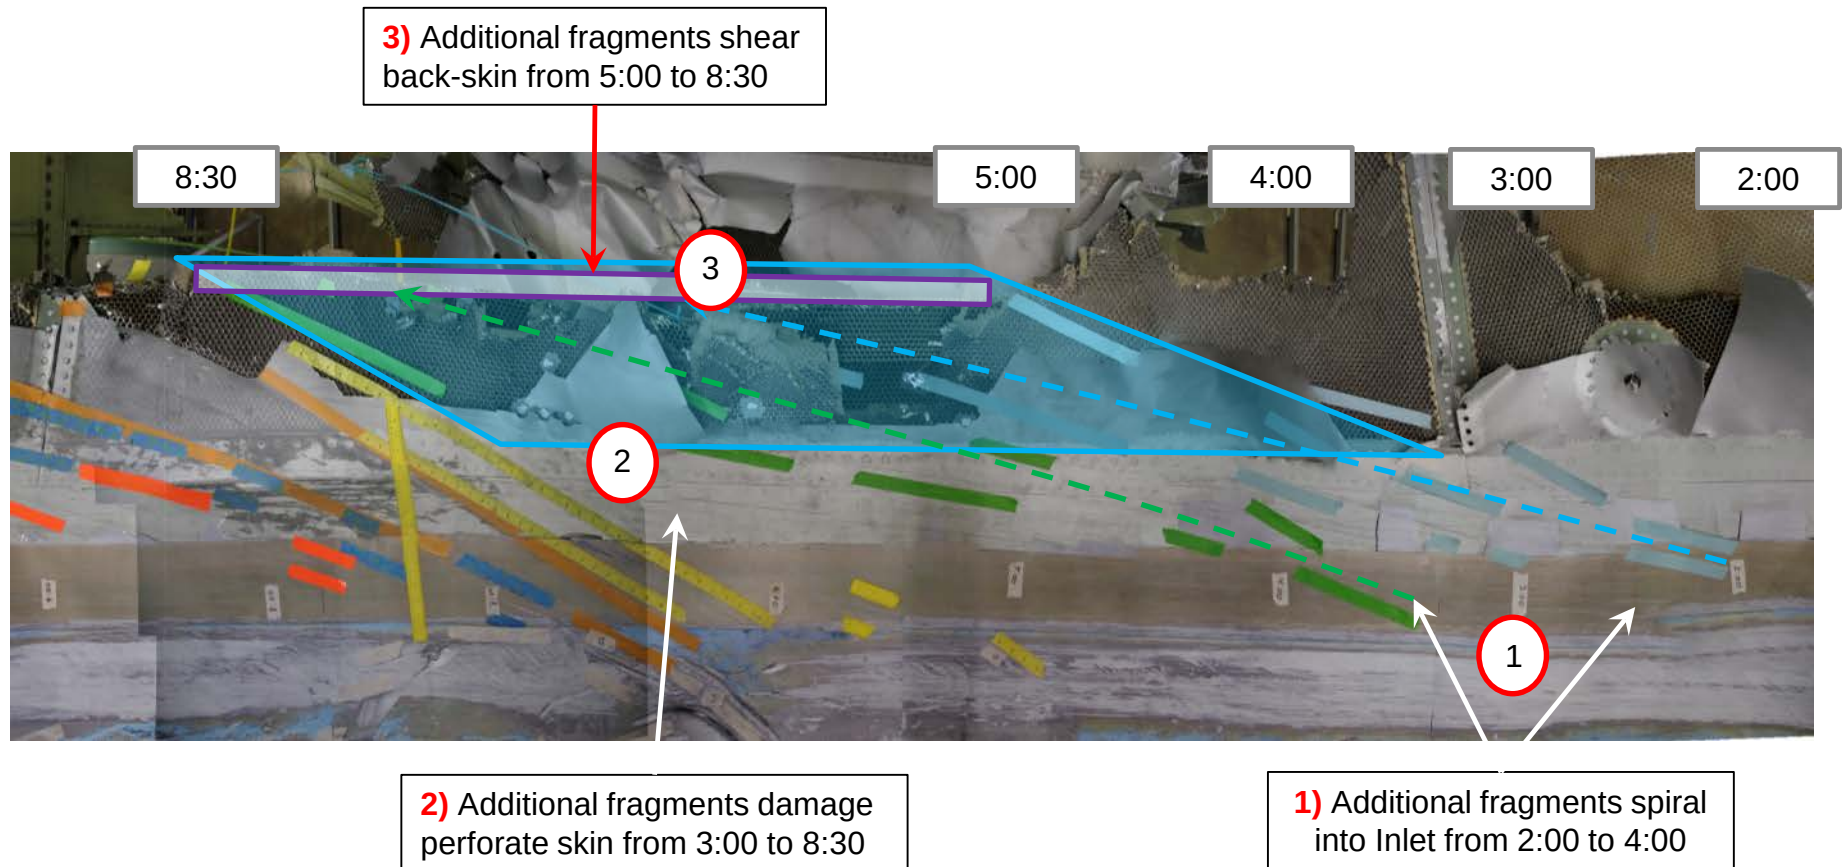
## ADDITIONAL BLADE FRAGMENTS DAMAGE PERFORATE SKIN AND BACK-SKIN

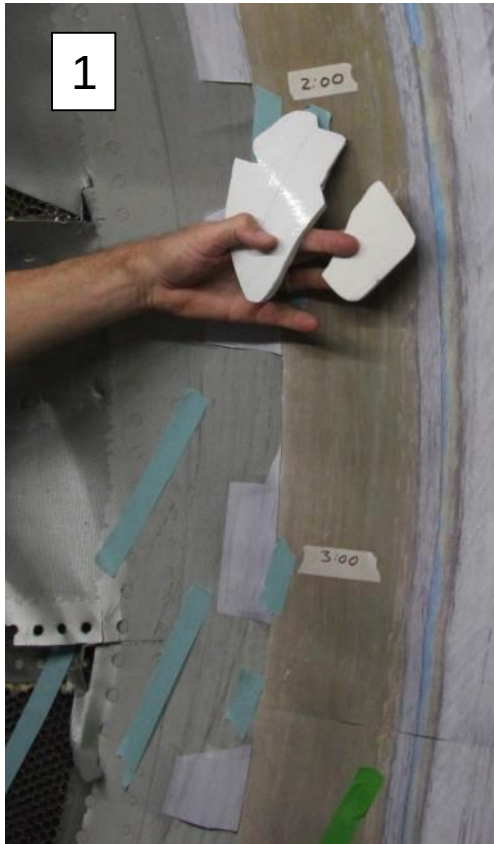
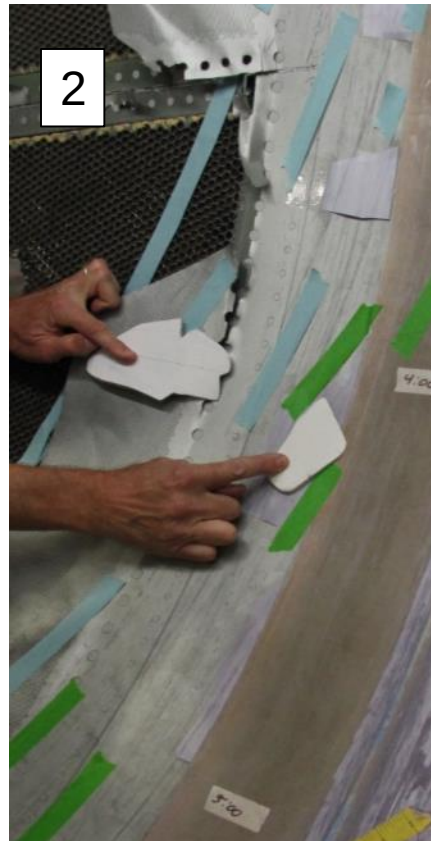
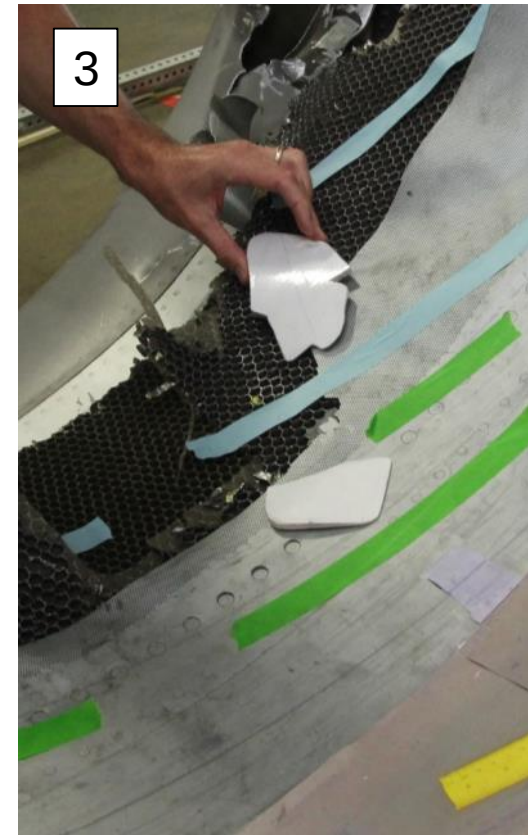
1), 2), 3) Additional fan fragments spiral into Inlet from 2:00 to 4:00 damaging perforate skin

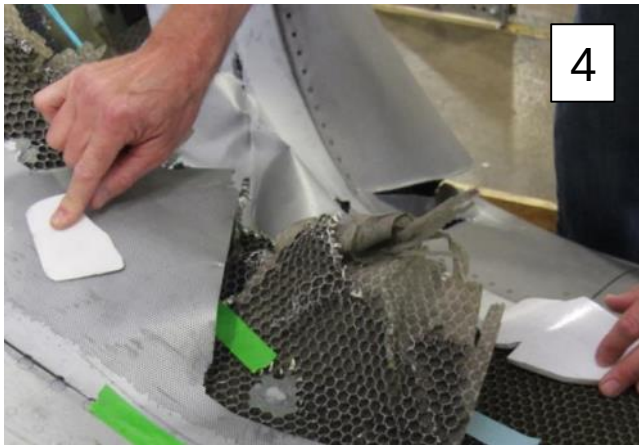
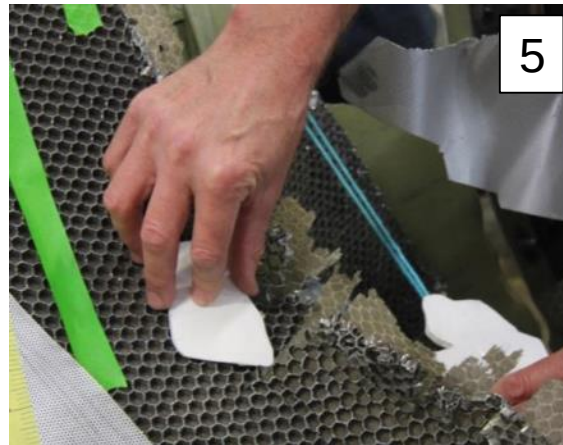
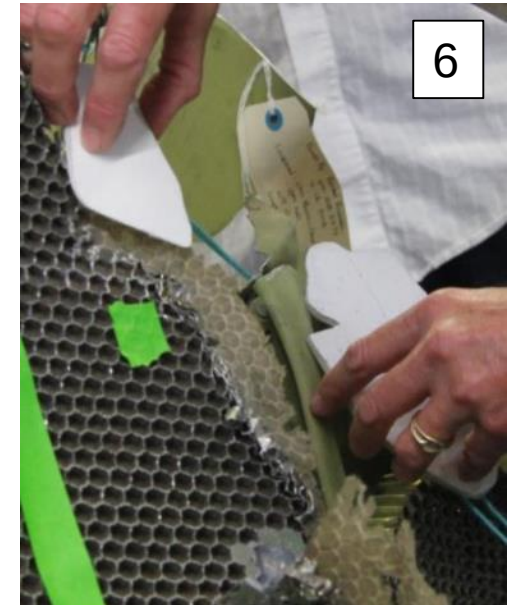
4), 5), & 6) Additional fan fragments damage perforate skin from 3:00 to 8:30

Ti-6Al-4V found in core and back-skin between 5:00 and 7:30

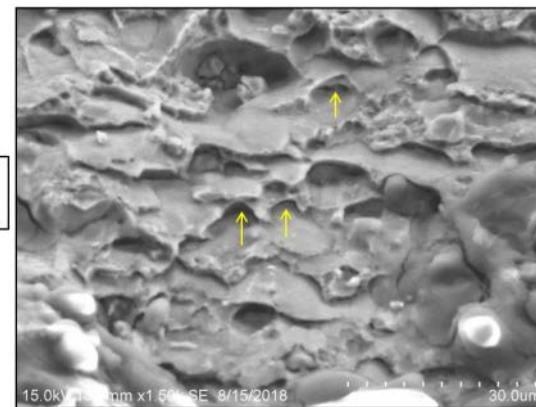
- 8:30 Back-Skin – Radial Outboard

FWD Skin Shear  
Radial Outboard

AFT (Back Skin) Microvoid Coalescence

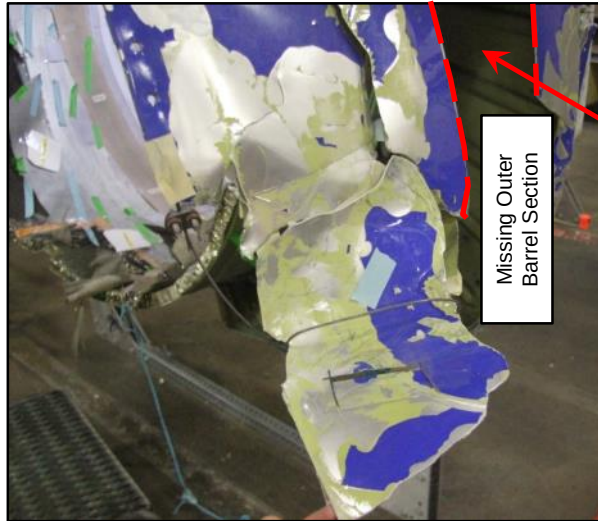
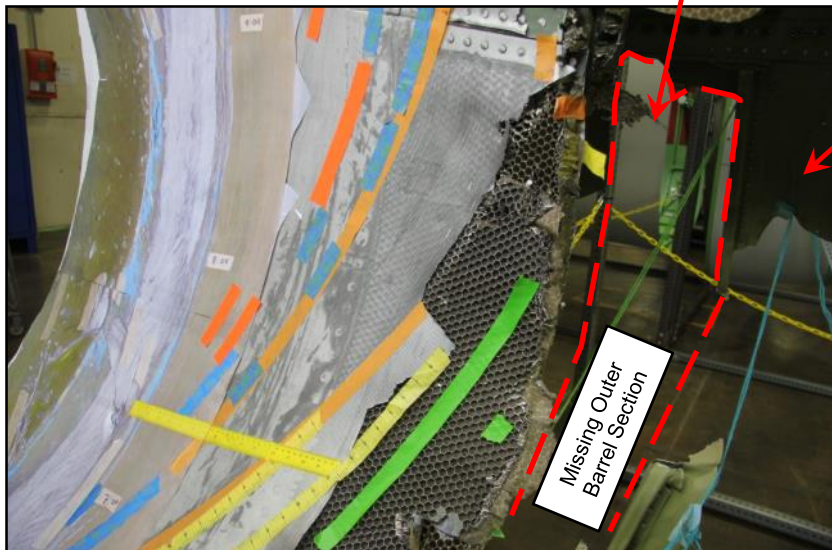
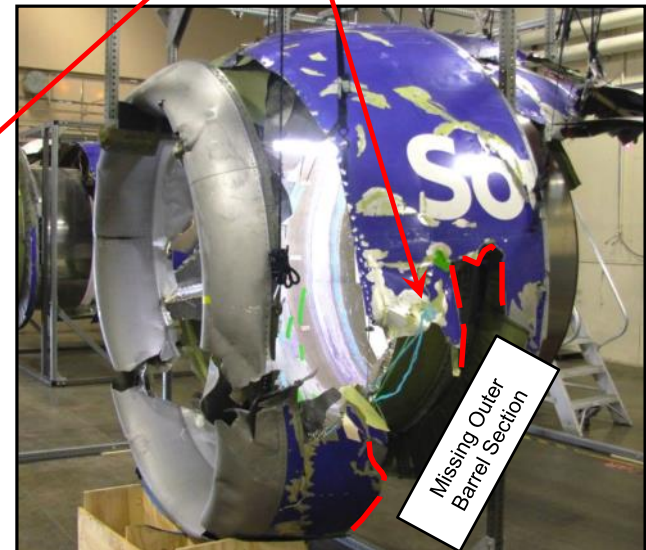
Trajectory of additional fan fragments projects through hole in outer barrel just forward of containment shield

Trajectory of additional fan fragments projects to outer barrel scratches containing Ti-6Al-4V particles
