# BACKGROUND

On April 17th, 2018 SWA 1380 experienced a fan blade out (FBO) event at FL 320. The FBO event resulted in portions of the inlet and fan cowl departing the aircraft, specifically the inlet d-duct, inlet outer barrel, forward sections of the inlet inner barrel and large sections of the fan cowl. In support of the NTSB, Collins Aerospace (Collins) documented the condition of the inlet and fan cowl components that remained on the aircraft as well as the recovered hardware that departed the A/C. The recovered hardware and the remaining portions of the inlet and fan cowl were removed from the aircraft and were shipped to the Collins facility in Chula Vista, California.

# Fan Blade Fragment Trajectories and Inlet Damage

# COLLINS INLET FAN FRAGMENT DAMAGE ASSESSMENT

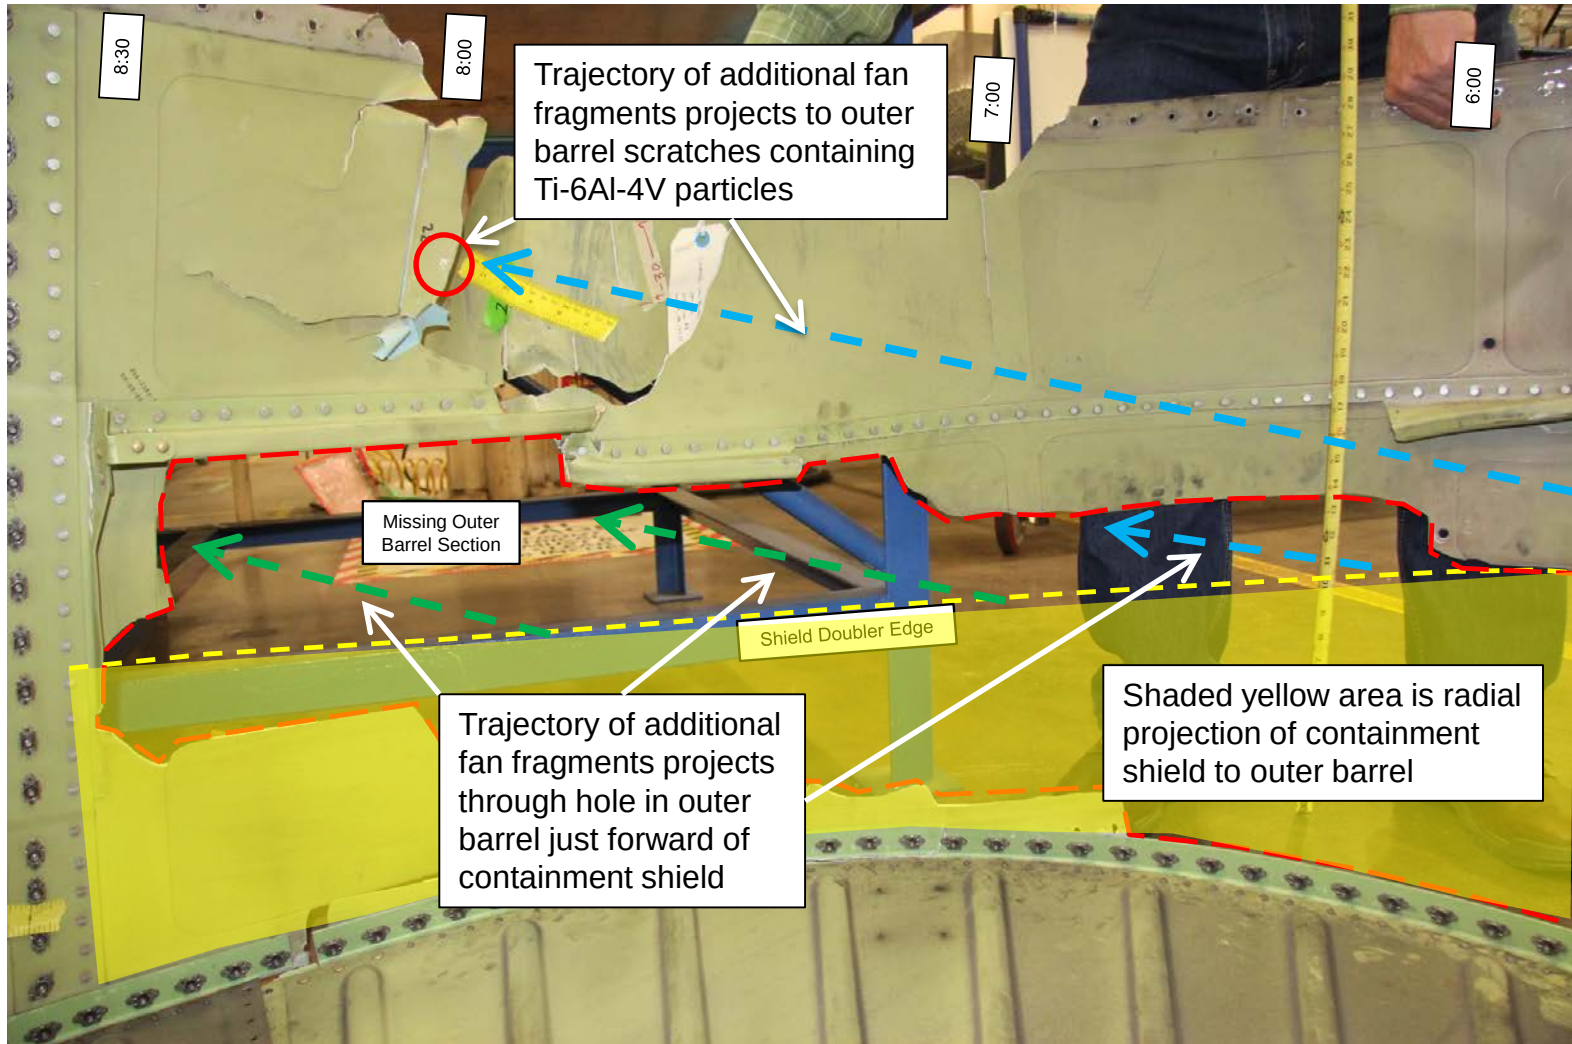
## ADDITIONAL FAN BLADE FRAGMENTS IMPACT OUTER BARREL

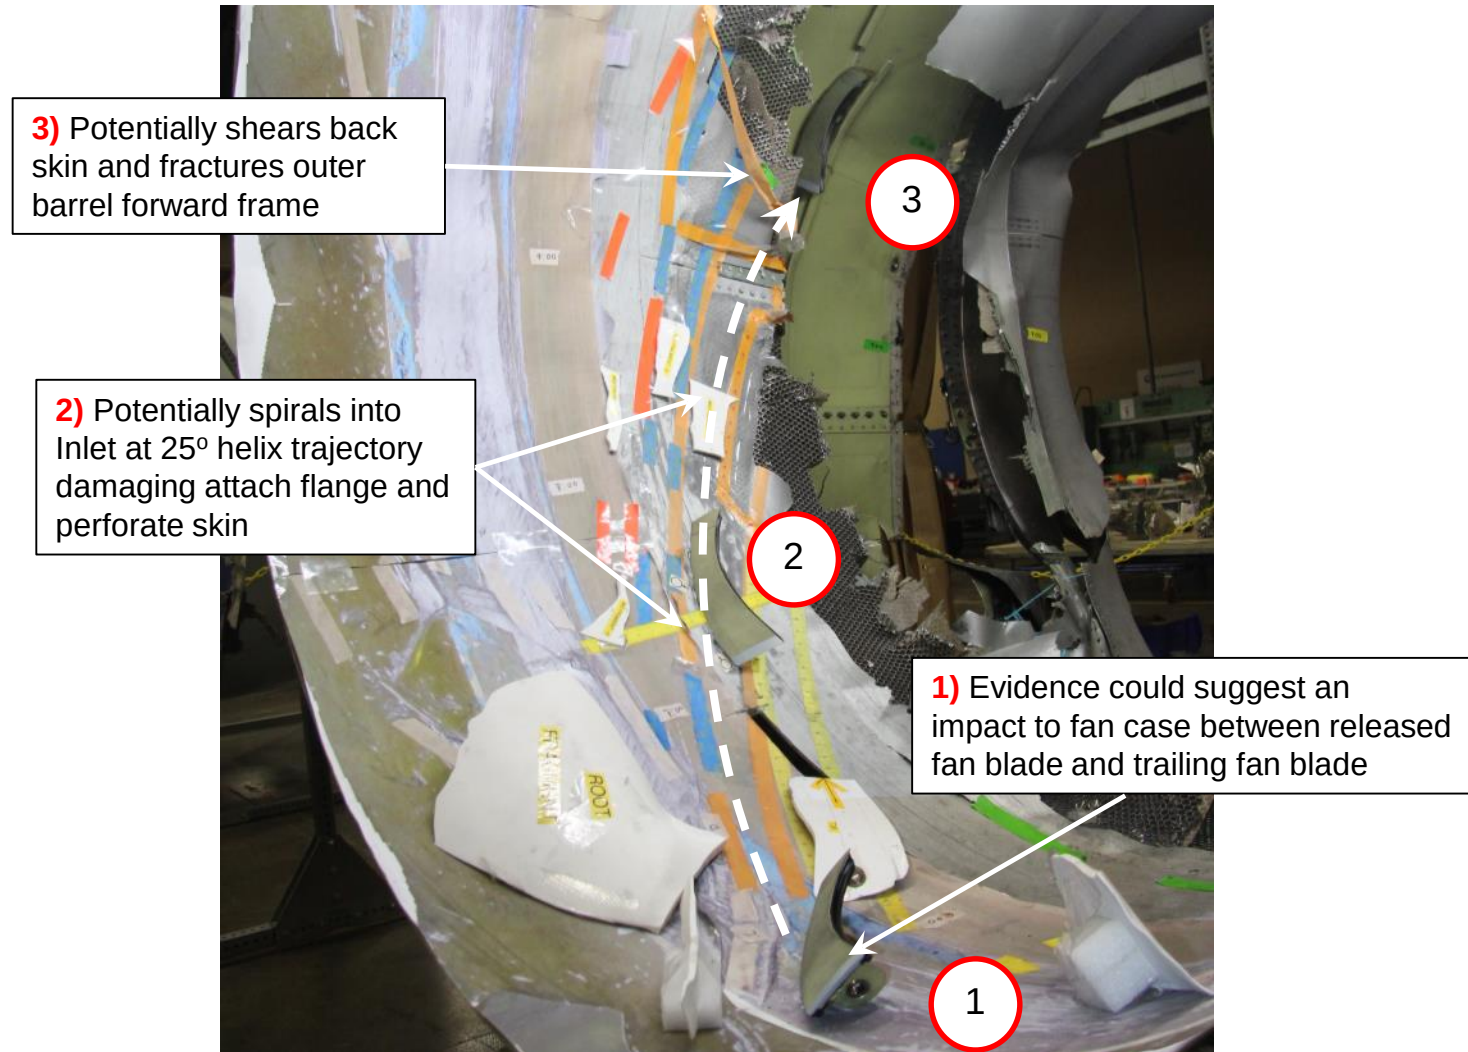
**PLATFORM POTENTIALLY DAMAGES INLET ATTACH FLANGE, PERFORATE SKIN, BACK-SKIN AND OUTER BARREL**

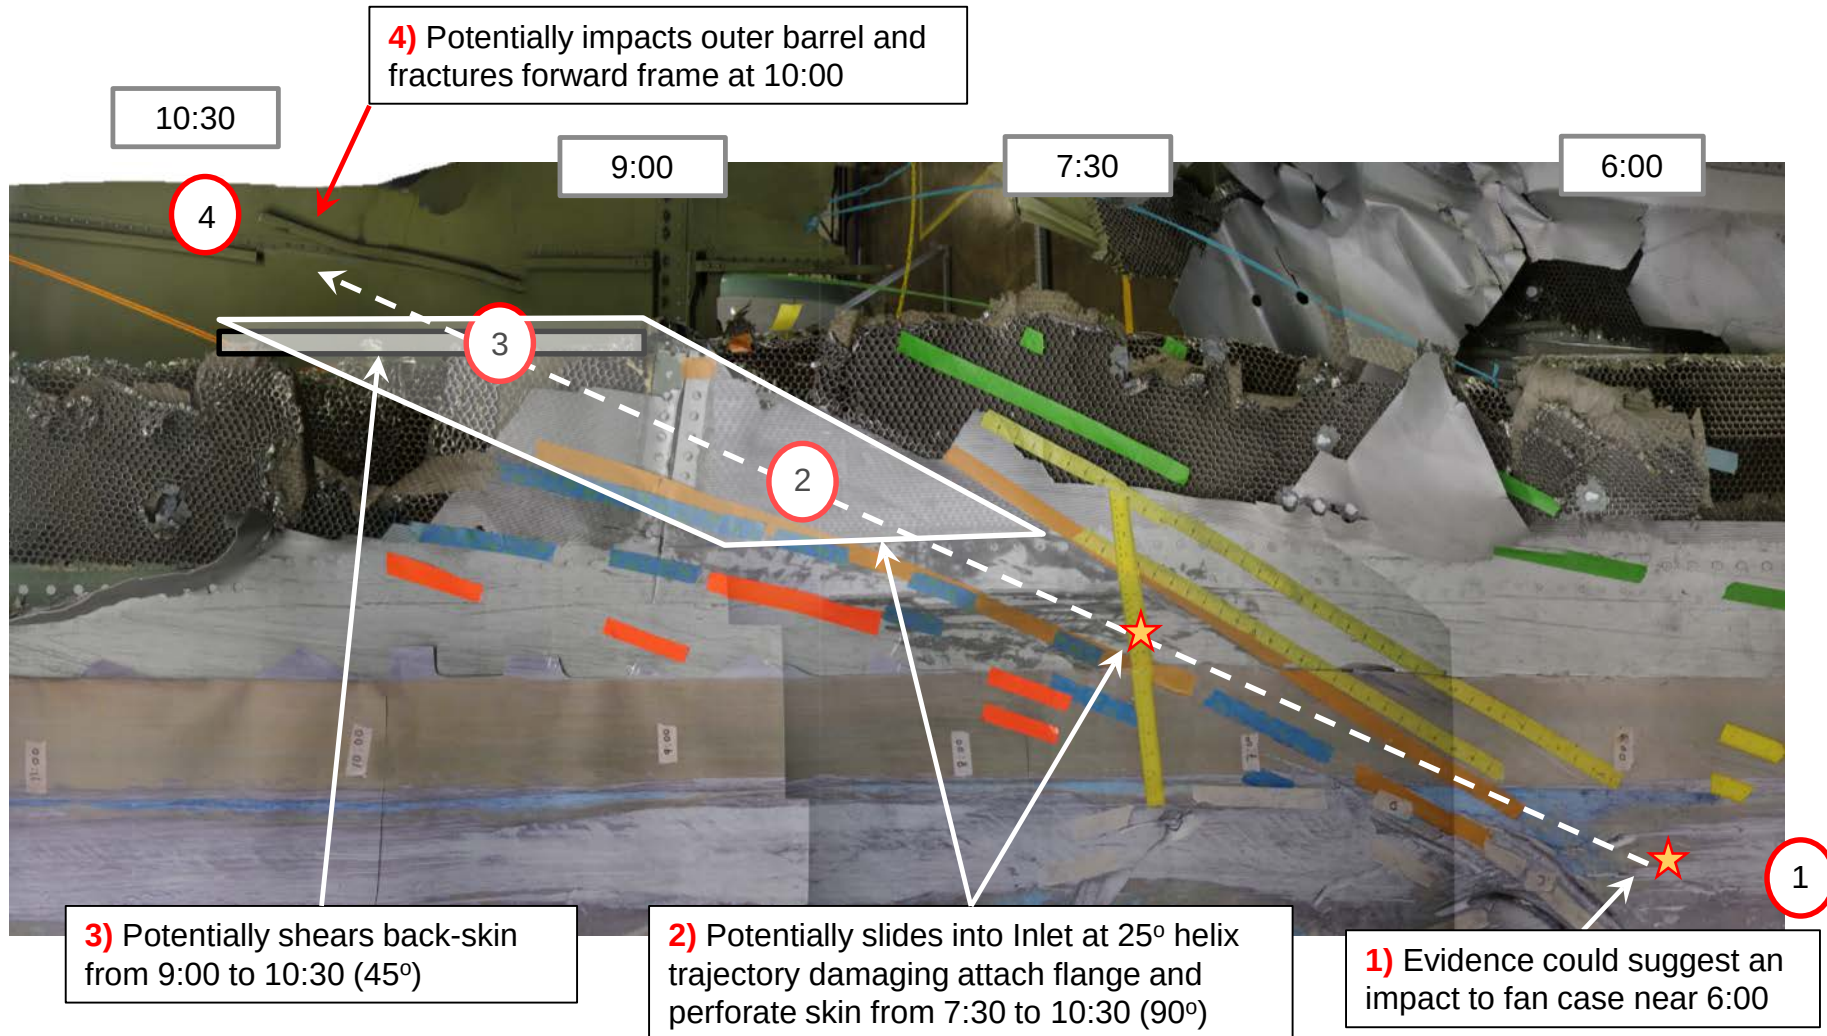
PLATFORM POTENTIALLY DAMAGES INLET ATTACH FLANGE, PERFORATE SKIN, BACK-SKIN AND OUTER BARREL

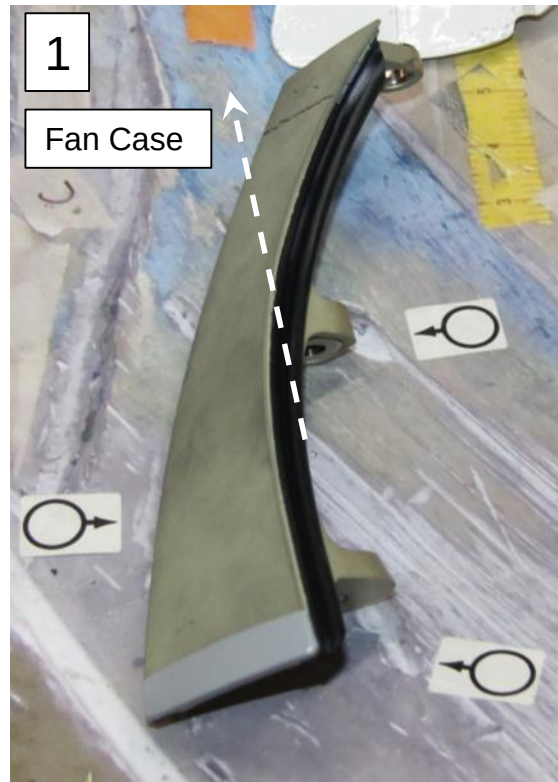
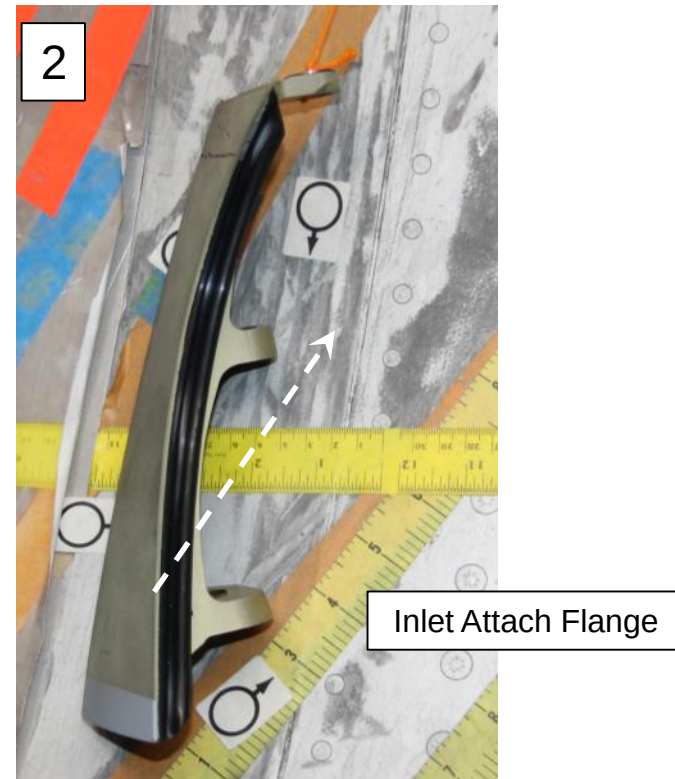
- 1) Scratches and gouges in fan case at 6:00 potentially align with platform edge and tangs
- 2) Scratches and gouges in Inlet attach flange at 7:30 potentially align with platform edge and tangs

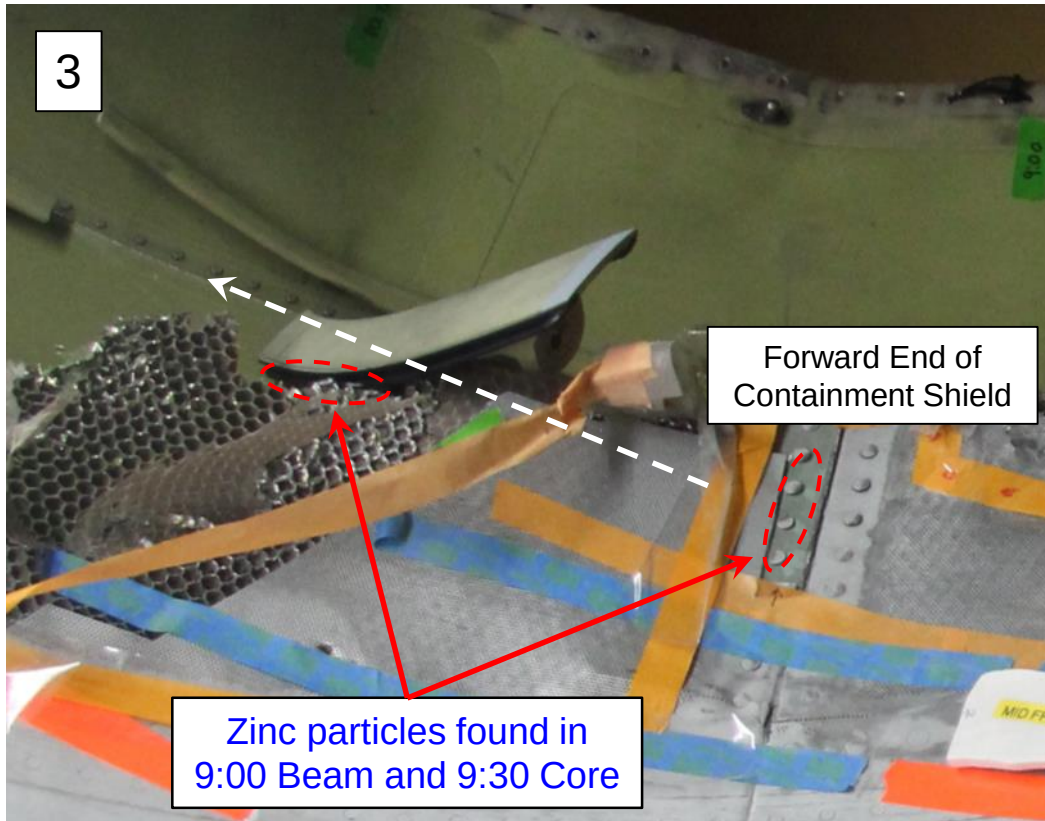
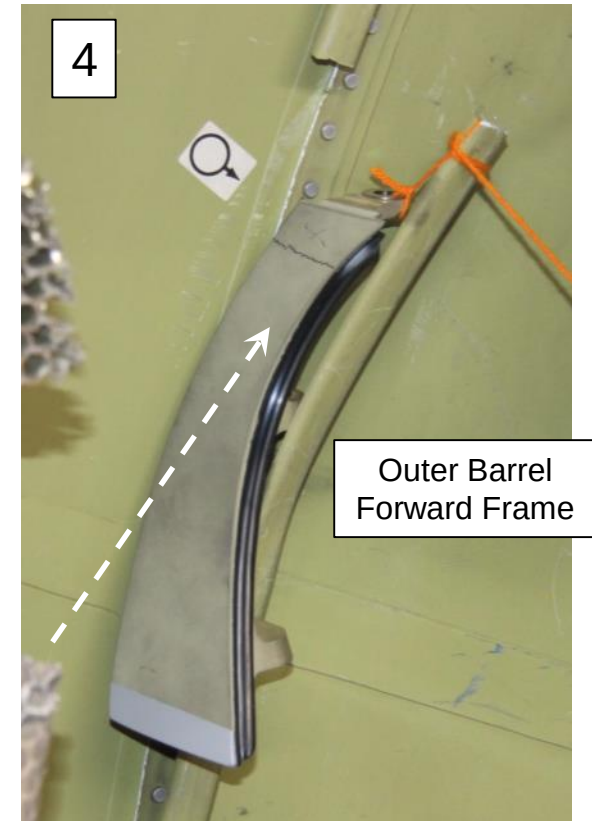
- 3) Potential trajectory projects through sheared Back Skin from 9:00 to 10:30 at forward end of Shield
- 4) Potential trajectory projects to fractured frame and scratches on Outer Barrel at 10:00

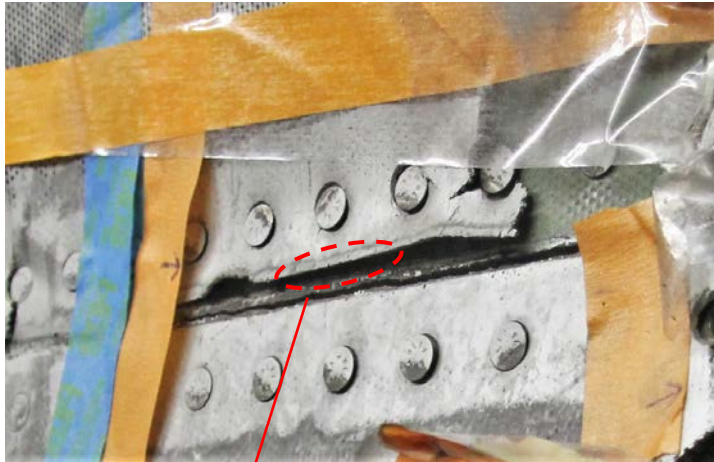
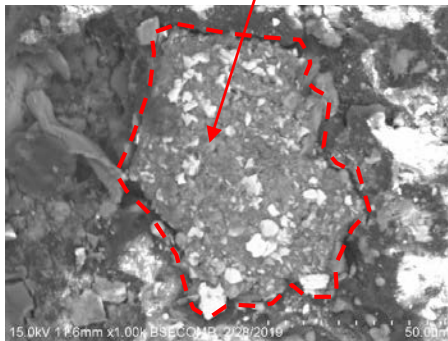
Area 64 (Beam Splice) – Position: 9:00

## ZINC PARTICLES FOUND IN 9:00 BEAM AND ACOUSTIC CORE

Zinc particles embedded

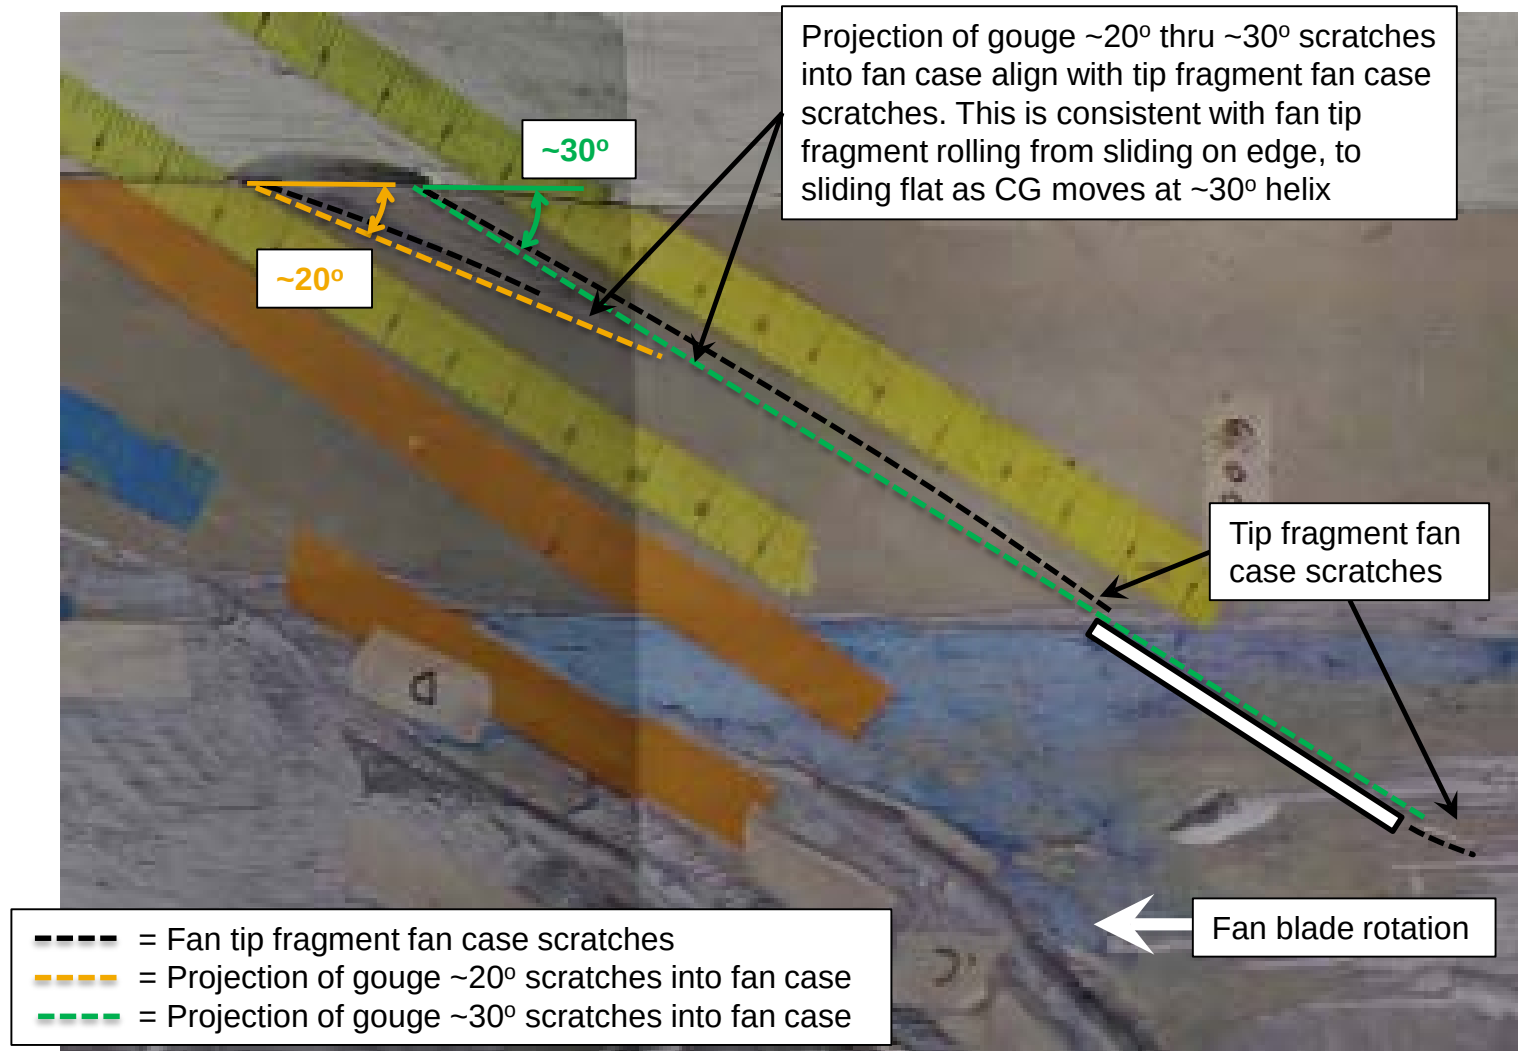
## TIP FRAGMENT CAUSED SCRATCHES LEADING INTO ATTACH RING GOUGE

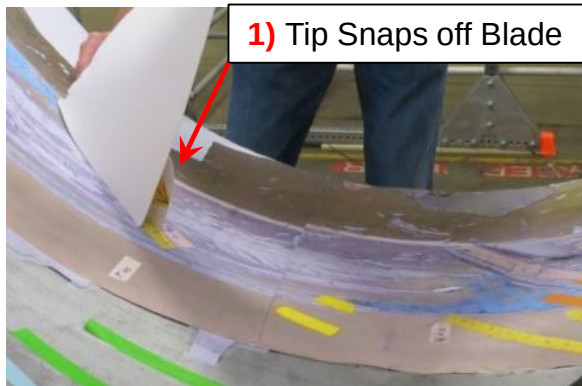
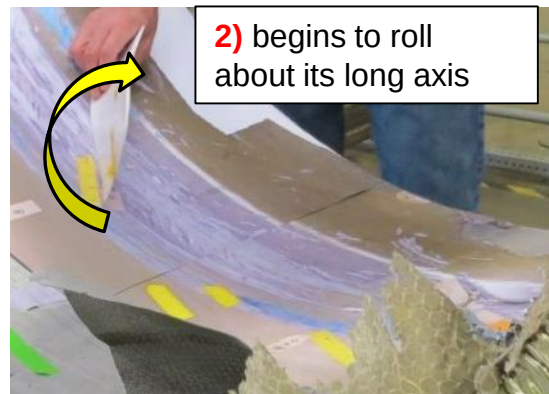
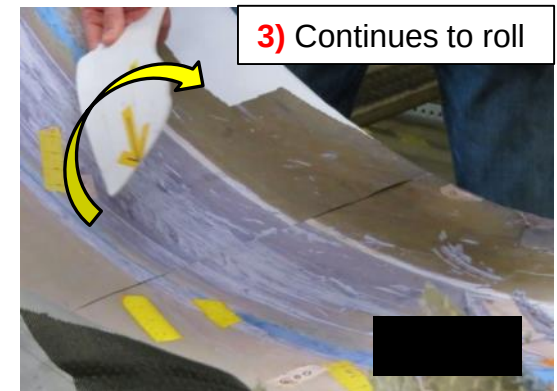
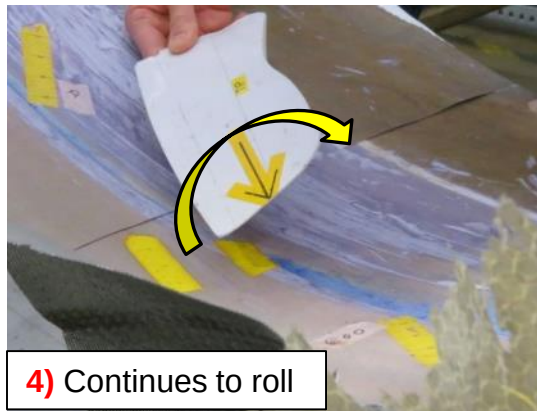
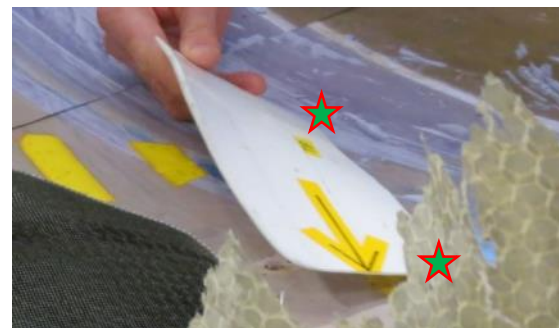
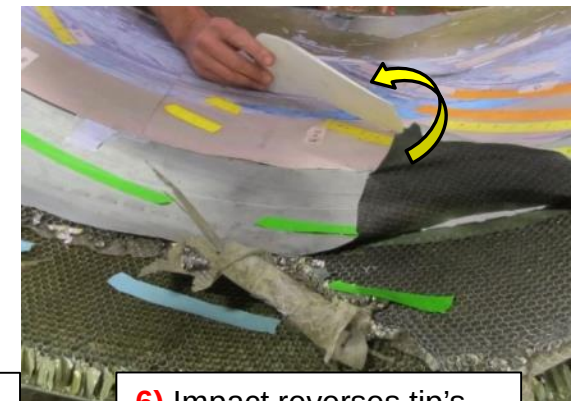
TIP FRAGMENT FRACTURED-EDGE IMPACT CHANGES ITS TRAJECTORY

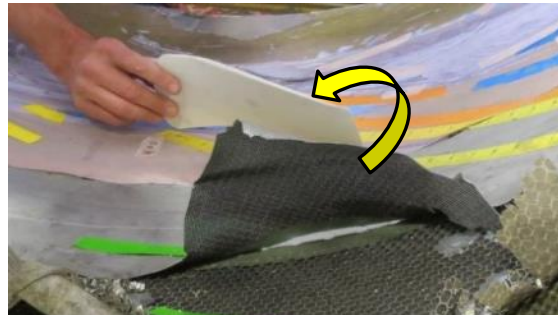
**6)** Impact reverses tip's roll direction and changes its trajectory to  $\sim 30^\circ$  helix

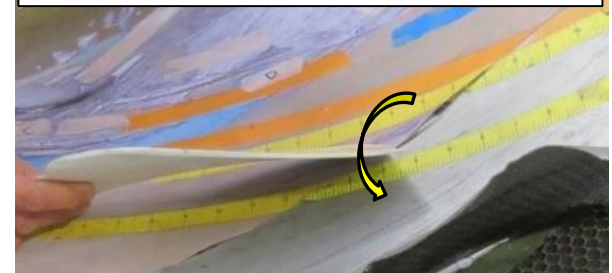
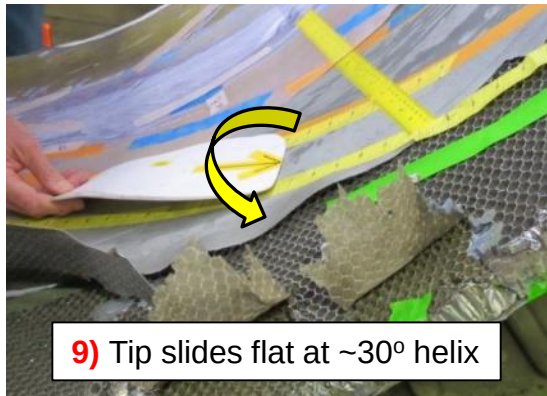
**7)** Tip rolls in reversed direction while its fractured-edge creates fan case scratches that begin with  $\sim 30^\circ$  helix

**8)** Tip's fractured-edge creates gouge scratches that change from  $\sim 30^\circ$  to  $\sim 20^\circ$  helix while tip rolls from sliding on fractured edge to sliding flat

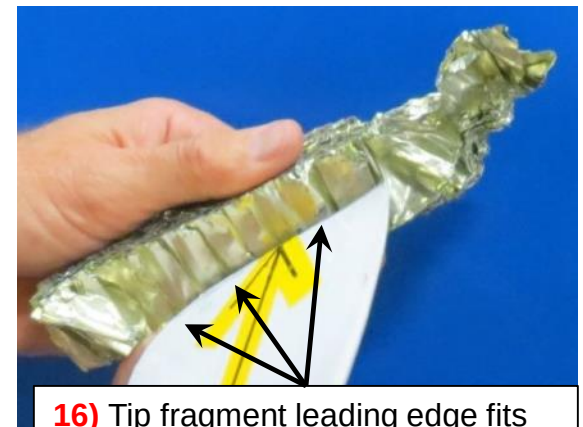
**15)** Collapsed acoustic core mates with 9:00 beam

**16)** Tip fragment leading edge fits in dents of collapsed acoustic core. Ti-6Al-4V found in dents.

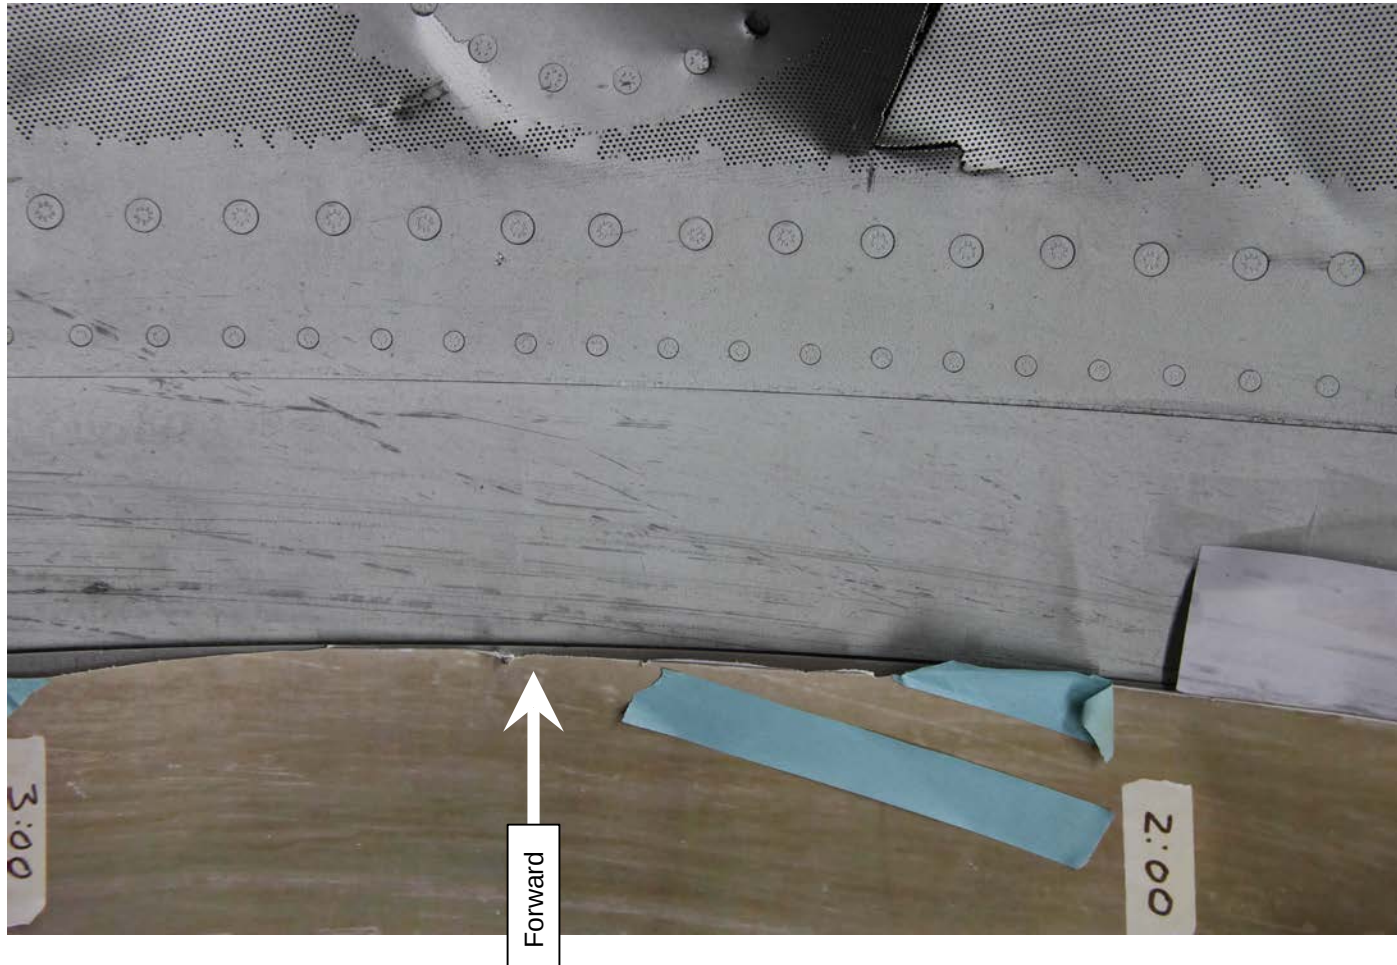
### Inner Barrel Scratch Marks 2:00-3:00

## ADDITIONAL FAN FRAGMENT SCRATCHES IN INNER BARREL

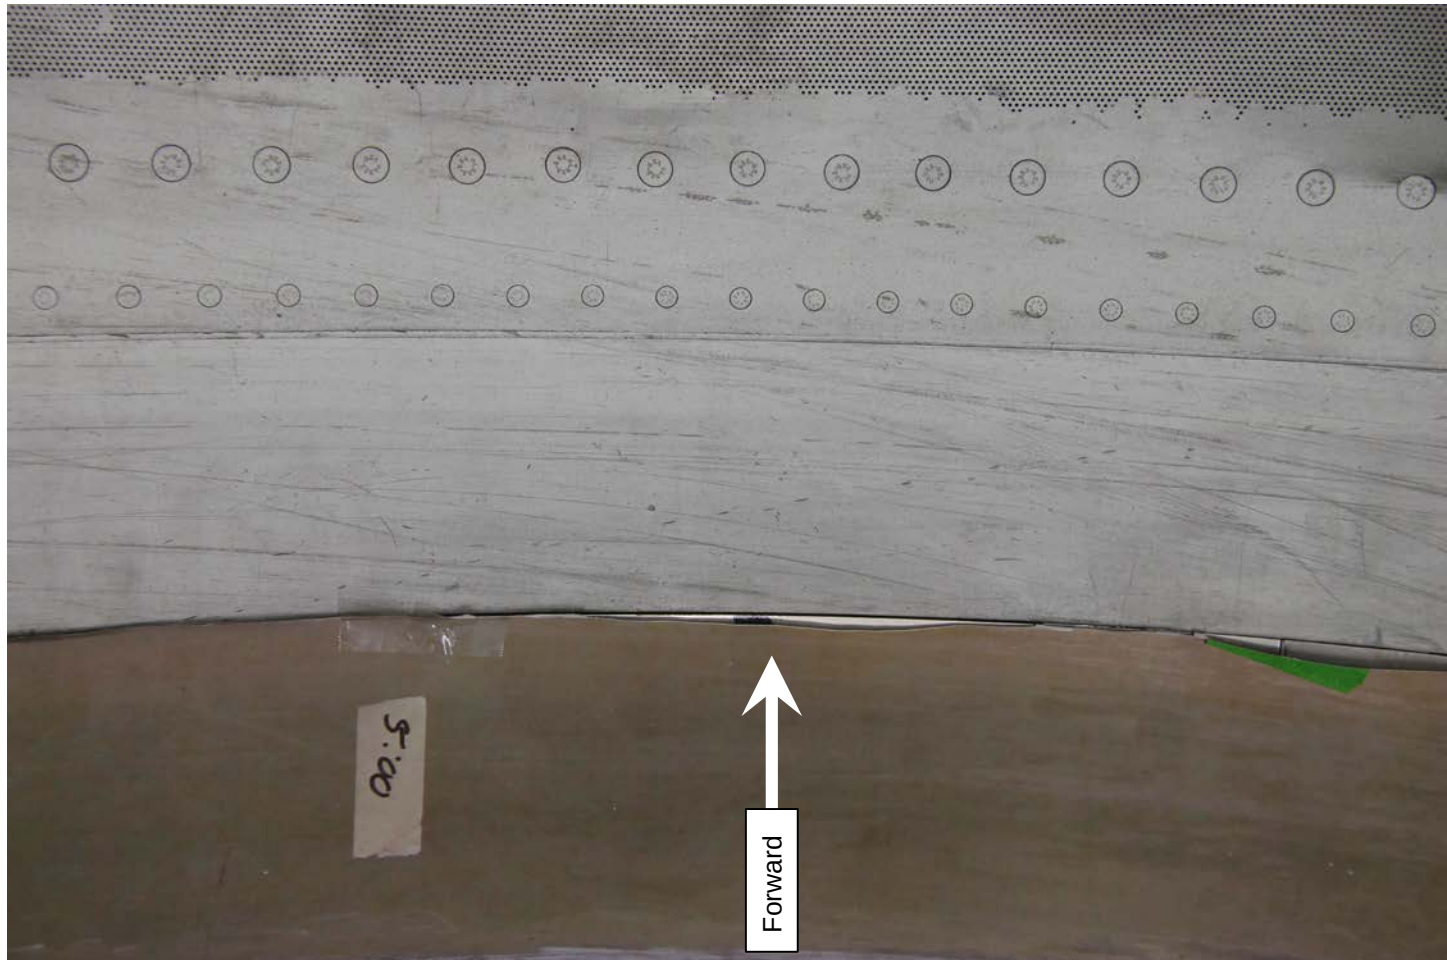
### Inner Barrel Scratch Marks 4:00-5:00

## ADDITIONAL FAN FRAGMENT SCRATCHES IN INNER BARREL

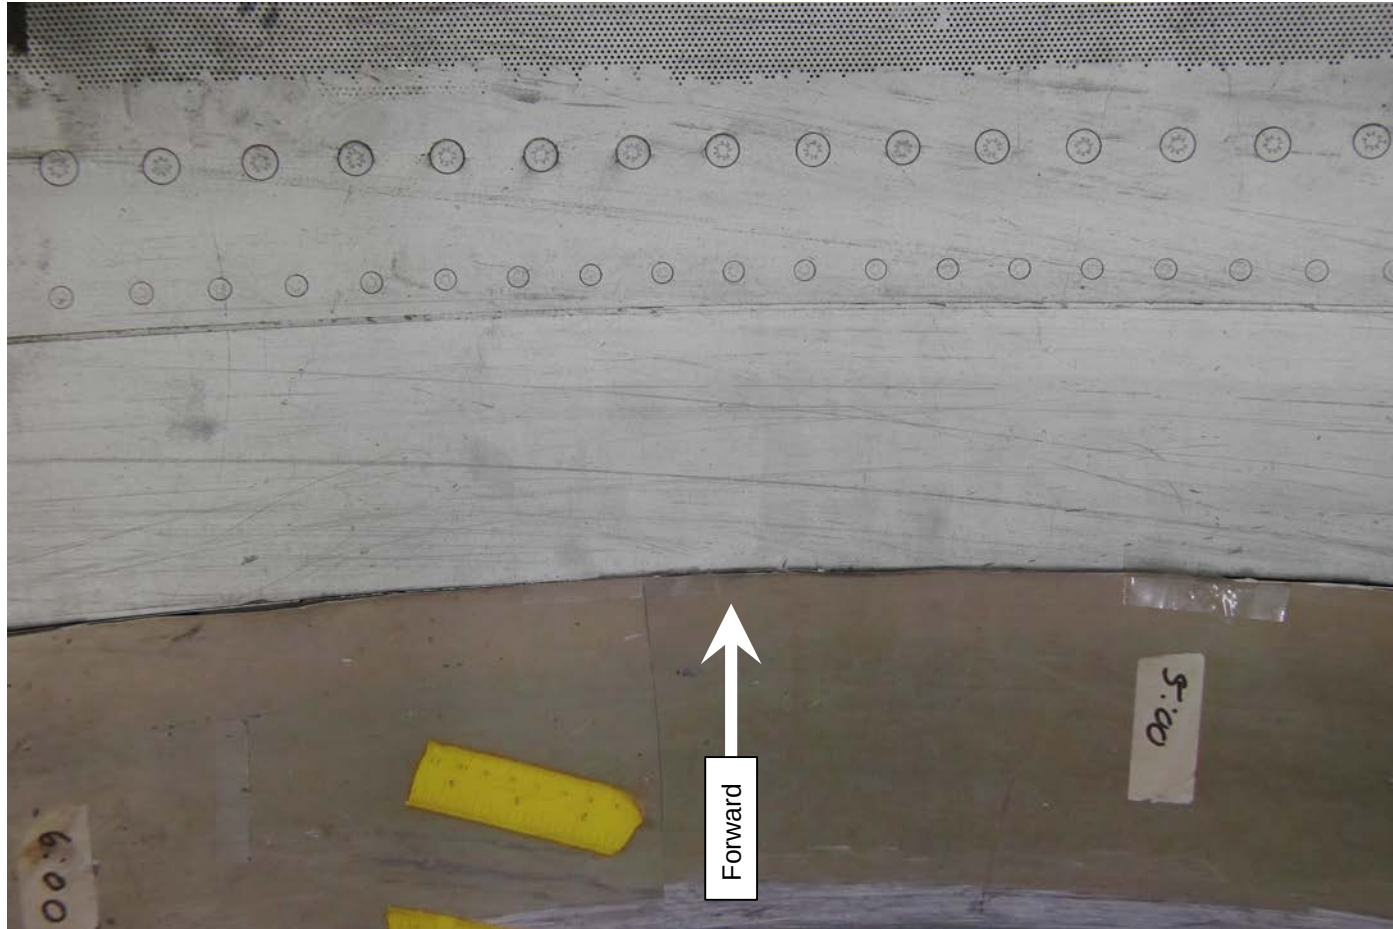
### Inner Barrel Scratch Marks 5:00-6:00

## ADDITIONAL FAN FRAGMENT SCRATCHES IN INNER BARREL

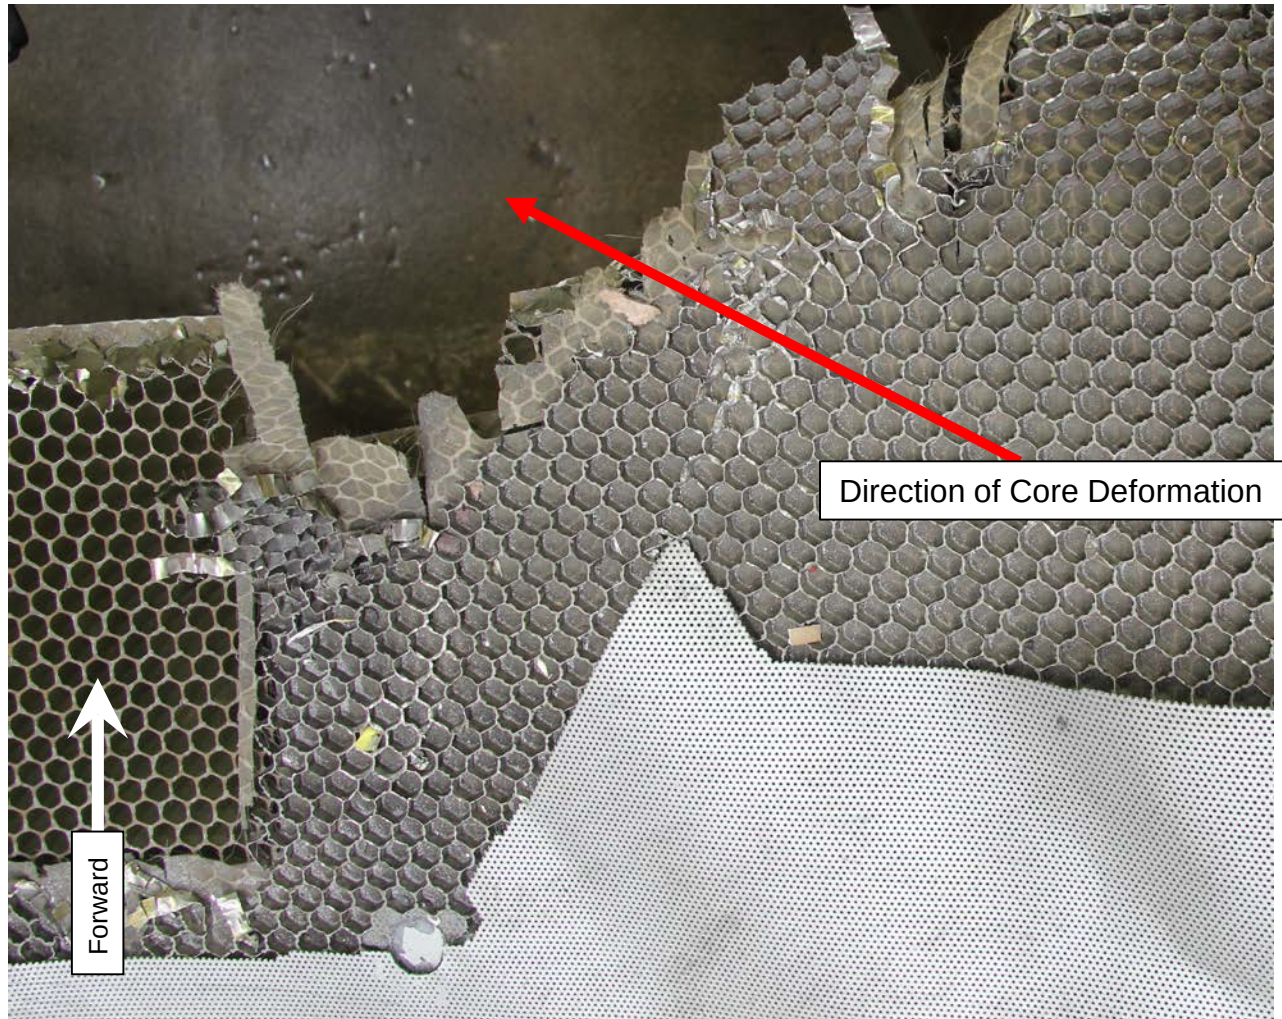
## ADDITIONAL FAN FRAGMENT CORE CRUSH AT 5:00

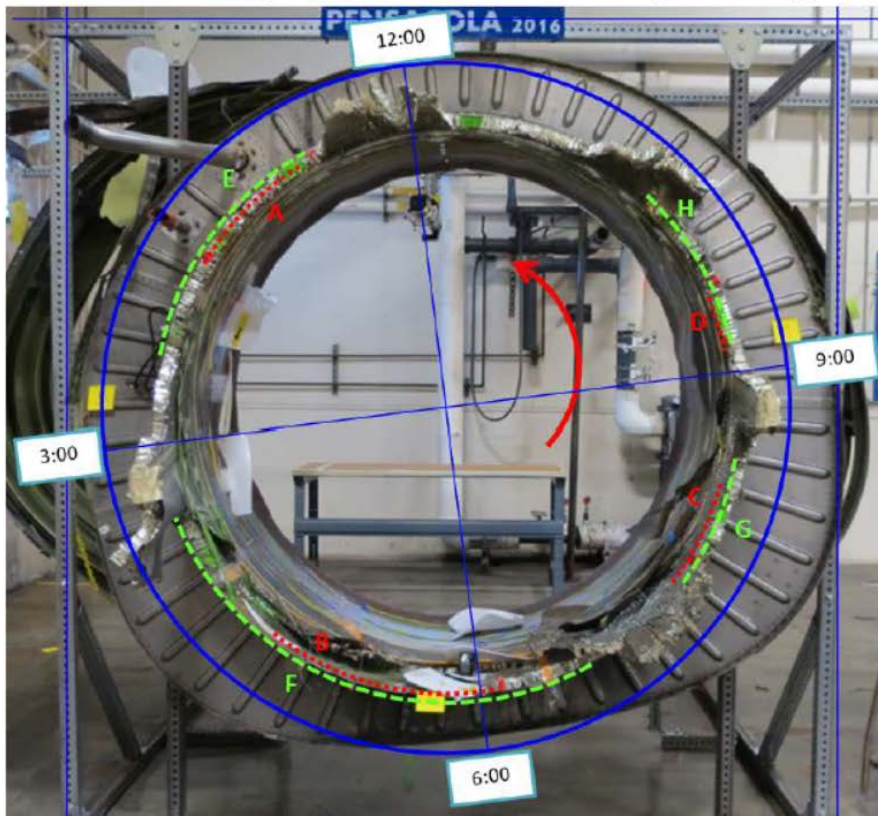
PHOTO 129: INLET INNER BARREL DAMAGE ASSESSMENT

## SW-3572 DAMAGE SIMILAR TO PHILADELPHIA SW-1380

### — Min/Max Inner Barrel Through Damage from Fan Blade Fragments
