## **CFM presentation**

### **Fan blades fragments trajectories and Philadelphia inlet damage assessment**

The objective of this report is to document the CFM assessment of fan blade fragments trajectories and Philadelphia inlet damage presented to the investigative parties during the meeting held March 5-6, 2019 in Cincinnati, Ohio.

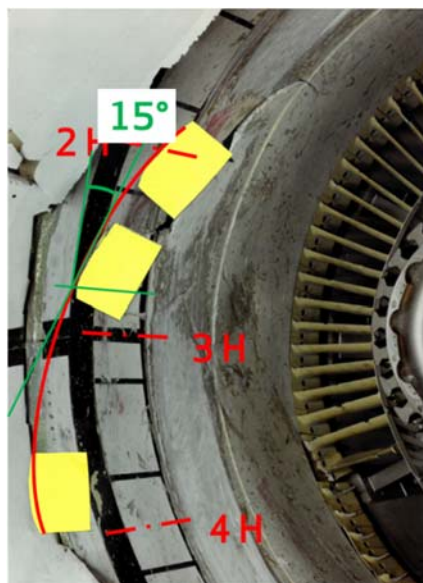
**Figure 3-2 : FBO Rig Test 4 - Tip blade fragment trajectory**

Review of photographs of Rig Test 4 shows continuous tip fragment trajectory aft and forward of A1 flange between 2 o'clock and 4 o'clock. Tip fragment edge crossed A1 flange with an angle of 15°. Continuous marks observed on fan case and inlet suggest that fragment center of gravity (CG) had same trajectory as tip fragment edge.

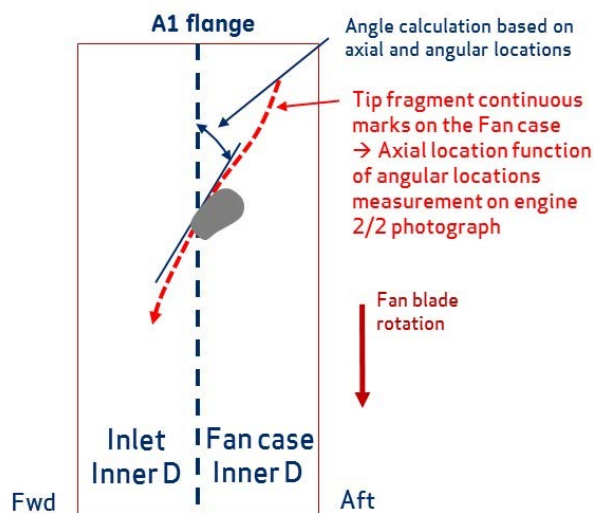
**Figure 3-4 : Tip fragment marks on Fan case and Inlet inner Diameter observed around A1 flange**

Those Tip fragment marks are made by the edge of the tip fragment and provide information on its trajectory. The position of those marks relative to A1 flange plane has been measured as illustrated in Figure 3-4.

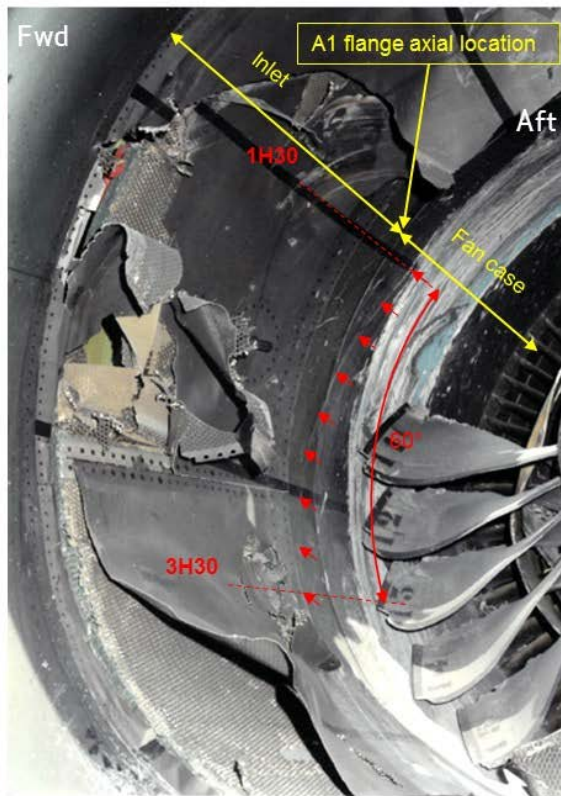
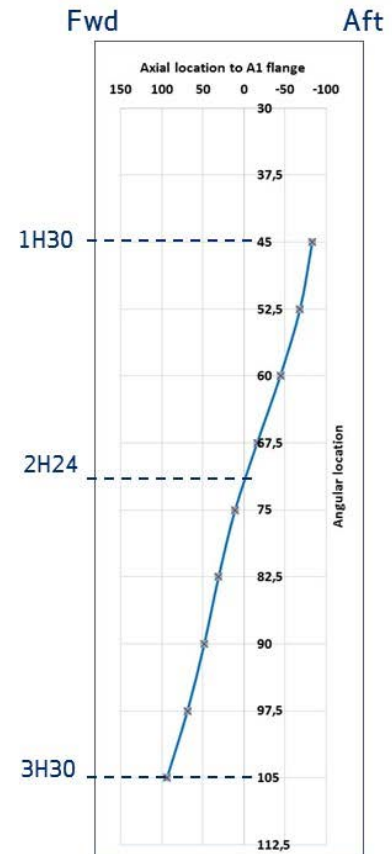
**Figure 3-5 : Tip fragment trajectory measured on engine 2/2 around A1 flange**

Tip fragment continuous marks observed from 1H30 to 3H30 over 60° circumferentially

Locations on Tip fragment marks path pointed with an arrow have been measured axially and circumferentially from 1H30 to 3H30

Based on continuous mark from tip fragment observed on Figure 3-5, there is no evidence of Tip fragment tumbling between 1:30 and 3:30.

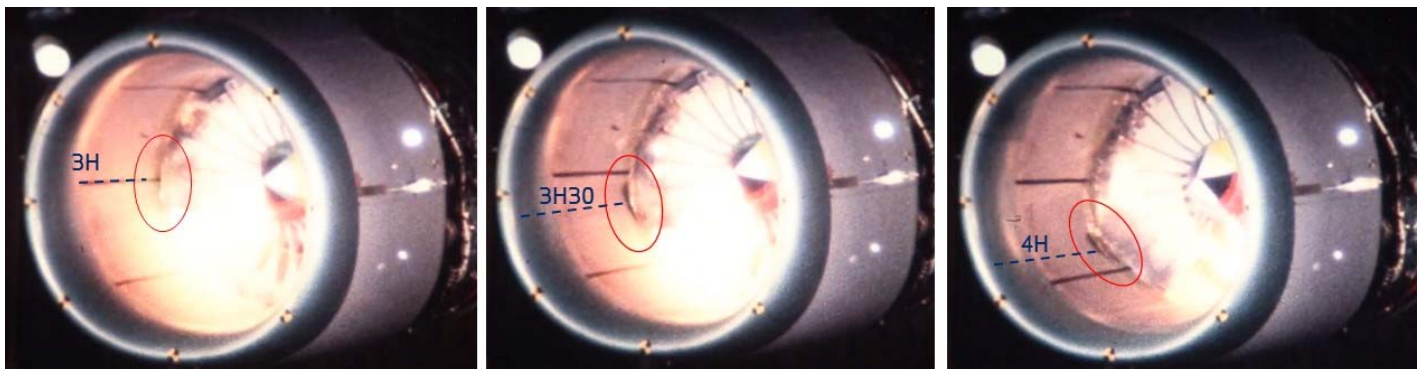
**Figure 3-6 : Tip fragment sliding between 3:00 and 4:00**

Moreover, on the engine 2/2 high speed films, no Tip fragment tumbling is observed between 3:00 and 4:00 on engine 2/2. Earlier than the 3:00 clock position, the Tip fragment cannot be observed on high speed films) as presented in figure 3-6. Only Tip fragment wobbling (not tumbling) is observed.

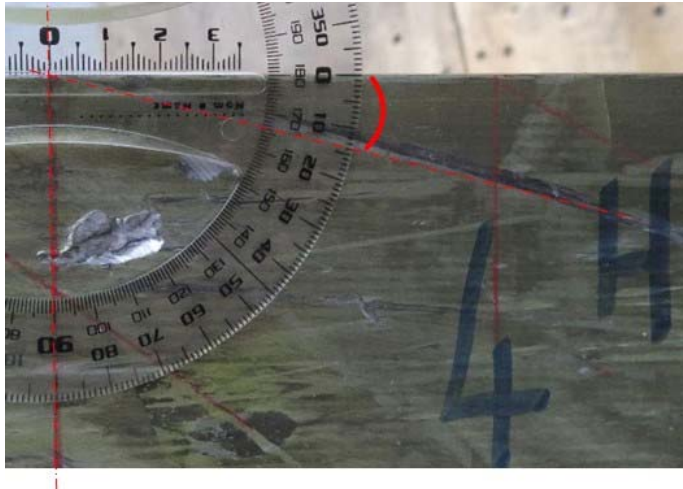
**Figure 4-2 : Tip fragment mark on the Fan case measured angle at A1 flange on Pensacola engine 874112 Fan case**

The angle of tip fragment witness marks on the Fan case at A1 flange location was measured on Pensacola Fan case: the result is  $\sim 14^\circ$  as illustrated on Figure 4-2.

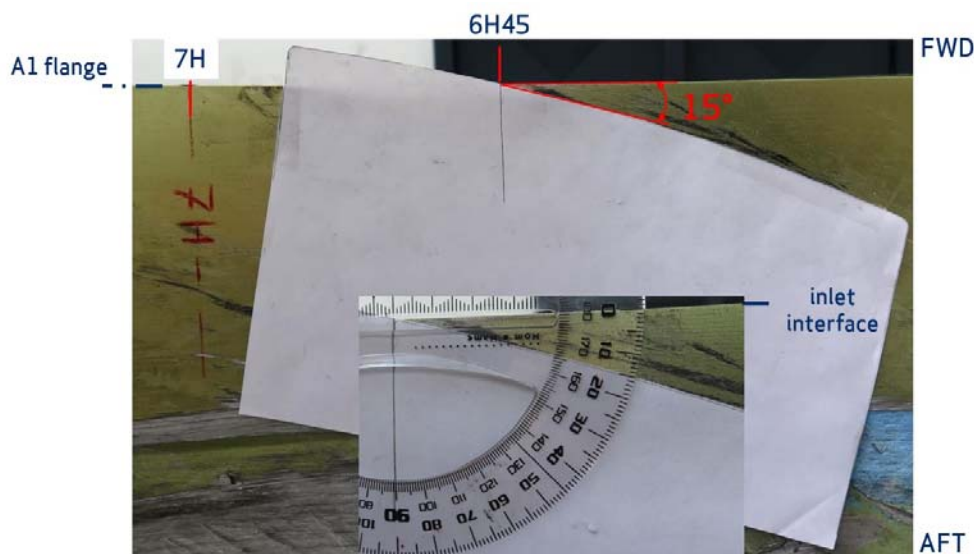
**Figure 4-3 : Tip fragment mark on the Fan case and angle measurement at A1 flange on Philadelphia engine 875134 Fan case**

The angle of last tip fragment mark on the Fan case at A1 flange location was measured on Philadelphia Fan case at 15° as shown in Figure 4-3.

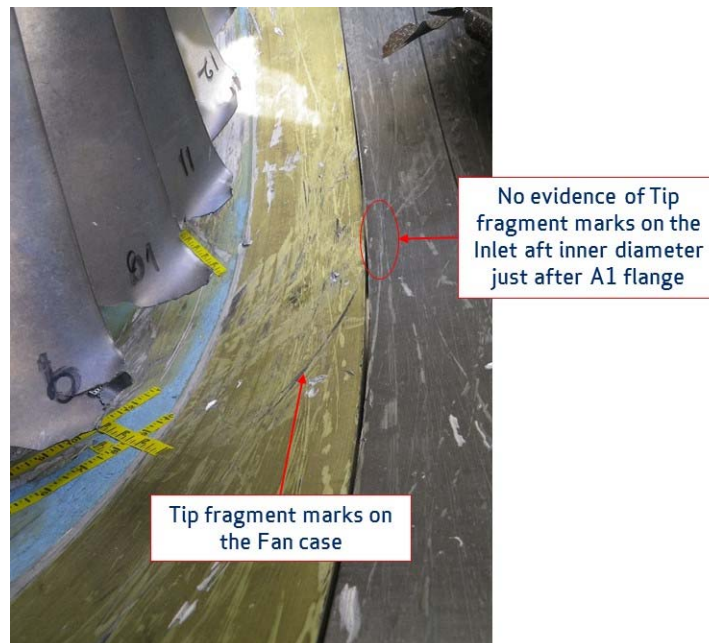
Figure 4-4 : Tip fragment marks observed on Pensacola engine 874112 Fan case

Tip fragment marks on the Fan case are the only data available to estimate the tip fragment edge trajectory up to A1 flange, as no evidence (witness marks) of tip fragment trajectory are observed on the Inlet inner diameter just forward of the A1 flange as shown in Figure 4-4.

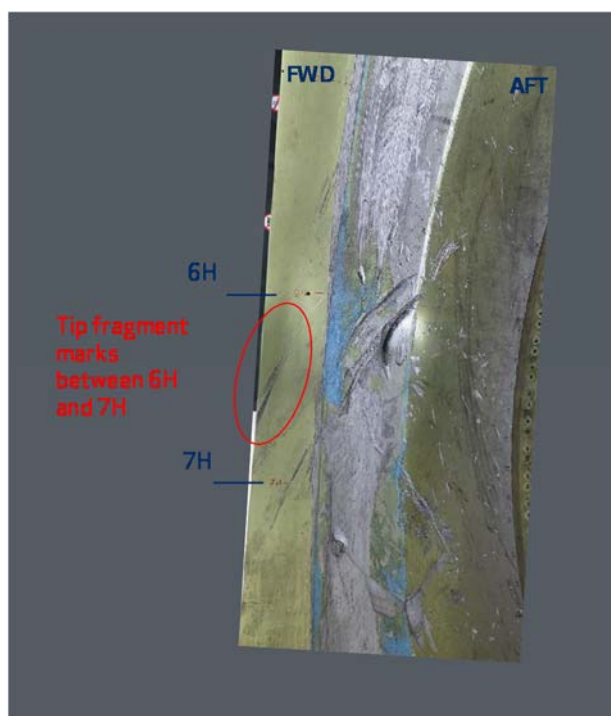
**Figure 4-8 : Tip fragment marks on Philadelphia engine 875134 Fan case between 6:00 and 7:00**

Tip fragments marks are observed between 6:00 and 7:00 on engine 875134 Fan case. See Figure 4-8.

Detailed analysis of these tip fragment marks on fan case show **three** distinct Tip fragment trailing edge imprints on the Fan case. A photograph of the blade Tip trailing edge radius is shown in Figure 4-9.

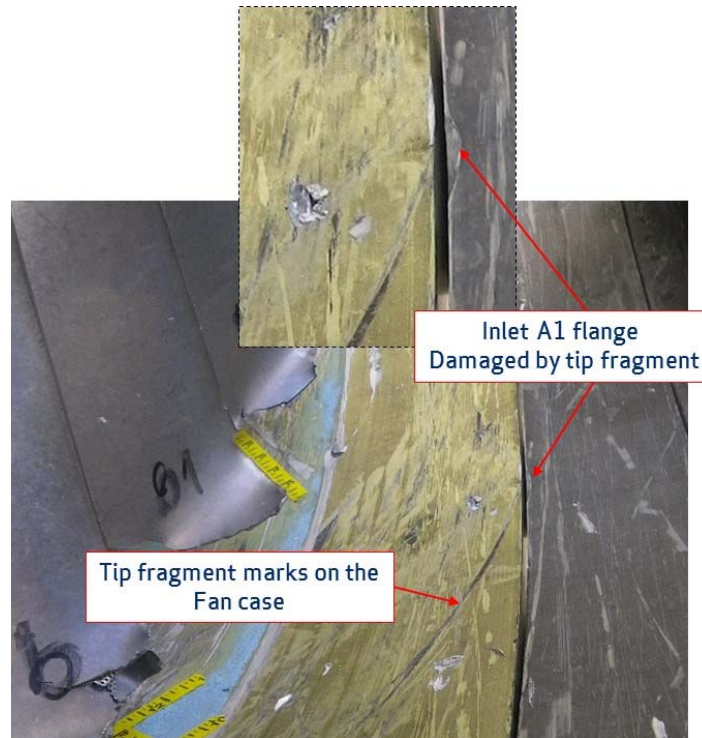
Figure 4-16 : Inlet A1 flange damaged by tip fragment on Pensacola engine 874112

Local damage on Inlet A1 flange shows that the tip fragment impacts Inlet A1 flange before entering into the Inlet inner diameter on both the Philadelphia and Pensacola engines, which was not observed during Rig test 4 or certification test 874 002/2.

On Pensacola and on Philadelphia engines, Tip fragment marks observed on the Fan case side are not continuous forward to A1 flange in the Inlet. A damage is noticeable at Inlet A1 flange lip due to Tip fragment impact.

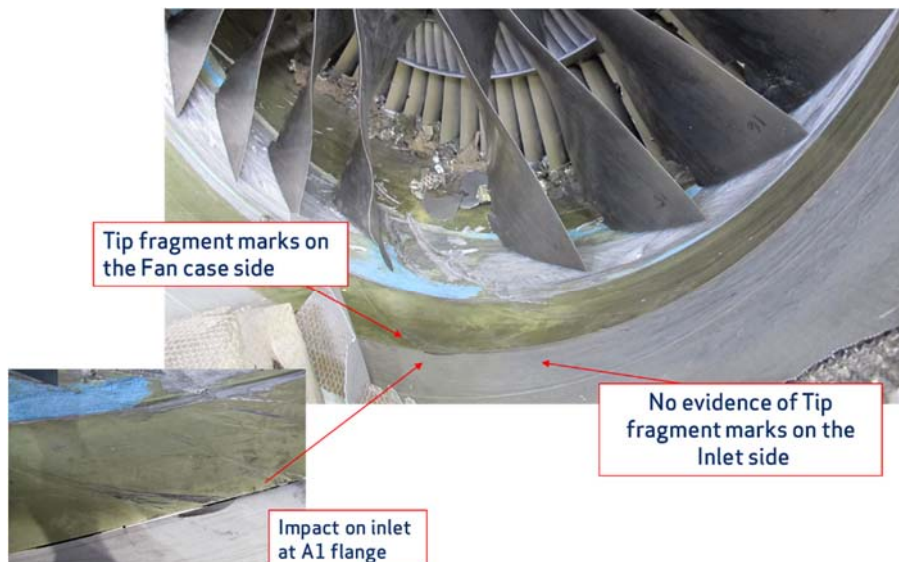
Figure 4-17 : Inlet A1 flange damaged by tip fragment on Philadelphia engine 875134

Physical evidence (witness marks) indicate the Tip impacted the inlet A1 flange lip, and sheared the “corner” of the flange resulting in a “divot” of missing material. A potential result of the impact is that the tip panel goes airborne (in lieu of continuing to slide) as shown in Figure 4-18.

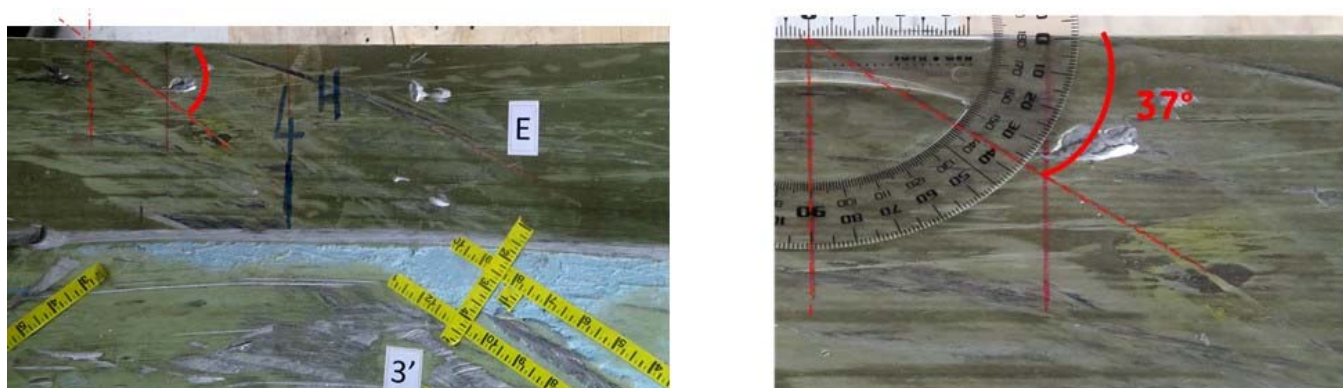
**Figure 5-2 : Pensacola engine 874112 Fan case Mid fragments marks and measured angle at A1 flange**

The measured angle of one Mid fragment trajectory with A1 flange plane is 37° as shown on Figure 5-2.

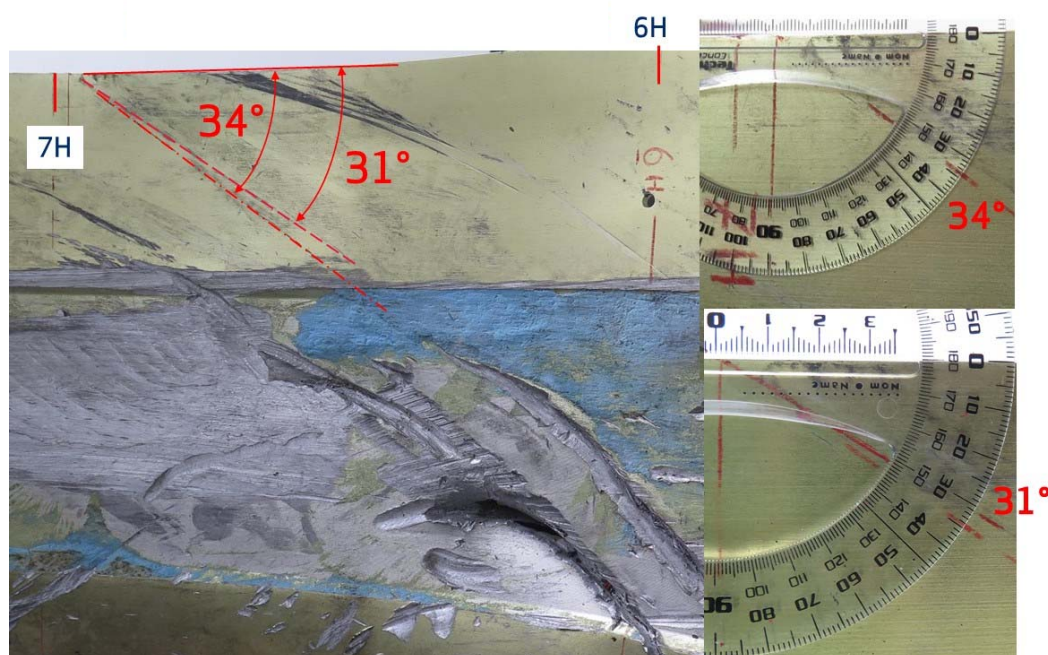
**Figure 5-3 : Philadelphia engine 875134 Fan case Mid fragments marks and measured angle at A1 flange at 7:00**

The angle of these Mid fragments witness marks on the Fan case side have been measured and are the described in Figure 5-3 and 5-4.

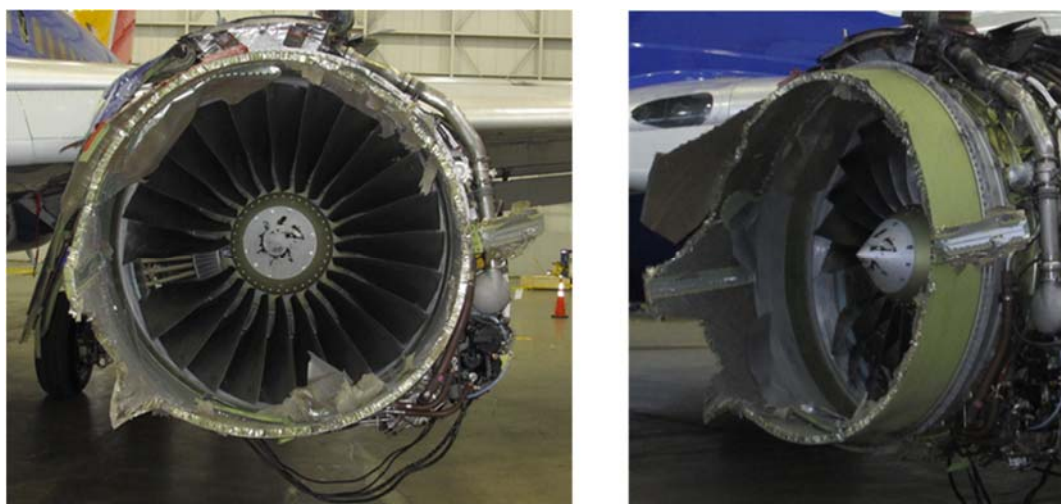
Figure 6-1 : Inlet condition Post event

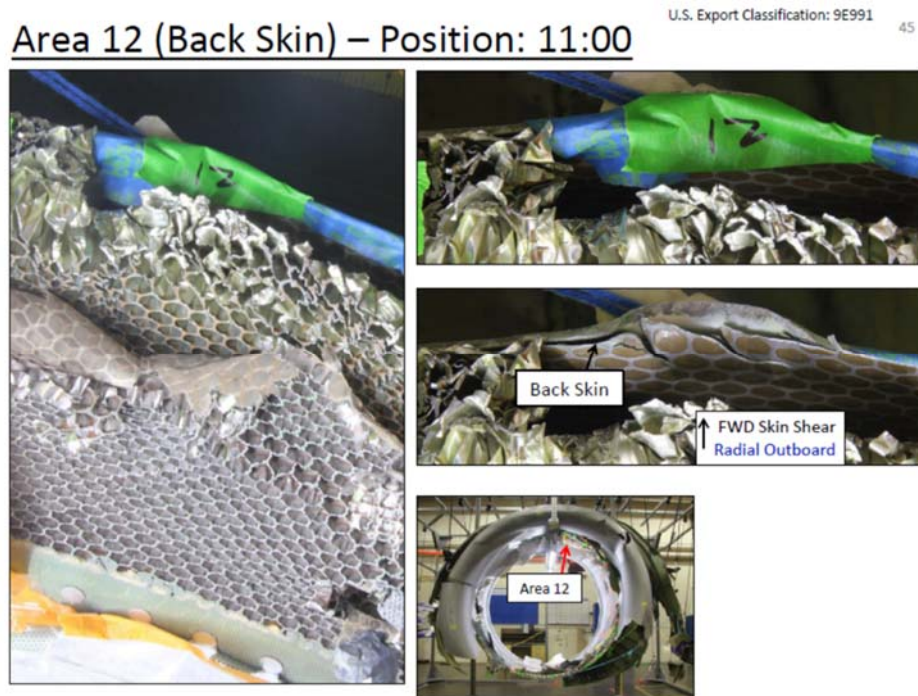
**Figure 8-4 : Position 11:00**  
*(Reference Oct. 2018 Structures Team Meeting)*

UTAS metallurgical results showed radial outboard direction of backskin fracture surface shear. Visual inspection shows backskin fracture at forward edge of containment doubler, with backskin and edge of doubler deformed radially outward. Titanium alloy particles were found on the deformed edge. There is technical basis to conclude that this damage is due to fragment penetration.

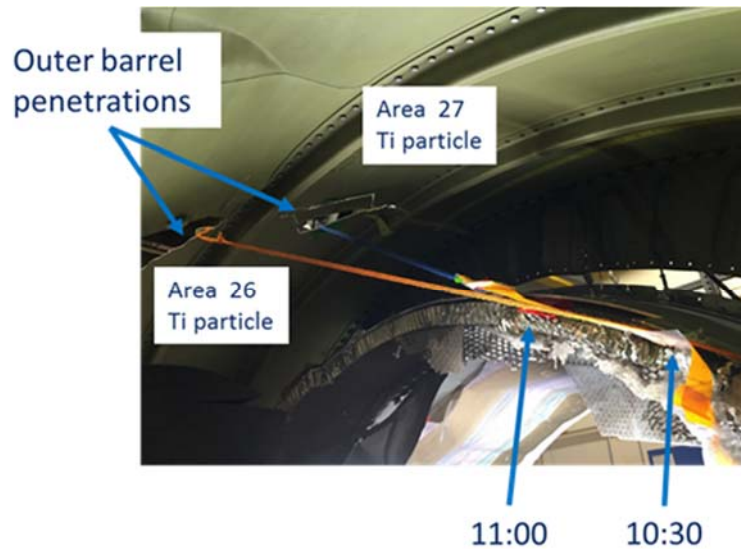
The inlet outer barrel exhibited damage at 12:00 and 12:30. Both locations contained titanium particles. These locations are consistent with fragment trajectories leaving the inner barrel between 10:30 and 11:00. See Figure 8-8. This outer barrel damage supports inner barrel fragment penetration between 10:30 and 11:00.

**Figure 8-8 : Position 11:30 Outer barrel**  
*(Reference Oct. 2018 Structures Team Meeting)*

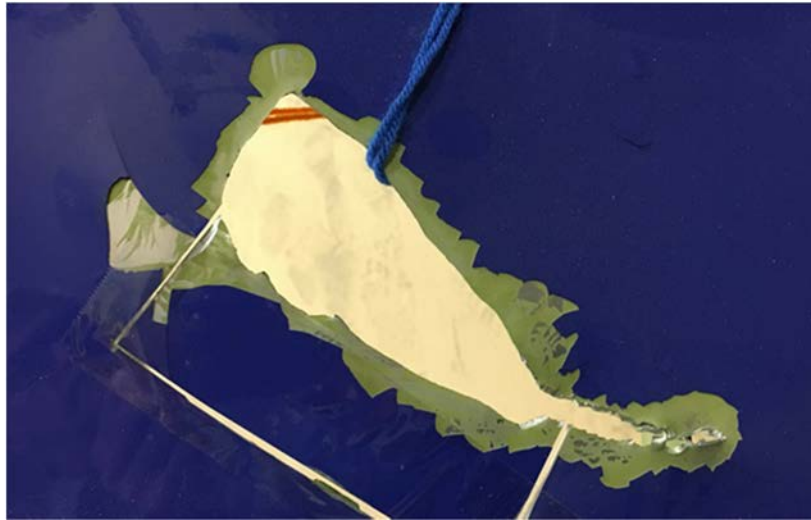
**Figure 8-10 Outer barrel fragment penetration at 12:00**  
*(Reference Oct. 2018 Structures Team Meeting)*

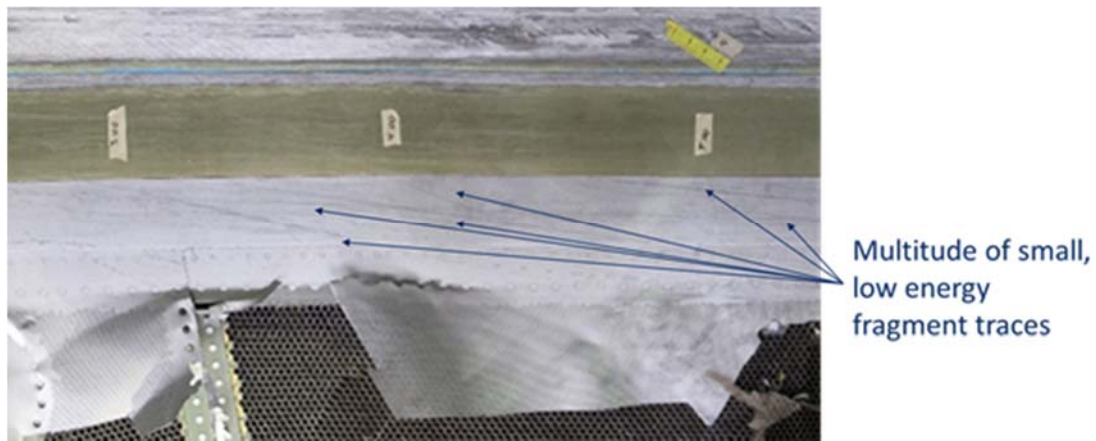
**Figure 9-10 Multiple small low energy fragment marks in PHL event inlet**

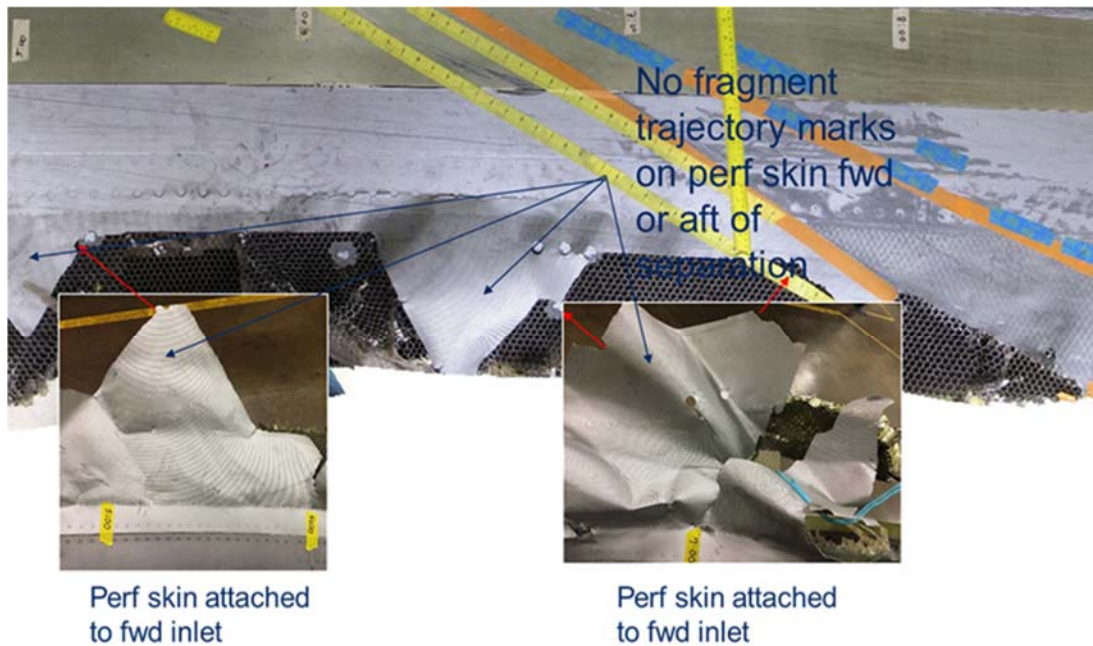
Figure 9-13 Perf skin conditions on both sides of separation in Phase 2 area

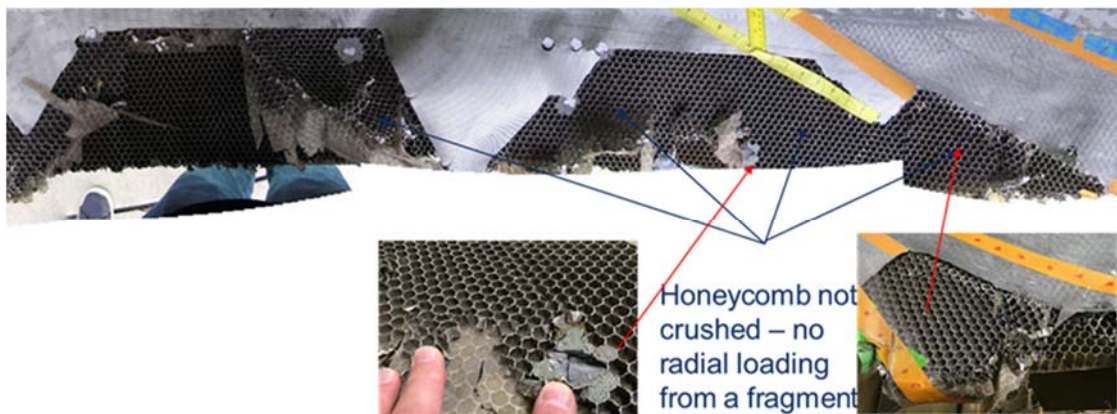
Figure 9-14 Honeycomb condition under perf skin in Phase 2 area

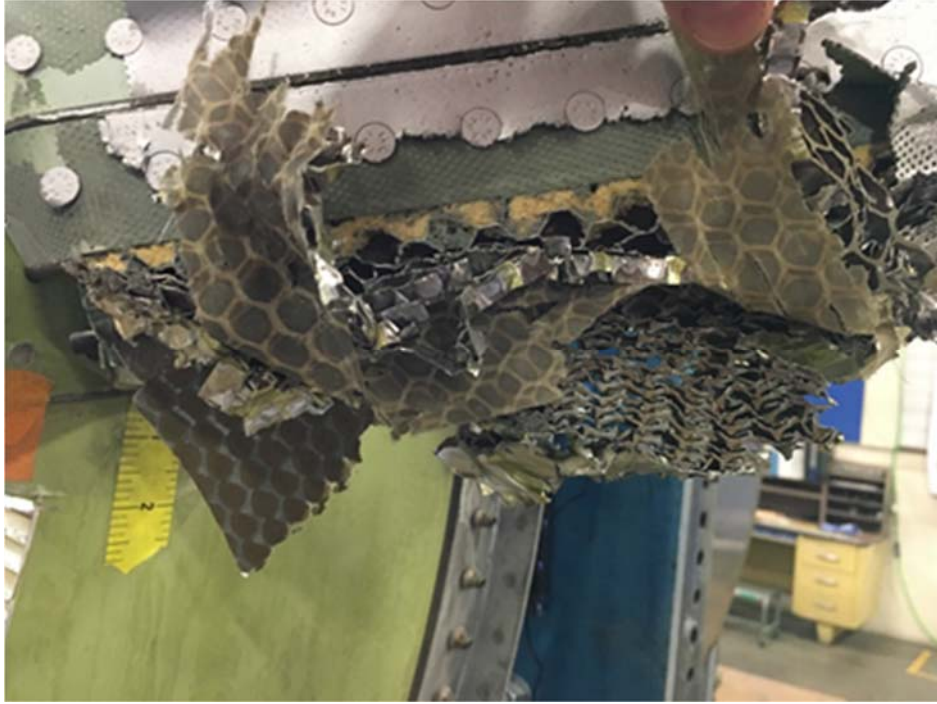
**Figure 9-16 Crushed Honeycomb Attached to 9:00 Splice Plate, Inner Side**

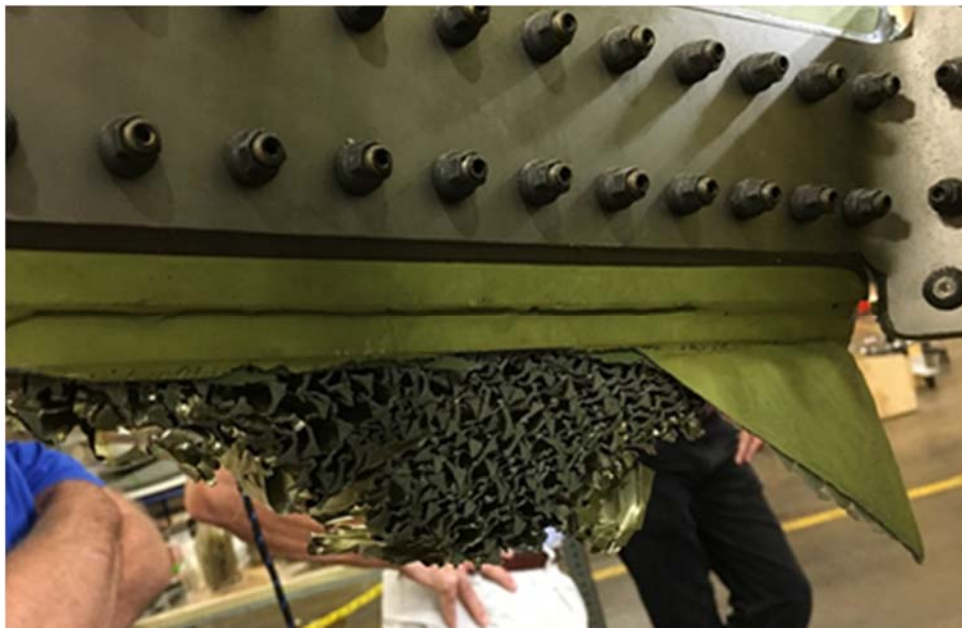
**Figure 9-17 Crushed Honeycomb Attached to 9:00 Splice Plate, Outer Side**

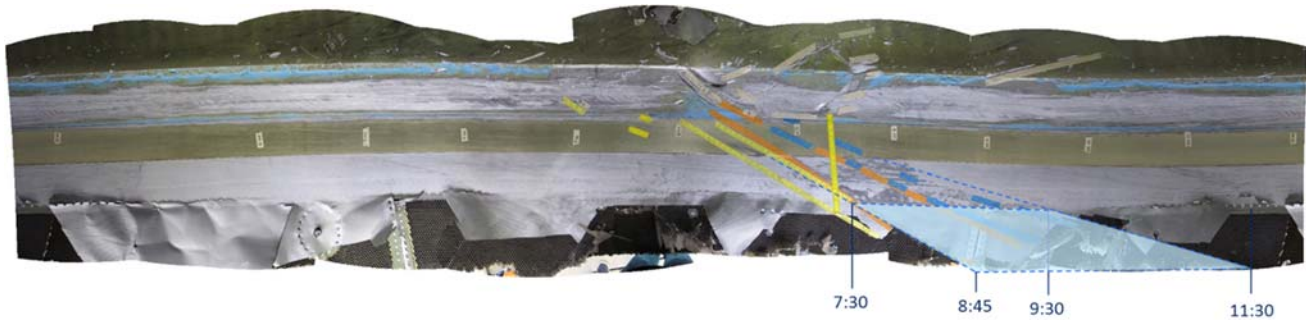
**Figure 10-1 Inner Barrel Perf Skin Damage Due to Fragments**
