22 October 2018  
66-ZB-H200-ASI-19067

Subject: Boeing EQA Report on T12 Sensor - Southwest Airlines 737-700 N772SW  
Engine failure and decompression Philadelphia, 17 Apr 2018

## Equipment Quality Analysis Report

**SUBJECT:** *Examination of T12 Sensor from Southwest Airlines (SWA) Aircraft YA070*

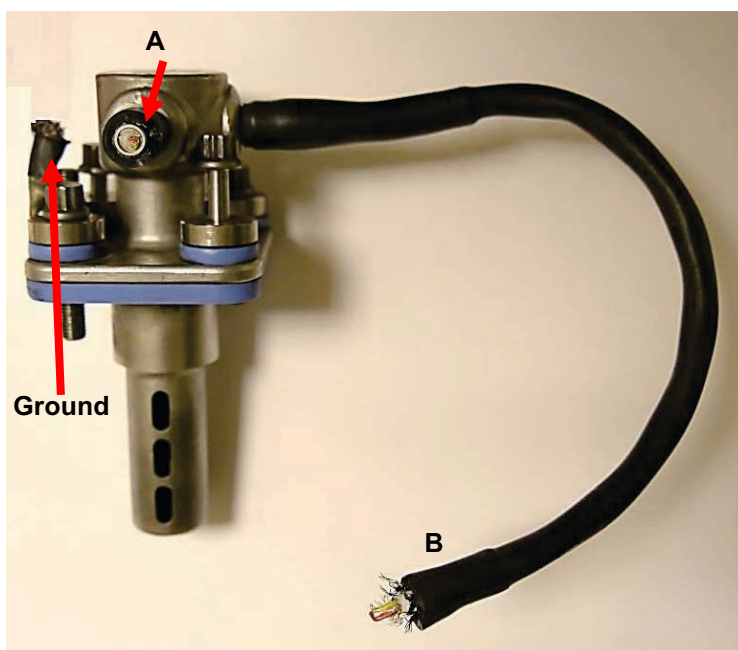
The T12 sensor was removed from the packaging and was visually examined. An overview of the T12 sensor with the three wire termination points labeled, is shown in Figure 2.

**Figure 2:** Overview of T12 sensor

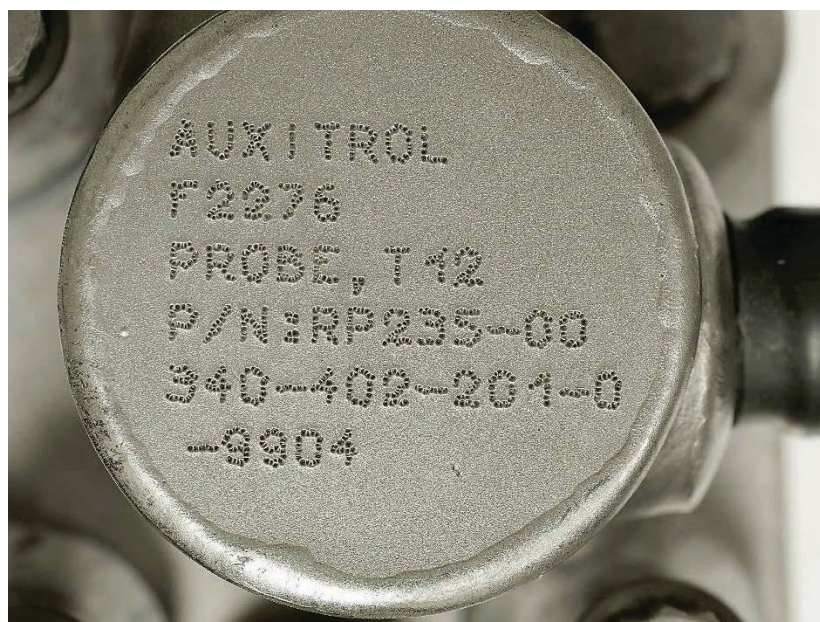
An overview of the data markings of the T12 sensor is shown Figure 3.

**Figure 3:** Data markings on T12 sensor

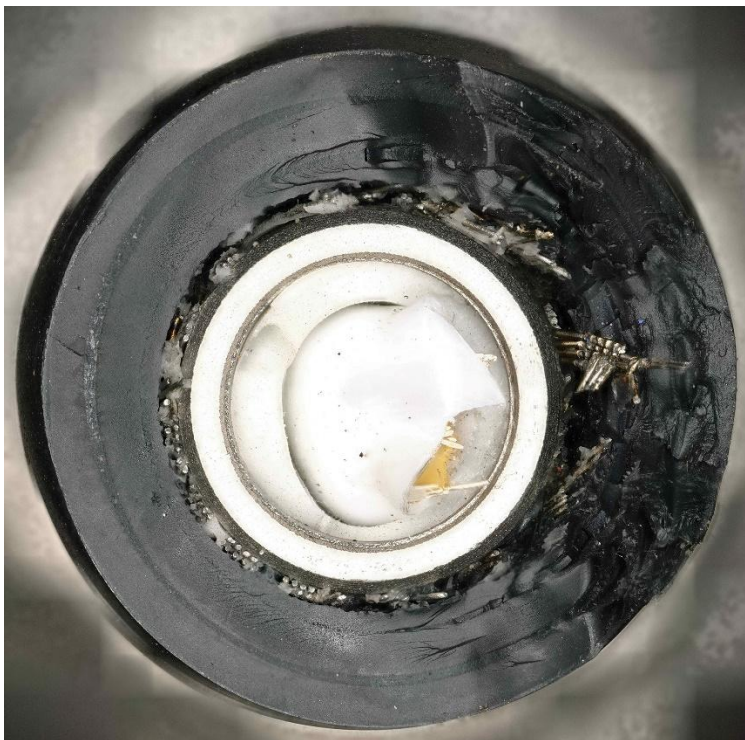
The fractured termination point of wire A is shown in Figure 4.

**Figure 4:** Fractured termination point of wire A

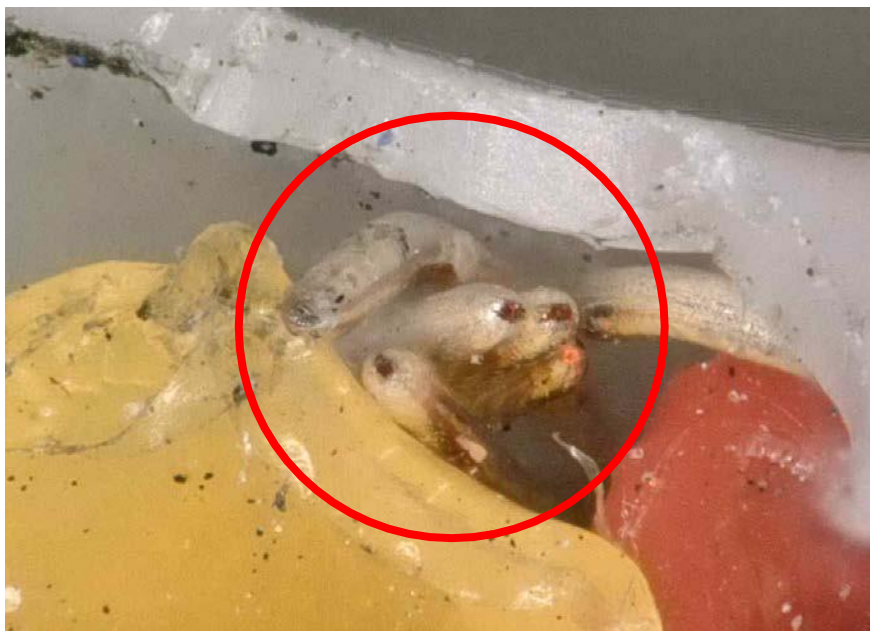
A magnified view of several fractured, individual wire strands at the wire A termination point is shown in Figure 5.

**Figure 5:** Fractured, individual wire strands at the wire A termination point

The NTSB directed that BR&T analyze the fracture surfaces of all three wire termination points, with the understanding that destructive analysis would be necessary. BR&T used scanning electron microscope (SEM) analysis to analyze the fracture surfaces, which concluded that reduction of area (necking) on all three wires is consistent with ductile separation or an overload of the wire strands; see enclosure A for more details.

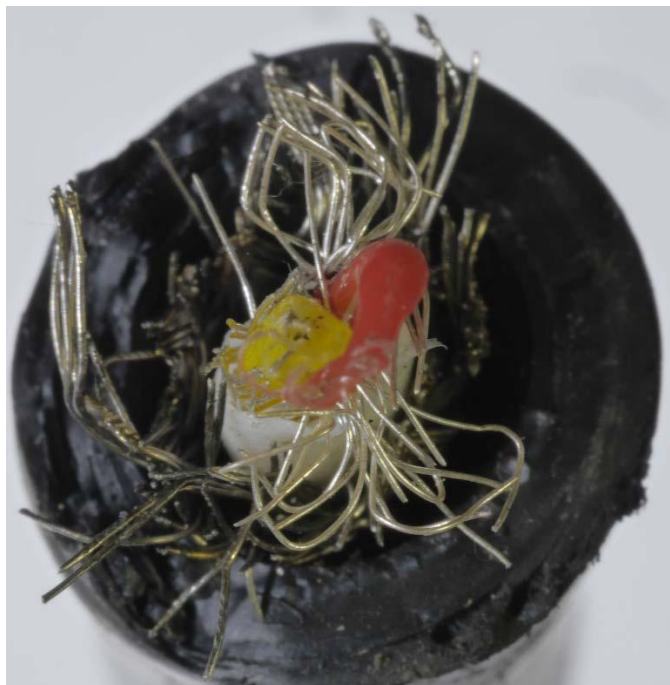
The fractured termination point of wire B is shown in Figure 6.

**Figure 6:** Fracture termination point of wire B

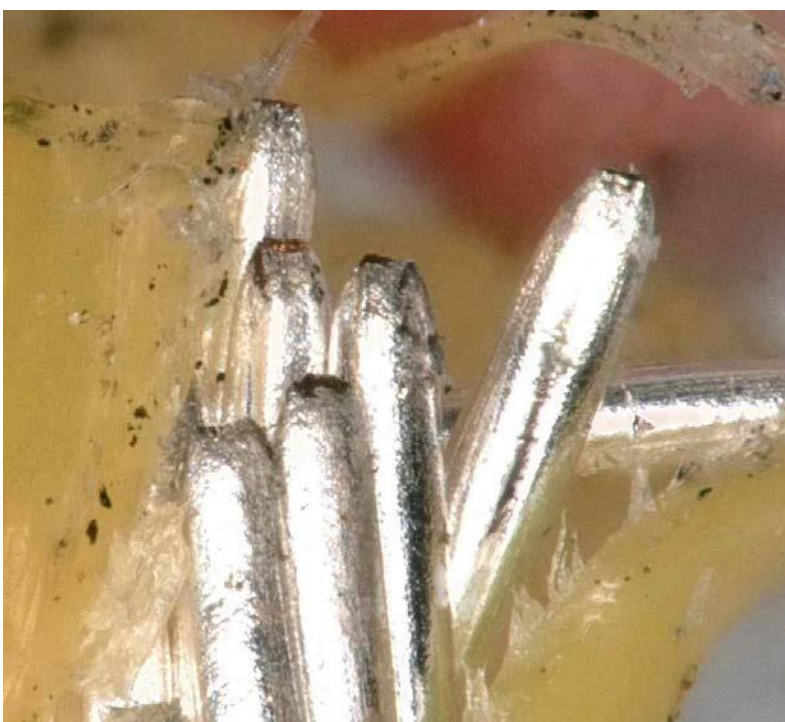
A magnified view of several of the fractured, individual wire strands at the wire B termination point is shown in Figure 7.

**Figure 7:** Fractured, individual wire strands at the wire B termination point

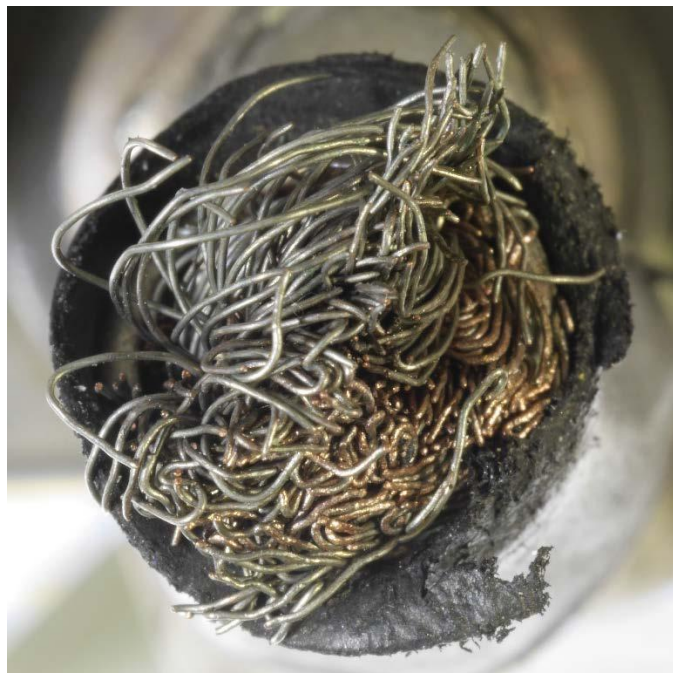
The fractured ground wire termination point is shown in Figure 8.

**Figure 8:** Fractured ground wire termination point

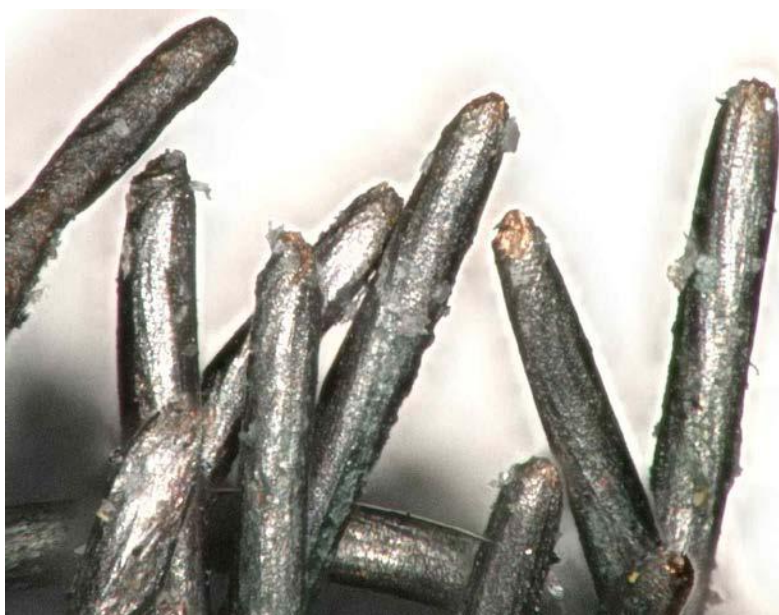
A magnified view of several of the fractured, individual wire strands at the ground wire termination point is shown in Figure 9.

**Figure 9:** Fractured, individual wire strands at the ground wire termination point

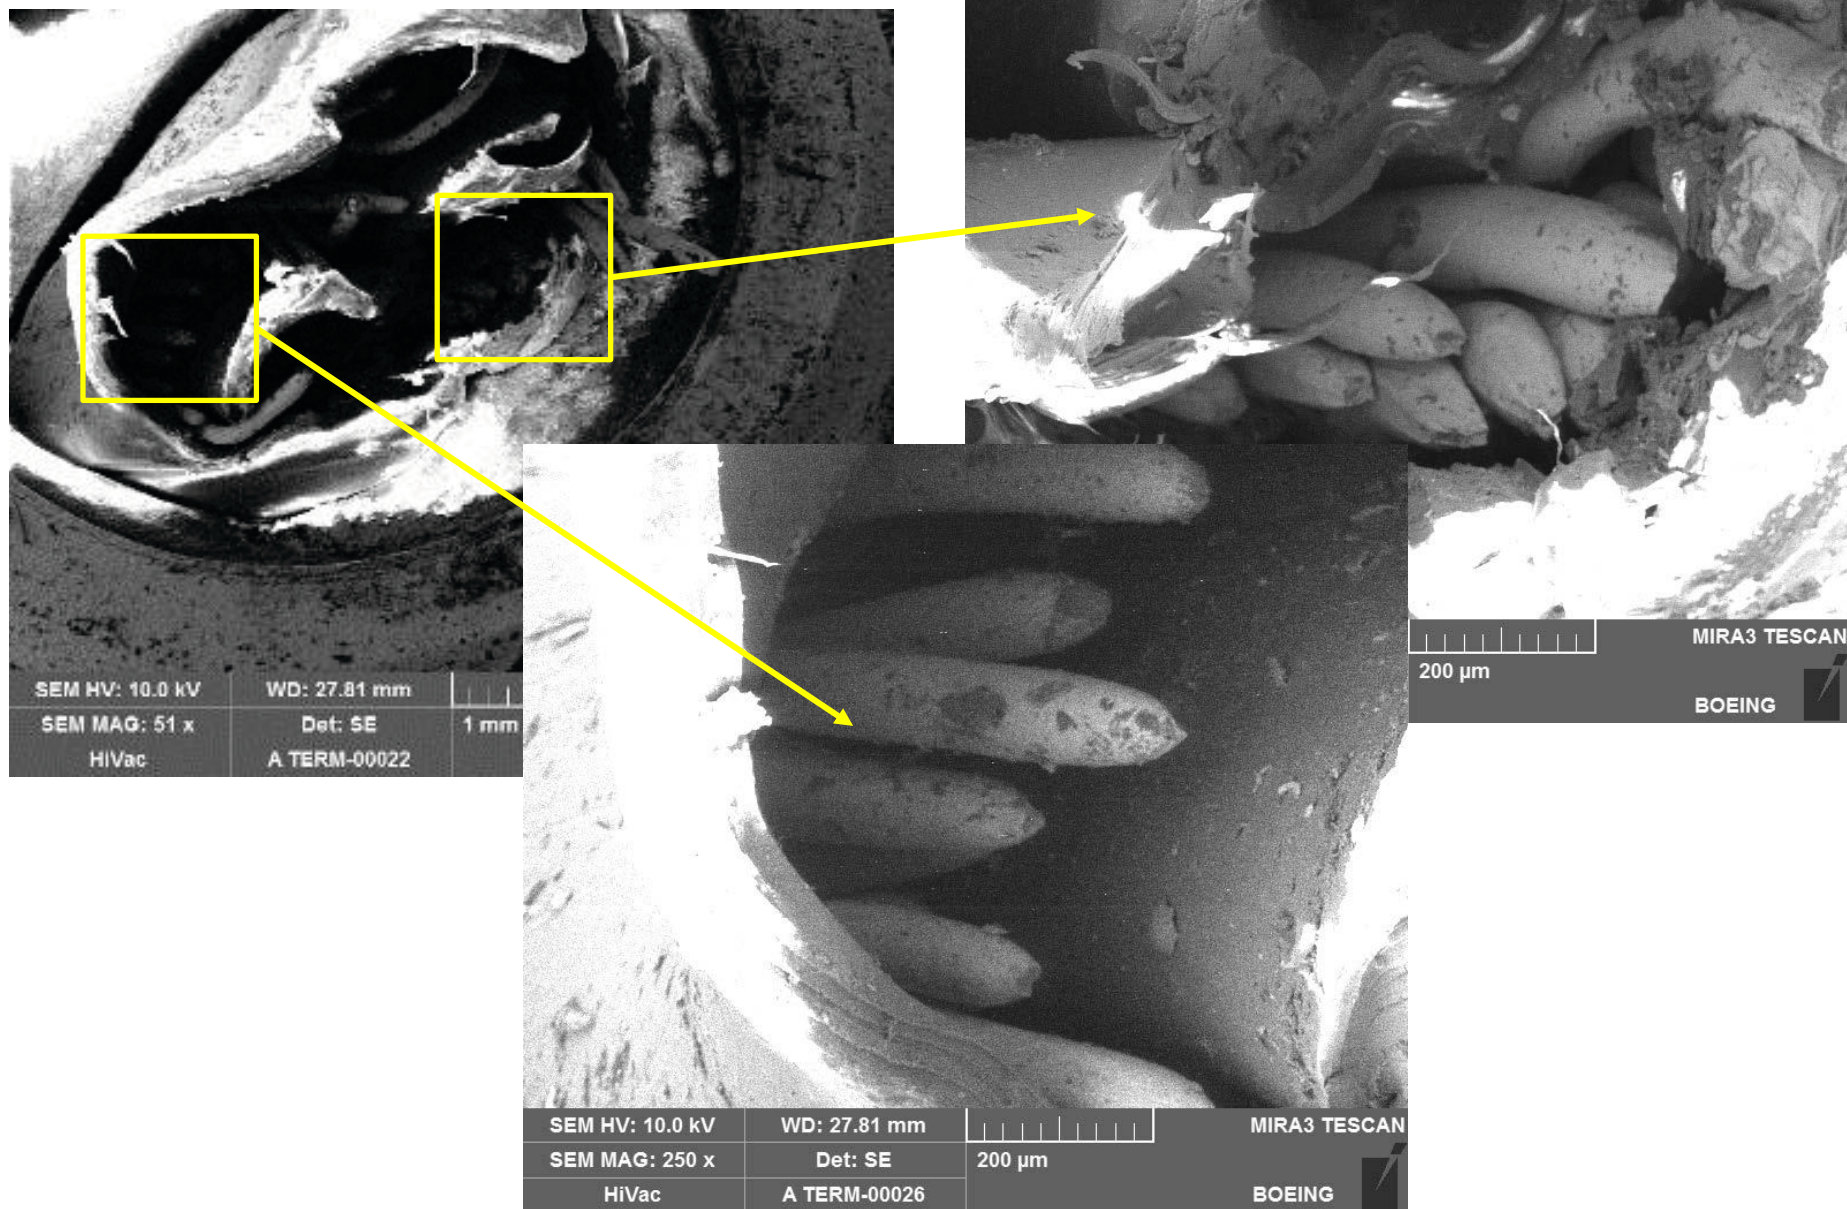
# A Terminal

**Reduction of area/necking was observed on the fracture surfaces of all three terminals, consistent with ductile separation/overload.**
