19 July 2019  
66-ZB-H200-ASI-19098

Subject: Boeing Submission for Southwest Airlines 737-700 N772SW Engine Failure and Depressurization, Philadelphia, PA - 17 April 2018

**Southwest Airlines 737-700 N772SW  
Engine Failure and Depressurization  
Philadelphia, PA  
17 April 2018**

**The Boeing Company  
19 July 2019**

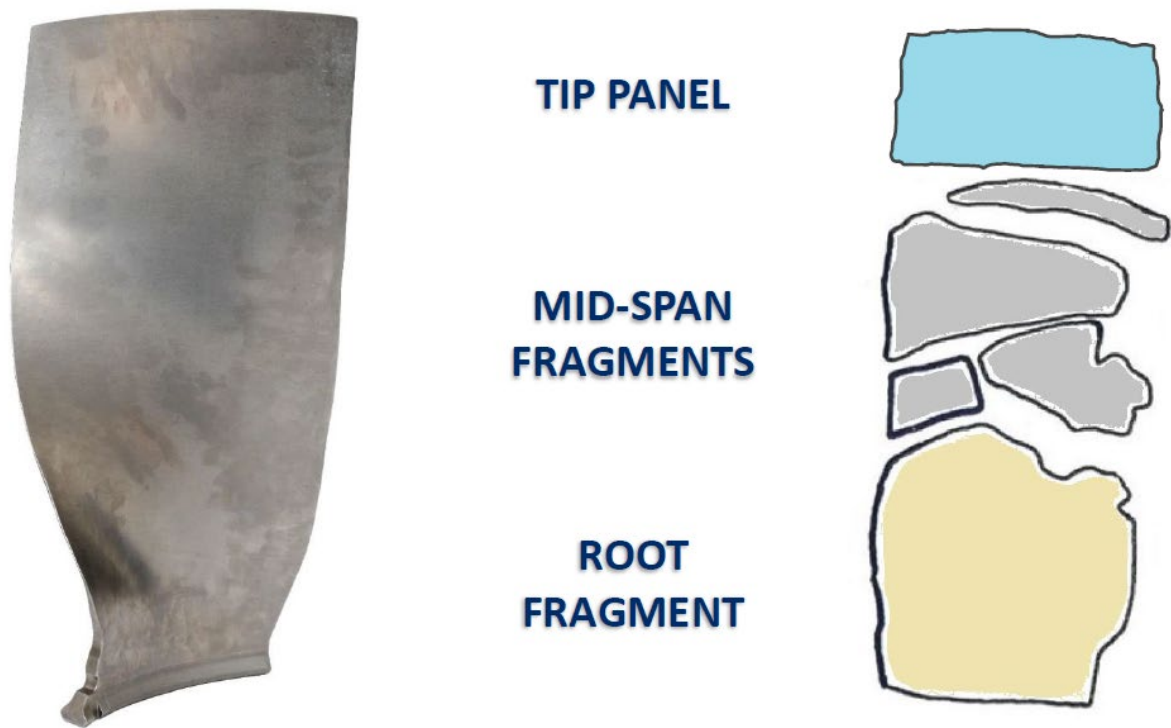
**Fig. 9.** Comparison of intact fan blade and the three blade fragment categories.

The tip panel is typically the most energetic fragment that enters the inlet.

Boeing and Collins calculated the helix angle at which the blade fragments entered the inlet during this event by examining scrapes inside the inlet (called witness marks) and the damage observed in the inlet. Based on witness marks, Boeing and Collins have concluded that the fan blade tip first hit the fan case at about the 6:00 o'clock position<sup>19</sup>. It then broke into a number of fragments, with the tip panel and some mid-span fragments traveling forward into the inlet. Based on witness marks, the tip panel entered the inlet near the 6:45 o'clock position with a helical trajectory angle of about 30 degrees. Traces of the fan blade material (titanium alloy Ti-6Al-4V) were found on a section of compressed core in the inlet. Tracing the path the fragments followed back to the fan case demonstrated that the tip panel was traveling at a 30-degree helix angle when it entered the inlet, consistent with the witness marks observed in the aft part of the inlet<sup>20</sup>. Evidence also demonstrates that the mid-span fragments of fan blade no. 13 entered the inner barrel at helix angles between 20 and 30 degrees.<sup>21</sup>

Boeing does not believe that the witness marks or the observed damage can be explained by a tip fragment traveling at a helix angle of less than 30 degrees.

The 30-degree angle observed in this event was significantly higher than the 15-degree angle that CFM had defined and validated based on data from development and certification tests.
