## **NATIONAL TRANSPORTATION SAFETY BOARD**

### **Specialist's Report**

# **OPERATIONAL FACTORS**

DCA19CA151

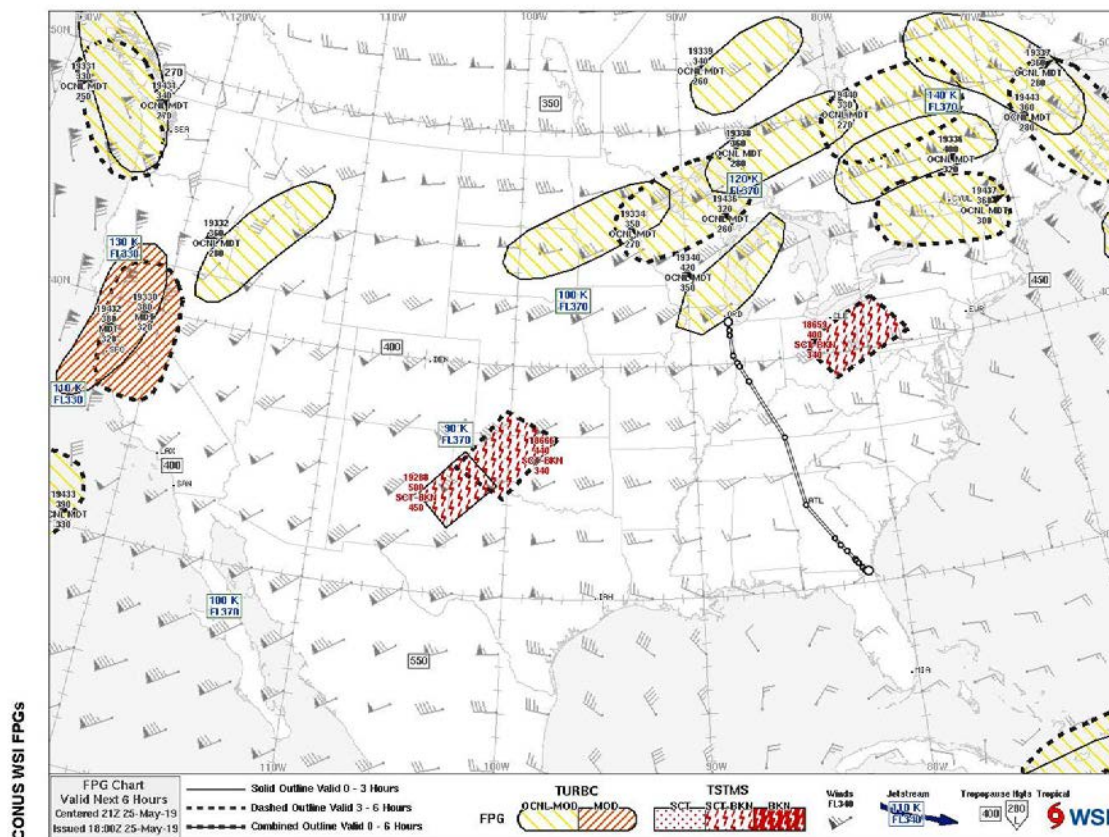
Figure 1: WSI FPG (Source: Southwest Airlines Weather Packet)

The Southwest Airlines weather packet included a graphical depiction of enroute hazards on the WSI<sup>22</sup> FPG page. The FPG provided a 12-hour forecast of enroute hazards for altitudes ranging from the surface to FL500 and were updated every 3 hours.<sup>23</sup> The graphical depiction in figure 1 was the FPG provided to the accident flight crew prior to departure. That graphical depiction indicated “occasional moderate” turbulence near the departure airport but did not indicate any forecasted turbulence near the arrival airport or near the accident location.

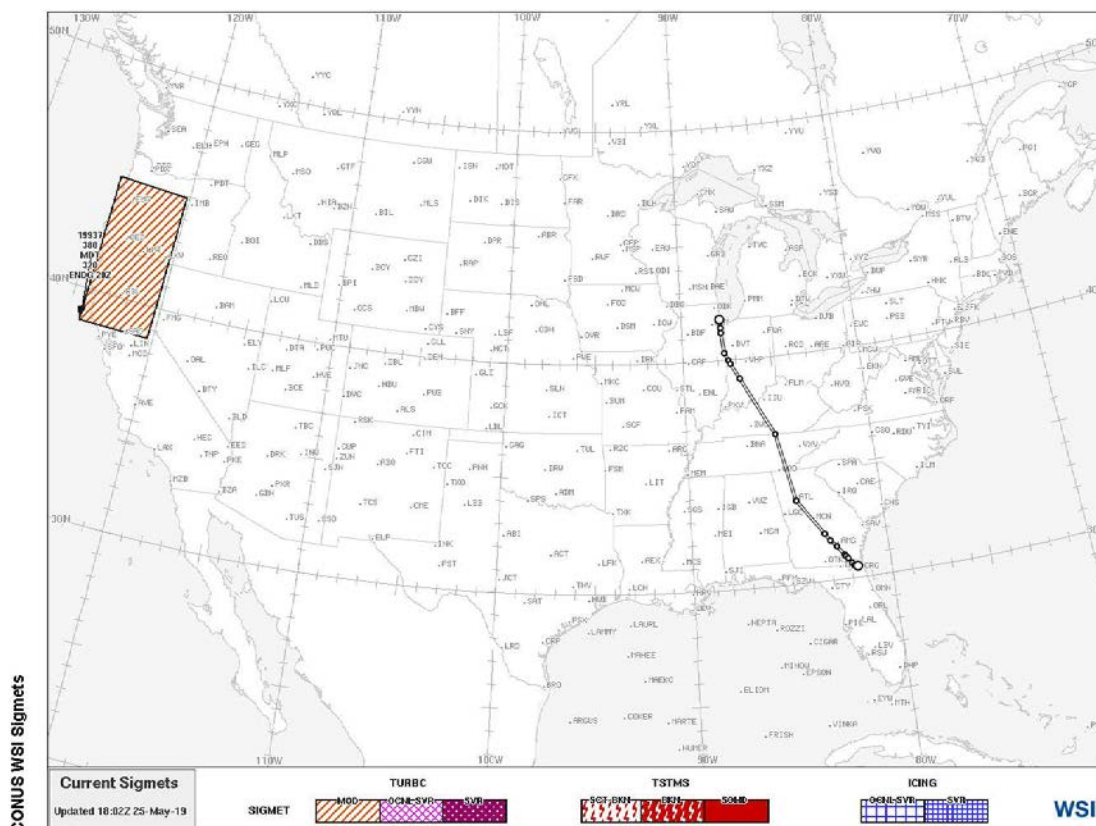
Figure 2: WSI SIGMET (Source: Southwest Airlines Weather Packet)

The Southwest Airlines weather packet included a graphical depiction of the WSI SIGMETs<sup>24</sup> throughout the Continental US (CONUS). The graphical depiction in figure 2 was the WSI SIGMET provided to the accident flight crew prior to departure. That graphical depiction did not indicate any SIGMETs along the entire route of flight nor around the destination airport.
