A/C 0436 Tail Strike Damage Assessment – Rev A

A/C: N75436 (Y4255, YH124),

The aircraft sustained a tail strike in DEN on 6/9/2019. After accomplishing a preliminary visual inspection. The damage starts forward of STA 827 and ends at aft of STA 907 between S26L and S26R.

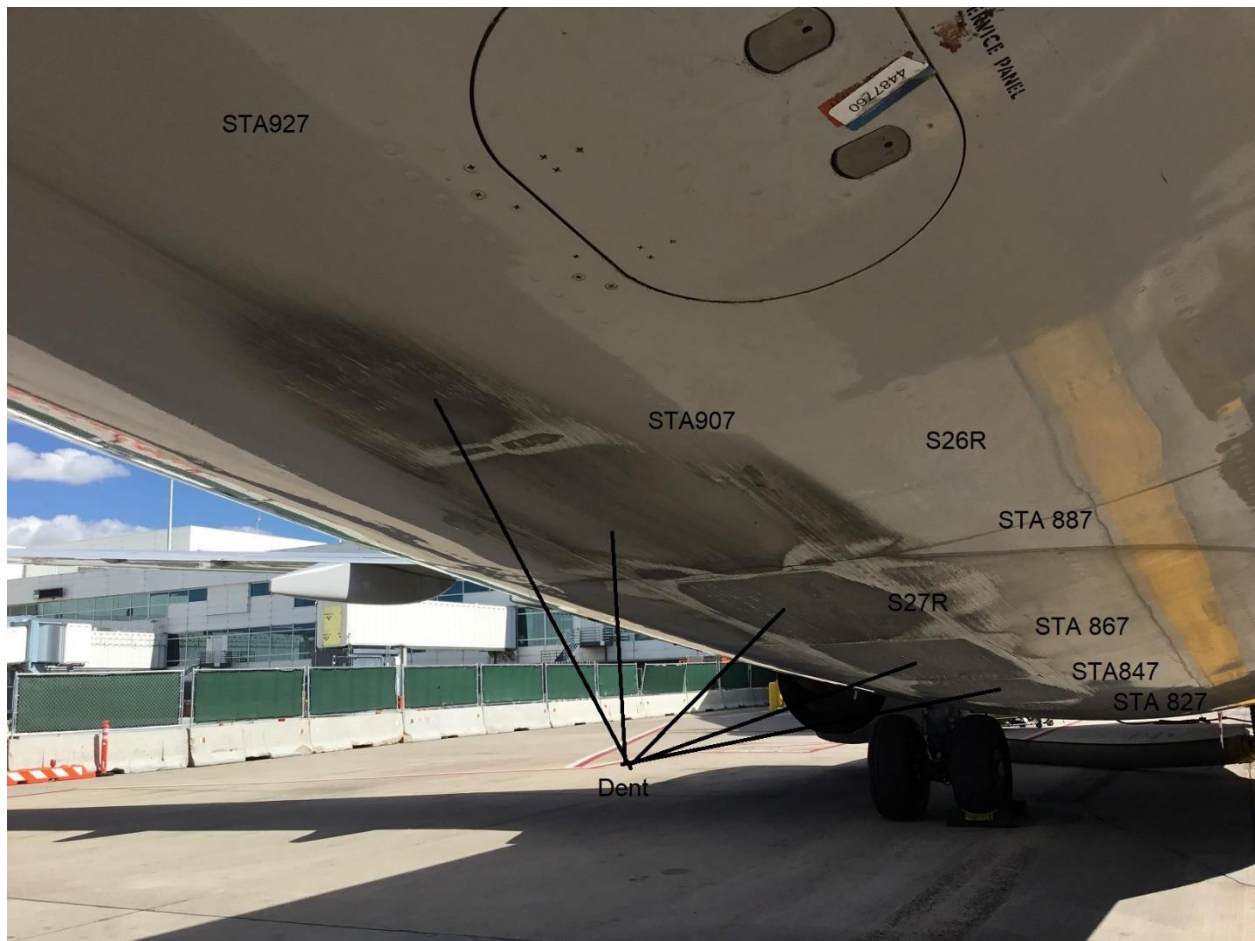
1. Skin worn through or crack at STA 827, STA847, STA867, STA 887 and STA 907.
2. Skin dent between the frames from STA 827 to STA 907.
3. STA847, STA 867 and STA 887 Frames cracked.
4. The stringer clips on S27L and S27R on STA 847, STA 867, STA 887 are buckled/bent.
5. The shear tie between S27L and S27R on STA 847 is cracked.
6. The Tailskid Cartridge is compressed

Figure 1-1 External Skin RH View

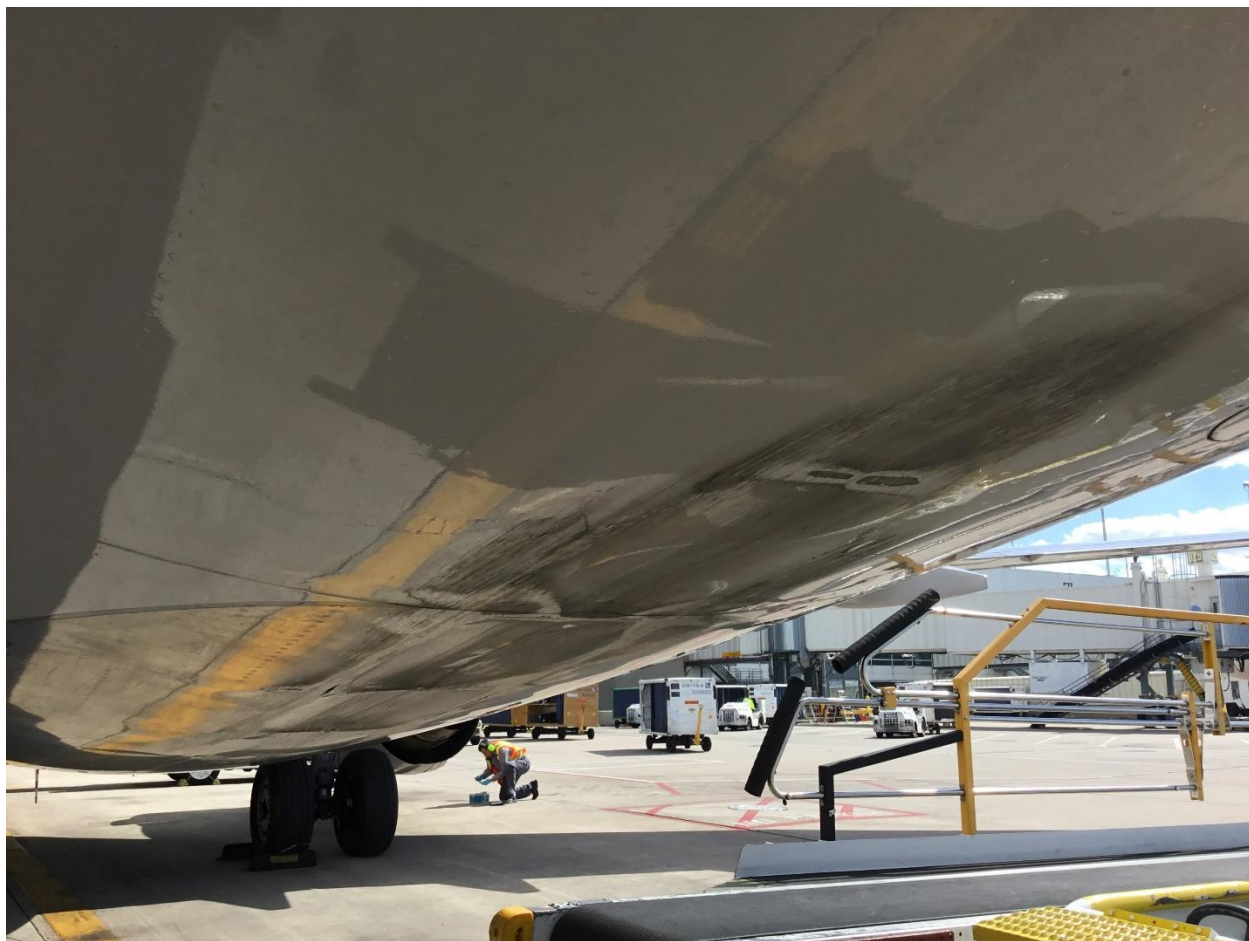
Figure 1-2 External Skin LH View

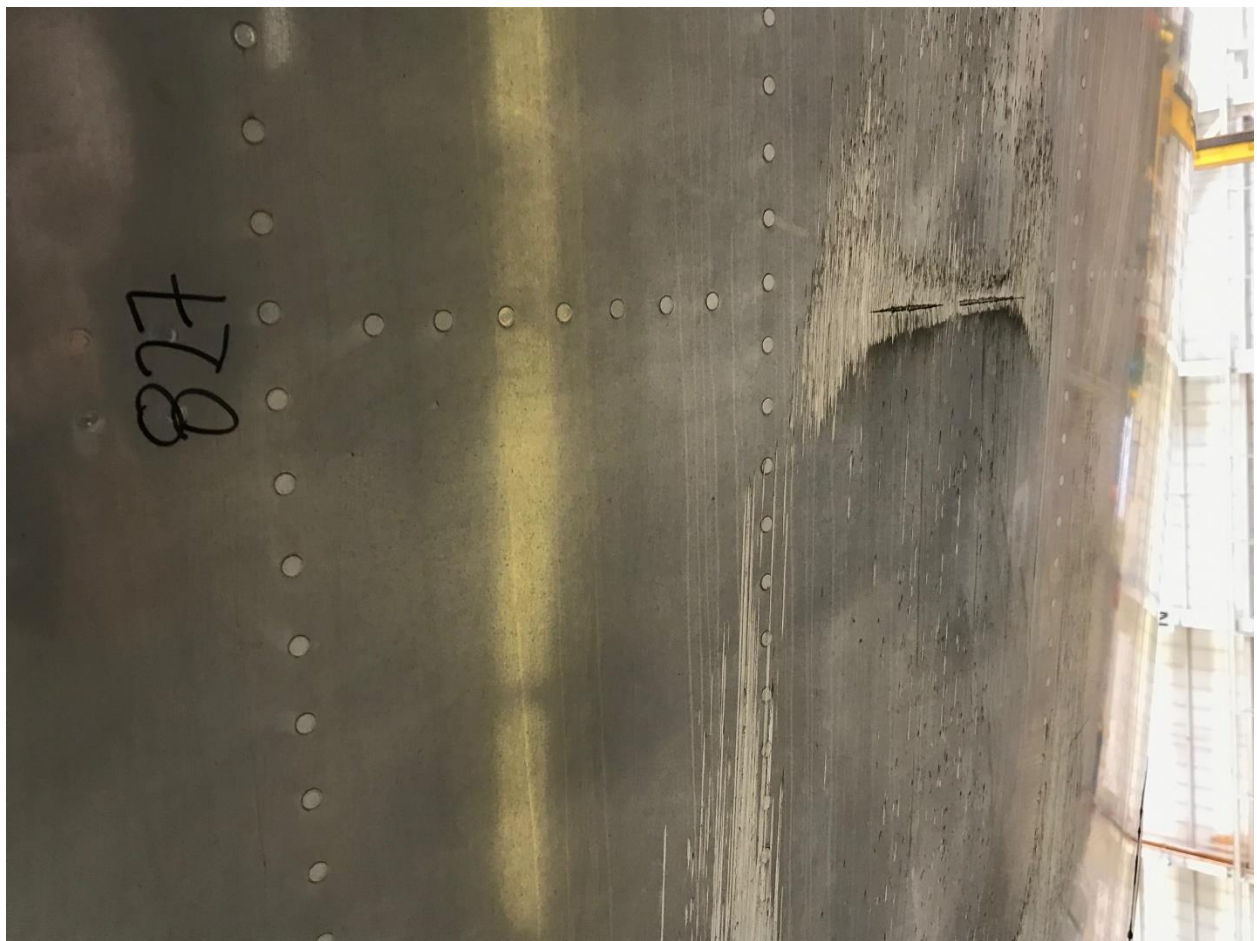
Figure 2-1 STA 827 Skin

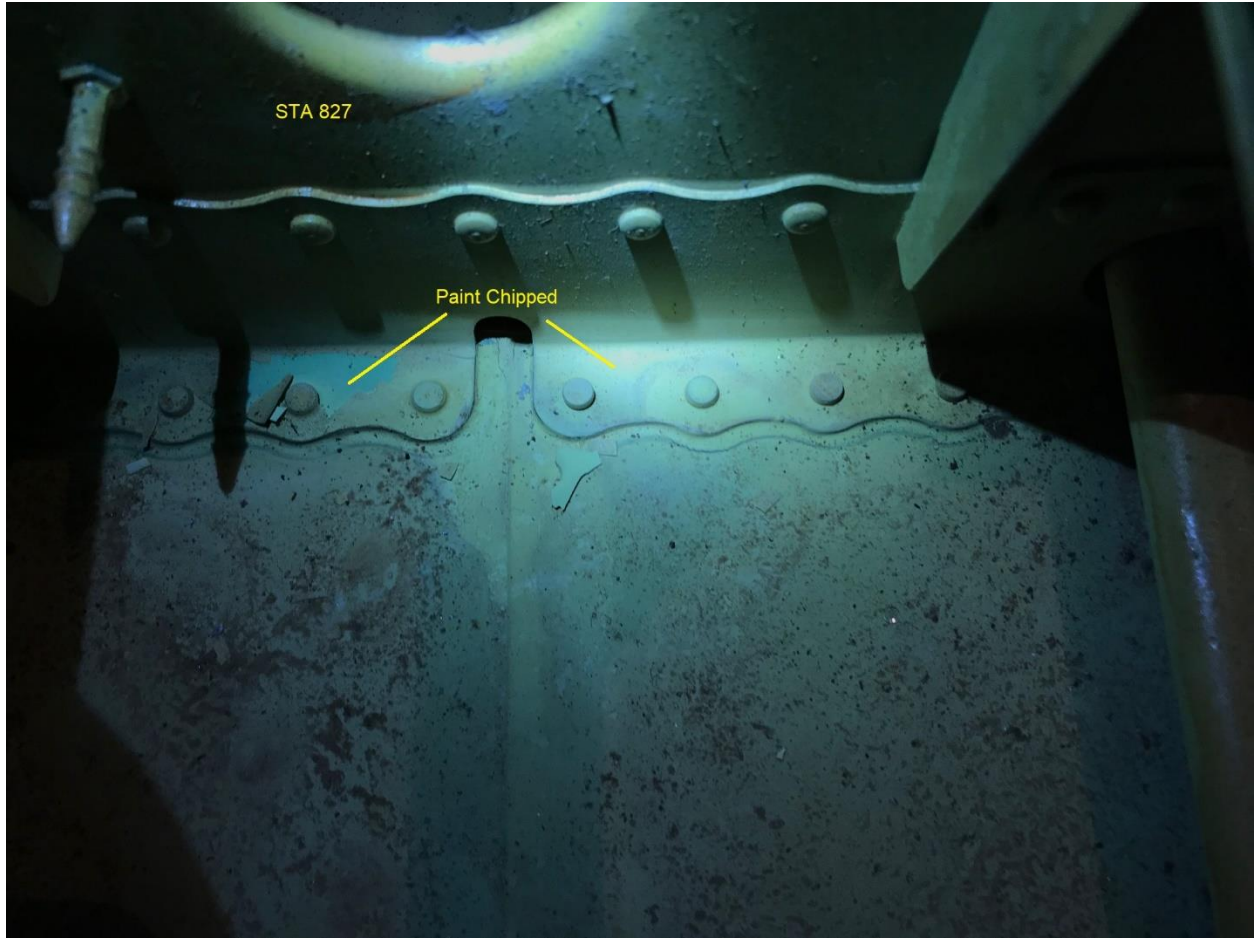
1. The Stringer 27L and 27R are possibly deformed.
2. The shear tie at STA827, STA867, STA887 and STA 907 between S27L and S27R are possibly deformed.
3. The STA887 Skin Splice plate is possibly damaged.

Figure 2-2 STA827 Shear tie

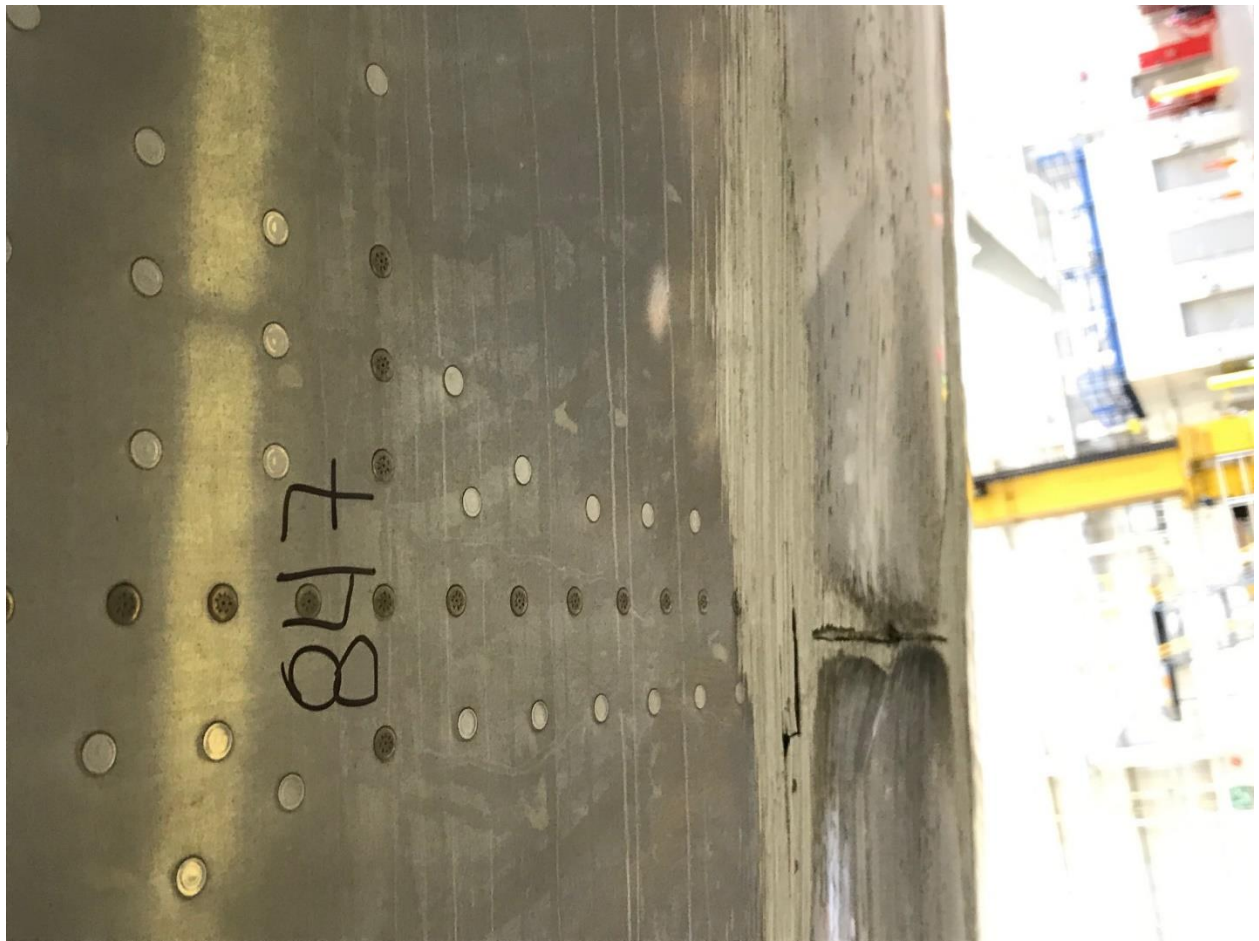
Figure 3-1 STA847 Skin

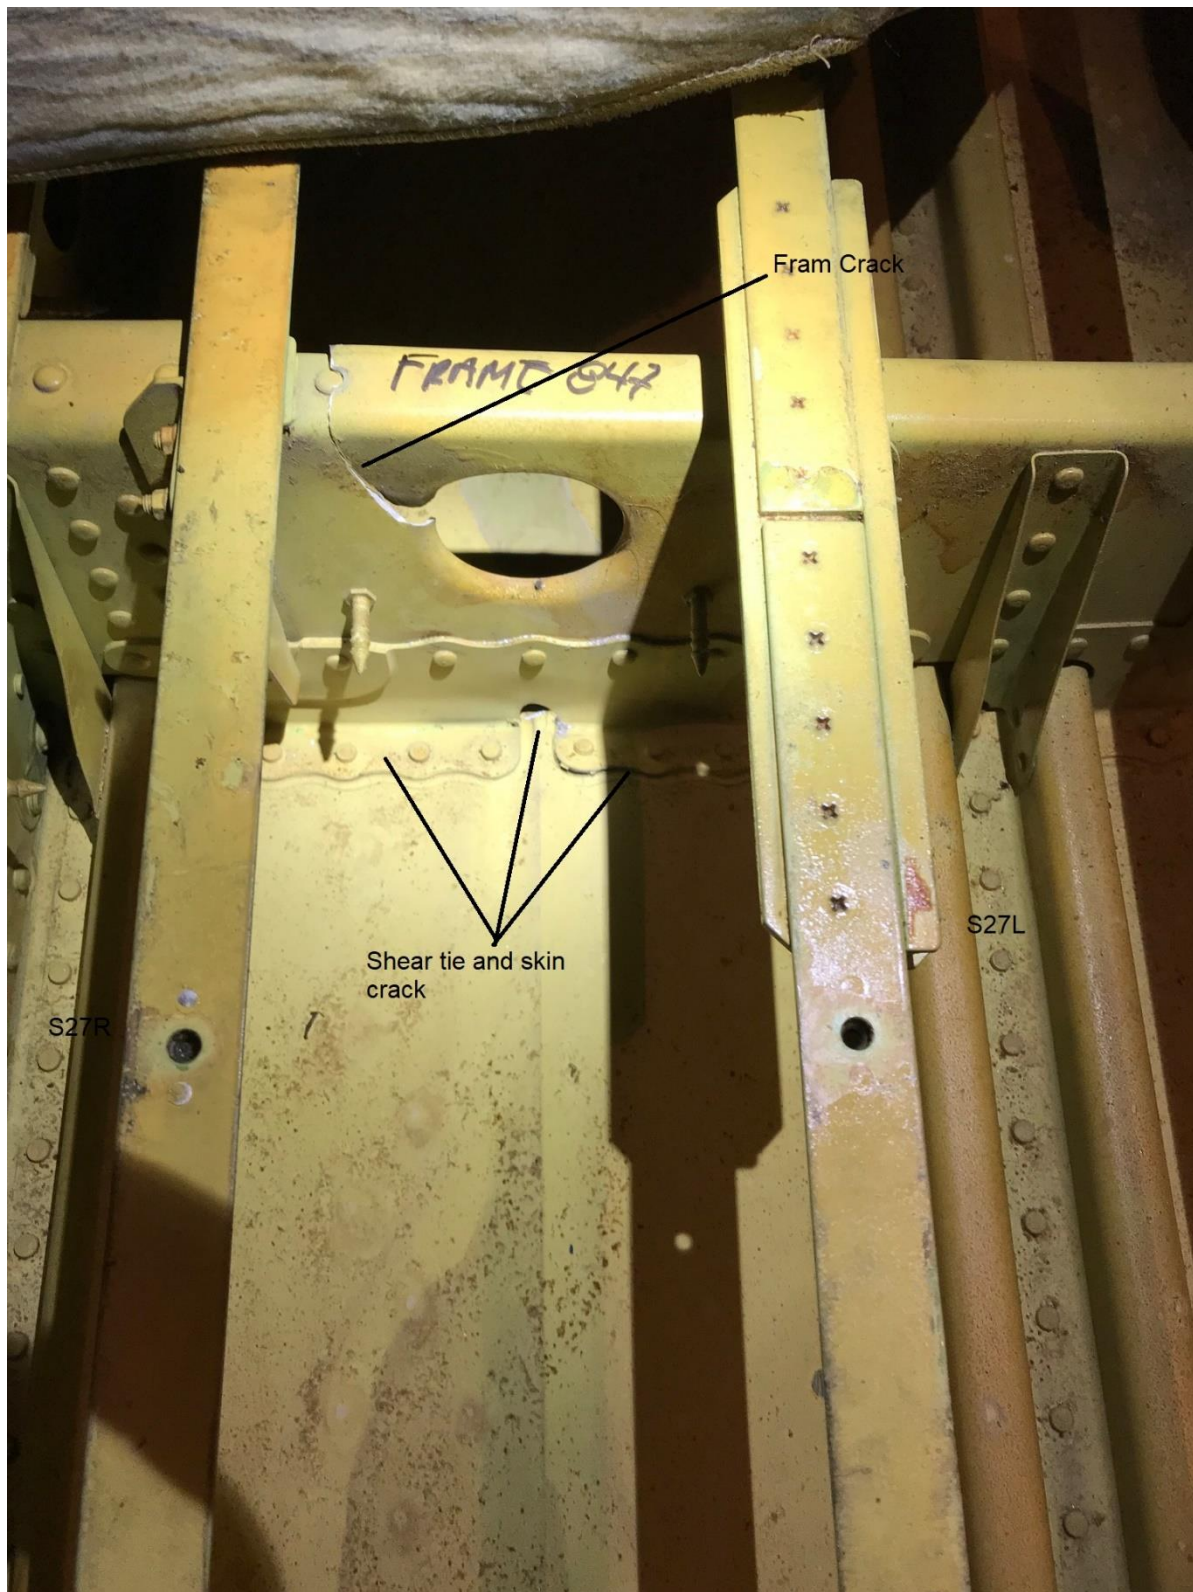
Figure 3-2 STA 847 Frame and Shear Tie

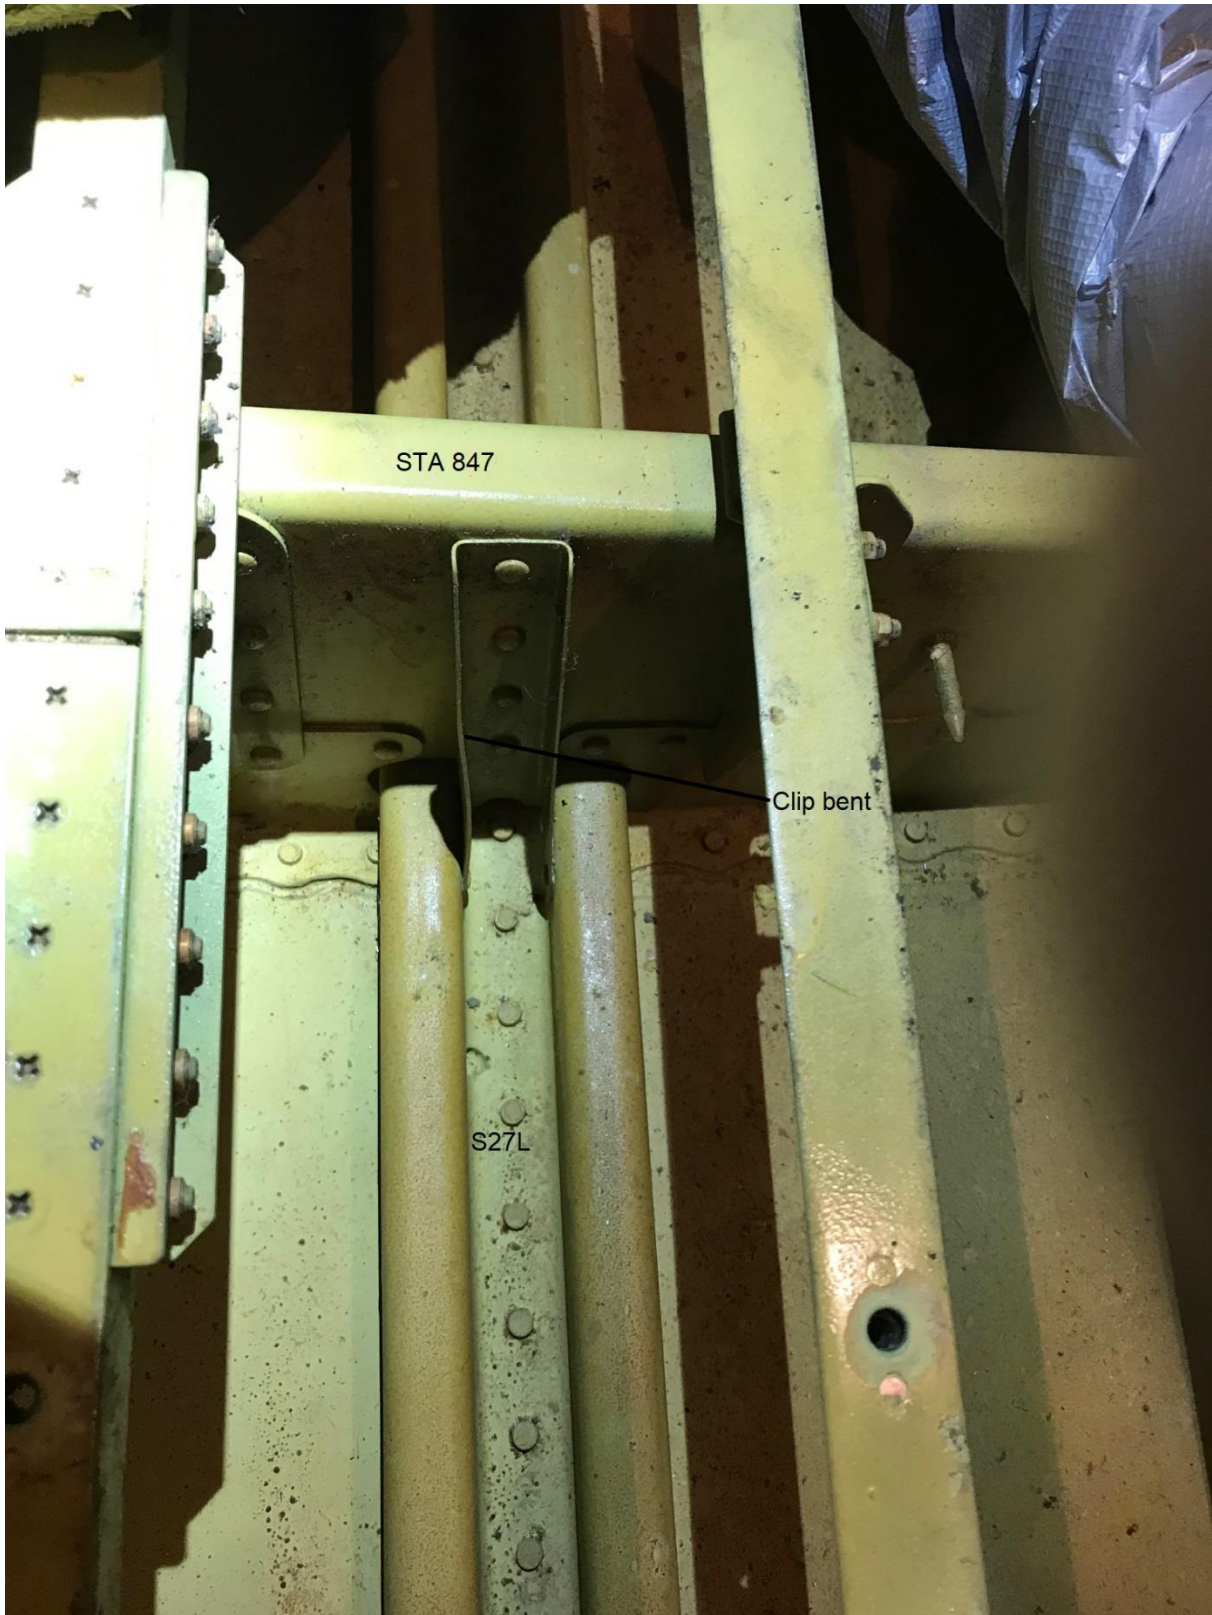
Figure 3-3 STA847 S27L Clip

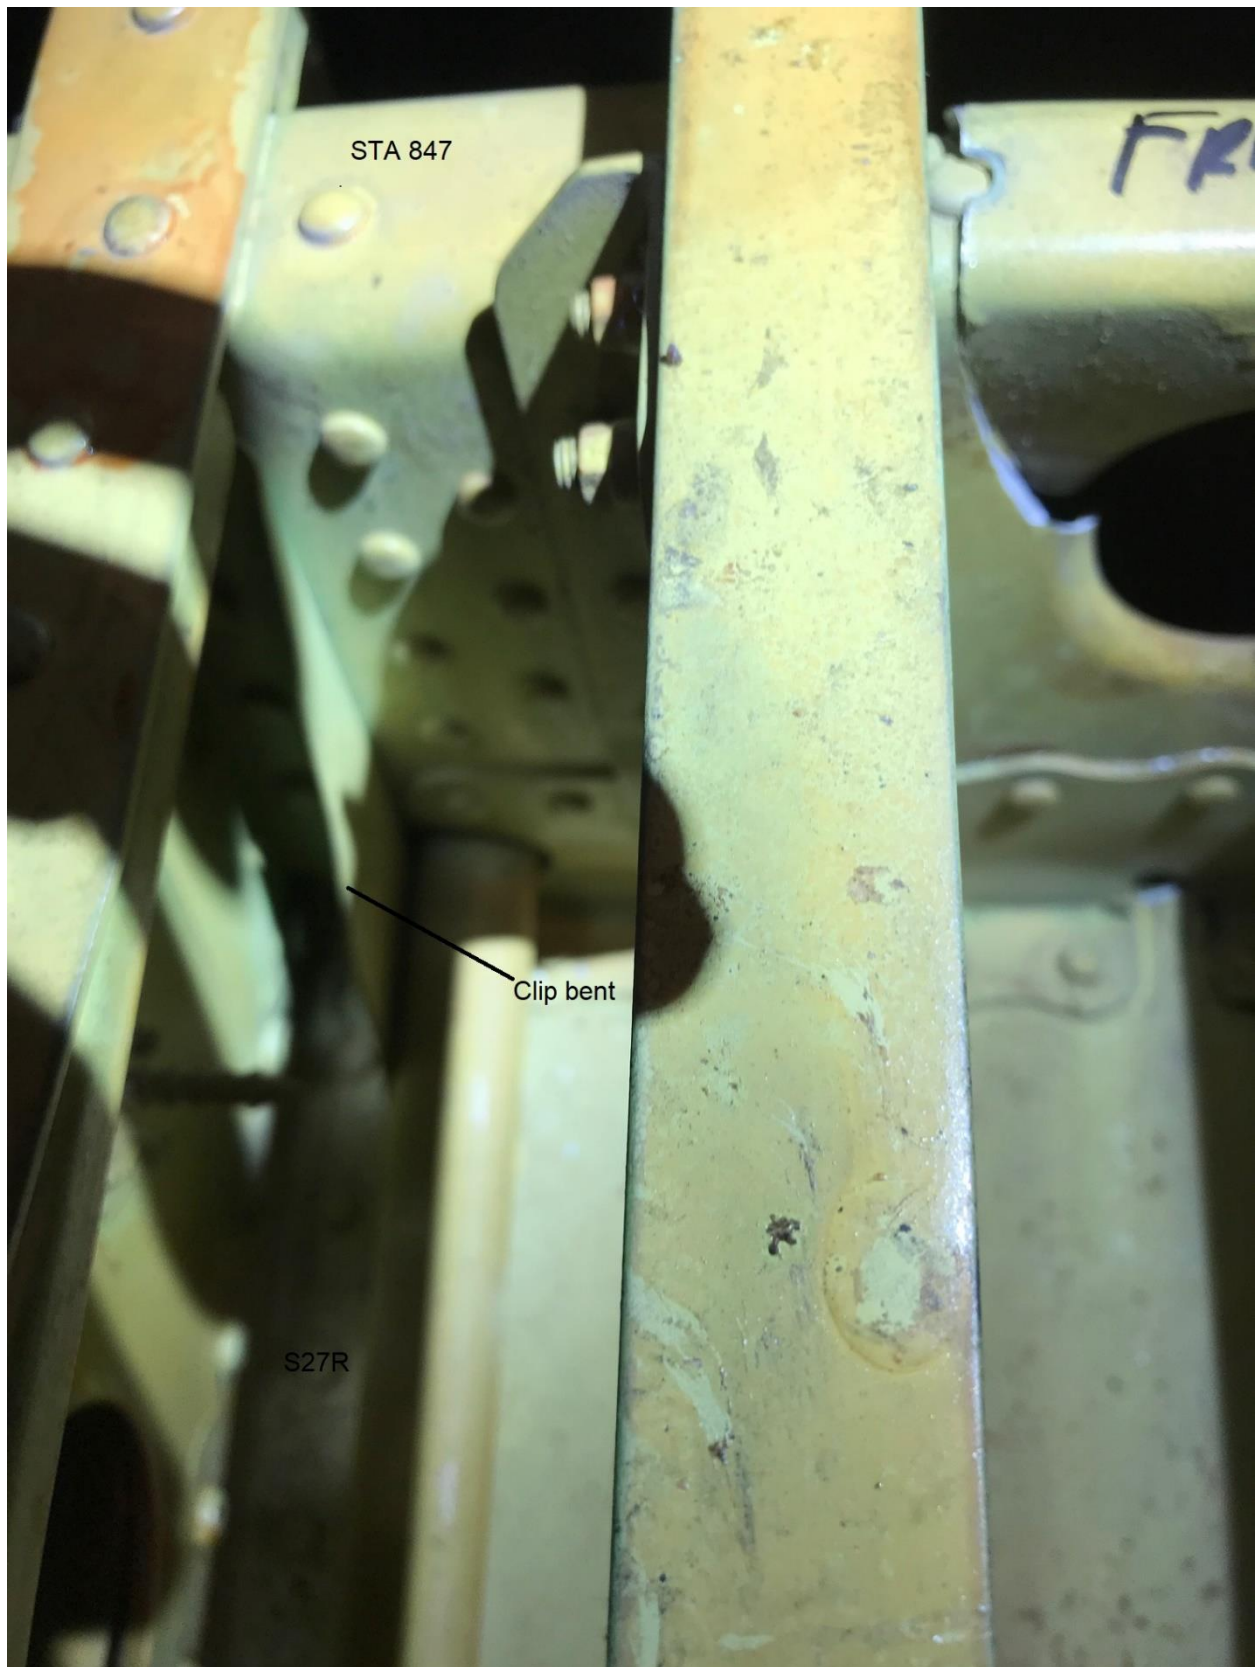
Figure 3-4, STA 847, S27R Clip

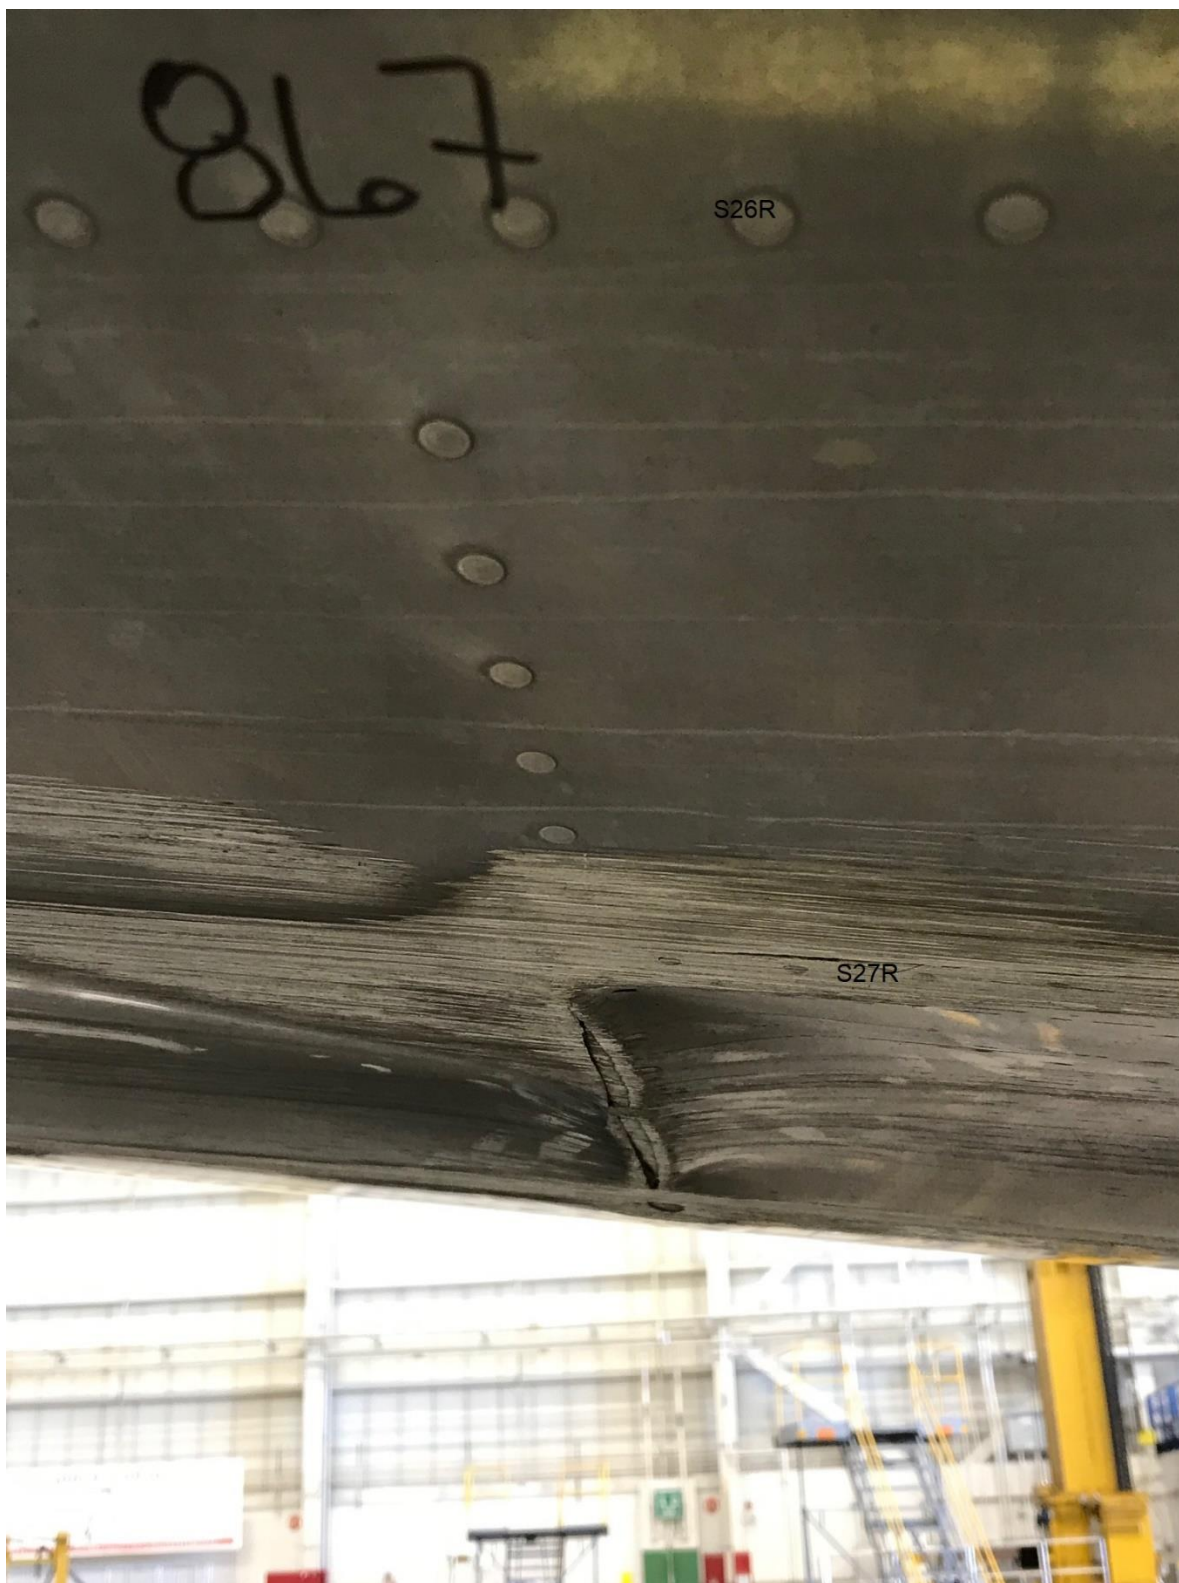
Figure 1-1 STA867 Skin RH View

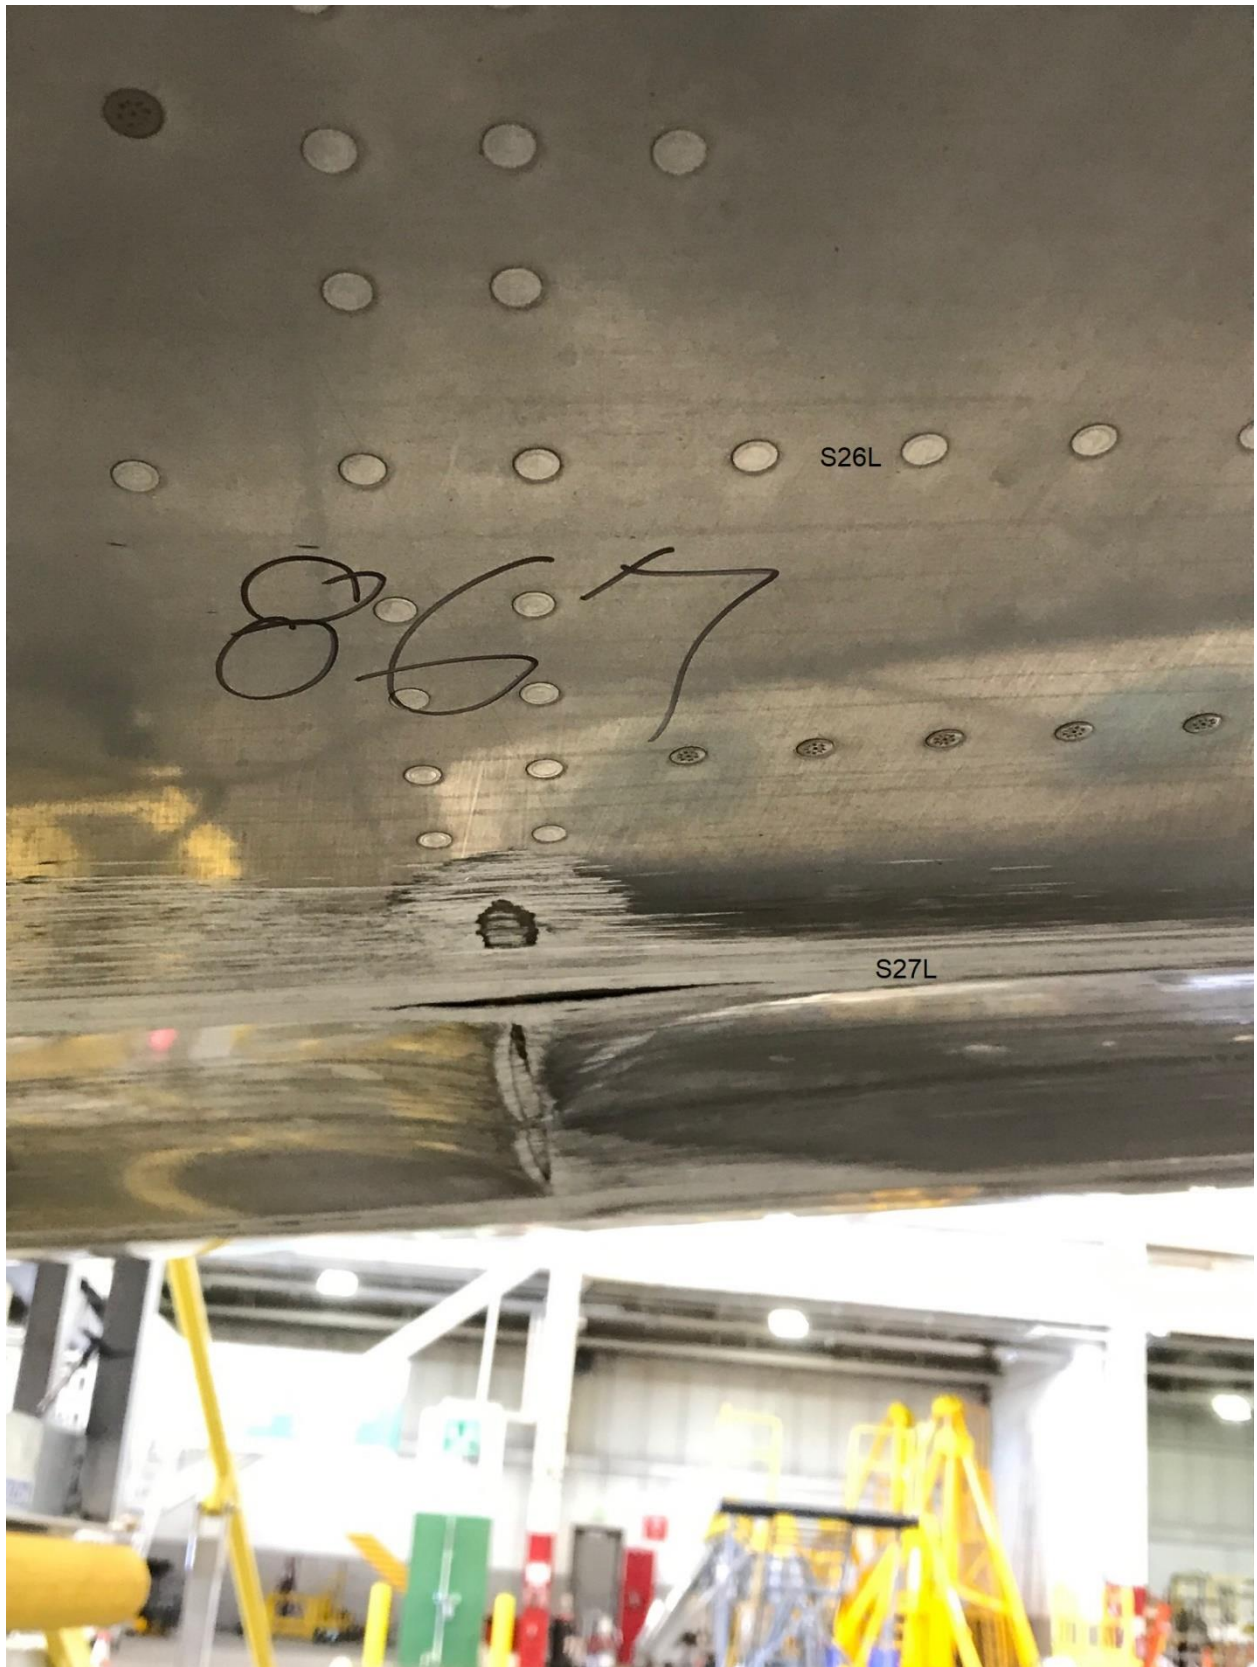
Figure 4-2 STA867 Skin LH View

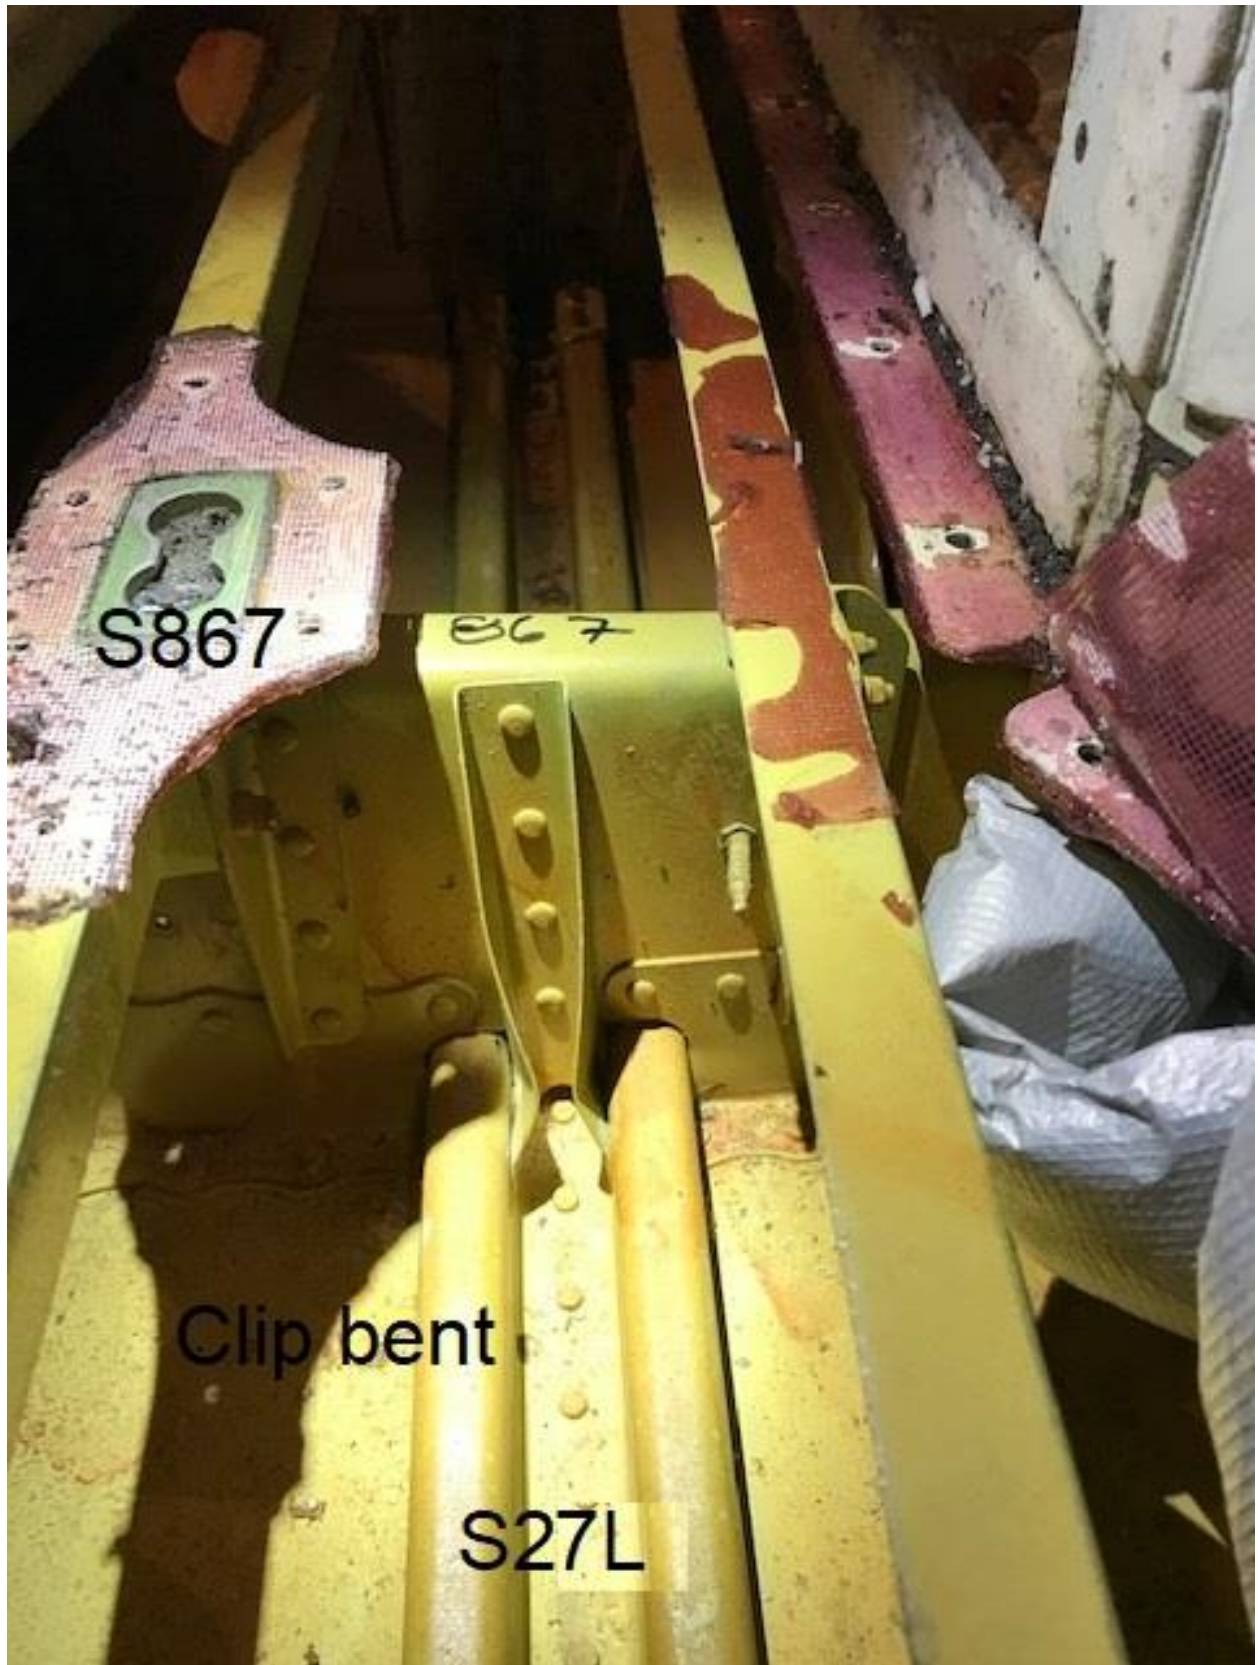
Figure 4-3 STA867 S27L Clip

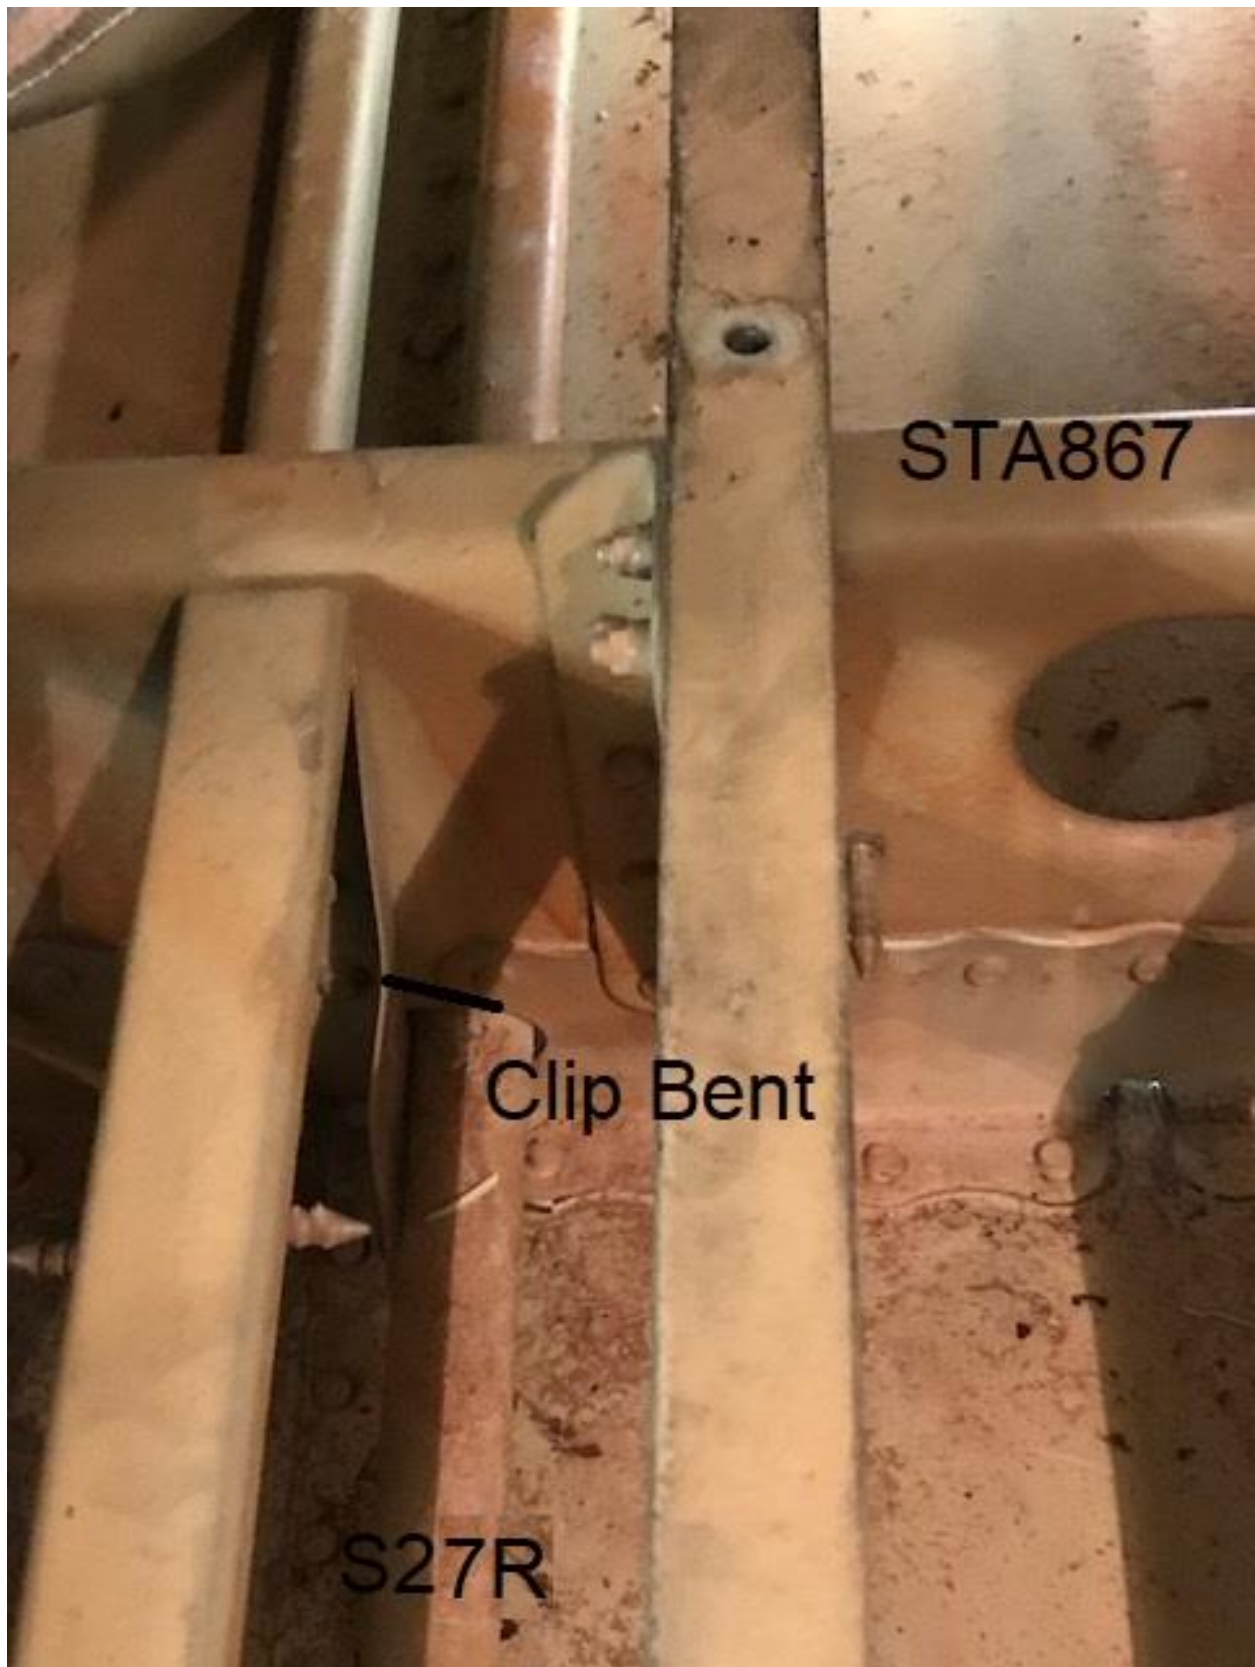
Figure 4-4 STA 867 S27R Clip

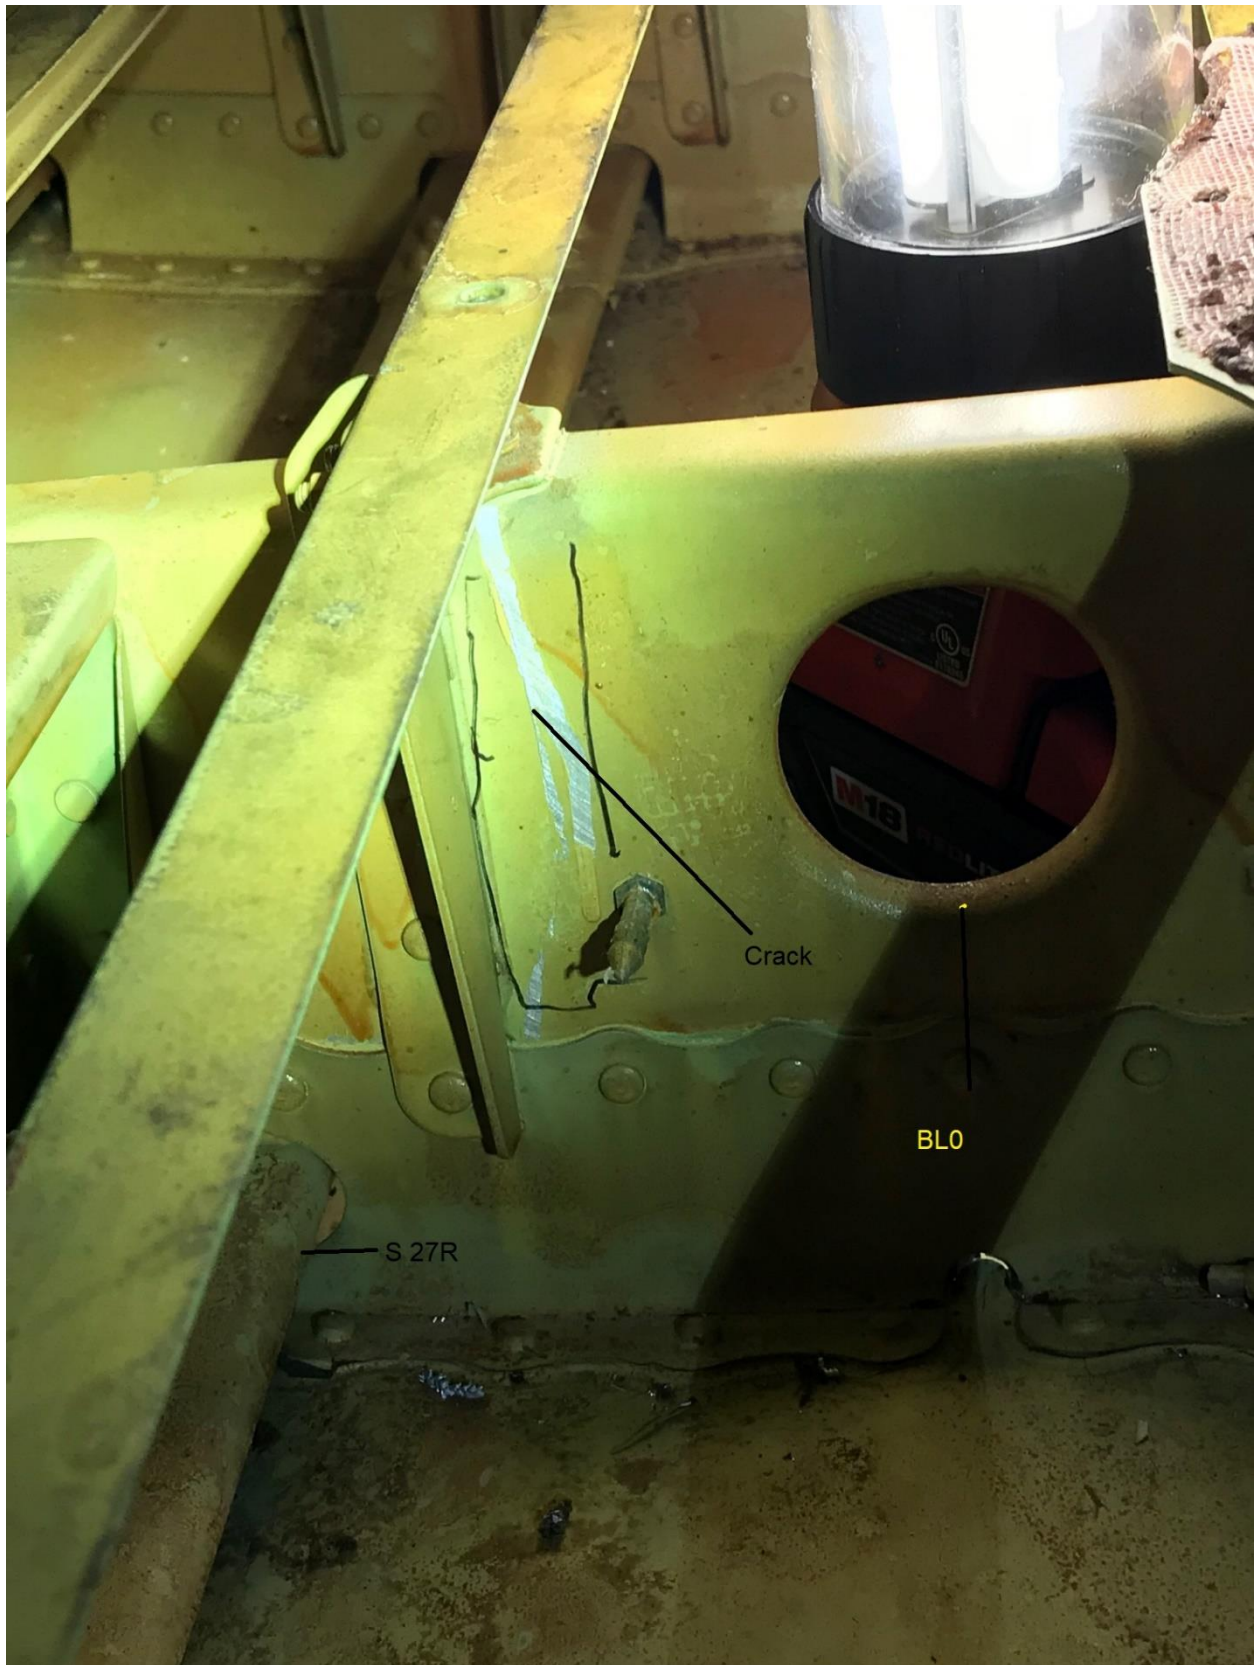
Revision A: Added STA867 and STA 887 Frames crack in figure 4-5 and 5-5

Figure 4-5 STA 867 Frame crack
