A/C 0436 Tail Strike Damage Assessment – Rev A

A/C: N75436 (Y4255, YH124),

The aircraft sustained a tail strike in DEN on 6/9/2019. After accomplishing a preliminary visual inspection. The damage starts forward of STA 827 and ends at aft of STA 907 between S26L and S26R.

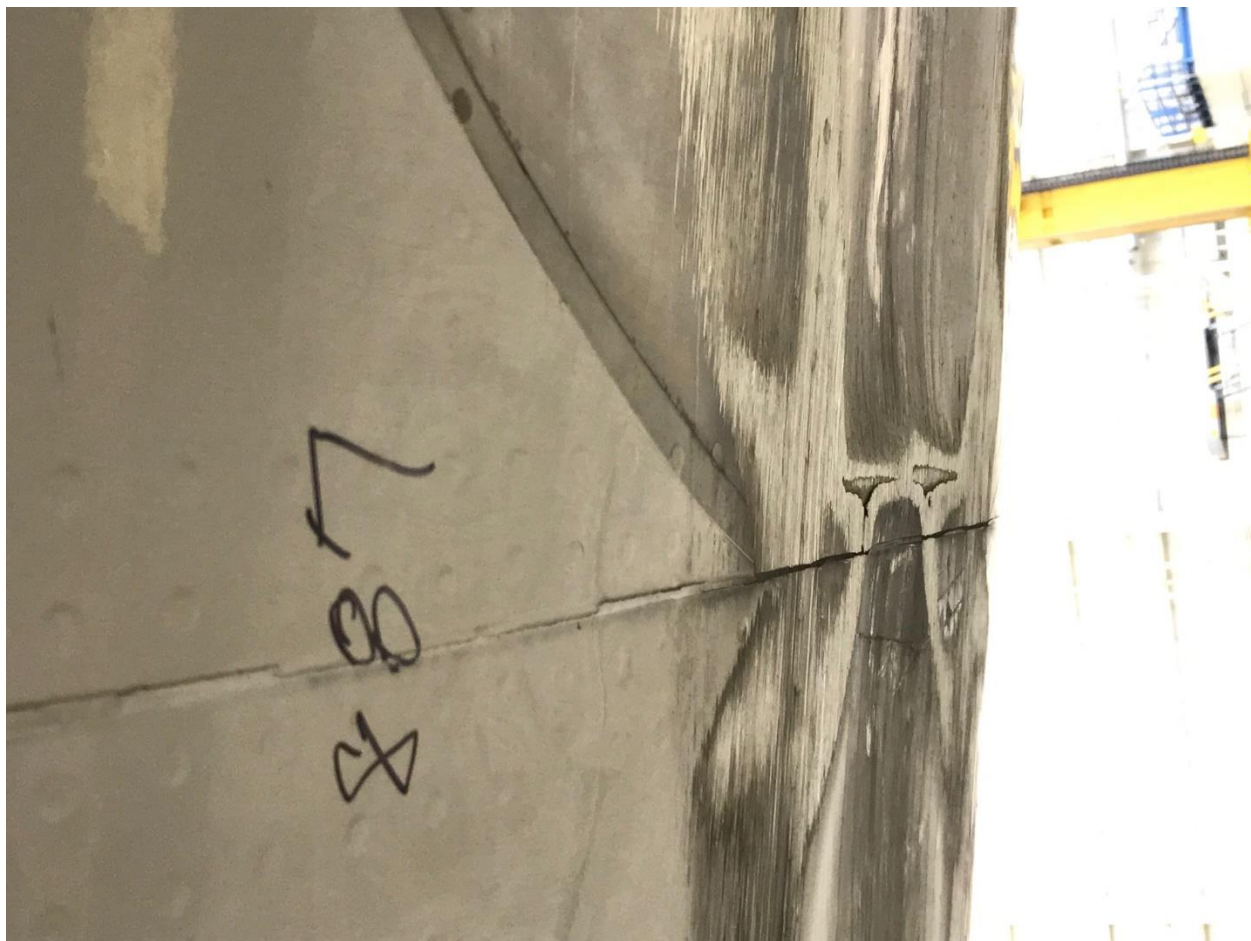
Figure 5-1 STA 887 Skin

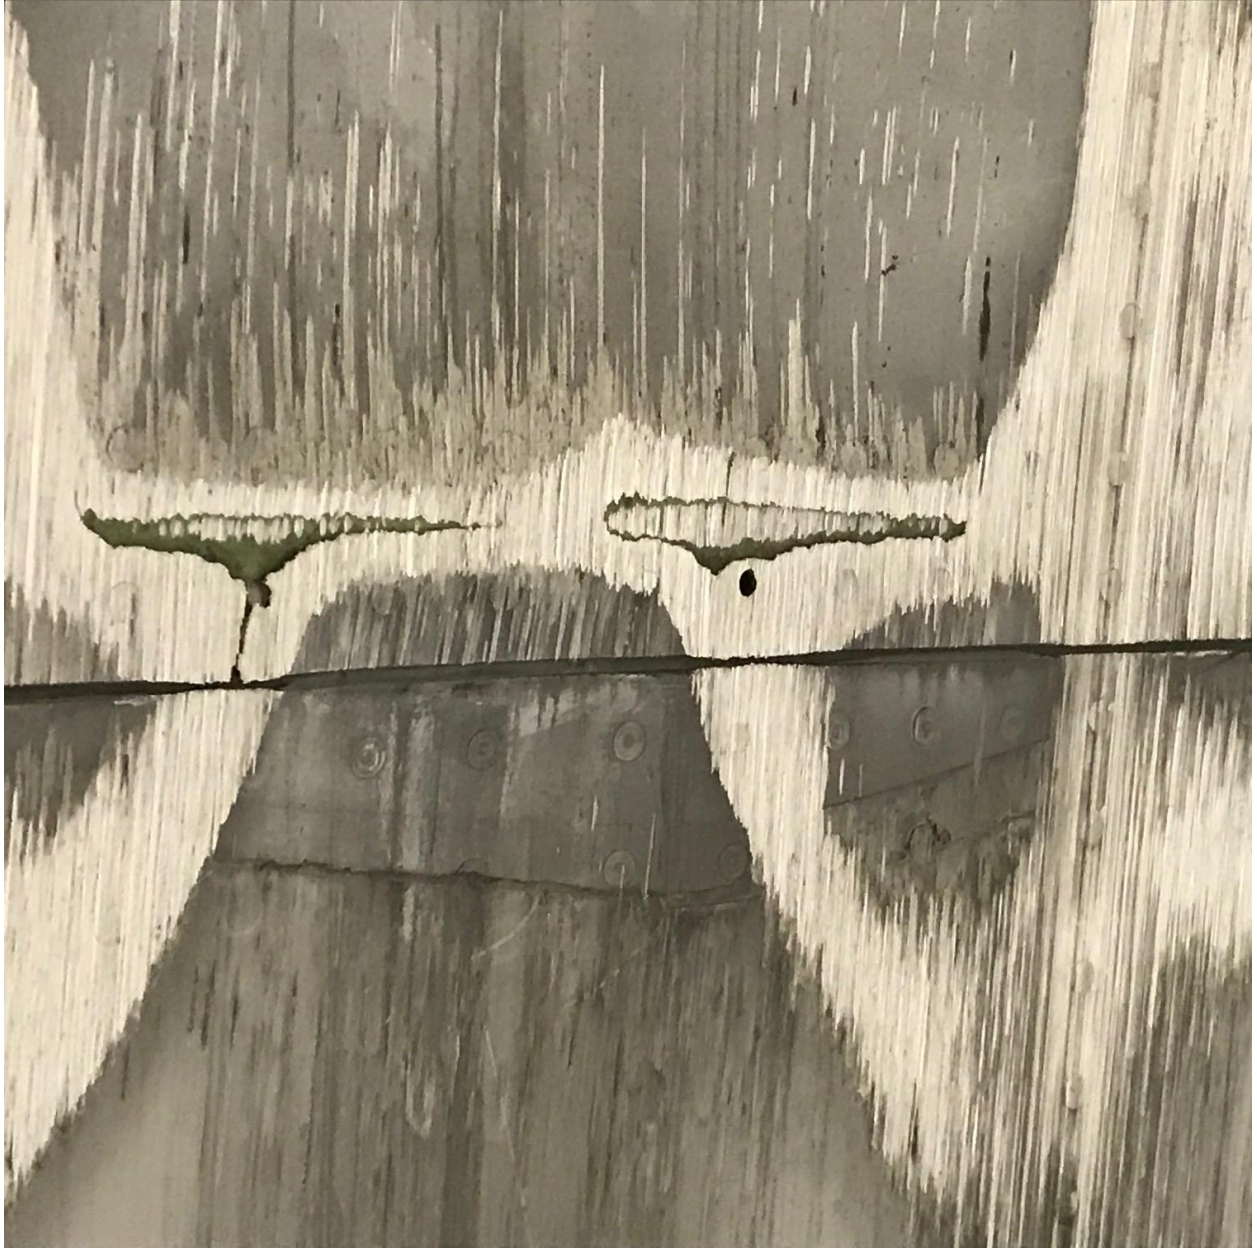
Figure 5-2 STA887 Skin (Detail)

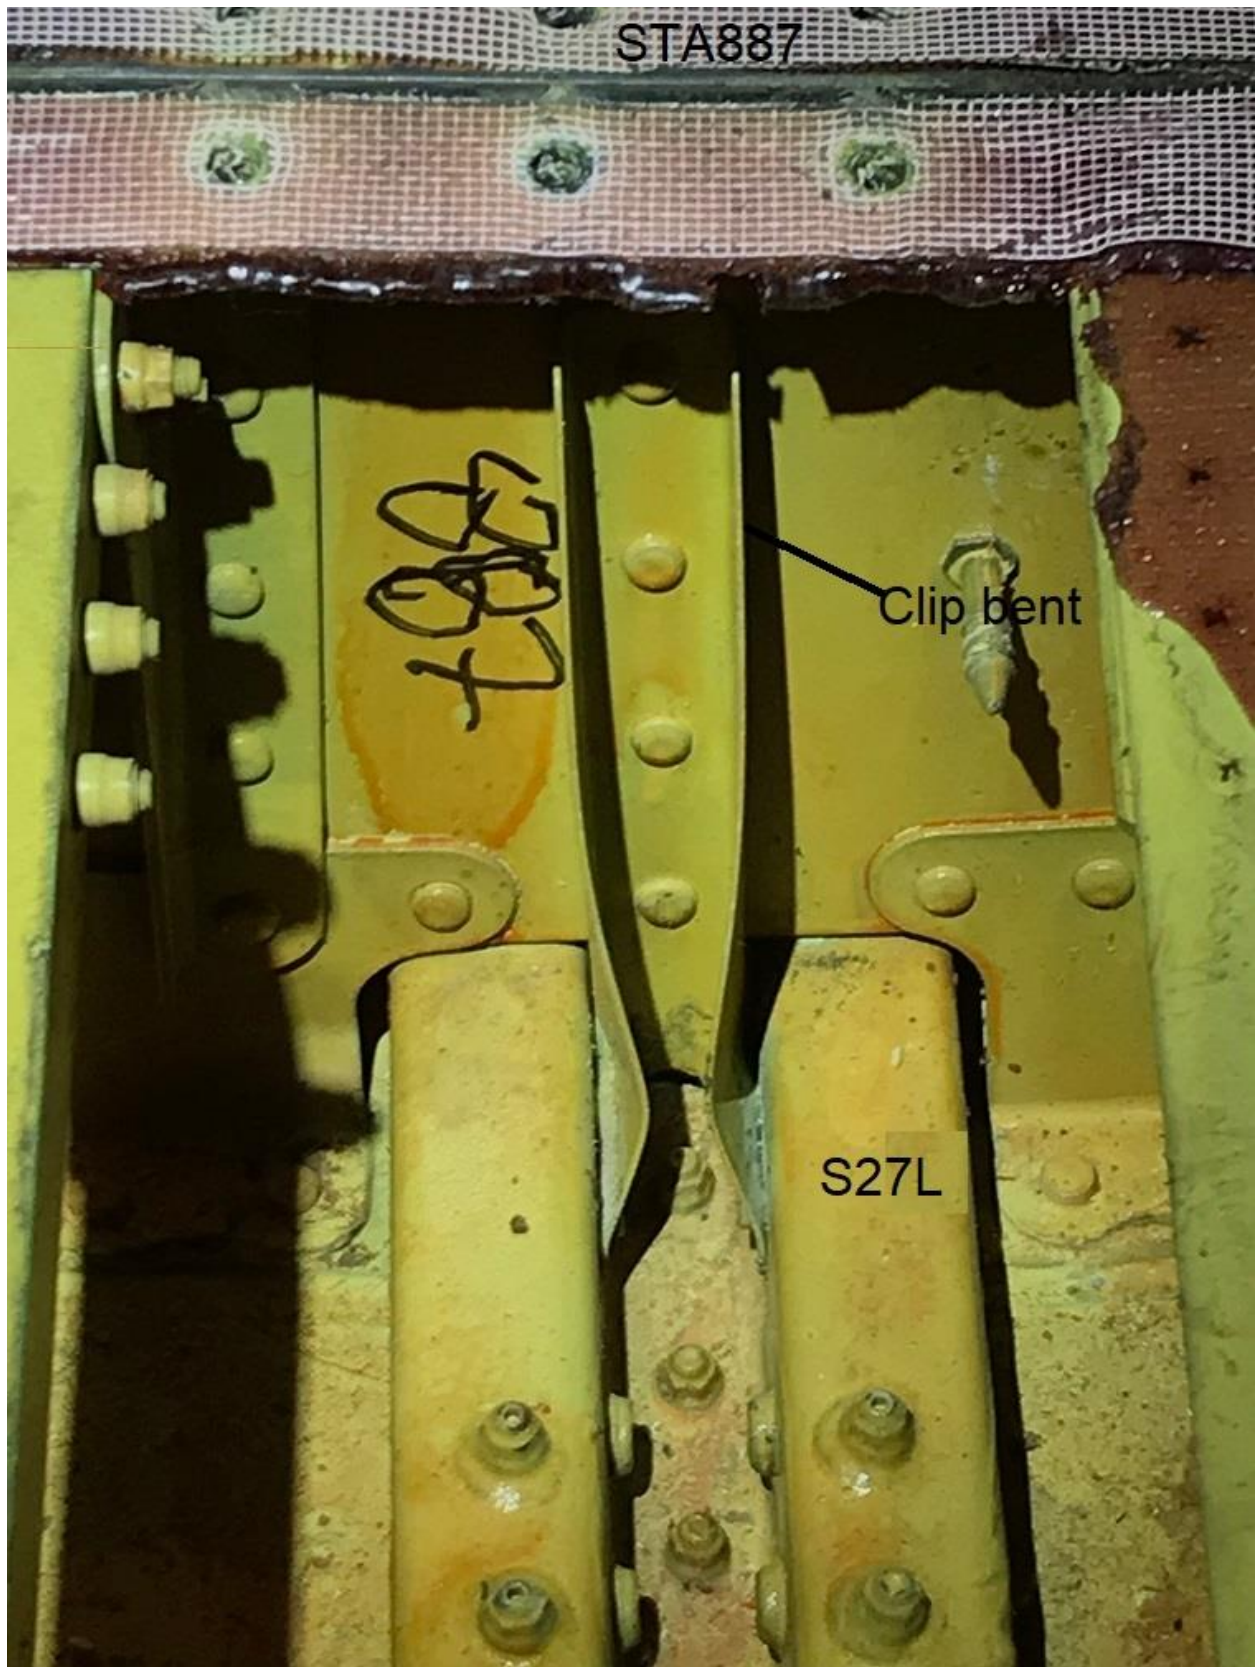
Figure 5-3 STA 887 S27L Clip

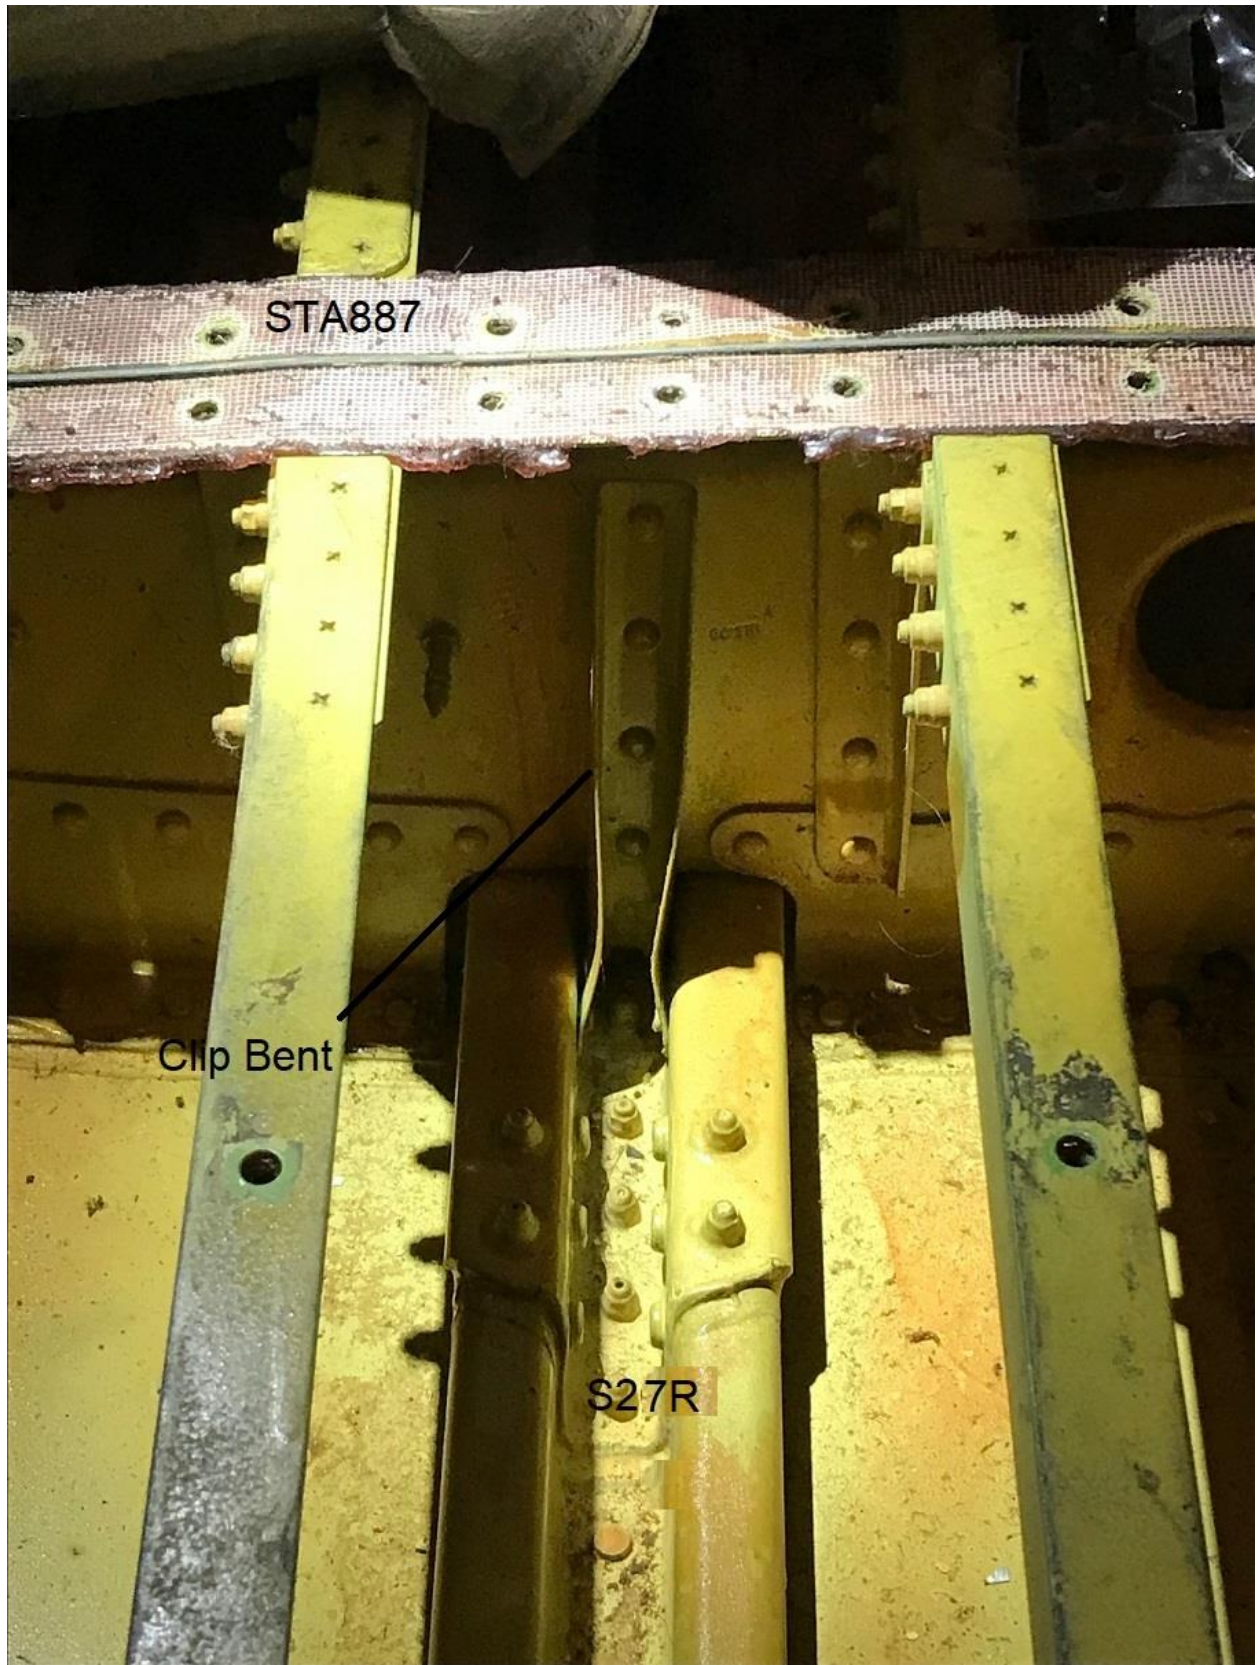
Figure 5-4 STA 887 S27R Clip

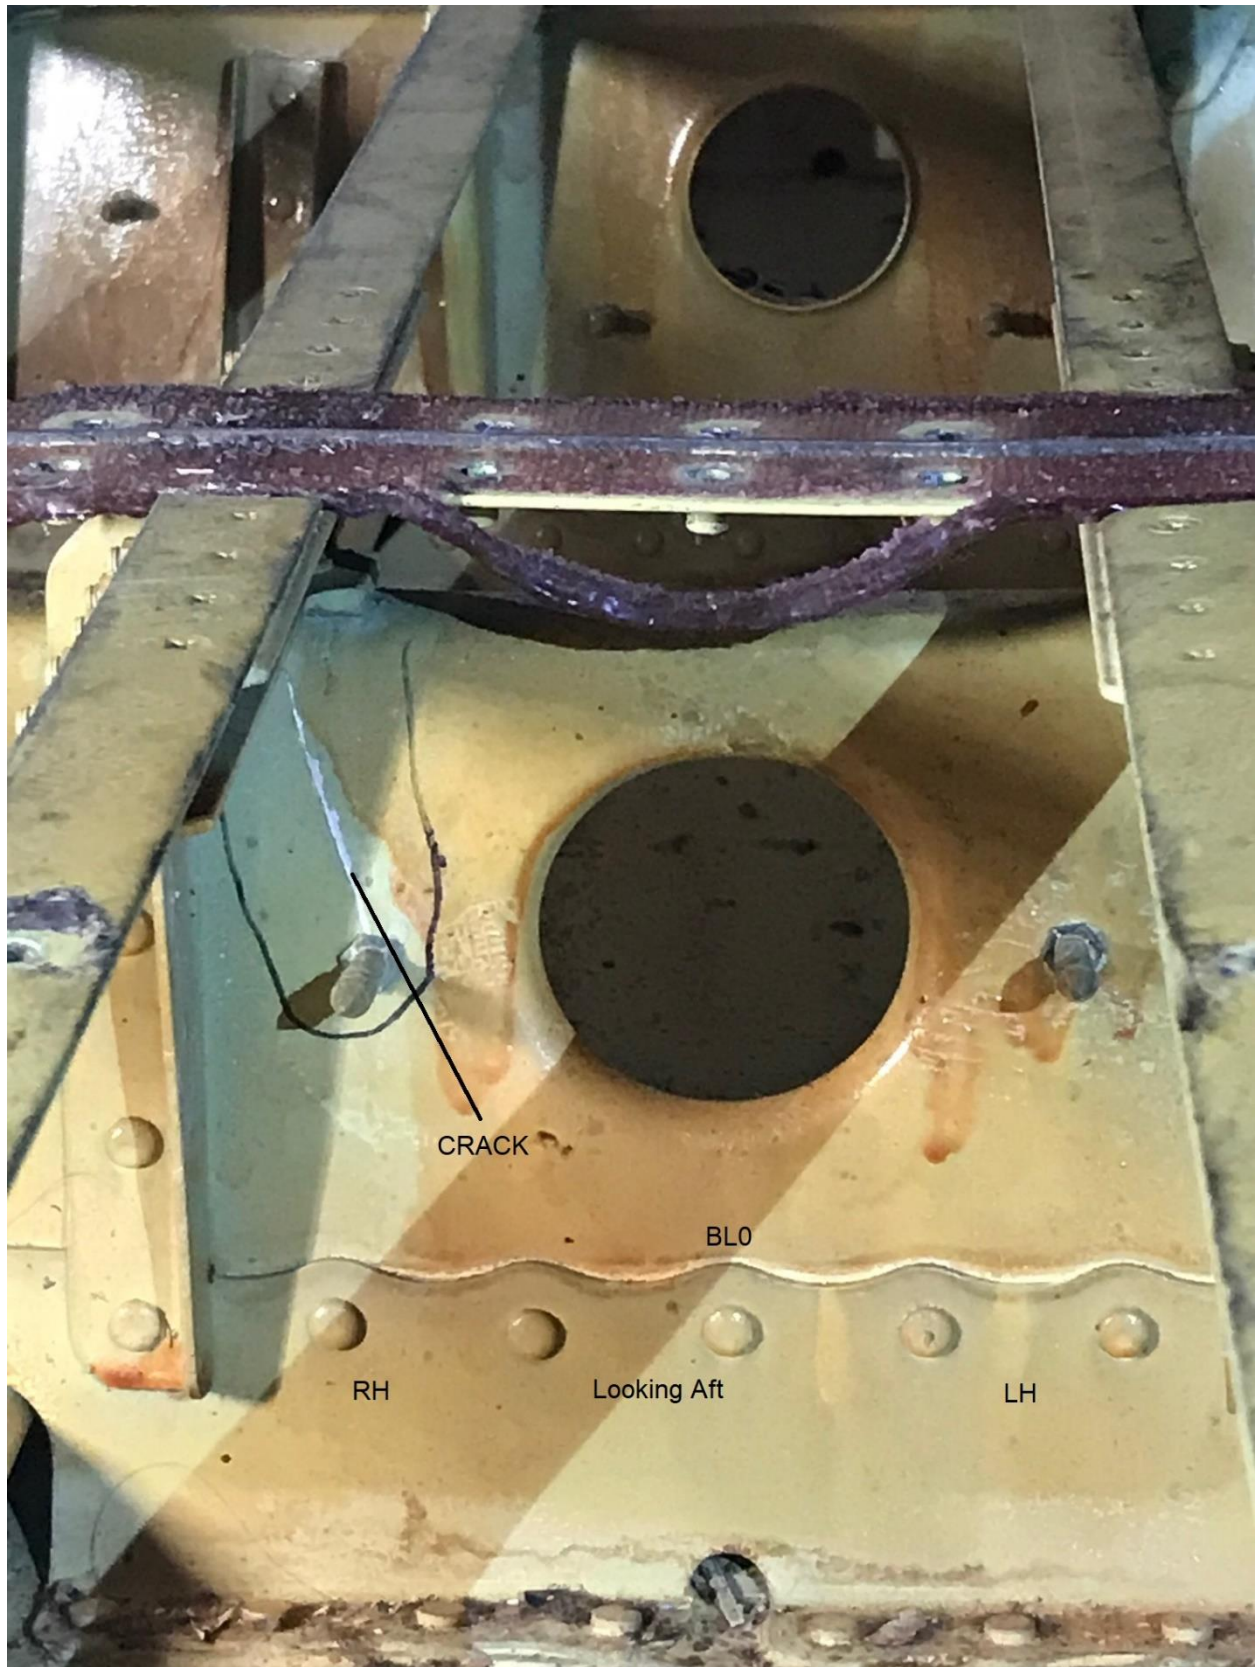
Revision A: Added STA867 and STA 887 Frames crack in figure 4-5 and 5-5

Figure 5-5 STA 887 Frame crack

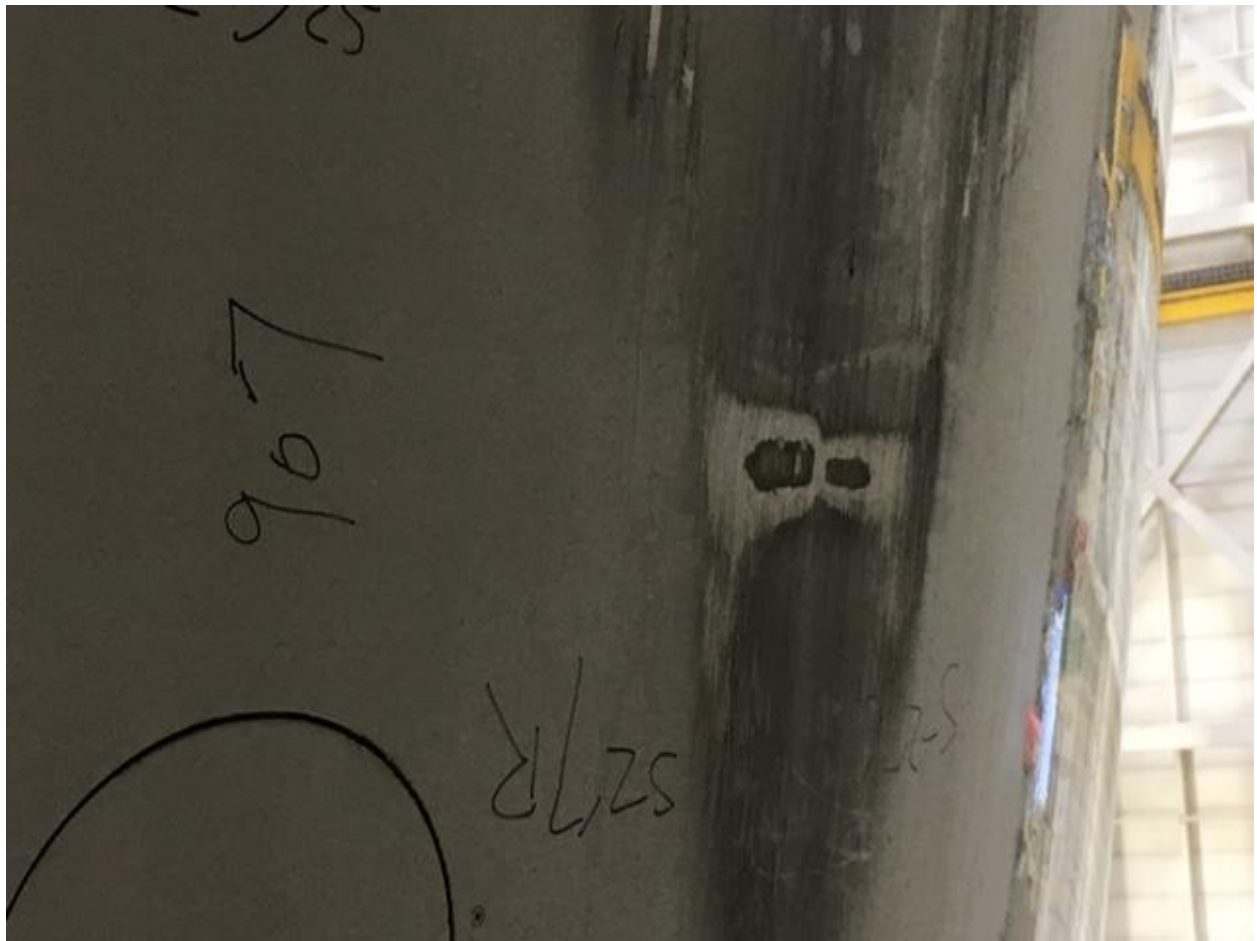
Figure 6 STA 907 Skin

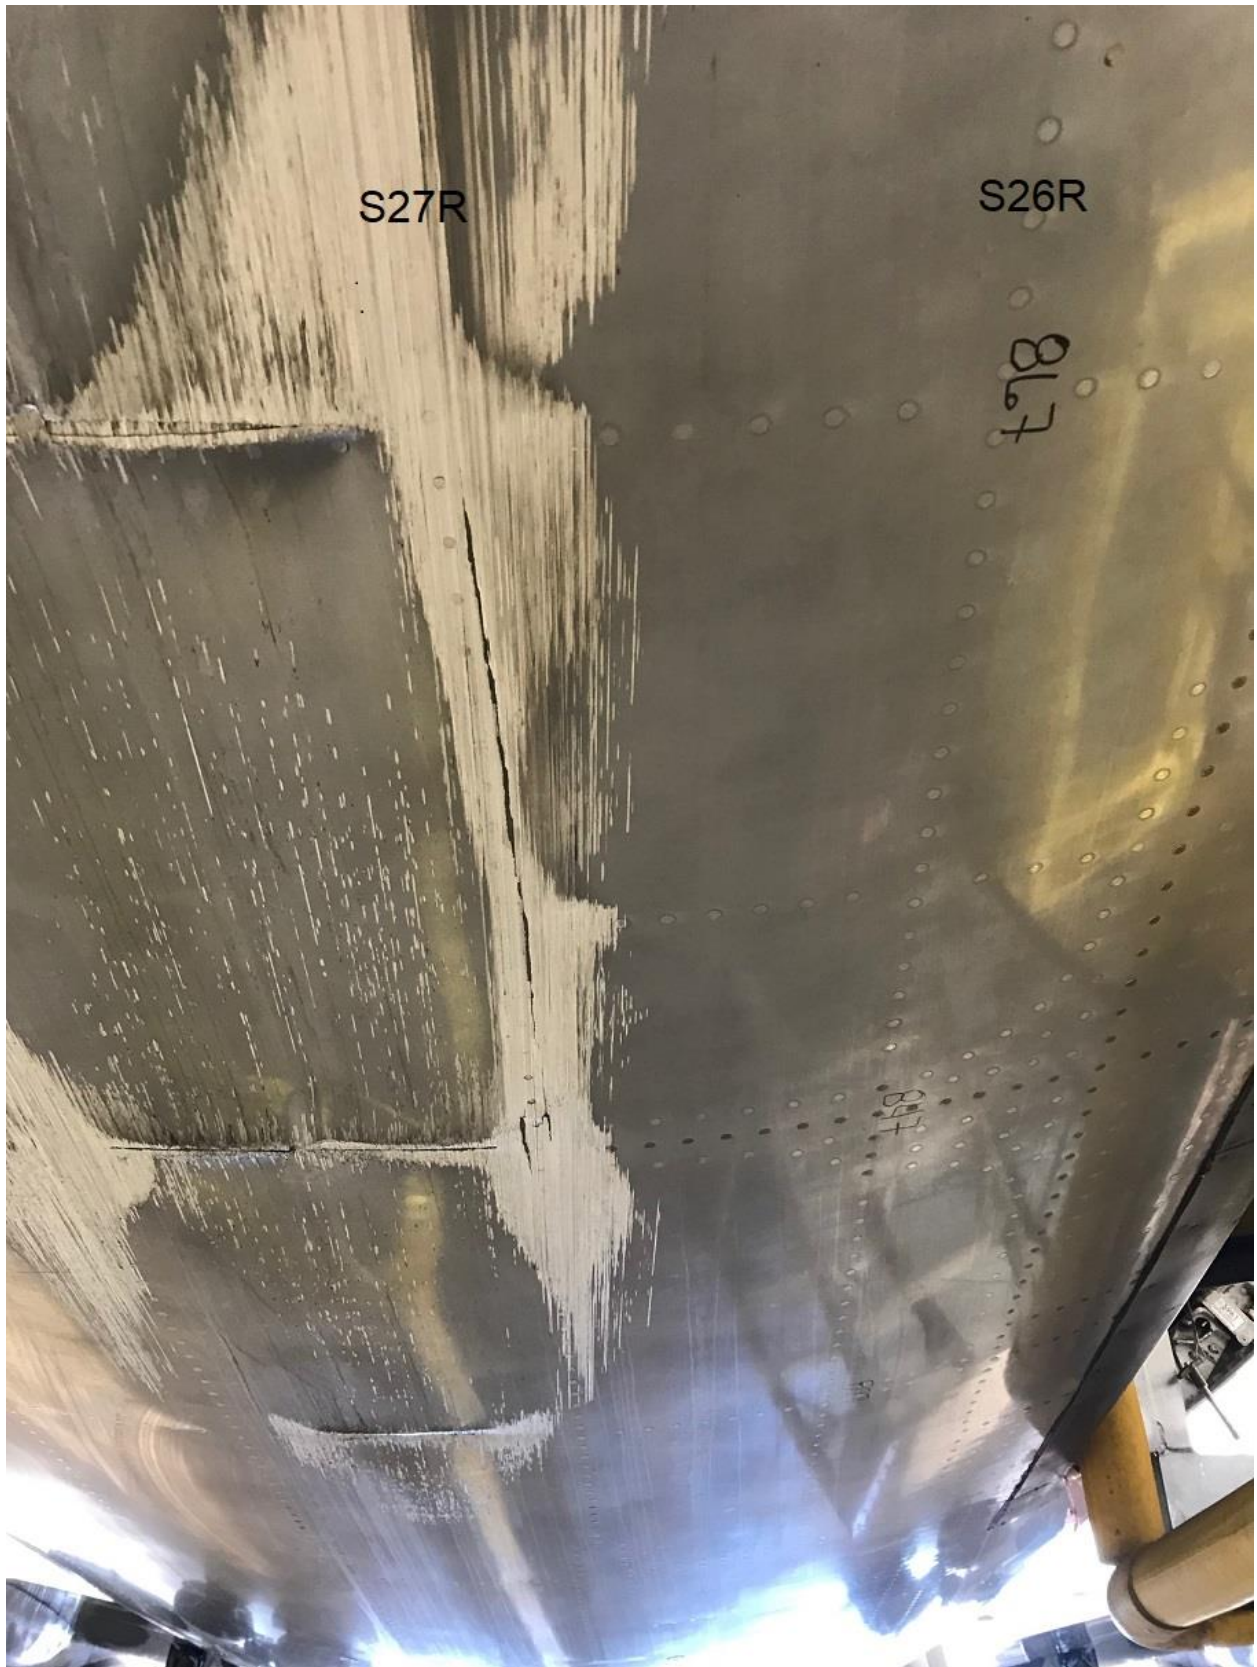
1. The Stringer 27L and 27R are possibly deformed.
2. The shear tie at STA827, STA867, STA887 and STA 907 between S27L and S27R are possibly deformed.
3. The STA887 Skin Splice plate is possibly damaged.

Figure 7 S27 R between STA 847 and STA 867

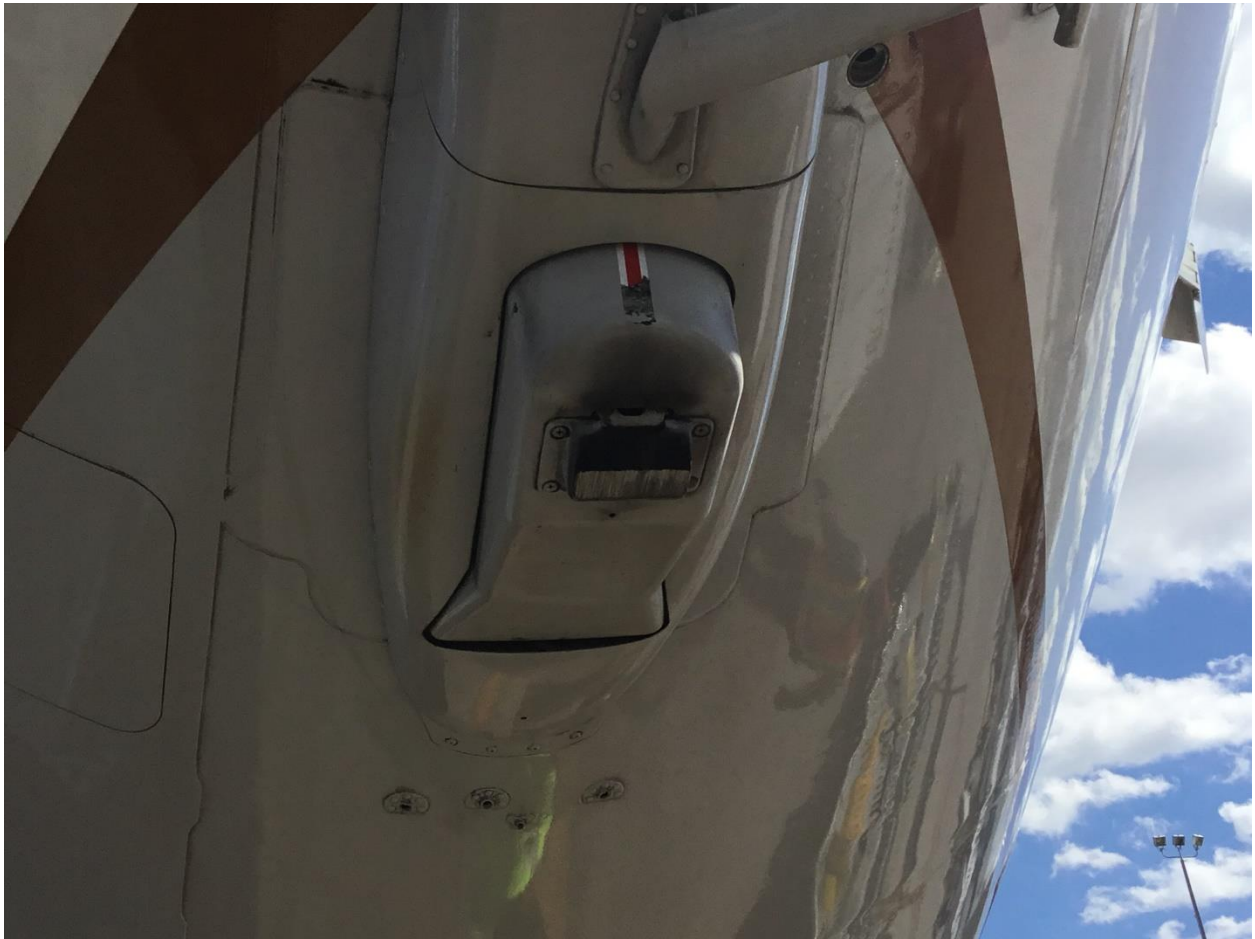
1. Skin worn through or crack at STA 827, STA847, STA867, STA 887 and STA 907.
2. Skin dent between the frames from STA 827 to STA 907.
3. STA847, STA 867 and STA 887 Frames cracked.
4. The stringer clips on S27L and S27R on STA 847, STA 867, STA 887 are buckled/bent.
5. The shear tie between S27L and S27R on STA 847 is cracked.
6. The Tailskid Cartridge is compressed

Figure 8 Tailskid Cartridge
